**Appendix A. Individual Evaluations of 30 Peak Discharges from
28 Extraordinary Floods in the United States**

Seco Creek near D'Hanis, Texas

Review of peak discharge for the flood of May 31, 1935

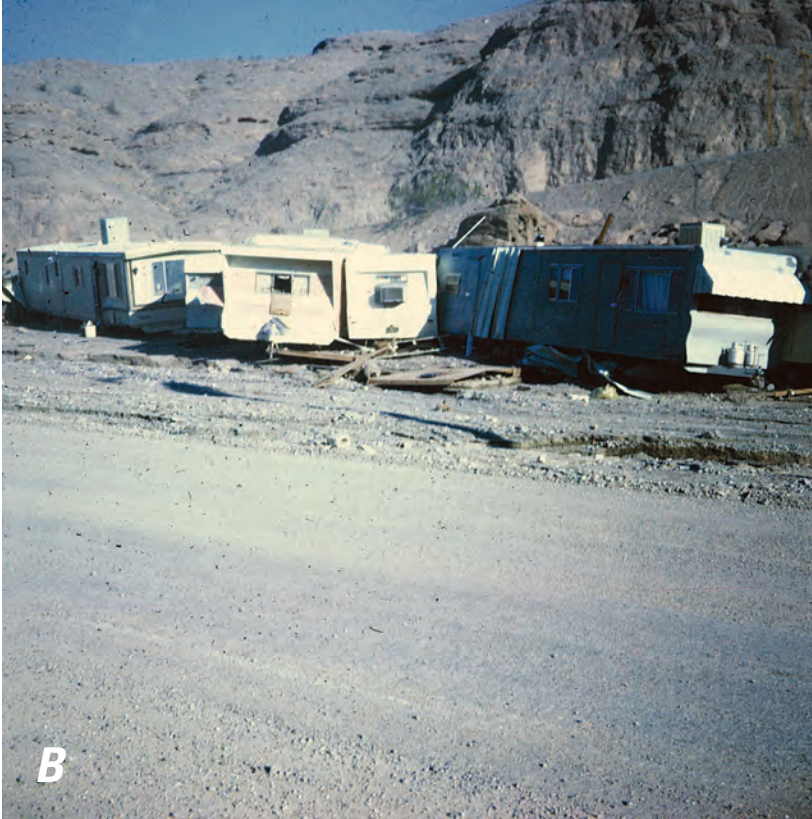
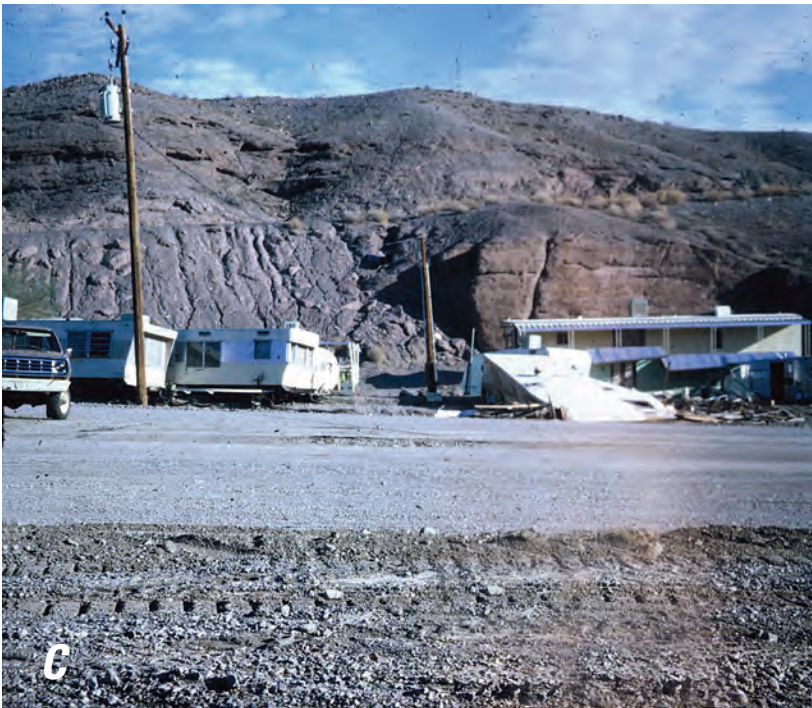
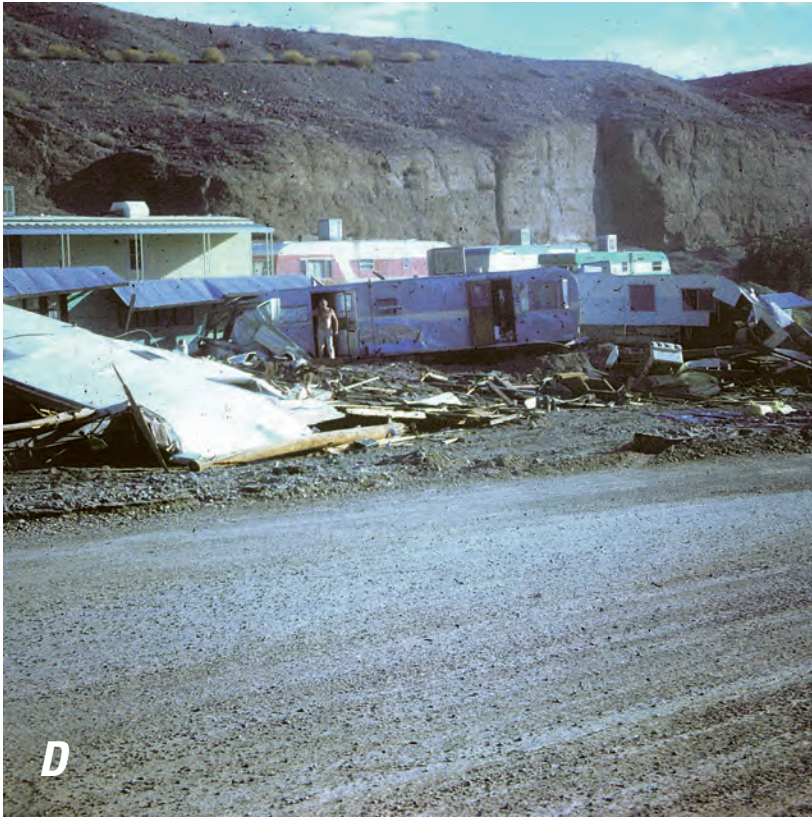
Figure A143. Damage to trailers (a), Eldorado Canyon at Nelson Landing, Nevada, September 1974.

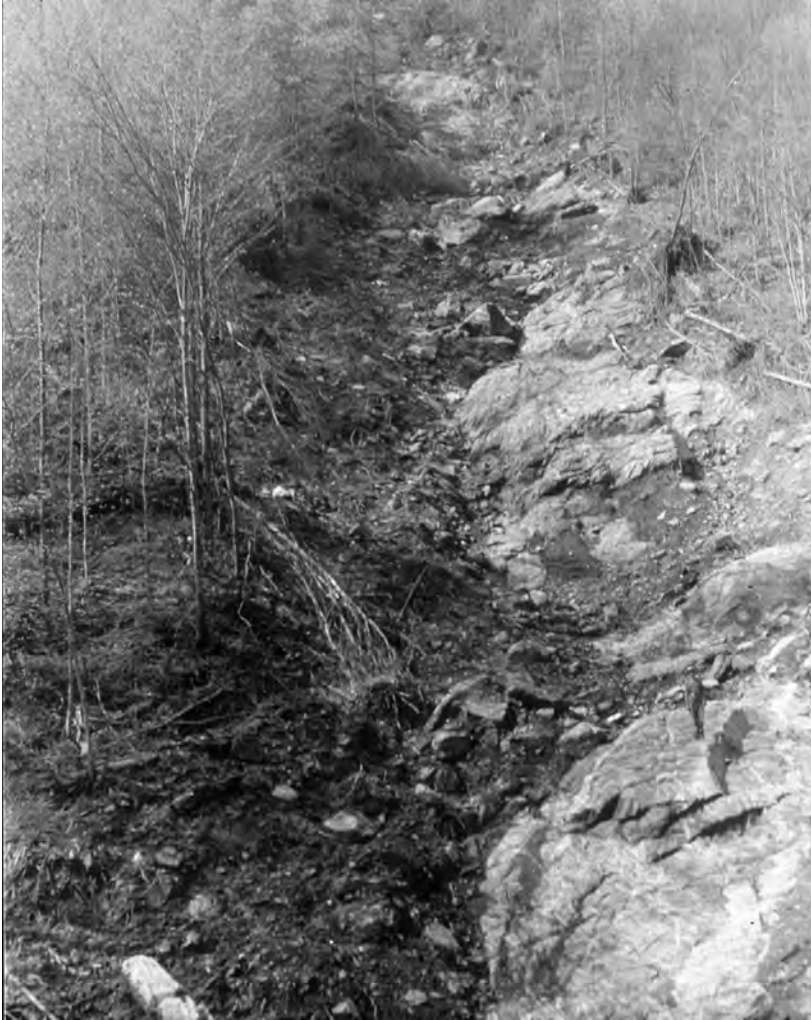
Figure A145. Debris avalanche scar in headwaters of Big Creek, Big Creek near Waynesville, North Carolina, August 1940.

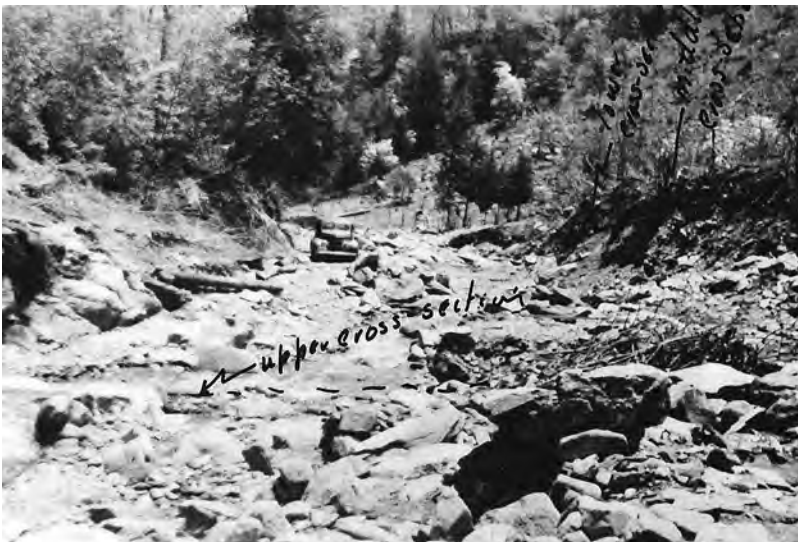
Figure A146. View looking downstream of slope-area reach, Big Creek near Waynesville, North Carolina, August 1940.

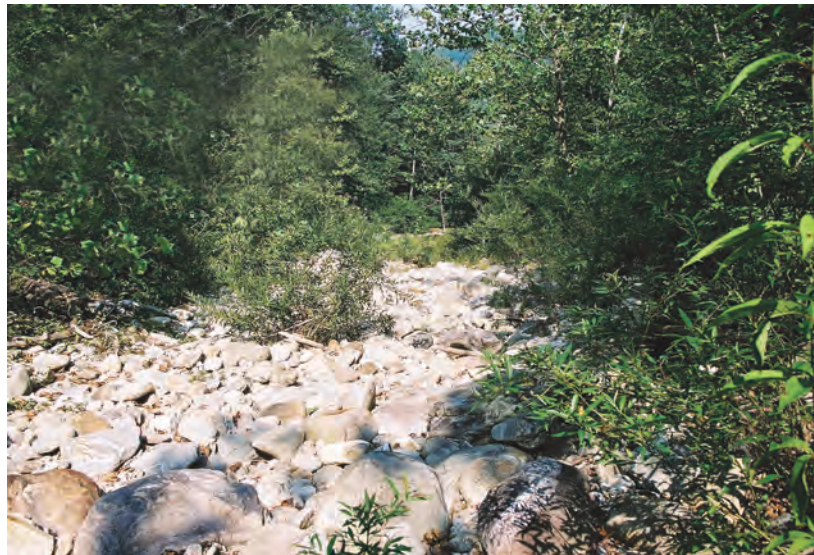
Figure A148. View looking downstream along right bank opposite mouth of Big Creek, likely source of coarse boulders, West Fork Pigeon River near Waynesville, North Carolina, August 25, 2003.

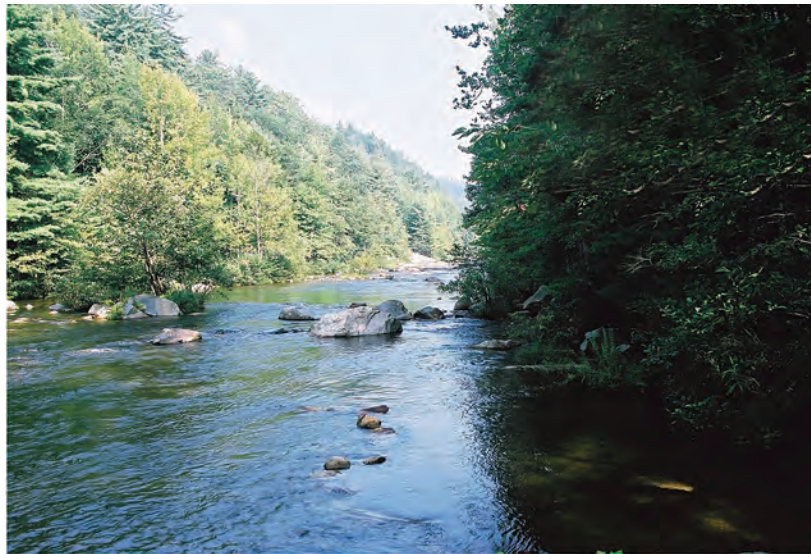
Figure A149. View looking upstream of slope-area reach, Wilson Creek near Adako, North Carolina, August 25, 2003. No original photographs of 1940 flood were found.

Recommendations: The original peak discharge of 99,000 ft³/s should be accepted as published on the basis of the field inspection and the rating should be an “estimate.” The drainage area should be checked using 1:24,000-scale maps.

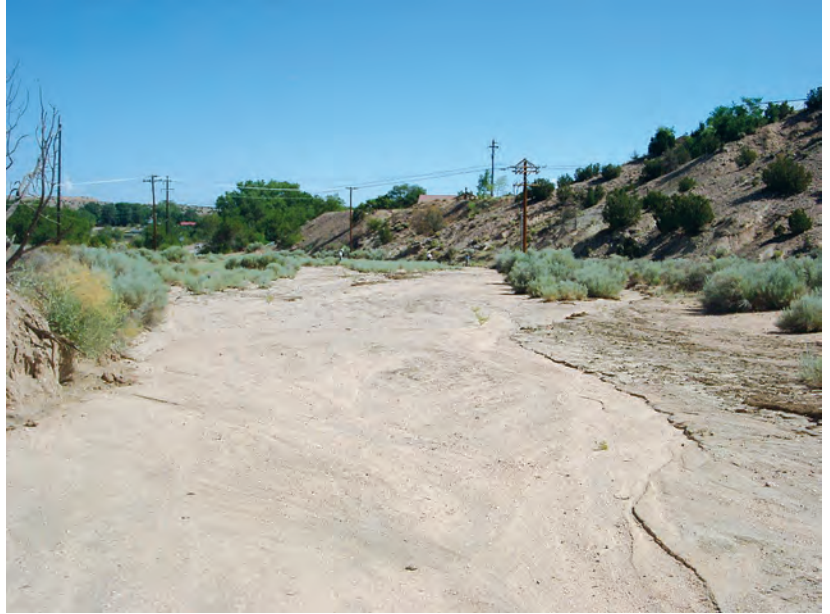
Figure A150. View looking downstream of cross section 1, El Rancho Arroyo near Pojoaque, New Mexico, August 5, 2003.

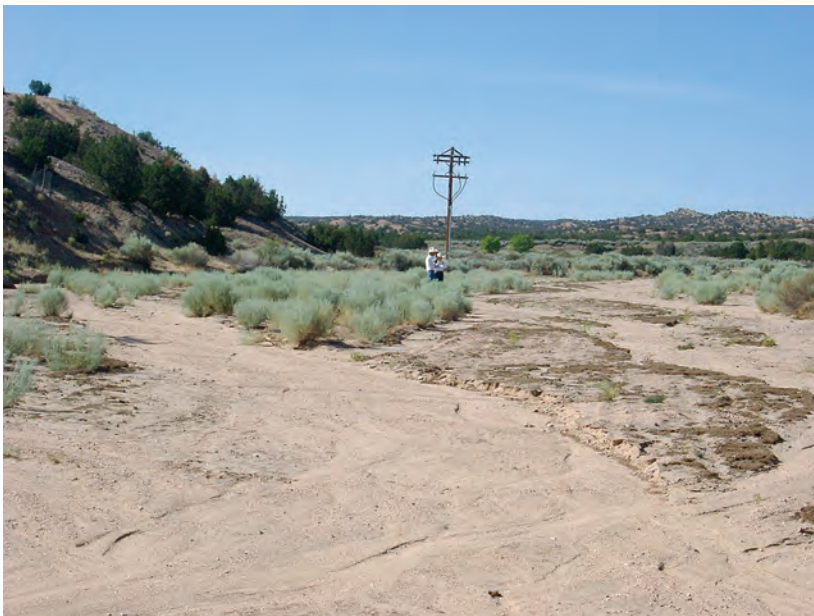
Figure A151. View looking upstream toward cross section 1, El Rancho Arroyo near Pojoaque, New Mexico, August 5, 2003.

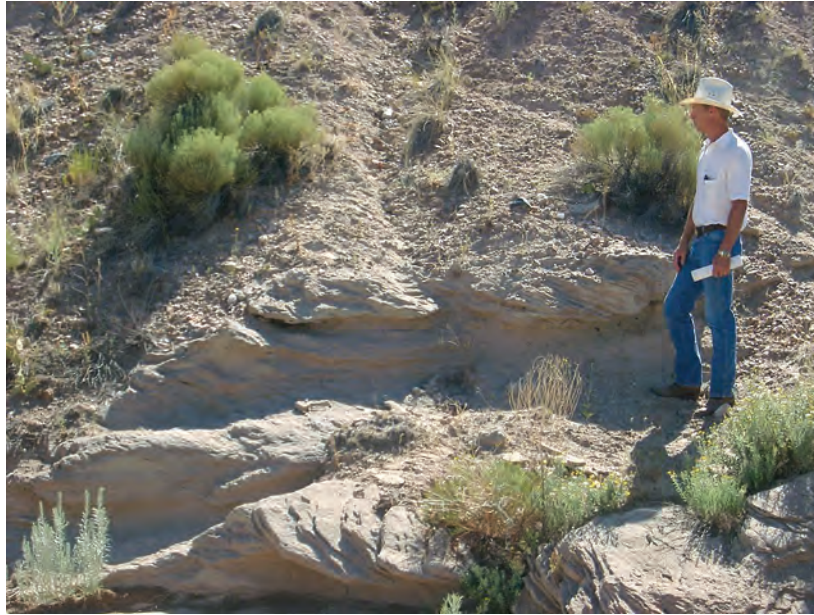
Figure A152. Right bank in slope-area reach with flood-scoured sandstone, El Rancho Arroyo near Pojoaque, New Mexico, August 5, 2003.

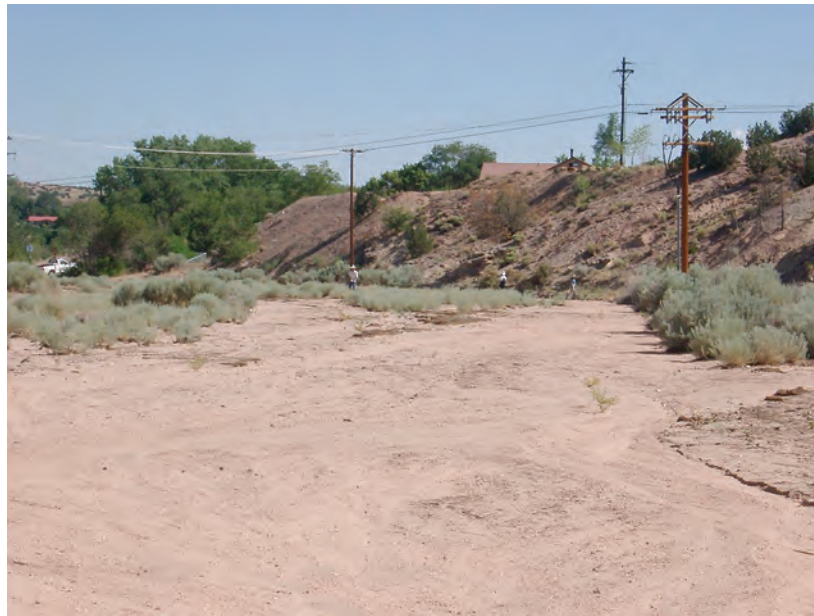
Figure A153. View downstream toward right bank, El Rancho Arroyo near Pojoaque, New Mexico, August 5, 2003.

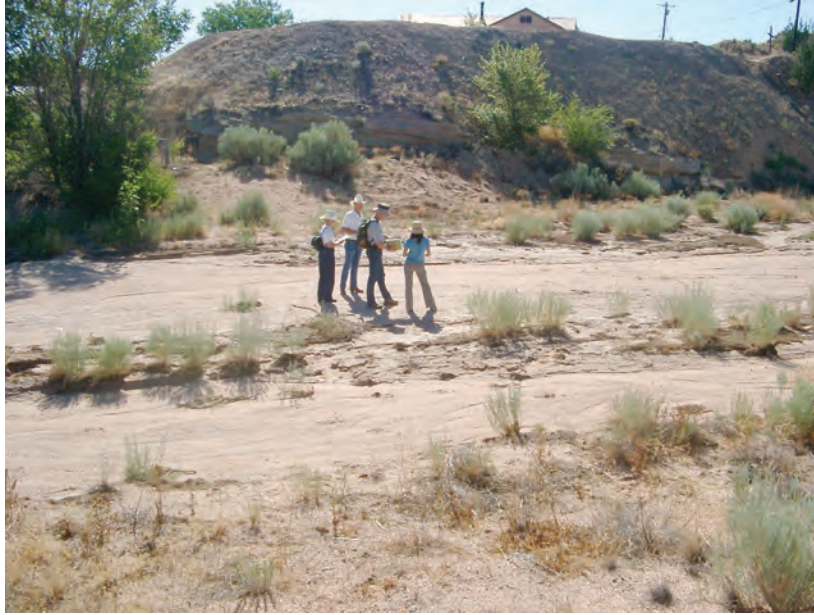
Figure A154. View to right bank at new cross-section 3, El Rancho Arroyo near Pojoaque, New Mexico, August 5, 2003.

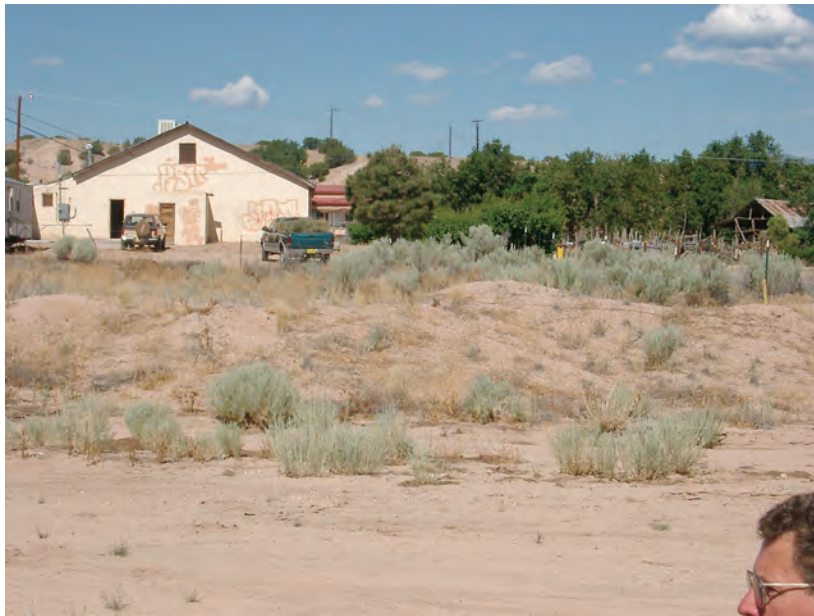
Figure A155. View toward left bank at new cross section 3, El Rancho Arroyo near Pojoaque, New Mexico, August 5, 2003.

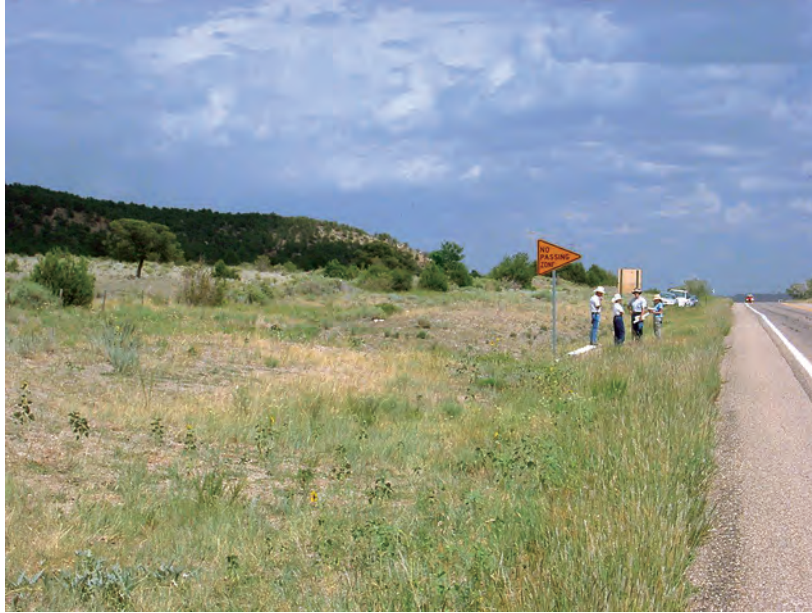
Debris blocking the culvert entrance is unlikely given the lack of evidence of blockage in photographs taken during the survey. However, the fill observed in the approach at the time of the survey possibly existed during the flood given the high rates of sand transport. The cross-sectional area computed for the approach was about 200 ft², of which about 35–40 ft² was filled with sand. Even if the sand had been present at the peak discharge, flow would have been subcritical in the approach, and the culvert inlet would have been the control (type I flow). Therefore, the discharge would have been essentially as originally computed.

Figure A156. Site of culvert measurement, Cimarron Creek Tributary near Cimarron, New Mexico, August 5, 2003.

Recommendations: The original peak discharge of 337 ft³/s should be accepted as published, but rounded to 340 ft³/s. The drainage area should be corrected to 0.15 mi², and the numbers updated in future references to this flood.

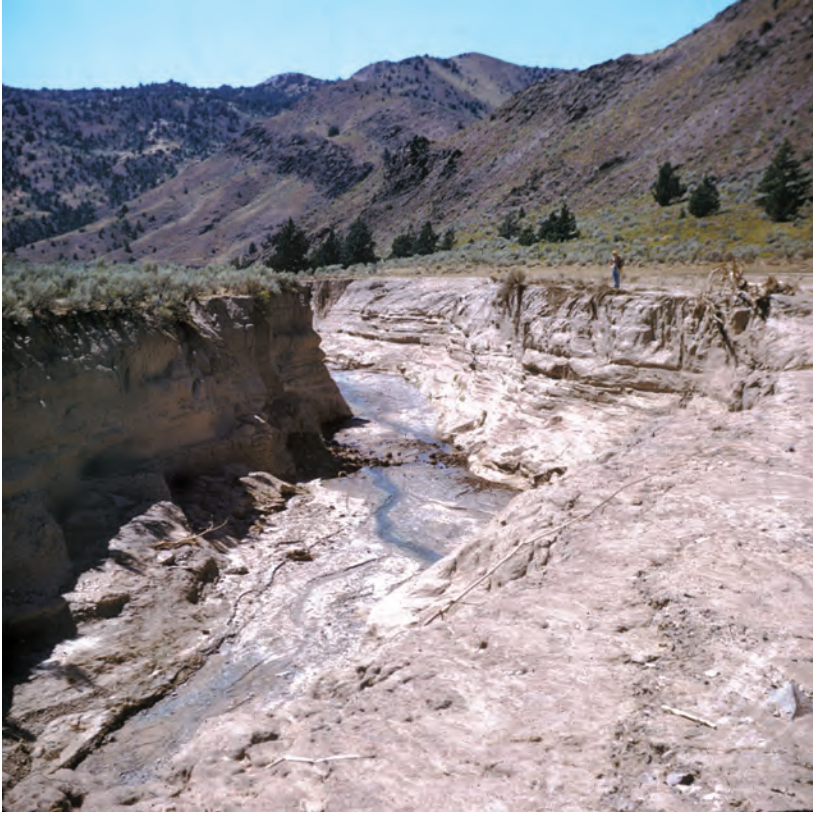
Figure A157. View looking downstream of slope-area reach, Meyers Canyon near Mitchell, Oregon, July 1956. Man standing at cross section B.

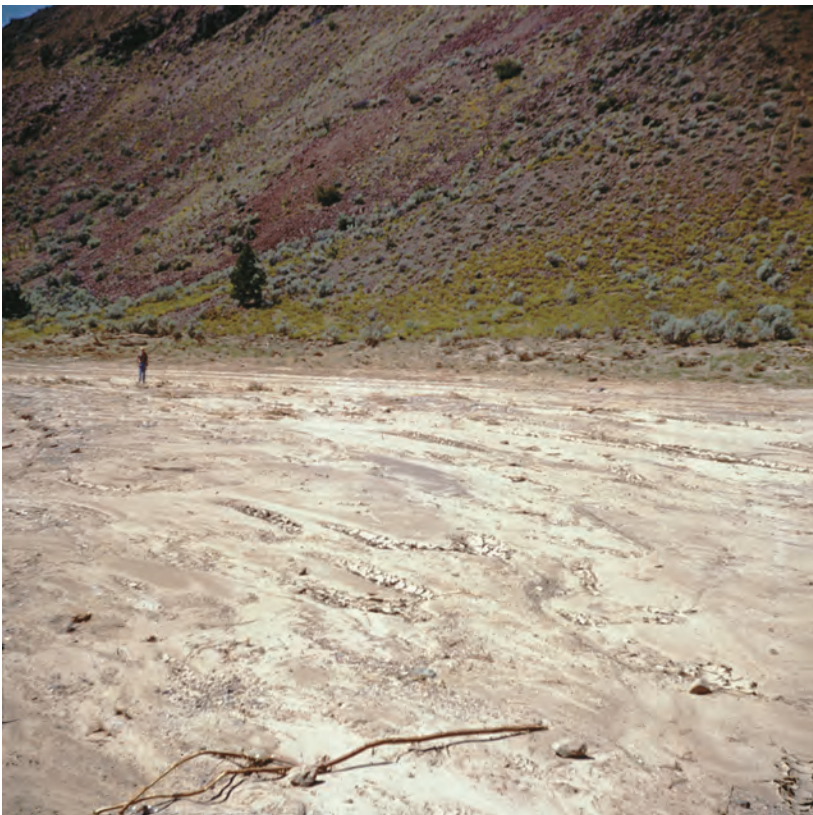
Figure A158. View of right-bank overflow, Meyers Canyon near Mitchell, Oregon, July 1956. Man standing at cross section B.

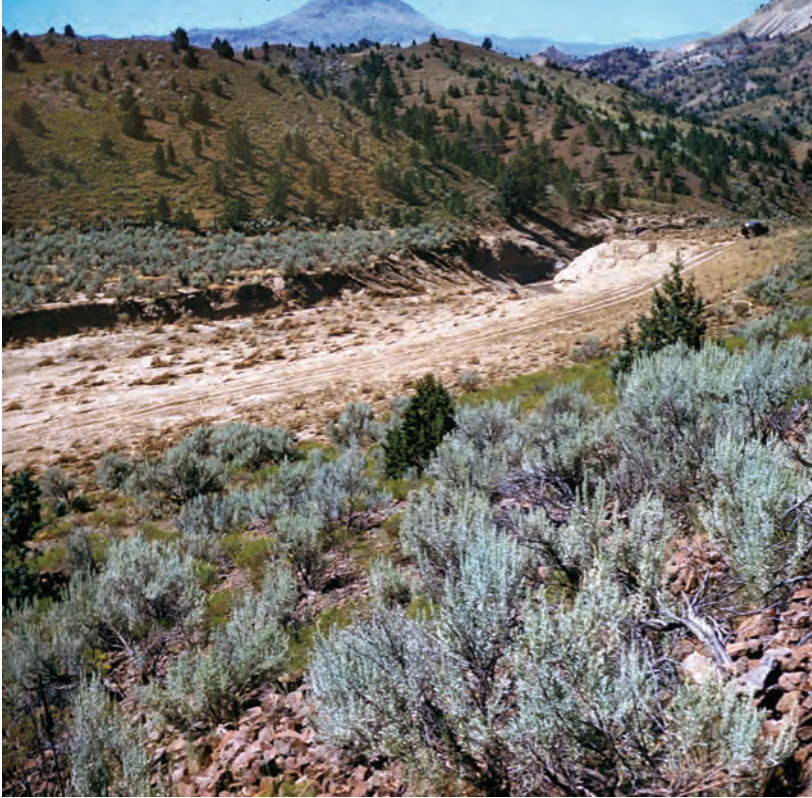
Figure A159. View looking downstream from above cross section B on right bank, Meyers Canyon near Mitchell, Oregon, July 1956.

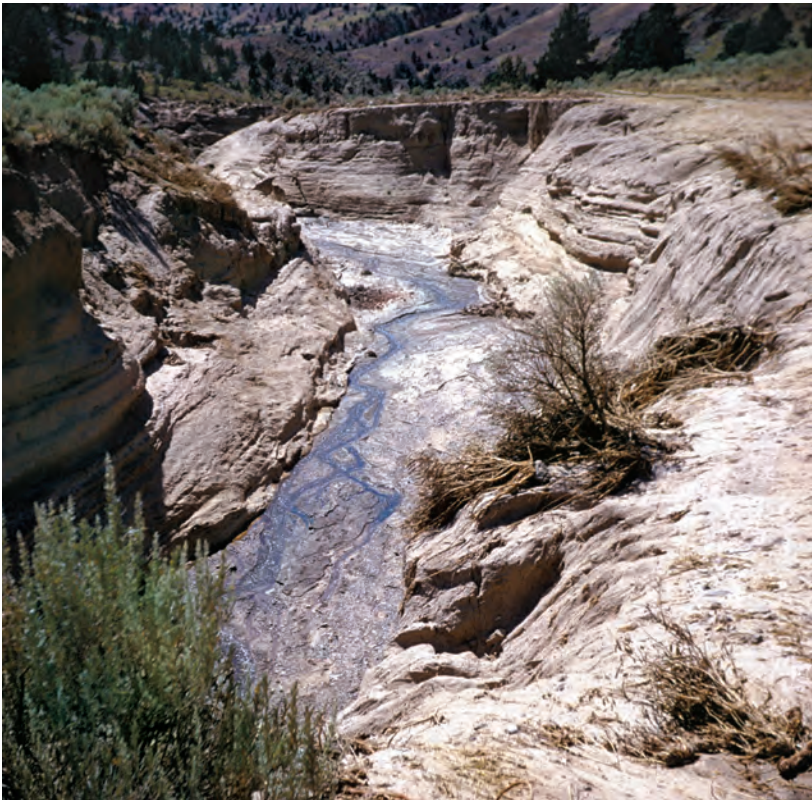
Figure A160. View looking downstream of cross section B to cross section C, Meyers Canyon near Mitchell, Oregon, July 1956.

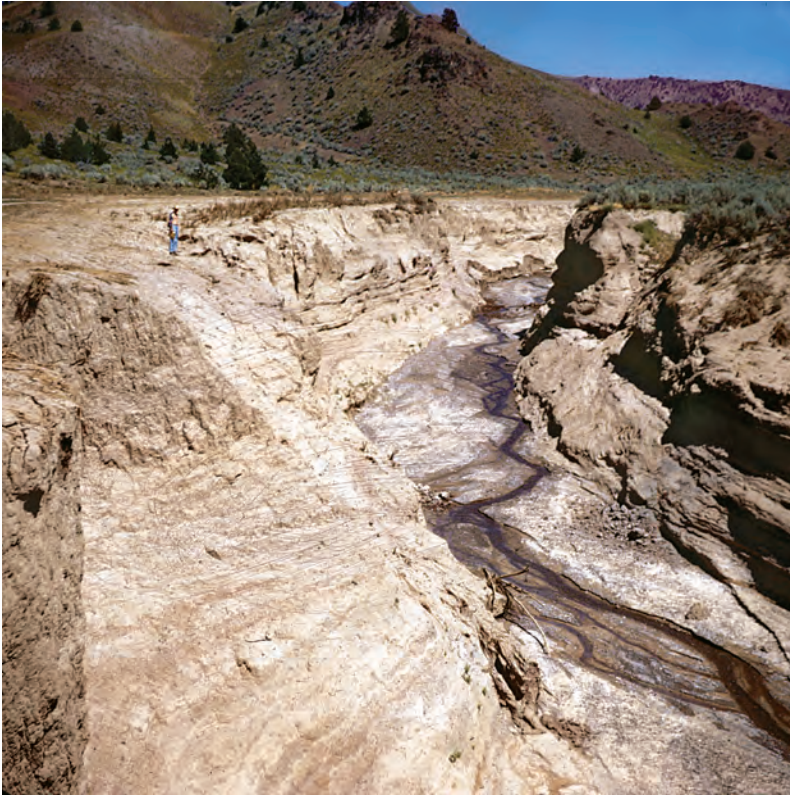
Figure A161. View looking upstream from downstream from cross section C, Meyers Canyon near Mitchell, Oregon, July 1956. Man standing at cross section C.

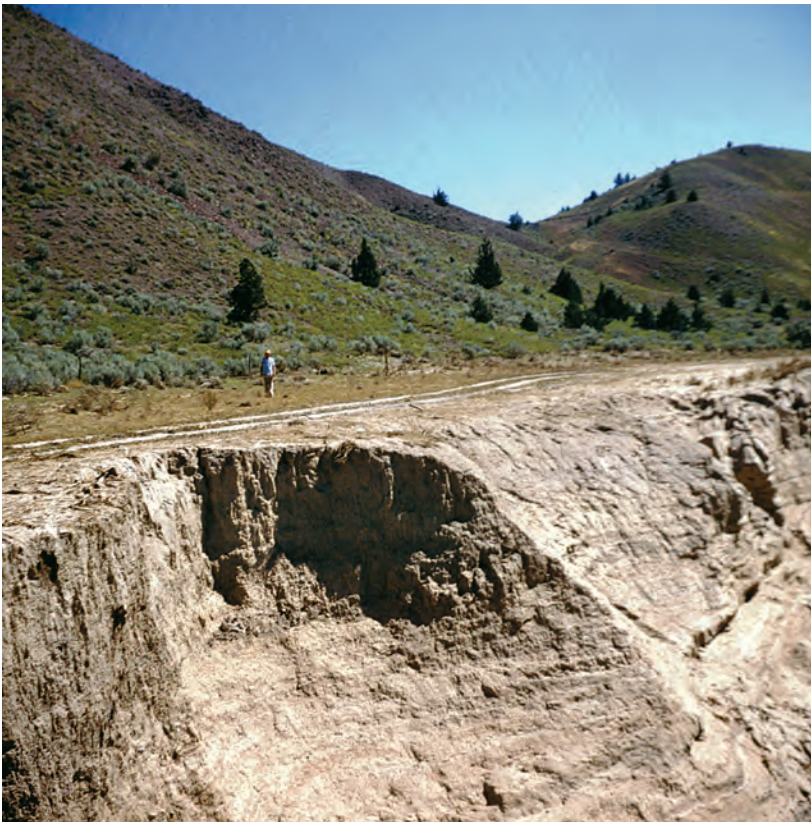
Figure A162. View looking upstream, Meyers Canyon near Mitchell, Oregon, July 1956. Man standing on right bank at cross section C.

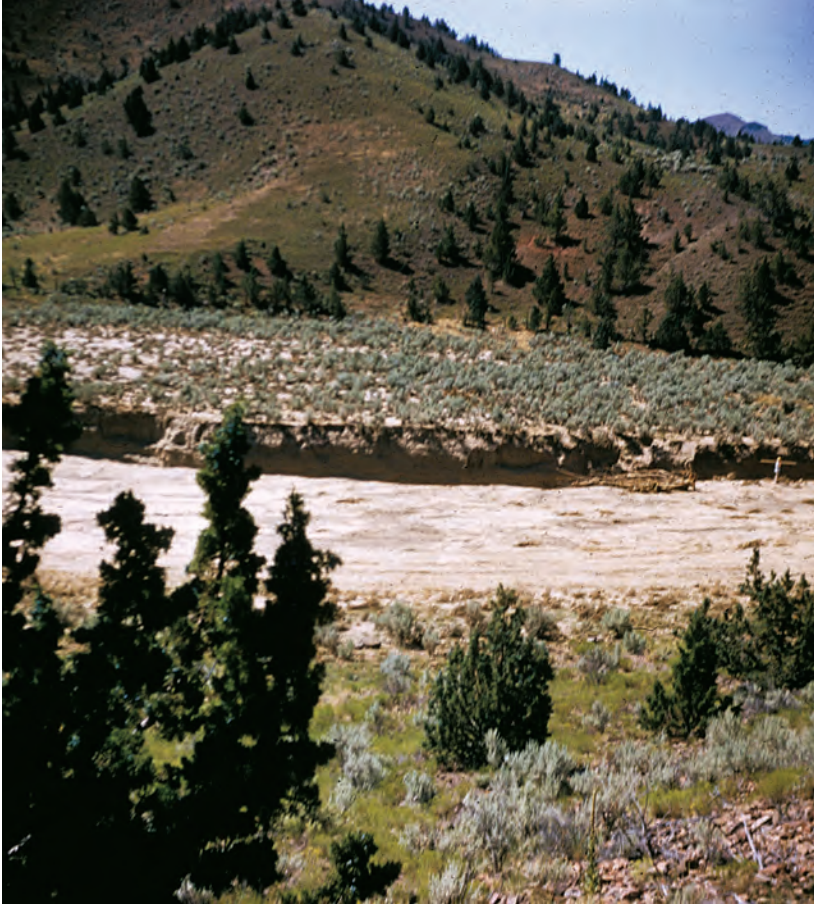
Figure A163. View looking from right to left bank, Meyers Canyon near Mitchell, Oregon, July 1956. Man standing at cross section C.

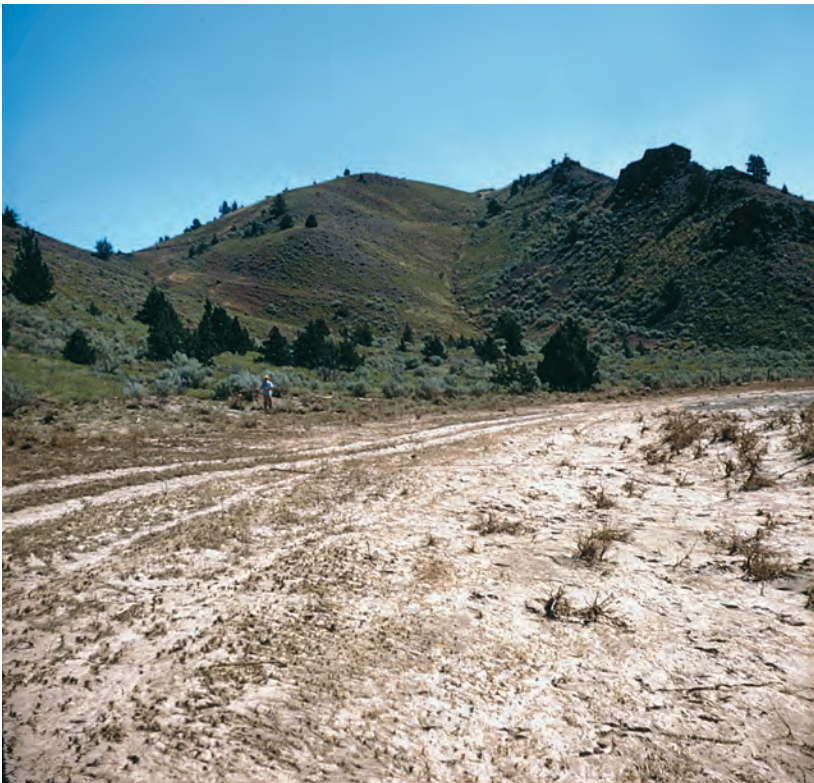
Figure A164. View looking upstream to cross section B, Meyers Canyon near Mitchell, Oregon, July 1956.

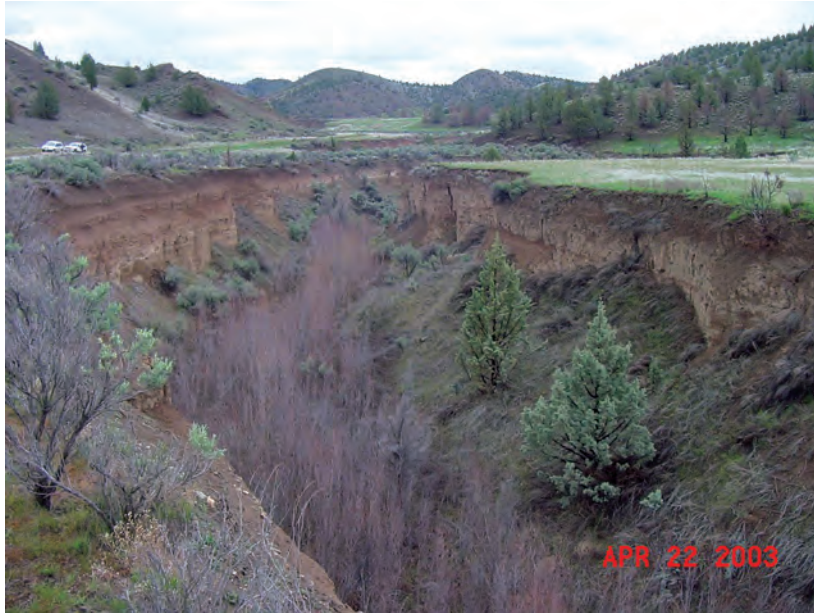
Figure A165. View looking upstream toward slope-area reach, Meyers Canyon near Mitchell, Oregon, April 22, 2003.

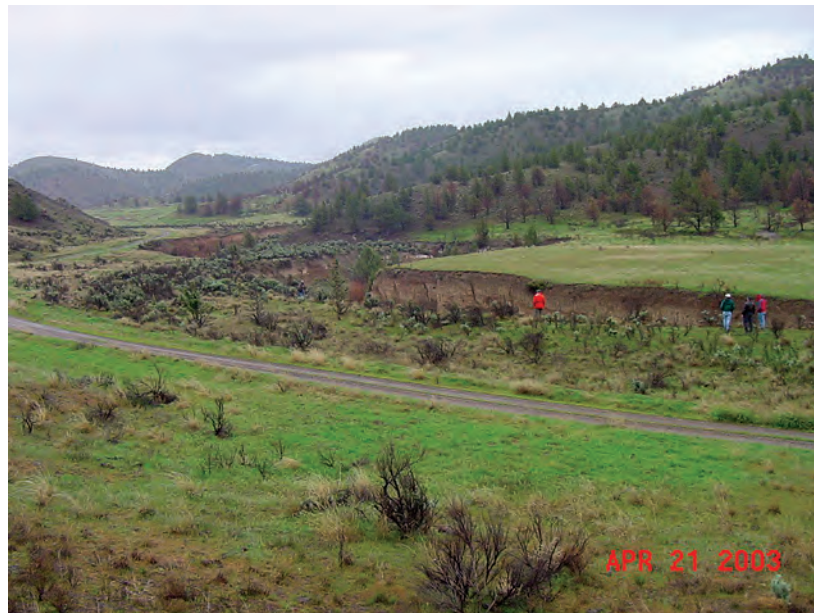
Figure A166. View looking upstream from right-bank hillslope across to slope-area reach, Meyers Canyon near Mitchell, Oregon, April 21, 2003.

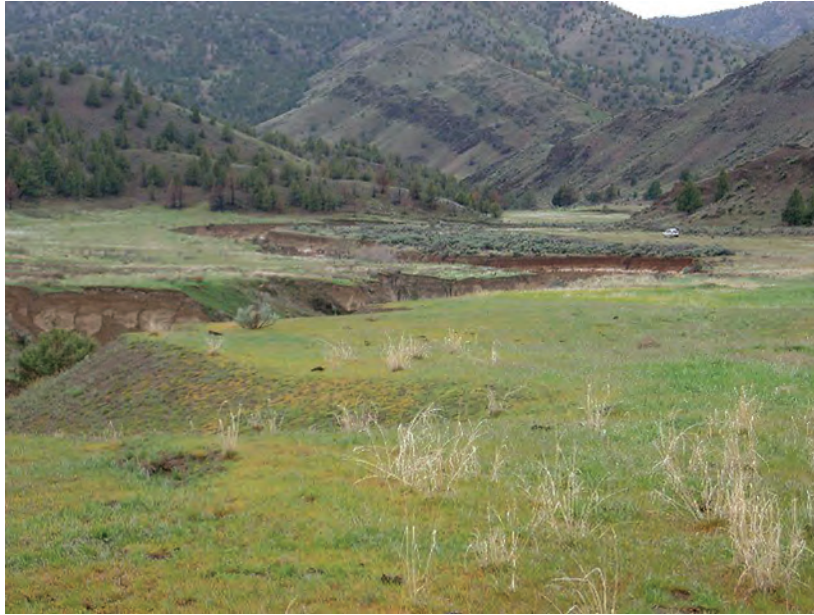
Figure A167. View looking downstream from area on right bank where flow likely broke out of canyon, Meyers Canyon near Mitchell, Oregon, April 21, 2003.

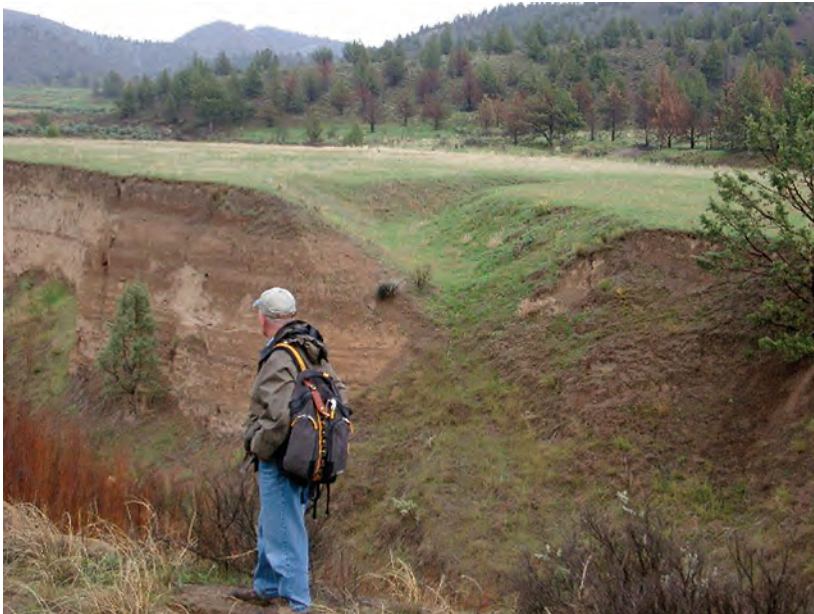
Figure A168. View from right bank looking across canyon toward possible return-flow gully that channeled flood-plain overflow back into canyon, Meyers Canyon near Mitchell, Oregon, April 21, 2003.

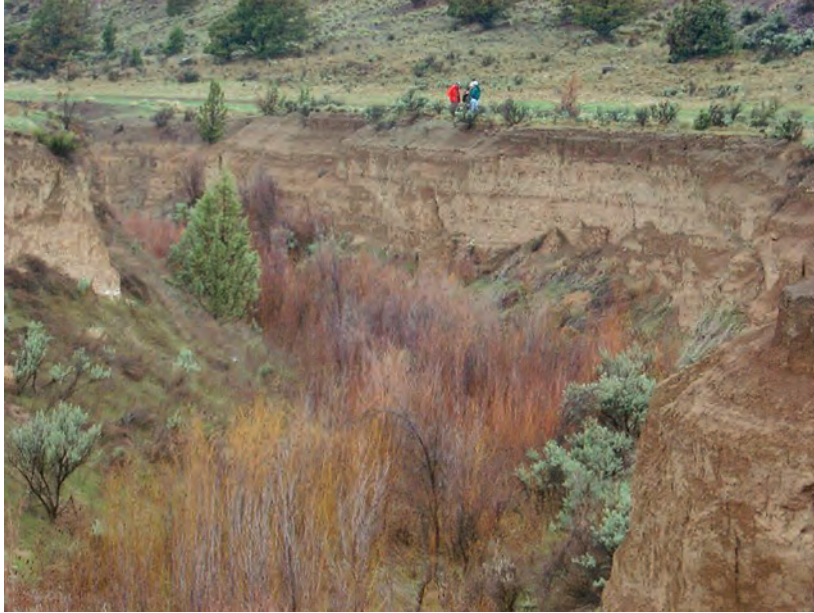
Figure A169. View looking downstream from left bank toward right bank and people standing in slope-area reach, Meyers Canyon near Mitchell, Oregon, April 21, 2003.

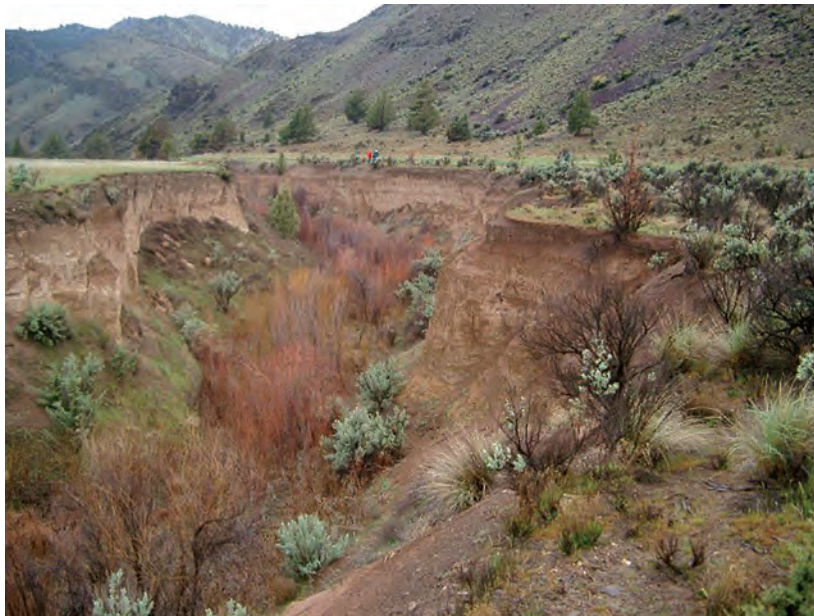
Figure A170. View looking downstream into main canyon toward slope-area reach, Meyers Canyon near Mitchell, Oregon, April 21, 2003.

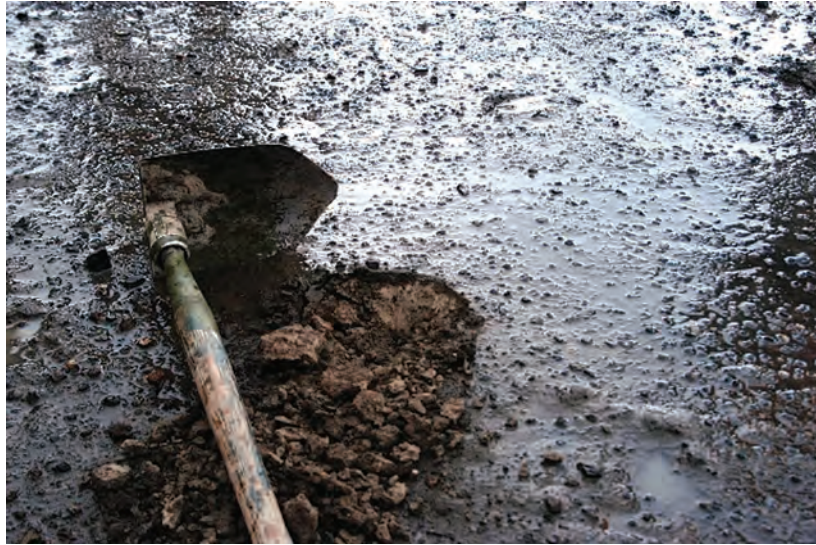
Figure A171. Overland flow following rainfall in upstream part of Meyers Canyon Basin, Oregon, April 21, 2003. Almost no infiltration into fine-grained surficial material.

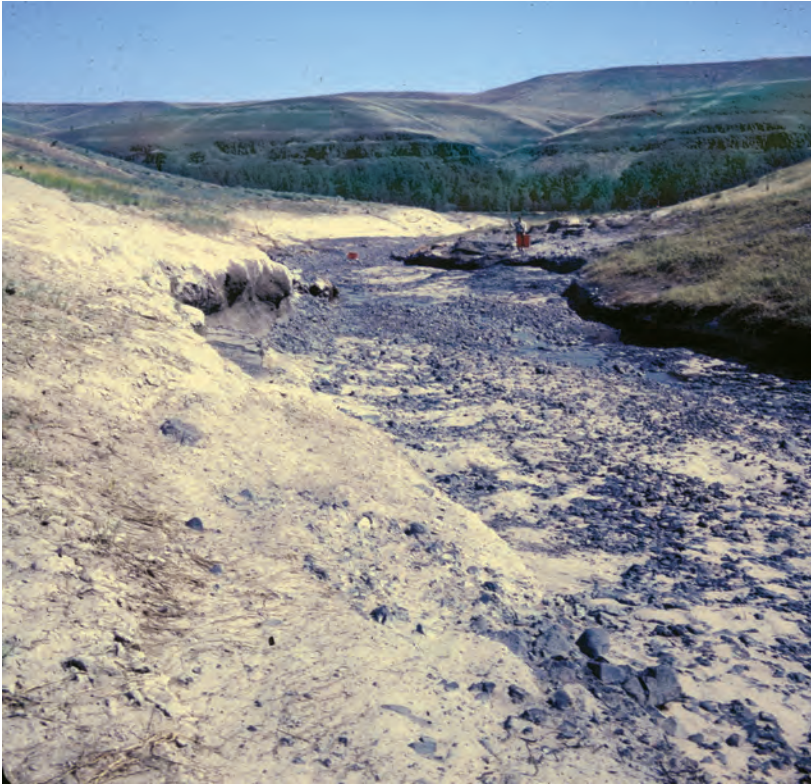
Figure A173. View looking downstream from upstream of cross section 1, Lane Canyon near Nolin, Oregon, August 1965.

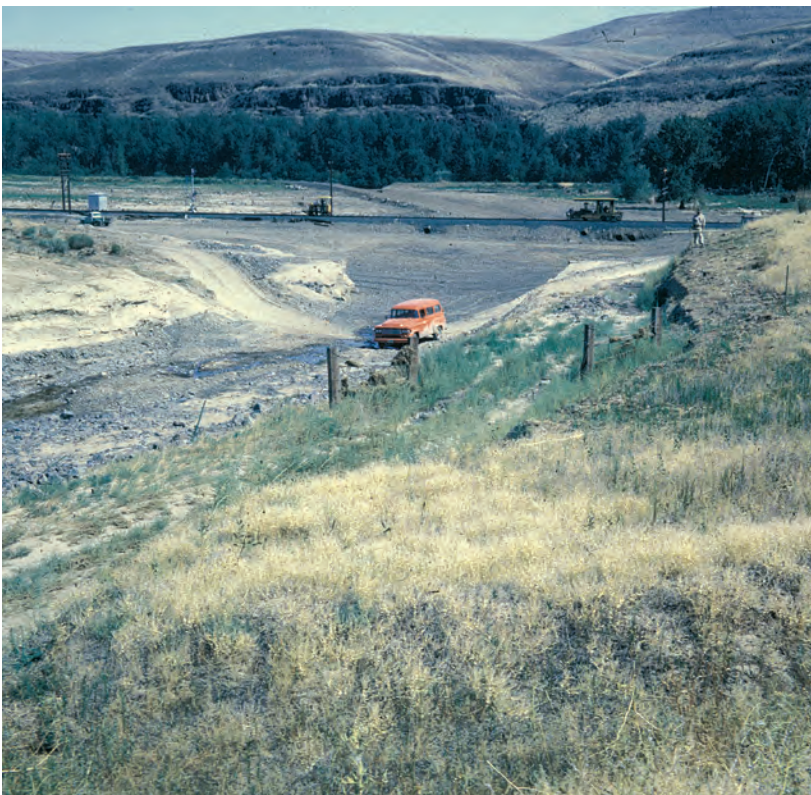
Figure A174. View looking downstream toward mouth of canyon from downstream of slope-area reach, Lane Canyon near Nolin, Oregon, August 1965.

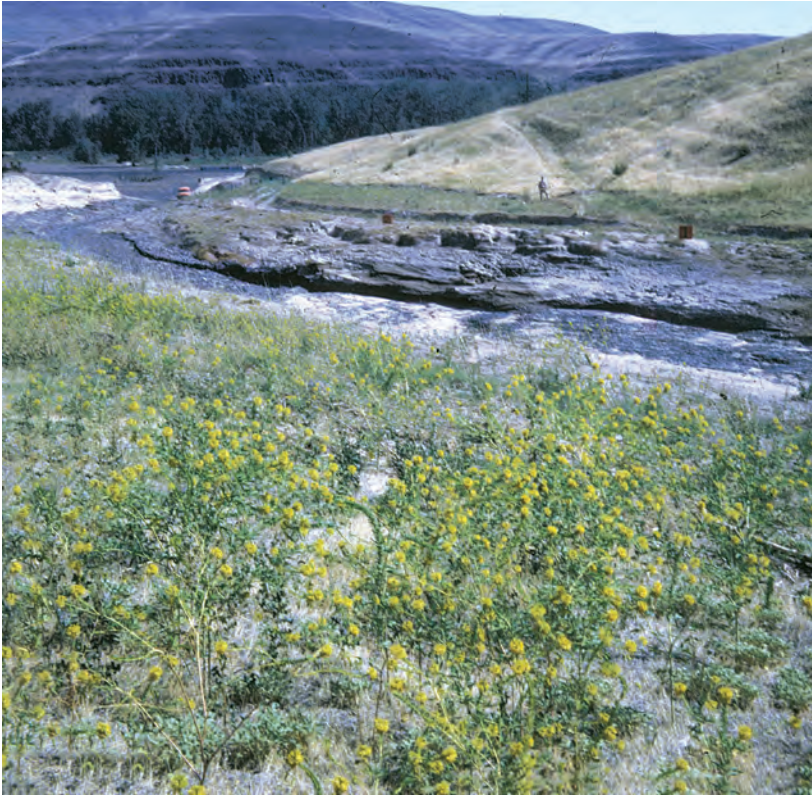
Figure A175. View of right bank from upstream of section 1, Lane Canyon near Nolin, Oregon, August 1965. Man is standing at section 1.

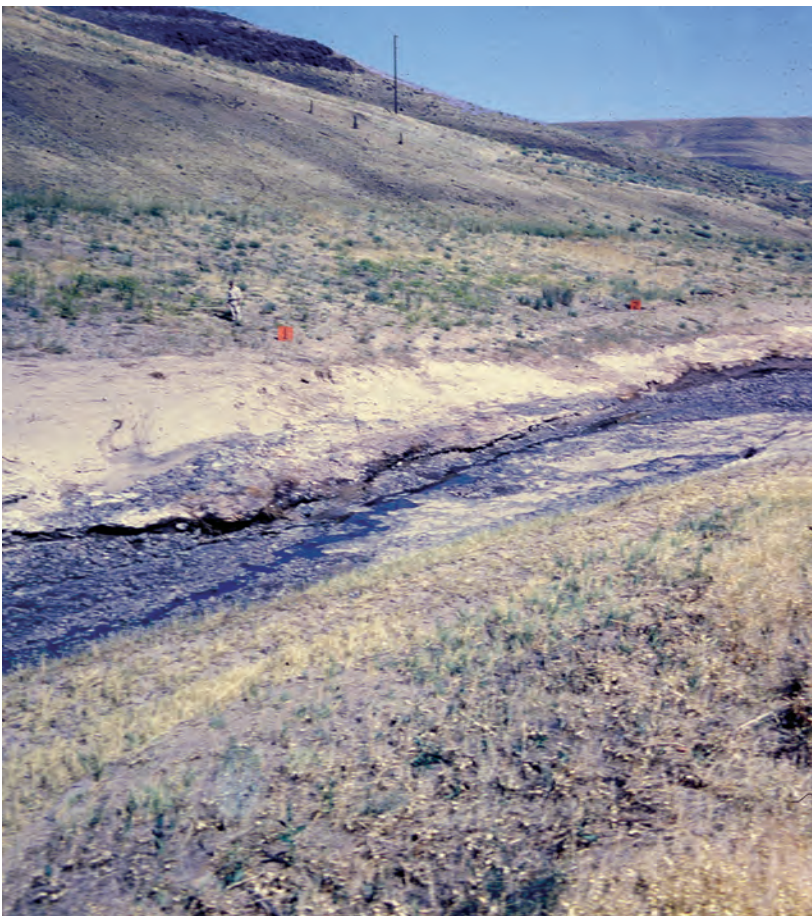
Figure A176. View looking downstream to left bank with sections 1 and 2 marked with orange signs, Lane Canyon near Nolin, Oregon, August 1965.

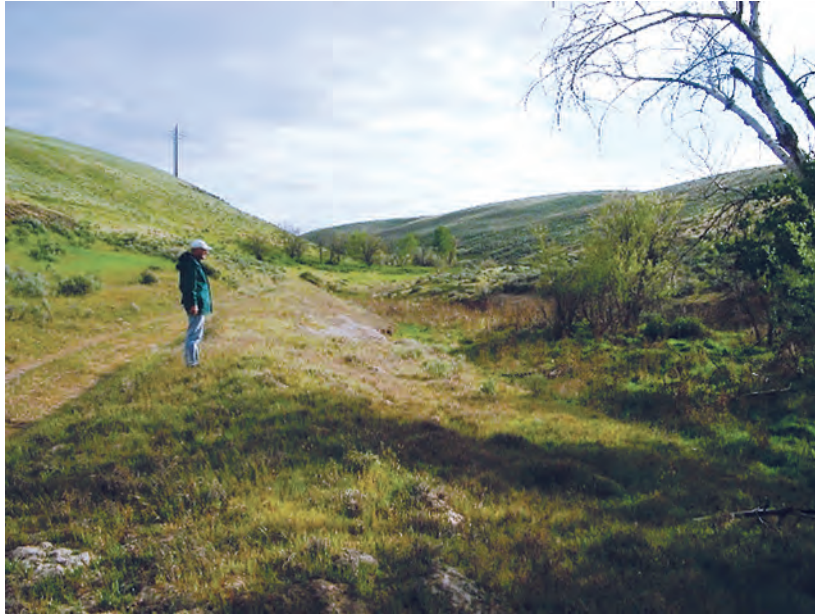
Figure A177. View looking upstream through slope-area reach, Lane Canyon near Nolin, Oregon, April 23, 2003.

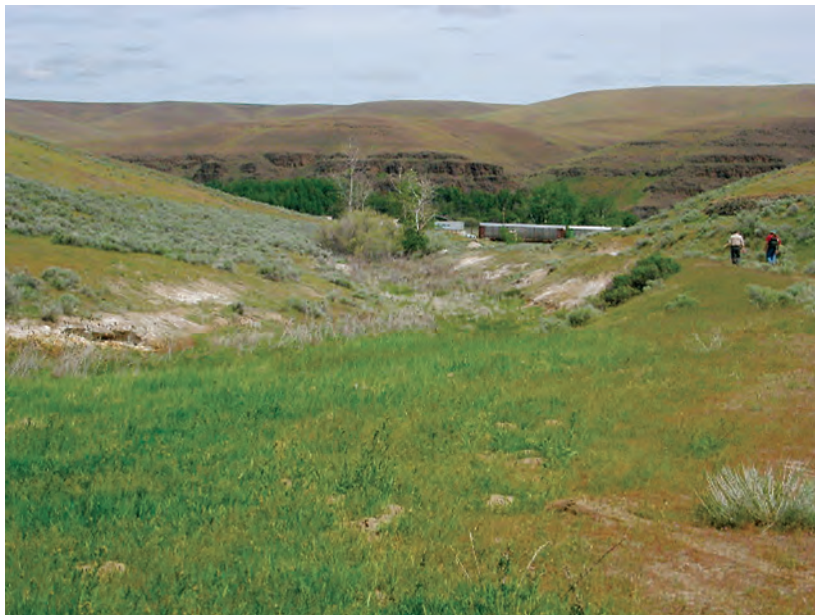
Figure A178. View looking downstream through slope-area reach, Lane Canyon near Nolin, Oregon, April 23, 2003.

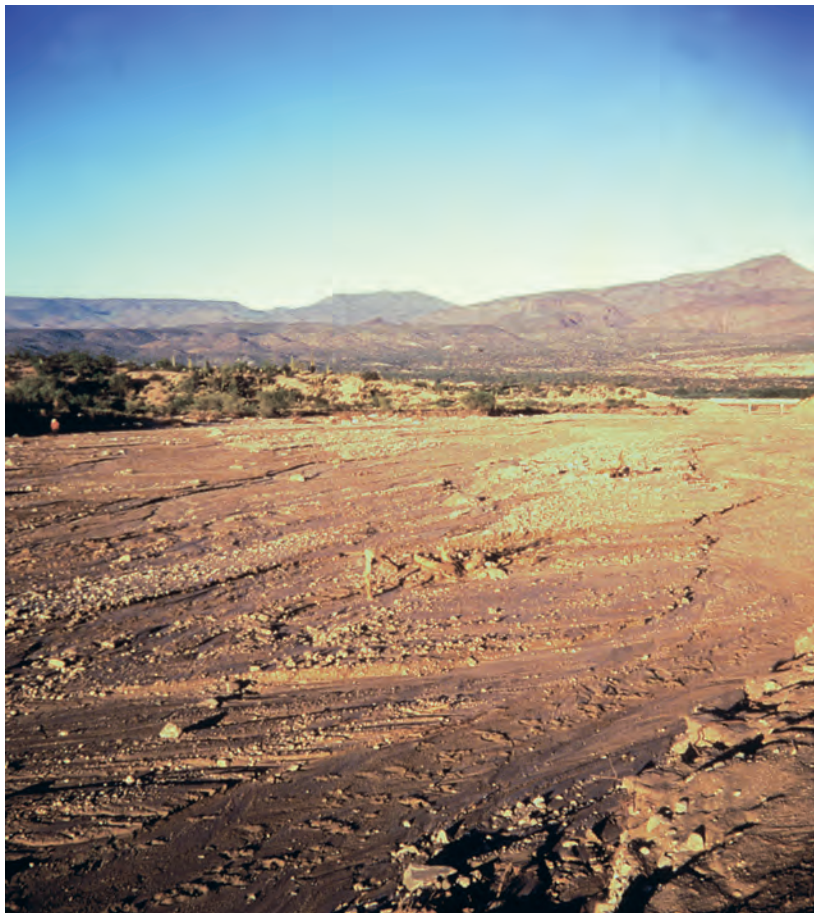
Figure A179. View looking downstream at cross section 1, Bronco Creek near Wikieup, Arizona, August 1971.

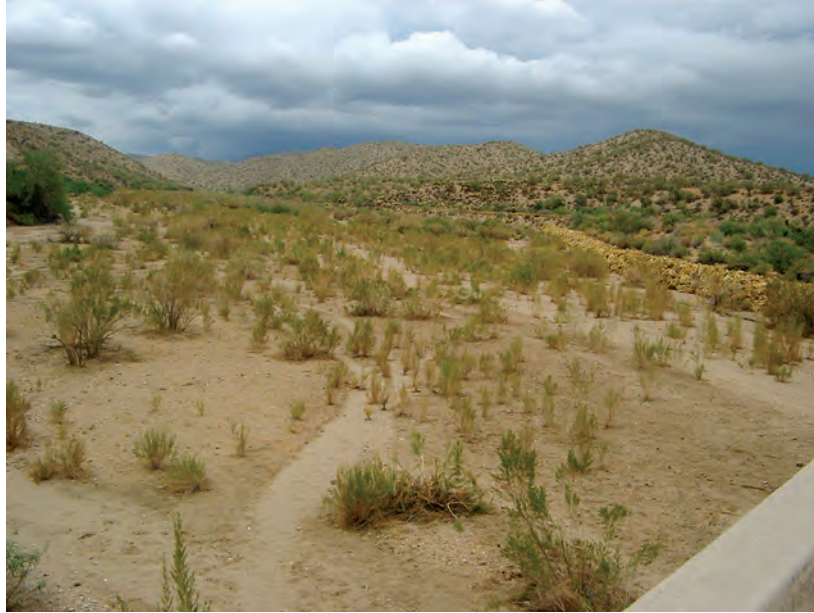
Figure A180. View looking upstream toward slope-area reach from U.S. Highway 93 bridge. Bronco Creek near Wikieup, Arizona, August 2003.
