**Appendix A. Individual Evaluations of 30 Peak Discharges from
28 Extraordinary Floods in the United States**

Seco Creek near D'Hanis, Texas

Review of peak discharge for the flood of May 31, 1935

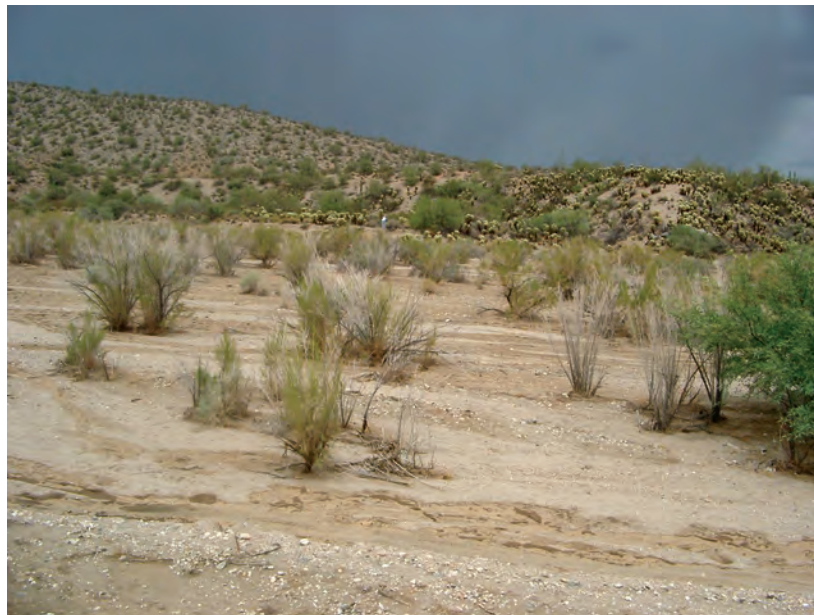
Figure A181. View from right bank to left bank near cross section 1, Bronco Creek near Wikieup, Arizona, August 2003.

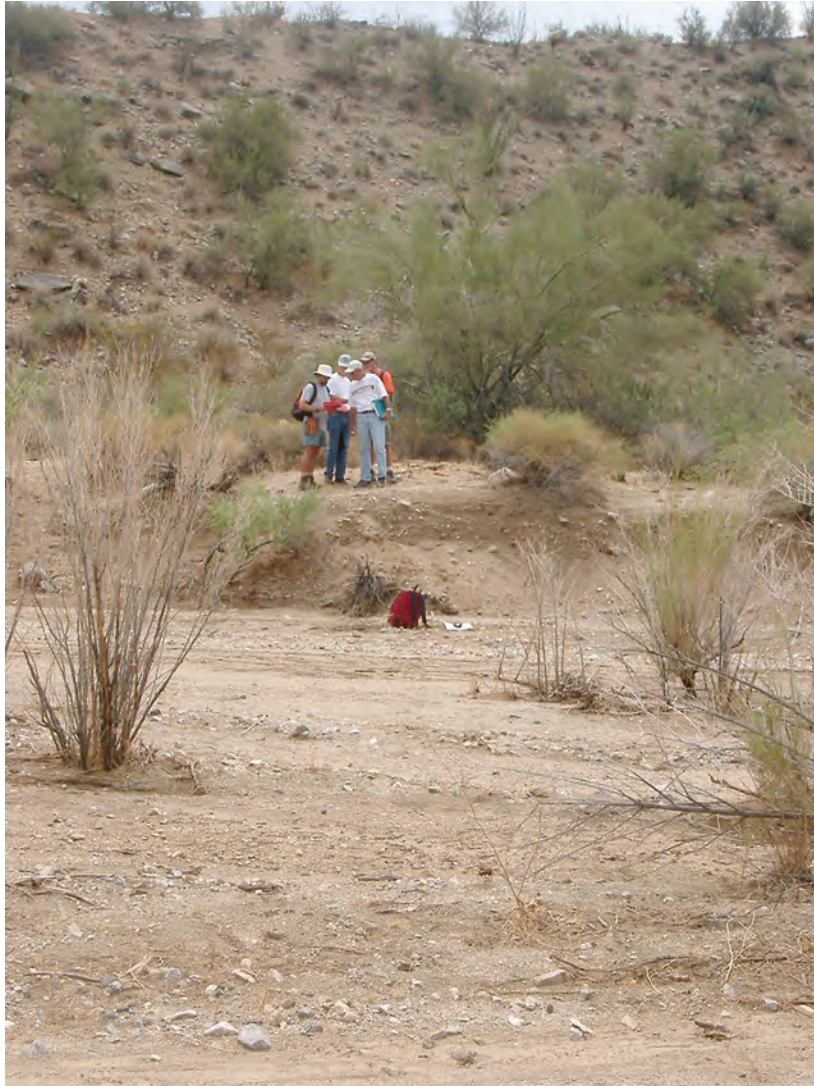
Figure A182. View toward right bank at cross section 1, Bronco Creek near Wikieup, Arizona, August 2003.

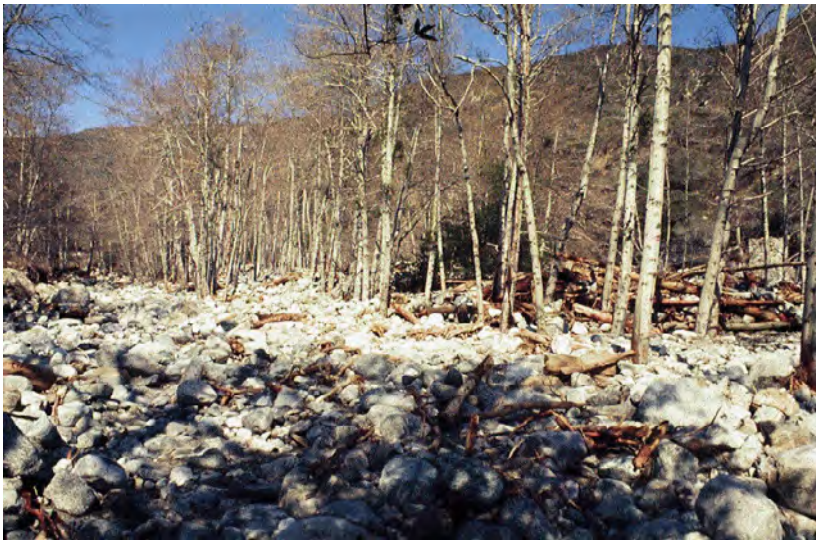
Figure A183. Unknown location in Day Creek, California, following debris flow showing abrasion on trees, but no major damage in spite of very coarse materials being moved.

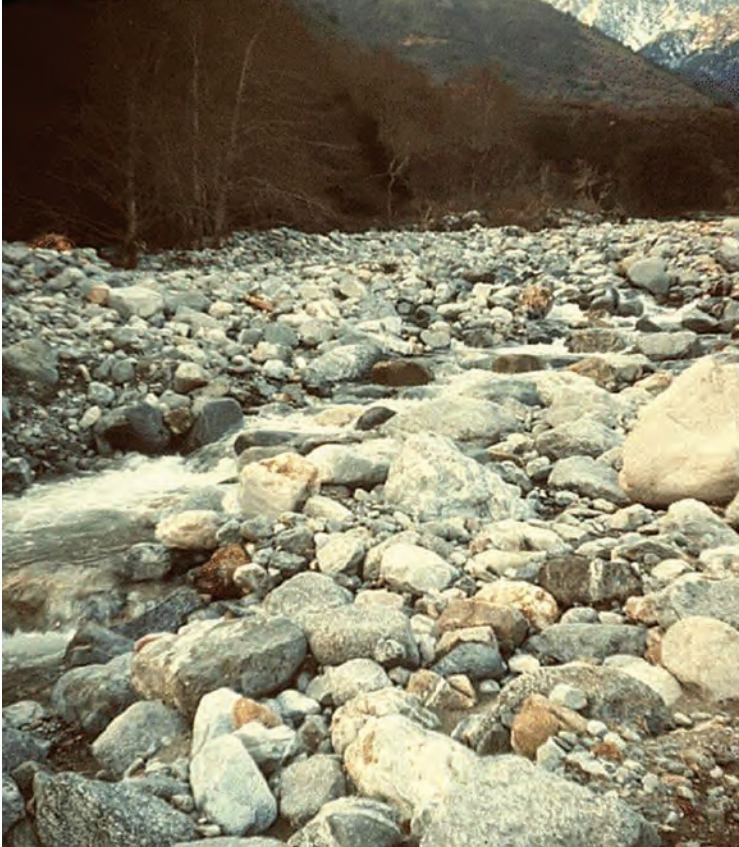
Figure A184. View looking upstream toward slope-area reach, Day Creek near Etiwanda, California, February 1969.

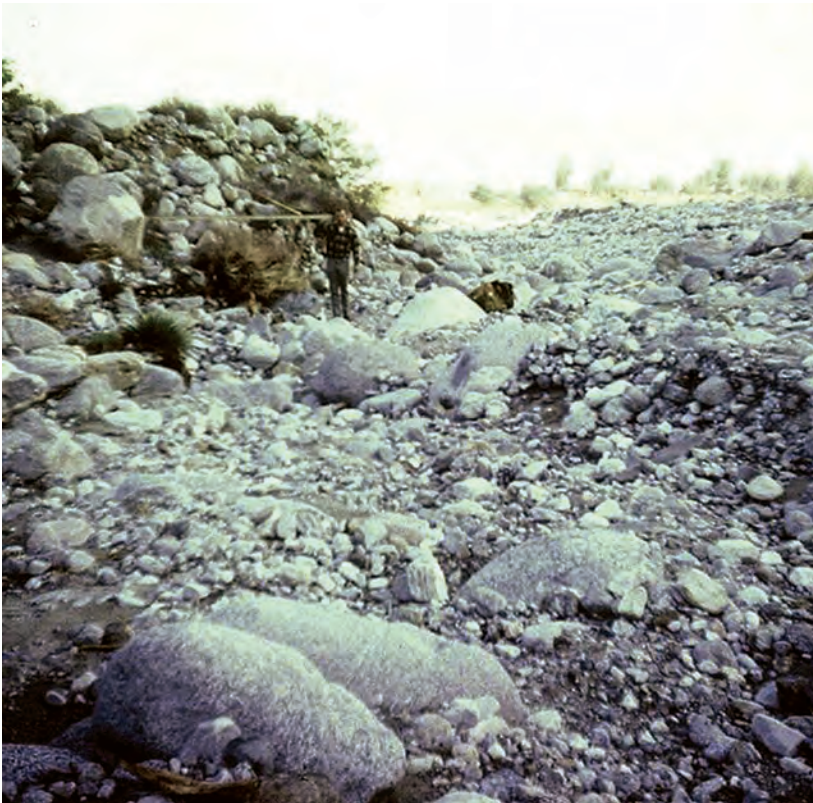
Figure A185. View looking downstream at left bank at cross section 2, Day Creek near Etiwanda, California, February 1969.

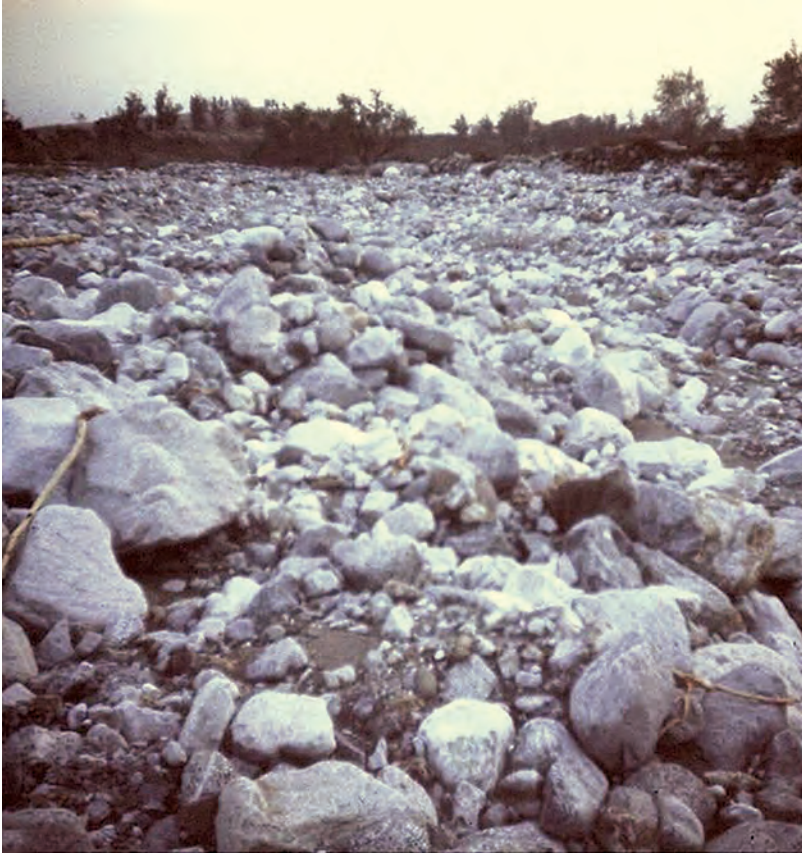
Figure A186. View looking downstream from cross section 3 toward cross section 4, Day Creek near Etiwanda, California, February 1969.

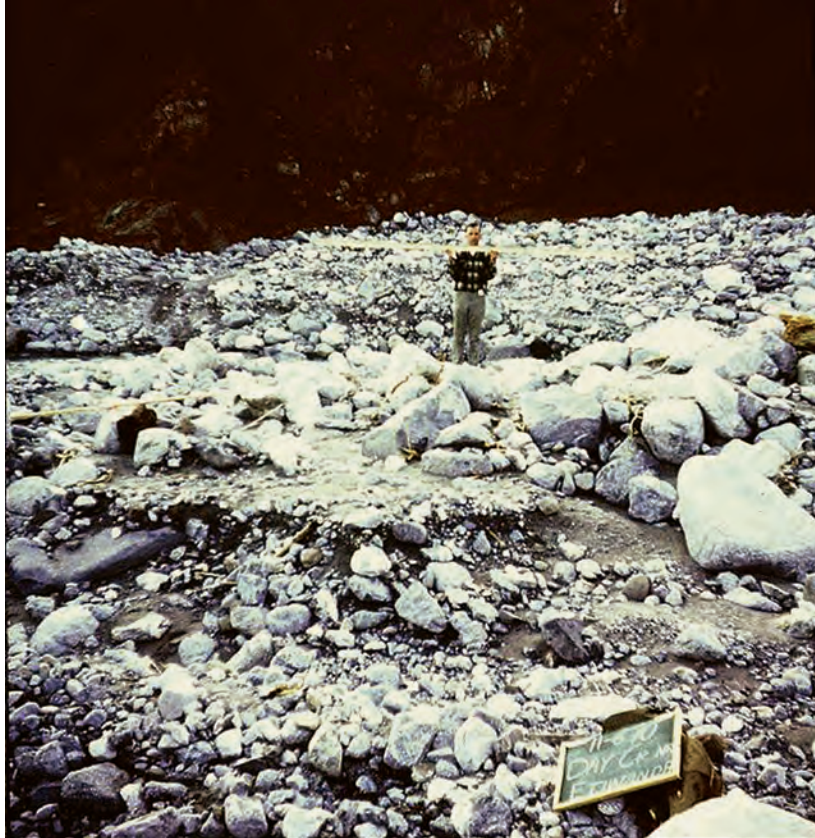
Figure A188. View of debris-flow lobe in slope-area reach, Day Creek near Etiwanda, California, November 1970.

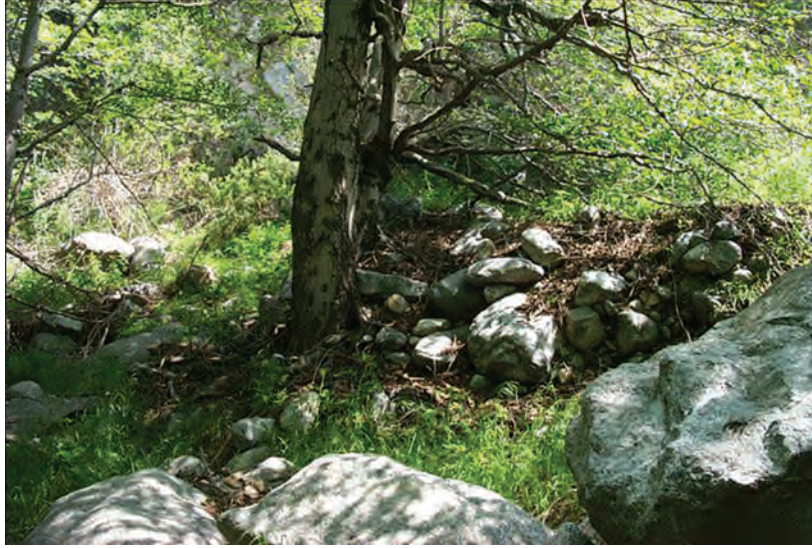
Figure A189. Debris-flow deposit arrested by tree near slope-area reach, Day Creek near Etiwanda, California, September 2002.

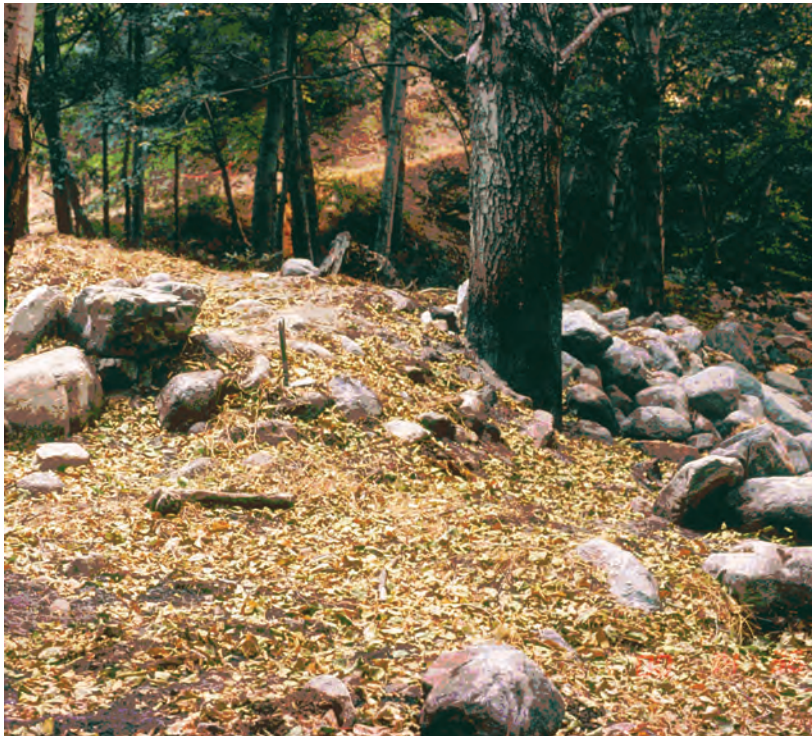
Figure A190. Boulder front of debris-flow lobe, Day Creek near Etiwanda, California, September 2002. Flow is from left to right.

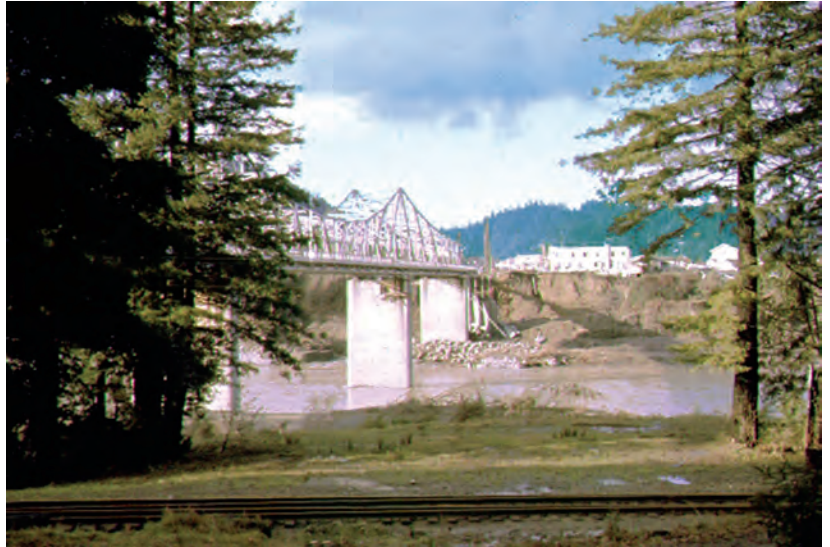
Figure A192. View from right-bank flood plain to left bank following flood in 1964, Eel River at Scotia, California. Streamflow-gaging station located on this bridge.

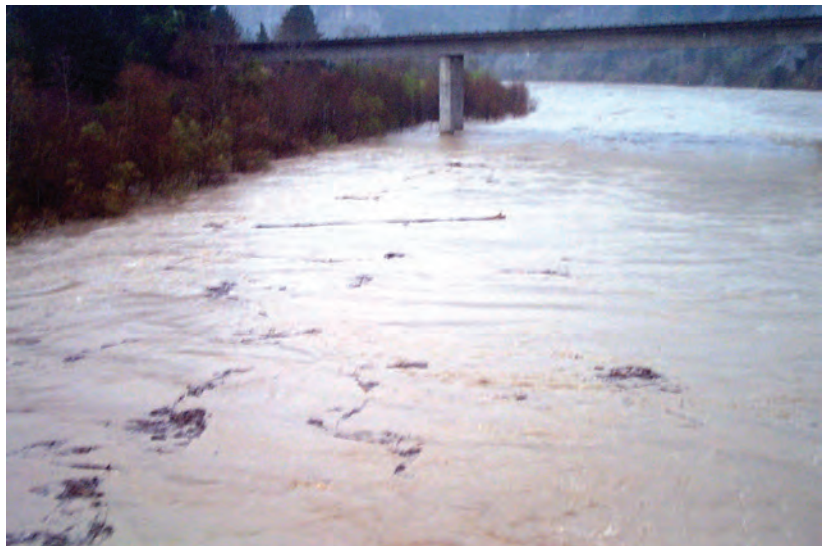
Figure A193. View of downstream bridge from streamflow-gaging station, Eel River at Scotia, California, during flow of about 200,000 cubic feet per second on February 17, 2004.

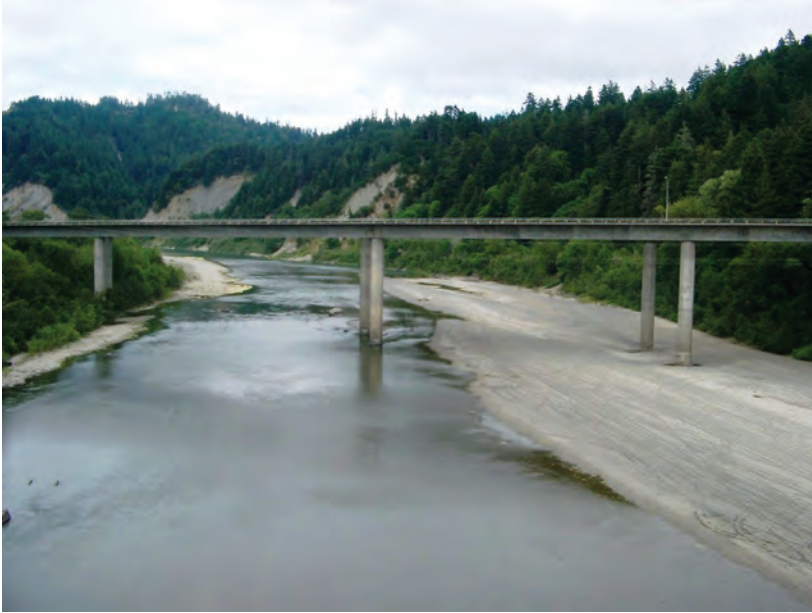
Figure A194. View of downstream bridge from streamflow-gaging station during low-flow period, Eel River at Scotia, California, July 13, 2003.

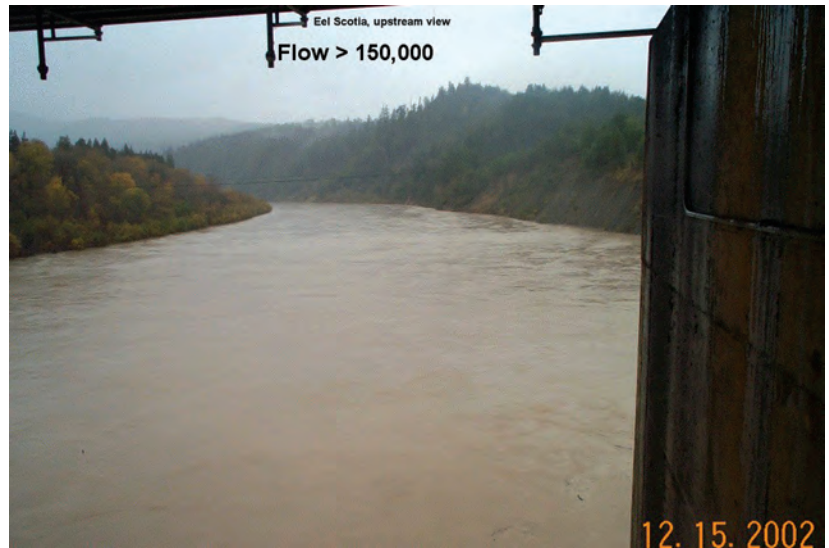
Figure A195. View upstream from streamflow-gaging station during flow greater than 150,000 cubic feet per second, Eel River at Scotia, California, December 15, 2002.

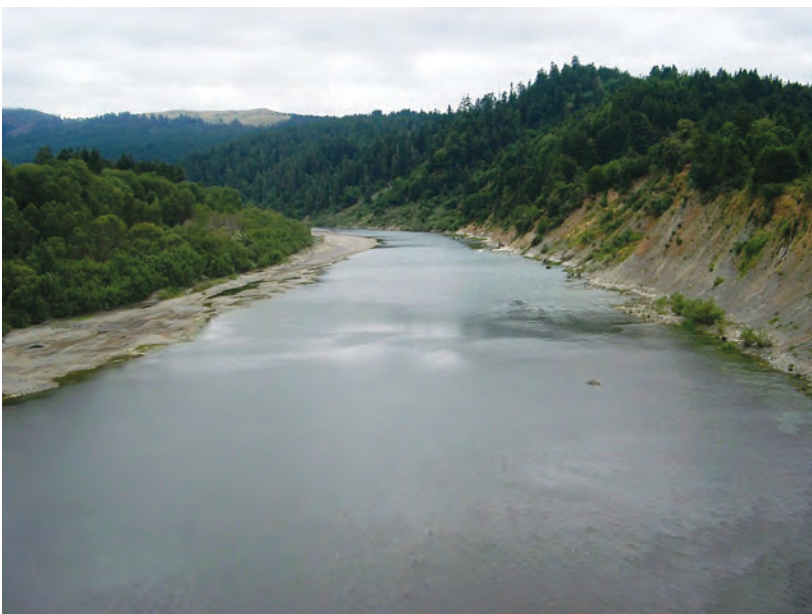
Figure A196. View looking upstream from streamflow-gaging station during low-flow period, Eel River at Scotia, California, July 13, 2003.

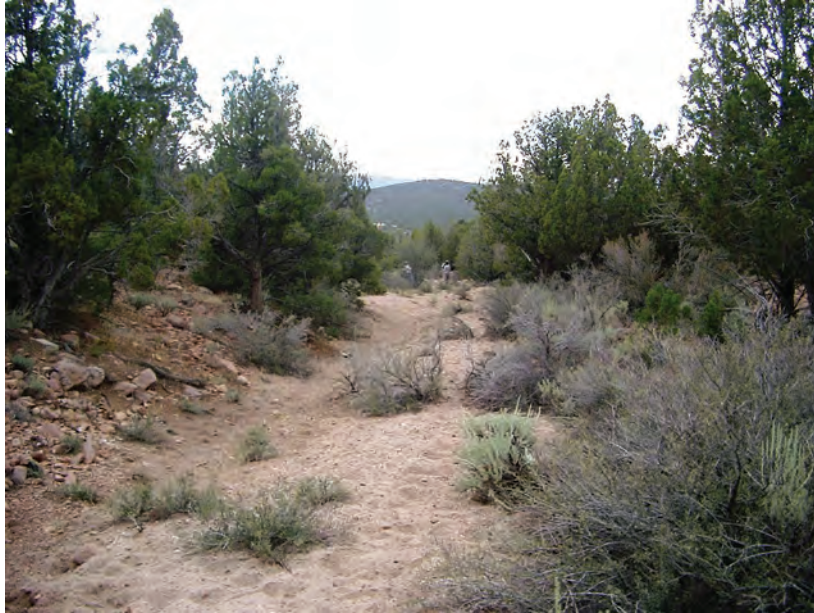
Figure A197. View looking downstream through slope-area reach, Little Pinto Creek tributary near Newcastle, Utah, August 26, 2003.

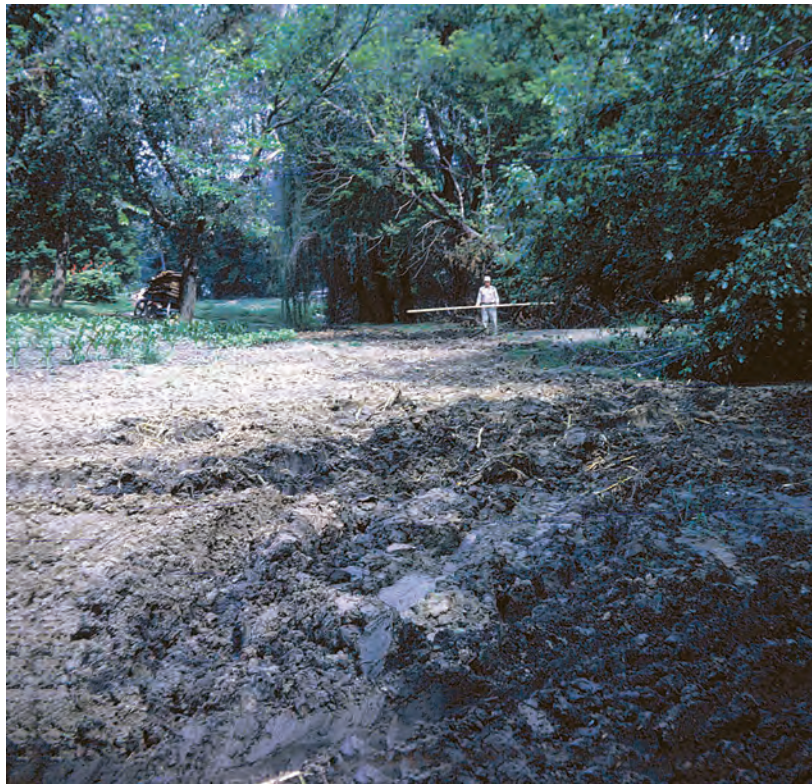
Figure 198. View looking downstream of left bank of cross section 3, Boney Branch at Rockport, Missouri, August 1965.

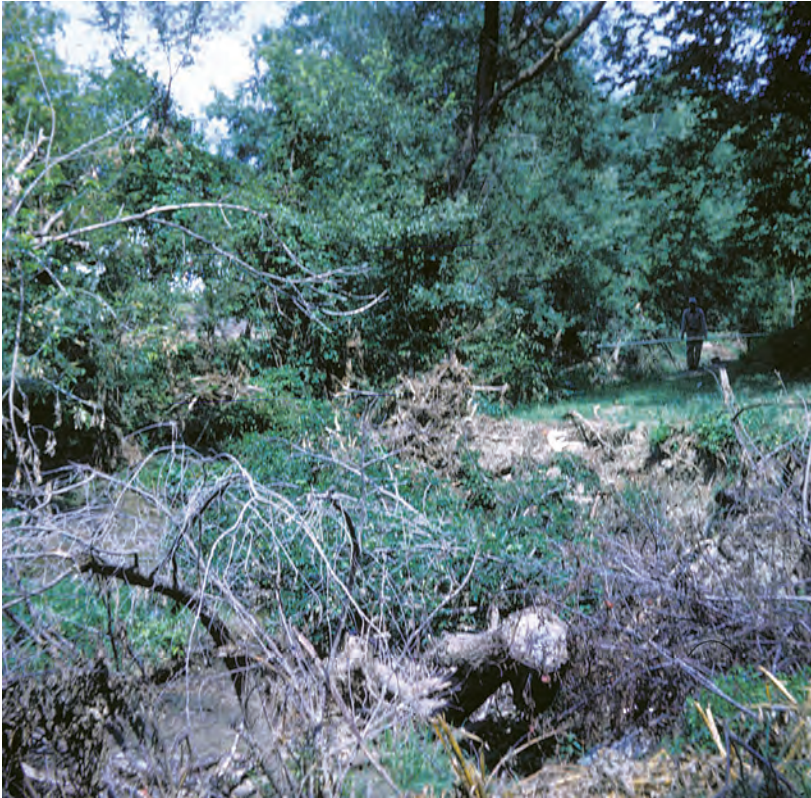
Figure A199. View looking downstream of right endpoint of cross section 2, Boney Branch at Rockport, Missouri, August 1965.

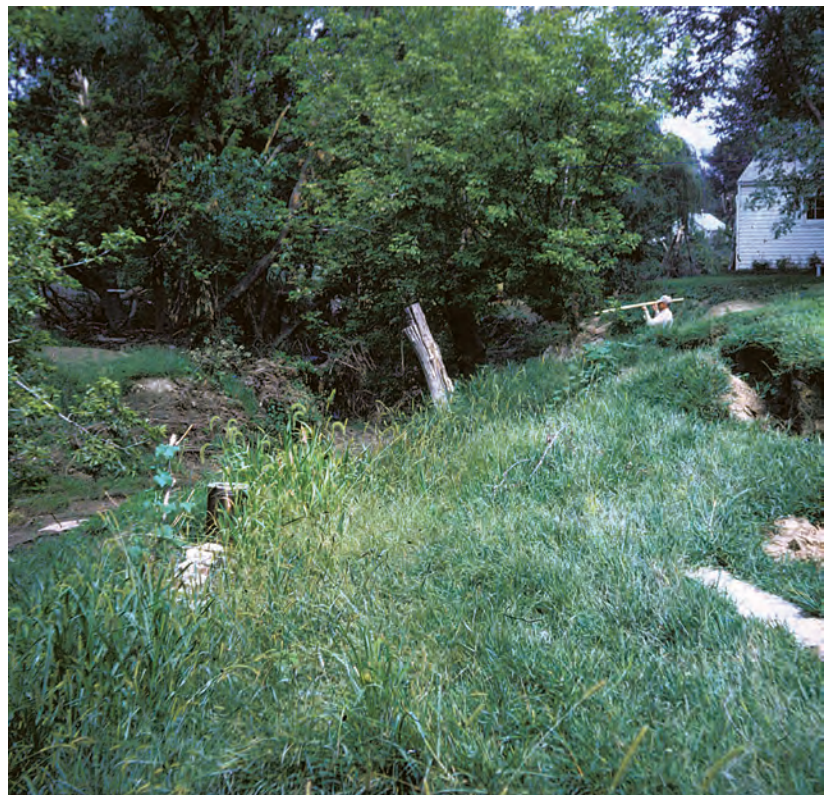
Figure A200. View looking downstream of right endpoint of cross section 3, Boney Branch at Rockport, Missouri, August 1965.

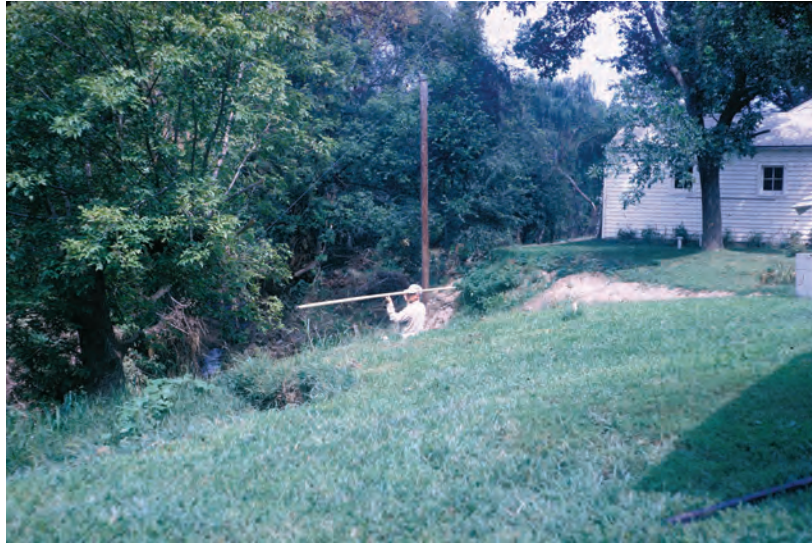
Figure A201. View looking downstream of right endpoint of cross section 1, Boney Branch at Rockport, Missouri, August 1965.

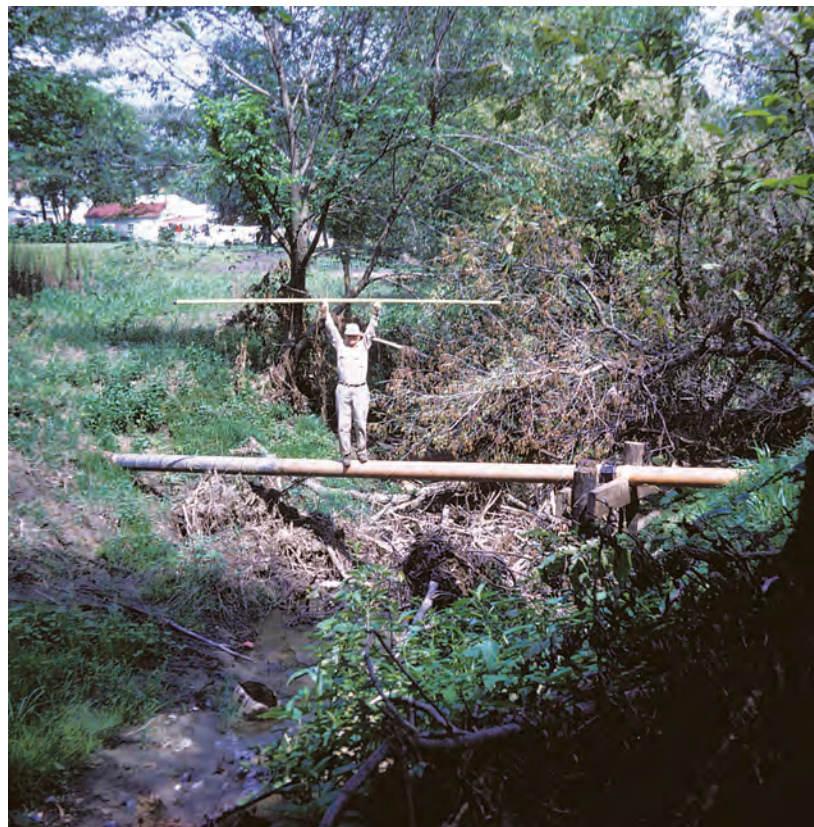
Figure A202. View looking downstream at cross section 1, Boney Branch at Rockport, Missouri, August 1965.

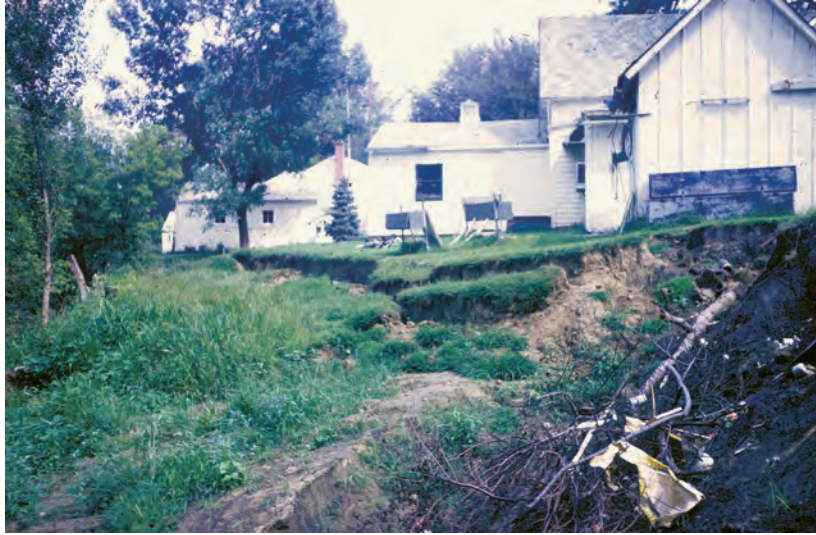
Figure A203. View looking downstream of right bank between sections 2 and 1, Boney Branch at Rockport, Missouri, August 1965.

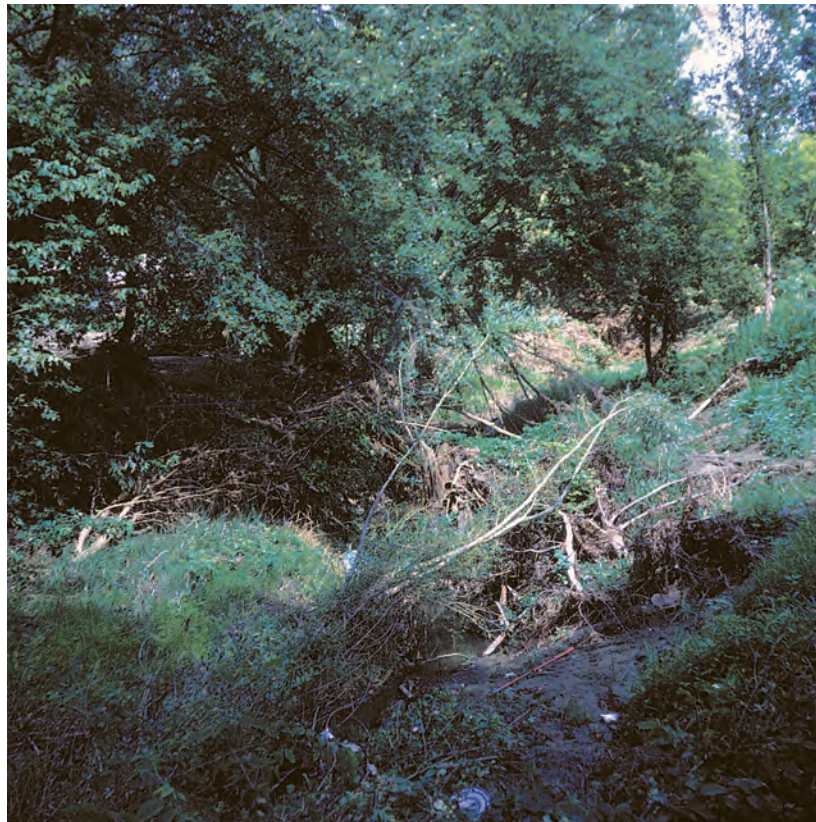
Figure A204. View looking downstream of cross section 2, Boney Branch at Rockport, Missouri, August 1965.

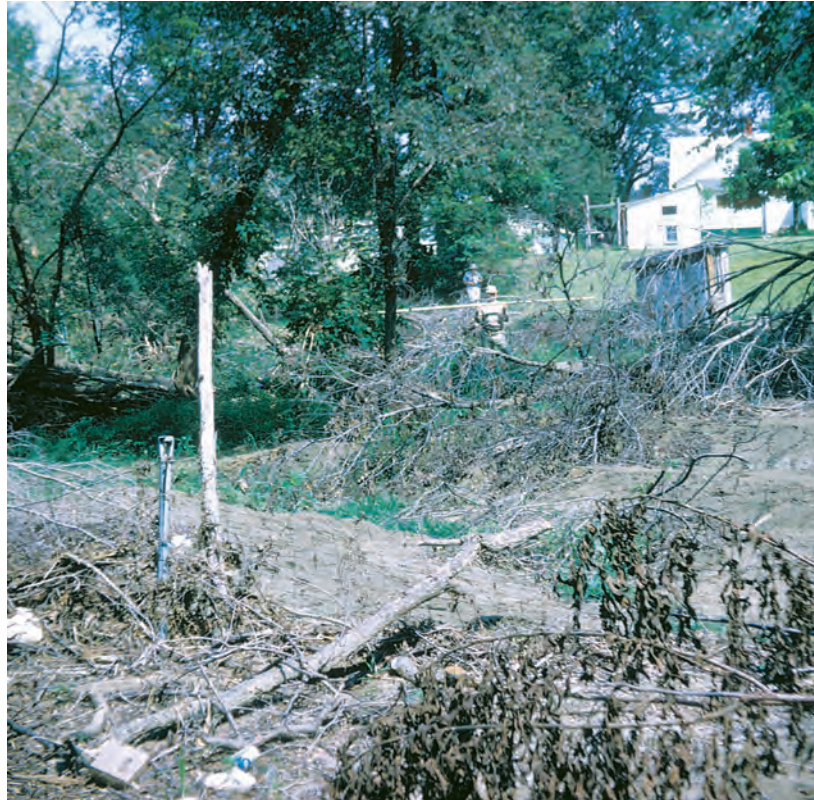
Figure A205. View looking downstream of cross section 1, Boney Branch at Rockport, Missouri, August 1965. Rod between sections 1 and 2.

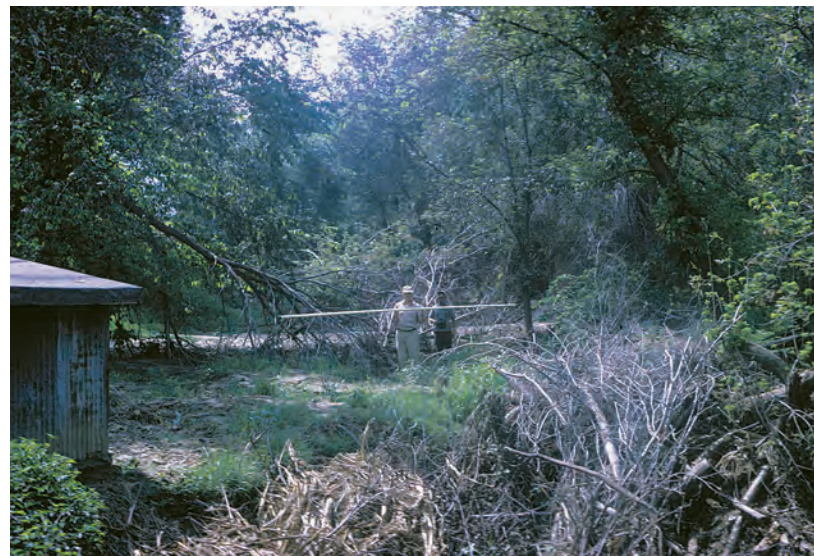
Figure A206. View looking upstream of right bank between cross sections 2 and 3, Boney Branch at Rockport, Missouri, August 1965.

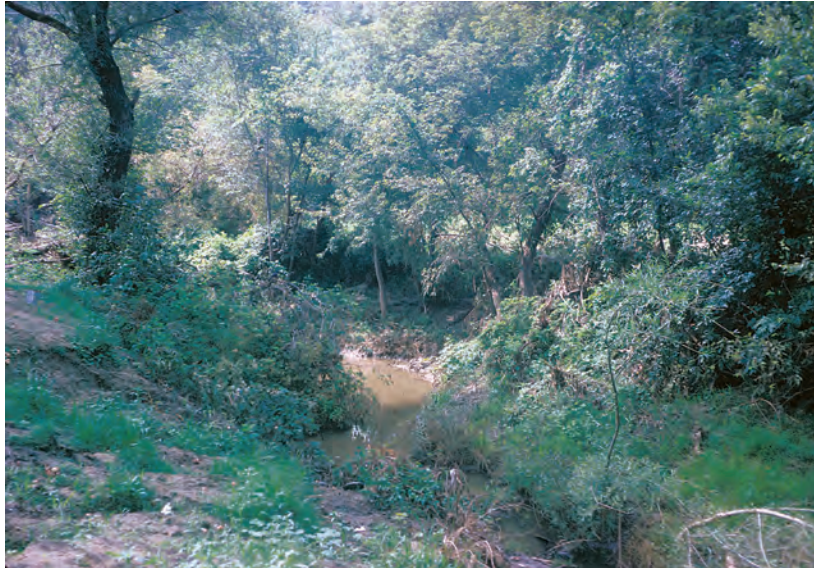
Figure A207. View looking upstream of cross section 1 to section 2, Boney Branch at Rockport, Missouri, August 1965.

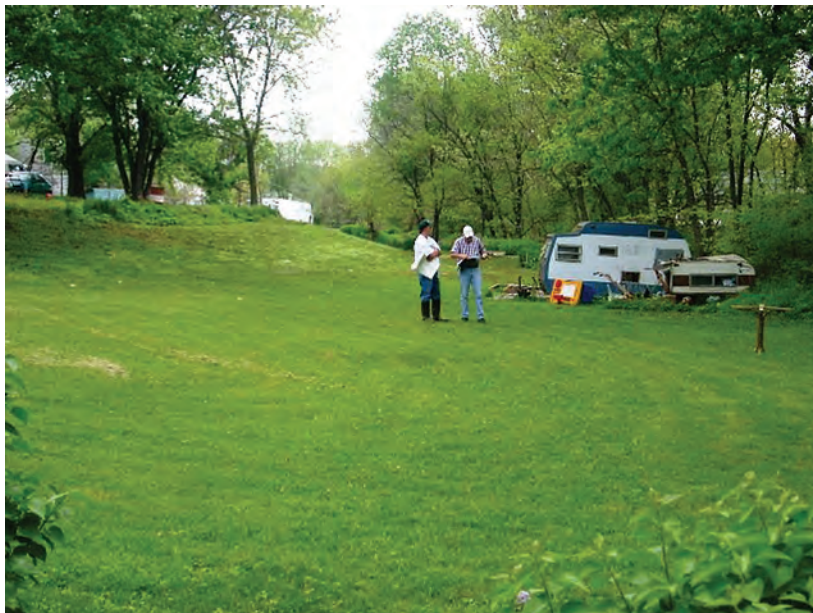
Figure A208. View looking downstream between cross sections 2 and 3, Boney Branch at Rockport, Missouri, May 6, 2003.

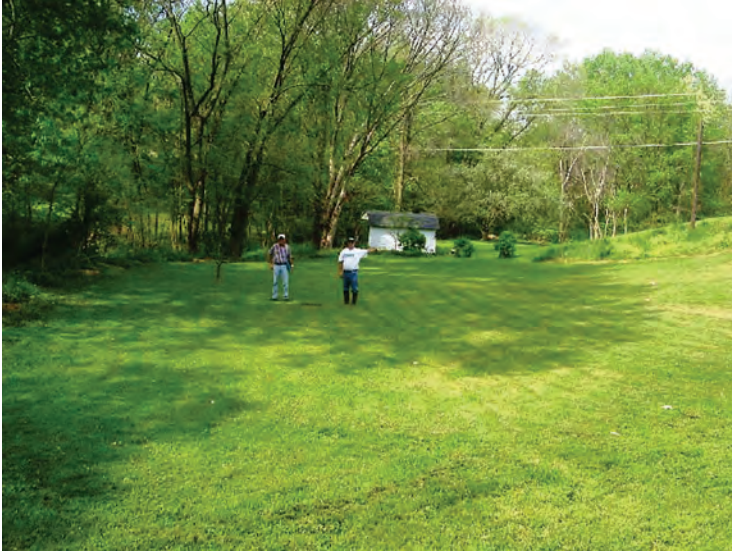
Figure A209. View looking upstream at cross section 2, Boney Branch at Rockport, Missouri, May 6, 2003.

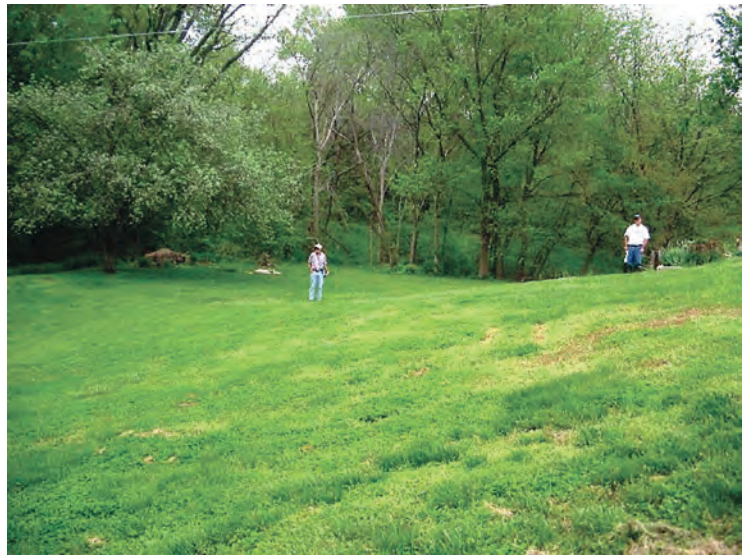
Figure A210. View looking upstream to cross section 2, Boney Branch at Rockport, Missouri, May 6, 2003.

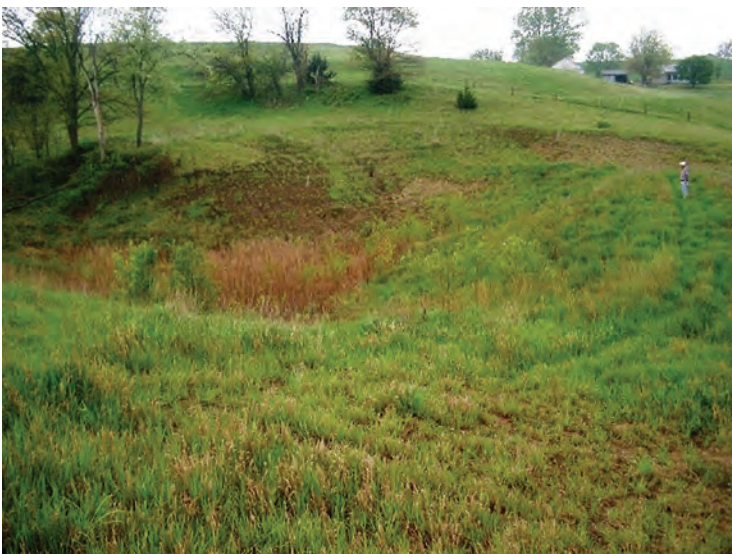
Figure A211. Small agricultural dams in loess headwaters of Boney Branch at Rockport, Missouri May 6, 2003.

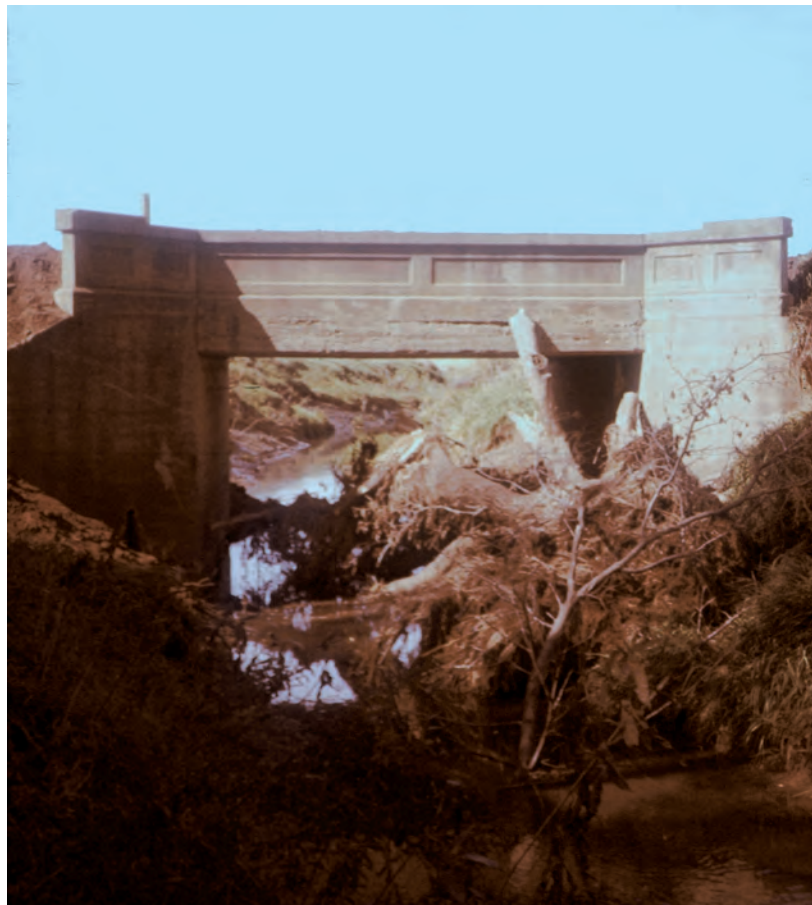
Figure A212. View looking downstream of road crossing and culvert, Stratton Creek near Washta, Iowa, August 1961.

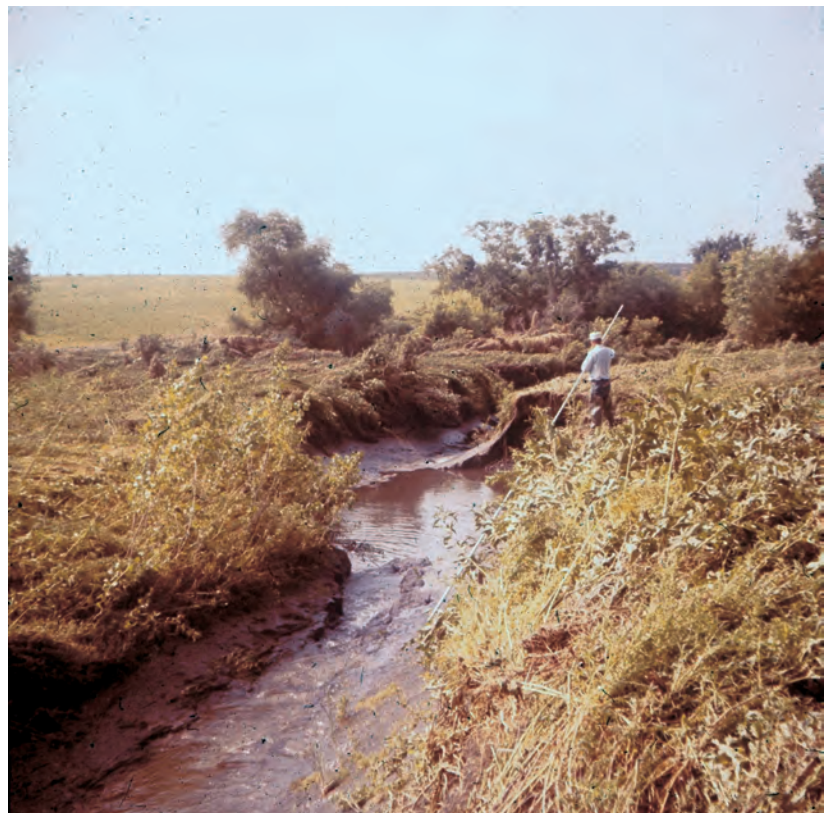
Figure A214. View looking downstream along channel upstream of cross section 1, Stratton Creek near Washta, Iowa, August 1961.

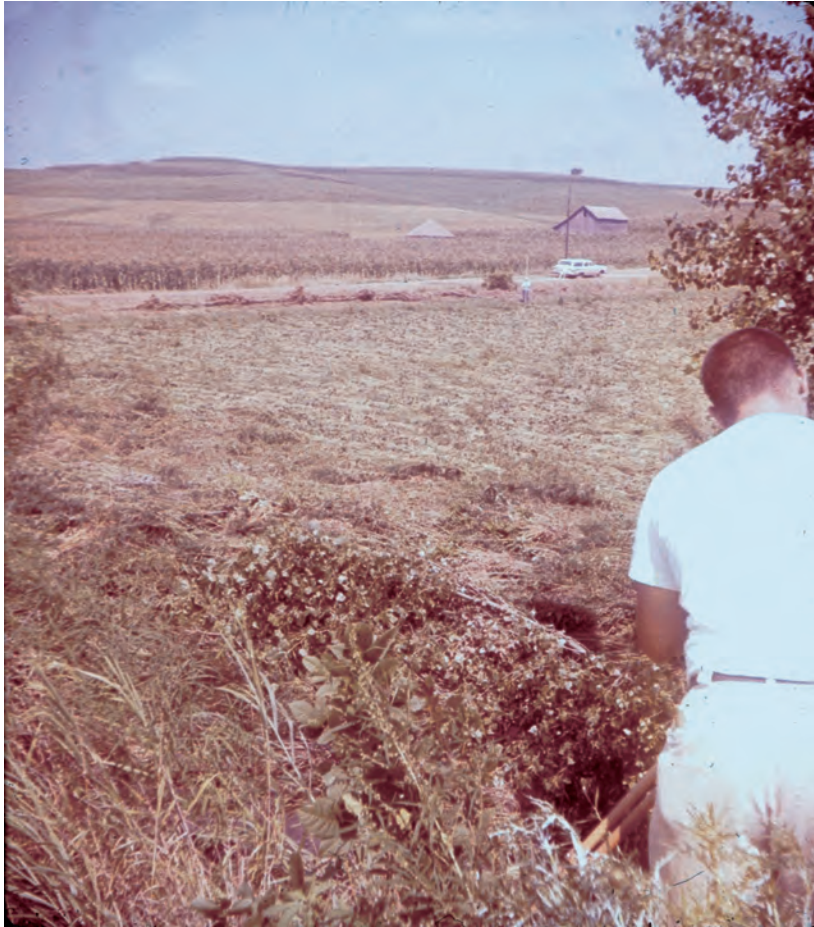
Figure A215. View looking from left bank to right bank long cross section 1, Stratton Creek near Washta, Iowa, August 1961.

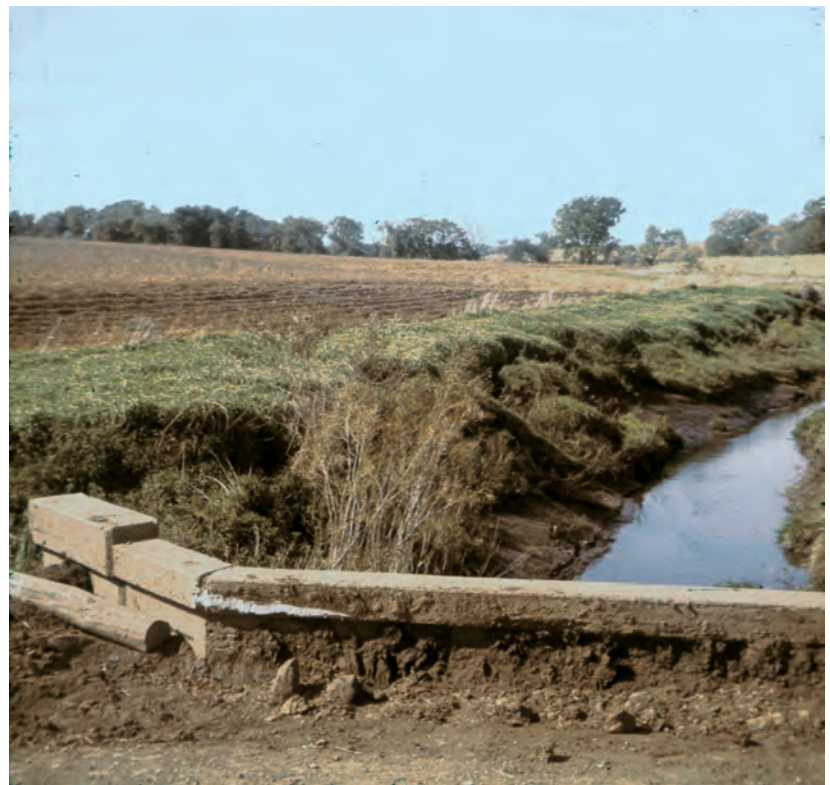
Figure A216. View looking downstream of left bank, Stratton Creek near Washta, Iowa, August 1961.

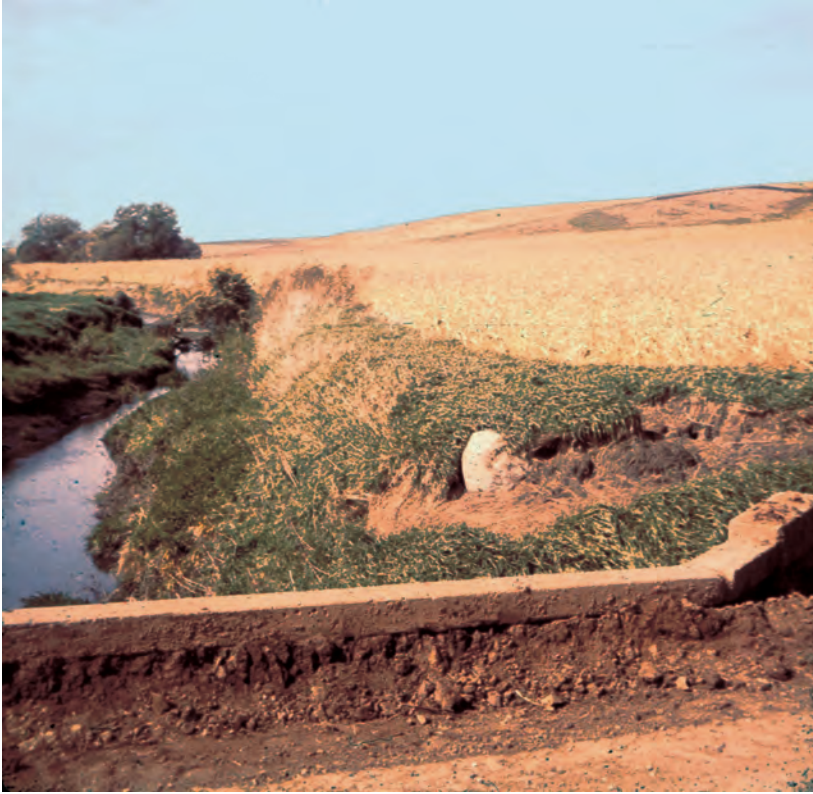
Figure A217. View looking downstream of right bank, Stratton Creek near Washta, Iowa, August 1961.

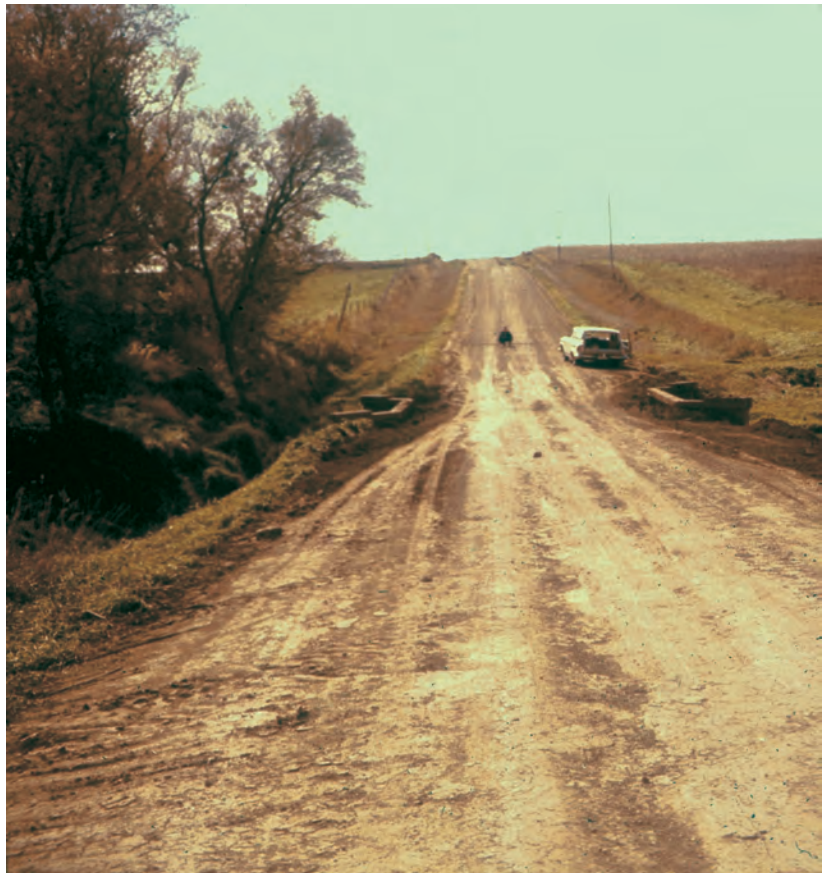
Figure A218. View of left bank high-water mark at bridge crossing, Stratton Creek near Washta, Iowa, August 1961. Flow is from left to right.

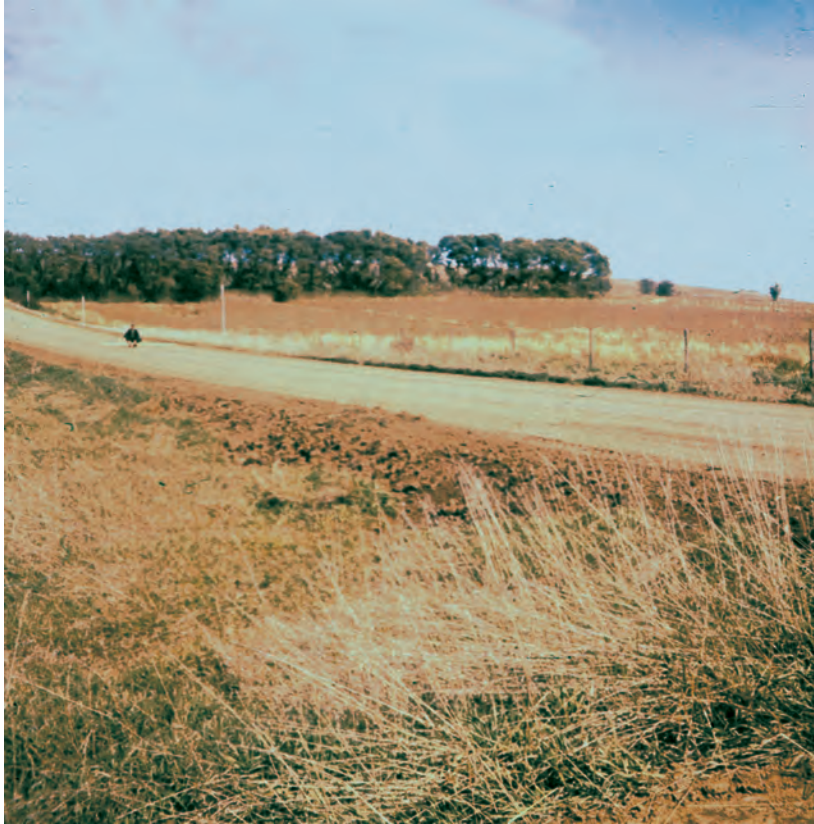
Figure A219. View of right bank high-water mark of downstream side of road and culvert crossing, Stratton Creek near Washta, Iowa, August 1961.

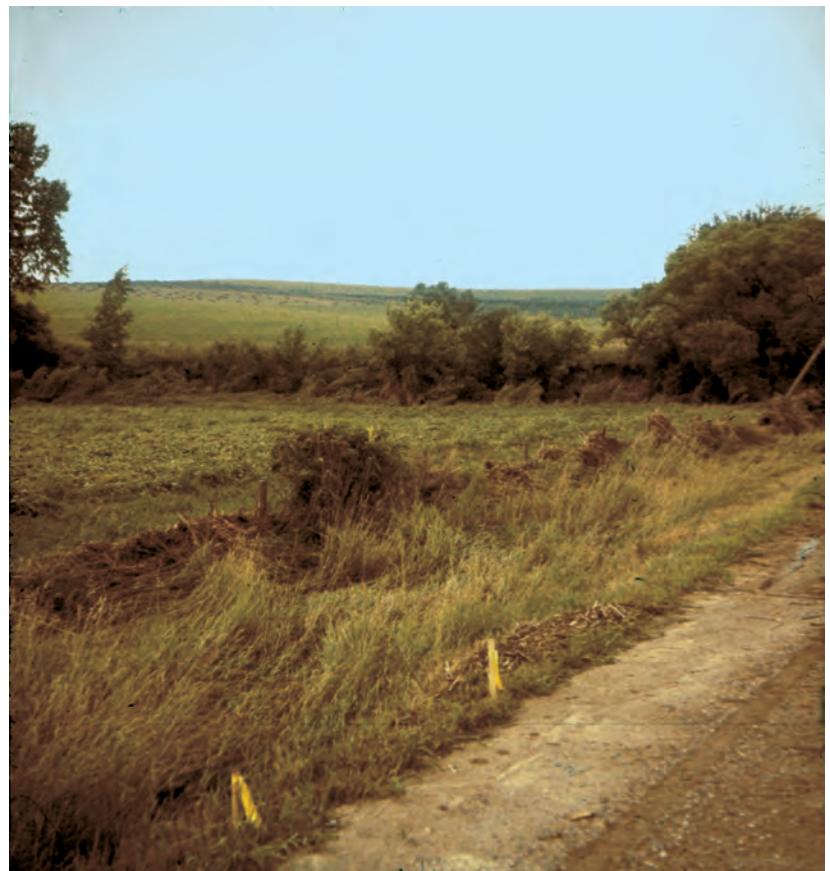
Figure A220. View of slope-area reach upstream of culvert, Stratton Creek near Washta, Iowa, August 1961. Flow is from left to right.
