**Appendix A. Individual Evaluations of 30 Peak Discharges from
28 Extraordinary Floods in the United States**

Seco Creek near D'Hanis, Texas

Review of peak discharge for the flood of May 31, 1935

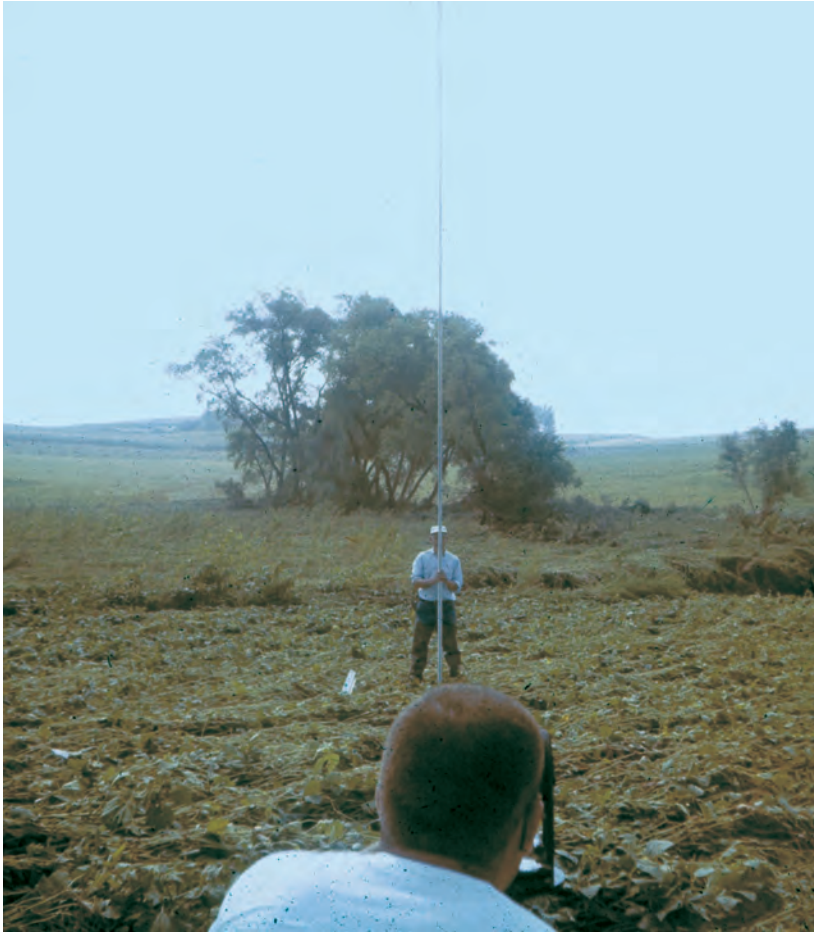
Figure A221. View looking from right to left along cross section 1, Stratton Creek near Washta, Iowa, August 1961.

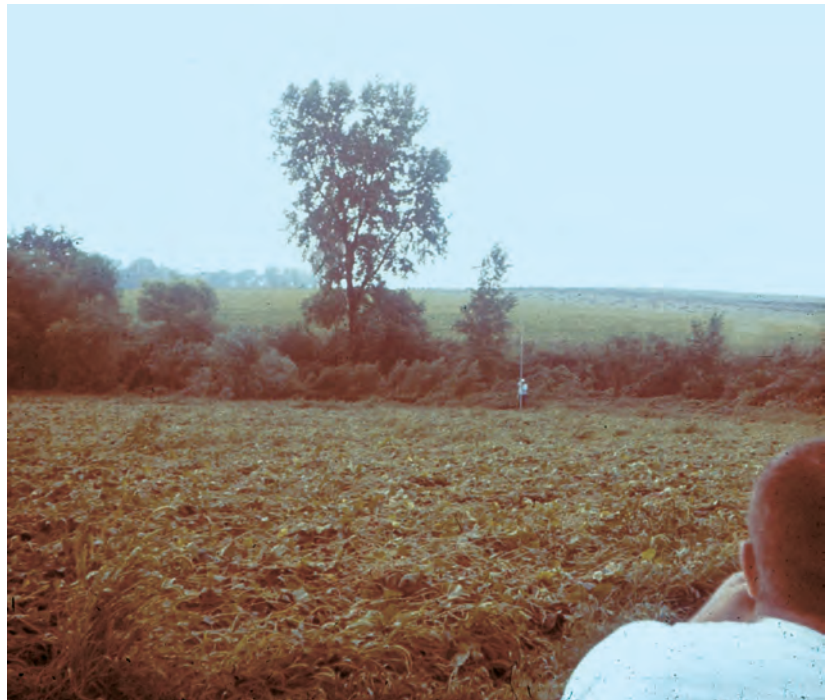
Figure A222. View looking from right to left along cross section 2, Stratton Creek near Washta, Iowa, August 1961.

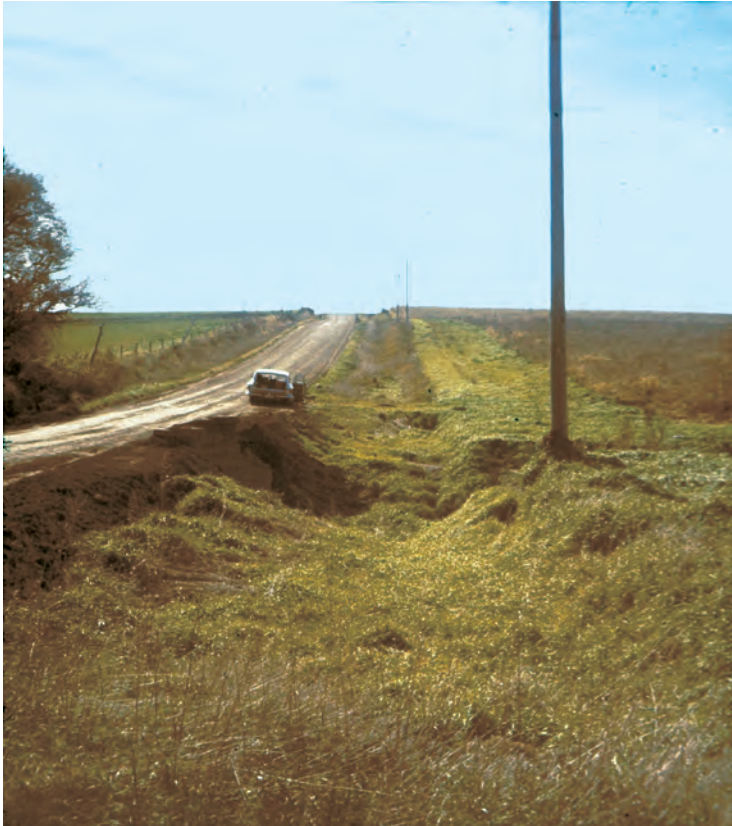
Figure A223. View looking toward left bank from downstream side of road and culvert, Stratton Creek near Washta, Iowa, August 1961.

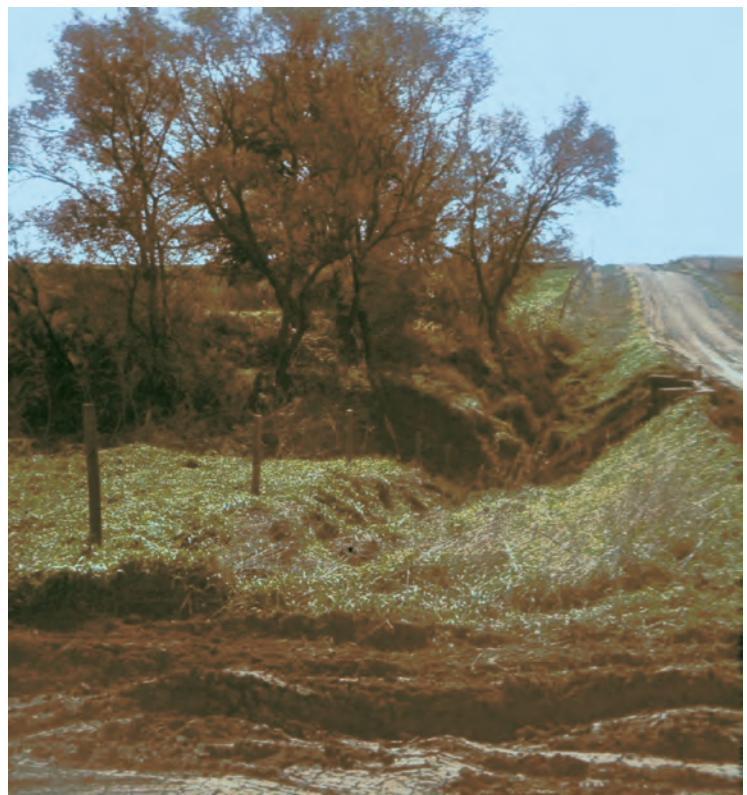
Figure A224. View looking toward left bank from end of cross section 2, Stratton Creek near Washta, Iowa, August 1961.

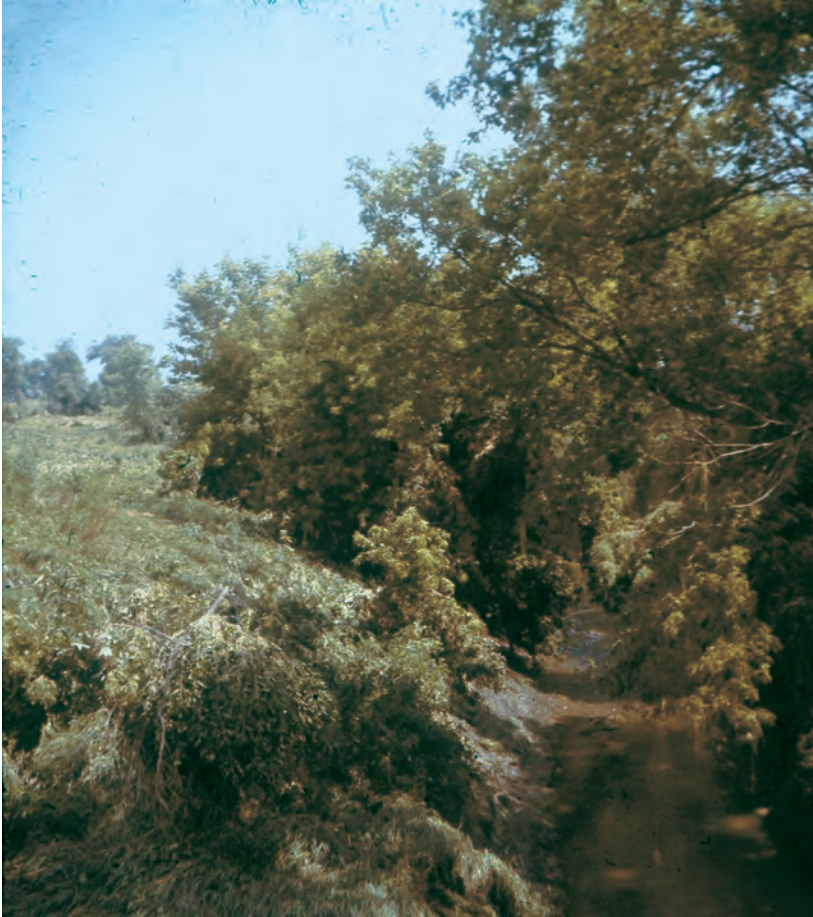
Figure A225. View looking upstream of culvert and road crossing, Stratton Creek near Washta, Iowa, August 1961.

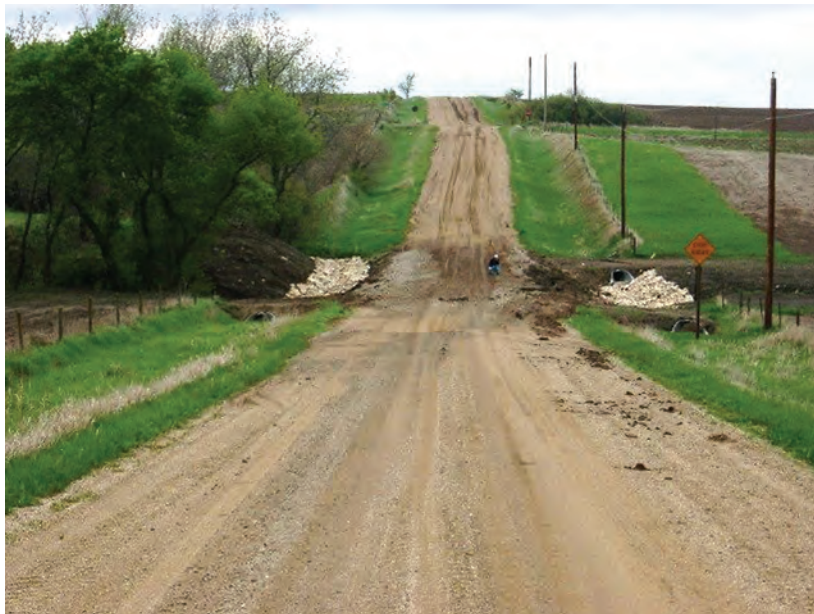
Figure A226. View looking from right to left bank along road crossing, Stratton Creek near Washta, Iowa, May 5, 2003.

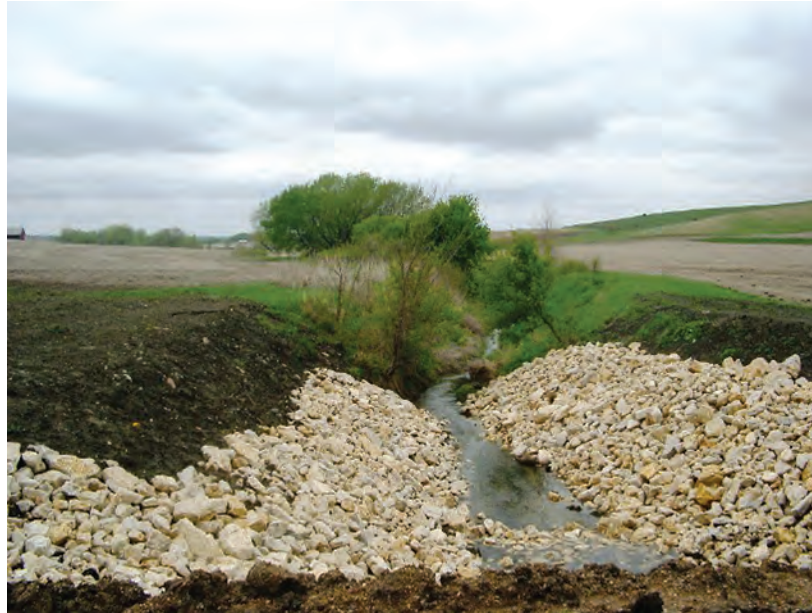
Figure A227. View looking downstream of culvert and road crossing, Stratton Creek near Washta, Iowa, May 5, 2003.

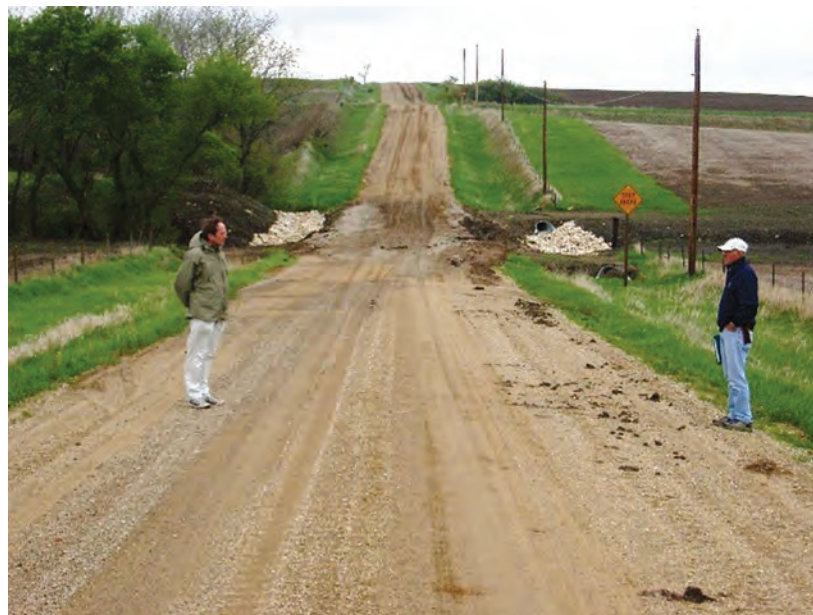
Figure A228. View looking from right to left bank with people standing on approximate high-water mark, Stratton Creek near Washta, Iowa, May 5, 2003.

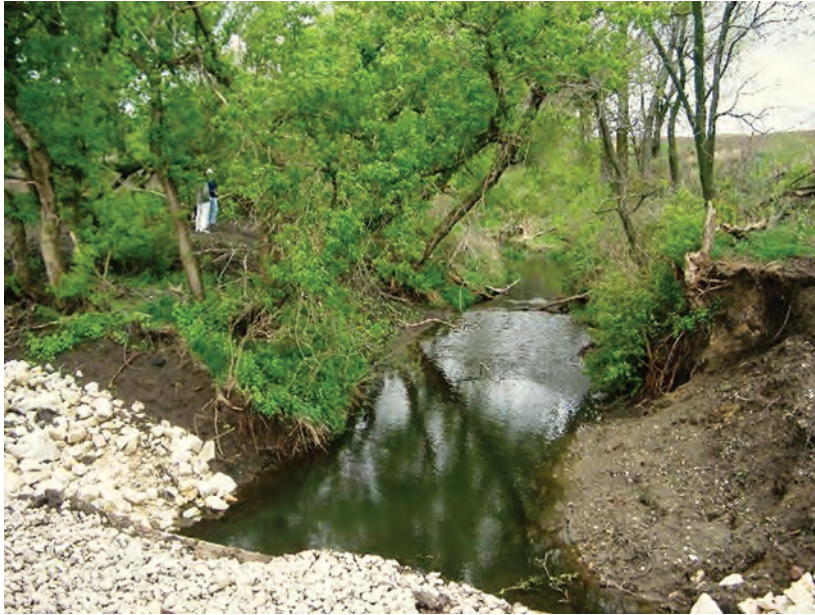
Figure A229. View looking upstream of culvert and road crossing, Stratton Creek near Washta, Iowa, May 5, 2003.

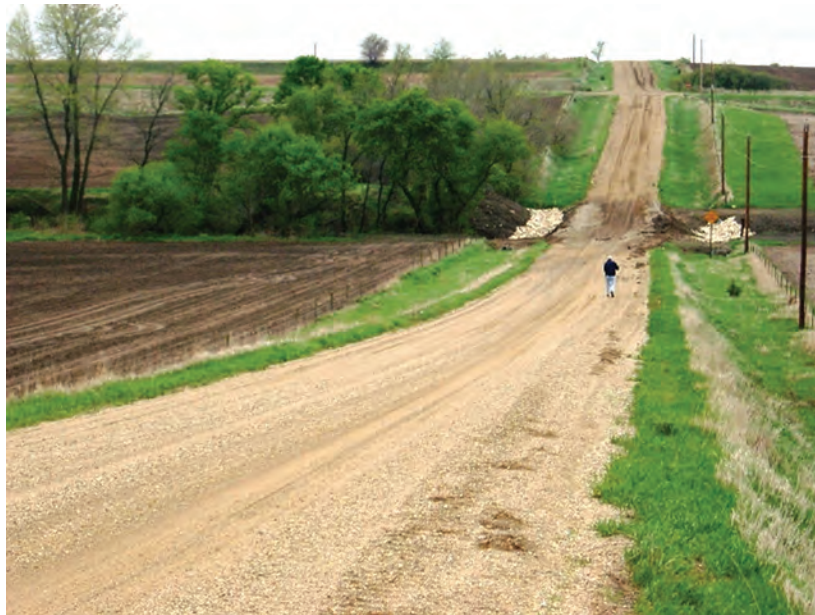
Figure A230. View looking from right to left bank at culvert crossing, Stratton Creek near Washta, Iowa, May 5, 2003. Flow is from left to right.

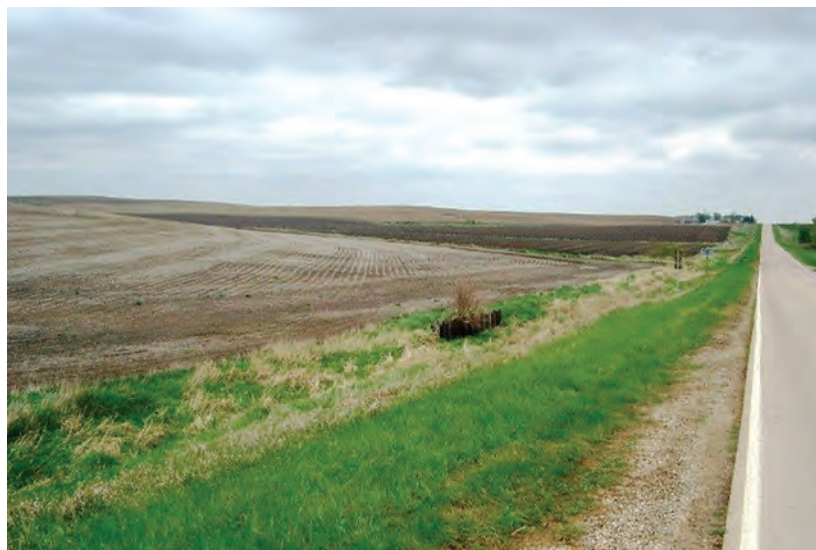
Figure A231. View of headwaters of Stratton Creek near Washta, Iowa, May 5, 2003.

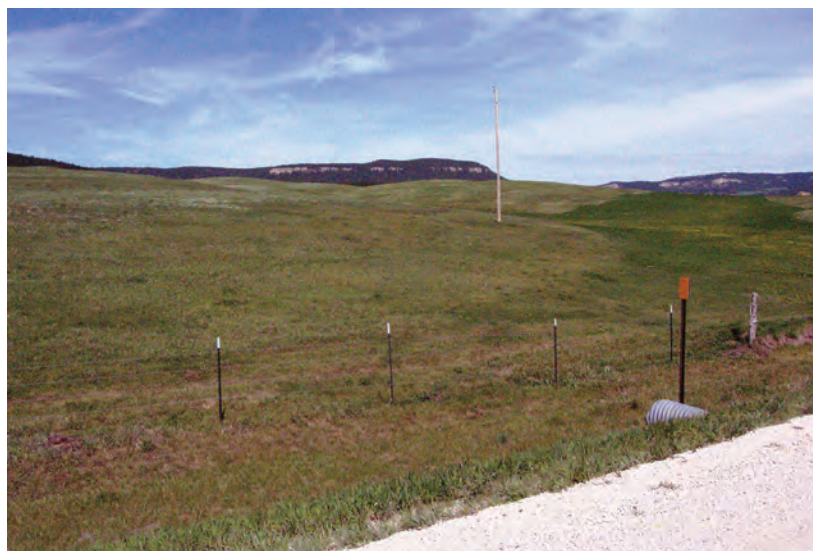
Figure A232. View looking upstream at the basin that produced the 1955 flood, Castle Creek Tributary No. 2 near Rochford, South Dakota, May 29, 2002. The basin perimeter is the grassed ridge in the near foreground (perhaps 300 yards away). The 1955 18-in. culvert has been replaced with a 24-in. culvert, and the road fill has been raised and is about twice as wide.

The original 18-in. culvert has been replaced with a 24-in. diameter culvert with spiraled corrugation. Therefore, the unusual entrance condition noted in the survey could not be examined. The county road also has been raised perhaps 1–2 ft and widened; the present culvert is about 50 ft long, whereas the original culvert length was 24 ft. Ralph Teller spoke to the county road crew chief, Heine Junge, who confirmed that the roadway has changed since 1955. It is unlikely, however, that there have been any significant changes to the basin that produced the flood. That basin, which is about 600 ft wide and extends about 1,000 ft upstream, has grass cover and no trees. Upstream from the roadway, the waterways are grassy swales, and there are no defined channels. Flow during extreme storms would essentially arrive at the roadway as sheet flow that converges at the culvert.

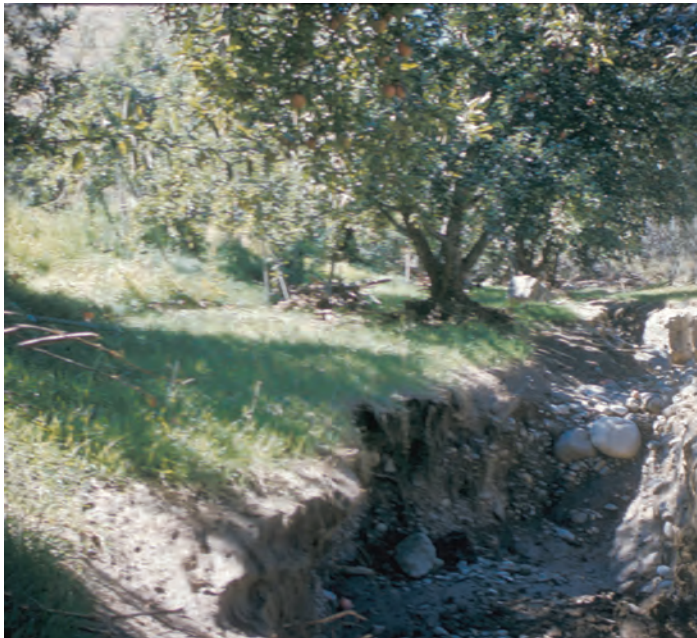
Figure A233. View upstream of lower reach of Wenatchee River tributary near Monitor, Washington, 1956. Section B at top of falls. Section A upstream of large rock.

Possible sources of error: The downstream slope-area measurement was made in a reach that had been filled in to create a level planting area for an orchard. The fill was eroded, and it is impossible to know the channel geometry at the time of the peak discharge. The cross-section geometry could have developed after the peak discharge when flow duration was long enough to cause extensive erosion. Roughness coefficients and hydraulic computations for extremely steep basins like this one are always questionable.

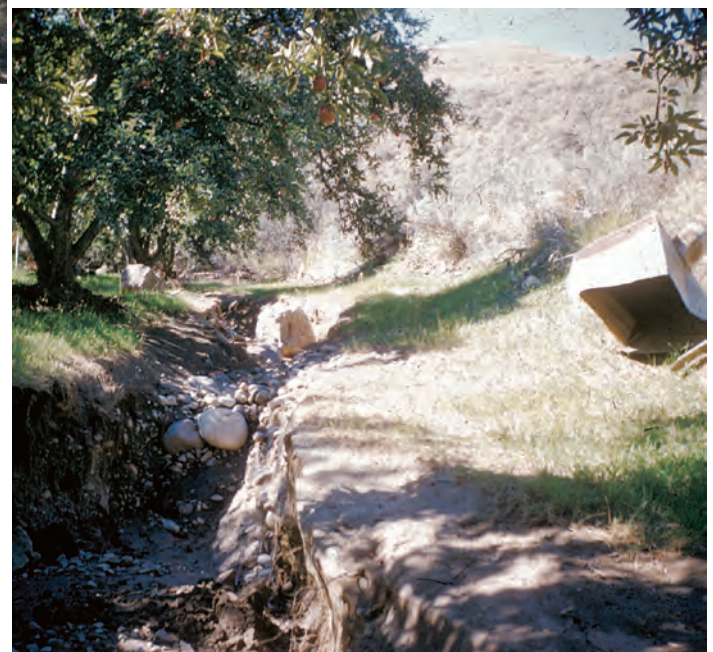
Figure A234. View upstream of sections A and B of lower reach of Wenatchee River tributary near Monitor, Washington, 1956.

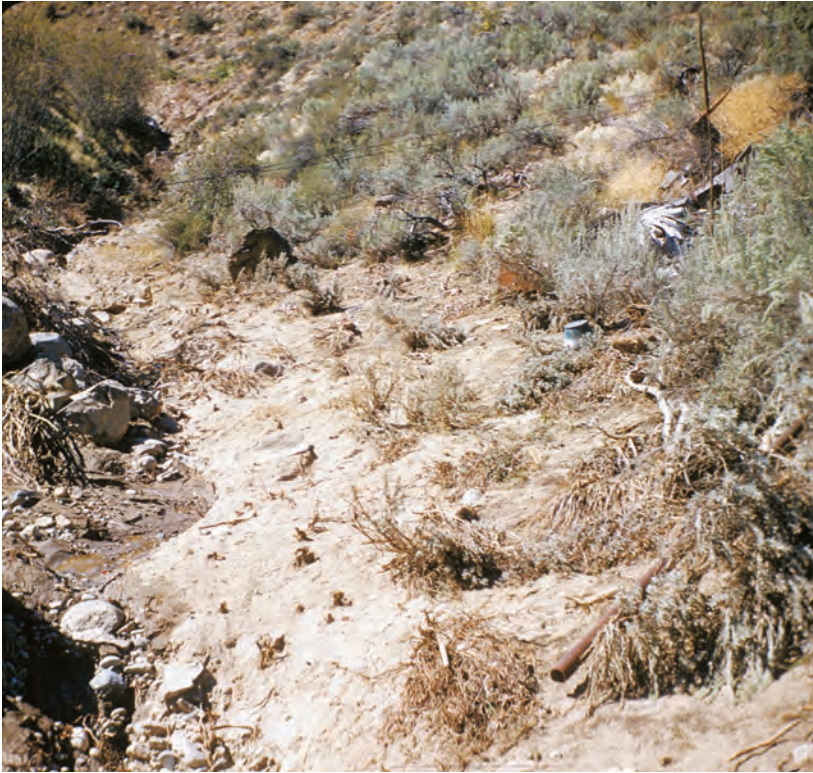
Figure A235. View upstream of sections A and C of upper reach of Wenatchee River tributary near Monitor, Washington, 1956. Section C at blue bucket.

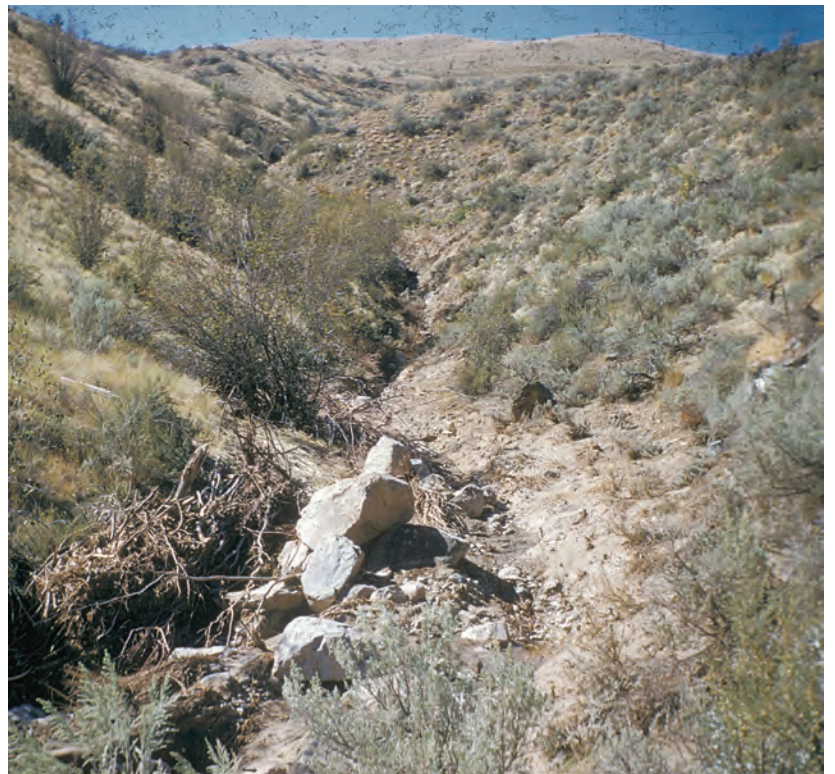
Figure A236. View upstream of sections A and B of lower reach of Wenatchee River tributary near Monitor, Washington, 1956.

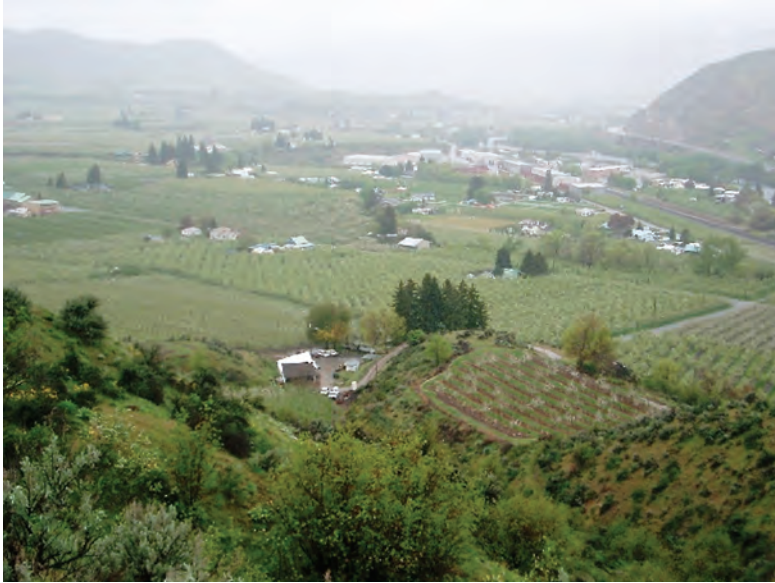
Figure A237. View downstream of headwaters, Wenatchee River tributary near Monitor, Washington, May 2003.

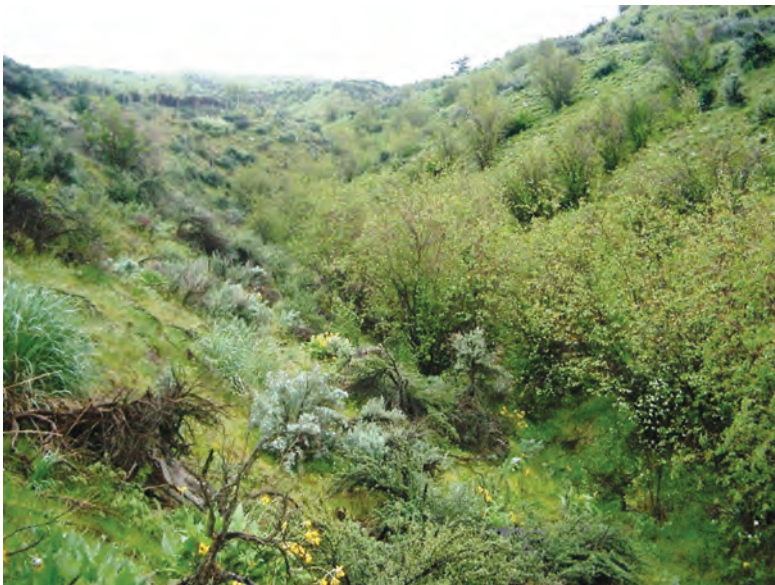
Figure A238. View upstream toward headwaters, Wenatchee River tributary near Monitor, Washington, May 2003.

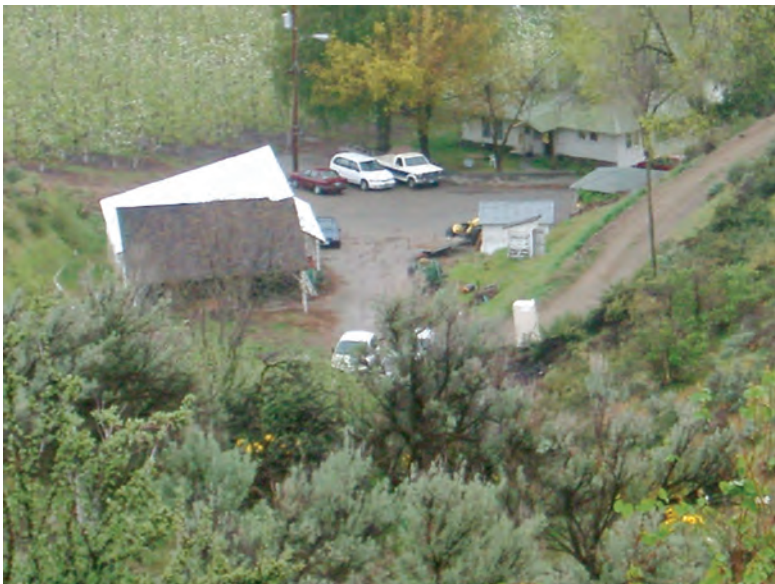
Figure A239. View downstream toward damaged house at mouth of basin, Wenatchee River tributary near Monitor, Washington, May 2003.

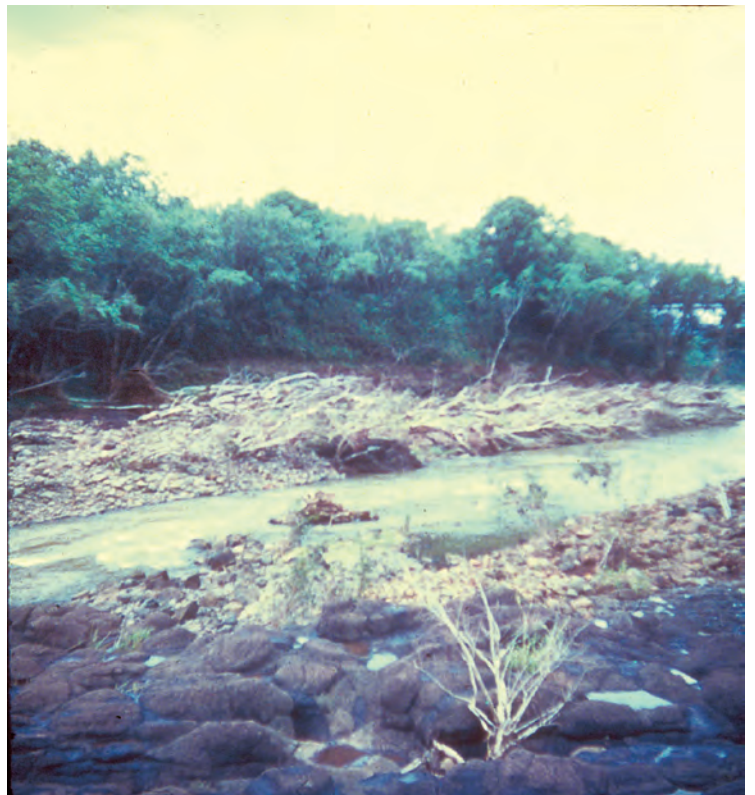
Figure A240. Reach looking downstream of streamgaging station, South Fork Wailua River near Lihue, Kauai, 1963.

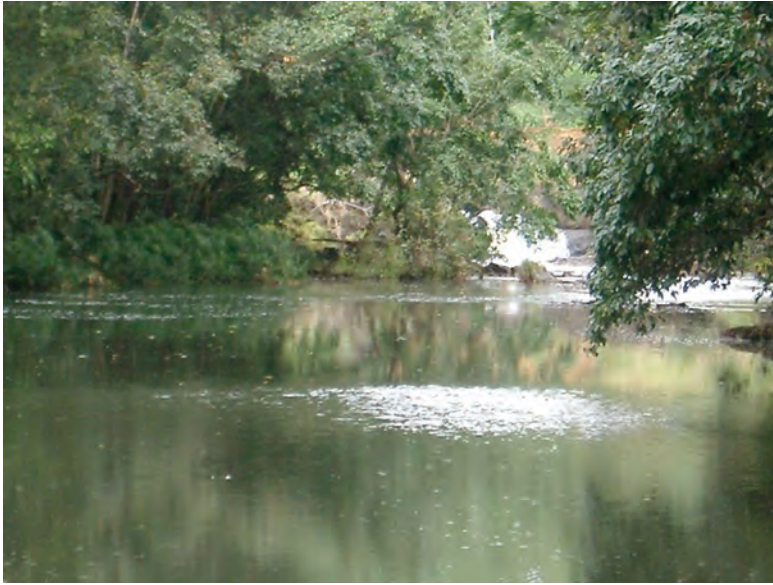
Figure A241. View upstream from cross-section 2, South Fork Wailua River near Lihue, Kauai, 2003.

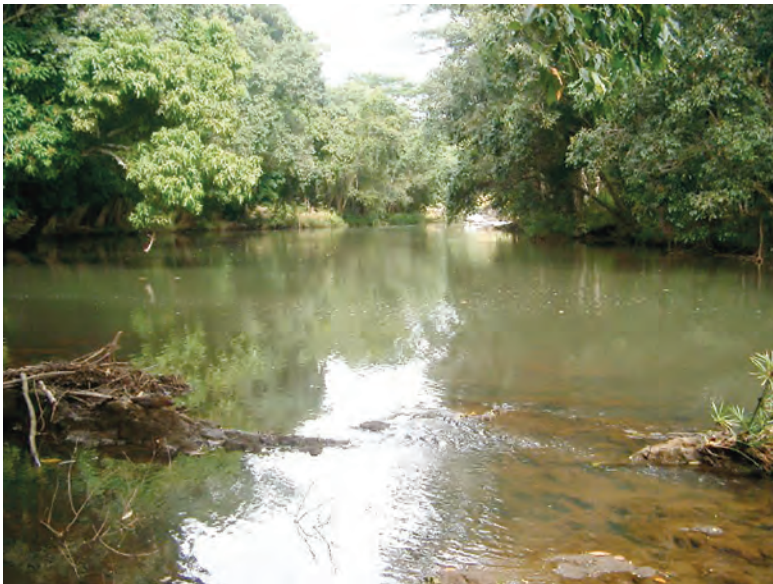
Figure A242. View downstream at cross sections A and B, South Fork Wailua River near Lihue, Kauai, 2003.

The hydraulic conditions are less than ideal because of road overflow and a road embankment failure at the upstream end of the reach and a wide cross section B with assumed flow reversal (noncontributing flow) along the right bank. The magnitude of the presumed eddy is unknown, but the right-bank profile had almost no fall along the right bank from about half way between the sections to the end of the reach. Reverse flow possibly was present at the time of the peak discharge. The eddy effect probably was caused by channel geometry and debris caught on an old railroad bridge abutment just downstream of section B. The conveyance did not likely vary uniformly between sections. Hydraulic conditions are further questioned because of the very rapid rise and decline in stage. The stage rose 6 ft in a matter of a few minutes that followed a fairly significant decline in stage. This type of change often occurs when water is released from storage behind an obstruction upstream. The rapid onslaught of a very wet period following a very dry period could have triggered slope failures in the upstream part of the basin. Slope failures could have created a series of dams, but direct evidence for this possibility is not available.

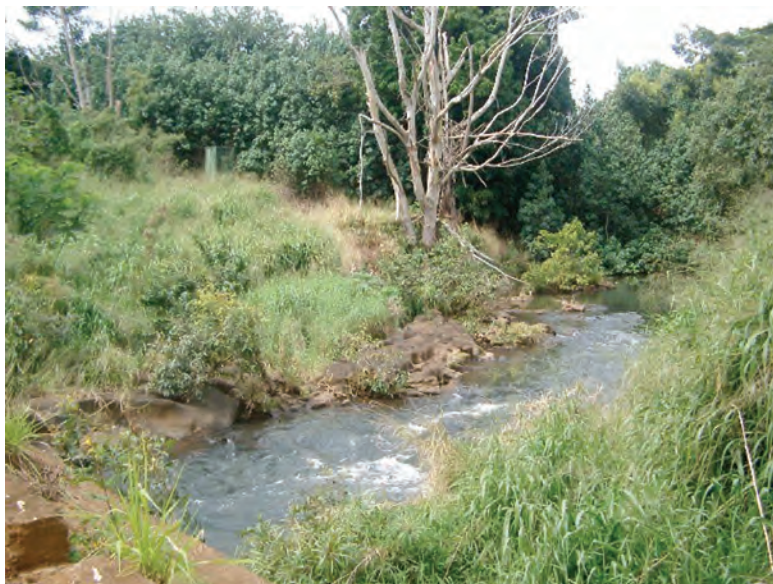
Figure A243. View upstream at streamflow-gaging station, South Fork Wailua River near Lihue, Kauai, 2003.

The recorded gage height for this peak discharge is verified by an inside high-water mark. No profile of outside high-water marks was surveyed past the gage, so it is unknown if the recorded peak discharge reflects the actual gage height. The alignment of the channel could cause a sloped water surface at the gage similar to the bank-to-bank discrepancy measured downstream. The road embankment breach assumably increased the peak stage by as much as 0.6 ft. Any increase in the rate of change in stage from the recorder trace is difficult to confirm. Peak stage should be verified by outside high-water marks for future peak discharges.

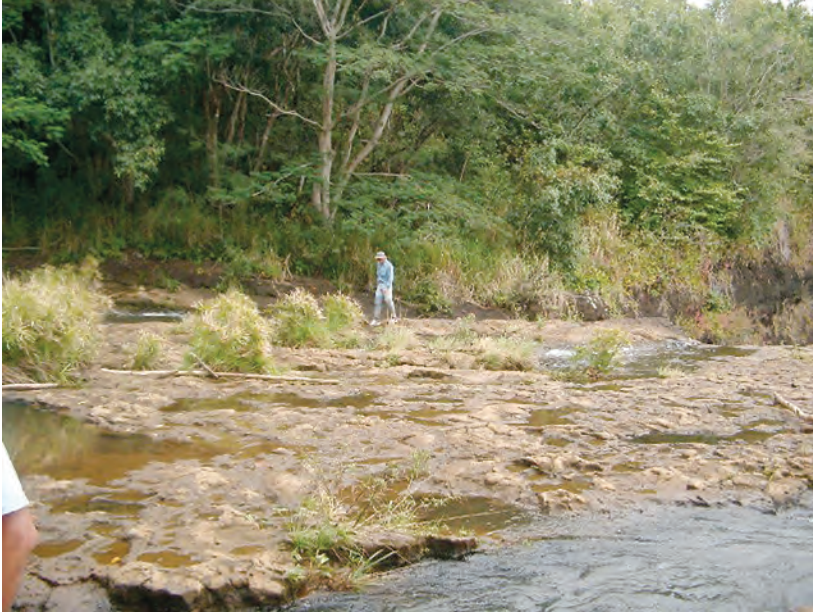
Figure A244. Top of Wailua Falls waterfall downstream of streamflow-gaging station but upstream of slope-area reach, South Fork Wailua River near Lihue, Kauai, 2003.

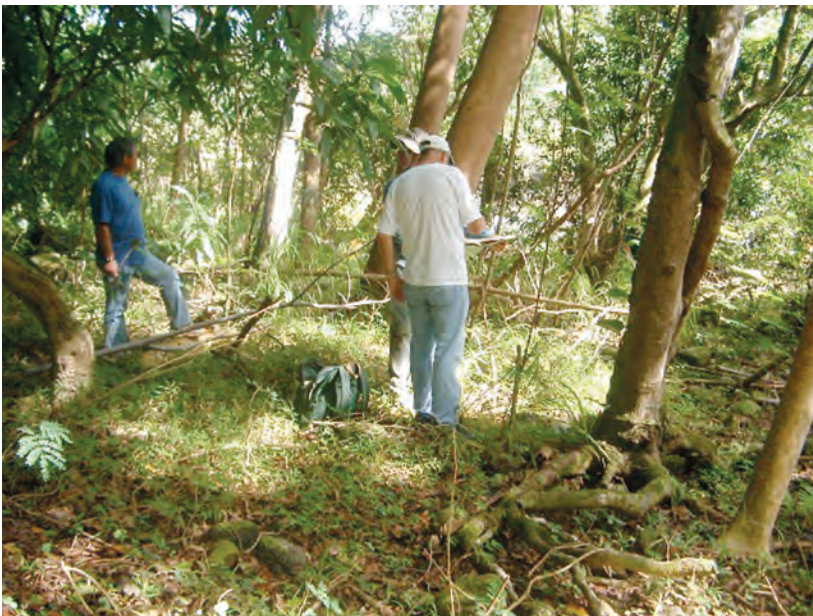
Figure A245. Left bank floodplain at cross section 1, South Fork Wailua River near Lihue, Kauai, 2003.

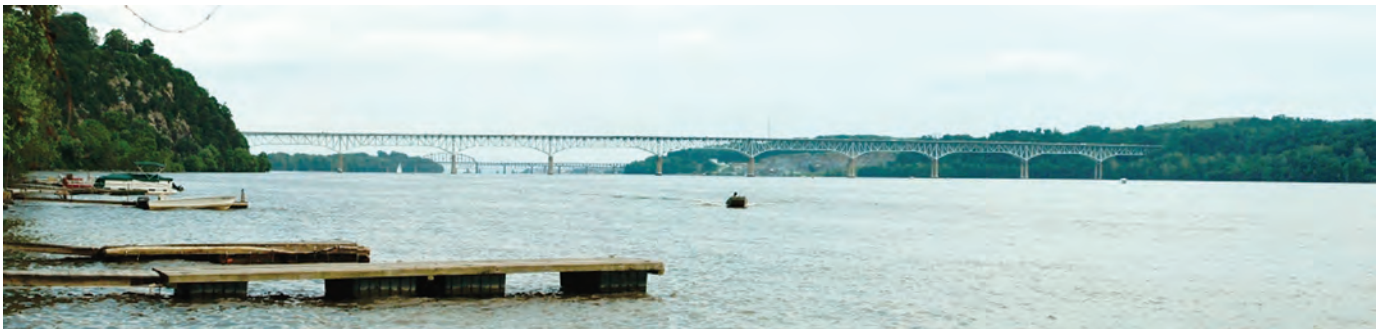
Figure A246. View upstream of Interstate Highway I-95 bridge across Susquehanna River where current-meter measurement was made of June 24, 1972 flood, Susquehanna River at Conowingo, Maryland.

Recommendations of what could have been done differently: The fact that a current-meter measurement was made so near the peak stage is highly commendable. The only thing that should have been done differently was to have made more detailed notes regarding the computation of vertical-angle corrections.

Recommendation: The original peak discharge of 1,130,000 ft³/s should be accepted as published, and rated good.

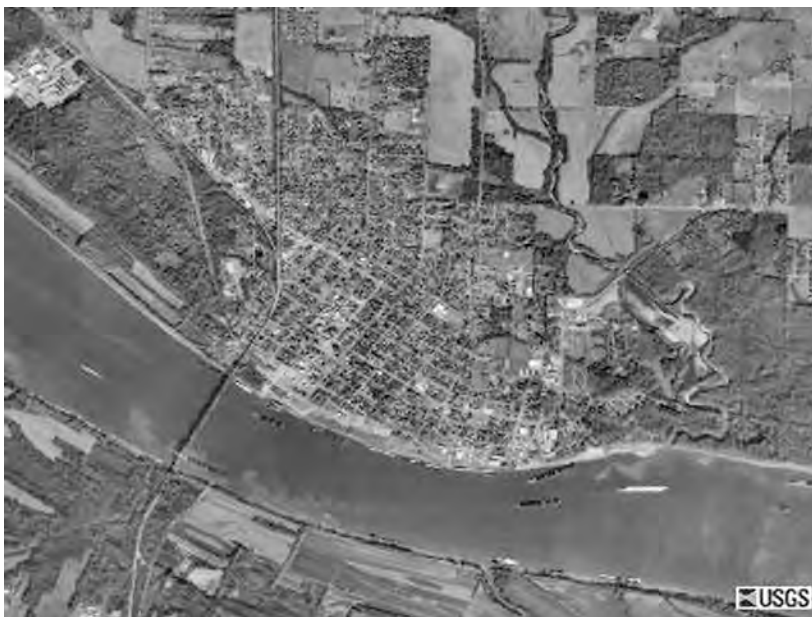
Figure A247. Aerial photograph of Metropolis, Ohio. Ohio River flows from right to left; bridge where discharge measurements were made in January and February 1937, appears in left-center of photograph.

Recommendation: The original peak discharge of 1,850,000 ft³/s should be accepted as published, and rated good.

In this case, the peak discharge is published as a mean daily rather than an instantaneous value. For a long-duration high peak, which this obviously is, there should be little difference between mean daily and instantaneous peaks.
