Cimarron Creek Tributary near Cimarron, New Mexico

Review of peak discharge for the flood of June 5, 1958

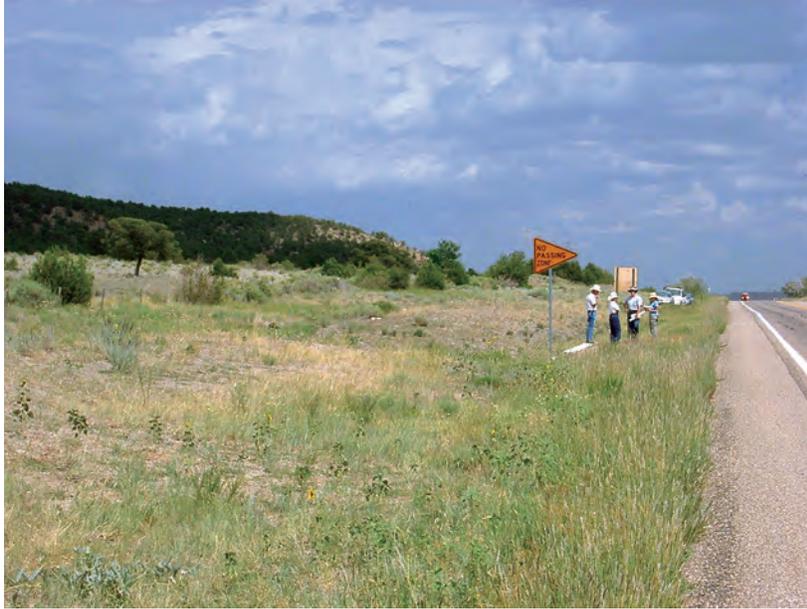
Site visit and review: The site was visited on August 5, 2003, by John Costa (USGS Office of Surface Water), Scott Waltemeyer (USGS New Mexico Water Science Center), Mark Smith (USGS Central Region), and Kenneth Wahl (USGS retired). The highway has been widened since 1958, and the culvert entrances have been changed to accommodate the wider roadway. However, the skewed culvert barrel is still in place. There was no evidence that past flows had been other than water floods that carry large amounts of sediment as bed load.

Figure A156. Site of culvert measurement, Cimarron Creek Tributary near Cimarron, New Mexico, August 5, 2003.

Data for storm causing flood: There is no information on the storm that caused the flood. The measurement summary notes only the location, type of computation, and result. The flooding undoubtedly was the result of a small, intense thunderstorm cell common in this part of New Mexico. A photograph taken during the 2003 review and described herein is provided in figure A156.

Debris blocking the culvert entrance is unlikely given the lack of evidence of blockage in photographs taken during the survey. However, the fill observed in the approach at the time of the survey possibly existed during the flood given the high rates of sand transport. The cross-sectional area computed for the approach was about 200 ft², of which about 35–40 ft² was filled with sand. Even if the sand had been present at the peak discharge, flow would have been subcritical in the approach, and the culvert inlet would have been the control (type I flow). Therefore, the discharge would have been essentially as originally computed.

Recommendations: The original peak discharge of 337 ft³/s should be accepted as published, but rounded to 340 ft³/s. The drainage area should be corrected to 0.15 mi², and the numbers updated in future references to this flood.
