11067000 Day Creek near Etiwanda, California

(Discontinued gaging station in the Santa Ana River basin,
USGS California Water Science Center)

Review of peak discharge for the flood of January 25, 1969

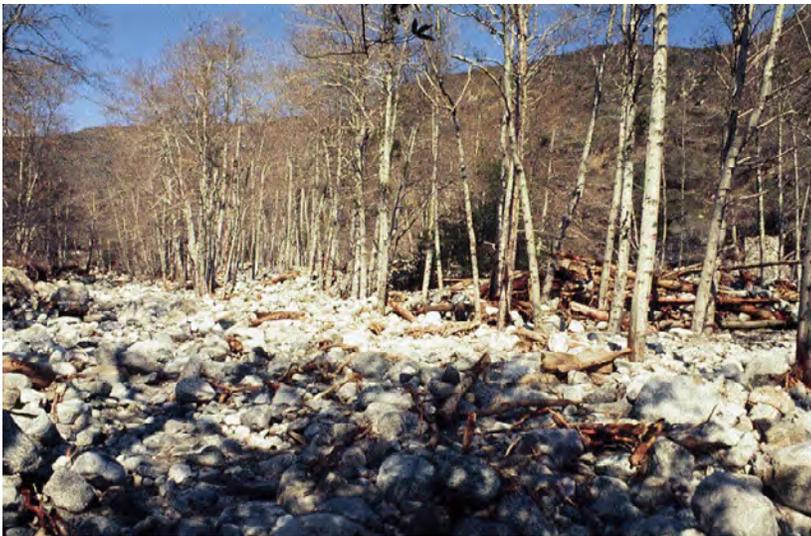
Figure A183. Unknown location in Day Creek, California, following debris flow showing abrasion on trees, but no major damage in spite of very coarse materials being moved.

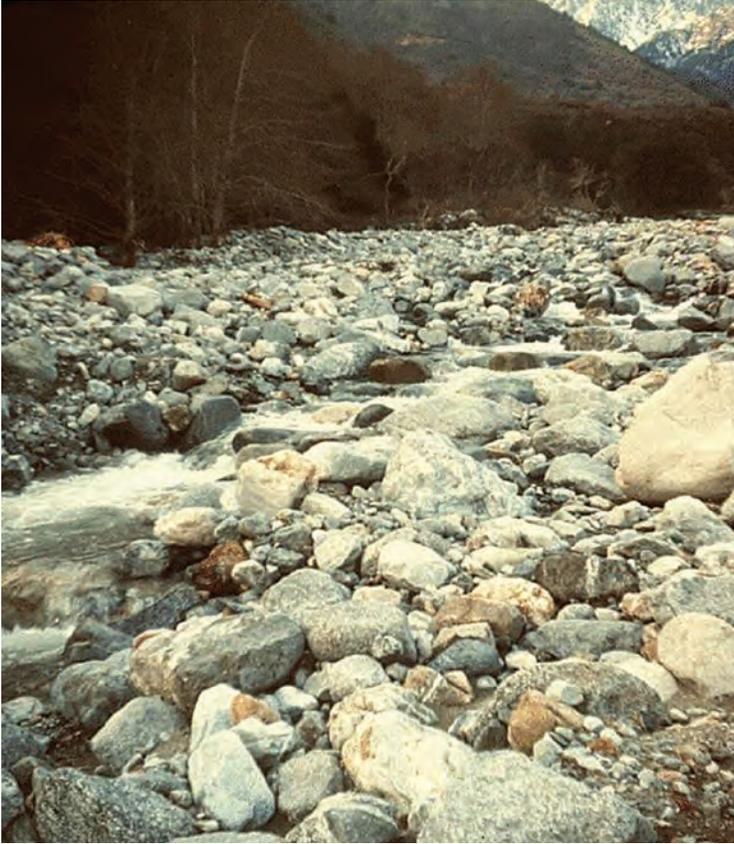
Figure A184. View looking upstream toward slope-area reach, Day Creek near Etiwanda, California, February 1969.

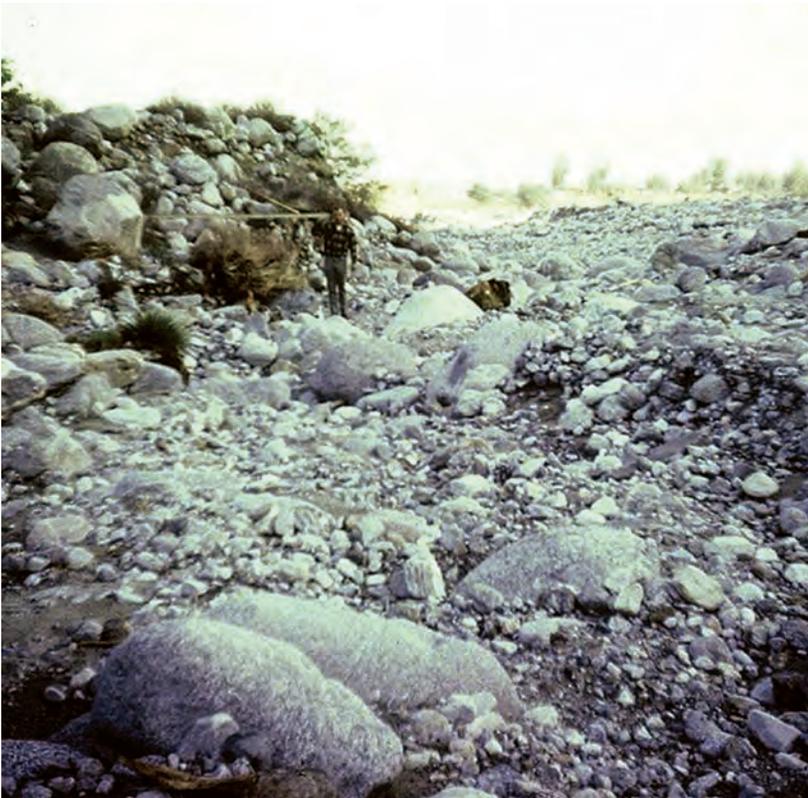
Figure A185. View looking downstream at left bank at cross section 2, Day Creek near Etiwanda, California, February 1969.

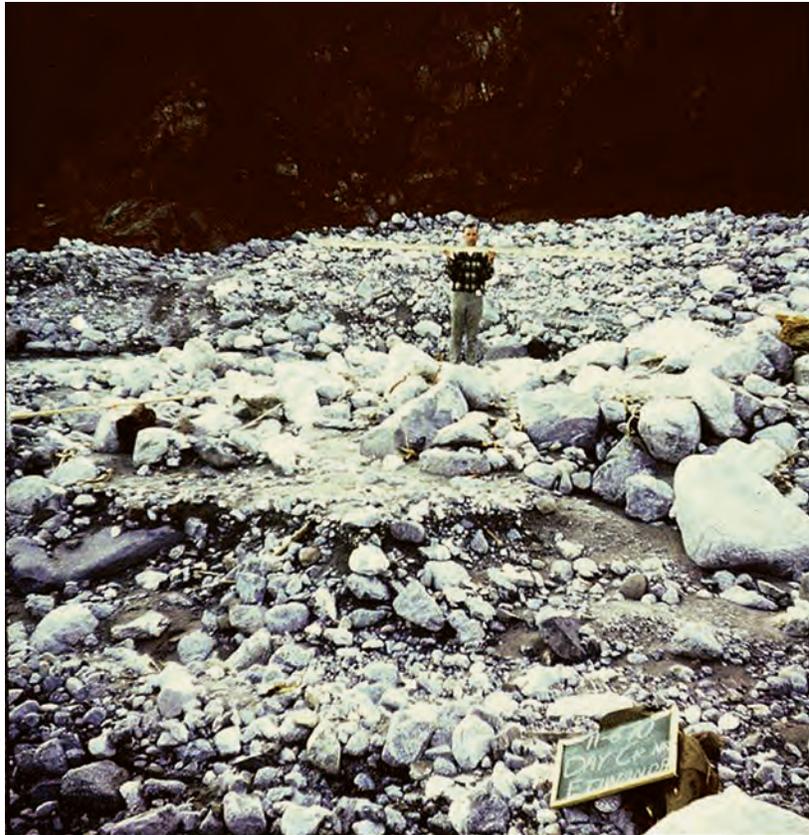
1. The remnants of the highest recent deposits in the valley cross section (matching the positions of the 1969 deposits shown in the 1969 photographs) show that the original depositional surface was broadly convex, with lobate lateral and frontal margins.
2. The lobes of debris were about 1-2 m high and had coarse clasts (boulders) concentrated on the outer margins of the lobes; the bouldery rims held back finer grained debris.
3. Except at the margins where boulders were concentrated, the deposit exhibited a clast-supported, extremely poorly sorted texture with no visible stratification. All voids between clasts were completely and tightly packed with matrix material.

Figure A188. View of debris-flow lobe in slope-area reach, Day Creek near Etiwanda, California, November 1970.

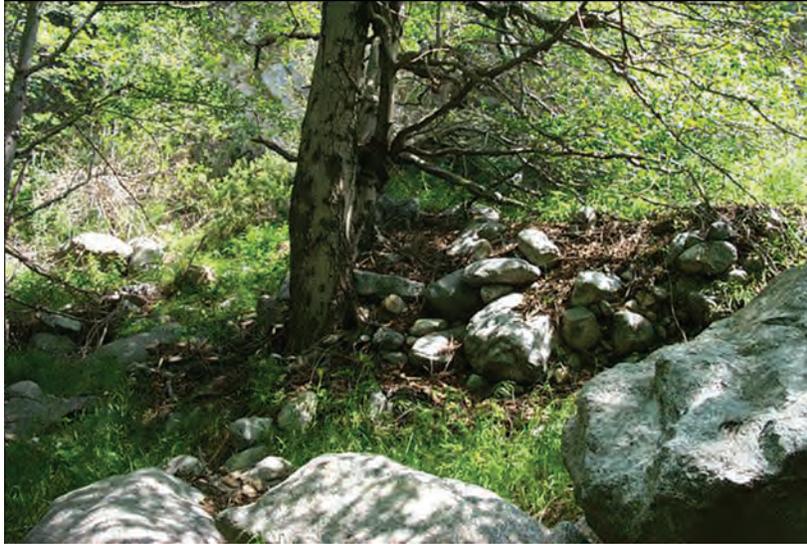
7. Trees (live oaks) buried in about 1 m of coarse debris from the 1969 event showed no abraisional damage on the upstream sides of their trunks; they were alive and appeared to be quite healthy.

Figure A189. Debris-flow deposit arrested by tree near slope-area reach, Day Creek near Etiwanda, California, September 2002.

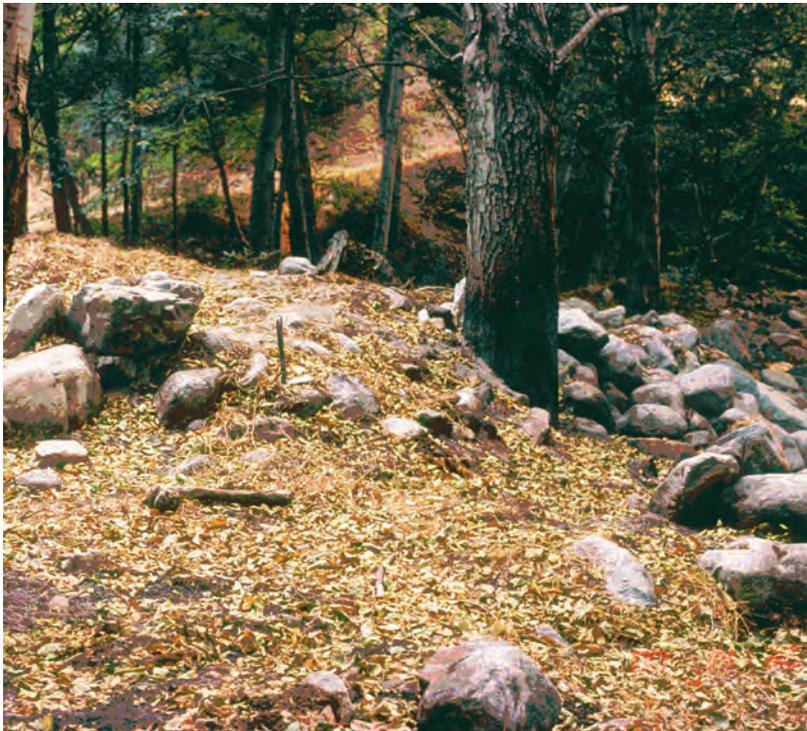
Figure A190. Boulder front of debris-flow lobe, Day Creek near Etiwanda, California, September 2002. Flow is from left to right.
