# Eldorado Canyon at Nelson Landing, Nevada

(Miscellaneous ungaged site, USGS Nevada Water Science Center)

## Review of peak discharge for the flood of September 14, 1974

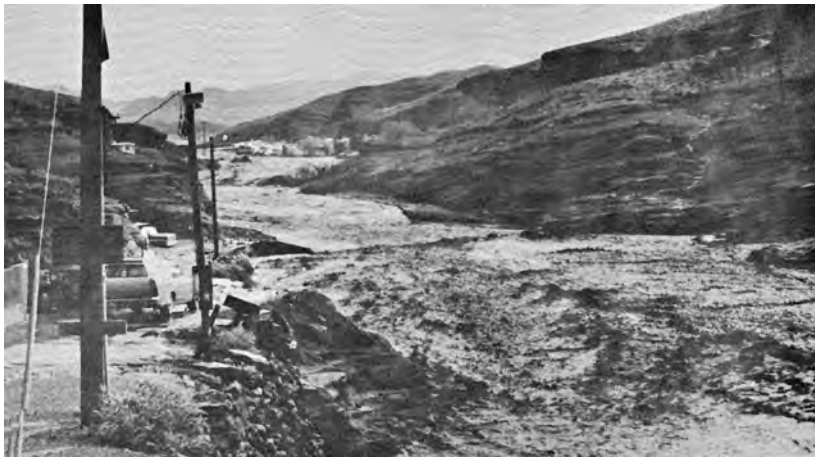
The September 17 issue of the Las Vegas Review-Journal carried a photograph (fig. A119) of the flood at the resort with the caption,

“The photograph was taken by a witness who ran to high ground and pointed his camera down the canyon.”

The same photograph is figure 7A of Glancy and Harmsen (1975) and has the caption

“On September 14, 1974, probably during the recession of flooding (photograph by Kenneth E. Beales, Las Vegas, Nevada).”

The photograph shows a water flood. However, the newspaper caption suggesting that the photograph was taken before the peak is in error. The restaurant is missing, giving graphic testimony that the photograph was taken after the destruction of the restaurant.

**Figure A119.** Flood in Eldorado Canyon at Nelson Landing, Nevada, September 14, 1974 (from Glancy and Harmsen, 1975, fig. 7A). Photograph taken by Kenneth E. Beales, Las Vegas, Nevada.

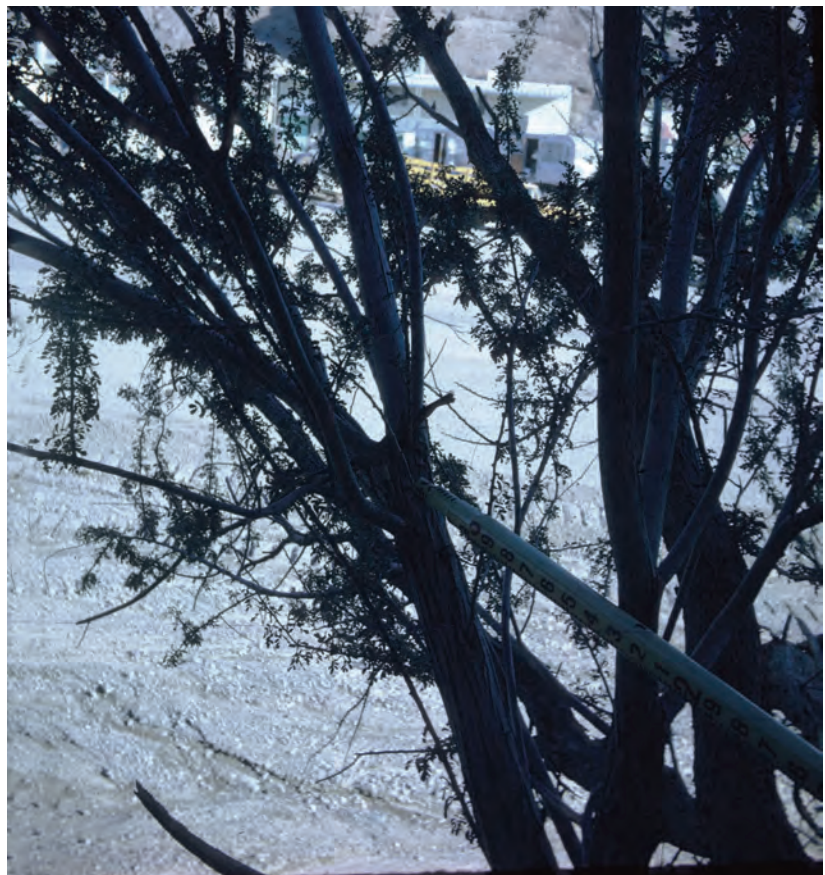
**Figure A121.** Mud marks in trees near right bank, Eldorado Canyon at Nelson Landing, Nevada, September 1974.

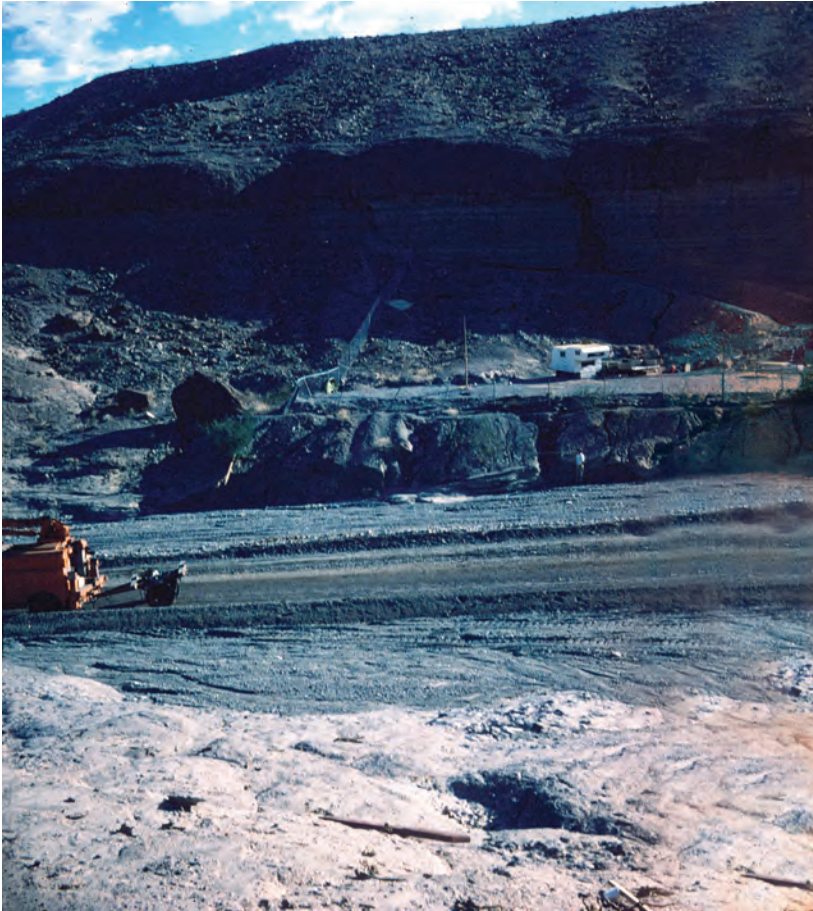
**Figure A122.** View of trailers from left bank to right bank, Eldorado Canyon at Nelson Landing, Nevada, September 1974.

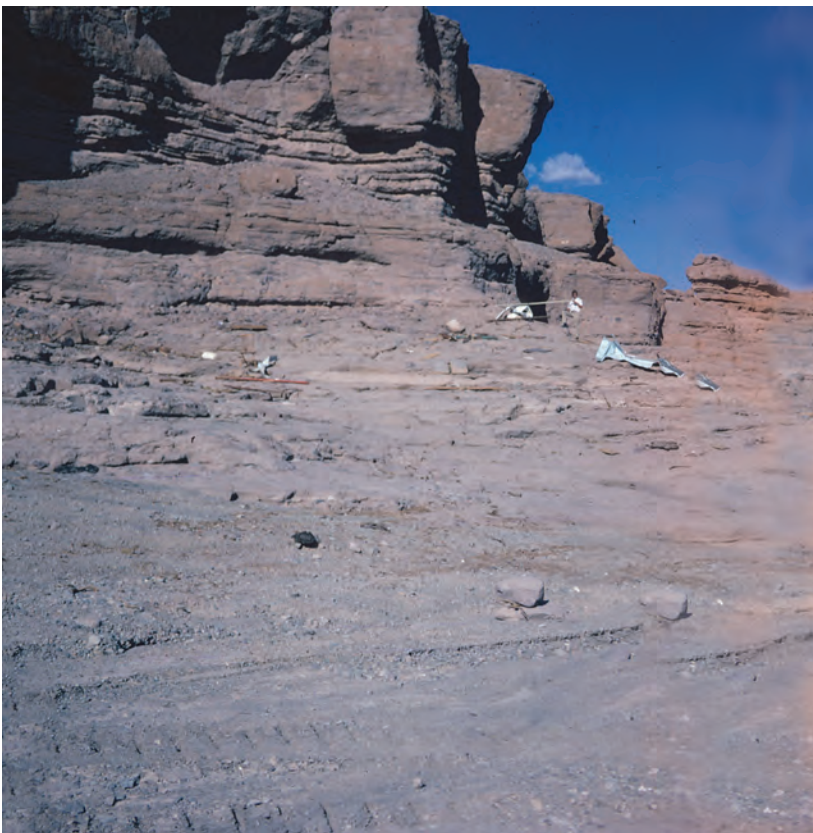
**Figure A123.** View of left bank high-water mark at trailer profile, Eldorado Canyon at Nelson Landing, Nevada, September 1974.

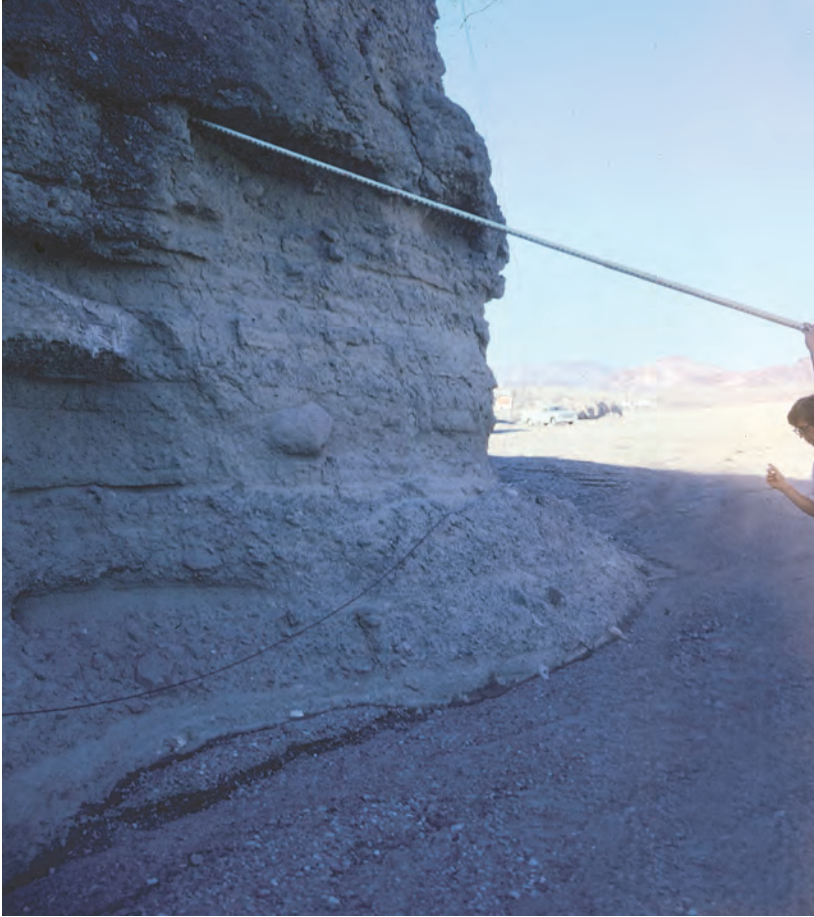
**Figure A124.** Right bank high-water mark at trailer profile, Eldorado Canyon at Nelson Landing, Nevada, September 1974.

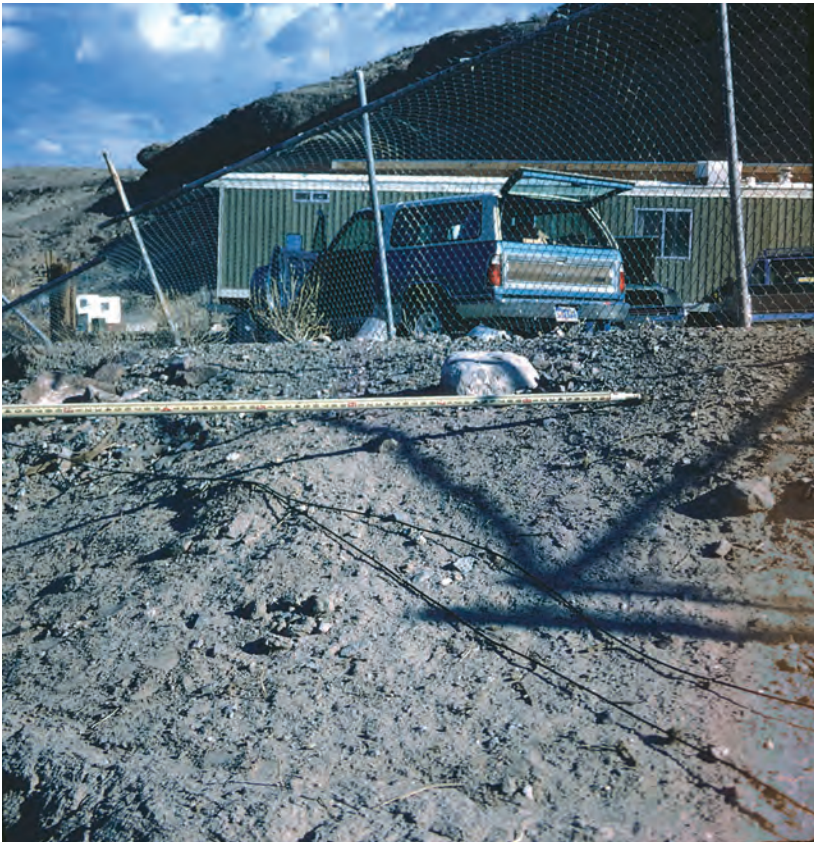
**Figure A125.** Right bank high-water mark at restaurant trailer, Eldorado Canyon at Nelson Landing, Nevada, September 1974.

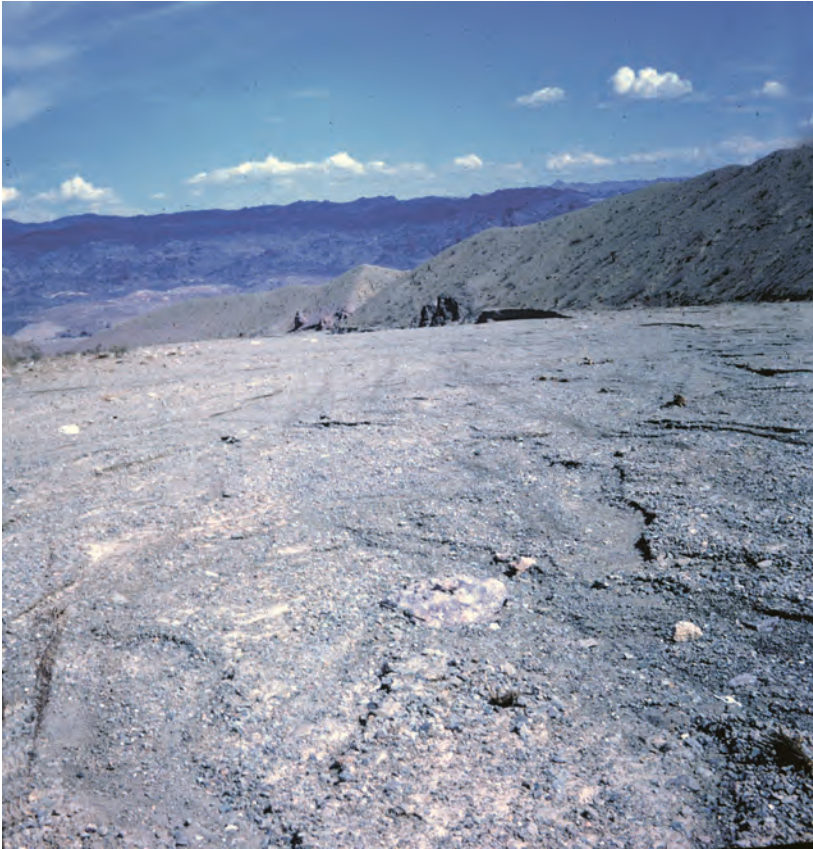
**Figure A126.** View downstream toward lower slope-conveyance site, Eldorado Canyon at Nelson Landing, Nevada, September 1974.

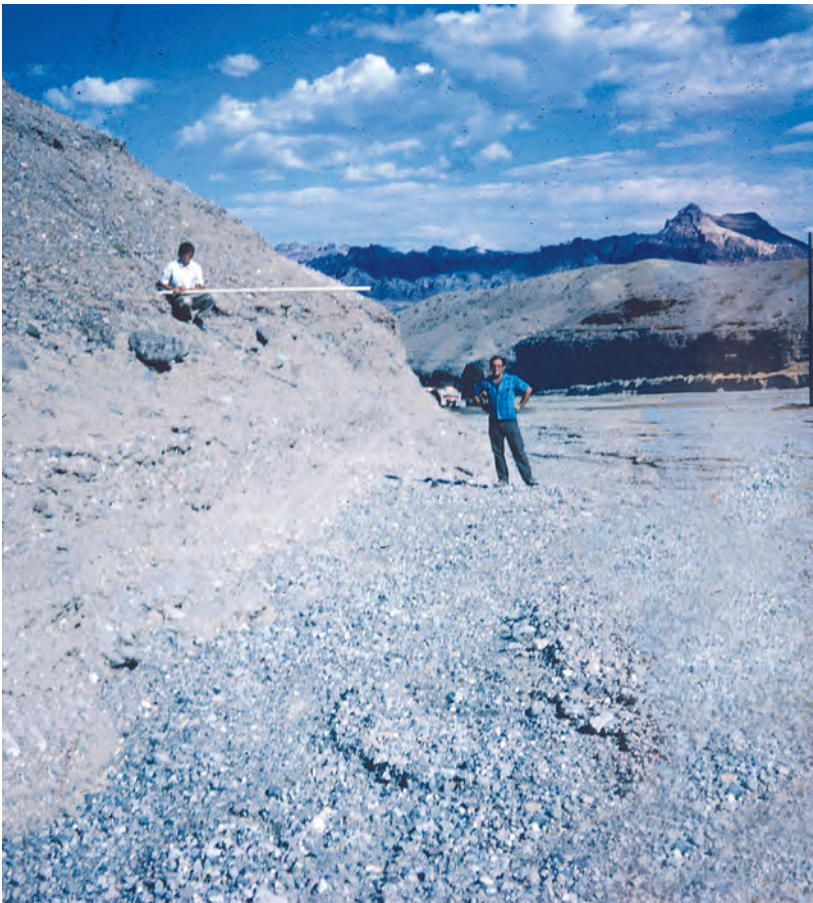
**Figure A127.** View downstream through cross-section 1, Eldorado Canyon at Nelson Landing, Nevada, September 1974.

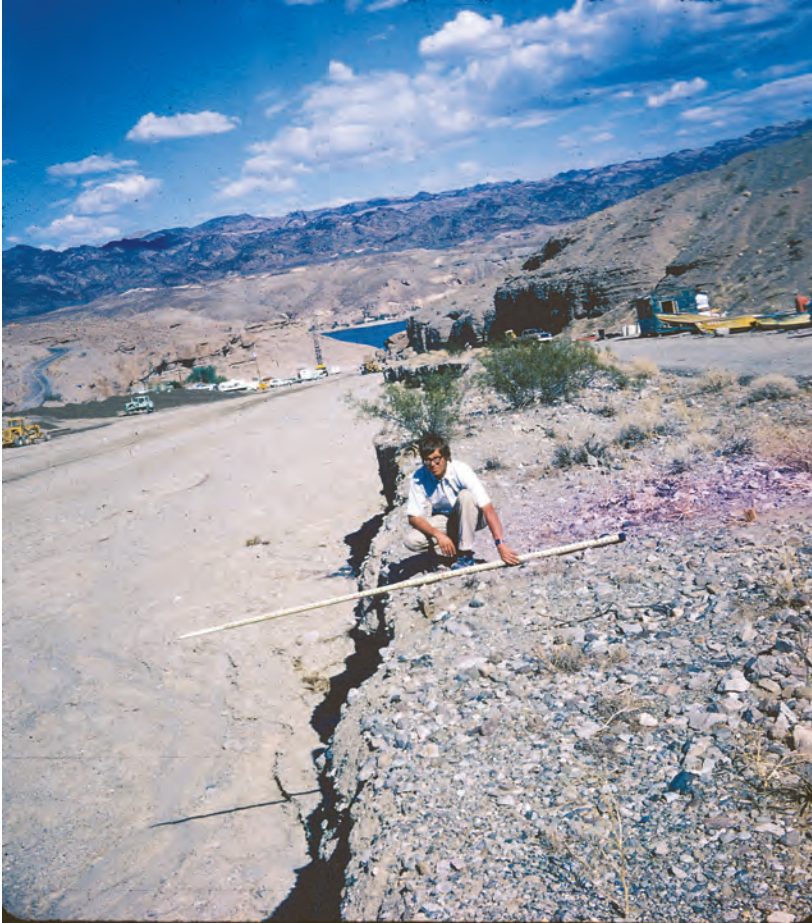
**Figure A128.** View downstream at right bank through cross section 1, Eldorado Canyon at Nelson Landing, Nevada, September 1974.

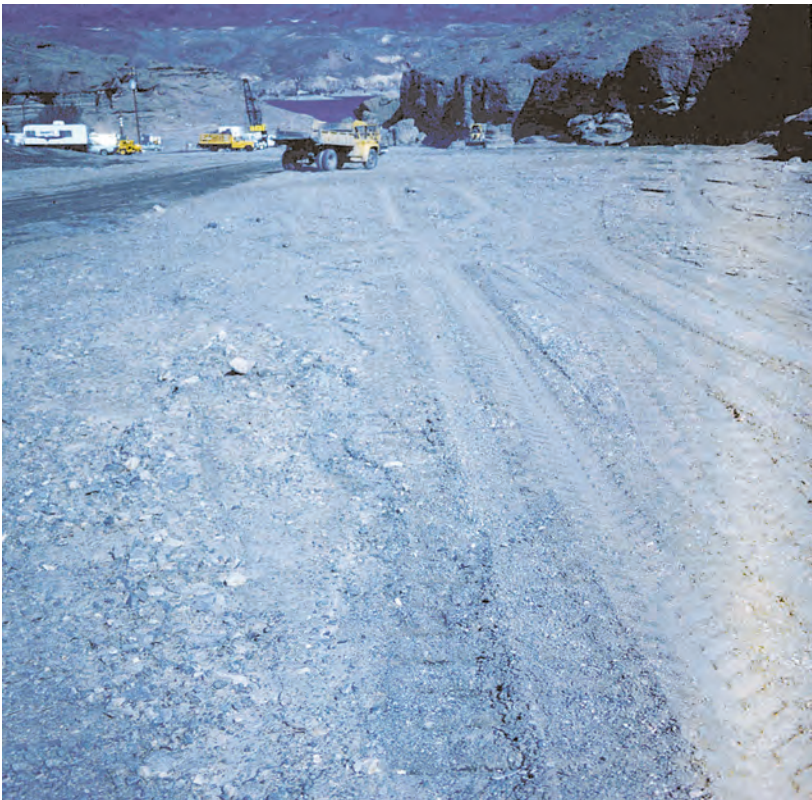
**Figure A129.** View downstream through cross-section 3, Eldorado Canyon at Nelson Landing, Nevada, September 1974.

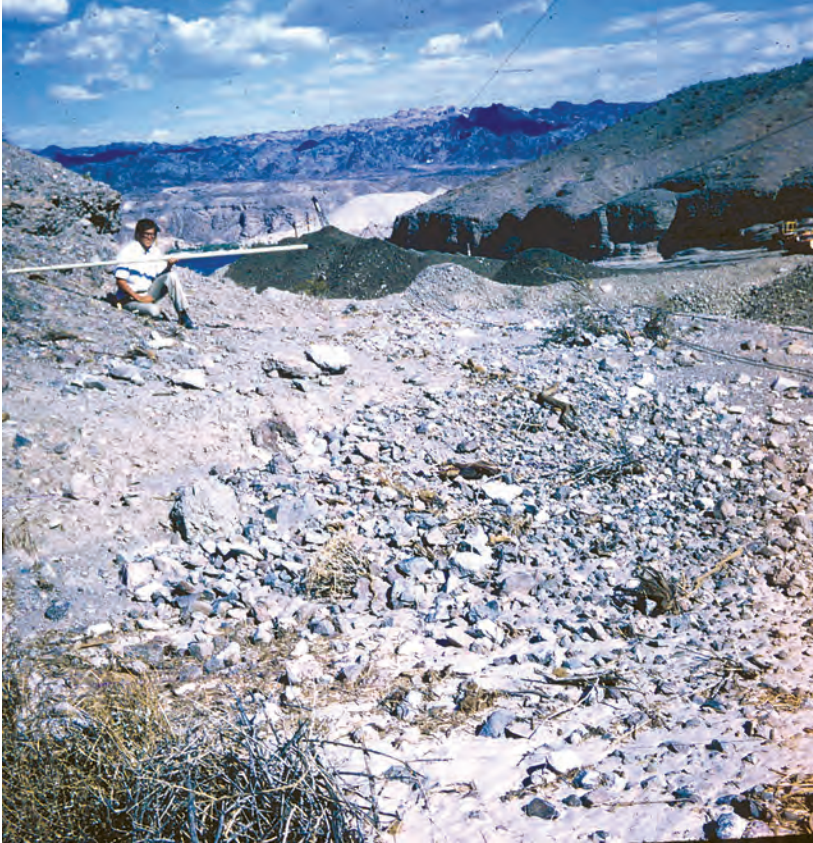
**Figure A130.** View downstream at left bank through cross section 3, Eldorado Canyon at Nelson Landing, Nevada, September 1974.

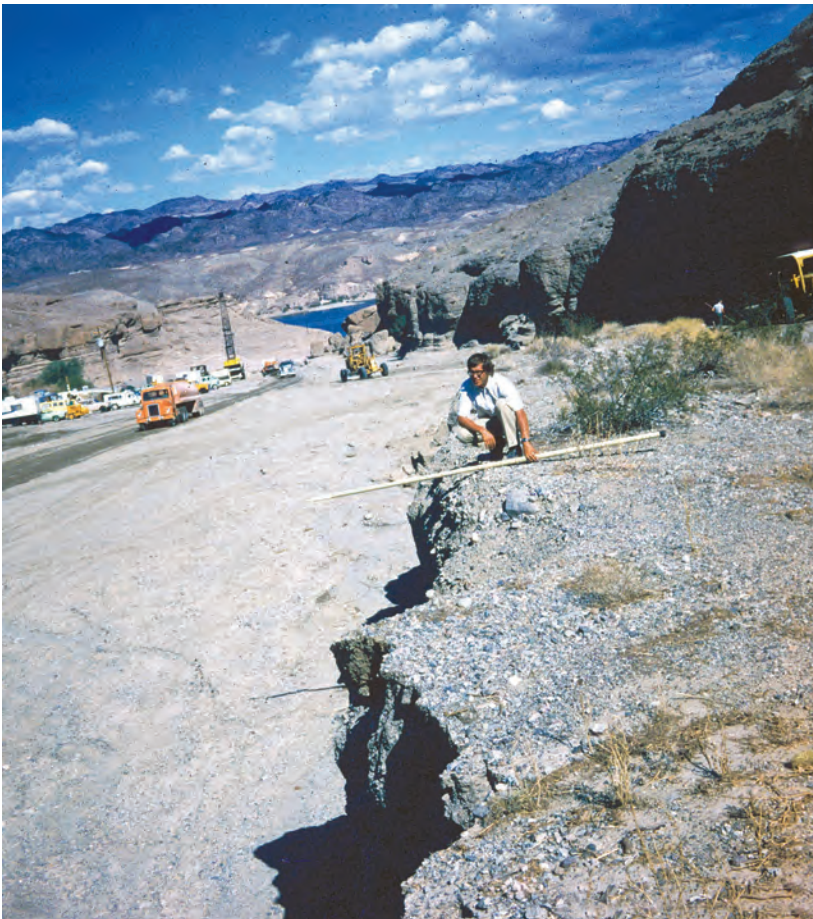
**Figure A131.** View downstream at right bank through cross-section 3, Eldorado Canyon at Nelson Landing, Nevada, September 1974.

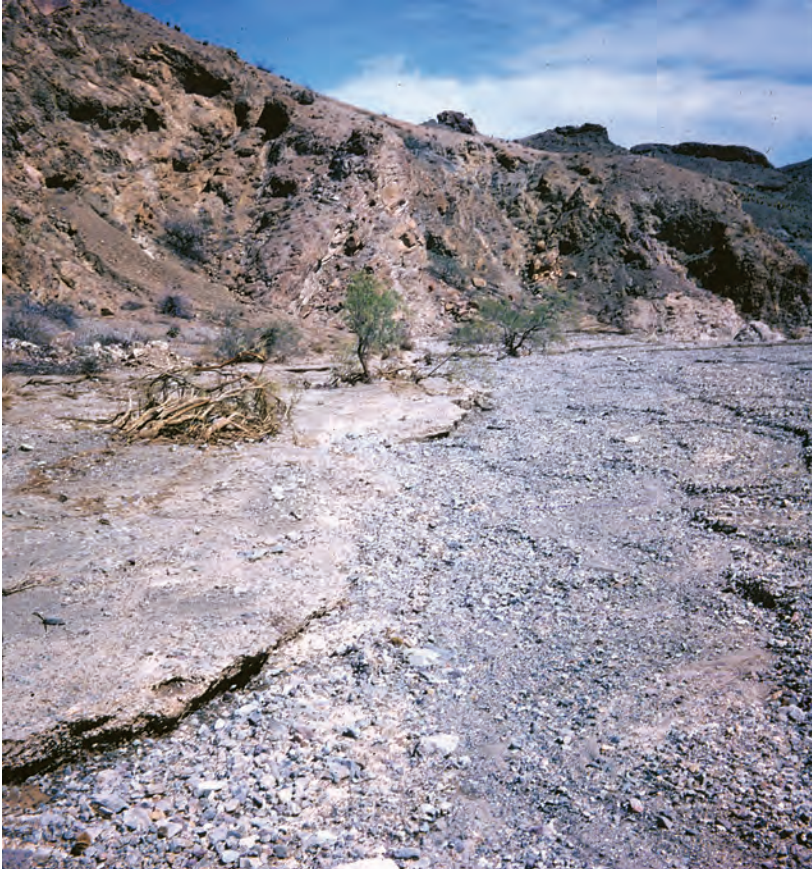
**Figure A132.** View downstream at upper slope-conveyance site, Eldorado Canyon at Nelson Landing, Nevada, September 1974.

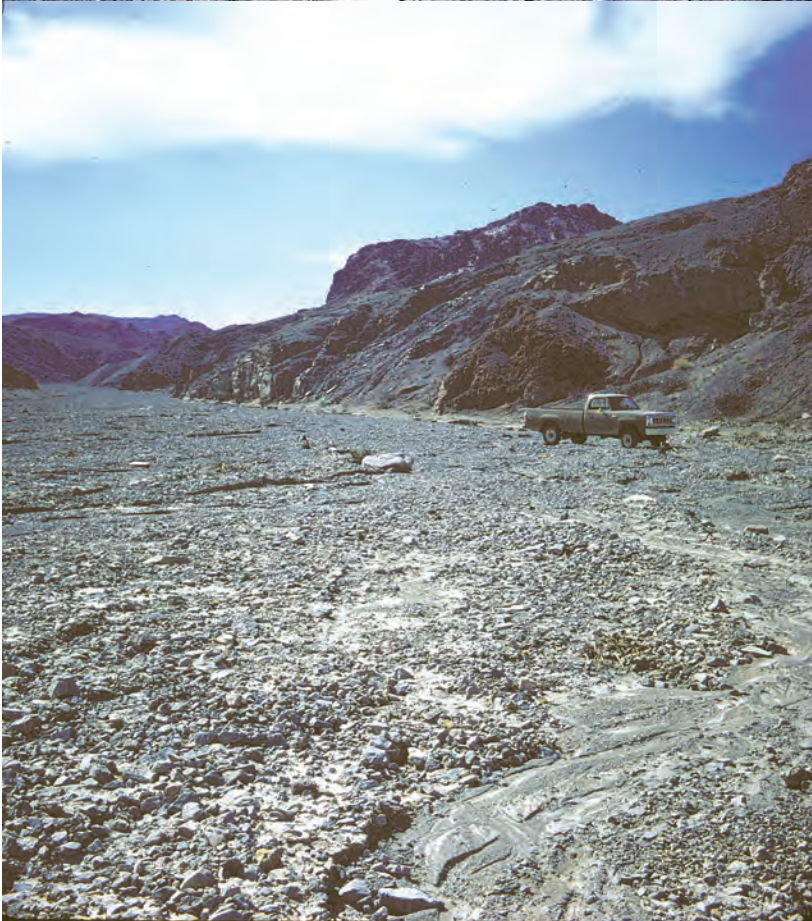
**Figure A133.** View upstream at lower slope-conveyance site, Eldorado Canyon at Nelson Landing, Nevada, September 1974.

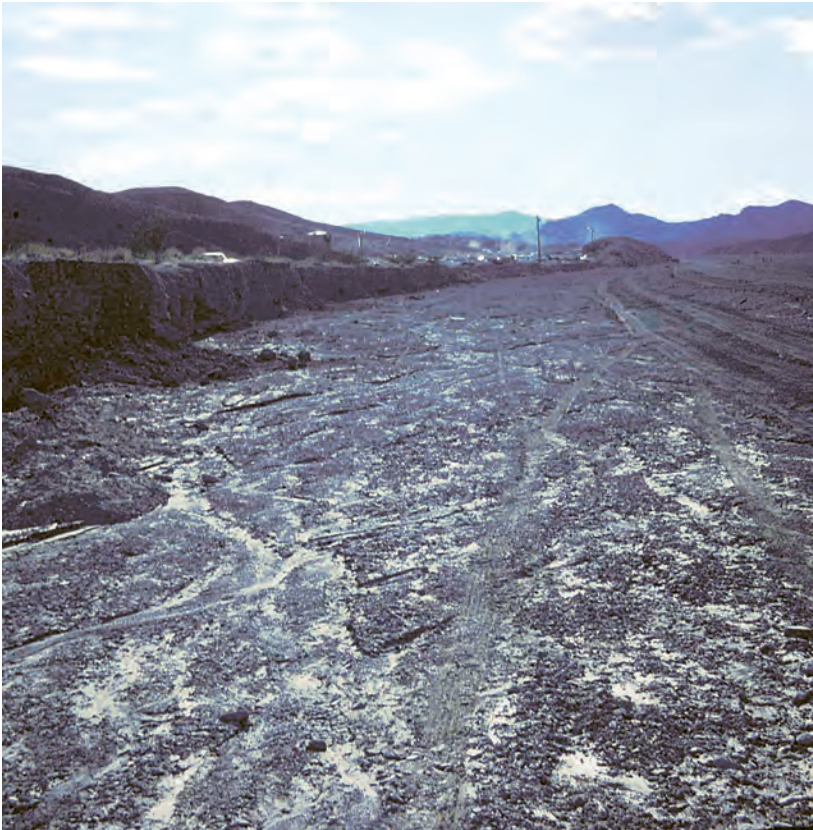
**Figure A134.** View upstream through cross-section 1, Eldorado Canyon at Nelson Landing, Nevada, September 1974.

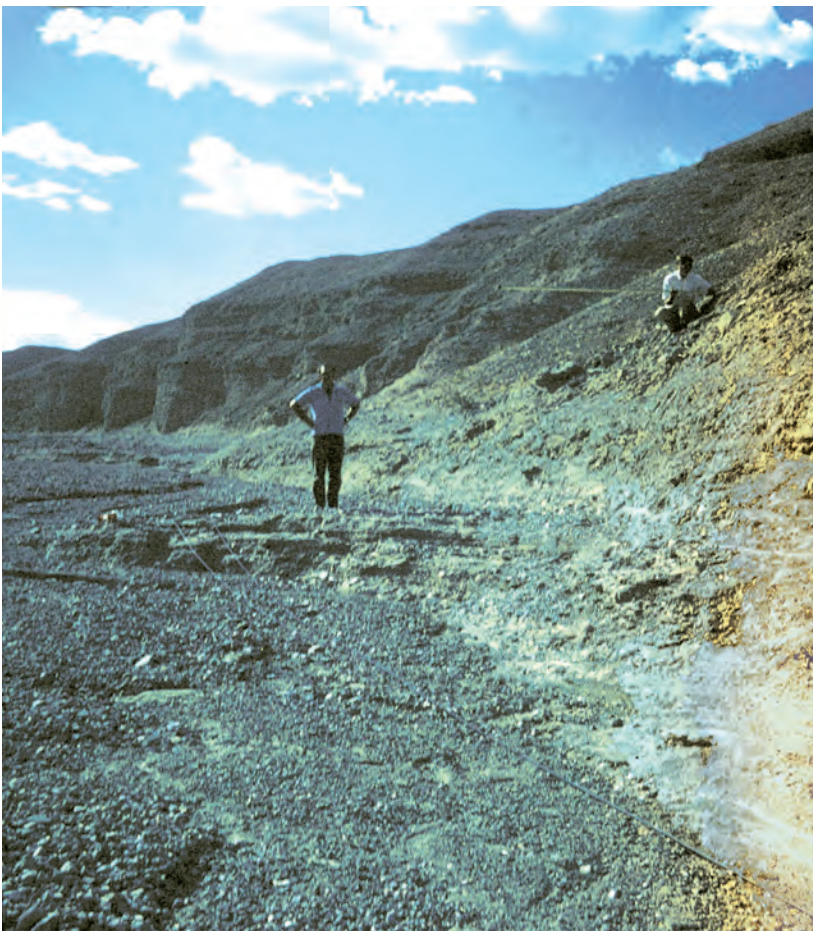
**Figure A135.** View upstream to left bank through cross-section 1, Eldorado Canyon at Nelson Landing, Nevada, September 1974.

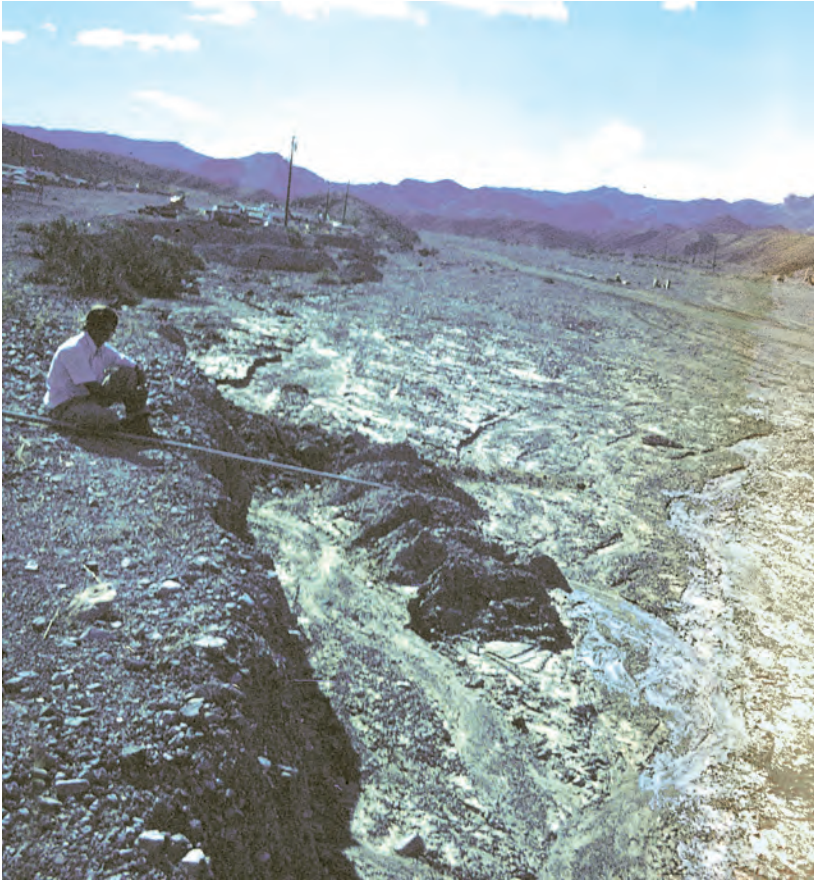
**Figure A136.** View upstream to right bank through cross-section 1, Eldorado Canyon at Nelson Landing, Nevada, September 1974.

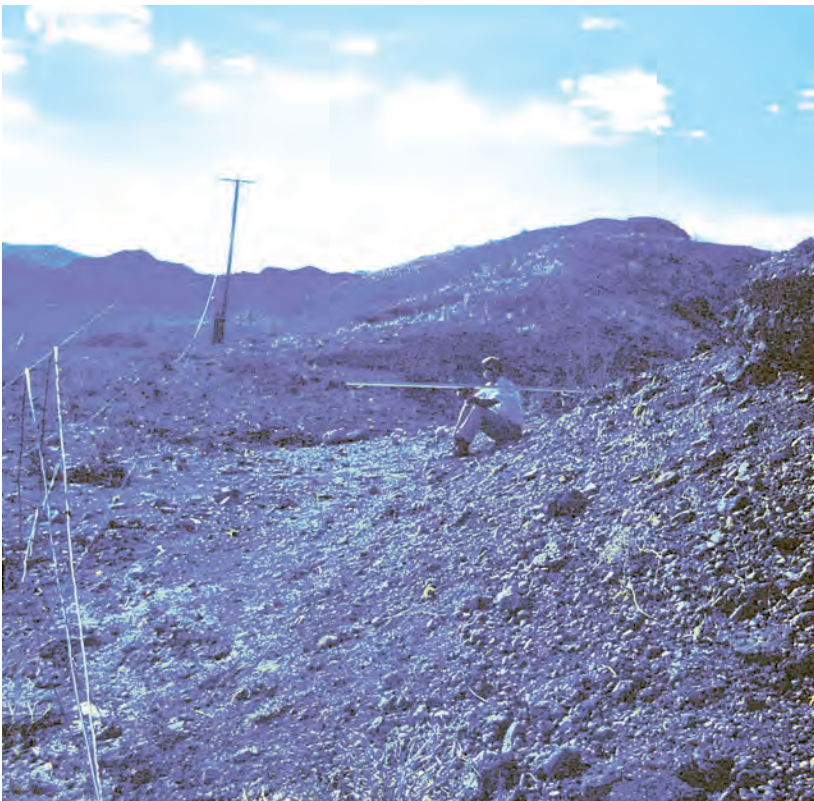
**Figure A137.** View upstream to left bank through cross-section 3, Eldorado Canyon at Nelson Landing, Nevada, September 1974.

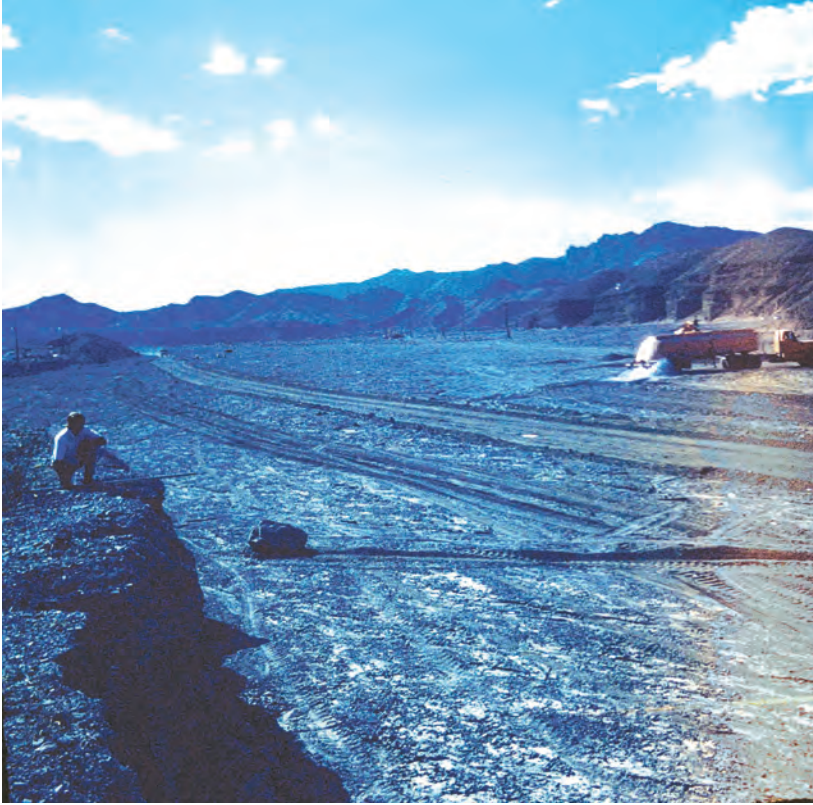
**Figure A138.** View upstream to right bank through cross-section 3, Eldorado Canyon at Nelson Landing, Nevada, September 1974.

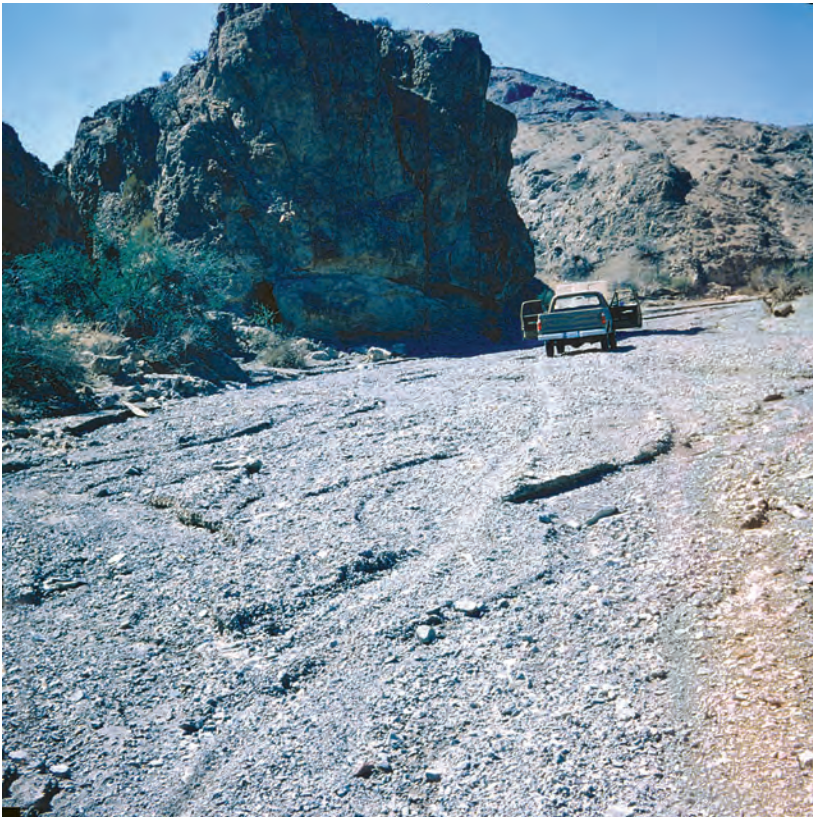
**Figure A139.** View upstream toward upper slope-conveyance site, Eldorado Canyon at Nelson Landing, Nevada, September 1974.

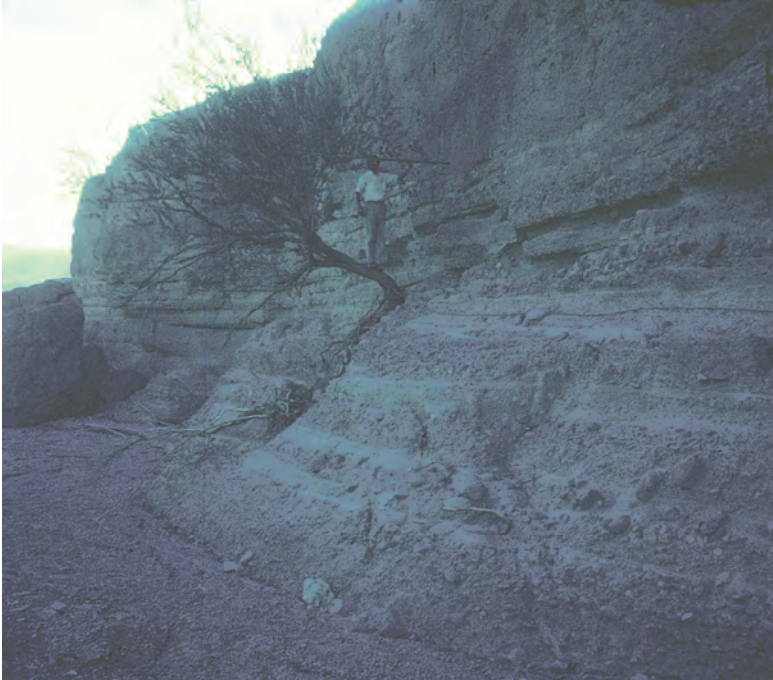
**Figure A140.** High-water mark in parking lot on right bank, Eldorado Canyon at Nelson Landing, Nevada, September 1974.

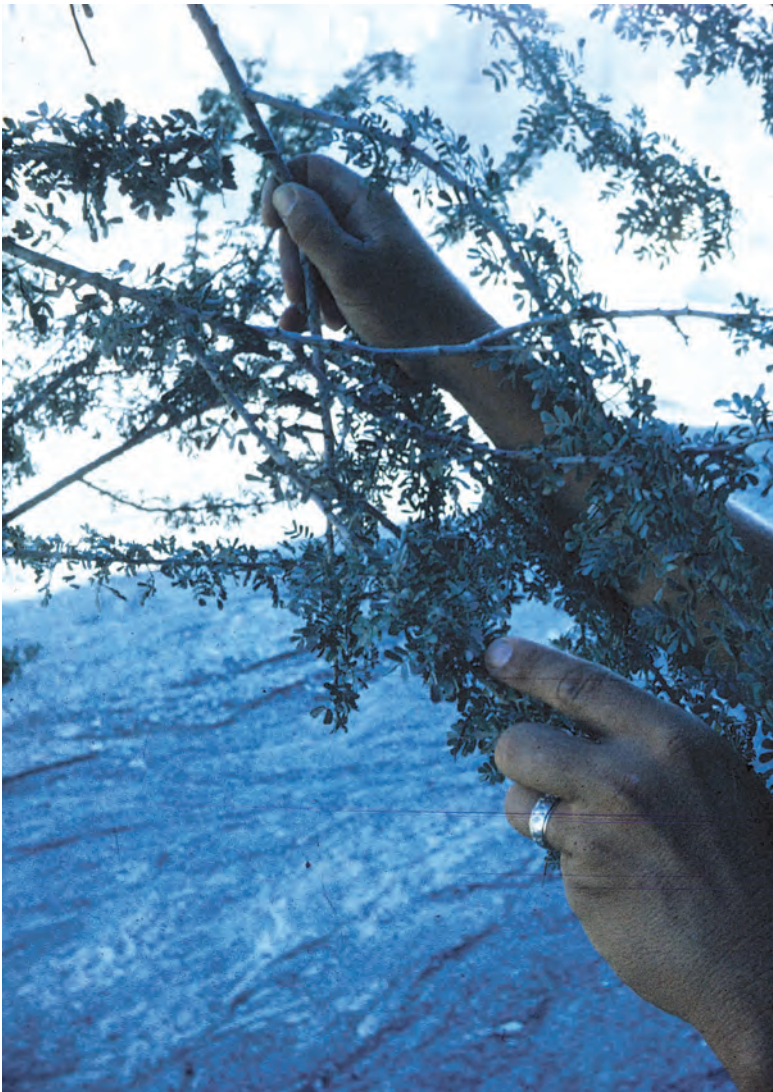
**Figure A141.** Mud on leaves near treetop, Eldorado Canyon at Nelson Landing, Nevada, September 1974.

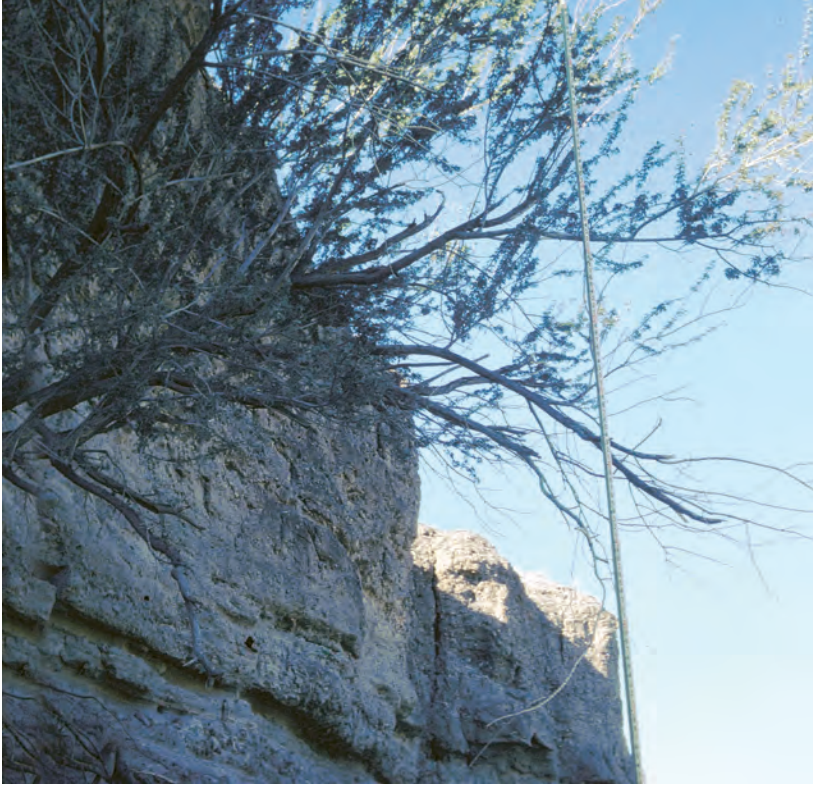
**Figure A142.** Mud on leaves of tree on right bank near trailers, Eldorado Canyon at Nelson Landing, Nevada, September 1974.

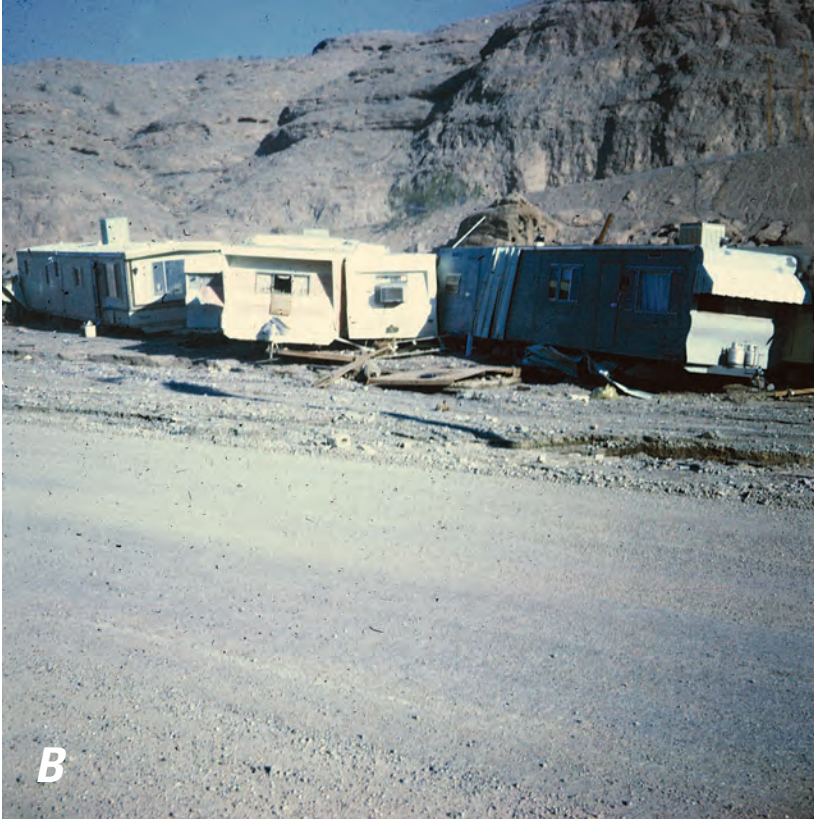
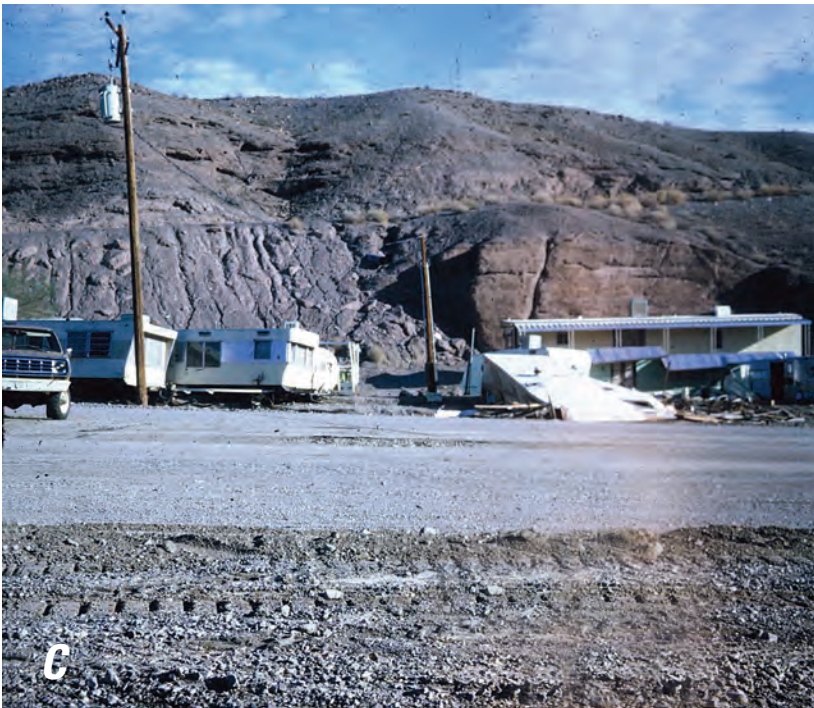
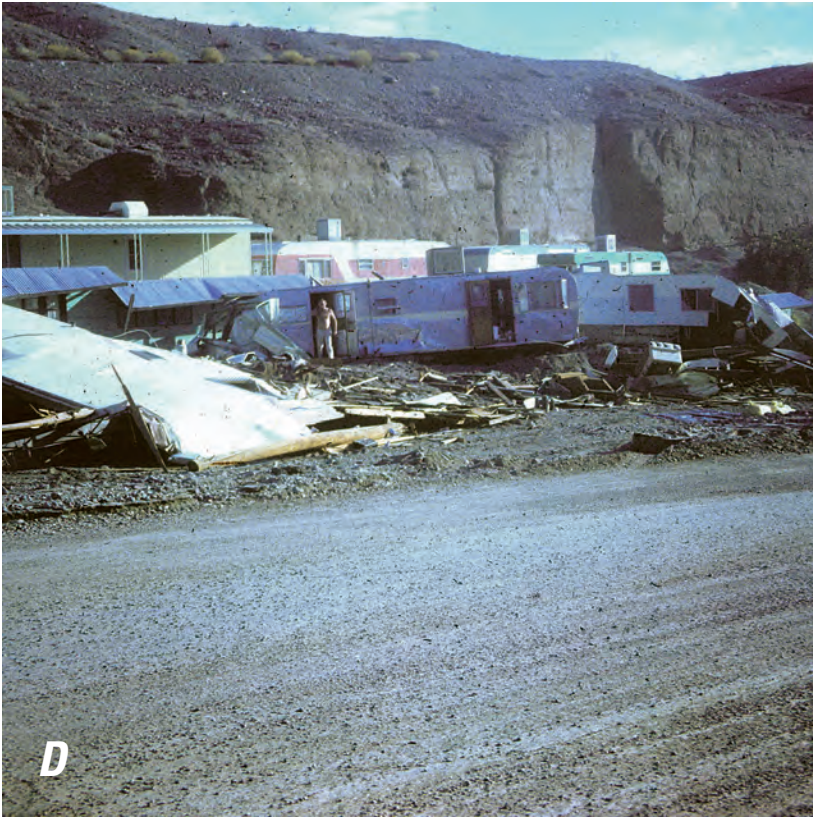
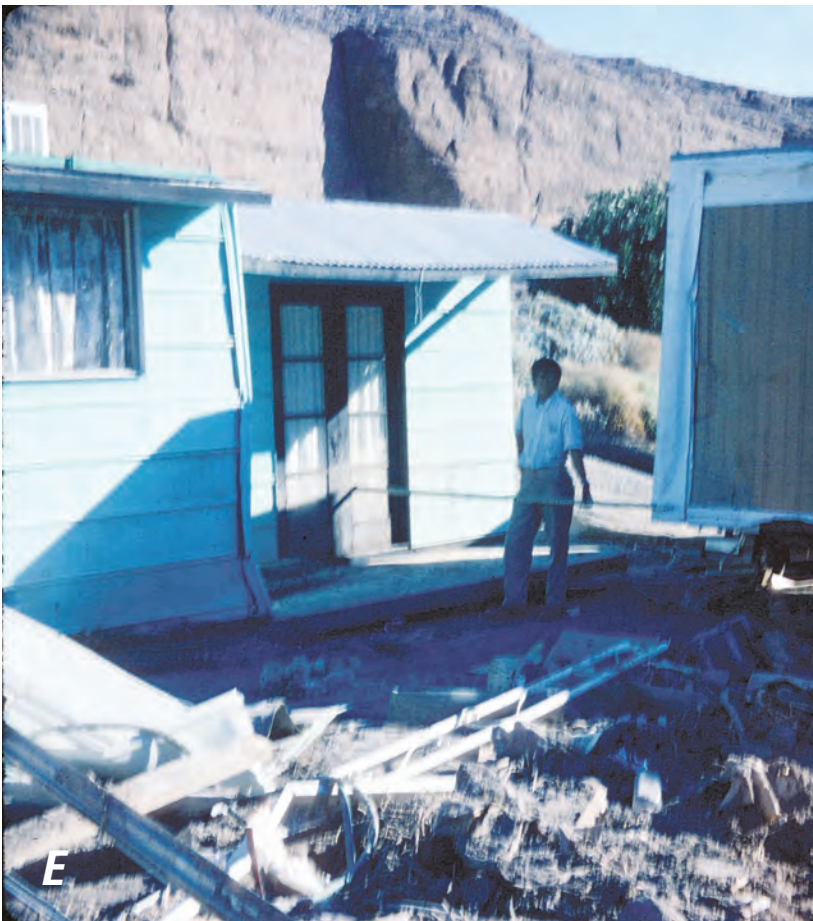
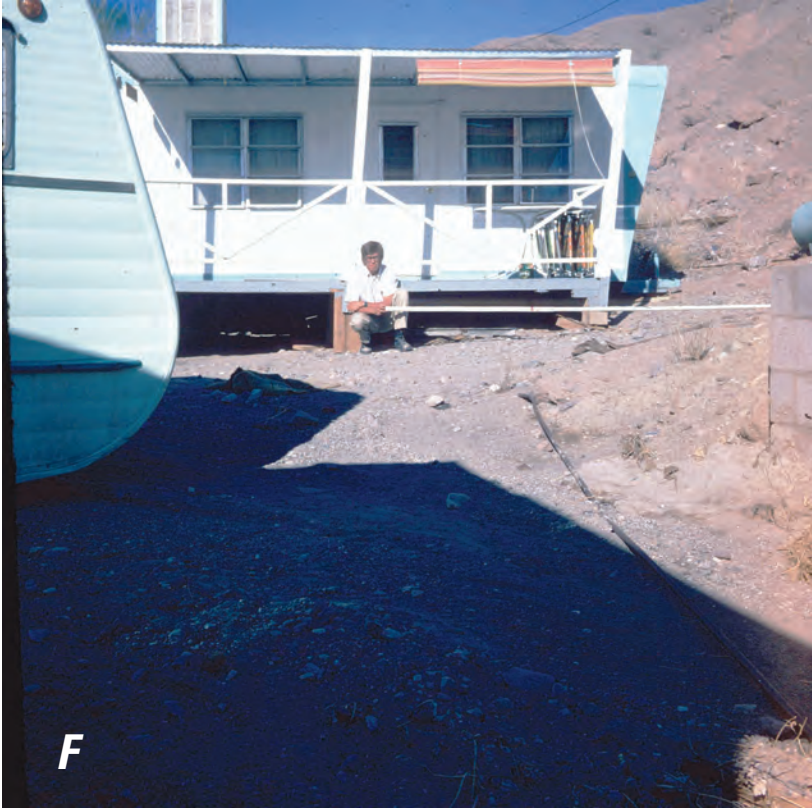
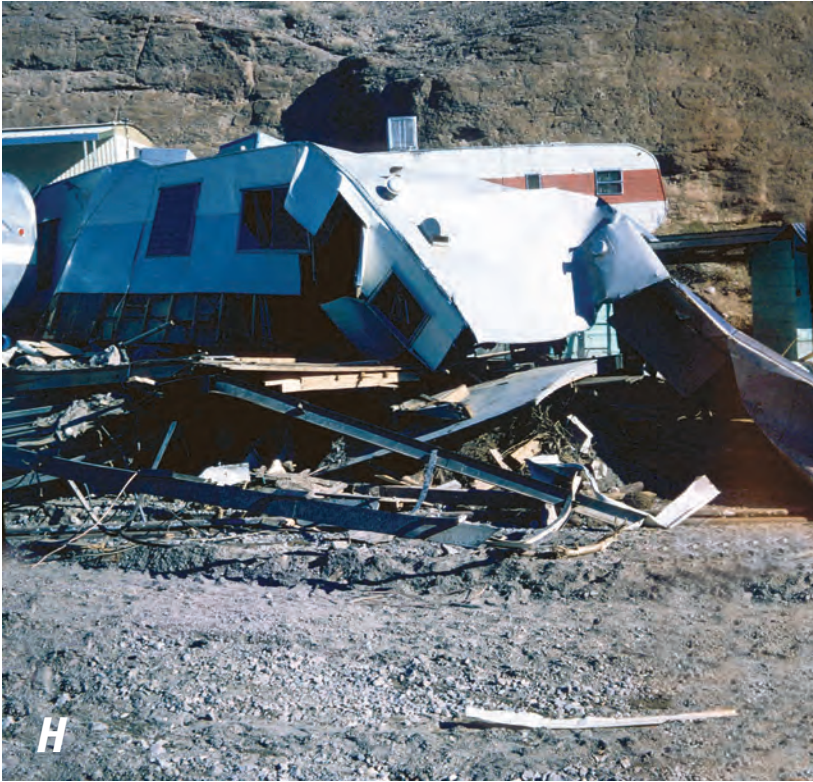
**Figure A143.** Damage to trailers (a), Eldorado Canyon at Nelson Landing, Nevada, September 1974.

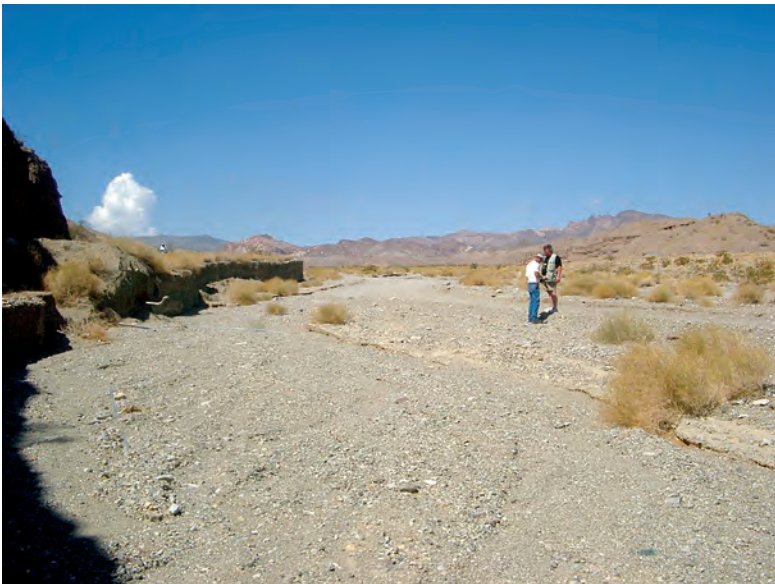
The slope-area reach is remarkably unchanged from the conditions present in 1974. There appears to have been very little net change in either the streambed or the banks. This is consistent with the observation that steep channels like this may act somewhat like conveyors during large flows—moving large amounts of bed material with little accumulation on or erosion from the streambed. Those present at the field visit agreed that there was no evidence that the 1974 peak had been a debris flow at the indirect measurement site.

**Figure A144.** View looking upstream through slope-area reach, Eldorado Canyon at Nelson Landing, Nevada, August 28, 2003.
