Lahontan Reservoir Tributary No. 3 near Silver, Nevada

(Miscellaneous ungaged site near Silver Springs, Nevada;
USGS Nevada Water Science Center)

Review of peak discharge for flood of July 20, 1971

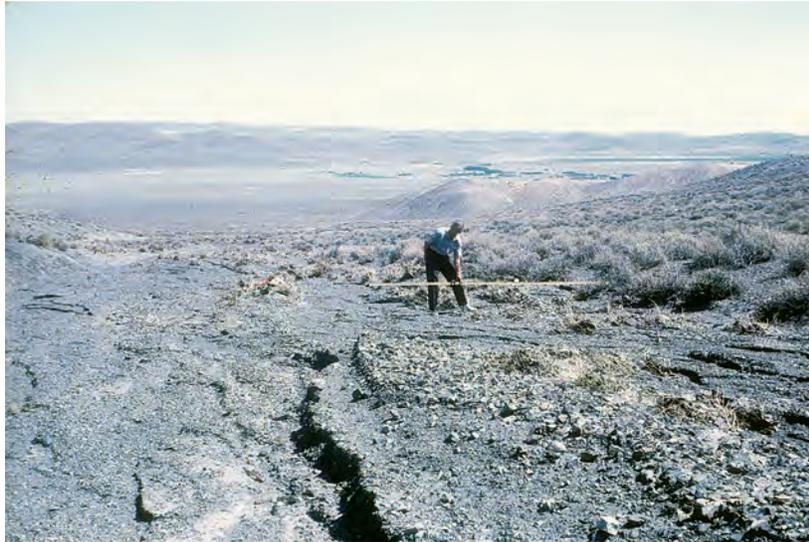
Figure A100. View looking downstream of slope-area reach, Lahontan Reservoir tributary no. 3 near Silver, Nevada, July 1971.

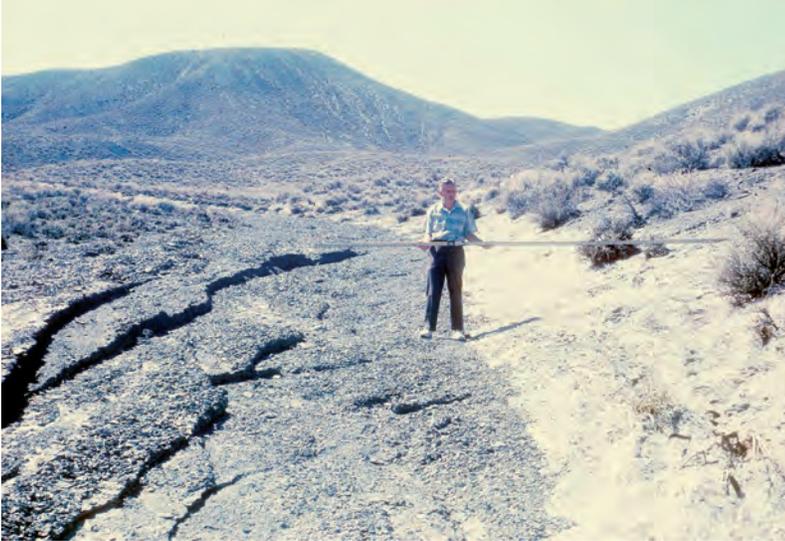
Figure A101. View looking upstream at cross section 2, Lahontan Reservoir tributary no. 3 near Silver, Nevada, July 1971.

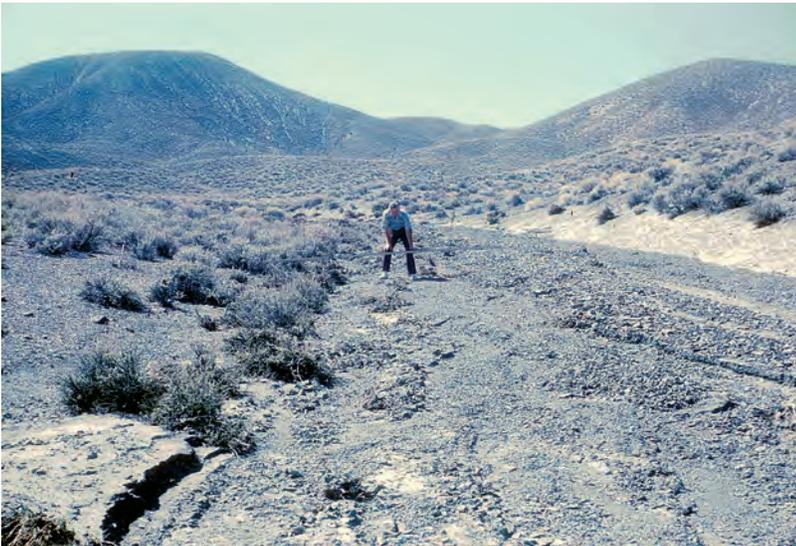
Figure A102. View looking upstream of slope-area reach, Lahontan Reservoir tributary no. 3 near Silver, Nevada, July 1971.

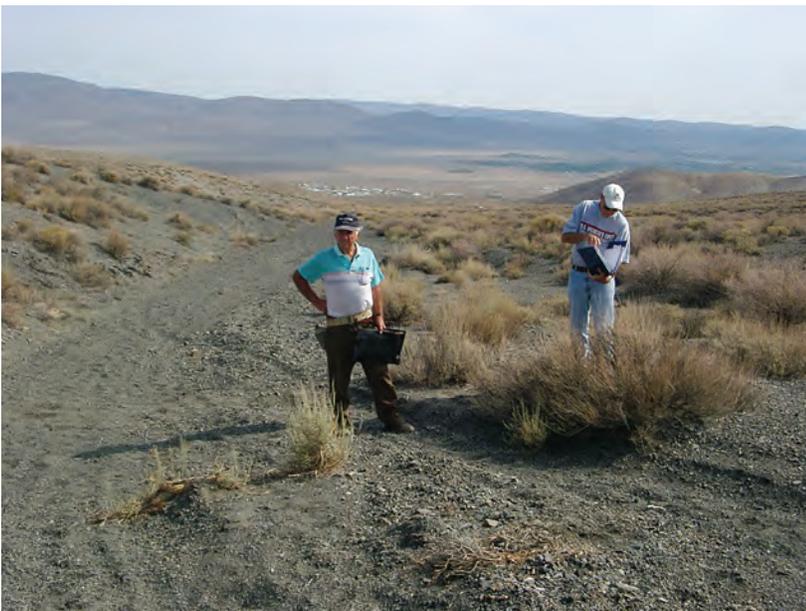
Figure A103. View looking downstream of slope-area reach, Lahontan Reservoir tributary no. 3 near Silver, Nevada, July 31, 2003.

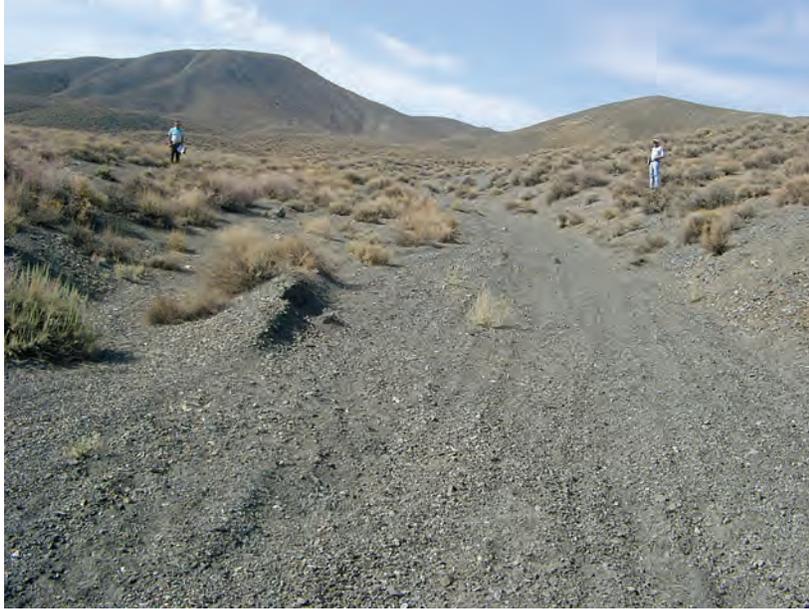
Figure A104. View looking upstream toward cross section 2, Lahontan Reservoir tributary no. 3 near Silver, Nevada, July 31, 2003.

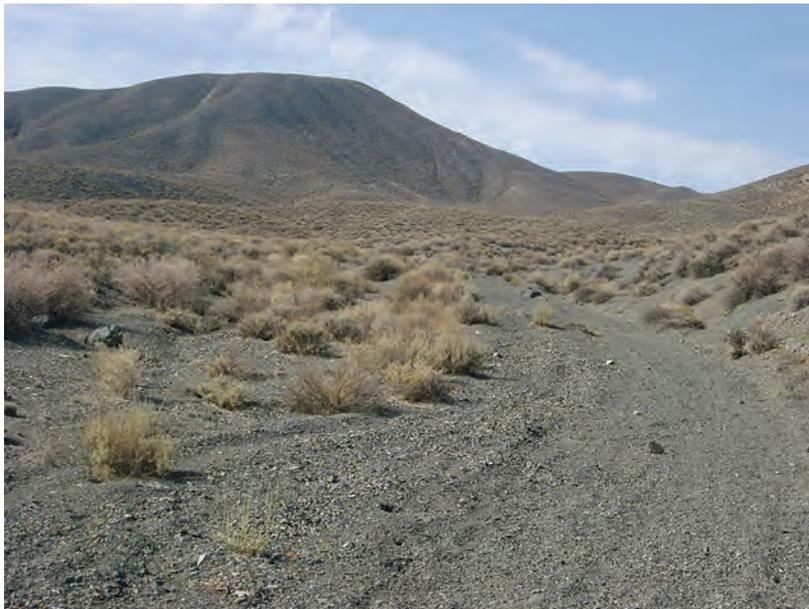
Figure A105. View looking upstream of slope-area reach, Lahontan Reservoir tributary no. 3 near Silver, Nevada, July 31, 2003.
