# Lane Canyon near Nolin, Oregon

## Review of peak discharge for the flood of July 26, 1965

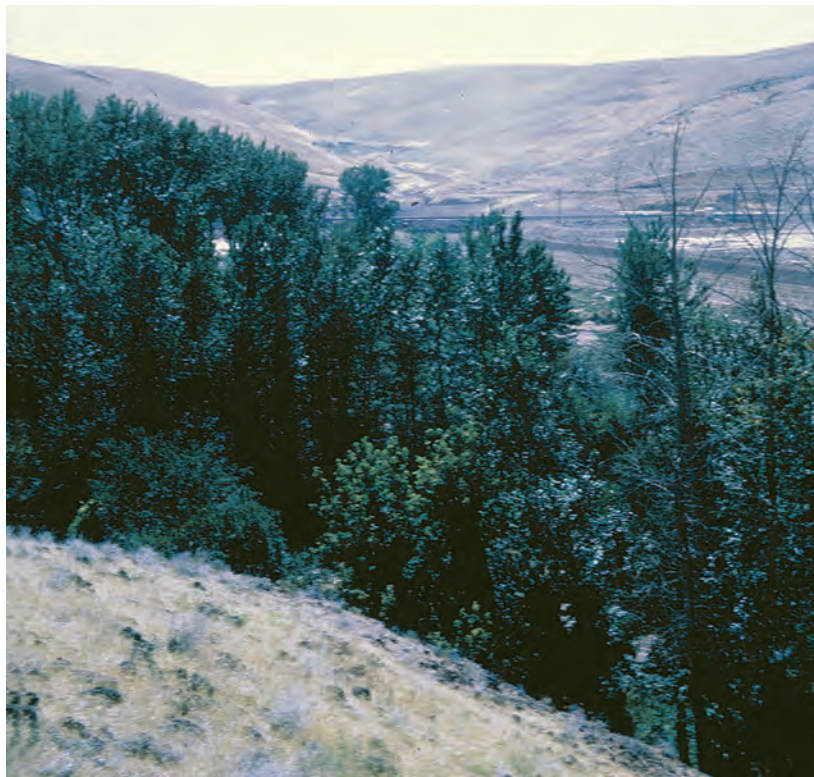
**Figure A172.** View looking across Lane Canyon toward Umatilla River Valley, Lane Canyon near Nolin, Oregon, August 1965.

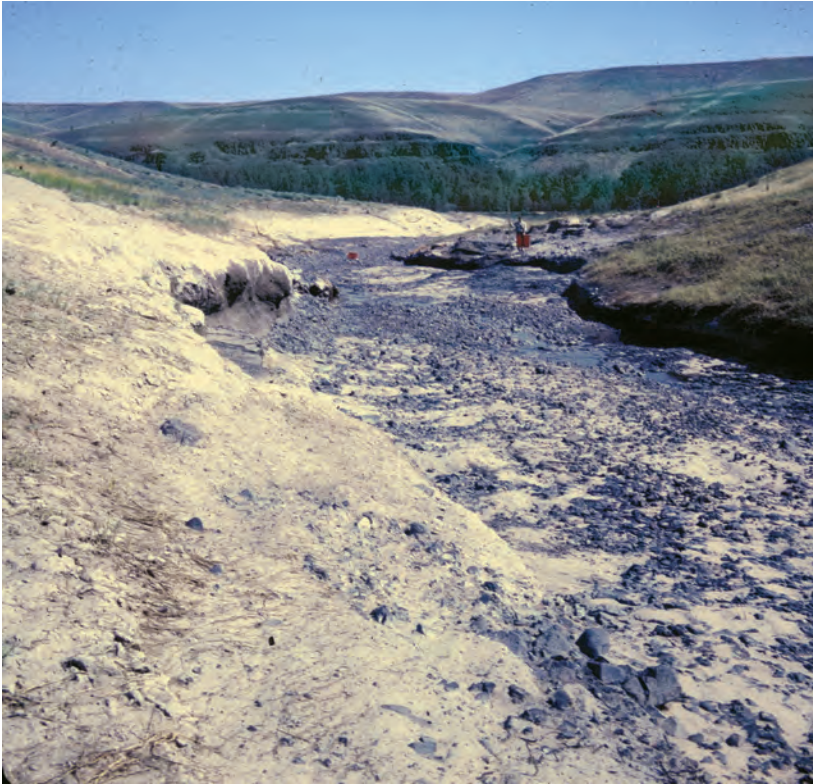
**Figure A173.** View looking downstream from upstream of cross section 1, Lane Canyon near Nolin, Oregon, August 1965.

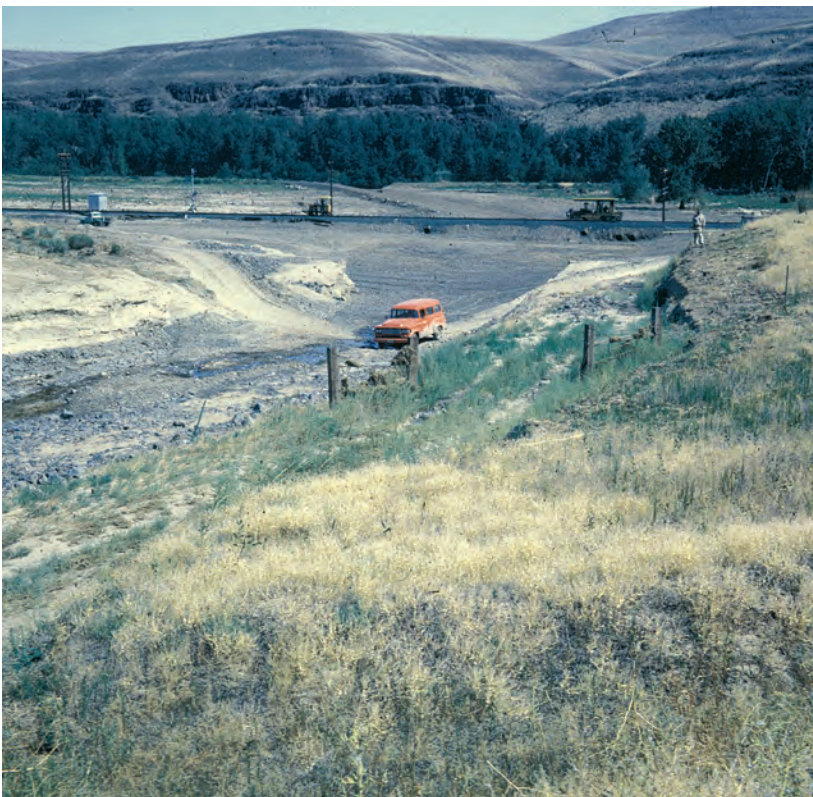
**Figure A174.** View looking downstream toward mouth of canyon from downstream of slope-area reach, Lane Canyon near Nolin, Oregon, August 1965.

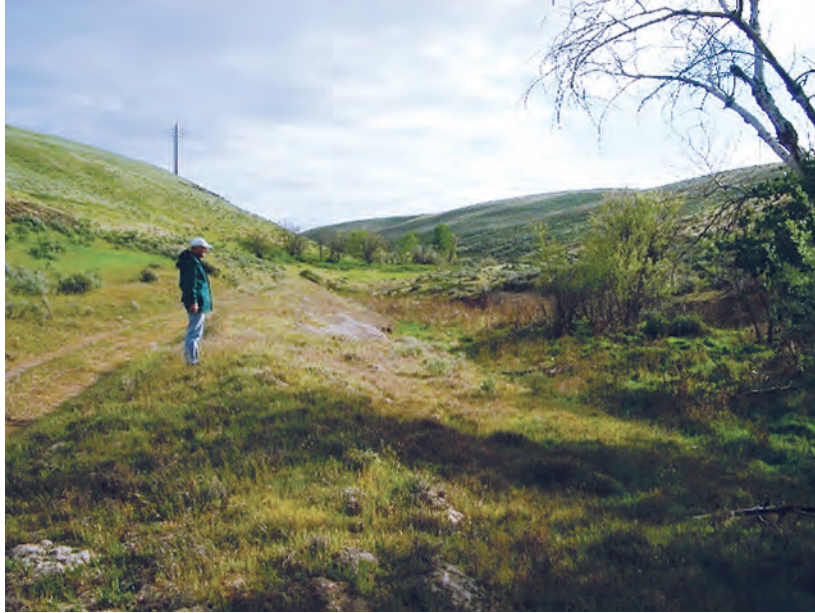
**Figure A177.** View looking upstream through slope-area reach, Lane Canyon near Nolin, Oregon, April 23, 2003.

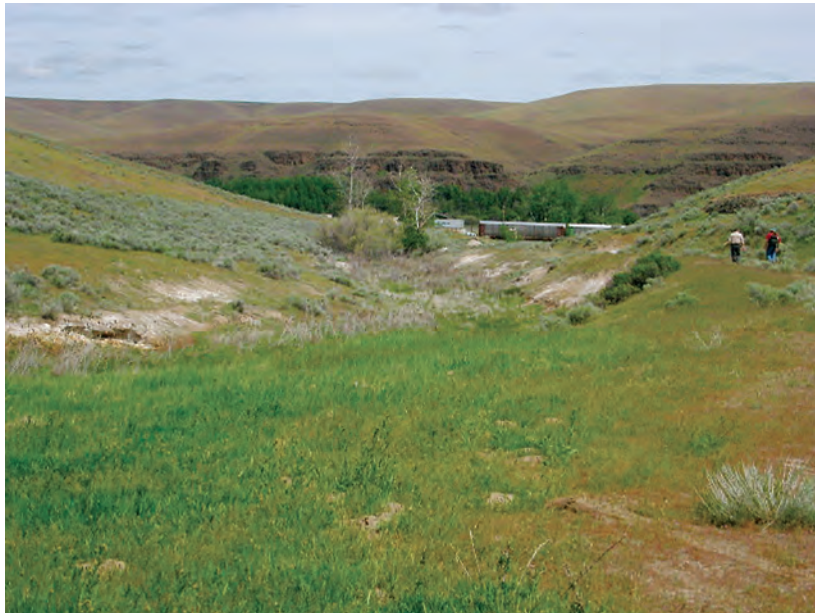
**Figure A178.** View looking downstream through slope-area reach, Lane Canyon near Nolin, Oregon, April 23, 2003.
