08086150 North Fork Hubbard Creek near Albany, Texas

(Discontinued gaging station in the Brazos River basin, USGS Texas Water Science Center)

Review of peak discharge for the flood of August 4, 1978

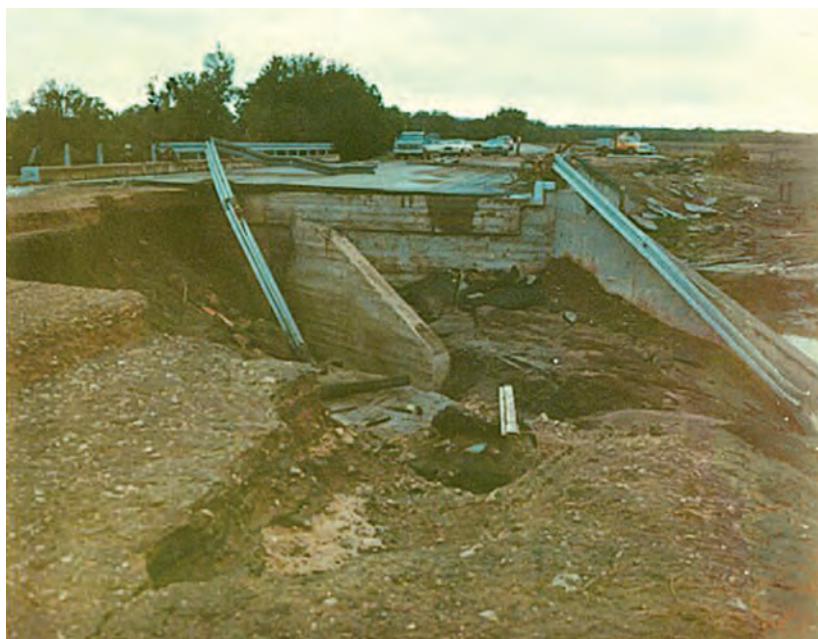
Figure A7. View from right end of bridge looking across bridge, North Fork Hubbard Creek near Albany, Texas, August 5, 1978. Flood of August 4, 1978, was about 2 feet over handrail.

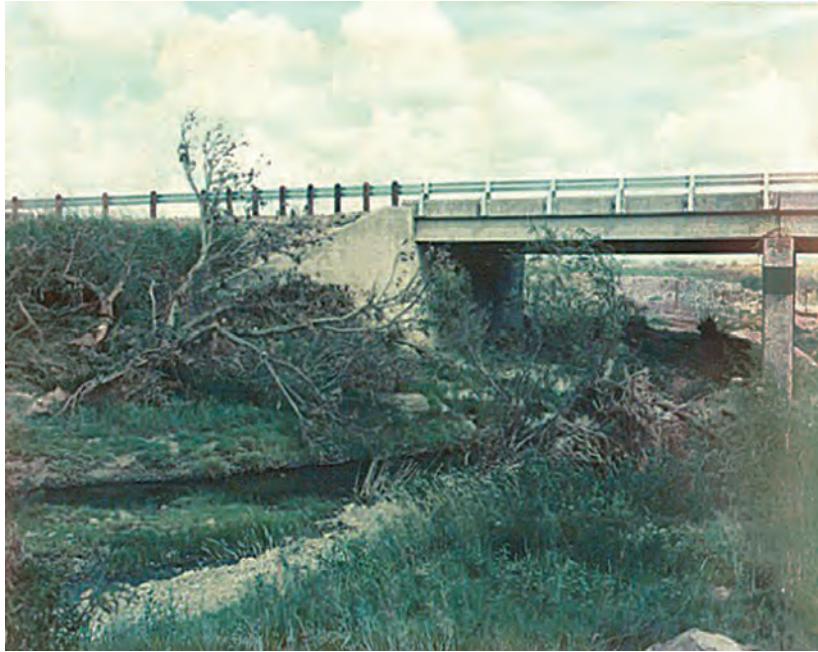
Figure A8. View of left abutment and upstream wingwall, North Fork Hubbard Creek near Albany, Texas, September 20, 1978.

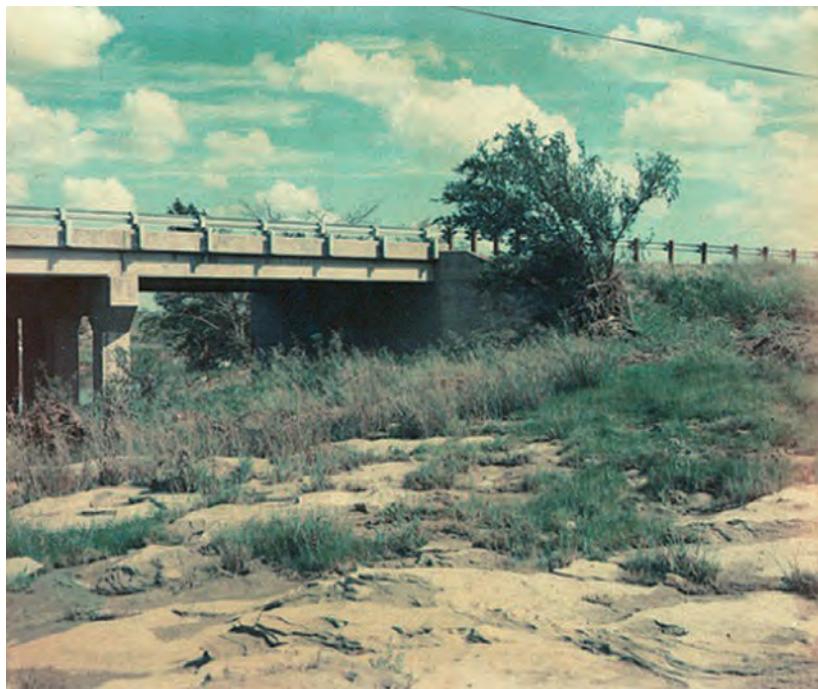
Figure A9. View of right abutment and upstream wingwall, North Fork Hubbard Creek near Albany, Texas, September 20, 1978.

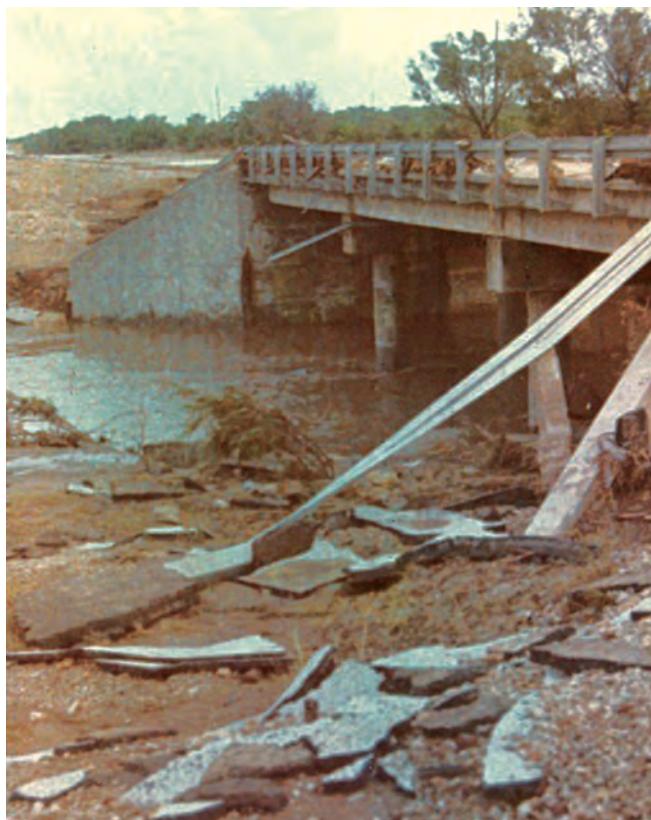
Figure A10. View looking downstream side of bridge from left bank, North Fork Hubbard Creek near Albany, Texas, August 4, 1978.

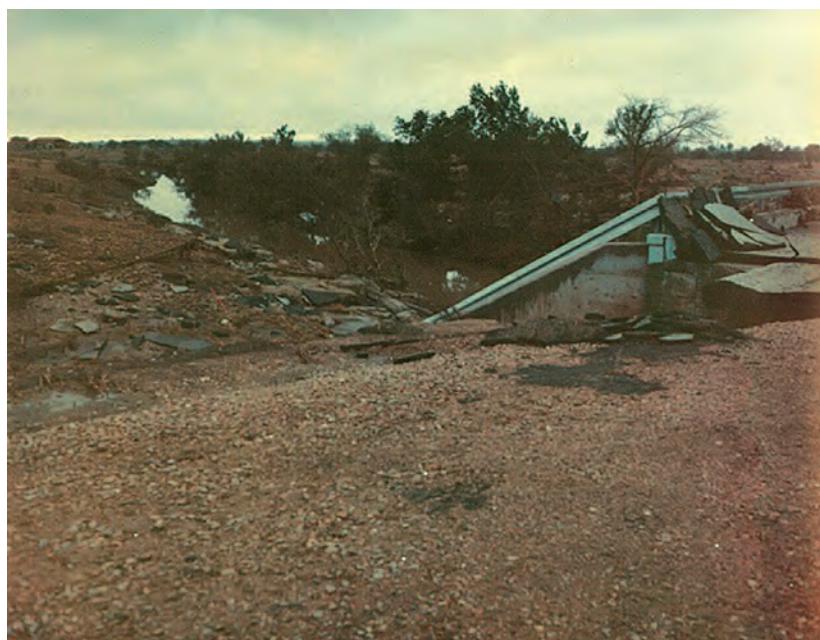
Figure A11. View from near left end of bridge at gaging station looking downstream, North Fork Hubbard Creek near Albany, Texas, August 5, 1978.

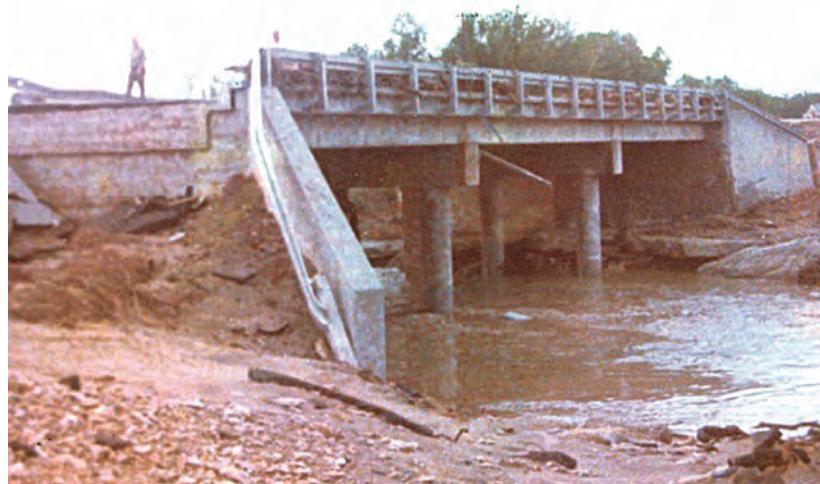
Figure A12. View of downstream side of bridge from right bank, gage shelter in center of stream, North Fork Hubbard Creek near Albany, Texas, August 4, 1978.

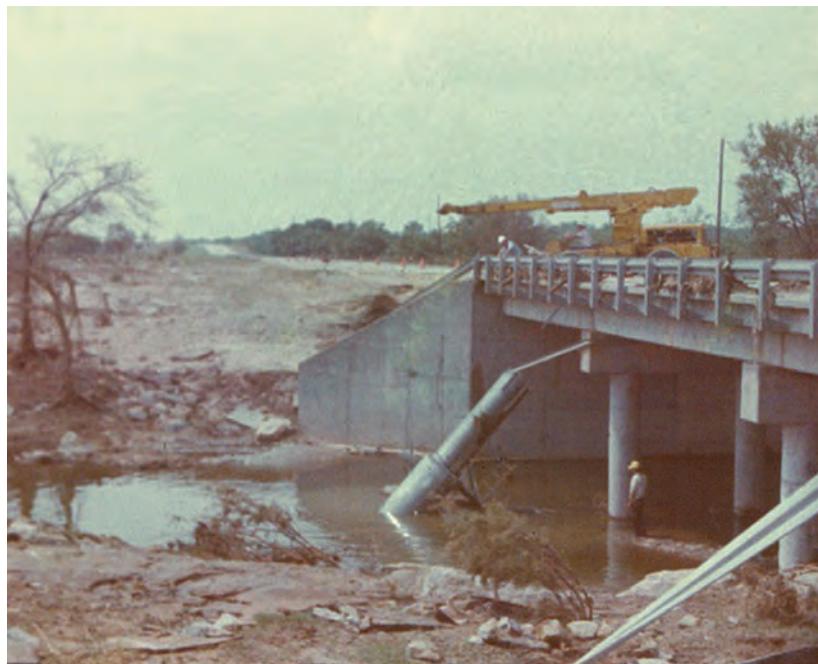
Figure A14. View of bridge and channel downstream from left bank, shelter and well being lifted out of stream, North Fork Hubbard Creek near Albany, Texas, August 10, 1978.

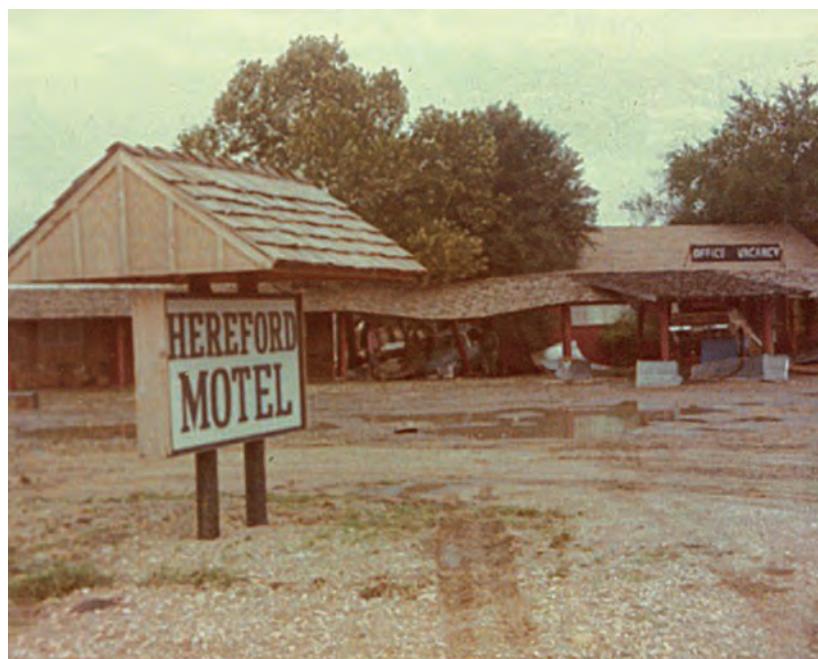
Figure A15. View of motel on right bank downstream of U.S. Highway 180 bridge at Albany, Texas. Two new cars forced into motel by water, North Fork Hubbard Creek near Albany, Texas, August 4, 1978.

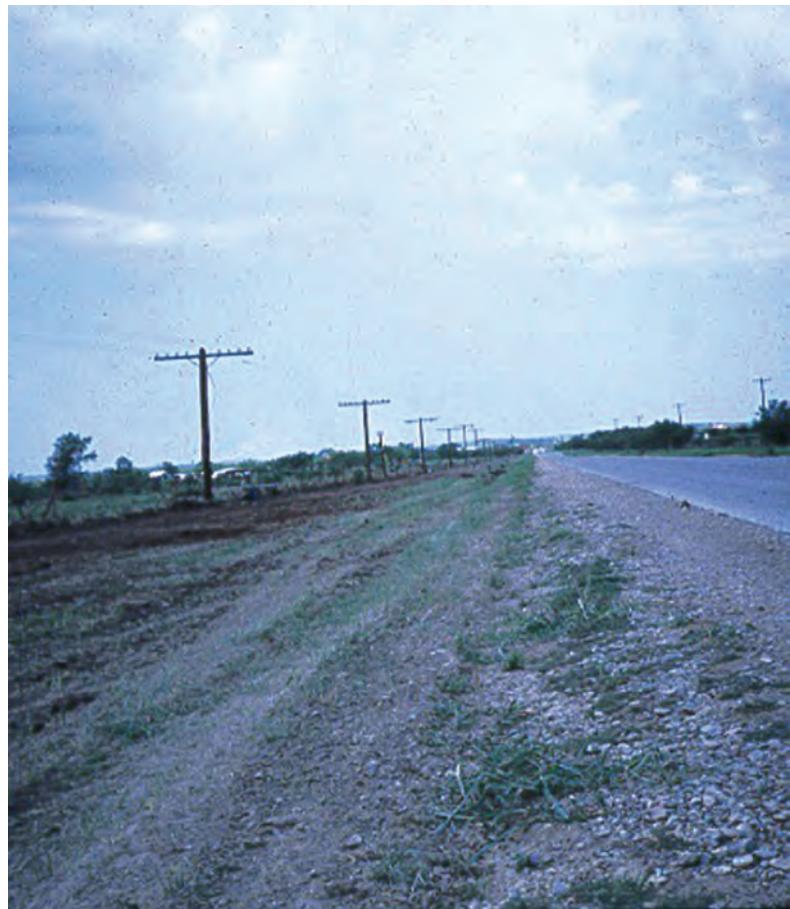
Figure A16. Upstream side of State Highway 6 overflow near right bank looking toward left bank with rod held near fence at the high-water mark in the approach section, North Fork Hubbard Creek near Albany, Texas, August 15, 1978.

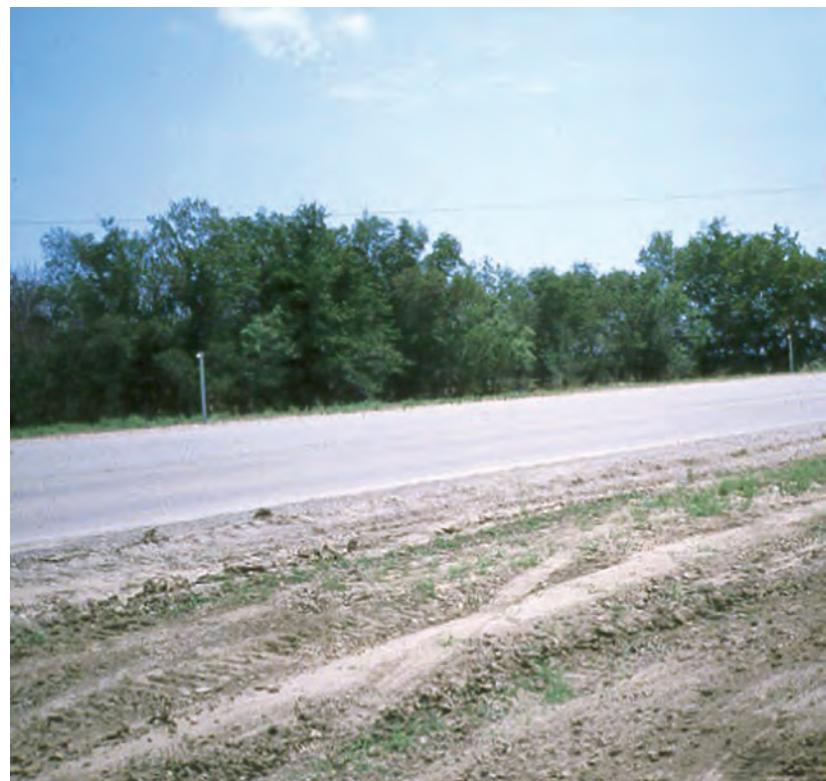
Figure A17. View from 50 feet upstream of State Highway 6 near left bank of main channel looking downstream with rod near high-water mark on left bank downstream of highway, North Fork Hubbard Creek near Albany, Texas, August 15, 1978.

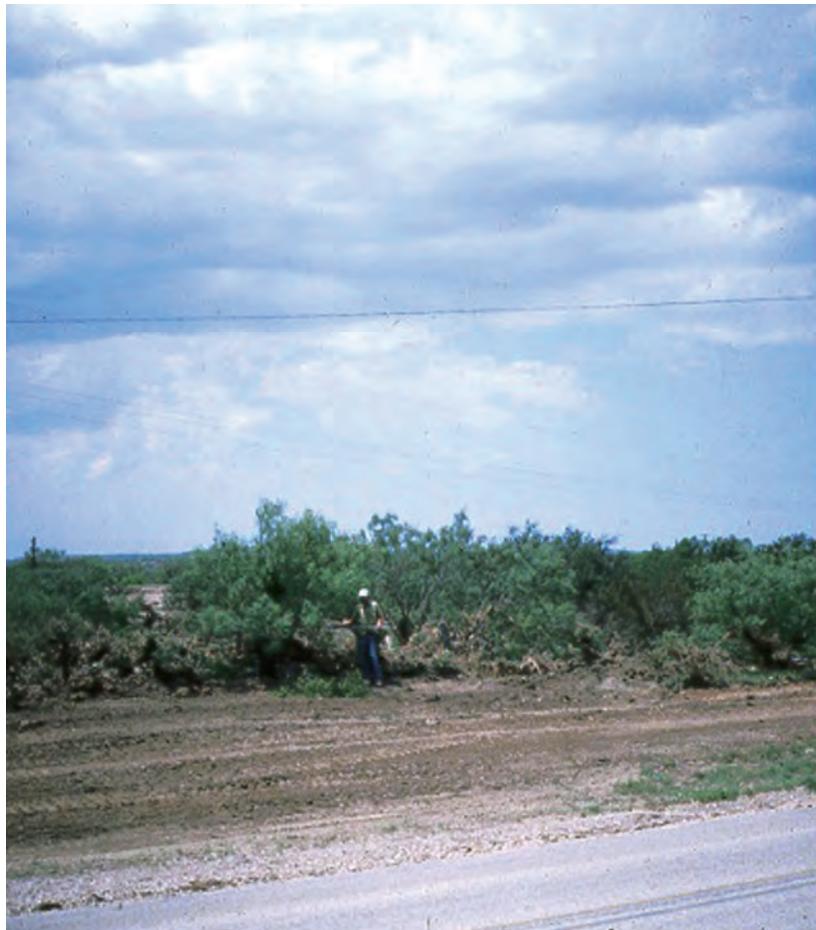
Figure A18. View near crest of State Highway 6 looking upstream with rod at high-water mark at approach section near left bank of main-channel overflow, North Fork Hubbard Creek near Albany, Texas, August 15, 1978.

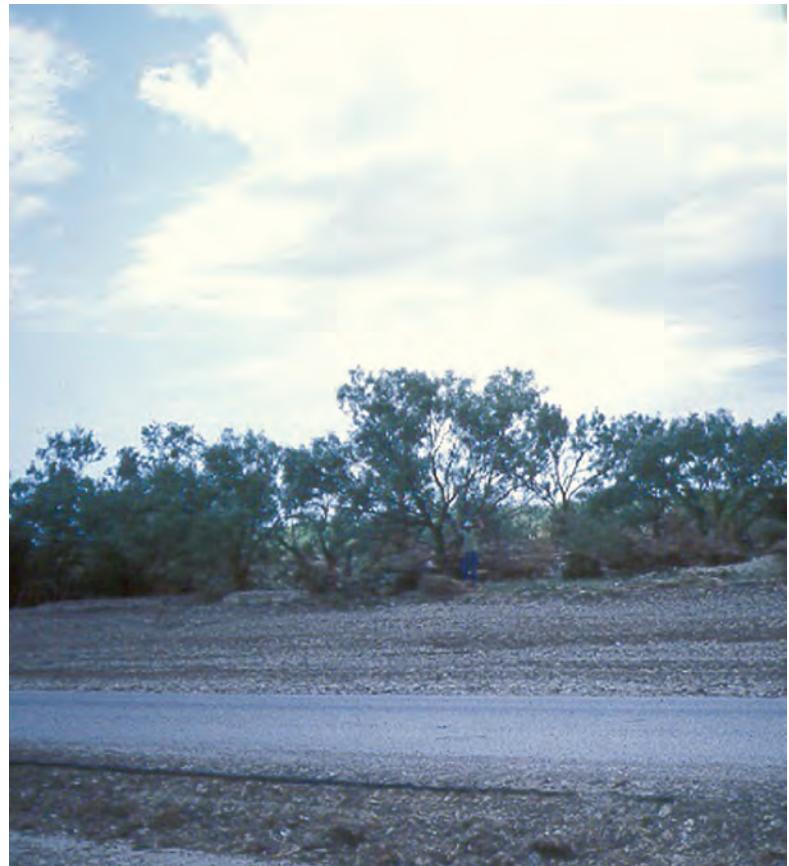
Figure A19. View from 200 feet to left of bridge and 25 feet downstream of State Highway 6 looking upstream across highway at approach section with rod held at high-water mark, North Fork Hubbard Creek near Albany, Texas, August 15, 1978.

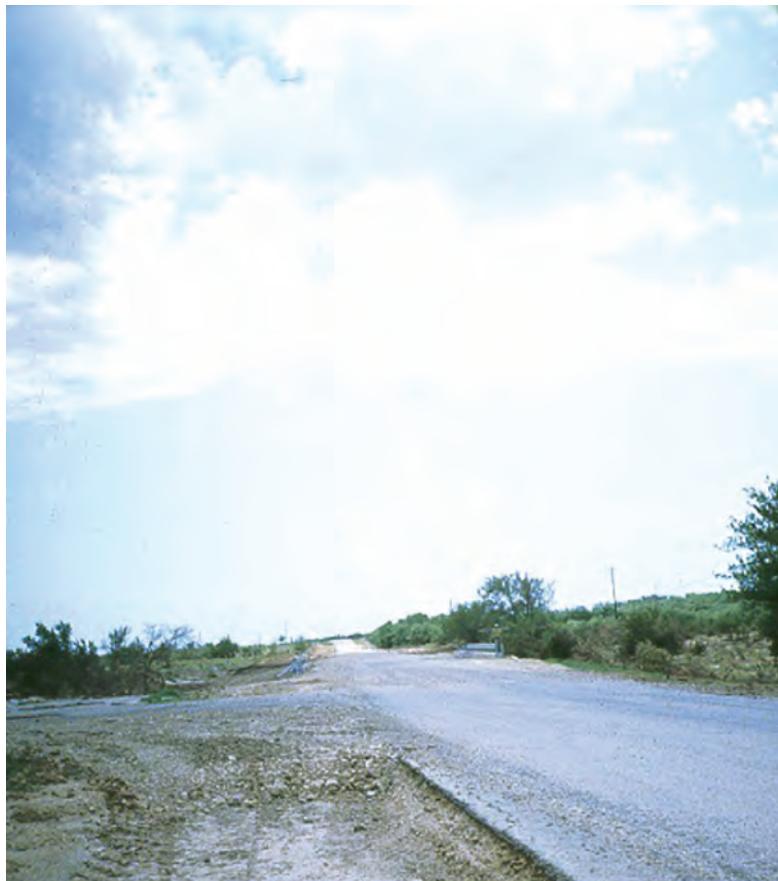
Figure A20. View from about 200 feet to left and 25 feet downstream of gaging station at bridge looking right and across at approach section and right bank. Rod held near high-water mark in approach section, North Fork Hubbard Creek near Albany, Texas, August 15, 1978.

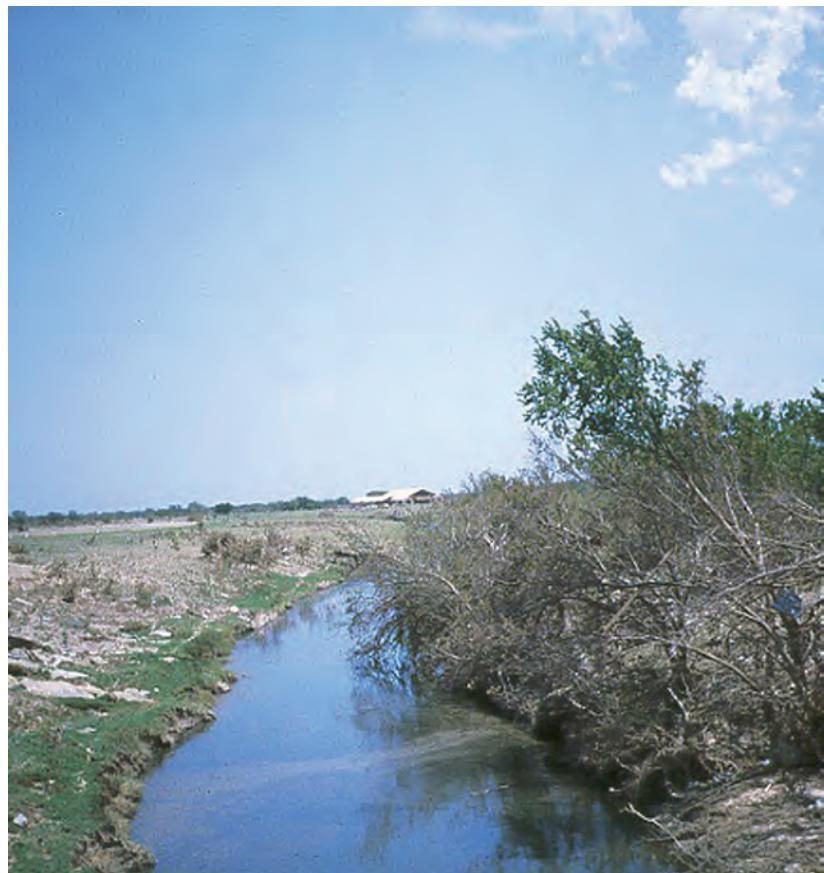
Figure A21. View from near gaging station at bridge looking downstream at channel, North Fork Hubbard Creek near Albany, Texas, August 15, 1978.

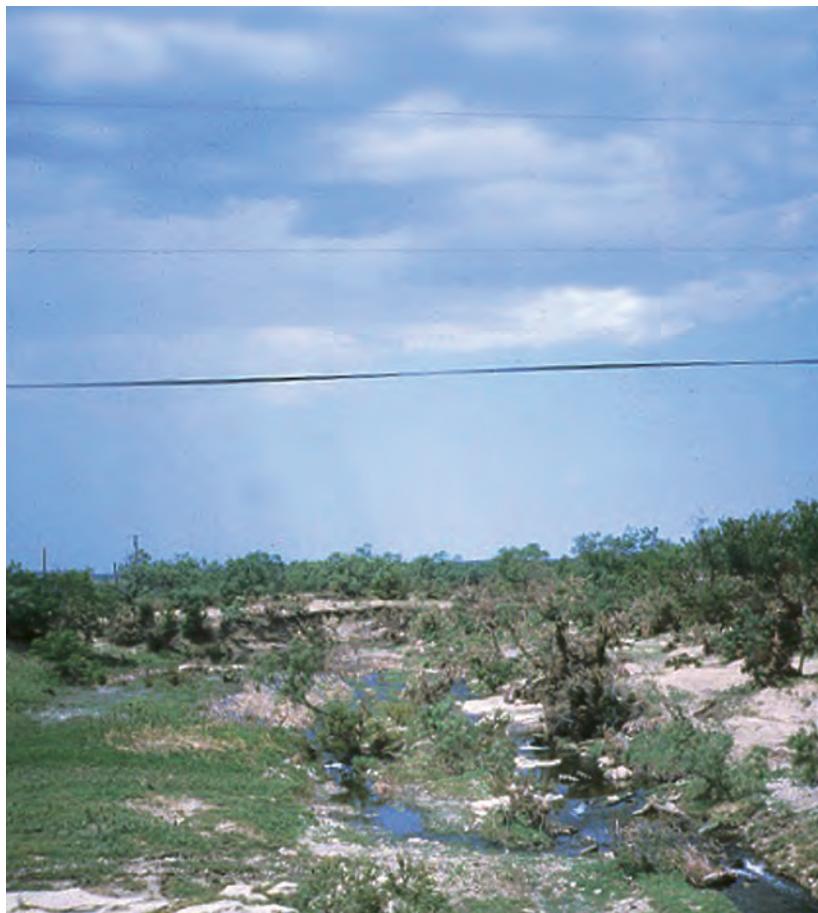
Figure A22. View from near gaging station on upstream side of bridge looking upstream, North Fork Hubbard Creek near Albany, Texas, August 15, 1978.

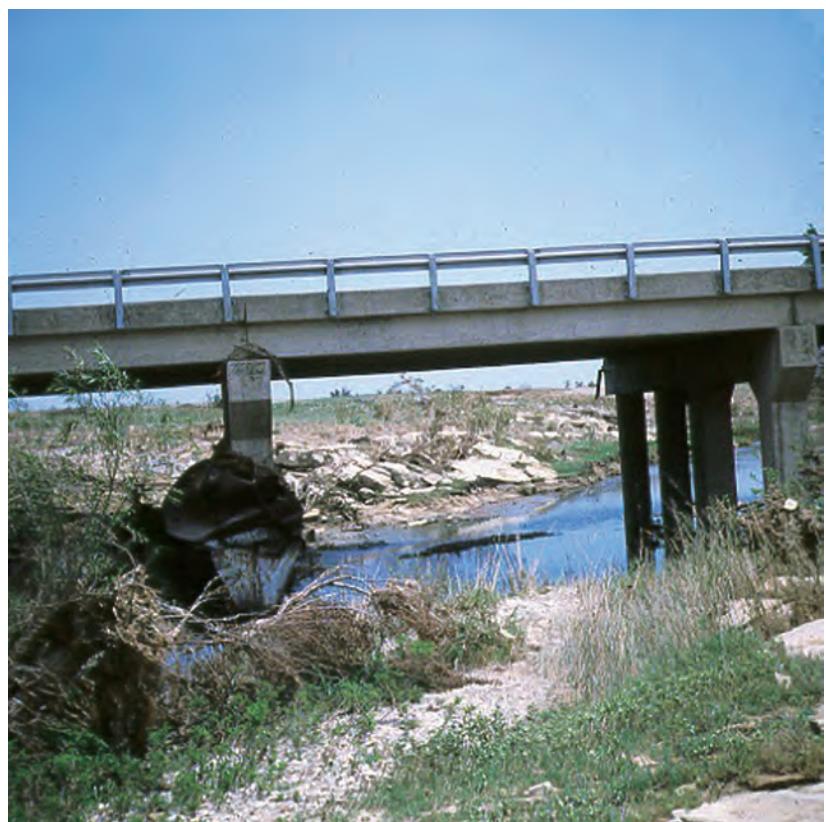
Figure A23. View at approach section to bridge at gaging station looking downstream at bridge and channel, North Fork Hubbard Creek near Albany, Texas, August 15, 1978.

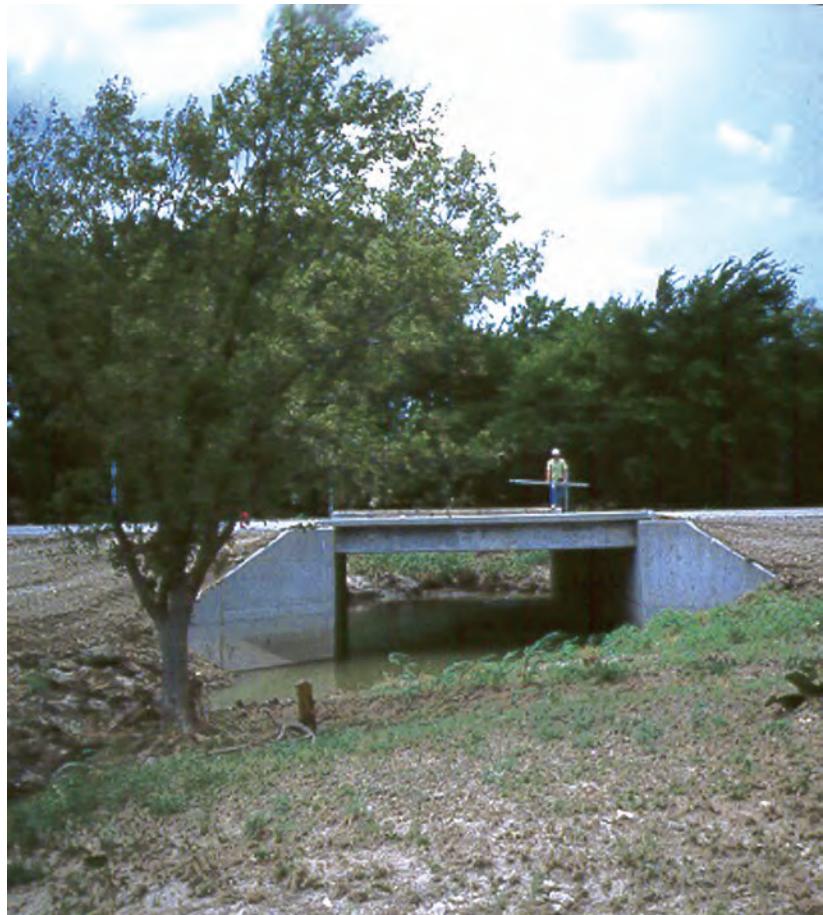
Figure A24. View from about 100 feet downstream of culvert located to right of gaging station looking upstream at culvert and approach section with rod held on upstream side of culvert near high-water mark in approach section, North Fork Hubbard Creek near Albany, Texas, August 15, 1978.

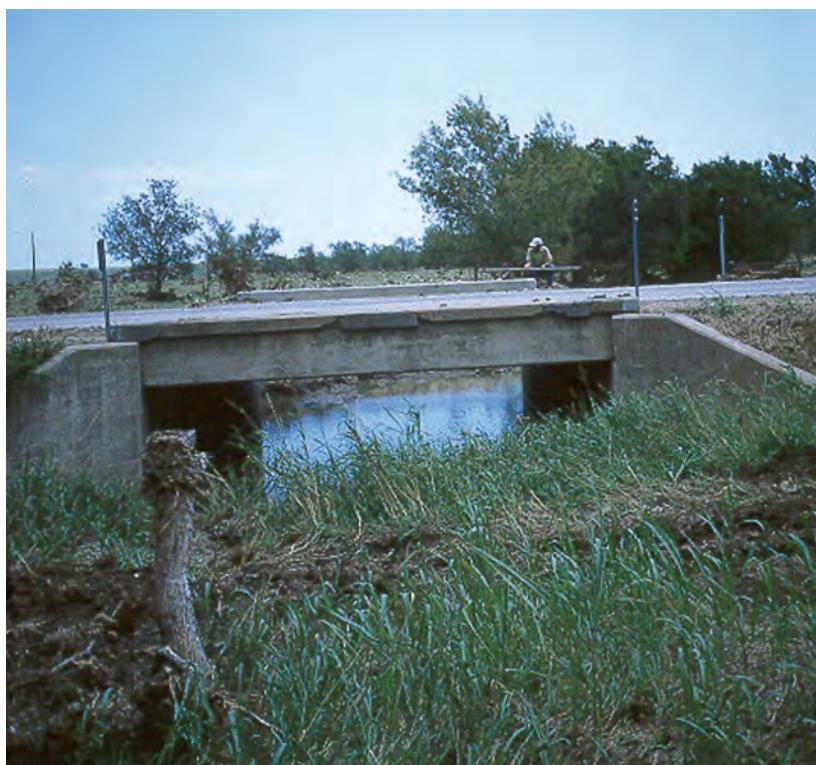
Figure A25. View at approach section of culvert looking downstream at culvert. Note flag in tree just above rod for elevation downstream of highway, North Fork Hubbard Creek near Albany, Texas, August 15, 1978.

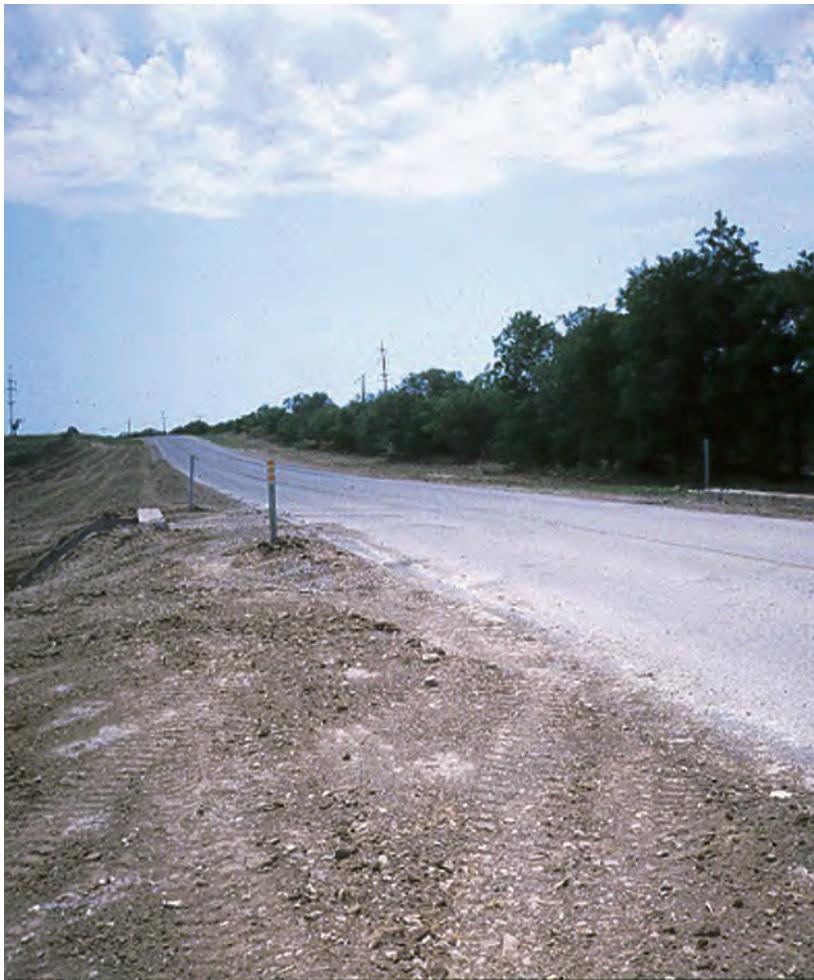
Figure A26. View about 100 feet to left of culvert on downstream shoulder of State Highway 6 looking across culvert at right bank and approach section. Rod held at high-water mark in approach, North Fork Hubbard Creek near Albany, Texas, August 15, 1978.

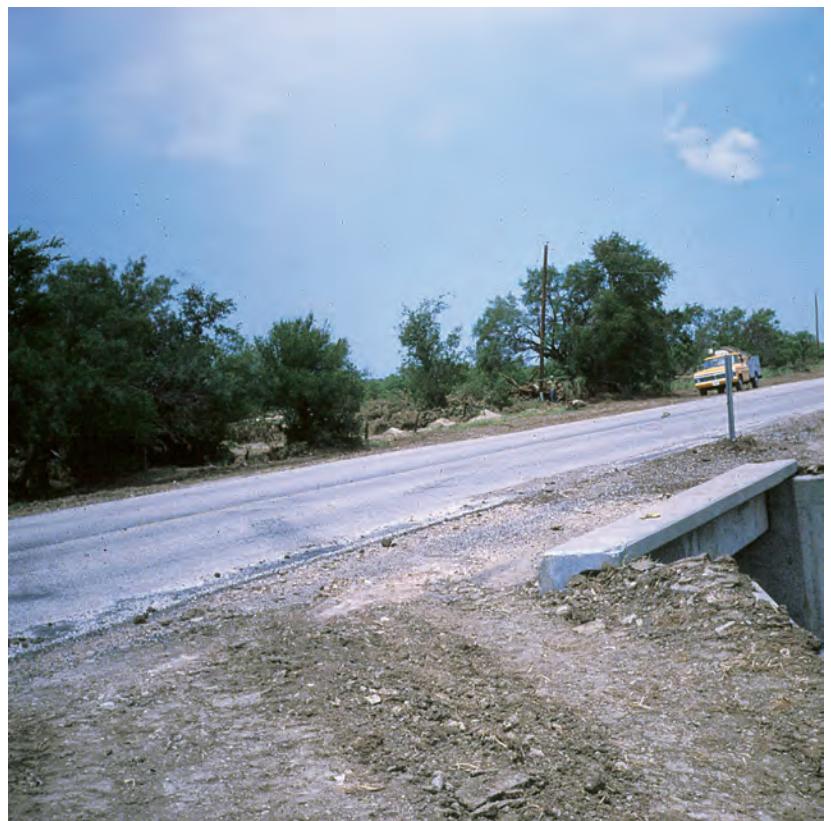
Figure A27. View from 50 feet to right of culvert on downstream shoulder looking across culvert with rod held at high-water mark in approach section, North Fork Hubbard Creek near Albany, Texas, August 15, 1978.

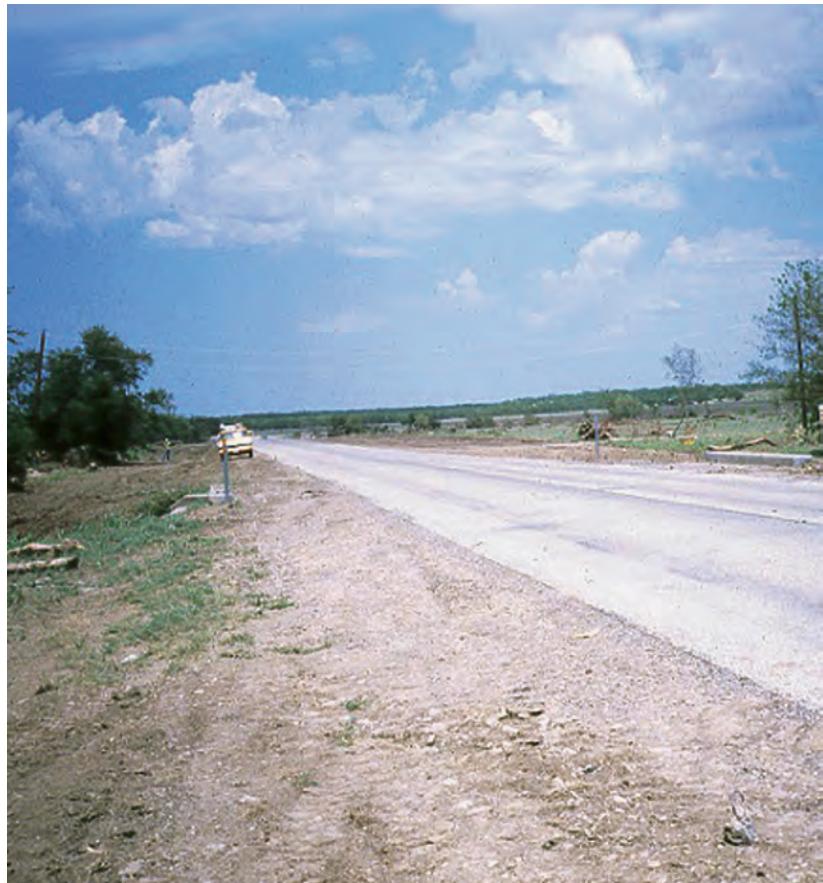
Figure A28. View about 100 feet to right of culvert on upstream shoulder looking slightly downstream and across to left bank. Rod held in approach section at high-water mark. The first string of trees is the main channel, North Fork Hubbard Creek near Albany, Texas, August 15, 1978.

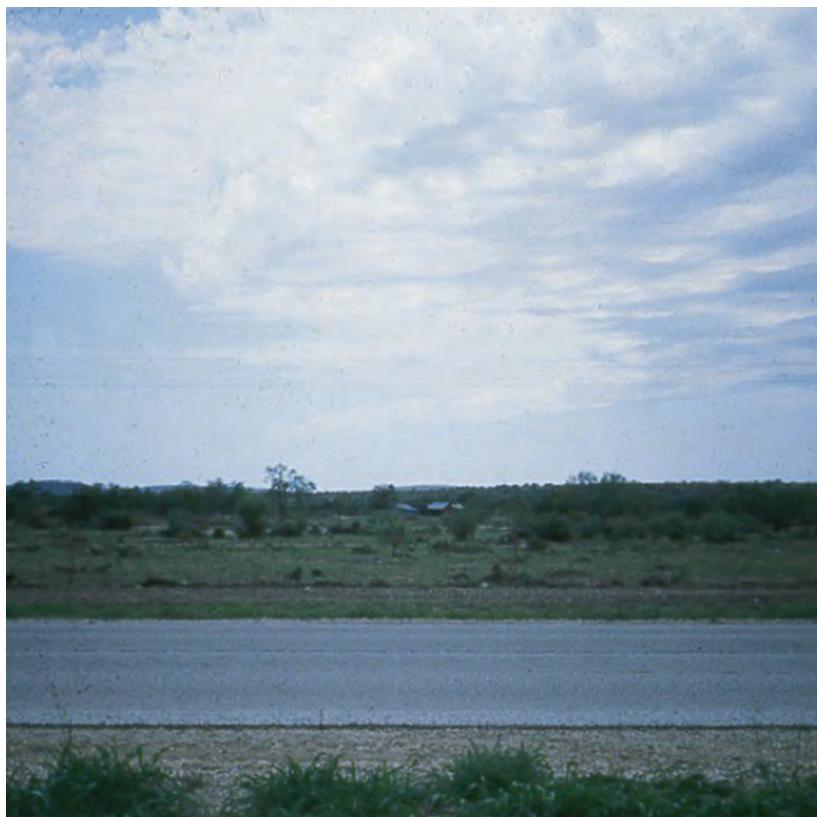
Figure A29. View from 25 feet downstream of State Highway 6 near left end of overflow looking upstream at approach section. Main channel in background is North Fork Hubbard Creek near Albany, Texas, August 15, 1978.

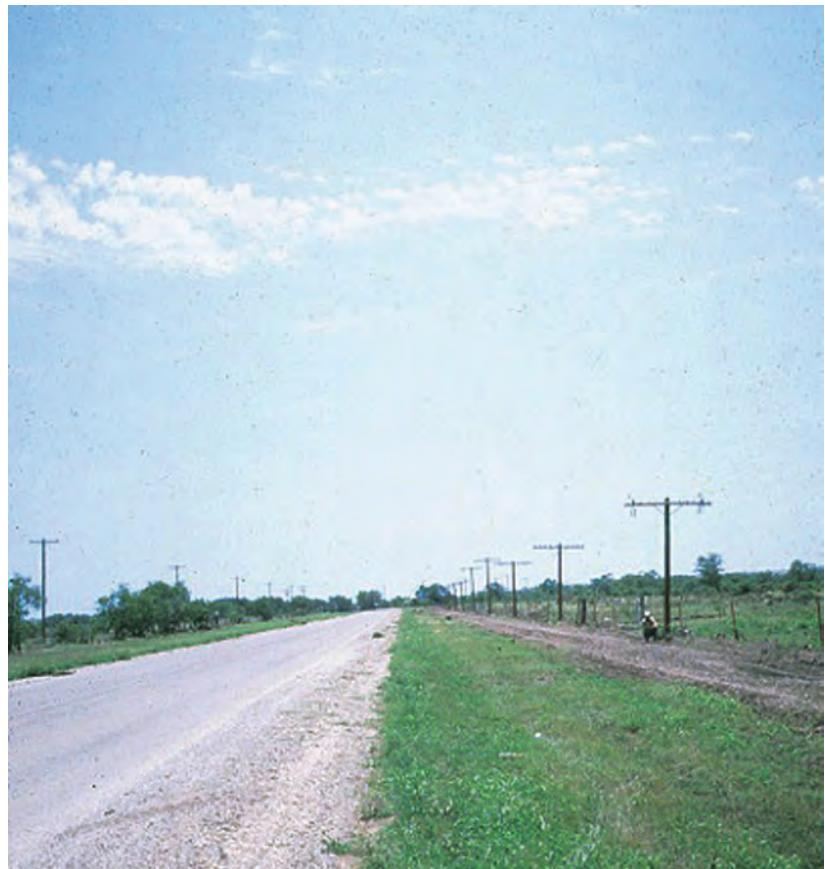
Figure A30. View from near left-bank overflow section looking to right bank showing State Highway 6 and approach section, North Fork Hubbard Creek near Albany, Texas, August 15, 1978.

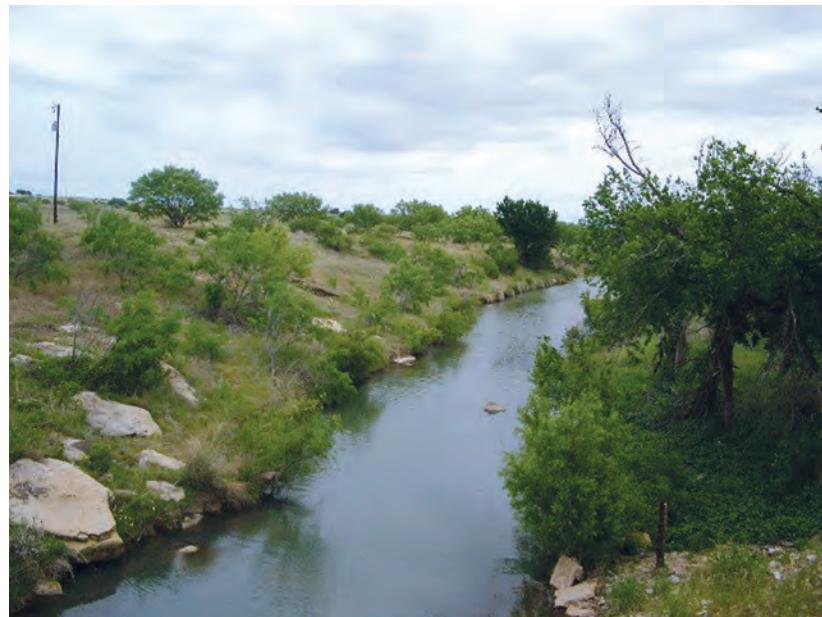
Figure A31. View looking downstream of bridge, North Fork Hubbard Creek near Albany, Texas, May 13, 2003.

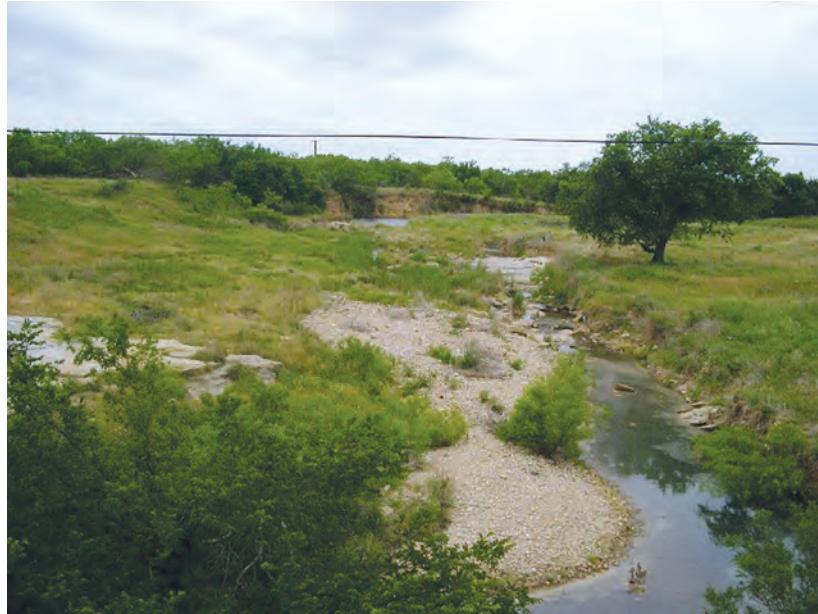
Figure A32. View looking upstream of bridge, North Fork Hubbard Creek near Albany, Texas, May 13, 2003.

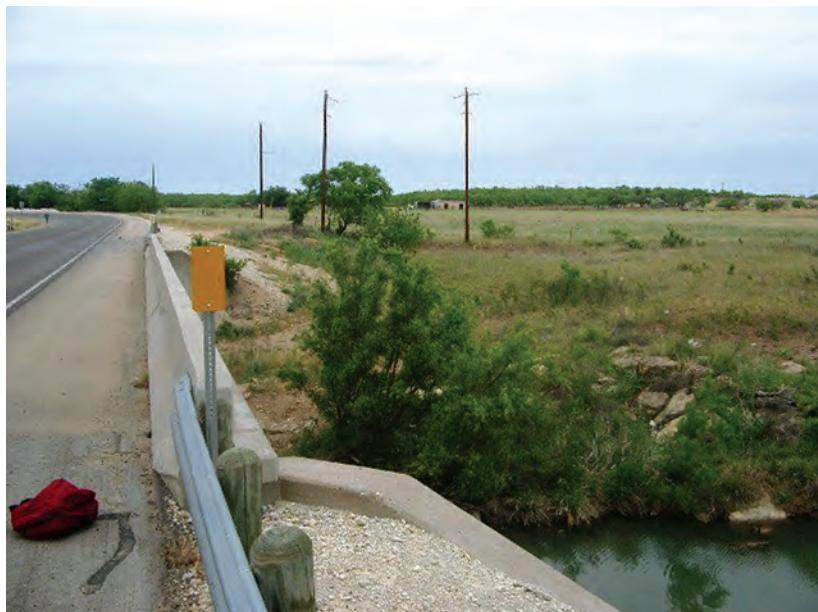
Figure A33. View looking across State Highway 6 and culvert toward left bank of flood plain, North Fork Hubbard Creek near Albany, Texas, May 13, 2003.

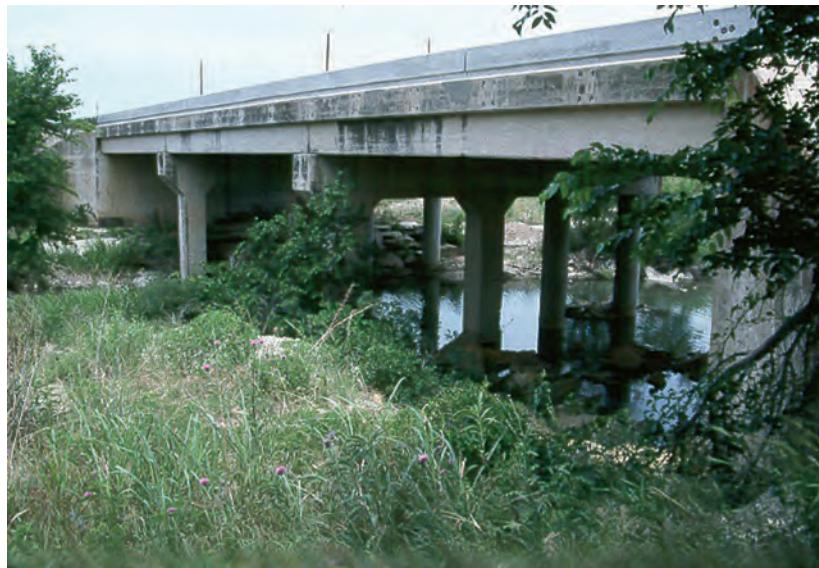
Figure A34. View from upstream side of State Highway 6 bridge, North Fork Hubbard Creek, near Albany, Texas, May 12, 2003.

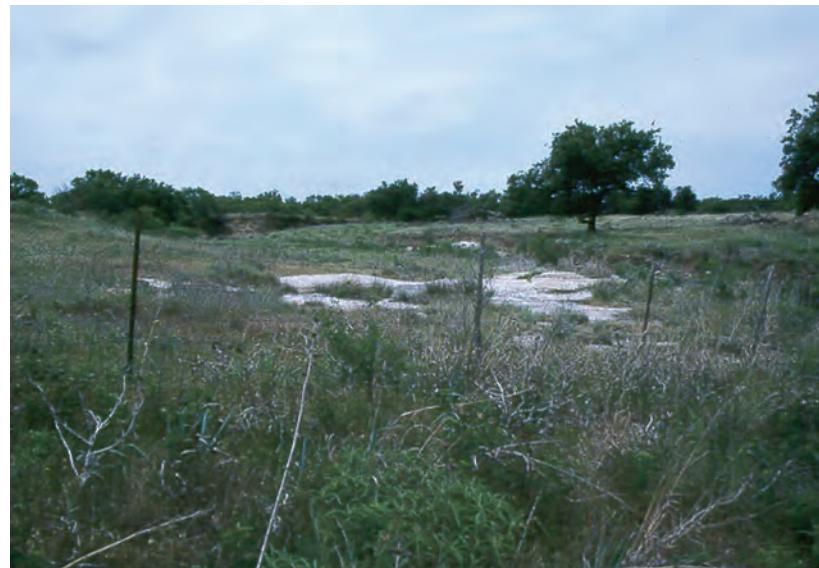
Figure A35. View looking upstream at main channel from State Highway 6 bridge, North Fork Hubbard Creek, near Albany, Texas, May 12, 2003.

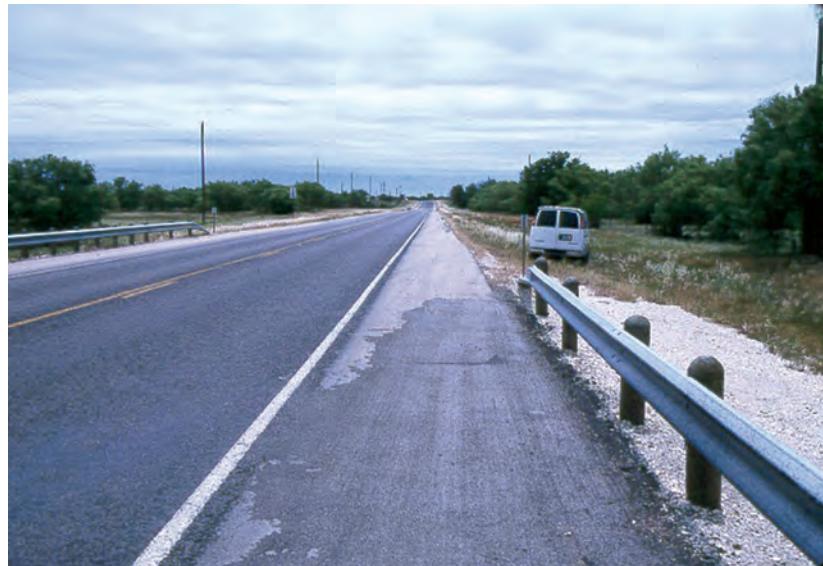
Figure A36. View looking left to right from State Highway 6 main-channel bridge, North Fork Hubbard Creek near Albany, Texas, May 12, 2003.

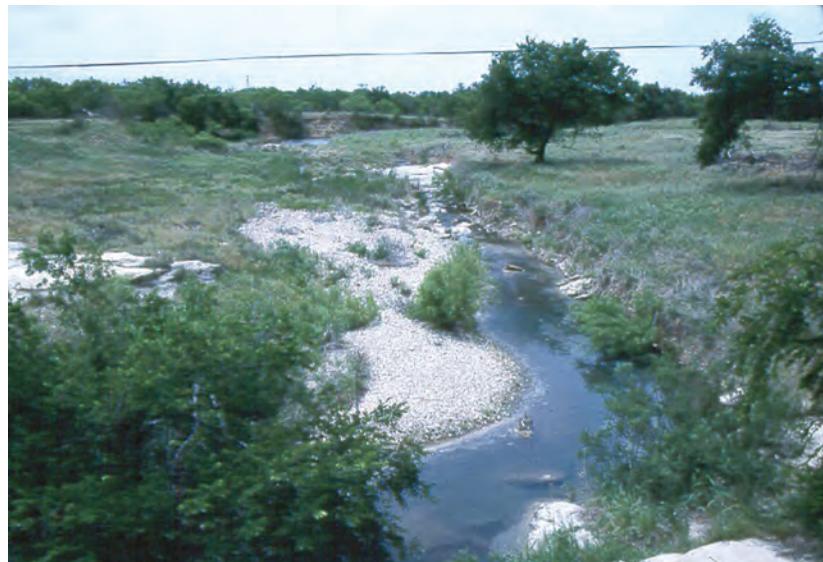
Figure A37. View looking upstream of State Highway 6 bridge, North Fork Hubbard Creek near Albany, Texas, May 12, 2003.

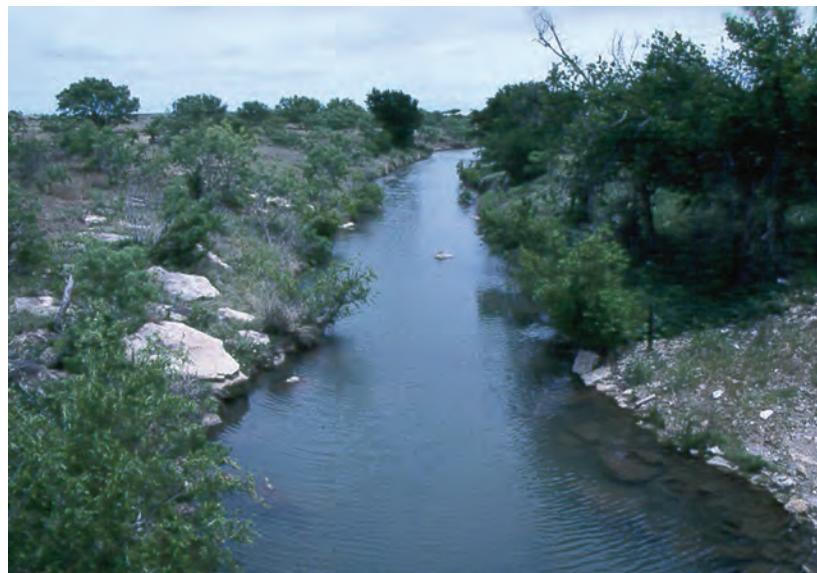
Figure A38. View looking downstream of State Highway 6 bridge, North Fork Hubbard Creek near Albany, Texas, May 12, 2003.

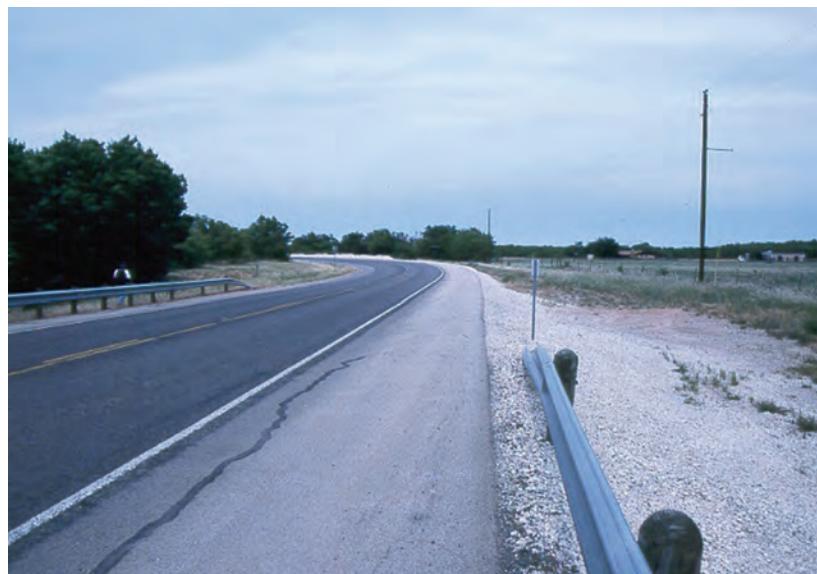
Figure A39. View looking right to left of State Highway 6 bridge, North Fork Hubbard Creek near Albany, Texas, May 12, 2003.

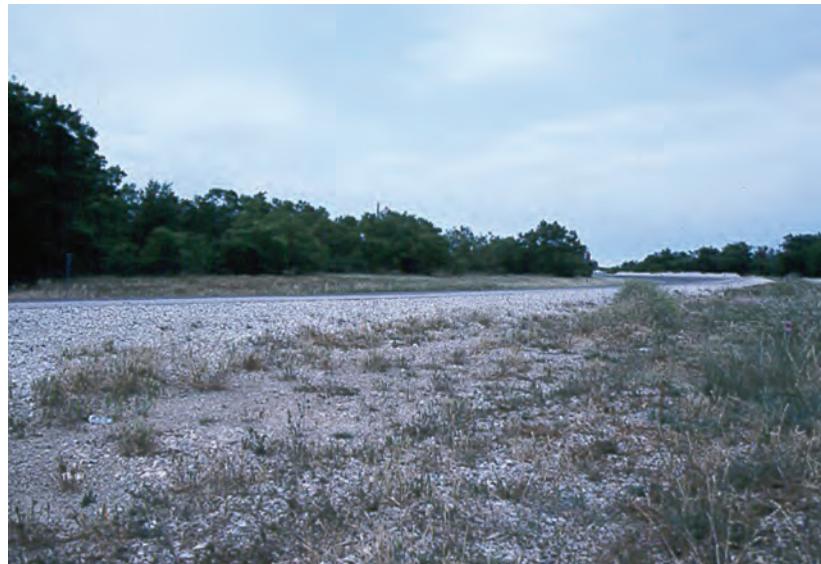
Figure A40. View looking upstream of downstream side of road near left end of bridge, North Fork Hubbard Creek near Albany, Texas, May 12, 2003.

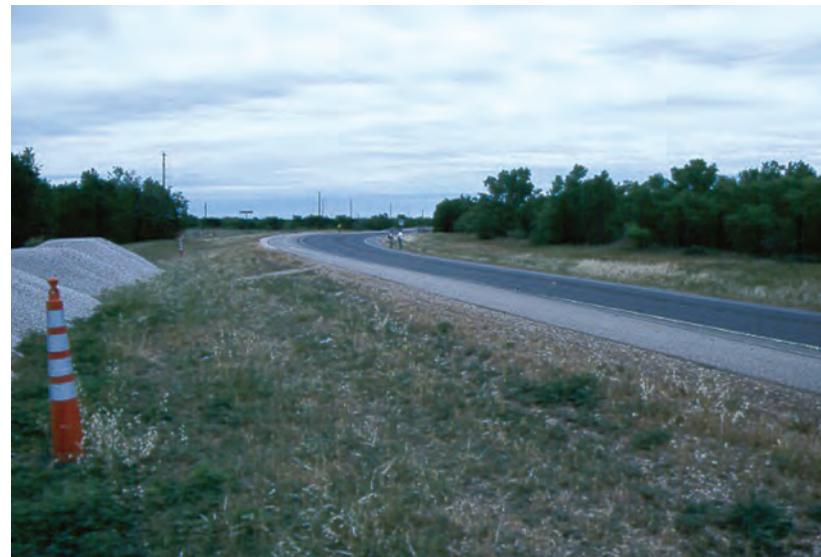
Figure A41. View looking left to right from curve in road, North Fork Hubbard Creek near Albany, Texas, May 12, 2003.
