West Fork Nueces River near Cline, Texas

(Miscellaneous ungaged site in the Nueces River basin, USGS Texas Water Science Center)

Review of peak discharge for the flood of June 14, 1935

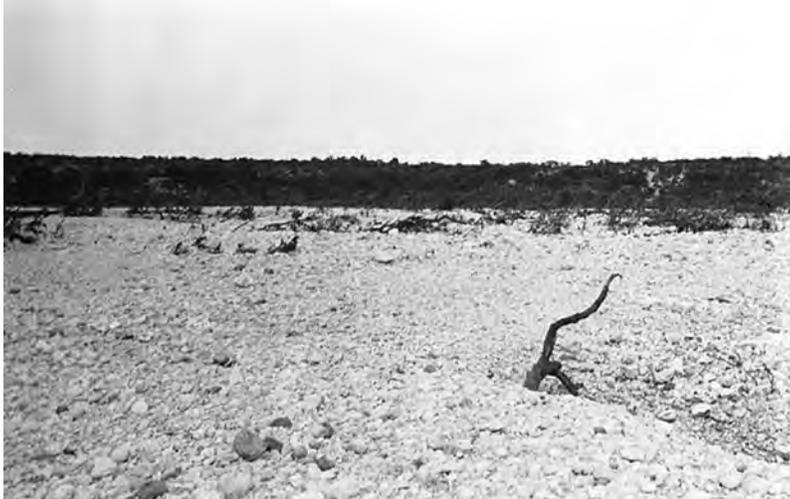
Figure A69. View looking across and upstream towards left bank from downstream cross section, West Nueces River 8 mi upstream of Cline, Texas. June 1935.

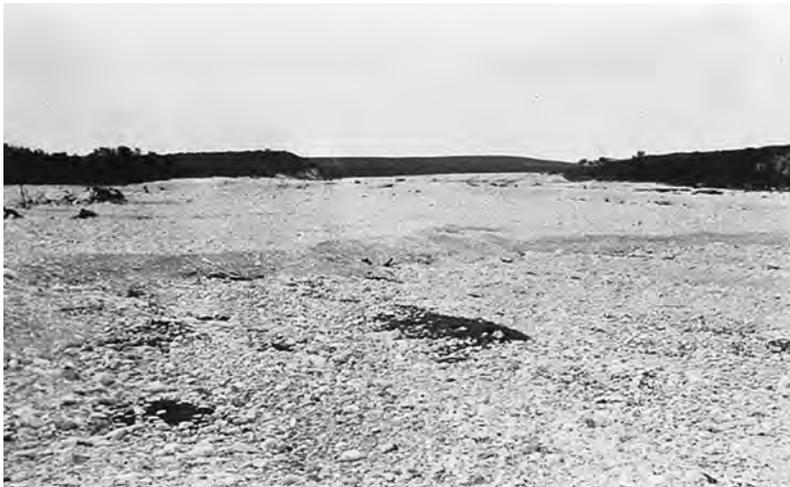
Figure A70. View looking at West Nueces River 8 mi upstream of Cline, Texas, June 1935.

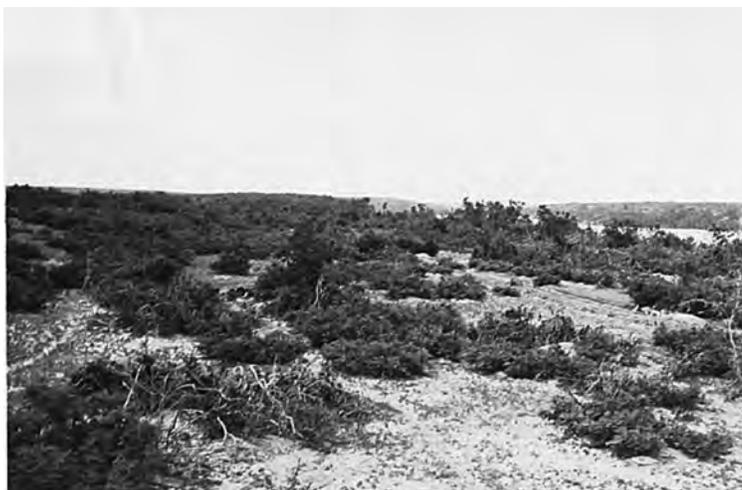
Figure A71. View looking upstream of downstream cross section at station 1, West Nueces River 8 mi upstream of Cline, Texas, June 1935.

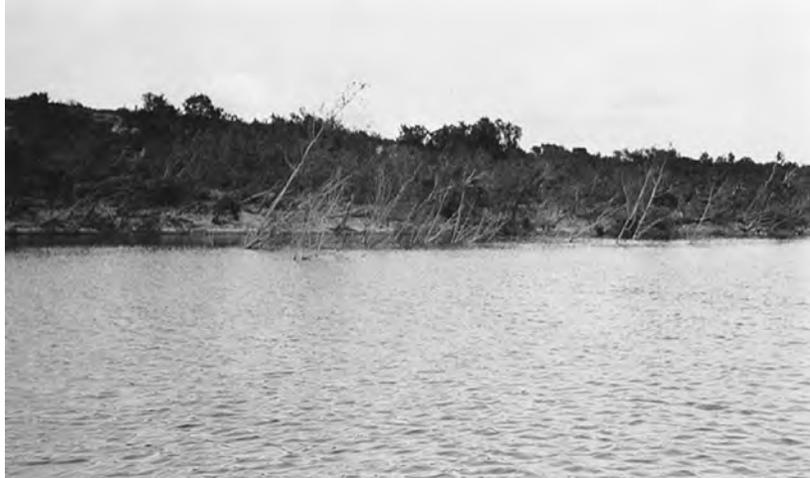
Figure A72. View looking toward left bank and downstream of upstream cross section, West Nueces River 8 mi upstream of Cline, Texas, June 1935.

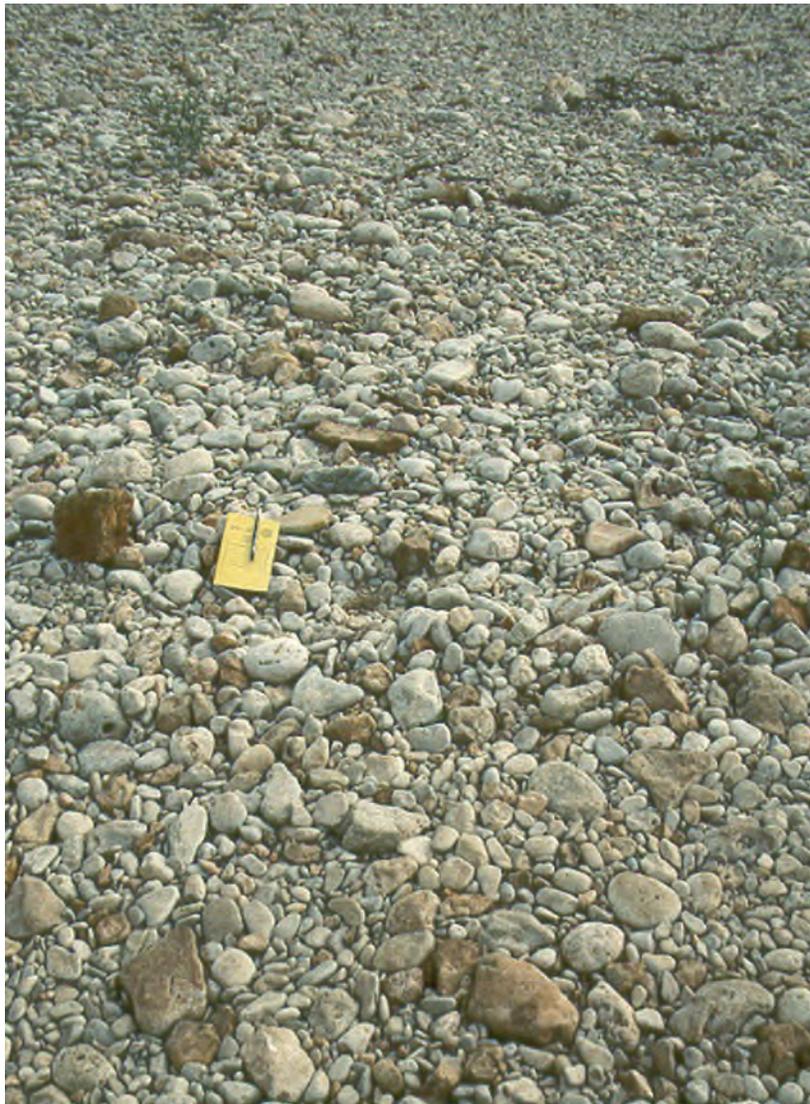
The main channel is relatively flat and open. The streambed consists of gravel, large cobbles, and small boulders. Both banks have a fairly dense growth of small trees and brush.

Figure A73. Coarse bed material in slope-area reach of West Nueces River 8 mi upstream of Cline, Texas, June 2003.

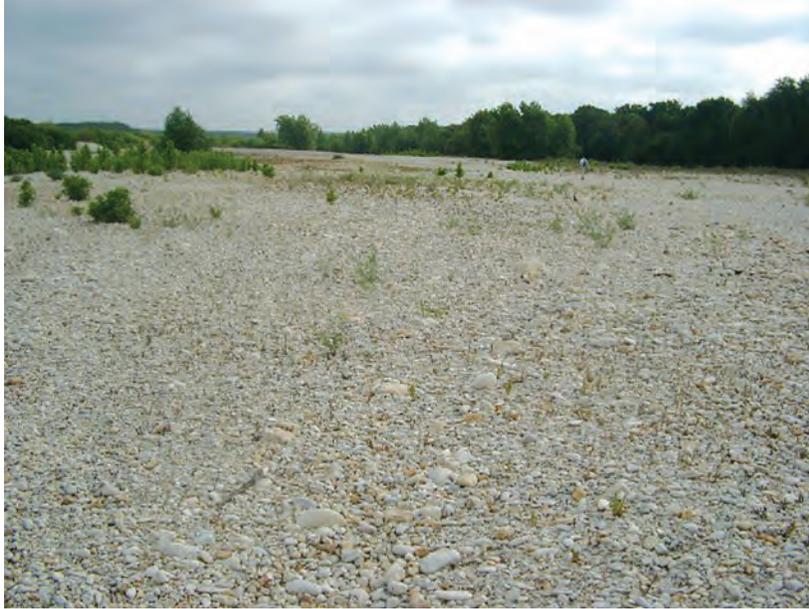
Figure A74. View looking upstream of slope-area reach, West Nueces River 8 mi upstream of Cline, Texas, June 2003.

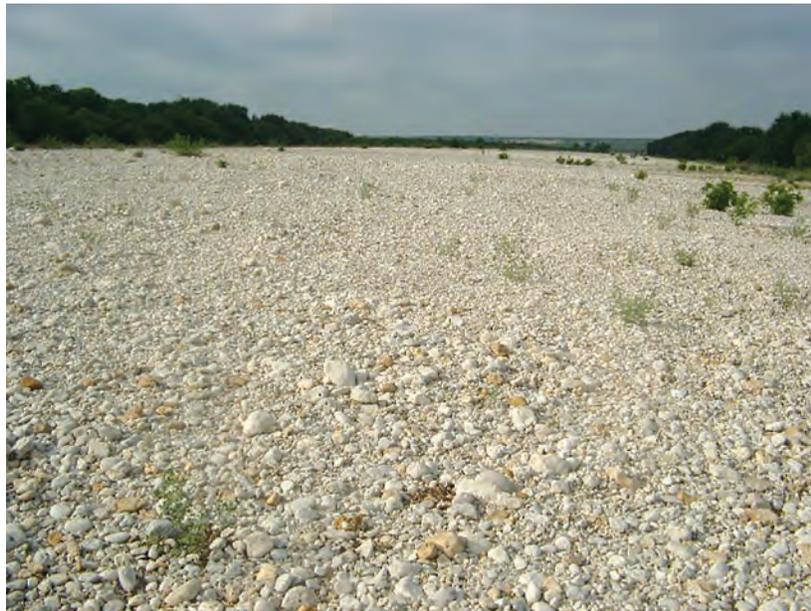
Figure A75. View looking downstream of slope-area reach, West Nueces River 8 mi upstream of Cline, Texas, June 2003.
