West Fork Nueces River near Kickapoo Springs, Texas

Review of peak discharge for the flood of June 14, 1935

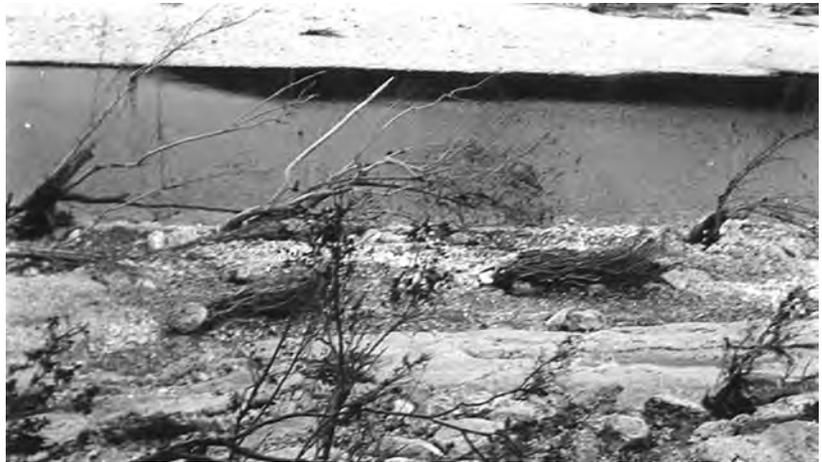
Figure A59. View looking across stream from right bank at upstream cross section, West Fork Nueces River near Kickapoo Springs, Texas, June 1935. Slope-area section for flood of June 14, 1935.

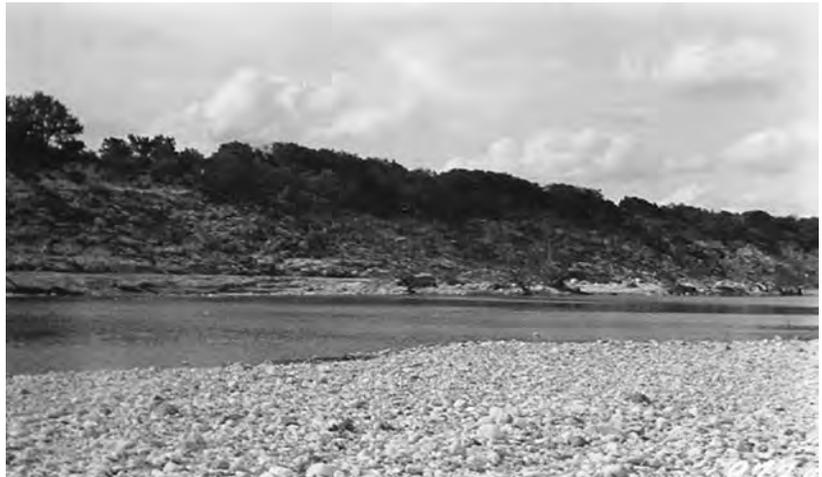
Figure A60. View looking across and upstream of downstream cross section, West Fork Nueces River near Kickapoo Springs, Texas, June 1935.

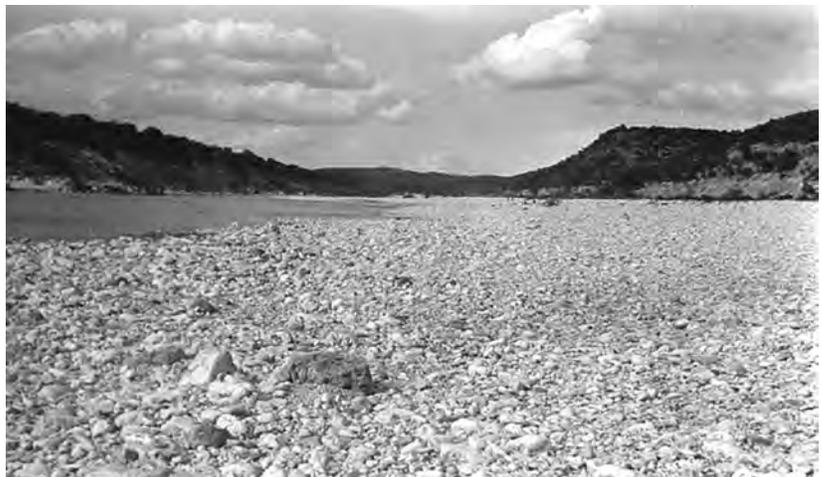
Figure A61. View looking upstream of downstream cross section, West Fork Nueces River near Kickapoo Springs, Texas, June 1935.

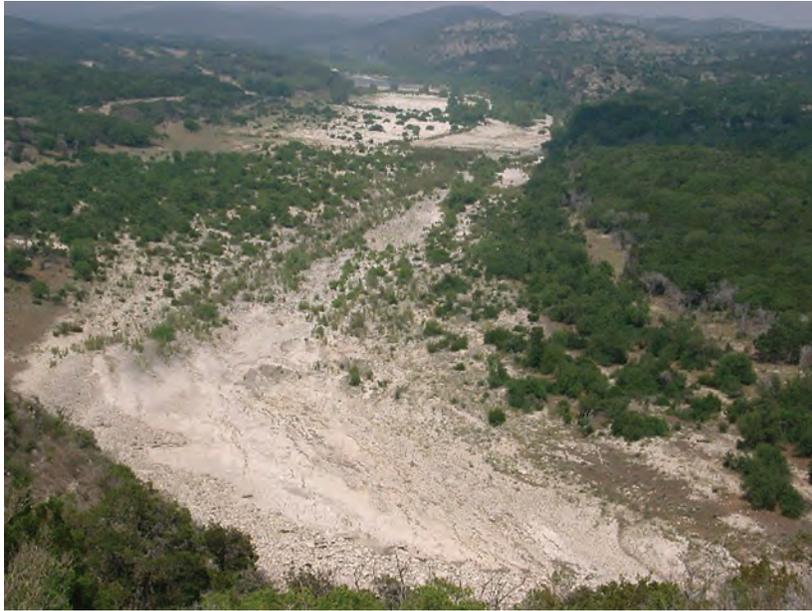
The channel is about 600 ft wide, relatively flat, and open. It is composed of gravel, large cobbles, and small boulders. Both banks are fairly steep. It appears to be a very good slope-area site, but the measurement is poor.

Figure A62. View looking upstream toward slope-area reach, West Fork Nueces River near Kickapoo Springs, Texas, June 13, 2003.

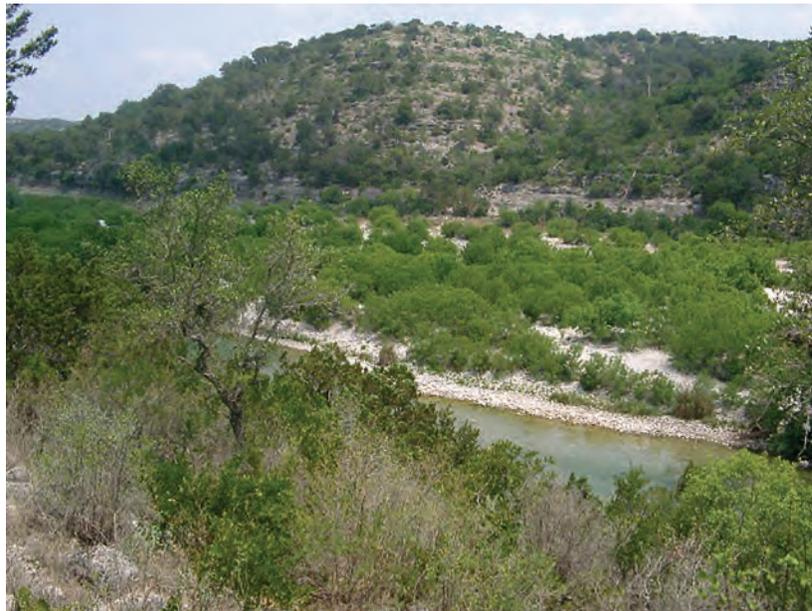
Figure A63. View looking from right to left bank in middle of slope-area reach, West Fork Nueces River near Kickapoo Springs, Texas, June 13, 2003.

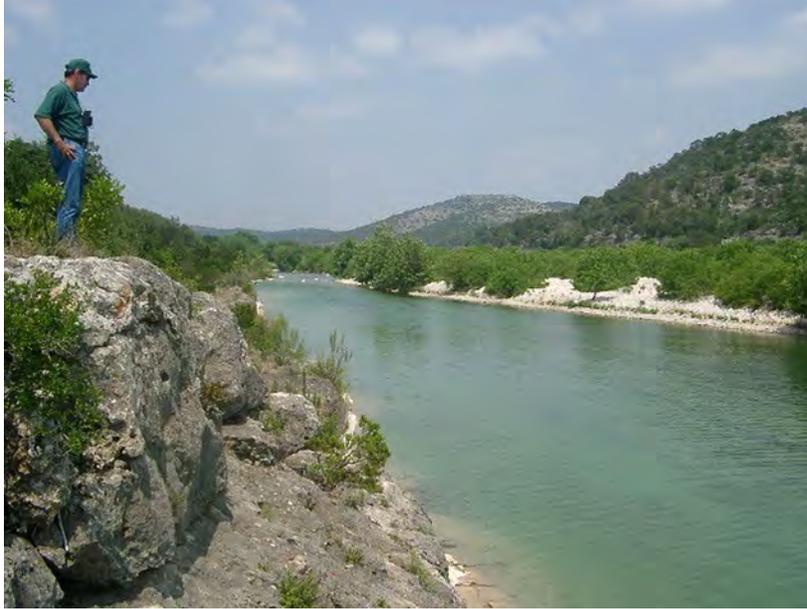
Figure A64. View looking upstream near middle of slope-area reach, West Fork Nueces River near Kickapoo Springs, Texas, June 13, 2003.

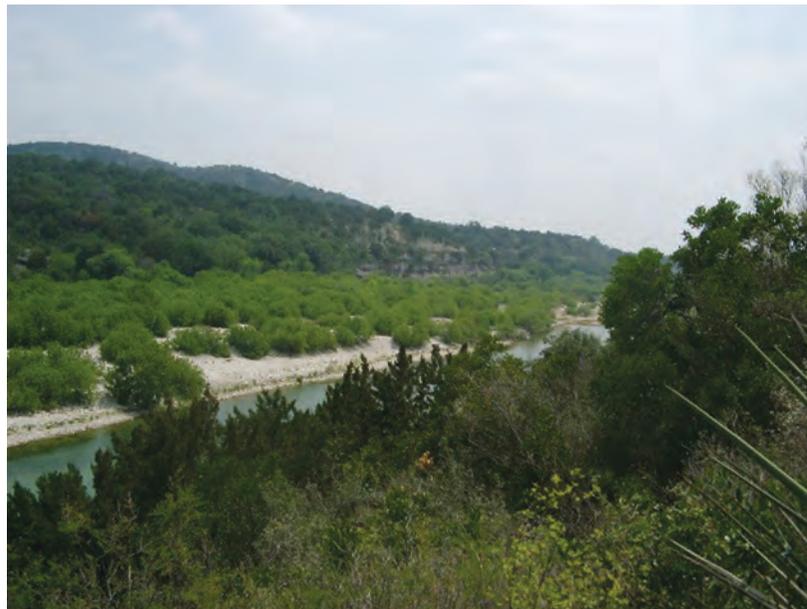
Figure A65. View looking downstream from right bank looking from middle of slope-area reach, West Fork Nueces River near Kickapoo Springs, Texas, June 13, 2003.
