Previously mapped surface geology of the hydrogeologic and geophysical study area, northeastern Bexar County, Texas, referred to as hydrogeologic units of the Edwards aquifer and upper part of the Glen Rose Limestone by Stein and Ozuna (1995).

Reinterpreted surface geology of the hydrogeologic and geophysical study area, northeastern Bexar County, Texas, showing members of Kainer and Person Formations equivalent to hydrostratigraphic units.

Geologic (hydrostratigraphic) section A-A', hydrogeologic and geophysical study area, northeastern Bexar County, Texas.

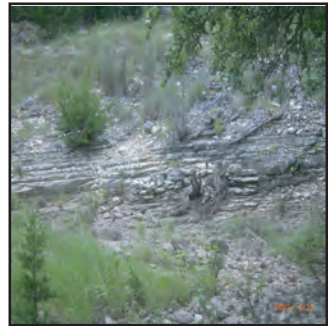
Photograph 1. Regional dense member (P1) in southern part of the study area, beds are dipping to south. Photograph taken looking west.

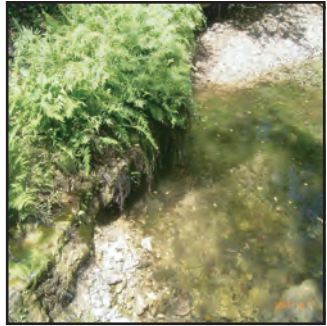
Photograph 3. Dripping springs (P3) near contact of the Glen Rose Limestone and the basal nodular member of the Kainer Formation. The spring is in the northern part of the study area. Photograph taken looking northeast.

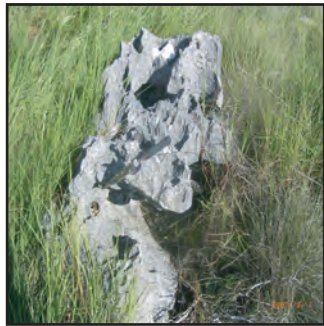
Photograph 5. Vug and channel dissolution porosity in the massive dolomitic member (P5) in the northwestern part of the study area. Photograph taken looking north.

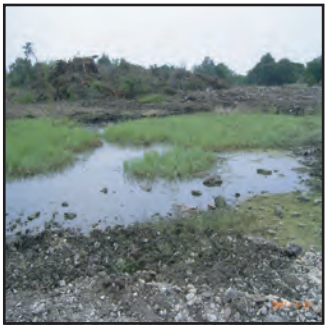
Photograph 2. Closed depression (P2) holding water in the leached and collapsed members (undivided) in southern part of the study area. Photograph taken looking southeast.

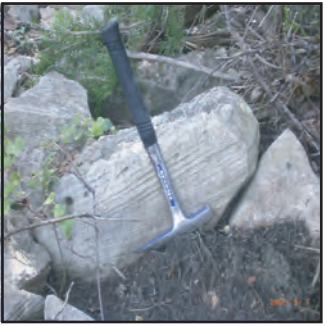
Photograph 4. Cross-bedded grainstone member (P4) located below the contact with the regional dense member in southern part of study area. Photograph taken looking south.

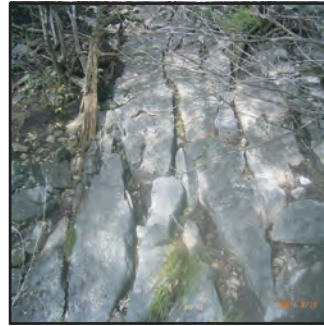
Photograph 6. Fracture porosity in the massive dolomitic member (P6) in the central part of the study area. Photograph taken looking northeast. Note solution-enlarged joints.
