Physical and Vegetative Characteristics of a Newly Constructed Wetland and Modified Stream Reach, Tredyffrin Township, Chester County, Pennsylvania, 2000–2006

Scientific Investigations Report 2009–5020

By Jeffrey J. Chaplin, Kirk E. White, and Leif E. Olson

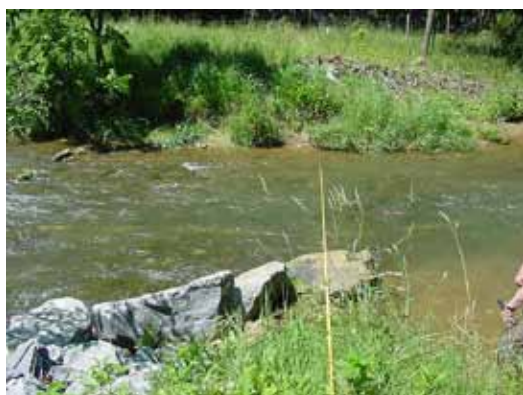
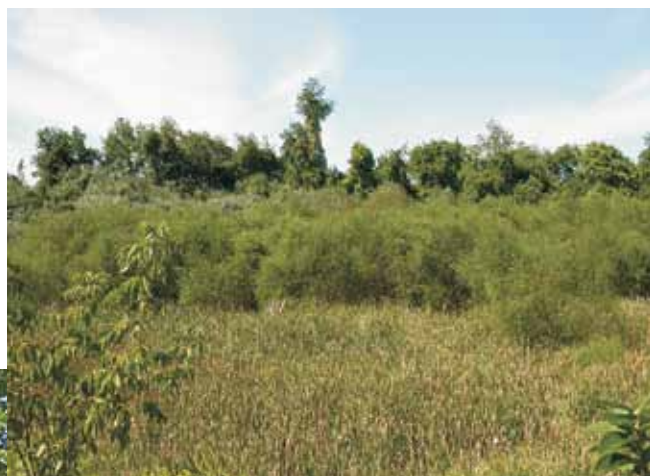
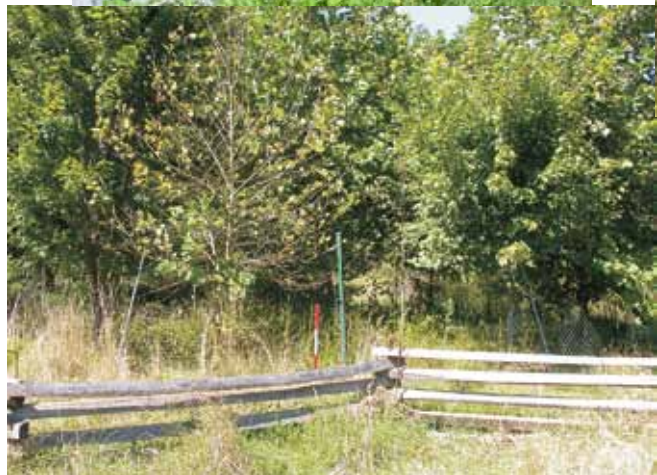
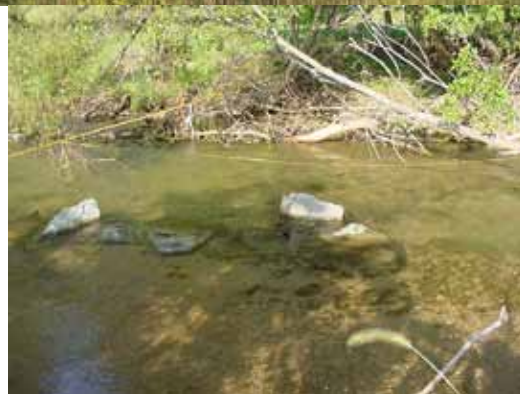
Cover.

1. View of the upstream rock deflector, June 2001.
2. Riparian-buffer plantings in group 15, September 2005.
3. View of the constructed wetland from photo station 3, September 2006.
4. View of downstream rock deflector, September 2006.

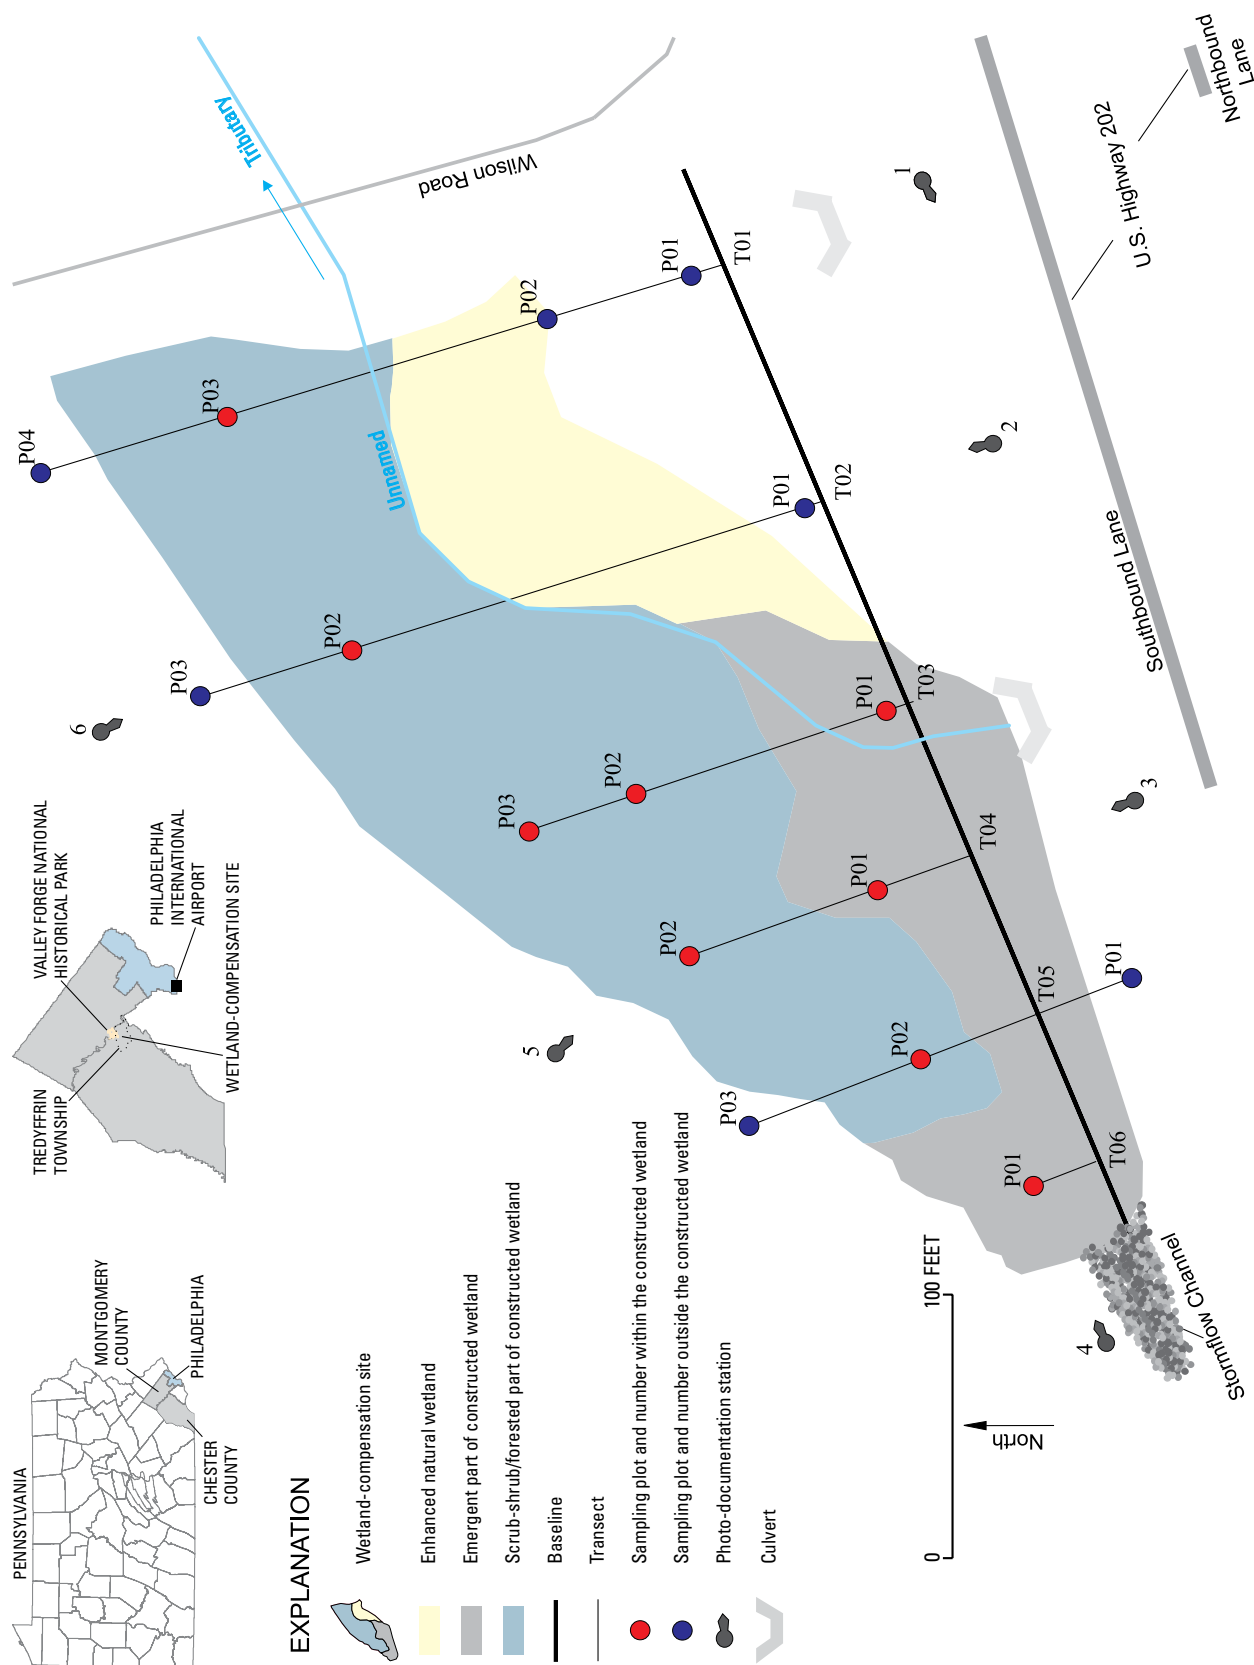
Figure 2. Wetland-compensation site, Tredyffrin Township, Chester County, Pennsylvania. [Plot locations shown in this figure are identified by a four-digit number in the text (0301 for example). The first two numbers represent the transect number (03), and the last two indicate the plot along that transect (01).]

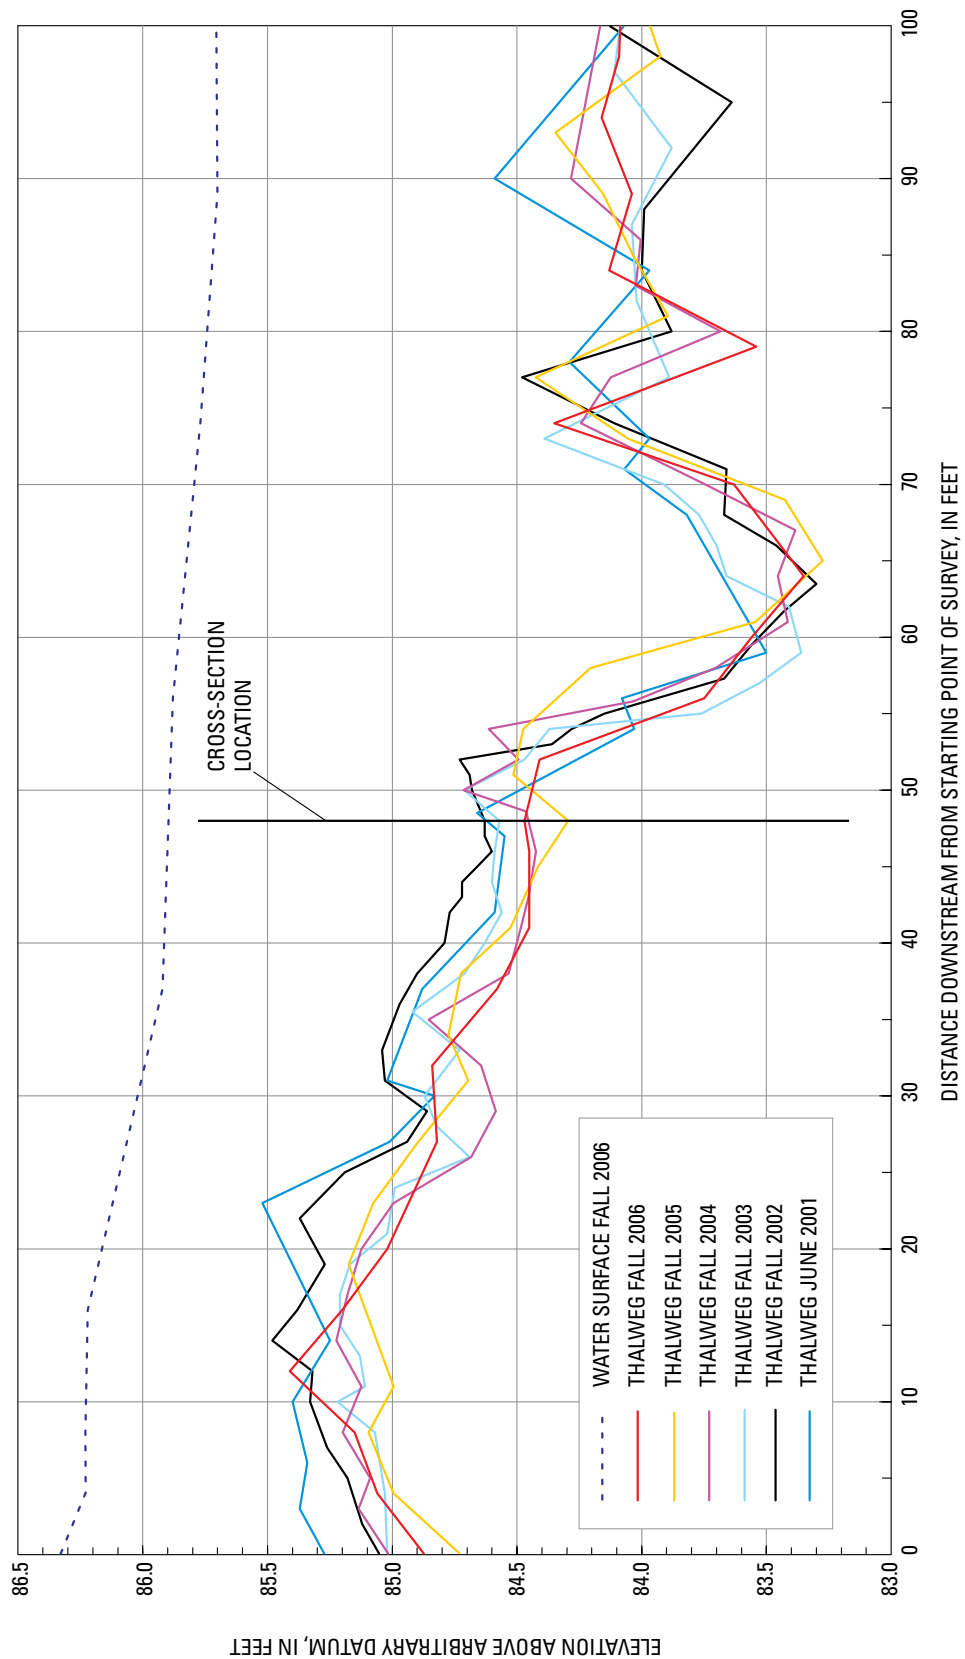
Figure 6. Longitudinal profile of the upstream reach of the modified stream reach, Tredyffrin Township, Chester County, Pennsylvania.
[Annual discrepancies in stationing along the longitudinal profile are because of changes in the thalweg and the resulting inability to place the measuring tape along the exact same path.]

Water-surface and streambed slopes at the two reaches (shown in figure 2) remained relatively stable during the monitoring period, ranging from 0.01 to 0.02 ft/ft in the upstream reach (table 5) and 0.01 to 0.04 ft/ft in the downstream reach (table 6) with no more than ± 0.01 ft/ft variation compared to the initial conditions established in June 2001. The minor slope fluctuations noted between annual surveys of the longitudinal profiles are not considered to be appreciable and, in many cases, are primarily the result of mathematical rounding in the slope computation. Changes in stationing, length of reach or riffle, or in the actual positions of distinct channel features are, in most cases, attributed to inconsistent placement of the measuring tape rather than changes to the reach profiles. Variations in the appearance of the upstream and downstream profiles, as displayed in figures 6 and 7, are evidence of slight deposition or erosion within the reaches and, in most instances, are considered more a function of transient material passing through the reaches than an actual lasting change. One possible exception is the apparent accumulation of material in the pool at the downstream reach in the vicinity of station 115 during the 2006 assessment. Continued monitoring over a range of hydrologic conditions would be necessary to determine if this was a change in the sediment transport of the reach or a temporary characteristic as displayed near station 70 in the 2002 profile. The overall consistency of the reach slopes is most likely because of the presence of bedrock at the streambed (visibly cropping out around stations 70–90 in the upstream reach) prohibiting downcutting of the channel and the presence of sufficient energy within the system to transport the material supplied to each reach.

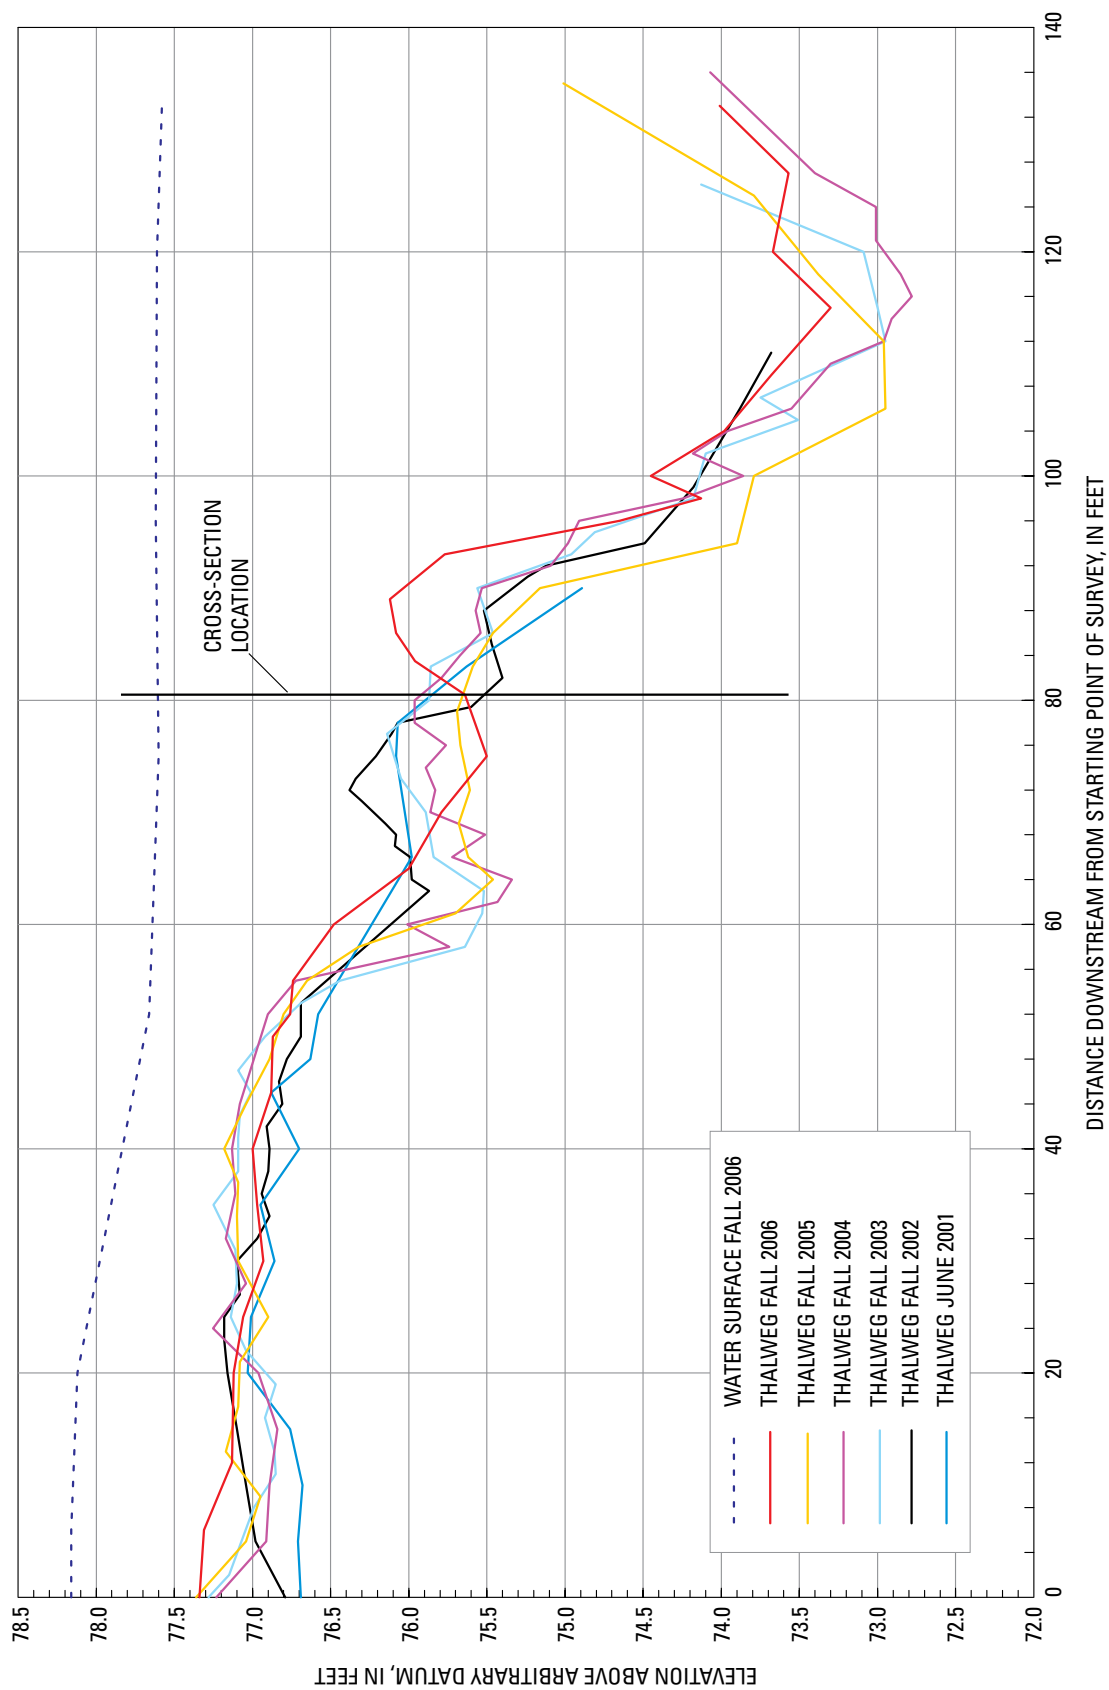
Figure 7. Longitudinal profile of the downstream reach of the modified stream reach, Tredyffrin Township, Chester County, Pennsylvania. [Annual discrepancies in stationing along the longitudinal profile are because of changes in the thalweg and the resulting inability to place the measuring tape along the exact same path.]

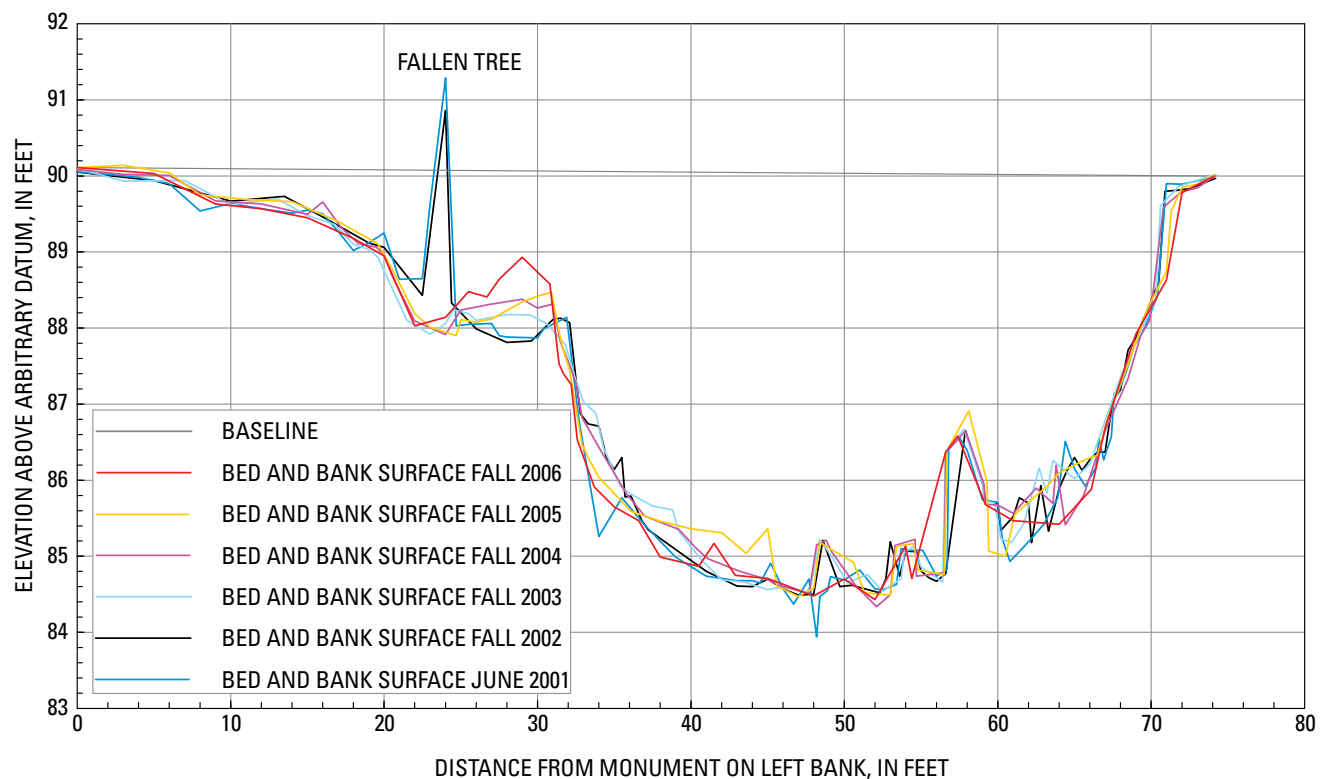
Figure 8. Surveys of the upstream cross section of the modified stream reach, Tredyffrin Township, Chester County, Pennsylvania.

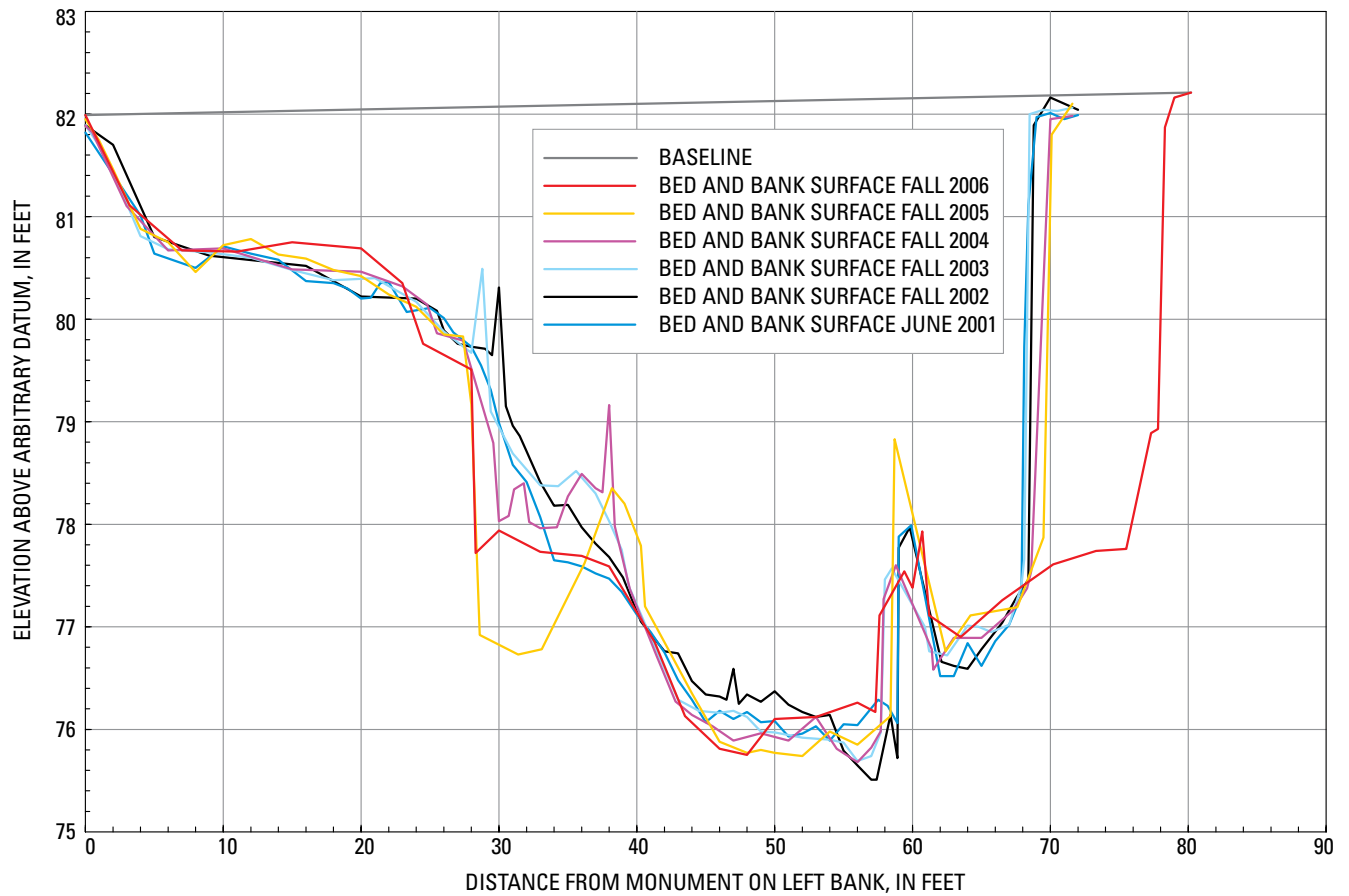
Figure 9. Surveys of the downstream cross section of the modified stream reach, Tredyffrin Township, Chester County, Pennsylvania.

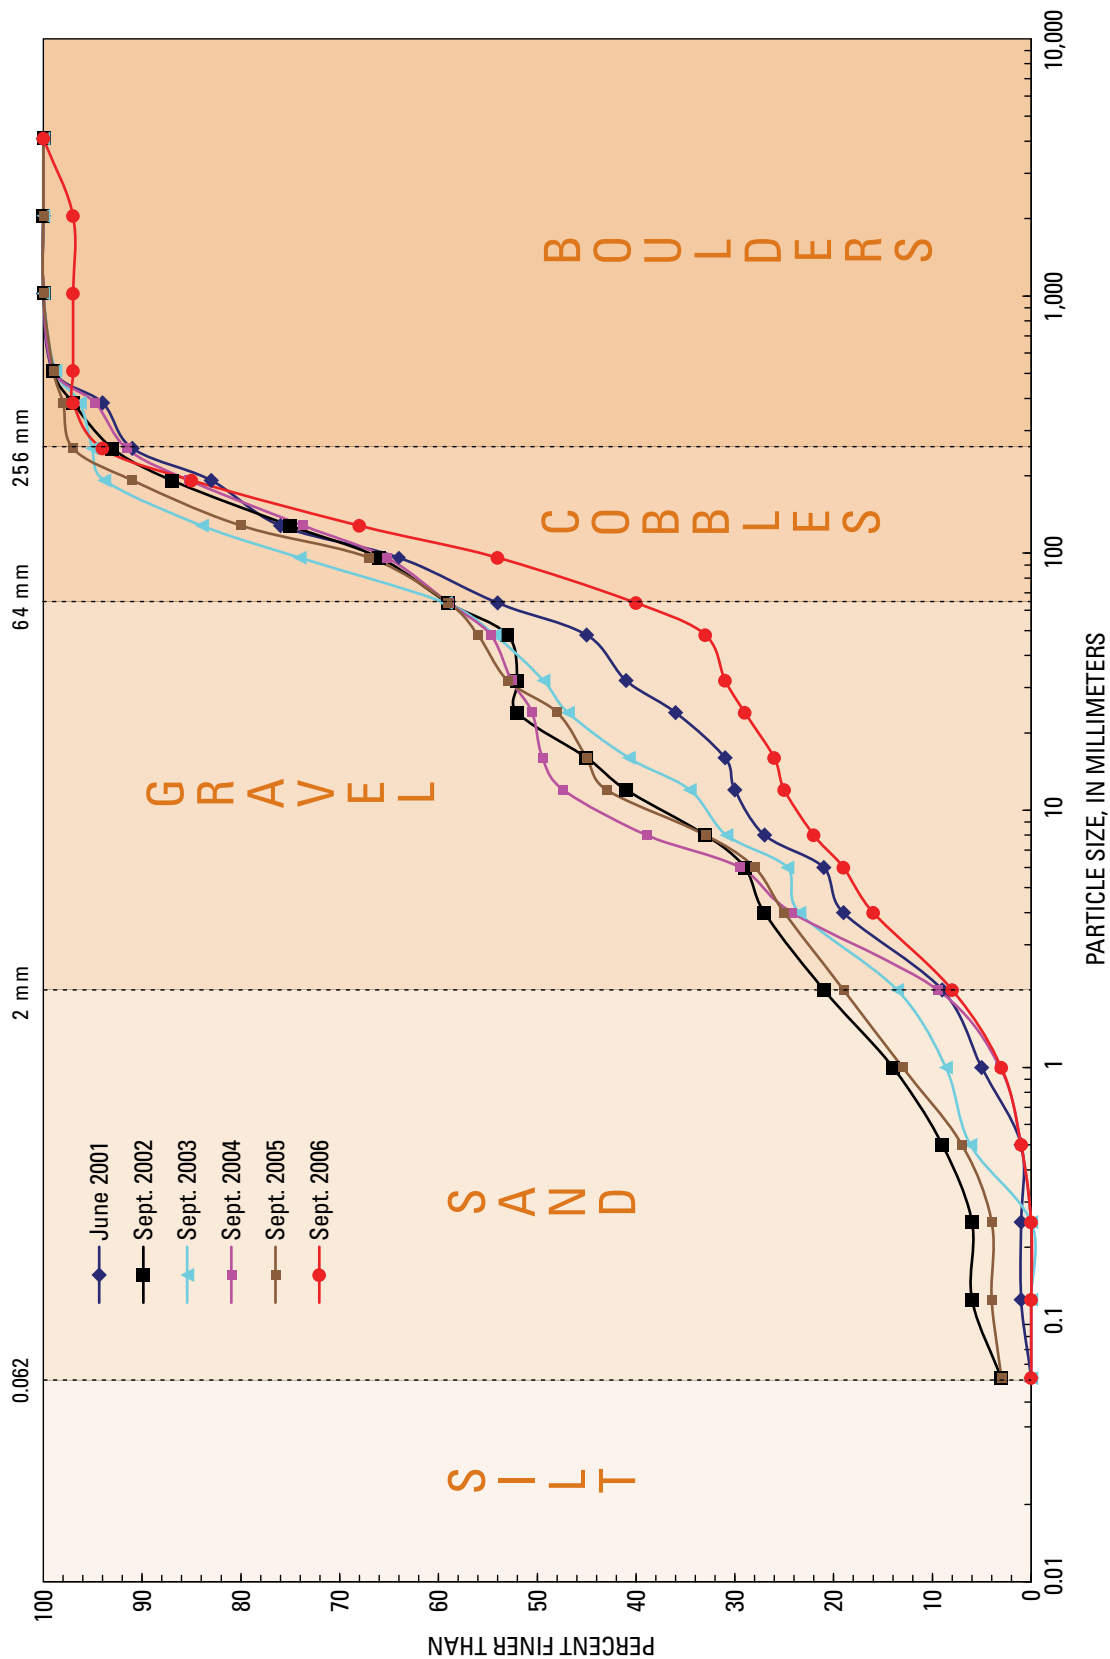
Figure 10. Comparison of particle-size distributions in the upstream cross section, 2001–2006.

average decrease of about 50 percent was noted in the D15 to D50 distribution categories, tending to be composed of coarse gravels. The average particle size for the D50 category, among all assessments, was 41 mm. The D84 and D95 categories decreased in size by an average of 24 percent and were characterized by cobbles and boulders. The pebble count during the 2006 assessment indicated a reversal of the previous trend toward smaller particles in the D15 to D50 categories, resulting, on average, in a 70-percent increase in particle sizes, still primarily gravels but noticeably coarser. The coarsening of the material in these size categories is most likely indicative of the load being carried by preceding storms and the continued capability of this reach to transport a majority of the material being provided. The D84 and D95 categories continued to be smaller than during the June 2001 assessment.

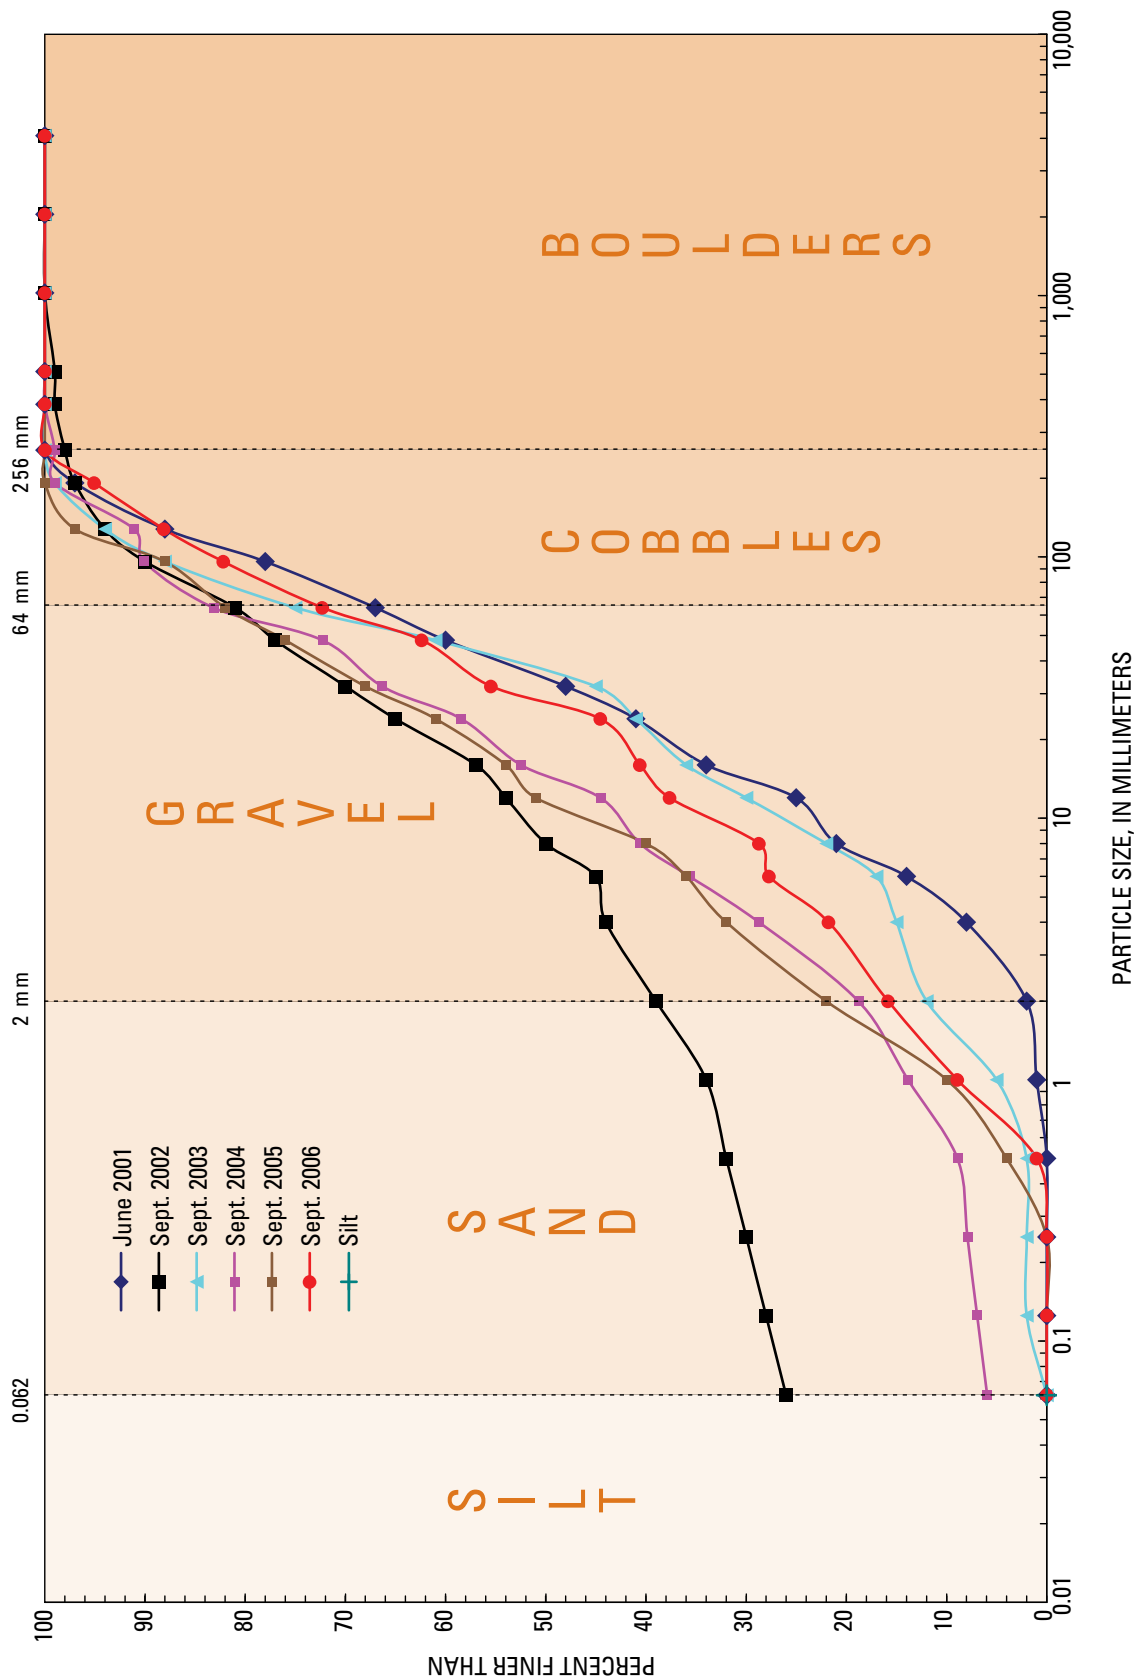
Particle distributions in the cross section in the downstream reach generally decreased in size in all categories and for all assessments with only two exceptions (table 8 and fig. 11). Similar to the upstream reach, an average decrease of about 50 percent was noted in the D15 to D50 distribution categories; most particles were characterized as coarse gravels. The average particle size for the D50 category, among all assessments, was 22 mm. The D84 and D95 categories decreased in size over the monitoring period by an average of 22 percent and were characterized by cobbles. Unlike the upstream reach, particle distributions in all size distributions, except the D95, decreased in size in 2006. The continued presence of finer material within the cross section, when compared to the June 2001 assessment, suggests a decrease in the sediment transport of this reach. This is commonly the case when a channel is actively widening, resulting in decreasing depths of streamflow which, in turn, decreases the ability of the stream to transport sediment.

Figure 11. Comparison of particle-size distributions in the downstream cross section, 2001–2006.

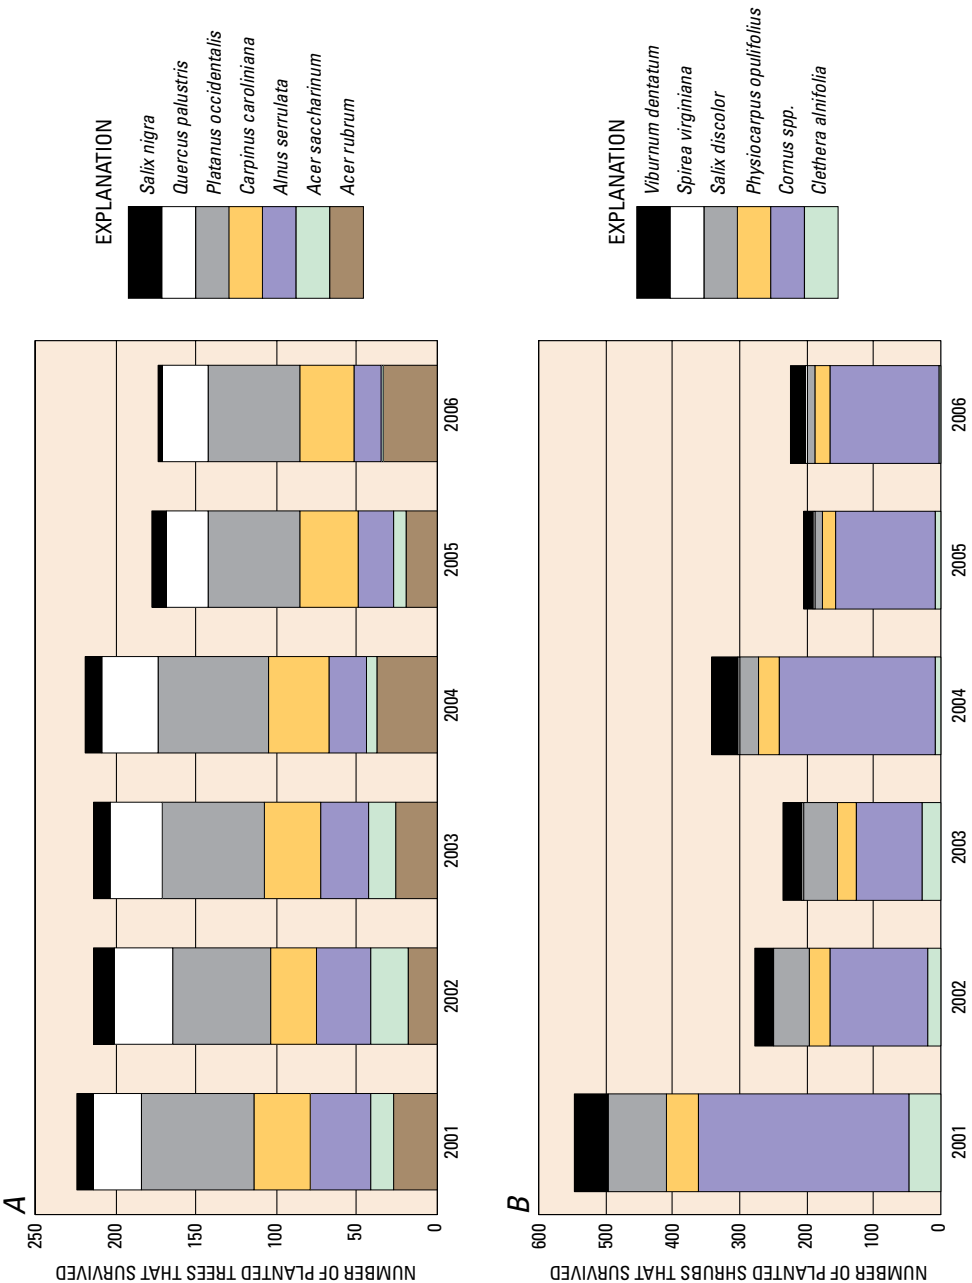
Figure 12. Number of planted trees (A) and shrubs (B) growing in the riparian buffer, Tredyffrin Township, Chester County, Pennsylvania, 2001–2006.

[*Platanus occidentalis* (sycamore), *Salix nigra* (black willow), *Alnus serrulata* (smooth alder), *Clethra alnifolia* (summersweet), and *Carpinus caroliniana* (ironwood) individuals that died during the 2001 growing season were replaced shortly after data collection in 2001 (October 2001). Additional trees and shrubs of the following species were replanted at various times before and after monitoring in 2002: *Cl. alnifolia*, *Ca. caroliniana*, *Pl. occidentalis*, *Acer rubrum* (red maple), *Cornus spp.* (dogwood species), *Salix discolor* (pussy willow), *Sal. nigra*, and *Al. serrulata*.]

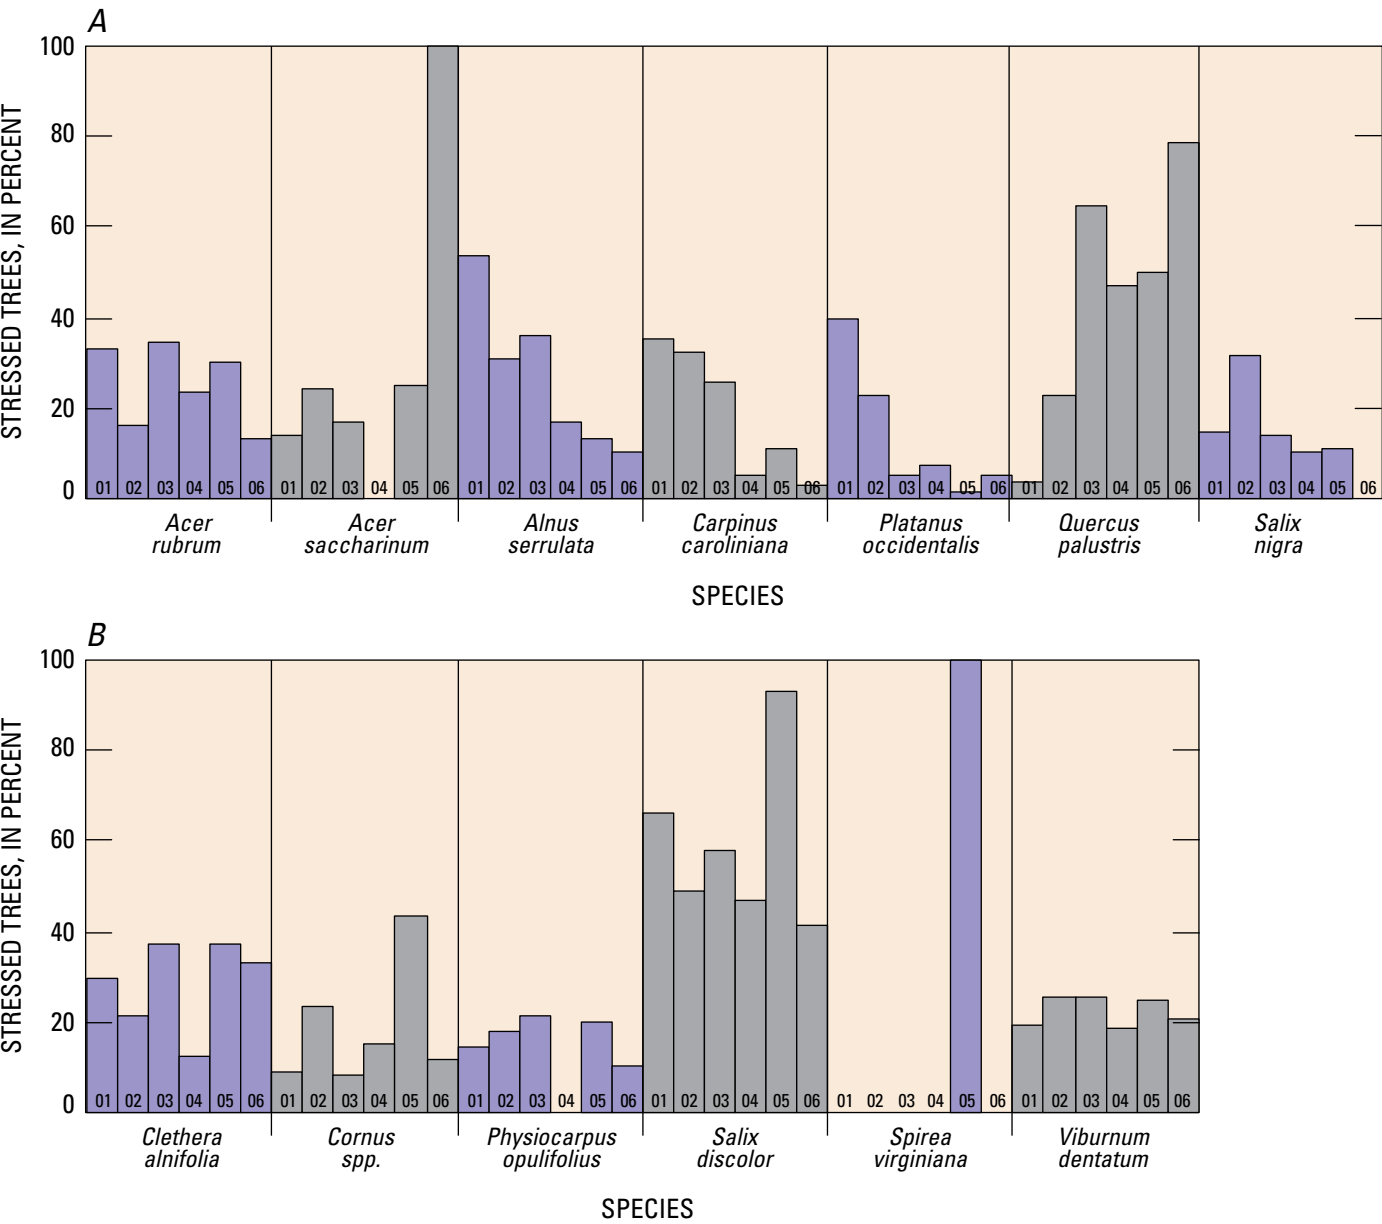
Figure 13. Percentage of planted species of trees (A) and shrubs (B) in the riparian buffer that were stressed, Tredyffrin Township, Chester County, Pennsylvania, 2001–2006.
[Year-to-year decreases in the percentage of stressed individuals over time may not indicate improvement in the overall well-being of a given species. For example, the percentage of stressed plants in a given year may decrease because the weakest plants died the year before, leaving only the healthiest, least-stressed plants.]

decrease because the weakest plants died the year before, leaving only the healthiest, least-stressed plants.

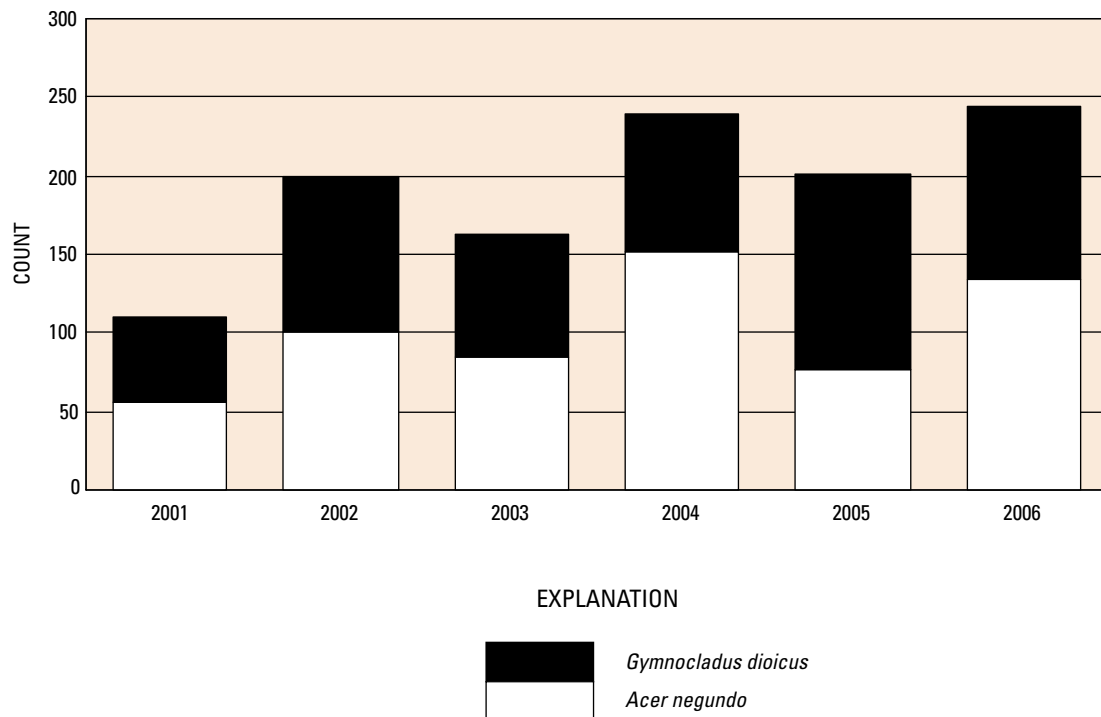
than doubled over the same time period (from 110 to 244 plants) (fig. 14). These two species are native to Pennsylvania (Rhoads and Block, 2000) and were most prevalent in group numbers 1 (*Ac. negundo* and *Gy. dioica*), 18, 28, and 34 (*Ac. negundo*), at the end of the study. The density of planted species at the end of the study was 382 plants per acre compared to 329 plants per acre for non-planted species (table 9). Although decreases in the number of planted individuals were appreciable, the remaining plants grew substantially in most groups, often achieving canopy closure (see photographs in figures 5-2 through 5-11 in appendix 5).

Figure 14. Number of *Acer negundo* (box elder) and *Gymnocladus dioica* (Kentucky coffee tree) plants growing in the riparian buffer, Tredyffrin Township, Chester County, Pa., 2001–2006.

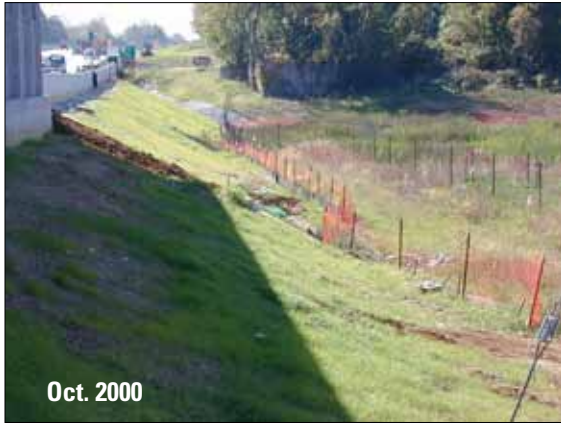
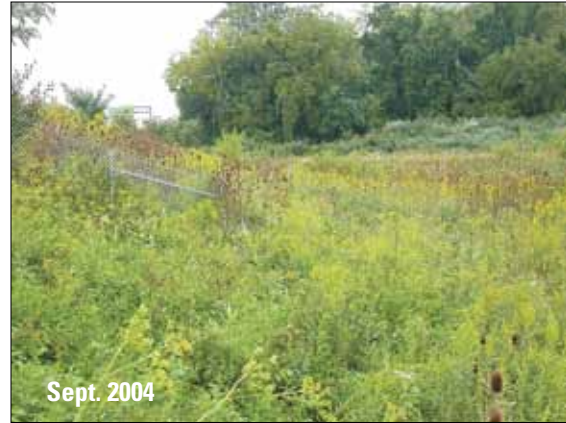
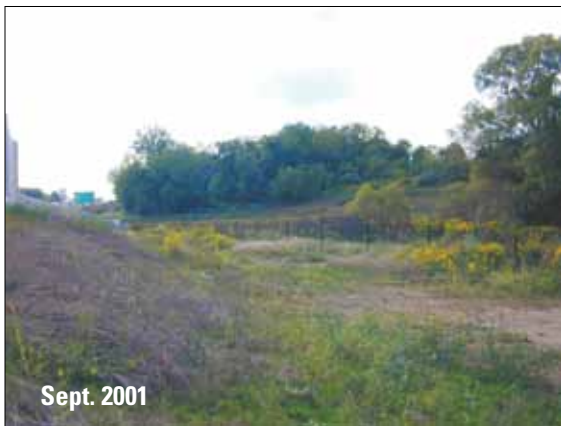
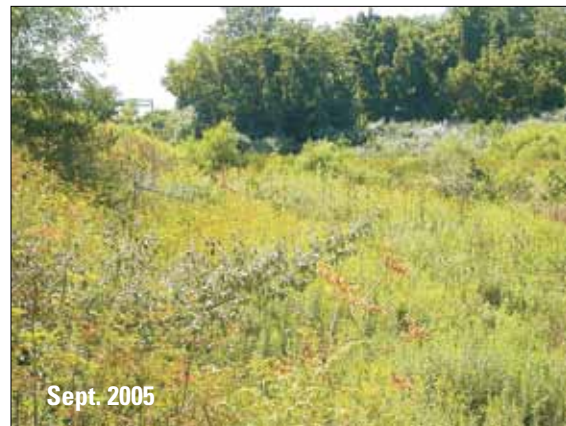
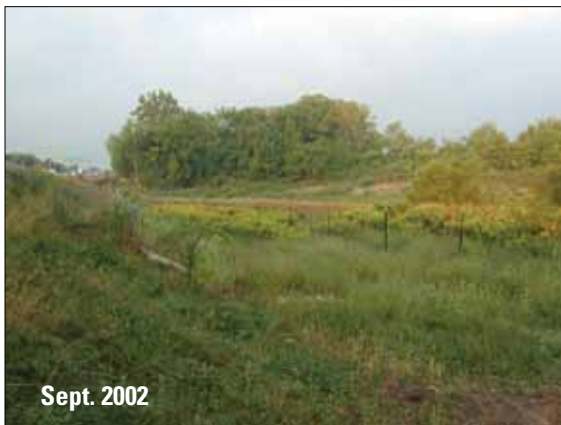
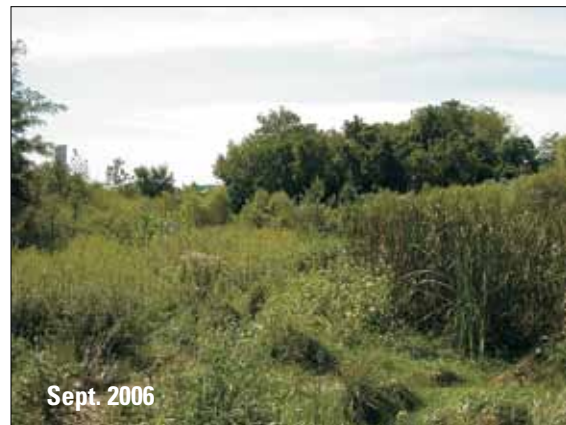
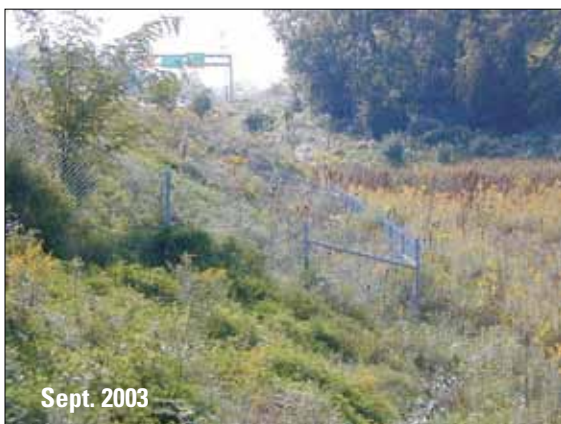
Figure 1-2. Annual views of the constructed wetland looking northeast to southwest from photo station 1, Tredyffrin Township, Chester County, Pennsylvania. (See figure 1-1 for location and orientation of photo station.)

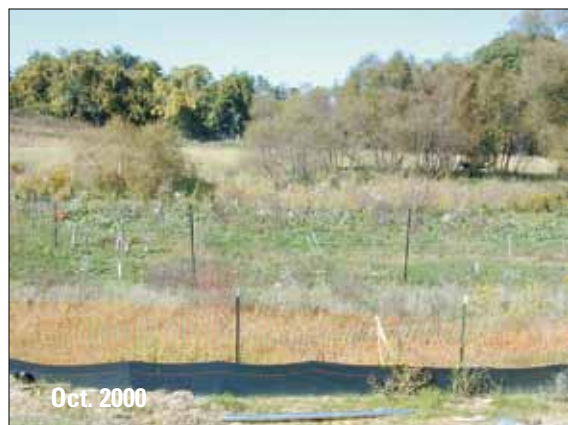
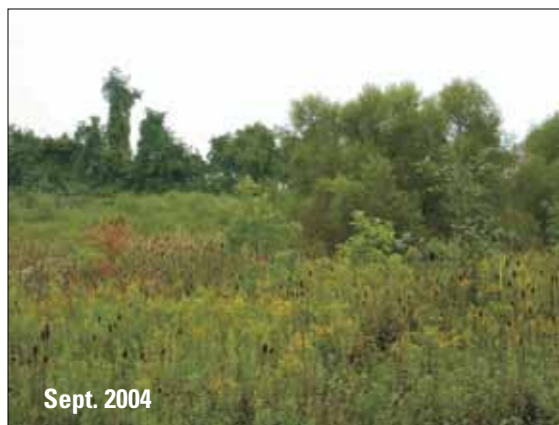
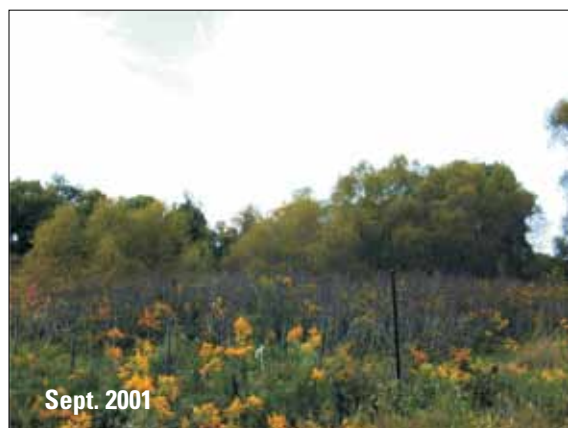
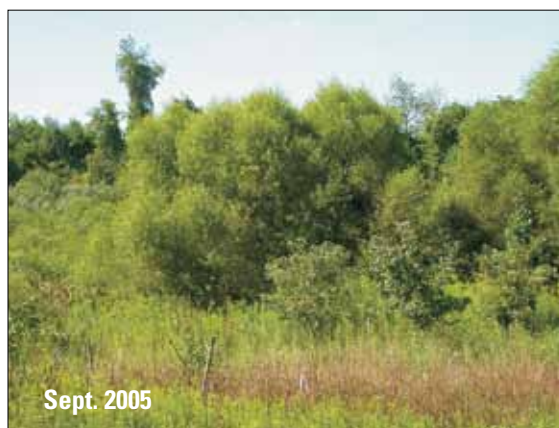
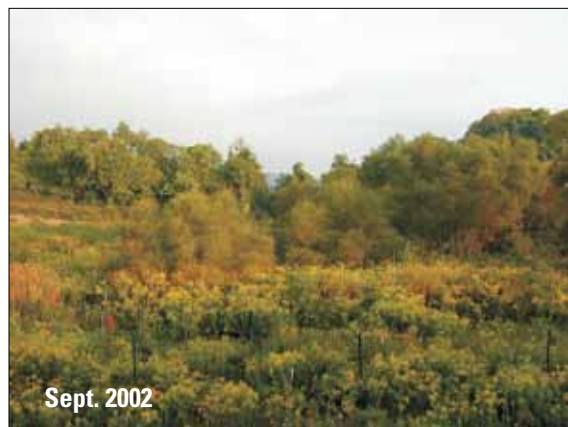
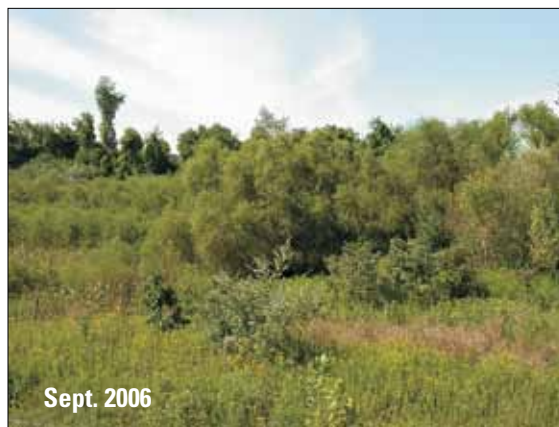
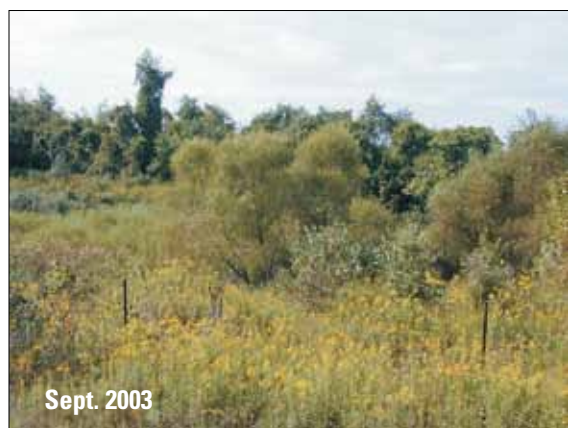
Figure 1-3. Annual views of the constructed wetland looking south to north from photo station 2, Tredyffrin Township, Chester County, Pennsylvania. (See figure 1-1 for location and orientation of photo station.)
