Physical and Vegetative Characteristics of a Newly Constructed Wetland and Modified Stream Reach, Tredyffrin Township, Chester County, Pennsylvania, 2000–2006

Scientific Investigations Report 2009–5020

By Jeffrey J. Chaplin, Kirk E. White, and Leif E. Olson

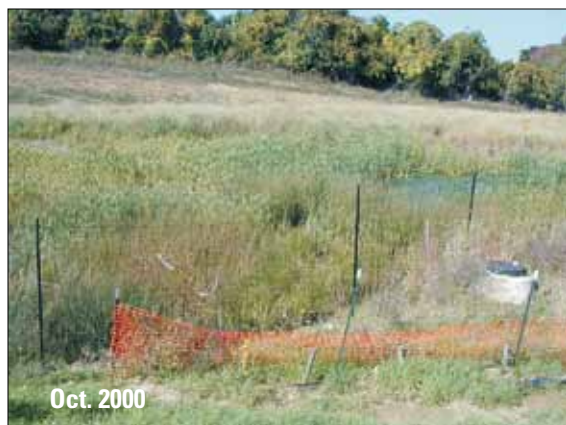
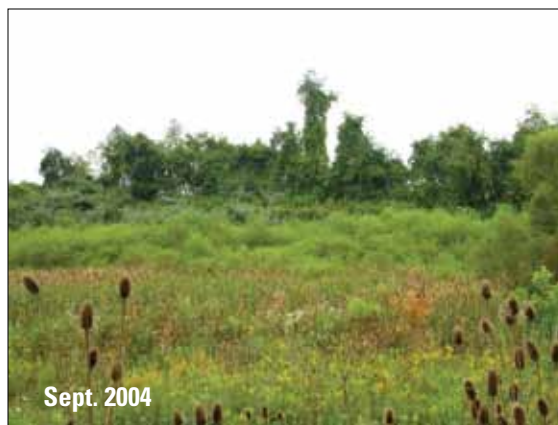
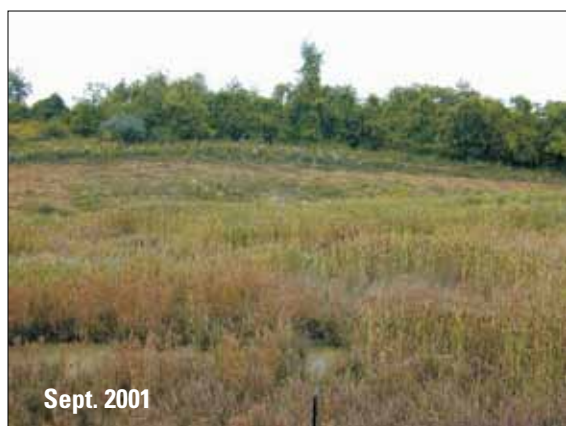
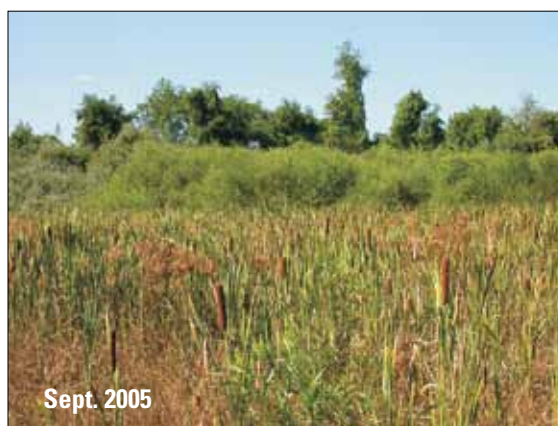
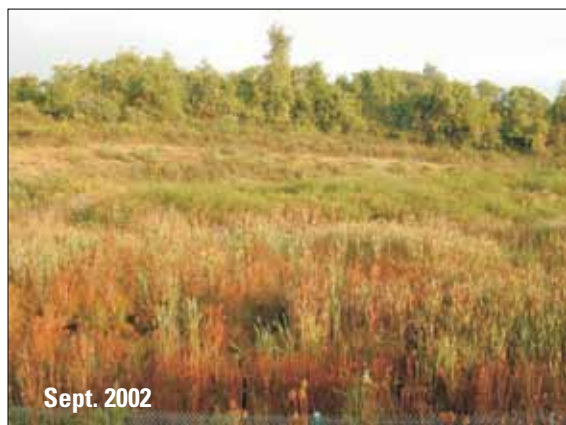
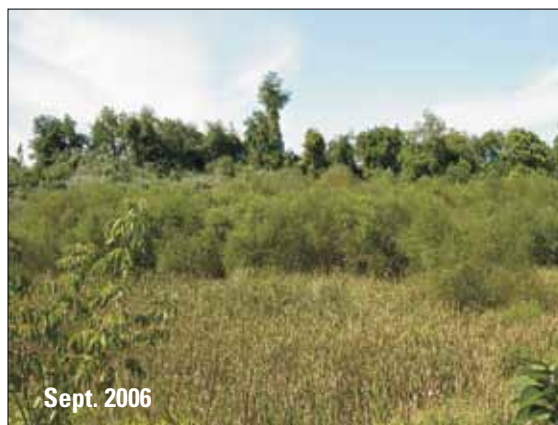
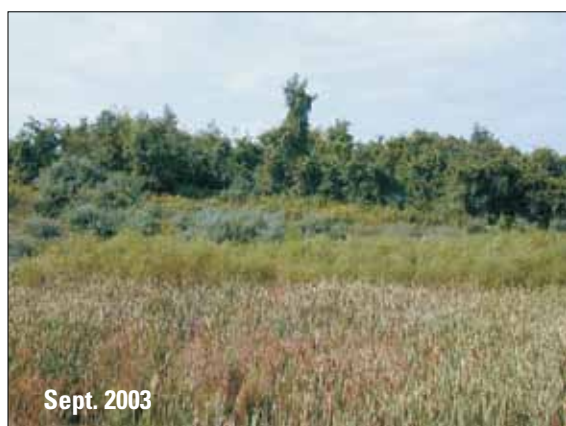
Figure 1–4. Annual views of the constructed wetland looking southeast to northwest from photo station 3, Tredyffrin Township, Chester County, Pennsylvania. (See figure 1–1 for location and orientation of photo station.)

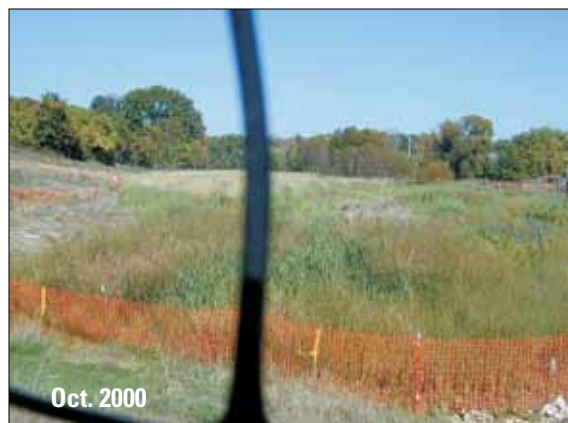
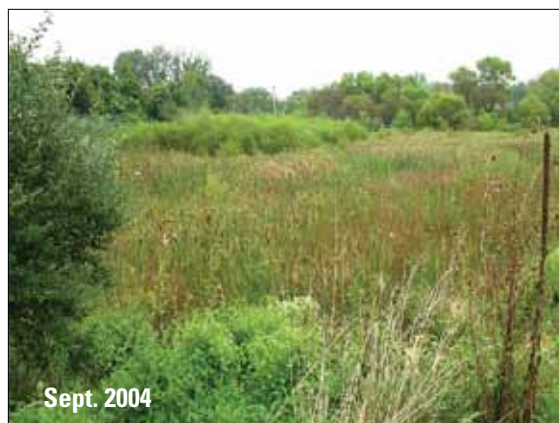
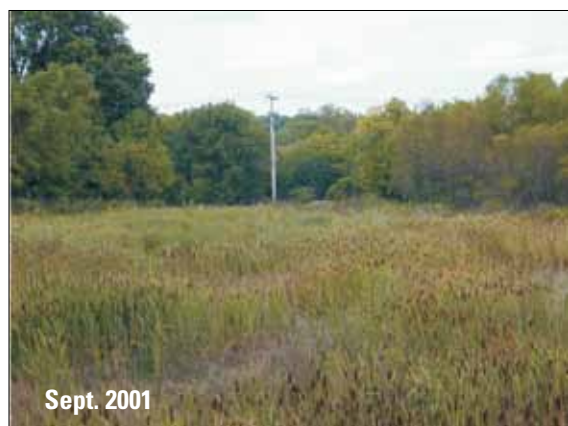
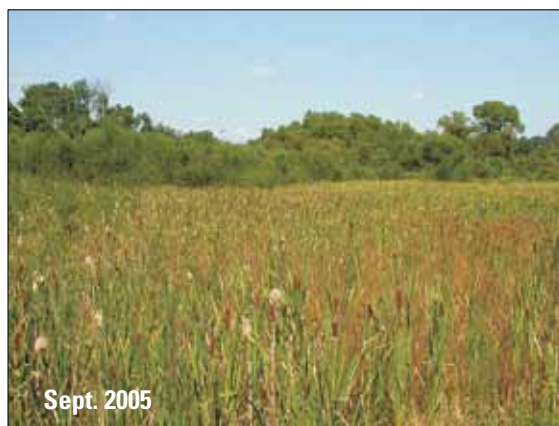
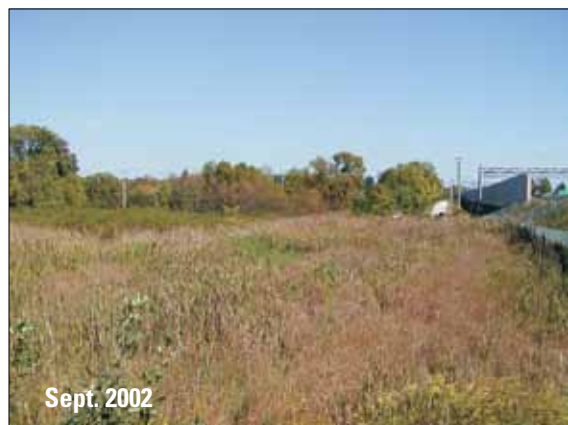
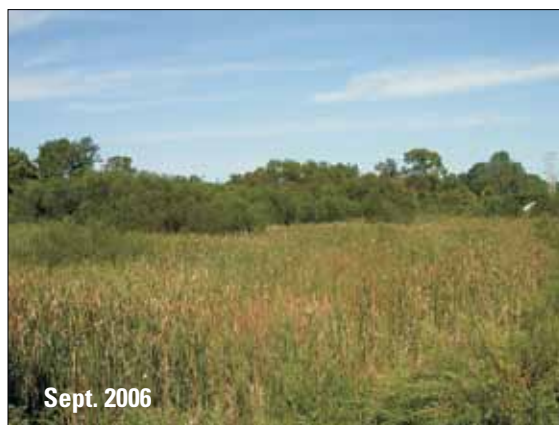
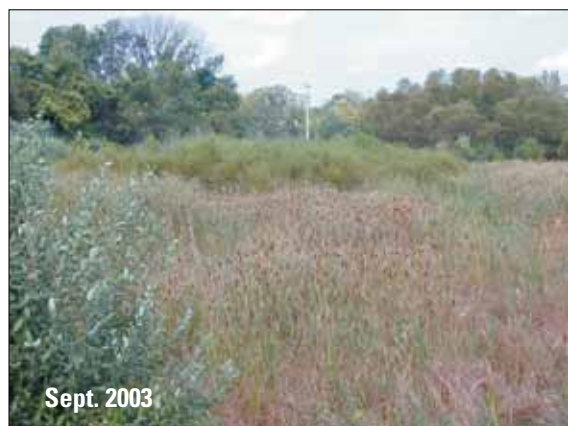
Figure 1–5. Annual views of the constructed wetland looking southwest to northeast from photo station 4, Tredyffrin Township, Chester County, Pennsylvania. (See figure 1–1 for location and orientation of photo station.)

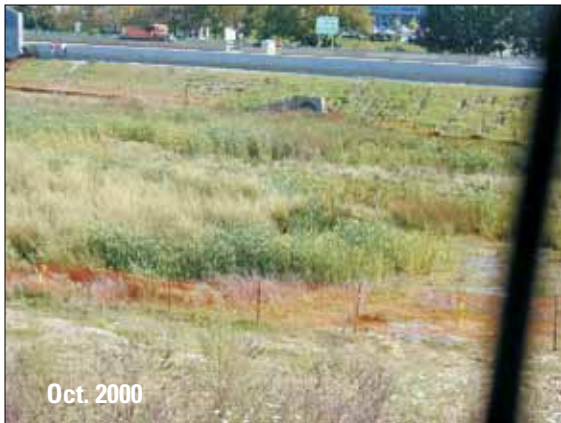
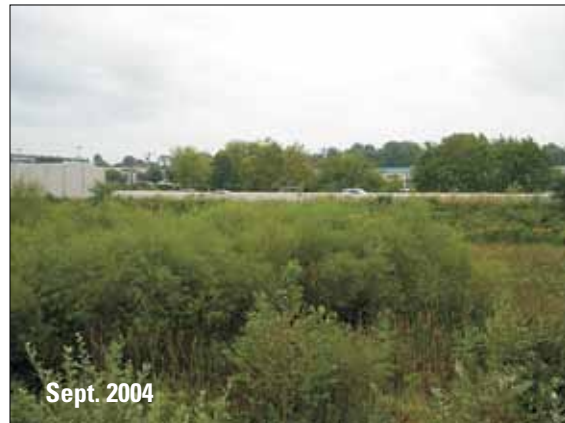
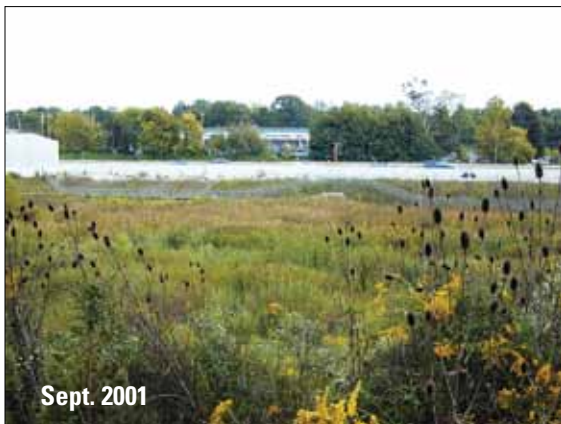
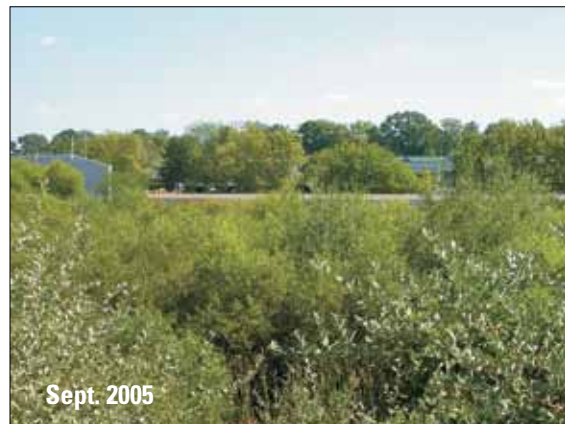
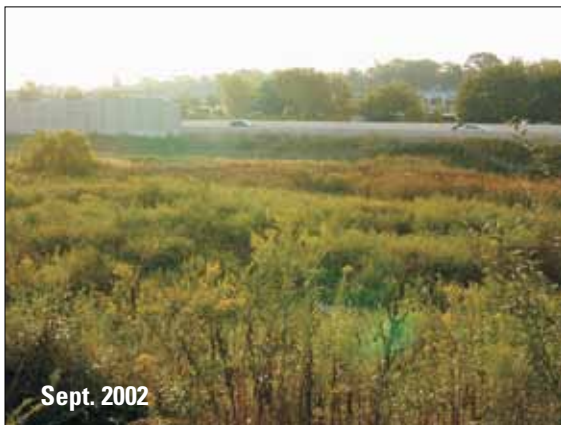
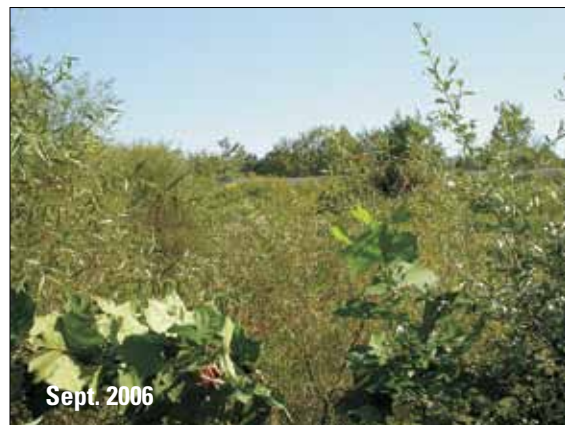
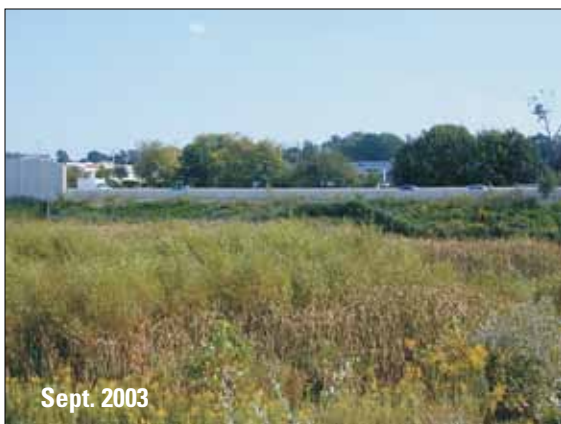
Figure 1-6. Annual views of the constructed wetland looking northwest to southeast from photo station 5, Tredyffrin Township, Chester County, Pennsylvania. (See figure 1-1 for location and orientation of photo station.)

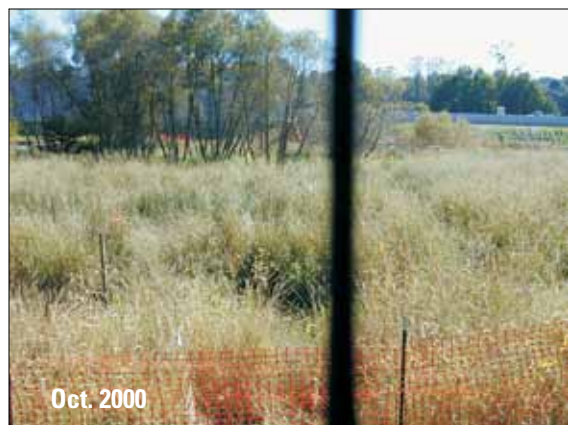
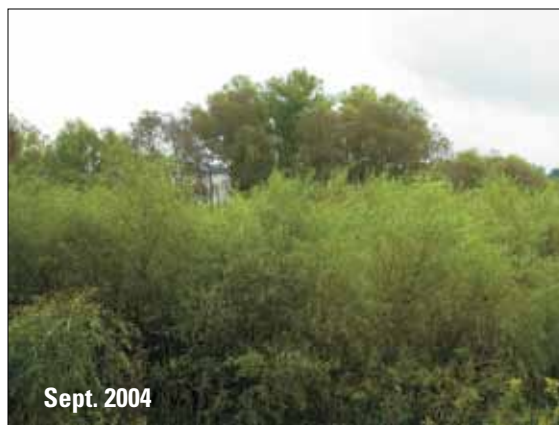
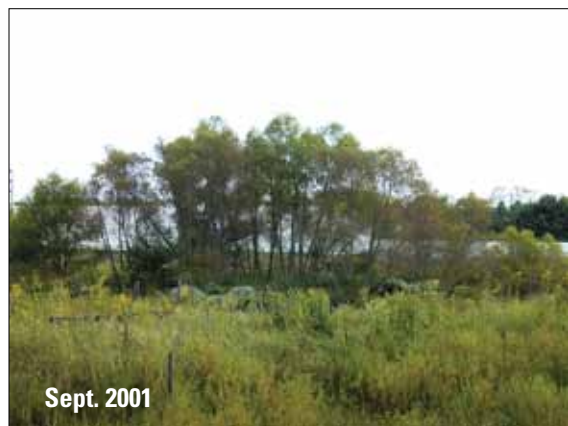
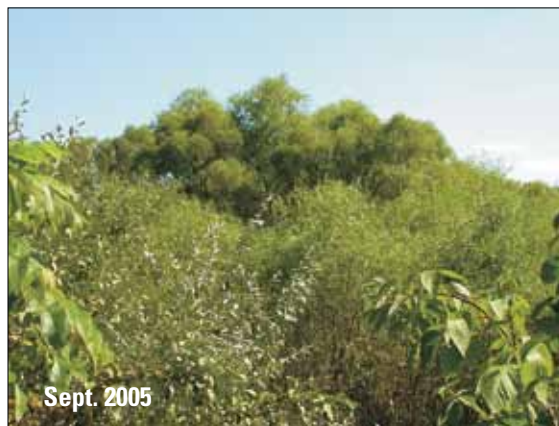
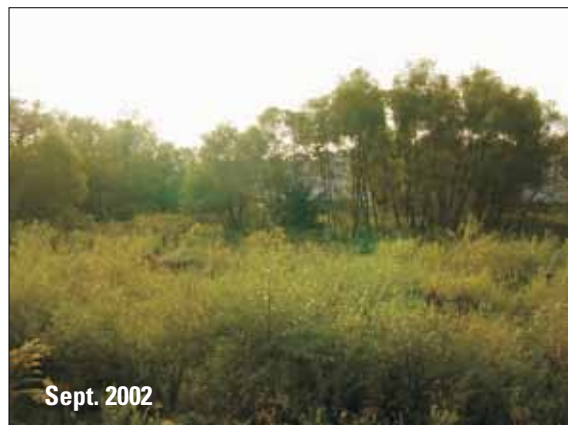
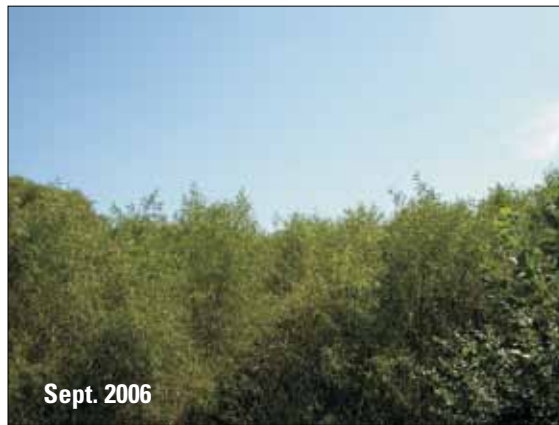
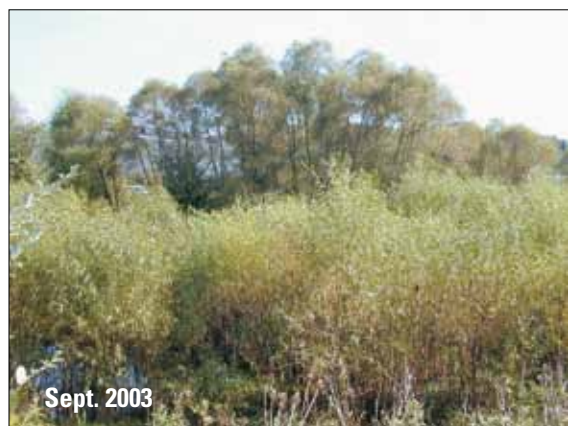
Figure 1–7. Annual views of the constructed wetland looking northwest to southeast from photo station 6, Tredyffrin Township, Chester County, Pennsylvania. (See figure 1–1 for location and orientation of photo station.)

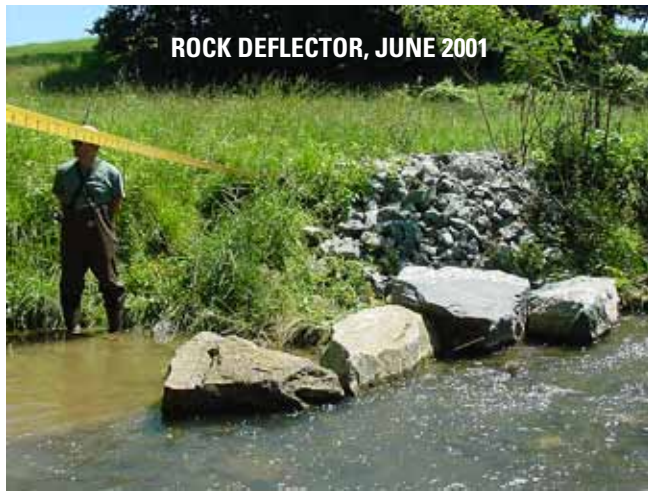
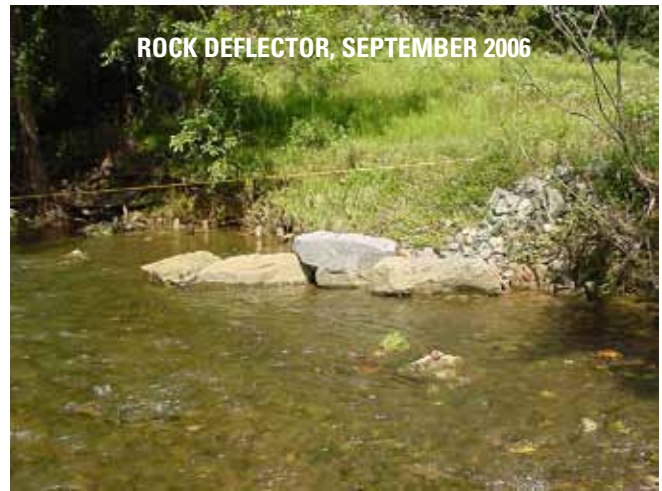
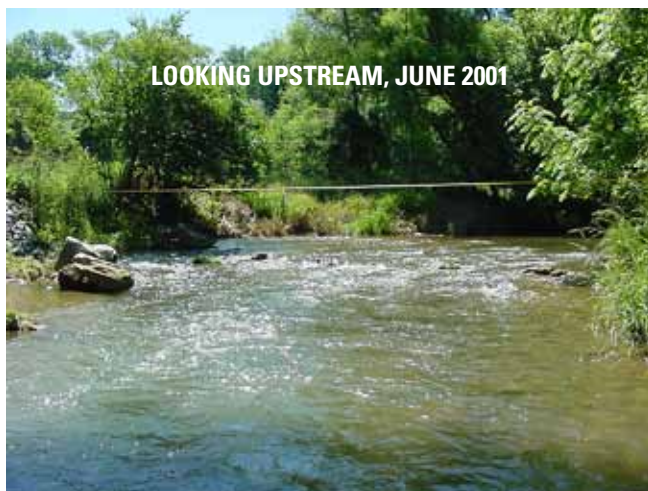
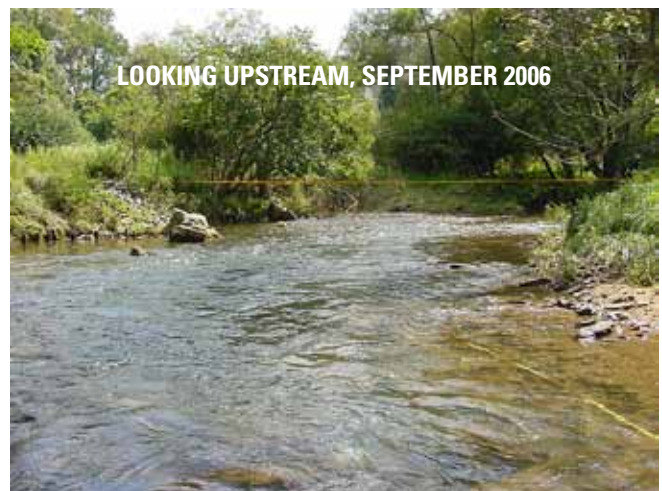
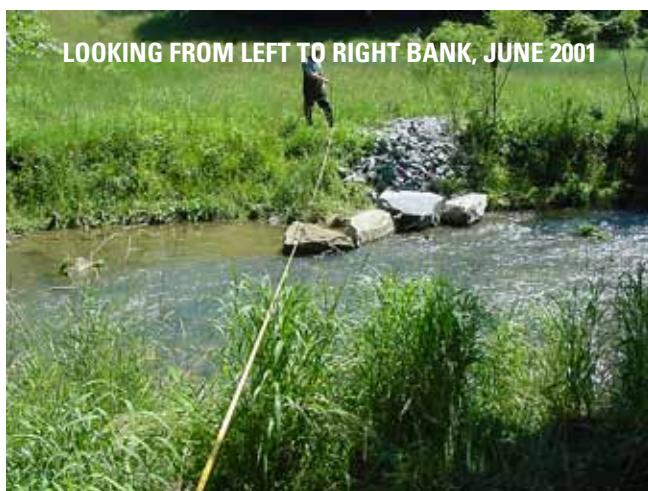
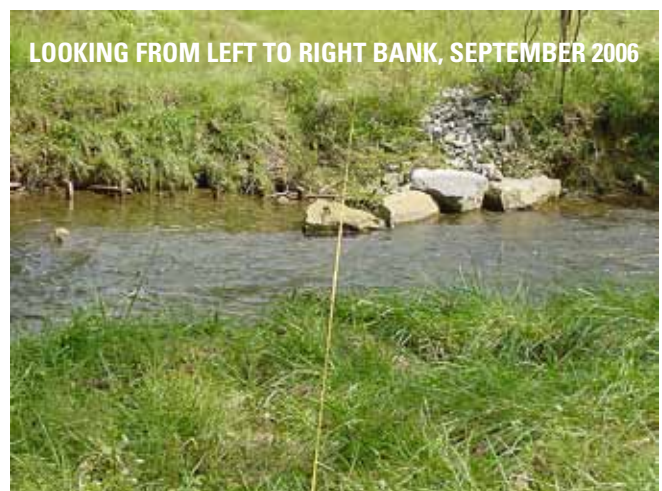
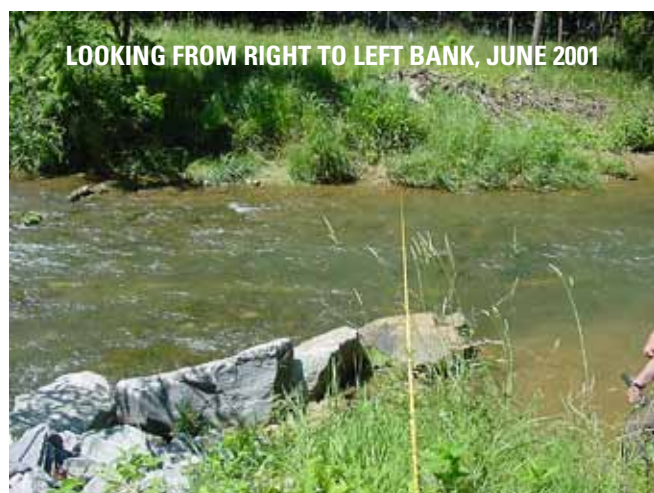
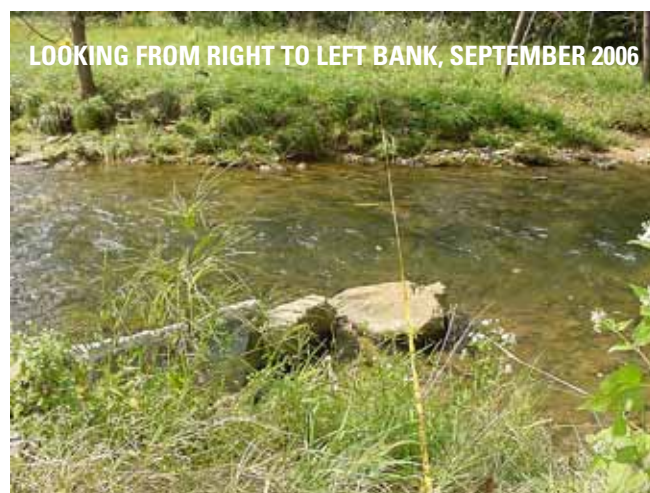
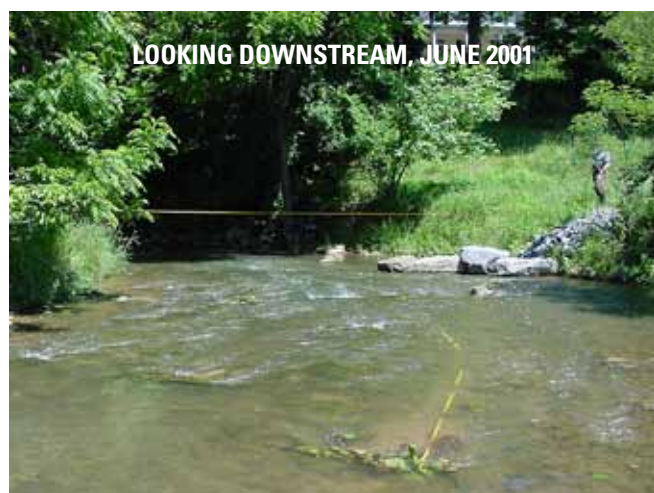
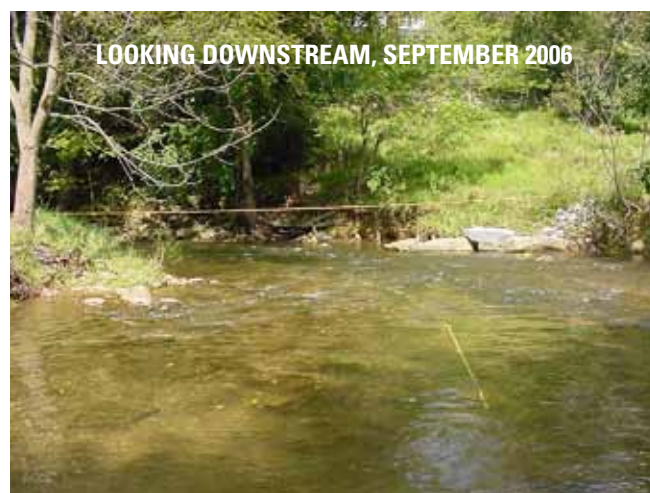
Figure 4–2. Views of the upstream rock deflector and cross section during the initial survey in June 2001 and last survey in September 2006.

Figure 4-2. Views of the upstream rock deflector and cross section during the initial survey in June 2001 and last survey in September 2006.—Continued

In spring 2001, PennDOT installed rock deflectors within Valley Creek to mitigate selected locations exhibiting active streambank erosion. The response of the channel following installation of the structures is a direct function of structure characteristics, channel morphology, and hydrologic conditions to which the modified stream channel was subjected. From June 2001 through September 2006, two reaches of the channel (see upstream and downstream reaches in figure 4) were monitored annually (see table 1 for dates of monitoring) to document changes at least partially attributable to this mitigation effort.

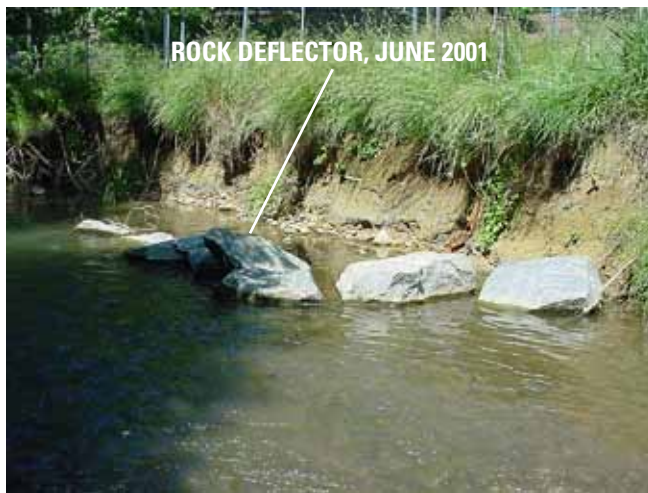
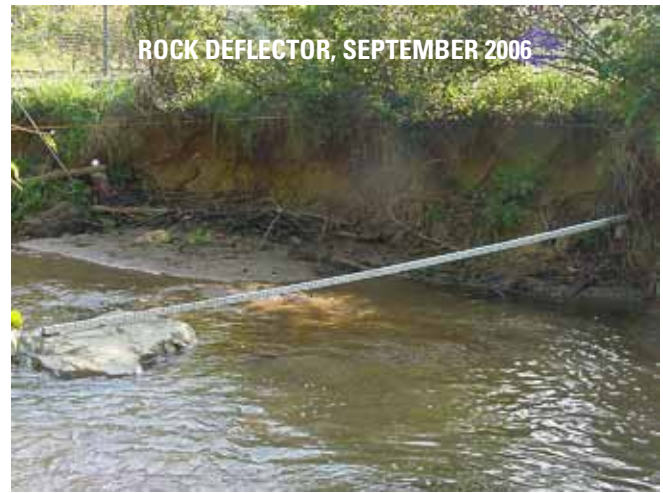
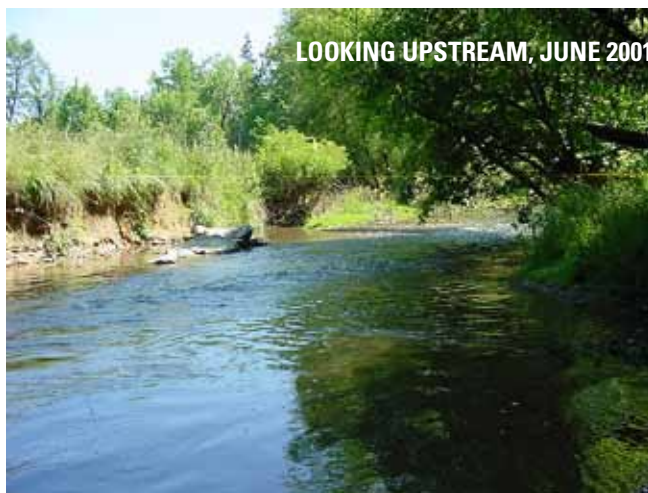
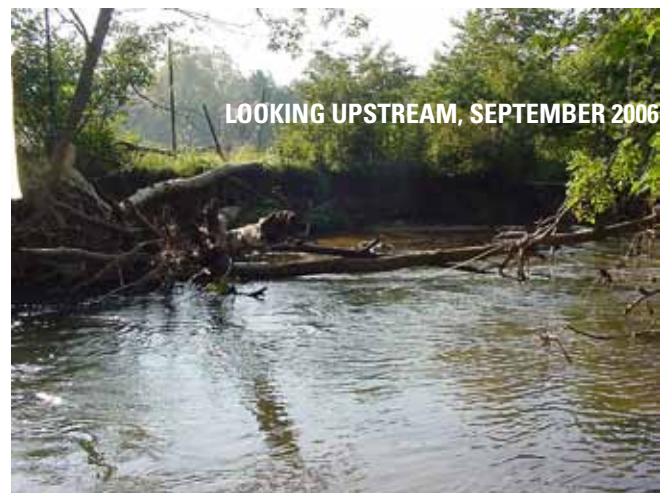
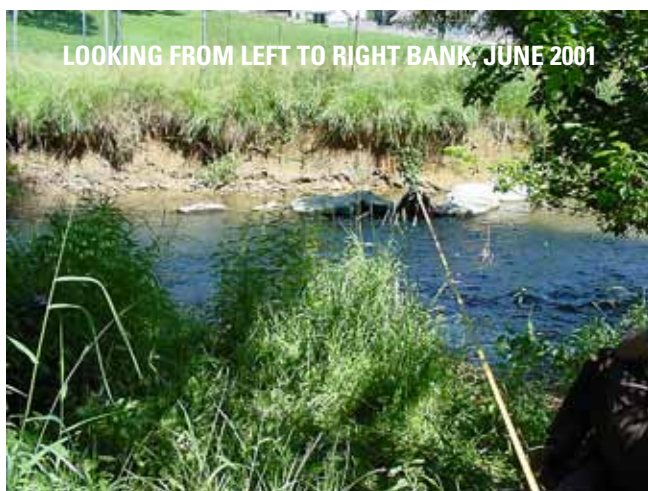
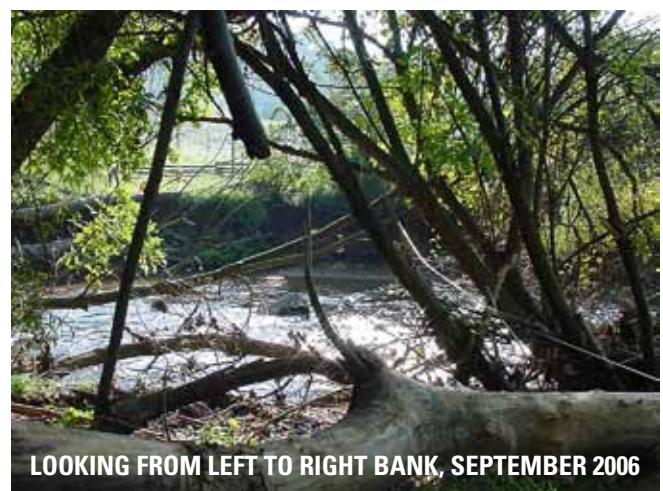
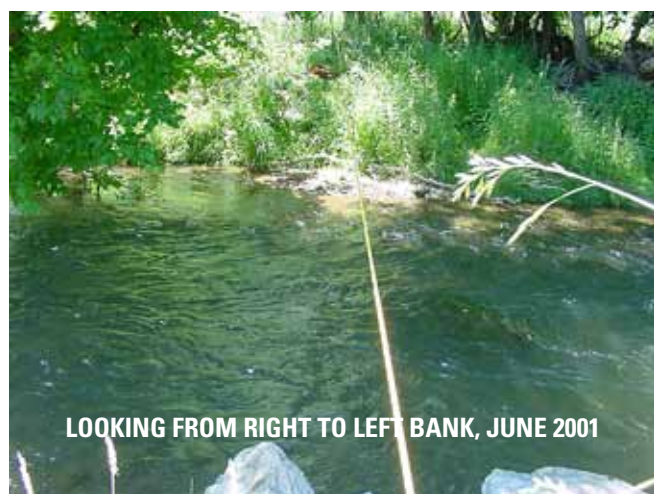
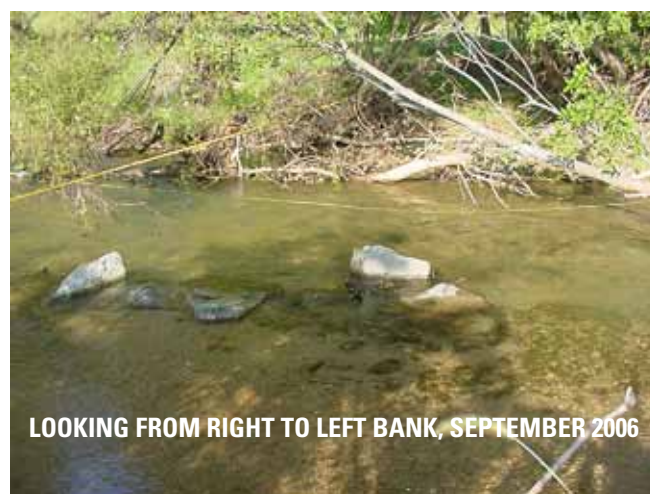
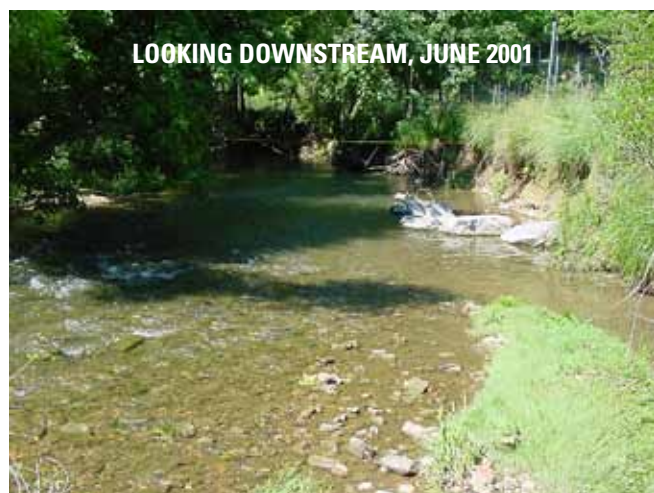
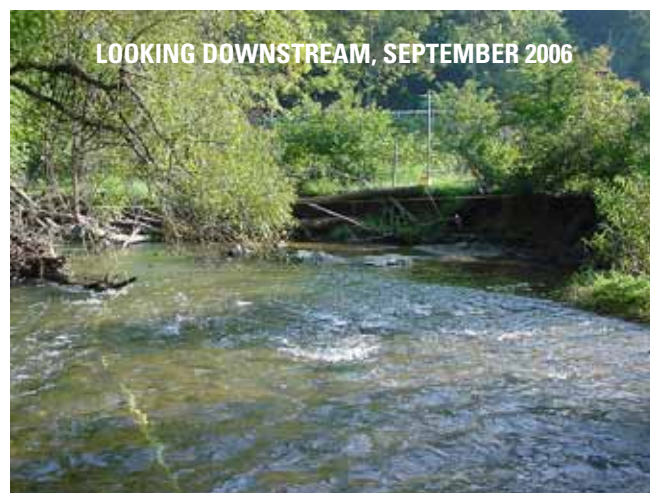
Figure 4-3. Views of the downstream rock deflector and cross section during the initial survey in June 2001 and last survey in September 2006.

Figure 4–3. Views of the downstream rock deflector and cross section during the initial survey in June 2001 and last survey in September 2006.—Continued

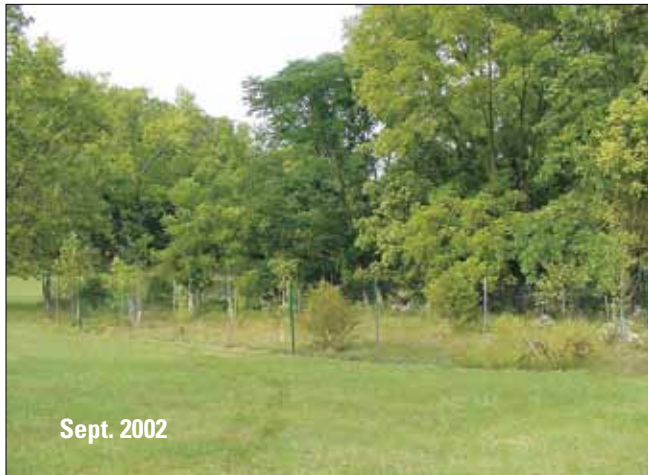
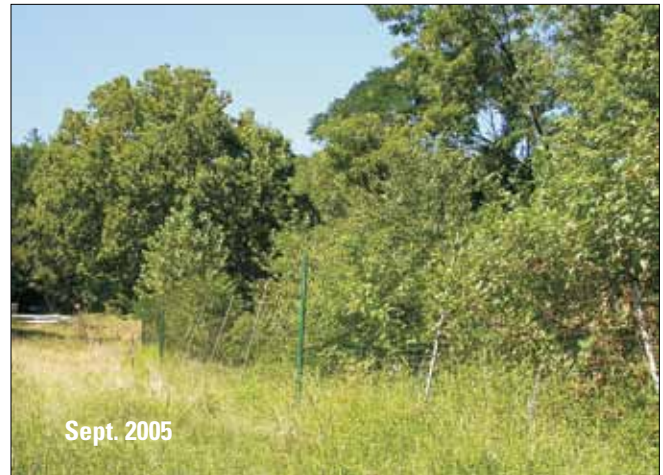
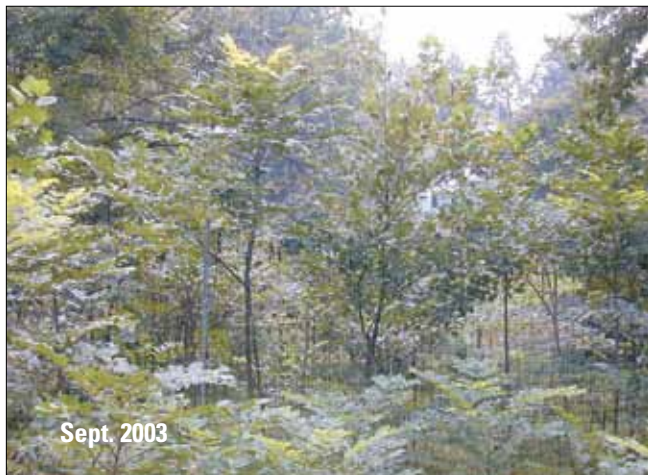
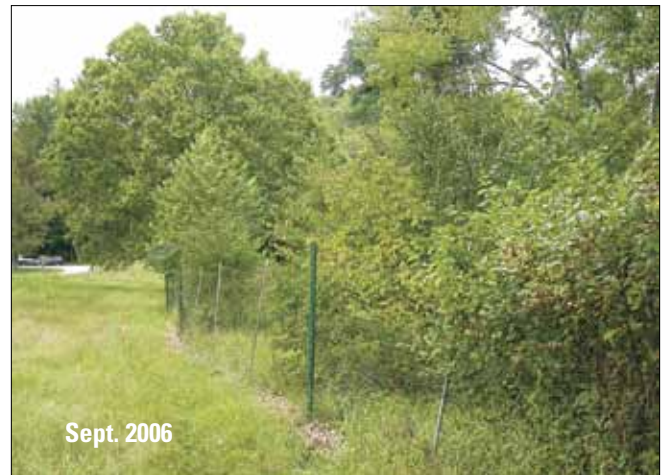
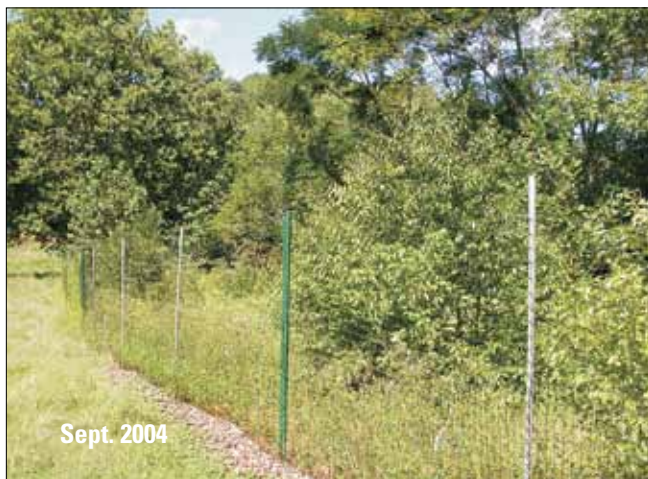
Figure 5-2. Annual views of riparian-buffer plantings in group 1, Tredyffrin Township, Chester County, Pennsylvania. (See figure 5-1 for location.)

than doubled over the same time period (from 110 to 244 plants) (fig. 14). These two species are native to Pennsylvania (Rhoads and Block, 2000) and were most prevalent in group numbers 1 (*Ac. negundo* and *Gy. dioica*), 18, 28, and 34 (*Ac. negundo*), at the end of the study. The density of planted species at the end of the study was 382 plants per acre compared to 329 plants per acre for non-planted species (table 9). Although decreases in the number of planted individuals were appreciable, the remaining plants grew substantially in most groups, often achieving canopy closure (see photographs in figures 5-2 through 5-11 in appendix 5).

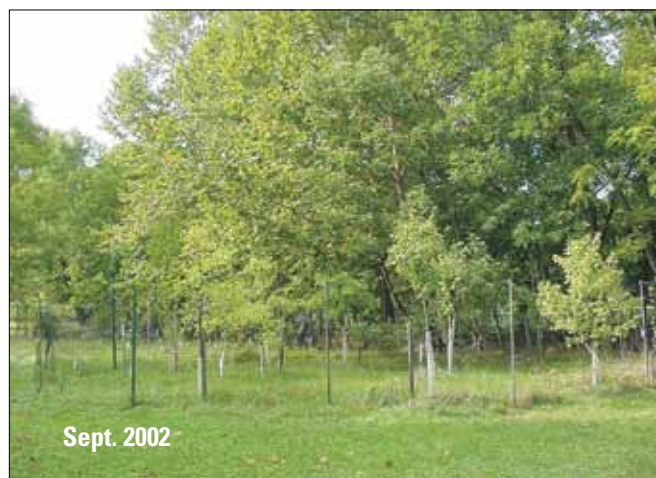
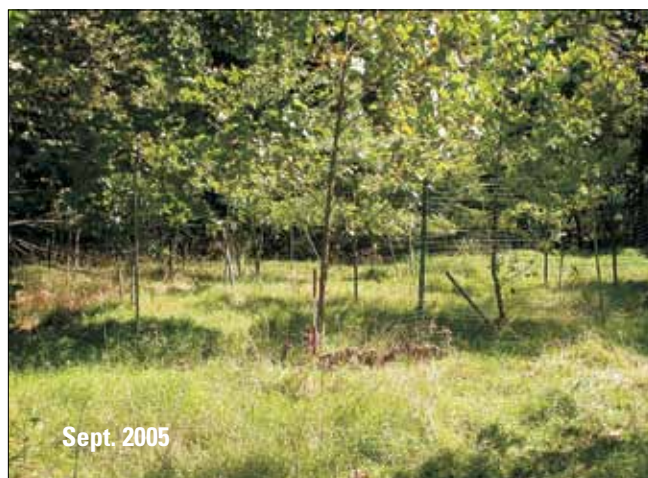
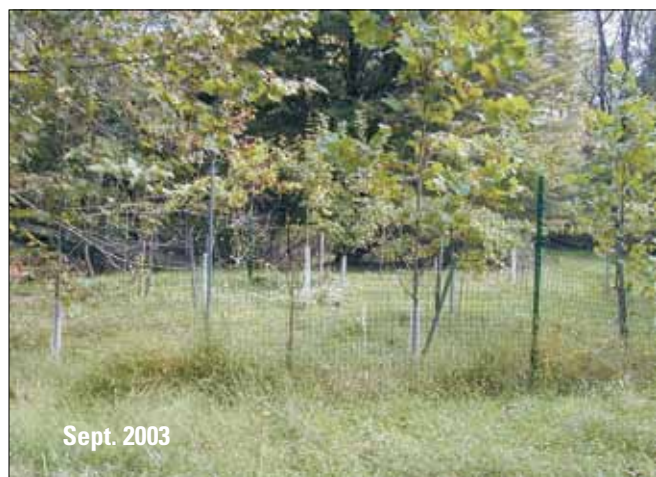
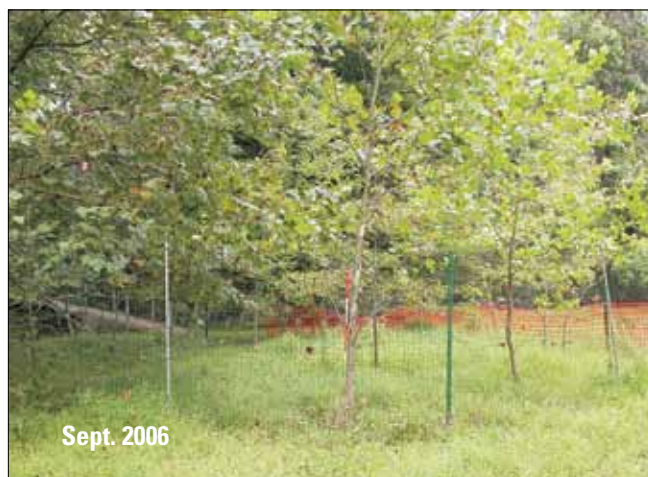
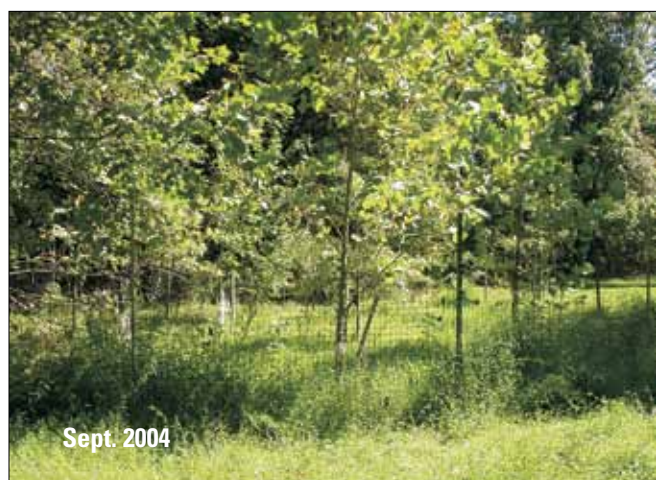
Figure 5-3. Annual views of riparian-buffer plantings in group 4, Tredyffrin Township, Chester County, Pennsylvania. (See figure 5-1 for location.)

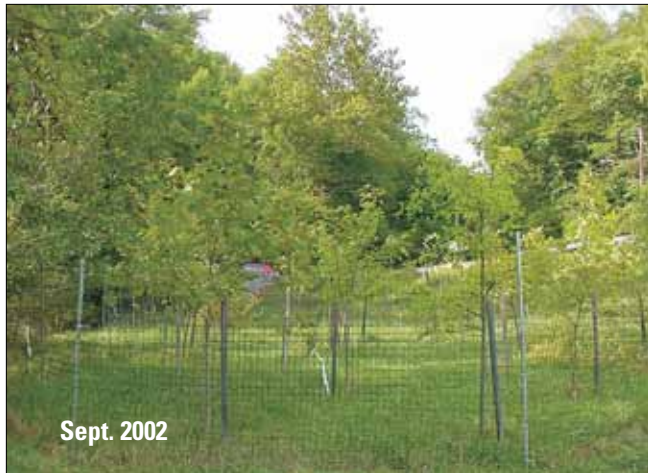
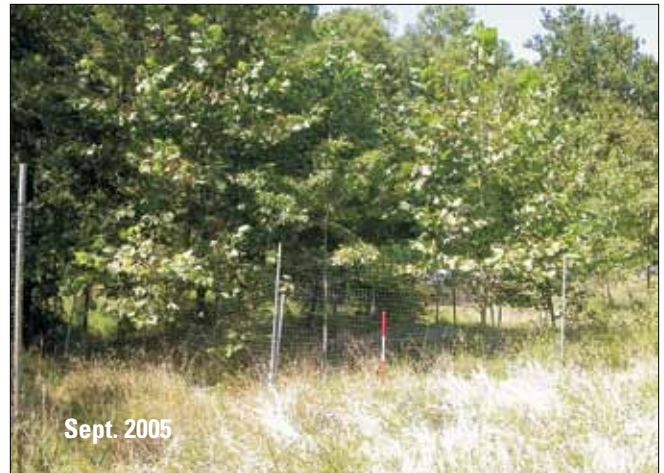
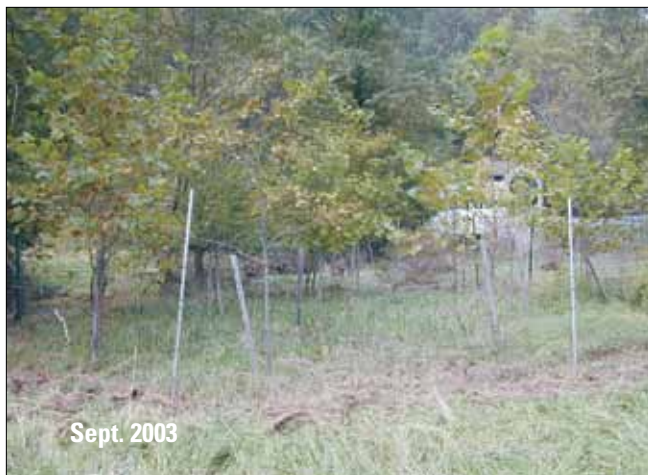
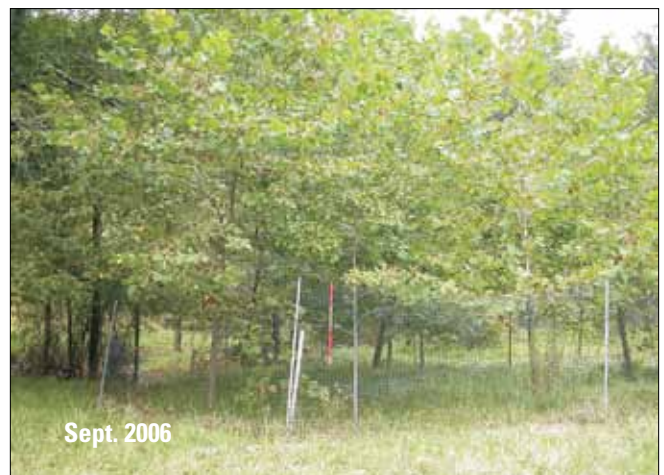
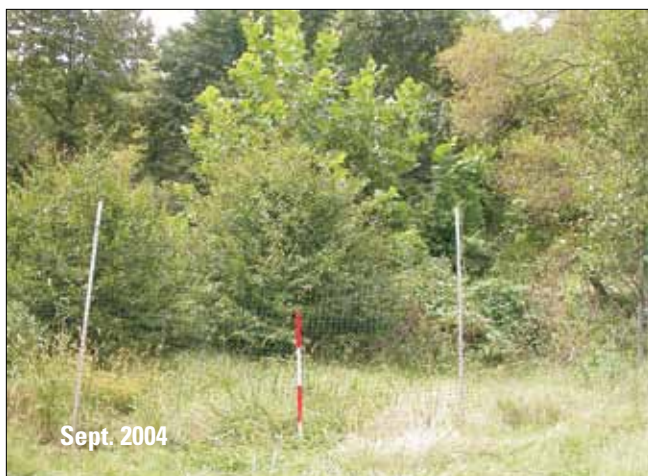
Figure 5-4. Annual views of riparian-buffer plantings in group 10, Tredyffrin Township, Chester County, Pennsylvania. (See figure 5-1 for location.)

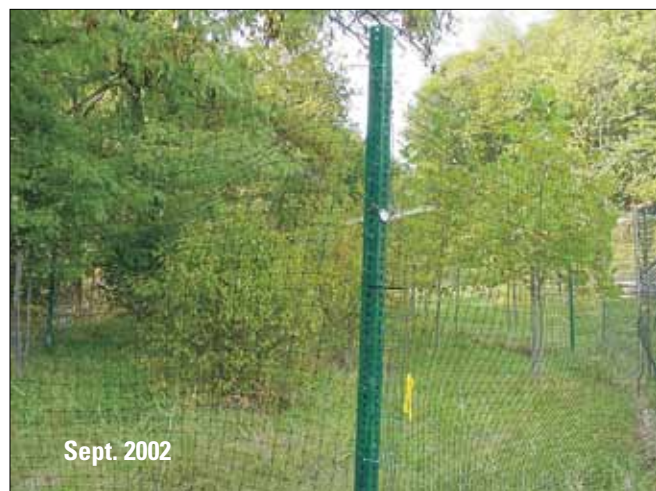
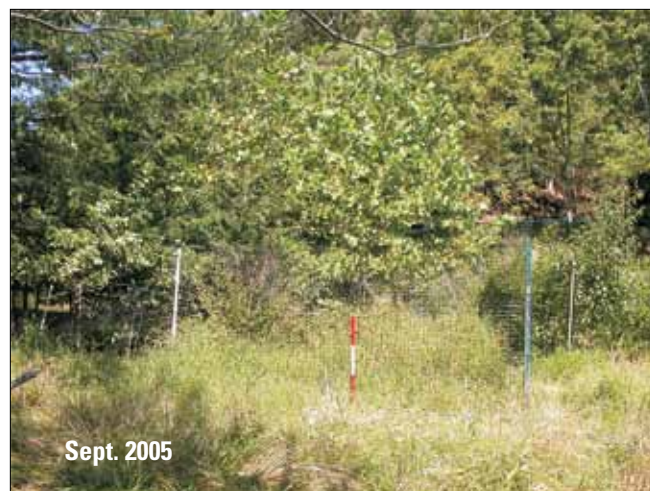
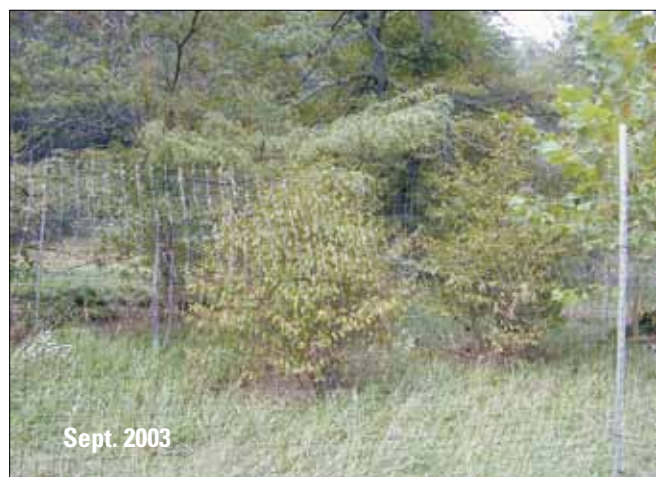
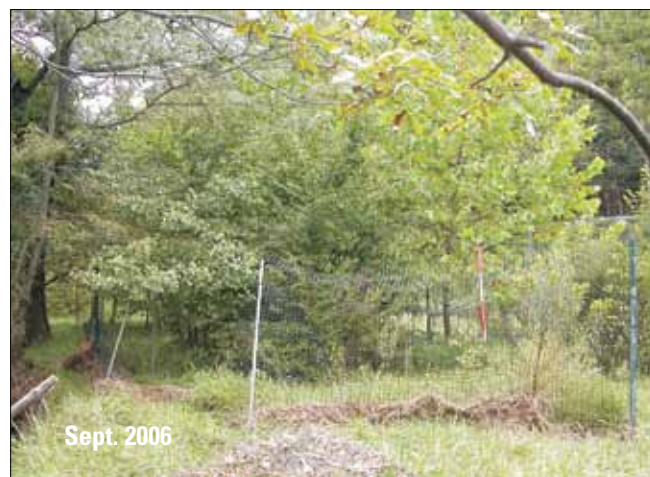
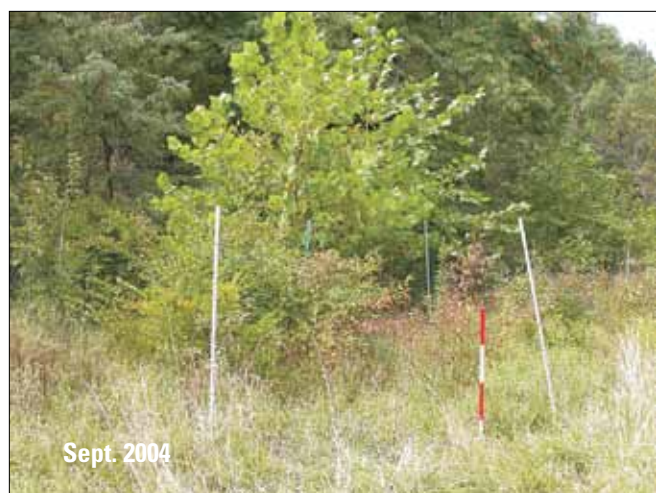
Figure 5–5. Annual views of riparian-buffer plantings in group 11, Tredyffrin Township, Chester County, Pennsylvania. (See figure 5–1 for location.)

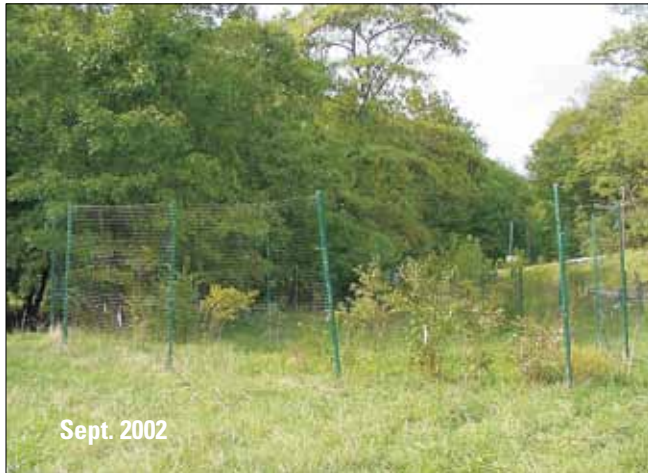
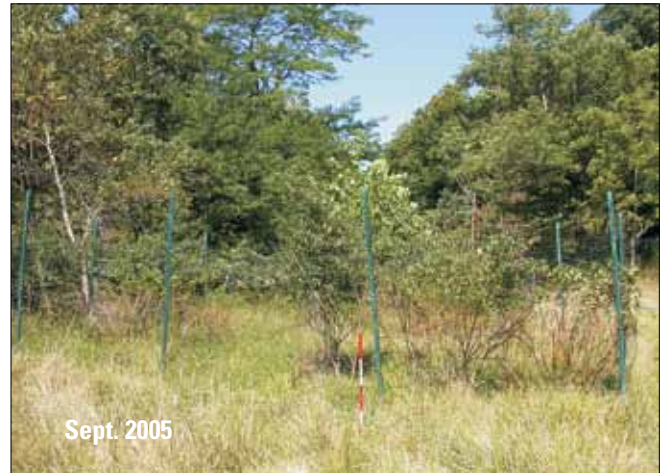
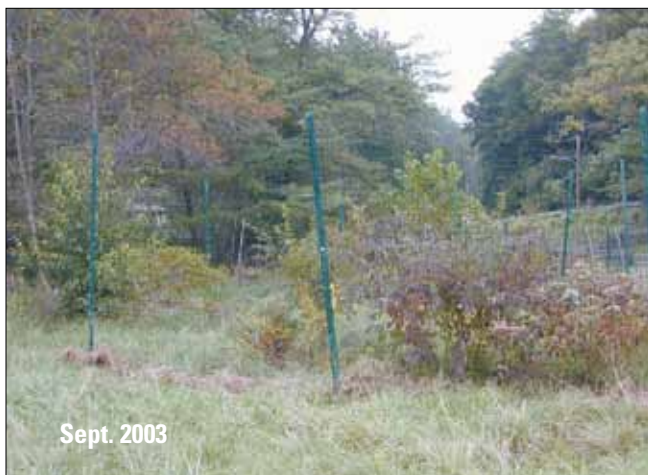
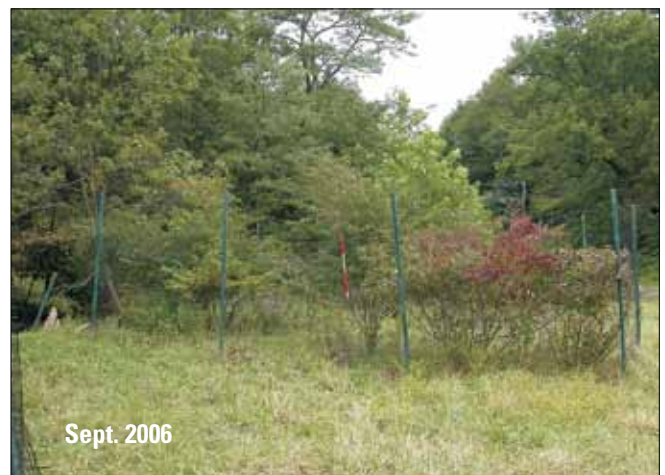
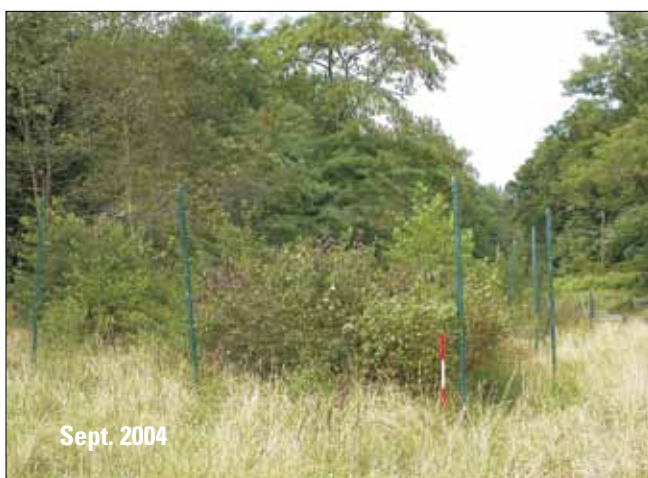
Figure 5-6. Annual views of riparian-buffer plantings in group 13, Tredyffrin Township, Chester County, Pennsylvania. (See figure 5-1 for location.)
