Physical and Vegetative Characteristics of a Newly Constructed Wetland and Modified Stream Reach, Tredyffrin Township, Chester County, Pennsylvania, 2000–2006

Scientific Investigations Report 2009–5020

By Jeffrey J. Chaplin, Kirk E. White, and Leif E. Olson

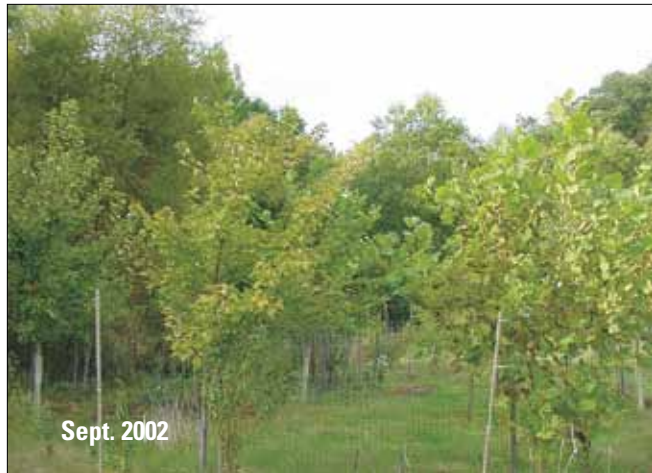
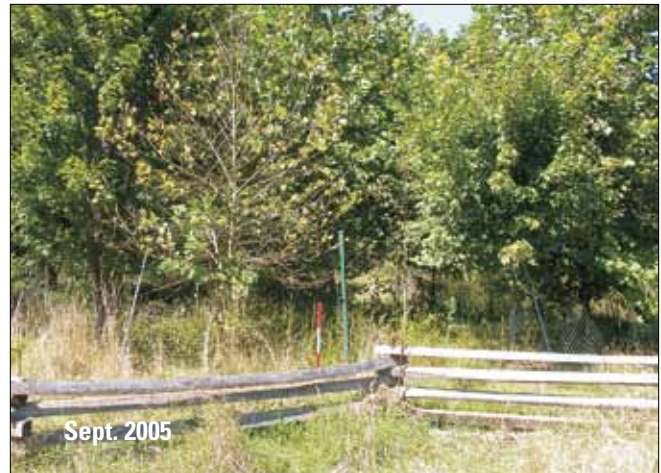
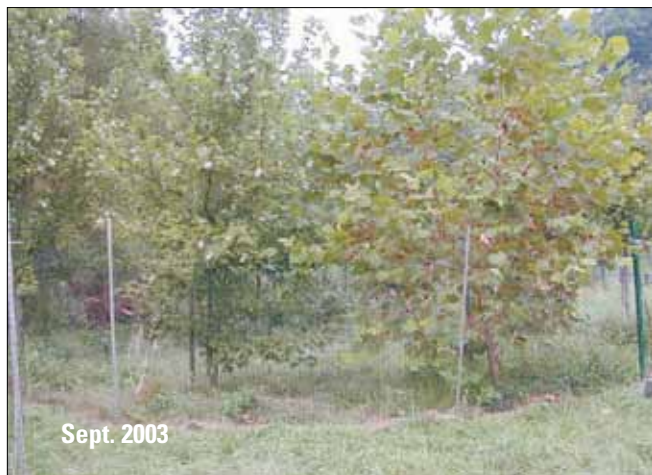
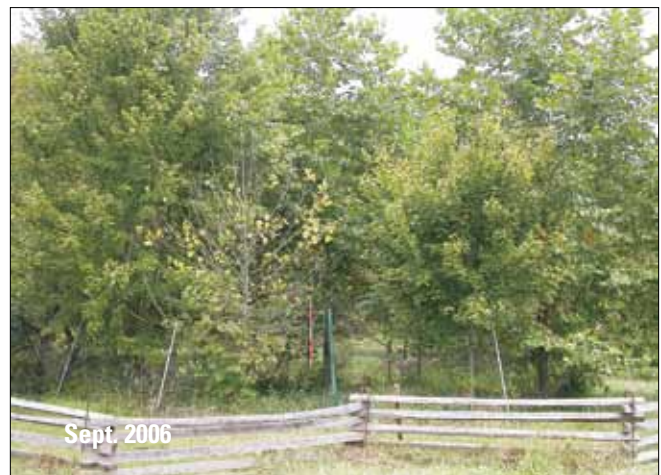
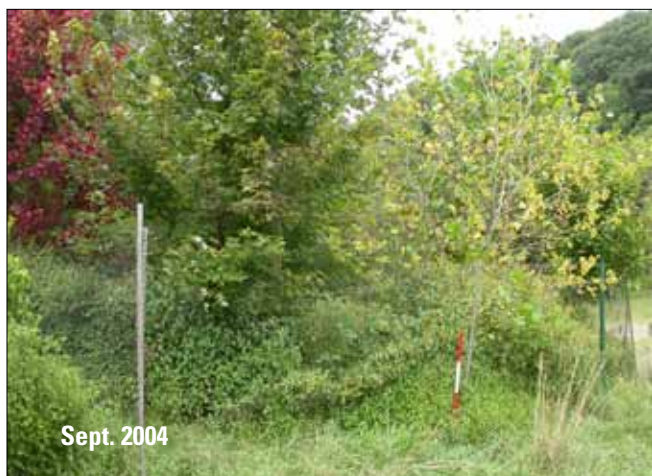
Figure 5-7. Annual views of riparian-buffer plantings in group 15, Tredyffrin Township, Chester County, Pennsylvania. (See figure 5-1 for location.)

than doubled over the same time period (from 110 to 244 plants) (fig. 14). These two species are native to Pennsylvania (Rhoads and Block, 2000) and were most prevalent in group numbers 1 (*Ac. negundo* and *Gy. dioica*), 18, 28, and 34 (*Ac. negundo*), at the end of the study. The density of planted species at the end of the study was 382 plants per acre compared to 329 plants per acre for non-planted species (table 9). Although decreases in the number of planted individuals were appreciable, the remaining plants grew substantially in most groups, often achieving canopy closure (see photographs in figures 5-2 through 5-11 in appendix 5).

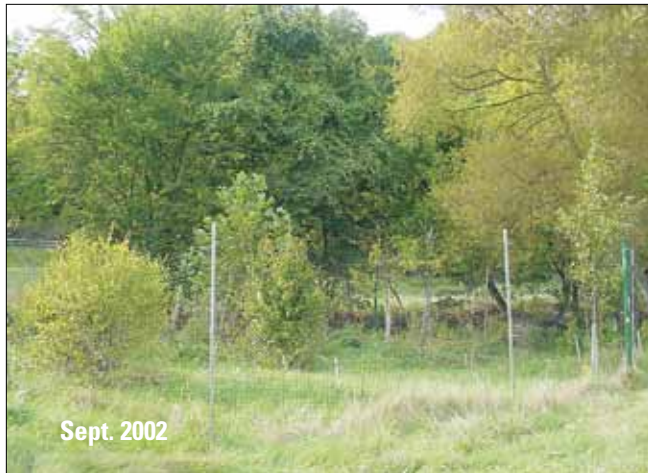
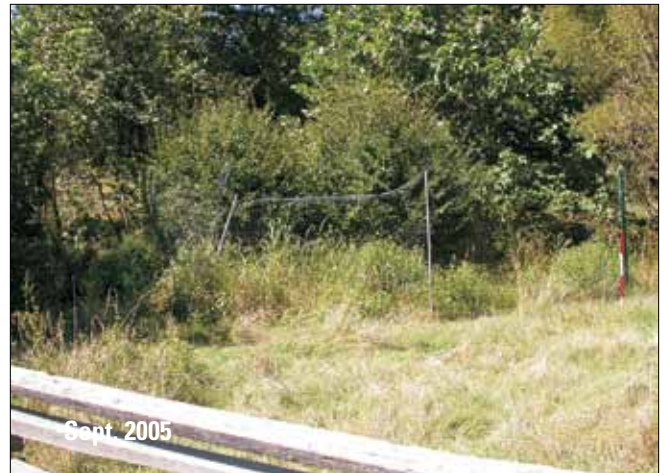
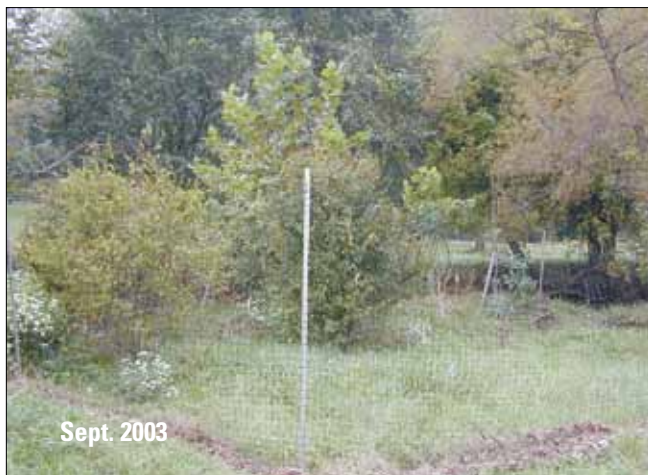
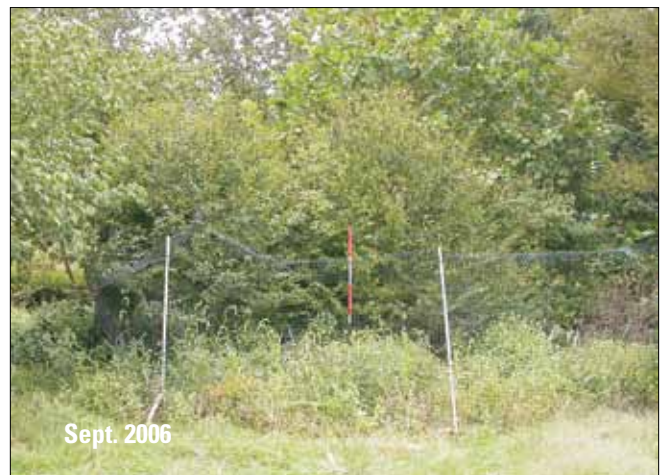
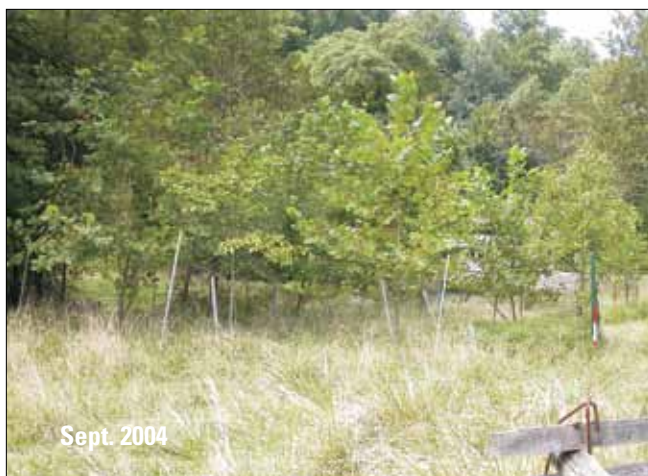
Figure 5–8. Annual views of riparian-buffer plantings in group 17, Tredyffrin Township, Chester County, Pennsylvania. (See figure 5–1 for location.)

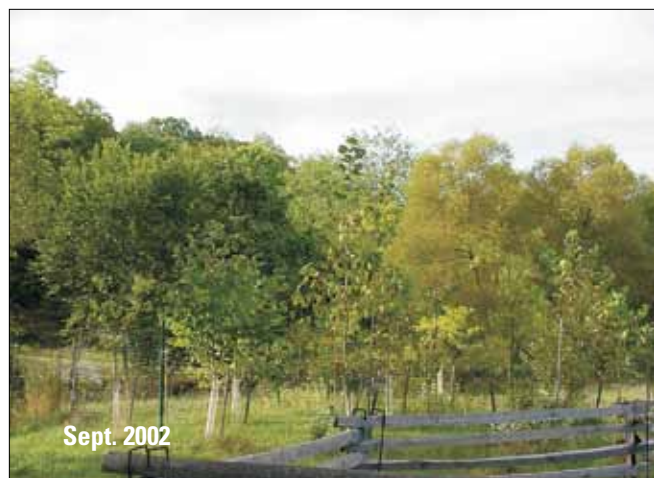
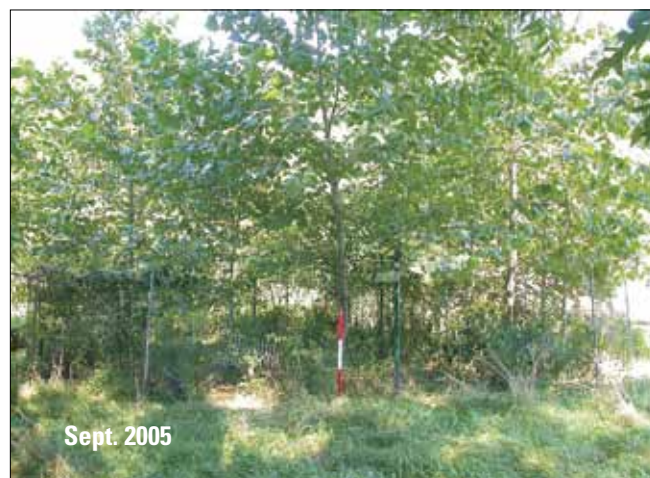
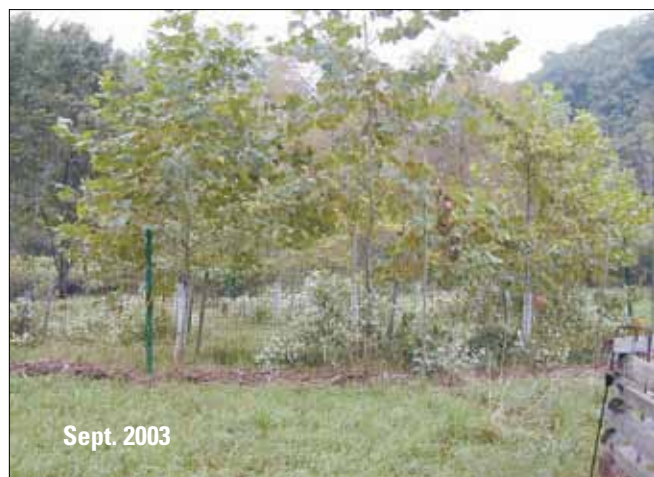
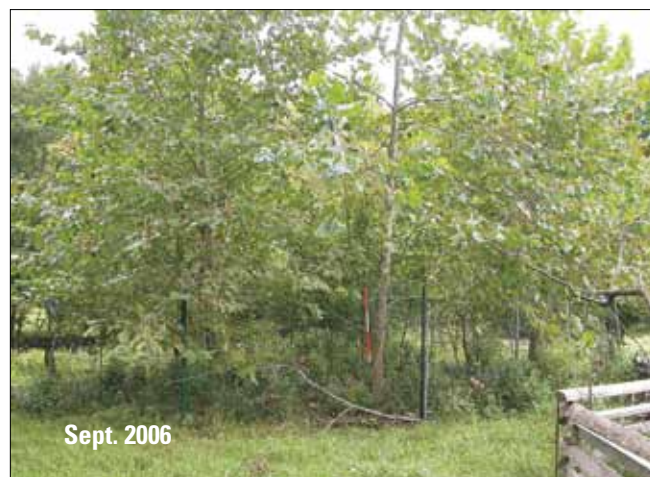
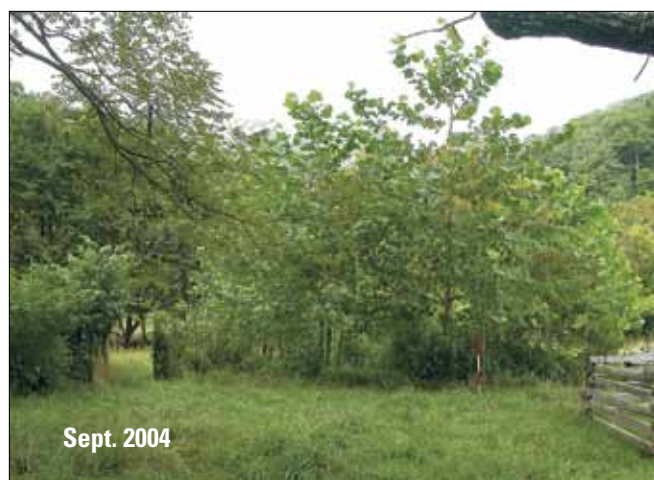
Figure 5-9. Annual views of riparian-buffer plantings in group 18, Tredyffrin Township, Chester County, Pennsylvania. (See figure 5-1 for location.)

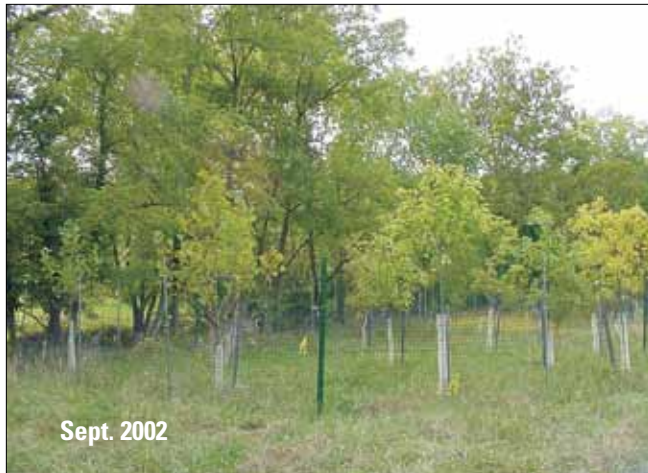
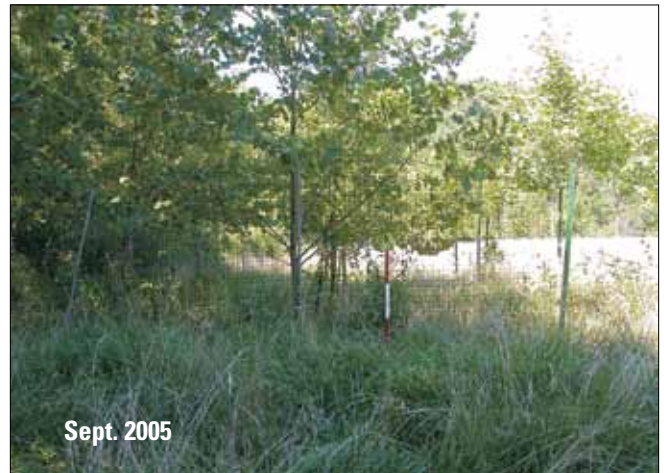
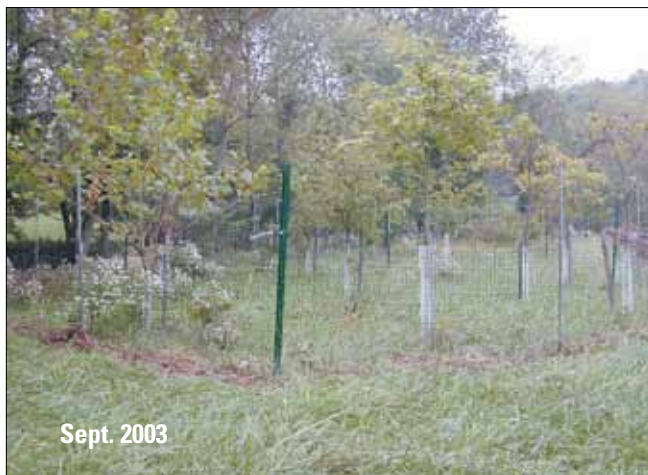
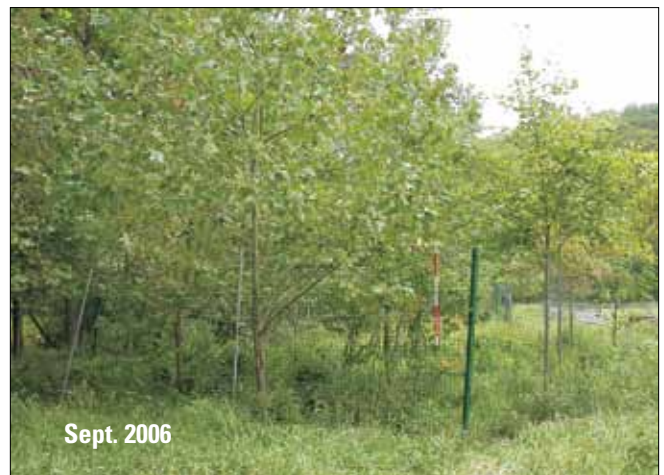
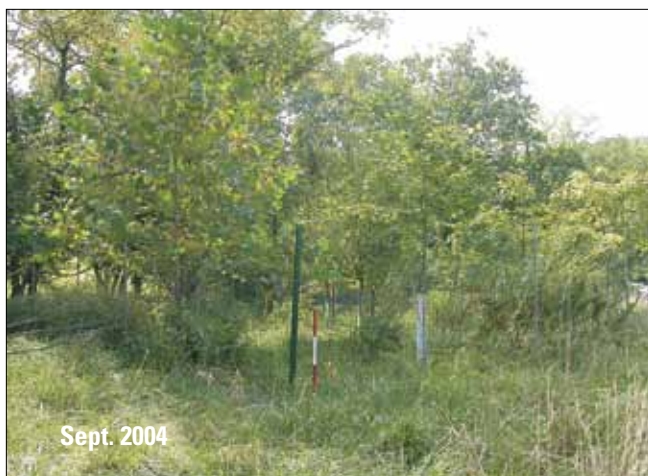
Figure 5-10. Annual views of riparian-buffer plantings in group 24, Tredyffrin Township, Chester County, Pennsylvania. (See figure 5-1 for location.)

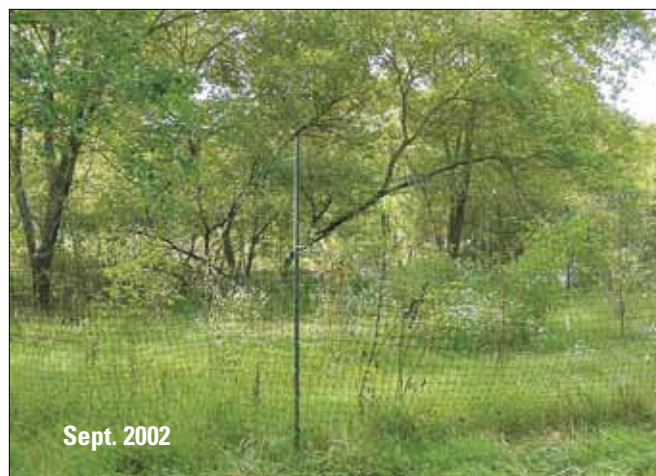
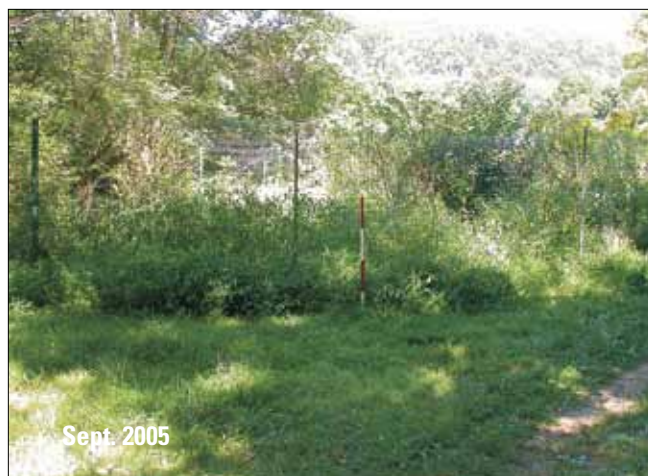
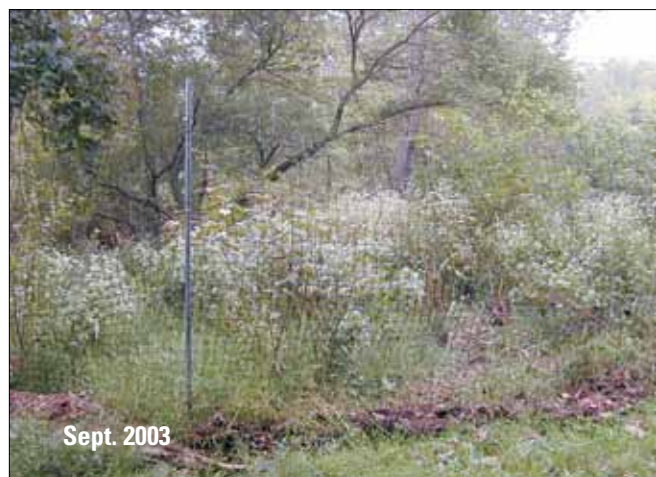
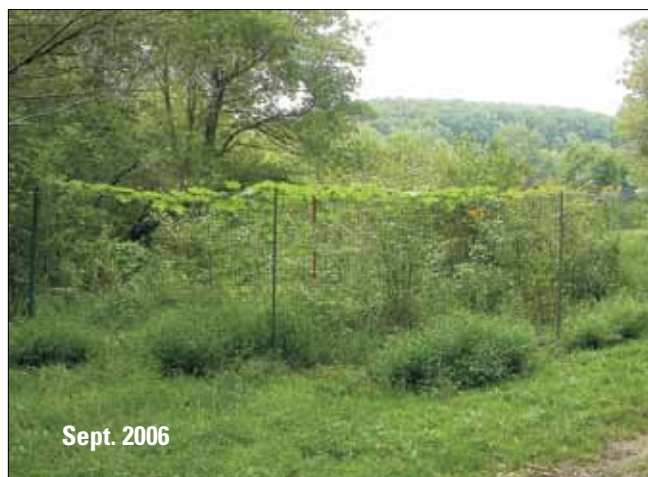
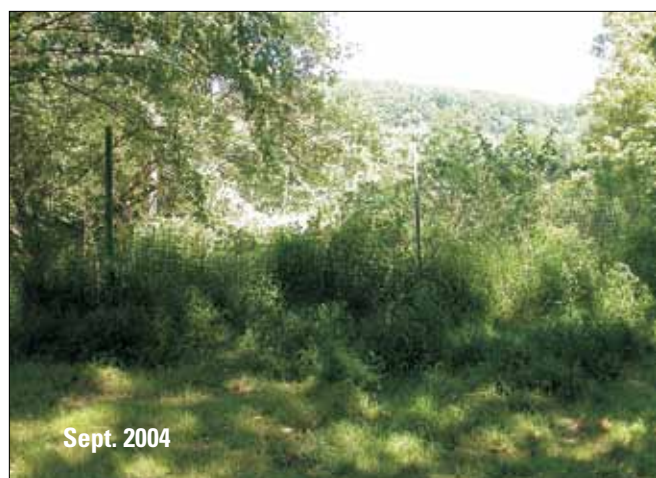
Figure 5-11. Annual views of riparian-buffer plantings in group 34, Tredyffrin Township, Chester County, Pennsylvania. (See figure 5-1 for location.)
