Flood of April 2007 in Southern Maine

Scientific Investigations Report 2009–5102

By Pamela J. Lombard

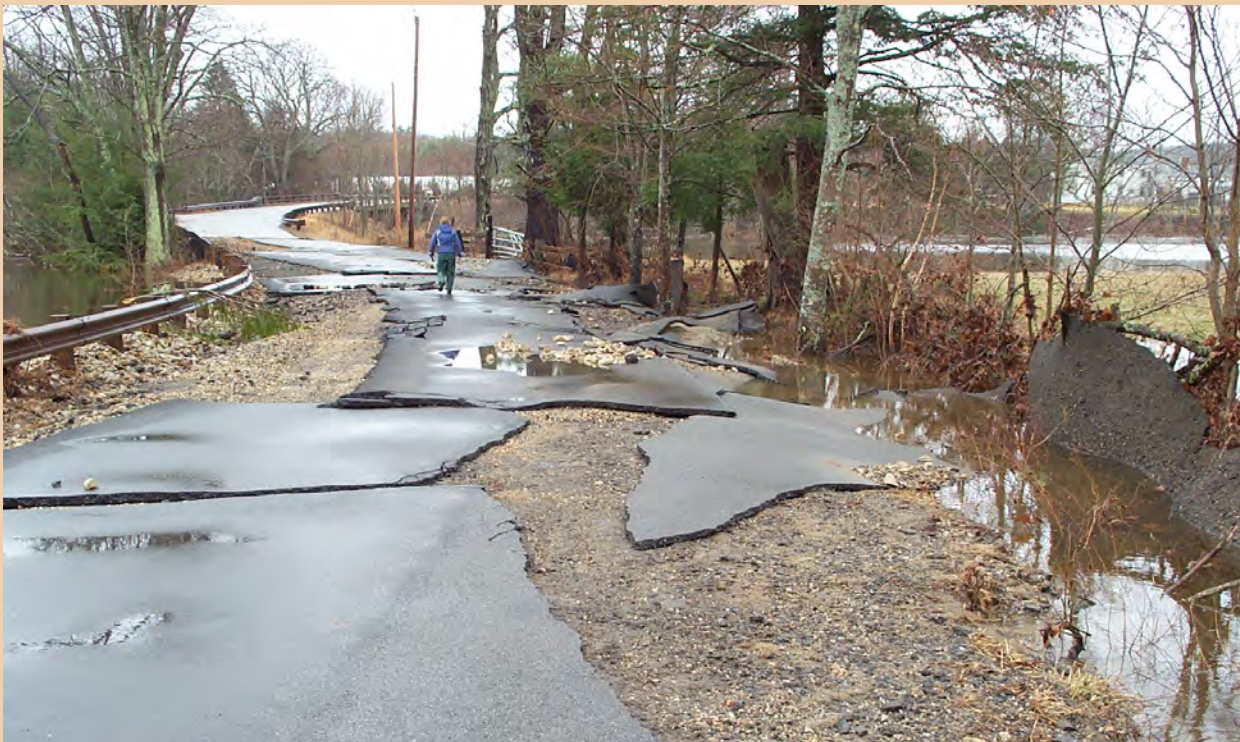
Cover. Photograph of Great Works River at Emery Bridge Road washout, South Berwick, Maine, April 2007.

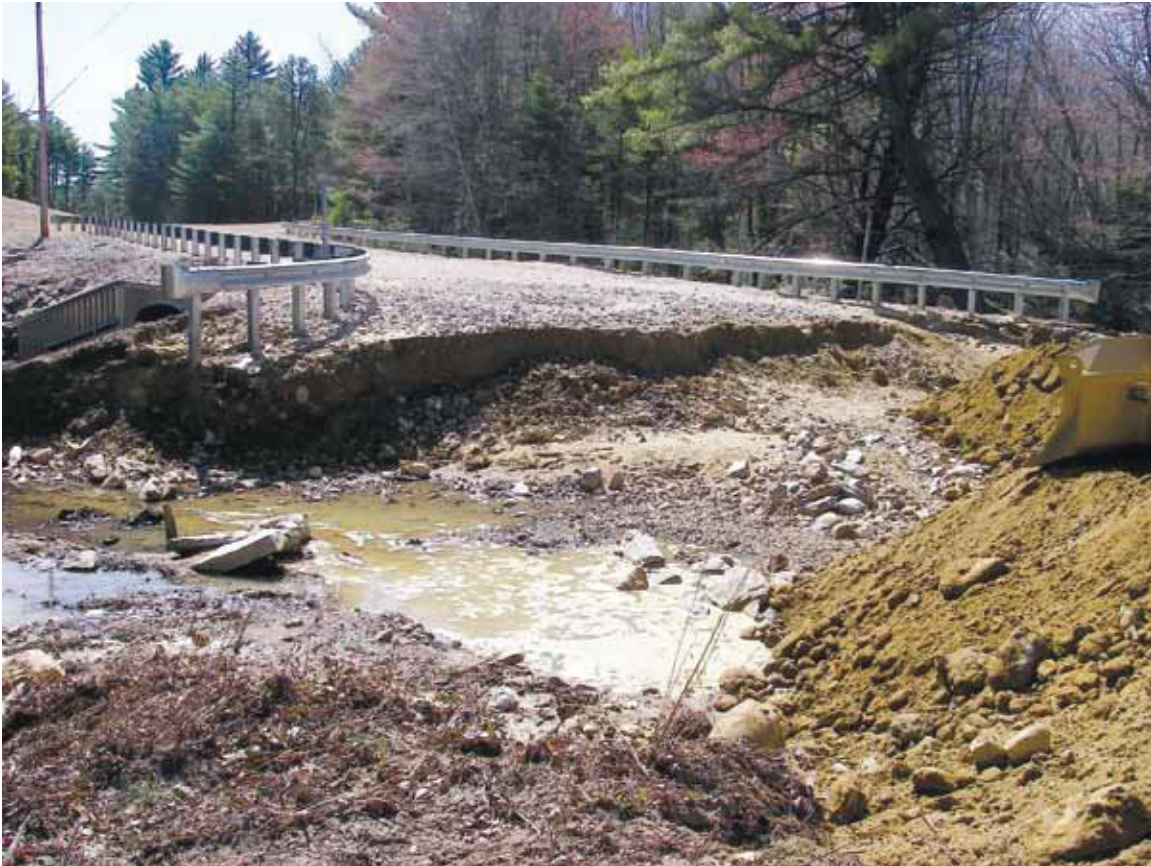
Figure 1. Keay Brook washout of Ridlon Road, April 2007, Berwick, Maine.

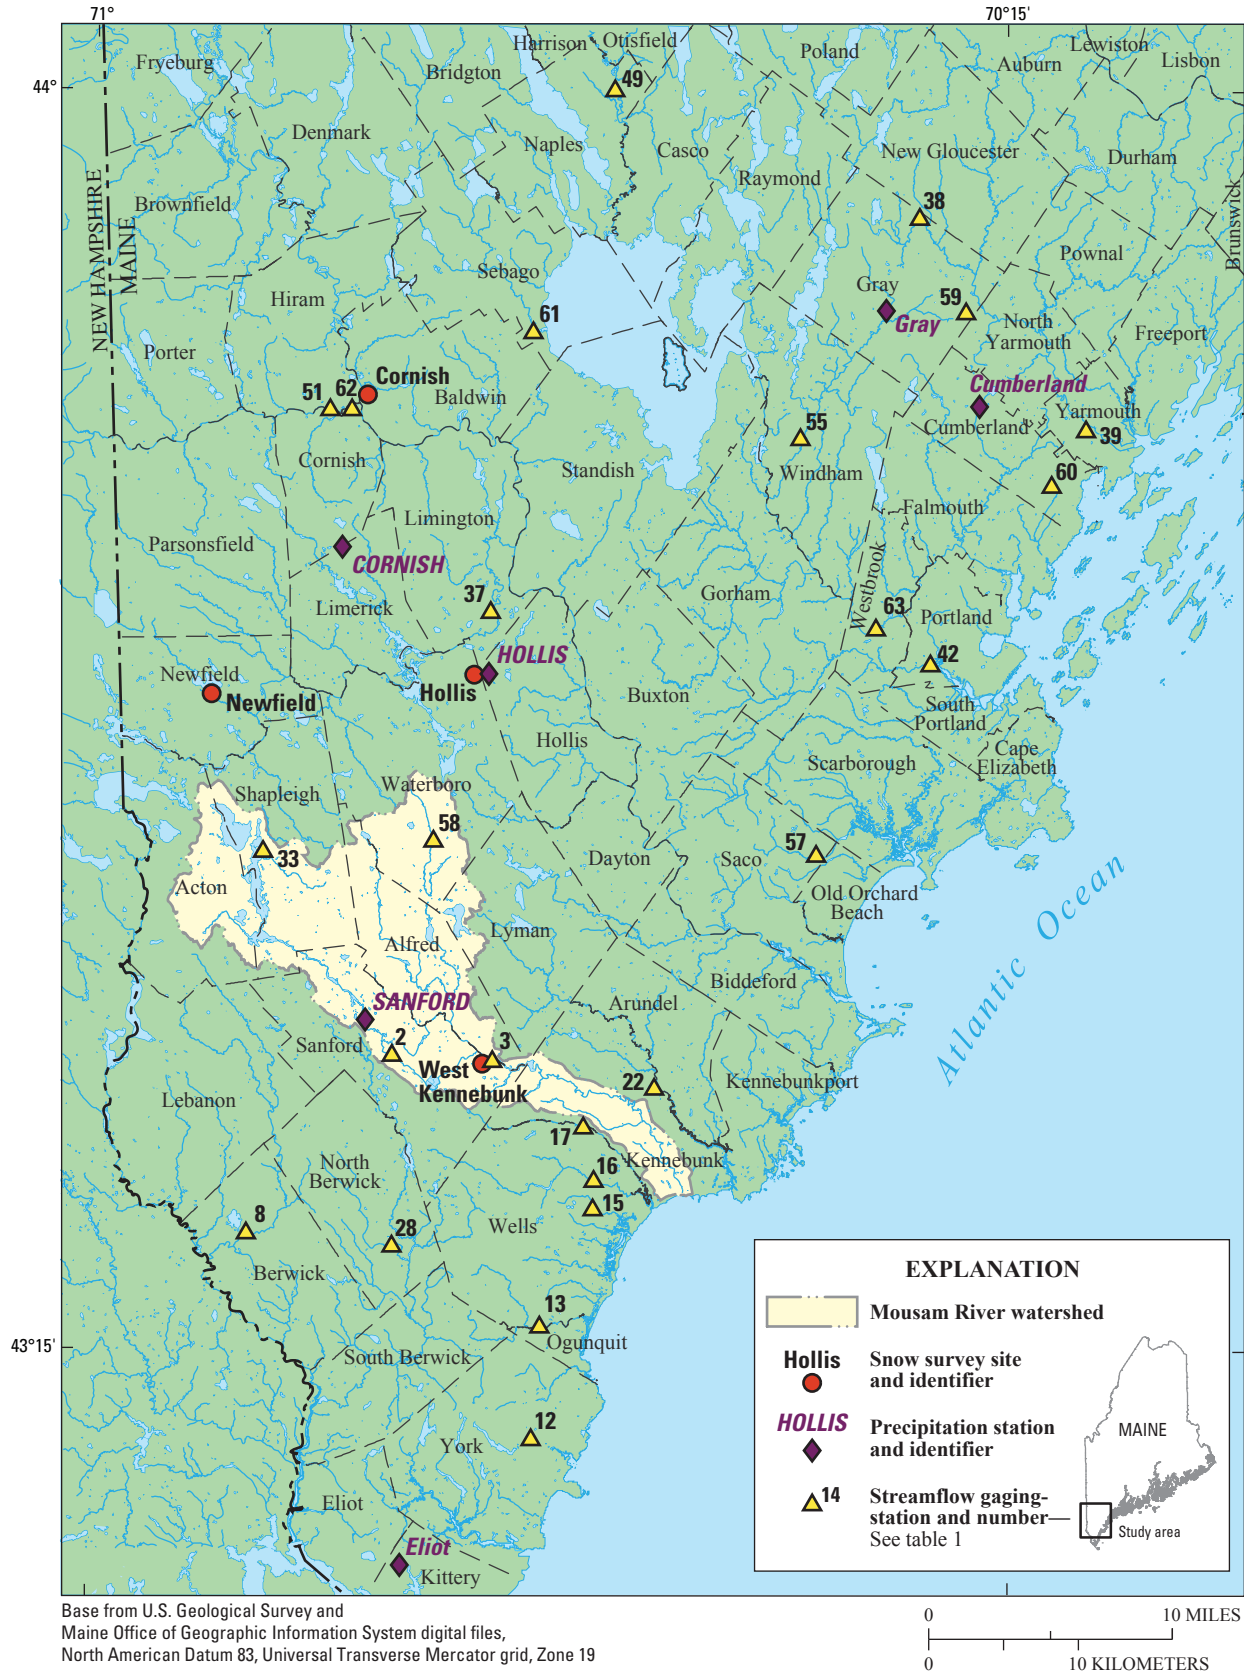
Figure 2. Location of study area and data-collection sites, southern Maine.

Severe flooding occurred in the Mousam River watershed (fig. 2) during both the May 2006 and April 2007 floods. This watershed is characterized by numerous small dams and reservoirs, and has the potential to be highly regulated. It was unclear to water-resource managers how much of an impact the dams could have on events equivalent to or greater than the 100-year event. This study includes estimates of how the storage capacities, inflows, and outflows of the many reservoirs might have interacted cumulatively to affect flooding in the Mousam River watershed during the April 2007 flood. Reservoir volumes and surface areas and dam dimensions were obtained from the Maine Department of Environmental Protection (MaineDEP) Emergency Action Plans and include many assumptions.

The largest streamflows in Maine typically occur in the spring (March, April, and May) when rain falls on a dense (ripe) snowpack or on saturated soils. Streamflows recede as snowmelt ends and evapotranspiration increases. In the spring of 2007, there were no active continuous-record streamflow-gaging stations in York County, Maine. March 2007 mean streamflow on the Saco River at Cornish in Cumberland County, Maine (site 62, fig. 2), was 2,490 ft³/s, which is in

the normal range for March. March 2007 mean streamflow on Stony Brook at East Sebago, Maine (also in Cumberland County) (site 61, fig. 2), was 2.37 ft³/s. Although this is in the normal range for March, there are only 12 years of record at this site. On the basis of the limited data available, antecedent streamflow conditions were in the normal range in March 2007 in southern Maine.

At Mousam River at Sanford (site 2, fig. 2), Little Ossipee River near South Limington (site 37, fig. 2), Royal River at Yarmouth (site 39, fig. 2), Blacksmith Brook at Wells (site 15, fig. 2), and Ogunquit River in Ogunquit (site 13, fig. 2), the observed water-surface elevations (determined from HWMs) from the April 2007 flood were bracketed by elevation profiles with higher than expected recurrence intervals given the observed peak streamflows and modeled elevations in the FIS. The computed water-surface elevations from the April 2007 flood at the Great Works River Dam in North Berwick (site 28, fig. 2) were bracketed by elevation profiles with the same recurrence intervals as would be expected given observed peak streamflows and modeled elevations. At the Stroudwater River Dam in Portland (site 42, fig. 2), the Merriland River in Wells (site 16, fig. 2), the Kennebunk River in Kennebunk (site 22, fig. 2), and Collyer Brook at Gray (site 38, fig. 2), observed water-surface elevations were bracketed by elevation profiles with the same recurrence interval as would be expected given

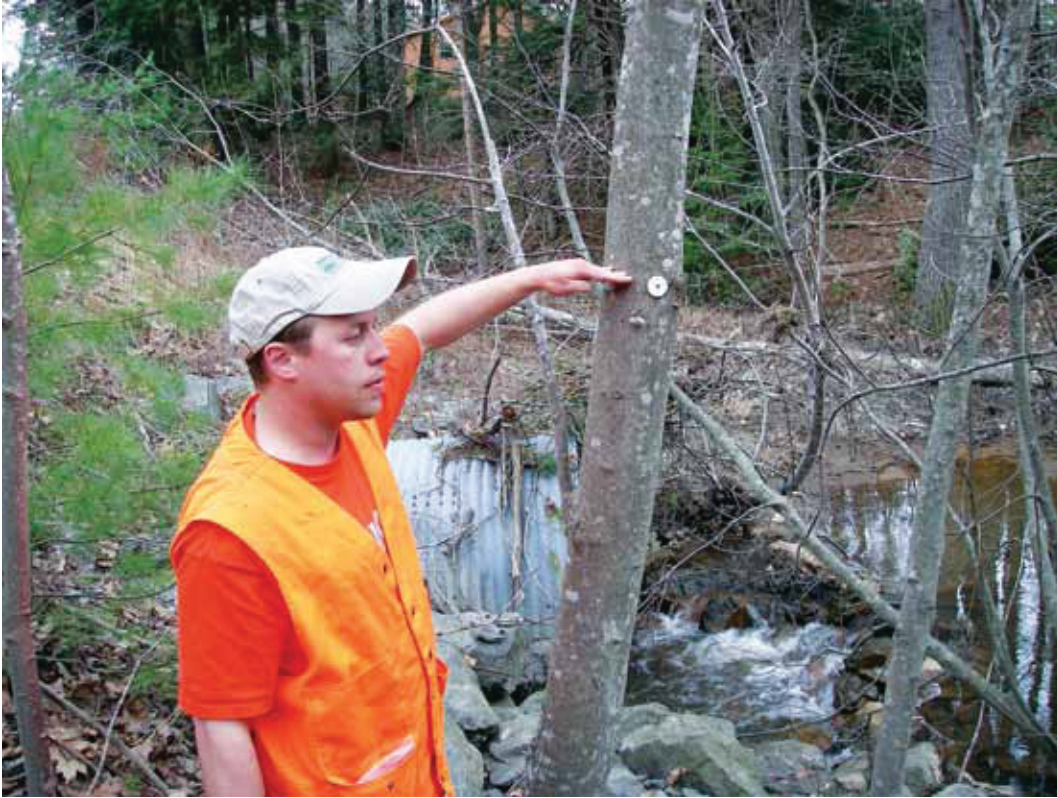
Figure 6. Marker indicating high-water elevation, April 2007 flood, southern Maine.

HWMs such as debris lines or wash lines caused by the flooding event can be located, marked, and rated in the days following a storm (fig. 6). Debris lines usually consist of fine material such as silt, hemlock needles, or seeds deposited by

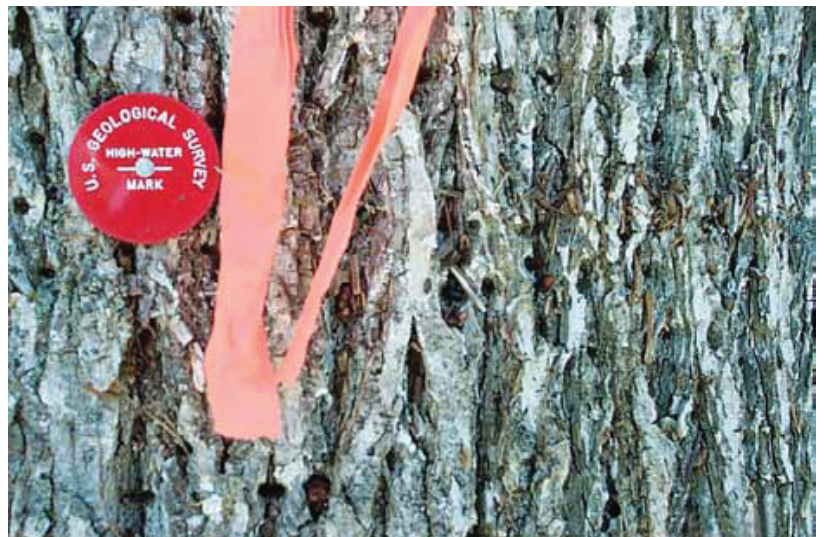
Figure 7. Marker at debris line on bark of tree indicating high-water elevation, April 2007 flood, southern Maine.

peak water surfaces on trees (fig. 7), bridge abutments, buildings, or streambanks (fig. 8). Wash lines are defined by the removal or washing away of soil, debris, and leaves by flood peaks. It is essential to mark all HWMs as soon as possible after the event because they can quickly fade or wash away in subsequent storms. HWMs are rated on the basis of the type and quality of the debris line or wash line as well as other corroborating evidence in the area. The accuracy of the mark is defined as follows: a high-water mark having an excellent rating is estimated to be within 0.05 ft of the actual peak water surface; a good mark is within 0.1 ft; a fair mark is within 0.2 ft; and a poor mark may be greater than 0.2 ft from the true peak water surface during the event.

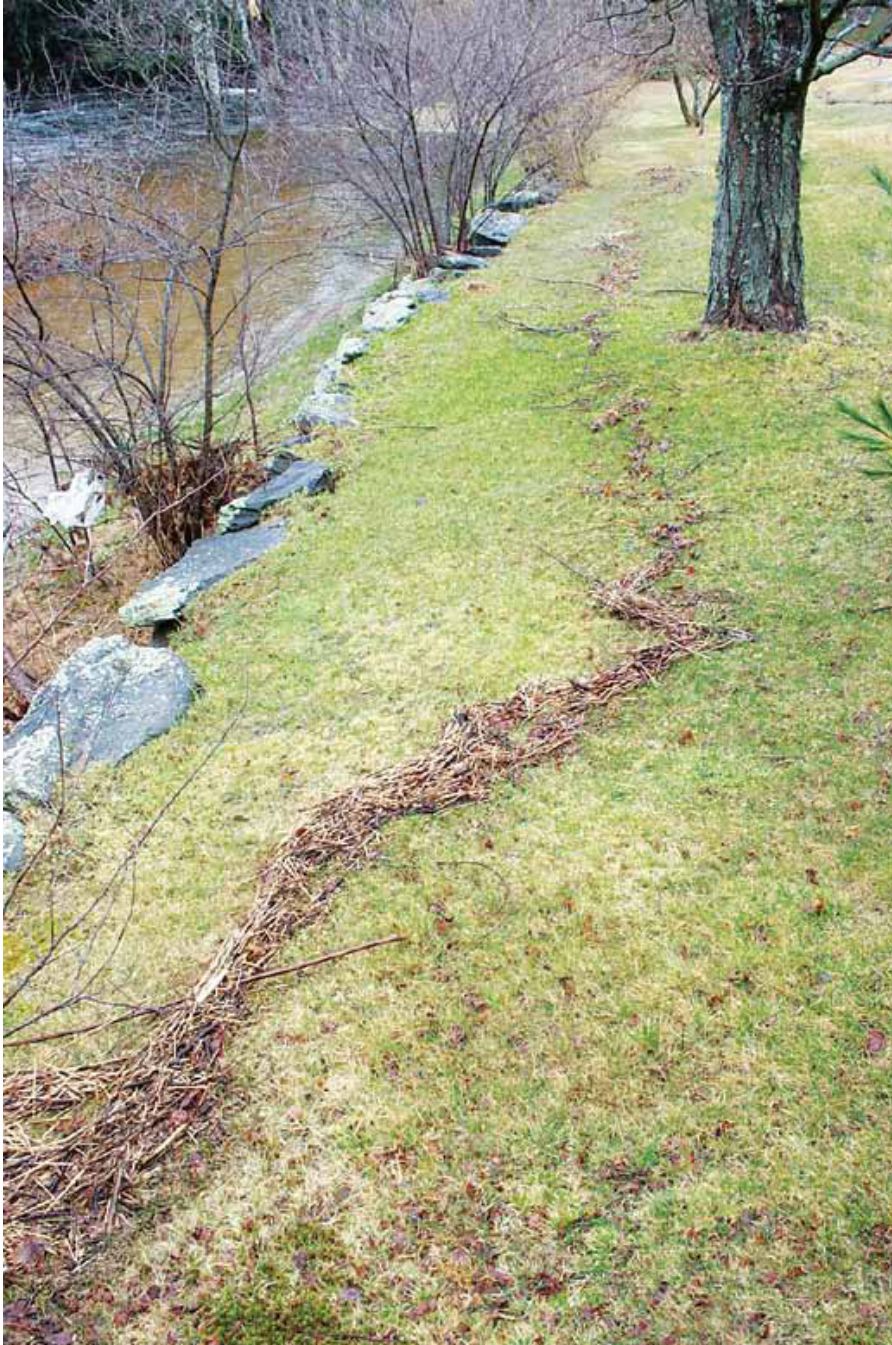
Figure 8. Debris line indicating high-water elevation along Little River near Longswamp Road, April 2007 flood, Berwick, Maine.

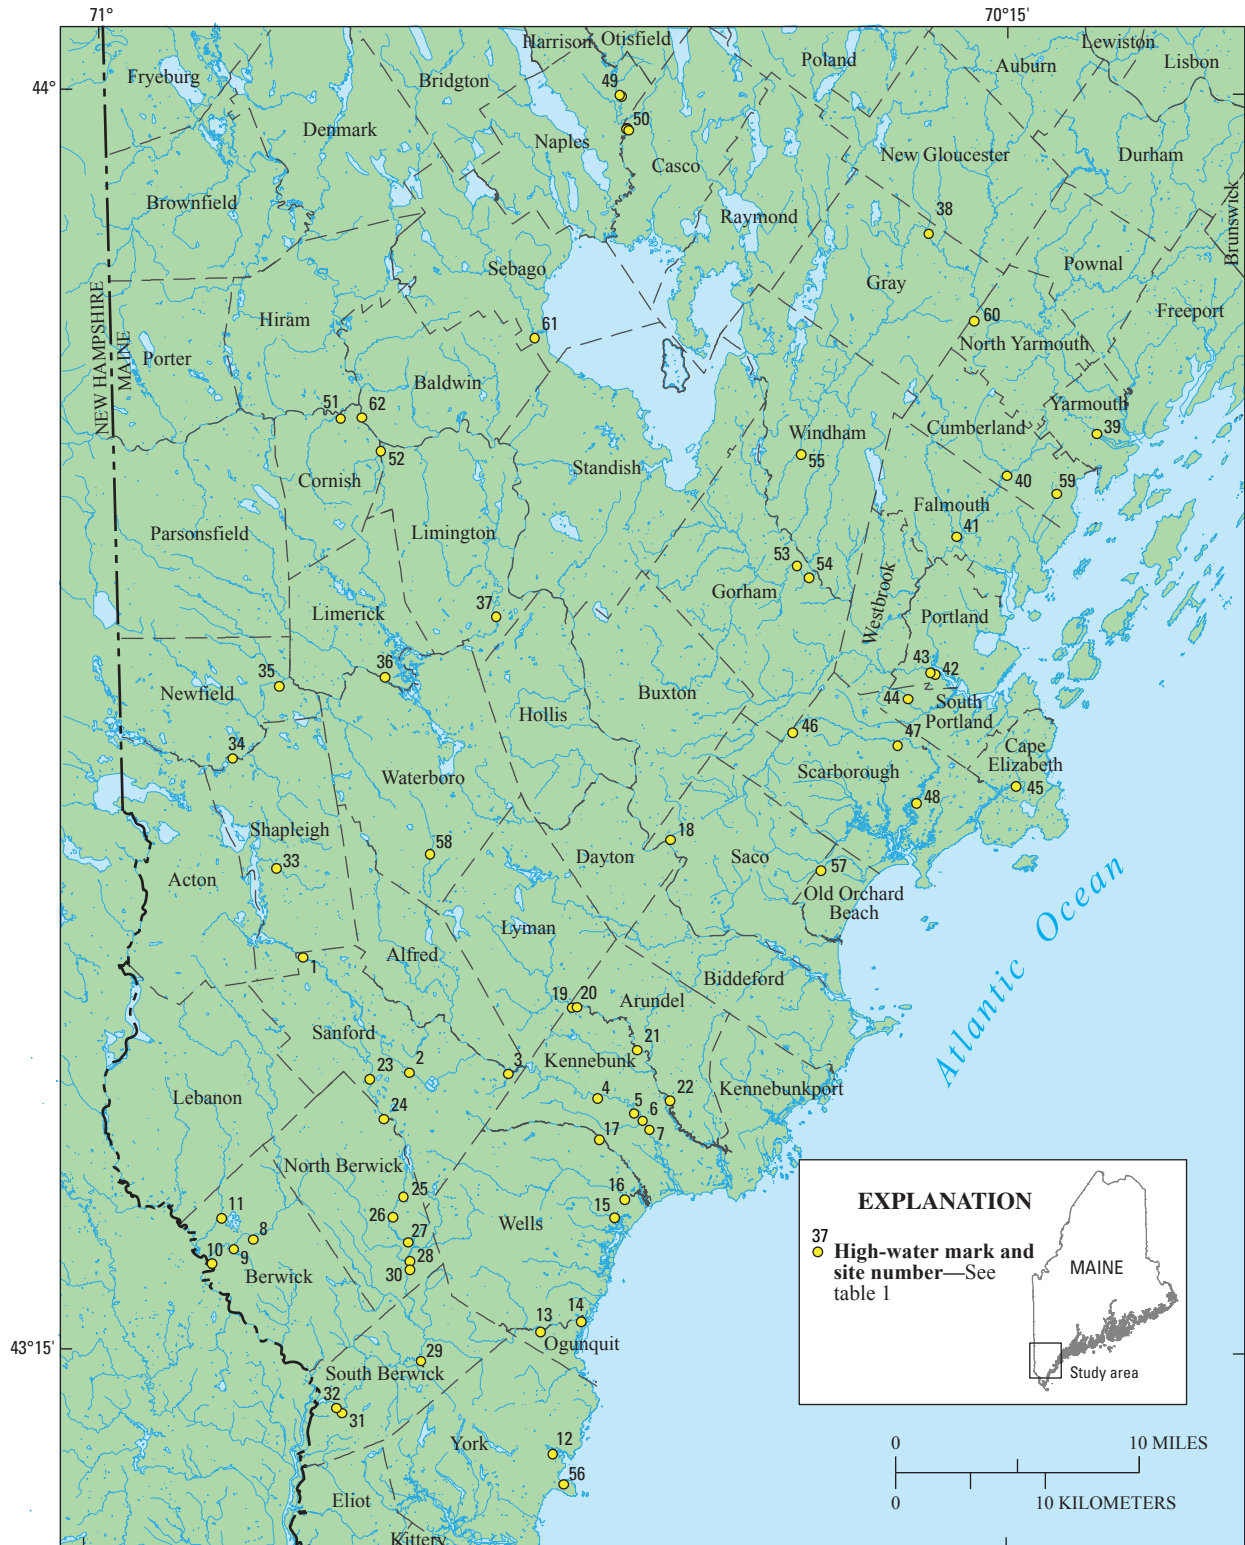
Figure 9. Location of sites where high-water marks were surveyed following the April 2007 flood in southern Maine.

Peak water-surface elevations were determined for 160 points at 62 sites on 33 rivers and streams in York and Cumberland Counties, Maine, following the April 2007 flood (table 1 in back of report, fig. 9). Most of the documented HWMs were upstream or downstream of bridges, culverts, and dams or at discontinued streamflow-gaging stations or crest-stage gaging stations. The locations of sites where HWMs were identified (one to four marks per site) are shown on figure 9, and the elevations of the HWMs are listed in table 1 (in back of report). All HWMs included in this report were referenced to NAVD 88 using High Precision Global Positioning System (GPS) instrumentation. At sites where a continuous-record streamflow-gaging station was in operation, peak water-surface elevations were recorded by the station and the identification of HWMs was unnecessary. The time of the peak elevation or the peak flow from the April 2007 flood is not known for any of the points listed in table 1 (in back of report) except at the continuously recording streamflow-gaging stations (sites 61–63).

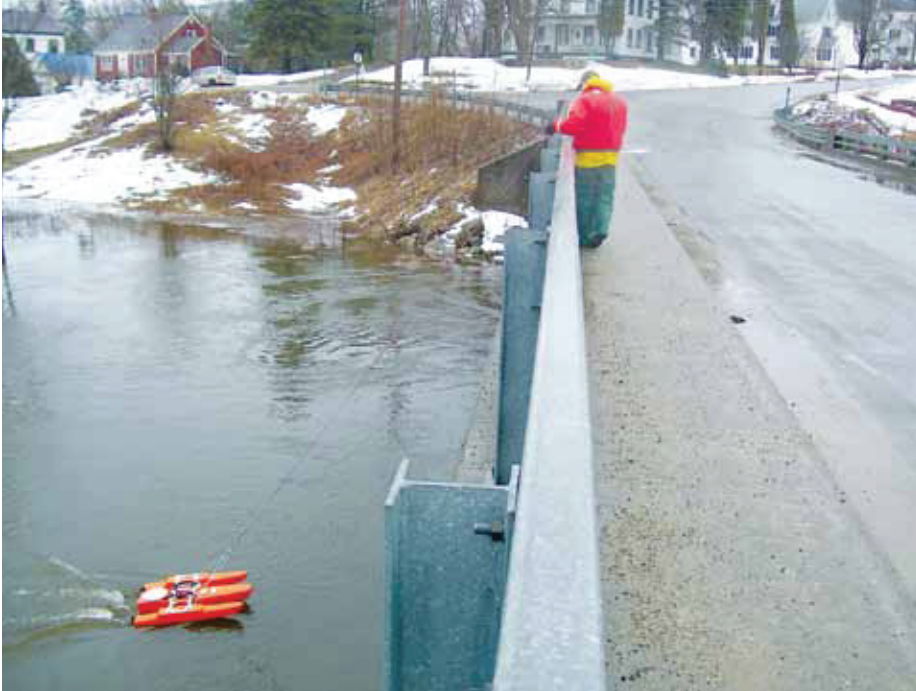
Figure 10. Streamflow measurement taken with acoustic Doppler current profiler on Nezinscot River, April 17, 2007, Turner, Maine.
