# **Causes and Movement of Landslides at Rainbow Creek and Rattlesnake Gulf in the Tully Valley, Onondaga County, New York**

By Kathryn L. Tamulonis, William M. Kappel, and Stephen B. Shaw

Scientific Investigations Report 2009–5114

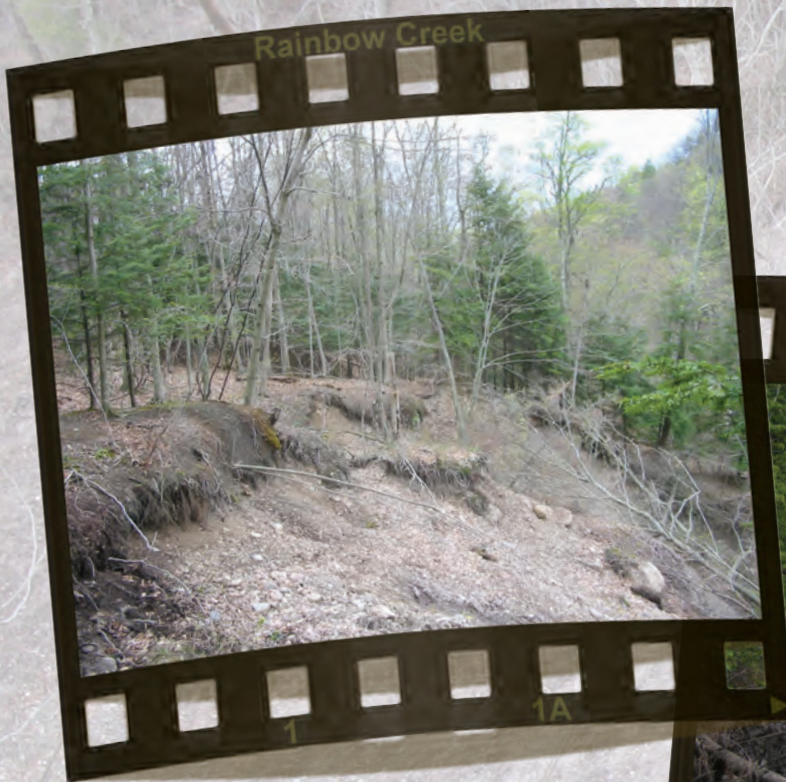
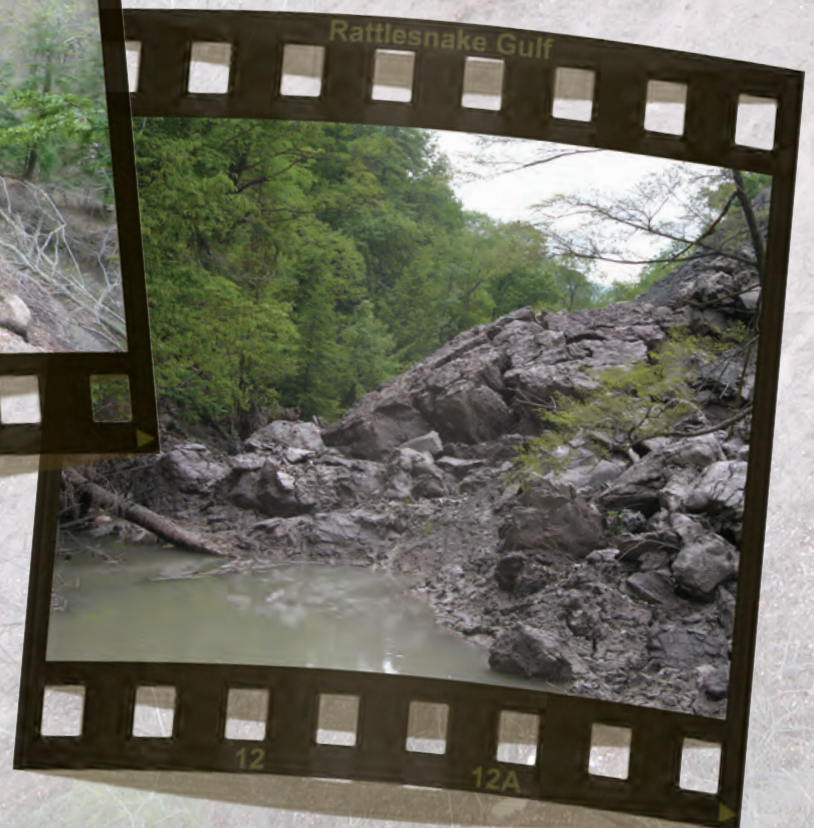
**Cover.** Left side picture—Upper scarp of the Rainbow Creek landslide - Spring 2007  
Right Side picture—Toe of Rattlesnake Gulf slide which has blocked Rattlesnake Gulf Creek - Summer 2006  
Background picture—Rainbow Creek slide in early spring

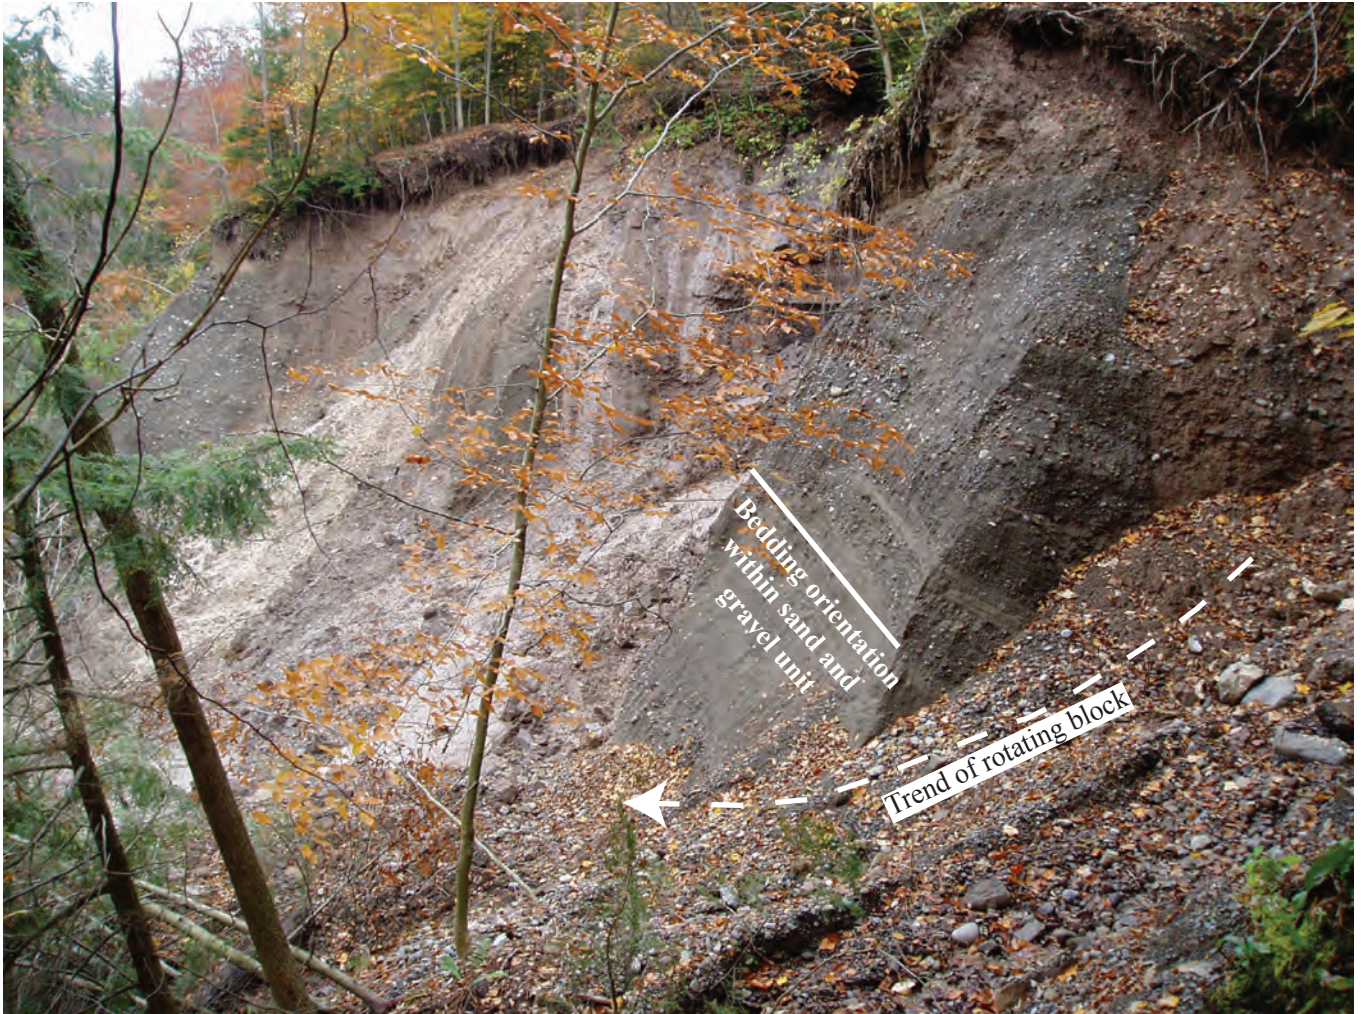
**Figure 3.** Hillside exposure of a rotated sand and gravel unit overlying fine-grained silt and clay in the Rainbow Creek landslide area, Onondaga County, New York. Photo is looking southeastward and side movement is toward the northwest (left in photo), toward Rainbow Creek.

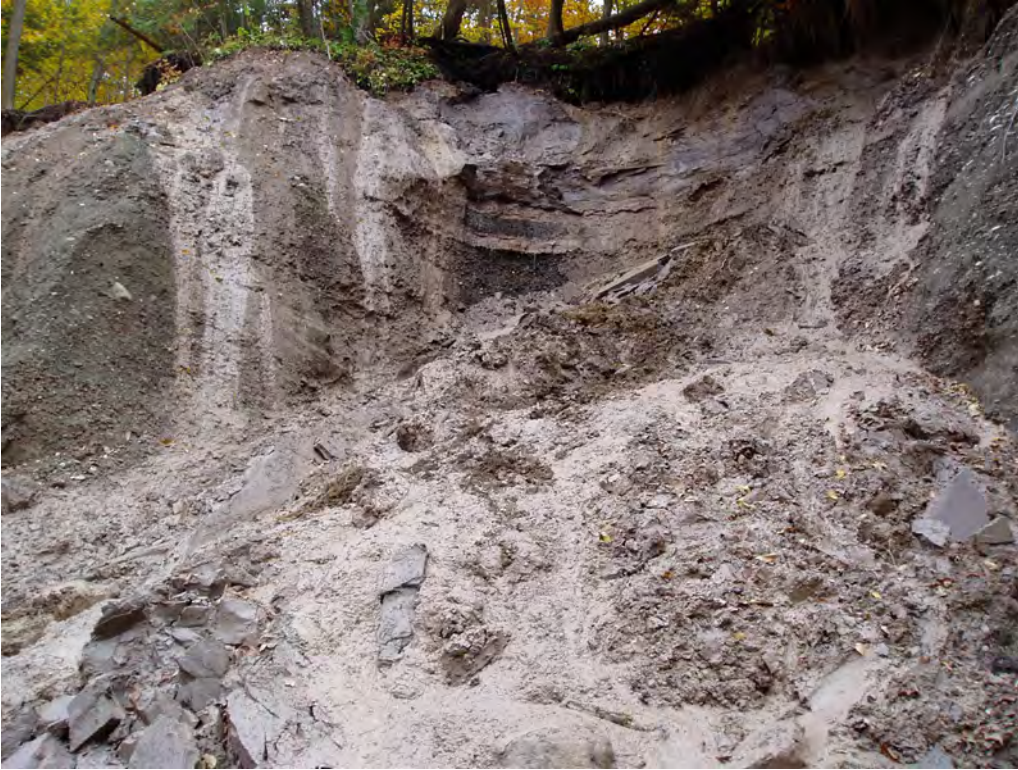
Failure of upper scarp of sand and gravel, revealing laminated and tilted silt and clay unit with overlying till at Rainbow Creek landslide.

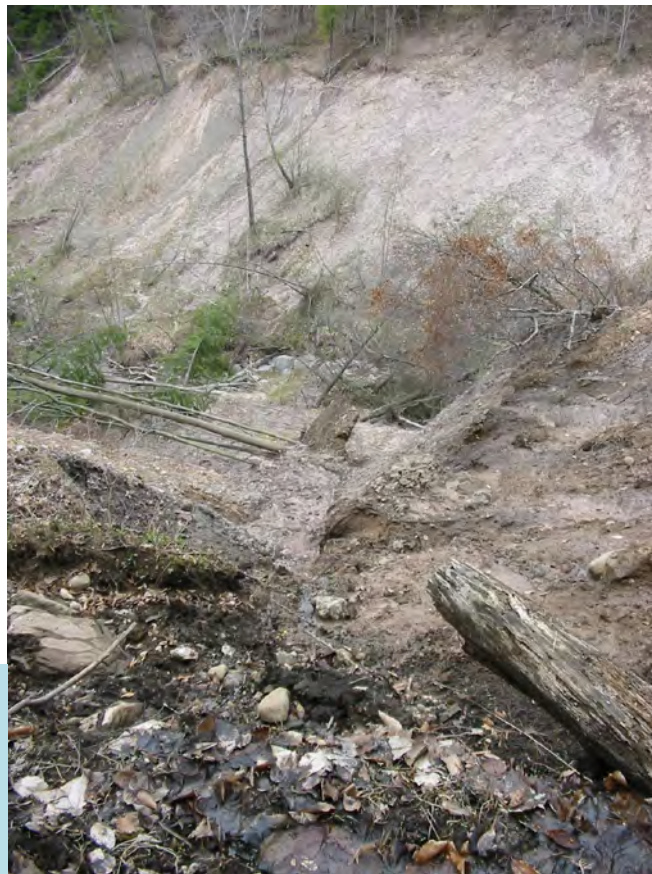
Toe of the slide area pictured above, showing debris flow and failure of opposite (north) slope of Rainbow Creek valley wall.

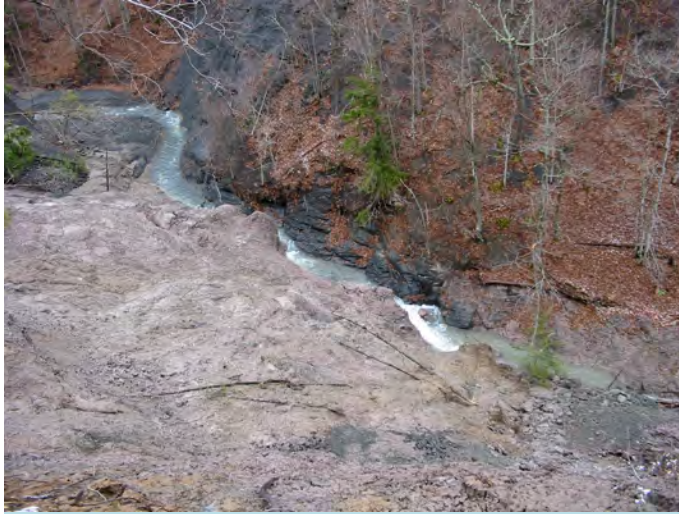
Slope failure which blocked Rattlesnake Gulf, late Winter, 2008, in the same area of the Spring 2006 slide pictured above.

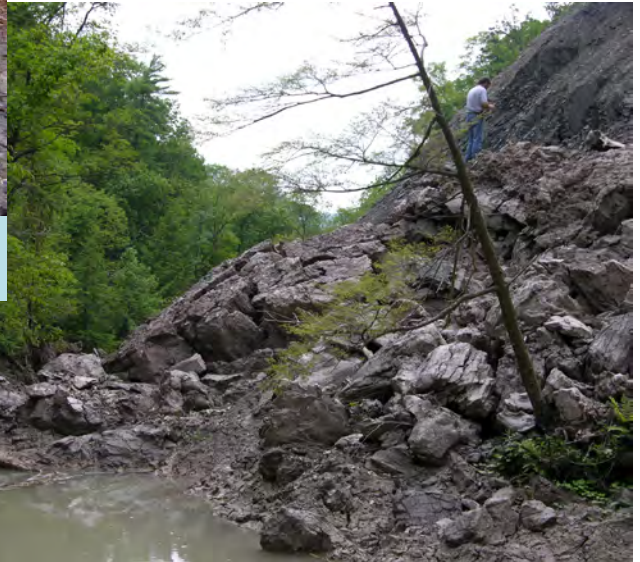
Toe of slope failure which blocked Rattlesnake Gulf, Spring 2006

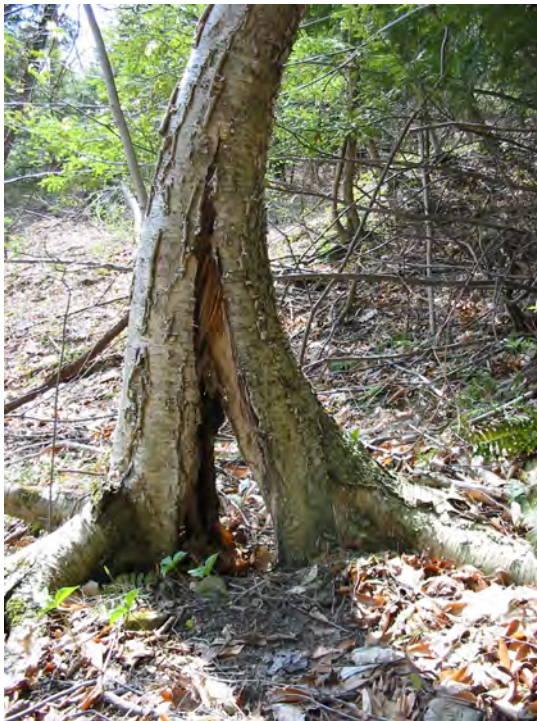
A split-tree found within the upper part of the Rattlesnake Gulf slide area.

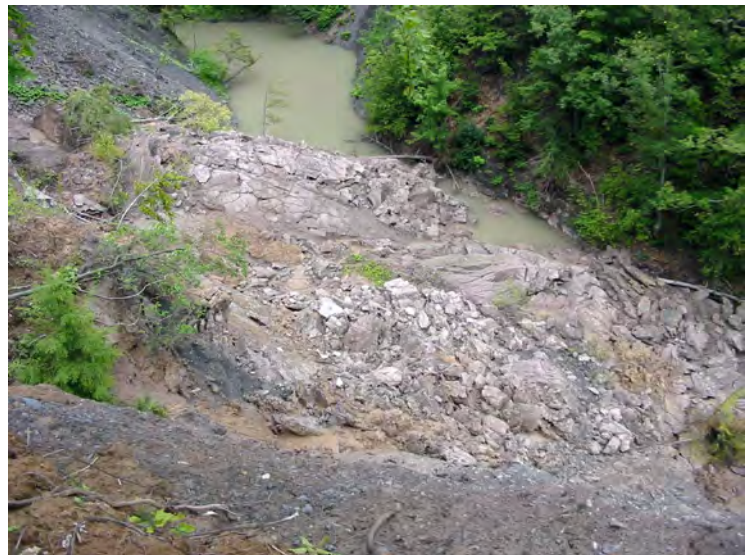
Slope failure which blocked Rattlesnake Gulf, Spring 2006.

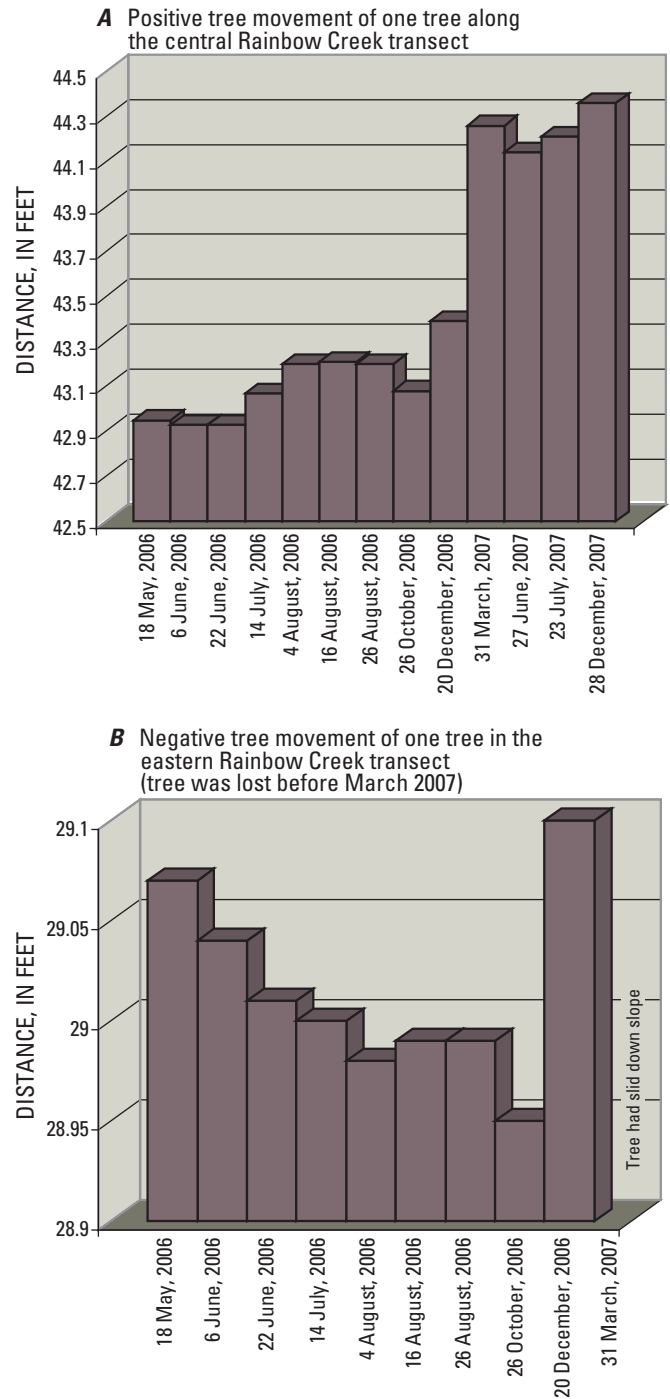
**Figure 9.** Tree movement along transects in the Rainbow Creek landslide area: (A) positive (increasing distance) movement, and (B) negative (decreasing distance) movement. (Note differing scales for 9A and 9B, and transect locations are shown in figures 2 and 4, respectively.)

Most of the trees along the western-most transect were adjacent to an ephemeral and quickly eroding stream channel, and most of these trees were incrementally lost over a period of 3 to 5 months as the slope continued to erode rapidly. The other two transects (central and eastern) at this landslide indicated the upper slope was slowly responding (inches per year) to erosion of the landslide face. Most of the trees were moving apart (positive movement of one tree in the central transect is plotted in figure 9A), but some were moving closer to each other (negative movement of one tree in the eastern transect is plotted in figure 9B). The trees with negative movement tended to lean uphill; several of these trees were anchored by their roots to the stable, upslope land surface such that the movement of the unstable, underlying soil caused these trees to tilt uphill. Many of these trees were later lost through slope failure, which ripped the remaining anchor roots and sent the trees toppling down the steep slope of the landslide. The average rate of positive movement of all trees along these two Rainbow Creek transects was 2.1 inches per year.

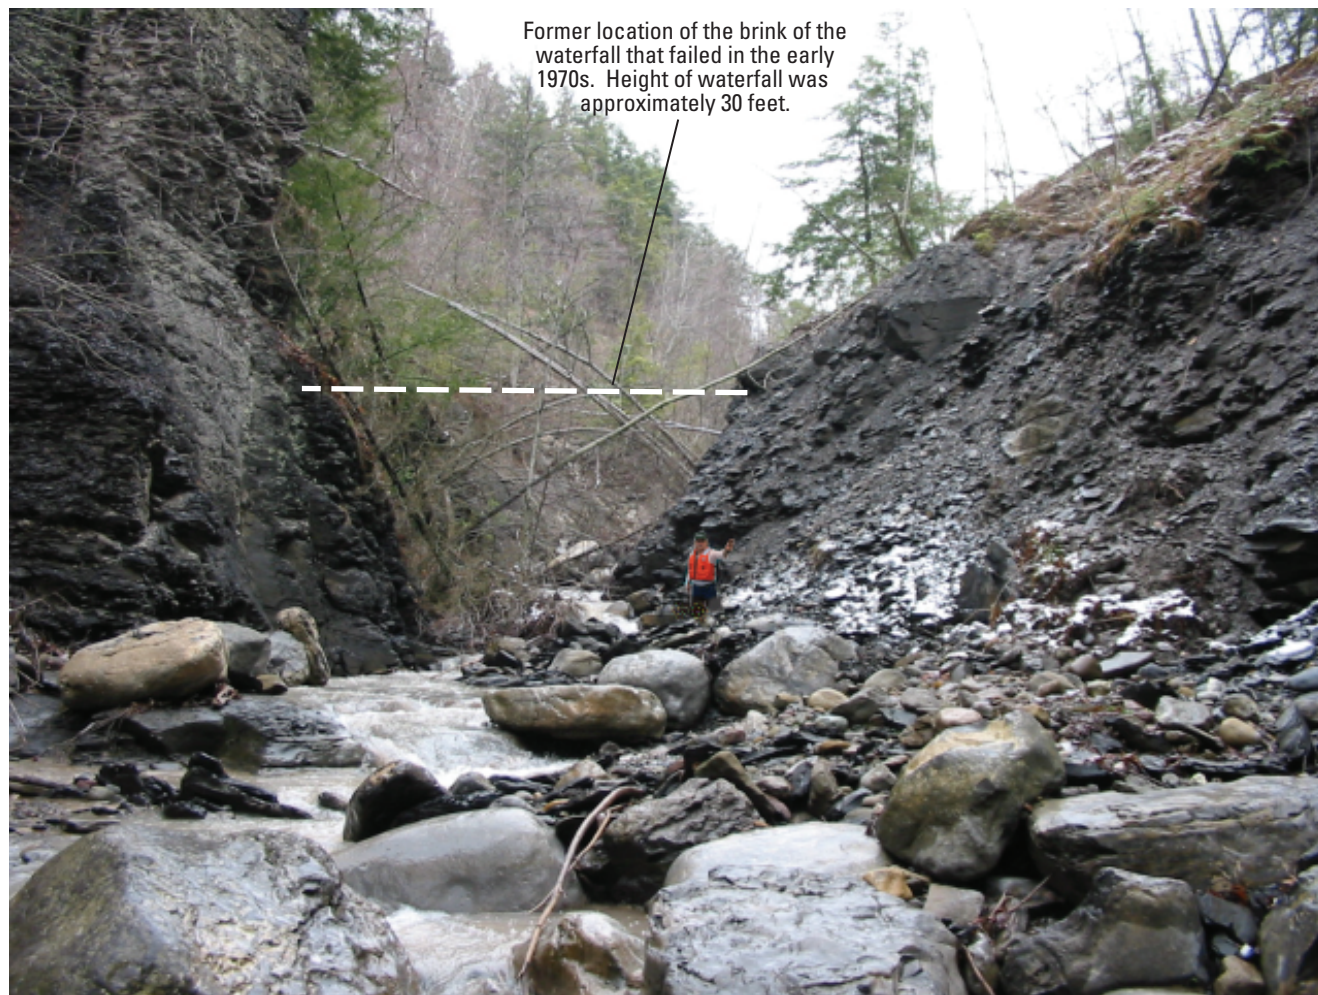
**Figure 10.** Location of the former bedrock waterfall along Rainbow Creek, just downstream from the active landslide area.

A local resident who has lived next to Rainbow Creek most of his life reported that little landslide activity or sedimentation occurred in the Rainbow Creek channel along the eastern wall of the Tully Valley before the 1970s but recalled that a 30- to 40-foot waterfall over shale bedrock (fig. 10) just downstream from the current landslide area collapsed in the early 1970s. The resulting change in the stream channel could not be confirmed from the aerial photographs, but a narrow, 30-foot-high notch in the shale just downstream from the current landslide (fig. 10) marks the location of the former waterfall in the still-eroding stream channel. Coarse gravel, boulders, and fine-grained sediment

The account by this resident and the physical evidence of the waterfall location indicate that landslide activity here was initiated by (1) failure of the shale bedrock at the waterfall, (2) the subsequent steepening of the upstream channel bed as streambed material eroded and moved downstream after the waterfall collapse, and (3) destabilization of the steep, fine-grained slopes along both sides of the eroding stream channel upstream from the waterfall during high-flow periods.
