Topographic Change Detection at Select Archeological Sites in Grand Canyon National Park, Arizona, 2006–2007

Scientific Investigations Report 2009-5116

Brian D. Collins, Diane Minasian, and Robert Kayen

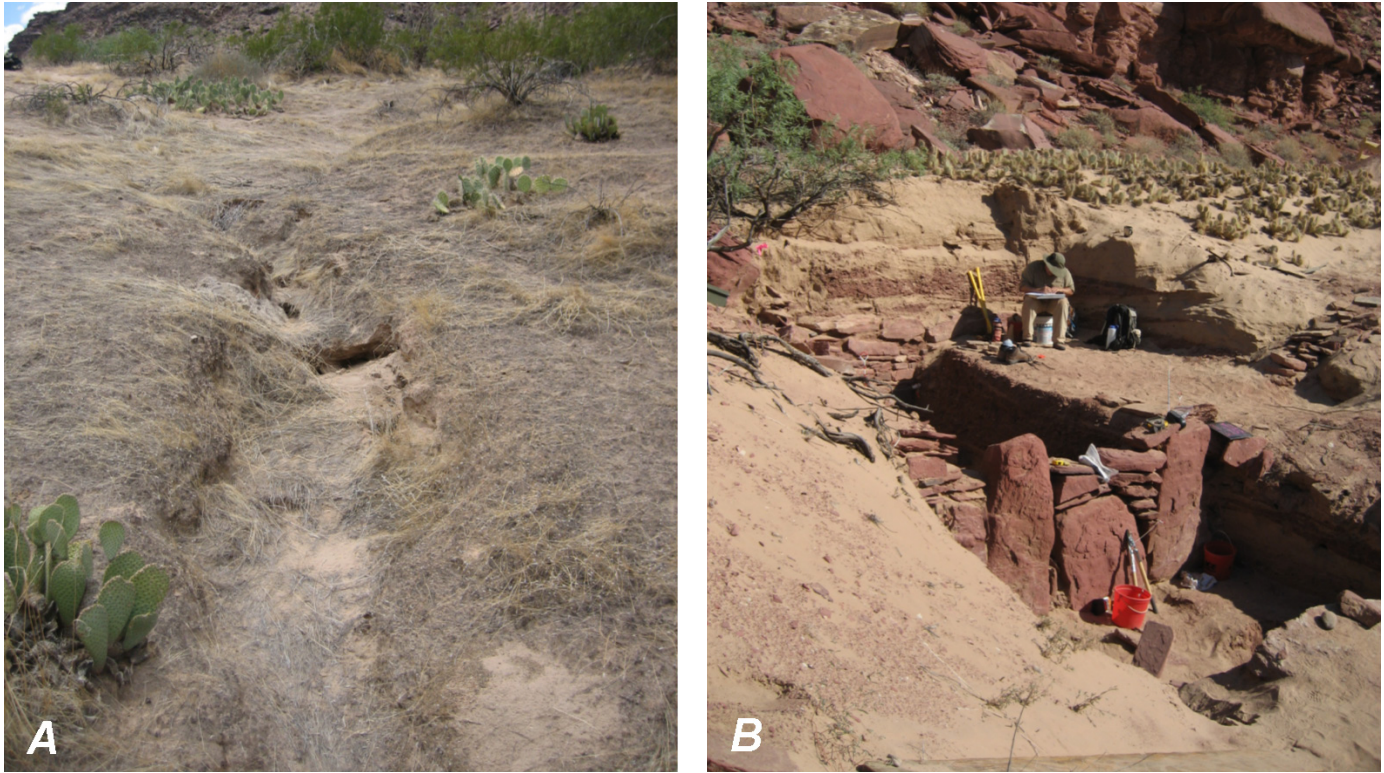
Figure 1. *A*, Gully of an archeological site in Grand Canyon National Park and *B*, excavation of a site when erosion threatens resources. The area in *B* was previously buried by aeolian deposition and emerged as precipitation runoff and wind deflation exposed small features of the habitation site.

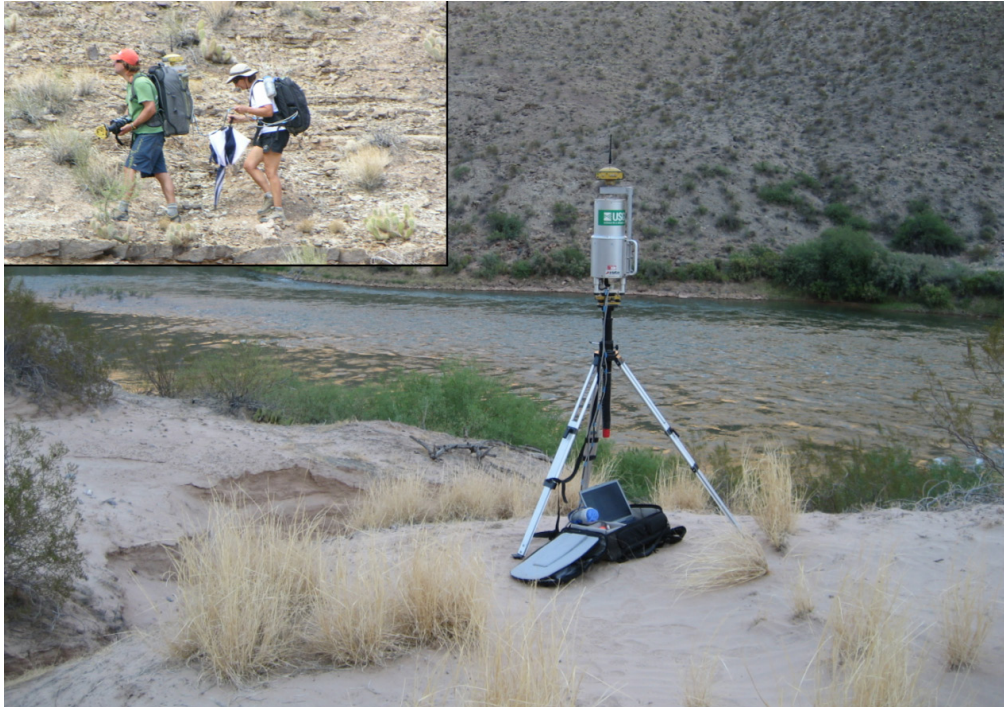
Figure 4. Terrestrial lidar data collection in Grand Canyon National Park. The extendable tripod allows a larger area of data collection and less oblique laser returns from areas of flat topography. Differential global positioning system (GPS) with a fixed radio-linked base station is used to georeference the instrument location. Inset shows typical transportation of the equipment.

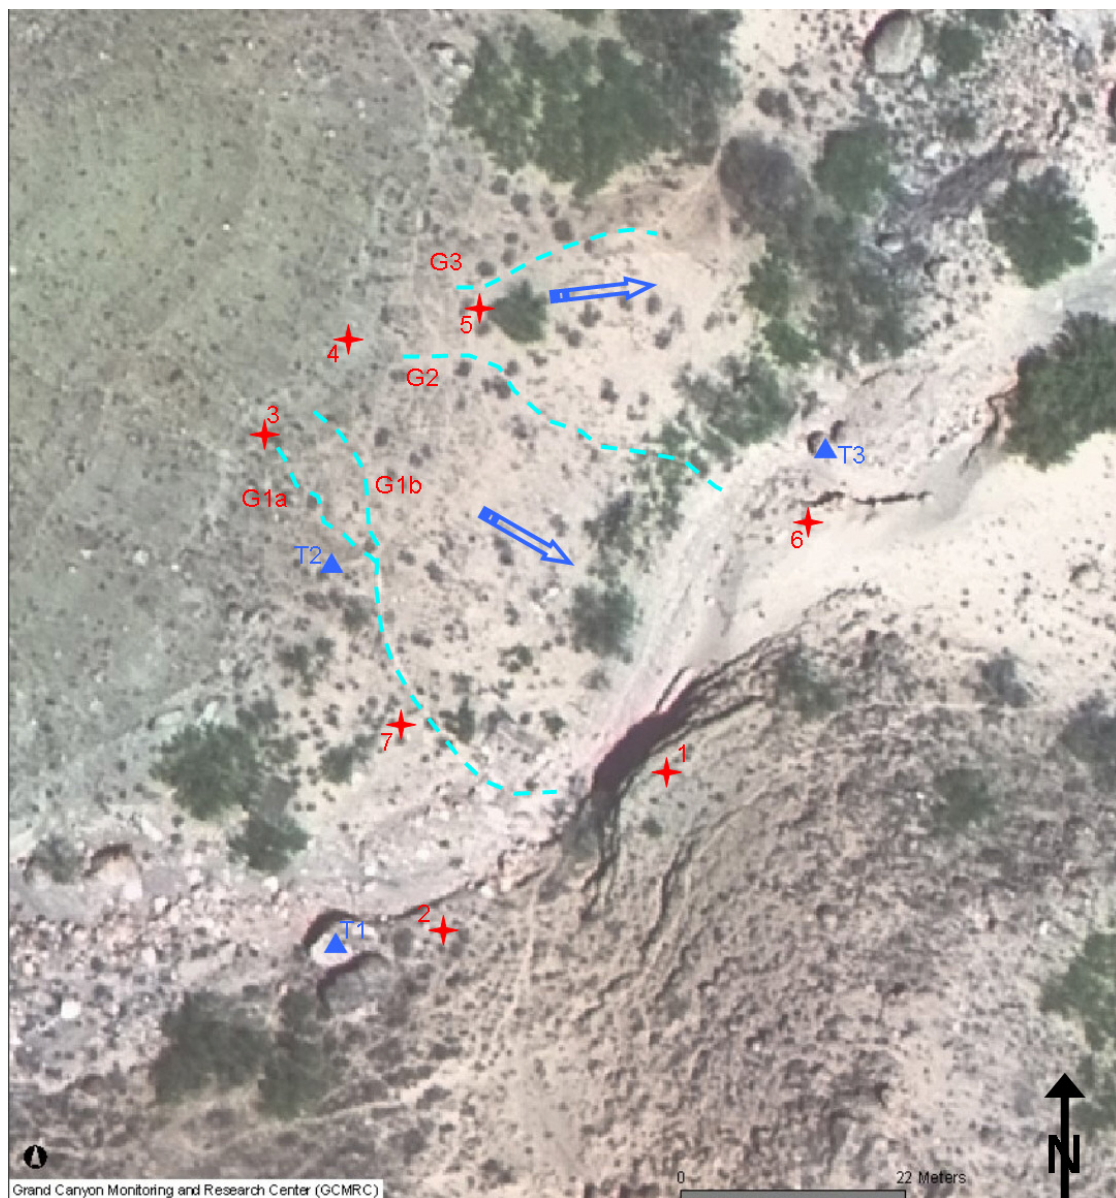
Figure 5. Site AZ:C:13:006 showing main gullies (dashed lines), general downhill flow direction (blue arrows), and laser scan (red crosses) and laser control point (blue triangles) locations.

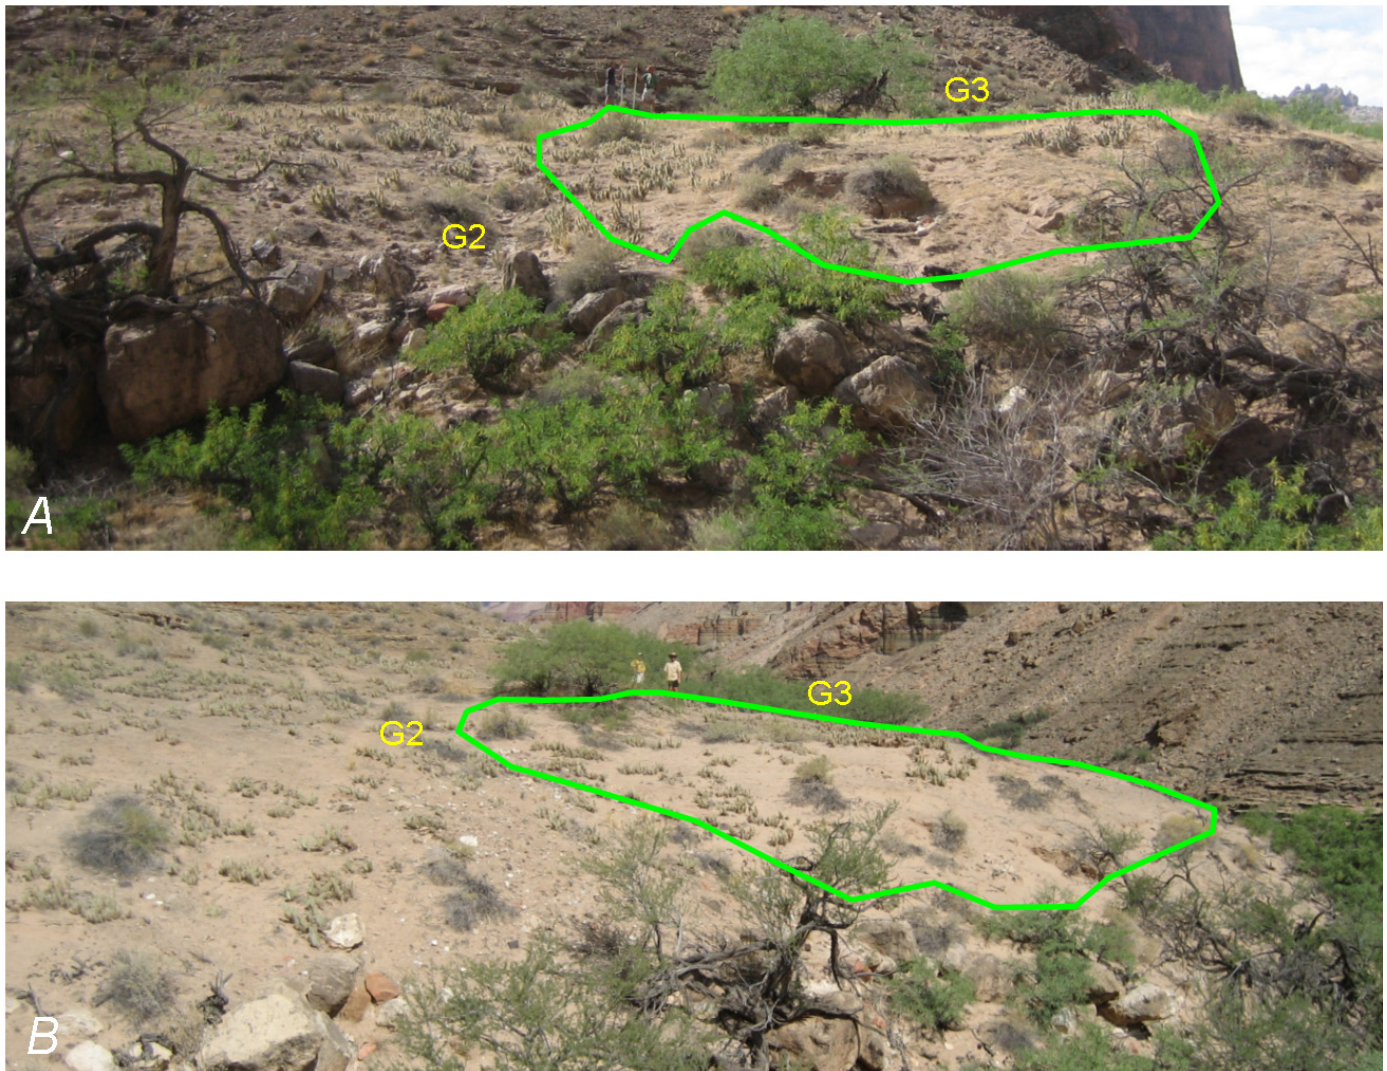
Figure 11. Site AZ:C:13:006 overview images showing area of as much as 30 cm deposition (polygons) measured between (A) May 2006 and (B) September 2007. Note grasses in A are buried in B.

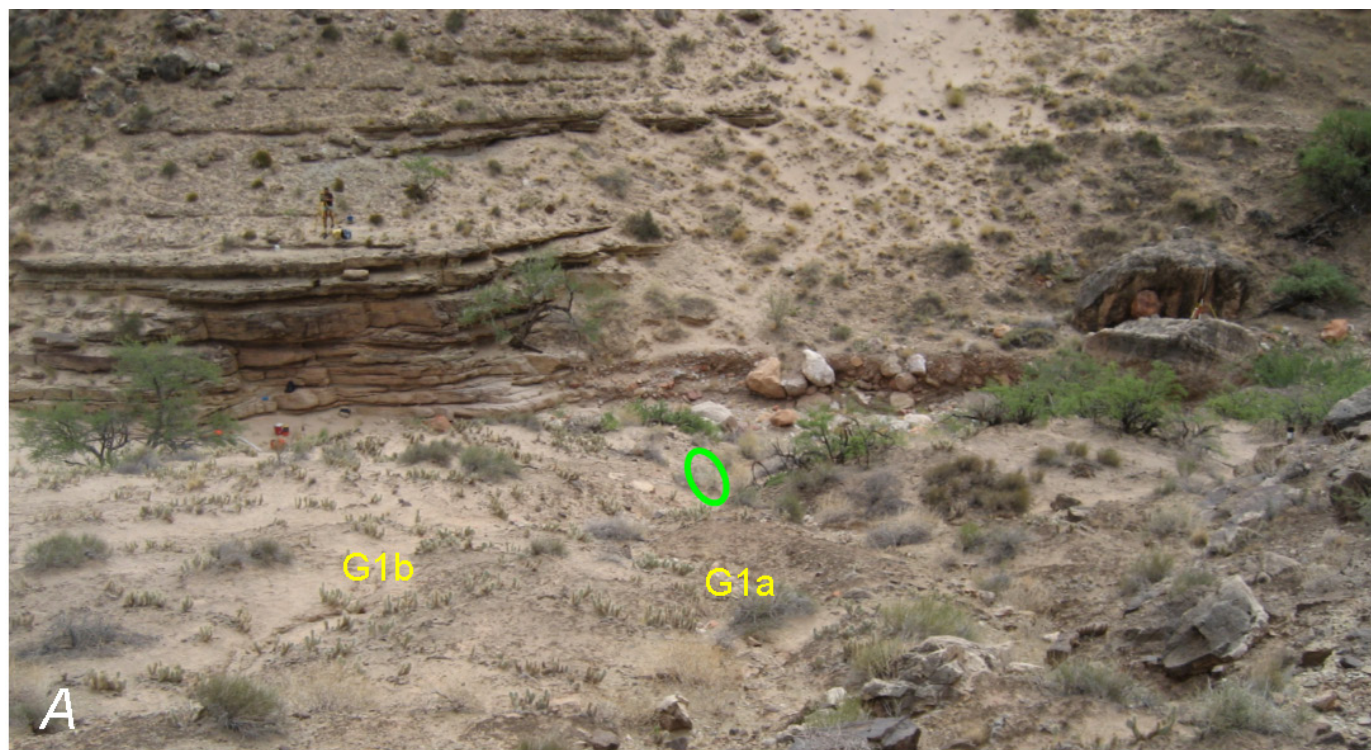
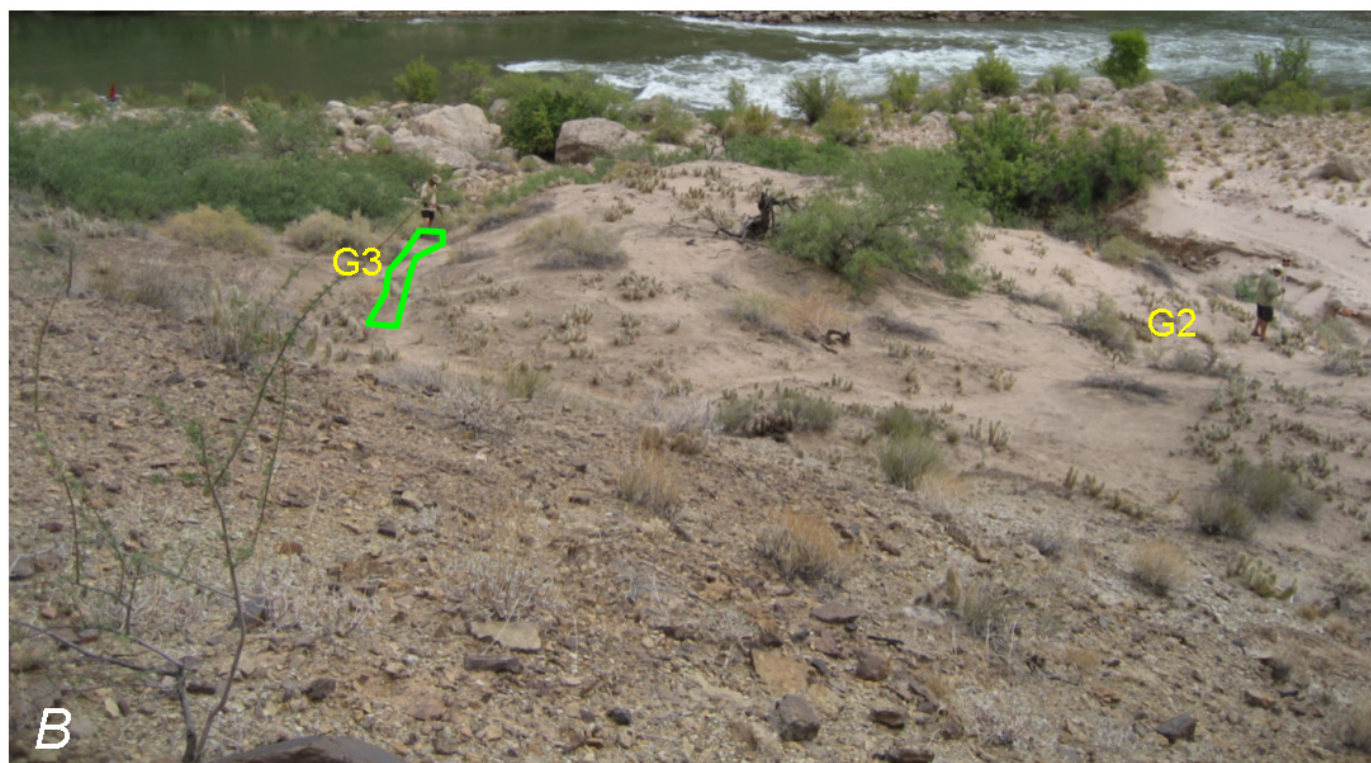
We also found statistically significant erosion along a 10-m length (over an approximately 10 m² area) of the upper portion of G3 (figs. 10 and 12) totaling 0.5 m³ in volume. Although the calculated surface change is on the order of 10 cm to 30 cm in places, we suspect that vegetation that is difficult to filter (that is, small prickly pear cacti) is responsible for at least a part of the measured change. However, an erosion signature is present for a majority of the drainage in this area, and therefore we conclude that the gully is actively eroding, albeit at the lower end of the detected change (on the order of 10 cm). Our observations indicate that channelized overland flow is responsible for this erosion.

Figure 12. Site AZ:C:13:006 overview images showing locations of erosion (oval and polygon). The majority of change in *A* occurred between May 2006 and May 2007, whereas the majority of change in *B* occurred between May 2007 and September 2007.

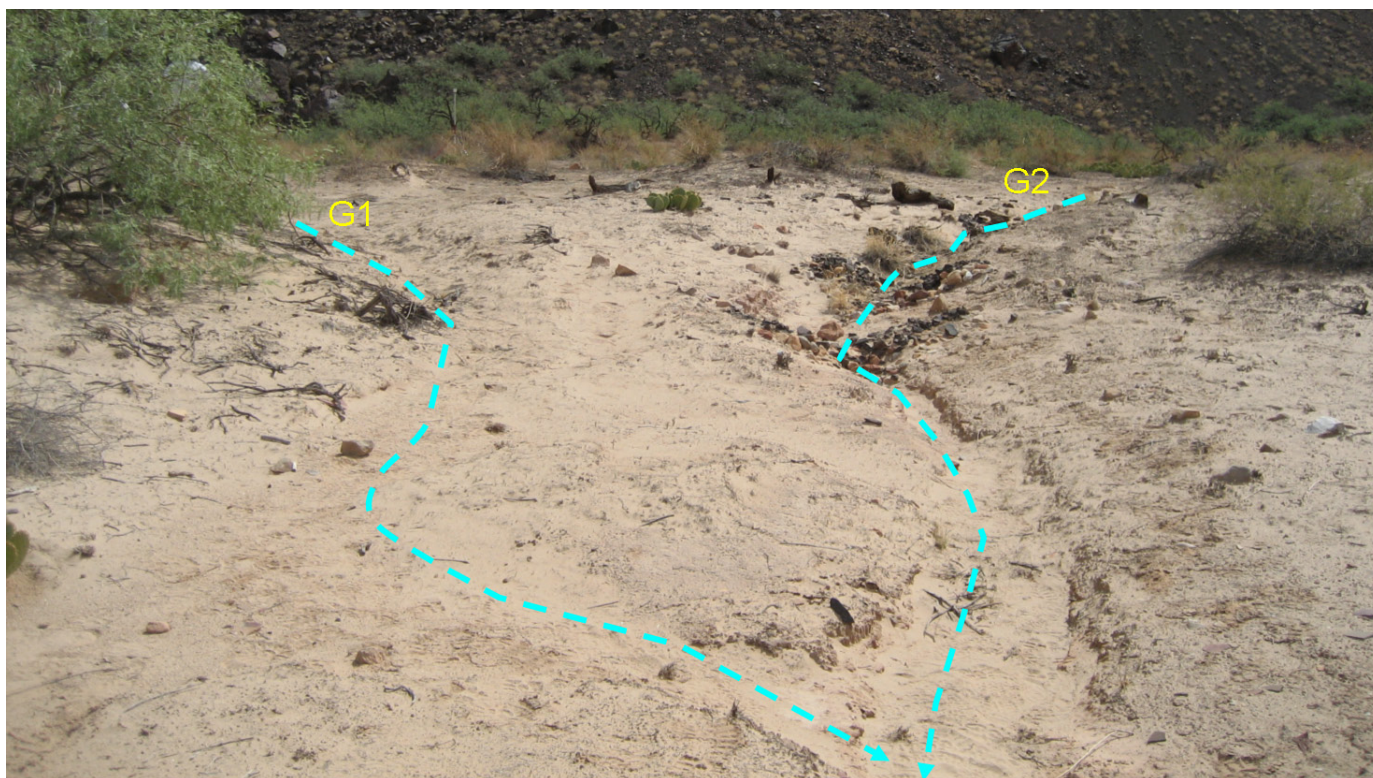
Figure 14. Site AZ:C:13:336 showing confluence of two drainages (dashed lines, G1 and G2) and rock check dam structures in the upper area of the site.

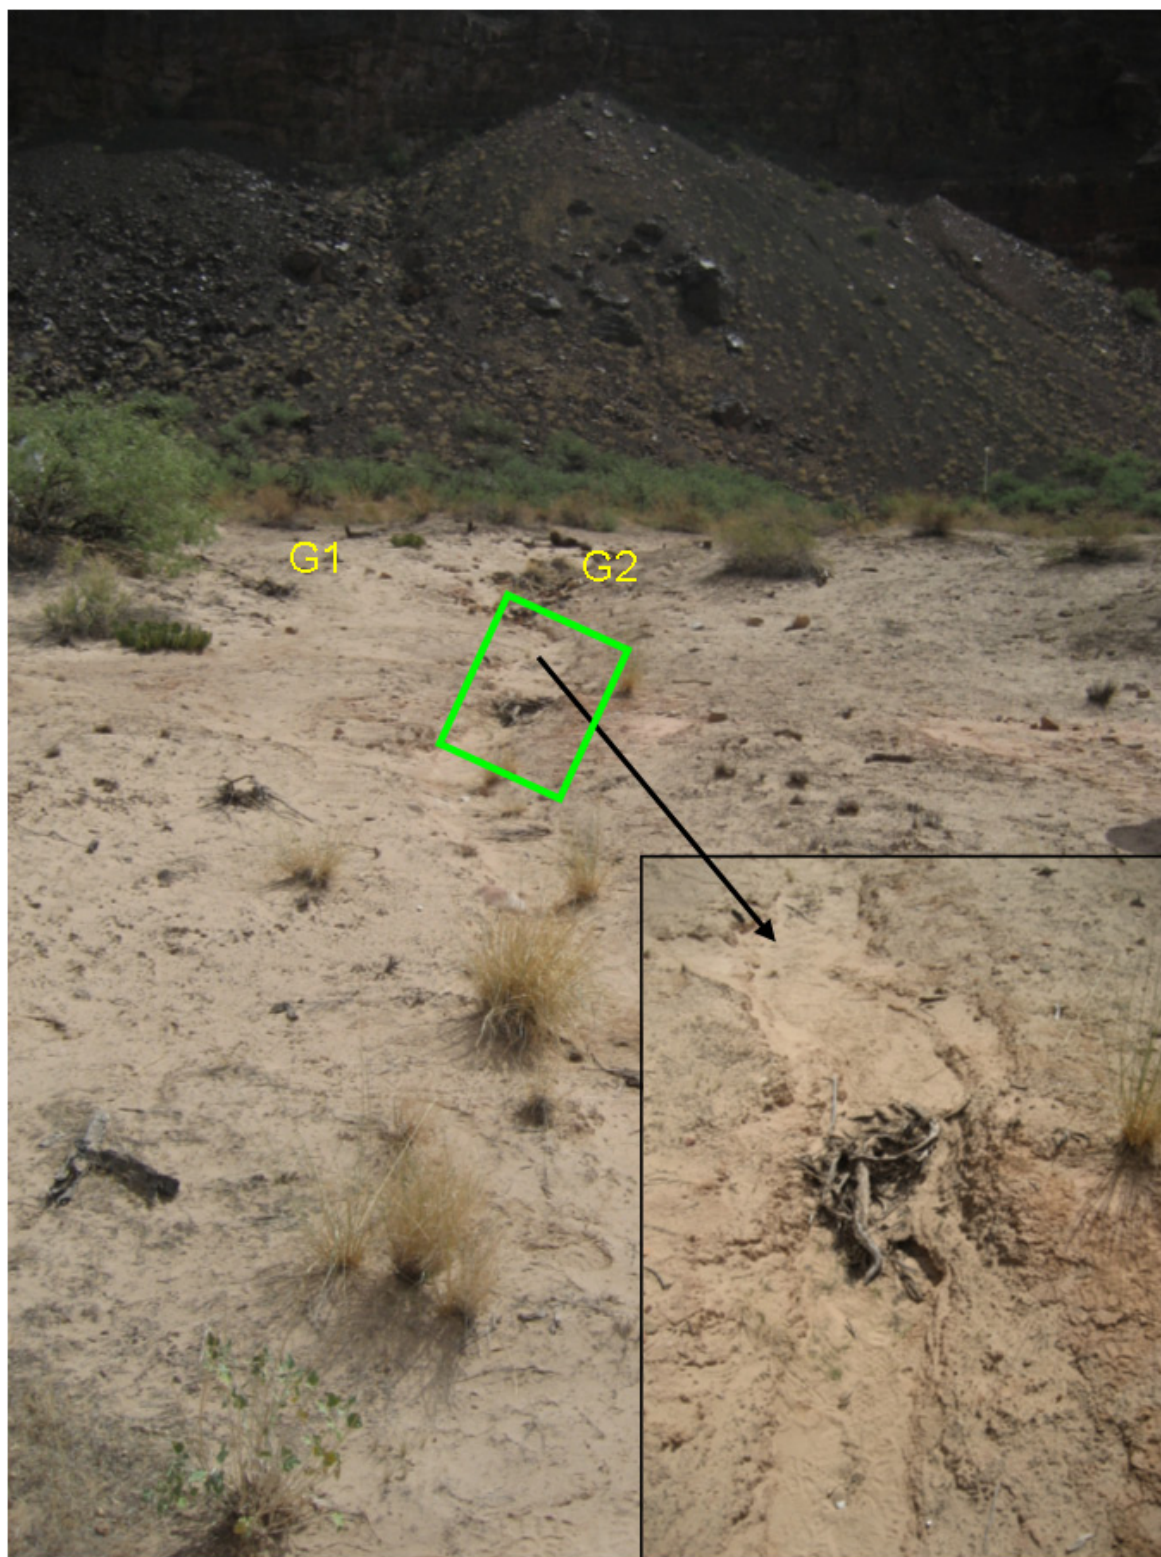
Figure 17. Site AZ:C:13:336—Photos of G2 depositional area (rectangle) in September 2007. Note brush check dam located immediately below area of deposition.

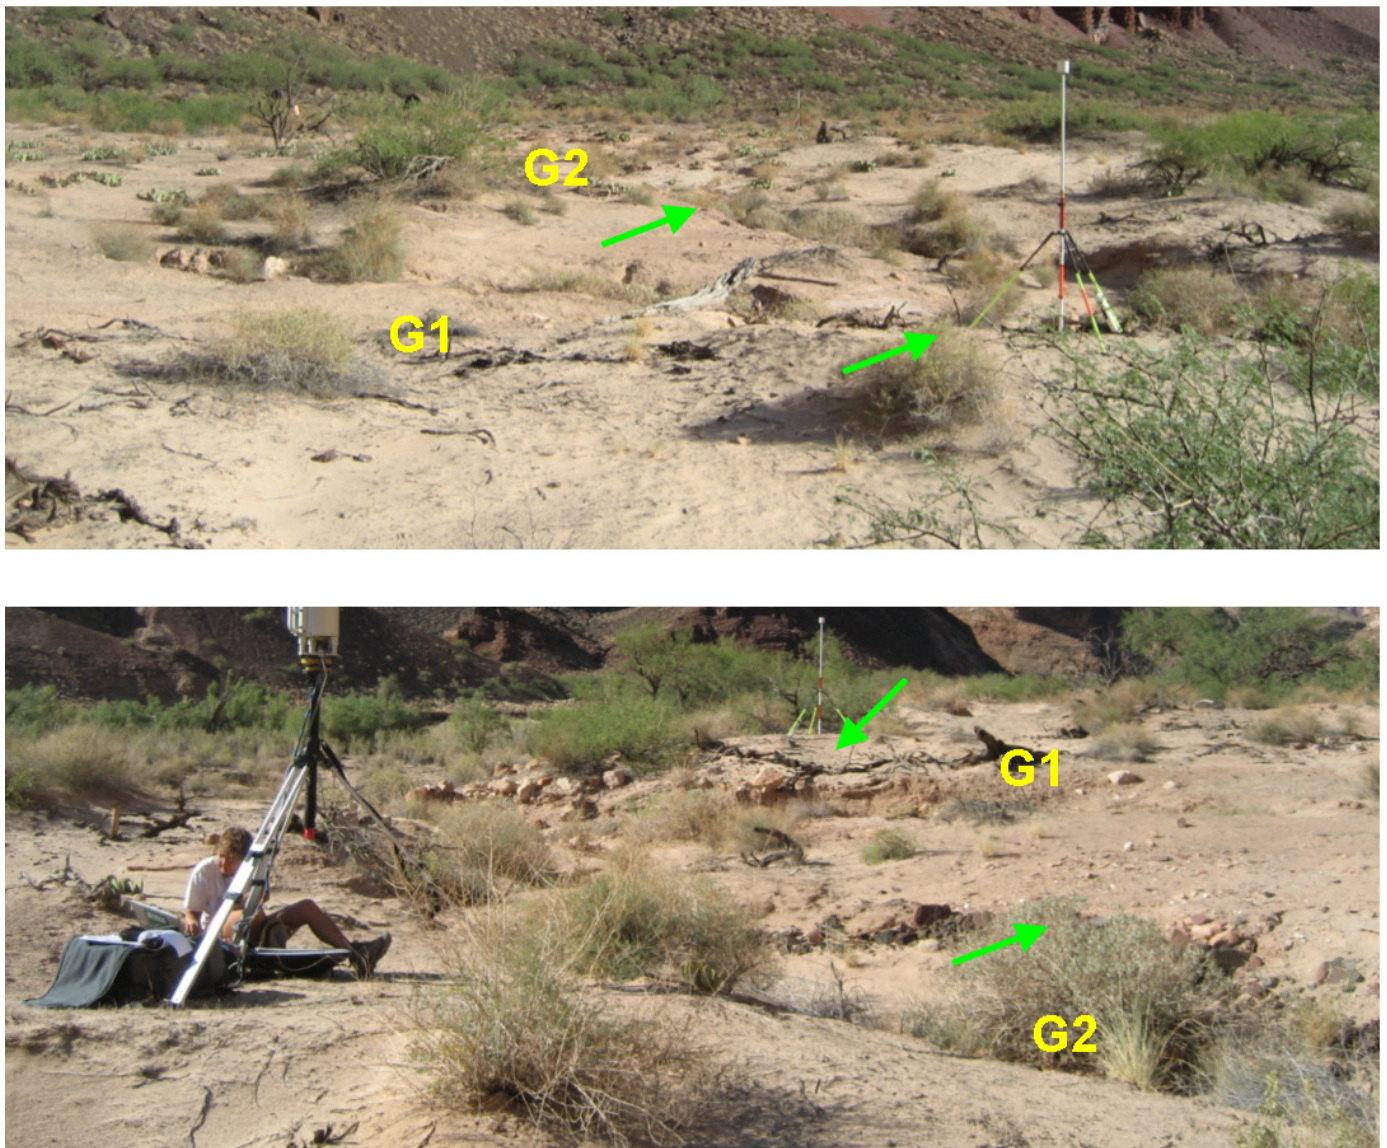
Figure 22. Site AZ:C:13:099—Site overview images showing locations of as much as 20 cm measured erosion (arrows) and location of gullies (G1 and G2).

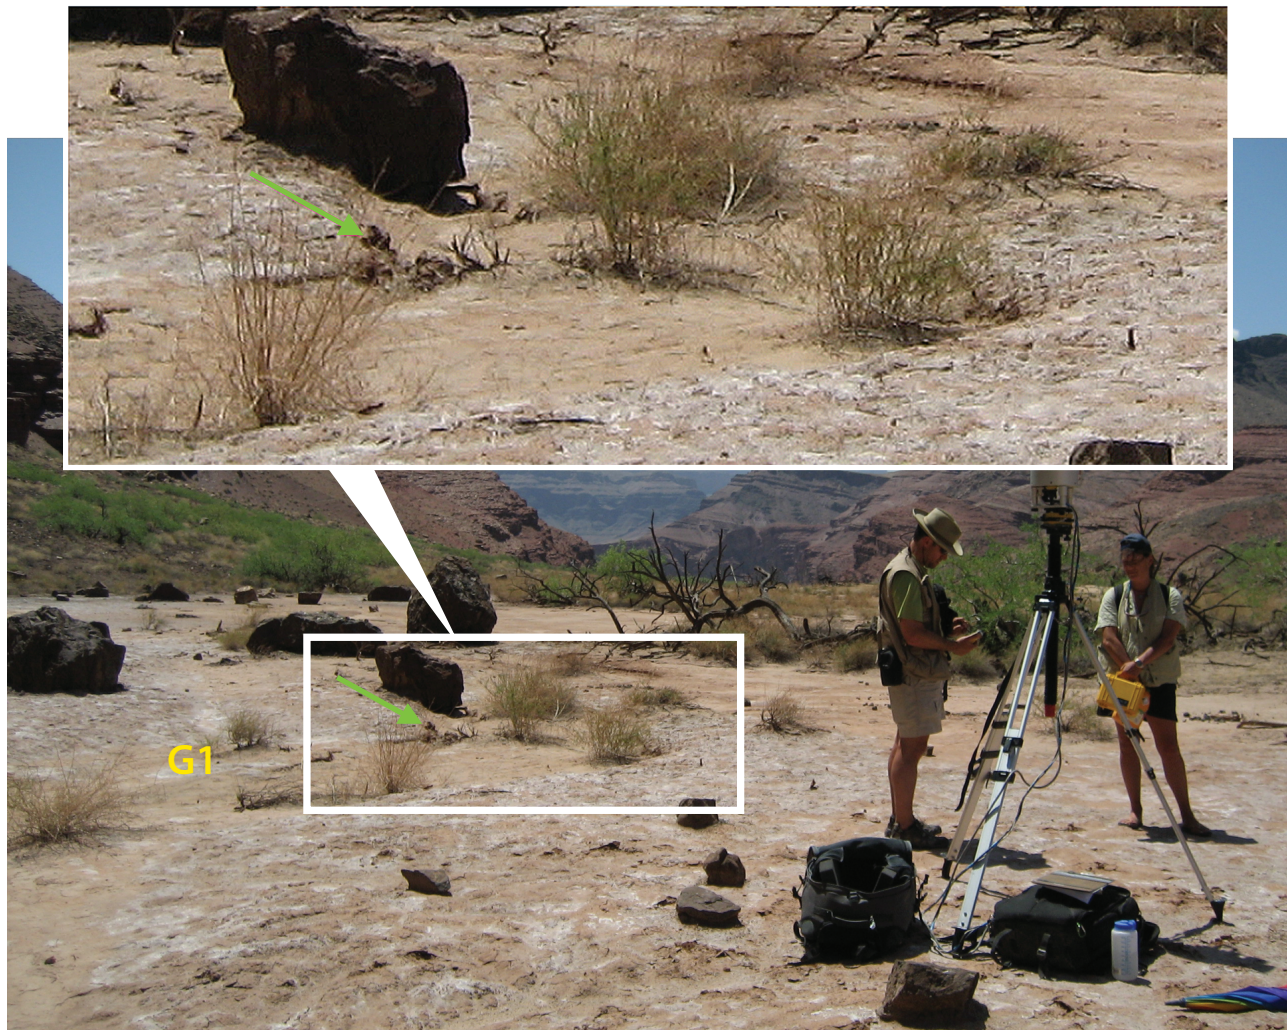
Figure 26. Site AZ:C:13:099 playa area—Image and inset showing area of as much as 12 cm measured erosion (arrows) and location of major gully (G1).

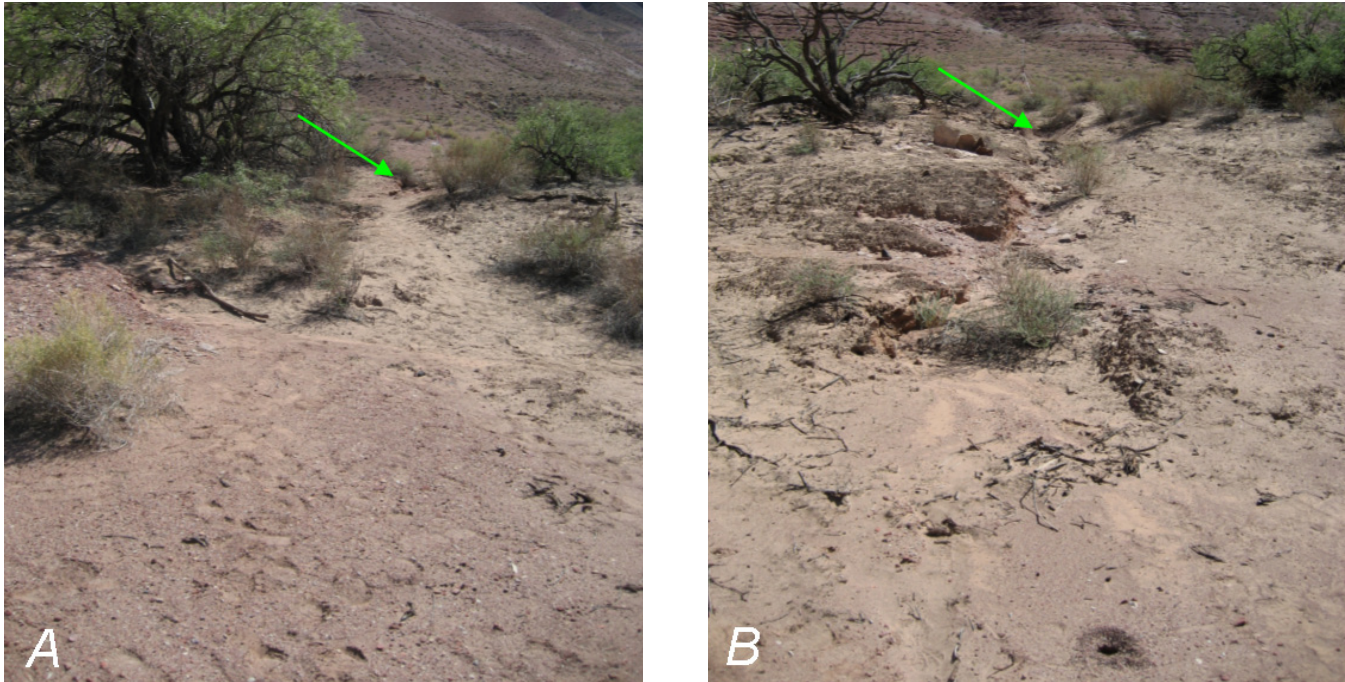
available, photos from September 2007 indicate the likelihood of erosion in these areas (fig. 31). However, given the small footprint of the areas and the proximity of the detected change to the error bound estimates, we were not able to definitely identify these as erosion areas. We identify them here as possible locations for future monitoring. If erosion is occurring, we propose it is caused either by surface-water sediment transport or trailing from the use of these gullies as access routes by archeologists and geomorphologists.

Figure 31. Site AZ:C:13:348—Images of (A) gully G1 and (B) gully G2 from September 2007 showing possible locations (arrows) of minor (about 8 cm) erosion.

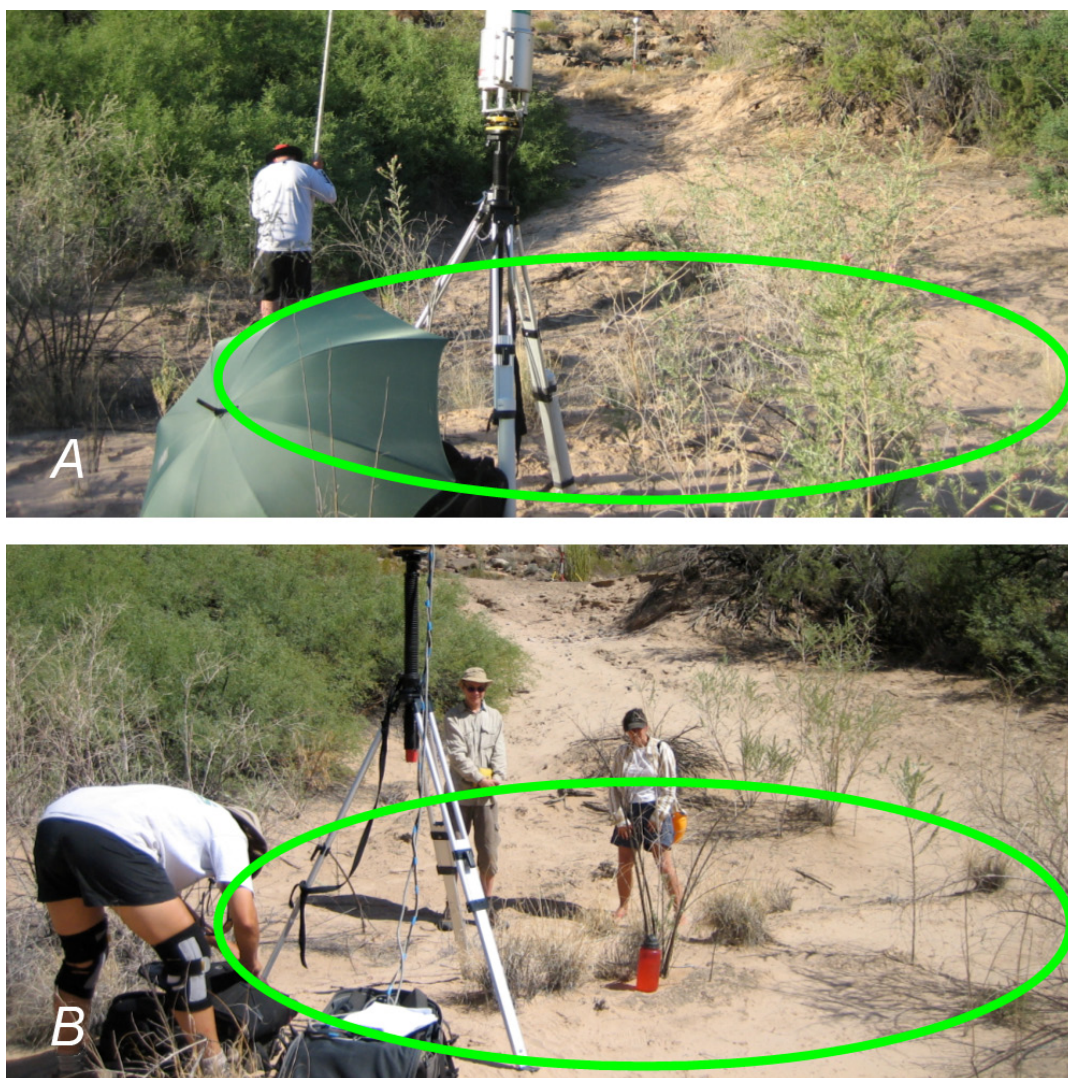
Figure 36. Site AZ:G:03:041—Images of gully G2 bottom slope area from (A) May 2006 and (B) September 2007 showing area of as much as 15 cm deposition (ovals).

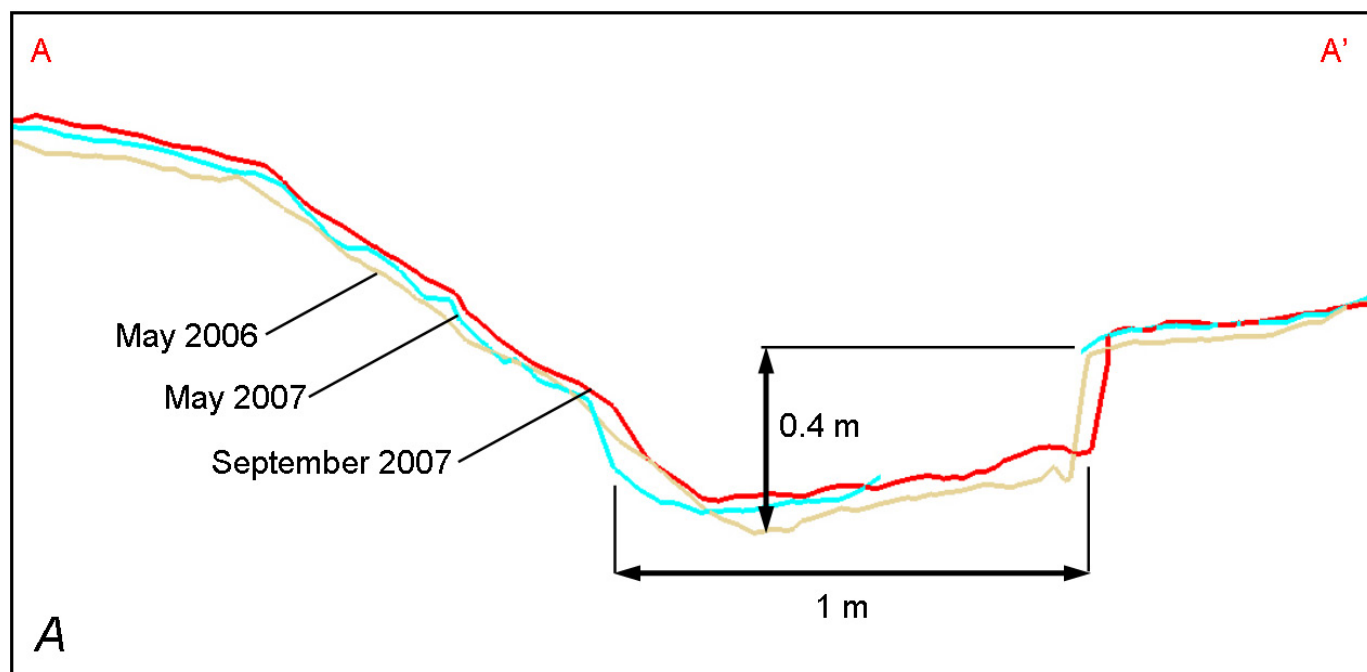
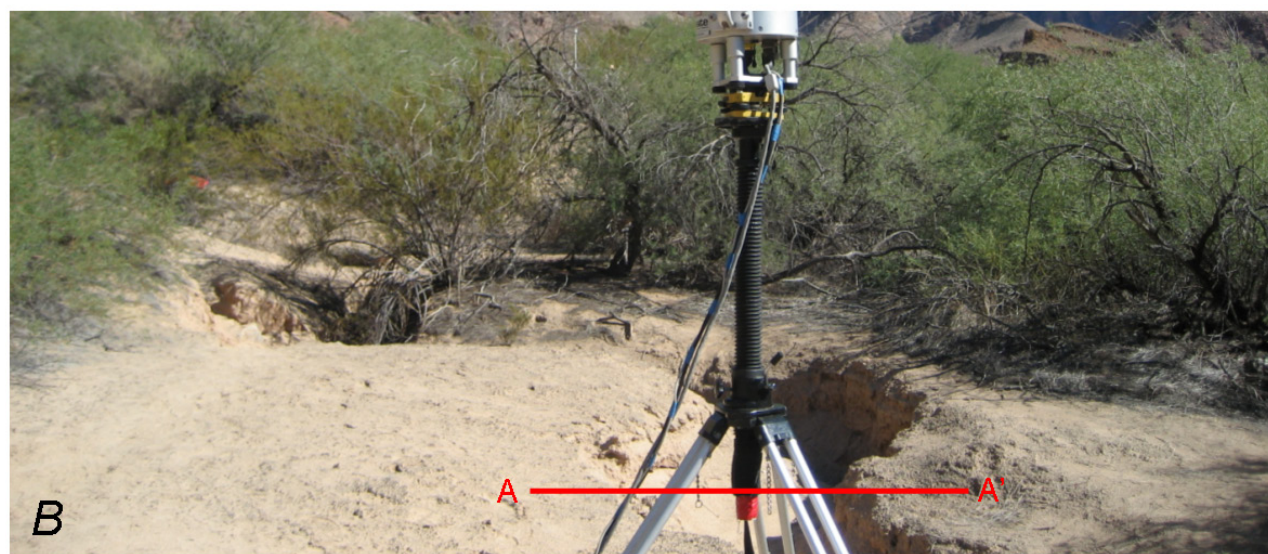
on two sections of the drainage, one in the immediate vicinity of the major gully knickpoint and another in the lowest section as the gully transitions out of the loose sand deposits. One small (<0.5 m²) section in the knickpoint area appears to have undergone very minor channel sidewall slumping and related gully bottom deposition, with as much as 10 cm of erosion and related deposition at the gully bottom. Given poor registration of the May 2007 data in this area, we were not able to determine whether this change occurred before or after this time. In the lower transition area, all measured change was within the error bounds (fig. 41). Given the difficulties associated with the data collection in such narrow confines, this area may not be well suited for whole-site monitoring using the presented terrestrial lidar methods. Instead, future surveys should focus on specific sections of the gully, with longer range scanner setup vantage points.

Figure 41. Site AZ:G:03:002—A, Cross-section analysis of lower G1 area from manual filtered point data. Average vertical distance between all sections is less than the error range (± 8 cm). B, Image showing cross-section location and narrow confines of this area.

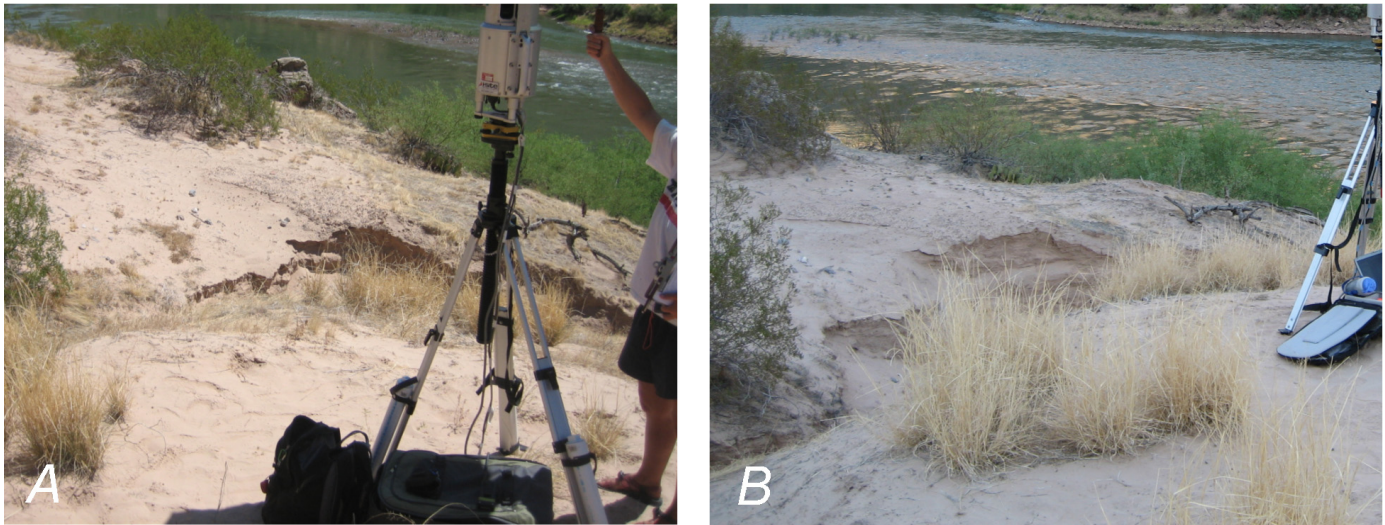
Figure 46. Site AZ:G:03:072 US—Photo comparison of G3 erosional area between (A) May 2006 and (B) May 2007.

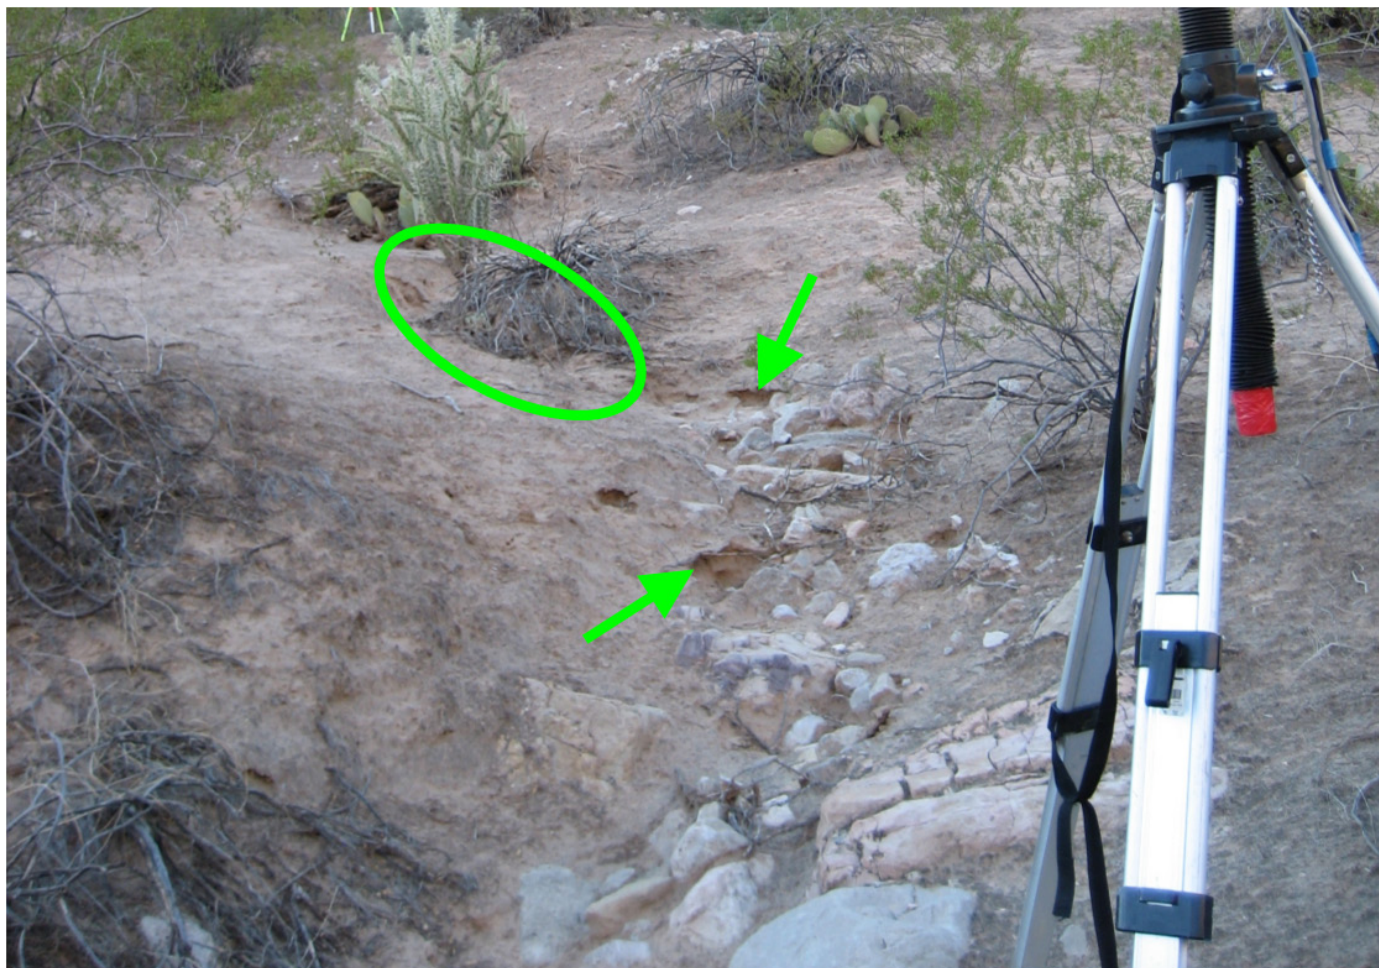
Figure 50. Site AZ:G:03:072 US—Photo of G1 erosional area (oval) in September 2007. Additional erosion lower in the gully (arrows) likely occurred but was within the error bounds of the data (change less than 8 cm) and therefore not detected in the comparison.

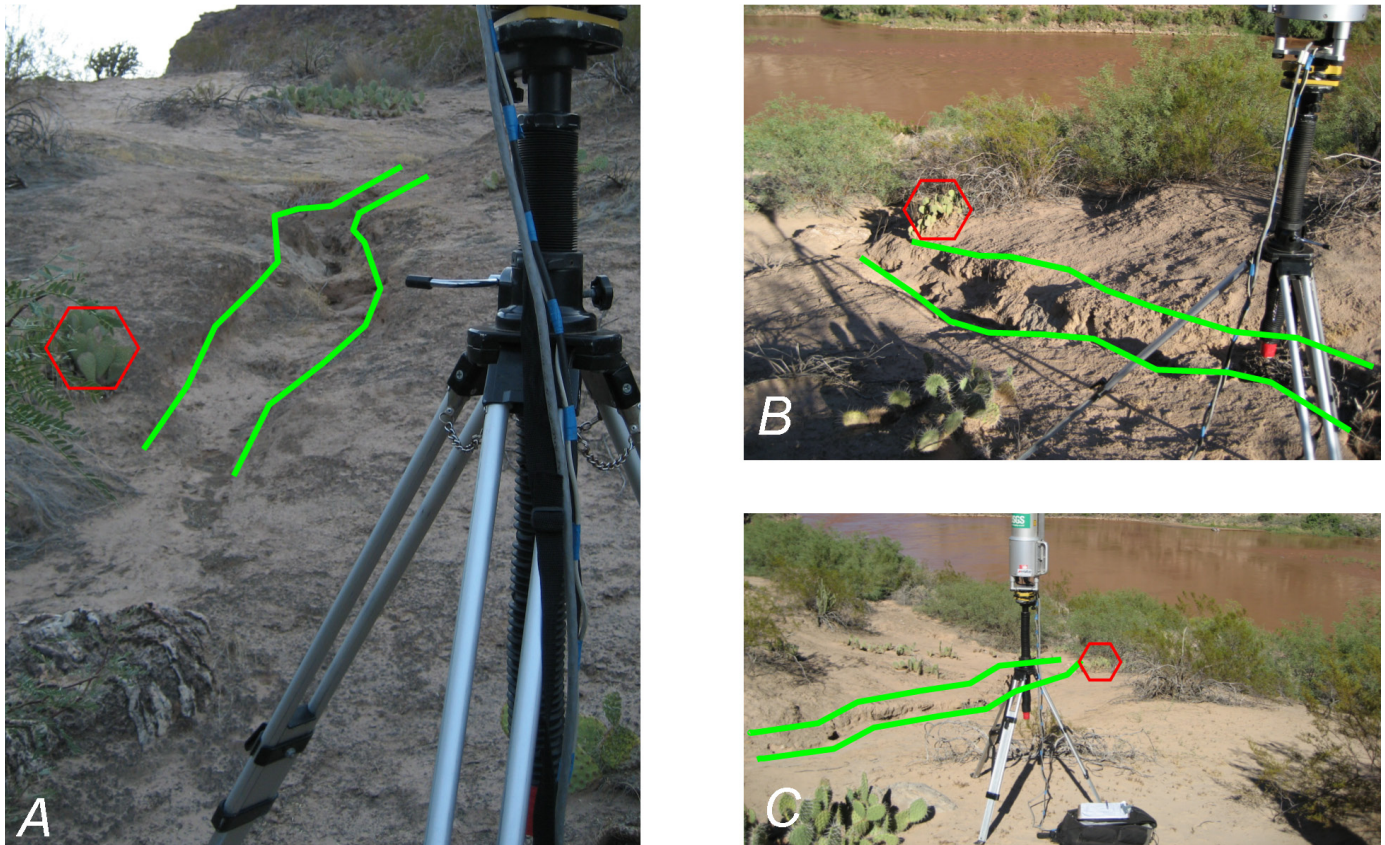
Figure 51. Site AZ:G:03:072 US—Photo comparison of G2 erosional area (parallel lines) between (A) May 2007 looking updrainage and (B and C) September 2007 looking downdrainage. Identical prickly pear cactus (hexagon) is highlighted in all photos for orientation.

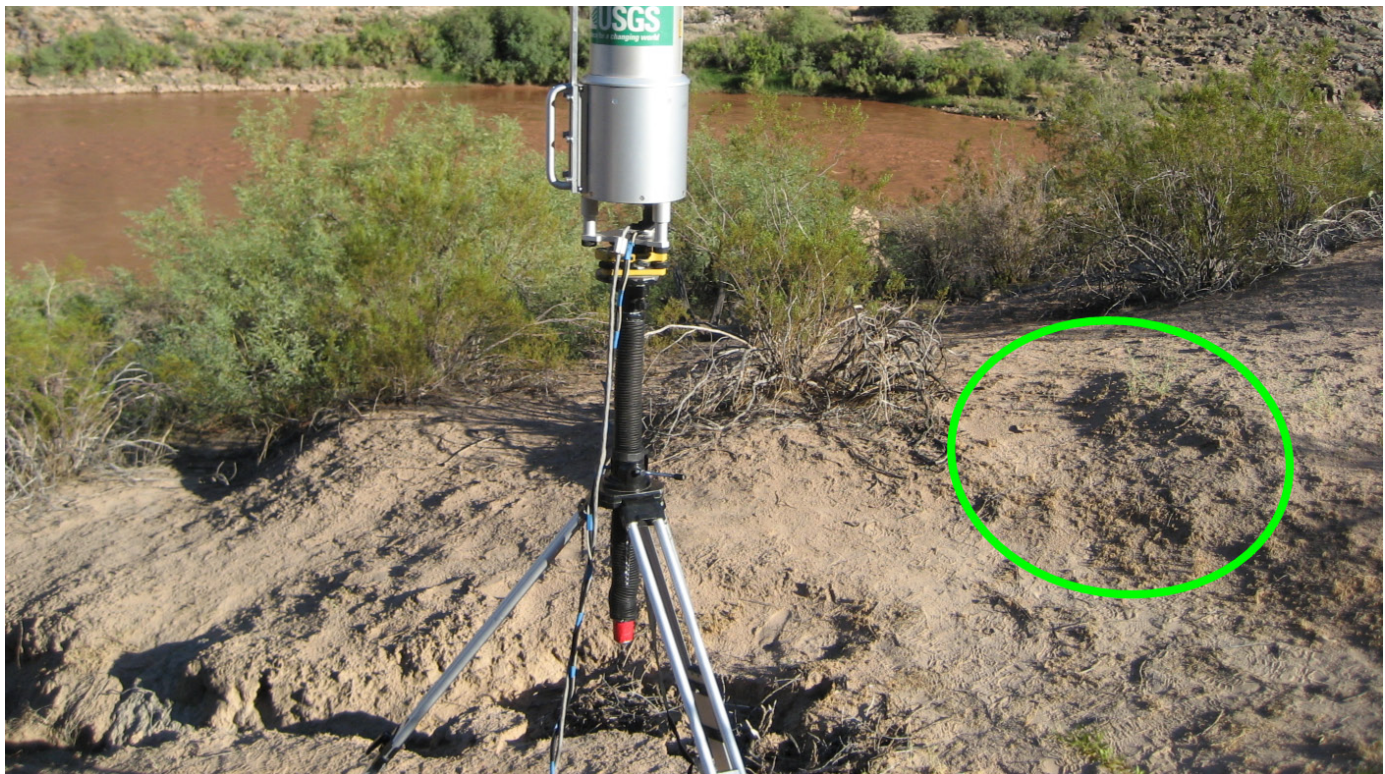
Figure 52. Site AZ:G:03:072 US—Photo of G2 slope erosional area (oval) in September 2007.

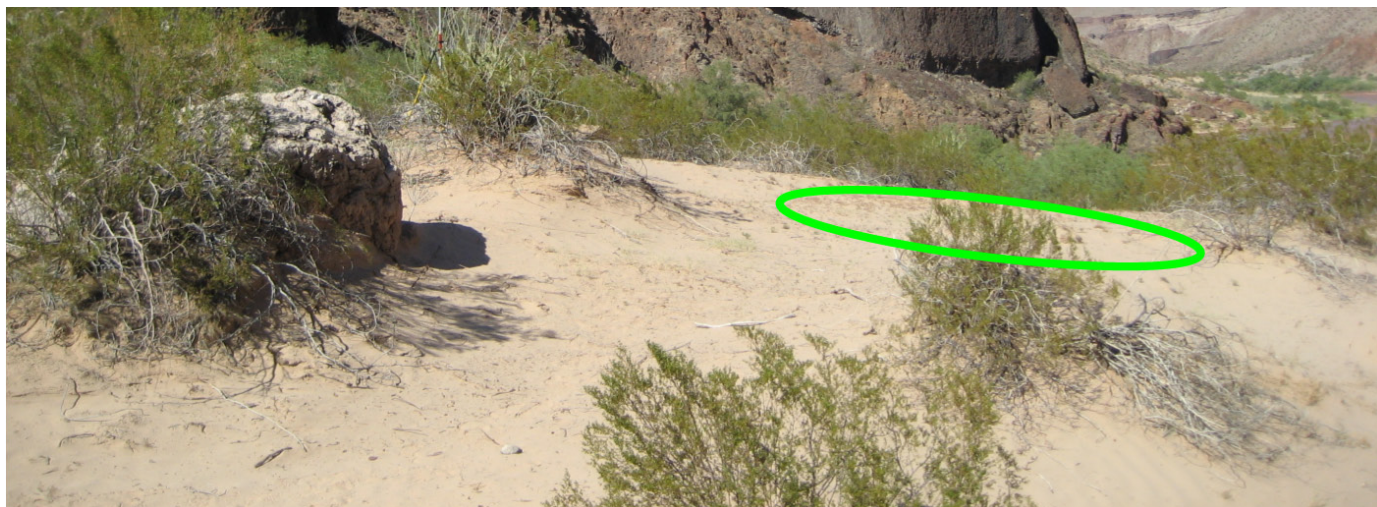
Figure 53. Site AZ:G:03:072 US—Photo of G1 dune erosional area (oval) in September 2007.
