Topographic Change Detection at Select Archeological Sites in Grand Canyon National Park, Arizona, 2006–2007

Scientific Investigations Report 2009-5116

Brian D. Collins, Diane Minasian, and Robert Kayen

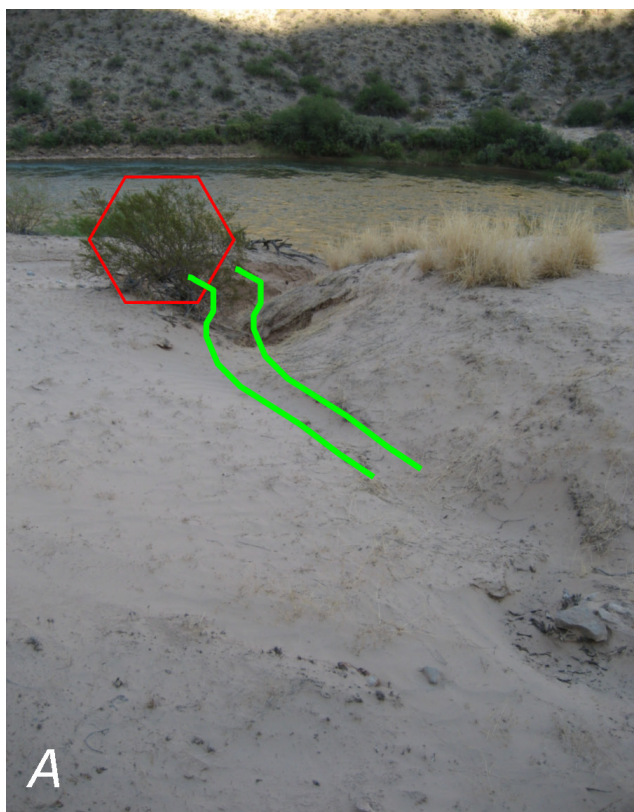
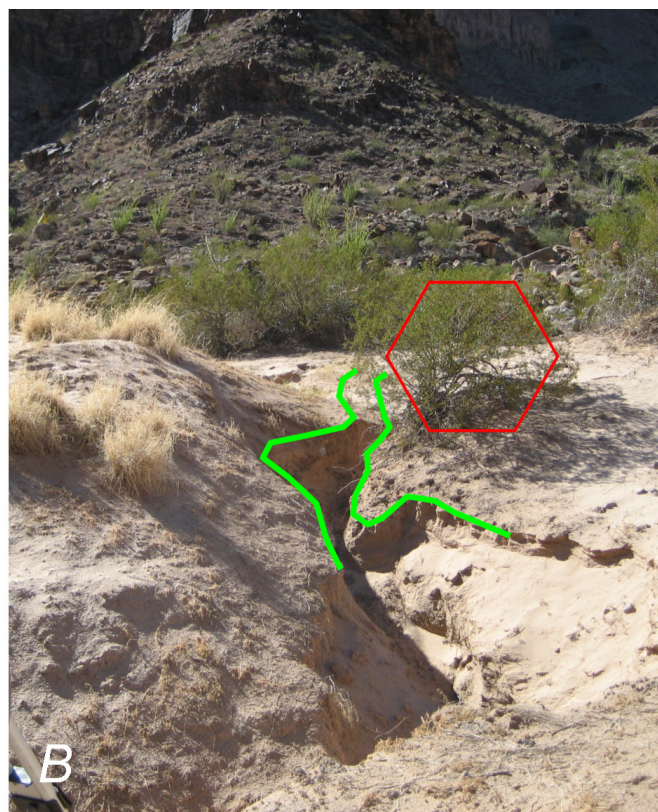
Figure 54. Site AZ:G:03:072 US—Photo comparison of G3 erosional area (parallel lines) between (A) May 2007 looking downdrainage and (B) September 2007 looking updrainage. Small creosote bush (hexagon) is highlighted in both photos for orientation.
