Hydrologic Conditions that Influence Streamflow Losses in a Karst Region of the Upper Peace River, Polk County, Florida

By P.A. Metz and B.R. Lewelling

Scientific Investigations Report 2009–5140

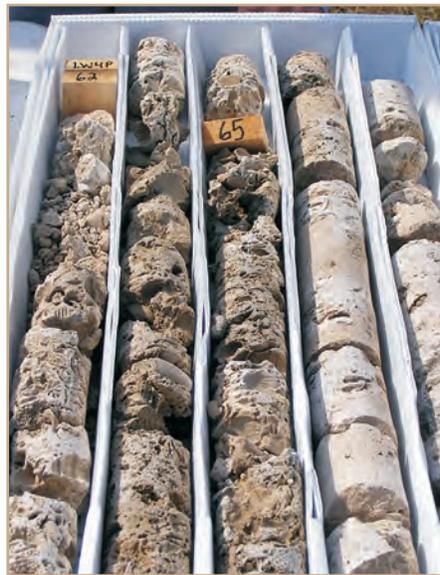
Geologic core samples.

Overlying the Ocala Limestone is the Suwannee Limestone, which in cores was composed of highly weathered, friable limestone and dolostone that was poorly consolidated, calcareous and chalky, and contained some clay stringers and numerous fossils at varying depths. A majority of the limestone identified in the Suwannee Limestone was rich in calcareous mud and was identified as mudstone and wackestone. The average thickness of the Suwannee Limestone, based on the three cores, was about 130 ft.

underlying Suwannee Limestone. The Hawthorn Group is exposed at places along the streambed and is in direct connection with the river. The cores that penetrated the Hawthorn Group are described as sequences of weathered dolomite that is fractured and contains pinpoint vugs, voids, and numerous fossils casts and molds that aid in the development of secondary porosity within this unit. Interspersed within the Hawthorn Group are sequences of stiff clays, sands, phosphate pebbles and grains, and thin layers of weathered limestone.

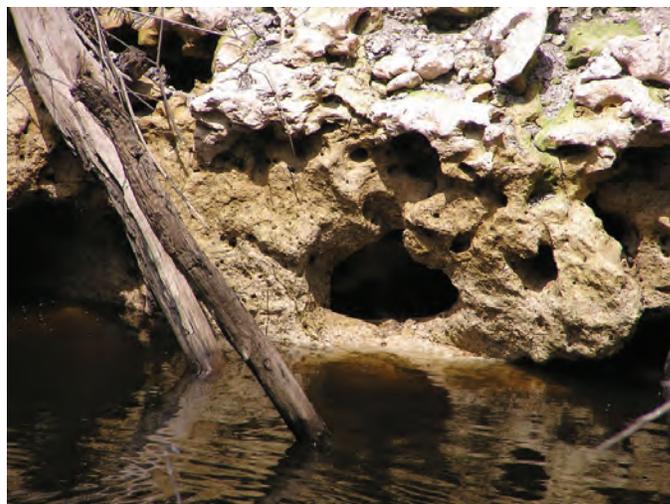
Figure 14. Secondary porosity of the Arcadia Formation within the intermediate aquifer system (Gator Sink). Photo credit: P.A. Metz, USGS

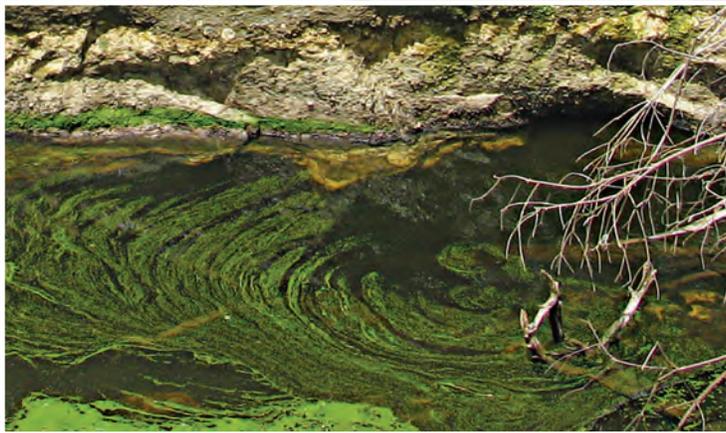
Gator Sink—A strong current of flow enters the western wall of the sinkhole; note the movement of duck weed on the water surface from the inflow (above).

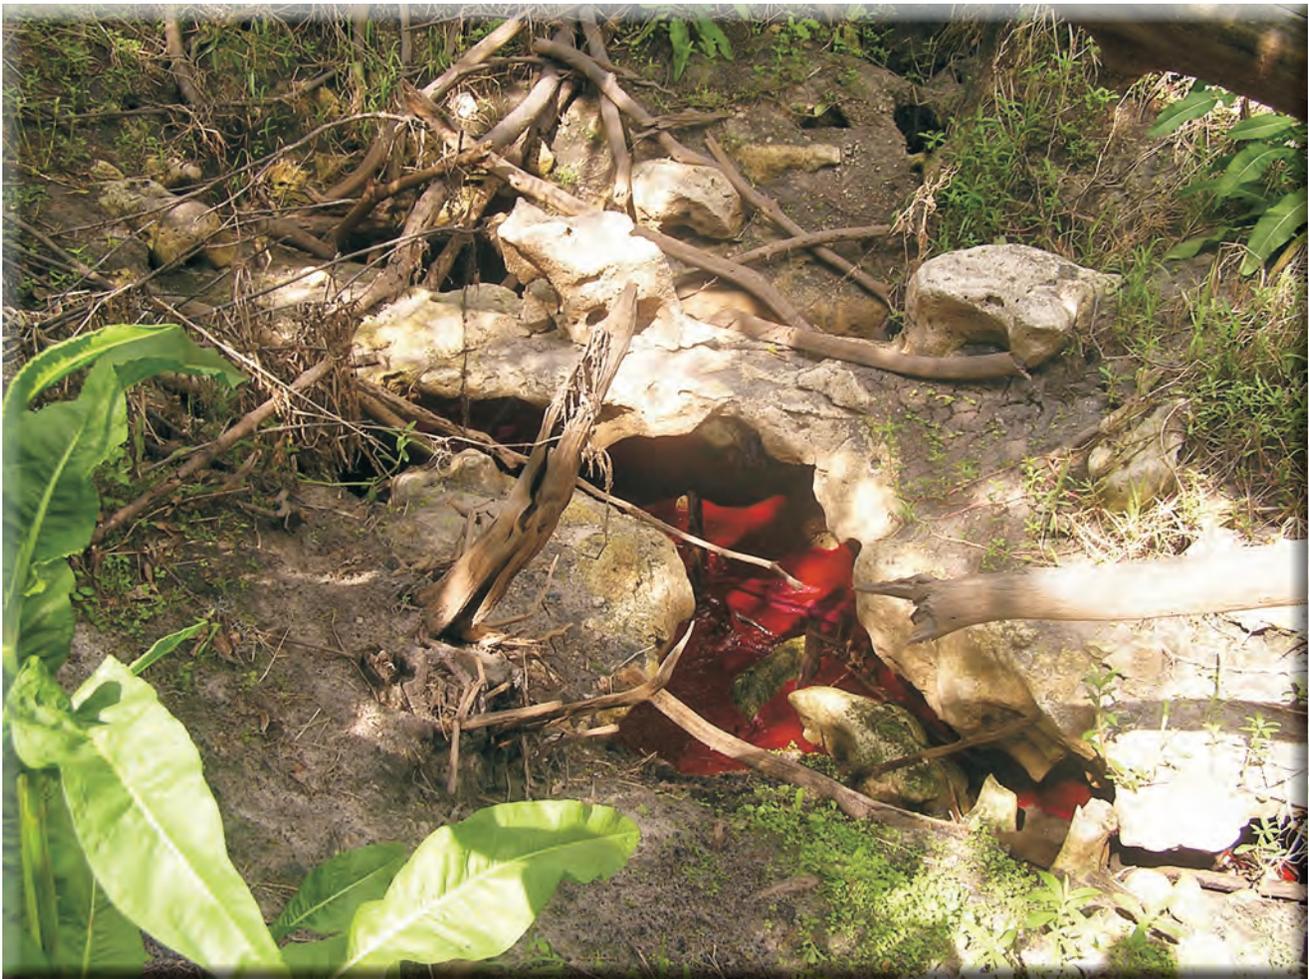
Rhodamine dye, as seen through a karst window (Catacombs No. 1). Photo credit: P.A. Metz, USGS

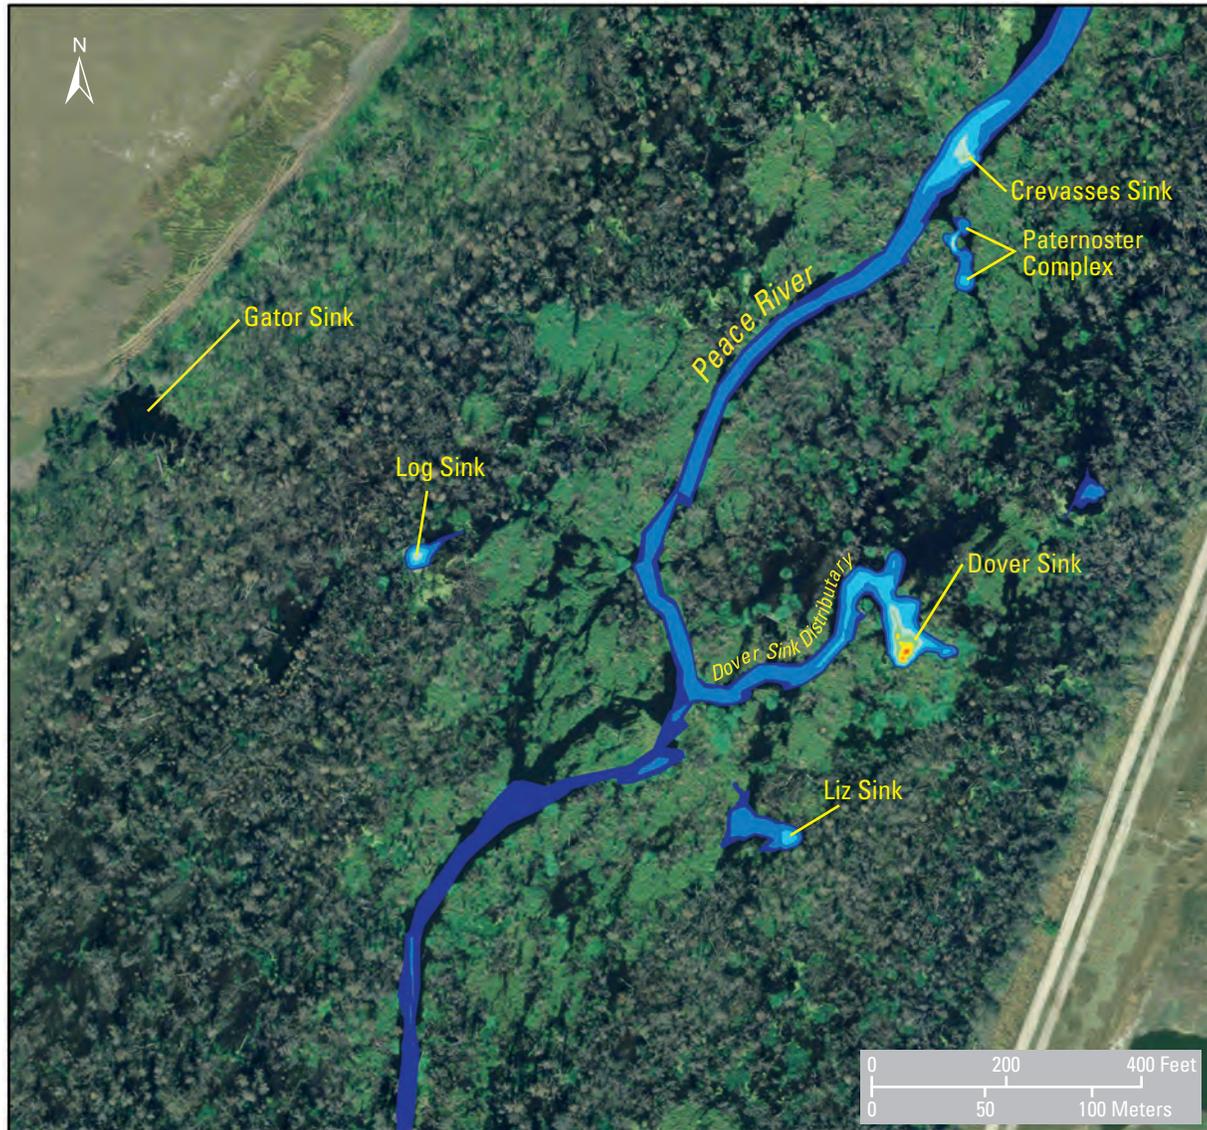
Figure 40. (A) Elevation of sinks and riverbed channel along the lower end of Reach 2, and (B) detailed view of Dover Sink.

Dover Sink, located in the eastern floodplain about 0.6 mi upstream from the Clear Springs gaging station (fig. 36, site 10), had the largest streamflow losses of all the karst features along the upper Peace River. Flow from the Peace River has eroded an approximate 500-ft-long distributary channel to Dover Sink (fig. 40A, 41D). The dimensions of Dover Sink are about 55 by 91 ft, and the size is continuously changing because of depositional and erosional processes. The bottom elevation of Dover Sink is presently about 13 ft below the elevation of the confluence of the Peace River and the distributary channel (fig. 40B). This steep elevation change allows large volumes of water to drain into the sink. At the bottom of the sink, the flow moves through a horizontal erosional crack in the wall of the Arcadia Formation.

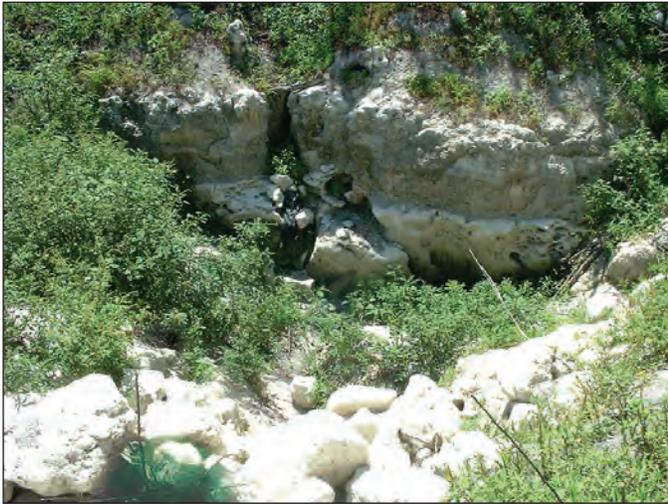
(A) Exposed rocks, 2002

Dover Sink exhibited the most structural changes of all the karst features observed during the period of investigation. The series of photographs in figure 41 shows Dover Sink over a range of hydrologic conditions. At the beginning of the study in 2002, the Dover Sink Distributary channel was mostly a sand-filled waterway with small remnant lenses of the Bone Valley Formation exposed in the distributary channel and exposed rocks of the Arcadia Formation in the main sink (fig. 41A). After the hurricanes in 2004 and high-water period in 2005, sediment accumulated in Dover Sink and covered much of the exposed rock (fig. 41B). Intermittent flows during 2006-2007 caused greater flow velocities in the distributary channel that washed away overlying sediments, exposing large limestone boulders of the Arcadia Formation (fig. 41C). This erosional exposure created a cascading waterfall effect at the approach to Dover Sink (fig. 41D). As a result of several high-water events at the end of the 2007 water year, sediment again accumulated and covered some of the exposed rocks (fig. 41E). The photograph in figure 41F shows Dover Sink in a ponded condition after the interconnected karst aquifer system was replenished.

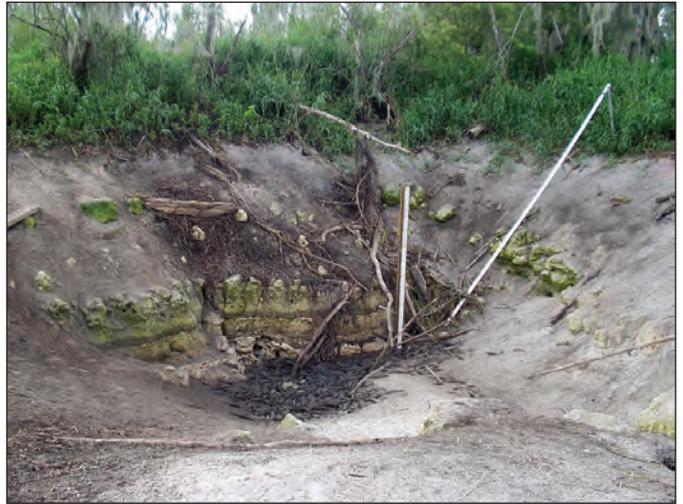
(B) Sediment and fish accumulation, 2006

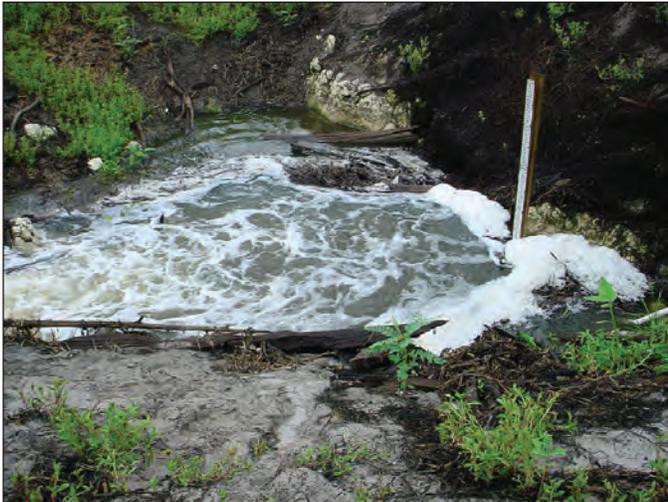
(C) Storm event at Dover Sink, 2006

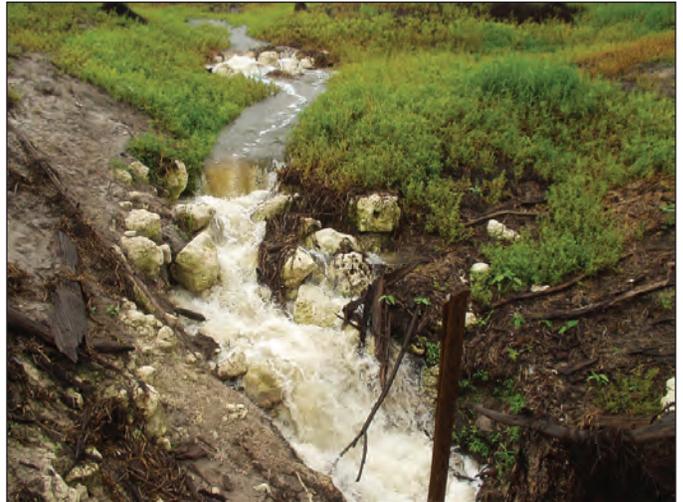
(D) Continued scouring of Dover Sink Distributary channel, 2007

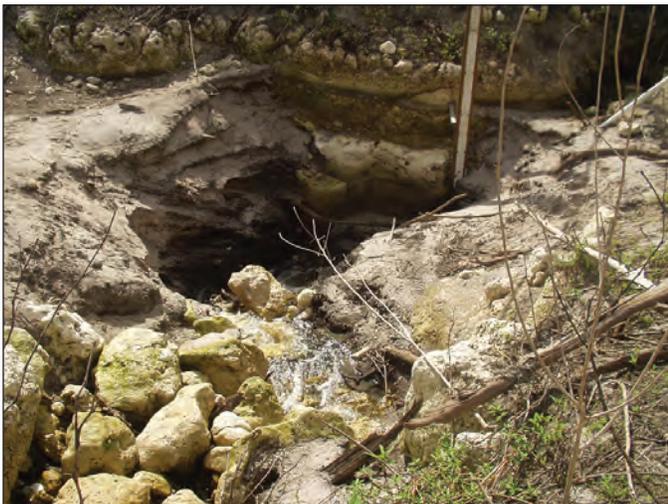
(E) Infilling and scouring at Dover Sink, 2008

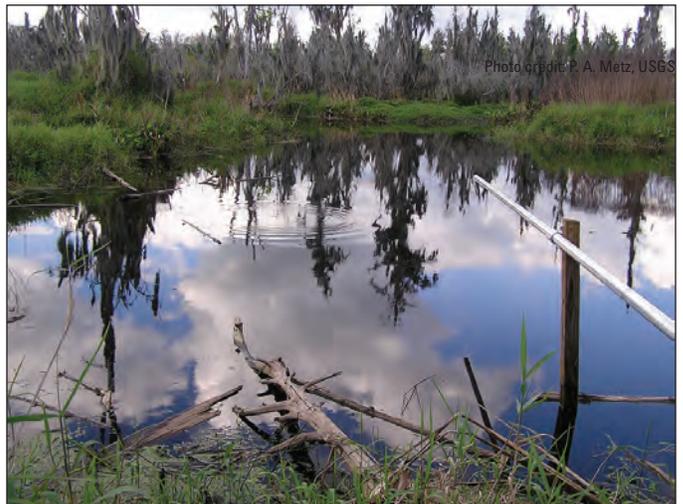
(F) Dover Sink ponded, 2008

Figure 41. Changing hydrologic conditions at Dover Sink.

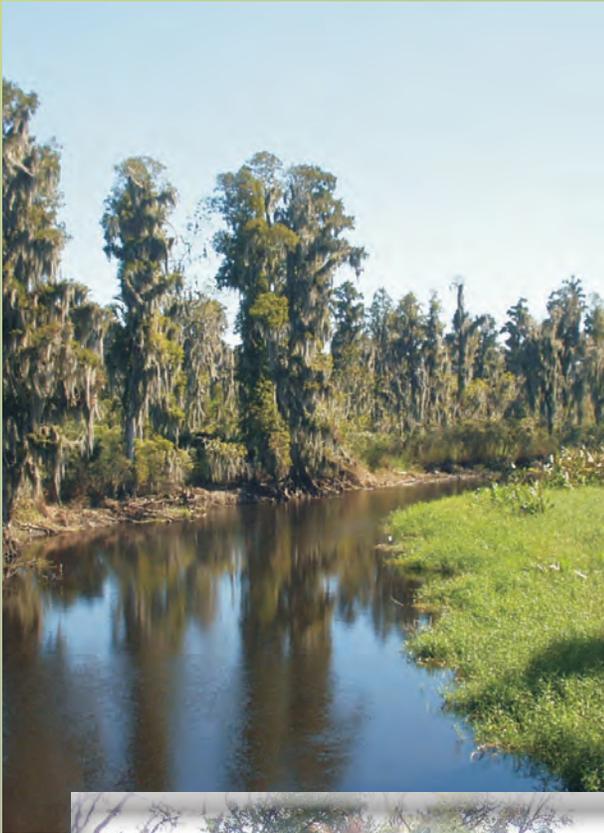
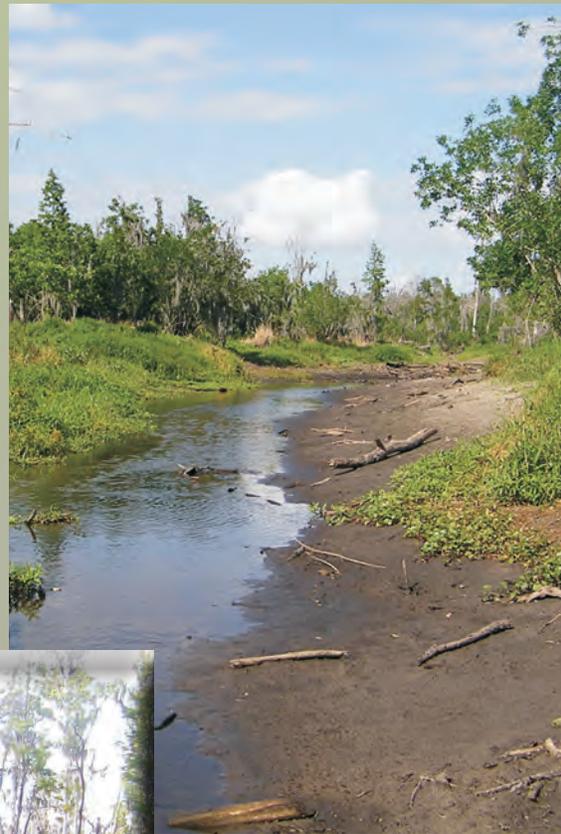
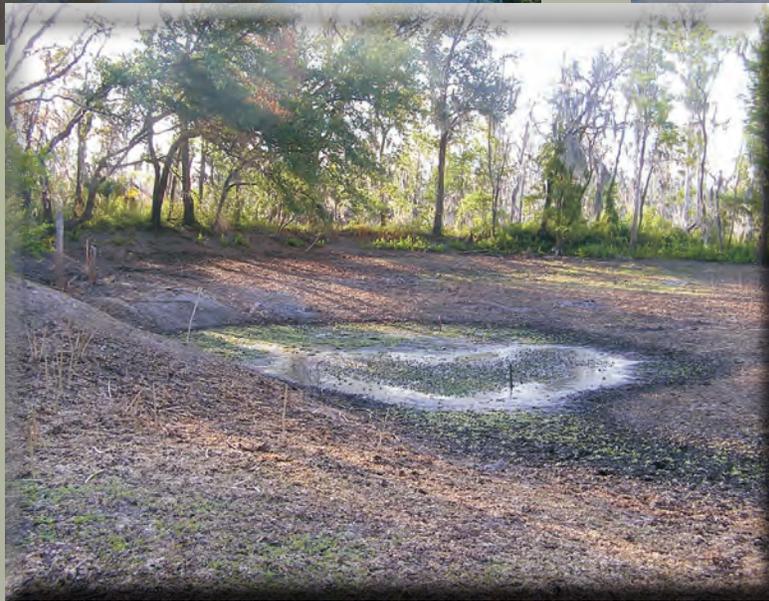
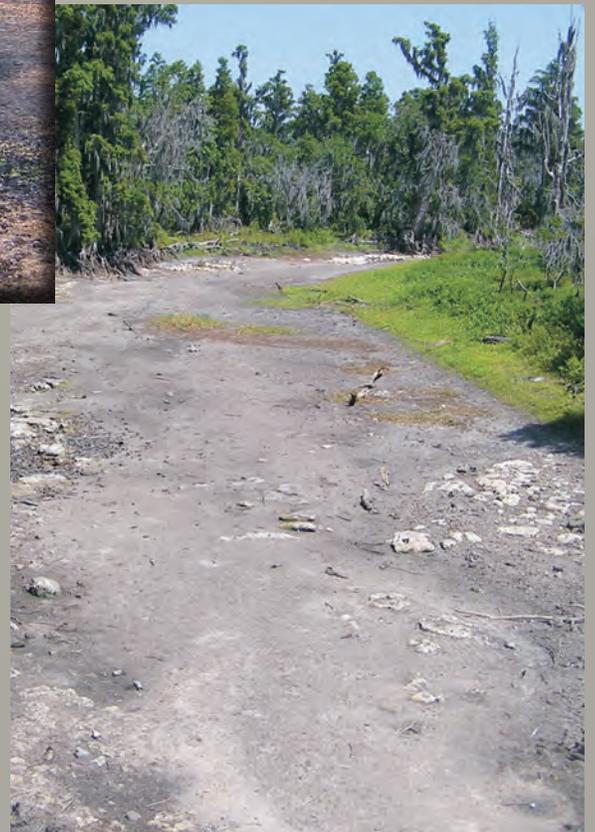
River and spring flow are influenced by groundwater conditions. Stages of riverflow, from flowing to dry (top and bottom); and mud puddle at inactive Kissengen Spring (center). Photo credit: P.A. Metz, USGS
