Geomorphology and River Dynamics of the Lower Copper River, Alaska

Scientific Investigations Report 2009–5257

Prepared in cooperation with the Alaska Department of Transportation and Public Facilities under Project: COPPER RIVER HWY MP 27-49 HYDROLOGY STUDY—AKSAS 61959

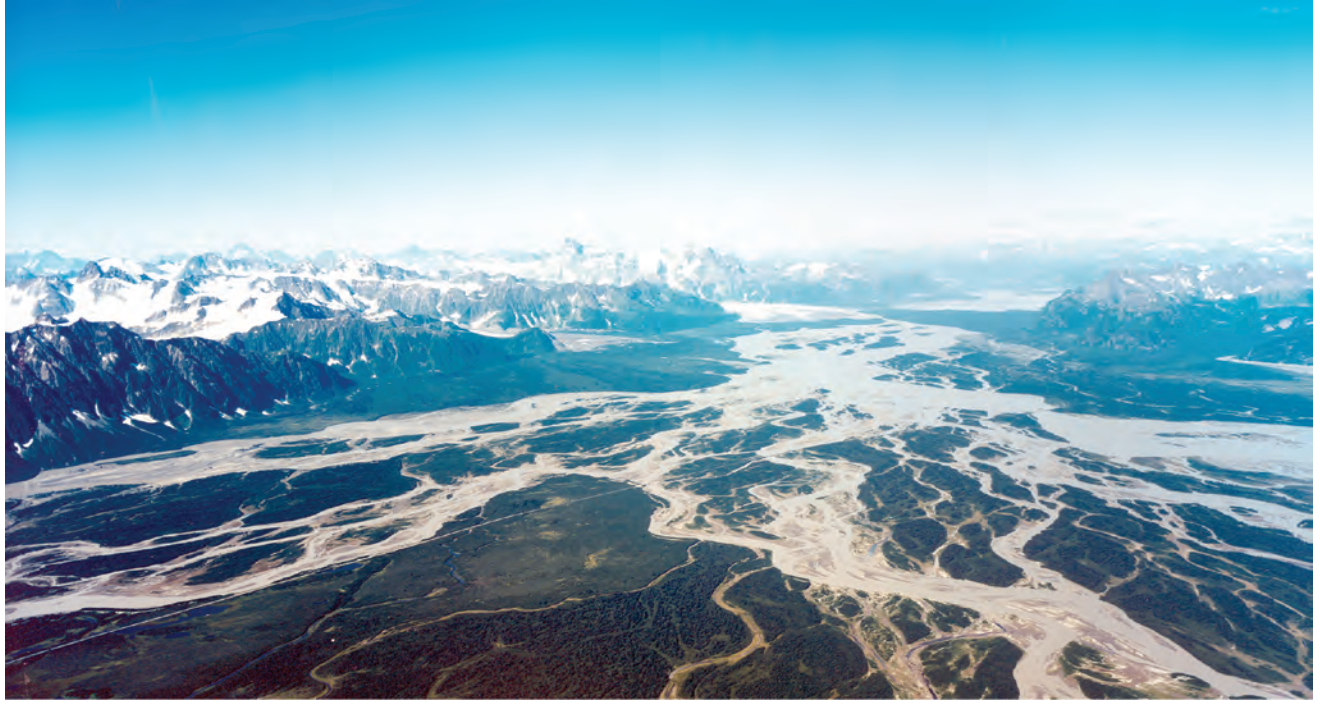
Figure 2. Lower Copper River, Alaska. (Photograph taken by AeroMetric, August 11, 2007.)

The lower Copper River flows into a large, relatively flat, alluvial plain near its mouth (figs. 1–2). As with many alluvial systems, the banks and streambeds of the lower Copper River are readily erodible and less permanent than most other aspects of the landscape. Many braided channels are formed, depending on the quantity and type of available sediment and the quantity and variability of discharge. The pattern of flow of

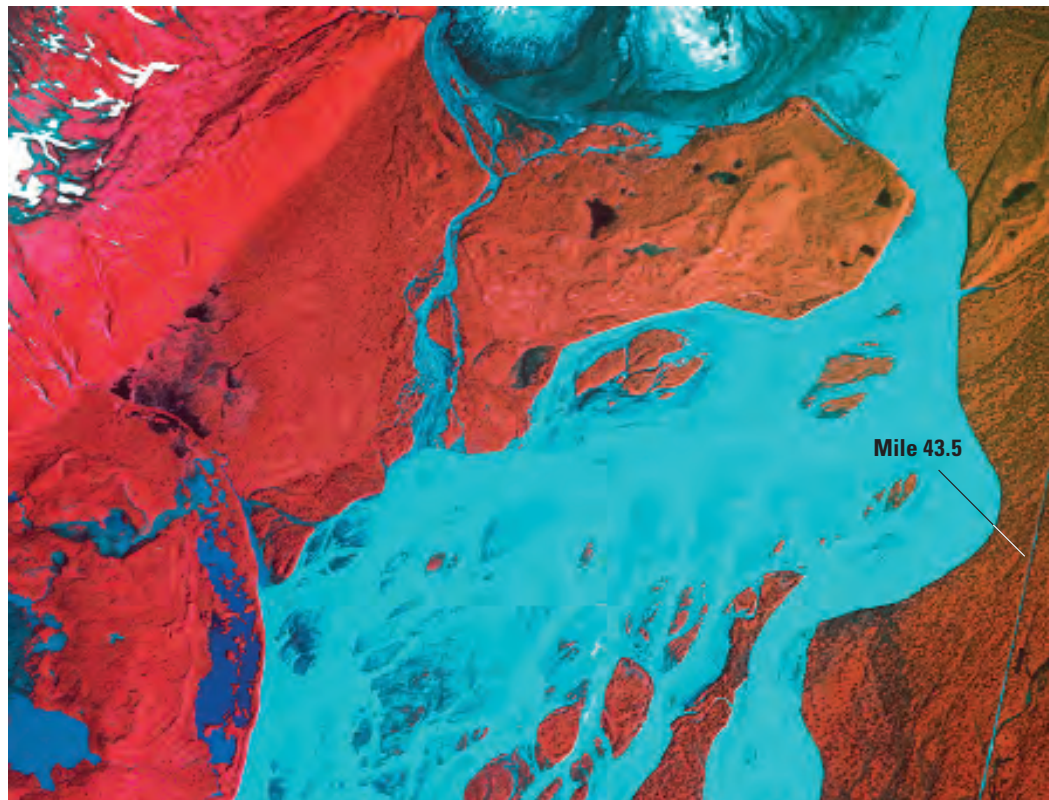
B. 1996

Photograph taken by U.S. Geological Survey, Earth Research Observation and Science (EROS) Center, July 16, 1996.

Analysis of aerial photography from 1991, 1996, 2002, 2006, and 2007 indicates the eastward migration of a channel of the Copper River that has resulted in damage to the Copper River Highway near Mile 43.5. Migration of another channel in the flood plain has resulted in damage to the approach of Bridge 339. As a verification of channel change, flow measurements were made at bridges along the Copper River Highway in 2005–07. Analysis of the flow measurements indicate that the total flow of the Copper River has shifted from approximately 50 percent passing through the bridges at Mile 27, near the western edge of the flood plain, and 50 percent passing through the bridges at Mile 36–37 to approximately 5 percent passing through the bridges at Mile 27 and 95 percent through the bridges at Mile 36–37 during average flow periods.

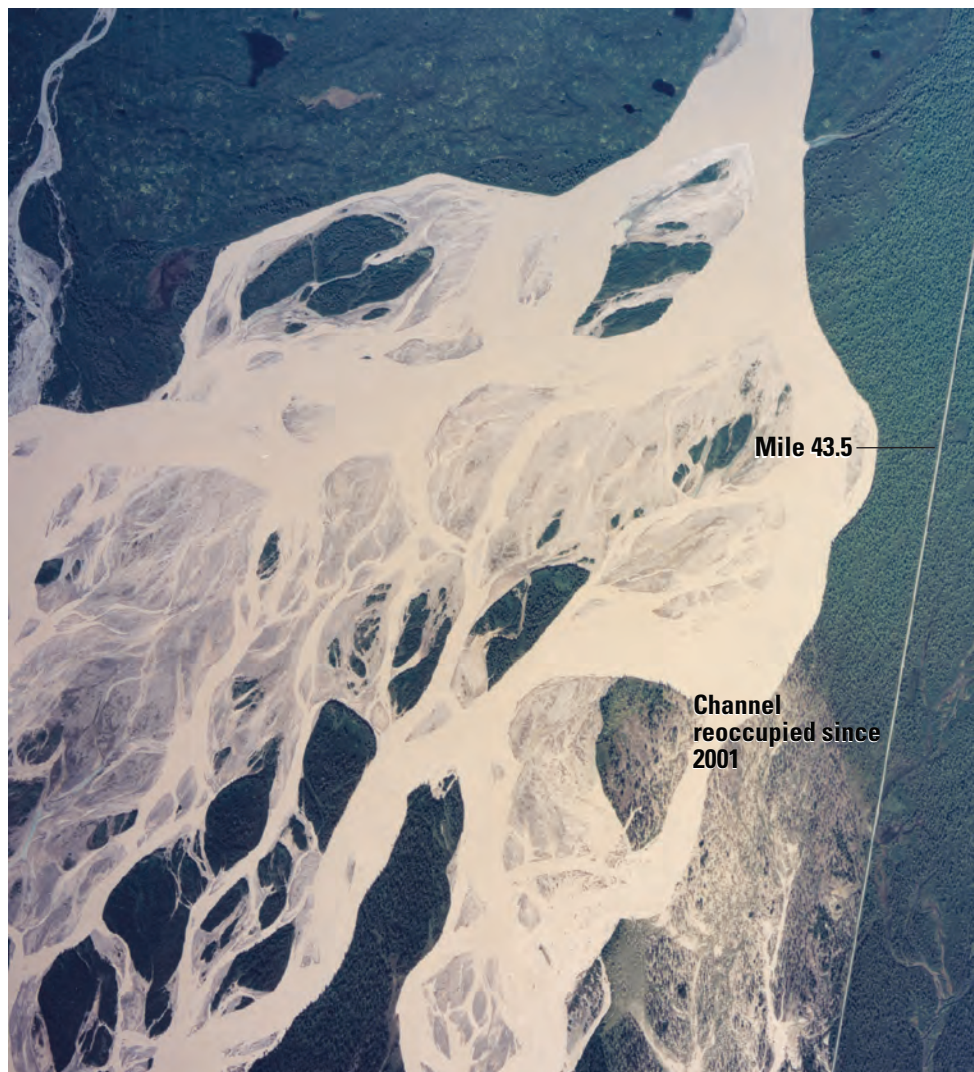
Figure 12. Area near Mile 43.5 along the lower Copper River, Alaska, 2002.

highway (fig. 12) and re-occupied an old channel, inundating an area adjacent to the highway (fig. 12). The second change was that the left channel near Bridge 342 (fig. 13) eroded. If erosion continues there, additional flow will pass through Bridge 344. The third change was a major channel shift that directed more flow toward Bridge 339 (fig. 13) and less flow toward the bridges at Flag Point.

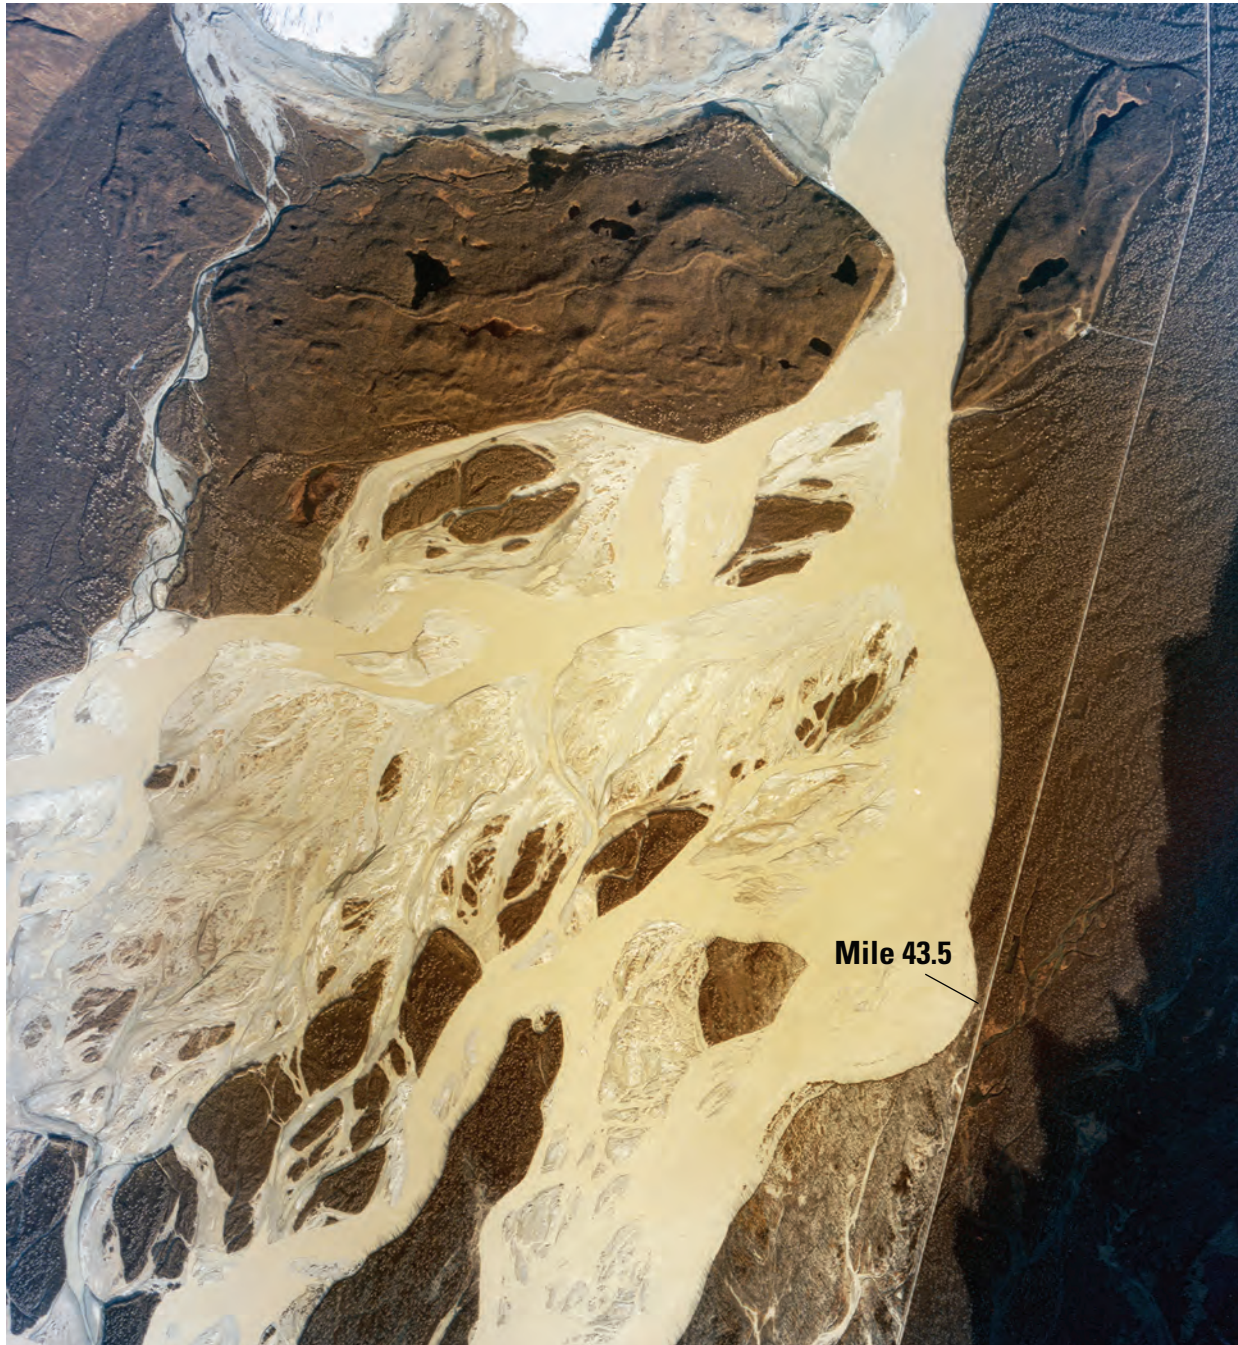
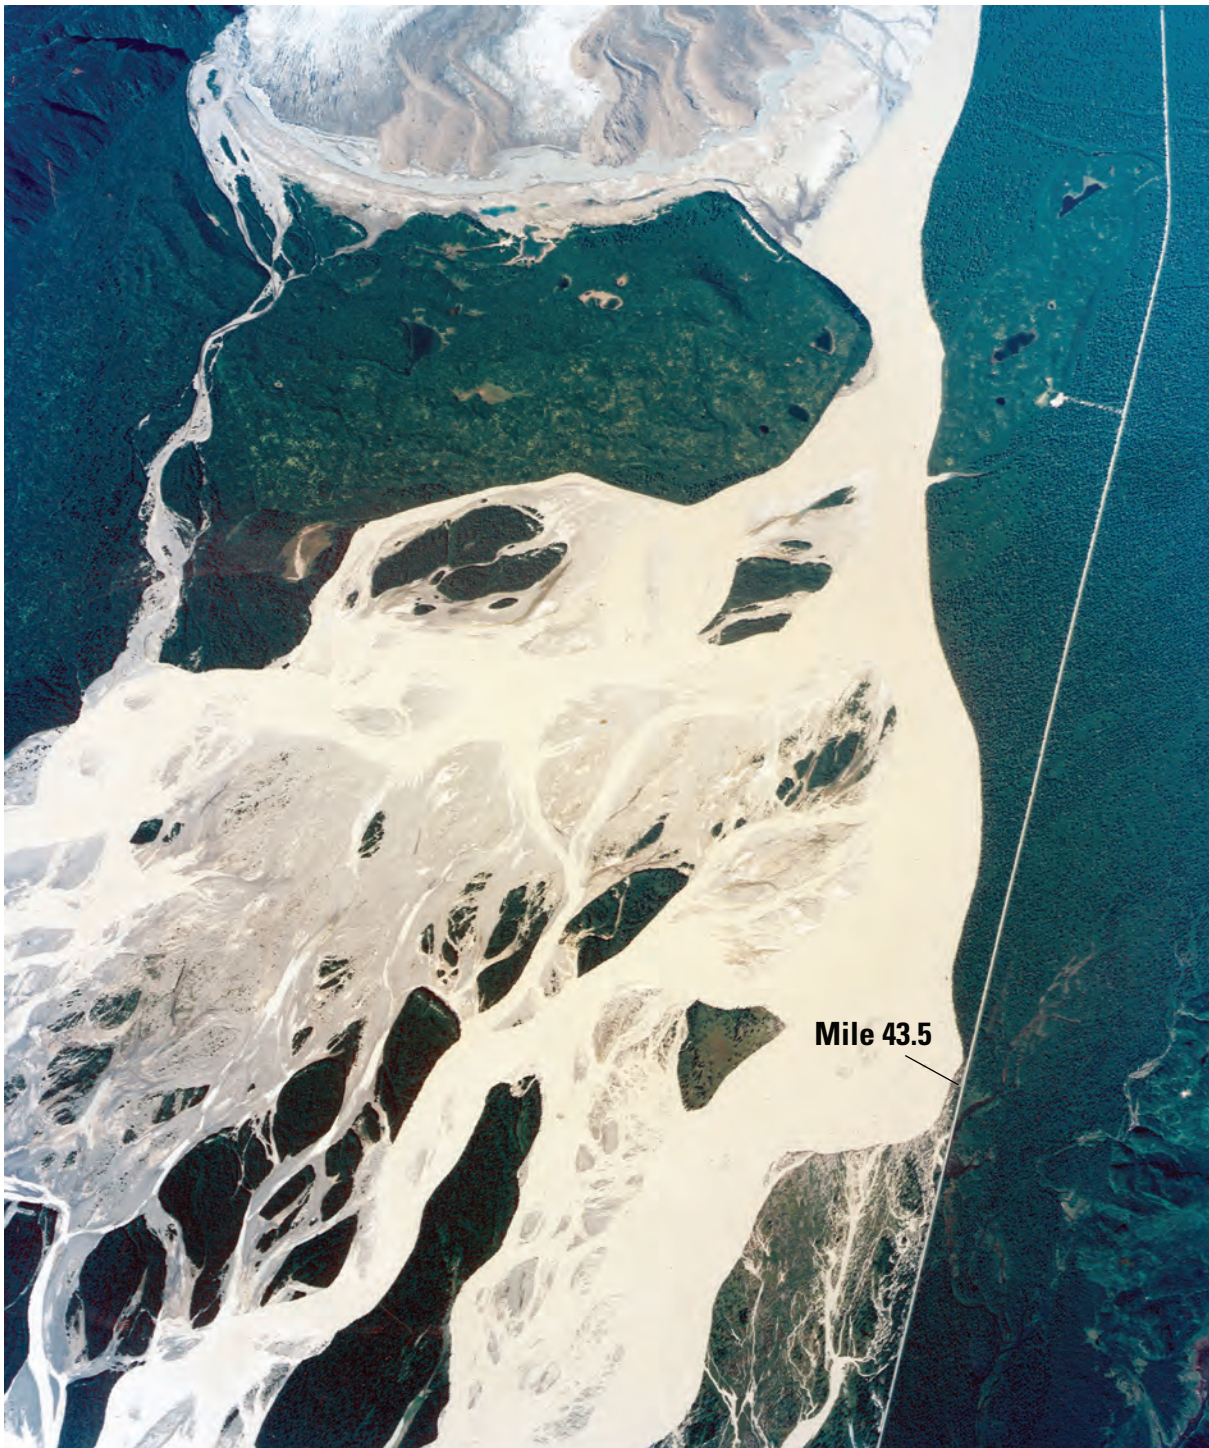
Figure 14. Area near Mile 43.5 in (A) 2006 and (B) 2007, lower Copper River, Alaska.

Aerial photography taken in 2006 and 2007 showed the continued erosion near Mile 43.5 of the Copper River Highway (figs. 14A, 14B). This continued erosion and channel encroachment near Mile 43.5 resulted in the inundation of the area adjacent to Mile 41 through Mile 44 during normal flow regimes (figs. 15–16). Rainfall from September 9 to 13, 2007

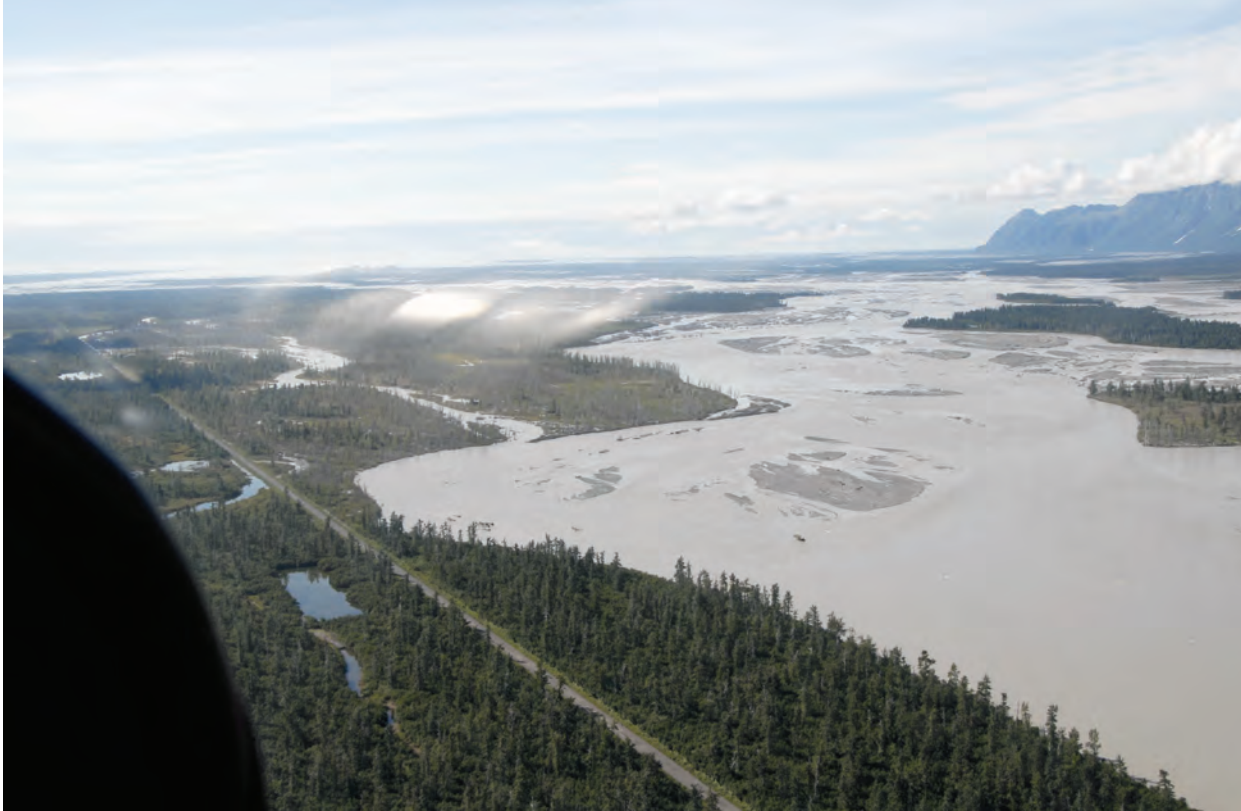
Figure 15. Copper River Highway looking downstream near Mile 45, lower Copper River, Alaska, August 30, 2007.

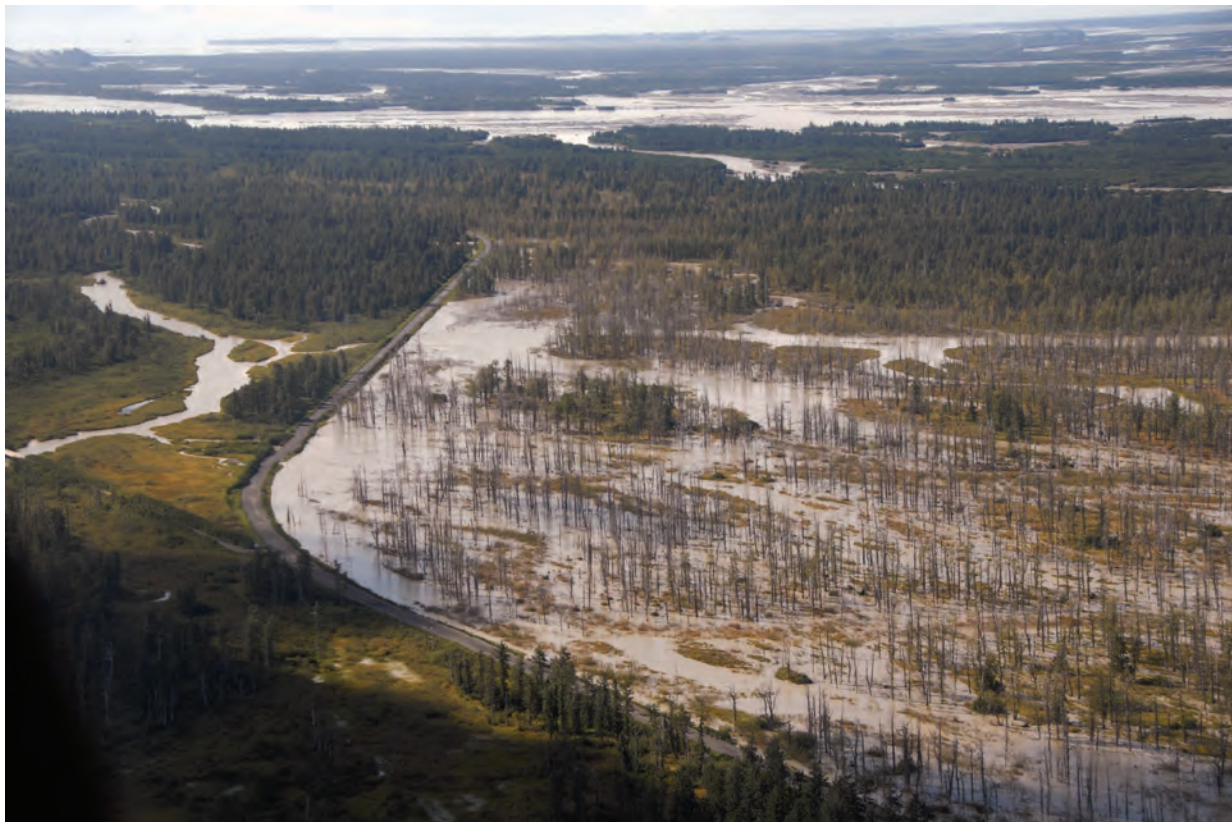
Figure 16. Copper River Highway from Mile 41 to Mile 44, lower Copper River, Alaska.

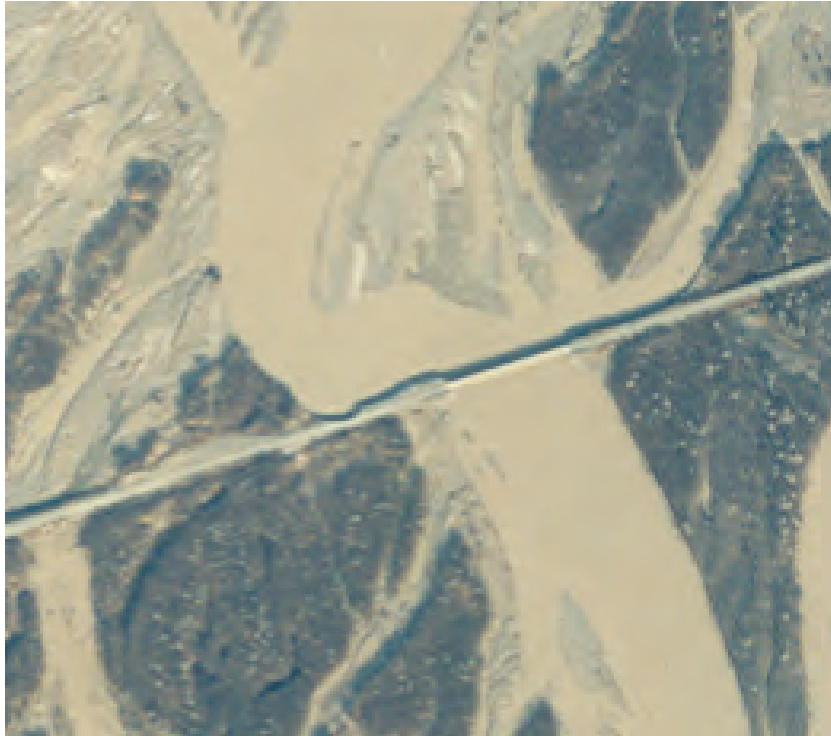
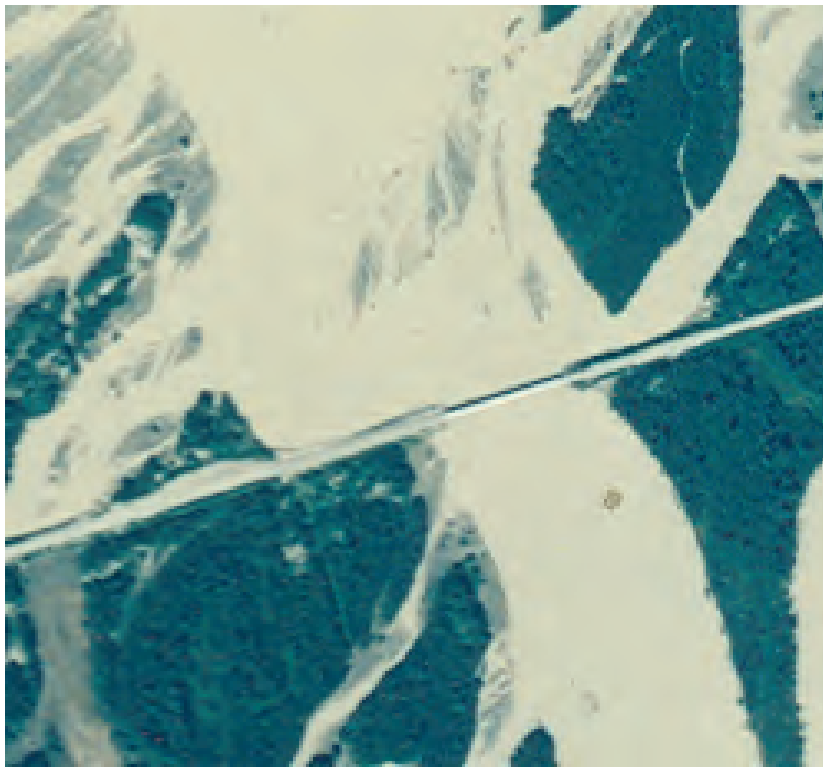
Figure 17. Area near Bridge 339 in (A) 2006 and (B) 2007, lower Copper River, Alaska.

increased the stage of the Copper River at the Million Dollar Bridge to 144.41 ft and this section of the highway was almost overtopped. Near Bridge 339, flow continued to erode the west approach to the bridge (fig. 17) and throughout 2006 and 2007, riprap was placed along the approach to stabilize the approach section (fig. 18).

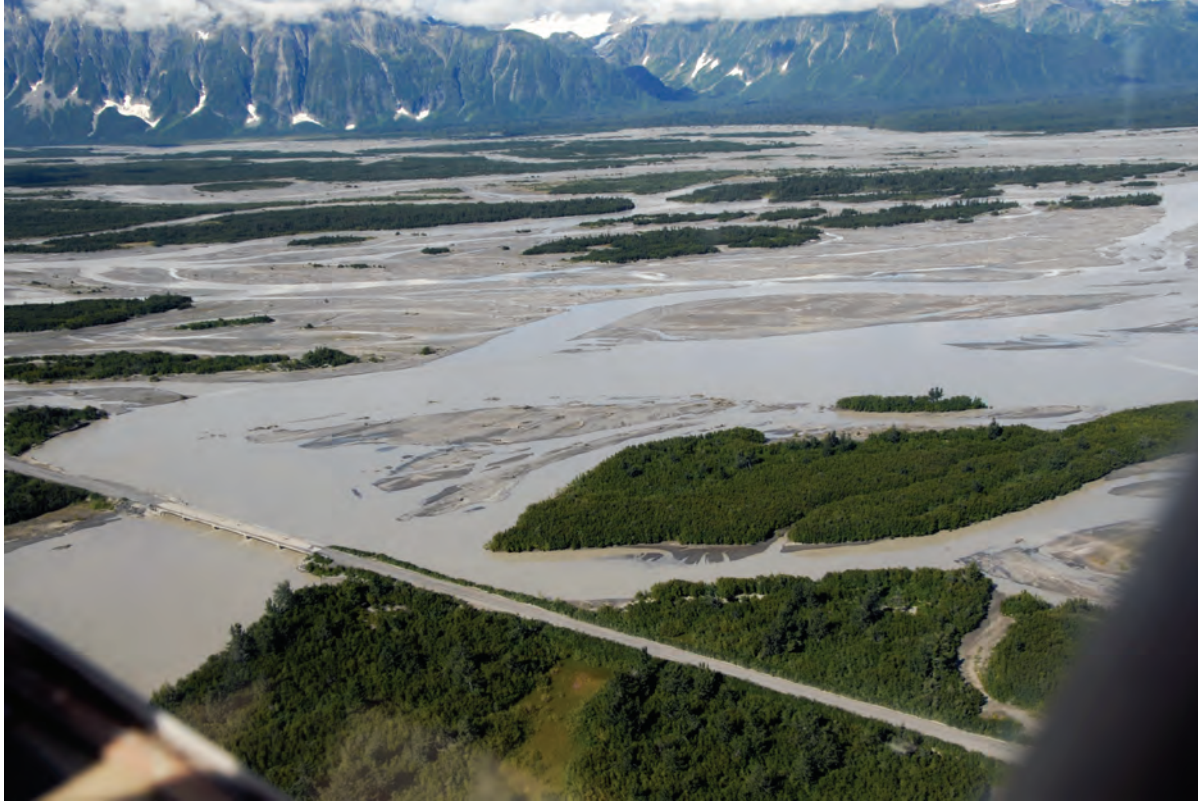
Figure 18. Copper River Highway at Bridge 339, lower Copper River, Alaska.

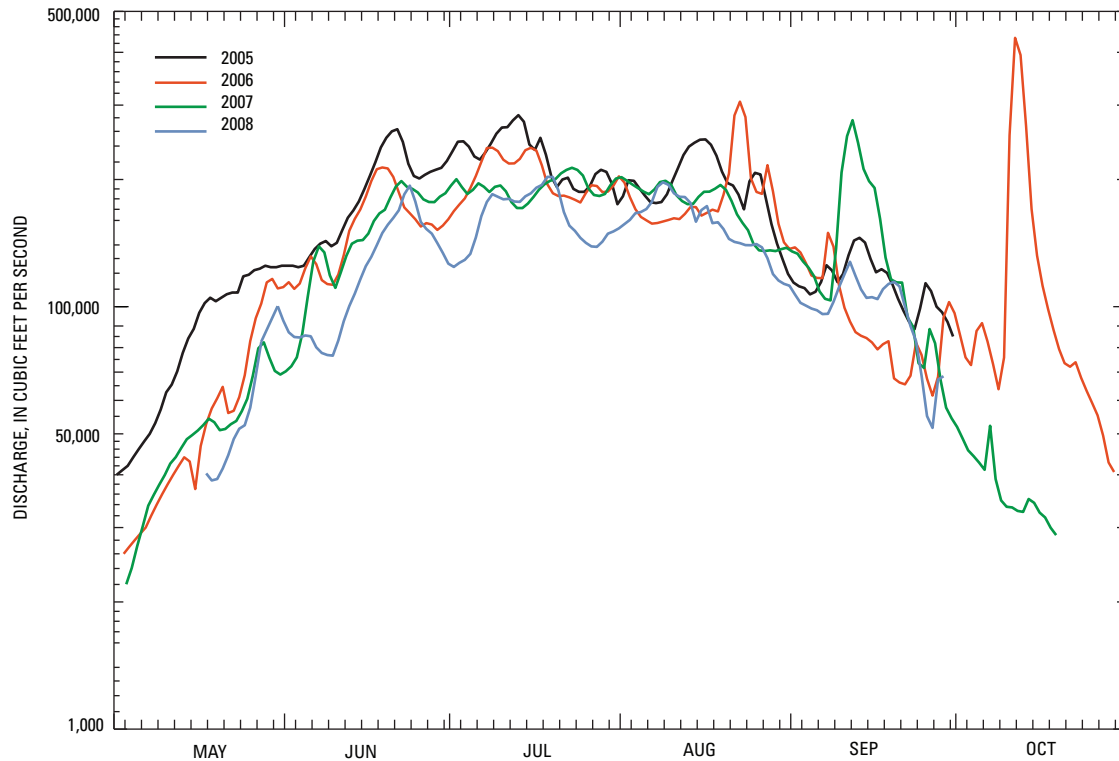
Figure 19. Discharge of the lower Copper River at the Million Dollar Bridge, lower Copper River, Alaska, 2005–08.

The instantaneous peak discharge, 287,000 ft³/s, has a 50 percent chance of occurrence. In 2006, there were multiple periods of high flow, and in May, an ice jam caused a washout at about Mile 41 of the Copper River Highway. Flow conditions were average until a storm in mid-August caused a rapid increase in stage of the Copper River. The peak discharge during this storm, 311,000 ft³/s, had approximately a 25 percent chance of occurrence. Flow then steadily declined until a large storm struck south central Alaska in October. The stage of the river rose quickly to about 151.33 ft ([fig. 19](#)). The peak discharge for this storm, 444,000 ft³/s, was estimated to have only a 1 to 1.5 percent chance of occurrence based on an analysis of peak discharges from 1950 to 1995 and 2005 to 2007. Flow conditions on the Copper River were average in 2007. One storm in early September rapidly raised the stage of the river to 144.41 ft, resulting in a peak discharge of 271,000 ft³/s, which has approximately a 50 percent chance of occurrence. Discharge on the Copper River was below average in water year 2008, primarily due to a cool summer in south central Alaska, resulting in reduced glacier melting.

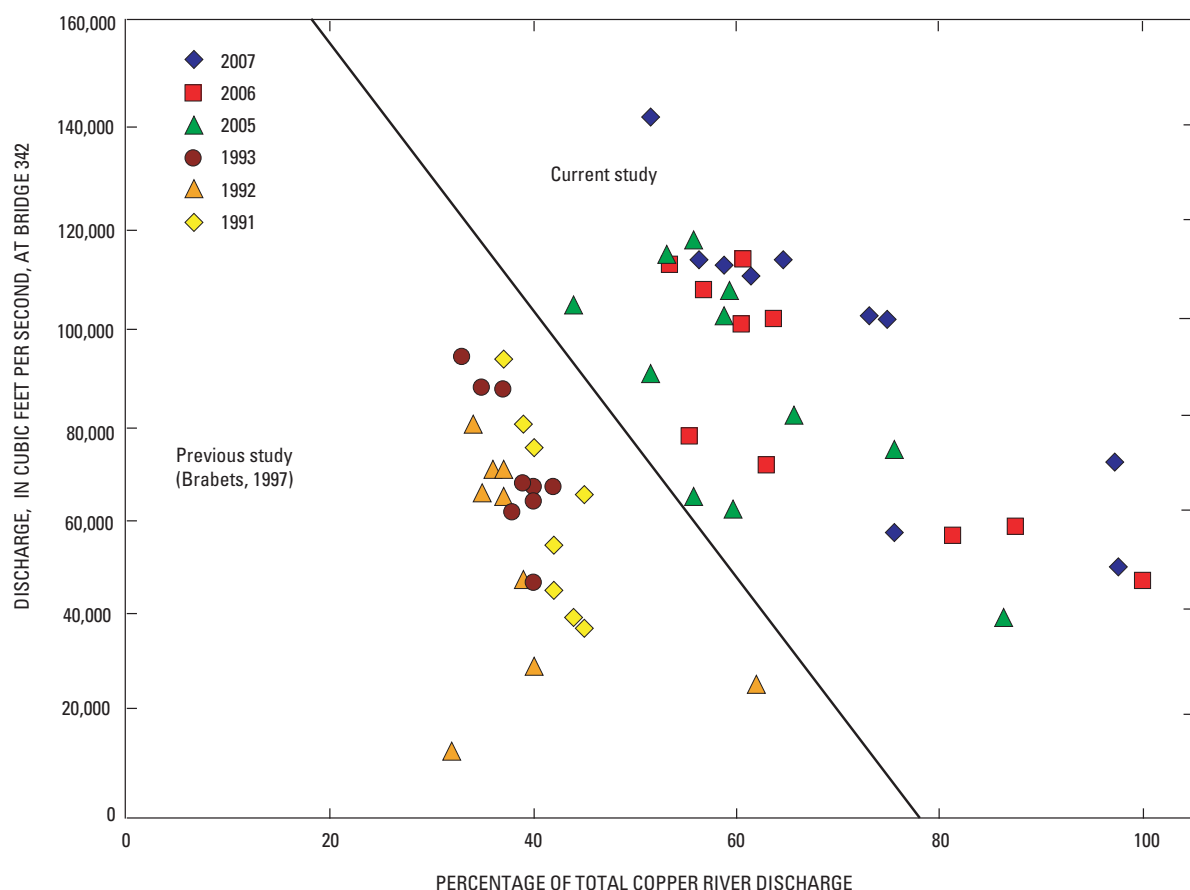
Figure 20. Percentage of total discharge at the Million Dollar Bridge that flows under Bridge 342, lower Copper River, Alaska, 1991–93 and 2005–07.

For the previous study of the lower Copper River (Brabets, 1997), a series of discharge measurements were made between 1991 and 1995 at the bridges along the Copper River Highway from Flag Point to the Million Dollar Bridge. These discharge measurements were made to determine the percentage of the total flow at the Million Dollar Bridge passing through each downstream bridge. If the percentages of flow (at the individual bridges) were to change, this would indicate a possible channel shift upstream of the respective bridge. These series of measurements were repeated in 2005–07 to determine if the percentages of flow had changed significantly since 1991–95.

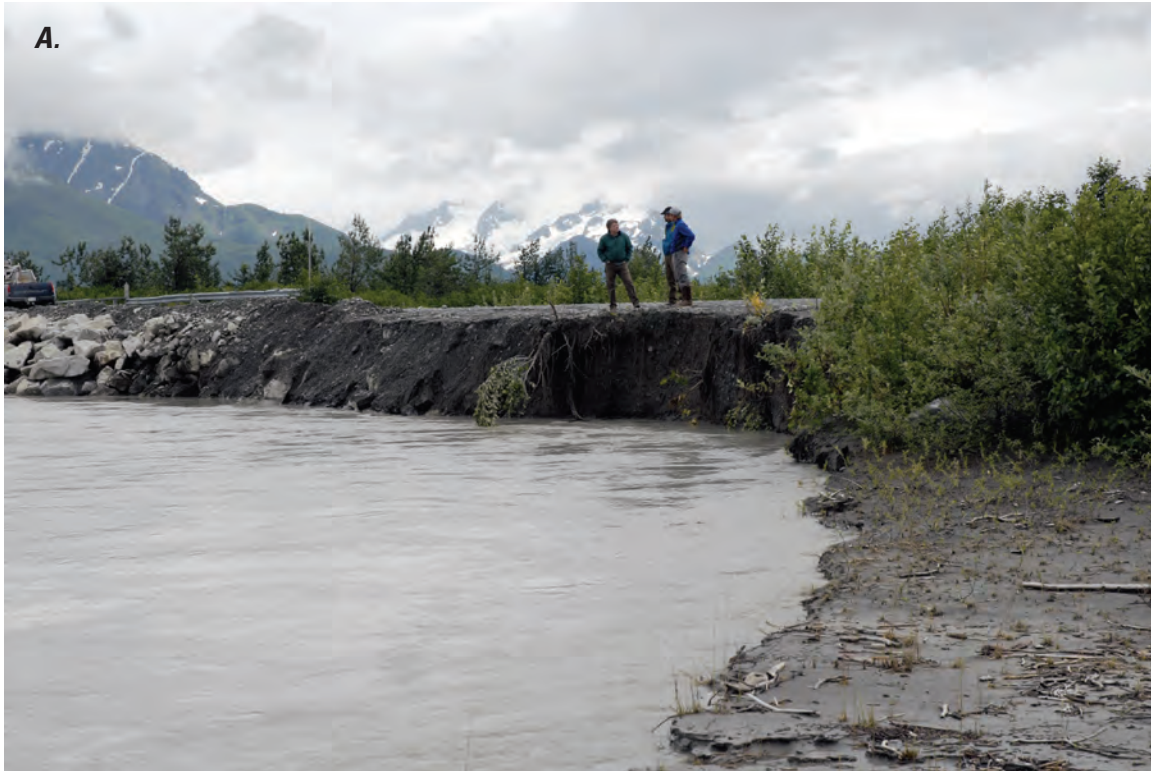
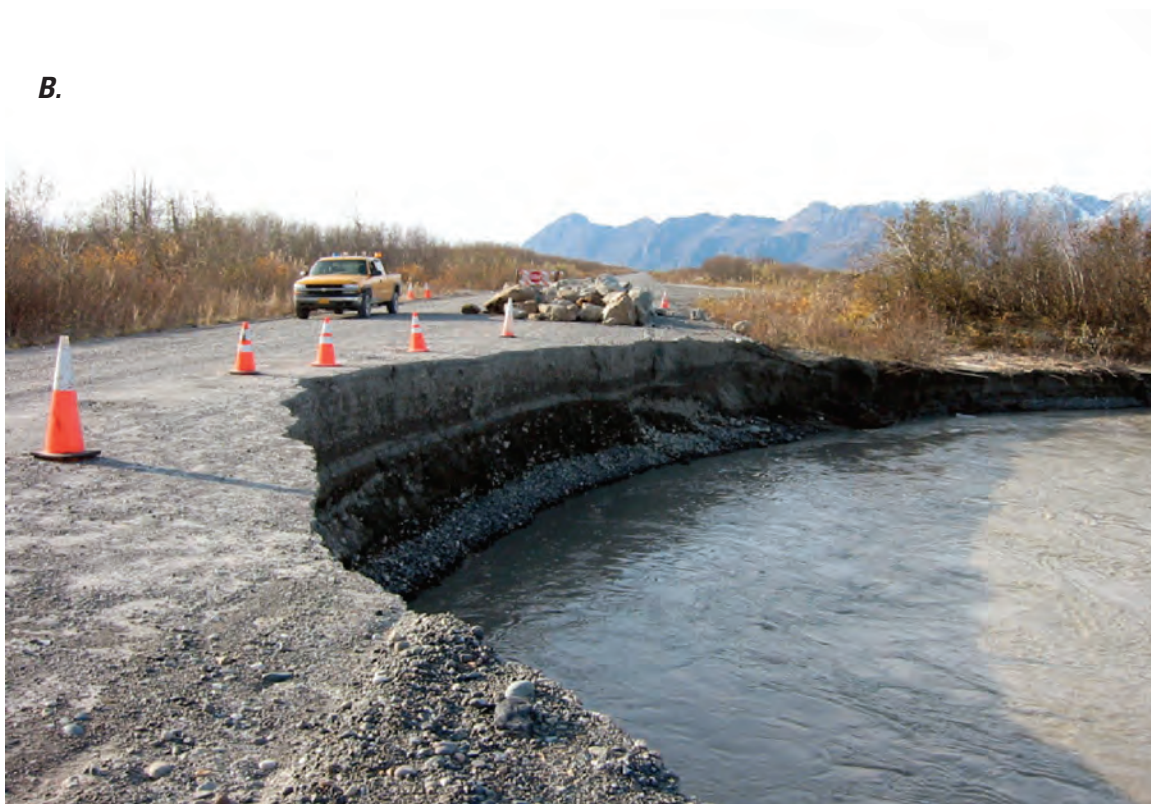
Figure 22. Copper River Highway road bank material near Bridge 339 (*A*) looking east and (*B*) looking west, lower Copper River, Alaska.

Erosion and undercutting of the west approach to Bridge 339 is likely to continue based on discharge measurements (and the corresponding velocities) made from 2005 to 2007 and field observations. The approach consists of fine-grained material ([fig. 22A](#)), and during this study ADOT&PF needed to replace the riprap repeatedly. Approximately 10,000 cubic yards of riprap have been placed along the approach since 2004, and during the October 2006 flood, all the material was washed away ([fig. 22B](#)).

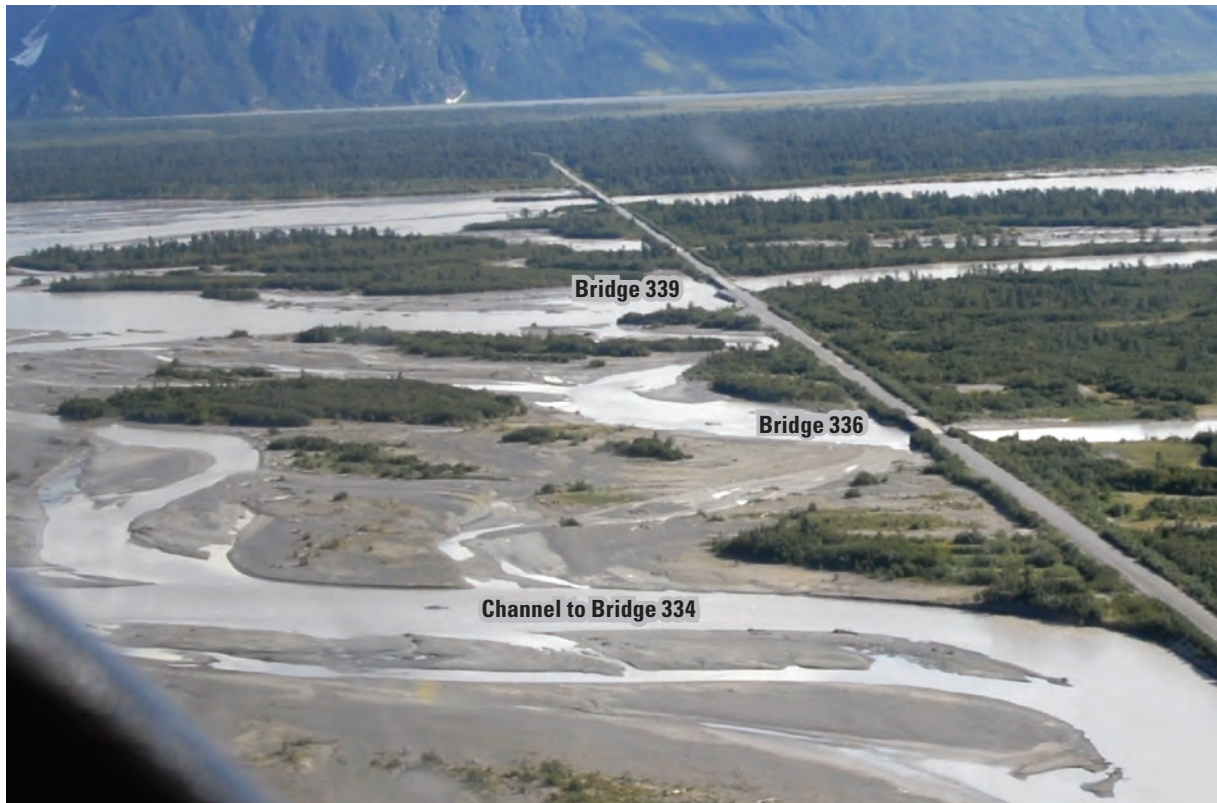
Figure 23. Copper River Highway river channels near Bridge 339, lower Copper River, Alaska.

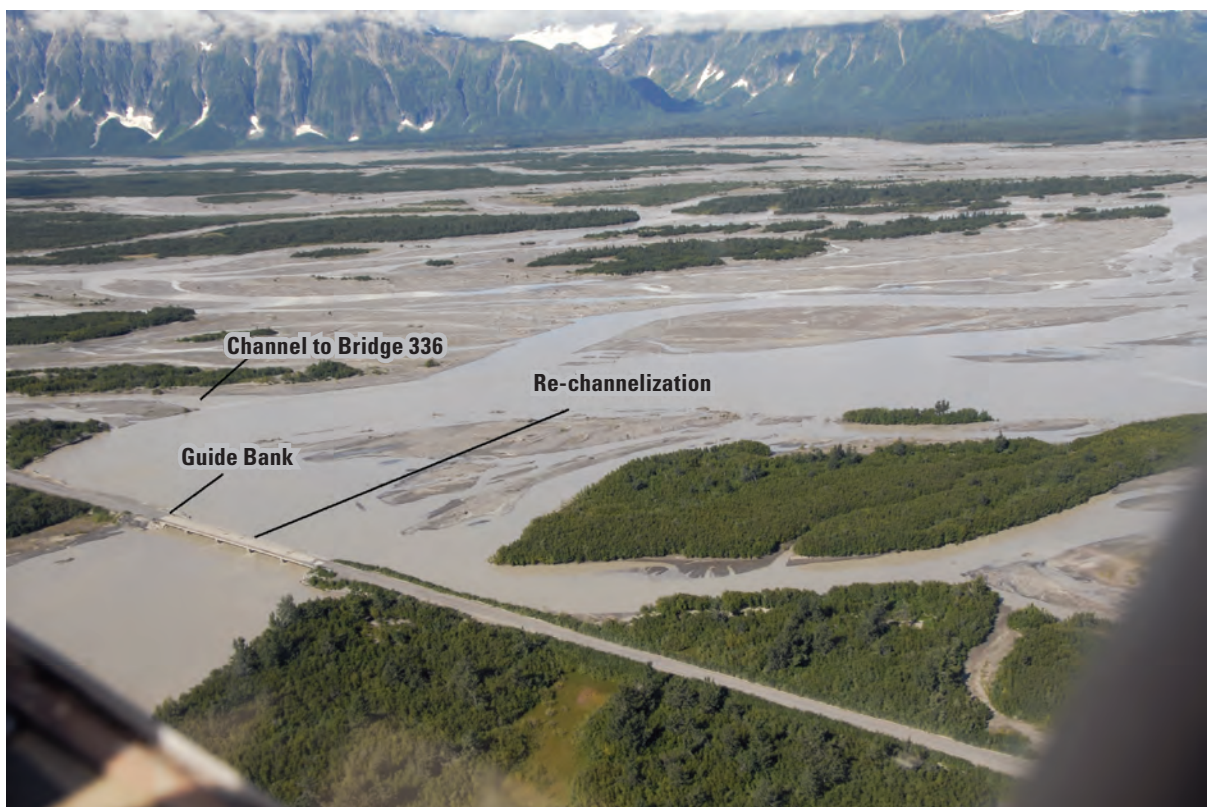
Figure 24. Copper River Highway at Bridge 339 showing possible betterments lower Copper River, Alaska.

Some solutions or betterments that have been considered for Bridge 339 are (1) constructing a 250 ft guide bank on the west upstream side of Bridge 339 to direct the water perpendicular to the bridge opening, (2) re-channelization of approximately 1,000 ft of channel directly upstream of Bridge 339 to align the flow perpendicular to the center of the bridge, and (3) extending the bridge 240 ft to the west ([fig. 24](#)). The developed MD_SWMS model was used to simulate flow conditions for these three betterment scenarios at a discharge of 32,500 ft³/s

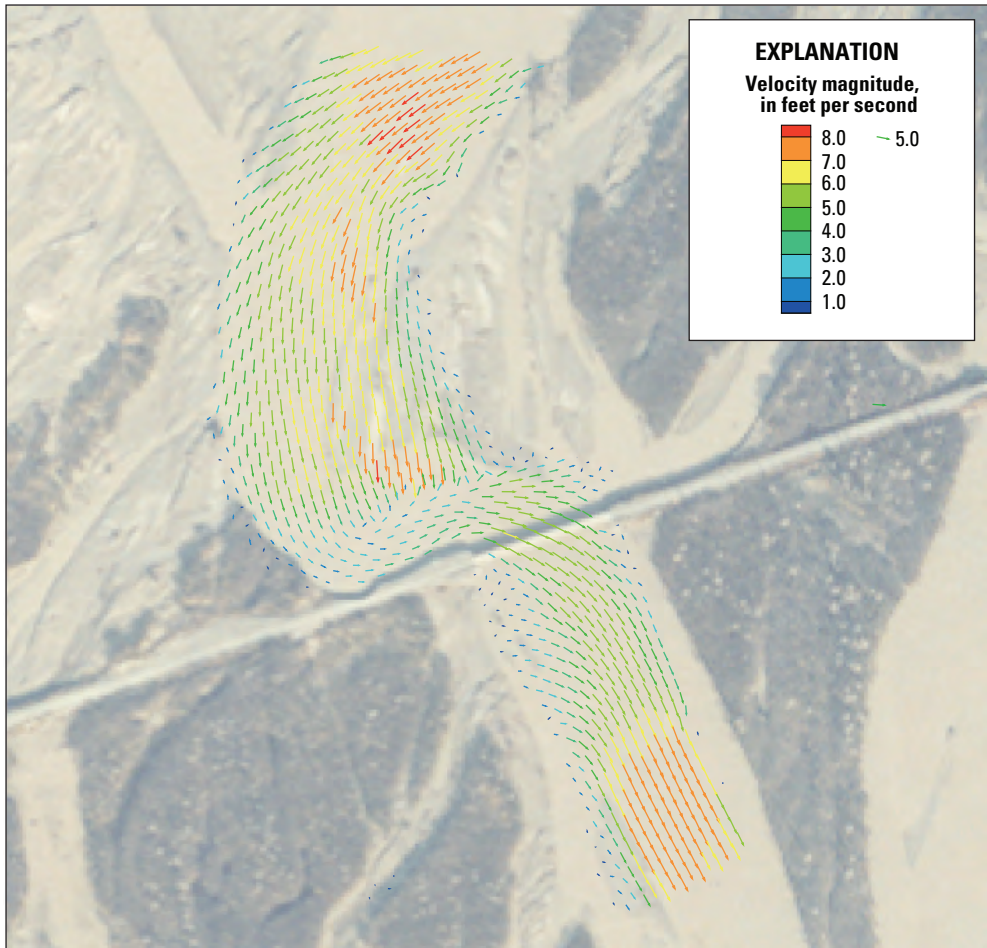
Figure 25. Results from MD_SWMS simulation of the main channel near Bridge 339 at a discharge of 32,500 ft³/s: (A) velocity, no changes, (B) shear stress, no changes, (C), water-surface elevation with 250 ft guide bank, (D) velocity with re-channelization, and (E) velocity with 240 ft bridge extension.

As proposed, a 250-ft long guide bank would be constructed perpendicular to the roadway and then angle slightly to the west to alter the direction of flow to be perpendicular to the opening of Bridge 339. However, the output from MD_SWMS, when the guide bank dimensions were added, did not indicate such a change in flow alignment would take place. Water velocities, velocity vectors, and bed shear stresses simulated by the model were nearly identical to those under current conditions, which would indicate that most of the flow still would be directed to the approach and not to the bridge ([fig. 25A](#)). The likely cause of this simulation result is that a 250-ft guide bank is too short to alter the flow direction and would need to be lengthened. A possible negative impact of the guide bank, based on the output from MD_SWMS, is that it would increase the water-surface elevation along the right bank ([fig. 25C](#)). Such an increase in water-surface elevation would increase flow toward Bridge 336. However, no attempt was made to determine the amount of flow toward this bridge.

If Bridge 339 were extended 240 ft to the west, modeling indicated that the water velocity would be lower than velocities under current conditions, and that flow would be uniform across the channel ([fig. 25E](#)). Thus, the flow would be more nearly centered through the bridge. On the basis of calculated shear stress values, the channel would still be considered mobile, but the potential for scour would be considered low due to the lower shear stress values.

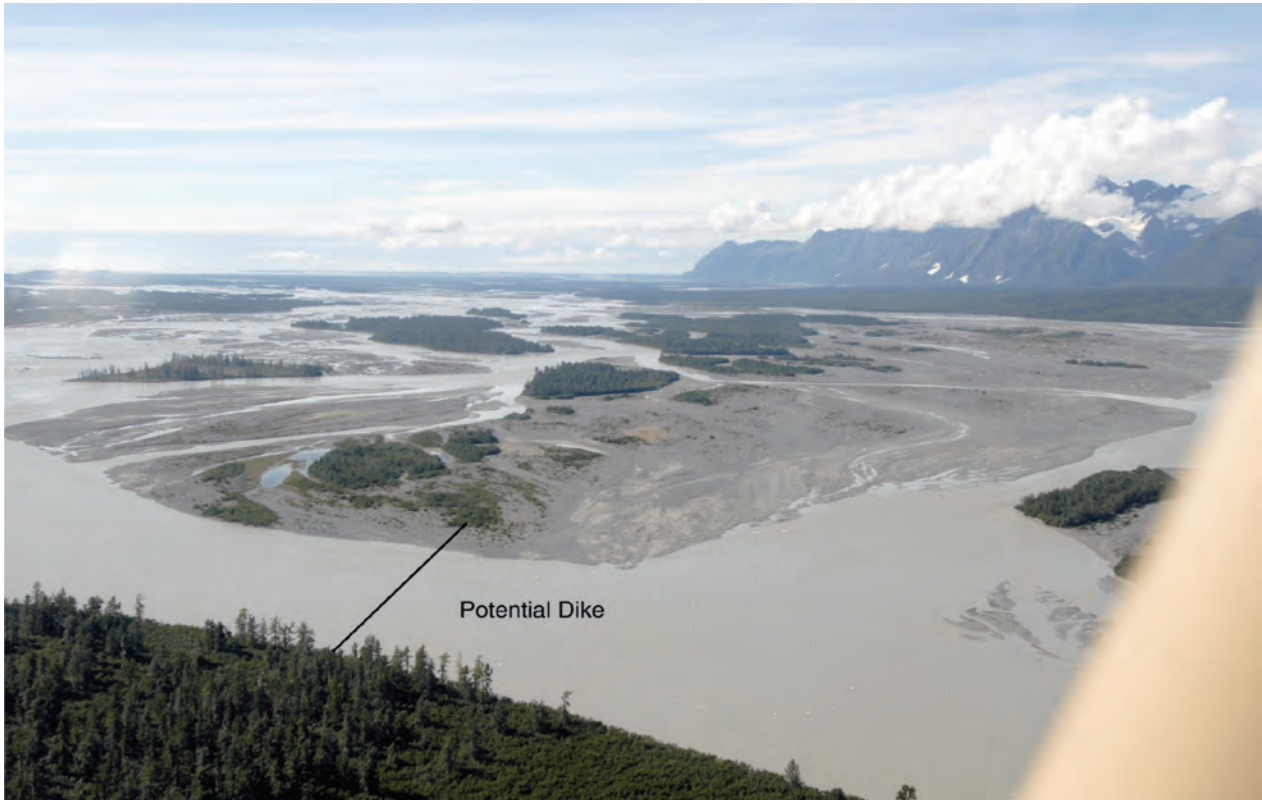
Figure 26. Area near Mile 45 looking downstream showing location of possible dike to change direction of flow toward the west, lower Copper River, Alaska.

After the model was calibrated for the nine discharges, a hypothetical dike was placed upstream of Mile 43.5, using tools in MD_SWMS that allow for adjustments to the topography. The dike was approximately 1,000 ft long and 100 ft wide, with an upper elevation of 125 ft (the same as the left-bank elevation). At the location of the dike, the model bathymetry was changed from 87 to 125 ft (top of bank). Comparisons between the MD_SWMS output for current conditions and conditions with the dike in place (fig. 28) showed that the dike would redirect flow to the west and would cause an increase in the water-surface elevation on the right side of the channel.

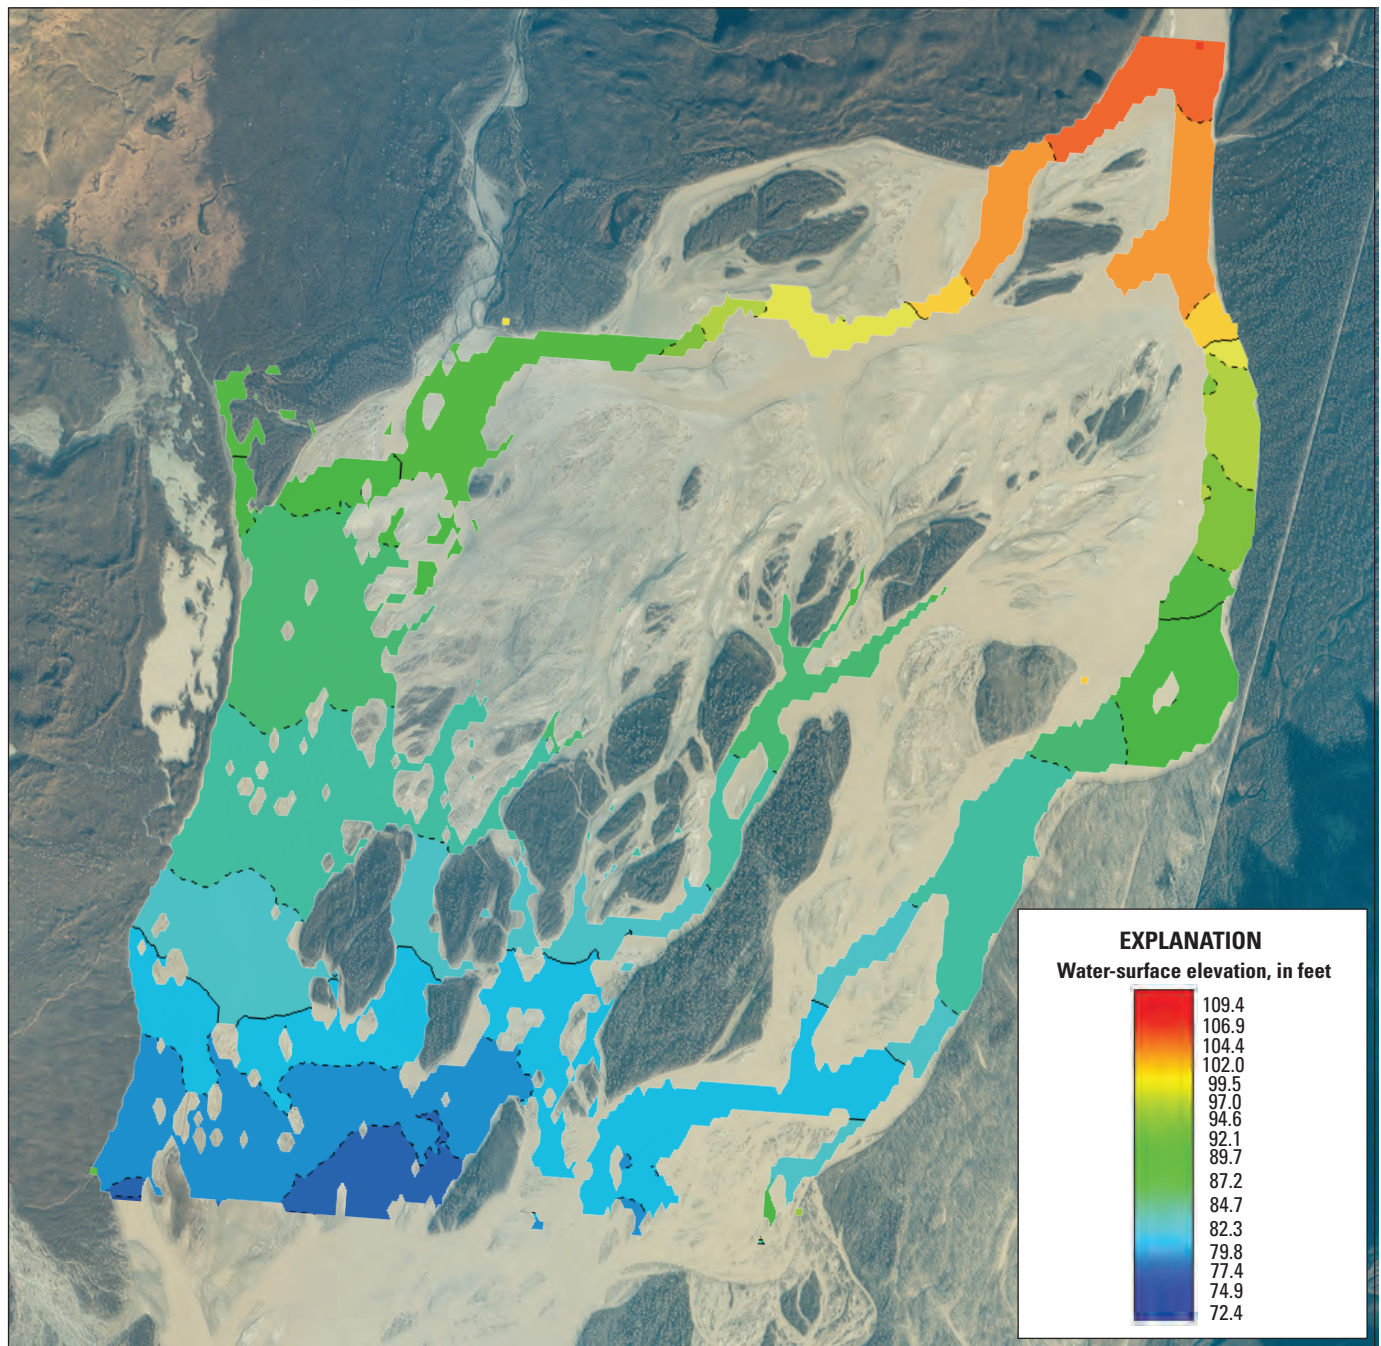
Figure 28. Water surface-elevations computed by Multi-Dimensional Surface Water Modeling System for a flow of 177,000 ft³/s (A) without dike and (B) with dike, near Mile 43.5, lower Copper River, Alaska.
