# "Design with Nature" Strategies for Shore Protection: The Construction of a Cobble Berm and Artificial Dune in an Oregon State Park

Paul D. Komar<sup>1</sup> and Jonathan C. Allan<sup>2</sup>

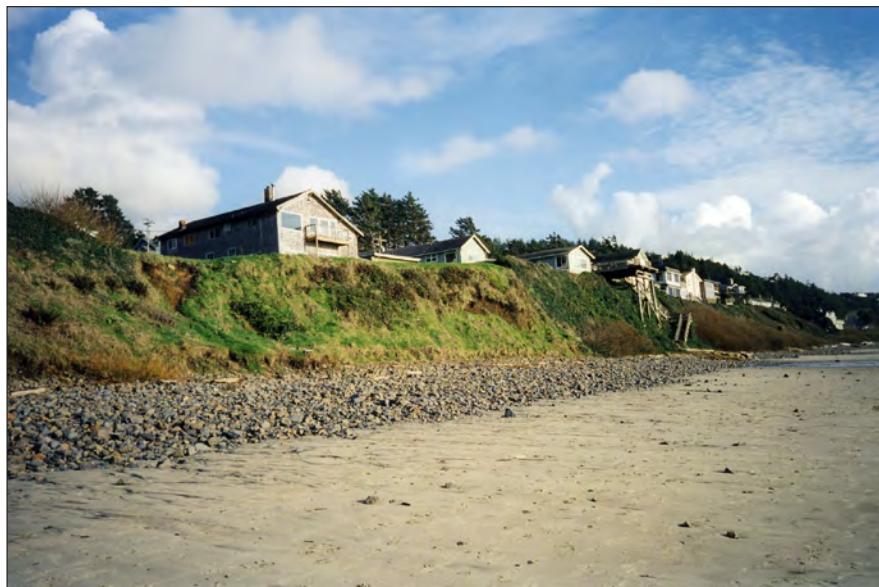
**Figure 1.** Natural cobble beach on the shore of Oceanside, Oregon, which has protected the sea cliff from erosion, evident in its extensive cover of vegetation.

presence of a natural cobble beach can provide a significant degree of protection to ocean-front properties. Figure 1 shows an example of such a beach on the shore of the community of Oceanside, where the absence of erosion is evident in the heavy vegetation that covers the sea cliff, with photos dating back to the early 20th century being essentially identical.

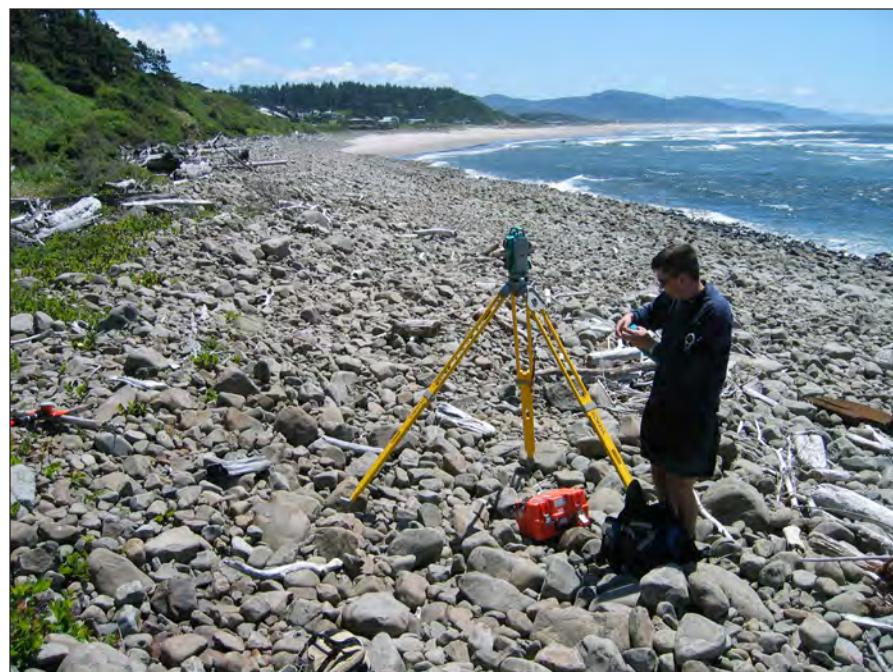
**Figure 2.** Natural cobble beach on the Oregon coast, being surveyed and with the cobble sizes measured to serve in the design of the artificial cobble berm for shore protection in Cape Lookout State Park.

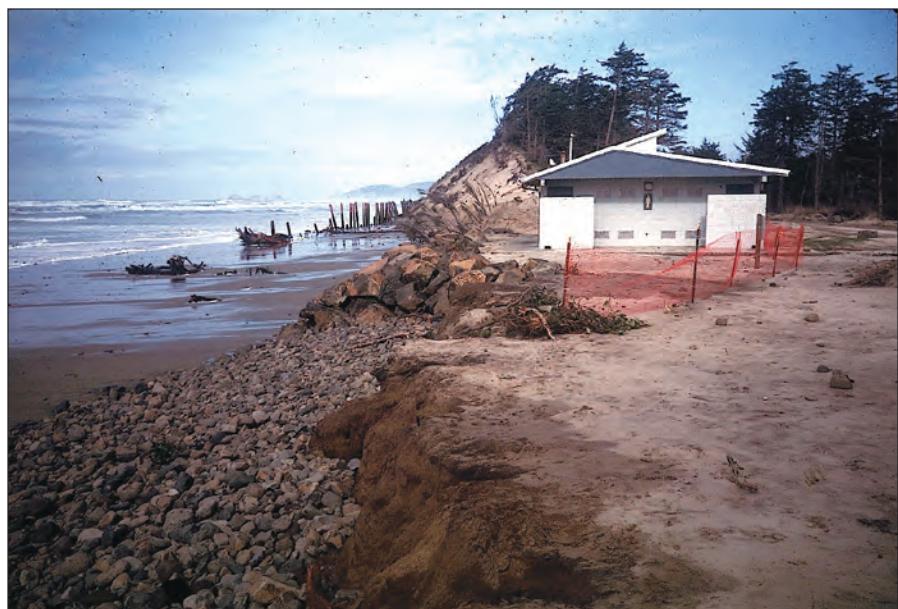
**Figure 4.** Erosion of Cape Lookout State Park, photographed during the 1997–98 El Niño. The remnants of the high dune ridge and a failed log seawall are seen in the background. Riprap temporarily protected the bathrooms, but they were removed after having been damaged the following winter when the March 1999 storm breached this area and washed through the campground (Allan and Komar, 2004).

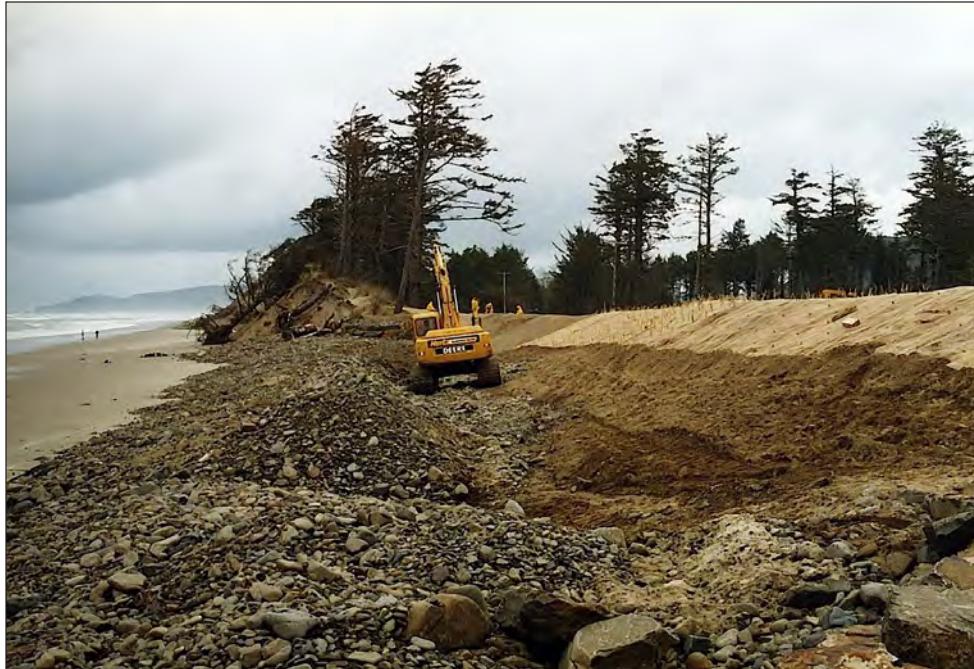
**Figure 6.** Construction of the cobble berm and artificial foredune in Cape Lookout State Park during the fall of 2000. A continuation of the old dune ridge is seen in the background, which had previously extended past this area of erosion.

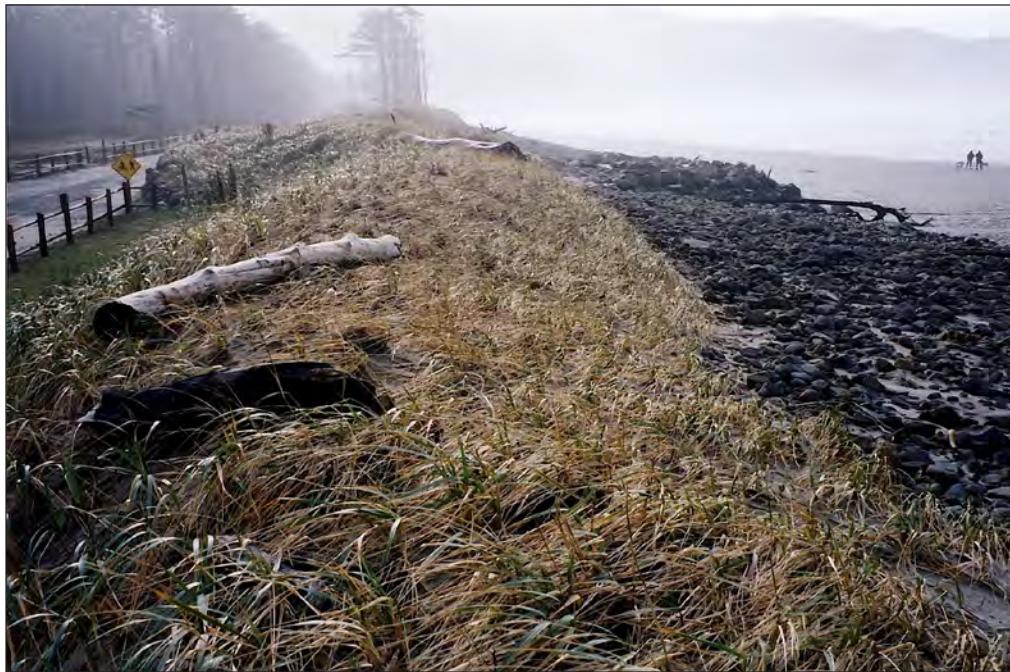
**Figure 7.** Completed cobble berm and foredune, having been overtopped by a winter storm along the stretch that had not been constructed to the designed elevations. The riprap that previously had protected the bathrooms (fig. 4) can be seen in the background.

Construction of the 300-m long cobble berm and artificial foredune was completed by December 2000, prior to subsequent major storm events. Growth of the planted vegetation quickly covered the dune so that, as seen in figure 7, the completed project had the desired appearance of a natural cobble beach and foredune as seen along the Oregon coast. Their construction was undertaken by Oregon State Parks and Recreation Department, with the employment of work-released labor from the State penitentiary. This kept the total cost of the project to approximately \$125,000, significantly less than the \$500,000 estimated cost for a conventional static riprap revetment having the same 300-m length.

NAVD 88 recommended elevation, although the southern one-half meet the specifications. As seen the photograph in figure 7, taken soon after a winter storm, the cobble berm experienced frequent attack by even modest storm waves, although the line of restored foredunes provided a variable level of defense, overtopping occurred along its northerly stretch of lowest elevation. On at least one occasion during our monitoring program, extreme waves were documented to have overtopped the entire length of the structure.

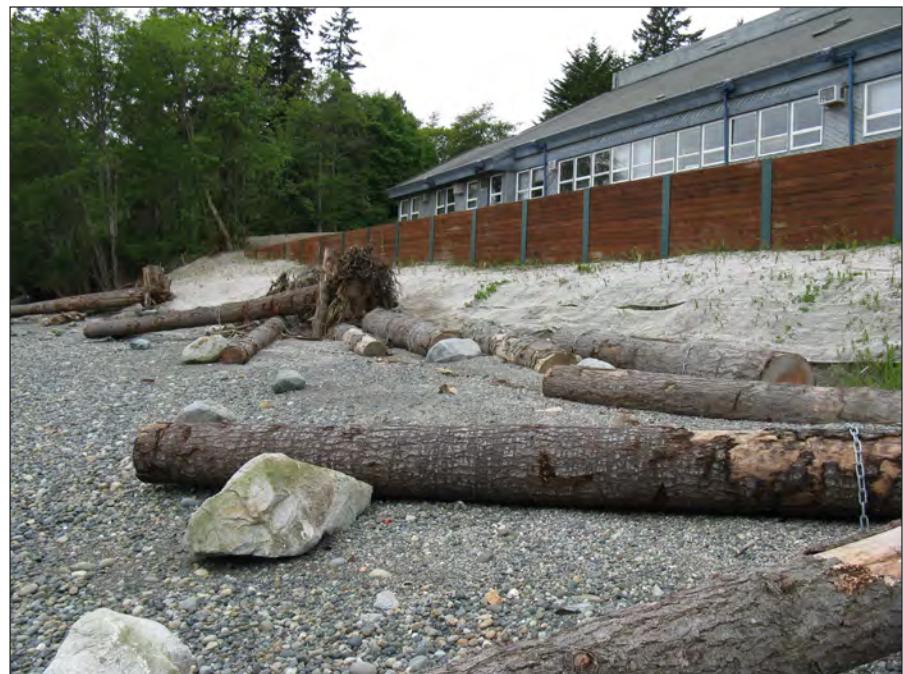
**Figure 9.** Logs at the back of a gravel beach on the shore of Puget Sound, placed to protect the property from high tides and waves.

An example of the use of logs for shore protection in Puget Sound, Washington, illustrated in figure 9, consists of a largely random arrangement of logs, held by anchored chains, that have been placed at the back and out across the beach. This example demonstrates the potential use of drift logs on low-fetch shores where drift wood is plentiful and the wave energy is relatively low. Interest in this approach likely also stems from it being a low-coast approach to protecting one’s property. However, the designs are questionable and there has been little or no monitoring to document their stability and effectiveness. Because most beaches in Puget Sound being composed of gravel and cobbles (fig. 9), a common strategy for shore protection involves beach nourishment or the construction of a cobble berm (Shipman, 2001), that expands the potential for employing a variety of “Design with Nature” approaches for shore protection in Puget Sound, with a reasonable expectation that the property will be defended for a number of years. The applications in Puget Sound, and along other coasts, only require a greater level of imagination and creativity rather than constructing still another massive rock revetment or seawall.
