Assessing Littoral Sediment Supply (Feeder Bluffs) and Beach Condition in King and Southern Snohomish Counties, Puget Sound, Washington

Jim Johannessen¹

Johannessen, J., 2010, Assessing littoral sediment supply (feeder bluffs) and beach condition in King and southern Snohomish Counties, Puget Sound, Washington, *in* Shipman, H., Dethier, M.N., Gelfenbaum, G., Fresh, K.L., and Dinicola, R.S., eds., 2010, Puget Sound Shorelines and the Impacts of Armoring—Proceedings of a State of the Science Workshop, May 2009: U.S. Geological Survey Scientific Investigations Report 2010-5254, p. 135-152.

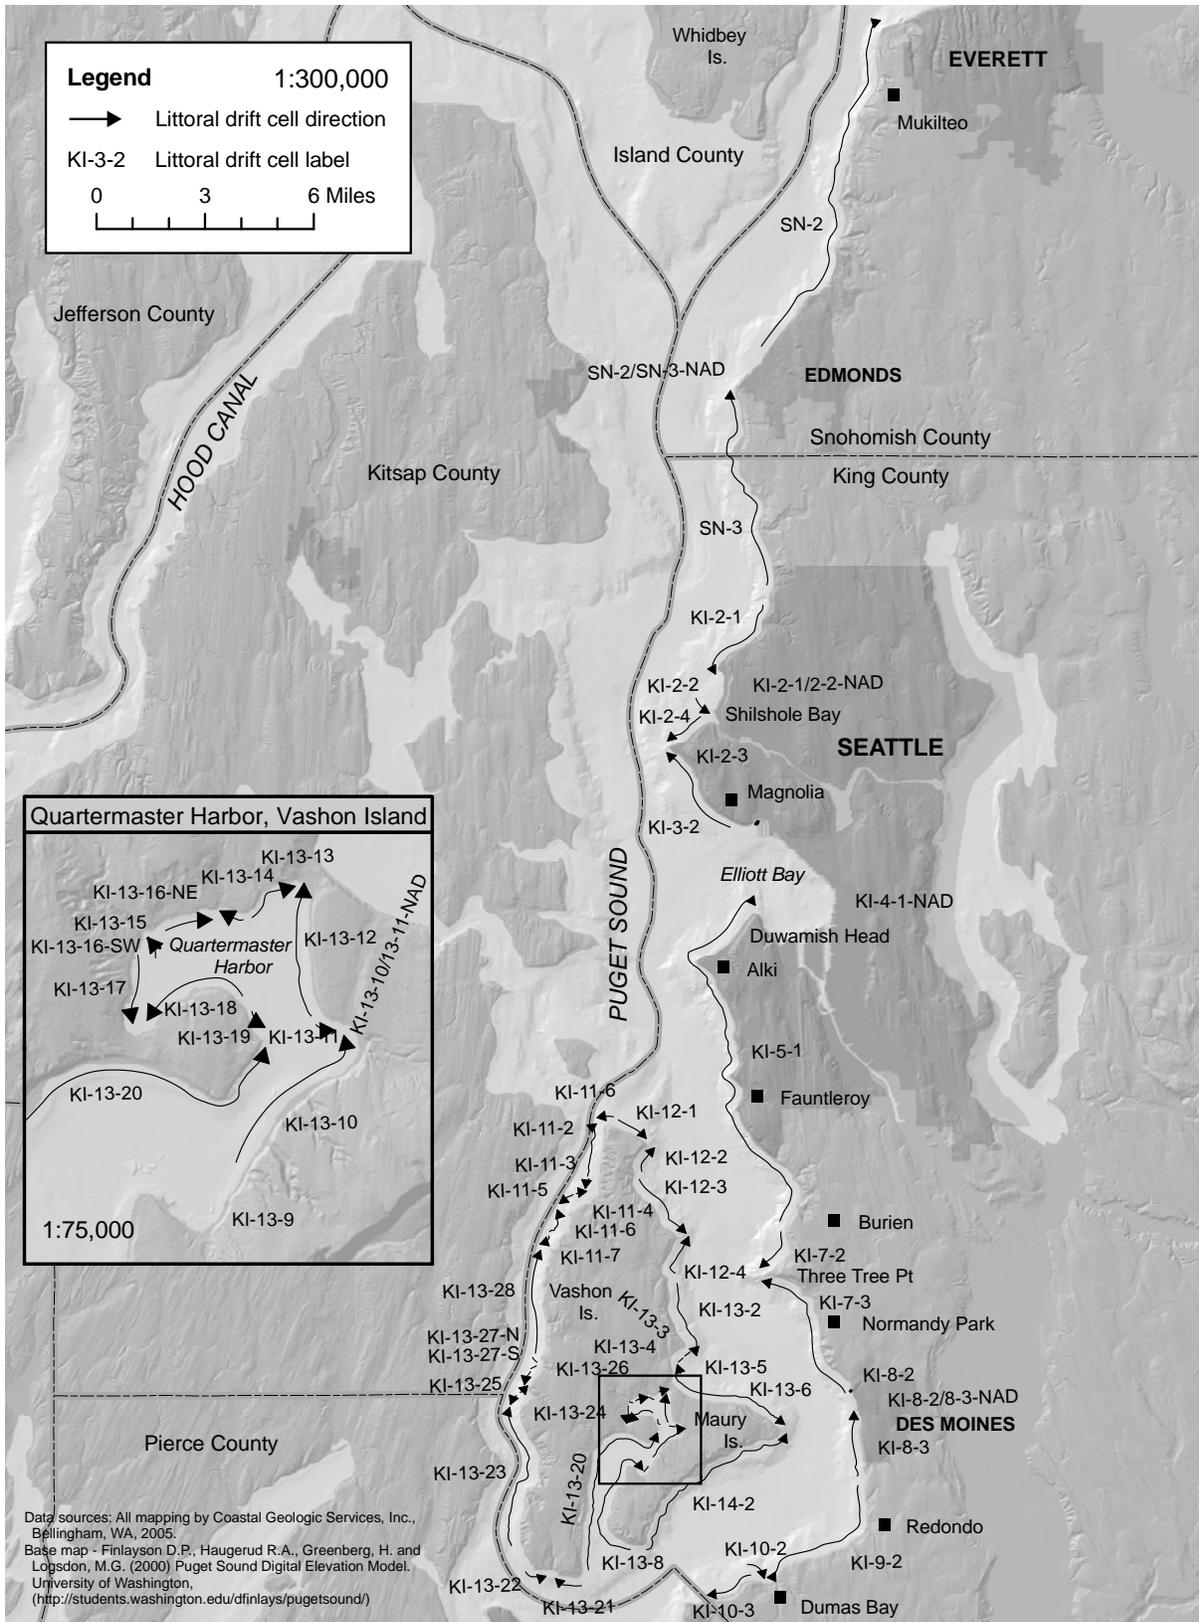
Figure 1. King County and southern Snohomish County study area, showing littoral cells and places described this paper.

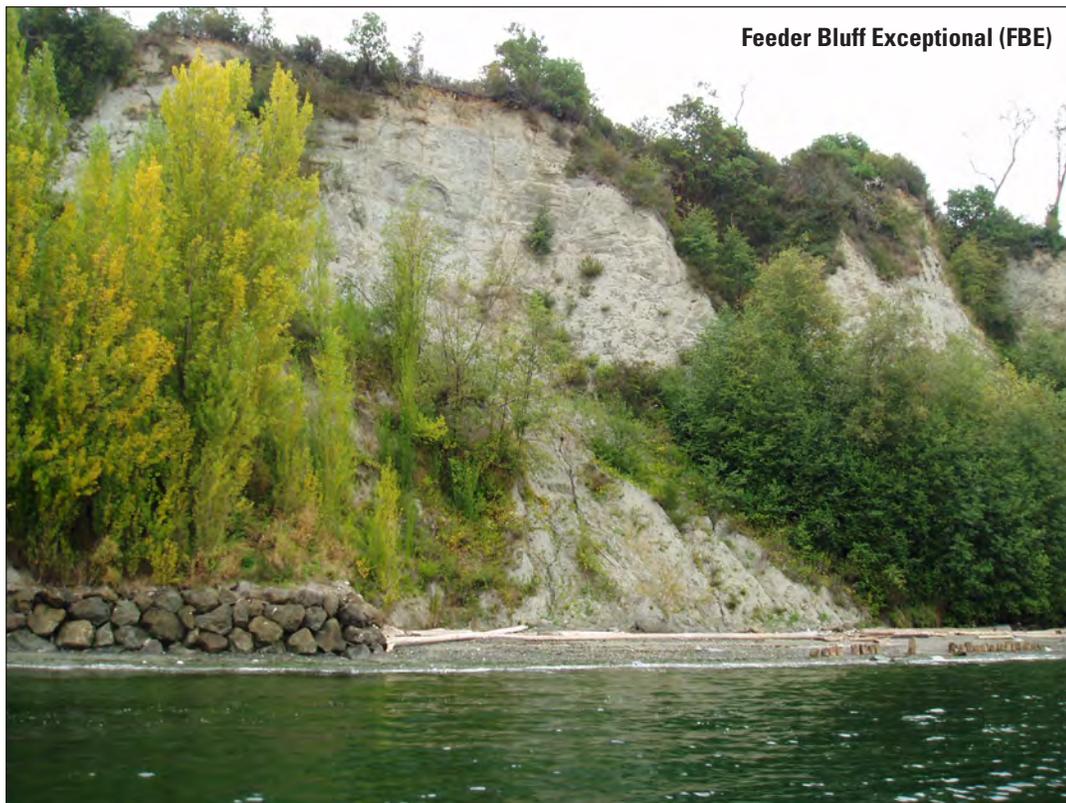
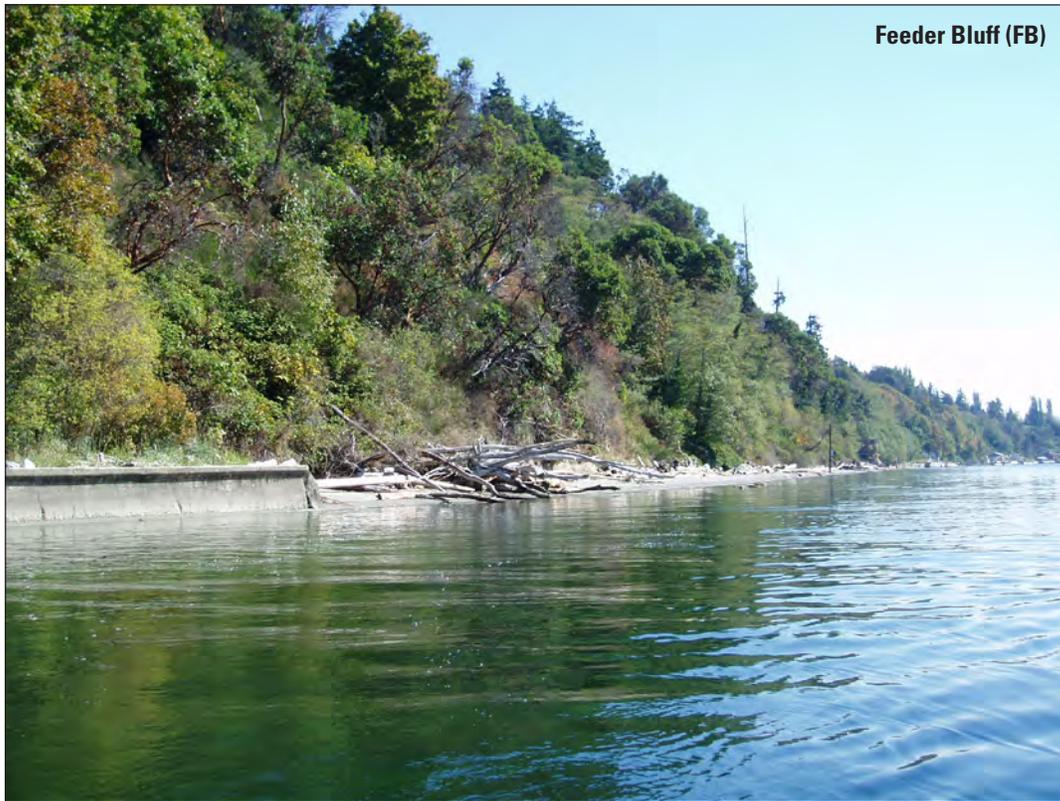
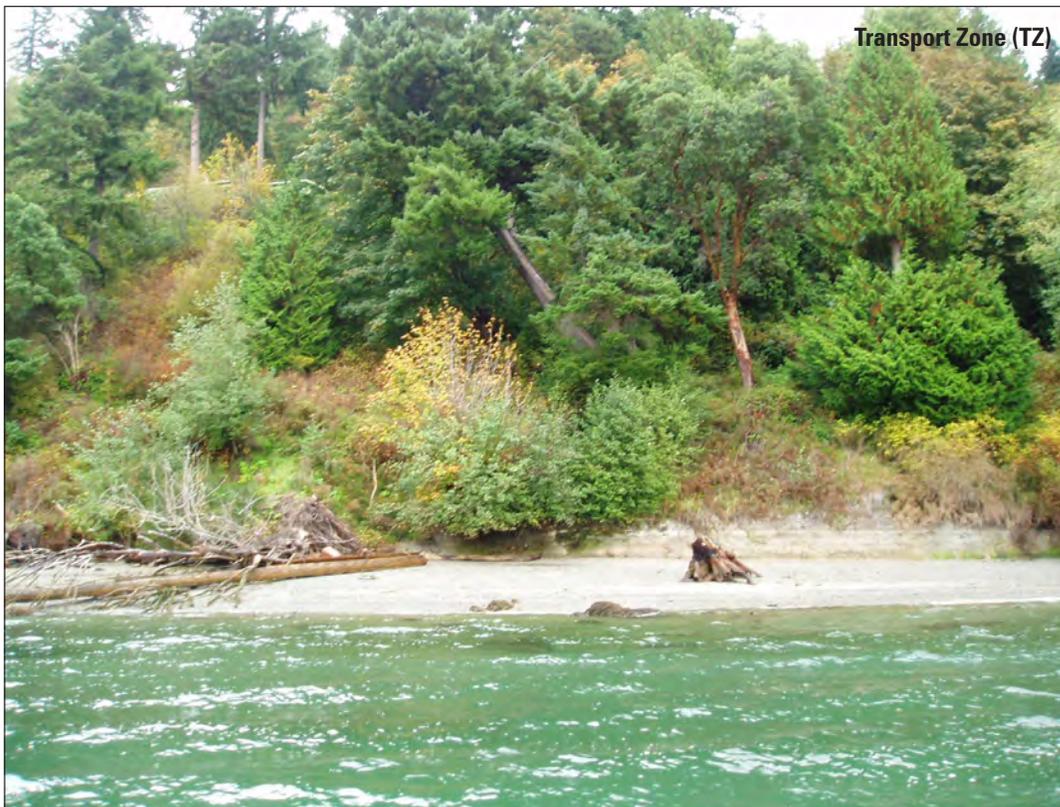
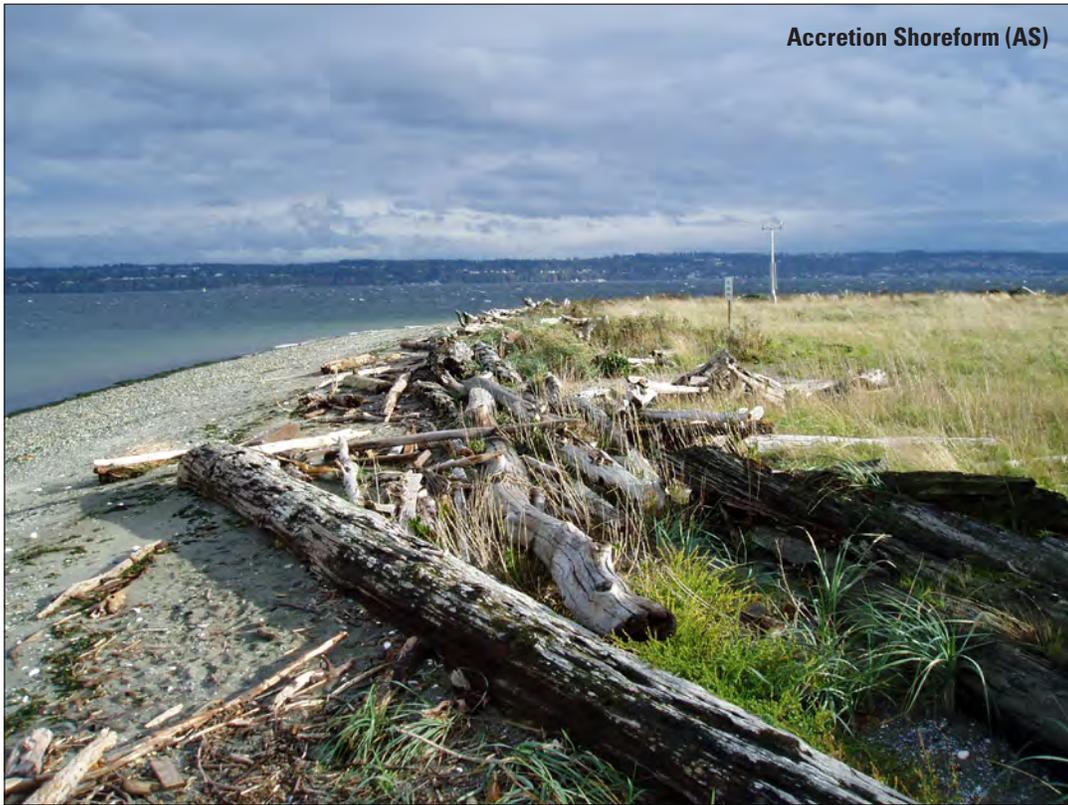
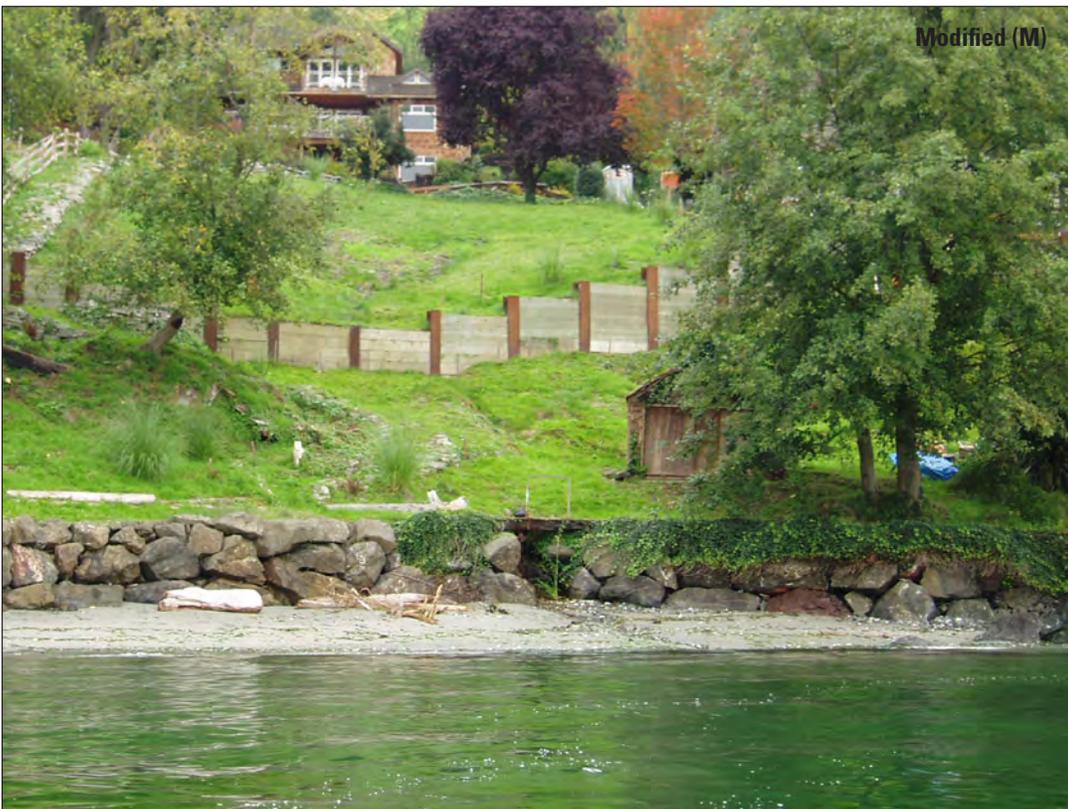
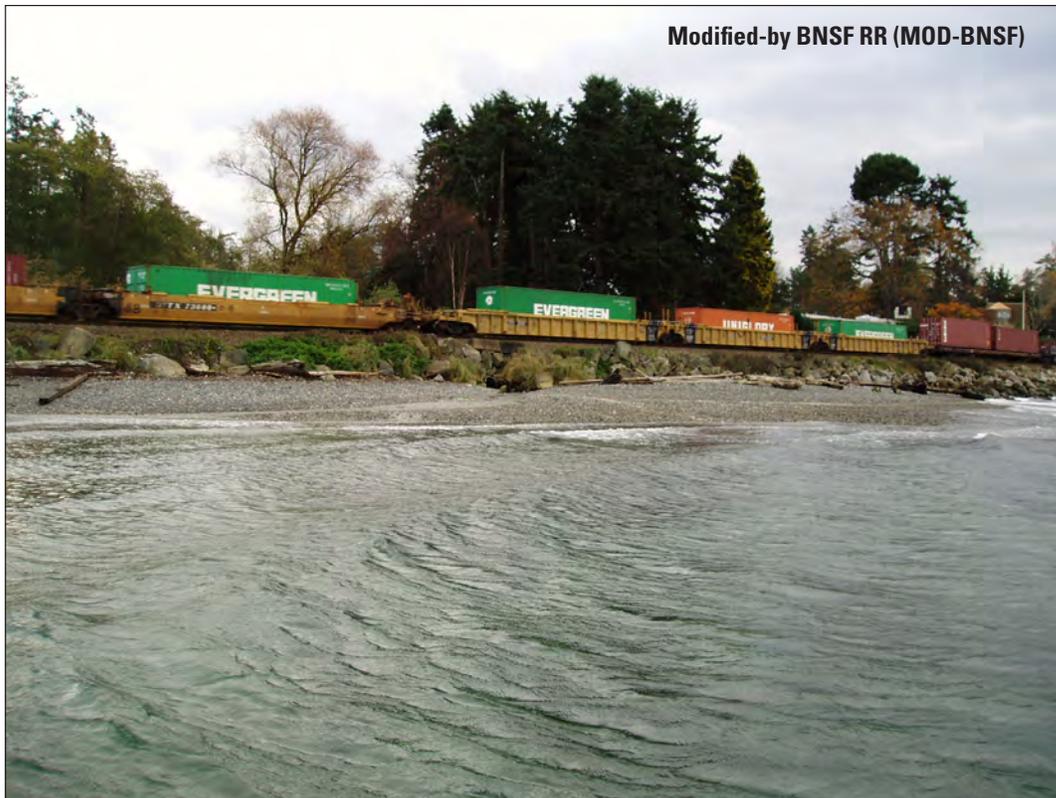
Figure 2. Examples of geomorphic shoretypes in the Puget Sound area. Mapping criteria are provided in table 1.

The **Feeder Bluff Exceptional (FBE)** classification was applied to bluff segments that were experiencing relatively rapid erosion/mass wasting (table 1, fig. 2). The **Feeder Bluff (FB)** classification was used for areas that had moderate erosion/mass wasting and sediment input into the littoral drift system. Feeder Bluff segments identified areas with a longer recurrence interval of sediment input as compared to Feeder Bluff Exceptional segments. **Transport Zone (TZ)** segments represented areas that did not appear to be contributing appreciable amounts of sediment to the system (not feeder bluffs) or showed evidence of past long-term accretion (not accretion shoreforms) and littoral sediment was generally transported alongshore. The **Modified (MOD)** classification was used to designate areas that had shoreline armoring (most commonly residential bulkheads) or that were otherwise altered by the modification such that the bank no longer provided sediment input to the beach system. The **Modified-by BNSF RR (MOD-BNSF)** classification was

used to designate segments that had been altered specifically by the Burlington Northern Santa Fe railroad (BNSF) seawall. The **Accretion Shoreform (AS)** classification identified areas that were depositional in the past or present such as spits or broad no-bank deposits. The **No Appreciable Drift (NAD)** classification was used in areas where there was no appreciable net volume of sediment being transported, following the methods developed by Schwartz and others (1991).

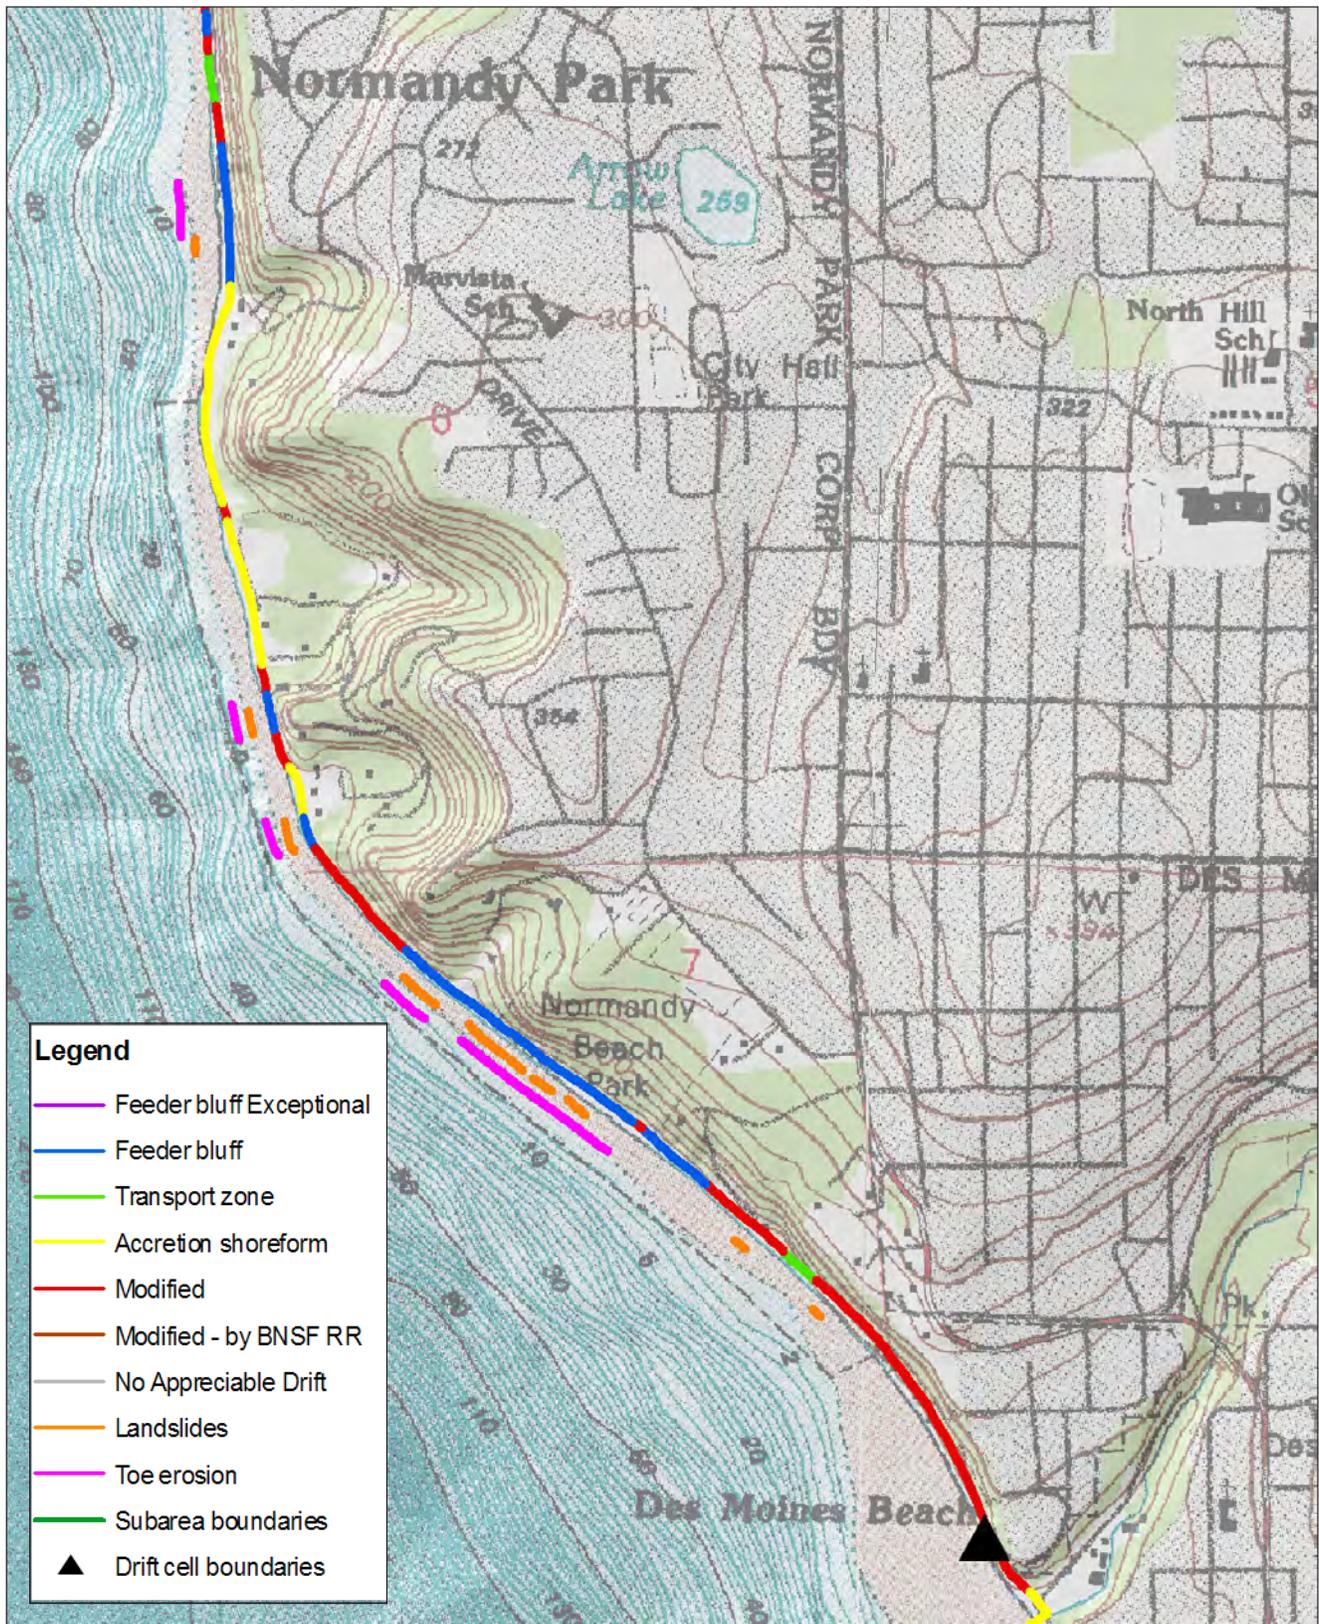
Figure 3. Example of current conditions mapping from Normandy Park in southern King County, Washington.

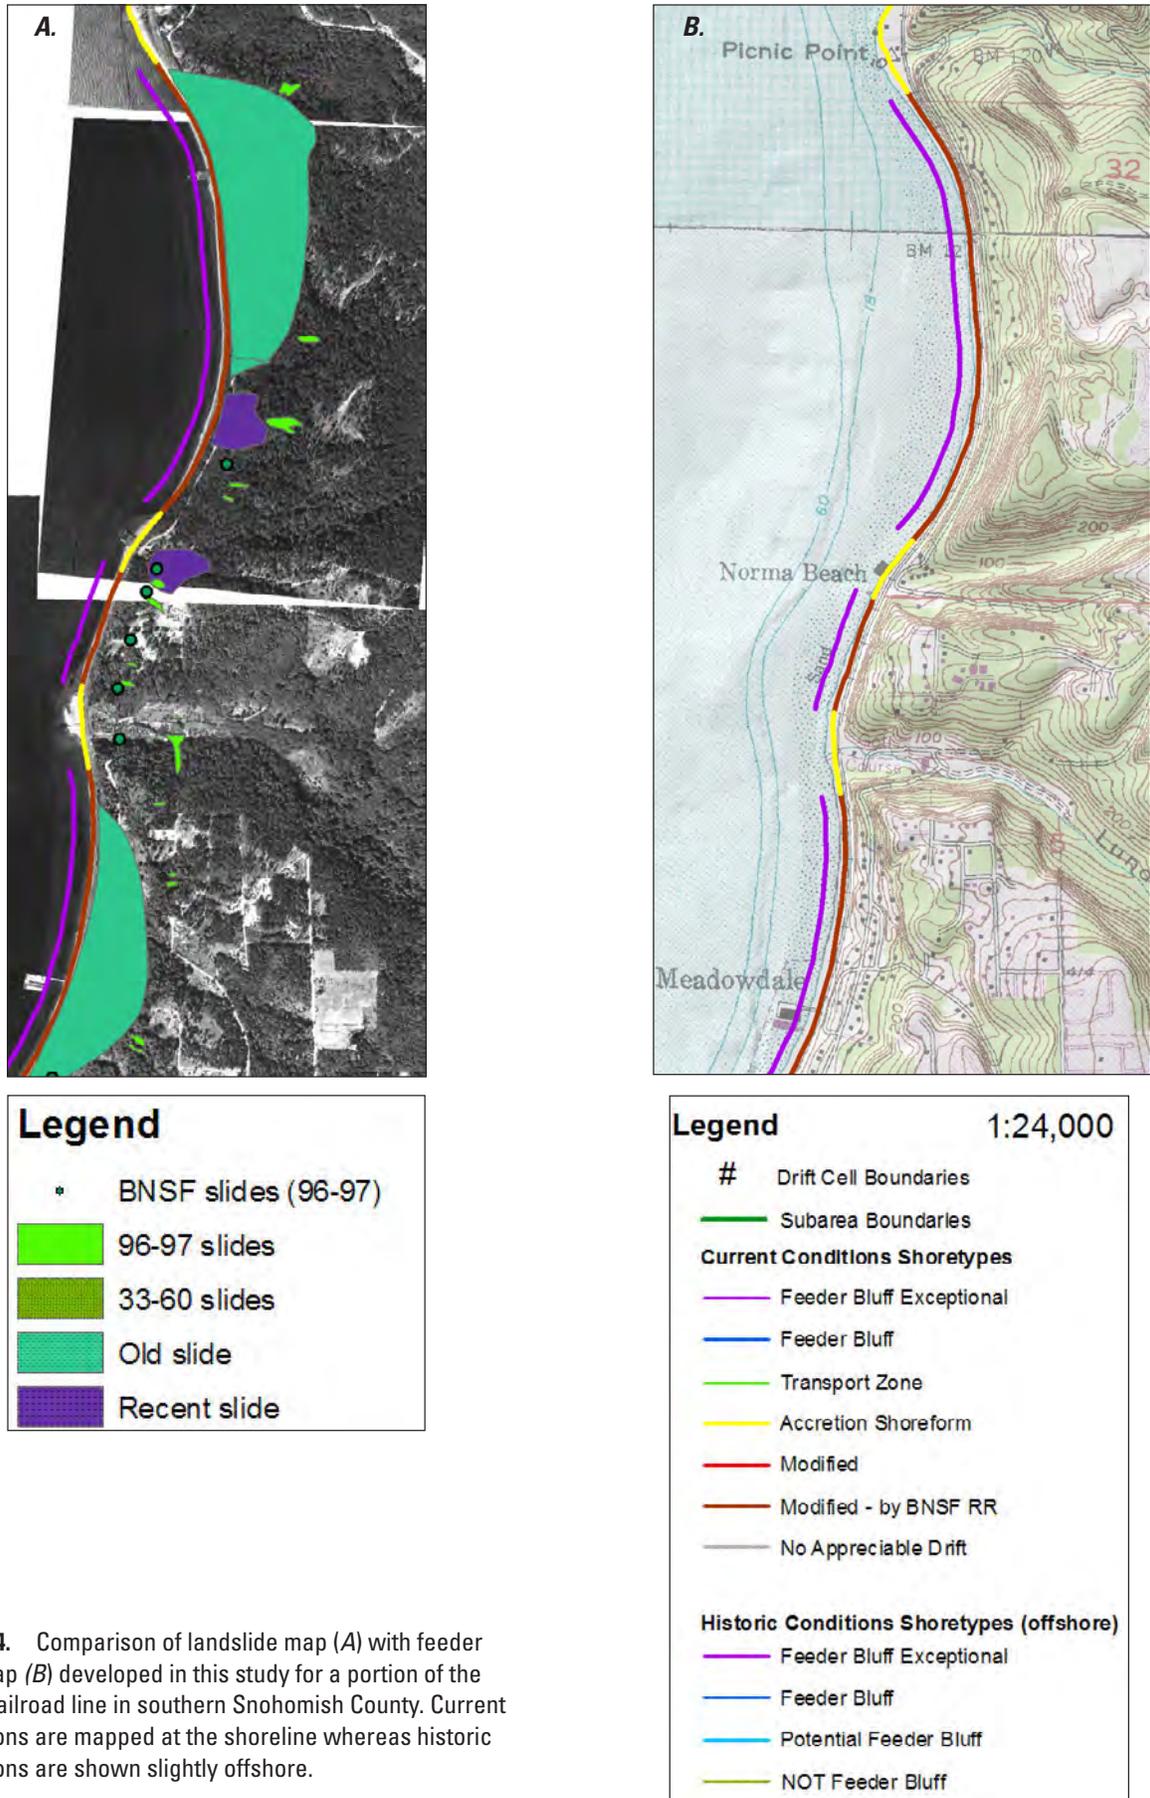
Figure 4. Comparison of landslide map (A) with feeder bluff map (B) developed in this study for a portion of the BNSF railroad line in southern Snohomish County. Current conditions are mapped at the shoreline whereas historic conditions are shown slightly offshore.

Comparison of current conditions to historic conditions mapping revealed that widespread and far-reaching changes have occurred to the study area coast, altering geomorphic processes in numerous ways (Johannessen and others, 2005). An example

of landslide datasets and historic mapping results for a section of the BNSF rail subarea is shown in figure 4. Historic analysis (combined with current conditions mapping) revealed that the most common shoretype mapped in pre-development conditions was Historic Feeder Bluff (table 4). Total historic sediment sources (Historic Feeder Bluff, plus Historic Feeder Bluff Exceptional) comprised one-half of the study area shoreline, as compared to only 18.4 percent in current conditions mapping. *Potential* Historic Feeder Bluffs were not counted as sediment sources because of the ambiguity of the data. When comparing current to historic sediment sources, there was a 63.4 percent loss for the entire study area, leaving only 36.6 percent of the historic sediment sources currently intact.

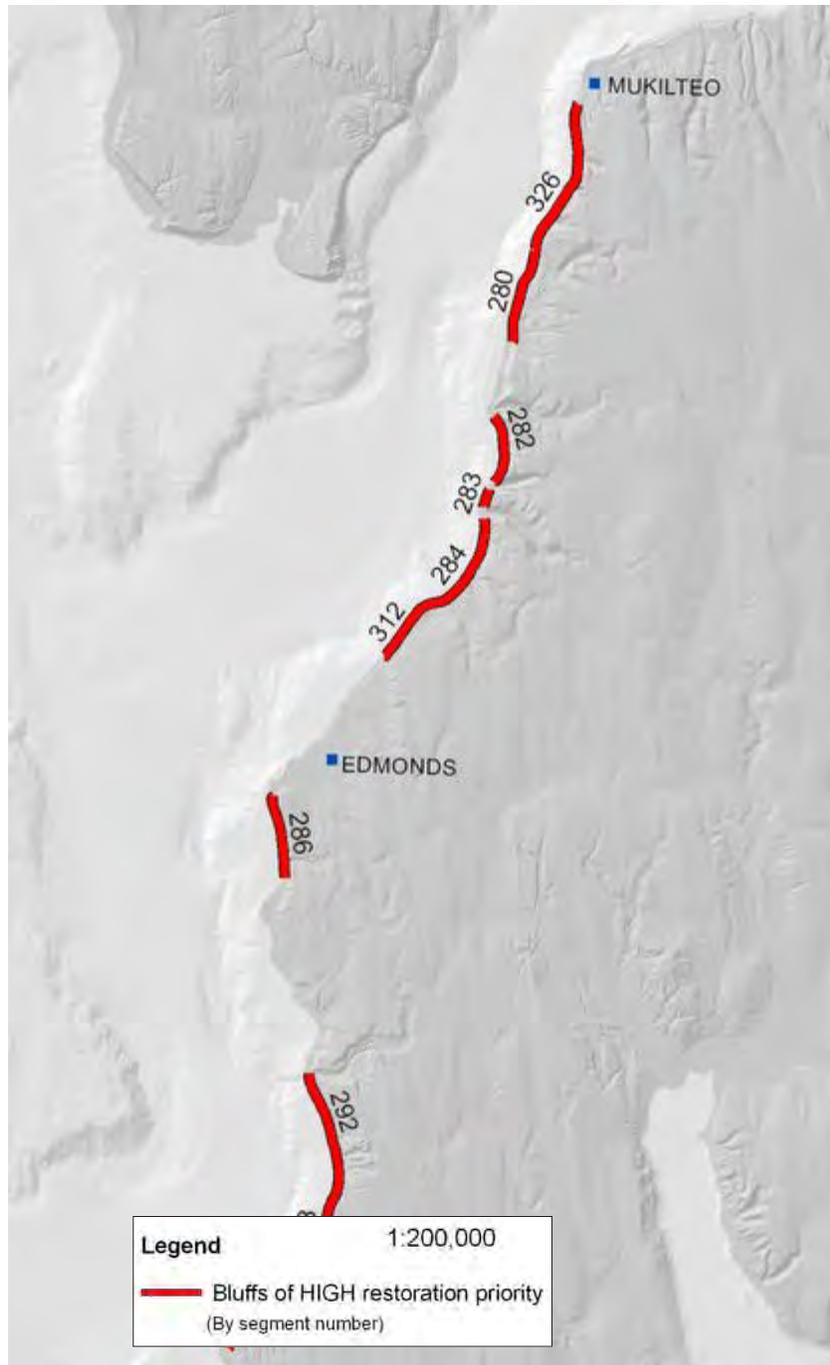
Figure 5. Example of restoration prioritization by segment in southern Snohomish County.

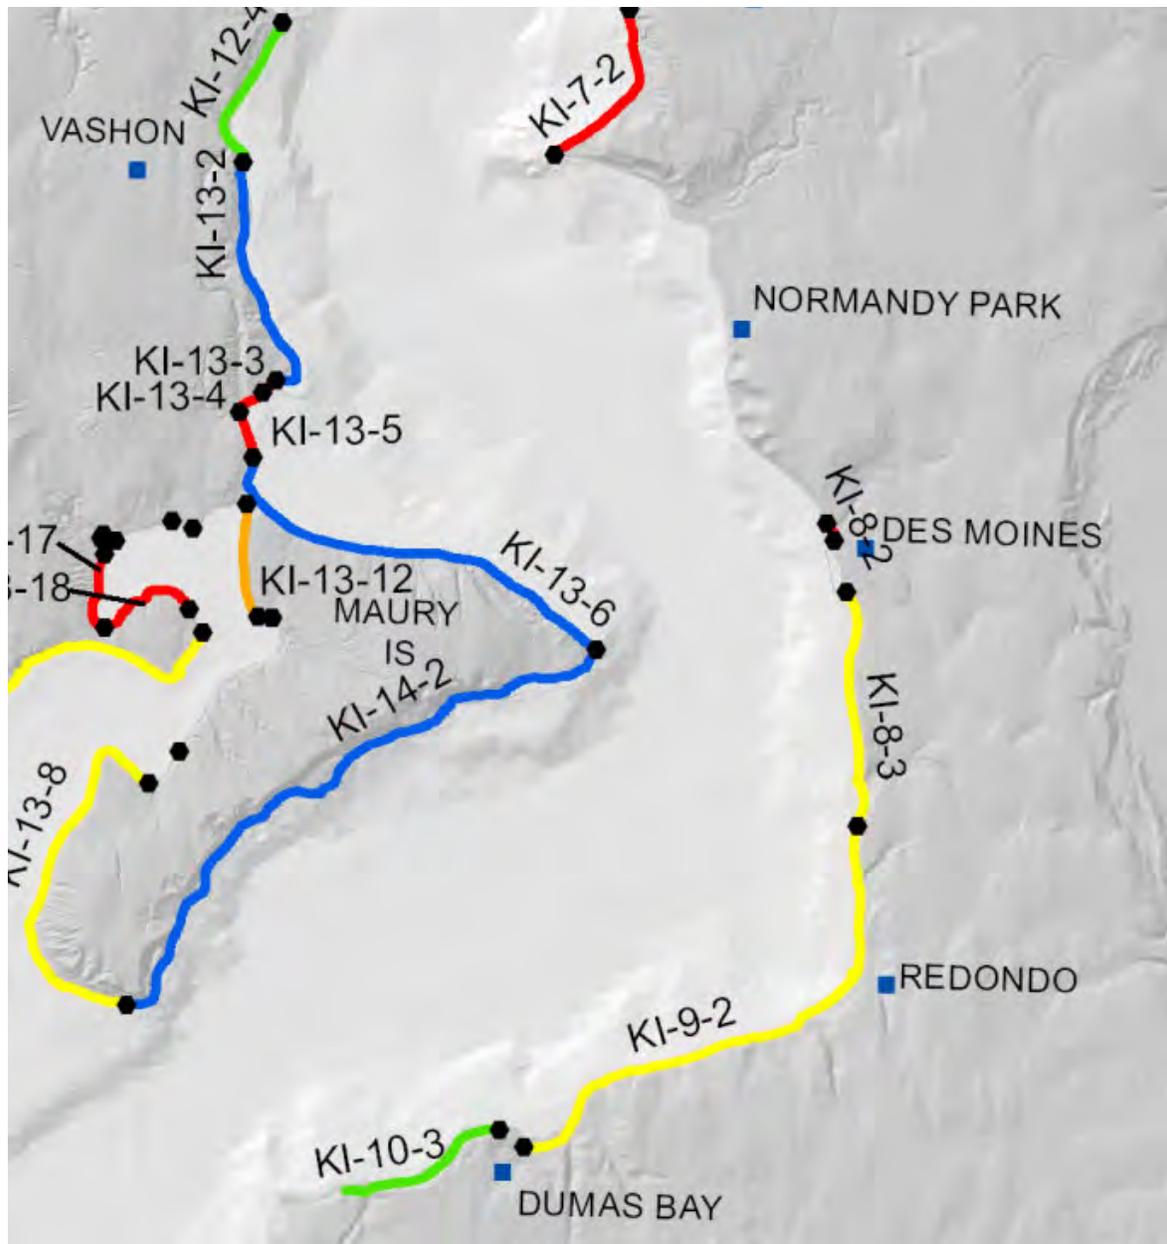
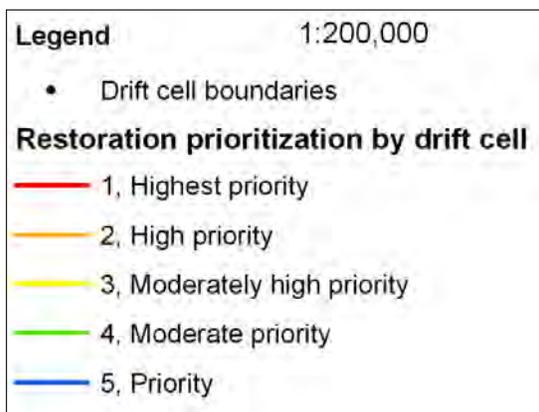
Figure 6. Example of restoration prioritization by drift cell in southern King County.

for entire drift cells and compared the scores across the study area. Results of the restoration prioritization indicate that drift cells with the highest priority for restoration were found along the entire Northern Railroad and Shilshole subareas (fig. 1). Additional drift cells of the highest restoration priority include cell KI-7-2, located on the northern side of Three Tree Point and cells KI-13-17 and KI-13-18 in Quartermaster Harbor (fig. 6).
