Prepared in cooperation with the Puerto Rico Aqueduct and Sewer Authority

# **Sedimentation Survey of Lago Cerrillos, Ponce, Puerto Rico, April–May 2008**

Scientific Investigations Report 2011–5057

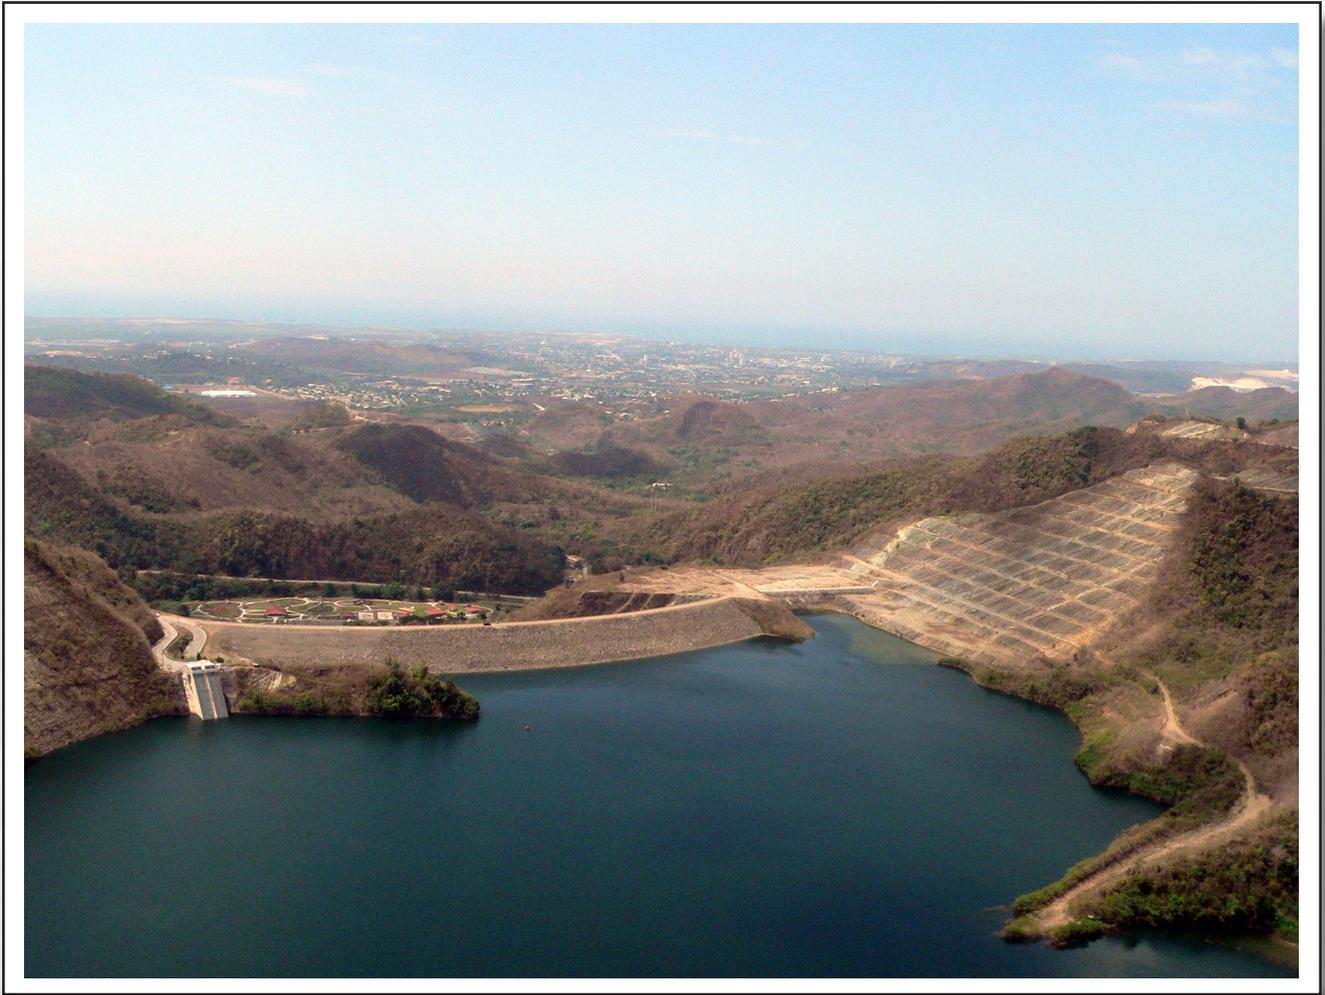
Aerial photograph of the Lago Cerrillos rockfill dam looking down stream. Photograph courtesy of the Puerto Rico Electric Power Authority, taken on May 9, 2006.
