Geomorphic Setting, Aquatic Habitat, and Water-Quality Conditions of the Molalla River, Oregon, 2009–10

Scientific Investigations Report 2012–5017

By Kurt D. Carpenter, Christiana R. Czuba, Christopher S. Magirl, Mathieu D. Marineau, Steve Sobieszczyk, Jonathan A. Czuba, and Mackenzie K. Keith

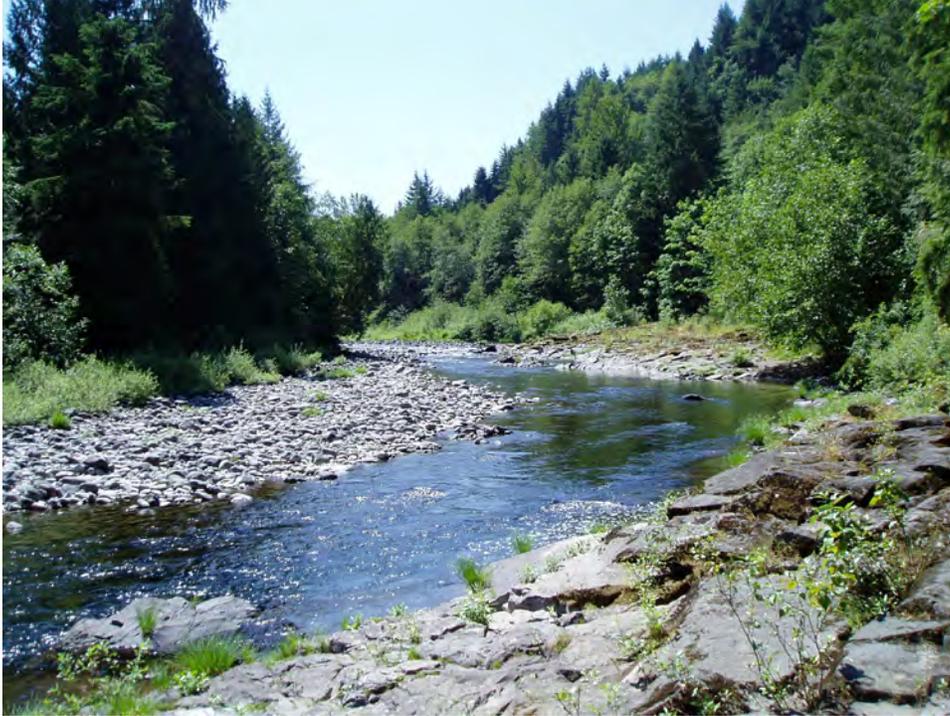
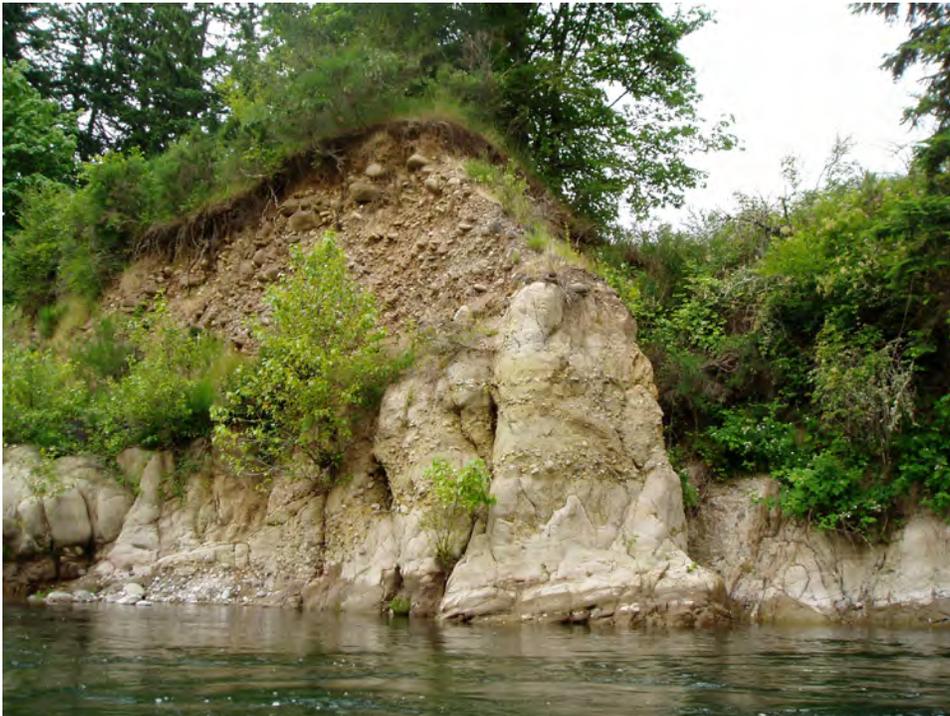
Photographs 1 and 2. Examples of bedrock confining channel migration in the upper Molalla River, GR6. (Photographs taken by Kurt Carpenter, July 30, 2010.)

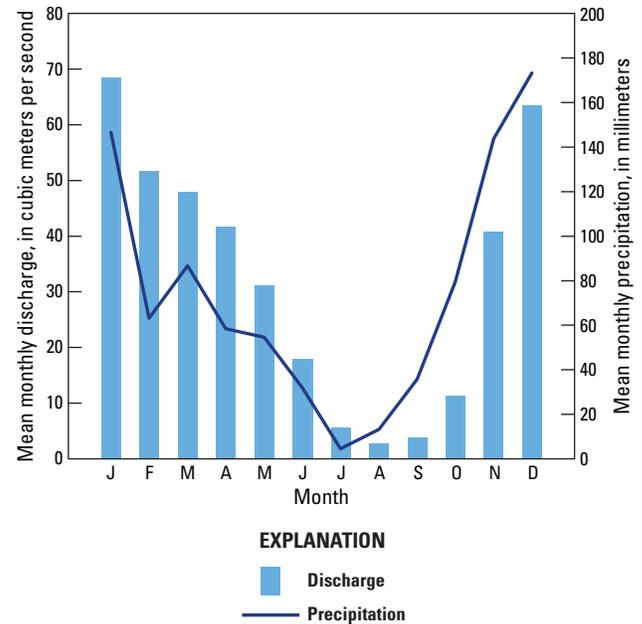
Figure 4. Monthly mean precipitation and discharge of the Molalla River measured at the U.S. Geological Survey streamflow-gaging station Molalla River near Canby, Oregon (14200000).

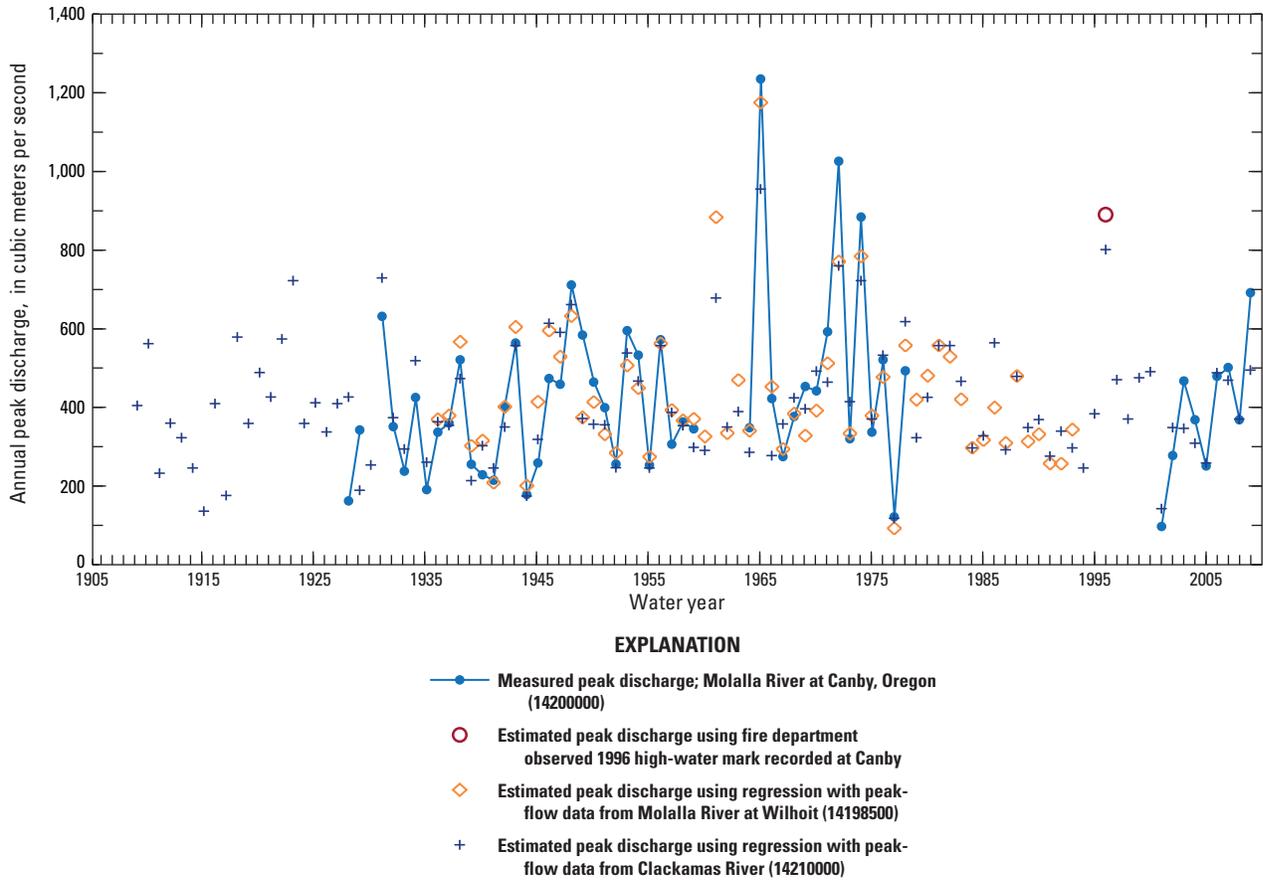
Figure 5. Enhanced annual peak streamflow for the Molalla River near Canby, Oregon, 1909–2009.

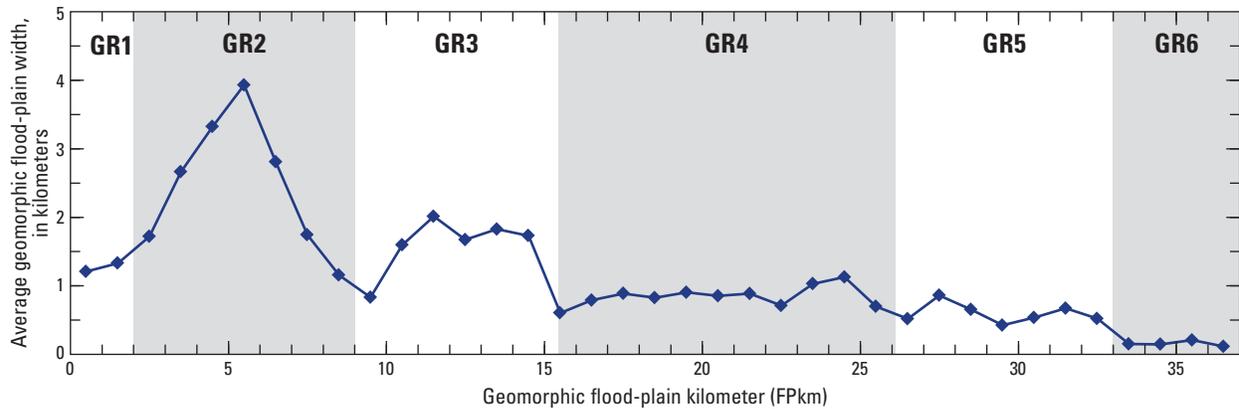
Figure 6. Geomorphic flood-plain width along the Molalla River, Oregon.

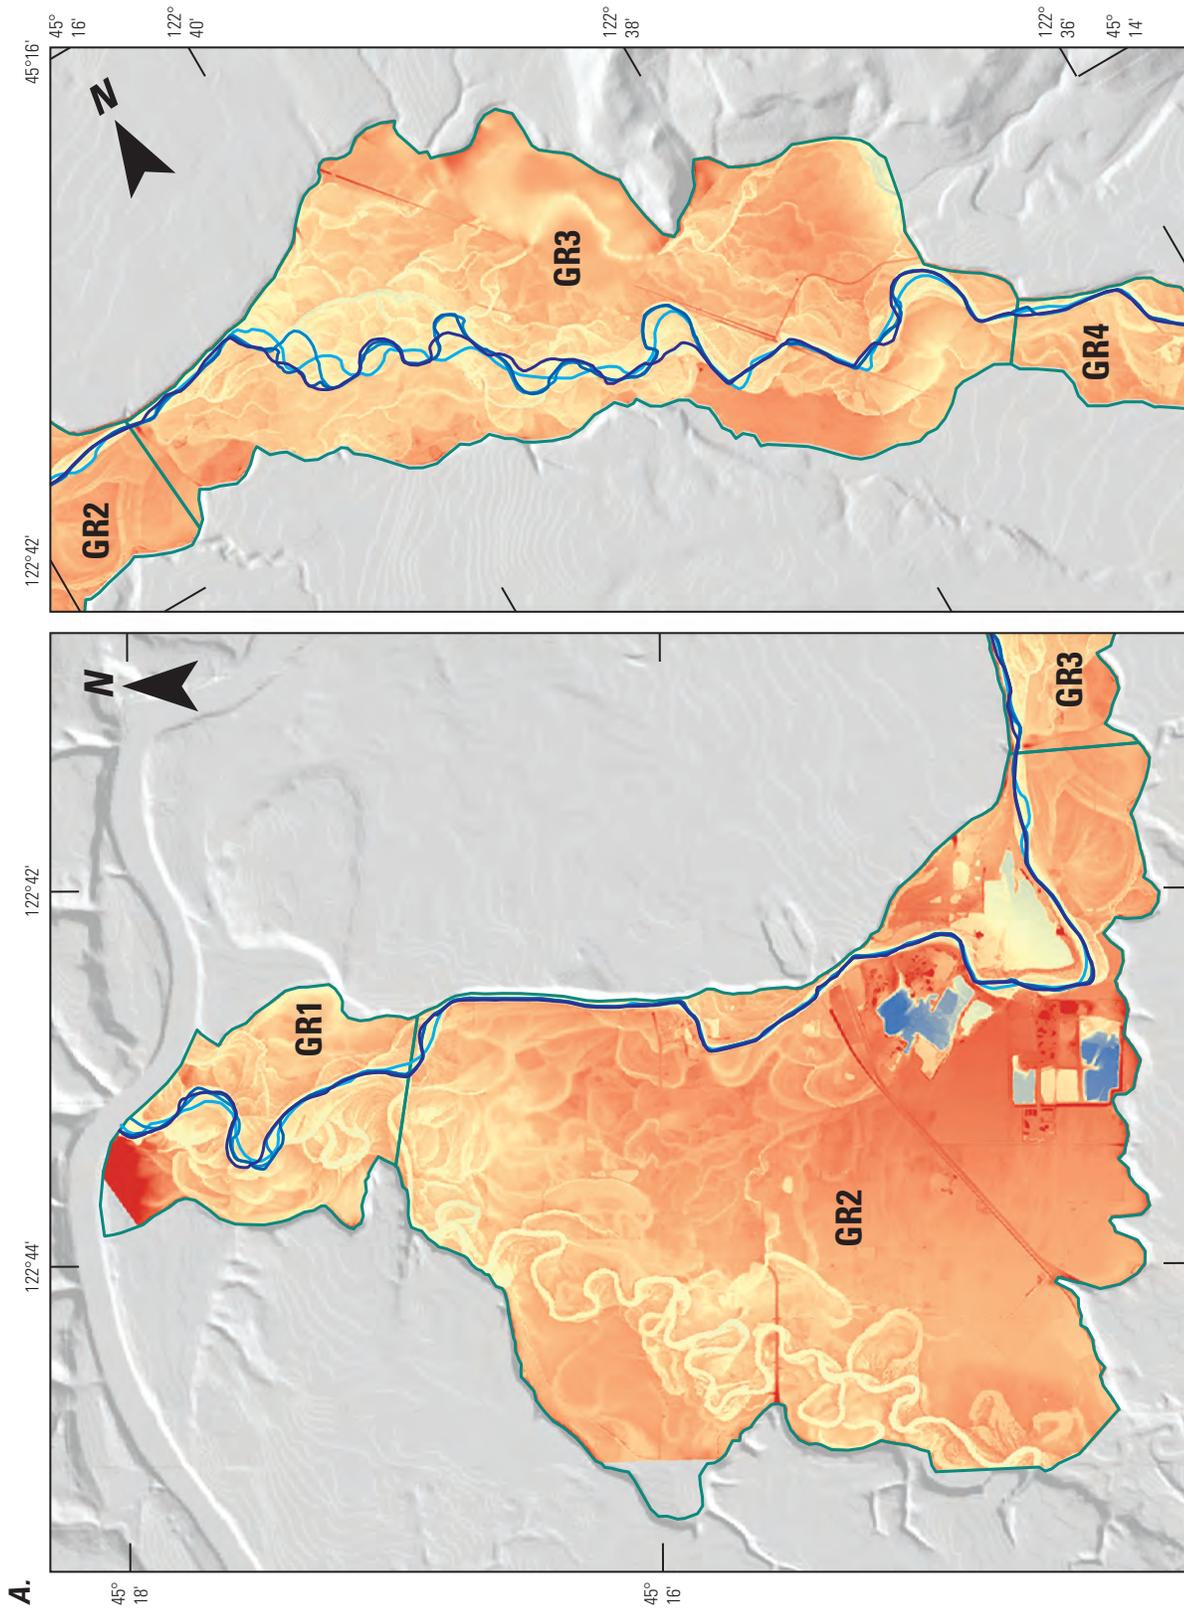
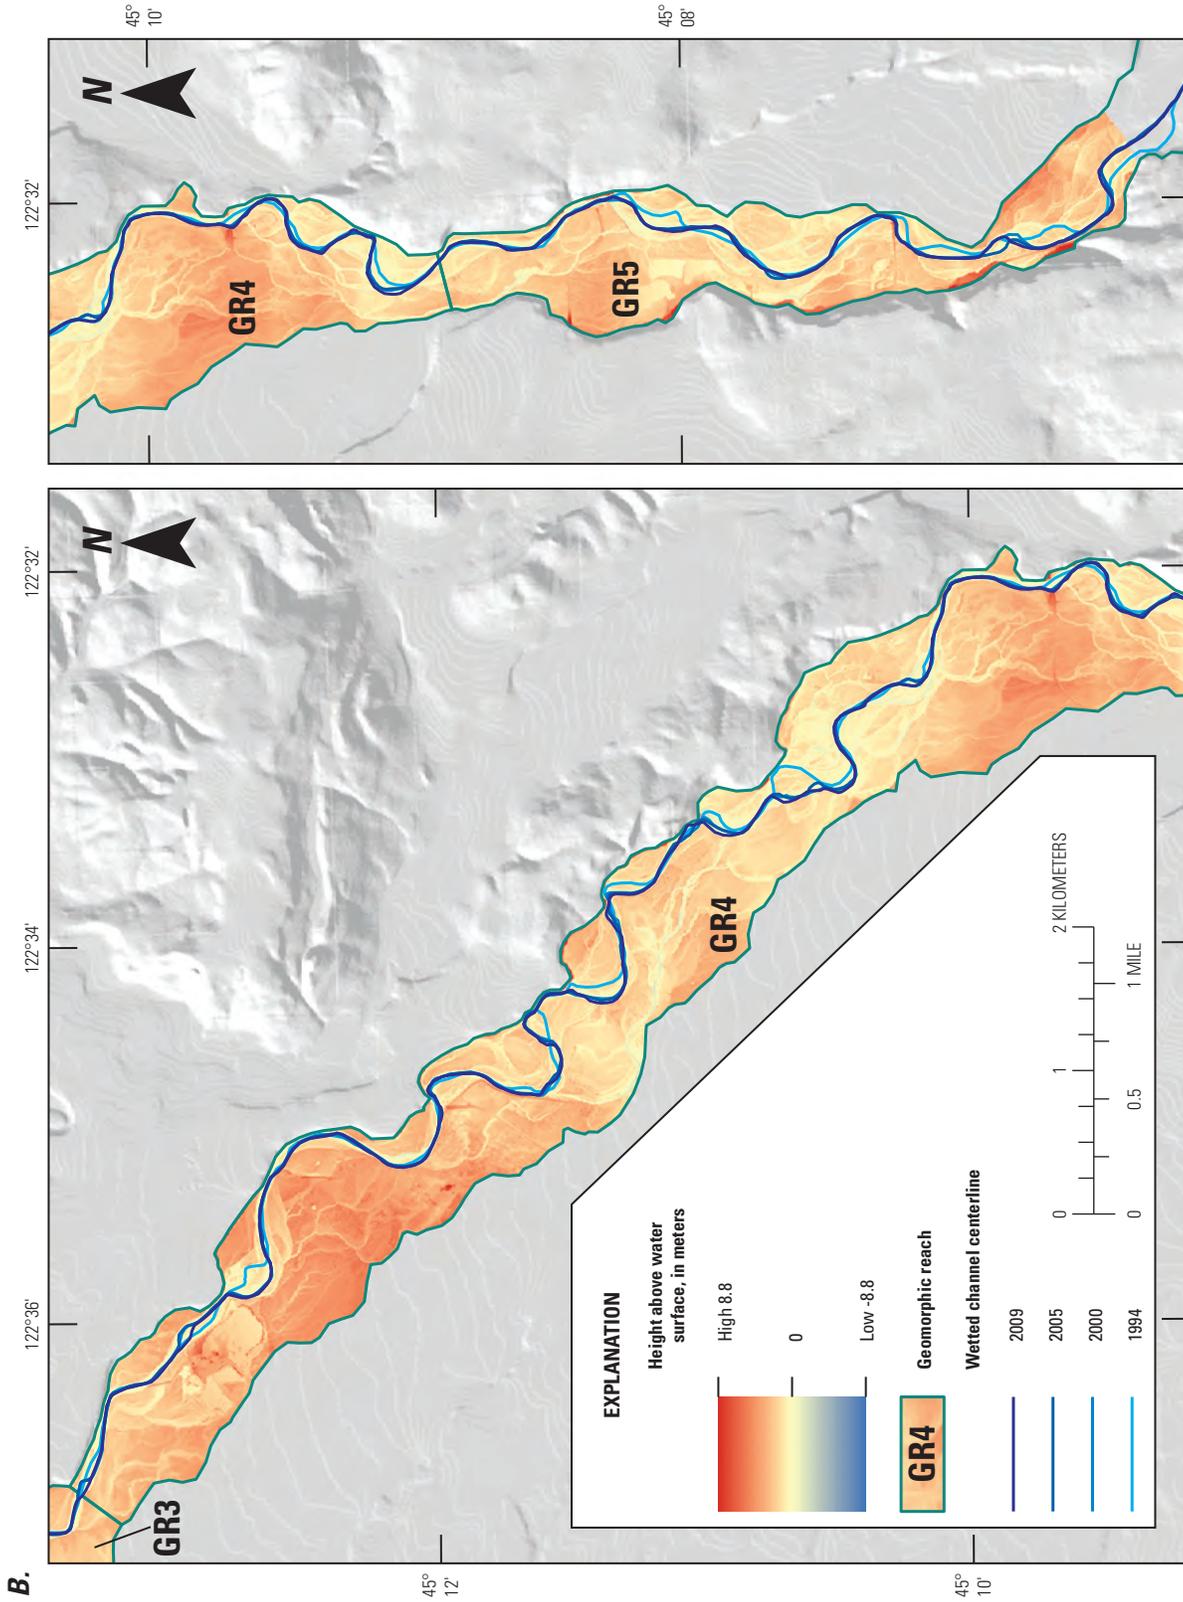
Figure 8. Height above water surface (HAWs) of the Molalla River centered on each geomorphic reach. (Using a technique to show elevation difference of the flood-plain topography relative to the river water surface [Jones, 2006], relict channels and pre-development morphologic structures of river reaches are readily identified.)

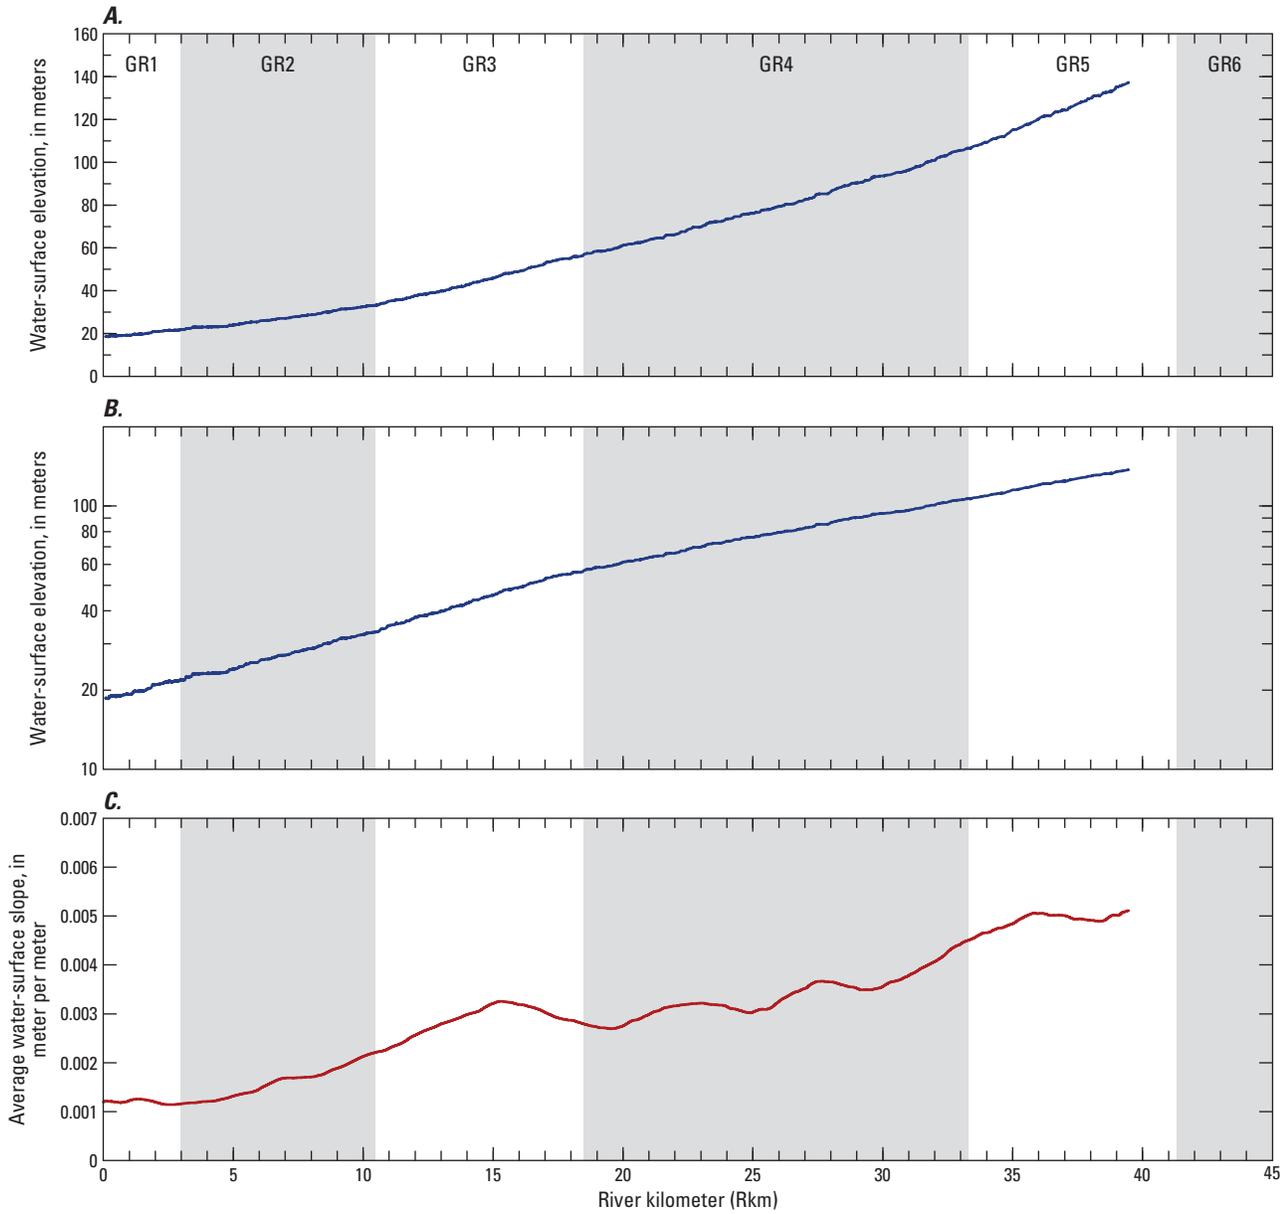
Figure 9. Light Detection and Ranging (LiDAR)-derived longitudinal water-surface elevation profile of the Molalla River, Oregon, with elevation plotted in (A) normal coordinates and (B) semi-log coordinates. (C) The slope of the water-surface elevation is also shown as a function of the river centerline.

The longitudinal water-surface elevation profile of the Molalla River ([fig. 9](#)) is generally concave, consistent with graded rivers that have adjusted their slope to sediment transport supplied from upstream (Macklin, 1948; Knighton, 1998). If the profiles are examined closely, however, they show that the Molalla River deviates from the concave profile of a graded river near Rkm 18 along the interface of GR3 and GR4 ([fig. 9A](#)). This change in curvature is more visible when the longitudinal profile is plotted on a semi-logarithmic scale ([fig. 9B](#)). The slope of the average water-surface ([fig. 9C](#)), computed as a 5-km moving average, shows the steepest portions of the river in the study area to be in the upstream extent with the gradient generally decreasing in the downstream direction to the Pudding River tributary. The increased slope at the upstream end of GR3 is also apparent in the slope data shown in [figure 9C](#).

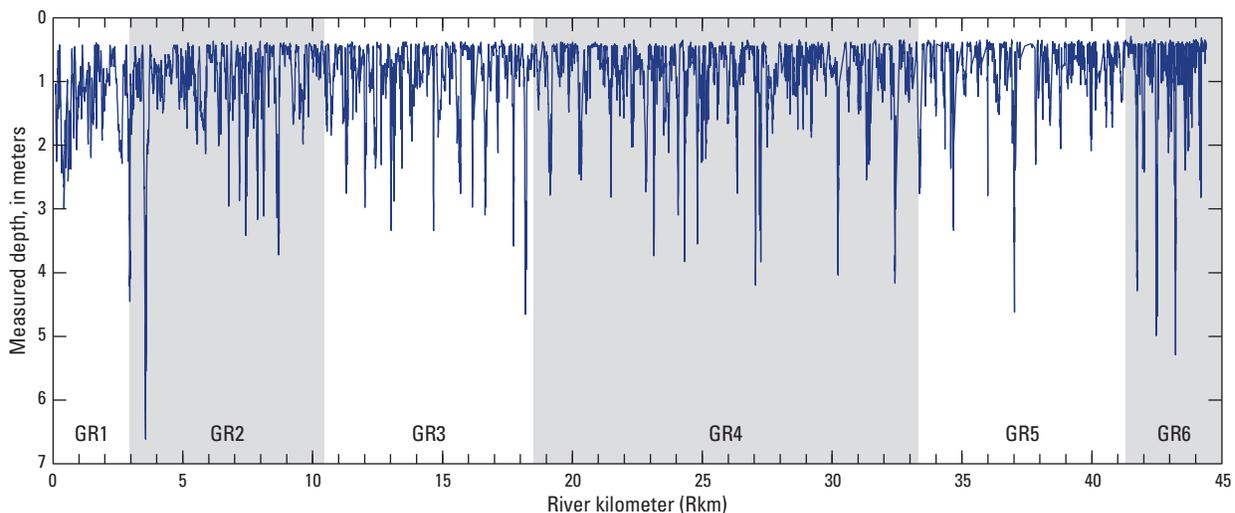
Figure 10. Water depth data from the Molalla River, Oregon, as measured in July 2010 by a fathometer mounted to boat floating down the river thalweg.

Water-depth data measured during the study were related to the river centerline and plotted for the entire study area in [figure 10](#). By joining the measured depth data to the nearest 1-m stationing point along the river centerline and the corresponding longitudinal water-surface elevation, a longitudinal bed-elevation profile was generated. Residual pool depth is defined as the difference between the maximum water depth of a pool and the limiting elevation of the riffle at the downstream extent of the pool (Lisle, 1987). After generating the bed-elevation profile, residual pool depth was computed from Rkm 0 to Rkm 39.41 using an algorithm and software developed by Madej (1999). The Madej algorithm identifies only pools deeper than a user-specified threshold, which was set to 1.0 m for the current study consistent with the threshold used by Madej and Ozaki (2009) for Redwood Creek, California. Redwood Creek, in the California Coastal Range where hydrology is similar to that in northwestern Oregon, drains 720 km², a drainage comparable to the Molalla River.

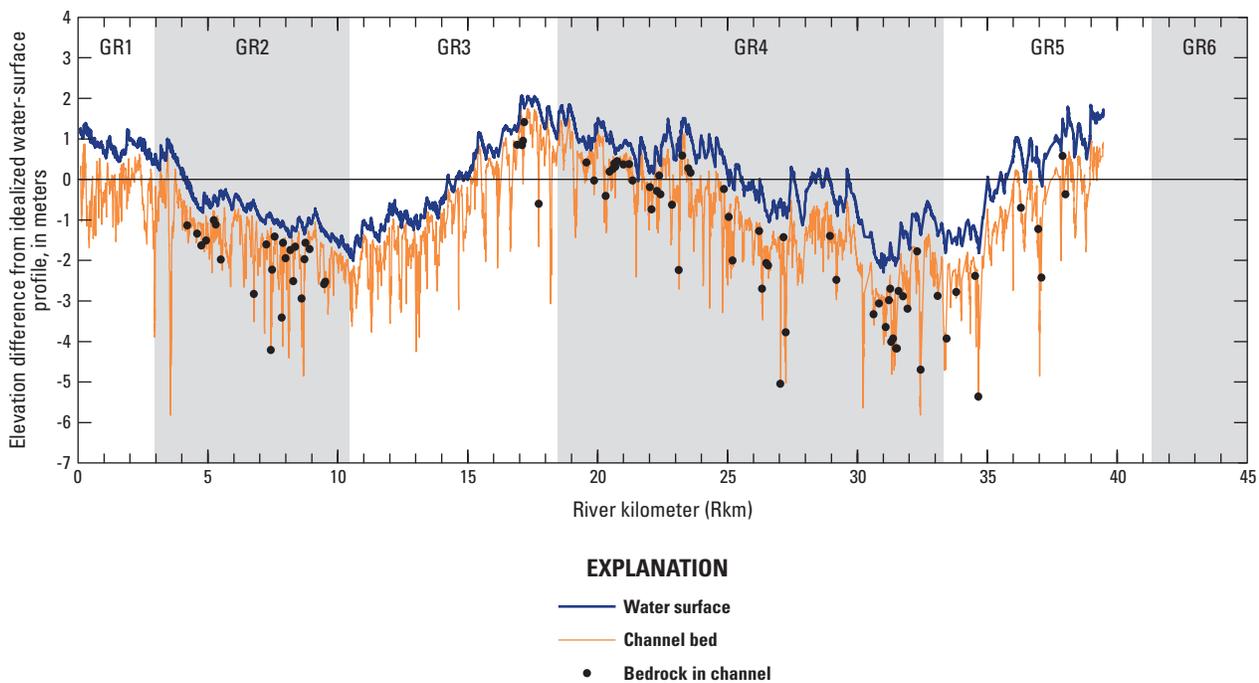
Figure 11. Deviation of water-surface elevation profile from second-order polynomial trendline, and measured channel-bed and bedrock within the channel, Molalla River, Oregon.

There is little evidence that the river in GR6, GR5, or GR4 is aggrading or otherwise filling with sediment. Channel bedrock is present through the river corridor in these reaches ([fig. 11](#)), and channel migration rates between 2005 and 2009 ([fig. 17](#)) were small compared to migration rates observed in GR3. Although there were indications that a pulse of sediment accumulated in GR4 by 1948, no contributing effects of this sediment are evident in the channel dynamics of the last few decades. Upon closer inspection, the gravel and cobble bars upstream of the Highway 211 bridge in GR5 and GR6 that appeared elevated when viewed from the flood plain were found to be deposited in the river corridor at an elevation controlled by underlying bedrock, not by excess sediment. Although not directly evaluated or calculated, the sediment transport capacity of the Molalla River appeared to exceed the available sediment load. Moreover, there is little evidence to support the hypothesis that large volumes of sediment are being transported into the study reach from the upper part of the catchment.

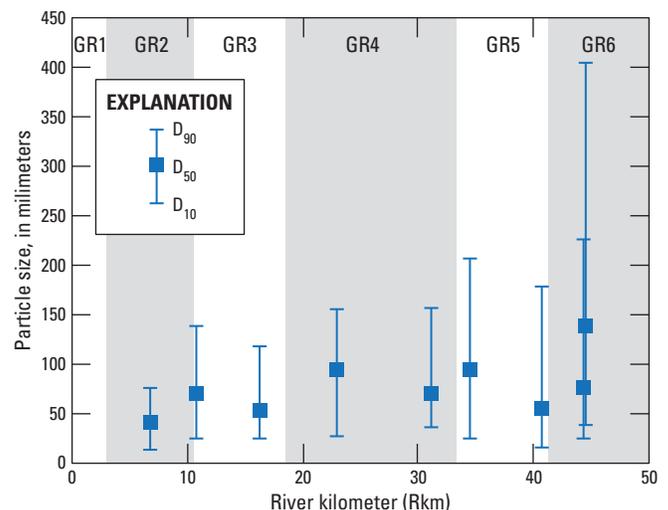
Figure 12. Distribution of particle-size data collected using Wolman (1954) pebble counts on nine freshly deposited bars along the river corridor of the Molalla River, Oregon.

Figure 12 shows the median particle-size (D_{50}), the 90th percentile particle-size (D_{90}), and the 10th percentile particle-size (D_{10}) data for the nine sampled bars in the Molalla River (appendix A). GR6 had the coarsest collection of particles, and median size decreased generally in the downstream direction, with GR2 having the finest particles. The farthest upstream location, just upstream of Glen Avon Bridge at Rkm 44.32, had a median particle size of 139 mm and a D_{90} of 405 mm. The bar just downstream of Glen Avon Bridge, at Rkm 44.12, had a median particle size of 76 mm and a D_{90} of 227 mm. This section of river, upstream of the North Fork Molalla River, had a plane-bed morphology with few recently deposited cobble bars. The sampled region upstream of Glen Avon Bridge, in particular, was a higher, exposed part of the main channel-forming bed composed of coarse particles and was not an accurate representation of the particles mobilized in a bankfull event. Instead, the sampled bar downstream of Glen Avon Bridge, with a smaller overall particle-size distribution, better represented the material mobilized in a bankfull event. Indeed, from this bar downstream of Glen Avon Bridge through GR3, the median grain size on the bars remained relatively constant, suggesting efficient transport, although there was a general downward trend in D_{90} (fig. 12). The one sampling location in GR2 showed a median size of 42 mm and a D_{90} of 77 mm.

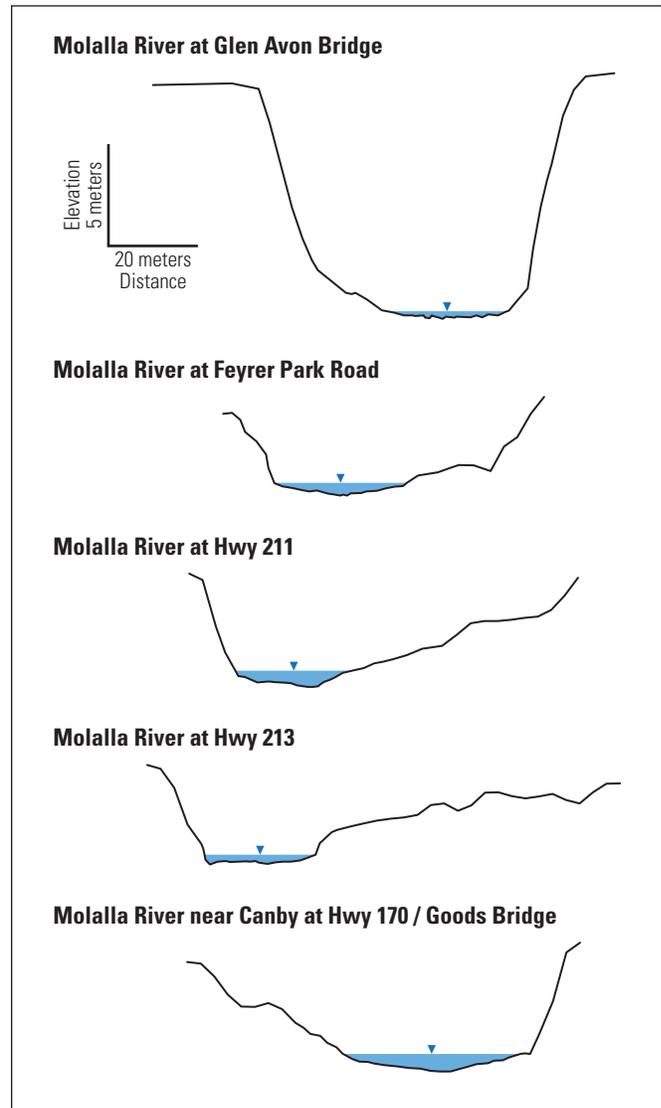
Figure 13. Comparison of measured geometry of five river cross sections surveyed on the Molalla River, Oregon. (The viewer's perspective is looking downstream and the horizontal blue line represents the water-surface elevation on the day of the survey. The vertical exaggeration is 4.6x.)

The five surveyed cross sections (fig. 3; fig. 13) show a general trend of increasing channel width downstream. At the Glen Avon Bridge, the river is relatively confined within the canyon. At the other cross sections, the river is less confined, with gravel and cobble bars (near the right bank at Feyrer Park, Highway 211, and Highway 213) and low terraces or benches (near the right bank at Highway 211 and Highway 213, and near the left bank at Goods Bridge) within the river banks.

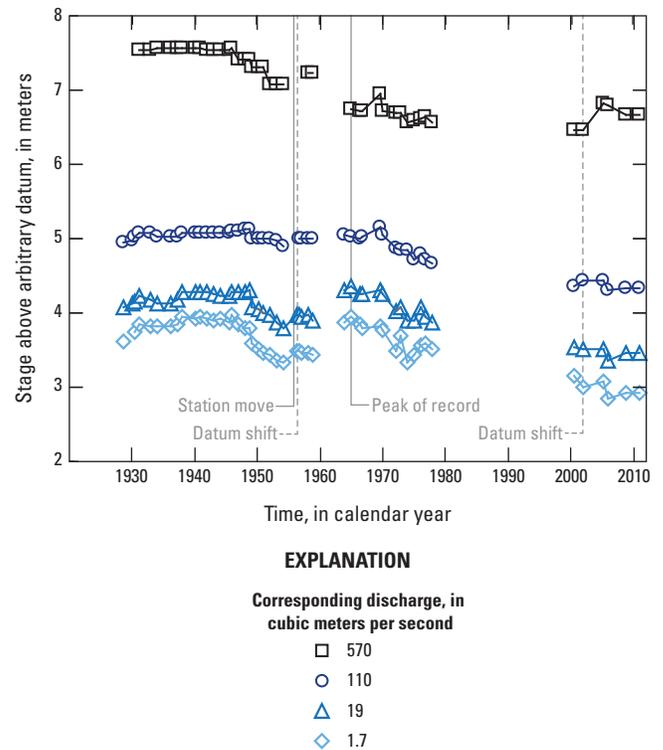
Figure 14. Trends in stage of water-surface elevation at the U.S. Geological Survey streamflow-gaging station 14200000, Molalla River near Canby, Oregon. (Stage was determined for the 5-year recurrence-interval peak [570 m³/s, or 20,100 ft³/s], the 5 percent exceedance value [110 m³/s, or 3,800 ft³/s], the median discharge [19 m³/s, or 670 ft³/s], and the 95 percent exceedance value [1.7 m³/s, or 60 ft³/s]. Gaging station moves and datum shifts are shown on the graph as is the peak of record on December 22, 1964.)

Figure 14 shows the overall trends in stage in the Molalla River near Canby (14200000) from 1928 to 2010. Each data point represents the reported stage for a given discharge value on that date. Two gaps in the data show when the gaging station was not in operation: November 1958 to October 1963 and November 1977 to October 2000. All data were corrected to accommodate station moves or shifts in the datum such that all the points shown in figure 14 are displayed relative to a common datum. As a result, all stage values for a given discharge are directly comparable, even across data gaps when the gaging station was not operating. From 1928 to about 1948, stage at all analyzed discharge values was relatively constant, shifting by no more than a few centimeters. From 1948 to 1953, stage decreased about 0.25 m for all discharge values, indicating a general trend of incision. This decrease may have been associated with gravel mining commonly practiced along the Molalla River in the middle 20th century (Cole and others, 2004). Between cessation of gaging station operation in 1958 and reactivation of the gaging station in 1963, low-flow stage increased about 0.25 m and high-flow stage decreased a similar amount. From 1958 to 1977, stage decreased at a steady rate. Between 1977 and 2000, the second period when the gaging station was not in operation, stage decreased by another 0.25 m. From 2000 to 2010, stage has fluctuated slightly, but there has been no consistent upward or downward trend. Taken as a whole, the gaging record at Canby shows a general trend of incision for the latter half of the 20th century. More importantly, there was no appreciable aggradation downstream of the gaging station in the past 10 years. Notably, the river downstream of the gaging station did not change appreciably after the December 1964 peak of record.

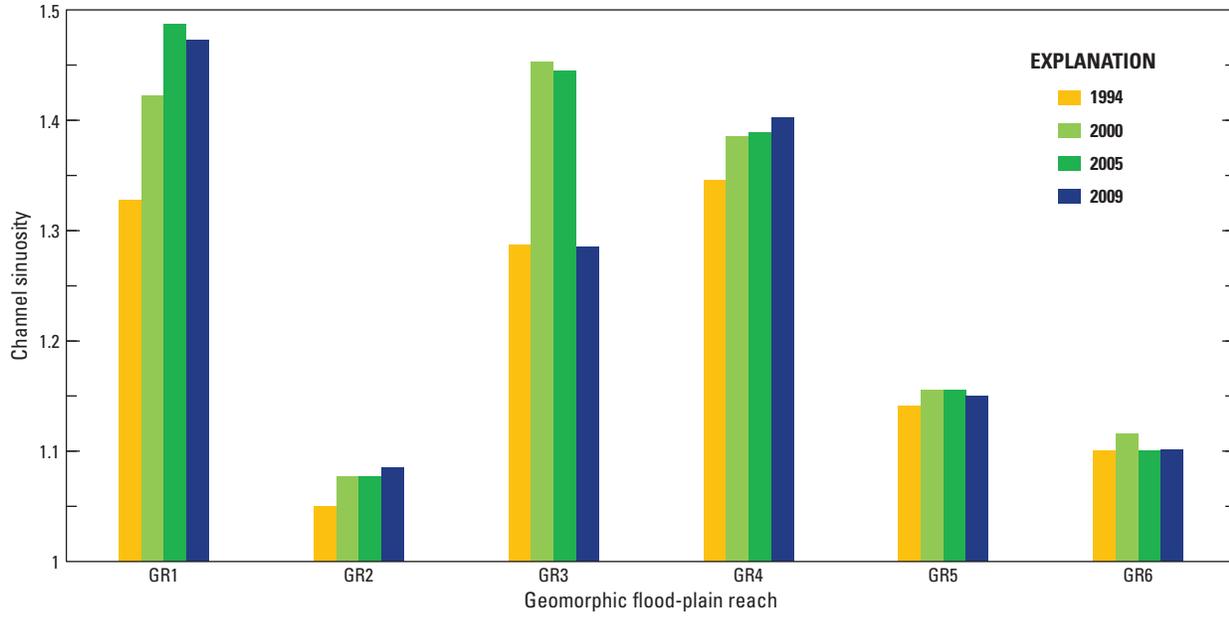
Figure 15. Historical changes in channel sinuosity, averaged over geomorphic flood-plain reaches, for the Molalla River, Oregon, 1994–2009.

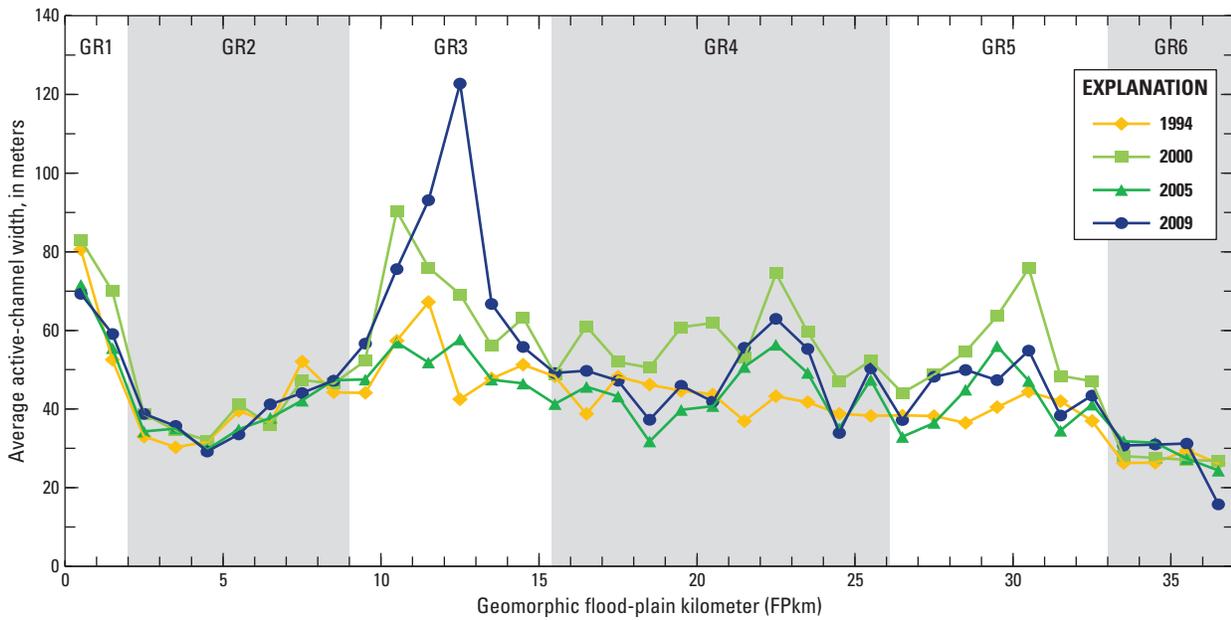
Figure 16. Historical changes in active-channel width, averaged over each 1-FPkm subreach segment, for the Molalla River, Oregon, 1994–2009.

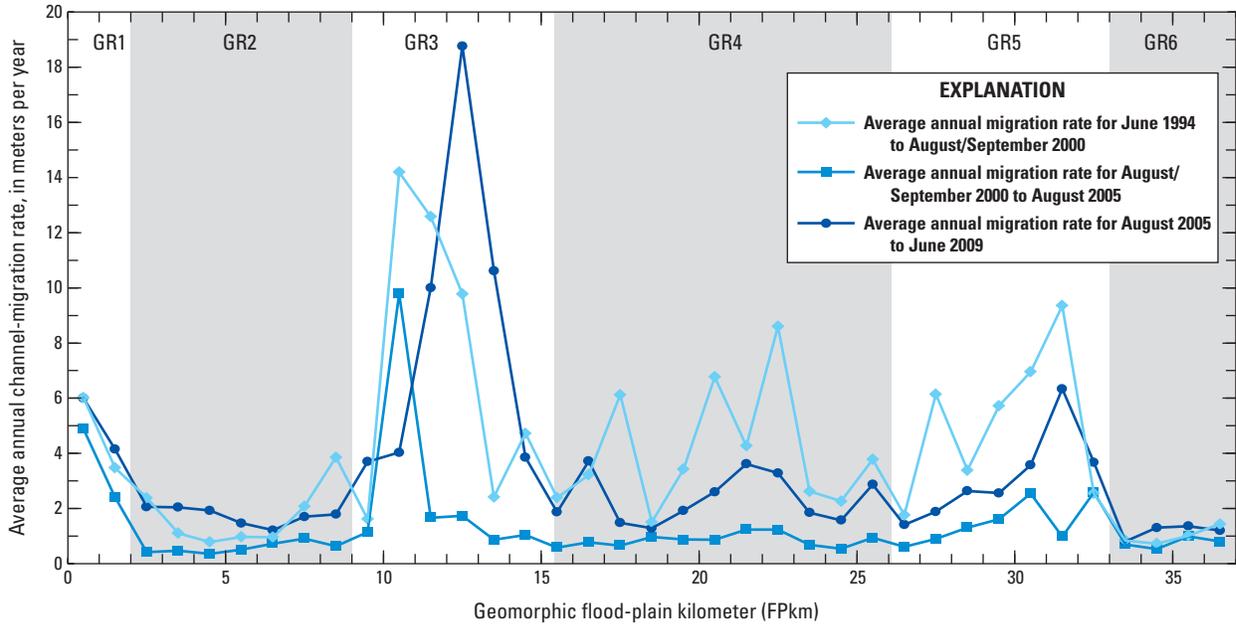
Figure 17. Average annual channel-migration rates, averaged over each 1-FPkm subreach segment, for three time periods between aerial imagery, Molalla River, Oregon, 1994–2009.

Consistent with the observed trends in active-channel width, calculated channel-migration rates were largest from GR5 downstream to GR3, and overall channel-migration rates were largest in GR3 ([fig. 17](#)), the reach of river prone to extensive management issues for residents living along the banks. In general, channel-migration rates were smallest from 2000 to 2005 throughout the entire study reach, which is indicative of a hydrologic period with smaller peak flows ([fig. 5](#)). Channel migration was largest within GR3 for all three periods, with the largest channel-migration rates occurring between 2005 and 2009. From 1994 to 2000, the period bracketing the large February 1996 high flow, channel-migration rates in GR4 and GR5 were generally larger than during the other two periods ([fig. 17](#)).

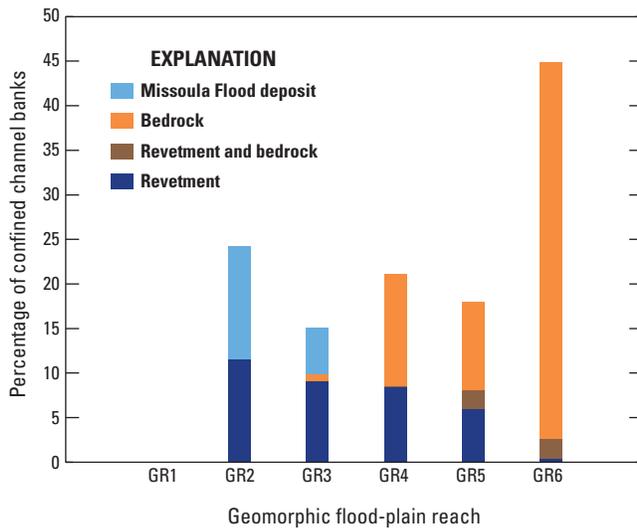
Figure 18. Percentage of channel banks confined by bedrock, revetment, or Missoula Flood deposits along the Molalla River, Oregon, in 2010.

The increased channel-migration rates observed from GR5 downstream to GR3 were due, at least partially, to the presence of fewer channel confinements ([fig. 18](#)). The percentage of channel margins confined by bedrock outcrops, revetments, or coarse-grained Missoula Flood deposits varied from 0 percent in GR1, where there were no significant revetments or bedrock outcrops on the banks, to nearly 45 percent in GR6 ([fig. 18](#)). In GR2, there were numerous revetments on both the left and right banks. Additionally, the right-bank channel abuts Missoula Flood deposits throughout much of GR2. Although there are revetments in GR3, most

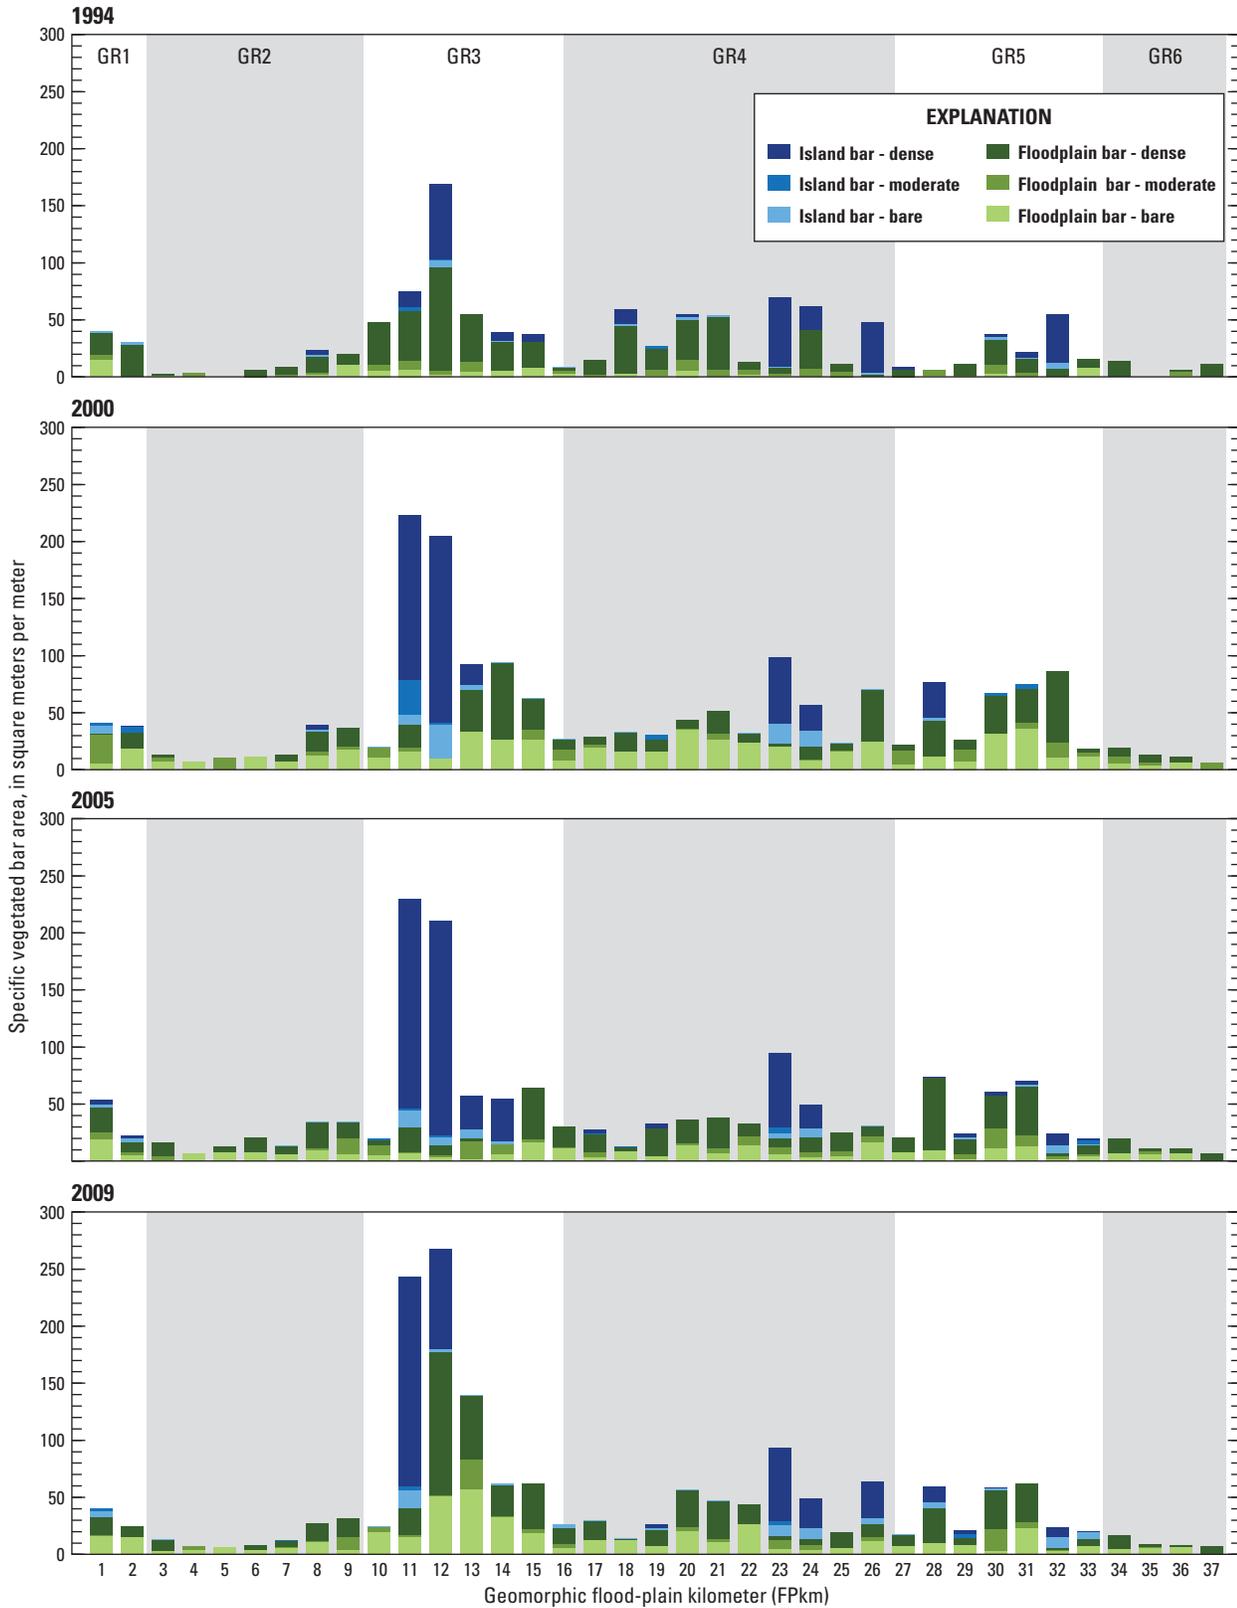
Figure 19. Historical changes in specific vegetated bar area averaged over each 1-FPkm subreach segment, separated by bar type and vegetation density, along the Molalla River, Oregon, 1994–2009.

Specific vegetated bar area (the total height of the columns on the graph) was greatest in GR3, indicative of active channel migration and a large riparian corridor ([fig. 19](#)). In contrast, specific bar area was smallest from restricted channel migration in GR2 and GR6 for all four time periods. Specific bar area is variable temporally in portions of GR3, GR4, and GR5. In 1994, most of the flood-plain and island
