Geomorphic Setting, Aquatic Habitat, and Water-Quality Conditions of the Molalla River, Oregon, 2009–10

Scientific Investigations Report 2012–5017

By Kurt D. Carpenter, Christiana R. Czuba, Christopher S. Magirl, Mathieu D. Marineau, Steve Sobieszczyk, Jonathan A. Czuba, and Mackenzie K. Keith

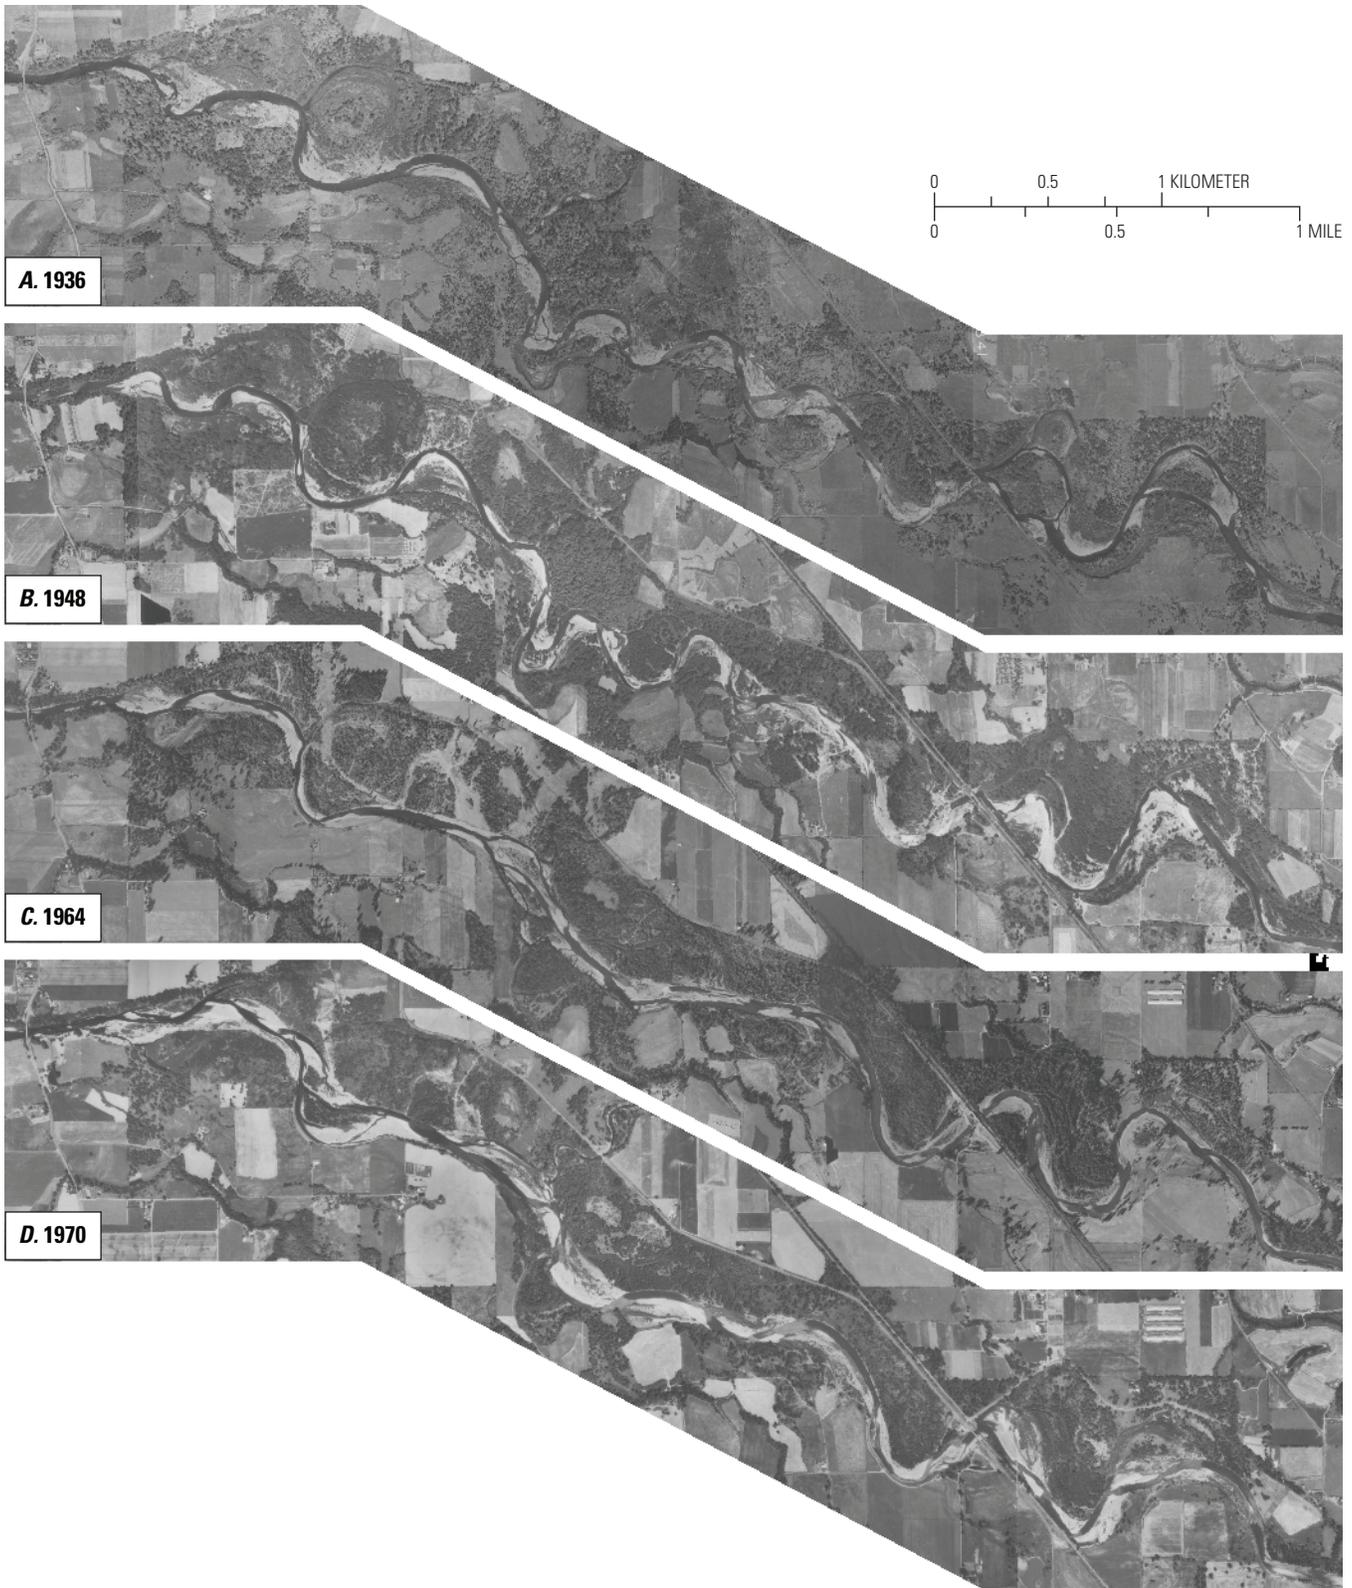
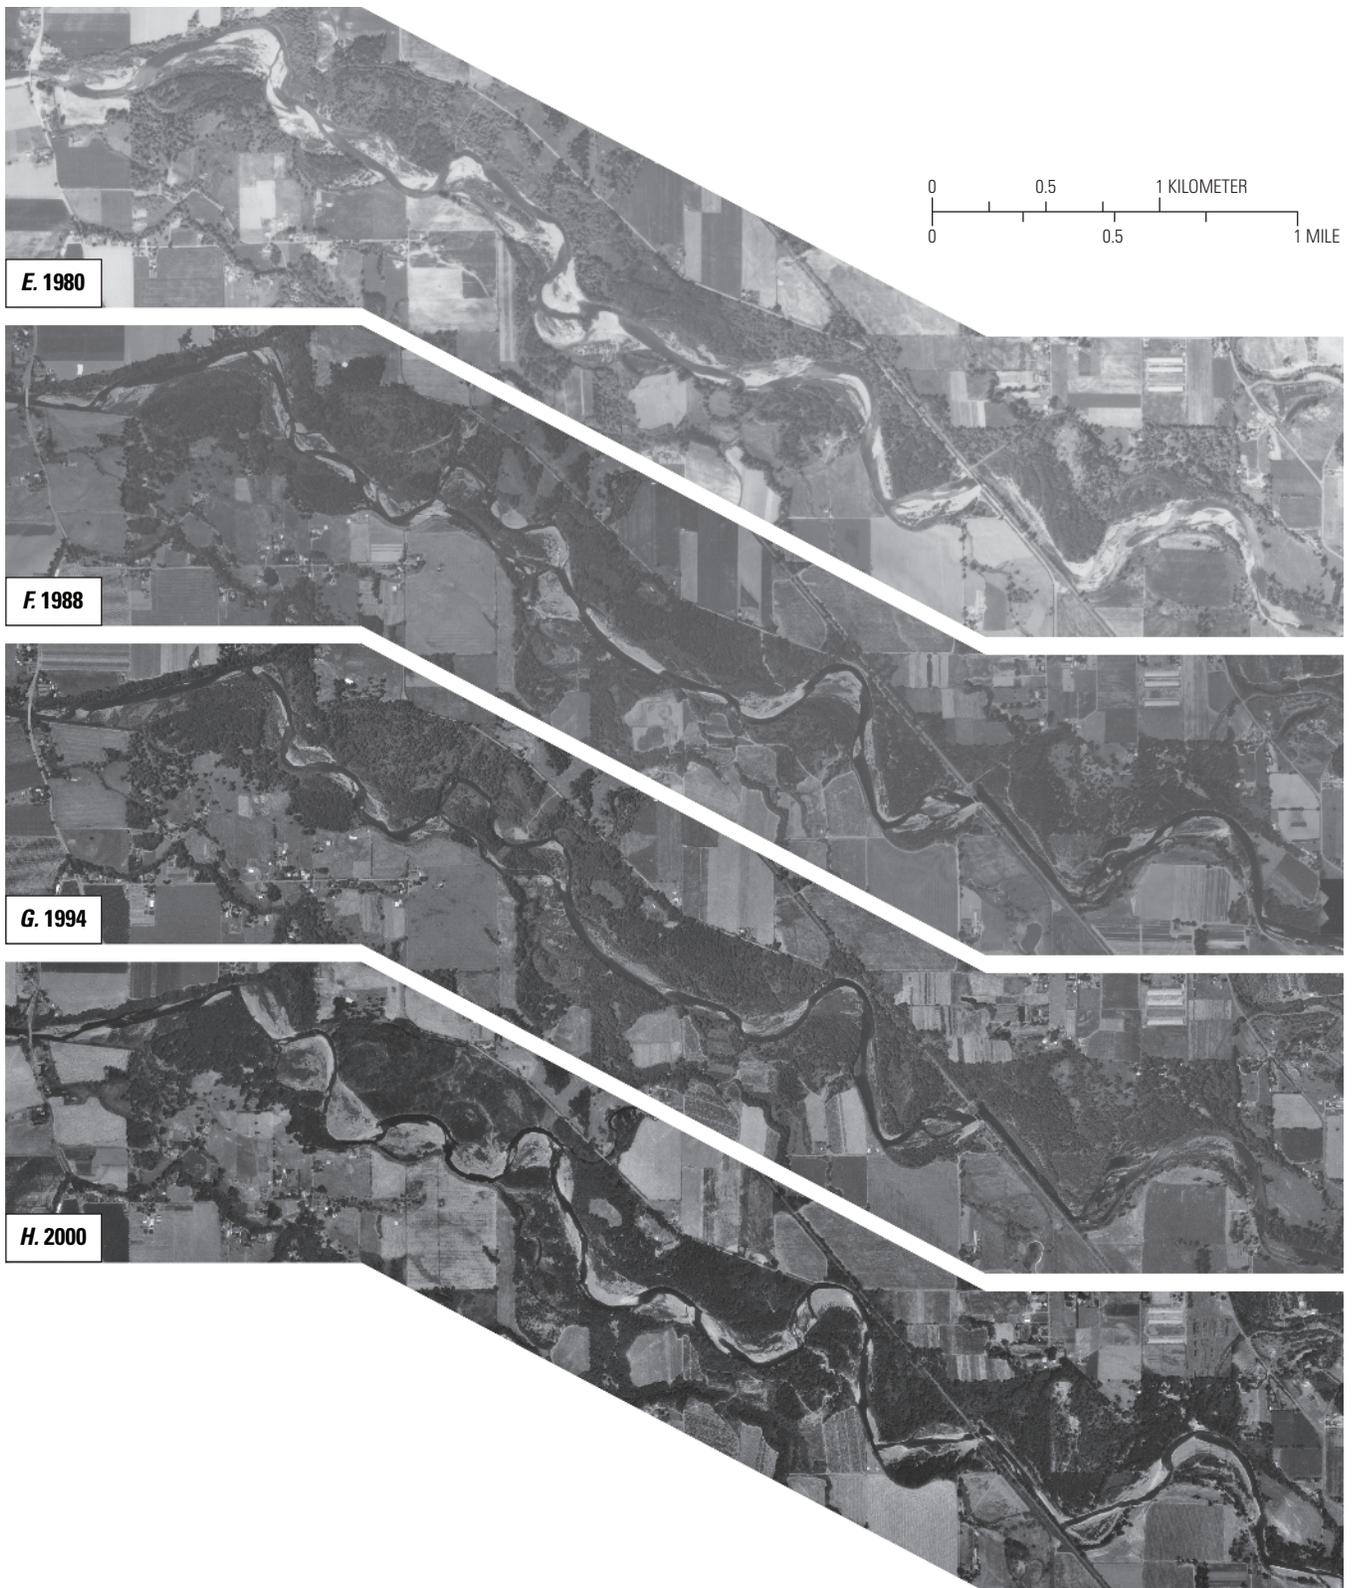
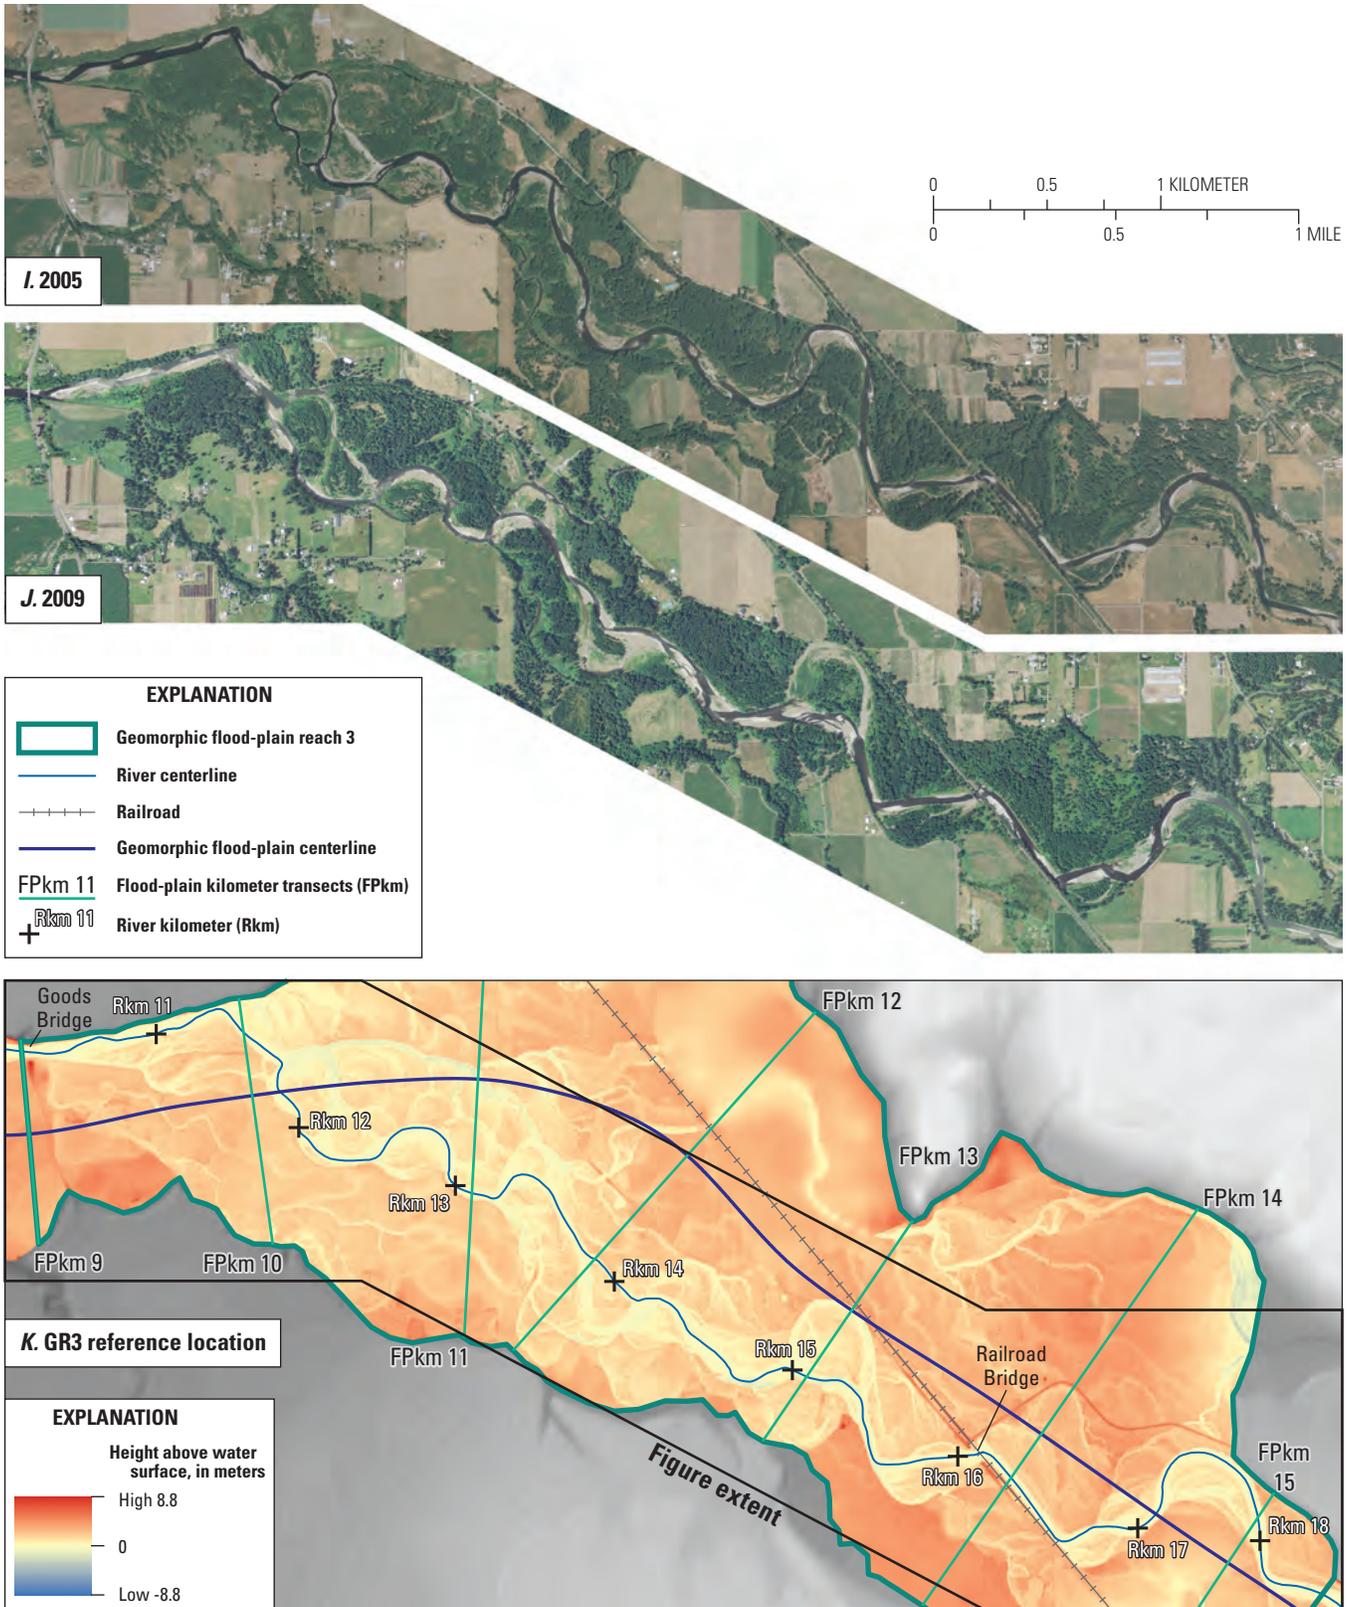
Figure 20. Paneled mosaics of imagery of the river corridor in geomorphic reach 3 (GR3) for all available sets of aerial imagery. (Panel K shows the height-of-water-surface (HAWS) map along GR3 with Goods Bridge and the railroad bridge labeled and the river-stationing coordinates.) An animation of historical geomorphic changes in active channel, at GR3, Molalla River, Oregon is available at <http://pubs.usgs.gov/sir/2012/5017/>.

Because problems caused by flooding and channel migration have been most acute in GR3 in recent years, the qualitative analysis was focused here. Figure 20 shows paneled mosaics of aerial imagery for all the available aerial images. In 1936, the Molalla River in GR3 was meandering with established riparian vegetation, extensive gravel point bars, and a wide active channel that appeared to be in a state of continual migration into the adjacent flood plain consistent with the fluvial mechanics of other alluvial rivers in the Willamette River Valley and the greater Pacific Northwest. Qualitatively, the Molalla River of 1936 in GR3 had a geomorphic plan-form appearance similar to the contemporary river (in 2009). The plan-form characteristics of the river in GR3, including sinuosity and active-channel width, changed little from 1936 to 1948, although large areas of exposed gravel bars appeared in the upper extent of GR3 just upstream of the railroad bridge (fig. 20B). These new gravel bars were probably deposited by the relatively large 711 m³/s (25,100 ft³/s, with a recurrence interval of about 10 years; table 4) flow that occurred in January 1948, six months prior to acquisition of the 1948 imagery (table 7).

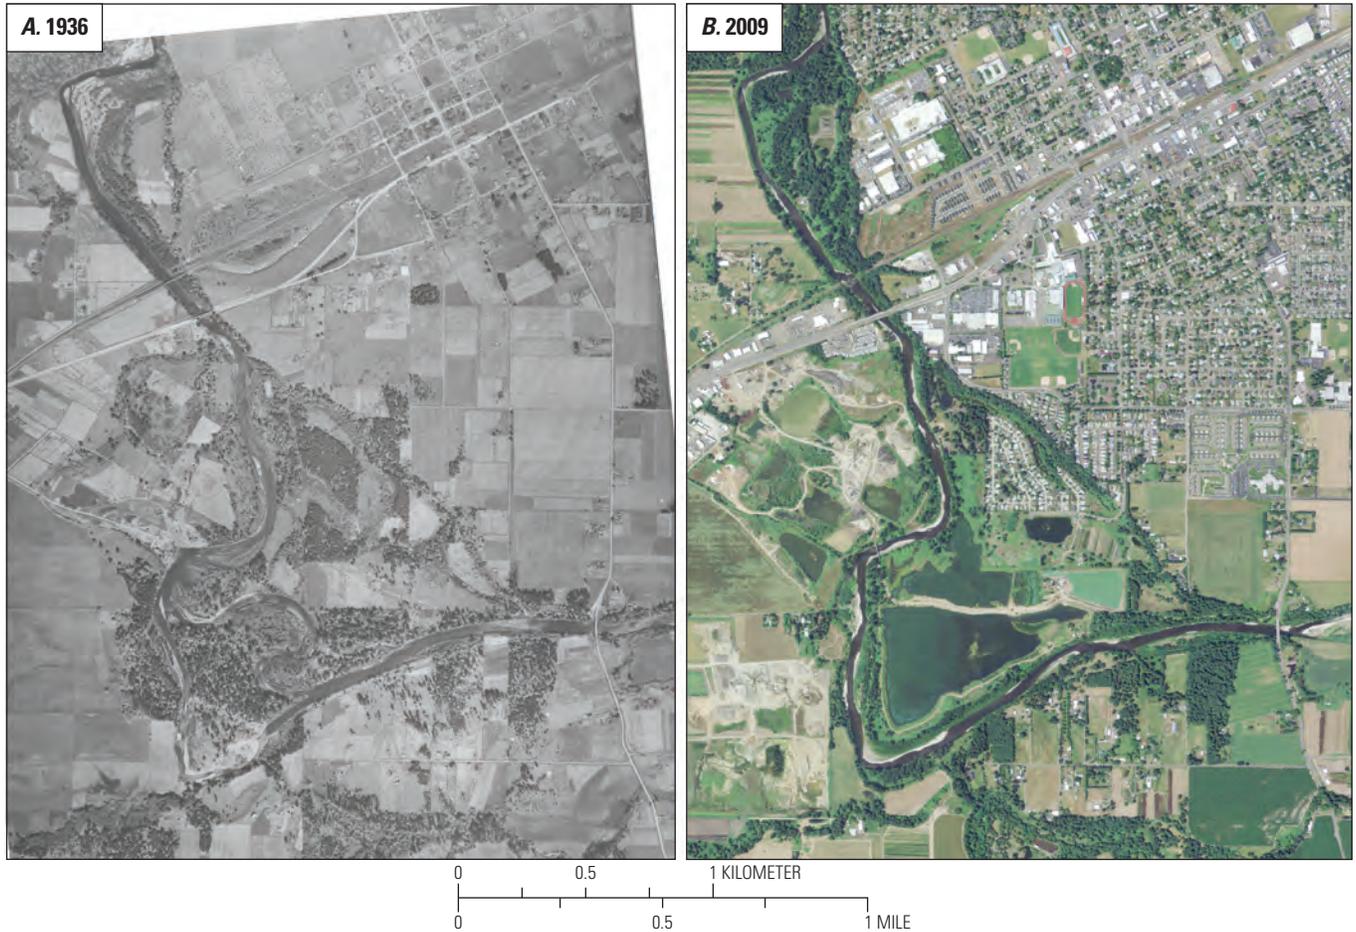
Figure 21. Aerial imagery of the Molalla River in geomorphic reach 2 (GR2) near Canby, Oregon, in (A) 1936 and (B) 2009, showing the relative stability of channel form and location during most of the 20th century.

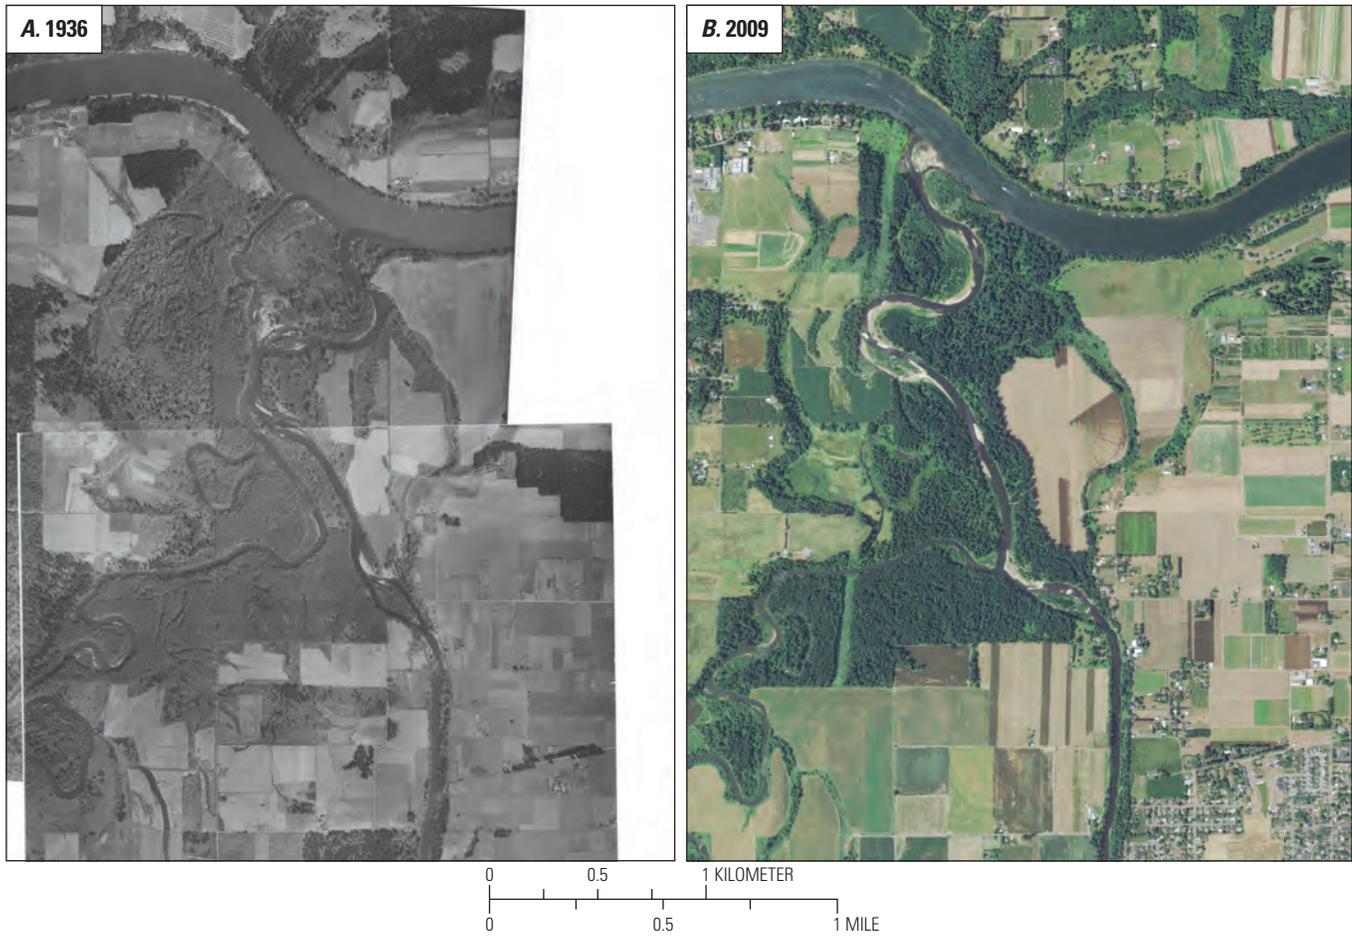
Figure 22. Aerial imagery of the Molalla River in geomorphic reach 1 (GR1) from near the confluence of the Willamette River in (A) 1936 and (B) 2009, showing a wide and active flood plain between the Pudding River and the Molalla River, Oregon.

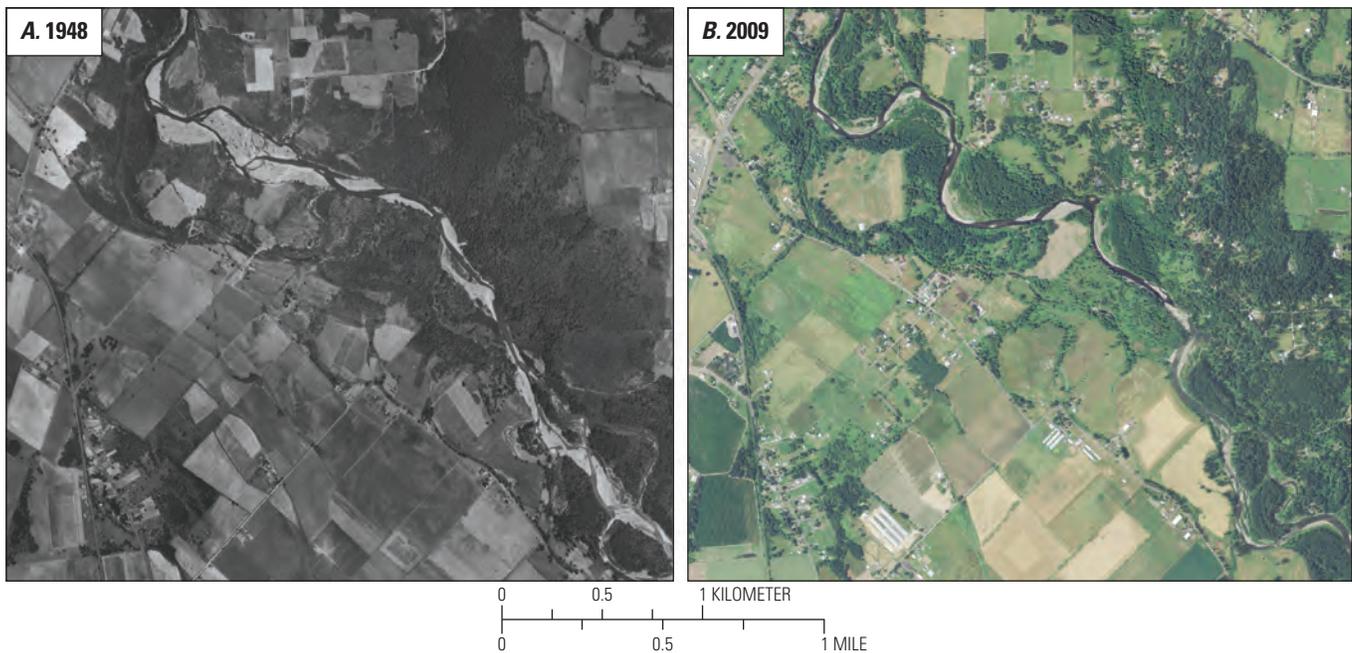
Figure 23. Aerial imagery of the Molalla River, Oregon, in geomorphic reach 4 (GR4) just upstream of Highway 213 bridge (FPkm 19.5) to about FPkm 23 in (A) 1948 and (B) 2009. (Some hydrologic high-flow event, a pulse of sediment and aggradation, or a combination of both led to a wide active channel and expansive gravel bars in 1948; subsequent revegetation decreased the active-channel width and increased sinuosity by 2009.)

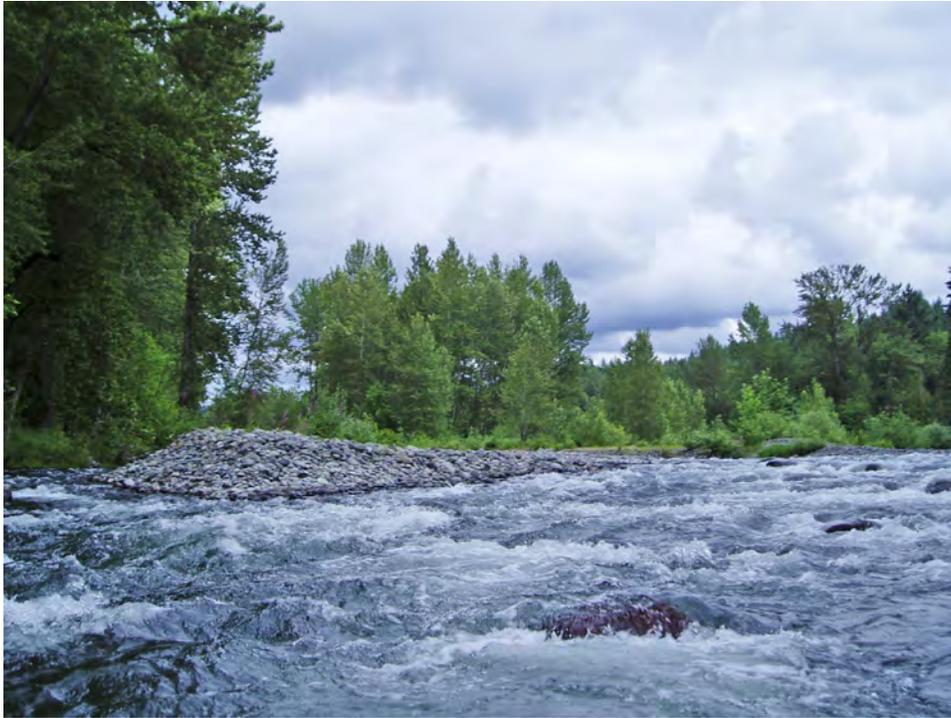
Photograph 3. Gravel deposit downstream of a channel avulsion in GR5. (Photograph taken by Kurt Carpenter, July 2010.)

The geomorphic analyses made in this study show that, in contrast to early hypotheses suggesting widespread sedimentation, it is unlikely the reach of the Molalla River in GR3 has been aggrading in the past ten years. Observations of the channel bedrock just upstream and downstream of GR3 ([fig. 11](#)) suggest the convexity in the long profile observed in GR3 is not the result of a wedge of alluvium. Although the total depth of alluvium above bedrock is unknown, the water-surface profile suggests that it is likely the Molalla River here has adjusted its gradient to transport sediment through this reach. The supply of bedload entering GR3 from upstream is probably small. Moreover, gaging-station data dating back to 1928 show that at the location of the Canby gaging station, the river has incised about 0.5 m since the 1960s ([fig. 14](#)). Aerial imagery acquired from 2005 to 2009 ([fig. 20](#)) also shows that the likely source of sediment that has affected some sections of the river in GR3 was derived locally from meander cut offs and not from upstream. An example of such a gravel deposit from GR5 is shown in [photograph 3, p. 44](#).

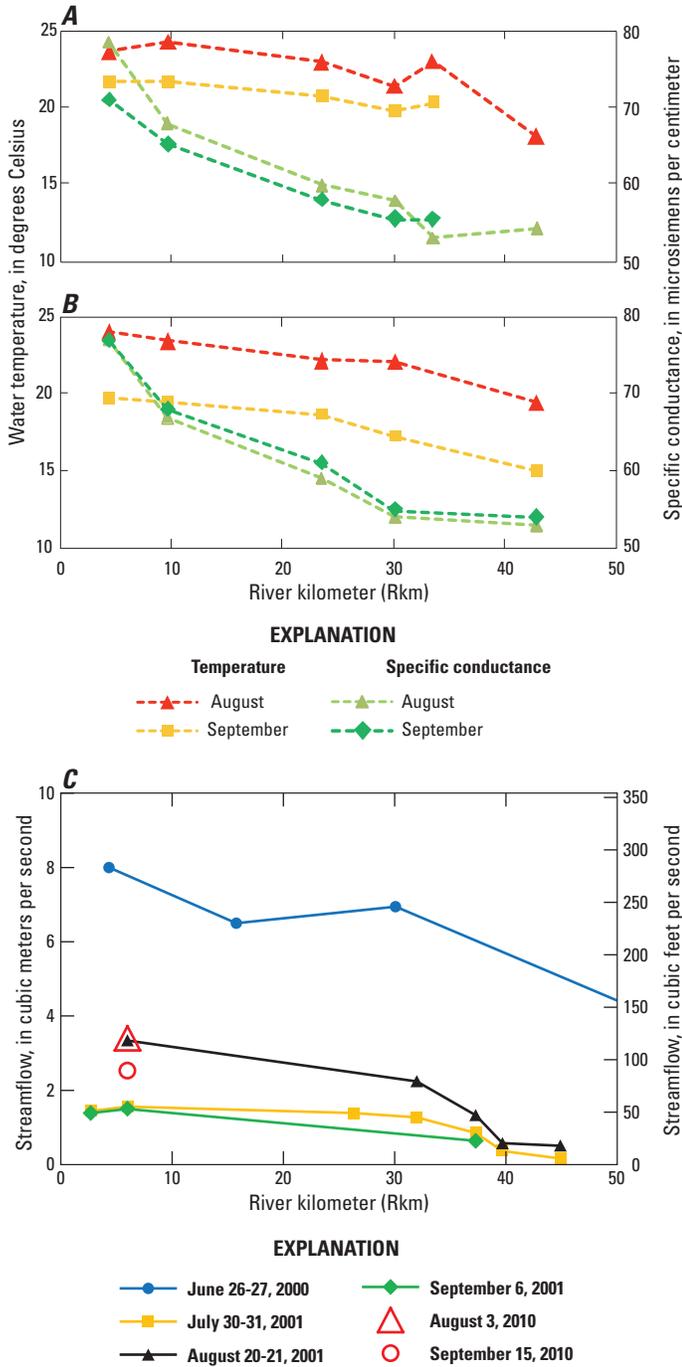
Figure 24. Afternoon water temperature and specific conductance values for (A) August–September 2000, (B) August–September 2010, and (C) longitudinal streamflow for various periods in the Molalla River, Oregon.

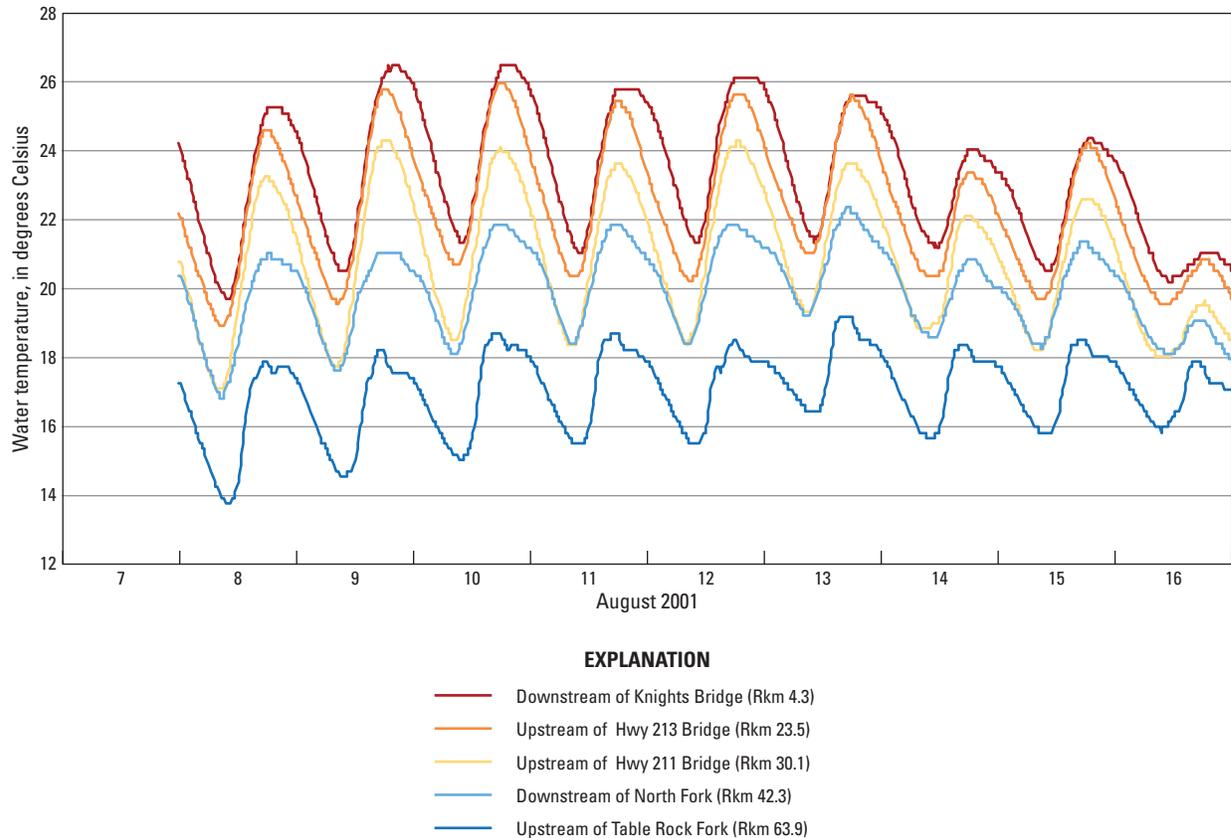
Figure 25. Water temperatures in the Molalla River, Oregon, August 2001.

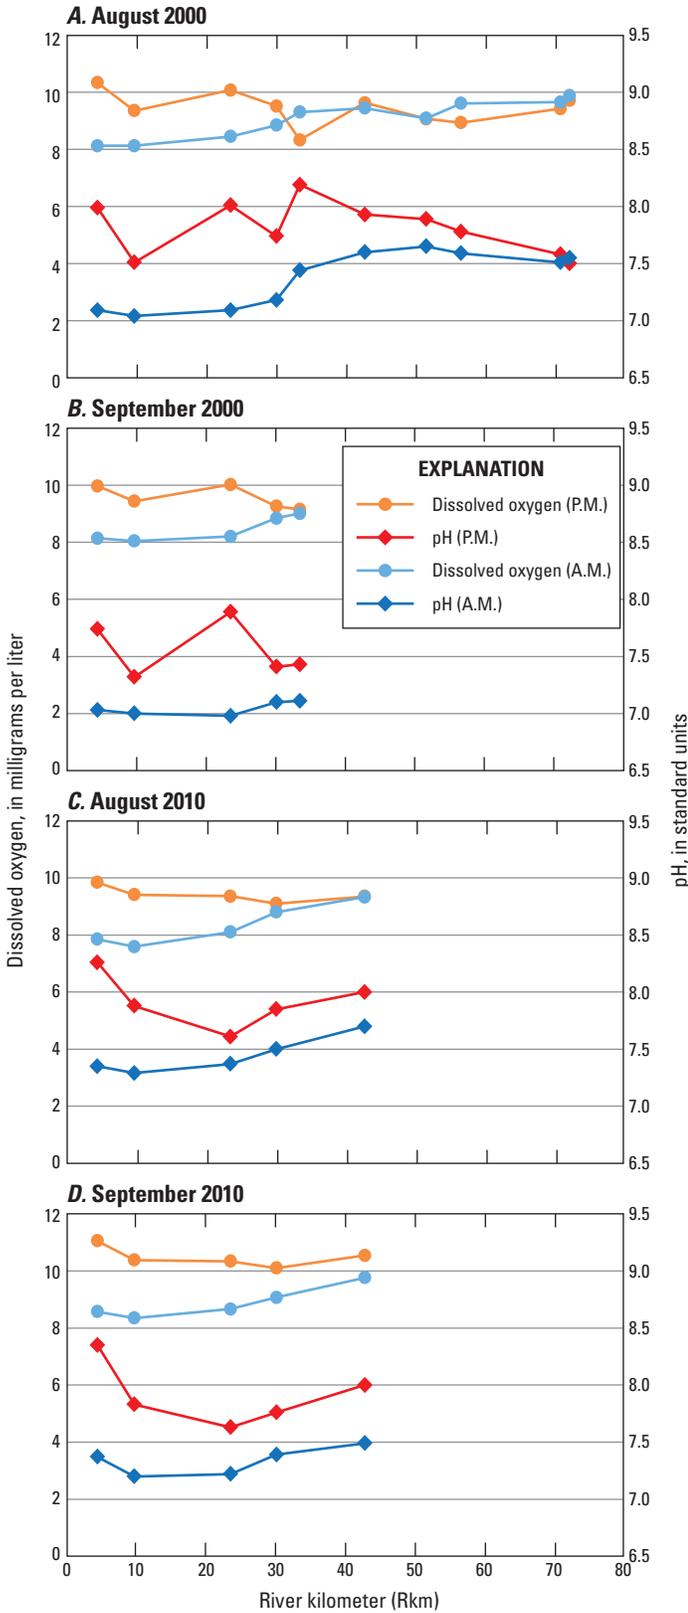
Figure 26. Concentrations of dissolved oxygen and pH levels in the Molalla River, Oregon in (A) August 2000, (B) September 2000, (C) August 2010, and (D) September 2010.

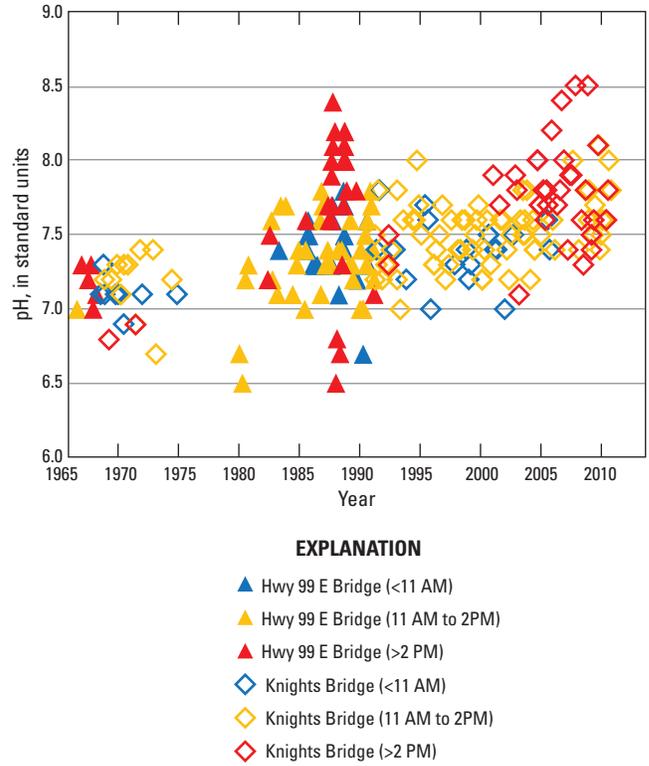
Figure 27. Long-term trend in pH values in the lower Molalla River, 1965–2010. (Data from the Oregon Department of Environmental Quality’s LASAR web application.)

Periodic measurements of pH were taken by ODEQ in the lower Molalla River since 1965 at Highway 99E and more recently at Knights Bridge (fig. 27). Although pH has been as high as 8.5 units, the highest value in 2010 was lower—only 8.0 units—on August 12 (Oregon Department of Environmental Quality, 2010). The lower maximum pH value could have resulted from the cooler than average temperatures and higher flows that delayed the algal growing season in 2010. Note that although pH values in figure 27 appear to be higher in recent years, that the time of day measurements are taken has a large effect, as would be expected in a productive river showing diel fluctuations in pH and dissolved oxygen. The highest values of pH occur after 2 P.M.

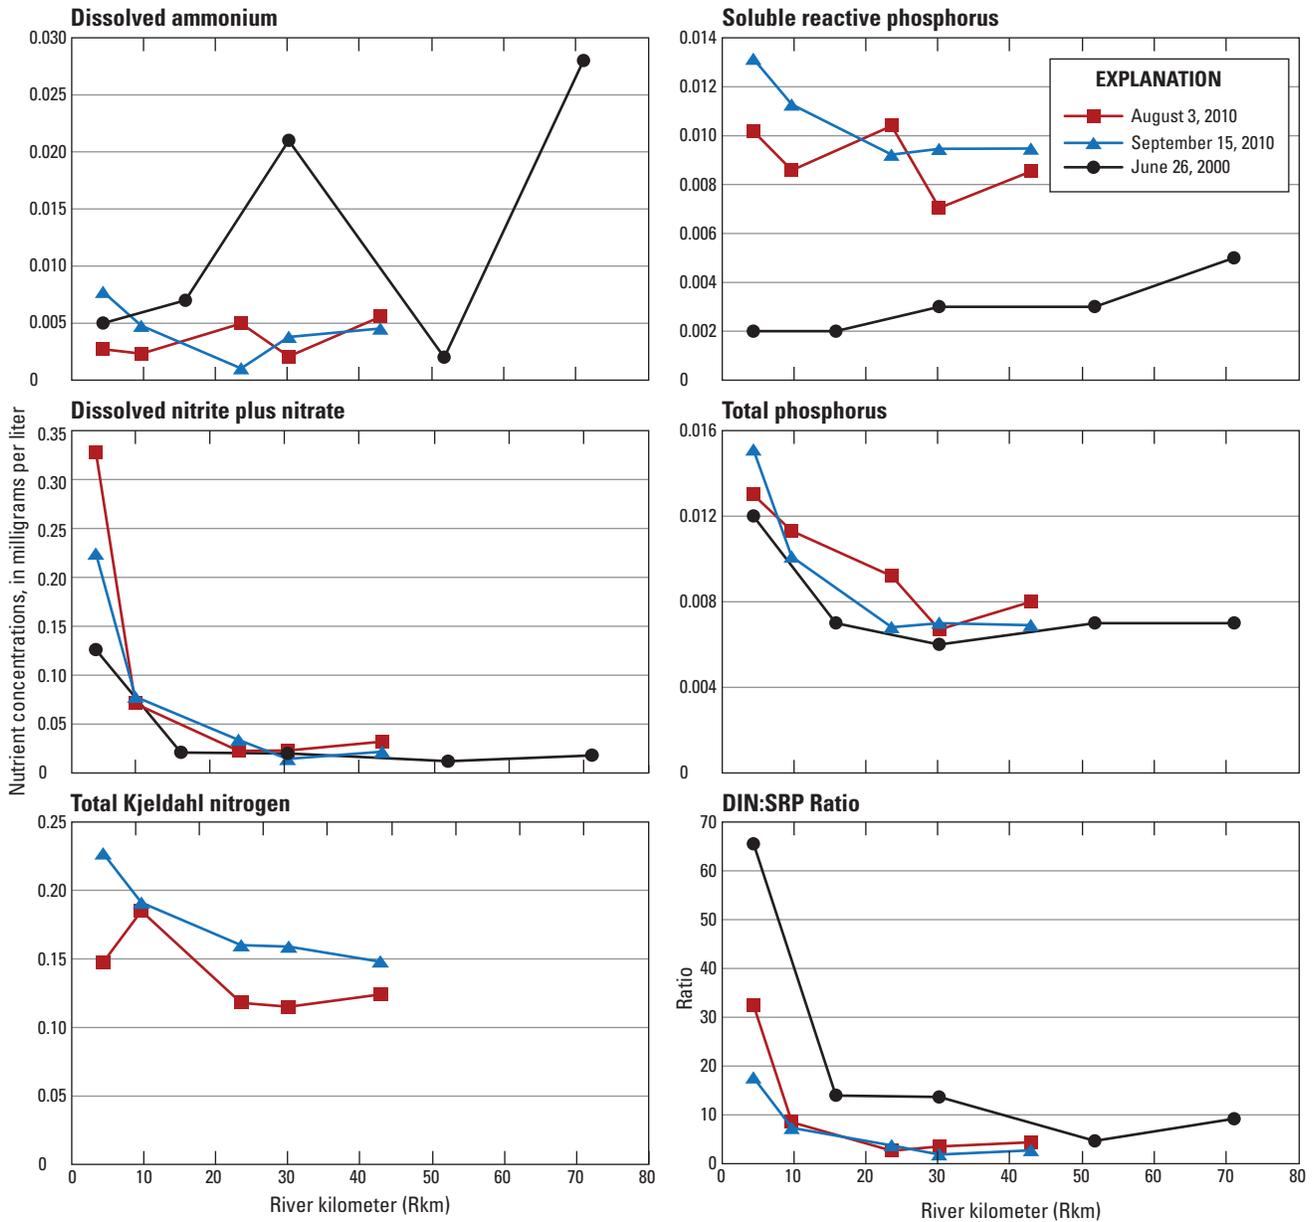
Figure 28. Longitudinal nutrient concentrations in the main-stem Molalla River, Oregon, August and September 2010 and June 2000.

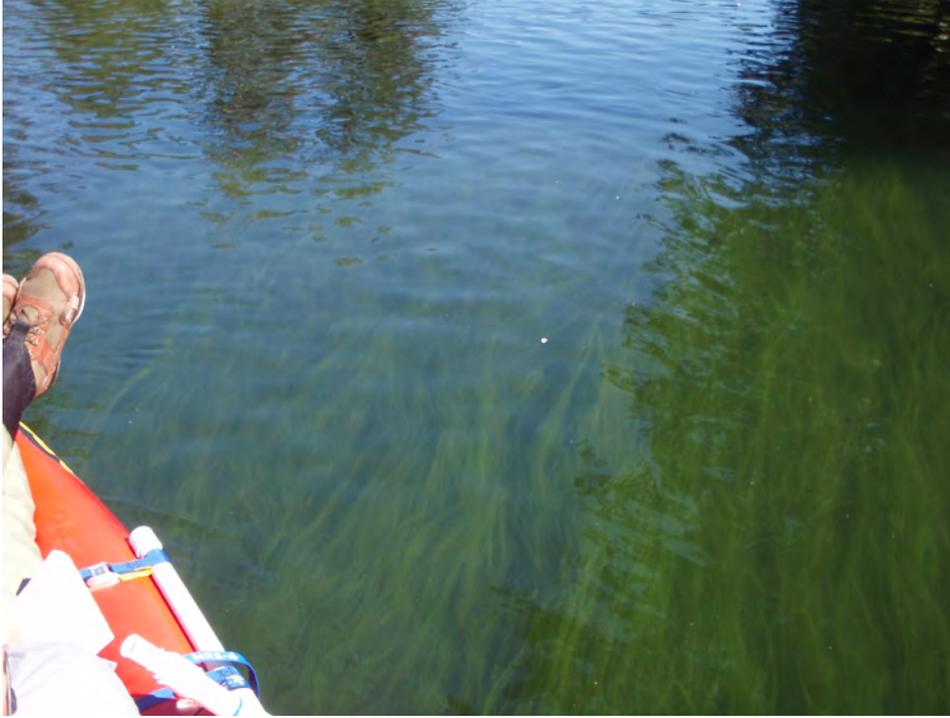
Photograph 4. *Cladophora glomerata*, filamentous green algae in the lower Molalla River near Canby. (Photograph taken by Jonathan Czuba, July 14, 2010).

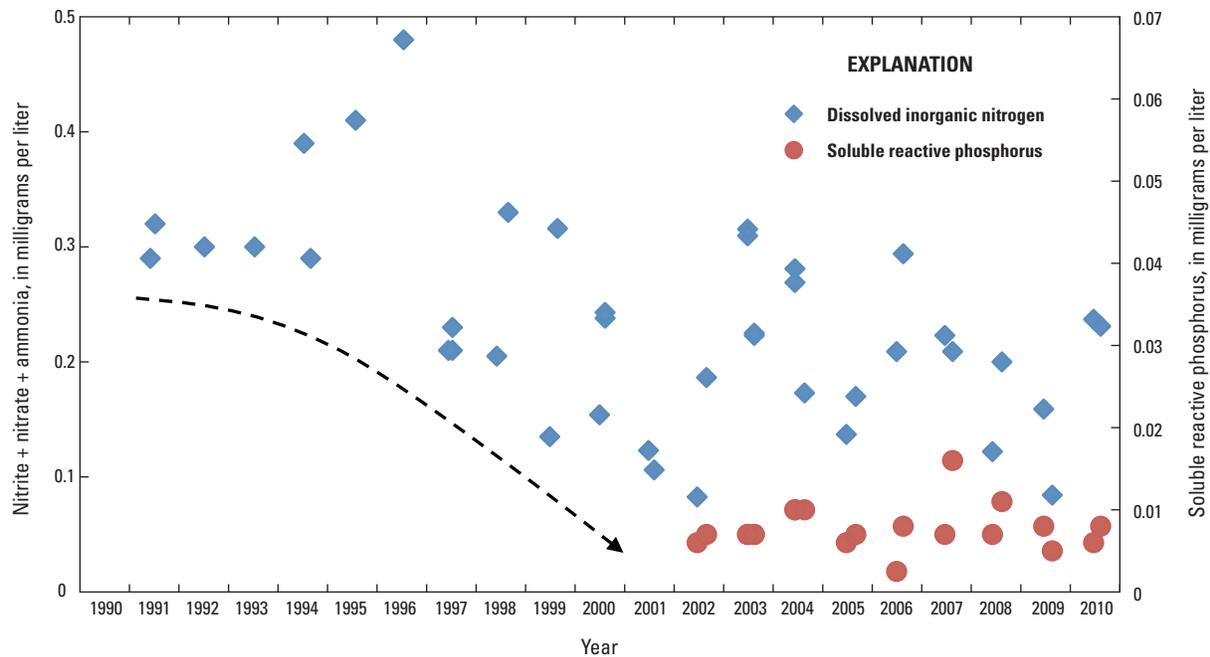
Figure 29. Summertime dissolved inorganic nitrogen and phosphorus concentrations in the Molalla River, Oregon, 1990–2010.

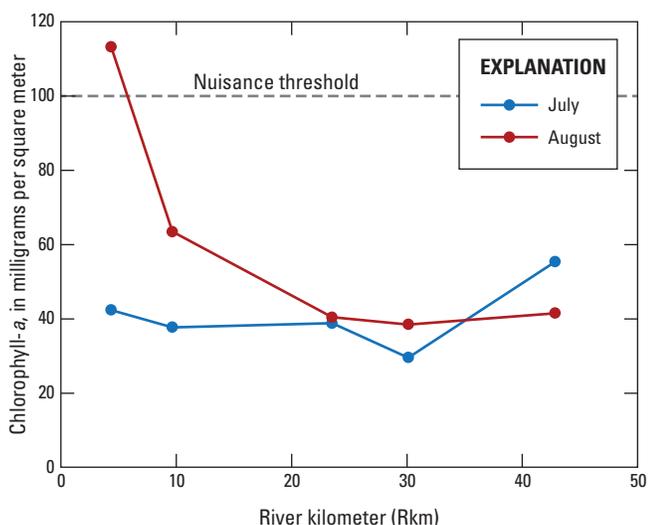
Figure 30. Longitudinal pattern in periphyton biomass (chlorophyll-*a*) in the main-stem Molalla River, Oregon, July and August 2010.

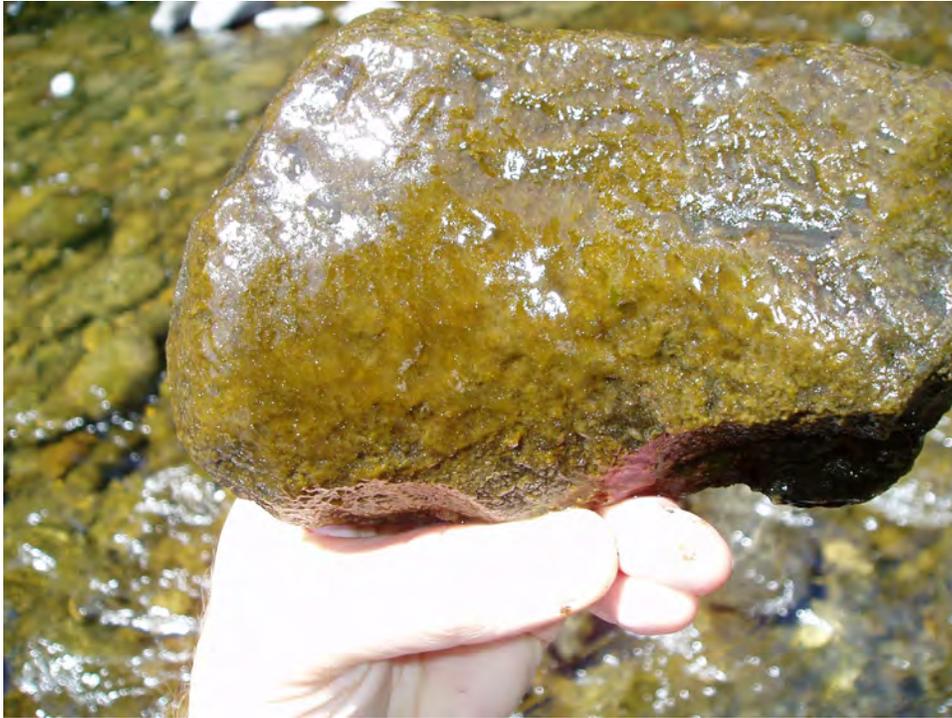
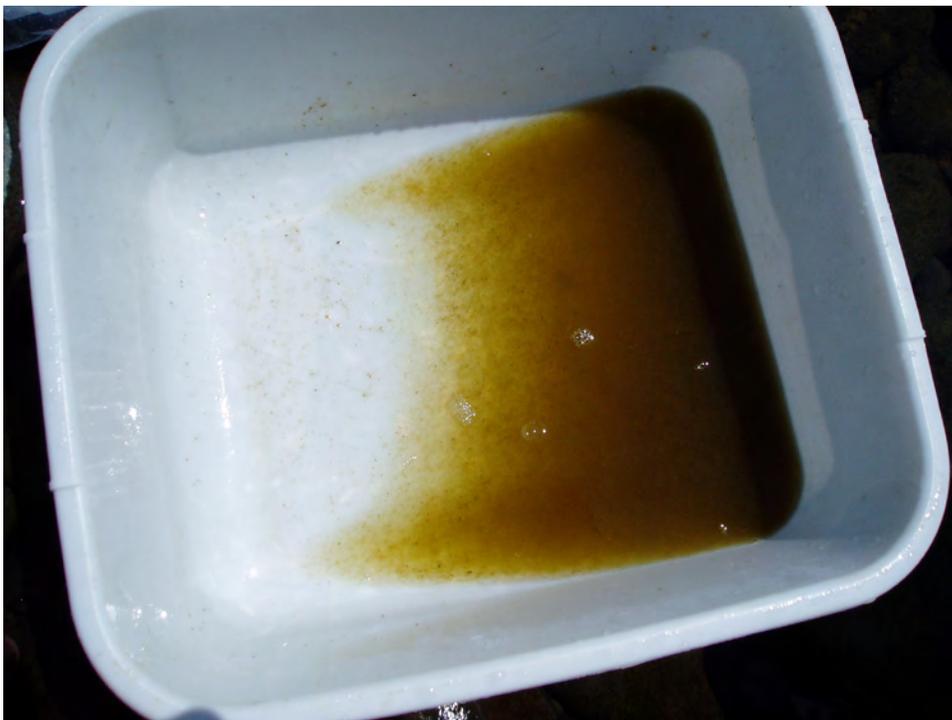
Photographs 5 and 6. Diatom biofilm on a rock collected from the Molalla River upstream of Glen Avon Bridge, and resulting slurry of algal material. (Photographs taken by Kurt Carpenter, July 30, 2010).

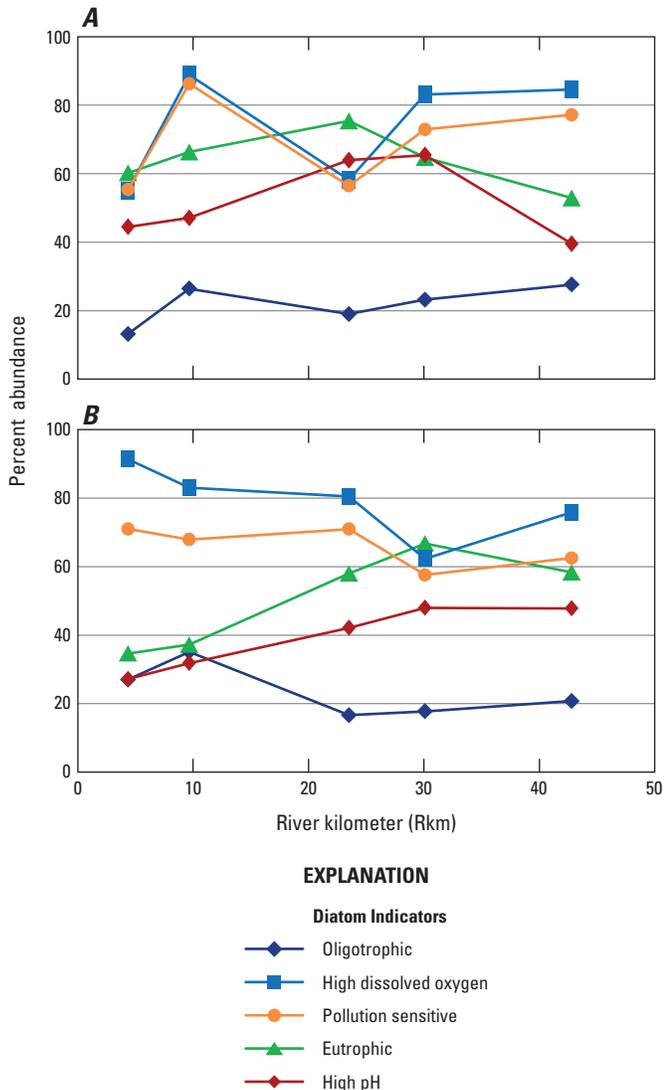
Figure 31. Longitudinal pattern in diatom indicators of water-quality conditions in the Molalla River, Oregon, in (A) July and (B) August 2010.

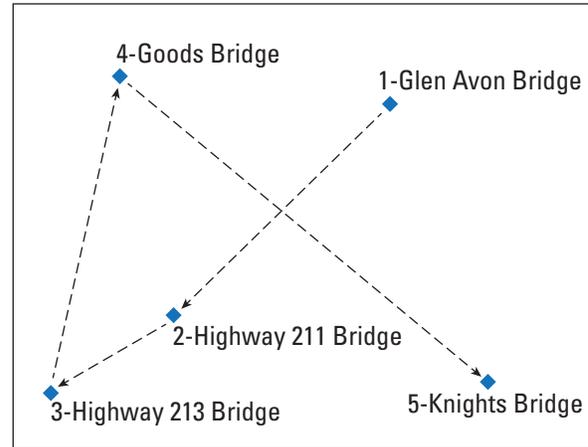
Figure 32. Multidimensional scaling (MDS) ordination plot of algal samples from the Molalla River, Oregon, for the combined July and August 2010 samples.
