Topographic Change Detection at Select Archeological Sites in Grand Canyon National Park, Arizona, 2007–2010

Scientific Investigations Report 2012–5133

Brian D. Collins, Skye C. Corbett, Helen C. Fairley, Diane Minasian, Robert Kayen, Timothy P. Dealy, and David R. Bedford

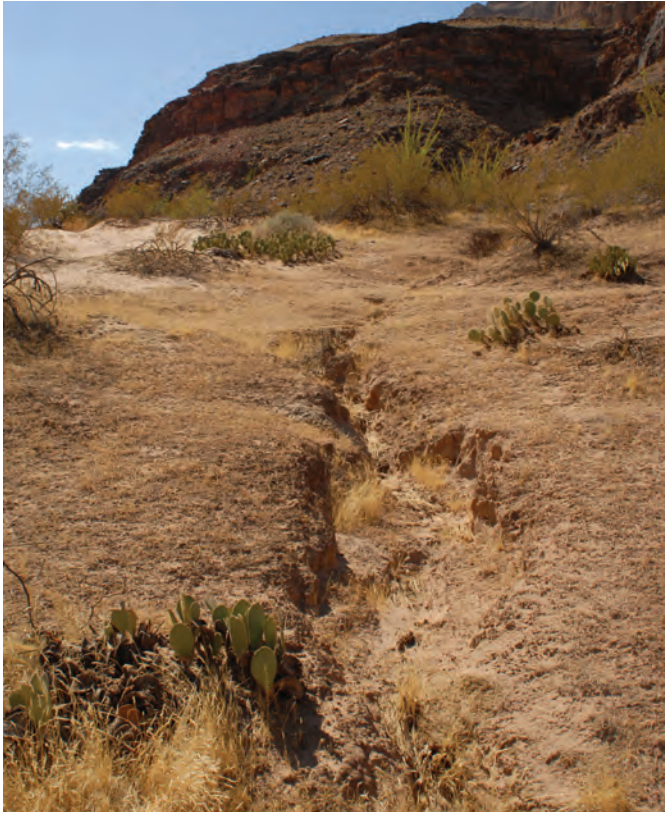
Figure 2. Gullying at an archeological site in Grand Canyon National Park. This area contains cultural artifacts buried by aeolian sediments and subject to precipitation-induced erosion.

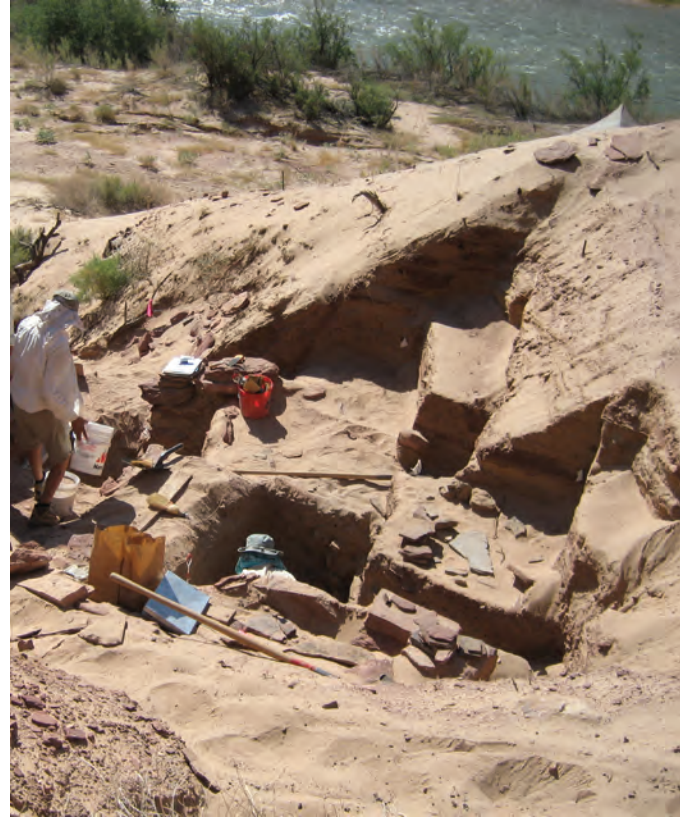
Figure 3. Excavation of an archeological site in Grand Canyon National Park. This site was previously buried by aeolian and alluvial sediments and emerged as precipitation runoff and wind deflation exposed habitation features.

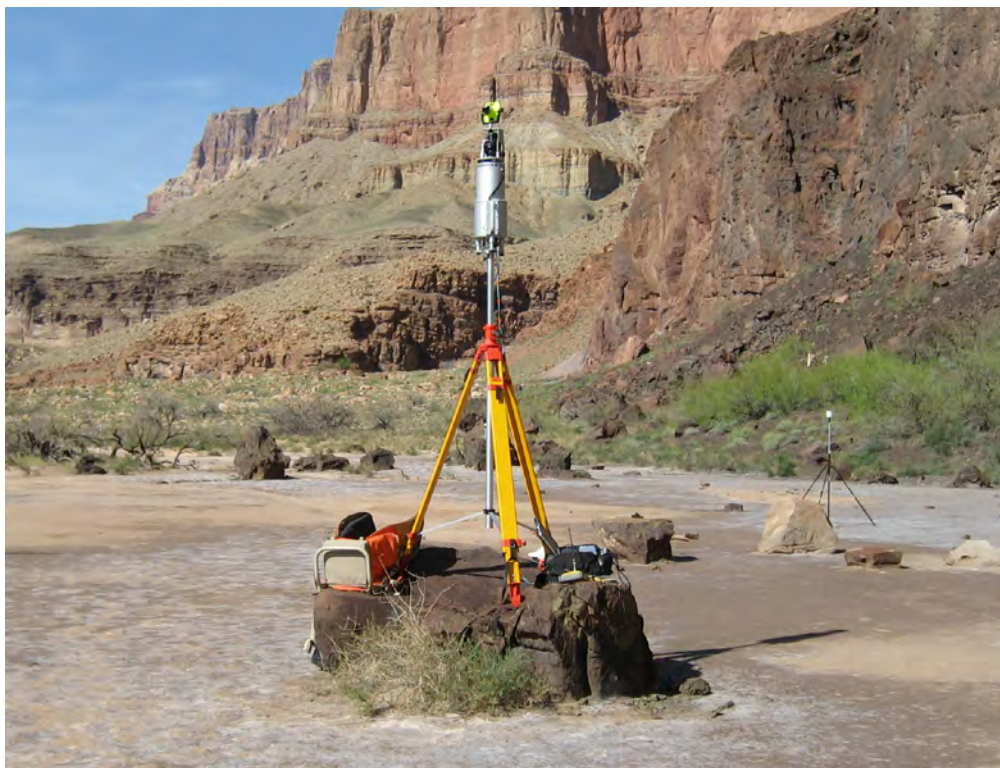
Figure 4. Terrestrial lidar data collection in Grand Canyon National Park. The extendable tripod allows a larger area of data collection and less oblique laser returns from areas of flat topography. Total station prism (shown) or differential global positioning system (GPS) unit with fixed radio-linked base station are used to georeference the instrument location, along with temporary reflector control points shown in mid-ground.

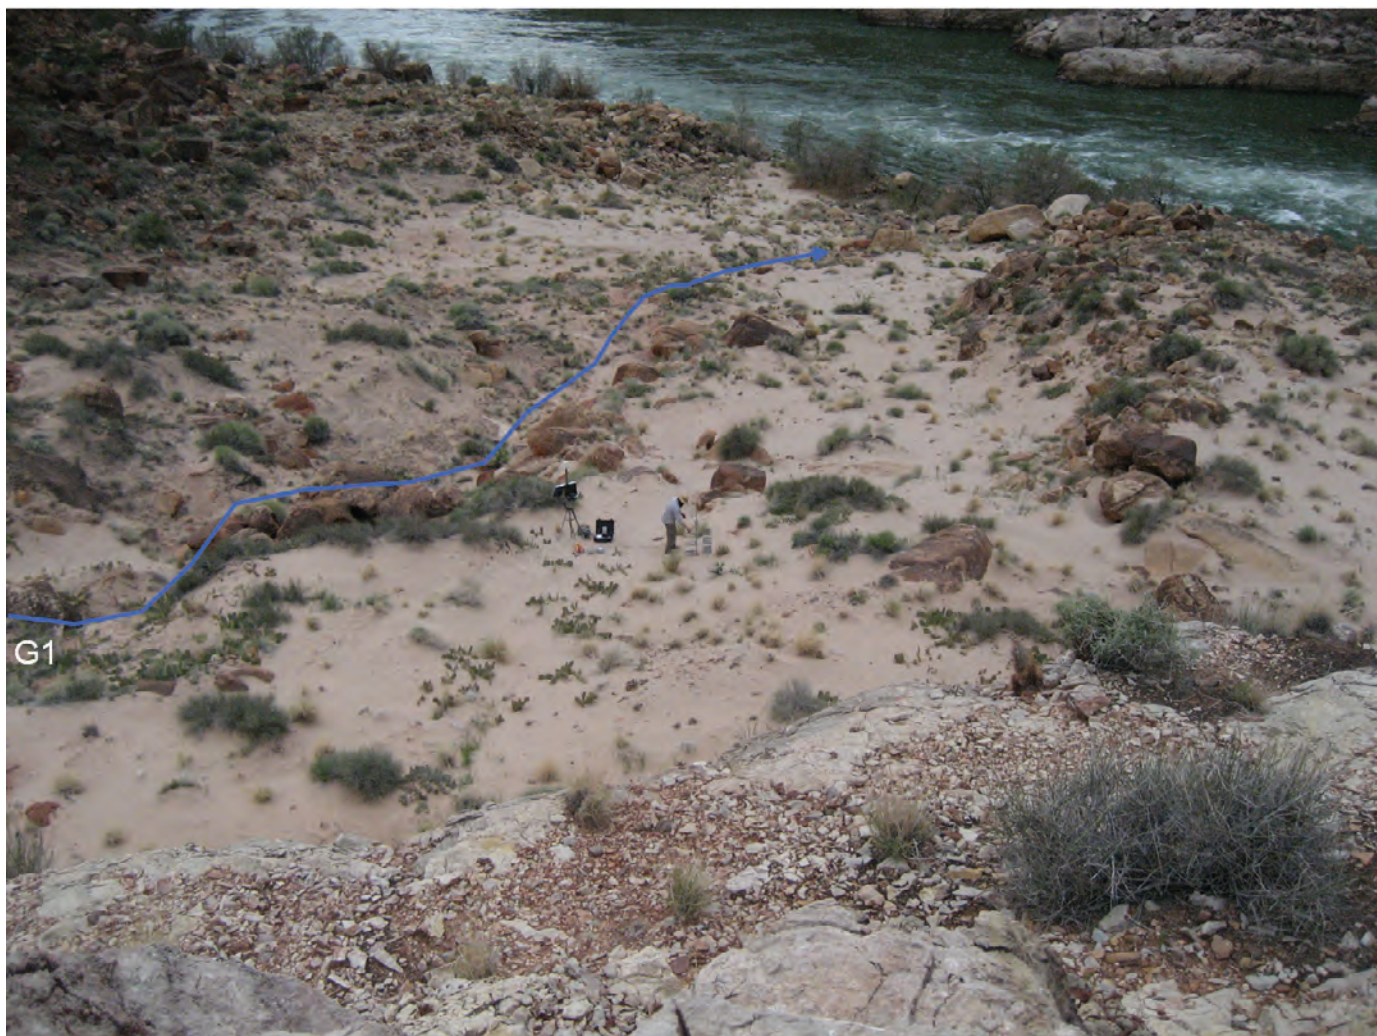
Figure 8. Site AZ:C:05:0031 survey area photo showing gully location (G1). View is to the southwest.

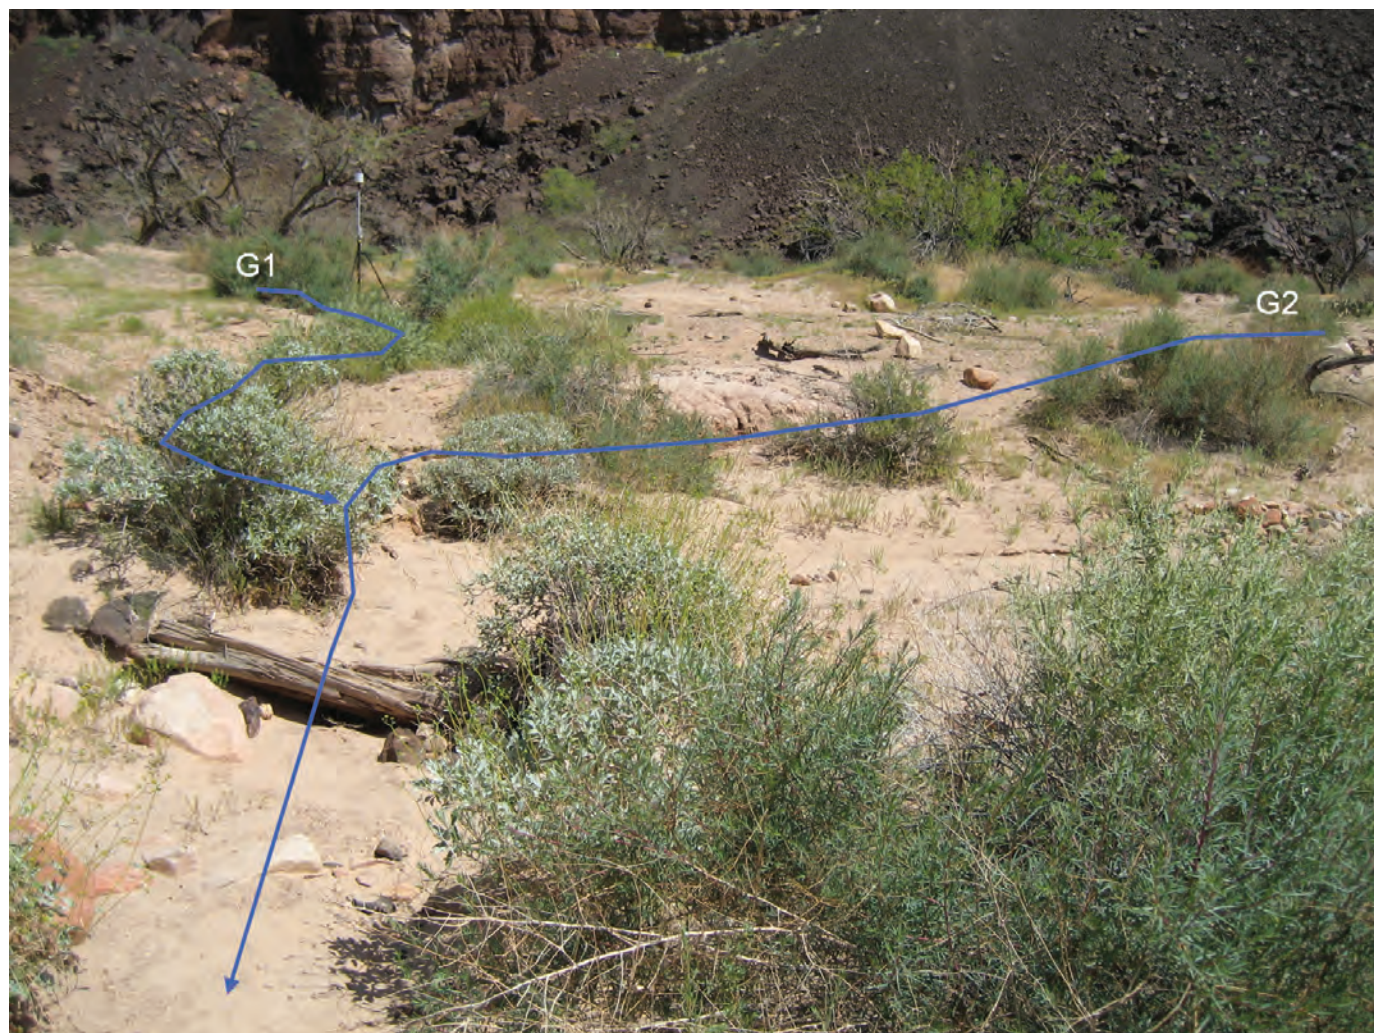
Figure 19. Site AZ:C:13:0099 survey area photo showing gully locations (G1 and G2). View is to the east.

Site AZ:C:13:0099 in the Palisades region has been monitored by terrestrial lidar five times since 2006. The site is archeologically important because of the high density of early-middle Pueblo II artifacts and habitation structures found here, with evidence of a pre-Puebloan occupation as well (Fairley and others, 1994). In addition, buried structures and a variety of artifacts have been exposed by gully sidewall erosion in recent years. The site is located north of Site AZ:C:13:0336, in and around a deeply (>1 m) incised gully system (figs. 18 and 19) that drains much of this area and begins as a series of smaller shallow tributary drainages to the east at the base of a steep talus slope. Rock check dams have been used in the past to mitigate ongoing erosion at several locations within this site. Vegetation occurs throughout the site, including large (several meters in canopy diameter) mesquite trees (*Prosopis glandulosa* var. *torreyana*) and smaller shrubs and grasses. O'Brien and Pederson (2009a) identified gullying, aeolian transport, and piping as the geomorphic processes affecting this site and noted that archeological resources were being destroyed by gullying here. Additional site details are included in O'Brien and Pederson (2009a).

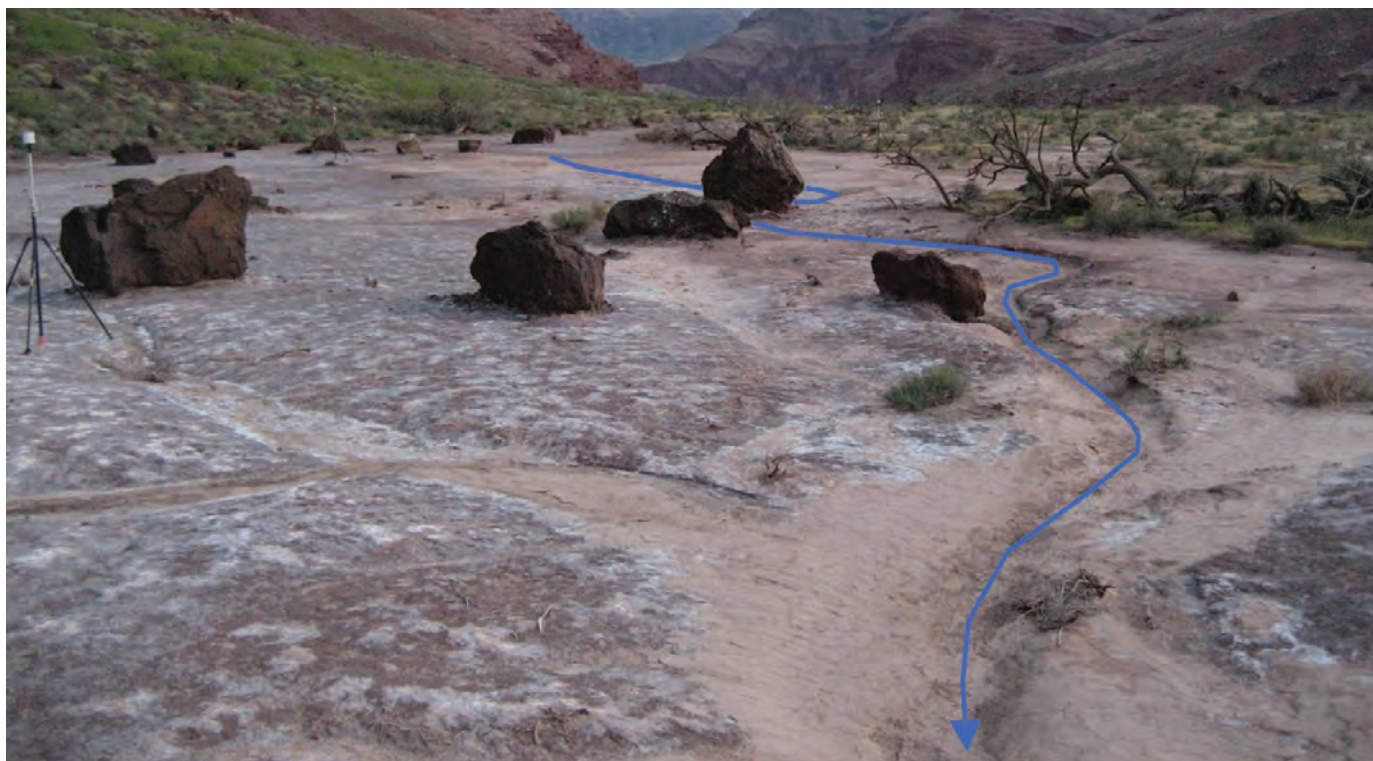
Figure 23. AZ:C:13:0099 playa survey area photo showing location of main channel (blue line). View is to the south.

Upstream of the AZ:C:13:0099 gully system is a formerly ponded area, now infilled by wind-blown sand and water-deposited silts and clays, colloquially called a “playa.” The area is a former backwater channel of the Colorado River and is a relatively flat surface in which water has ponded and evaporated (figs. 22 and 23). A hard-pan, evaporite-rich, fine grained crust covers most of the site, potentially providing at least some protection to rapid gullying from overland flow. The playa area has been monitored by terrestrial lidar five times since 2006. Although not an archeological site in itself, several such sites border the playa, and evidence of ongoing channelized flow erosion indicates that this area could be an indicator for potential change at these other archeological sites. Overland flow on the playa surface has created several shallow channels that drain to a single major channel that runs through the playa (fig. 22) and into the AZ:C:13:0099 site (gully G2, fig. 18). Isolated rockfall deposits, consisting of large boulders several meters in maximum dimension, are located throughout the area and generally redirect the paths of smaller drainages that converge at the north end of the playa. Whereas the playa itself is devoid of any vegetation, mature mesquite trees (*Prosopis glandulosa* var. *torreyana*) border it in many locations. We identified overland flow as the primary geomorphic process affecting this site.

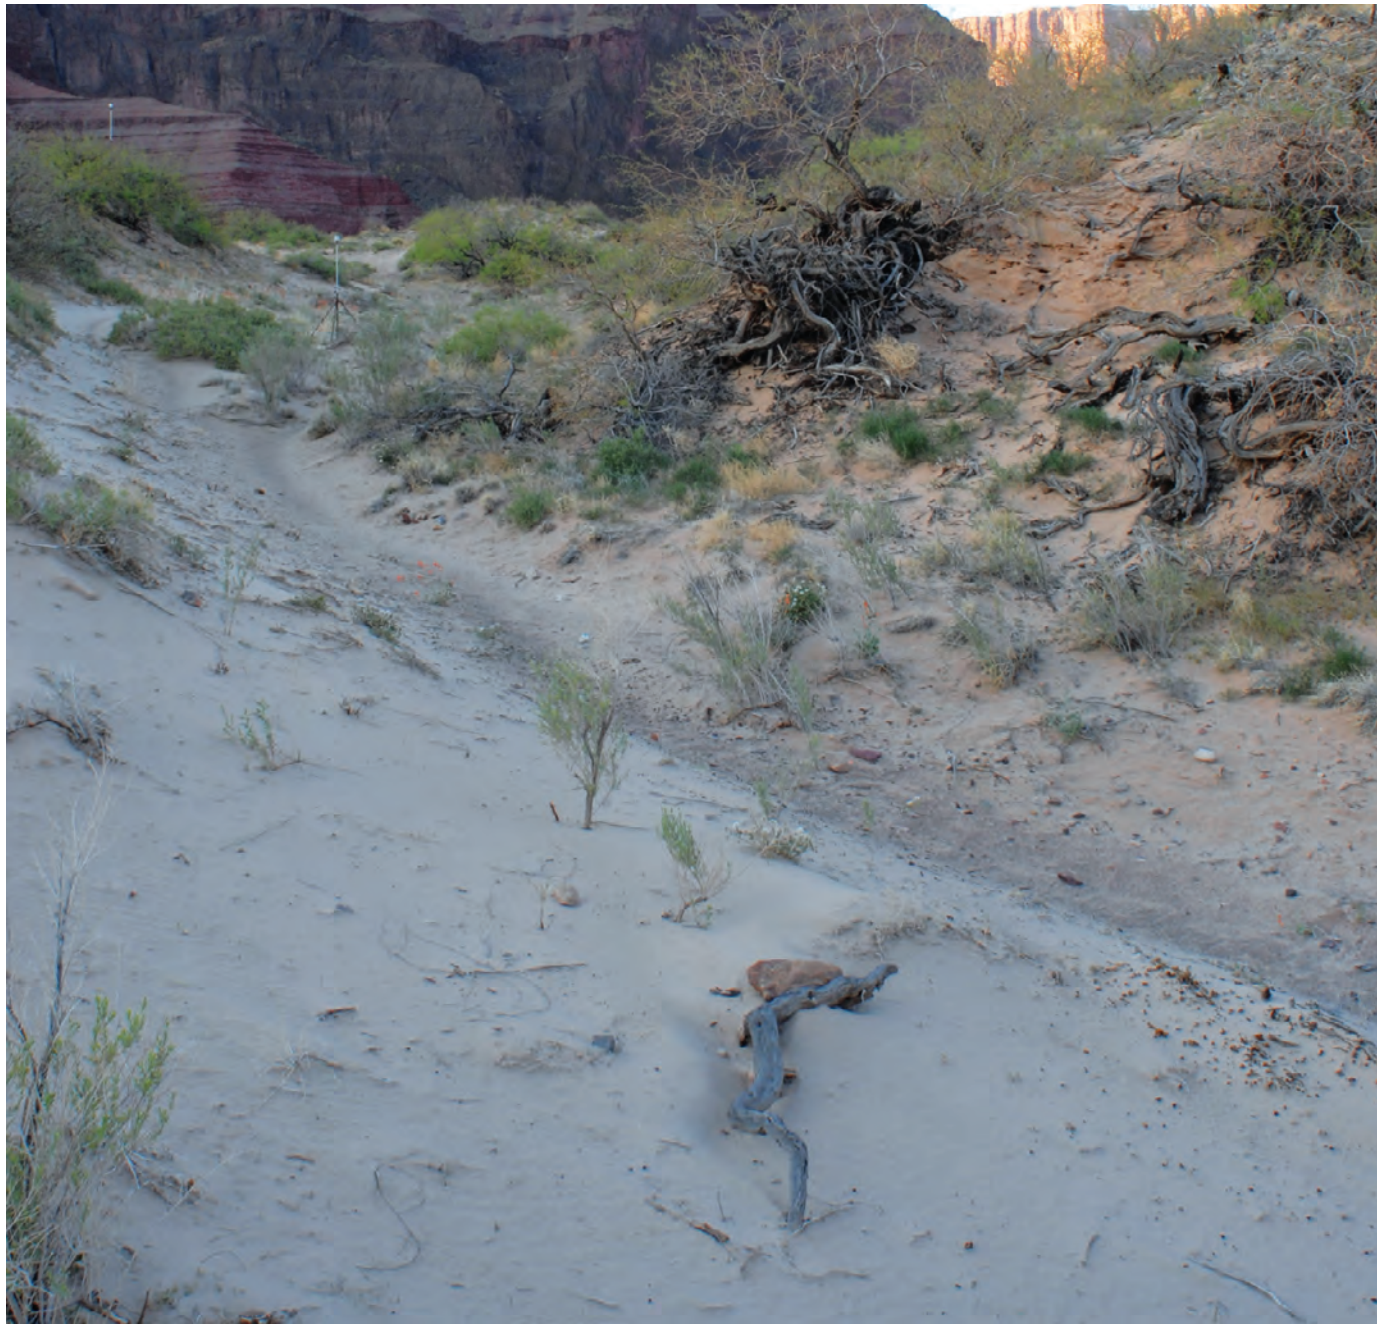
Figure 27. Site AZ:C:13:0321 survey area photo. View is to the north.

Site AZ:C:13:0321 was not investigated by previous lidar surveys, and therefore the April and September 2010 surveys presented the first opportunity for detailed change detection analysis. The site is located very close (~ 60 m) to the Colorado River within an active dune area that receives sediment from a neighboring river sand bar (figs. 26 and 27). An archeologically important slab-lined roasting feature, which contains fire-cracked rocks, ash, and wood charcoal, is located within the sand dunes and just above the lowest part of a channel-shaped hollow formed between the dunes (Fairley and others, 1994). The feature is intermittently buried by aeolian sand, and thus its protection is tied directly to the geomorphology of the nearby sand bar. The hollow between the dunes slopes towards the river’s edge, but no indications of overland flow are readily evident (O’Brien and Pederson, 2009a). This hollow is often used as a hiking path by river runners accessing terrain inland from a popular camping beach. Whereas the site is predominantly located within dune sands, several areas of gravel-pebble slope wash are also located in the hollow bottom. Western honey mesquite trees (*Prosopis glandulosa*) with a full spectrum of maturity (that is, some dying, others with healthy vigor) surround the site. Within the site, a wide variety of isolated vegetation is established within the dune sands and gravel substrate, including globemallow (*Sphaeralcea* sp.), arrow weed (*Pluchea sericea*), four-wing saltbush (*Atriplex* sp.), sand verbena (*Abronia elliptica*), and nonnative Russian

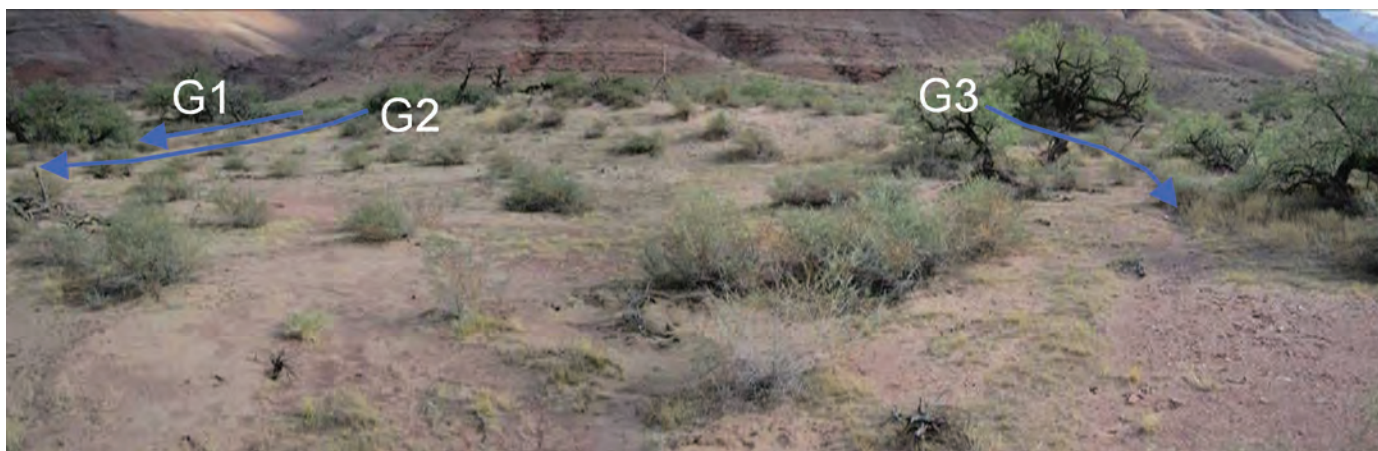
Figure 30. Sites AZ:C:13:0346 and AZ:C:13:0348 survey area photo showing gully locations (G1 to G3). View is to the south.

Sites AZ:C:13:0346 and AZ:C:13:0348 (both of which are referred to collectively as AZ:C:13:0348 when reporting change detection analysis results) are two adjoining sites that have been monitored by terrestrial lidar four times since 2006. The sites are archeologically important as an area of Puebloan II habitation and contain remains of jacal-type structures, built by planting wood posts in the ground, weaving sticks between the posts, and plastering the wooden framework with mud (Fairley and others, 1994). The area also contains dense deposits of surface artifacts, including pottery sherds and stone tools. The combined site areas include the terminus of a broad alluvial fan of slope-wash deposits that grades into an alluvial terrace scarp adjoining a former flood plain of the Colorado River (figs. 29 and 30). Three small gullies (G1, G2, and G3) traverse the sites and terminate on the alluvial terrace, which in turn grades into an area of sand dunes that cap the terrace along the river's edge. Brush and rock check dams have been used in gullies G1 and G3 in the past to mitigate ongoing erosion at several locations within this site (O'Brien and Pederson, 2009b). Vegetation consists of irregularly spaced, small desert seepweed bushes (*Suaeda moquinii*) and larger mesquite trees (*Prosopis glandulosa* var. *torreyana*), which in some cases are sufficiently dense to partially obscure gullies from overhead observations. O'Brien and Pederson (2009a) identified gullying, aeolian transport, and overland flow as the geomorphic processes affecting these sites but also observed that visitor-induced trailing was also causing erosion. They also noted that whereas the majority of the site appeared stable with respect to erosion of archeological resources, additional gullying could lead to negative site impacts. Additional site details are included in O'Brien and Pederson (2009a,b).

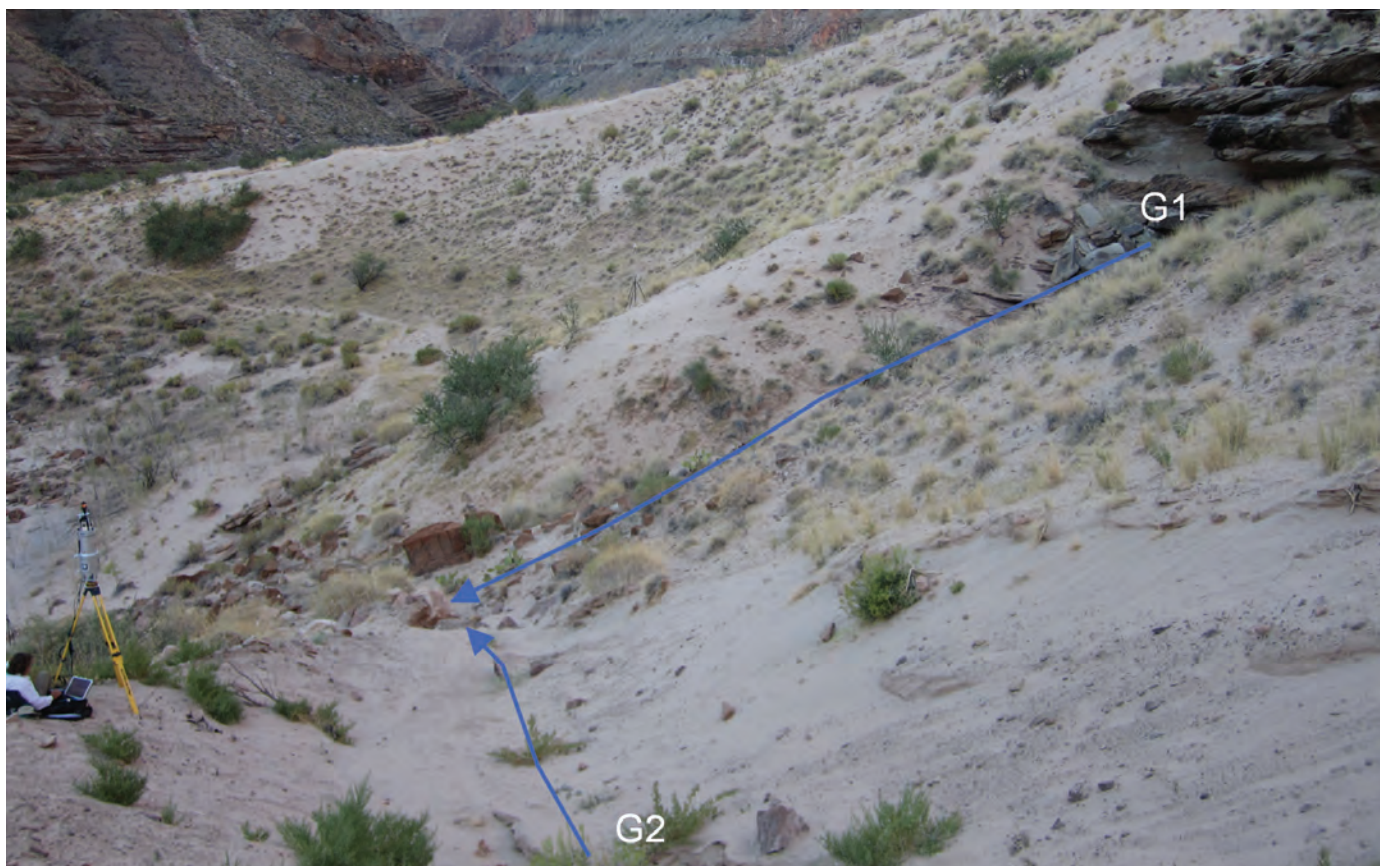
Figure 33. Site AZ:B:10:0225 survey area photo showing gully locations (G1 and G2). View is to the southwest.

Site AZ:B:10:0225 was previously surveyed only once, in September 2007. Thus, the most recent September 2010 survey data presented the first opportunity to conduct detailed change detection analysis at this site. The site is very close (~ 30 m) to the Colorado River and is located on a sand ramp that is backed by steep and sometimes overhanging Tapeats Sandstone ledges (figs. 32 and 33). The ledges formed shelters for the prehistoric people that formerly inhabited the area, and the slope below these shelters is littered with pottery sherds, lithic debitage, fire-cracked rocks, and other artifacts (Fairley and others, 1994). Two large gullies (G1 and G2) traverse the edges of the site and fall steeply over sandstone ledges, terminating near the river's edge in a deposit of large (~20 cm to 1 m diameter) boulders. The gullies are infilled with aeolian sand transported from nearby dunes and potentially from a large river sand bar located directly across the river from the site. Area vegetation includes isolated catclaw acacia (*Acacia greggii*), prickly pear (*Opuntia* sp.), goldenbush (*Isocoma acradenia*), ephedra (*Ephedra* sp.), brittlebush (*Encelia* sp.), trixis (*Trixis californica*), and perennial bunch grasses such as Indian rice grass (*Achnatherum hymenoides*). Tamarisk (*Tamarix ramosissima*) and arrowweed (*Pluchea sericea*) border the site near the river's edge and lower dune areas. O'Brien and Pederson (2009a) identified gullying, overland flow, aeolian transport, and creep as the geomorphic processes affecting this site and noted that both gullying and creep were incrementally eroding artifacts here. Additional site details are included in O'Brien and Pederson (2009a).

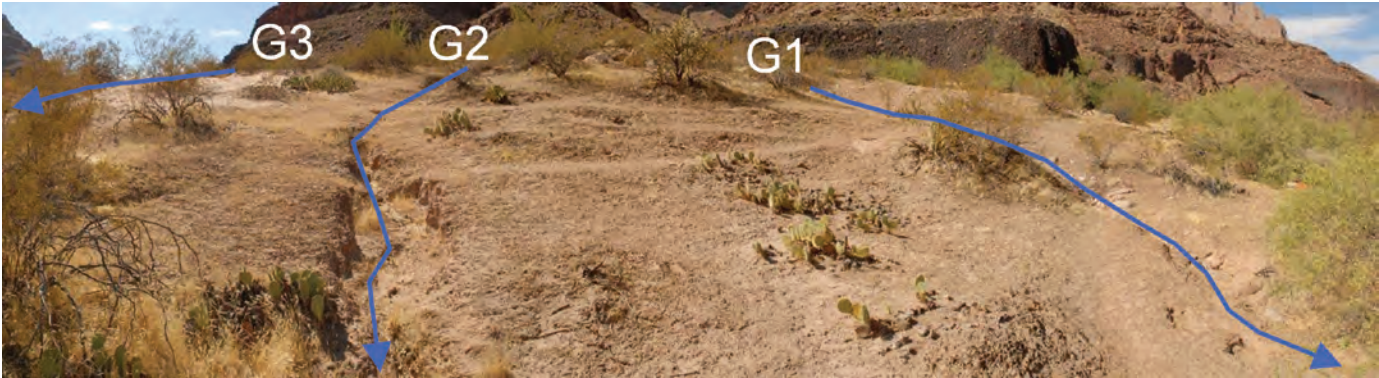
Figure 36. Site AZ:G:03:0072 US survey area photo showing gully locations (G1 to G3). View is to the west.

Site AZ:G:03:0072 US (upstream) and site AZ:G:03:0072 DS (downstream) form a single archeological site but were divided into two survey areas because of their large spatial extent. The entire site has been monitored by terrestrial lidar four times since 2006. This site is a prehistoric and protohistoric habitation area containing sparse surface artifacts and numerous agave roasting pits (Fairley and others, 1994). The upstream survey area (AZ:G:03:0072 US) consists of a convex hillslope that bounds an alluvial terrace that slopes down to the Colorado River, and it is further bounded on one side by a boulder-choked channel and on the other by steep slopes and outcrops of basalt cliffs (figs. 35 and 36). Three gullies traverse this part of the site; two (G1 and G2) are founded on alluvial fill cobbles and boulders, whereas the other (G3) cuts through an active sand dune. The sand dune extends from gully G2 to the western edge of the site near the boulder-choked channel. Brush check dams were installed in gully G2 in May 2006 (O'Brien and Pederson, 2009b). Vegetation consists of clumps of grasses, smaller bushes, and prickly pear cactus (*Opuntia basilaris*), along with taller groups of ocotillo (*Fouquieria splendens*), cholla (*Cylindropuntia acanthocarpa*), and larger creosote (*Larrea tridentata* var. *tridentata*) and catclaw acacia (*Acacia greggii*) several meters in height. O'Brien and Pederson (2009a) identified gullying, creep, aeolian transport, and overland flow as the geomorphic processes affecting this site and noted that archeological features were actively being eroded by these processes. Additional site details are included in O'Brien and Pederson (2009a,b).

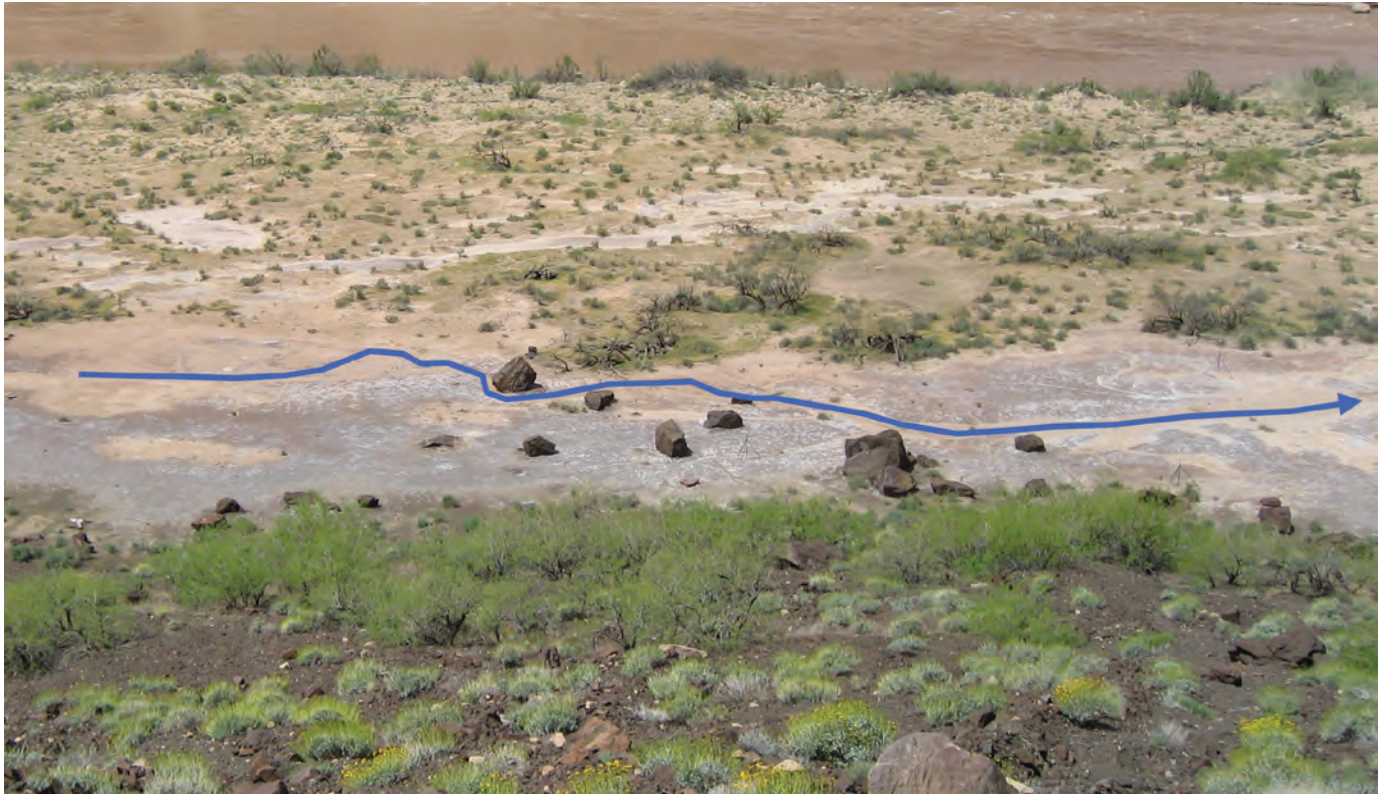
Figure 46. Oblique image overview of AZ:C:13:0099 playa area showing length of main channel thalweg (blue line) for long profile analysis. View is to the west (see fig. 22).

The second method of direct thalweg mapping on the colored point cloud was much more successful. Here, approximately 100 m of the thalweg was mapped using 136 points (compared to 37 using total station) on a combined colored point cloud consisting of data from five separate scan locations. Horizontal plane accuracy was good (fig. 47), with maximum differences on the order of 20 cm. In general, these were due to the coarser resolution of the total station data. Profile view accuracy was also exceptional (fig. 48), with mean difference errors between the long profiles generated by lidar and total station of only 0.2 cm and 84 percent of the data within a 2-cm vertical error bound. This is therefore a vast improvement over the results obtained by Collins and others (2008), especially so because the thalweg investigated here is relatively flat—such situations had earlier been highlighted as a limitation of lidar methods.

Because the lidar-generated thalweg was based on an order-of-magnitude larger number of points, the long profile is evidently longer and more variable. However, in only two locations (at approximately the 33-m and 65-m distance marks—see fig. 48) were the lidar data significantly different from the total station data. Here, we determined that the differences were due to a lack of point density in the total station data—the differences were located in two low-lying areas of the thalweg where “pools” developed (a result of filling and subsequent drying of the channel), such that the total station likely missed locating these lower visibility features. In summary, the use of photo-colored point clouds for mapping channel thalwegs proved to be a vast improvement over previous attempts to identify subtle topographic features such as these. This method thus shows much promise for mapping geomorphic change in gully systems, as long as the limitations discussed by Collins and others (2008) are avoided (namely, surveying in highly vegetated areas that obscure any view of the gully thalweg).
