Determination of Flow Losses in the Cape Fear River between B. Everett Jordan Lake and Lillington, North Carolina, 2008–2010

Scientific Investigations Report 2012–5226

By J. Curtis Weaver and Kristen Bukowski McSwain

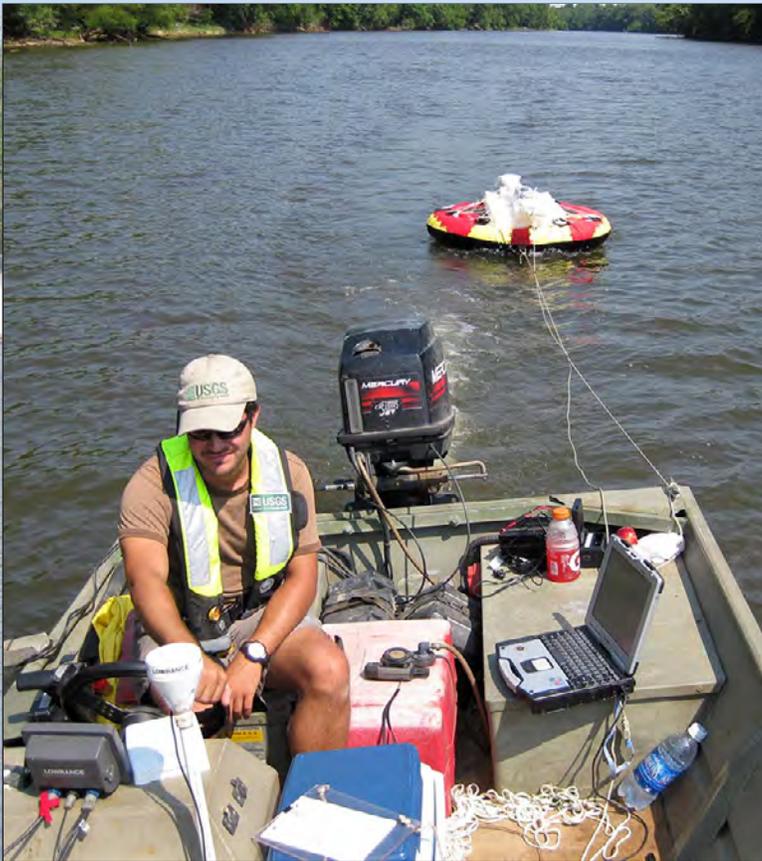
Front cover. Left: Brad Huffman (USGS) towing a multifrequency electromagnetic sensor behind a boat on the Cape Fear River upstream from Lillington, North Carolina (N.C.), July 10, 2009. Top right: Wildlife on the diversion canal adjacent to Cape Fear River near Buckhorn Dam, September 9, 2009. Bottom right: Streamgage at USGS station 02098198 on Haw R below B. Everett Jordan Dam near Moncure, N.C., November 19, 2009. All photos by Curtis Weaver.

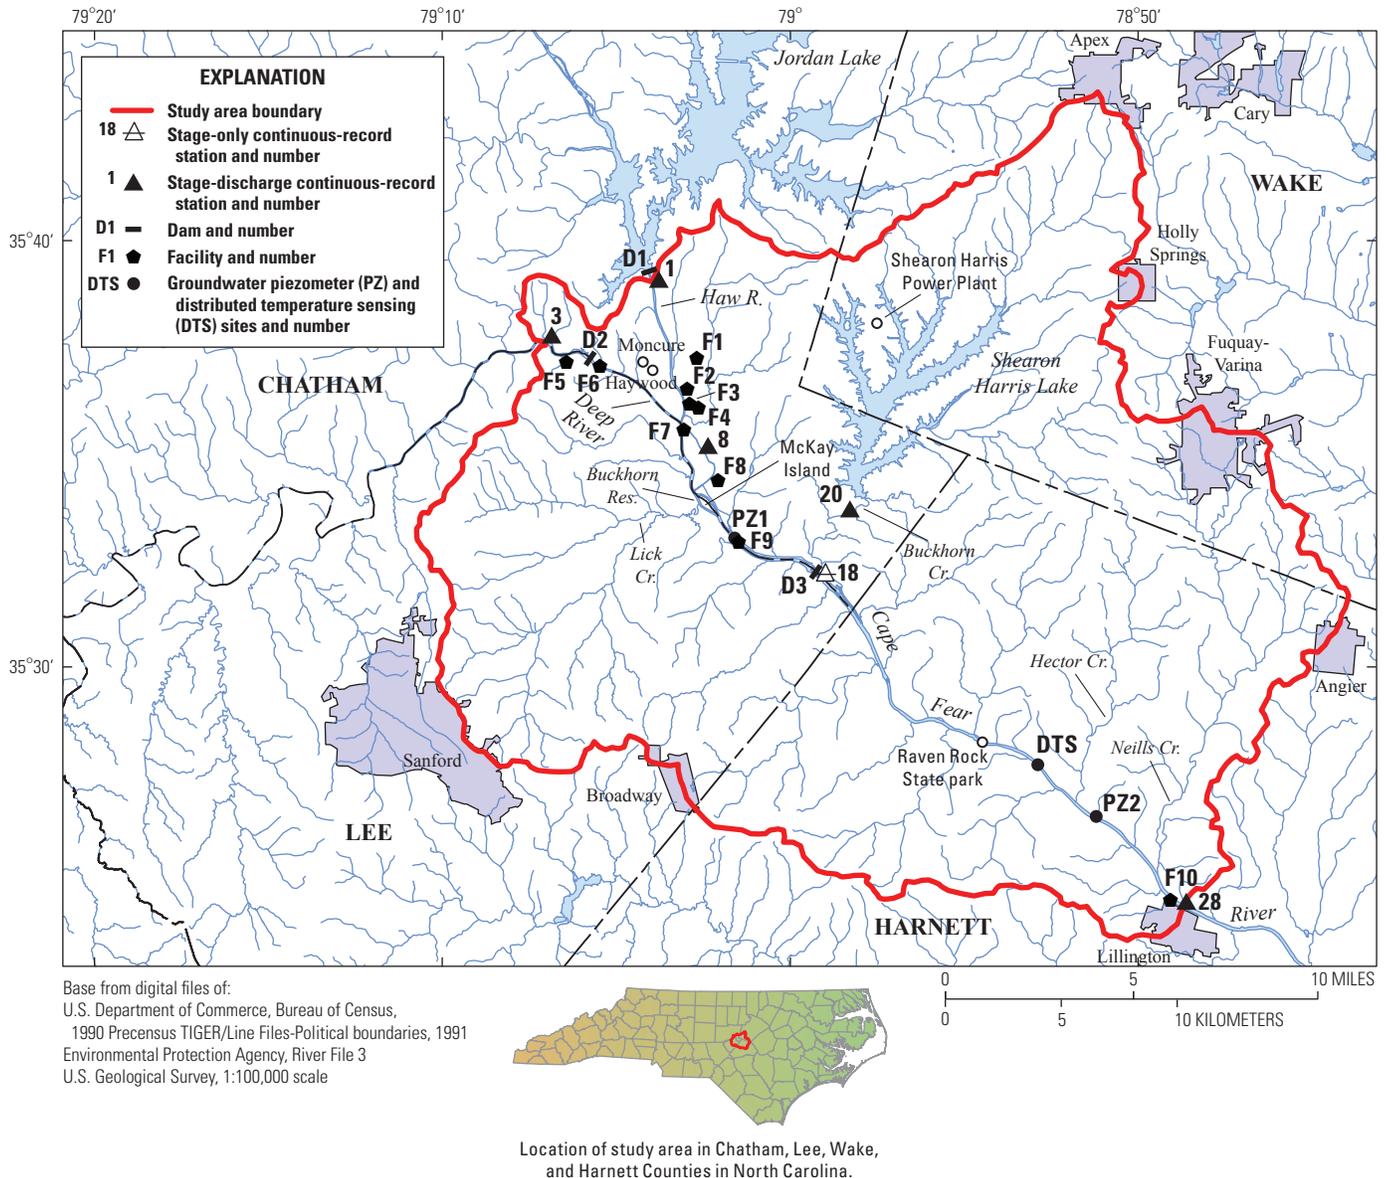
Figure 1. Location of study area between B. Everett Jordan Lake and Lillington, North Carolina.

Water withdrawals and return discharges also are made by five private industries (fig. 1), four of which (sites F1–F4) are located on the Haw River upstream from its confluence with the Deep River. The fifth industry (site F8) withdraws water from the diversion canal adjacent to the Cape Fear River. Groundwater withdrawals by a quarry operation (site F5) upstream from the Lockville hydropower dam also were identified as a possible cause of flow loss, because groundwater is intercepted that would be otherwise discharged to the Deep River.

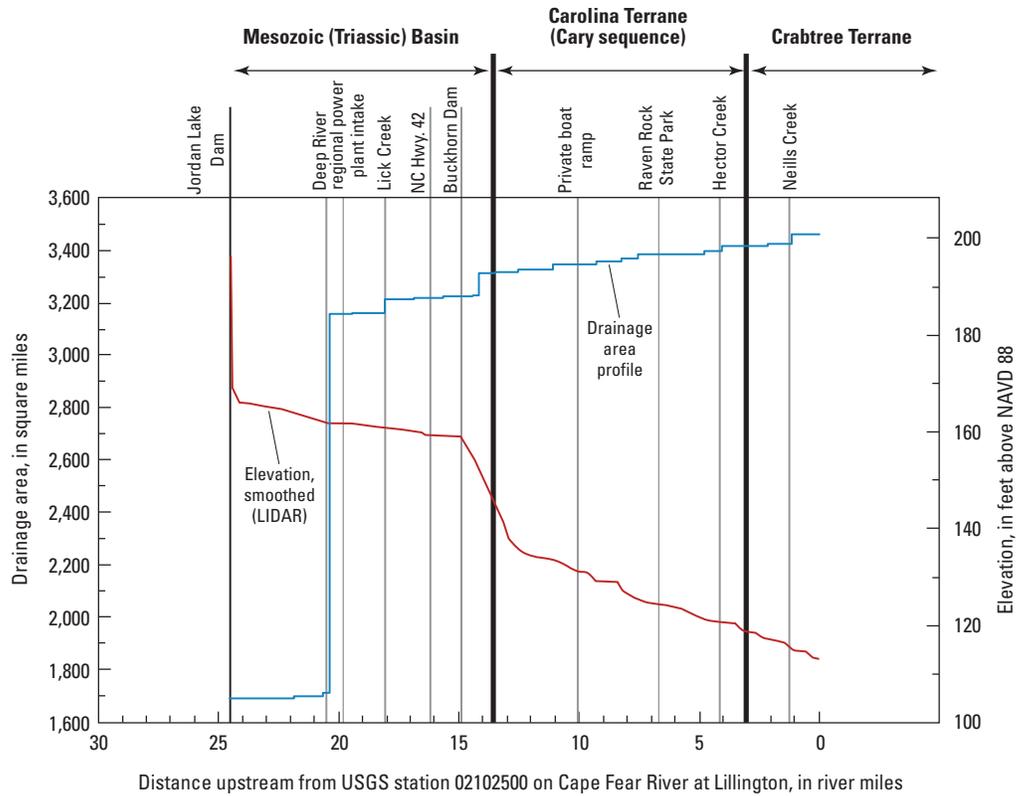
Figure 2. Drainage area and elevation profiles on the Haw and Cape Fear Rivers between Jordan Lake Dam and Lillington, North Carolina.

outcrops of varying size, ranging from small cobbles to substantial boulders. Navigation using motorized craft is limited in this section of the river, particularly during base-flow conditions. Between Buckhorn Dam and the Lillington streamgage (site 28), the channel slope varies from about 7 ft/mi in the 3-mi reach below the dam to about 1.6 ft/mi in the downstream most 11.5-mi reach (fig. 2).

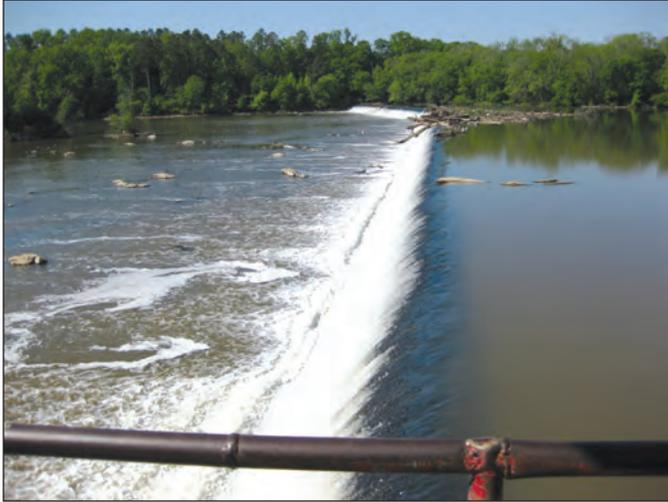
Figure 3. Cape Fear River at Buckhorn Dam (site D3) near Corinth, North Carolina. (Photo by J. Curtis Weaver on April 27, 2009)

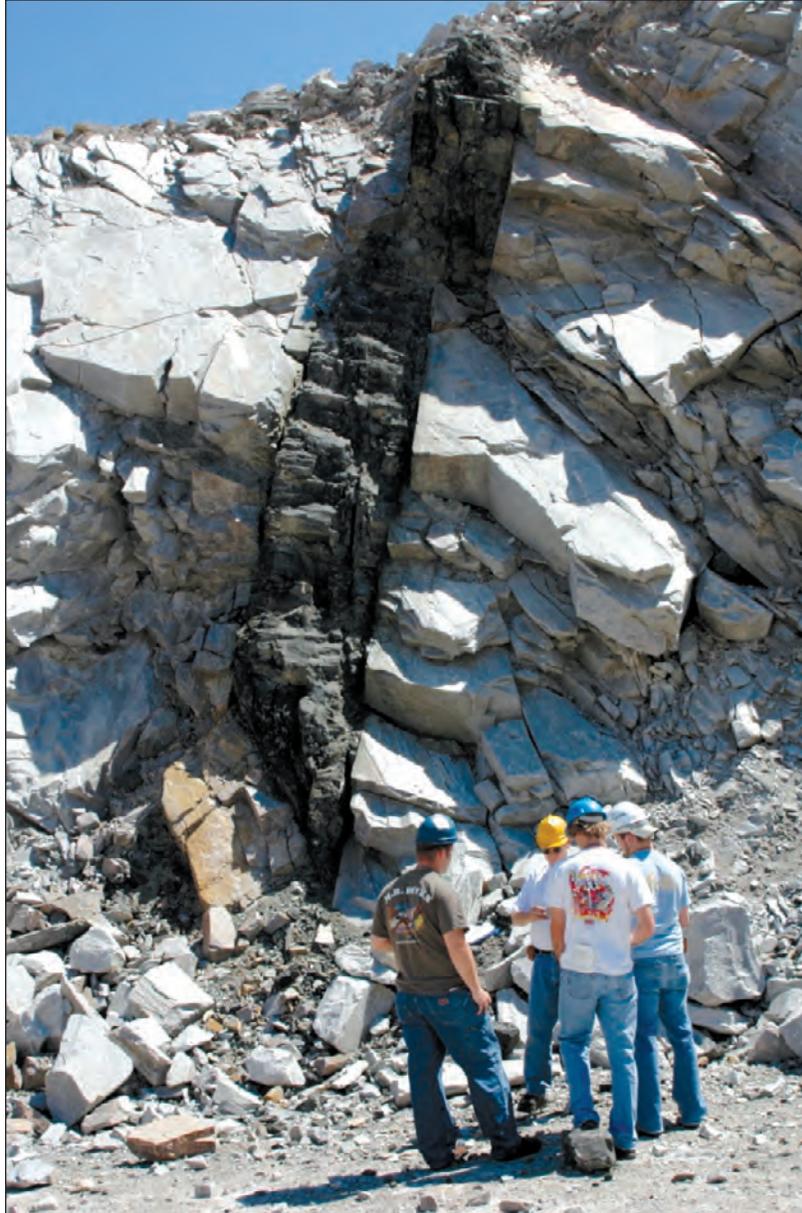
Figure 5. An example of a diabase dike (dark feature near center) that vertically intrudes the subsurface of a quarry near Cary, North Carolina. (Photo by Richard Bolich, North Carolina Division of Water Quality, April 5, 2005).

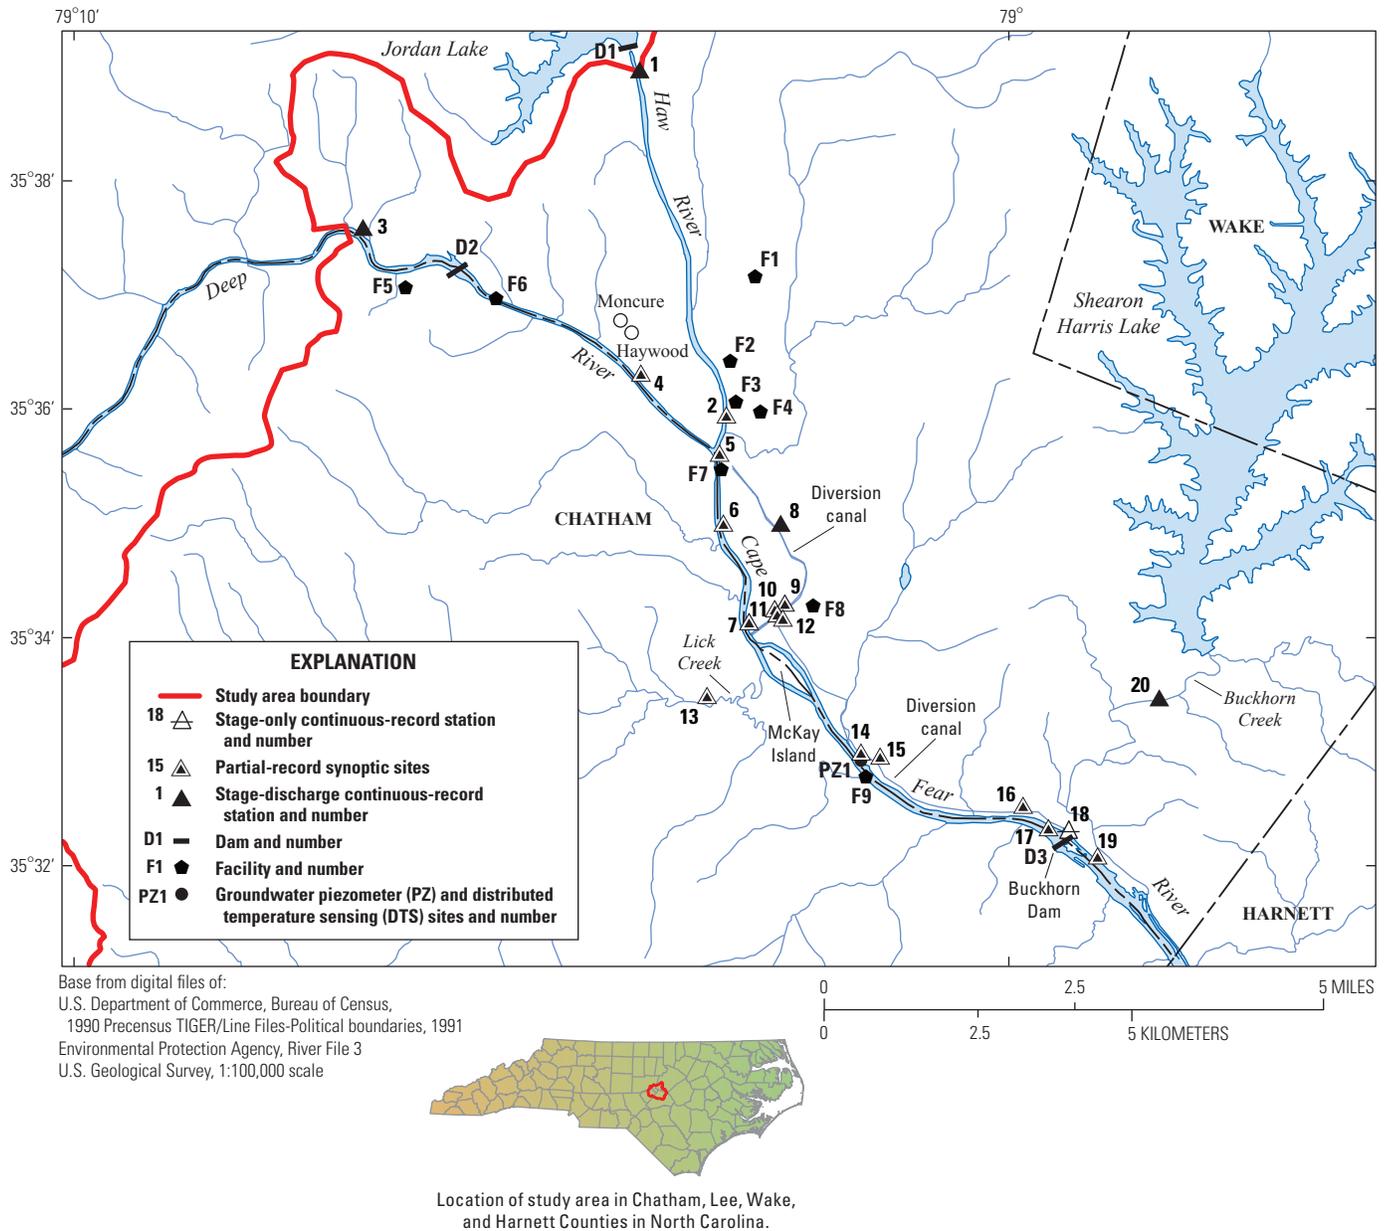
Figure 6. Locations upstream from Cape Fear River at Buckhorn Dam where discharge measurements were made during the series of synoptic measurements in 2009.

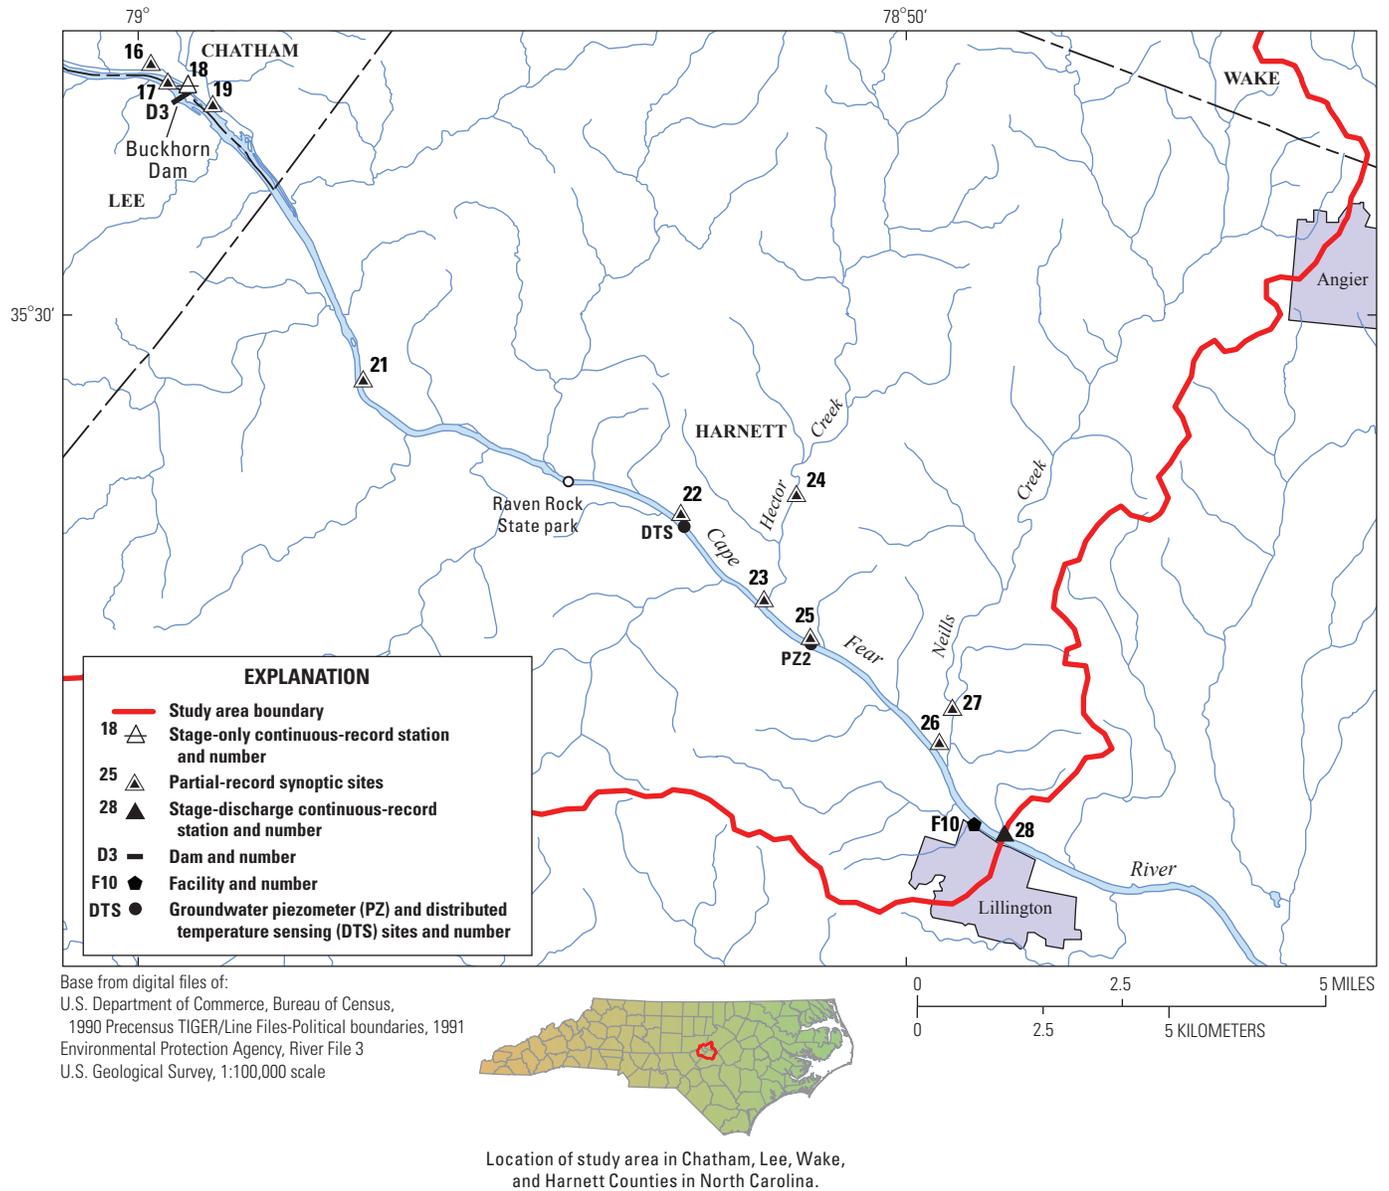
Figure 7. Locations downstream from Cape Fear River at Buckhorn Dam where discharge measurements were made during the series of synoptic measurements in 2009.

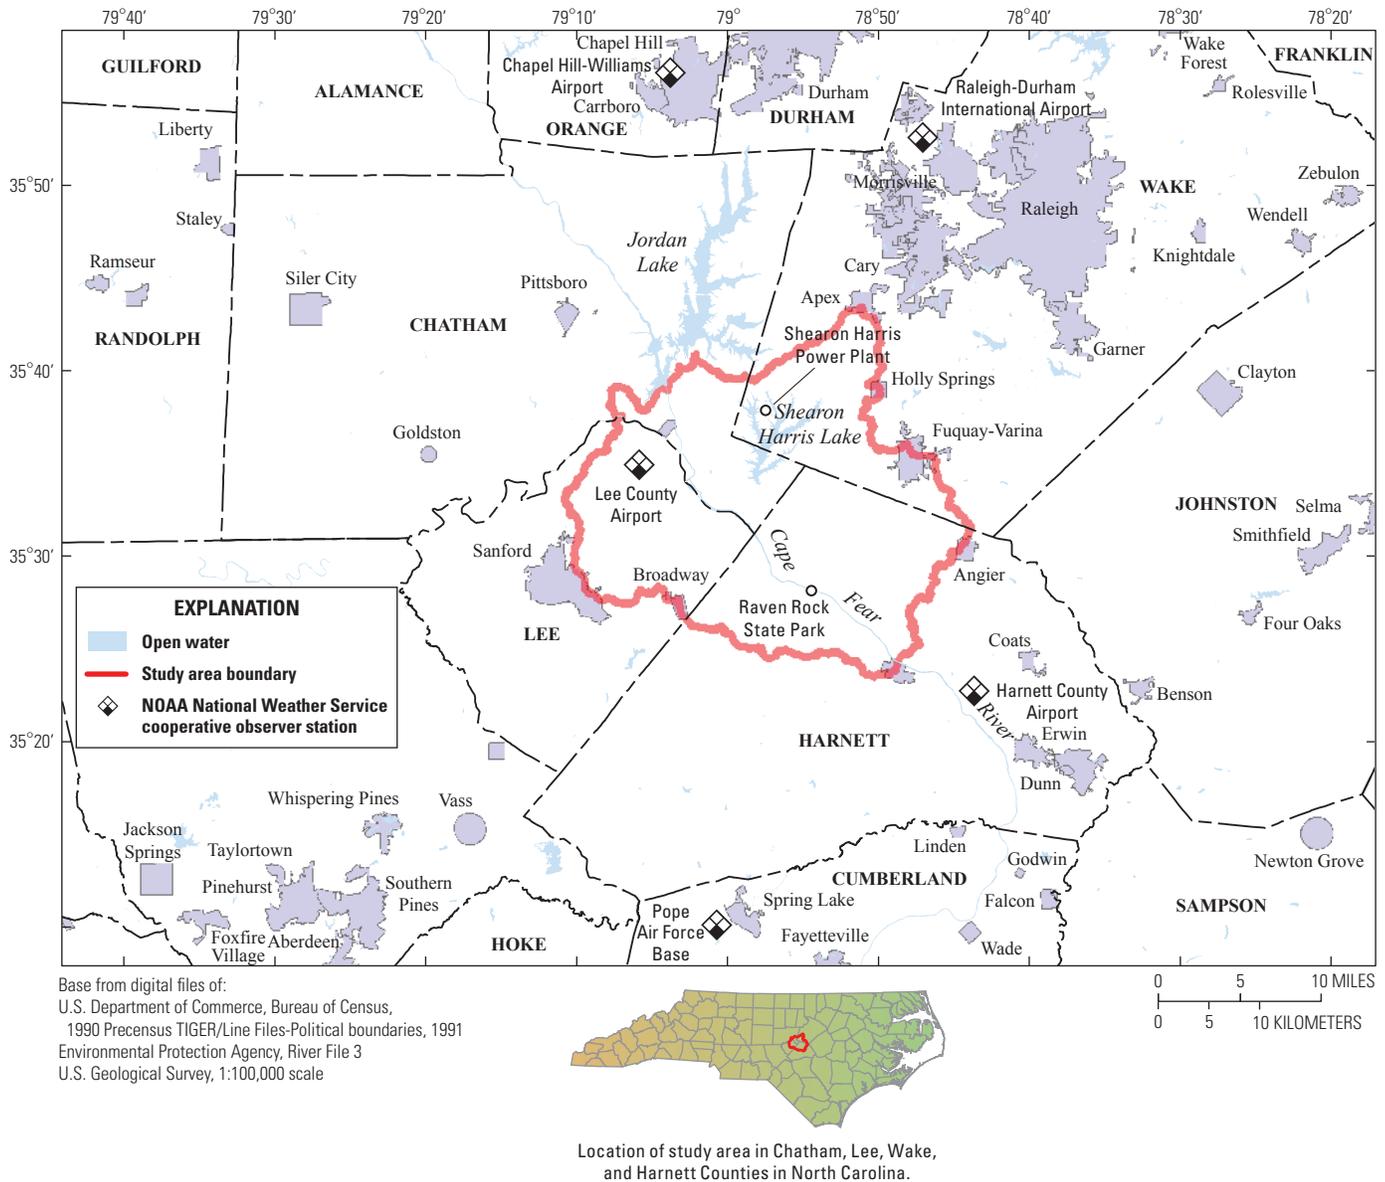
Figure 8. Locations of nearby National Oceanic and Atmospheric Administration National Weather Service cooperative observer stations where daily reference, open-water evaporation data were compiled for the study based on the Penman-Monteith method.

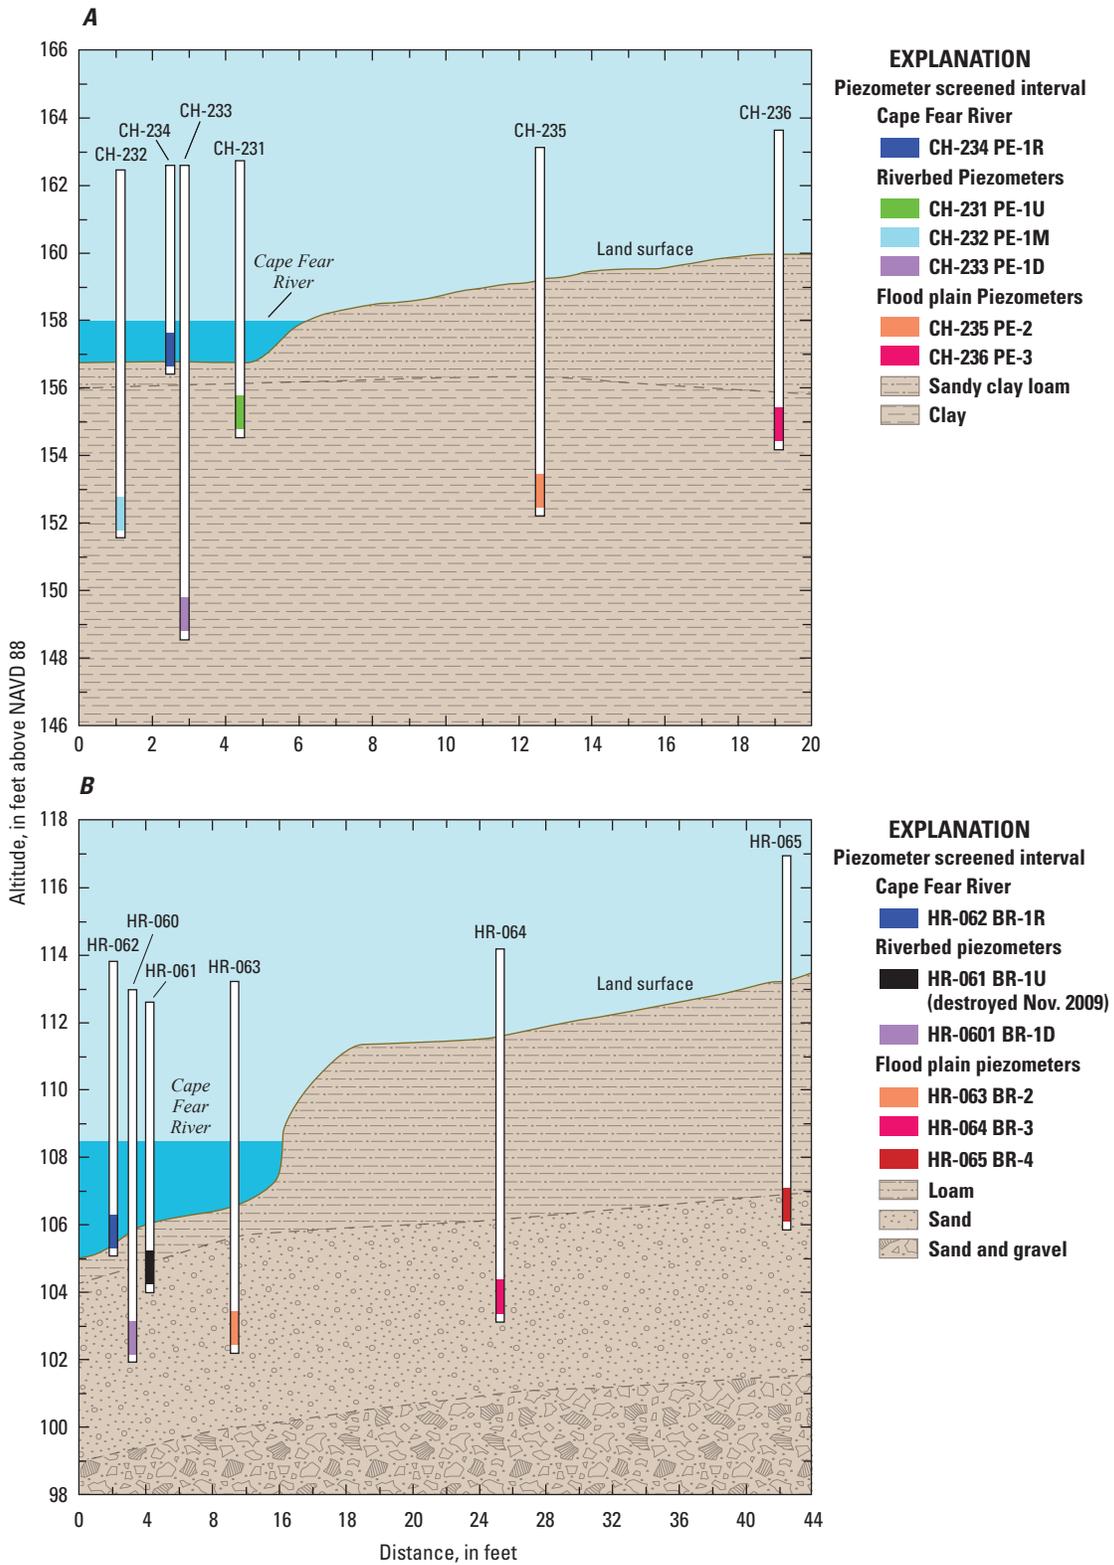
Figure 9. Piezometer profiles and soils encountered at the (A) regional power plant transect (PZ1) near Corinth and (B) Bradley Road transect (PZ2) near Lillington, North Carolina (sites shown in fig. 1).

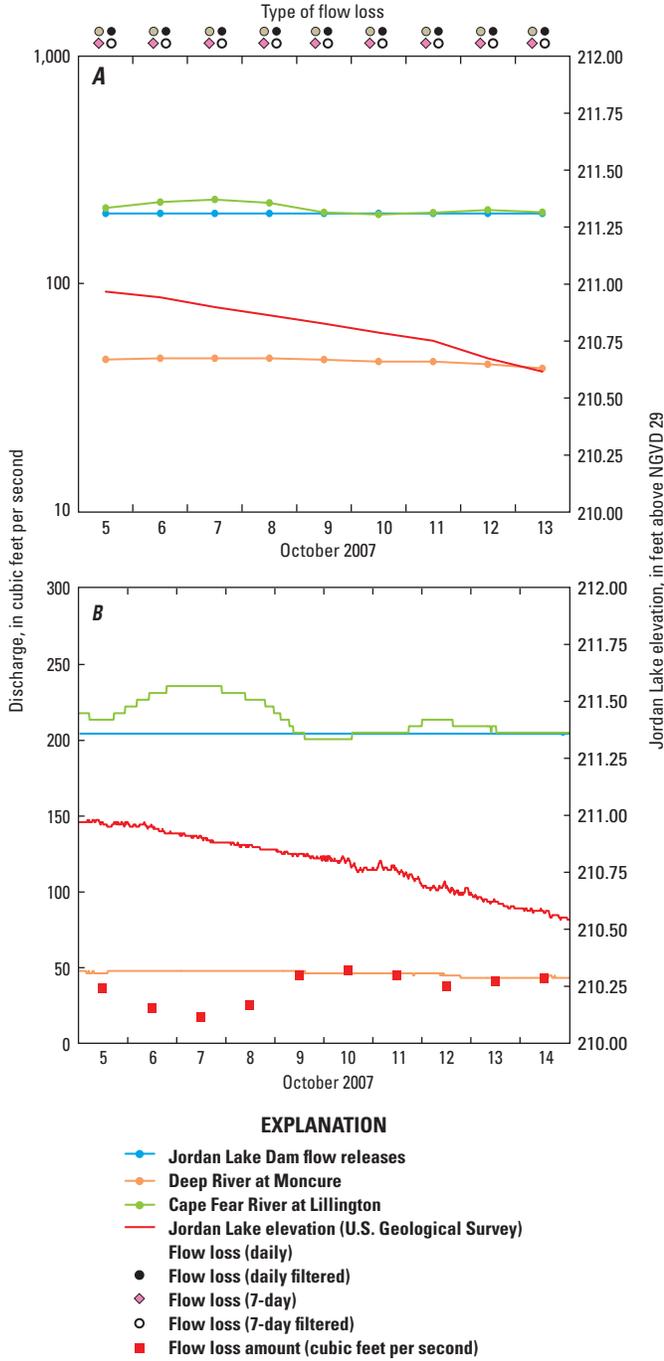
Figure 10. (A) Daily mean and (B) instantaneous discharges in the Cape Fear River and tributaries, North Carolina, during October 5–14, 2007, with daily and 7-day flow losses based on daily discharge flow comparison 3.

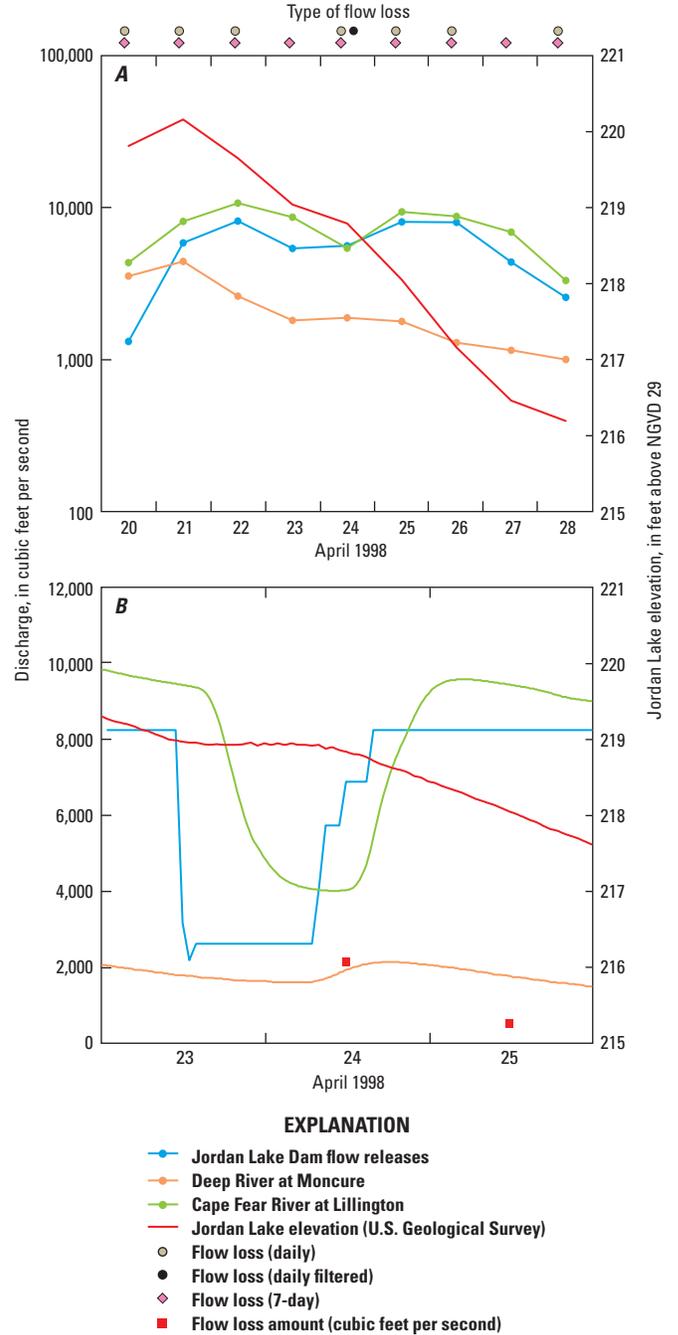
Figure 11. (A) Daily mean and (B) instantaneous discharges for days prior to and following April 24, 1998, on which maximum flow loss occurred in the Cape Fear River and tributaries, North Carolina, based on daily discharge flow comparison 3.

Examination of the maximum flow loss amounts, particularly for flow comparisons 3 and 5 (table 3), indicates the filtered assessments did not filter out all nonpeak-flow conditions, because flow losses at this magnitude are not true flow losses. The maximum flow loss determined for comparison 3 highlighted an interesting occurrence in the flow patterns at the Lillington streamgage where flows decreased and then increased again by about 5,000 ft³/s within a 36-hour period during April 23–25, 1998 (fig. 11). Limited information is available to fully explain this unusual flow pattern, suspicion of possible sudden changes in flow release were confirmed by the USACE (Terry Brown, U.S. Army Corps of Engineers (retired), written commun., December 16, 2009). Of note, the lake elevation for Jordan Lake on April 21, 1998, exceeded 220 ft, more than 4 ft above the guide curve elevation of 216 ft used in daily lake-management operations (fig. 11A).

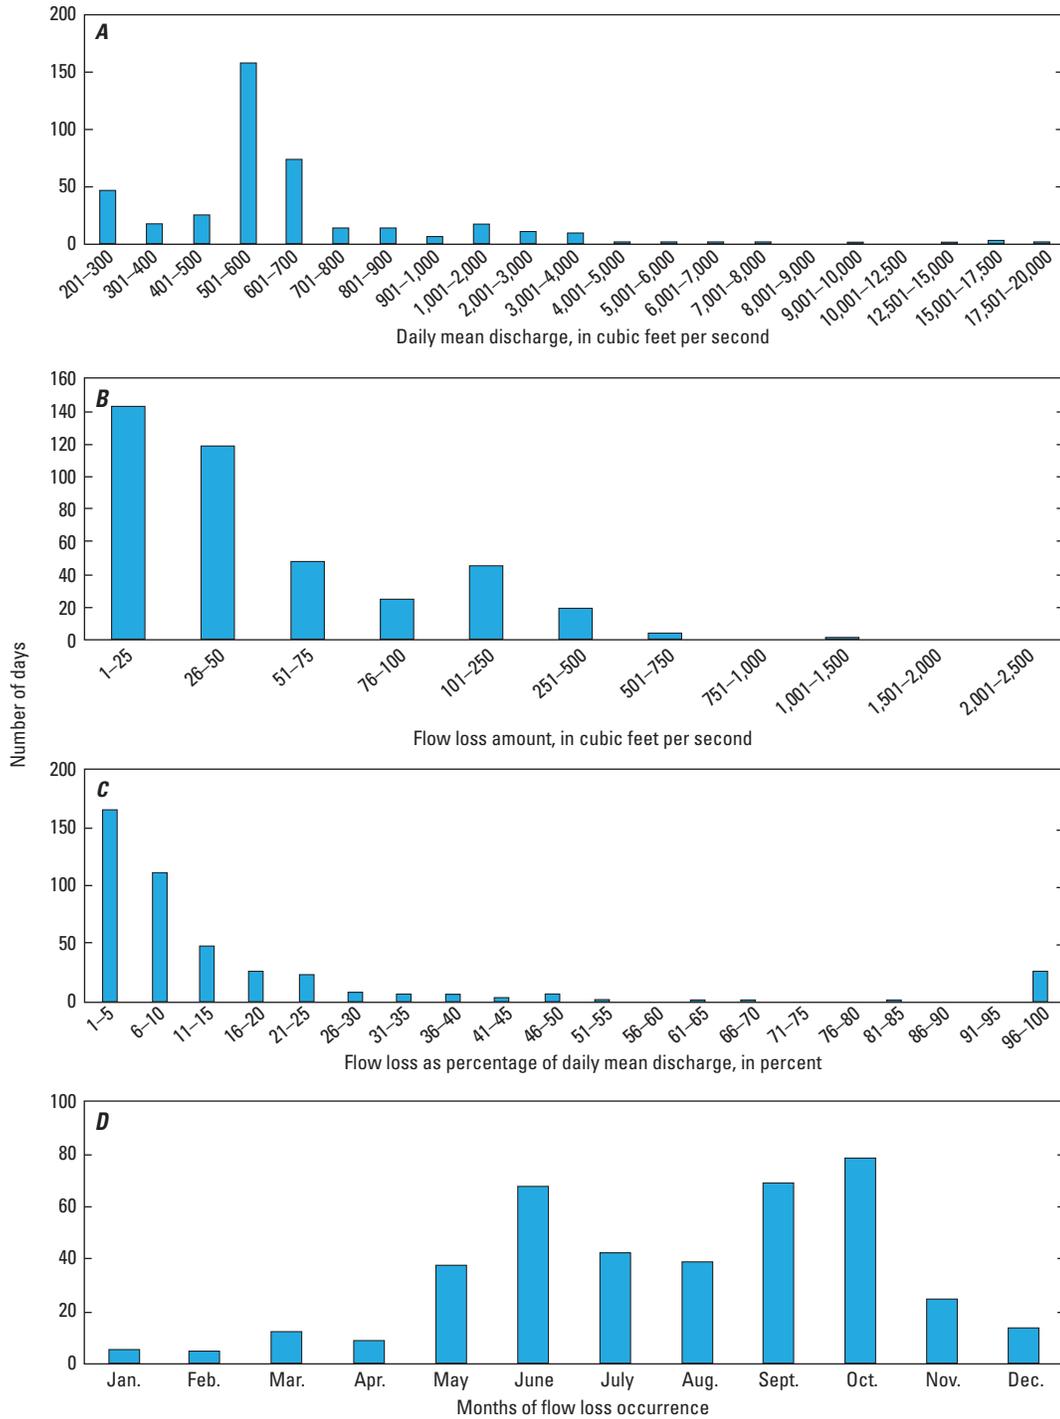
Figure 12. Filtered flow-loss occurrences in the Cape Fear River determined in flow comparison 3 based on (A) daily mean discharge, (B) flow-loss amount, (C) percentage of daily mean discharge, and (D) month of occurrence.

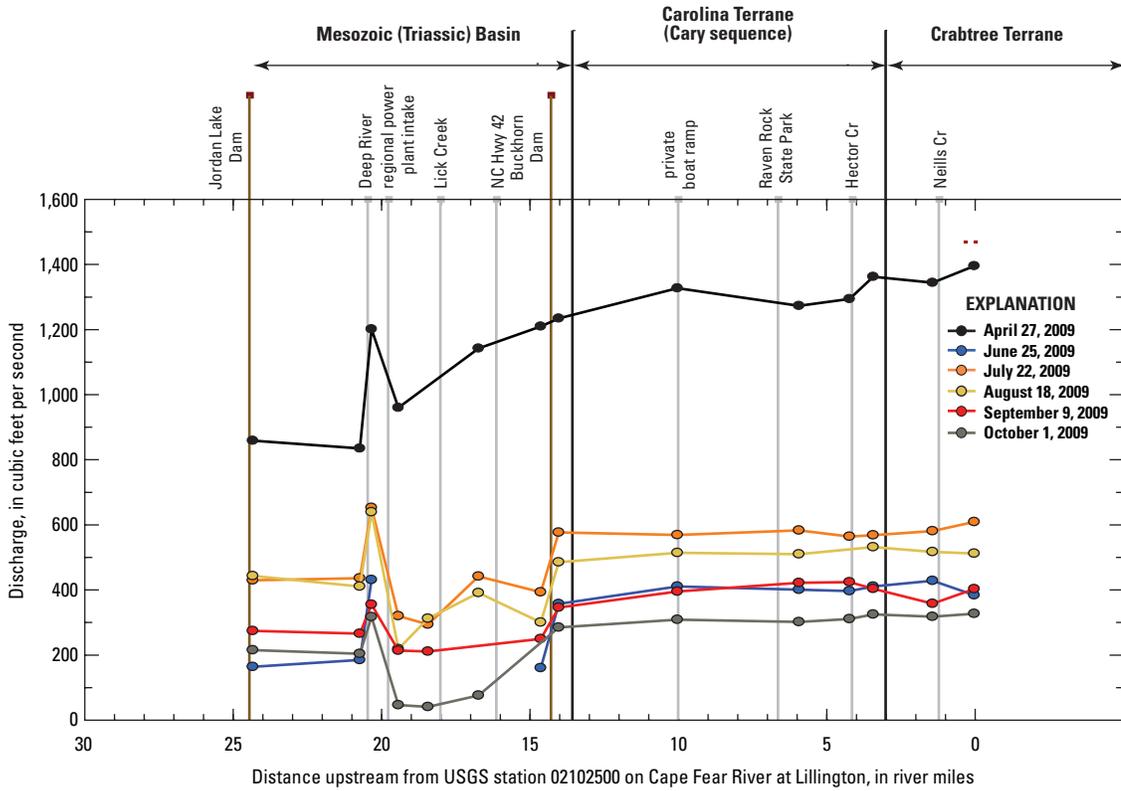
Figure 13. Discharges measured during a series of six synoptic discharge measurements in 2009 on the Haw and Cape Fear Rivers between Jordan Lake Dam and Lillington, North Carolina.

A series of synoptic discharge measurements were made at selected locations along the main stem between Jordan Lake Dam (fig. 1, site D1) and the Lillington streamgage (site 28) on six different occasions in 2009 (fig. 13). The purpose of each series of synoptic measurements was to create a “snapshot” of the flow conditions along the main stem to determine if a particular pattern could be detected that might identify a consistent flow-loss location, thereby leading to further investigation into the cause(s) for flow loss at that location. Because the flow analyses indicated the majority of flow losses occurred under base-flow conditions during the warmer months, all synoptic-measurement series except the April 27 series were conducted under these conditions on June 25, July 22, August 18, September 9, and October 1, 2009

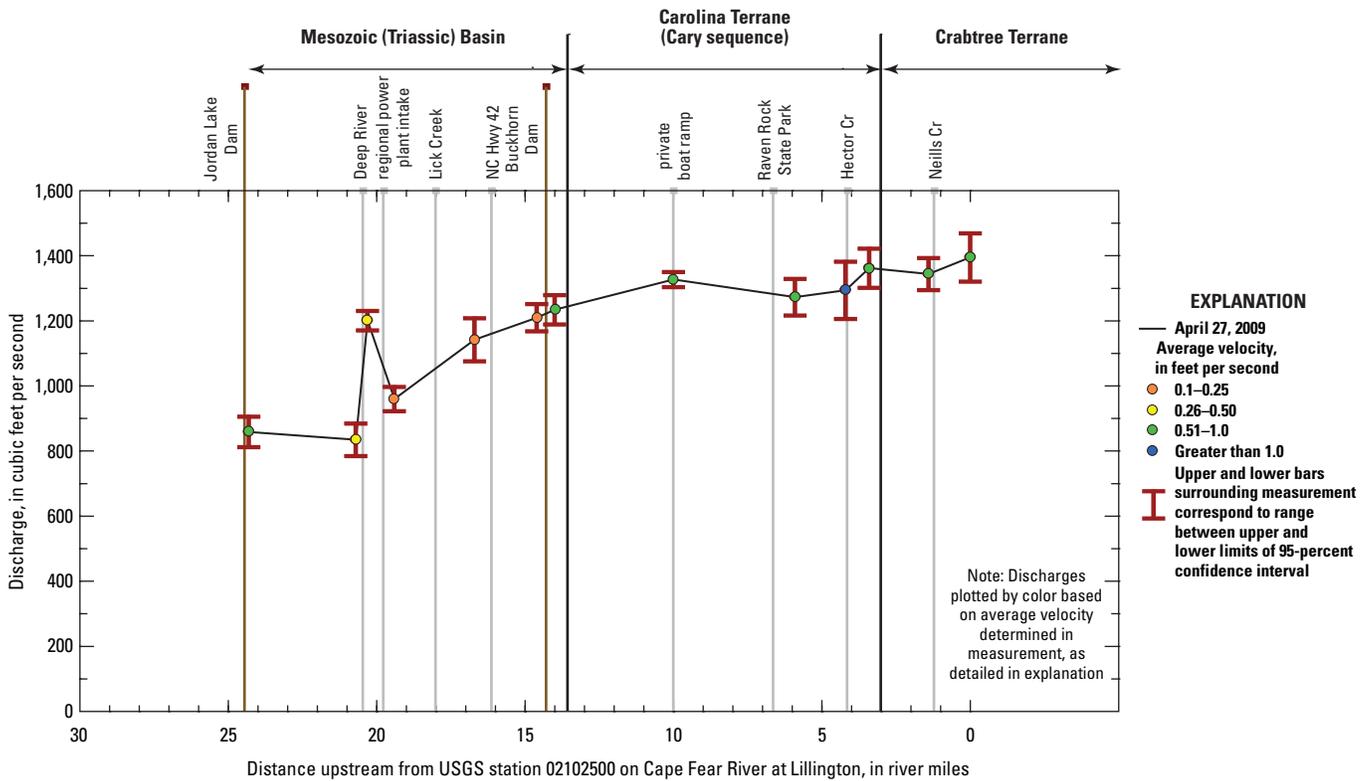
Figure 14. Measured discharges on April 27, 2009, on the Haw and Cape Fear Rivers between Jordan Lake Dam and Lillington, North Carolina.

(figs. 14–19; tables 4–9). The completion of each synoptic-measurement series indicated that the largest change in the main-stem flow occurs immediately downstream from the regional power-plant intake (fig. 1, site F7). However, the synoptic measurements did not indicate any other location where another previously unknown flow loss was observed consistently on each date.

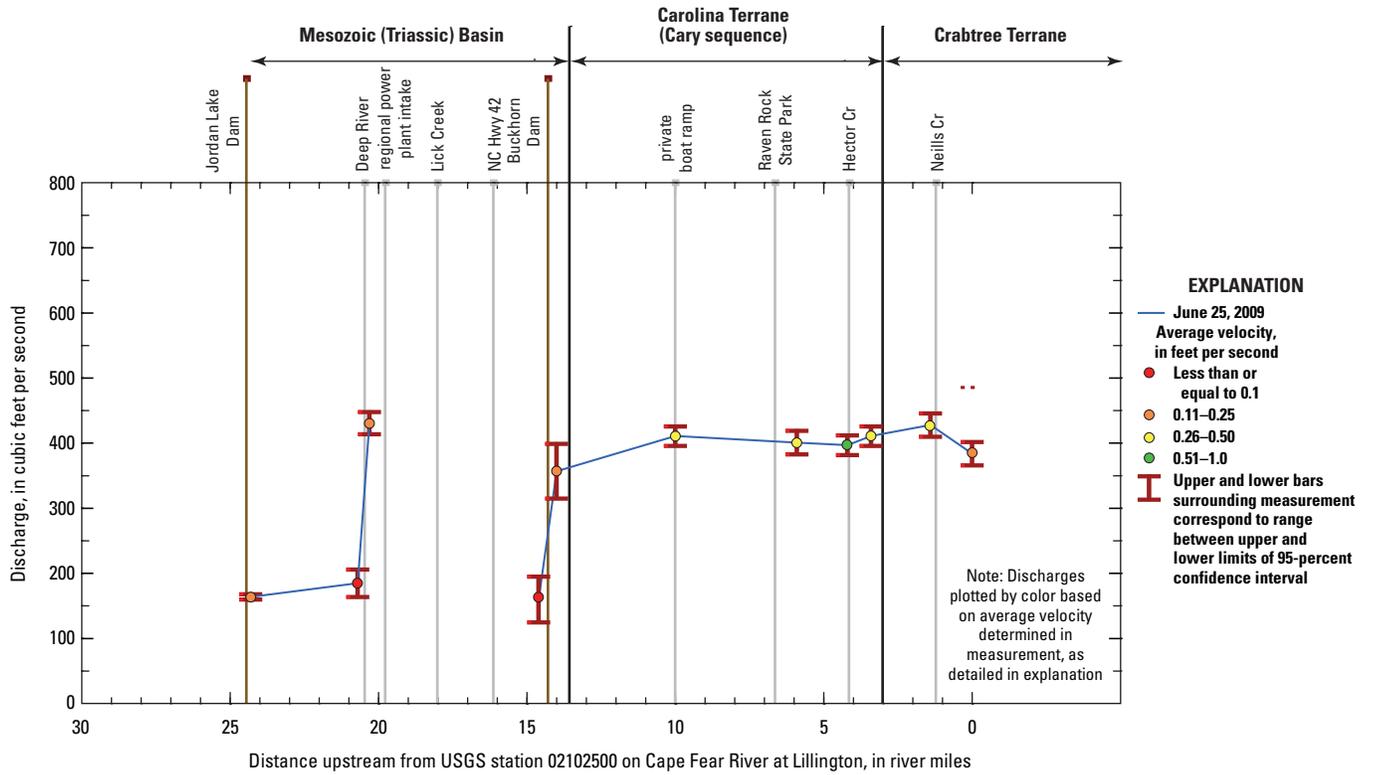
Figure 15. Measured discharges on June 25, 2009, on the Haw and Cape Fear Rivers between Jordan Lake Dam and Lillington, North Carolina.

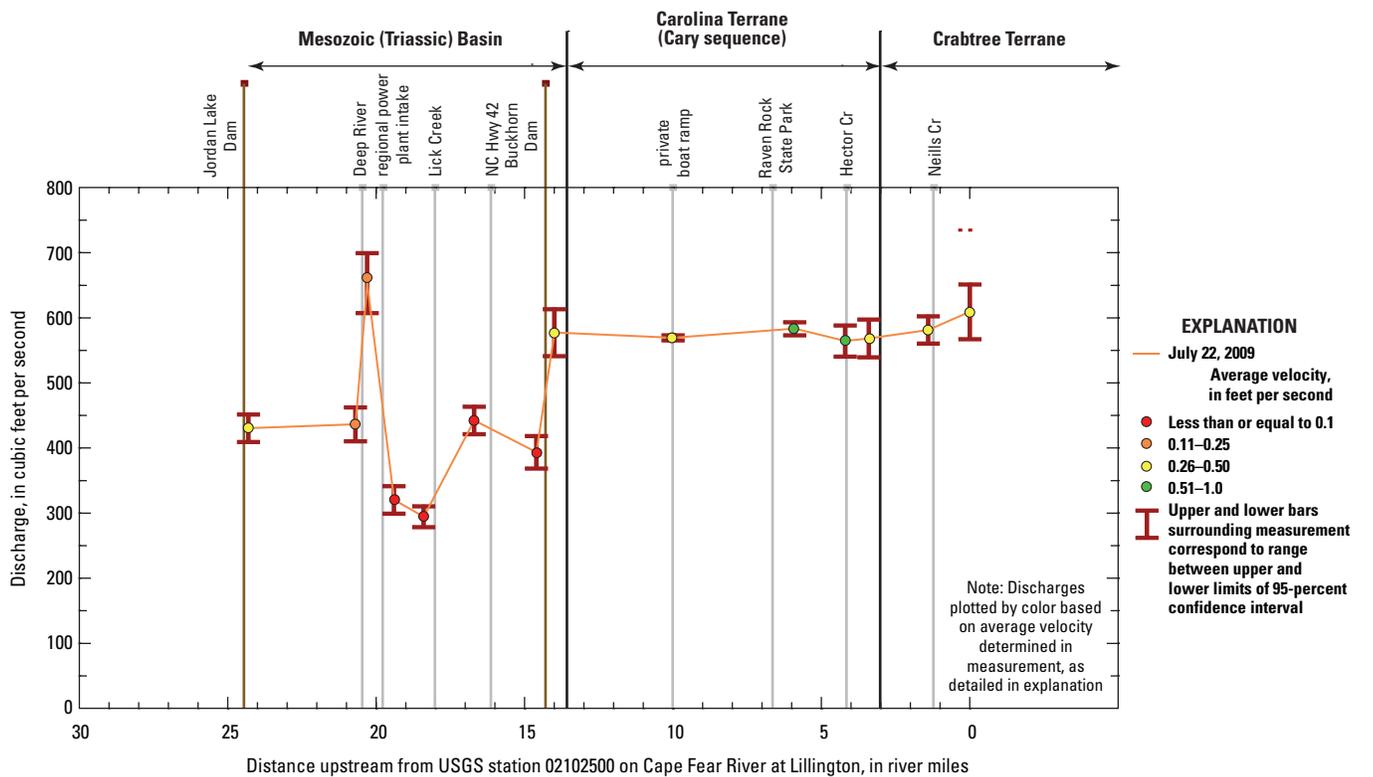
Figure 16. Measured discharges on July 22, 2009, on the Haw and Cape Fear Rivers between Jordan Lake Dam and Lillington, North Carolina.

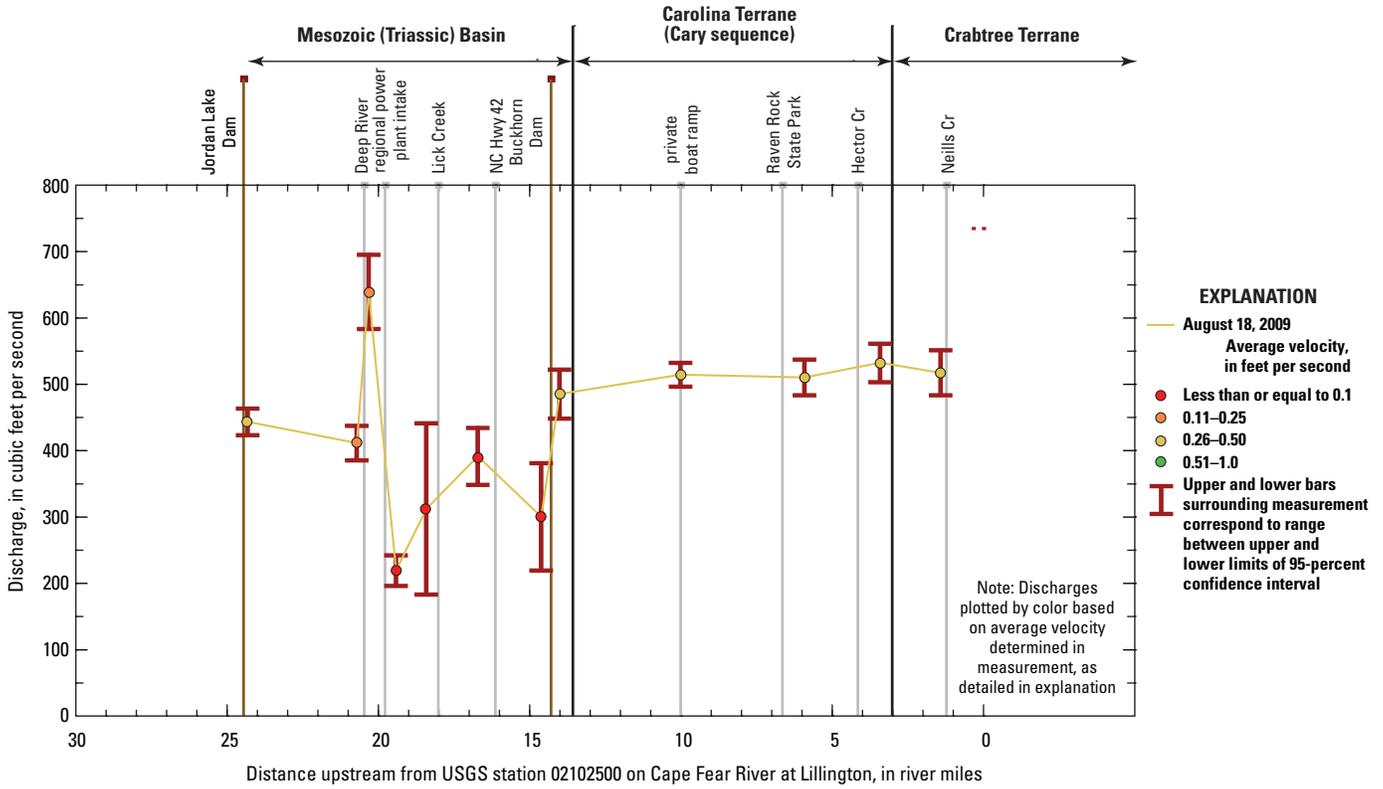
Figure 17. Measured discharges on August 18, 2009, on the Haw and Cape Fear Rivers between Jordan Lake Dam and Lillington, North Carolina.

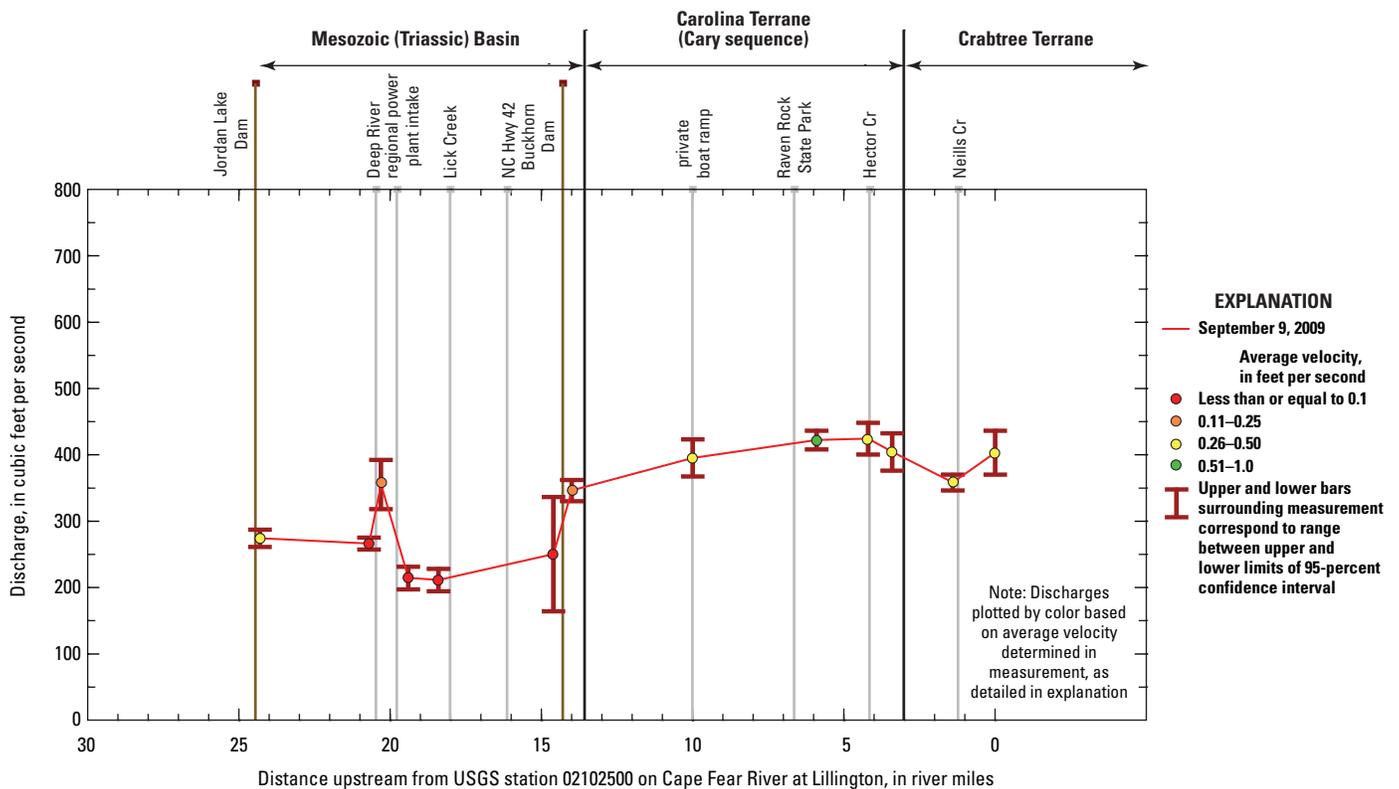
Figure 18. Measured discharges on September 9, 2009, on the Haw and Cape Fear Rivers between Jordan Lake Dam and Lillington, North Carolina.
