Determination of Flow Losses in the Cape Fear River between B. Everett Jordan Lake and Lillington, North Carolina, 2008–2010

Scientific Investigations Report 2012–5226

By J. Curtis Weaver and Kristen Bukowski McSwain

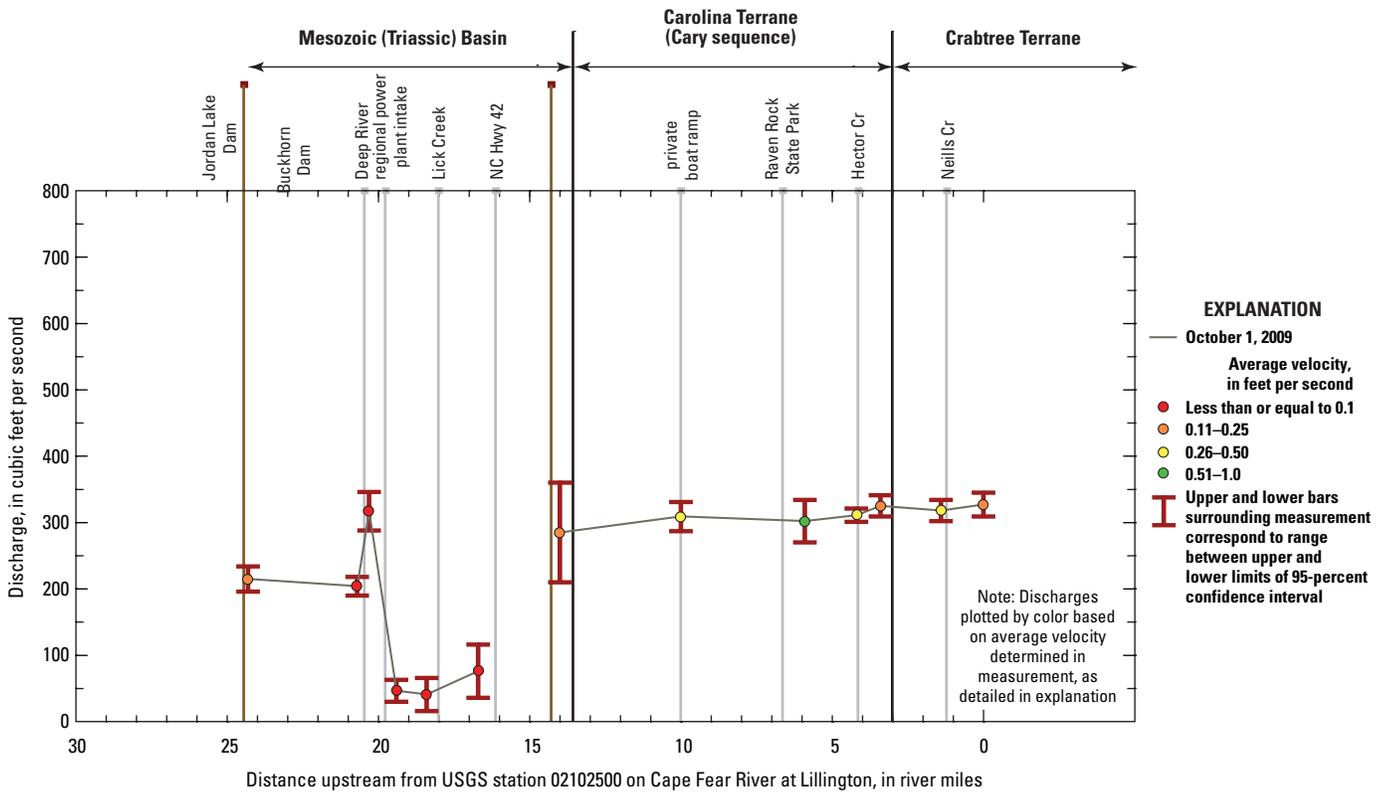
Figure 19. Measured discharges on October 1, 2009, on the Haw and Cape Fear Rivers between Jordan Lake Dam and Lillington, North Carolina.

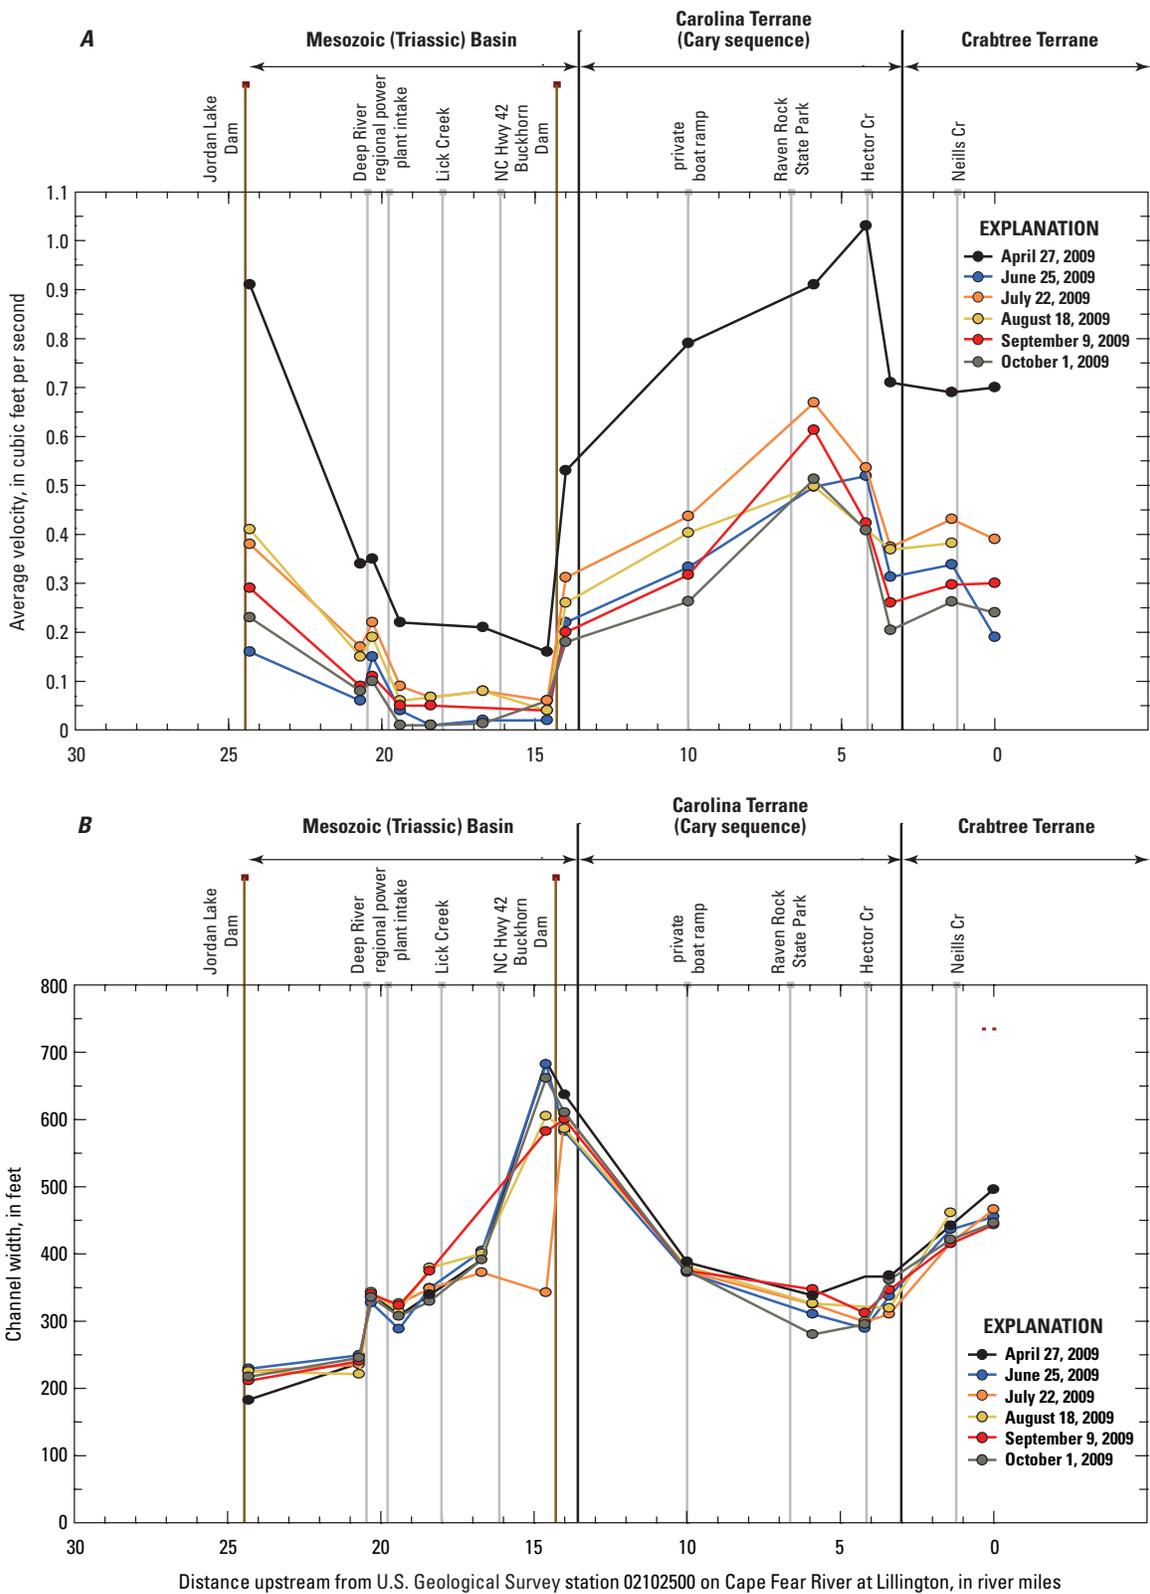
Figure 20. (A) Average velocities and (B) channel widths determined from the series of synoptic measurements made during 2009 on the Haw and Cape Fear Rivers between Jordan Lake Dam and Lillington, North Carolina.

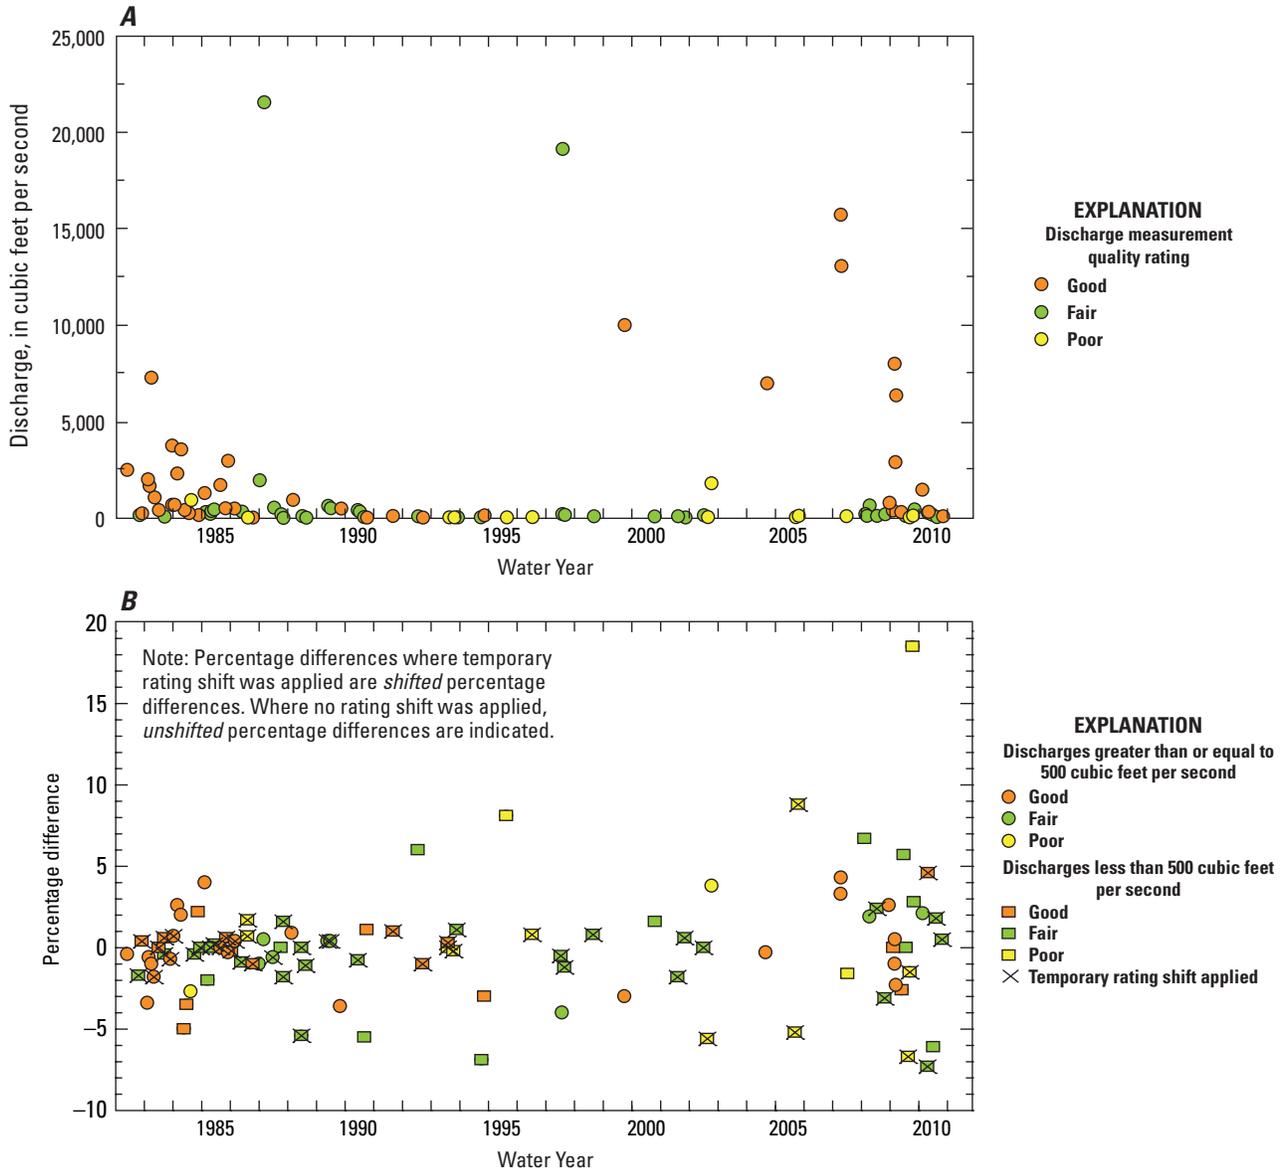
Figure 21. Quality ratings of (A) discharge measurements and (B) percentage differences from shifted, where applied, base rating at Deep River at Moncure (site 3), North Carolina, during the 1982–2011 water years.

Percentage differences at Deep River at Moncure (site 3) during the 1982–2011 water years ranged from about –7.5 percent to nearly +19 percent with values within plus or minus (+/–) 5 percent for 85 measurements (fig. 21B). For the measurements followed by a temporary rating shift (indicated by X symbol in fig. 21B), the percentage differences indicated are the shifted percentage differences. The measurement with a percentage difference of almost 19 percent was rated as

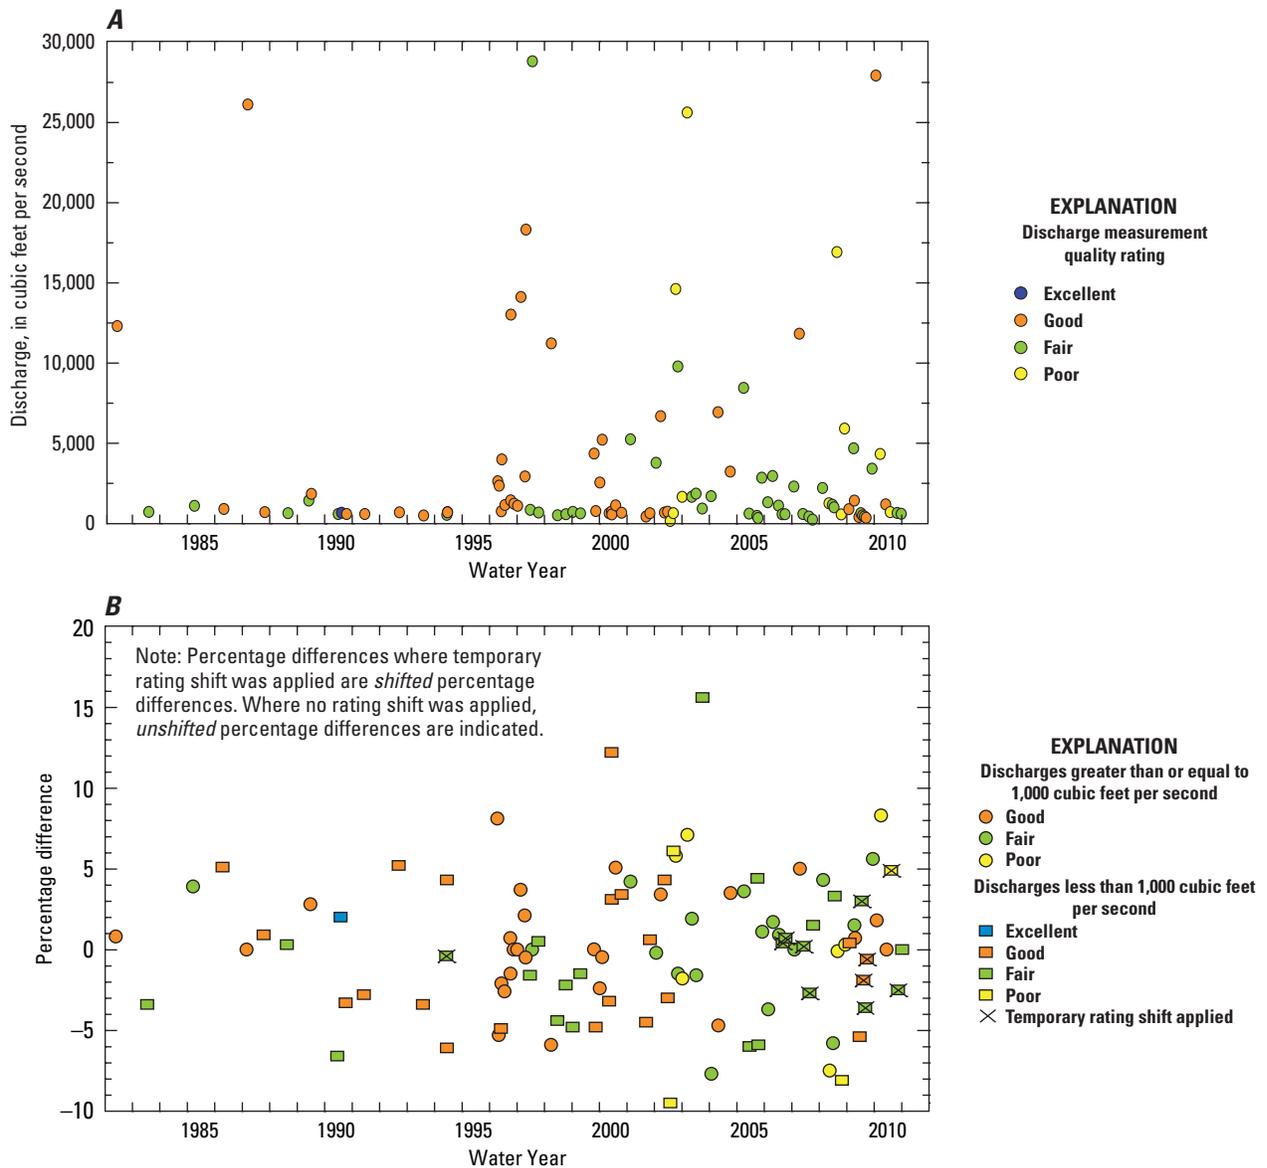
Figure 22. Quality ratings of (A) discharge measurements and (B) percentage differences from shifted, where applied, base rating at Cape Fear River at Lillington (site 28), North Carolina, during the 1982–2011 water years.

Four ratings have been used for the Cape Fear River at Lillington streamgage (site 28) since December 1976. A total of 103 discharge measurements made at this streamgage during the 1982–2011 water years range from 133 to 28,800 ft³/s (fig. 22A). The measurements made during this period were rated as excellent (1 percent), good (47 percent), fair (42 percent), or poor (11 percent). Among these measurements, 51 were measured at discharges of 1,000 ft³/s or less. Among these 51 discharge measurements, the distribution of

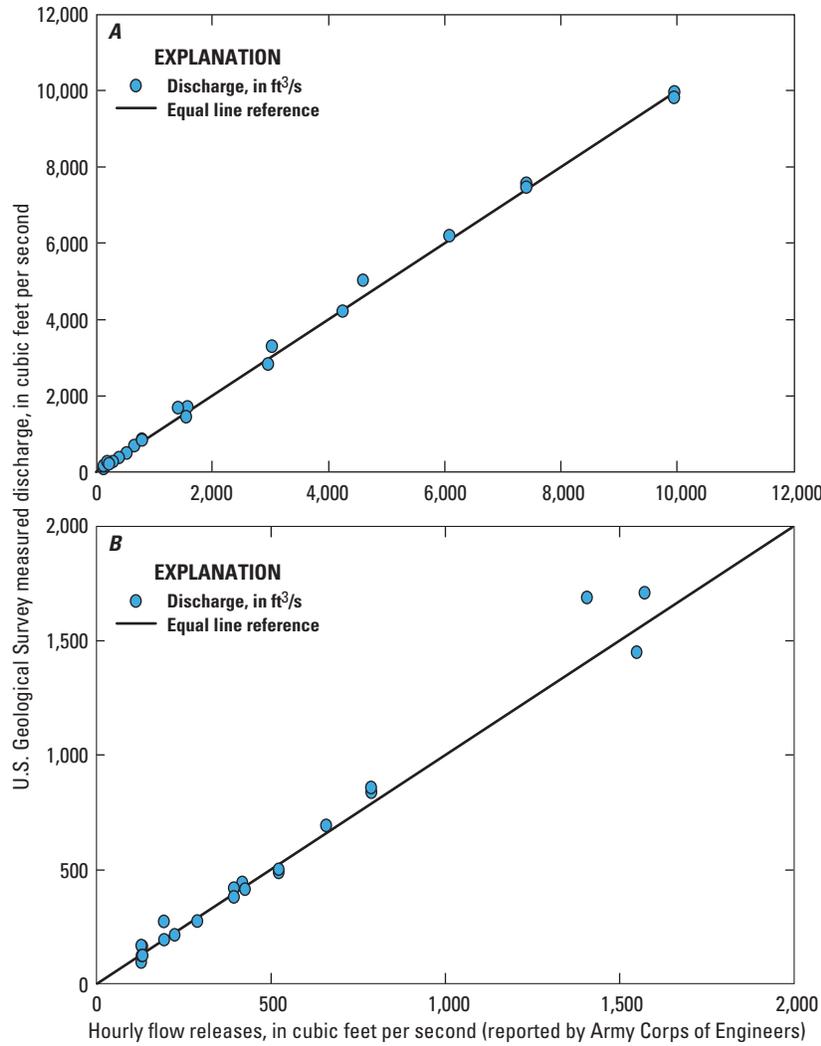
Figure 23. (A) Full range of measured discharges at Haw River below B. Everett Jordan Lake near Moncure (site 1), North Carolina, and (B) measured discharges less than 2,000 cubic feet per second.

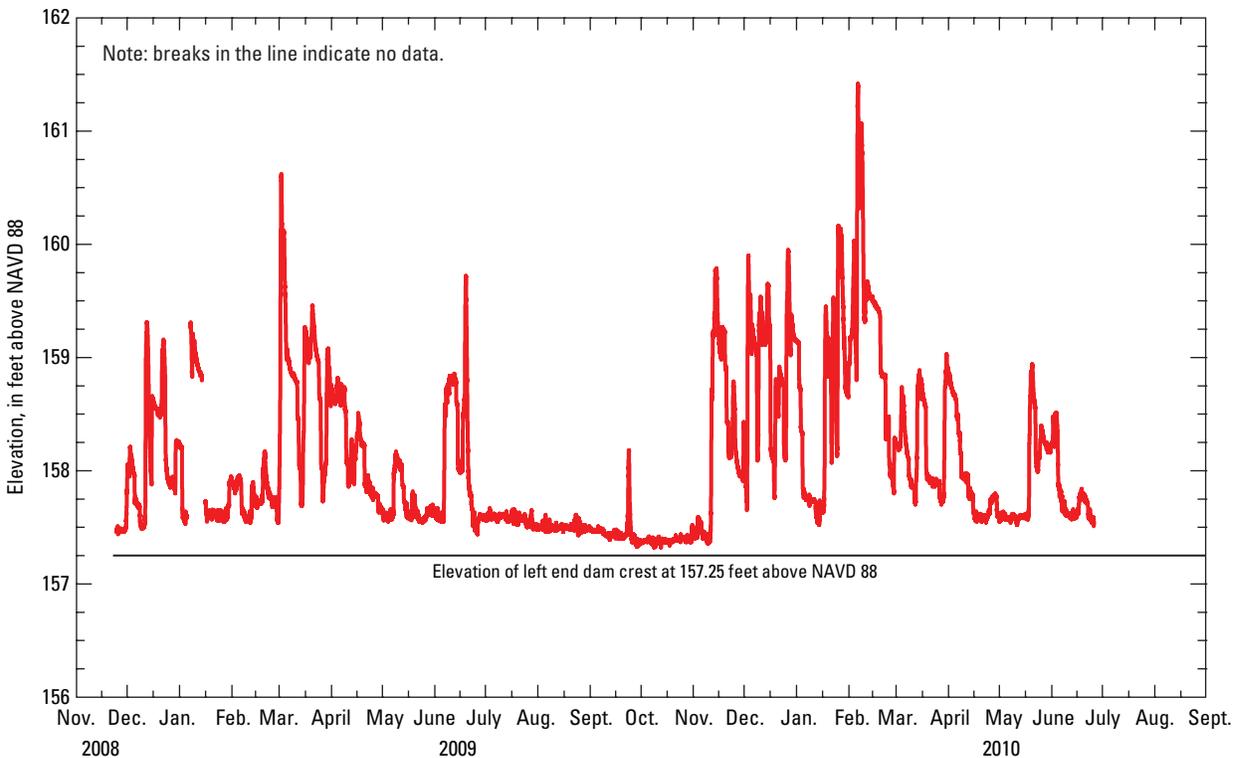
Figure 24. Instantaneous elevation of water surface on the Cape Fear River at Buckhorn Dam near Corinth (site 18), North Carolina, November 2008 through July 2010.

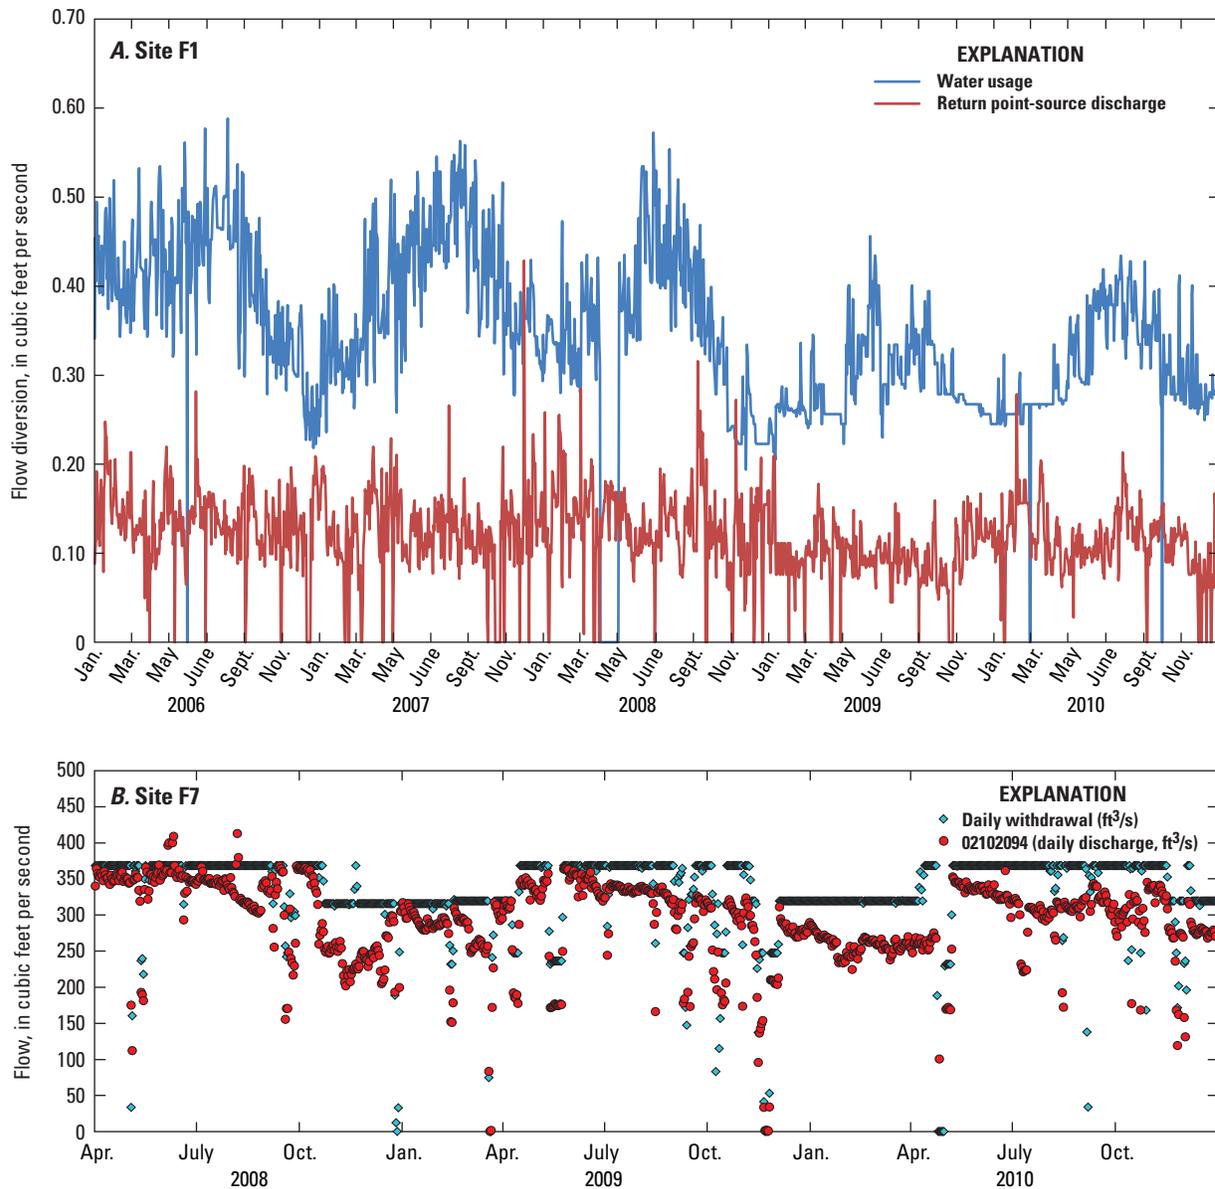
Figure 25. Flow diversions at (A) industrial facility (site F1) on the Haw River during 2006–2010, and (B) regional power plant (site F7) during 2008–2010, North Carolina.

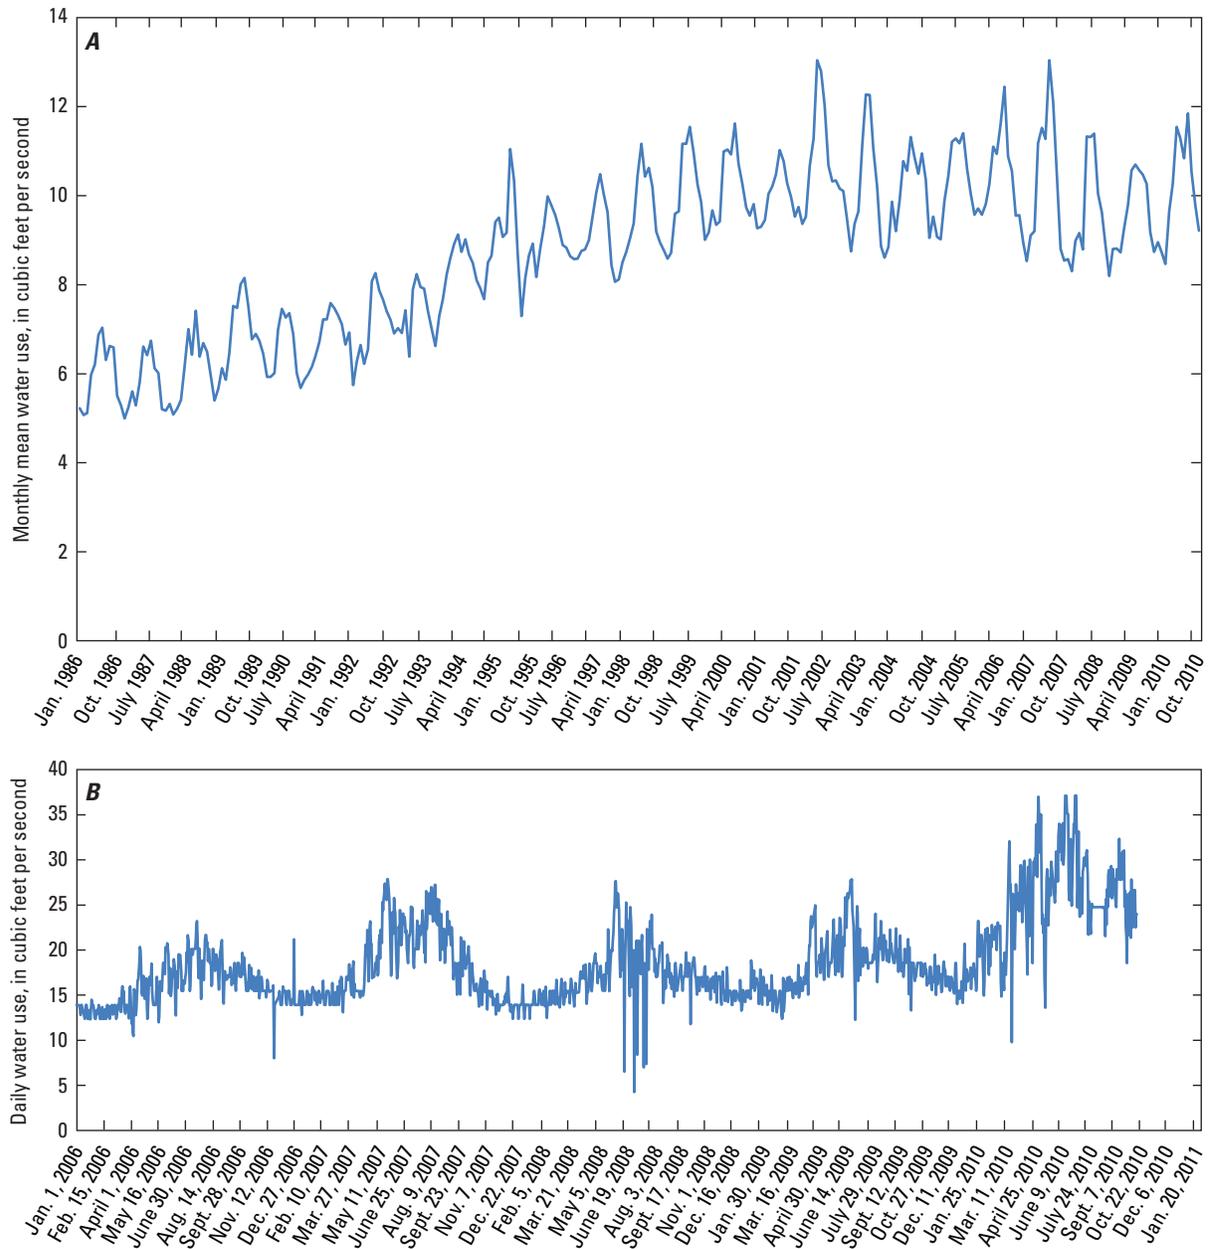
Figure 26. Water use reported for (A) municipal facility F9 for 1986–2010, and (B) municipal facility F10 for 2006–2010 in the Cape Fear River study area, North Carolina.

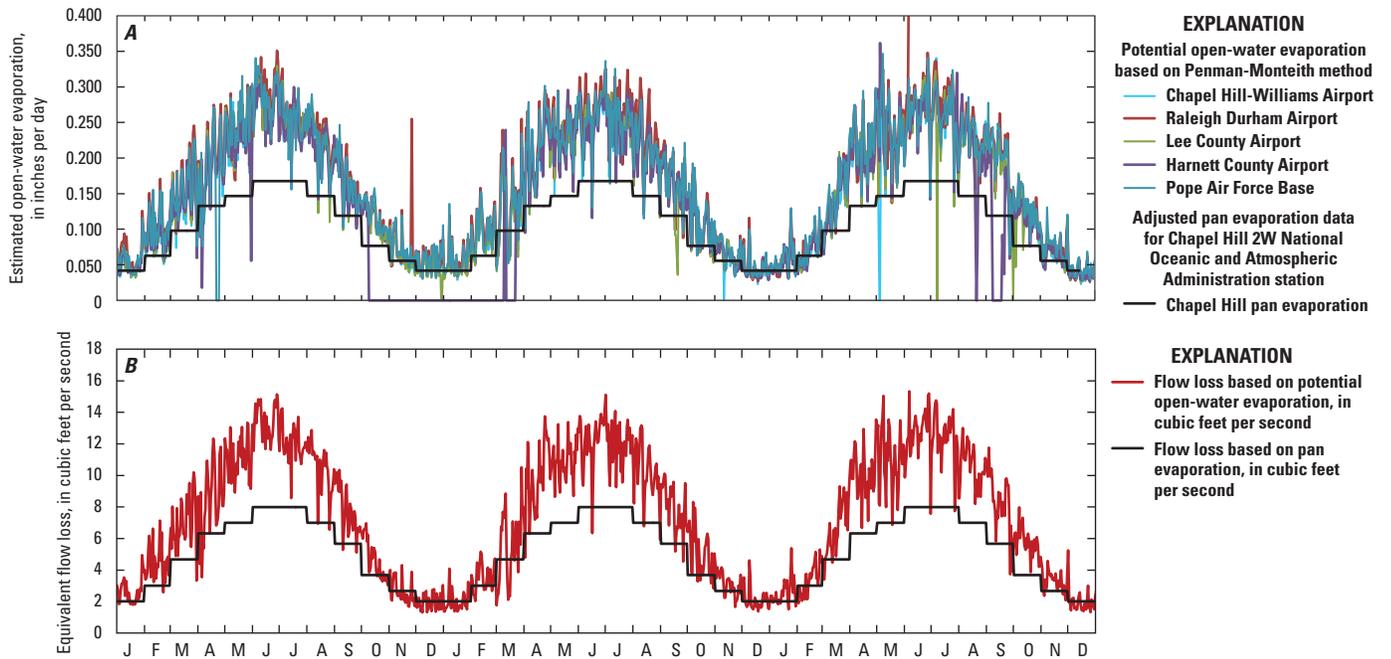
Figure 27. (A) Estimated open-water evaporation and (B) equivalent flow loss in the study reach from potential open-water evaporation based on the Penman-Monteith model at five nearby National Oceanic and Atmospheric Administration (NOAA) stations and pan-evaporation data for the Chapel Hill 2W NOAA station (State Climate Office of North Carolina, 2010).

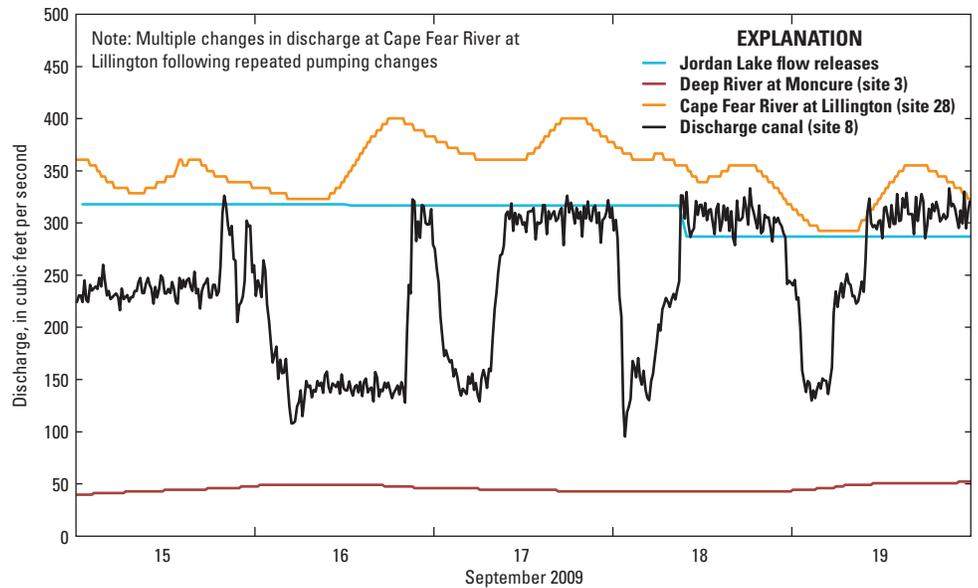
Figure 28. Effect of changes in instantaneous discharges at diversion canal streamgauge (site 8) and Cape Fear River at Lillington (site 28), North Carolina, on September 15–19, 2009.

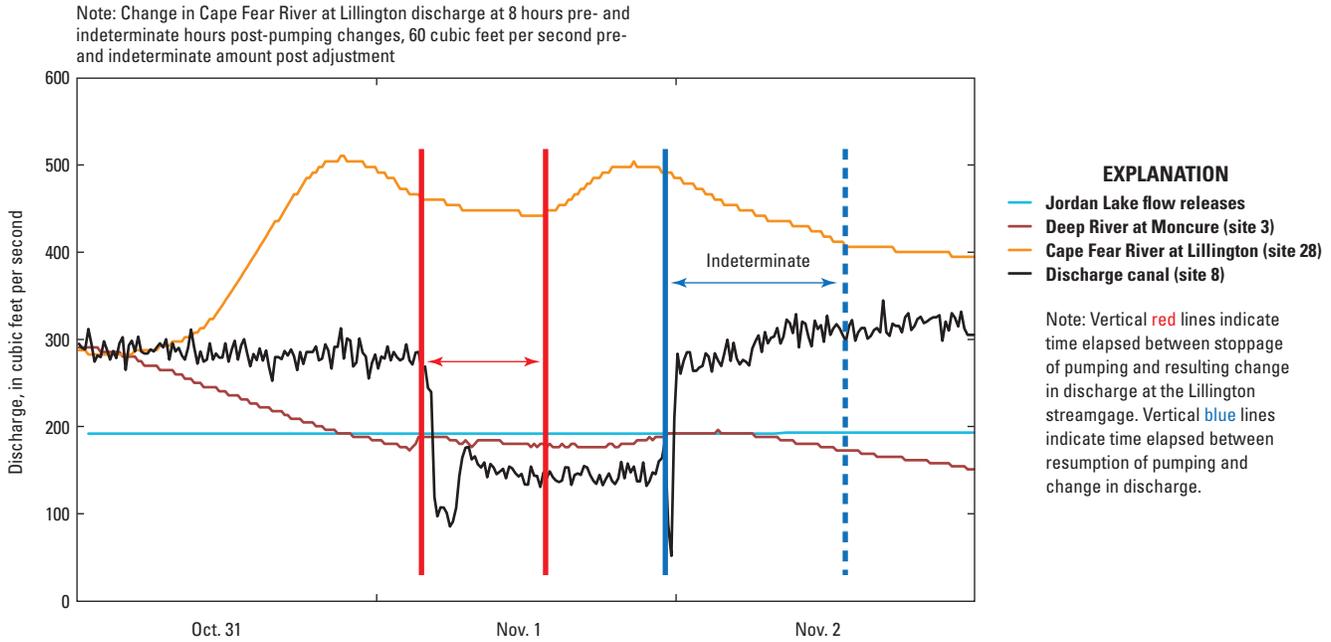
Figure 29. Effect of changes in instantaneous discharges at diversion canal streamgauge (site 8) and Cape Fear River at Lillington (site 28), North Carolina, on November 1, 2009.

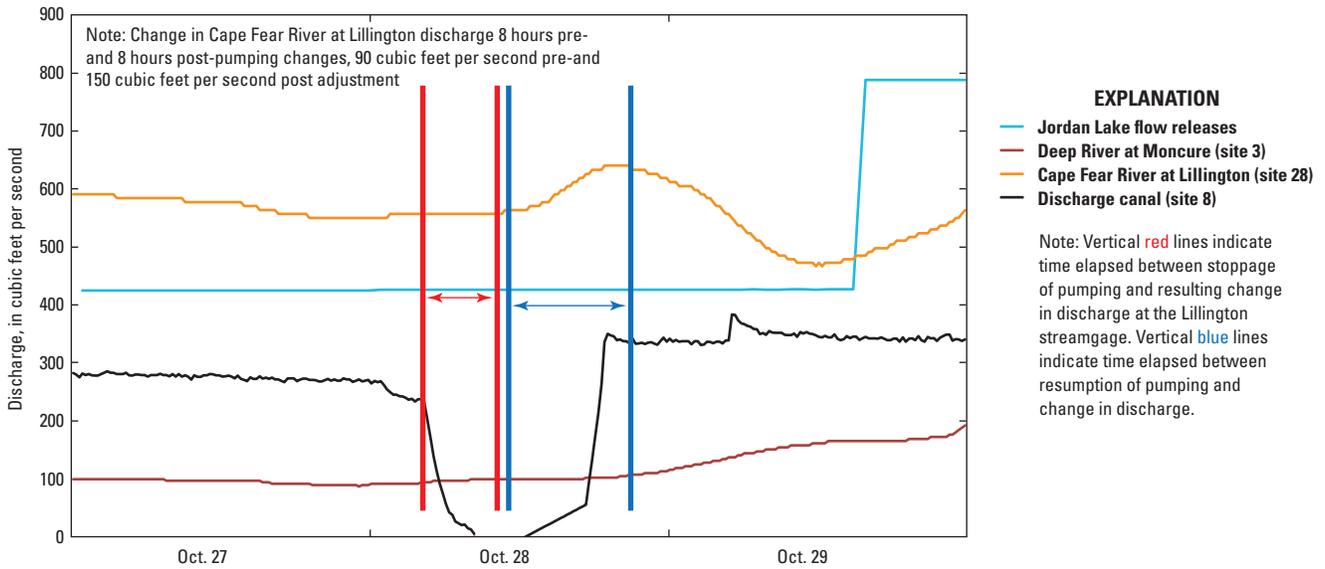
Figure 30. Effect of changes in instantaneous discharges at diversion canal streamgauge (site 8) and Cape Fear River at Lillington (site 28), North Carolina, on October 28, 2010.

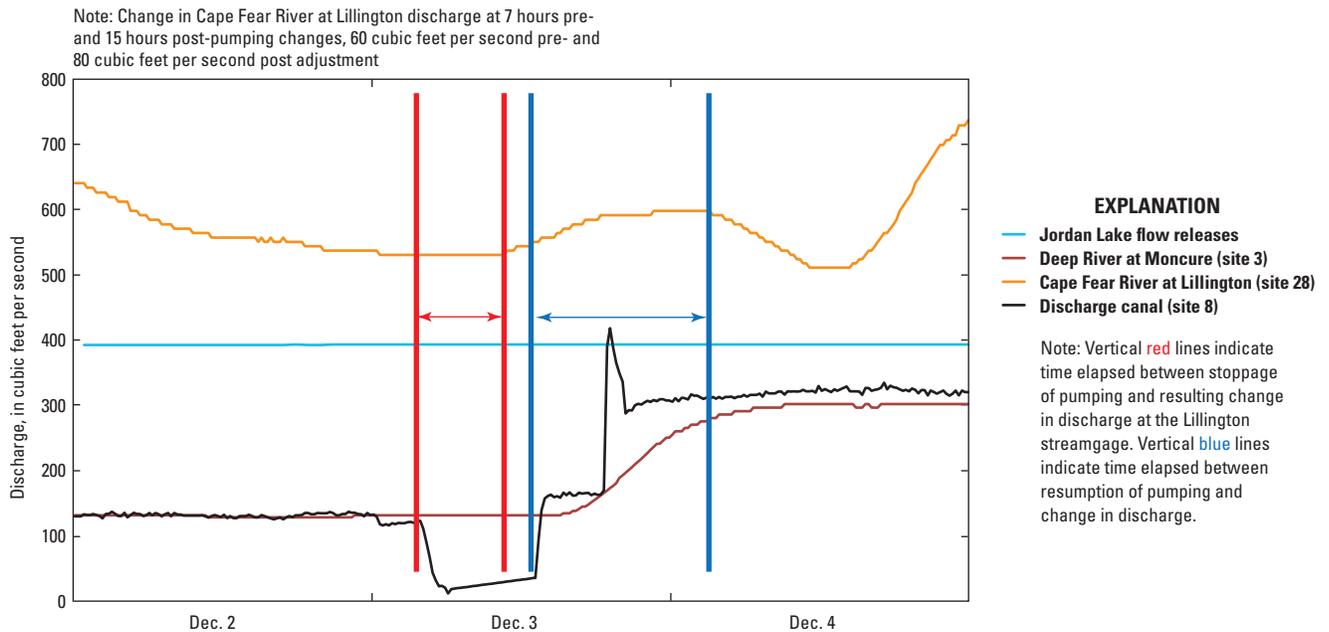
Figure 31. Effect of changes in instantaneous discharges at diversion canal streamgage (site 8) and Cape Fear River at Lillington (site 28), North Carolina, on December 3, 2010.

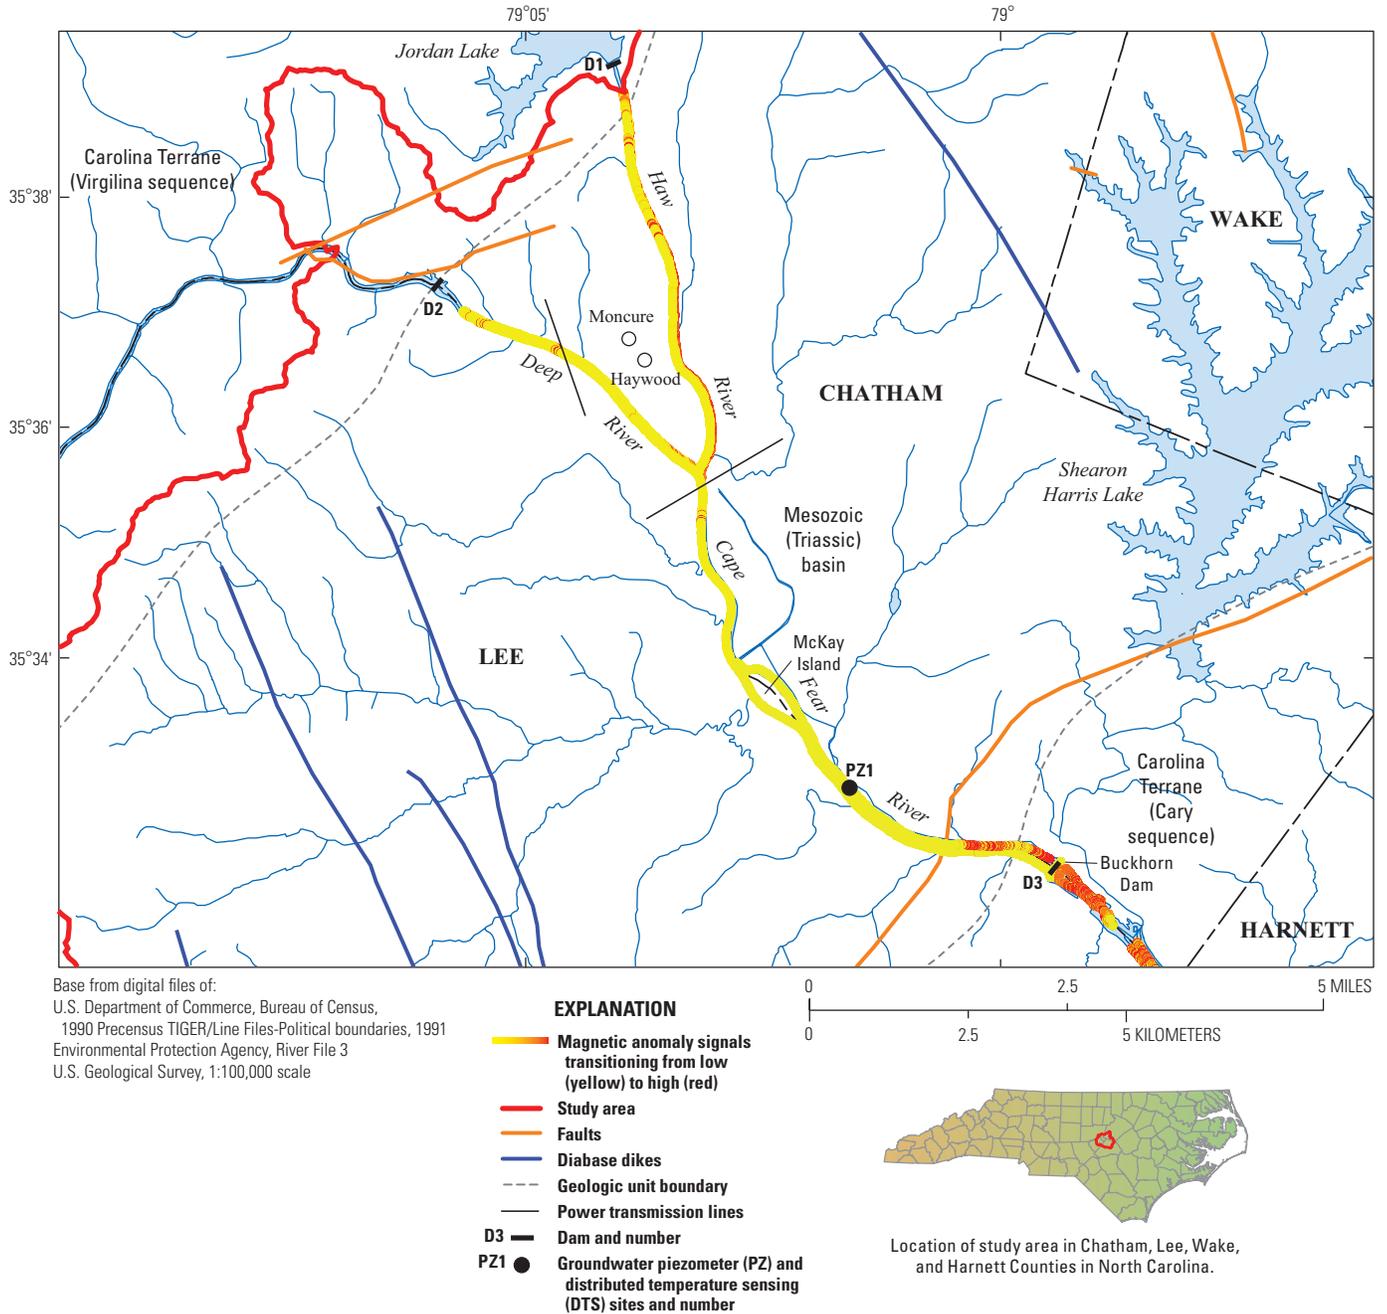
Figure 32. Locations of increased magnetic anomalies in the upstream reach from Buckhorn Dam, North Carolina.

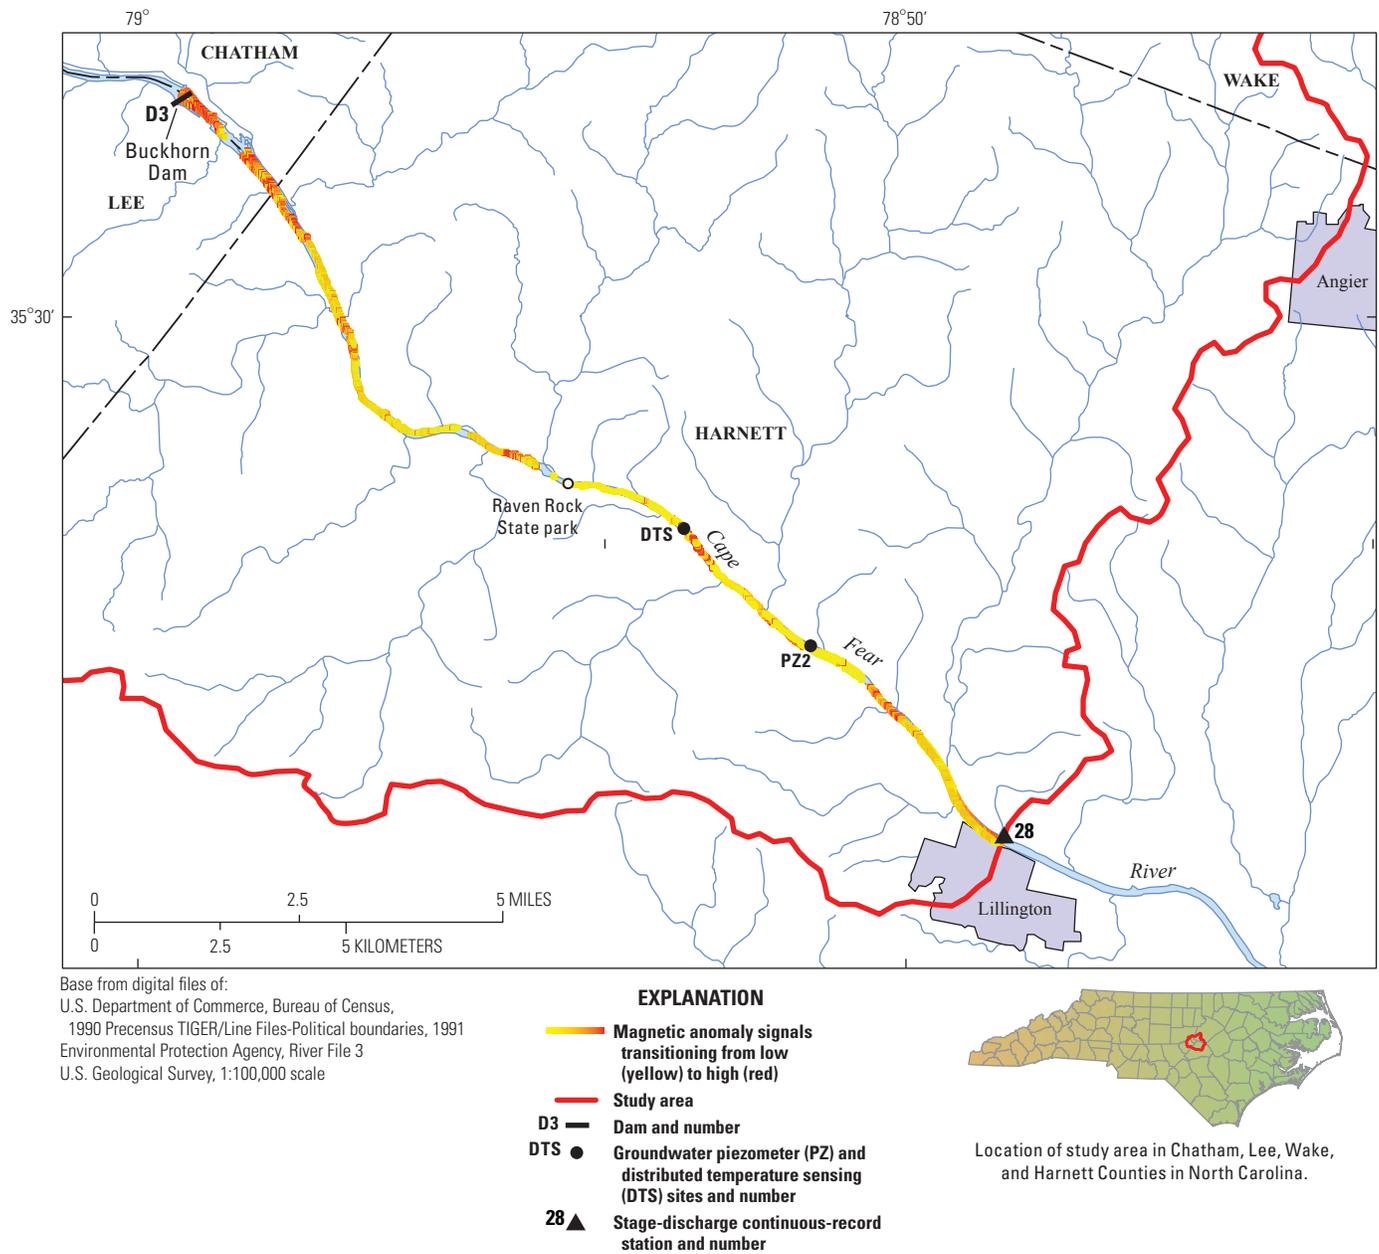
Figure 33. Locations of increased magnetic anomalies in the downstream reach from Buckhorn Dam, North Carolina.

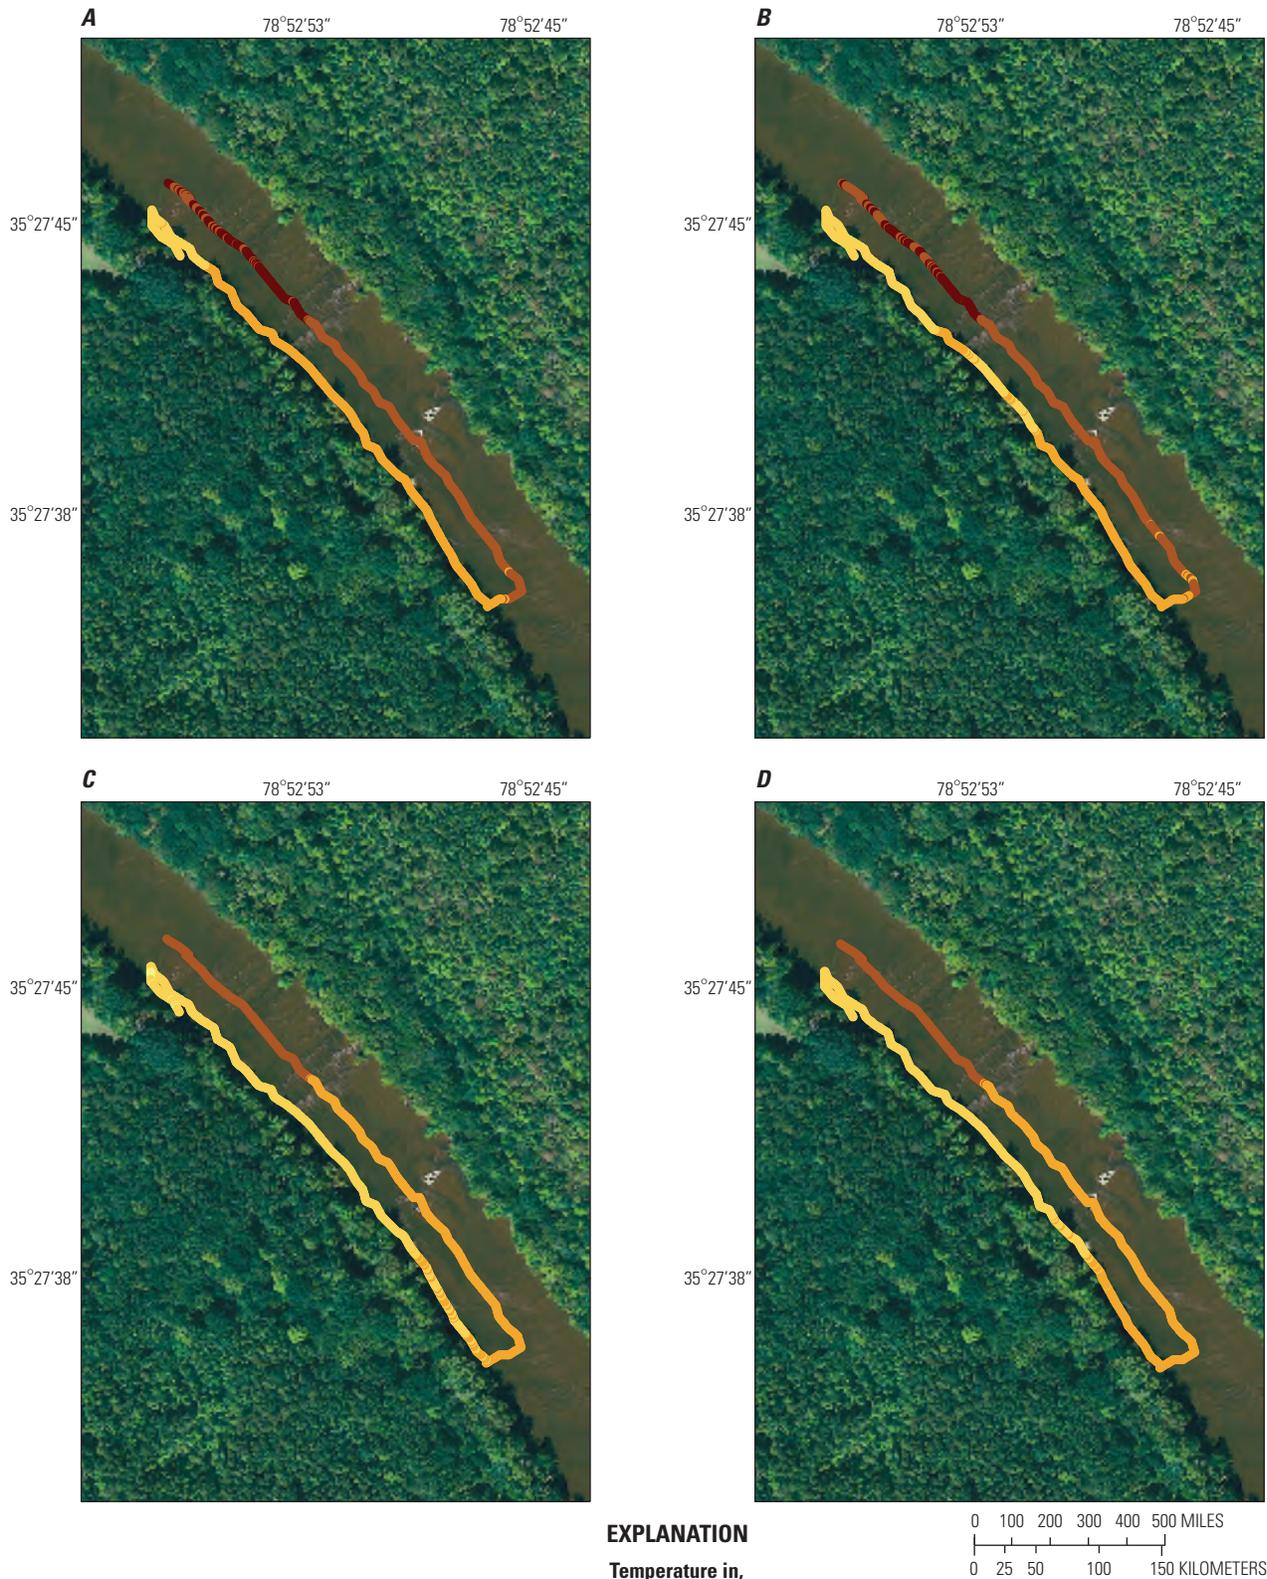
Figure 34. Results of the FO-DTS survey showing temperature of the river bottom on August 12, 2009, at (A) midnight, (B) 0600 hours, (C) noon, and (D) 1800 hours in the Cape Fear River near Raven Rock State Park, North Carolina.

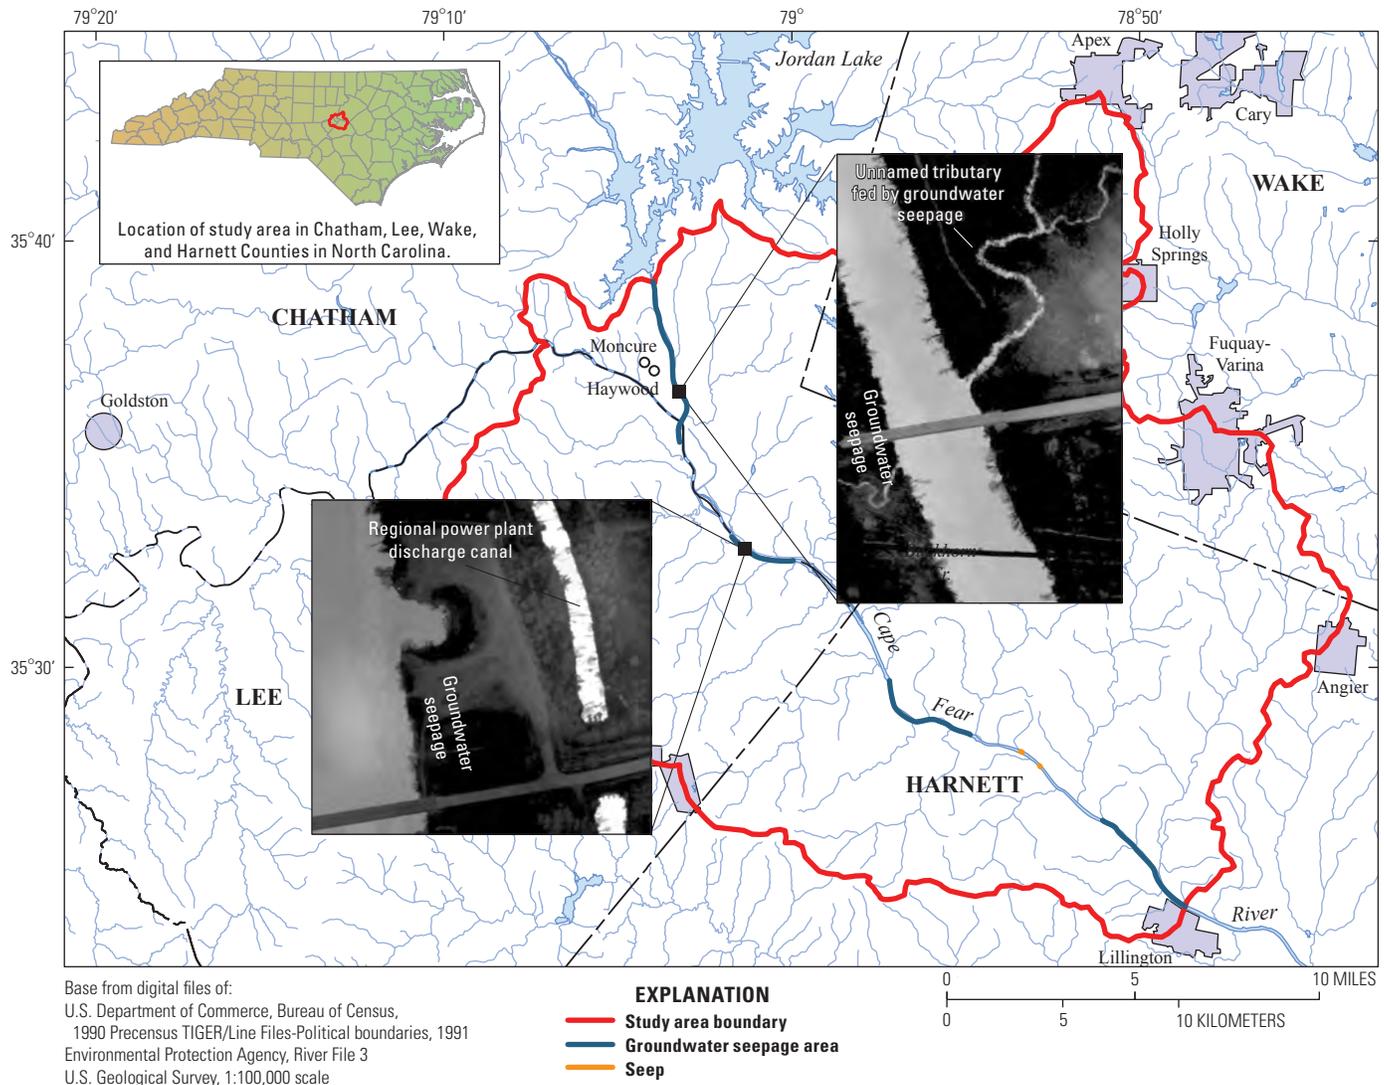
Figure 35. Areas of groundwater discharge to the Cape Fear River between Jordan Lake Dam and Lillington, North Carolina, identified by thermal infrared imaging, February 27, 2010.
