Determination of Flow Losses in the Cape Fear River between B. Everett Jordan Lake and Lillington, North Carolina, 2008–2010

Scientific Investigations Report 2012–5226

By J. Curtis Weaver and Kristen Bukowski McSwain

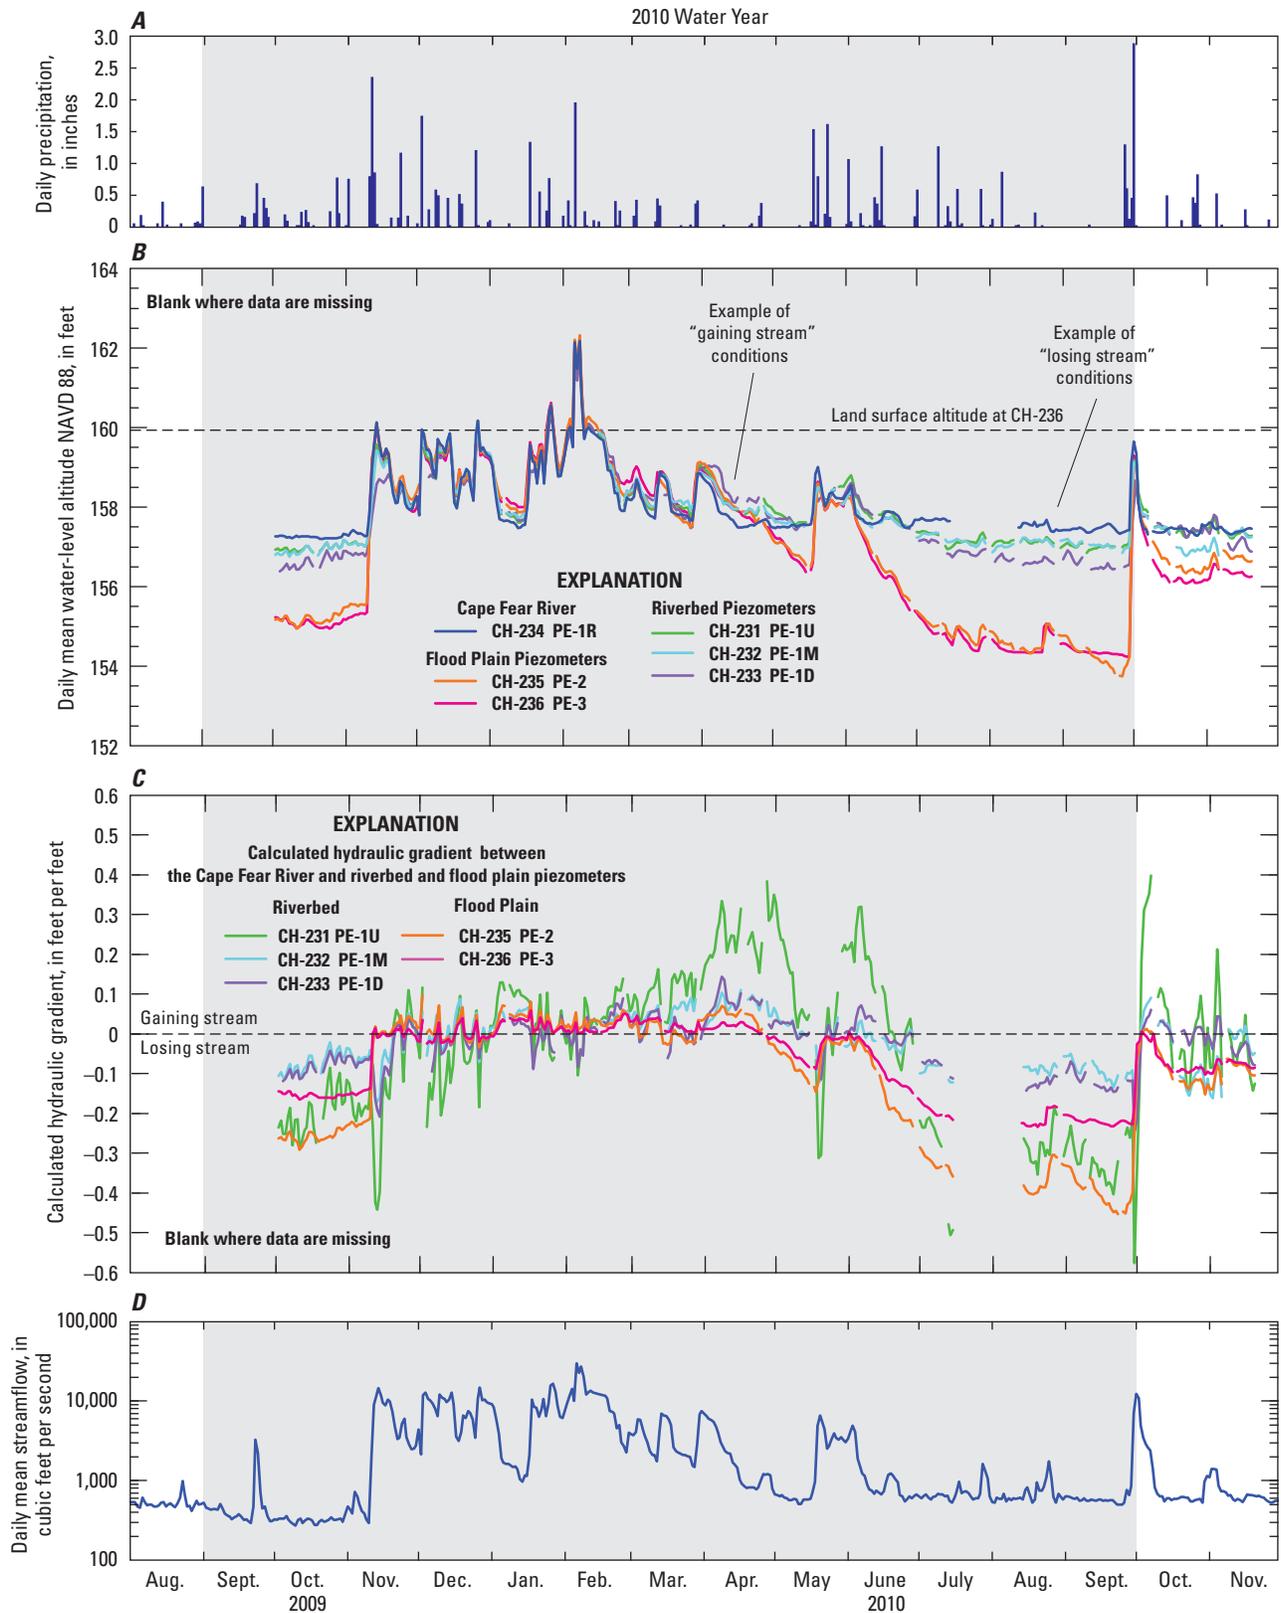
Figure 36. (A) Daily precipitation measured at the Siler City Airport (SILR), (B) daily mean water level and (C) calculated hydraulic gradients at the regional power plant piezometer transect (PZ1) near Corinth, and (D) daily mean streamflow measured in the Cape Fear River at Lillington (site 28), North Carolina.

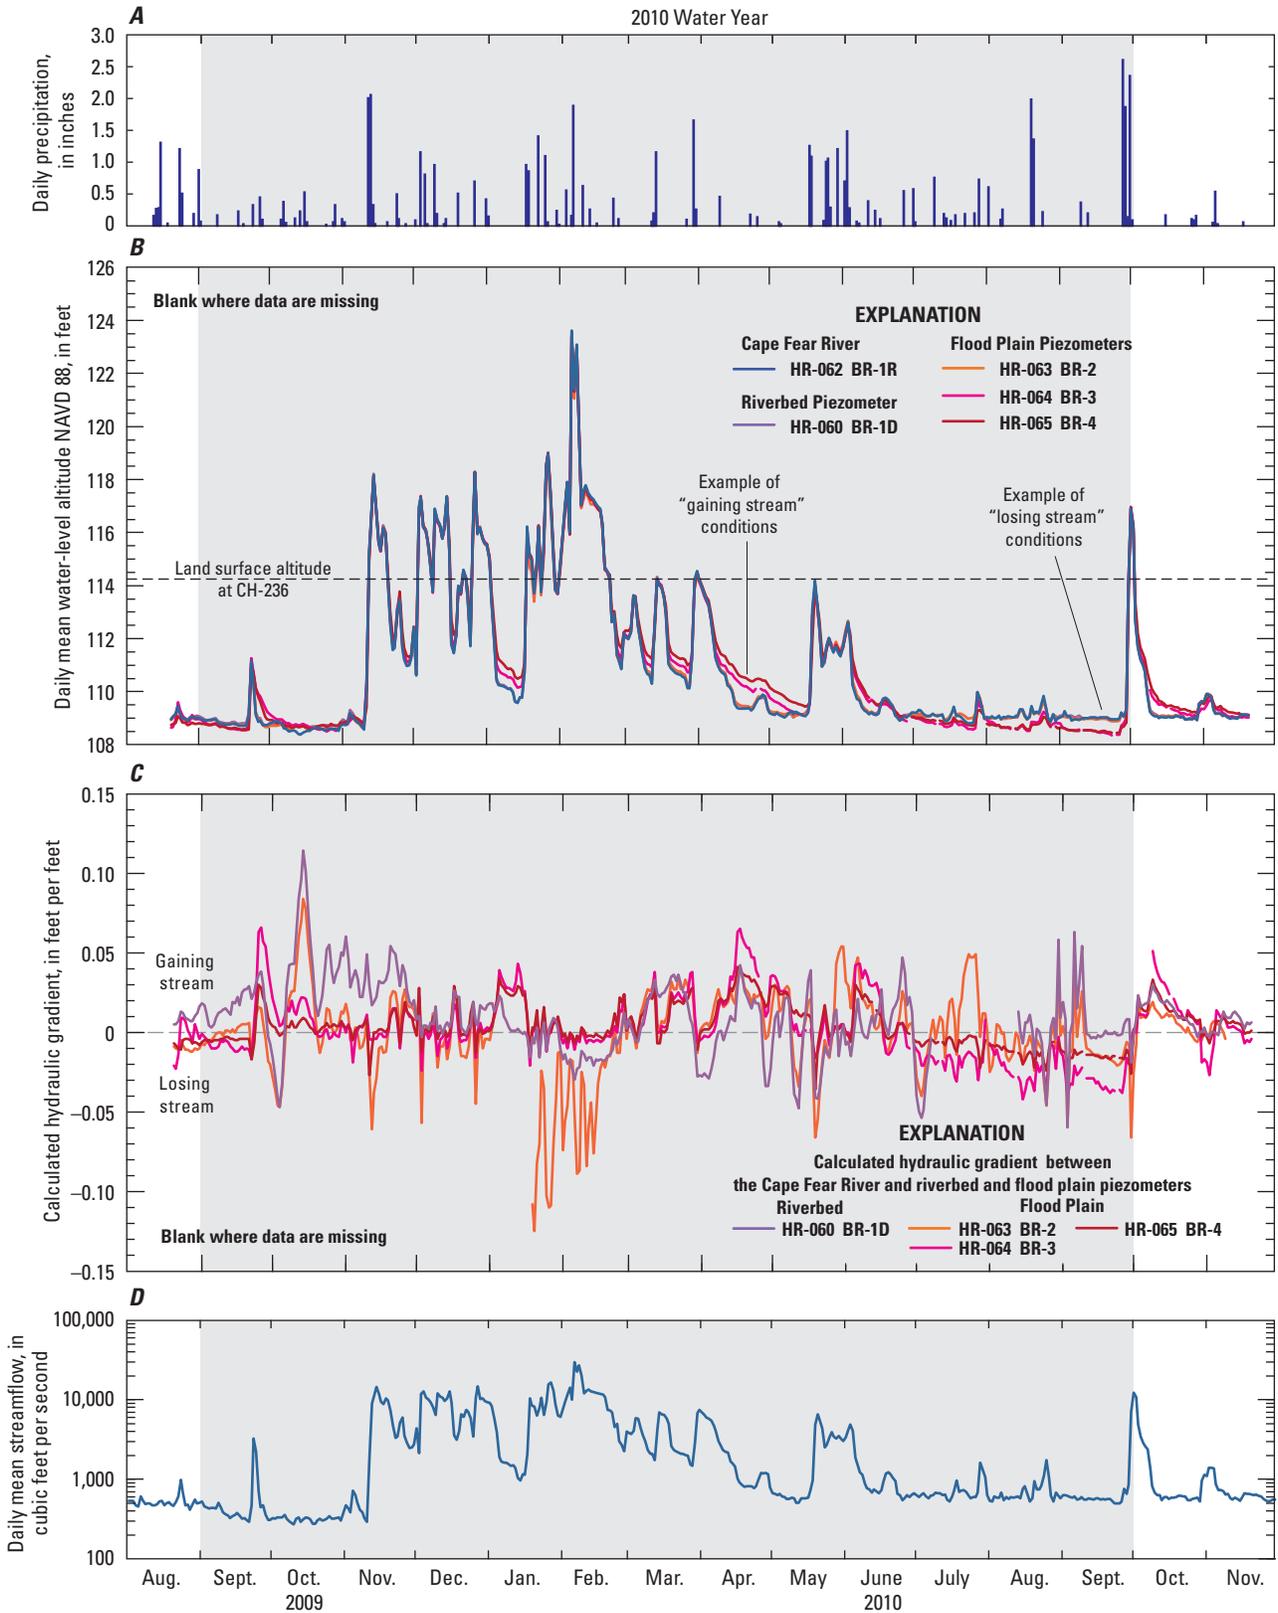
Figure 37. (A) Daily precipitation measured at the Fayetteville Public Works Commission (313017) Cooperative station, (B) daily mean water level and (C) calculated hydraulic gradients at the Bradley Road piezometer transect (PZ2) near Lillington, and (D) daily mean streamflow measured in the Cape Fear River at Lillington (site 28), North Carolina.

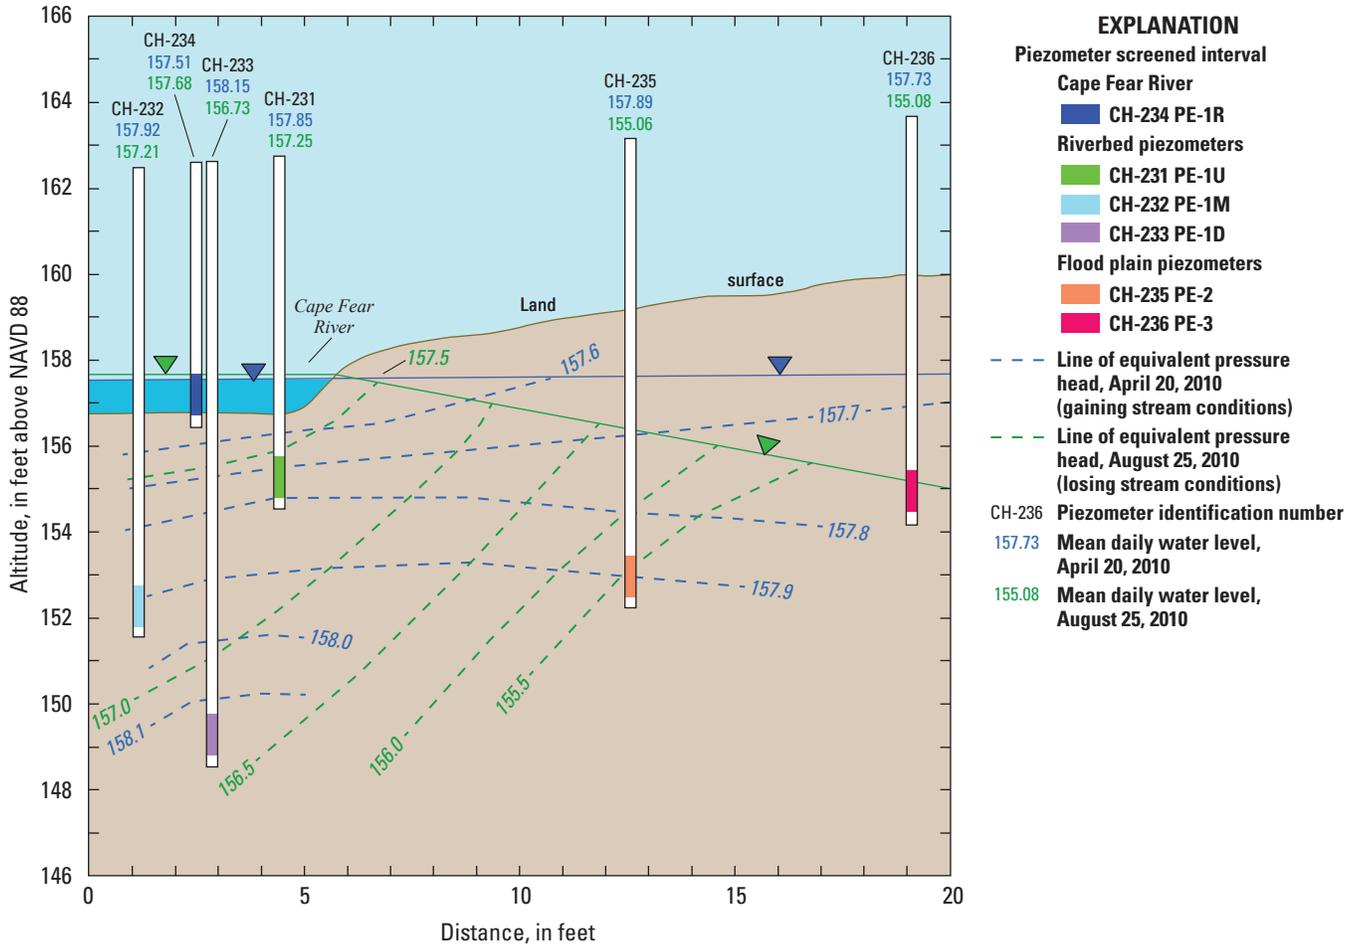
Figure 38. Piezometers and interpolated lines of equivalent pressure head under gaining- and losing-stream conditions at the regional power plant transect (PZ1) near Corinth, North Carolina (location shown in fig. 1).

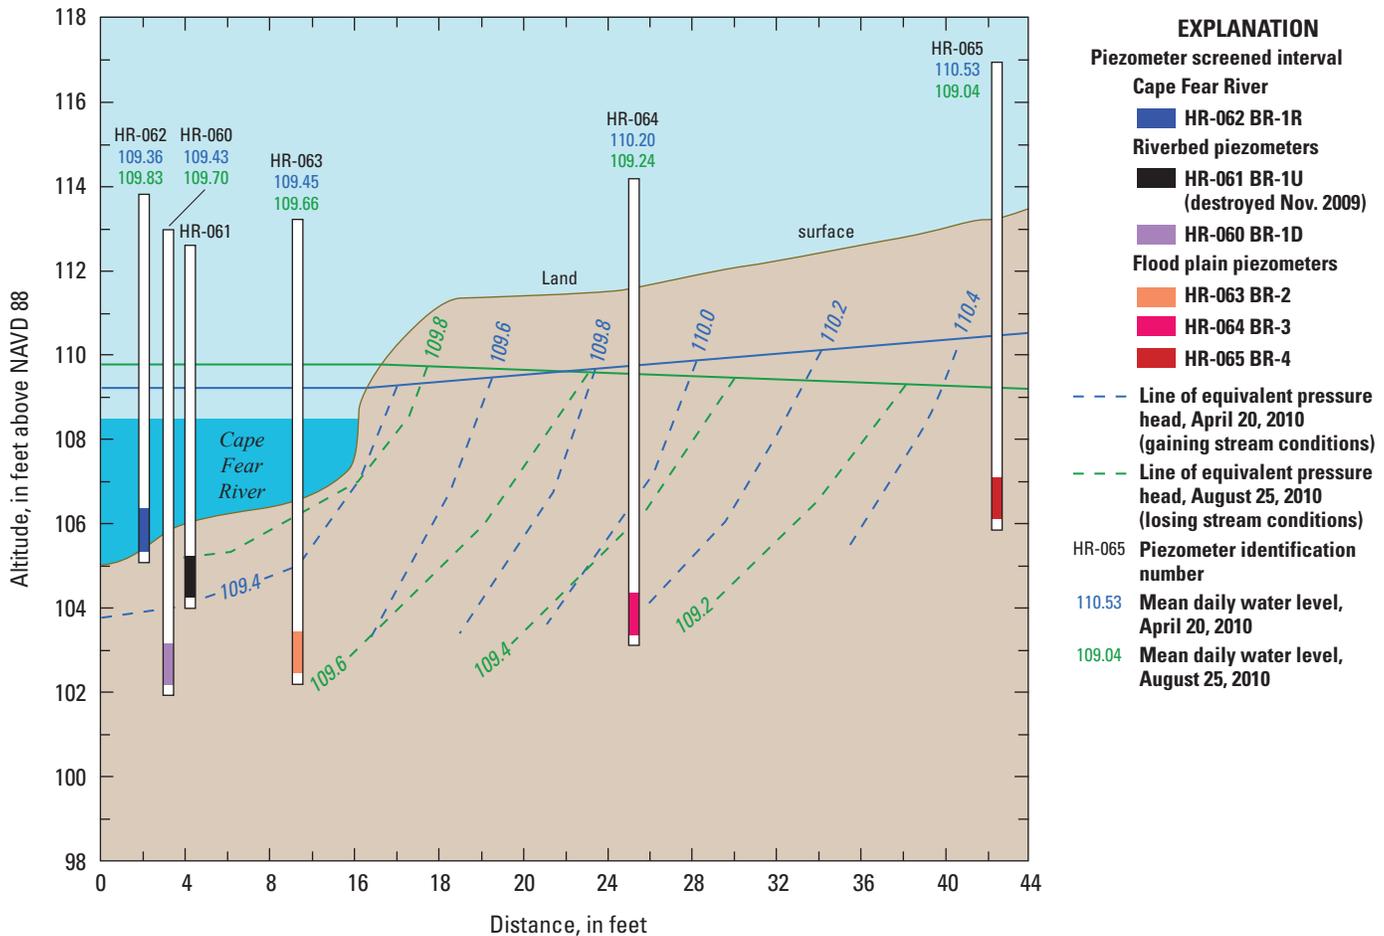
Figure 39. Piezometers and interpolated lines of equivalent pressure head under gaining- and losing-stream conditions at the Bradley Road transect (PZ2) near Lillington, North Carolina (location shown in fig. 1).

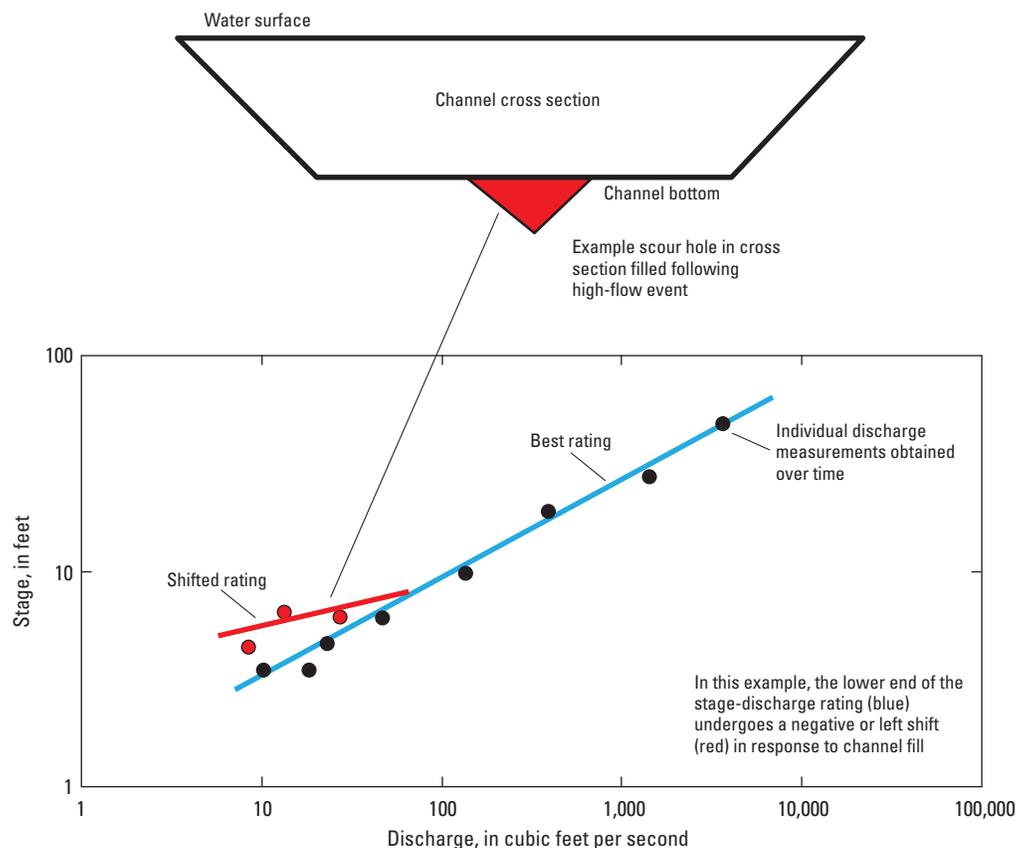
Figure 1–1. Schematic showing theoretical shift in stage-discharge rating in response to changes in river channel geometry.
