Erosional and Depositional Changes Wrought by the Flood of May 1978 in the Channels of Powder River, Southeastern Montana

Scientific Investigations Report 2013–5035

By Robert H. Meade and John A. Moody

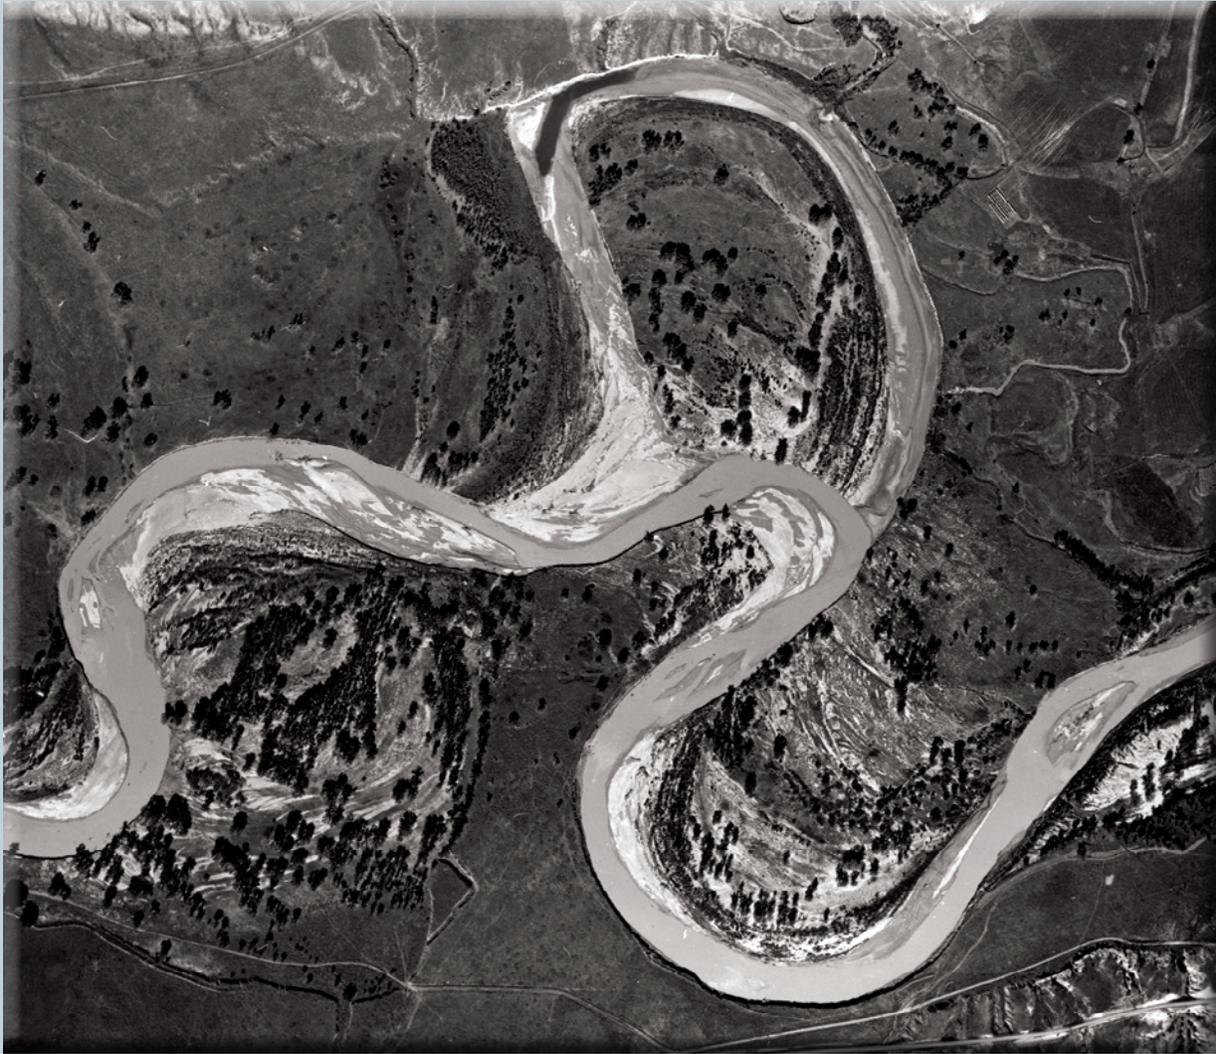
Cover. Vertical aerial photograph of Powder River at mouth of Bloom Creek, southeastern Montana, on September 24, 1978, showing effects of May 1978 flood: cutoff of large meander, and newly deposited sediment (white areas) on terraces, flood plains, point bars, and other riparian lands (photo taken by Bill Woodcock).

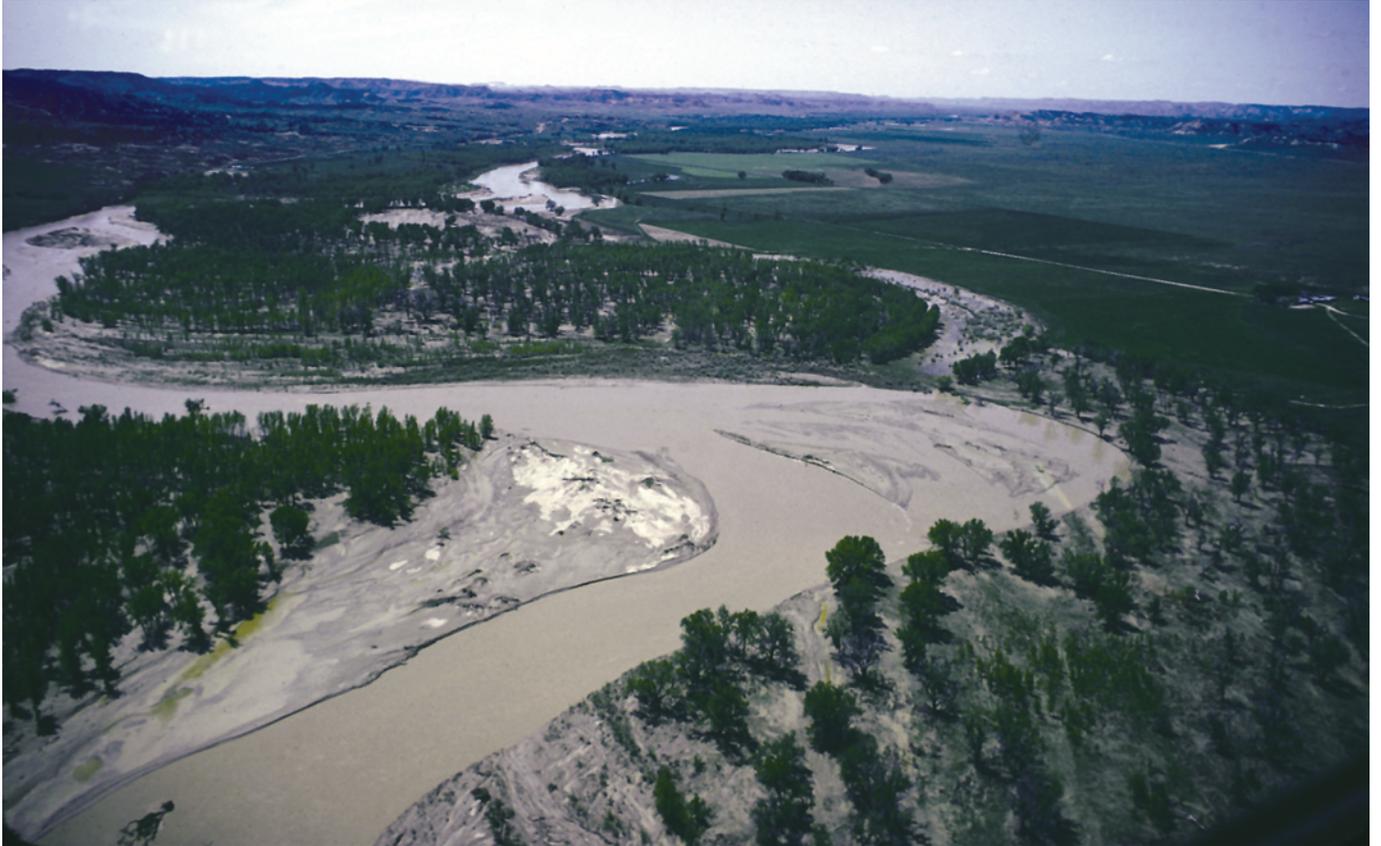
Figure 8. Powder River at section PR175 during the falling stages of the flood, on May 25, 1978. View upriver. Note that the upriver perspective on section PR175 in this photograph is the reverse of the downriver perspective shown in the cross section in figure 7. Center of photo shows the main flow of Powder River coming toward the viewer (along the left margin of the photograph) and through the new cutoff channel formed only days earlier, while newly deposited sediment on the old pointbar (right center of photograph) and in the old channel (narrow channel along the bend apex, far right center of photograph) is being exposed to view by the falling waters. The now-abandoned arcuate older channel in the farther center of the figure was for some decades the main channel of Powder River until, at some time during the late 1940s or early 1950s, it was cut off artificially (Martinson and Meade, 1983, Sheet 2). Rice ranch house near the right margin of the picture. For further assistance in orientation, compare the photograph (view south-southwest) with plate 1 at Section 15 of T6S, R50E.

the upper panel of fig. 7.) During the rising stages, the flood waters eroded the old cutbank at the meander apex (between stations 0 and +10) laterally for a distance of about 7 m. When the river rose high enough to pass through a low swale (inferred to have been near station +200) across the neck of the bend, most of the force of the flow was diverted into it, in response to the local increase in downriver gradient. This began the further excavation of the new channel. Meanwhile, the older, outer sections of the bend (stations +2 to roughly 180) were receiving deposits of new sand that averaged about 1 m in thickness on the old pointbar and eventually reached 2 m in the old channel. A photograph of section PR175, taken during the falling stages of the flood, is shown in figure 8.

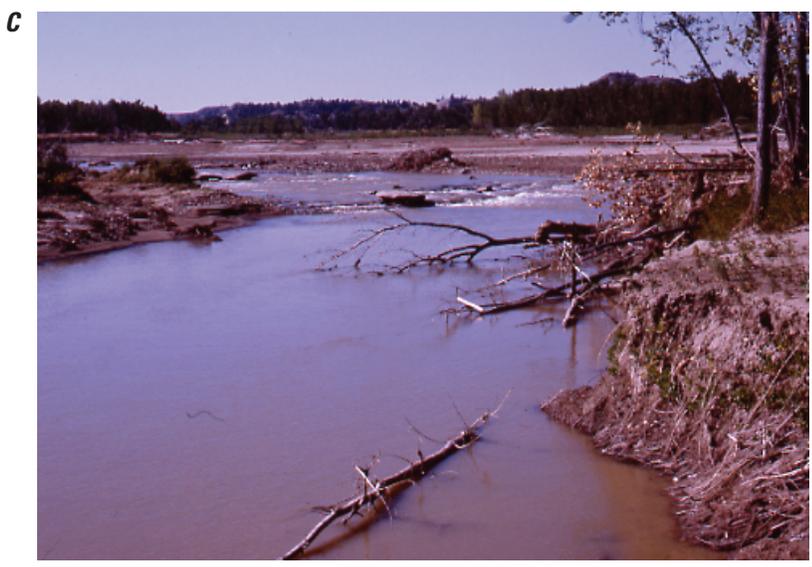
Figure 11. Upriver views of Powder River near Flood Creek, showing meander bend cutoff during and after flood of May 1978. *A*, sketch by Bobbie Myers, from oblique aerial photo taken by R.H. Meade during the falling stages of the flood, on May 25, 1978. Flood waters still high in old meander bend and in new cutoff channel. *B*, closer view of Powder River at same locality. Photo taken May 25, 1978. New cutoff channel is partly obscured by large cottonwood trees. Flood Creek is the small channel crossing under Moorhead road and entering Powder River on the left bank near the bend apex. *C*, view upriver through new cutoff channel, September 4, 1978. Bedrock ledges form the channel bottom at the upriver edge of the new channel. For comparison, see the photograph taken on same day of the dry channel of the abandoned meander (fig. 13, A).

gullies were initiated here during the early stages of the flood of 1978 – in much the same manner as those observed to have formed on the neck of another meander on Powder River during an ice-jam flood in March 1989 (Gay and others, 1998, p. 653–656; see also the graphic portrayal of Ghinassi, 2011, his fig. 12). The first of these gullies to breach the upriver bank of the neck of the meander bend near Flood Creek became the new main channel of Powder River. Aerial views of the new cutoff channel, only a few days old, are shown in figure 11.

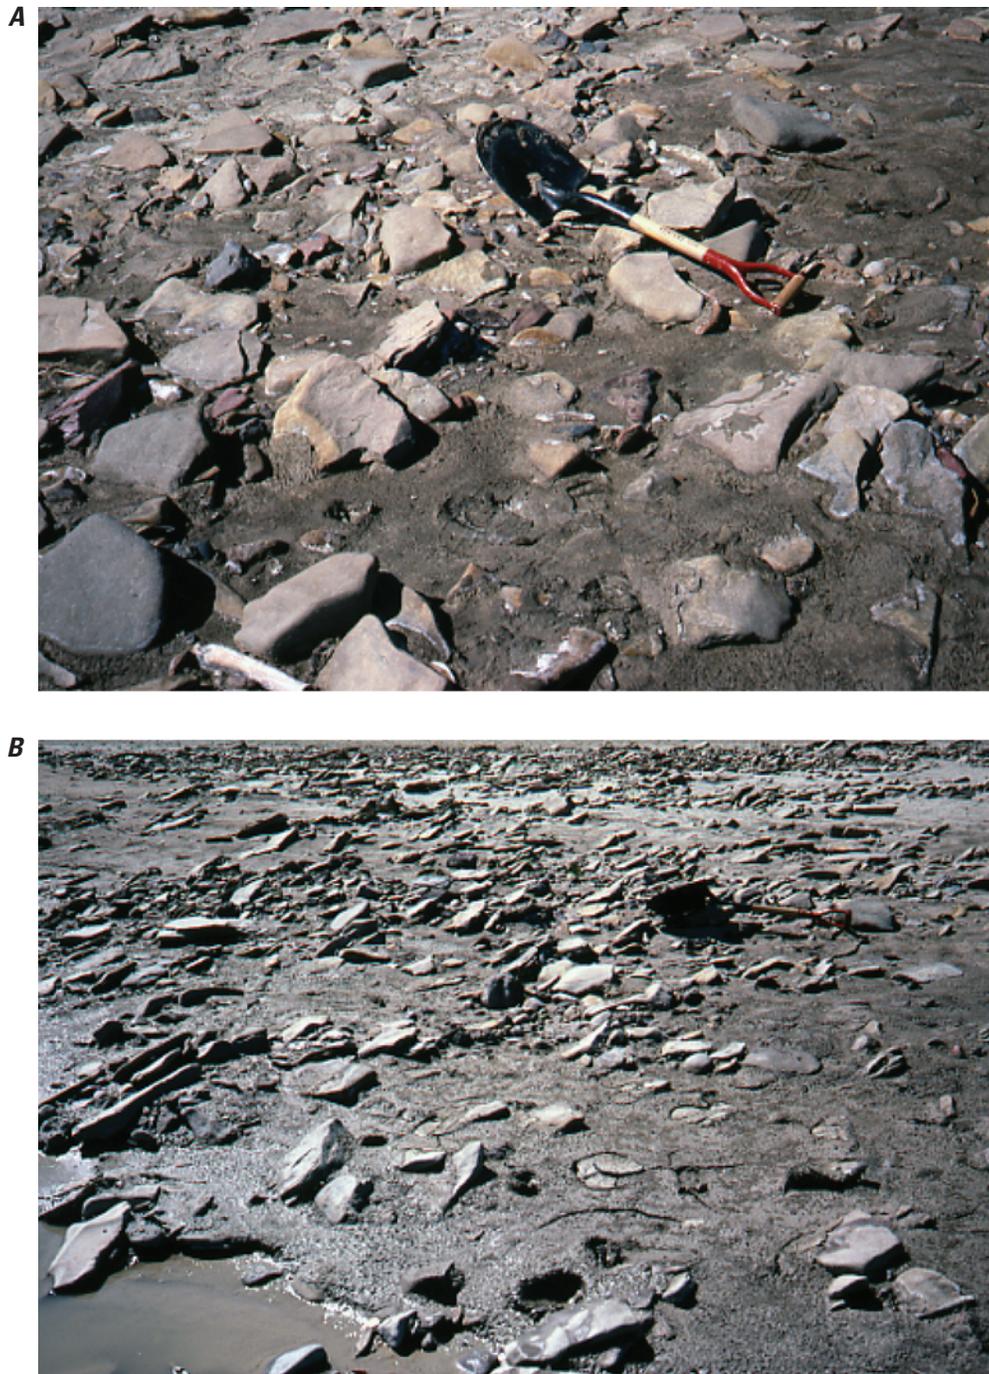
Figure 15. Photographs showing cobble-size gravels transported by the flood of May 1978, and deposited in section PR125. Length of shovel about 1.0 m. Both photos taken September 2, 1978. *A*, view downriver of edge of new gravel bar, about 10 m upriver of cross-channel station 50, section PR 125. *B*, cross-channel view (toward left bank) of new gravel bar that filled the previous year's thalweg channel. Note the imbricate arrangement of the large cobble-size slabs of sandstone. Centerline of photo is about 10 m upriver of line of section PR125.
