Settlement of the *USS Arizona*, Pearl Harbor, Hawaii

Scientific Investigations Report 2013–5096

By Brad A. Carkin and Robert E. Kayen

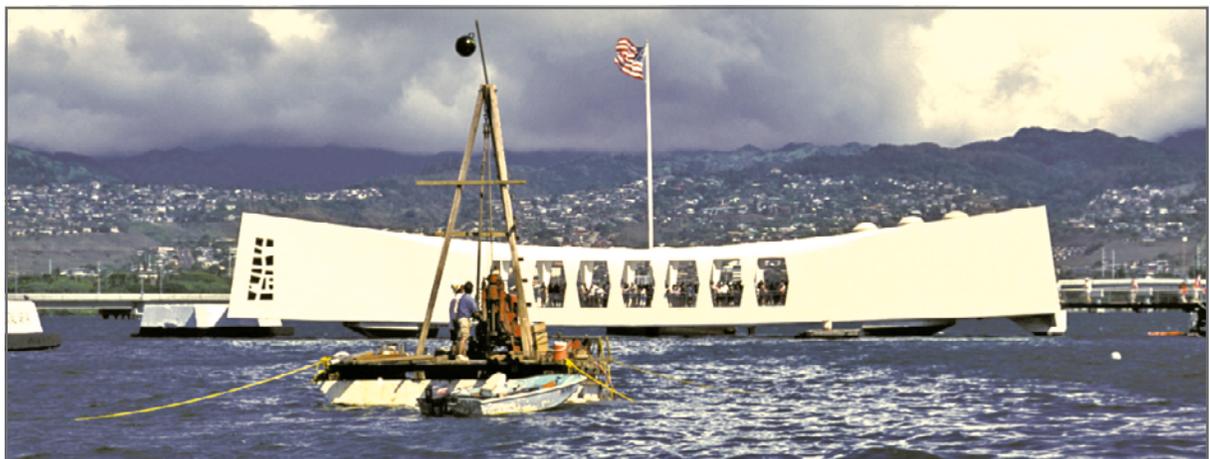
Figure 3. The Hirata and Associates drilling barge shown anchored at boring location B3 near the bow of the USS *Arizona*. National Park Service photo by Brett Seymour.

Boring B3 is located (E608749, N2362811) about 30 m southwest of the bow of the USS *Arizona* (fig. 3). Water depth was 11.3 m at 11:25 a.m. on November 15, 2003 (Hirata, 2003). The tide elevation at the time of depth measurement was 0.48 m MLLW, based on the Honolulu Harbor tide station. Twelve Shelby tubes were recovered from the boring, representing a total recovery of 66 percent of the total depth sampled. Eight tubes form a nearly continuous recovery sequence beginning at 8.2 m subbottom depth to the bottom of the boring at 14.5 m.

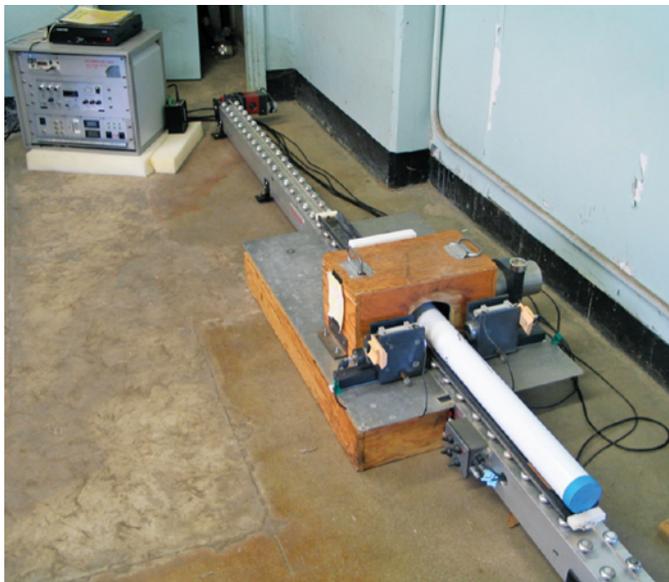
Figure 14. The USGS multisensor core logger set up in Navy Building 42, Ford Island, during the drilling operations. In this photo, an enameled steel Shelby tube is being scanned. The tube travels along the track from lower right to upper left.

Bulk density is the ratio of the total soil weight to the soil volume. The configuration of our device allows for a core to pass between a scintillation counter and a lead-shielded, sealed, ¹³⁷Cs radiation source emitting a 1-cm collimated beam of gamma rays. Sediment bulk density (ρ_b) is calculated from the gamma ray attenuation characteristics of the cores according to Lambert’s law (Haynes, 2012). For a user-defined time period, the number of gamma decays emitted from the ¹³⁷Cs source, passing through the core and received at the scintillation detector, is counted.

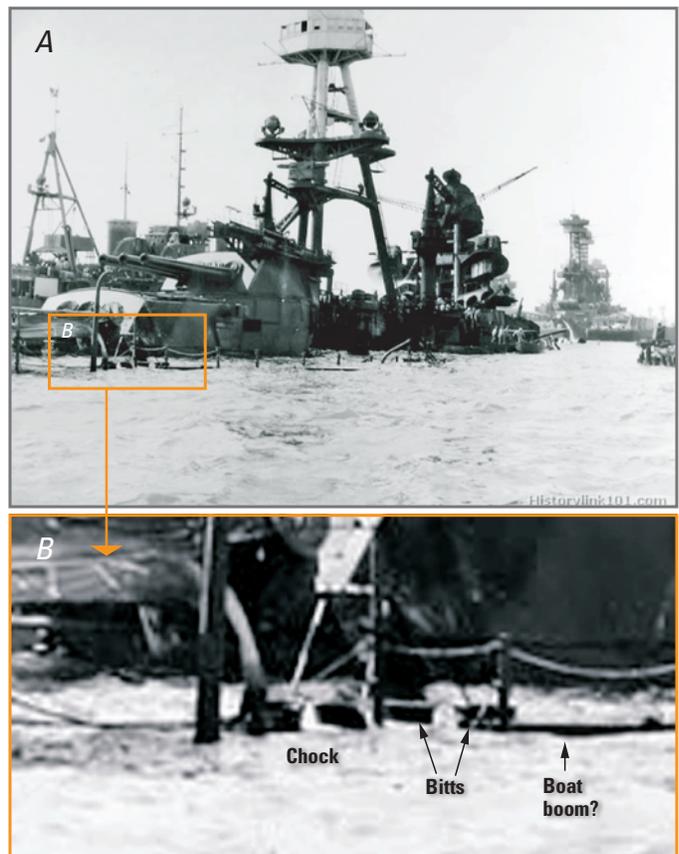
Figure 26. Mooring bits at the starboard aft side of the USS *Arizona*. *A*, Photo 80-G-32609 taken on December 9, 1941 (Stillwell, 1991), as shown by the Navajo and Tern at the port side, as in figures 19 and E-4. This is Photo 3 in figure 32. *B*, Enlargement of outlined area in *A*. Two bits are visible just aft of turret 4, opposite the pair of bits on the port side. The apparent edge of the deck at the bits may be a boat boom attached near the chock; the dark edge is too high relative to the bitt tops to be the top of the bulwark. A similar boom is present on the port side and can be seen extended in the full size photo PR-52 (fig. E-2).

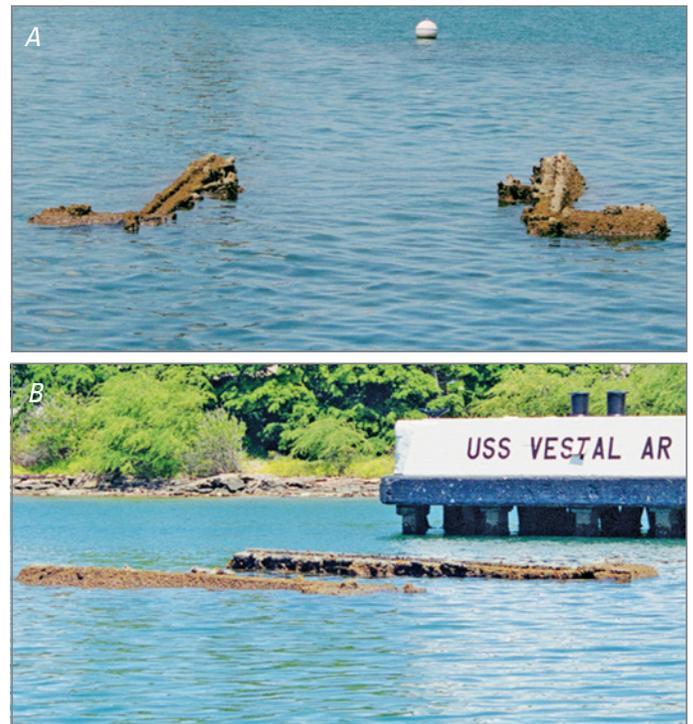
Figure 29. Views of the top edges of turret 2 during a very low tide in 2000. The top of the turret and guns were removed in 1943. A, The turret as viewed from the USS *Arizona* Memorial toward the bow. The rangefinder projections are visible at the breech (near) end of the turret. The port tilt between the two forward ends measures about 0.5°; the port tilt across the aft ends measures 1.25°. A portion of photo DN-SC-02-05621, dated June 3, 2000 from www.defenseimagery.mil/. B, The turret as viewed from the port side looking toward Ford Island, with the aft tilt visible. The port side edge has an aft tilt of about 1.5°; the starboard side about 1.3°. A portion of photo DN-SC-02-05620, dated June 3, 2000, from www.defenseimagery.mil/. The tilts were determined from measurements made on March 4, 2008.

A more recent view of turret 2 is shown in figure 29. Measurements taken on March 4, 2008, reveal that the four corners of the turret (table 8) have an average tide-corrected elevation of 0.12 m MLLW. The settlement of the turret since December 7, 1941, based on this average height amounts to 1.22 m. The maximum settlement is 1.37 m at the port aft corner; the minimum settlement is 1.06 m at the forward starboard corner.

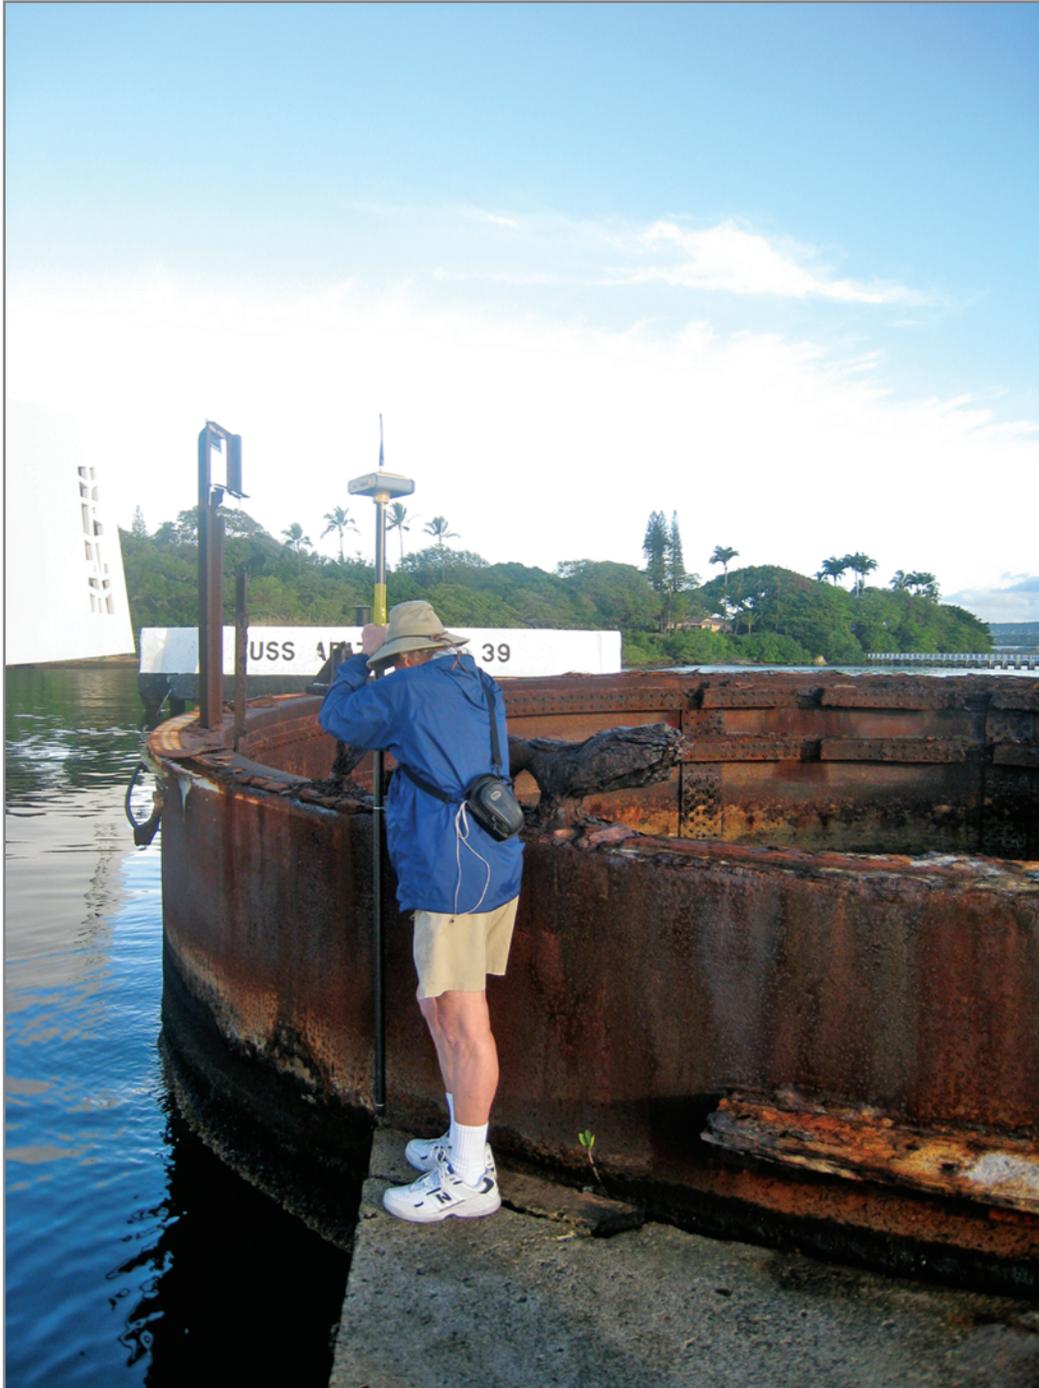
A field assistant making Global Positioning System (GPS) measurements at the USS Arizona on the mooring platform at barbette 3, March 4, 2008. The Memorial structure is on the left.
