Hurricane Irene and Associated Floods of August 27–30, 2011, in New Jersey

Scientific Investigations Report 2013–5234

By Kara M. Watson, Jerilyn V. Collenburg, and Robert G. Reiser

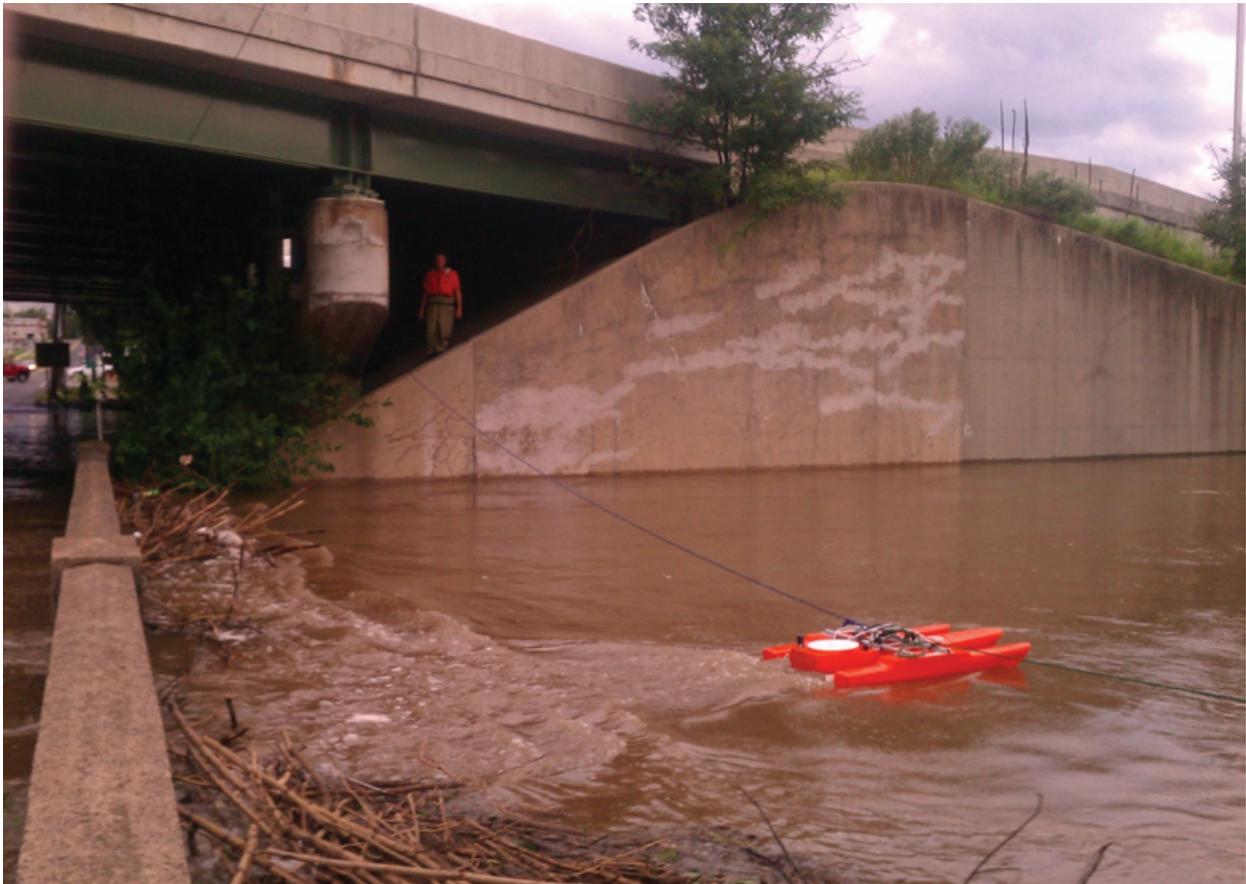
Figure 3. Peak-streamflow measurement along the Saddle River at Lodi, New Jersey (U.S. Geological Survey station 01391500) on August 28, 2011. (Photograph by John J. Trainor, U.S. Geological Survey)

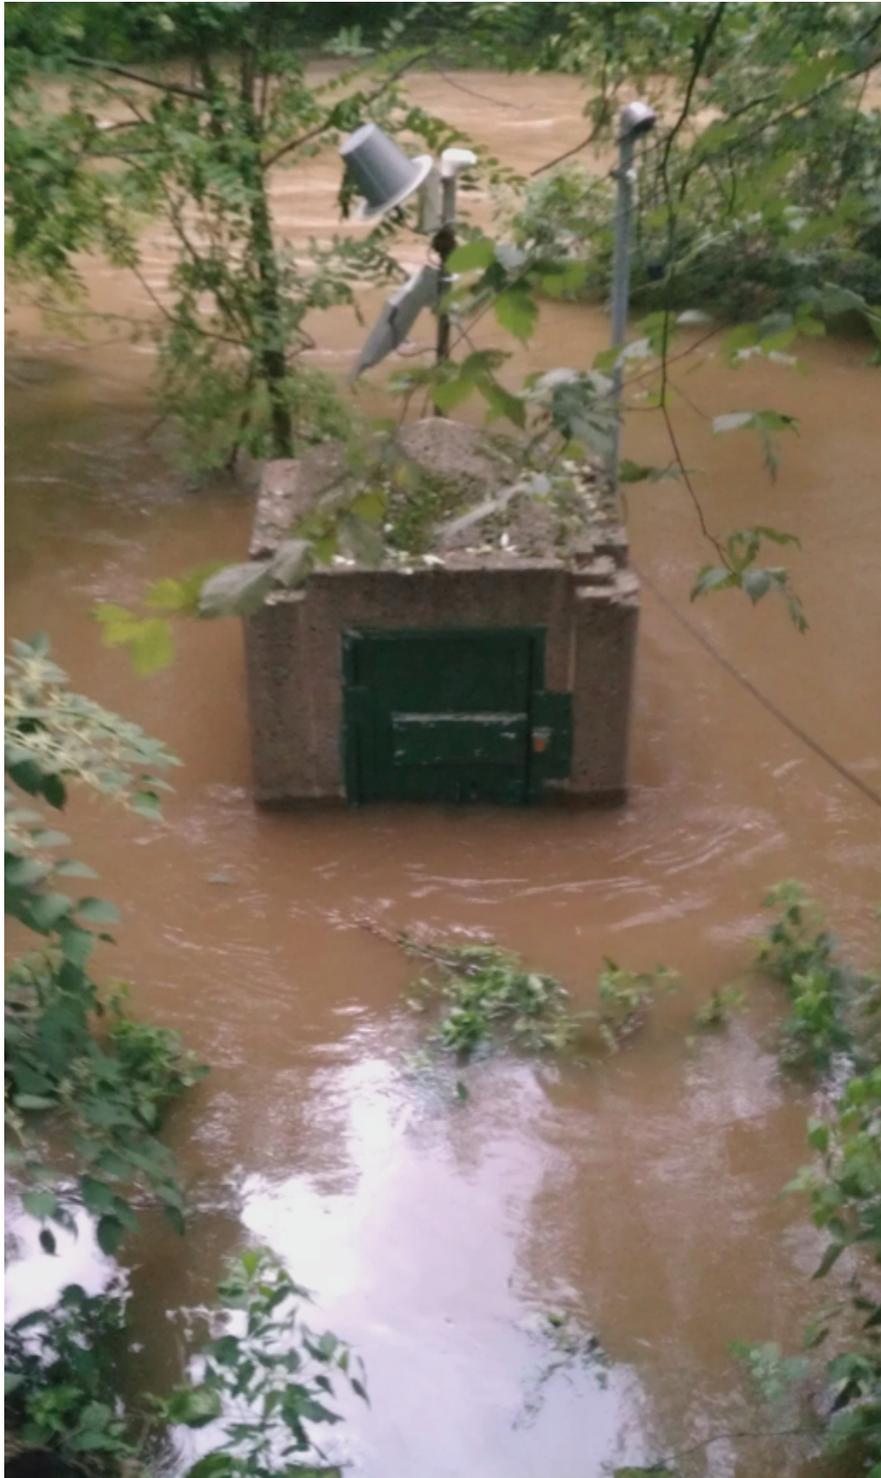
Figure 4. Flooding at the streamgage on the Saddle River at Lodi, New Jersey (U.S. Geological Survey station 01391500), after the peak on August 28, 2011. (Photograph by John J. Trainor, U.S. Geological Survey)

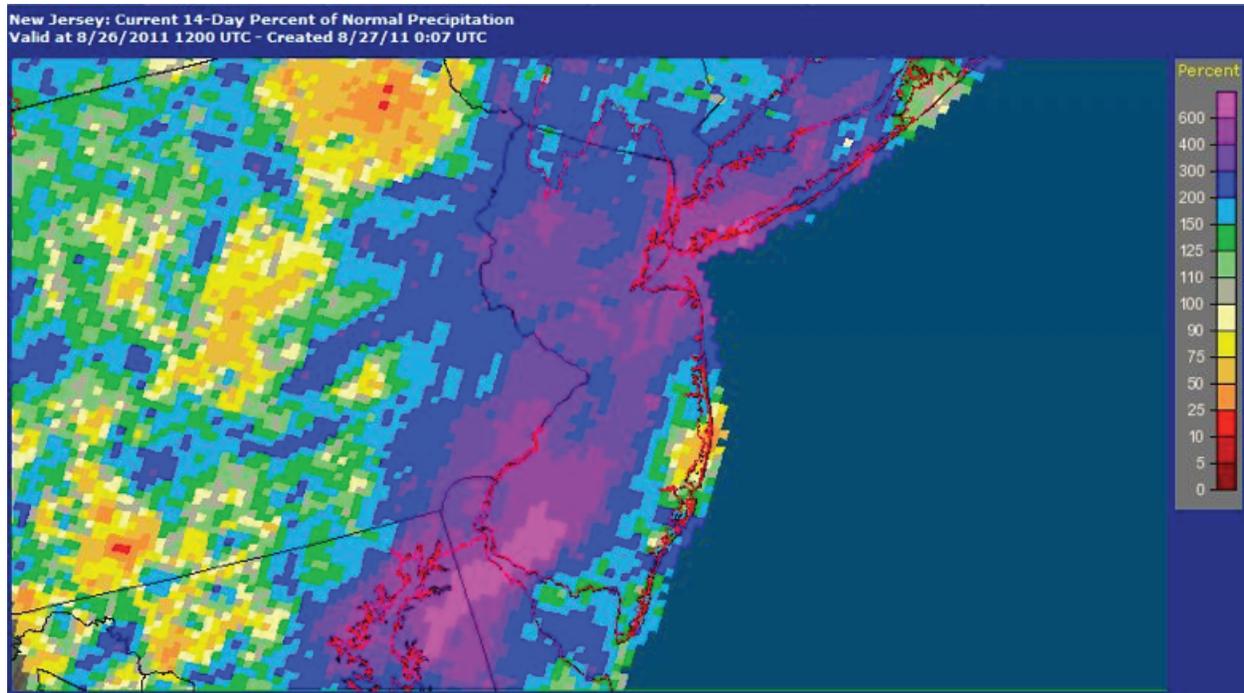
Figure 5. National Weather Service map showing the percent of normal precipitation in New Jersey and vicinity observed for the 2-week period preceding Hurricane Irene, August 26, 2011. (From National Weather Service, 2011)

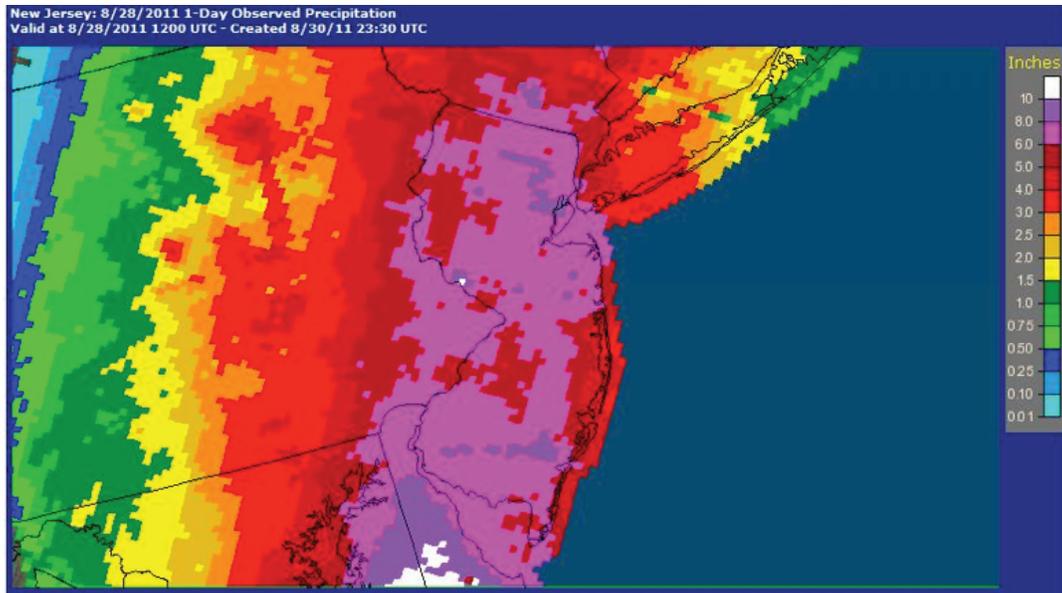
Figure 7. National Weather Service map of total observed precipitation in New Jersey and vicinity for 24-hour period ending August 28, 2011, at 0800 hours eastern daylight time. (From National Weather Service, 2011)

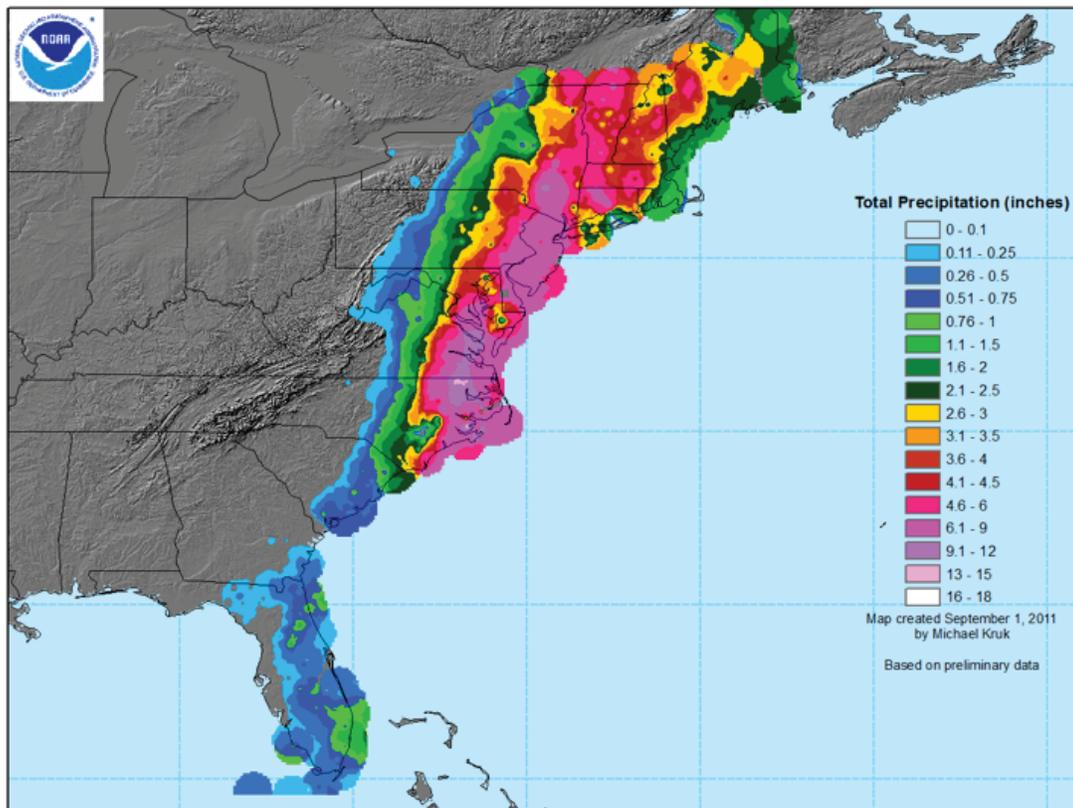
Figure 8. Total precipitation amounts from Hurricane Irene, August 25–29, 2011. Courtesy of the National Oceanic and Atmospheric Administration.

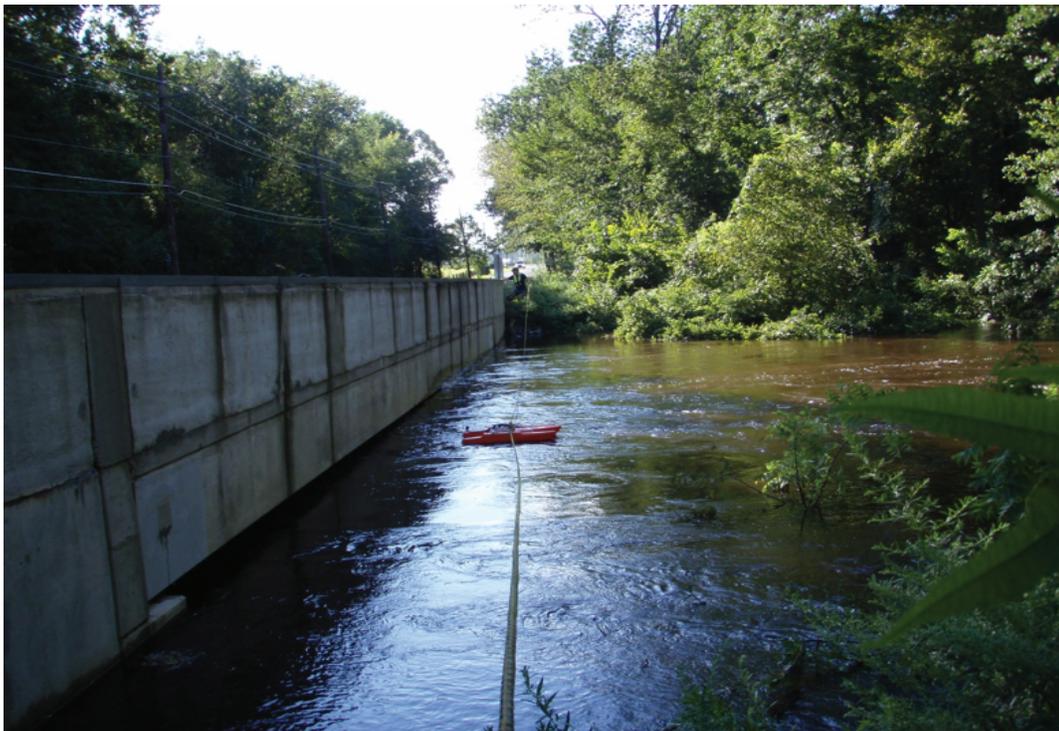
Figure 9. Peak-flow measurement along the South Branch Rancocas Creek at Vincenttown, New Jersey (U.S. Geological Survey station 01465850) made on August 28, 2011. (Photograph by Richard W. Edwards, U.S. Geological Survey)

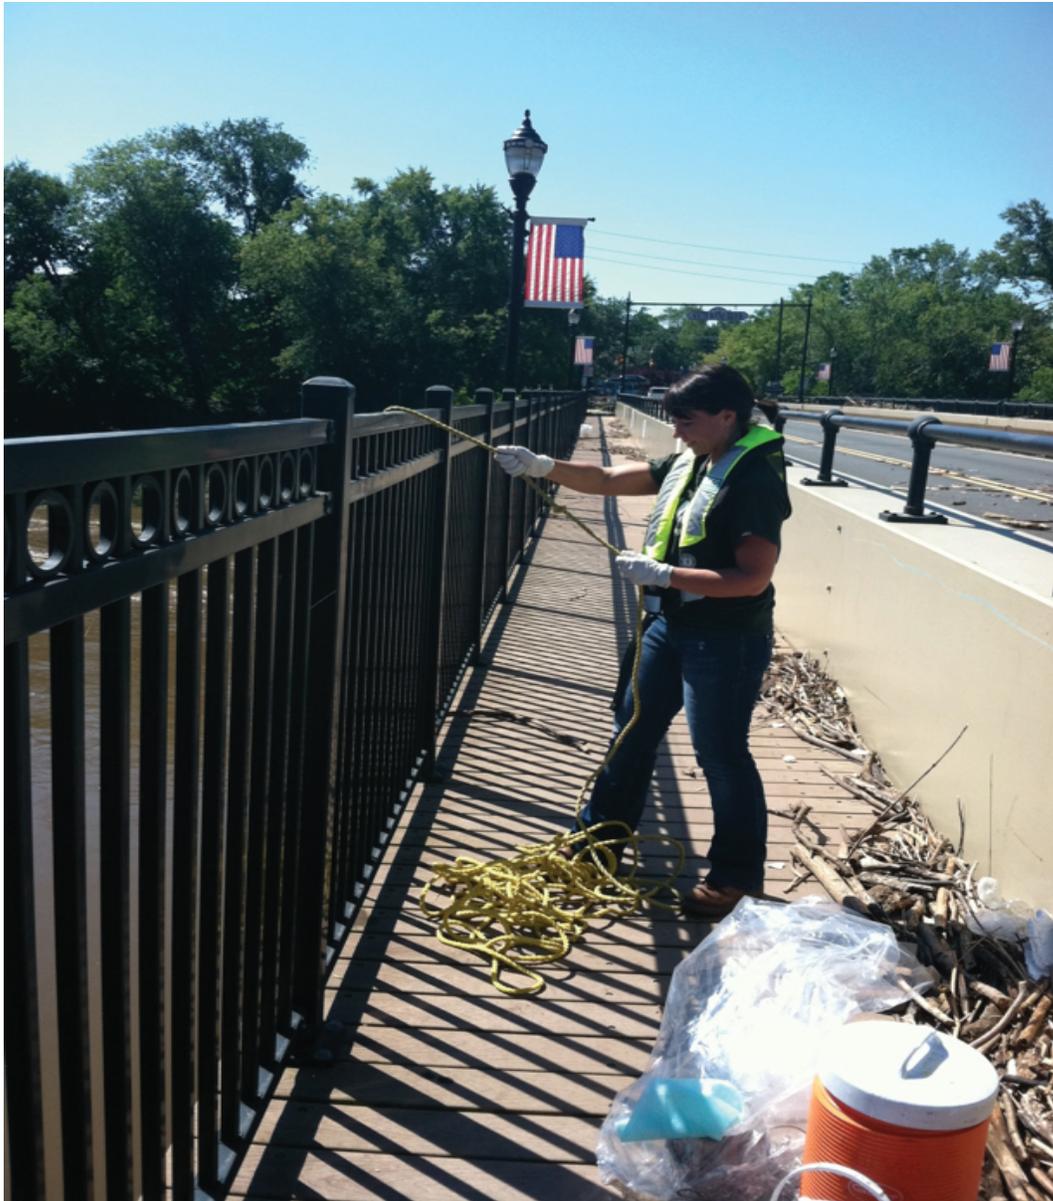
Figure 10. Water-quality sampling along the Raritan River at Queens Bridge at Bound Brook, New Jersey (U.S. Geological Survey station 01403300), following Hurricane Irene. (Photograph by Pamela Reilly, U.S. Geological Survey)

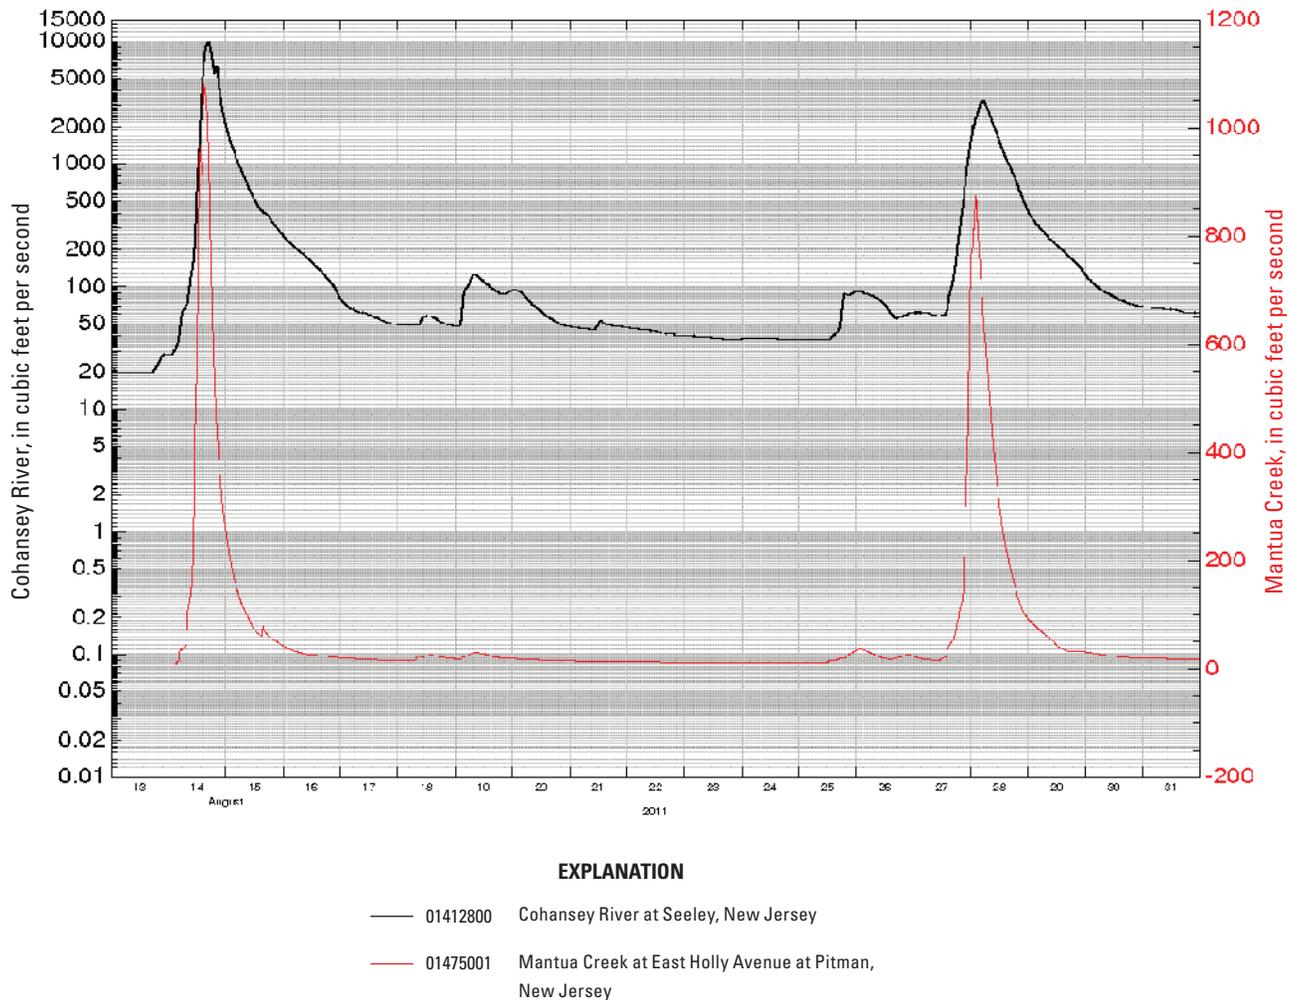
Figure 12. Computed discharge at U.S. Geological Survey continuous-record streamflow-gaging stations Cohansey River at Seeley, New Jersey (01412800) and Mantua Creek at East Holly Avenue at Pitman, New Jersey (01475001), August 13–31, 2011.

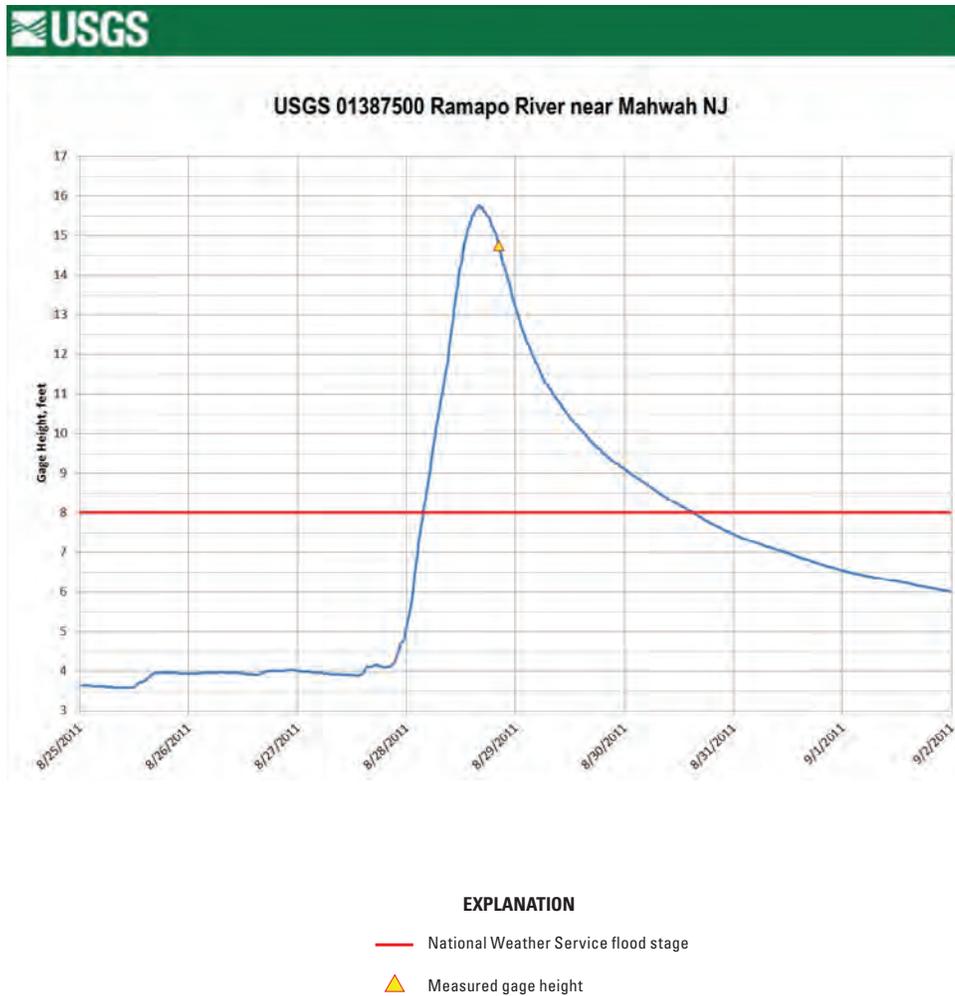
Figure 16. Hydrograph showing the record peak stage on August 28, 2011, at the U.S. Geological Survey continuous-record streamflow-gaging station on the Ramapo River near Mahwah, New Jersey. (U.S. Geological Survey station 01387500)

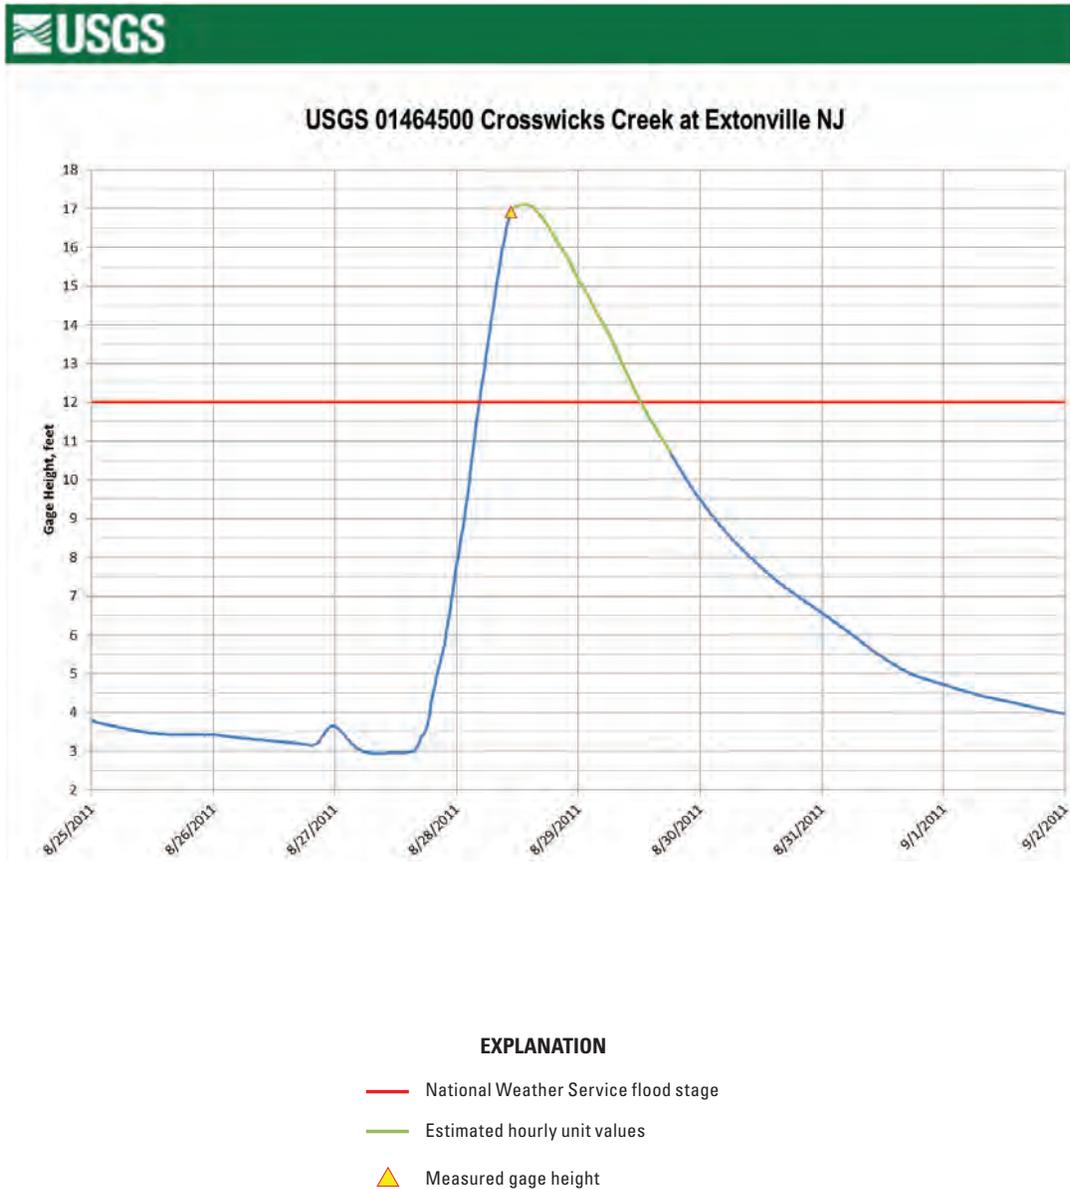
Figure 20. Hydrograph showing record peak stage on August 28, 2011, at the continuous-record streamflow-gaging station on Crosswicks Creek at Extonville, New Jersey (U.S. Geological Survey station 01464500).

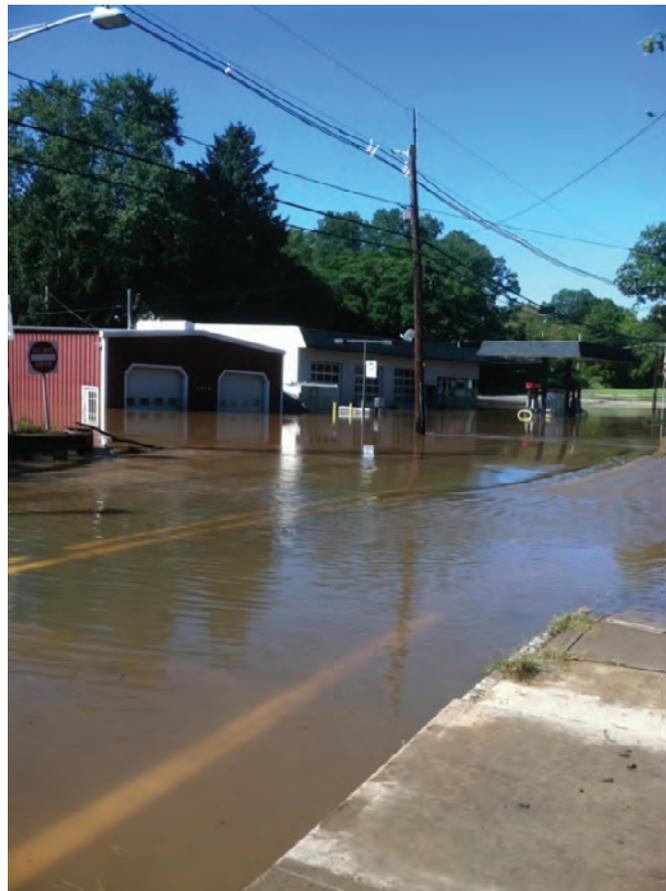
Figure 29. Numerous roads throughout the State of New Jersey, such as this highway bridge on Blackwells Mills Causeway at Blackwells Mills in Somerset County (U.S. Geological Survey station 01402000) became hazardous to cross after the flooding caused by Hurricane Irene. (Photograph by Andrew F. Watson, U.S. Geological Survey)

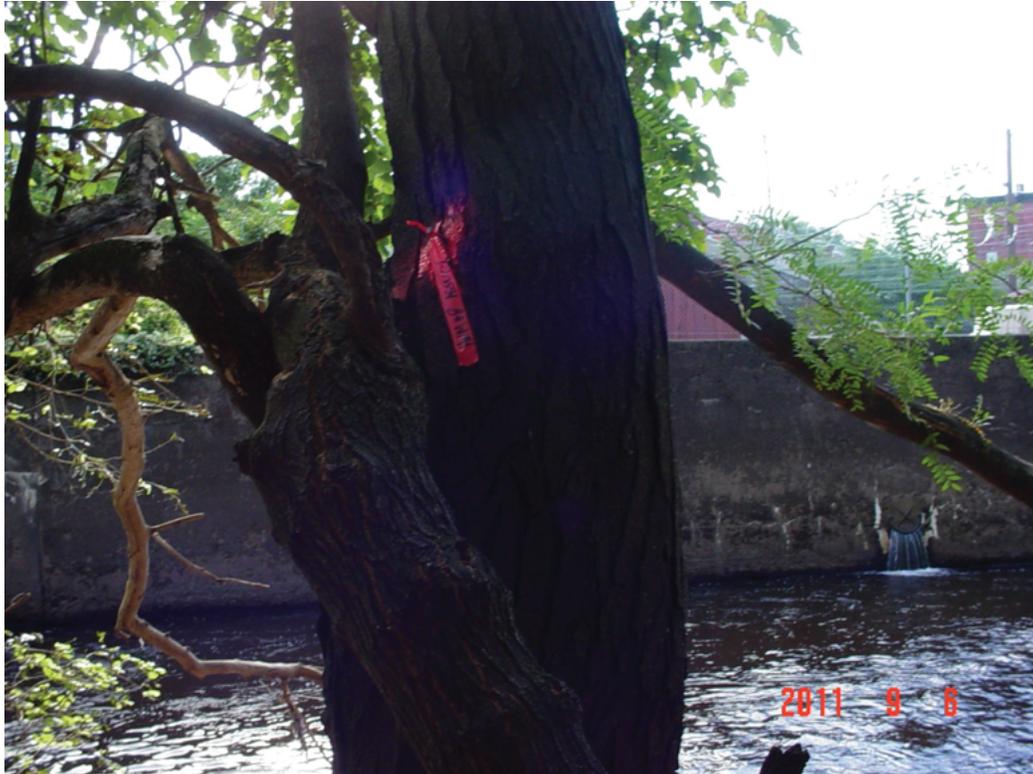
High-water mark on bank of Assunpink Creek in Trenton, Mercer County, New Jersey (ASSU1).

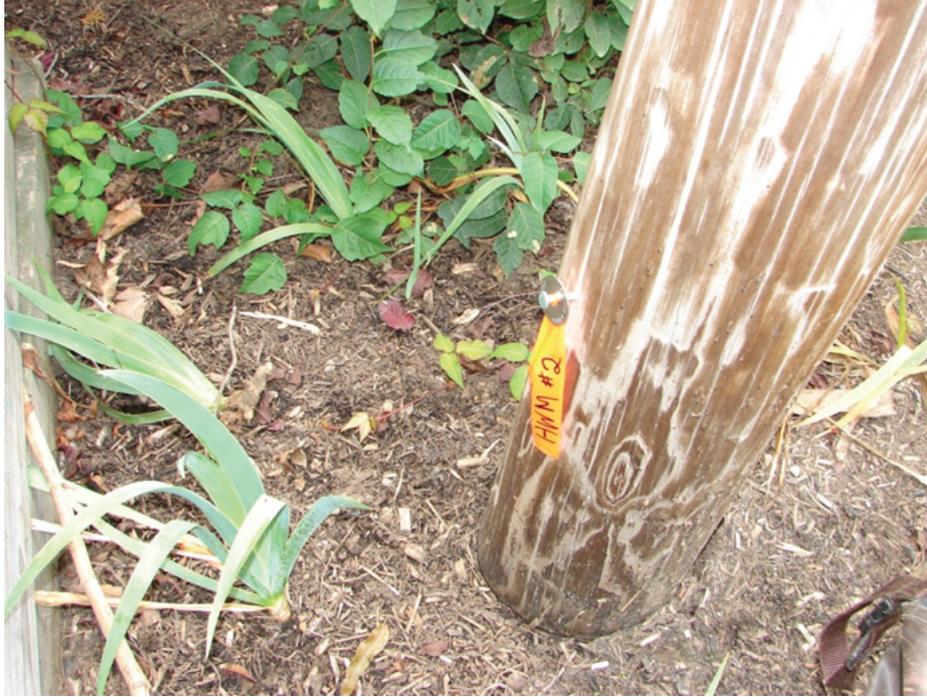
High-water mark on upstream left bank of Crosswicks Creek at New Egypt, Ocean County, New Jersey (CROS3).

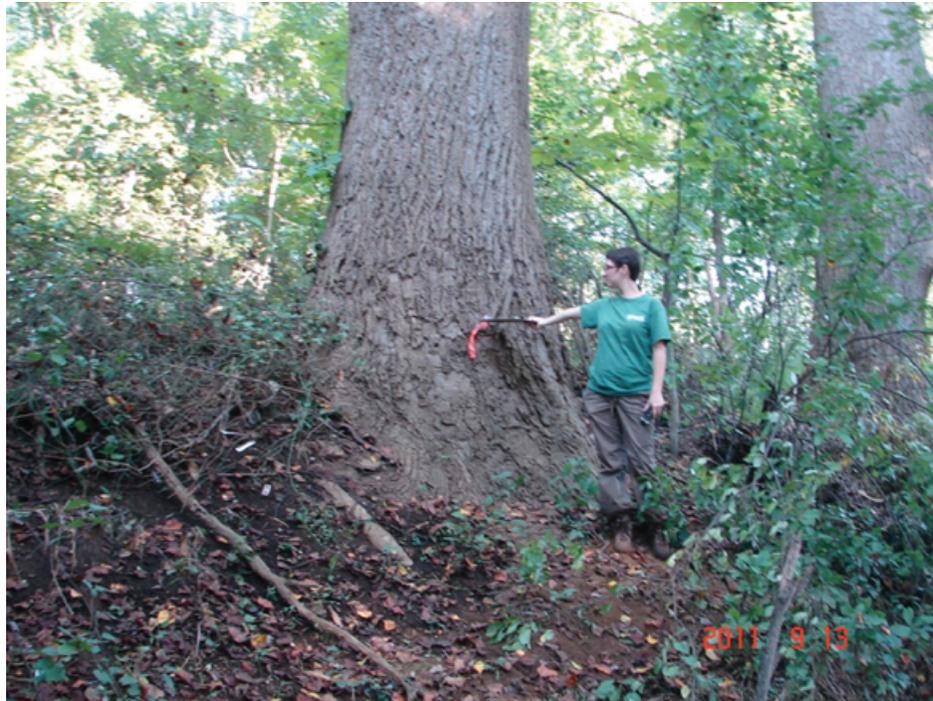
High-water mark on downstream right bank of Manasquan River at West Farms, Monmouth County, New Jersey (MANA1).

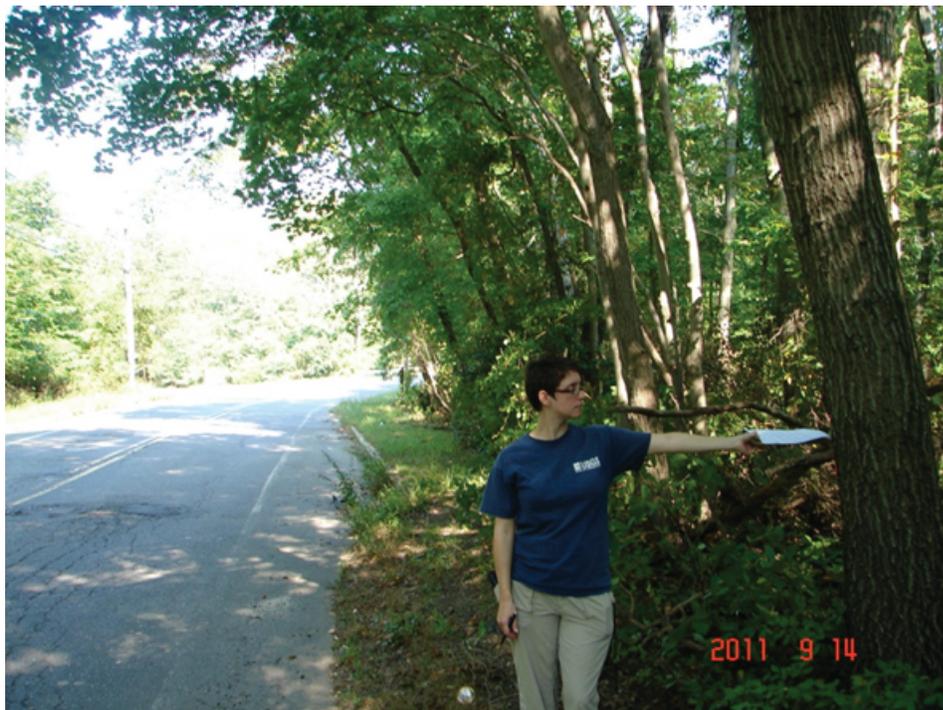
High-water mark on downstream right bank of Manasquan River at Farmingdale, Monmouth County, New Jersey (MANA3).

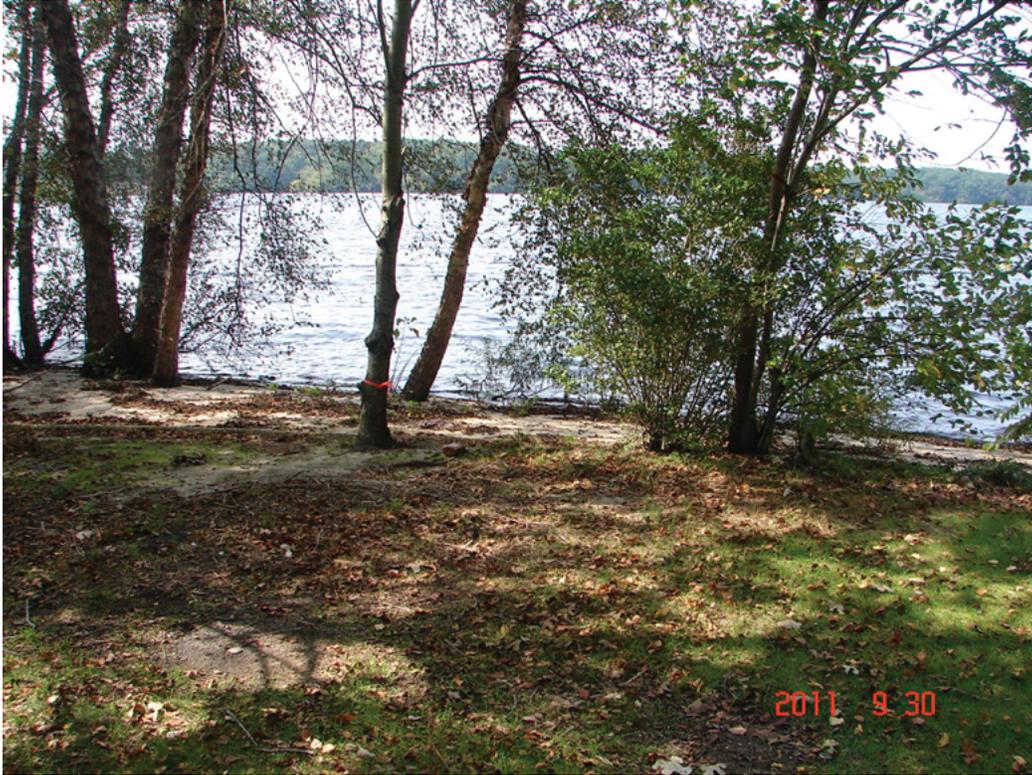
High-water mark on upstream left bank of Maurice River at Millville, Cumberland County, New Jersey (MAUR2).

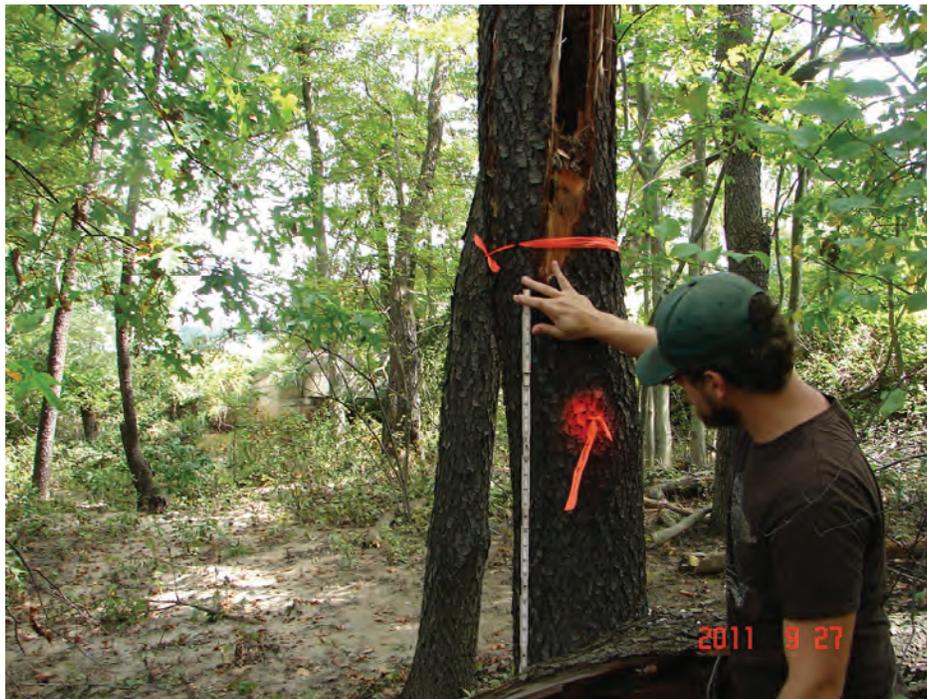
High-water mark on downstream left bank of Millstone River at Hightstown, Mercer County, New Jersey (MILL2).

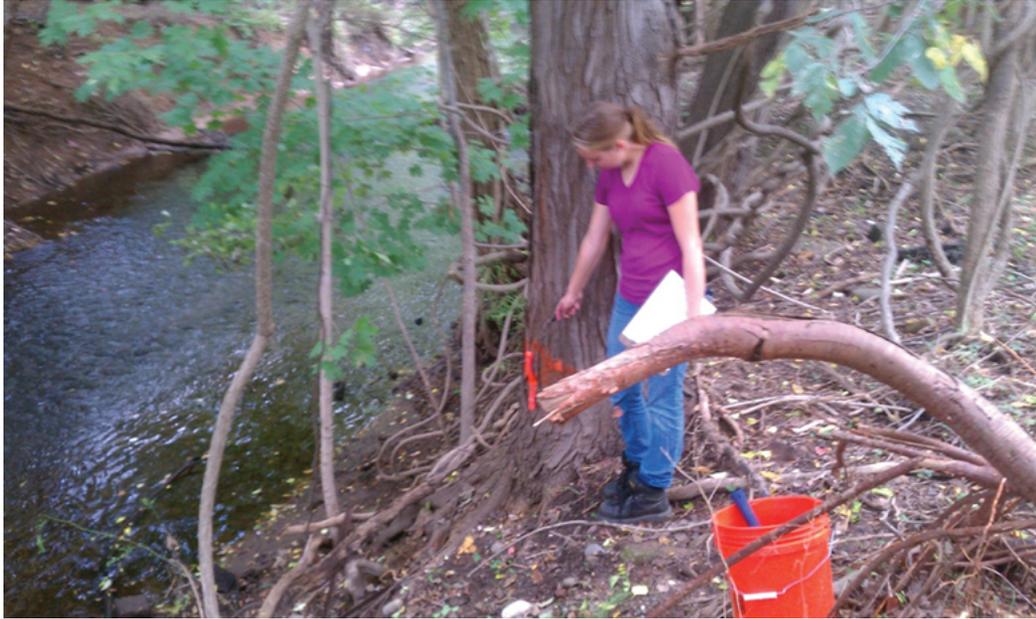
High-water mark on downstream right bank of Musquapsink Brook at Westwood, Bergen County, New Jersey (MUSQ1).

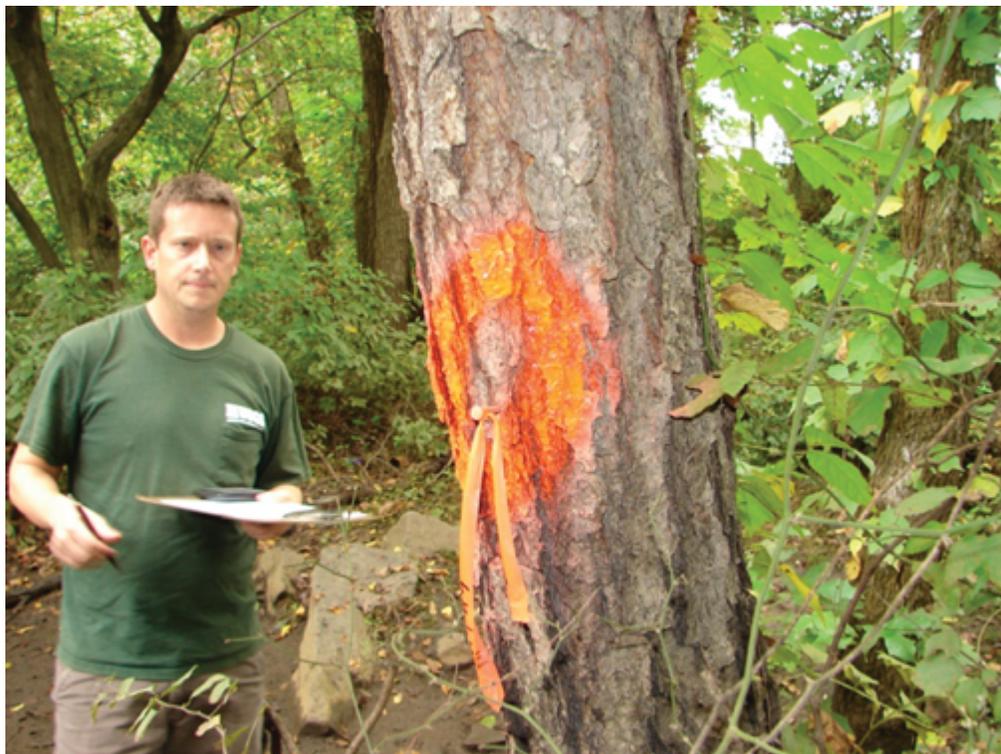
High-water mark on downstream right bank of the North Branch Rancocas Creek at Mt. Holly, Burlington County, New Jersey (NBRAN1).

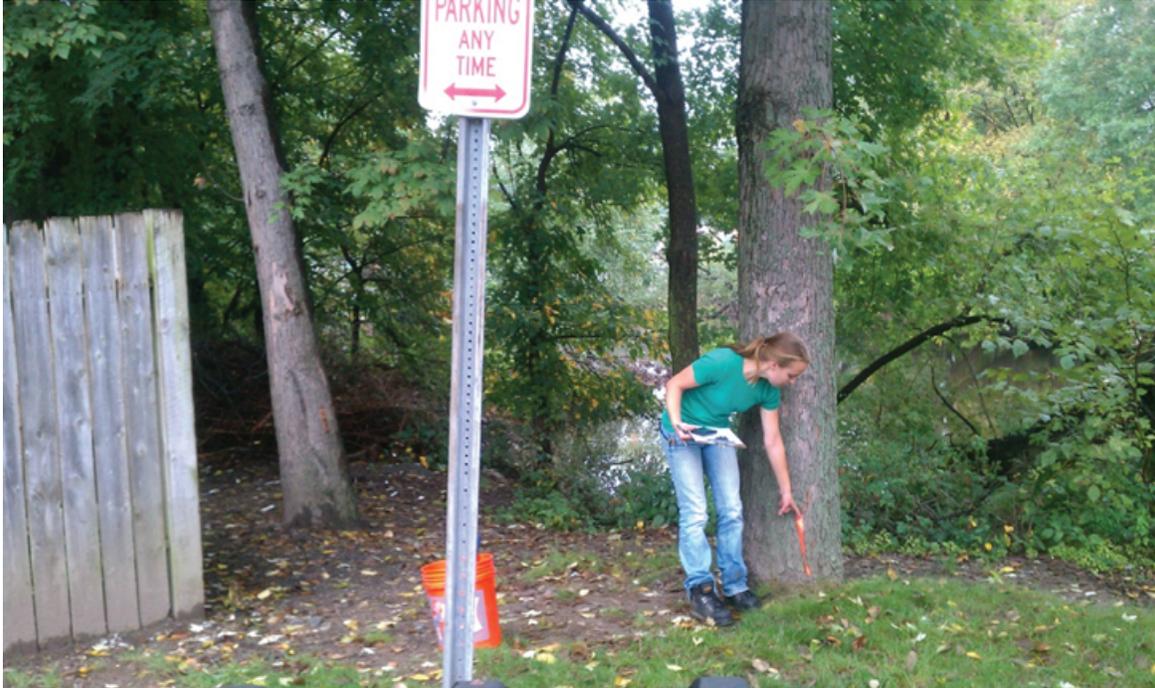
High-water mark on downstream right bank of Rockaway River at Pine Brook, Morris County, New Jersey (ROCK1).
