Monitoring and Research to Describe Geomorphic Effects of the 2011 Controlled Flood on the Green River in the Canyon of Lodore, Dinosaur National Monument, Colorado and Utah

Scientific Investigations Report 2014–5022

By Erich R. Mueller, Paul E. Grams, John C. Schmidt, Joseph E. Hazel, Jr.,
Matt Kaplinski, Jason A. Alexander, and Keith Kohl

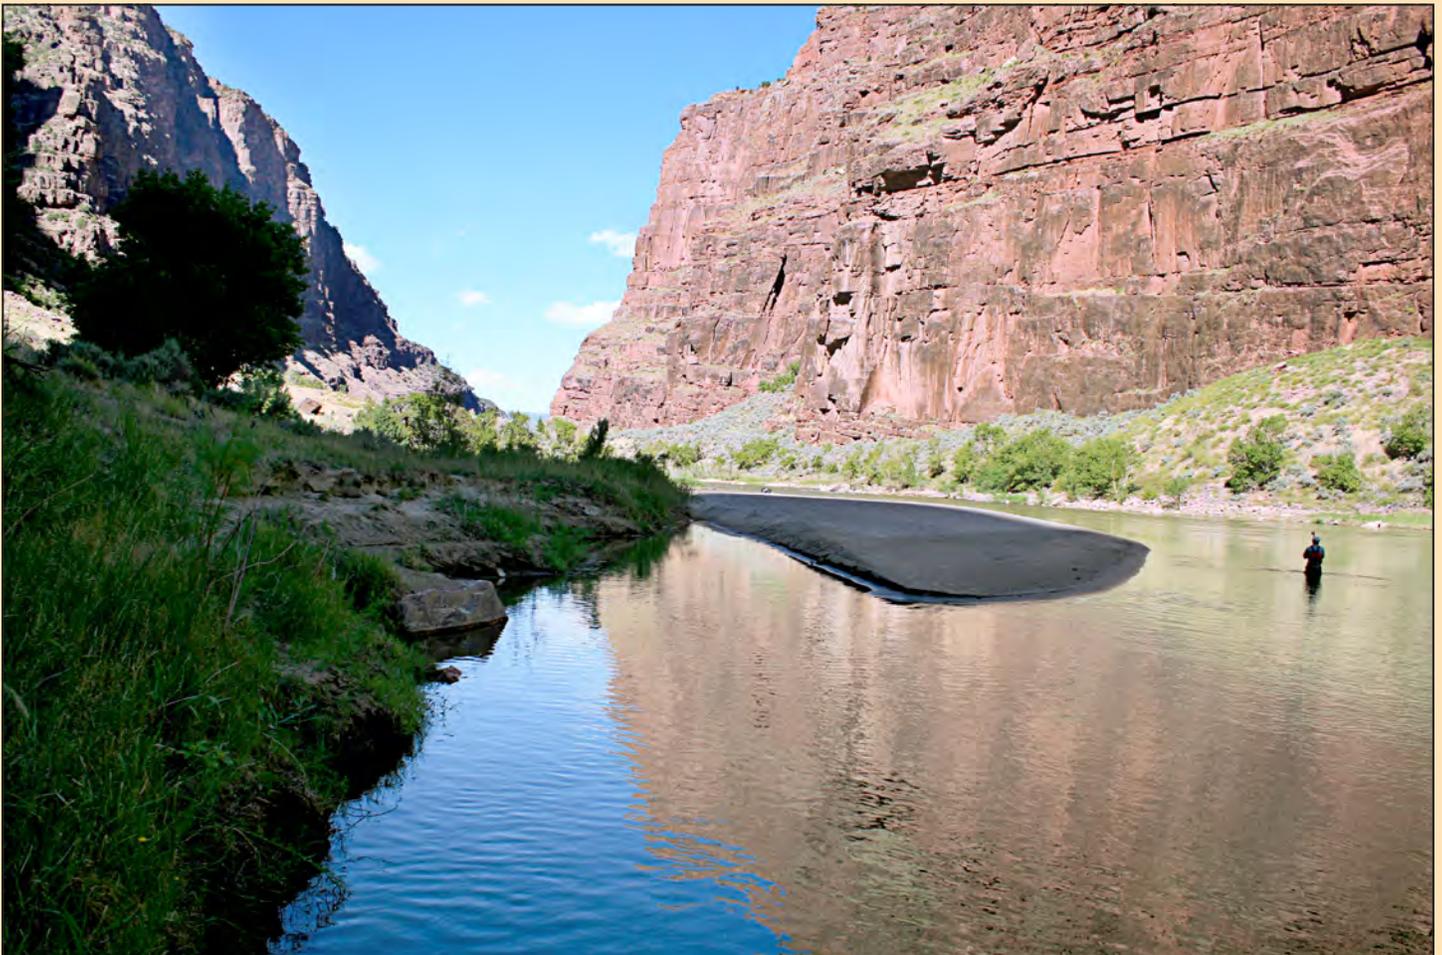
COVER
Topographic surveying of the Green River near Gates of Lodore, Dinosaur National Monument, Colorado and Utah (U.S. Geological Survey photograph by Ted Melis).

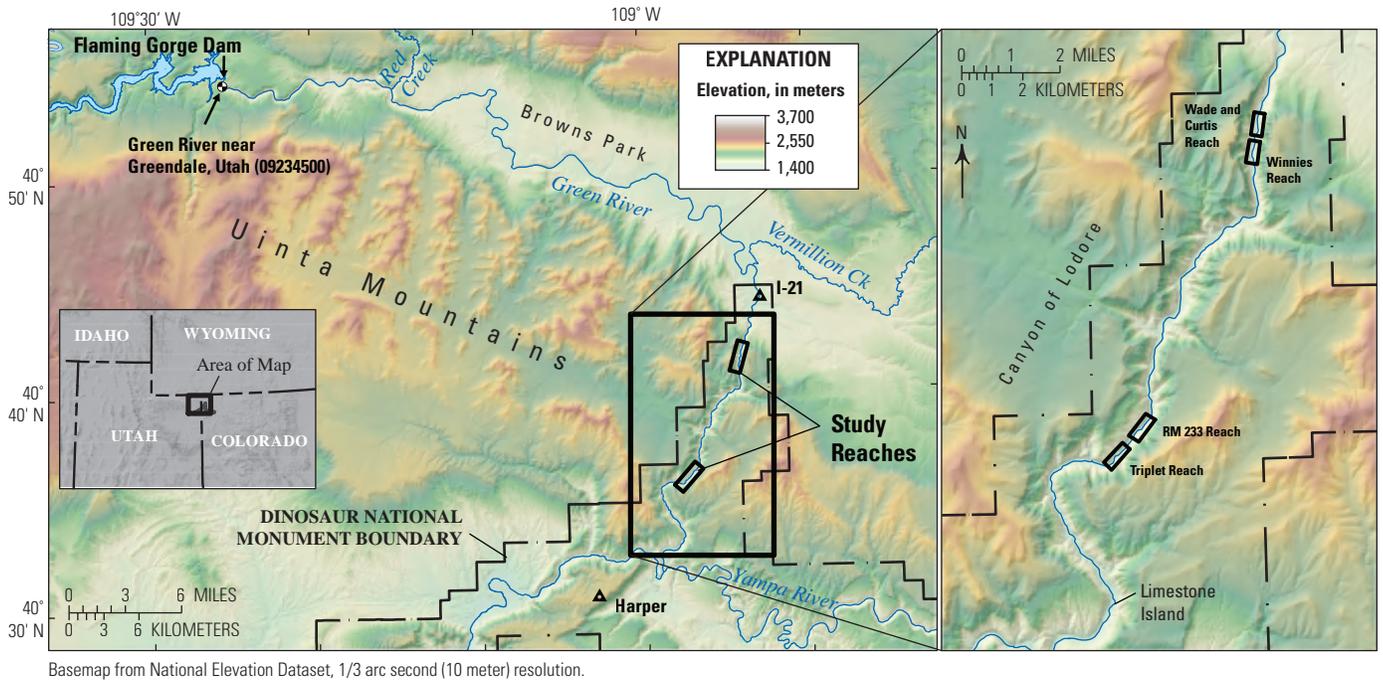
Figure 1. Location of the Canyon of Lodore within Dinosaur National Monument, Colorado and Utah, with the sites of newly occupied control stations shown as triangles (left); area shown in the rectangle indicates locations of study reaches on the Green River within the Canyon of Lodore (right).

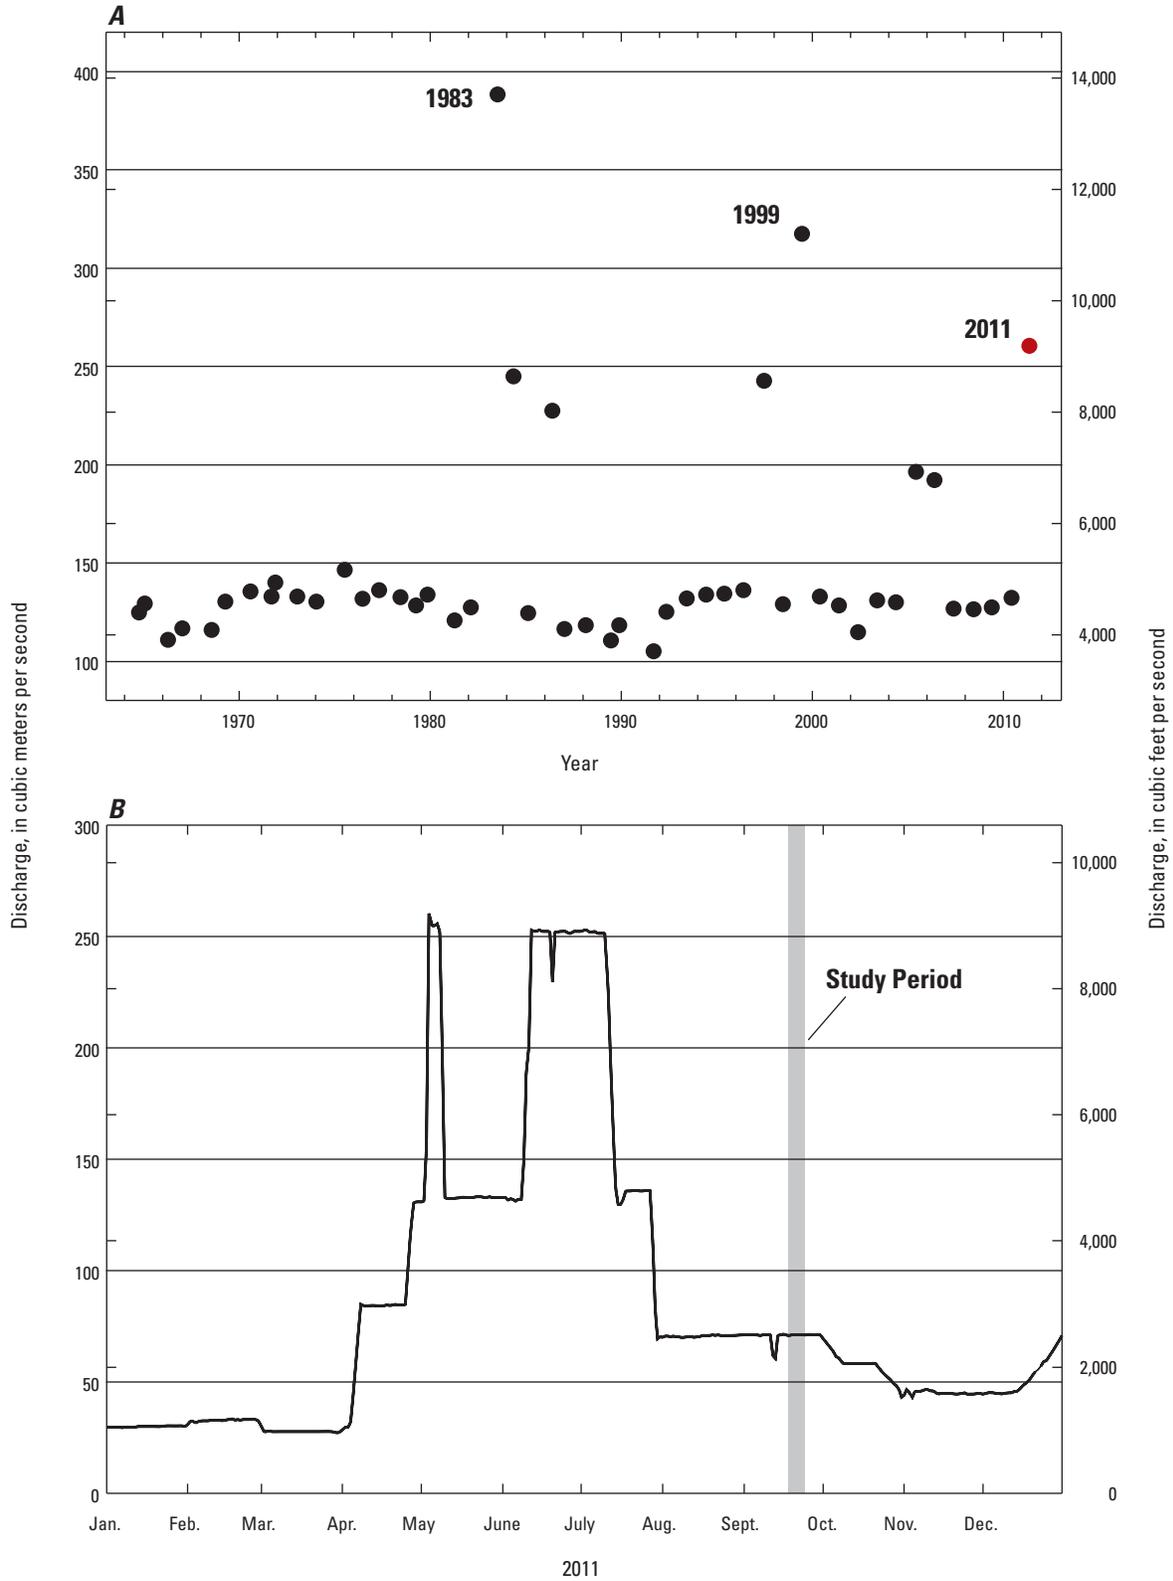
Figure 2. Discharge for the Green River near Greendale, Utah. *A*, Annual peak discharge since initial closure in November 1962 of Flaming Gorge Dam, Utah, measured at stream gage 09234500. *B*, Mean daily flow hydrograph for 2011.

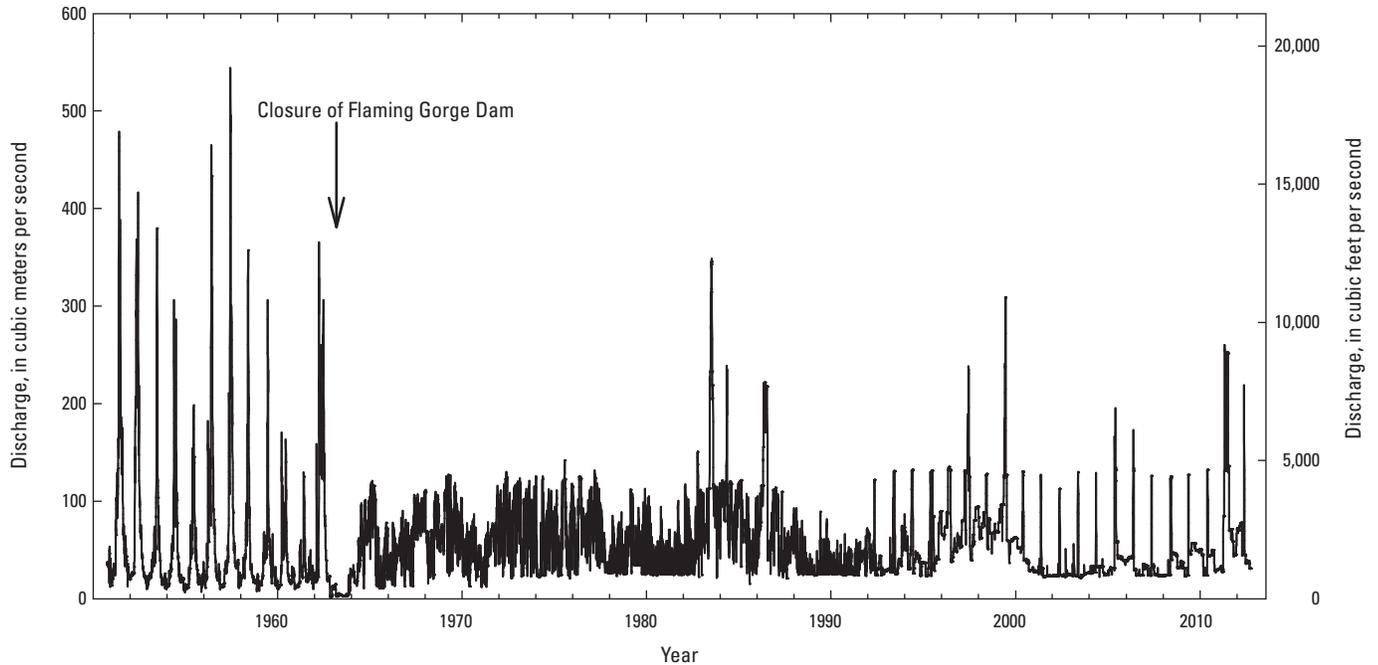
Figure 3. Mean daily discharge of the Green River near Greendale, Utah, from 1950 to 2012. Initial closure of Flaming Gorge Dam in November 1962 is indicated.

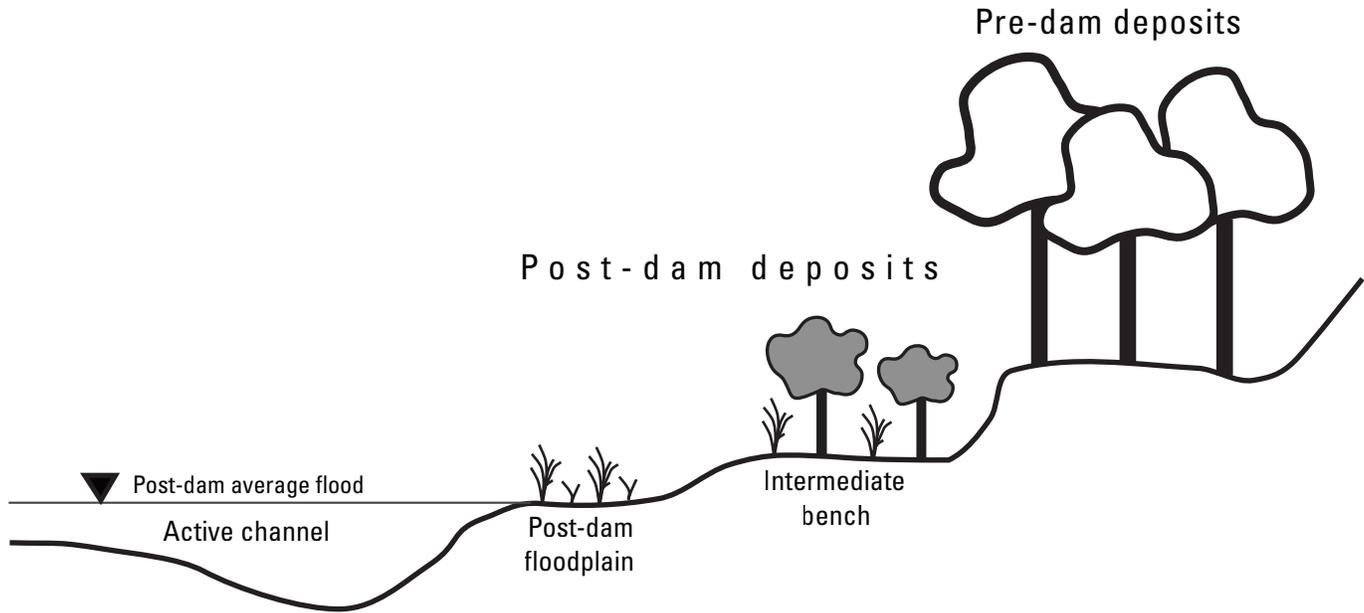
Figure 4. Geomorphic levels (terrace and floodplain surfaces) relative to the stage of a typical post-dam flood for the Green River downstream from Flaming Gorge Dam, Colorado and Utah (modified from Grams and Schmidt, 2005).

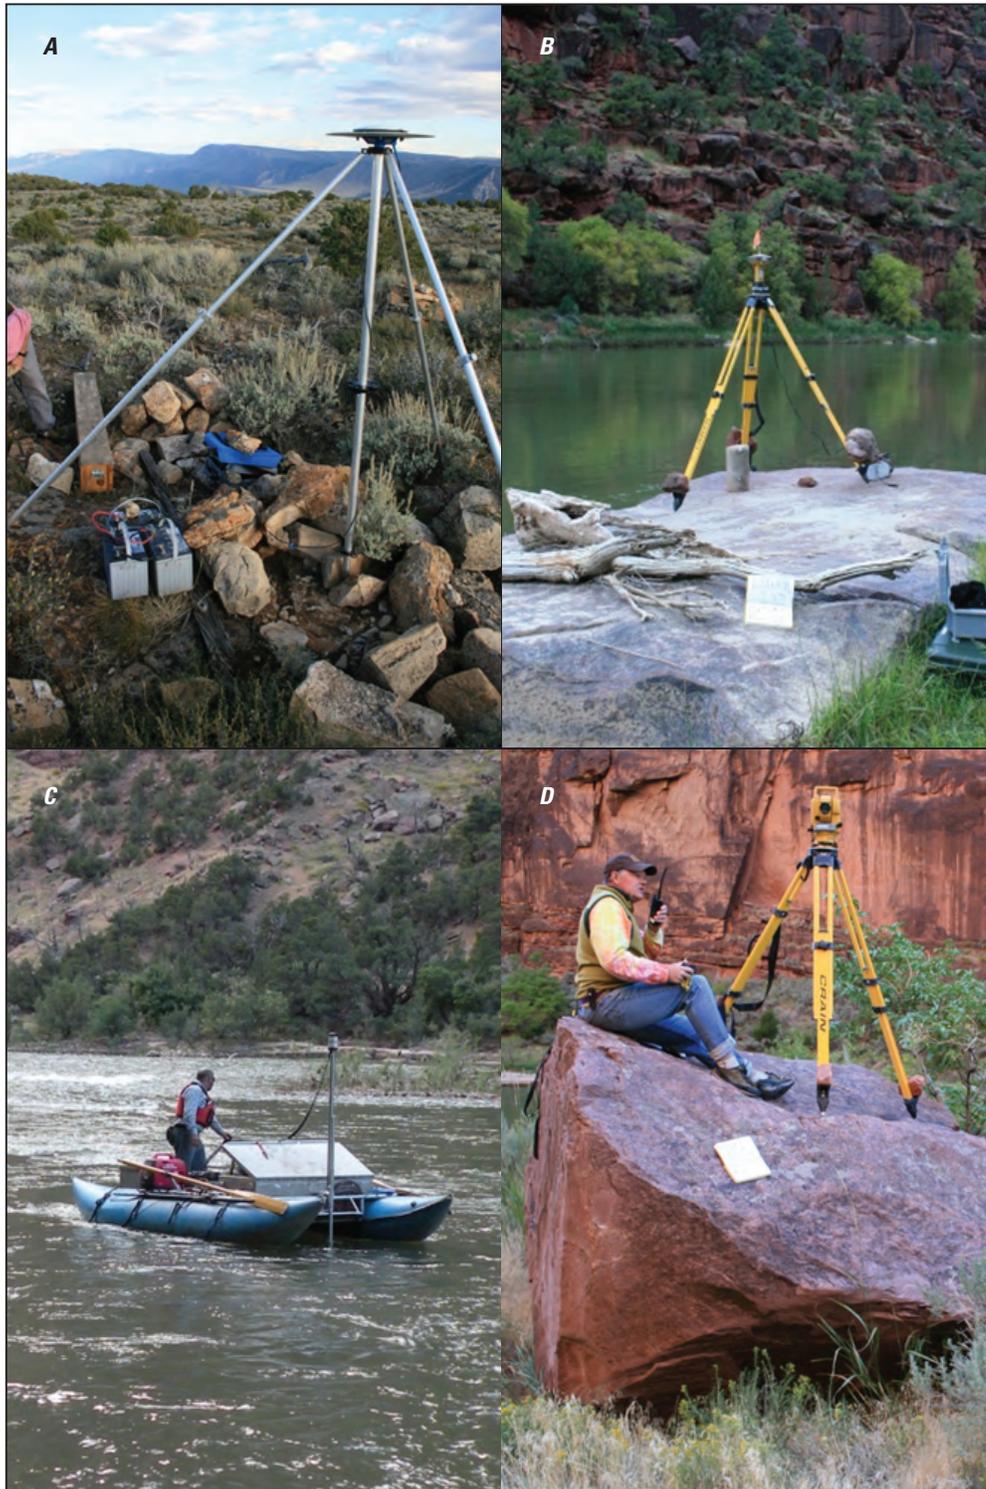
Figure 5. Field photographs from the Canyon of Lodore, Dinosaur National Monument, Colorado and Utah, showing (A) Global Navigation Satellite System (GNSS) receiver set up at a canyon-rim station (Harper); (B) GNSS receiver positioned at a river corridor control point (RM233, GR233.19L); (C) bathymetric surveying where front mast on raft is equipped with a positioning laser target on top (for tracking using a geodimeter) and a submerged transducer on the bottom for single-beam sonar; and (D) total station set up for conventional surveys in river corridor (Winnies reach, GR248.48R).

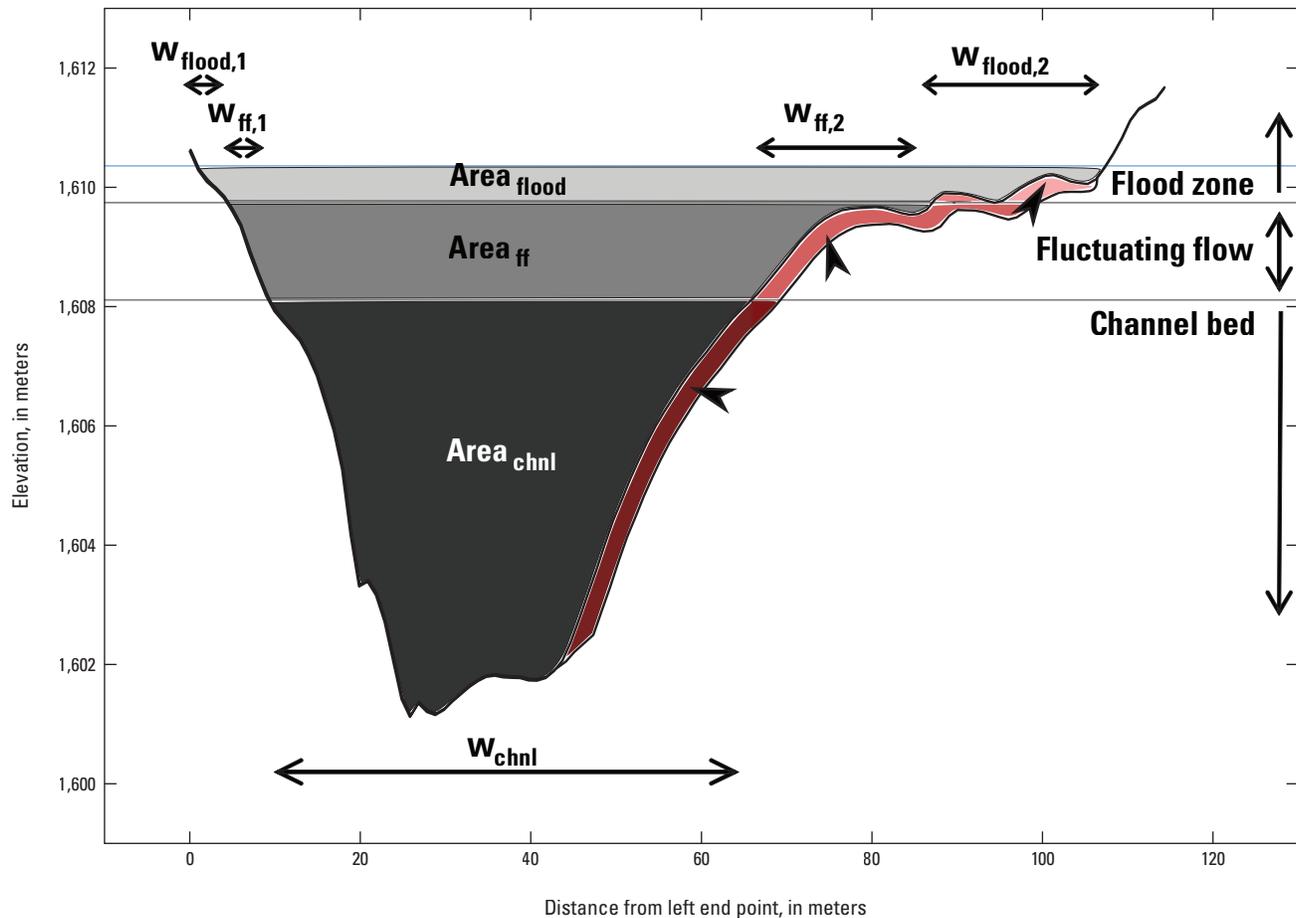
Figure 6. Methods used to calculate changes in cross-section area and bed elevation at monumented cross sections based on repeated surveys of the Green River in the Canyon of Lodore, Dinosaur National Monument, Colorado and Utah. Widths of the flood, fluctuating flow, and channel zones are given as w_{flood} , w_{ff} , and w_{chnl} , and subscripts 1 and 2 represent the river left and right parts of the flood and fluctuating zones, respectively. Areas of the flood, fluctuating flow, and channel zones are given as $\text{Area}_{\text{flood}}$, Area_{ff} , and $\text{Area}_{\text{chnl}}$.

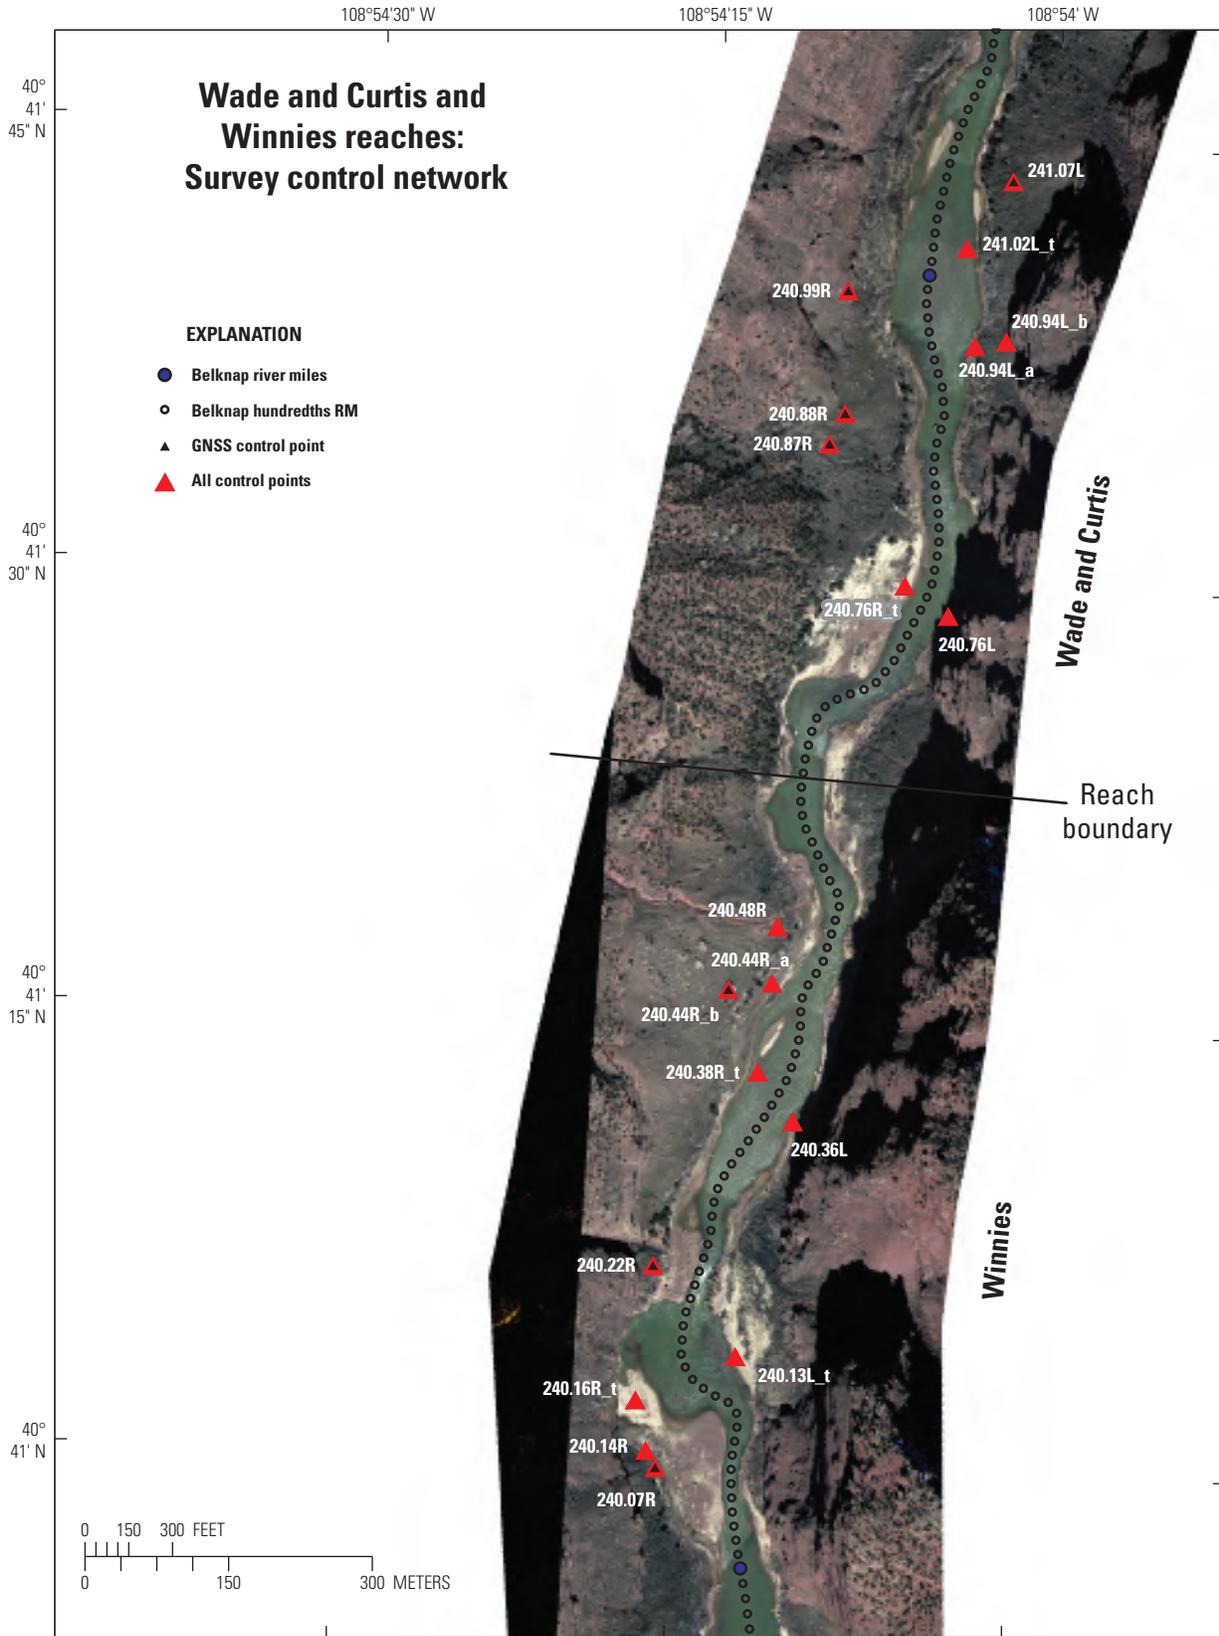
Figure 7. Survey control network for the Wade and Curtis and Winnies reaches on the Green River in Canyon of Lodore, Dinosaur National Monument, Colorado and Utah. Coordinates for individual points are given in table 1. Streamflow is from north to south. GNSS, Global Navigation Satellite System; RM, river mile.

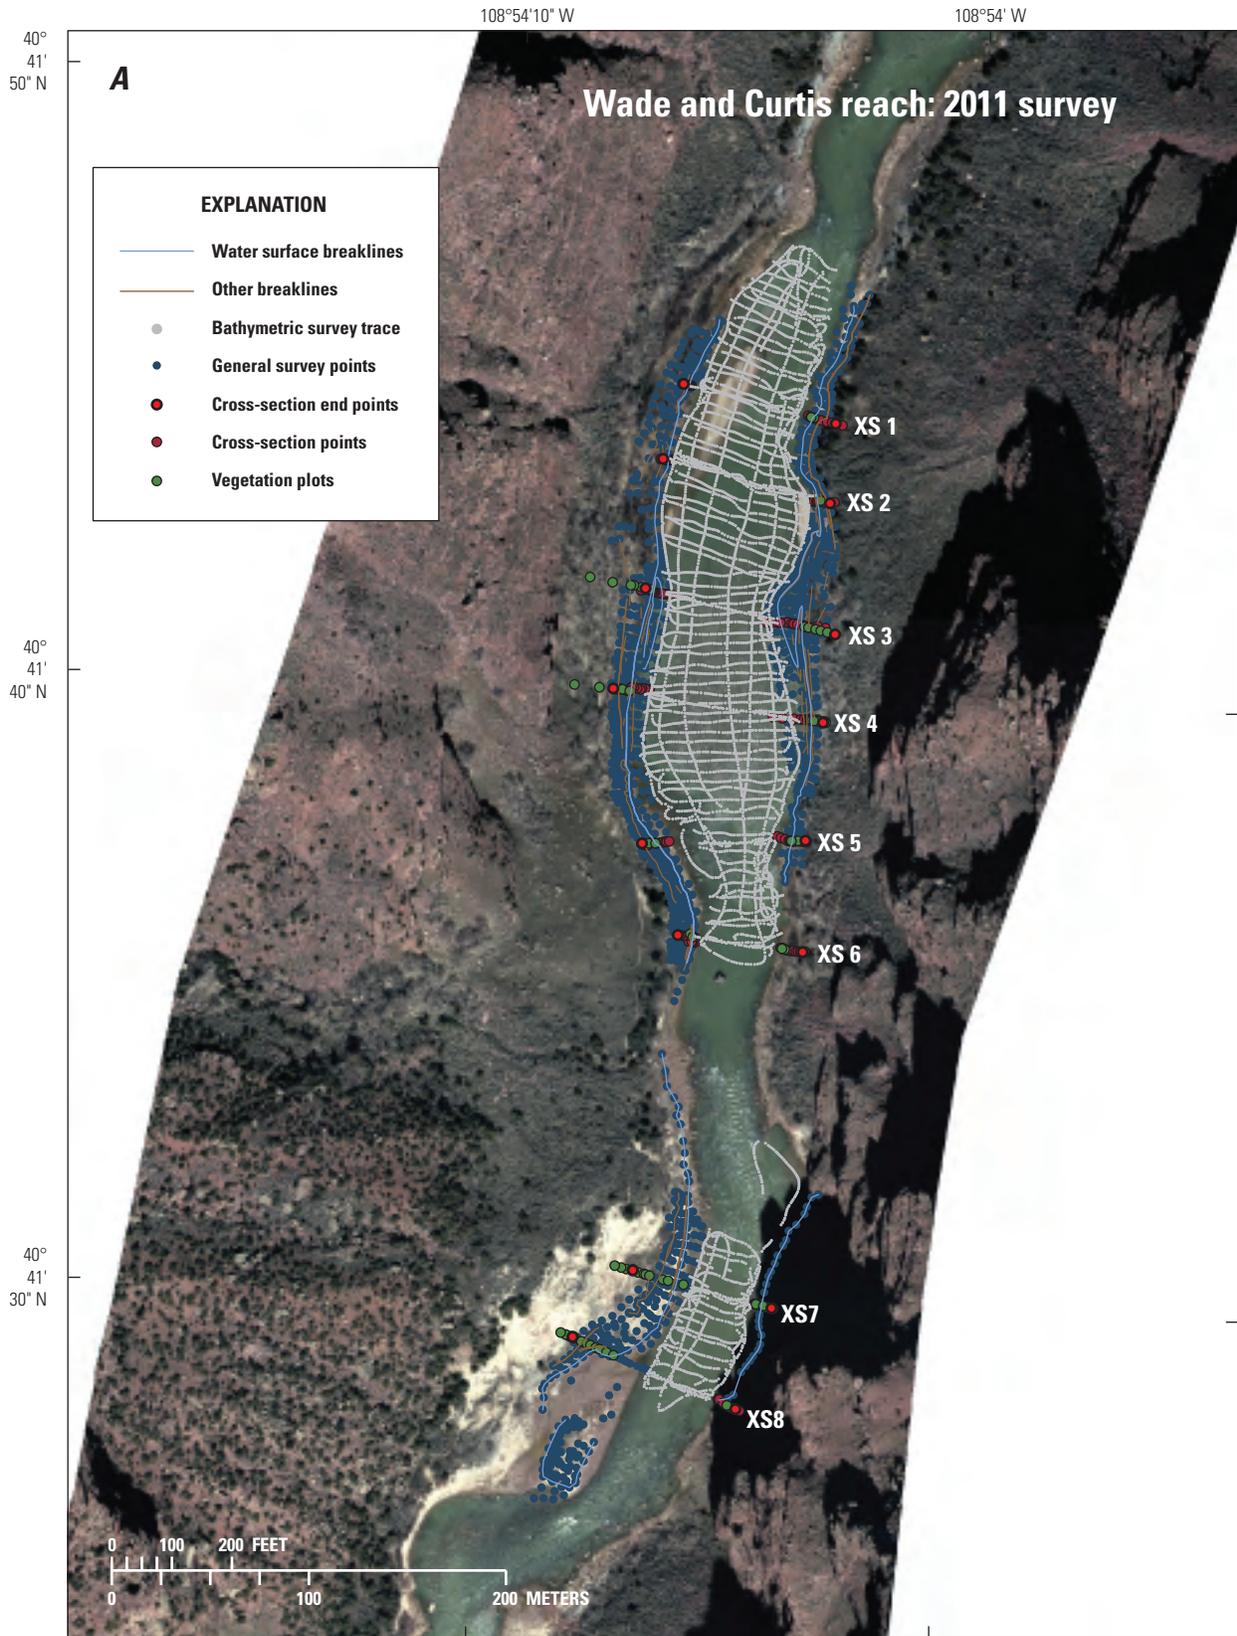
Figure 9. The Wade and Curtis reach on the Green River in Canyon of Lodore, Dinosaur National Monument, Colorado and Utah. *A*, survey points; *B*, 1-meter digital elevation model (DEM) derived from triangular irregular network (TIN) surface. The letters indicate geomorphic characteristics referred to in the discussion: S, scour pool; EB, eddy bar; GB, gravel bar; XS, cross section. Streamflow is from north to south.

In the Wade and Curtis reach, deep erosion in the pool at the upstream end of the reach was clearly evident, with as much as 5 m of degradation having occurred since the 2006 survey (figs. 9 and 17). Evidence for this degradation is also shown in the 2001–2011 DEM difference maps (fig. 13A), which depict the erosion of eddy sandbars in the upstream part of the reach. However, the data also show that these sandbars, which formed during relatively modest flows, likely shifted downstream in the high-flow event, as sandbars near both the left and right banks are shown in both the DEM (fig. 9) and in cross section (XS) 4 (fig. 17). Excavations into the 2011 flood deposit in each of these sandbars indicate that the minimum deposit thicknesses were 0.5–0.8 m (figs. 15 and 16). The lower part of this reach was not surveyed in as great of detail; however, the gravel bar on river right was significantly entrained, and there was some damage to tamarisk.

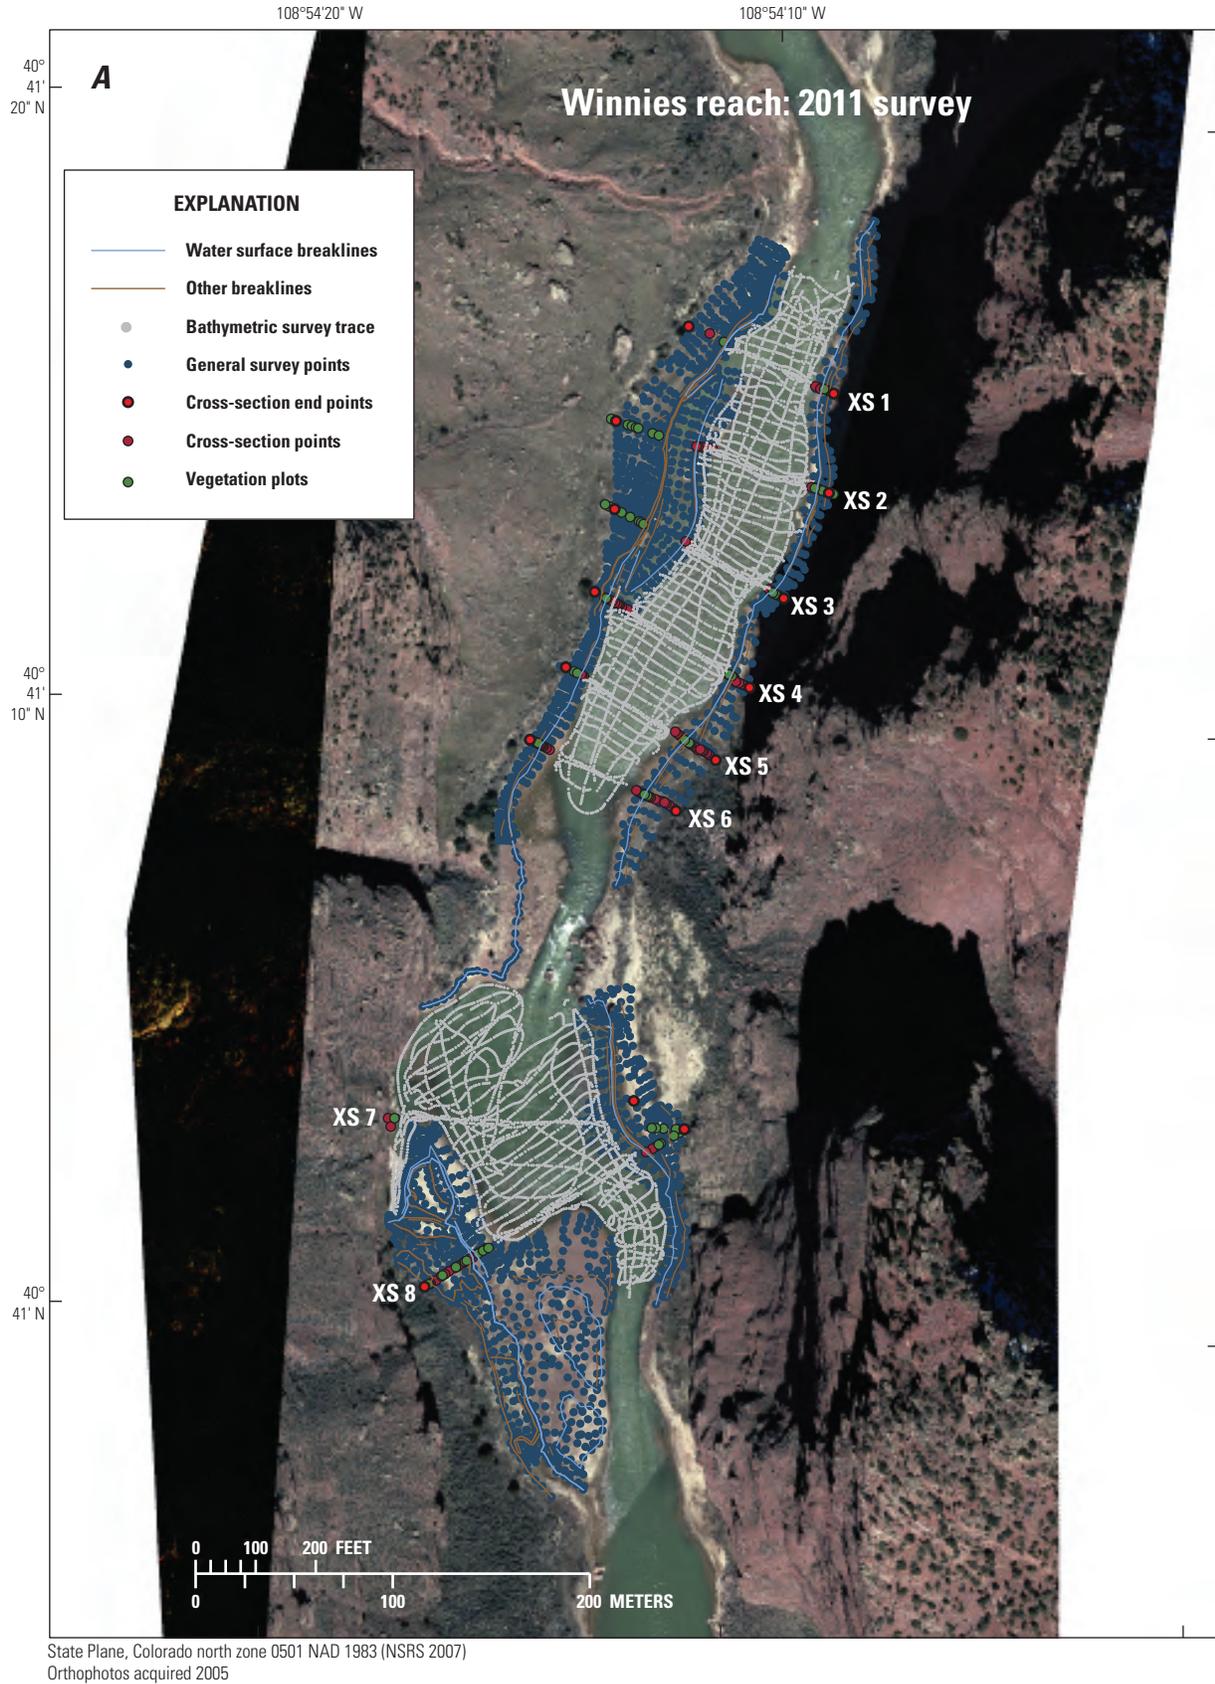
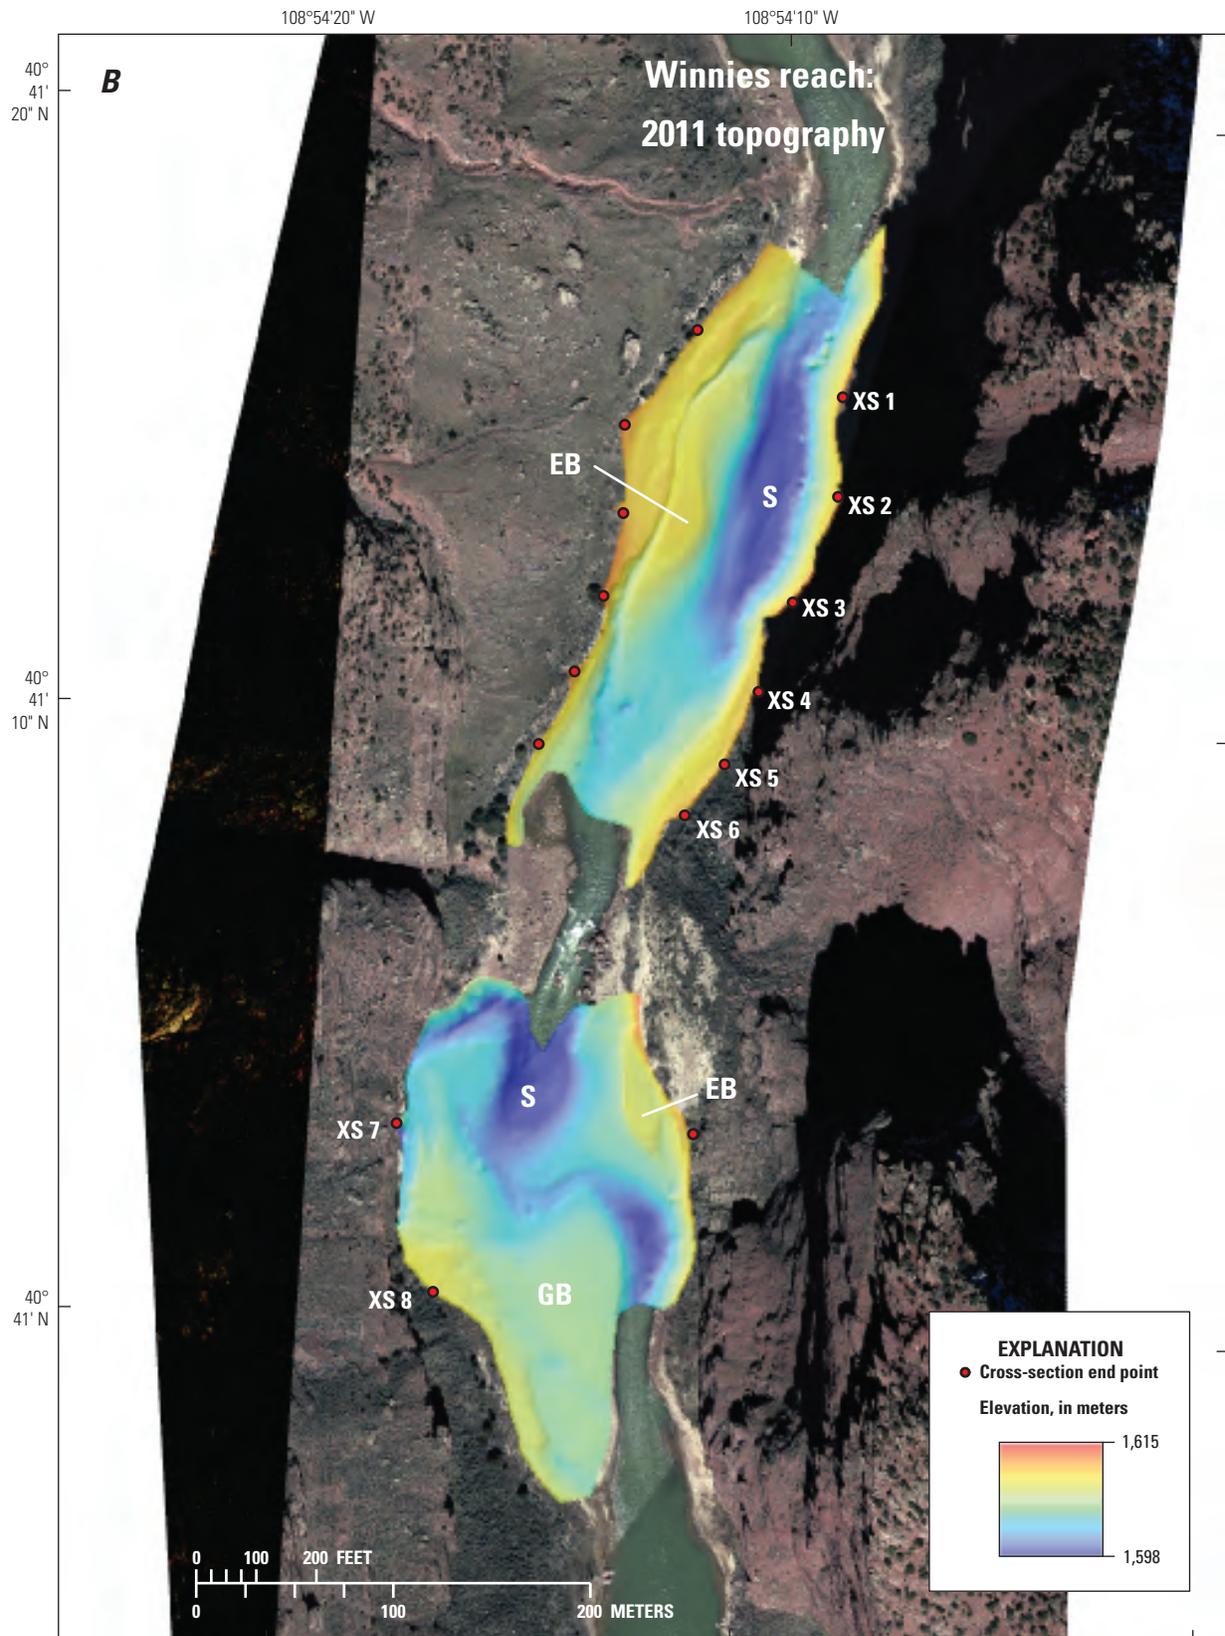
Figure 10. Winnies reach on the Green River in Canyon of Lodore, Dinosaur National Monument, Colorado and Utah. *A*, survey points; *B*, 1-meter digital elevation model (DEM) derived from triangular irregular network (TIN) surface. The letters indicate geomorphic characteristics referred to in the discussion: S, scour pool; EB, eddy bar; GB, gravel bar; XS, cross section. Streamflow is from north to south.

Figure 10. Winnies reach on the Green River in Canyon of Lodore, Dinosaur National Monument, Colorado and Utah. *A*, Survey points; *B*, 1-meter digital elevation model (DEM) derived from triangular irregular network (TIN) surface. The letters indicate geomorphic characteristics referred to in the discussion: S, scour pool; EB, eddy bar; GB, gravel bar; XS, cross section. Streamflow is from north to south. —Continued

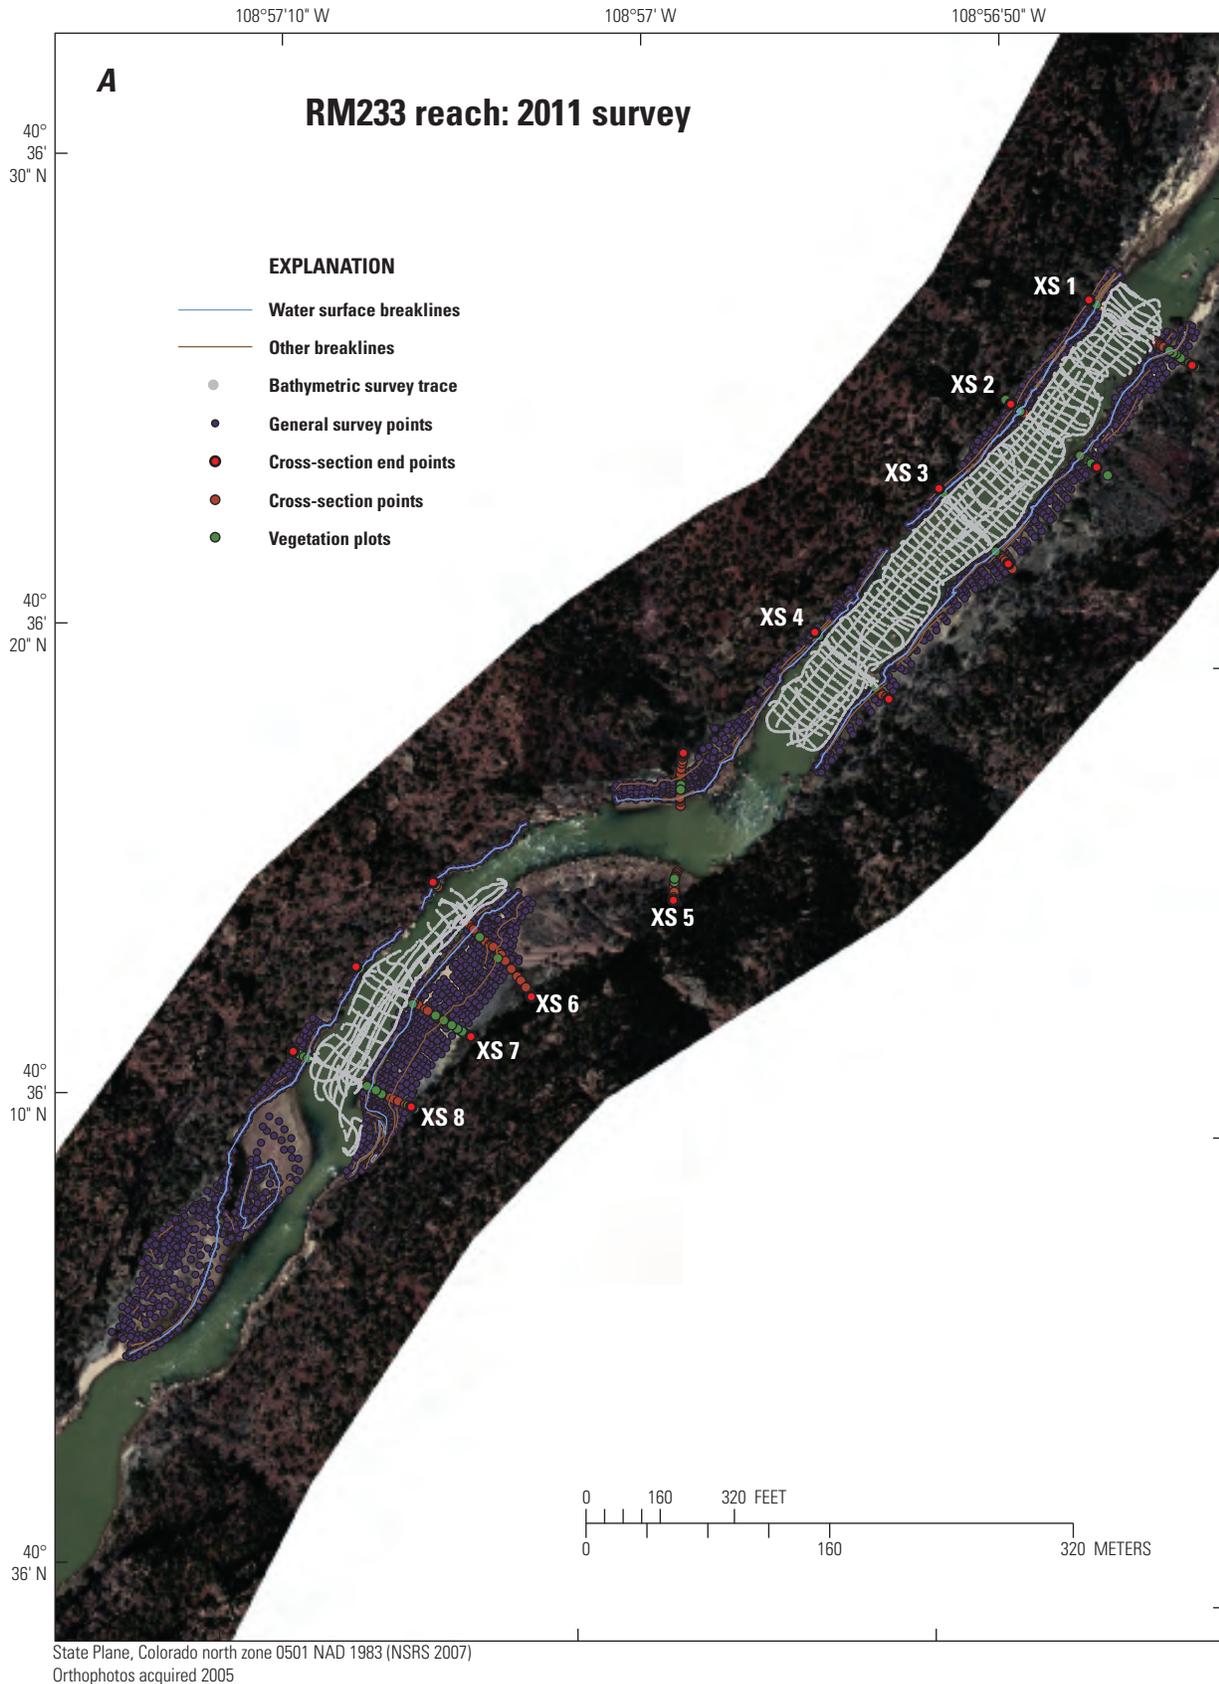
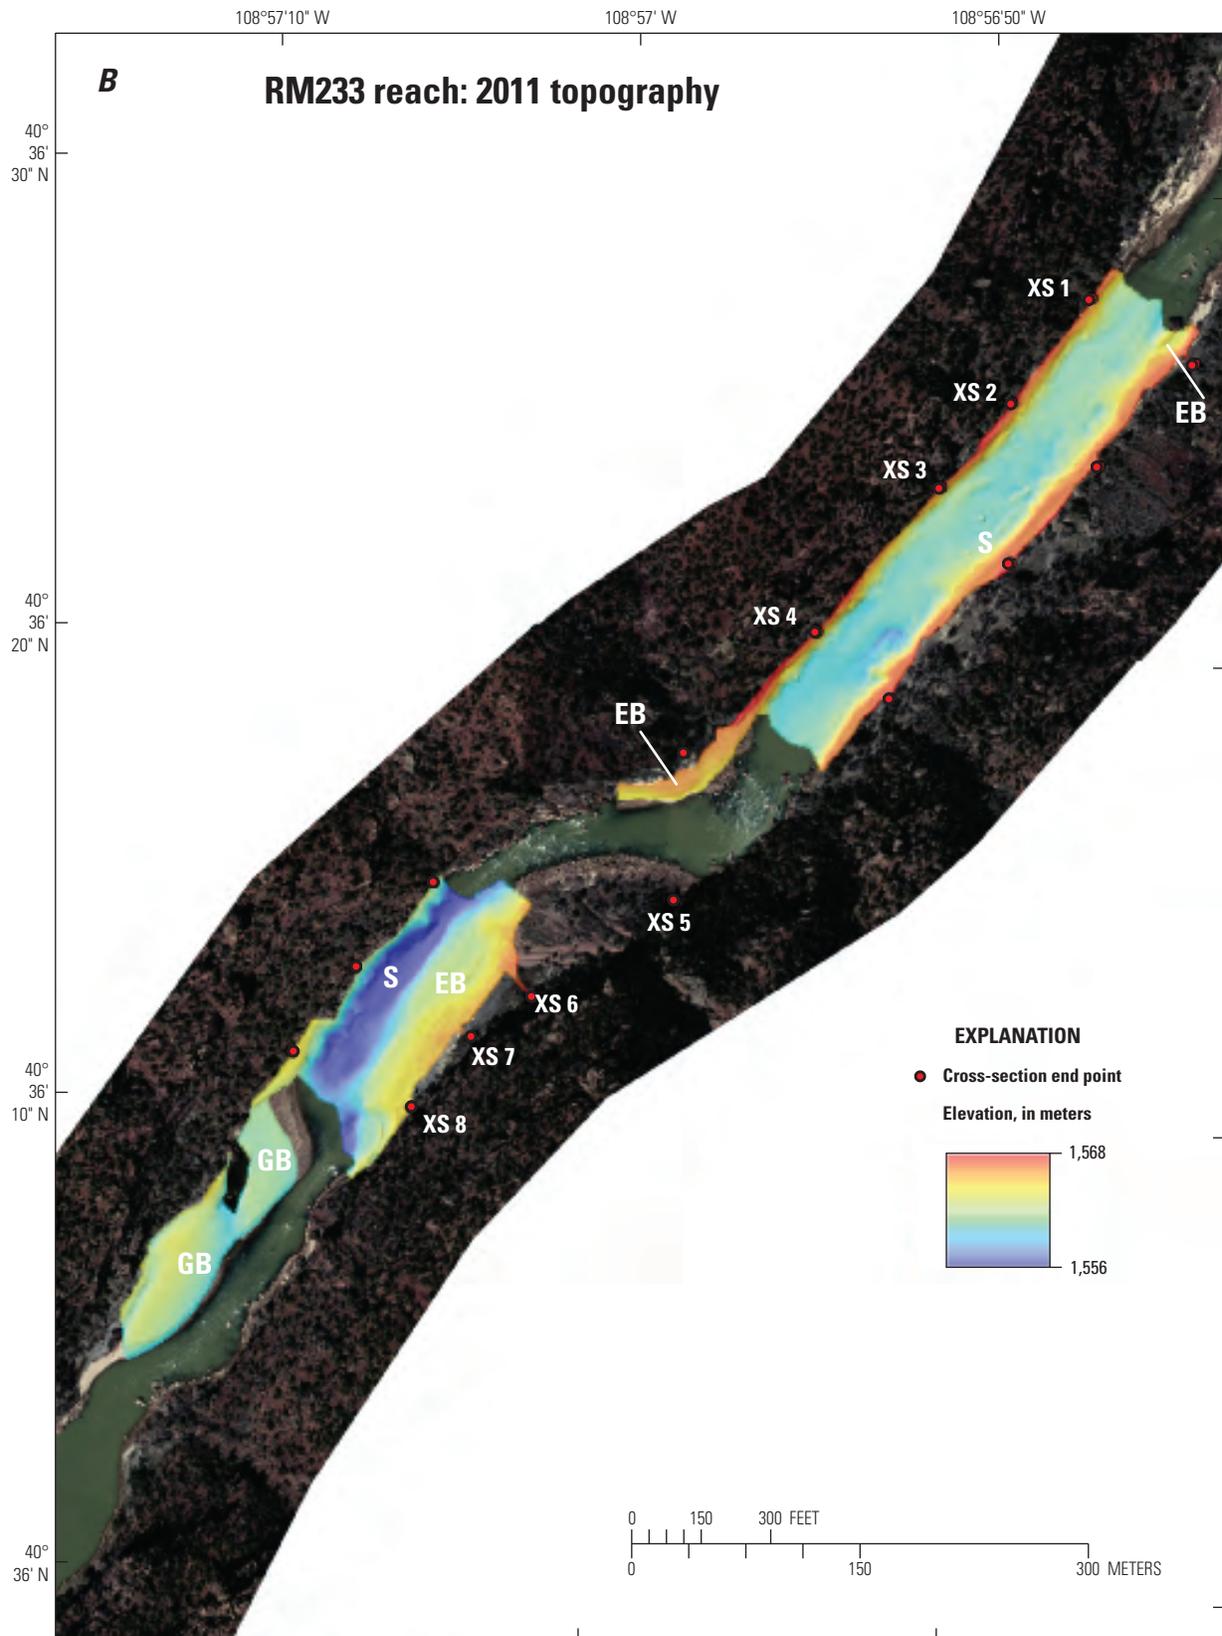
Figure 11. RM233 reach on the Green River in Canyon of Lodore, Dinosaur National Monument, Colorado and Utah. *A*, survey points; *B*, 1-meter digital elevation model (DEM) derived from triangular irregular network (TIN) surface. The letters indicate geomorphic characteristics referred to in the discussion: S, scour pool; EB, eddy bar; CM, channel-margin deposit; GB, gravel bar; XS, cross section. Streamflow is from northeast to southwest.

Figure 11. RM233 reach on the Green River in Canyon of Lodore, Dinosaur National Monument, Colorado and Utah. A, Survey points; B, 1-meter digital elevation model (DEM) derived from triangular irregular network (TIN) surface. The letters indicate geomorphic characteristics referred to in the discussion: S, scour pool; EB, eddy bar; CM, channel-margin deposit; GB, gravel bar; XS, cross section. Streamflow is from northeast to southwest. —Continued
