Monitoring and Research to Describe Geomorphic Effects of the 2011 Controlled Flood on the Green River in the Canyon of Lodore, Dinosaur National Monument, Colorado and Utah

Scientific Investigations Report 2014–5022

By Erich R. Mueller, Paul E. Grams, John C. Schmidt, Joseph E. Hazel, Jr.,
Matt Kaplinski, Jason A. Alexander, and Keith Kohl

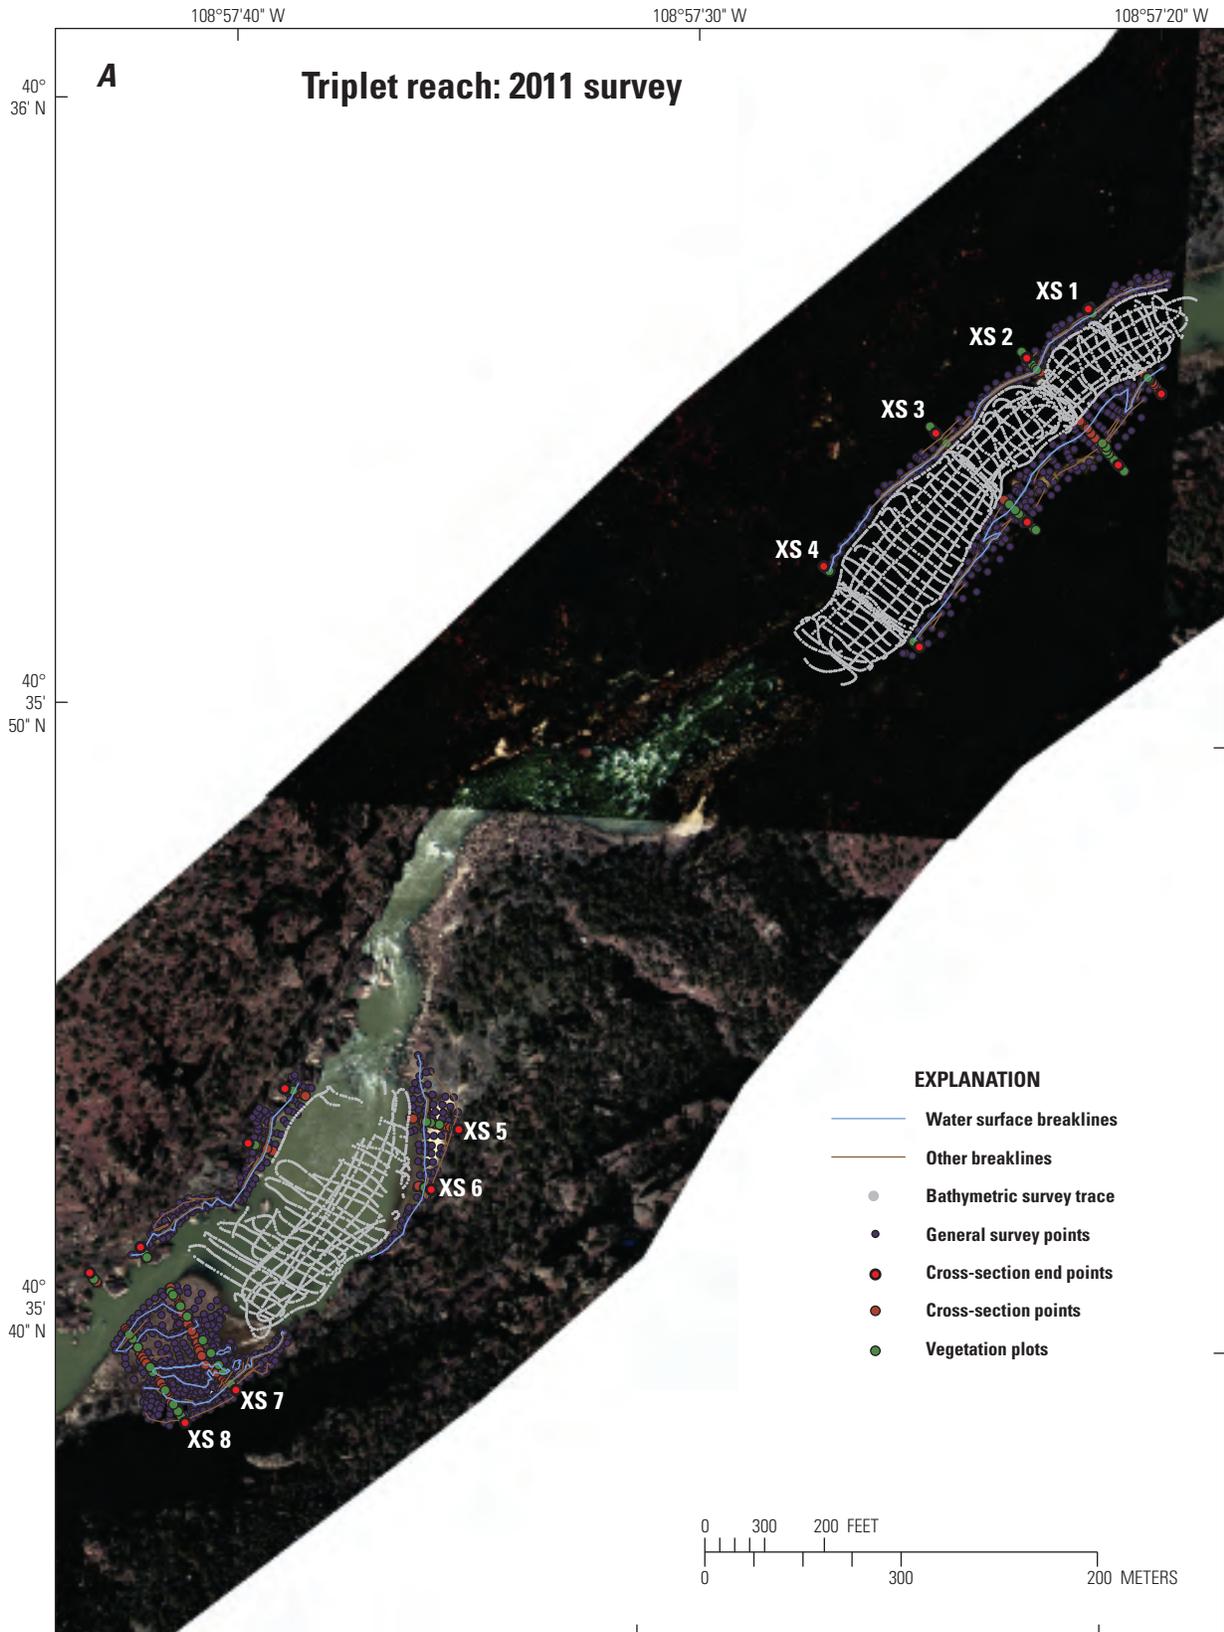
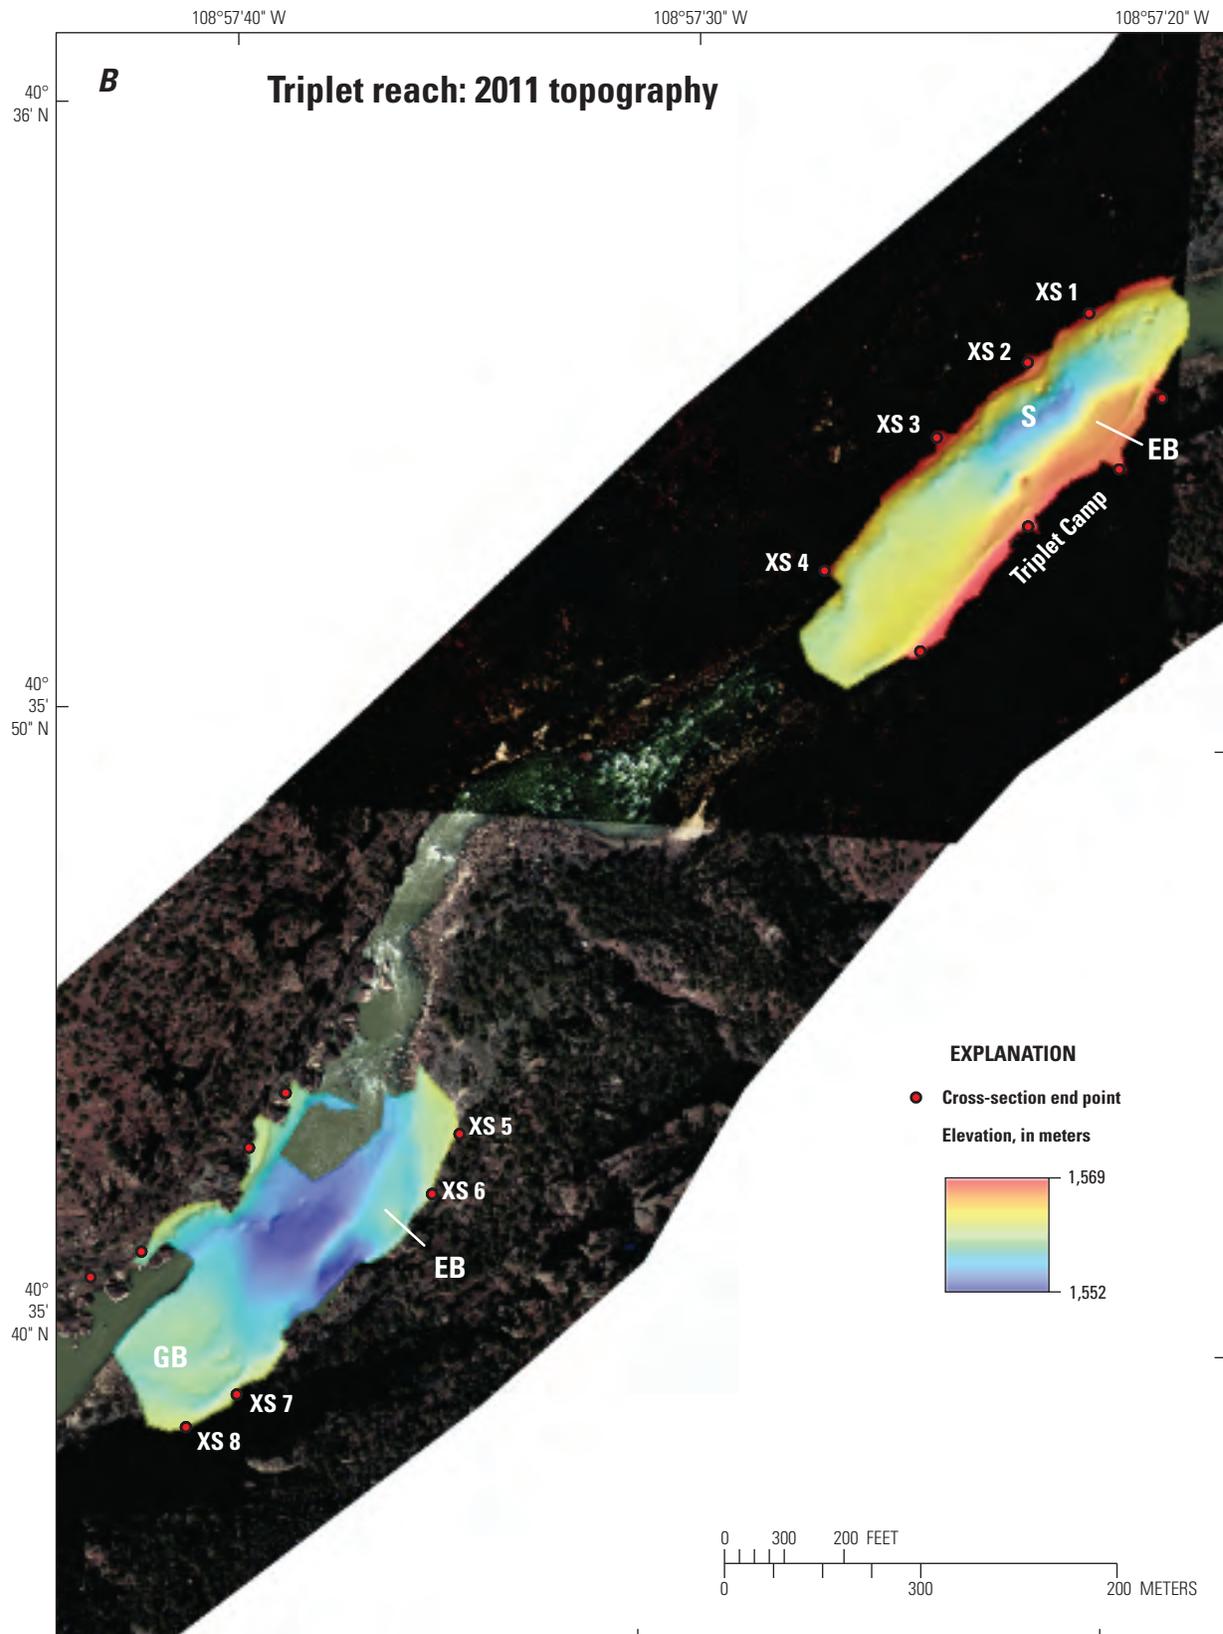
Figure 12. Triplet reach on the Green River in Canyon of Lodore, Dinosaur National Monument, Colorado and Utah. *A*, survey points; *B*, 1-meter digital elevation model (DEM) derived from triangular irregular network (TIN) surface. The letters indicate geomorphic characteristics referred to in the discussion: S, scour pool; EB, eddy bar; GB, gravel bar; XS, cross section. Streamflow is from northeast to southwest.

Figure 12. Triplet reach on the Green River in Canyon of Lodore, Dinosaur National Monument, Colorado and Utah. *A*, Survey points; *B*, 1-meter digital elevation model (DEM) derived from triangular irregular network (TIN) surface. The letters indicate geomorphic characteristics referred to in the discussion: S, scour pool; EB, eddy bar; GB, gravel bar; XS, cross section. Streamflow is from northeast to southwest. —Continued

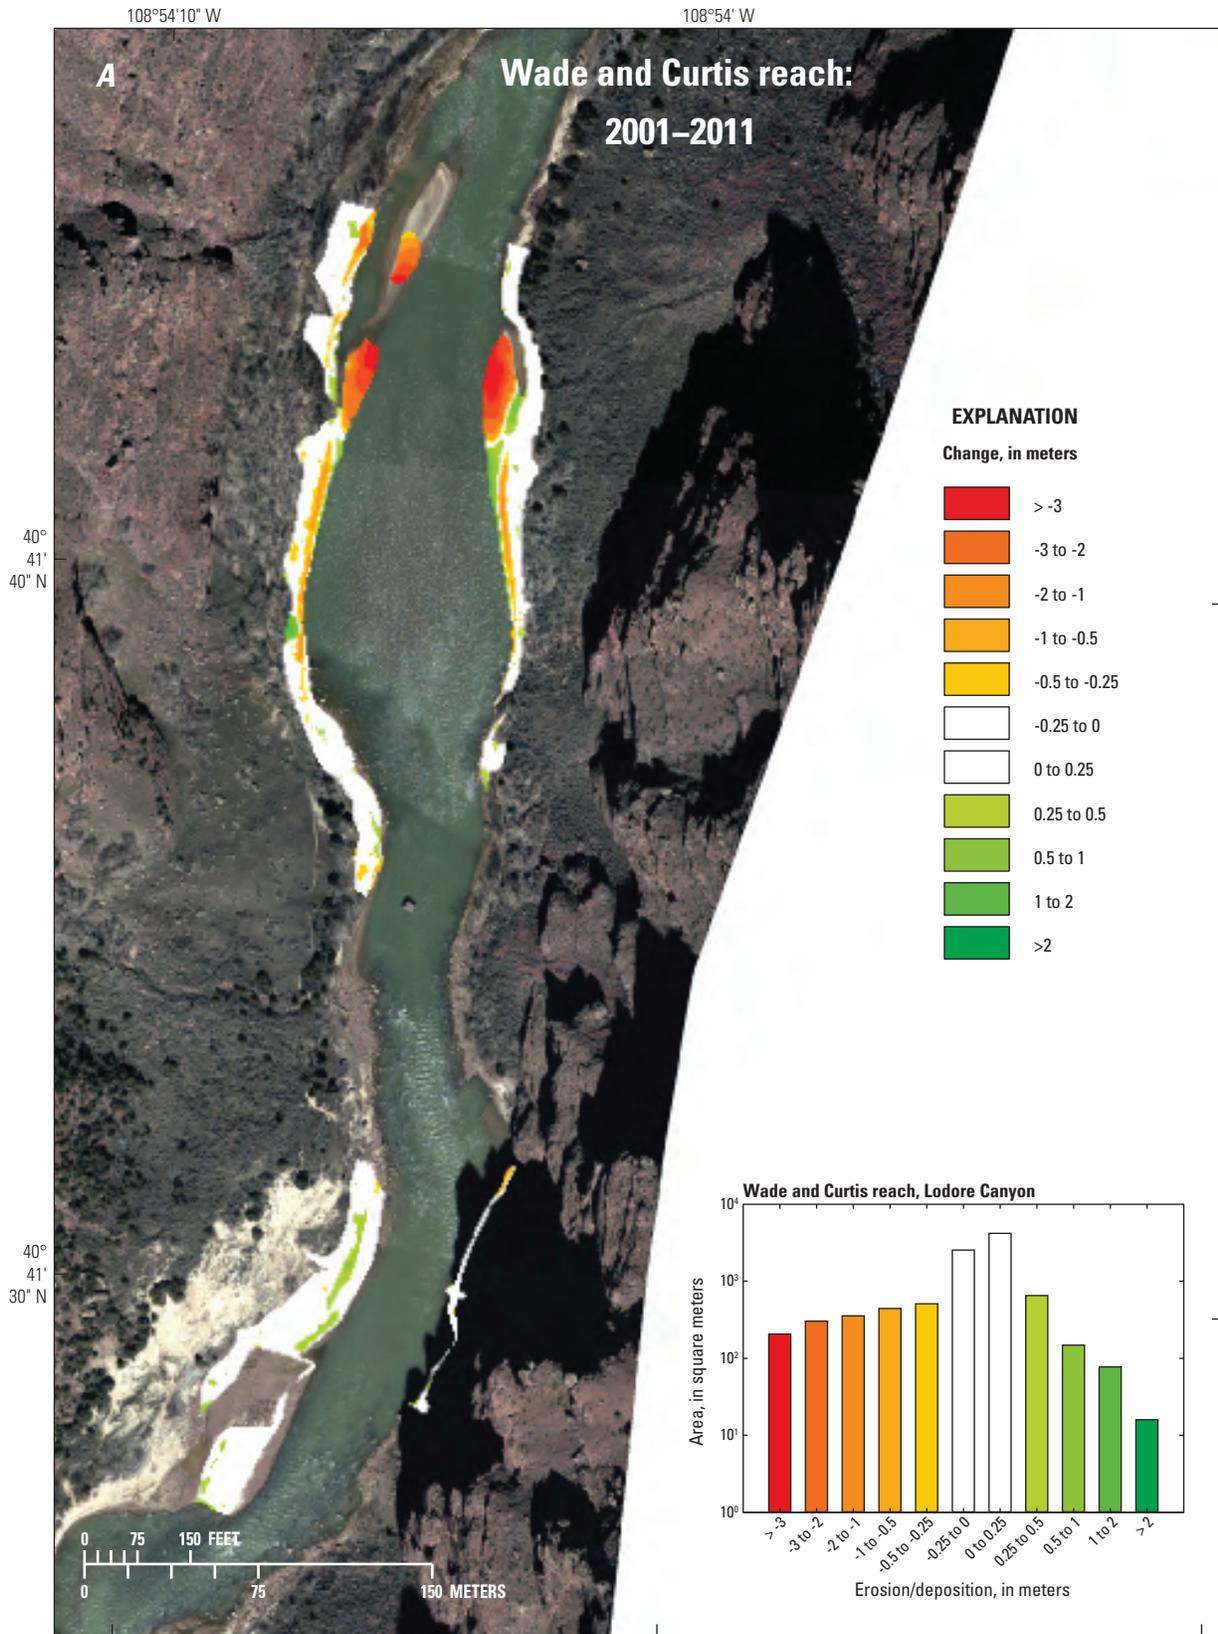
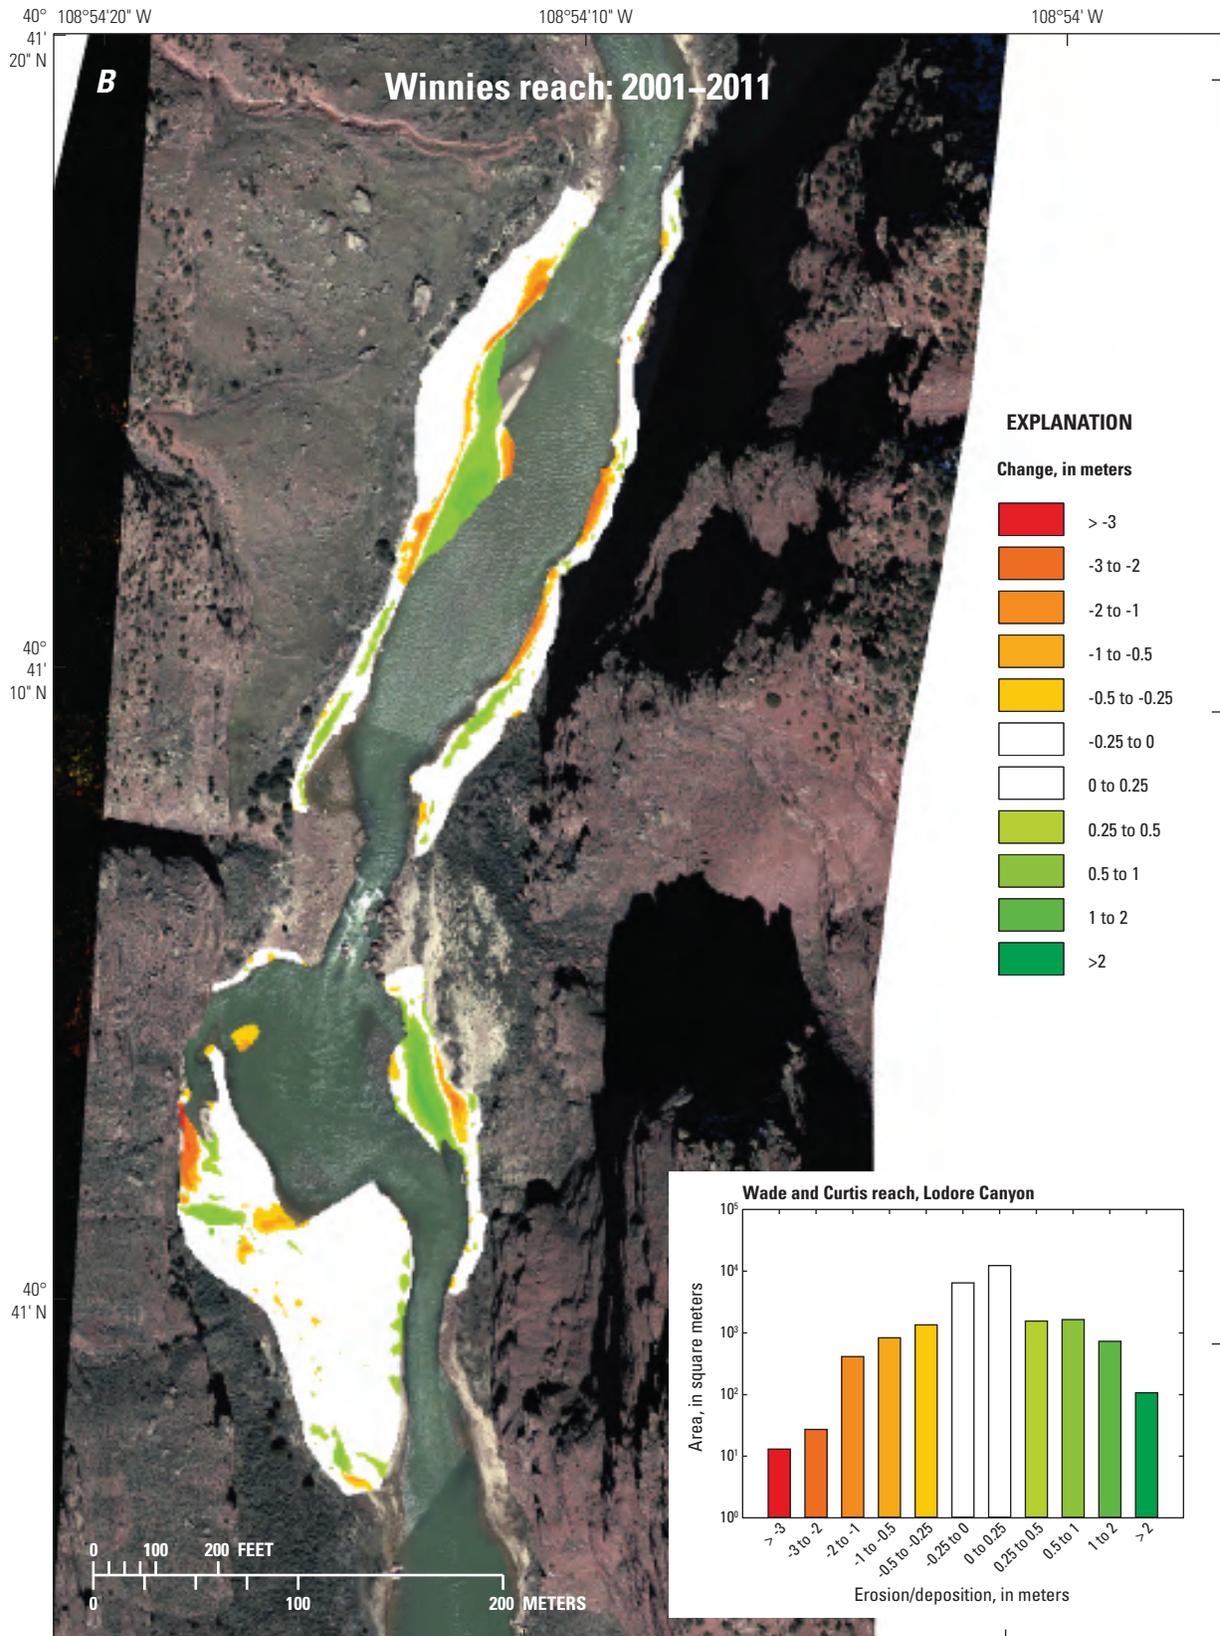
Figure 13. Geomorphic change between 2001 and 2011 surveys for the (A) Wade and Curtis reach and (B) Winnies reach on the Green River in Canyon of Lodore, Dinosaur National Monument, Colorado and Utah. Inset shows a histogram of area change for different erosion/deposition depths. The significance threshold for change of approximately ± 0.25 meters is shown in white on the map. Streamflow is from north to south. >, greater than.

Figure 13. Geomorphic change between 2001 and 2011 surveys for the (A) Wade and Curtis reach and (B) Winnies reach on the Green River in Canyon of Lodore, Dinosaur National Monument, Colorado and Utah. Inset shows a histogram of area change for different erosion/deposition depths. The significance threshold for change of approximately ± 0.25 meters is shown in white on the map. Streamflow is from north to south. >, greater than. —Continued

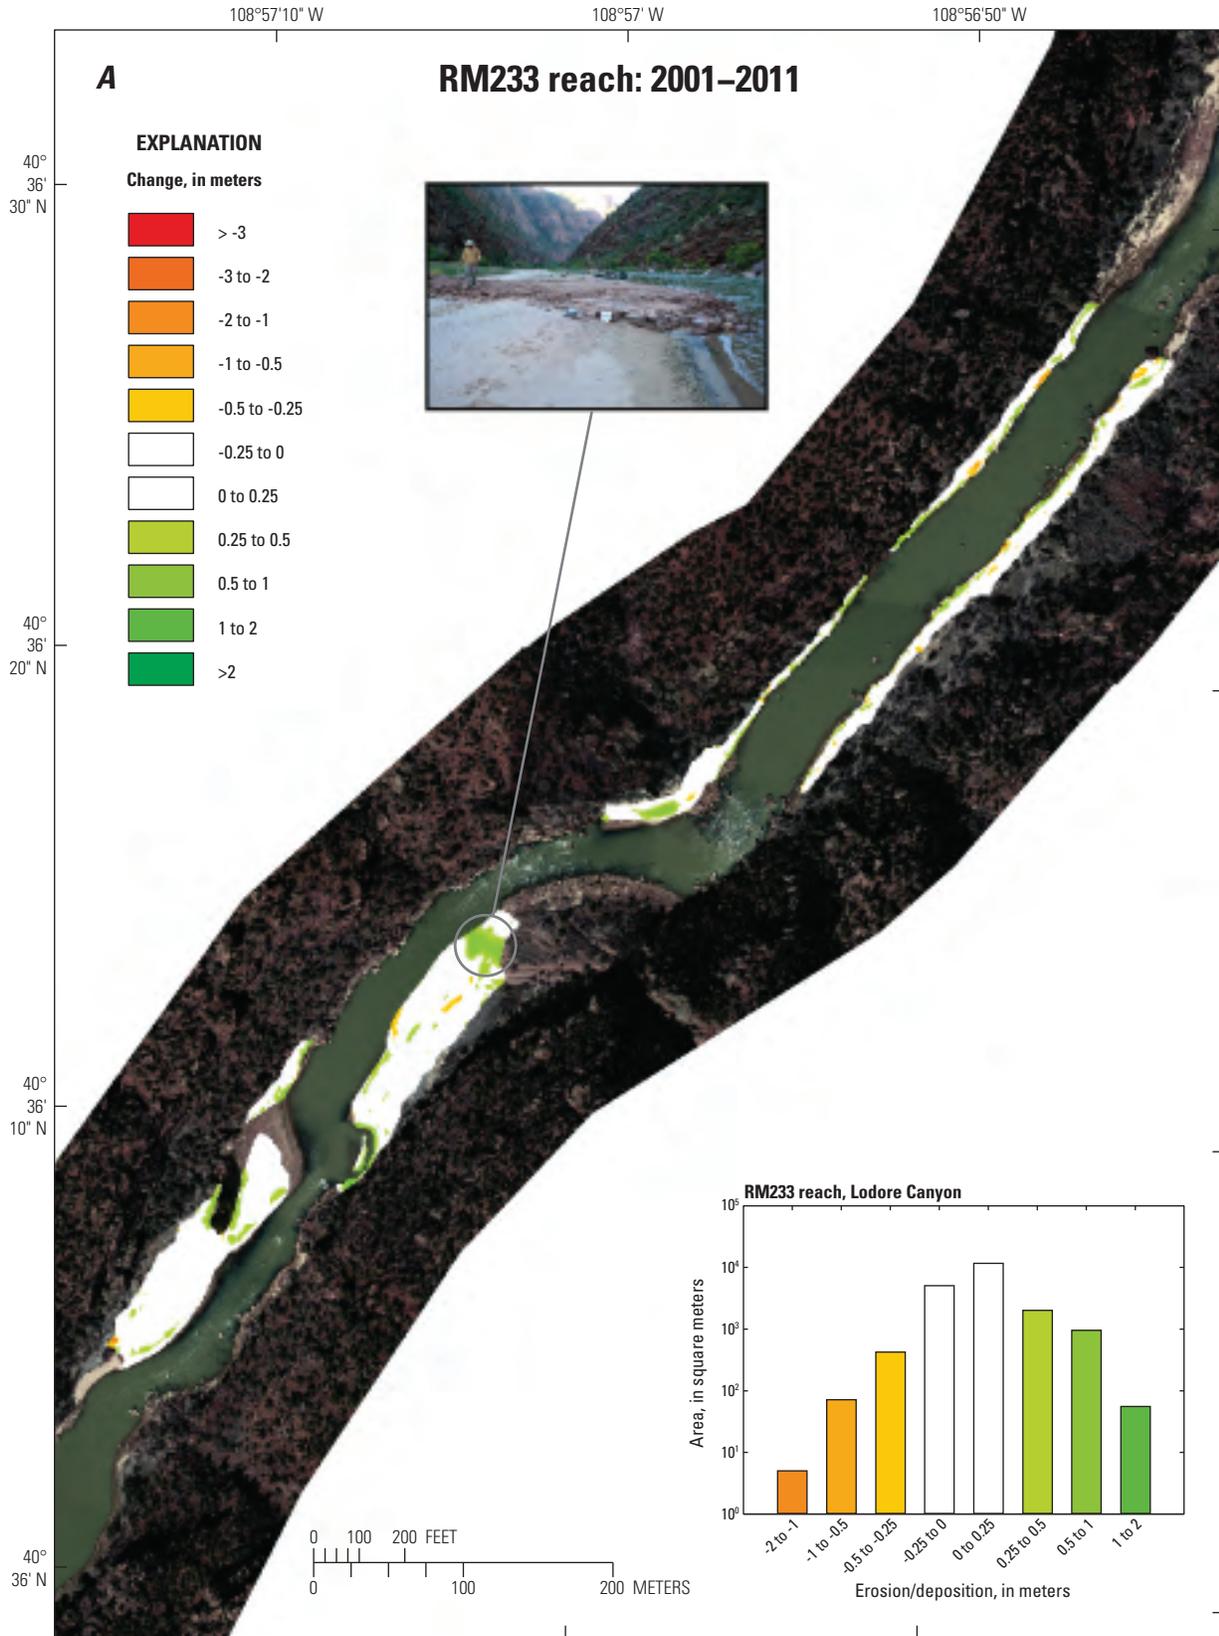
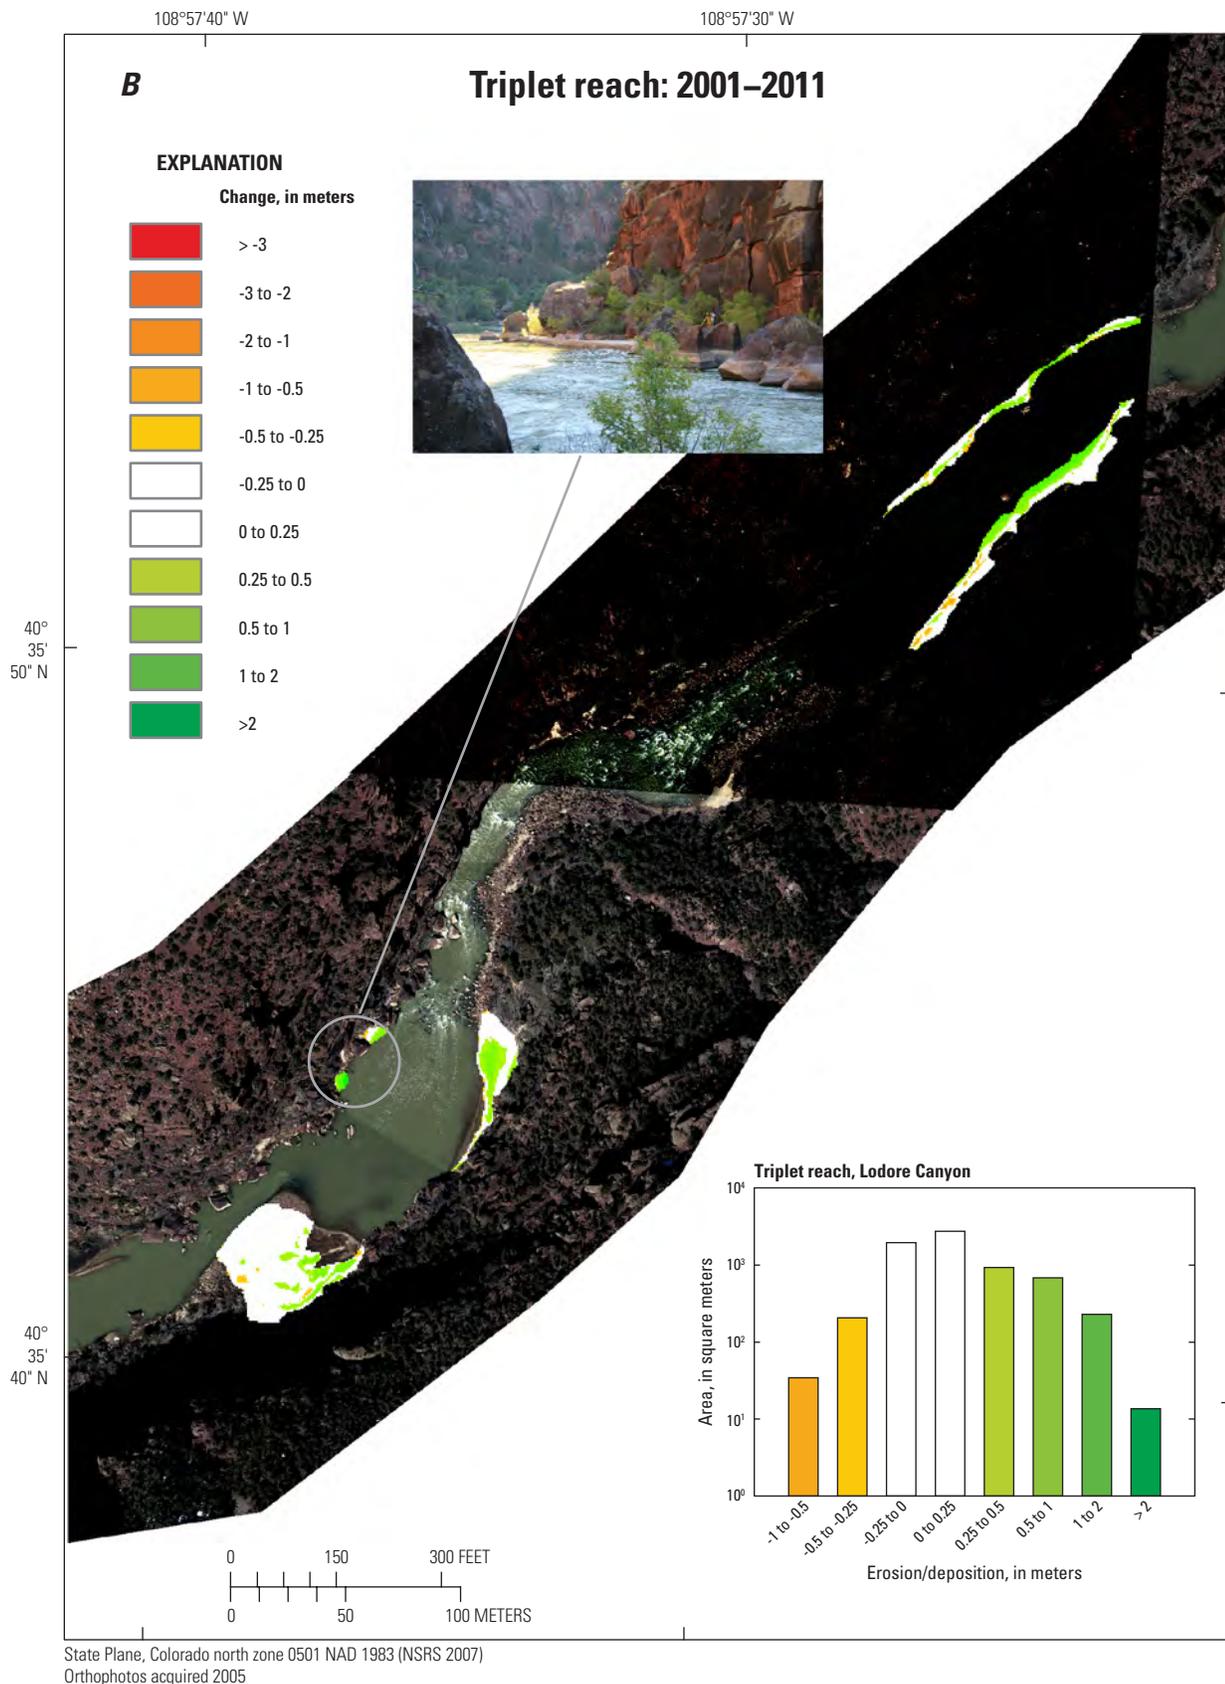
Figure 14. Geomorphic change between 2001 and 2011 surveys for the (A) RM233 reach and the (B) Triplet reach on the Green River in Canyon of Lodore, Dinosaur National Monument, Colorado and Utah. Inset shows a histogram of area change for different erosion/deposition depths. The significance threshold for change of approximately ± 0.25 meters is shown in white on the map. A, shows fresh debris flow on sandbar; B, shows fresh sand deposits along the channel margin on river right. Streamflow is from northeast to southwest. >, greater than.

Figure 14. Geomorphic change between 2001 and 2011 surveys for the (A) RM233 reach and the (B) Triplet reach on the Green River in Canyon of Lodore, Dinosaur National Monument, Colorado and Utah. Inset shows a histogram of area change for different erosion/deposition depths. The significance threshold for change of approximately ± 0.25 meters is shown in white on the map. A, shows fresh debris flow on sandbar; B, shows fresh sand deposits along the channel margin on river right. Streamflow is from northeast to southwest. >, greater than. —Continued

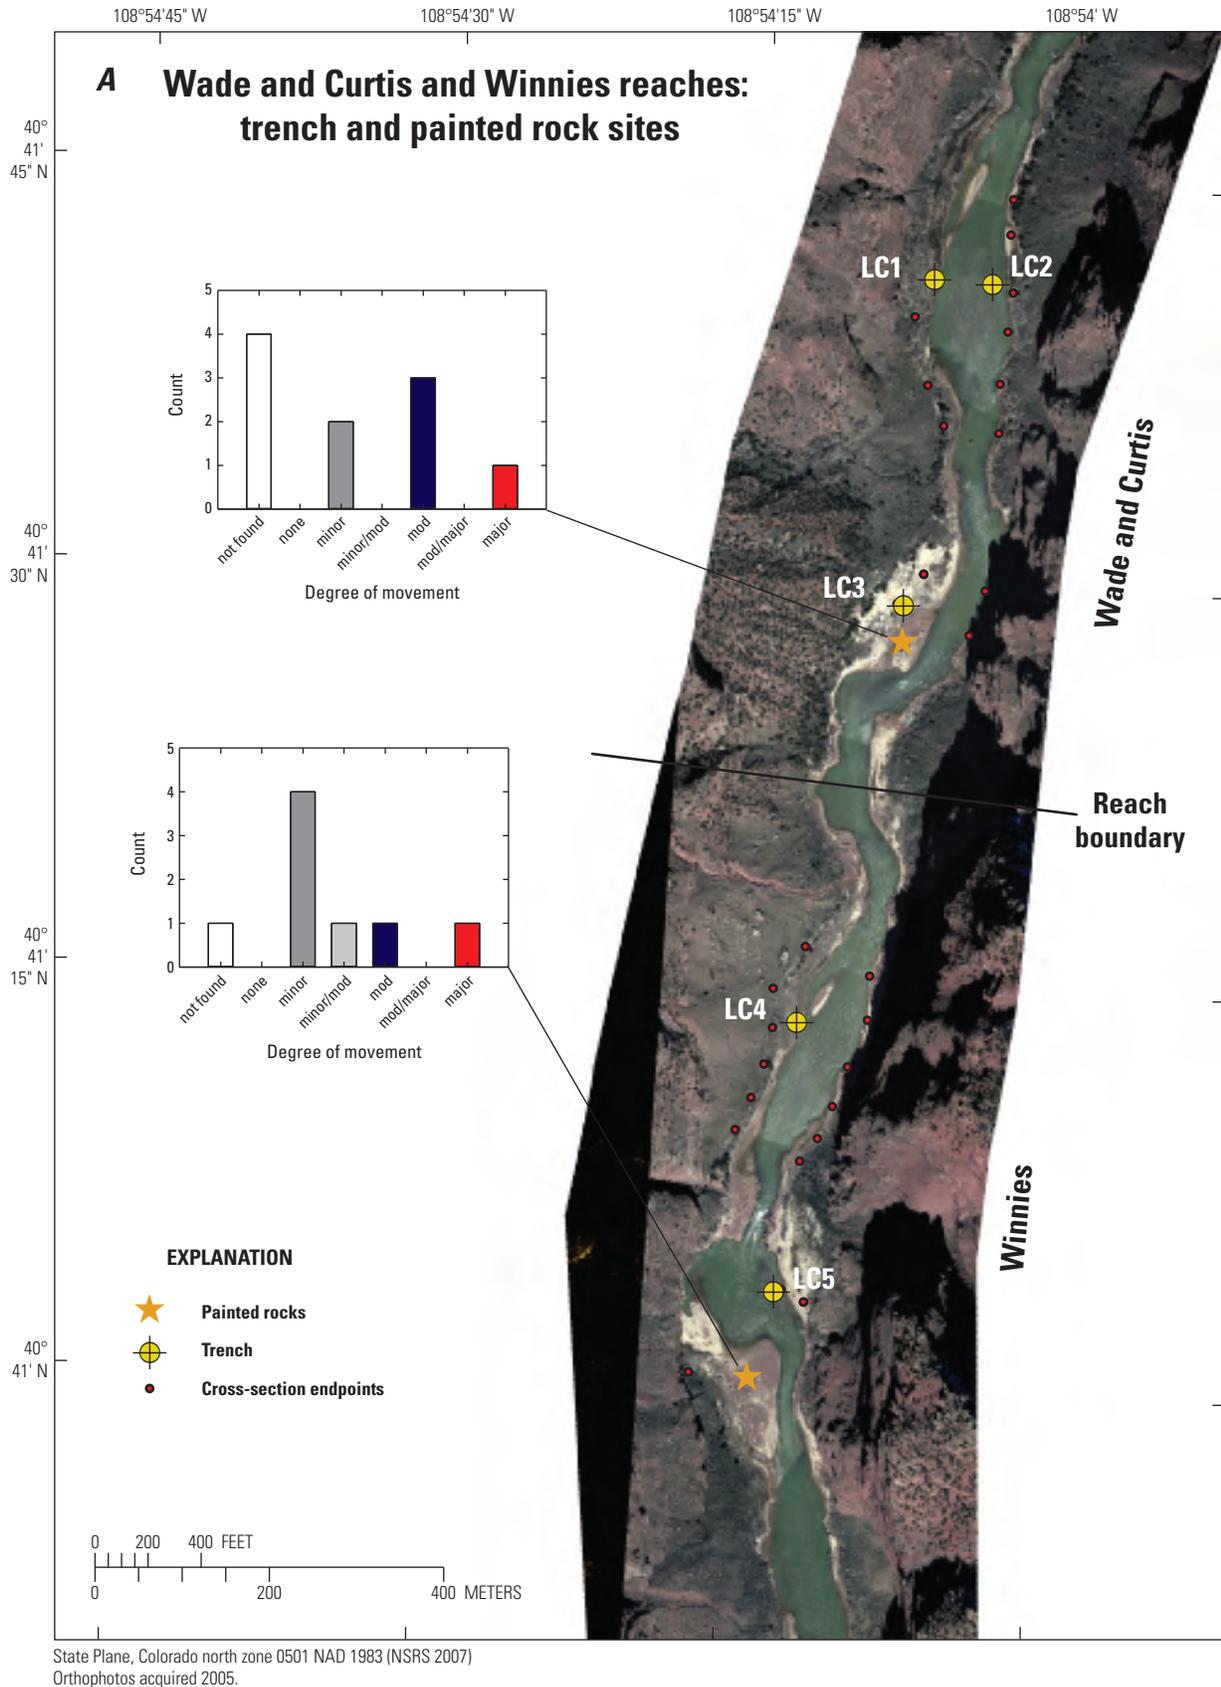
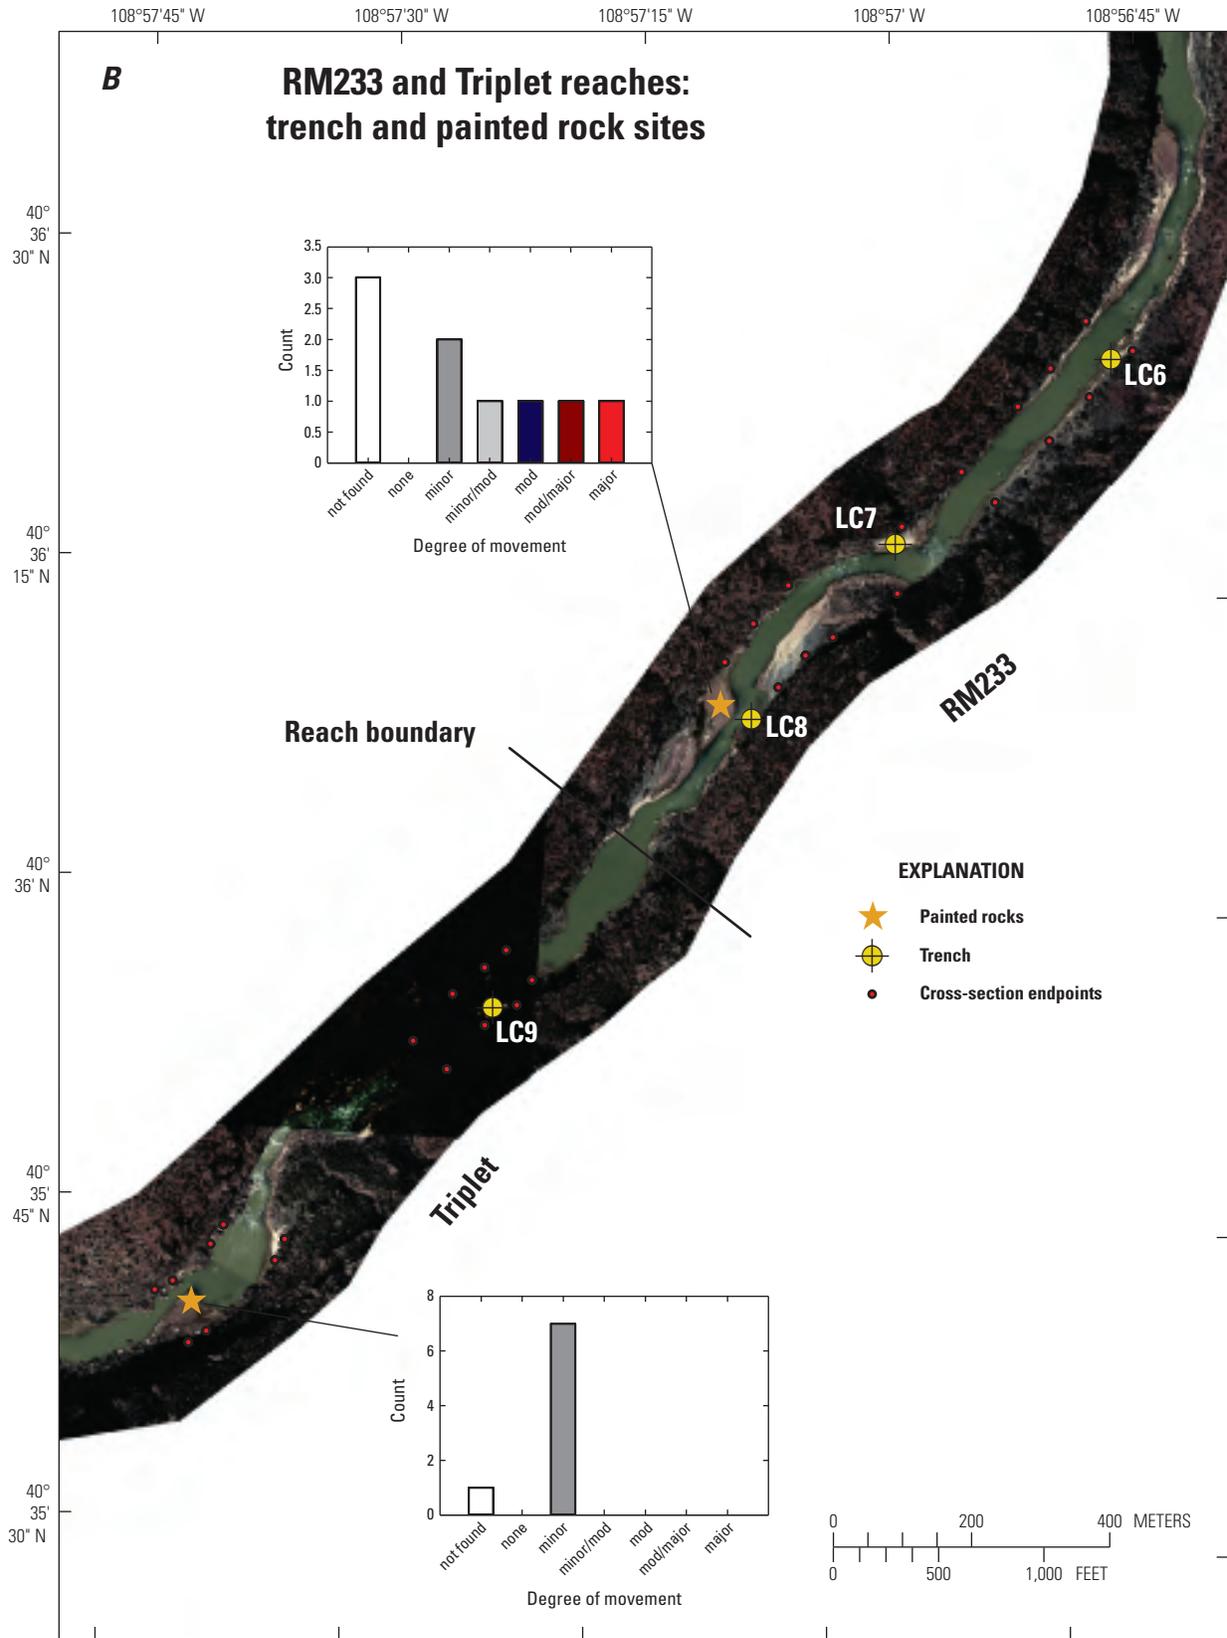
Figure 15. Locations of trenches and painted tracer rock sites for (A) the Wade and Curtis and Winnies reaches and for (B) the RM233 and Triplet reaches on the Green River in Canyon of Lodore, Dinosaur National Monument, Colorado and Utah. Cross-section end points for reference. Inset bar graphs show degree of painted rock movement as described in table 4. Streamflow is from north to south in A and northeast to southwest in B. mod, moderate.

Figure 15. Locations of trenches and painted tracer rock sites for (A) the Wade and Curtis and Winnies reaches and for (B) the RM233 and Triplet reaches on the Green River in Canyon of Lodore, Dinosaur National Monument, Colorado and Utah. Cross-section end points for reference. Inset bar graphs show degree of painted rock movement as described in table 4. Streamflow is from north to south in A and northeast to southwest in B. mod, moderate. —Continued

patches; two locations experienced minor entrainment. At sites where gravel motion was significant, tamarisk were damaged but not removed. Rocks as large as 180 mm were moved in several locations, but in general the coarsest clasts (greater than 128 mm) were stable. Additionally, significant amounts of fresh sand accreted on parts of the gravel bar. At the Winnies gravel bar, most of the painted rocks were relocated, although one location was deeply scoured and not found. Four out of the eight patches at Winnies experienced minor movement, although in some cases sand was scoured from the bed. The other three sites showed moderate to major movement. Even in the cases of major movement, approximately 50 percent of the clasts remained in place, even though coarse grains as large as 128 mm moved.

For the RM233 gravel bar, painted rocks in general showed moderate to major movement, with only two locations showing minor movement (fig. 15B). Three sites were never found, but individual clasts from these patches were found as much as 15–25 m downstream, suggesting other clasts were transported further. Significant motion of clasts ranging from 45–90 mm was evident, as well as movement of one 256-mm particle. Very minor movement was found at all locations at the Triplet gravel bar, with all recovered patches showing 90–95 percent of clasts in place (fig. 15B, table 4). Most motion occurred in the 22–64 mm range, with some lesser movement of bigger particles as large as 128 mm, although this activity was very limited. Painted rock recovery was very poor at Limestone Island and may indicate significant movement or simply burial by accreted sand (table 4). Zero to minor movement and some sand deflation was evident at the downstream end of the island, which was largely too high to be inundated. The upstream part of the gravel bar was covered in new sand, suggesting that this part of the bar was submerged, and some gravel transport would have been possible in the missing patches. Overall, the combined data from the gravel bars suggest significant movement of coarse particles in many locations, but not wholesale gravel-bar reworking, with major movement isolated to individual gravel bars or localized areas of intense flow. Nevertheless, this coarse particle mobility represents the most significant observed since monitoring began in the early 2000s.

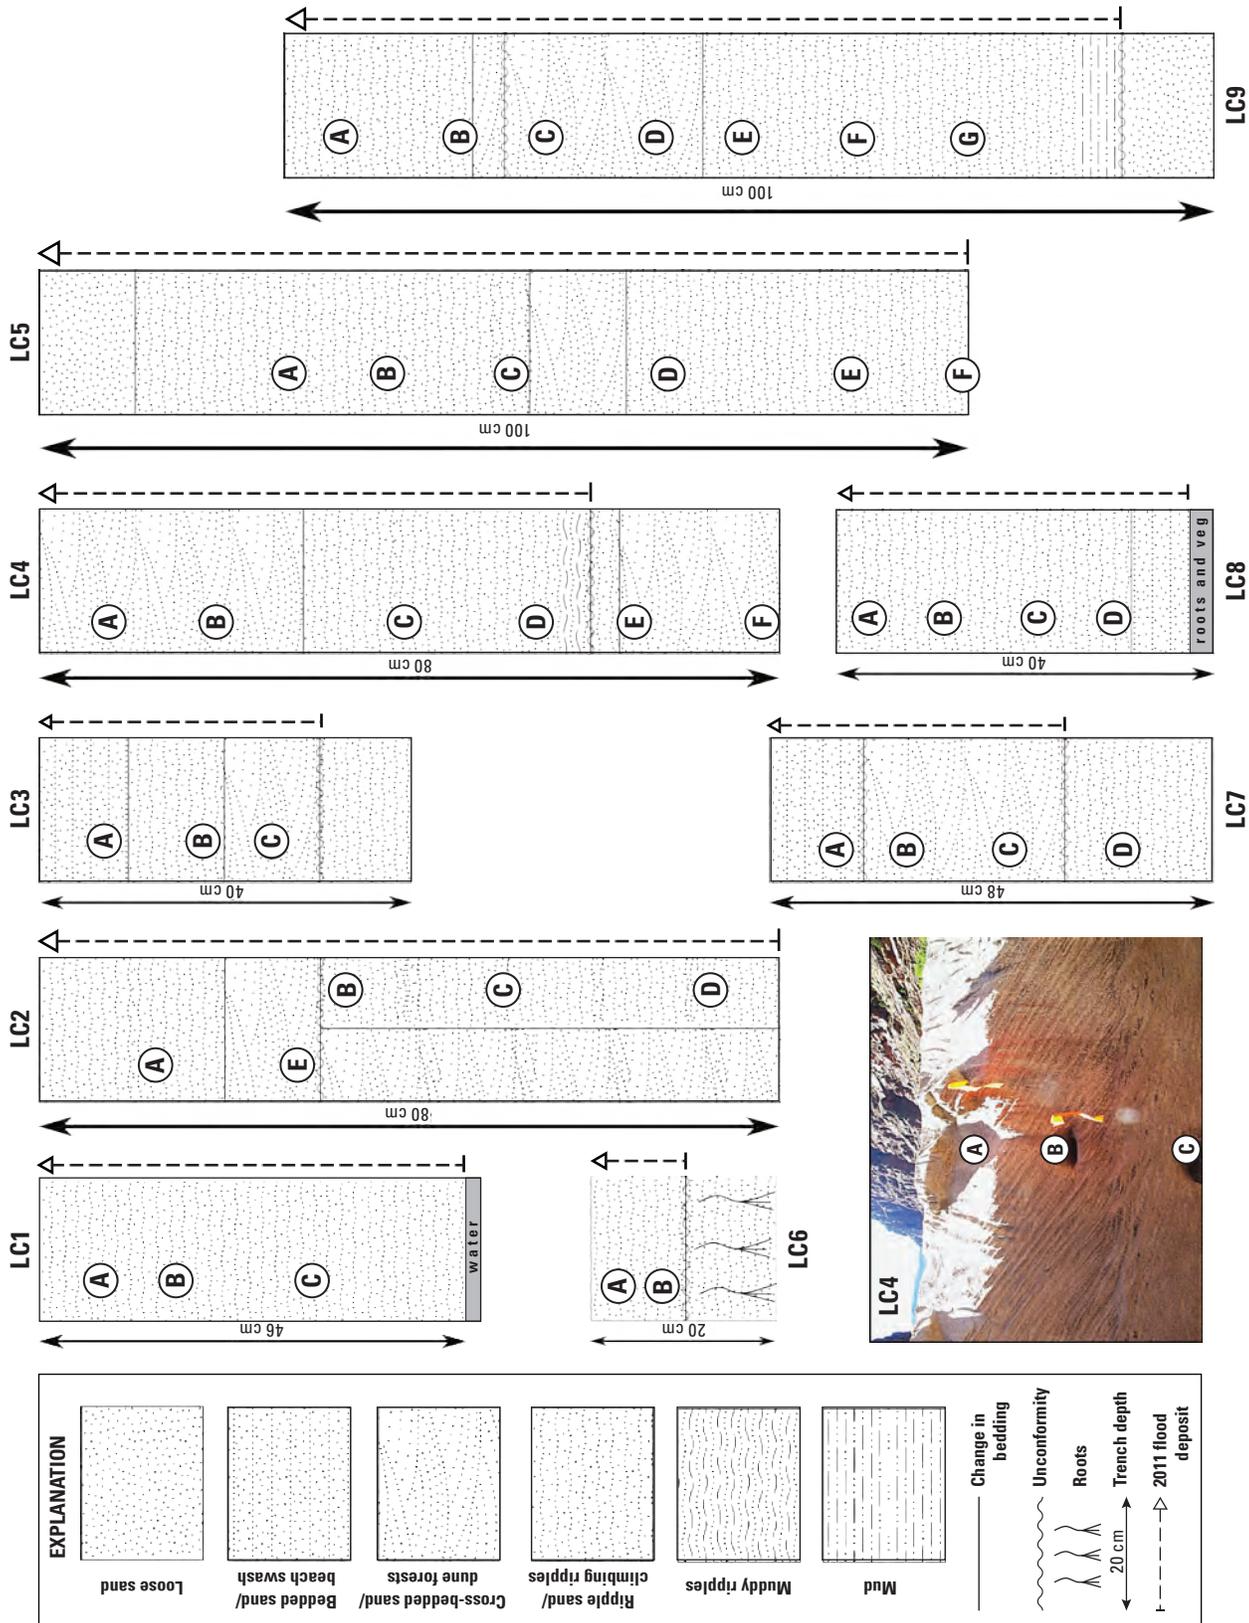
Figure 16. Schematic representations of the trench stratigraphy on the Green River in Canyon of Lodore, Dinosaur National Monument, Colorado and Utah, showing sedimentary bedding, depth of 2011 flood deposits, and locations of sediment samples indicated by letter (see appendix 2 for detailed descriptions of each depositional unit and grain size). Inset photograph shows top part of trench LC4, with sediment sampling locations shown for reference. Top part of photo shows distinct onshore migrating cyclic foresets, whereas lower part shows multidirectional ripples increasing in size toward the base of the foresets. Scale of sand face is roughly 40 centimeters (cm).

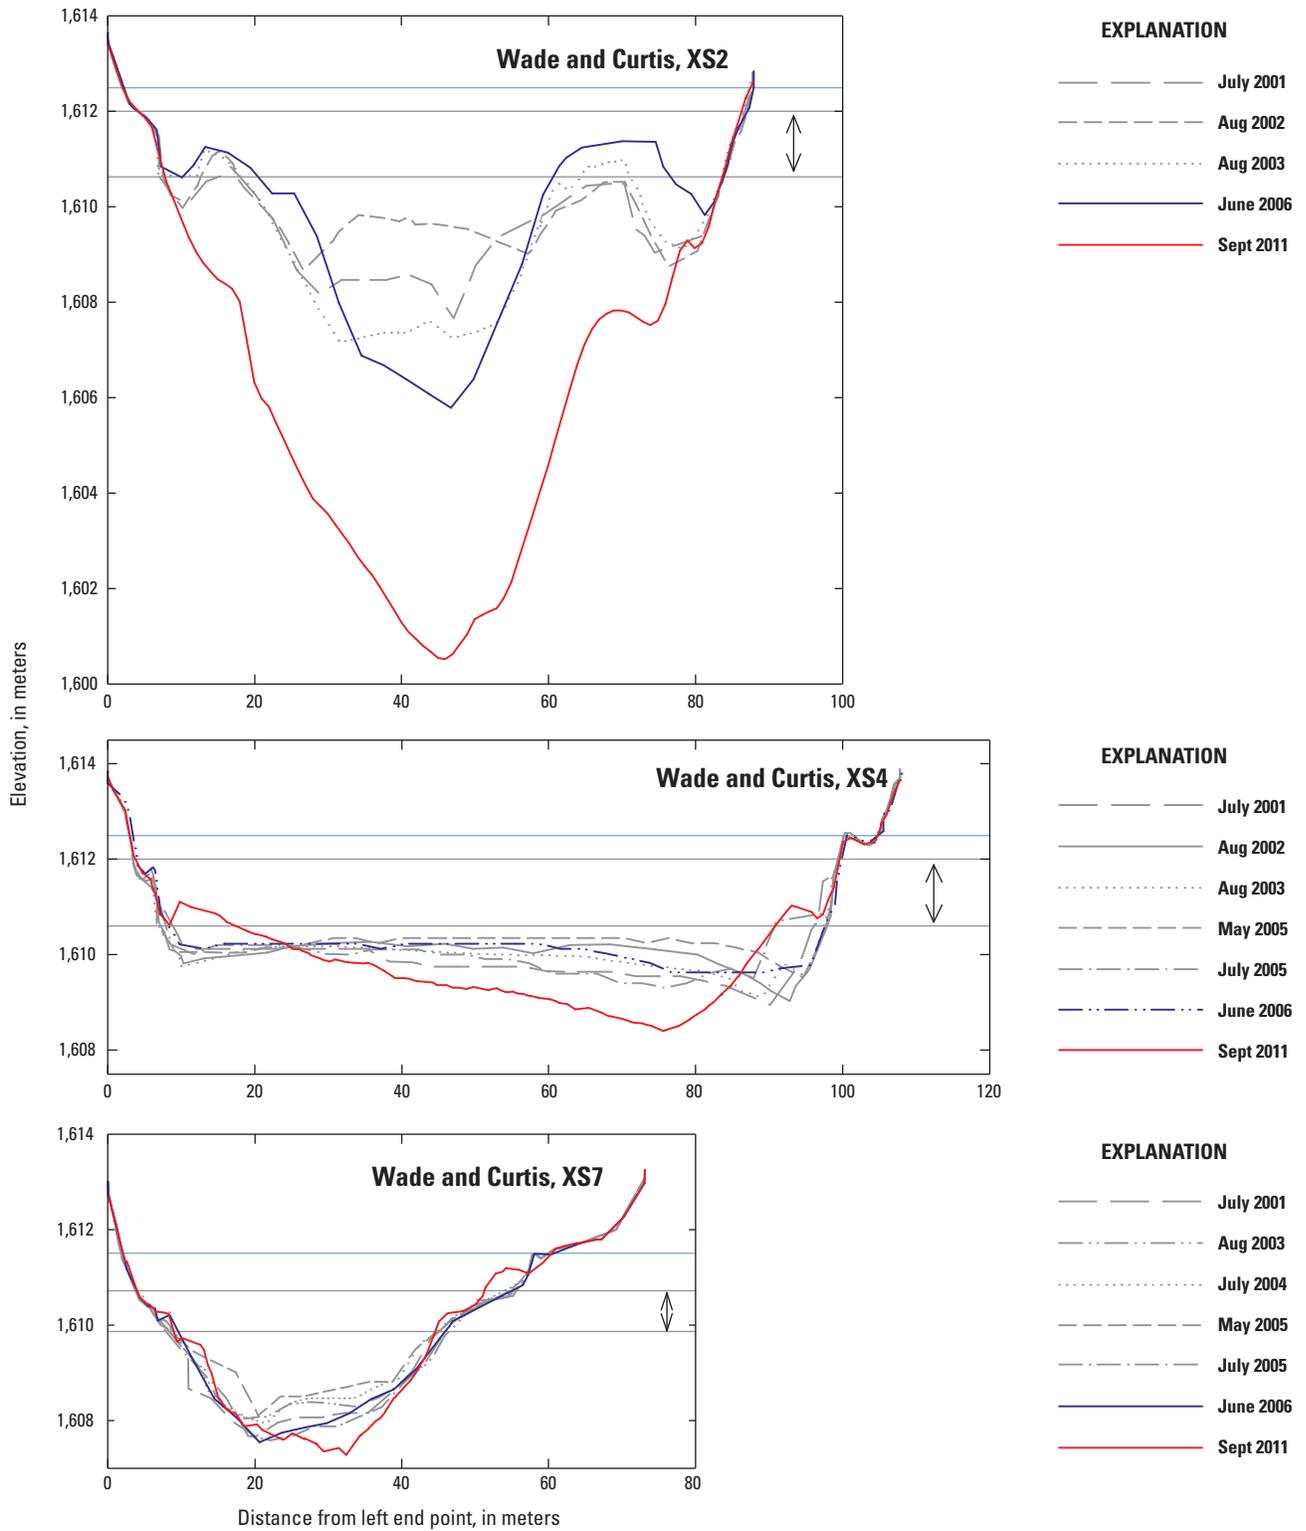
Figure 17. Channel change at select cross sections for the Wade and Curtis reach on the Green River in Canyon of Lodore, Dinosaur National Monument, Colorado and Utah. Upper light blue line indicates the 2011 flood elevation; lower gray lines delineate the fluctuating flow zone. Vertical double arrows indicate typical range in normal dam operational flows. XS, cross section.

In the Wade and Curtis reach, deep erosion in the pool at the upstream end of the reach was clearly evident, with as much as 5 m of degradation having occurred since the 2006 survey (figs. 9 and 17). Evidence for this degradation is also shown in the 2001–2011 DEM difference maps (fig. 13A), which depict the erosion of eddy sandbars in the upstream part of the reach. However, the data also show that these sandbars, which formed during relatively modest flows, likely shifted downstream in the high-flow event, as sandbars near both the left and right banks are shown in both the DEM (fig. 9) and in cross section (XS) 4 (fig. 17). Excavations into the 2011 flood deposit in each of these sandbars indicate that the minimum deposit thicknesses were 0.5–0.8 m (figs. 15 and 16). The lower part of this reach was not surveyed in as great of detail; however, the gravel bar on river right was significantly entrained, and there was some damage to tamarisk.
