Monitoring and Research to Describe Geomorphic Effects of the 2011 Controlled Flood on the Green River in the Canyon of Lodore, Dinosaur National Monument, Colorado and Utah

Scientific Investigations Report 2014–5022

By Erich R. Mueller, Paul E. Grams, John C. Schmidt, Joseph E. Hazel, Jr.,
Matt Kaplinski, Jason A. Alexander, and Keith Kohl

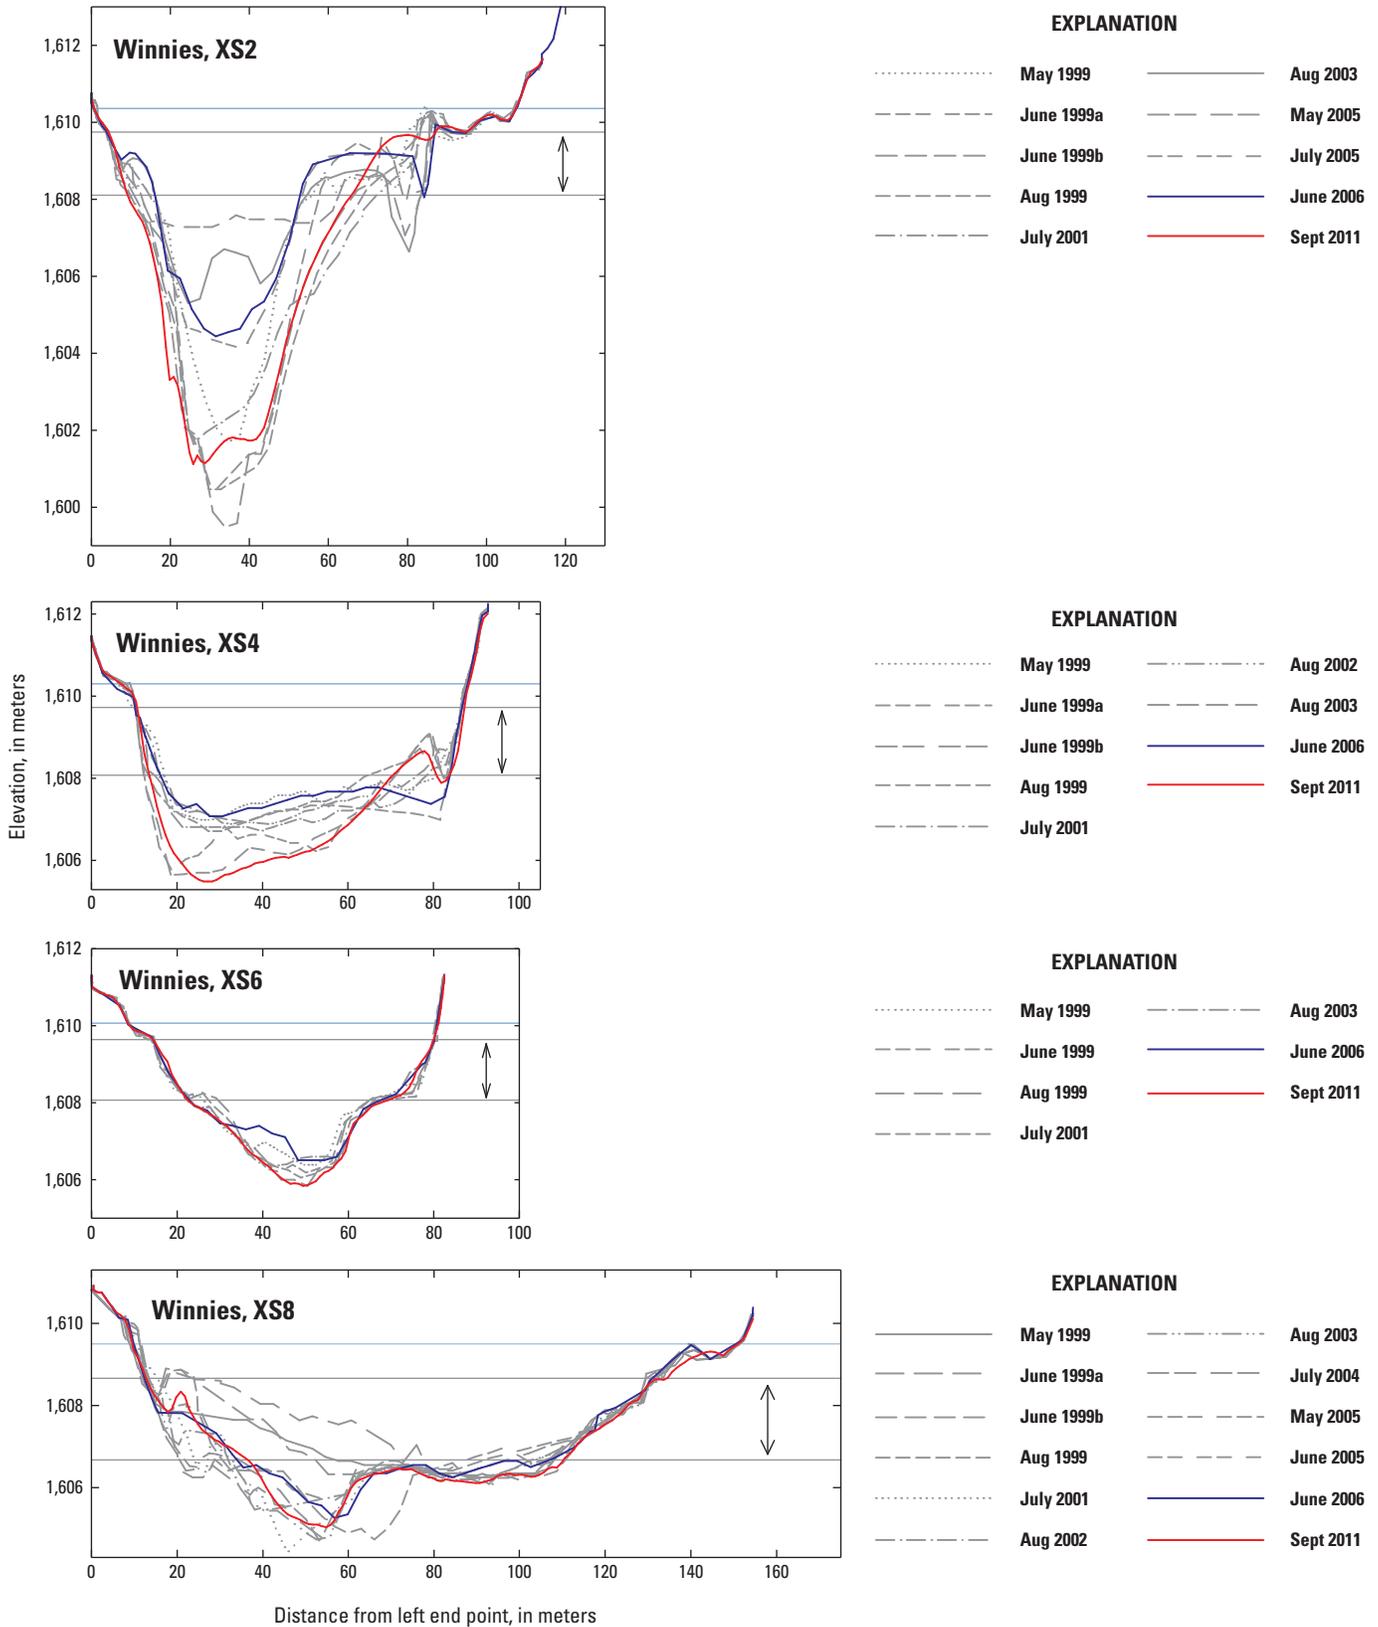
Figure 18. Channel change at select cross sections for Winnies reach on the Green River in Canyon of Lodore, Dinosaur National Monument, Colorado and Utah. Upper light blue line indicates the 2011 flood elevation; lower gray lines delineate the fluctuating flow zone. Vertical double arrows indicate typical range in normal dam operational flows. XS, cross section.

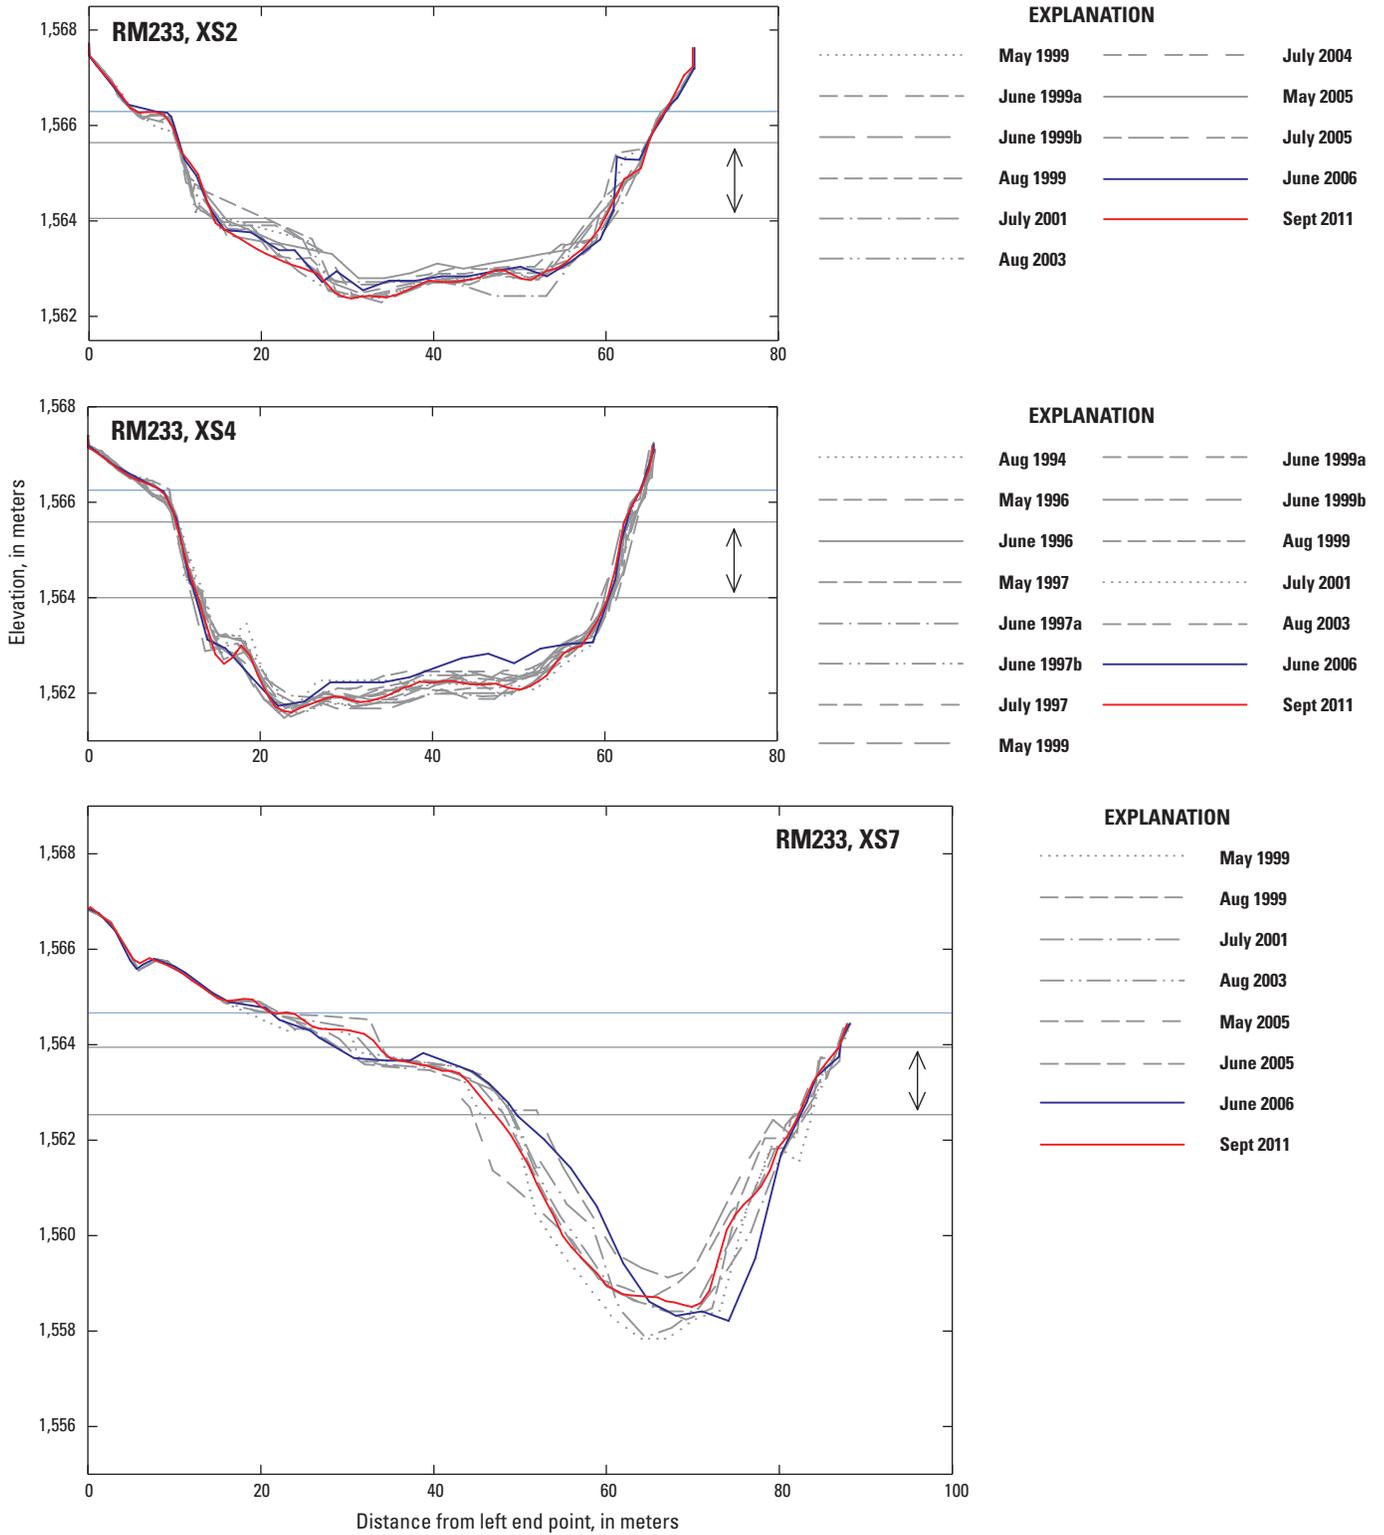
Figure 19. Channel change at select cross sections for the RM233 reach on the Green River in Canyon of Lodore, Dinosaur National Monument, Colorado and Utah. Upper light blue line indicates the 2011 flood elevation; lower gray lines delineate the fluctuating flow zone. Vertical double arrows indicate typical range in normal dam operational flows. XS, cross section.

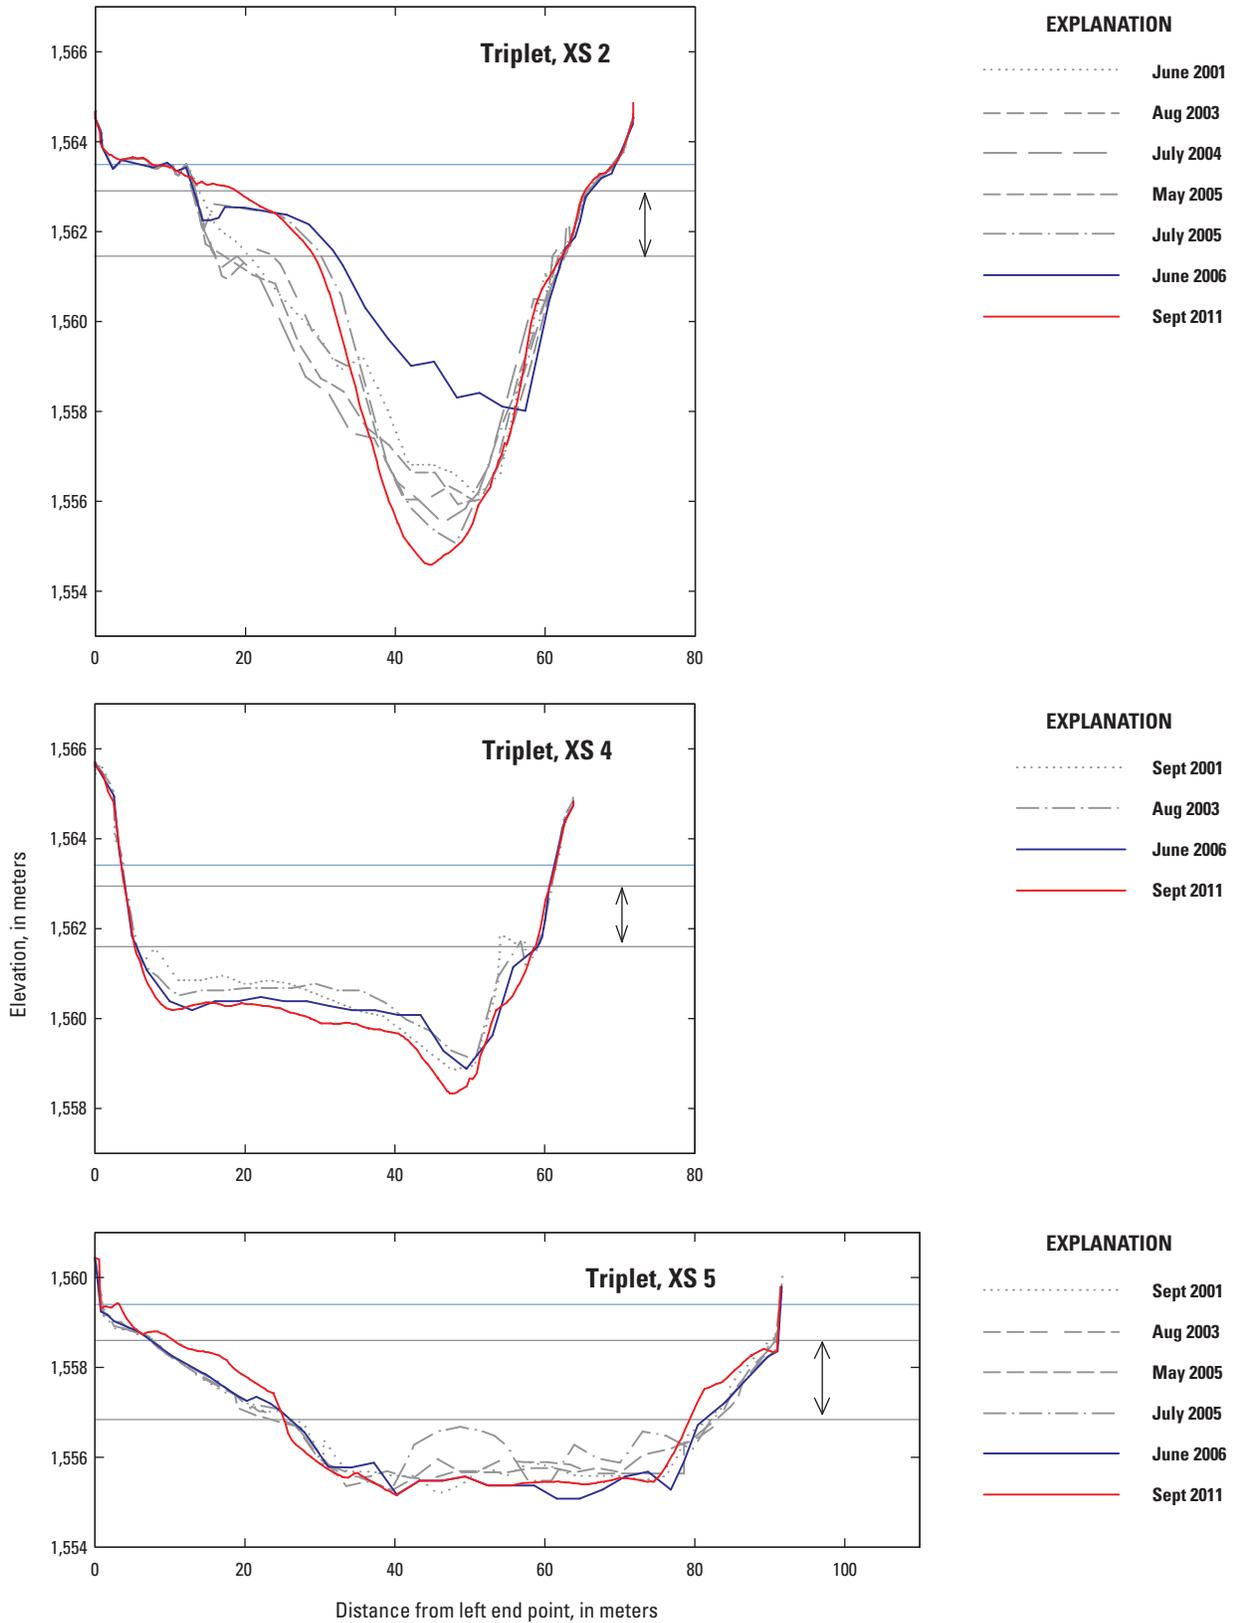
Figure 20. Channel change at select cross sections for the Triplet reach on the Green River in Canyon of Lodore, Dinosaur National Monument, Colorado and Utah. Upper light blue line indicates the 2011 flood elevation; lower gray lines delineate the fluctuating flow zone. Vertical double arrows indicate typical range in normal dam operational flows. XS, cross section.

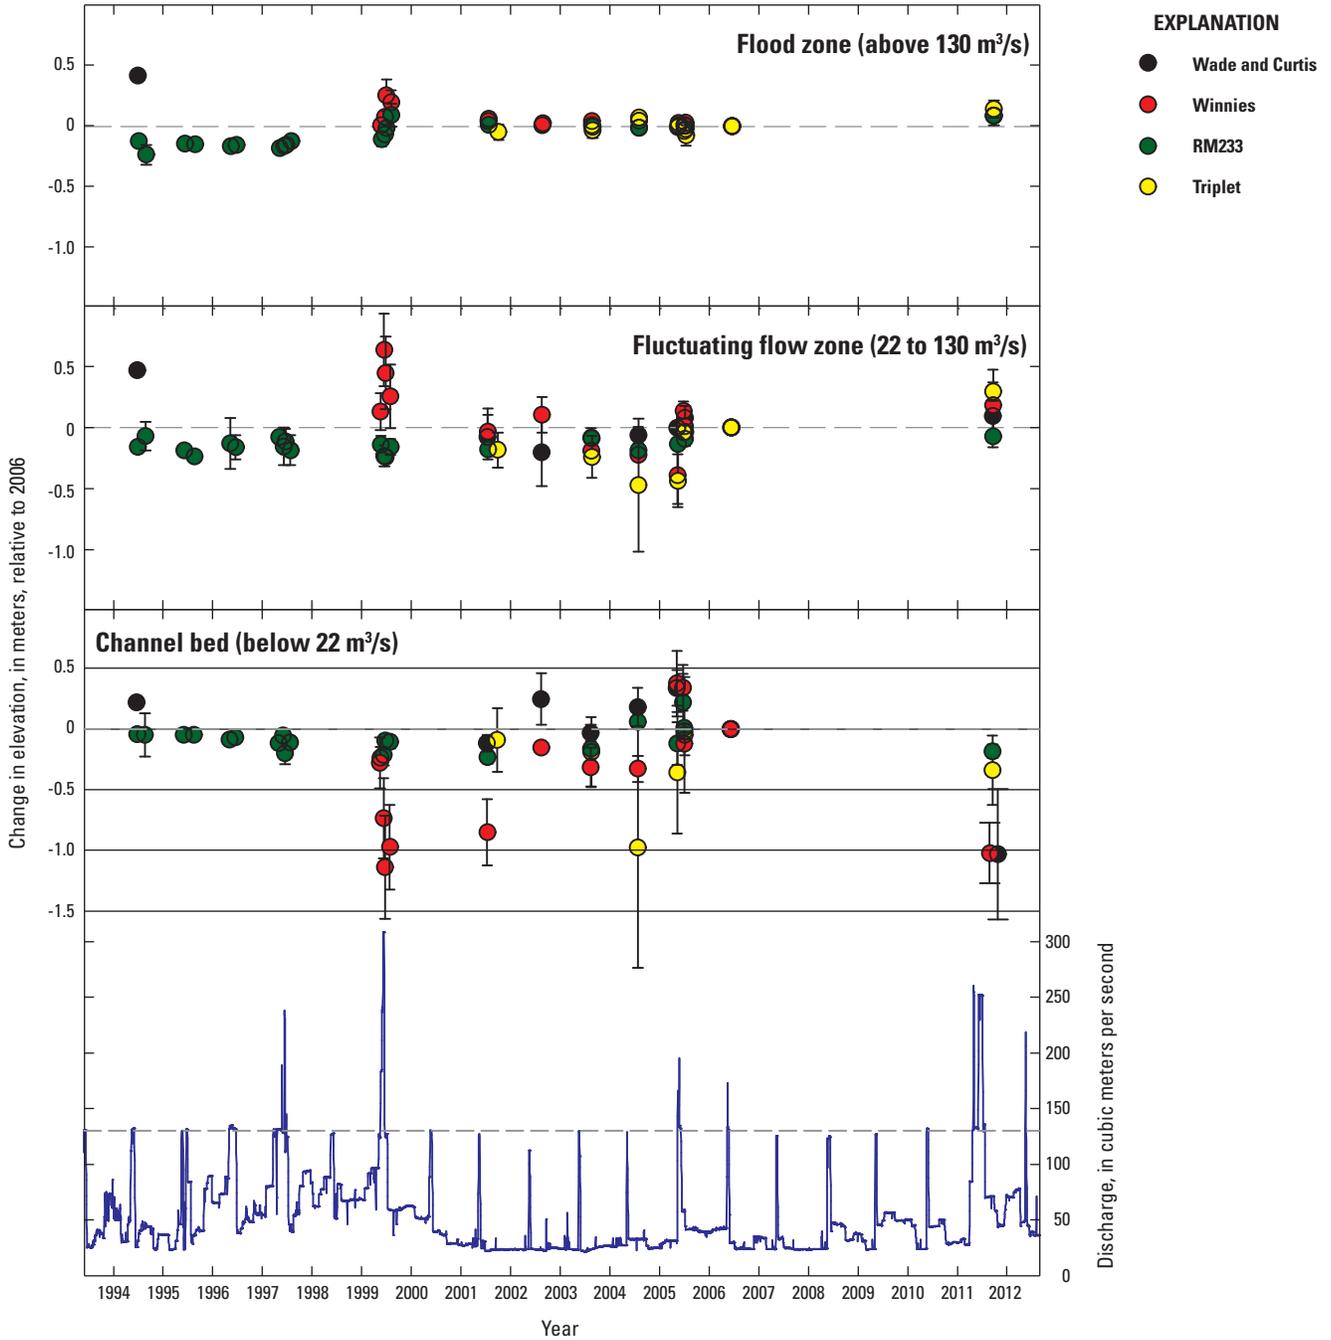
Figure 21. Change in average elevation for sandbars in the flood zone (top), fluctuating flow zone (middle), and main channel bed (bottom) of the Green River in Canyon of Lodore, Dinosaur National Monument, Colorado and Utah. Points indicate mean for all cross sections in a reach and error bars indicate the standard error of the mean. All plots are at the same scale. The mean daily hydrograph is shown for reference. m³/s, cubic meters per second.

Changes in mean bed and sandbar elevation are shown for individual reaches in figure 21 and averaged over the entire study area in figure 22; each figure has three panels showing the flood, fluctuating flow, and channel bed zones as shown schematically in figure 6 and delineated in the cross-section time series shown in figures 17–20. In each figure, we plot changes in bed elevation at the same scale for the different zones, and we include the mean daily flow hydrograph for the period of observation for comparison. Elevation changes in the flood zone have been modest during the study period, although some minor (approximately 100 mm) aggradation did occur in both 1999 and 2011. The 1997 flood did not show this signal, but only RM233 was monitored during this event, and this reach has been relatively insensitive to change compared to the other monitoring sites. Data from 1994 at Wade and Curtis is based on a single cross section, and may not be representative of the longer reach. Changes in sandbar elevation for the fluctuating flow zone are more variable than in the flood zone. For example, sandbars in the Winnies reach aggraded by more than 0.5 m during the 1999 event (fig. 21). Subsequently, the sandbars eroded in the early 2000s, then were partially rebuilt during bypass floods in 2005, 2006, and 2011. The 2011 flood increased sandbar elevations in the fluctuating flow zone by hundreds of millimeters in most reaches, although data from Winnies reach suggest the 1999 floods were more effective. These changes in sandbar elevation are subtle overall, and this is partially due to the relatively narrow elevation range of the flood (approximately 0.1–1 m) and fluctuating flow (approximately 1–2 m) zones as shown in figure 6. As shown in the DEMs of difference (figs. 13 and 14) and cross-section time series (figs. 17–20), localized erosion and deposition has been commonly more than 2 m.

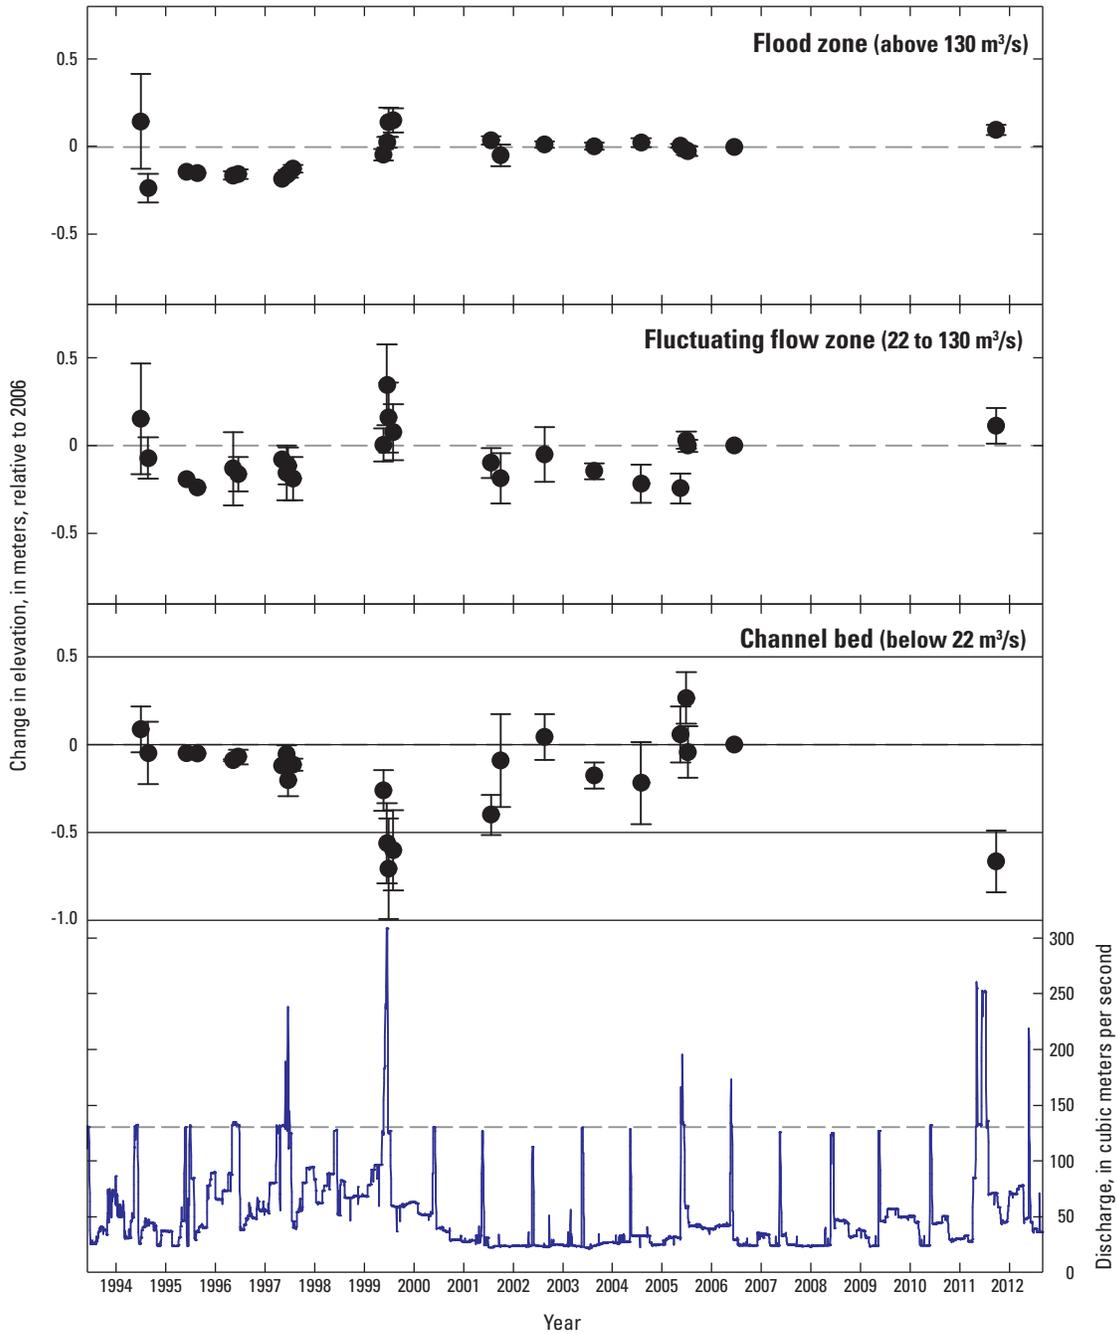
Figure 22. Change in average elevation for sandbars in the flood zone (top), fluctuating flow zone (middle), and main channel bed (bottom) of the Green River in Canyon of Lodore, Dinosaur National Monument, Colorado and Utah. Points indicate mean for all cross sections in the study area and error bars indicate the standard error of the mean. All plots are at the same scale. The mean daily hydrograph is shown for reference. m³/s, cubic meters per second.

Changes in bed elevation within the channel were both greater in magnitude and more variable than changes in the fluctuating flow and flood zones, particularly in pools. These data indicate that as much as a meter of bed scour was caused by the 1999 flood, and that the pools primarily aggraded thereafter until 2005; the 2011 flood caused significant erosion comparable to what had occurred in 1999 (figs. 21 and 22). The Wade and Curtis and Winnies reaches were the most degraded in 2011, an average of 1 m of bed lowering relative to 2006, and most of this erosion occurred in the upstream pools. Thus, these two sites in the upstream part of Lodore Canyon were most sensitive to flood flows. In both cases, the upstream pools in these reaches aggrade with fine sediment during typical dam operations (figs. 17 and 18). During high flows, such as in 2011, flow constrictions by debris fans just upstream from these pools concentrate flow and cause deep bed scour. Bed scour during floods appears less pronounced in downstream pools in these reaches, and may be related to coarser, less erodible substrate adjacent to gravel bars in these pools. In contrast, bed degradation in the RM233 and Triplet reaches was relatively subtle—only 0.1–0.2 m for an average cross section. At RM233 in particular, the upstream part of the reach is essentially flat with little bank variation and channel form has changed very little in more than a decade of monitoring.

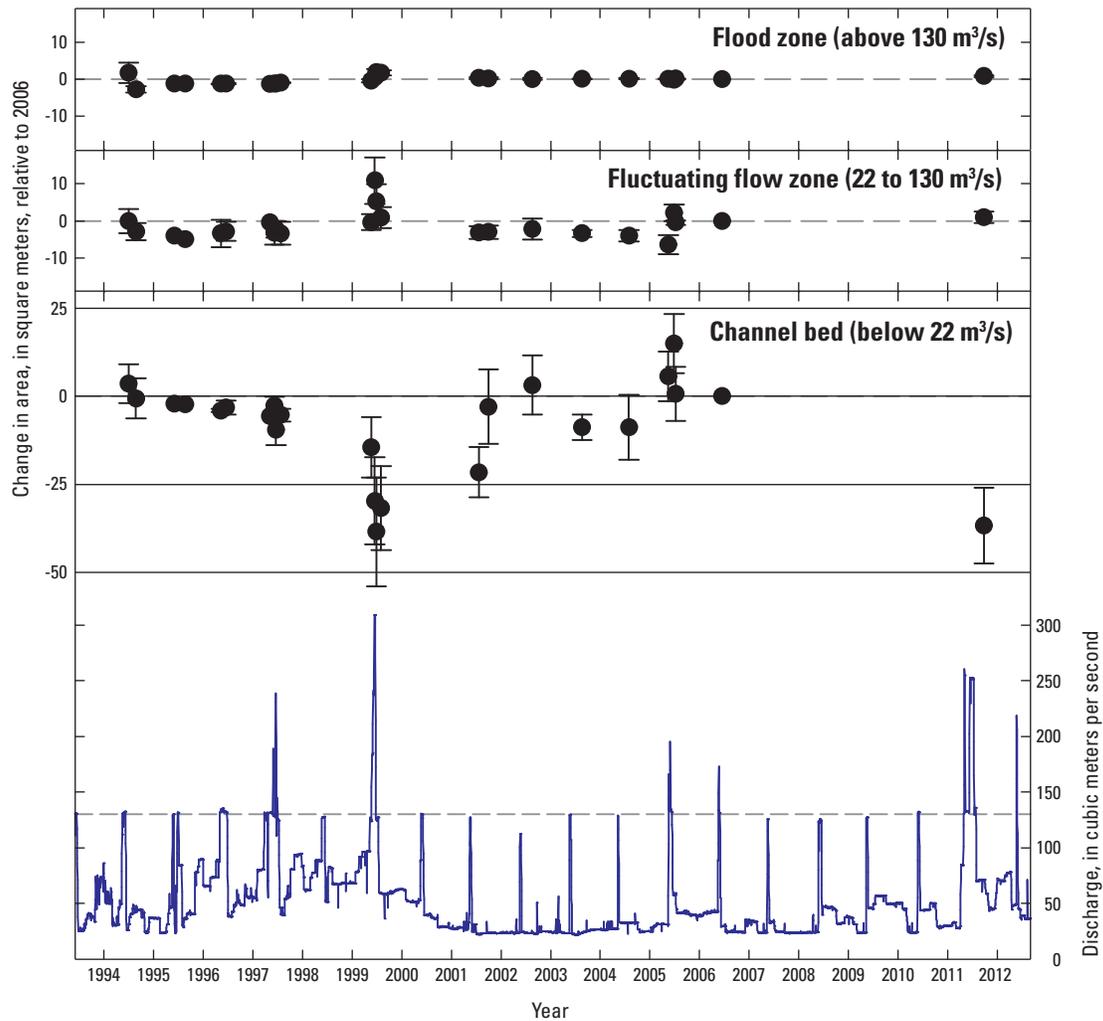
Figure 23. Change in average area for sandbars in the flood zone (top), fluctuating flow zone (middle), and main channel bed (bottom) of the Green River in Canyon of Lodore, Dinosaur National Monument, Colorado and Utah. Points indicate mean for all cross sections in the study area and error bars indicate the standard error of the mean. All plots are at the same scale. The mean daily hydrograph is shown for reference in each figure. m³/s, cubic meters per second.

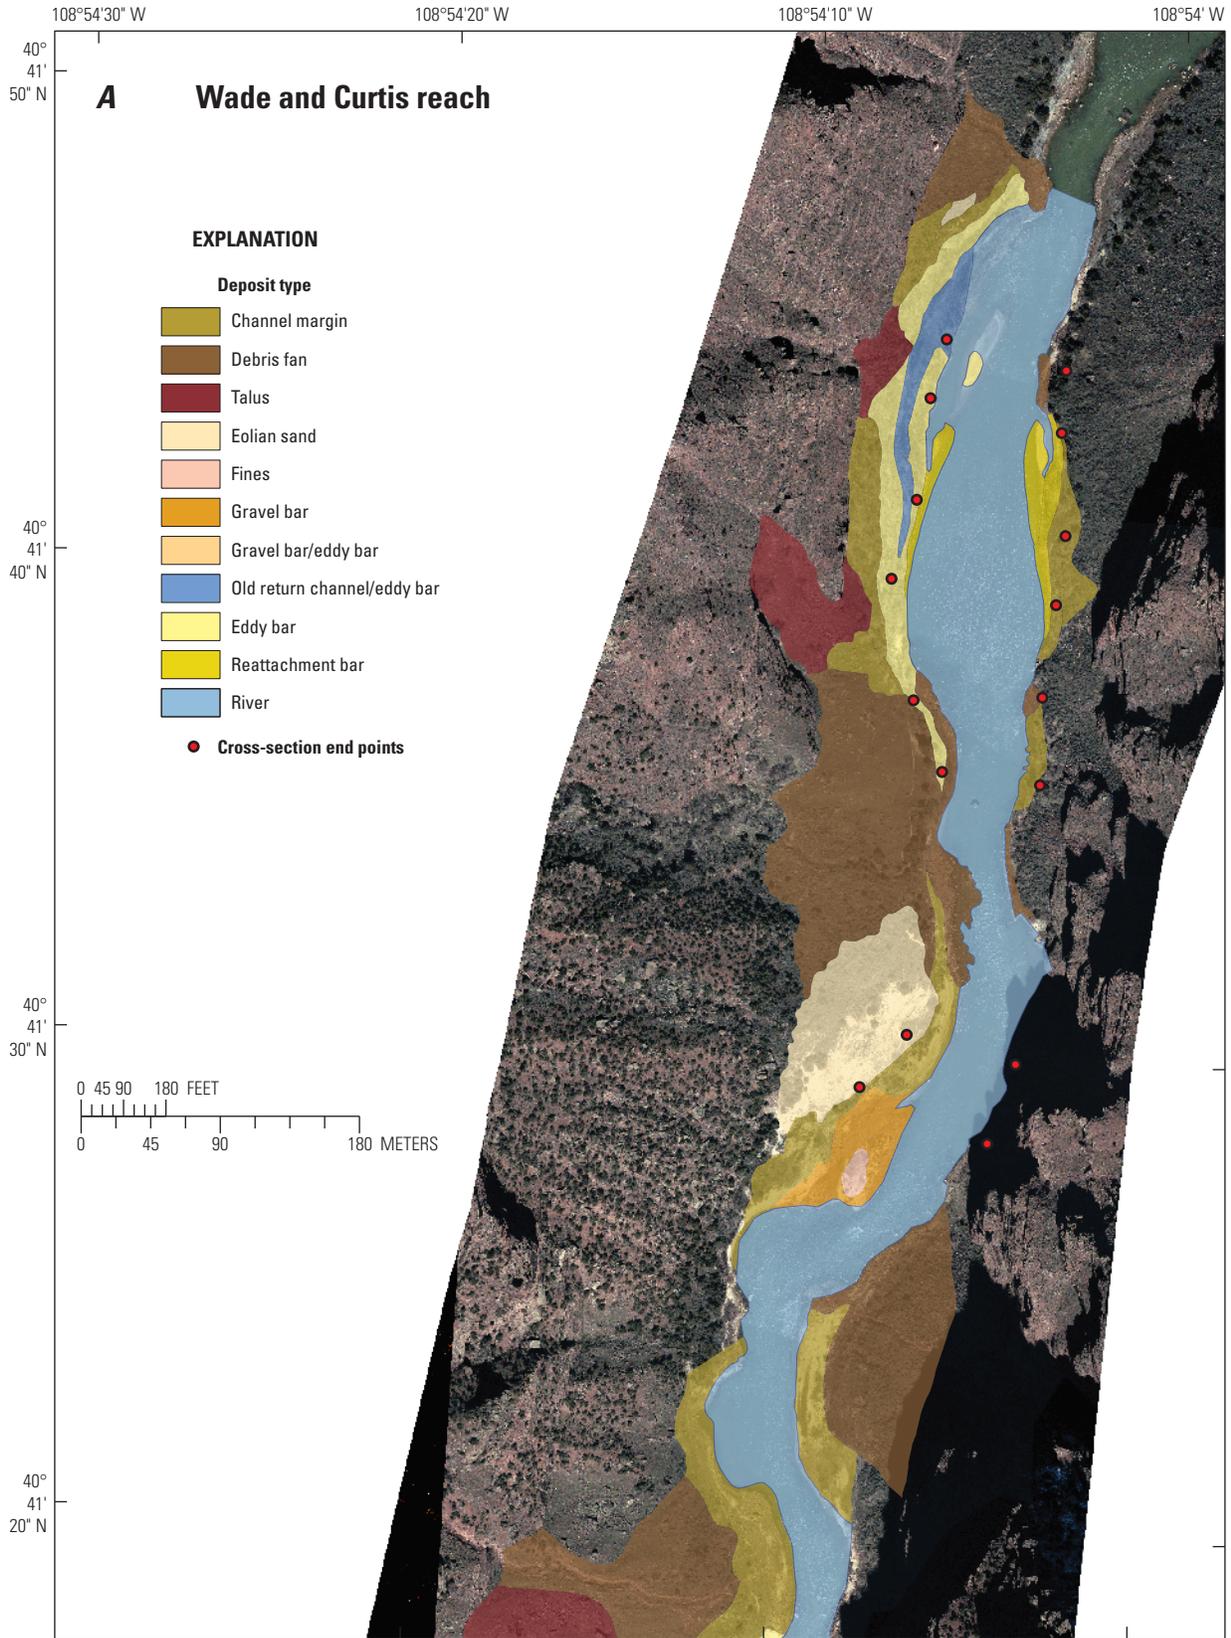
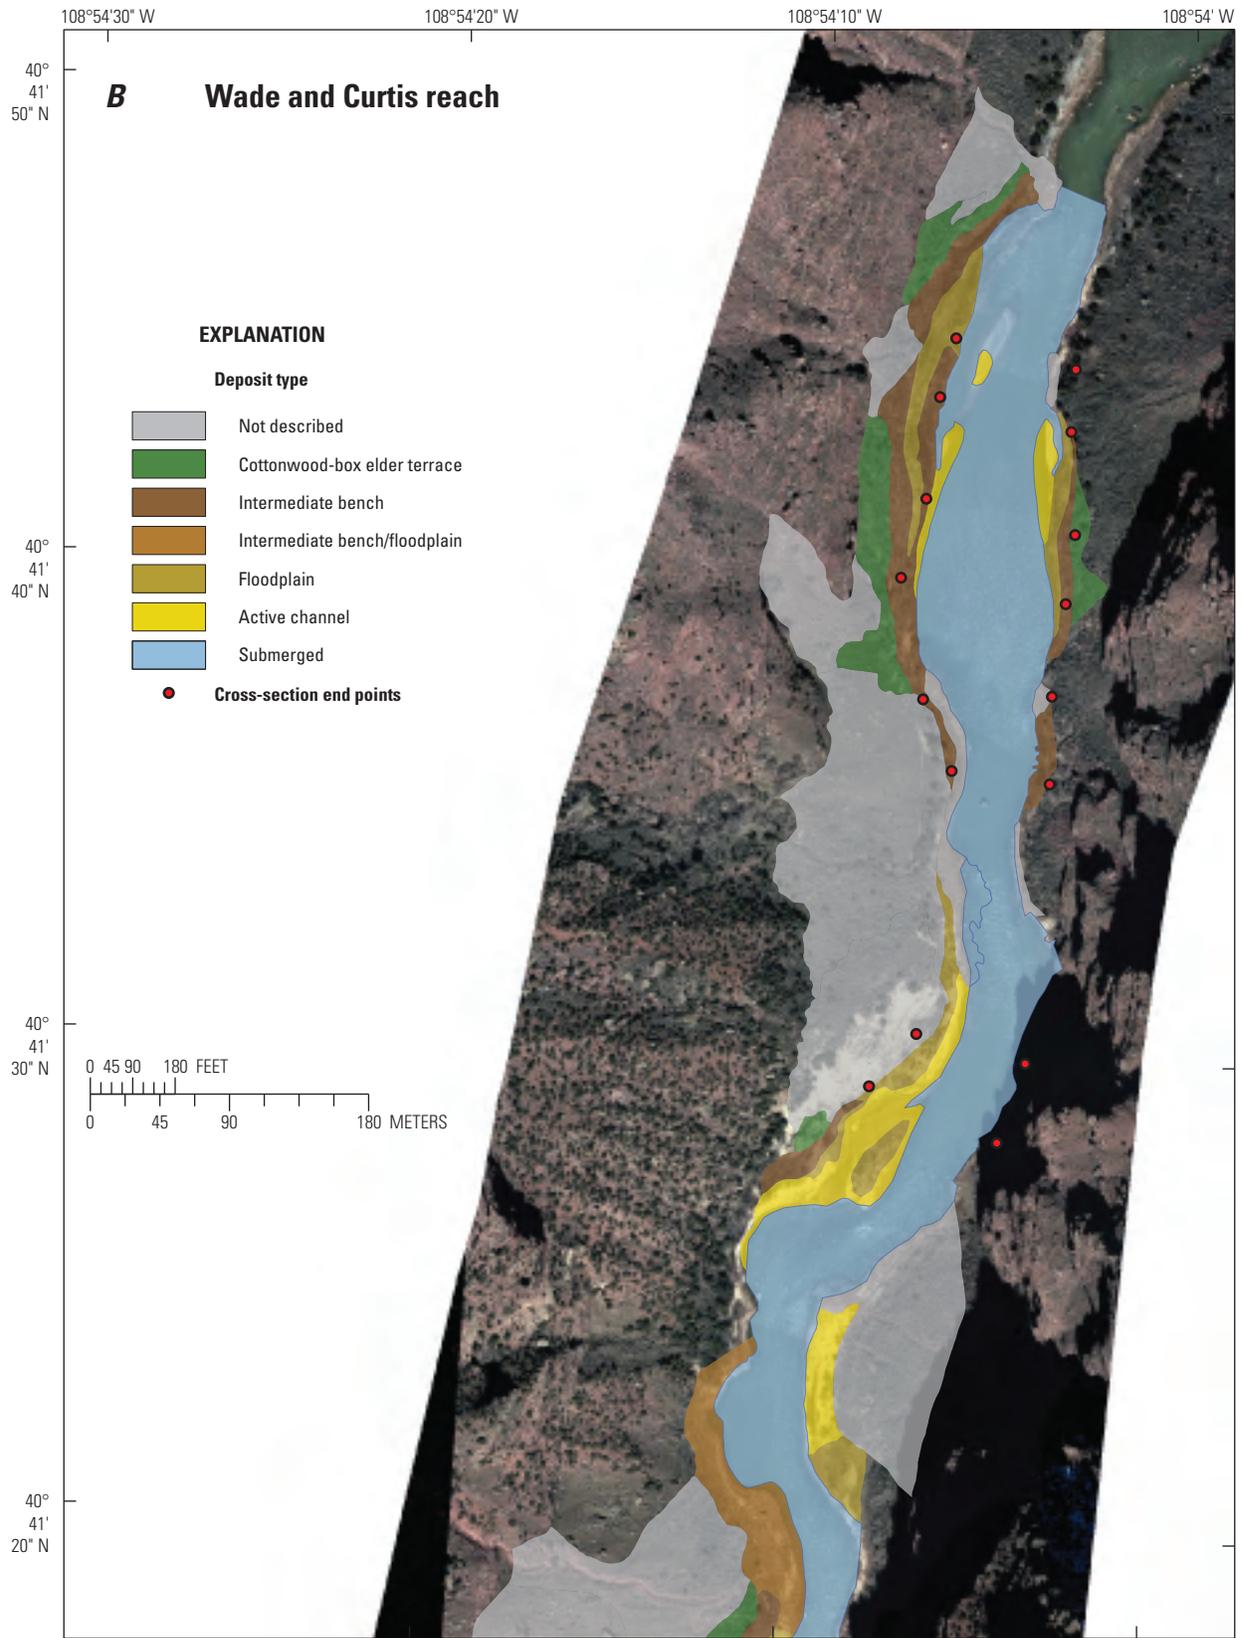
Figure 1-1. Primary depositional environments (A) and geomorphic surface levels (B) for the Wade and Curtis reach, Canyon of Lodore, Dinosaur National Monument, Colorado and Utah.

Figure 1-1. Primary depositional environments (A) and geomorphic surface levels (B) for the Wade and Curtis reach, Canyon of Lodore, Dinosaur National Monument, Colorado and Utah. —Continued

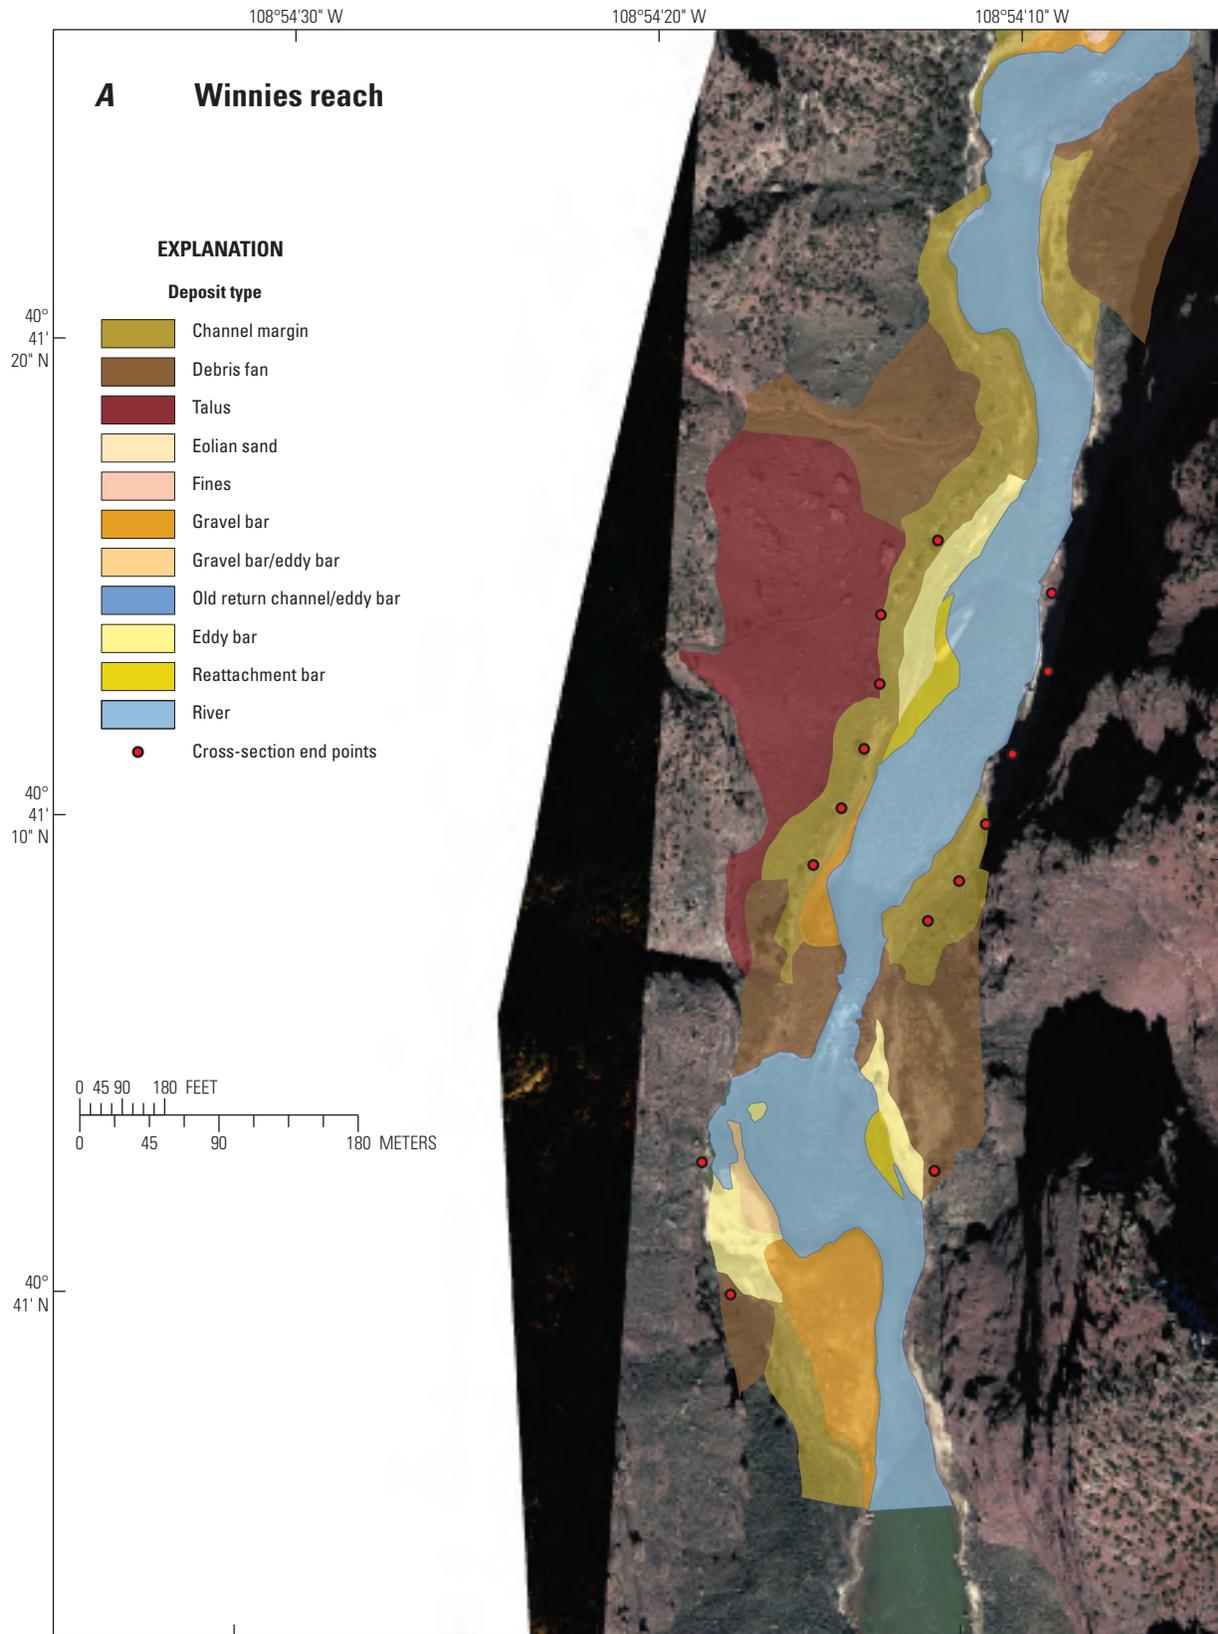
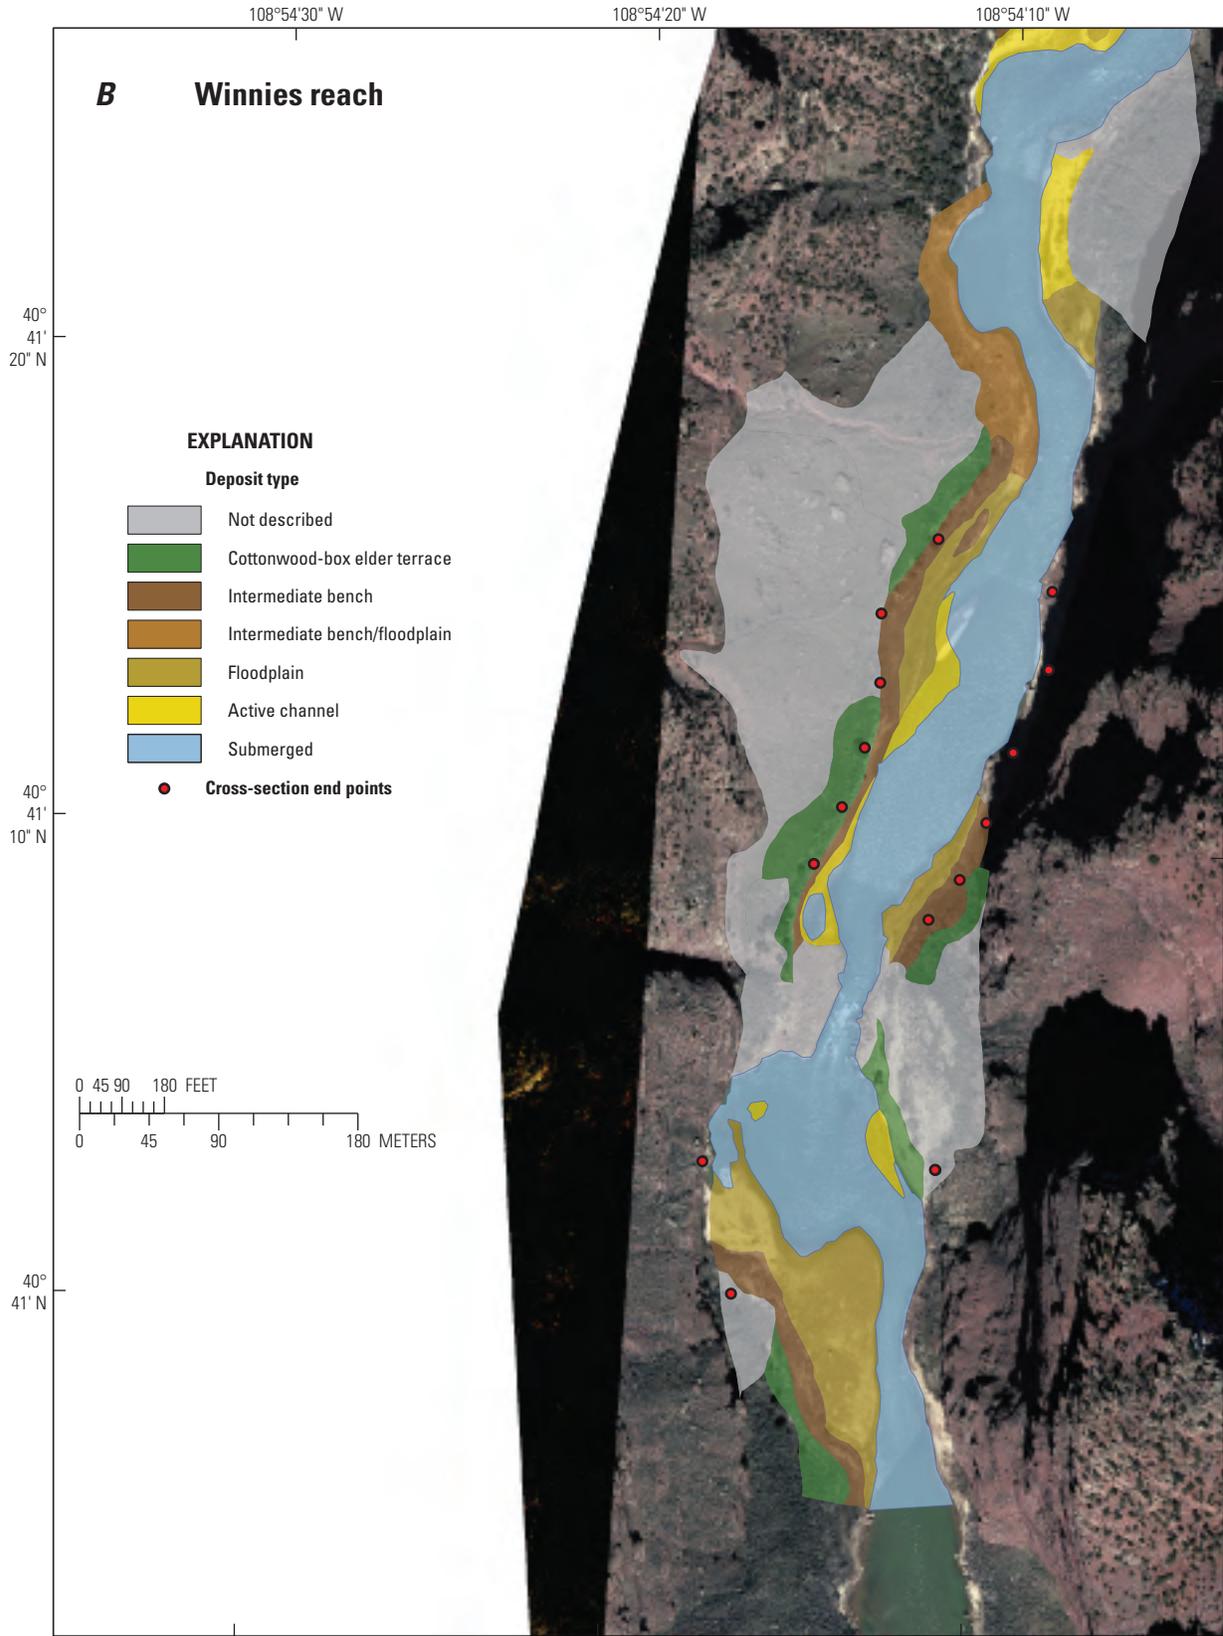
Figure 1-2. Primary depositional environments (A) and geomorphic surface levels (B) for the Winnies reach, Canyon of Lodore, Dinosaur National Monument, Colorado and Utah.

Figure 1-2. Primary depositional environments (A) and geomorphic surface levels (B) for the Winnies reach, Canyon of Lodore, Dinosaur National Monument, Colorado and Utah. —Continued
