Monitoring and Research to Describe Geomorphic Effects of the 2011 Controlled Flood on the Green River in the Canyon of Lodore, Dinosaur National Monument, Colorado and Utah

Scientific Investigations Report 2014–5022

By Erich R. Mueller, Paul E. Grams, John C. Schmidt, Joseph E. Hazel, Jr.,
Matt Kaplinski, Jason A. Alexander, and Keith Kohl

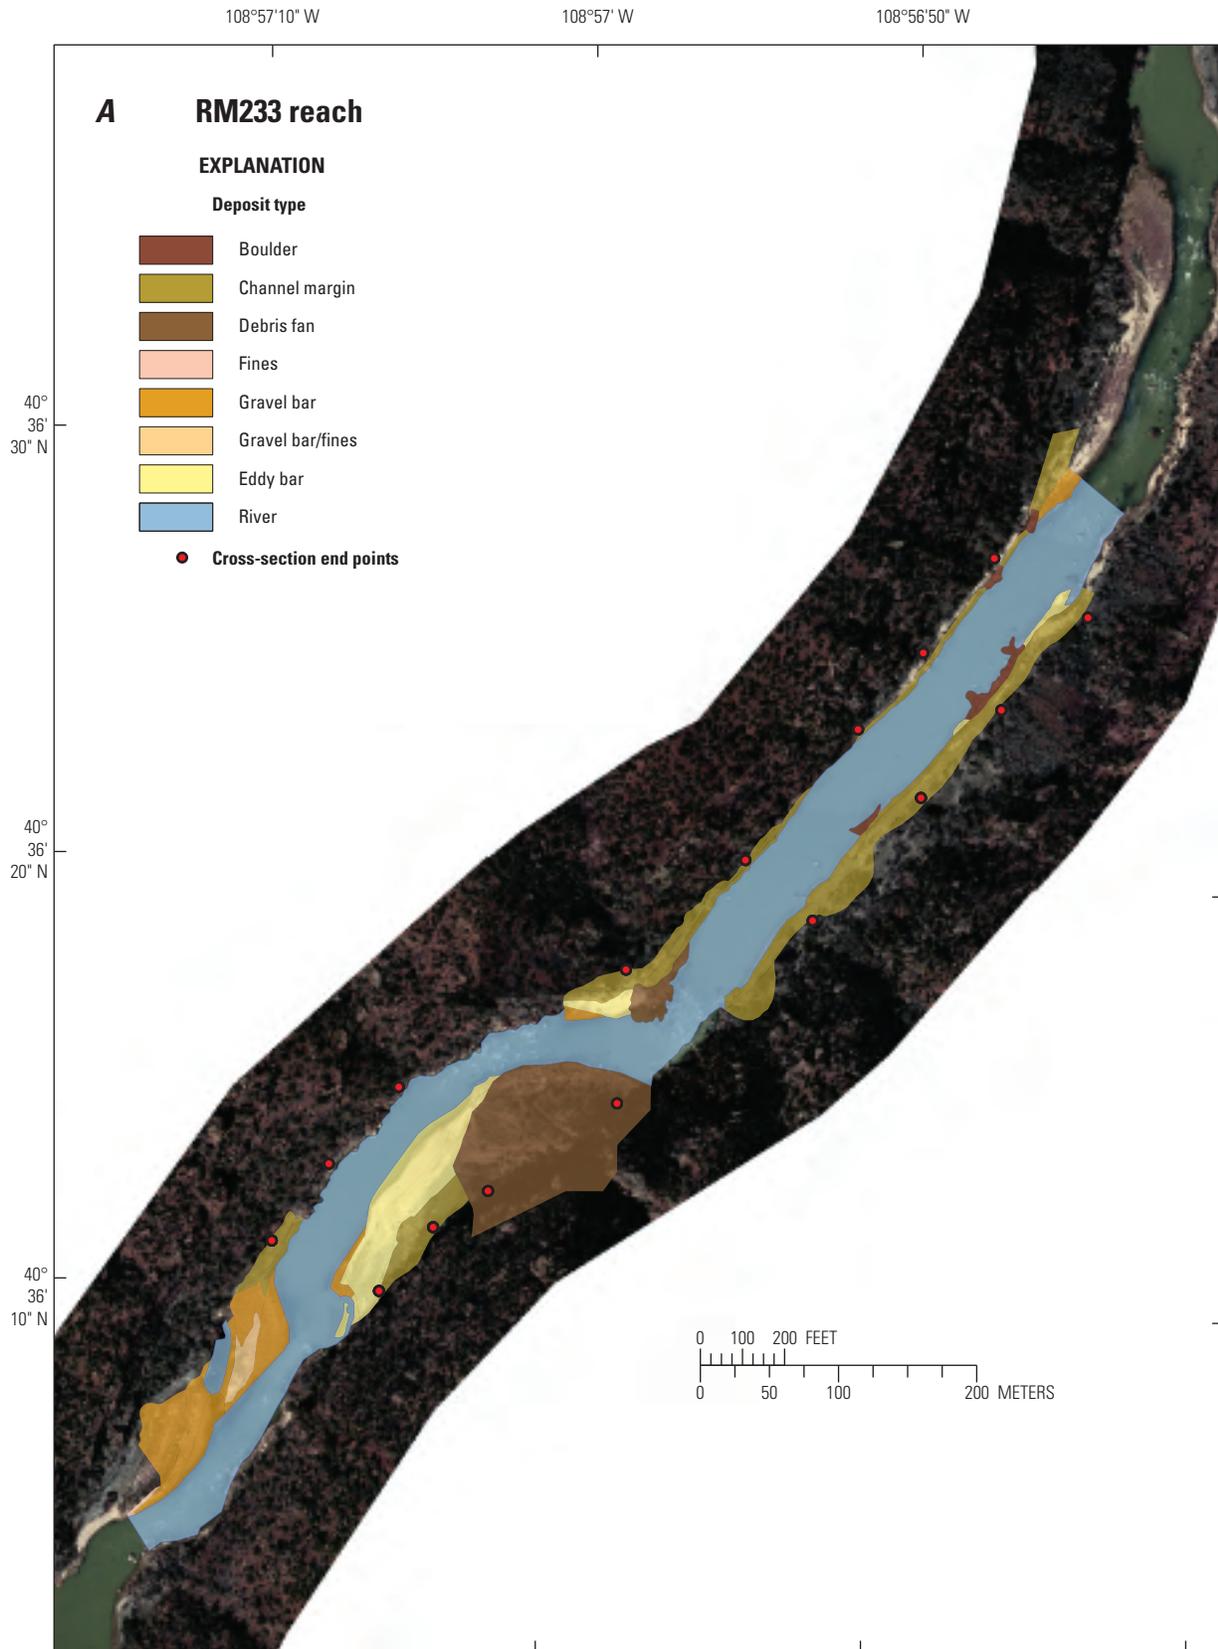
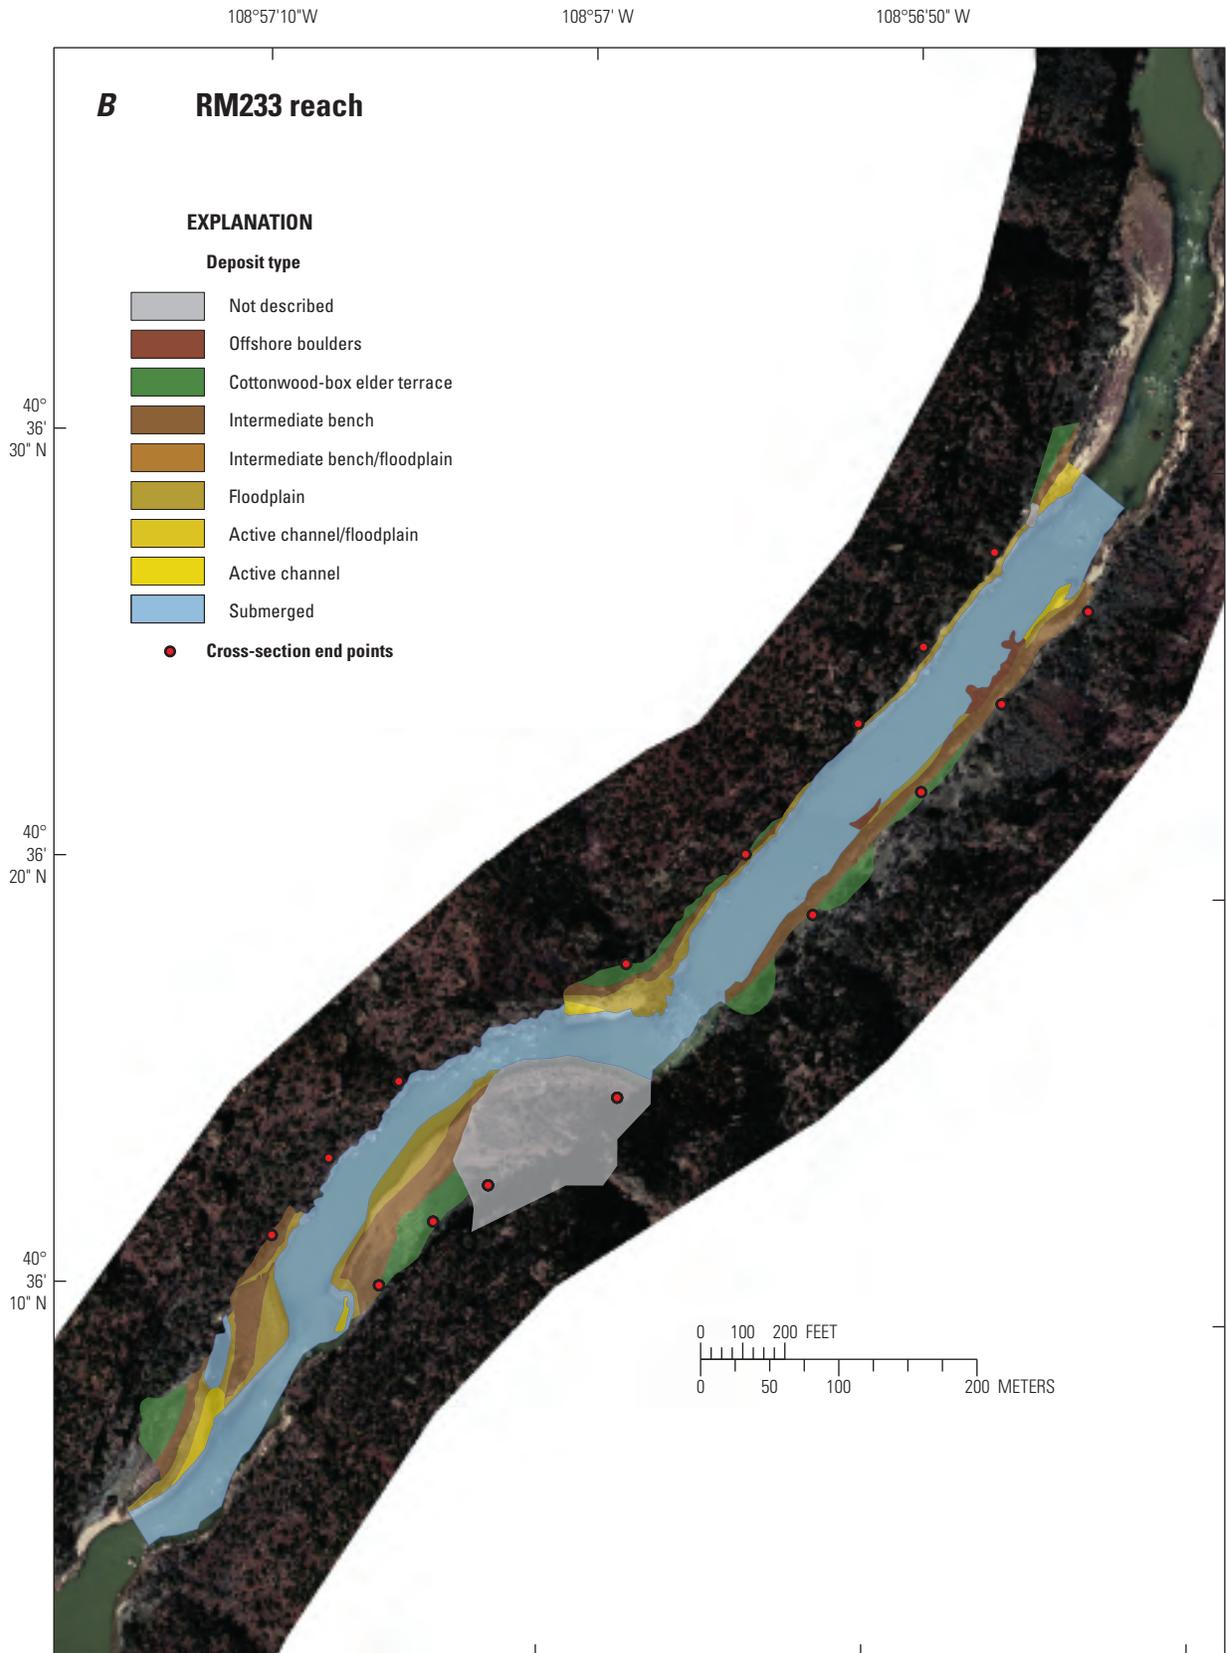
Figure 1-3. Primary depositional environments (A) and geomorphic surface levels (B) for the RM233 reach, Canyon of Lodore, Dinosaur National Monument, Colorado and Utah.

Figure 1-3. Primary depositional environments (A) and geomorphic surface levels (B) for the RM233 reach, Canyon of Lodore, Dinosaur National Monument, Colorado and Utah. —Continued

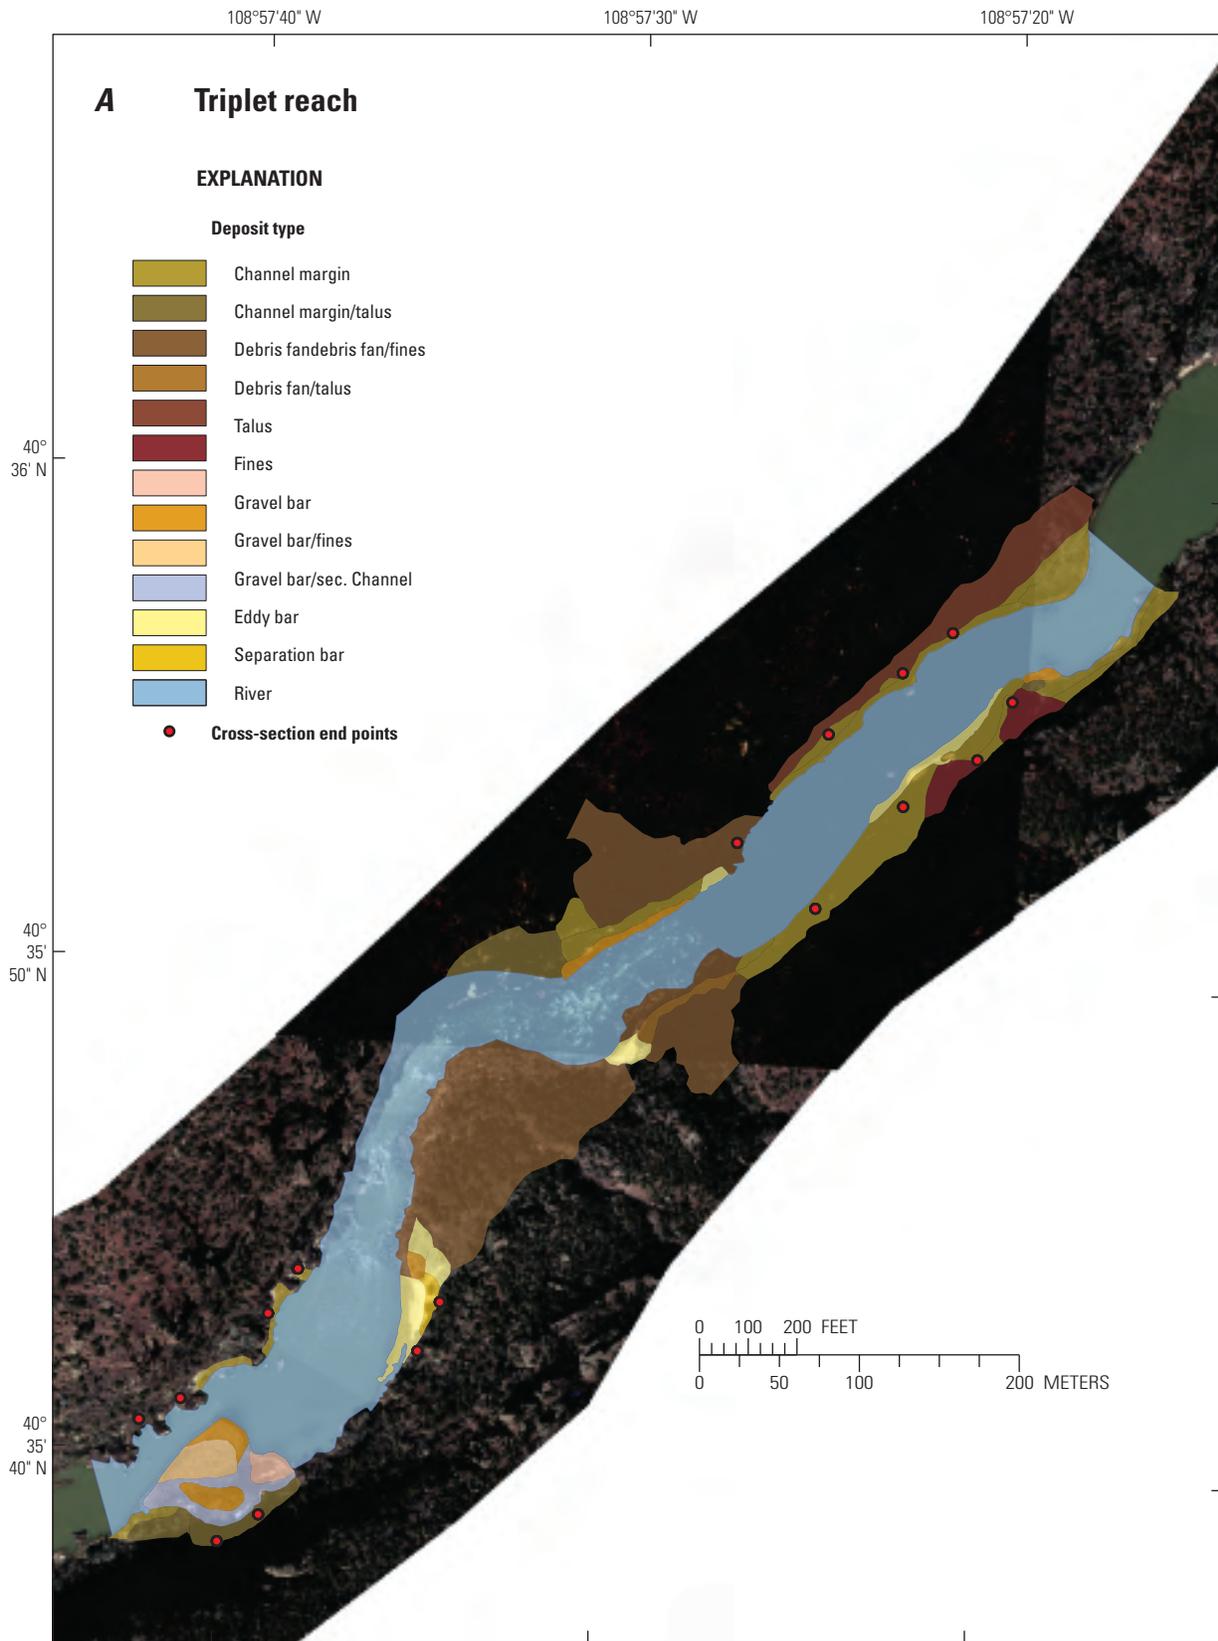
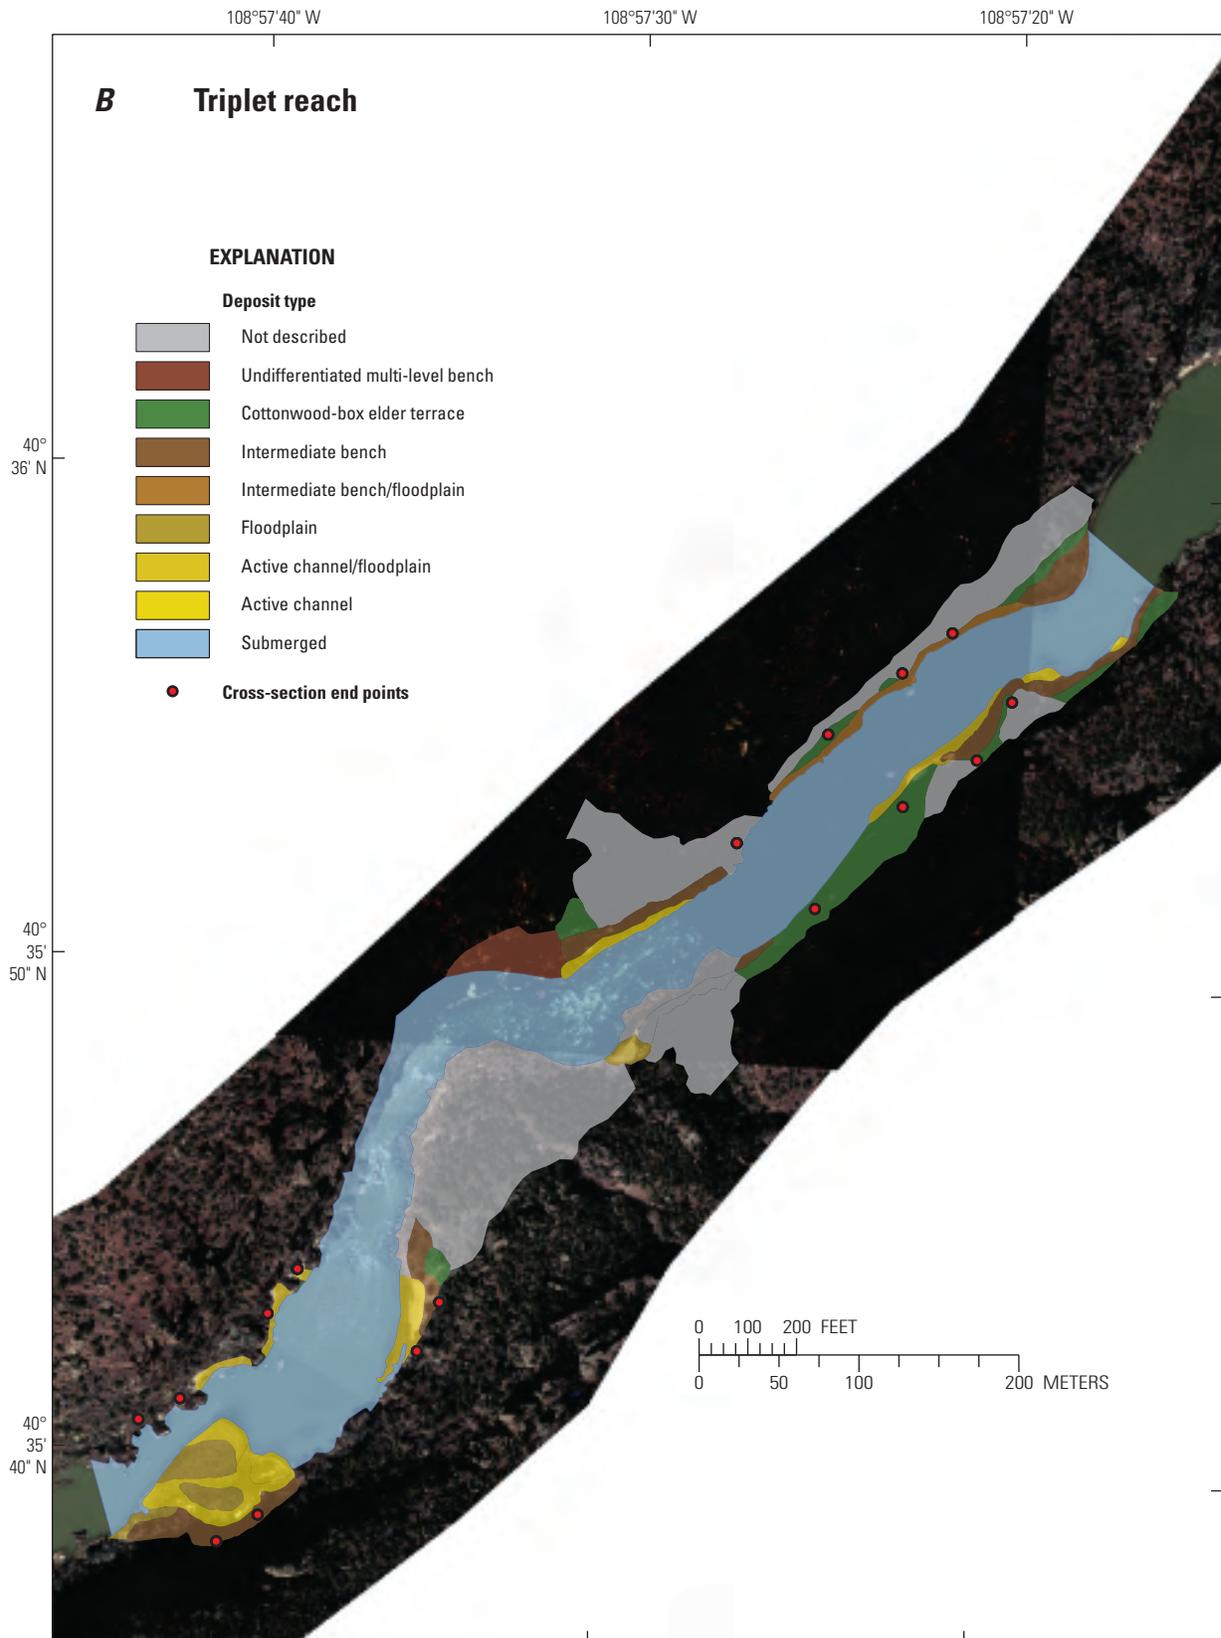
Figure 1-4. Primary depositional environments (A) and geomorphic surface levels (B) for the Triplet reach, Canyon of Lodore, Dinosaur National Monument, Colorado and Utah.

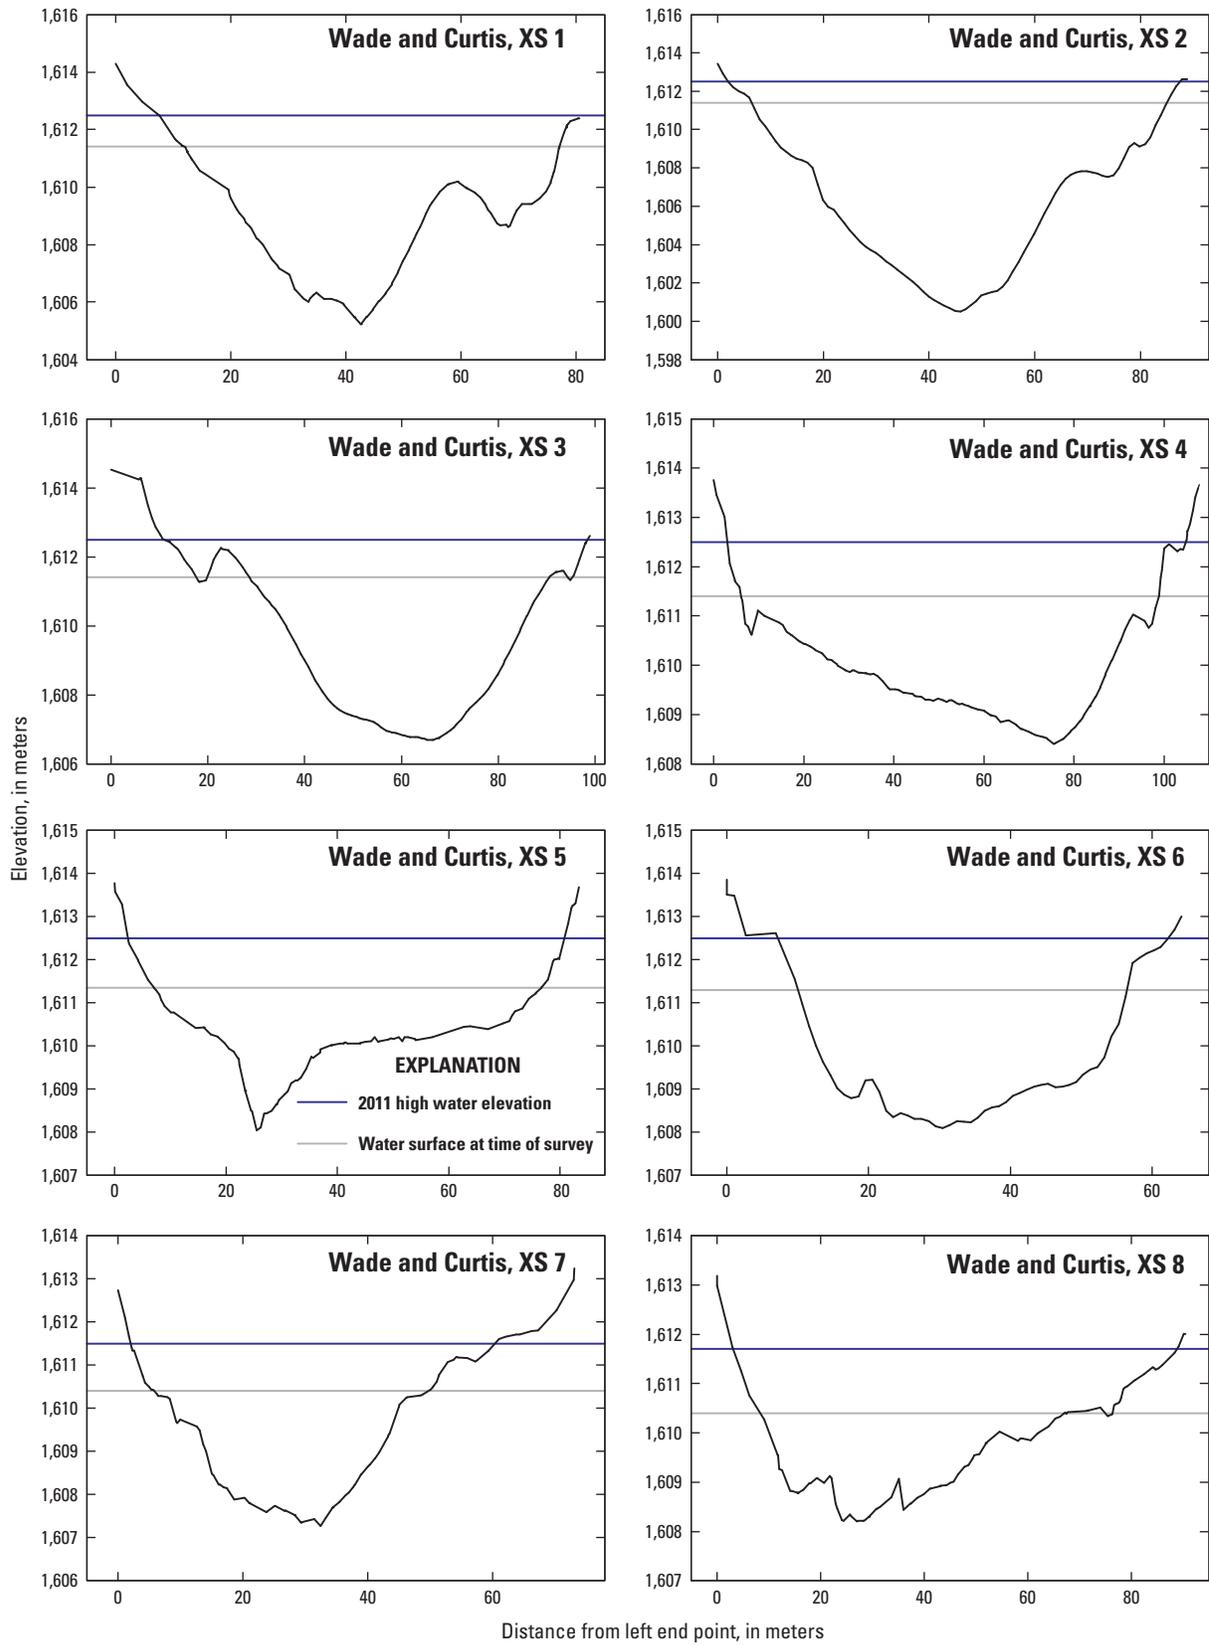
Figure 3-1 Long-term monitoring cross-sections extracted from the 2011 digital terrain models (DTMs) for the Wade and Curtis reach, Canyon of Lodore, Dinosaur National Monument, Colorado and Utah.

Appendix 3 consists of four long-term monitoring cross-sections extracted from the 2011 digital terrain models (DTMs) for the Wade and Curtis, Winnies, RM233, and Triplet reaches, Canyon of Lodore, Dinosaur National Monument, Colorado and Utah (figs. 3-1 through 3-4).

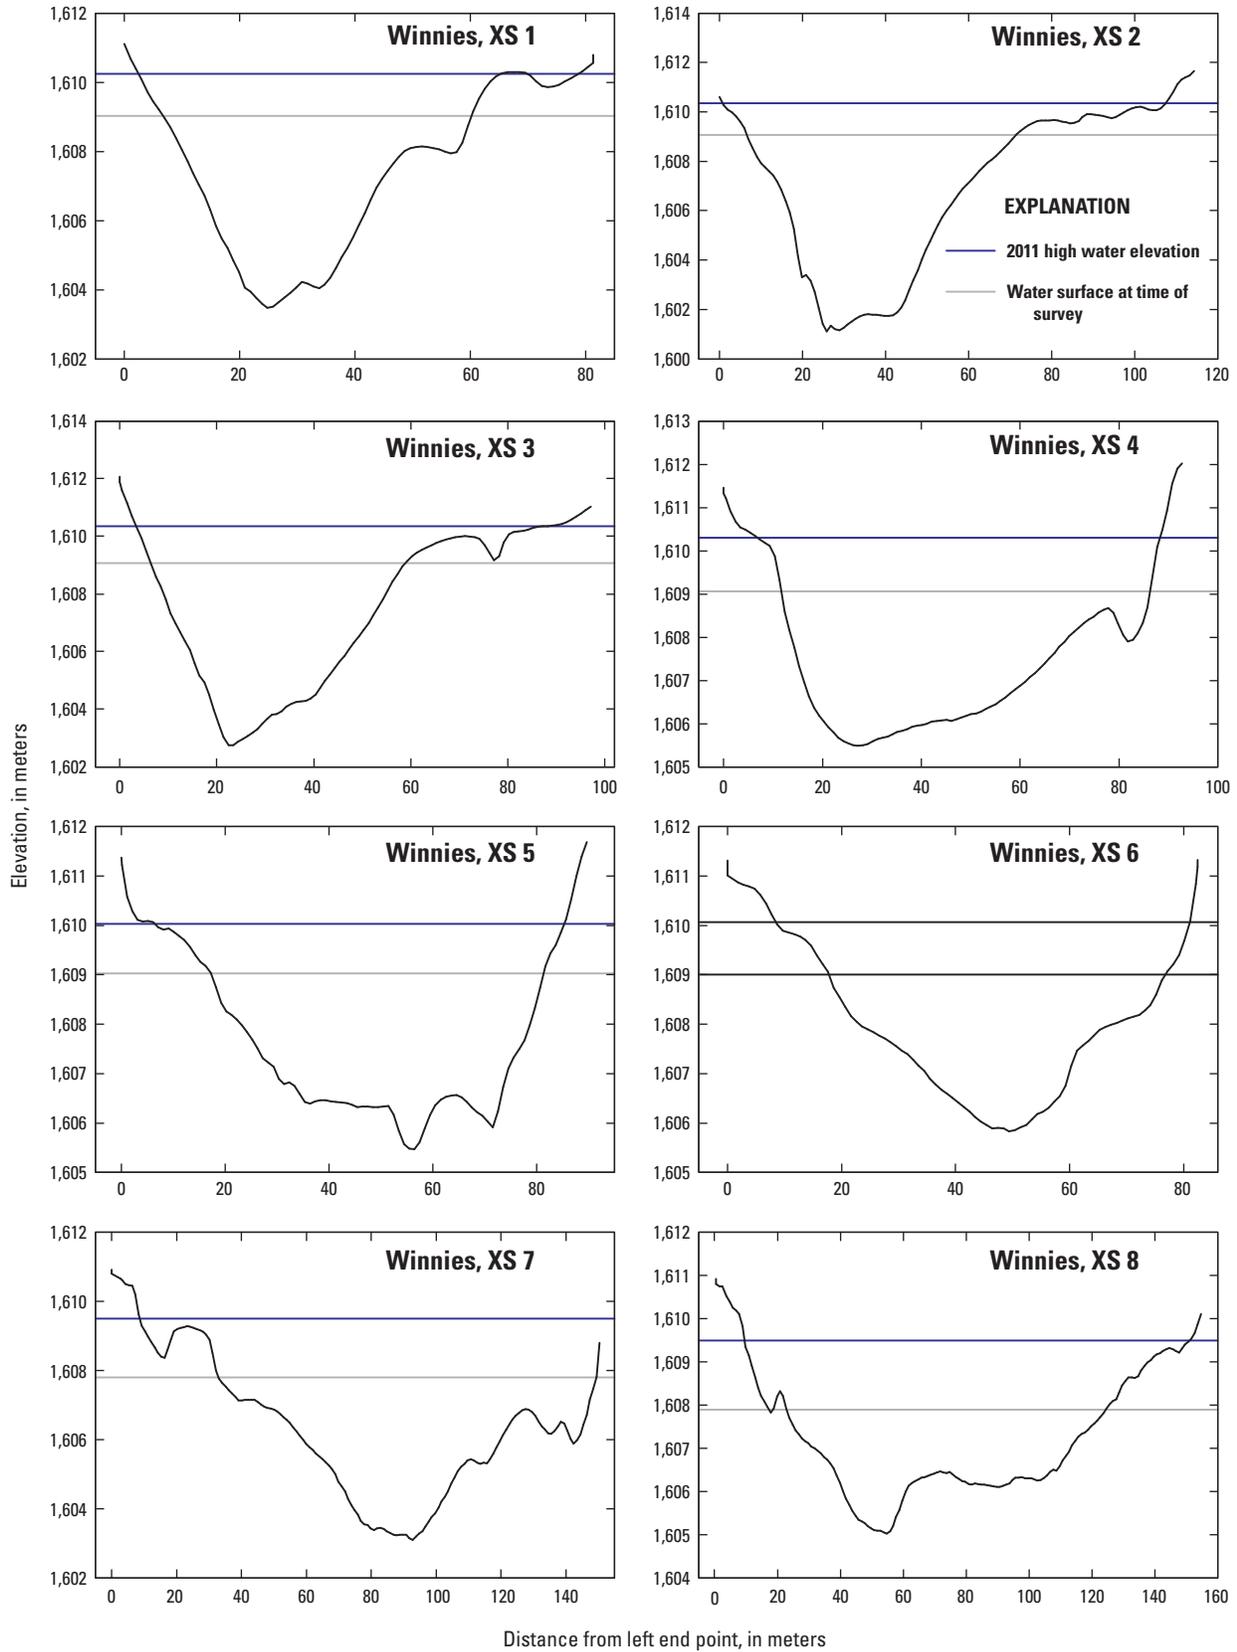
Figure 3-2 Long-term monitoring cross-sections extracted from the 2011 digital terrain models (DTMs) for the Winnies reach, Canyon of Lodore, Dinosaur National Monument, Colorado and Utah.

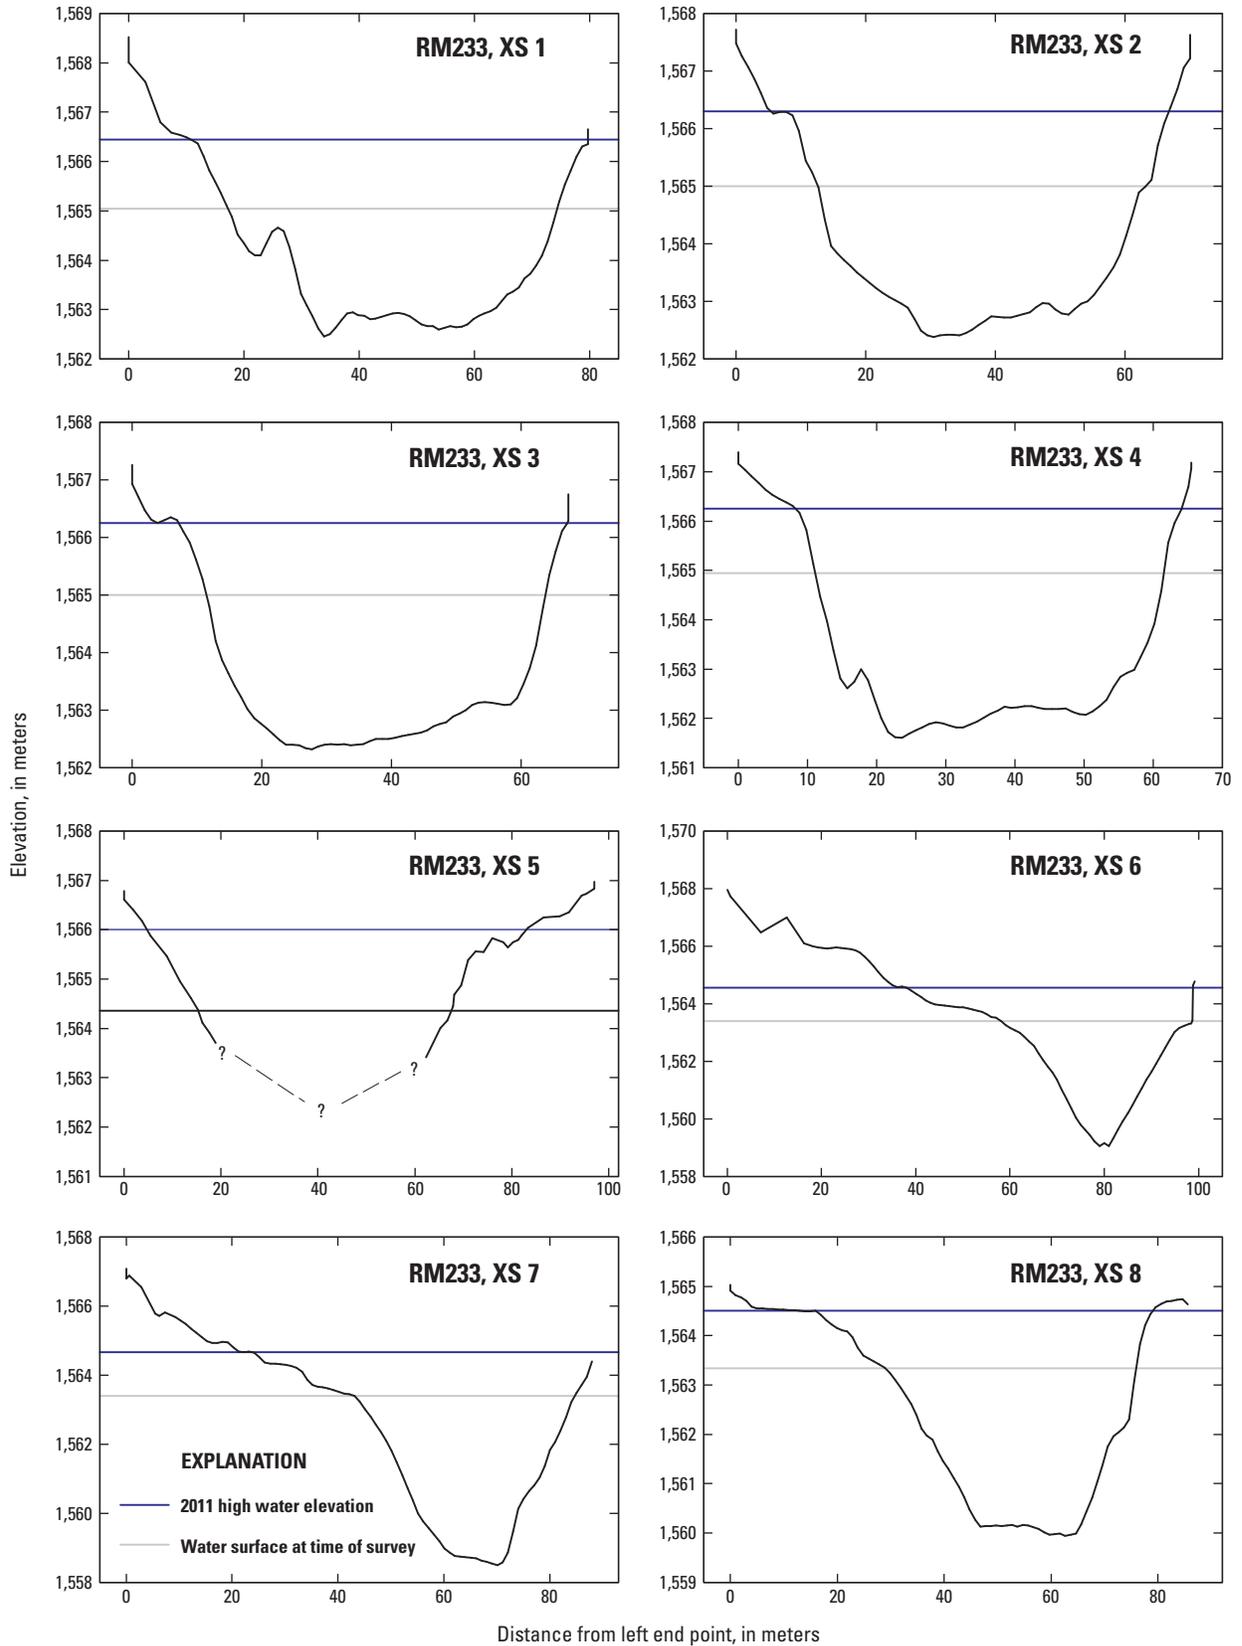
Figure 3-3 Long-term monitoring cross-sections extracted from the 2011 digital terrain models (DTMs) for the RM233 reach, Canyon of Lodore, Dinosaur National Monument, Colorado and Utah.

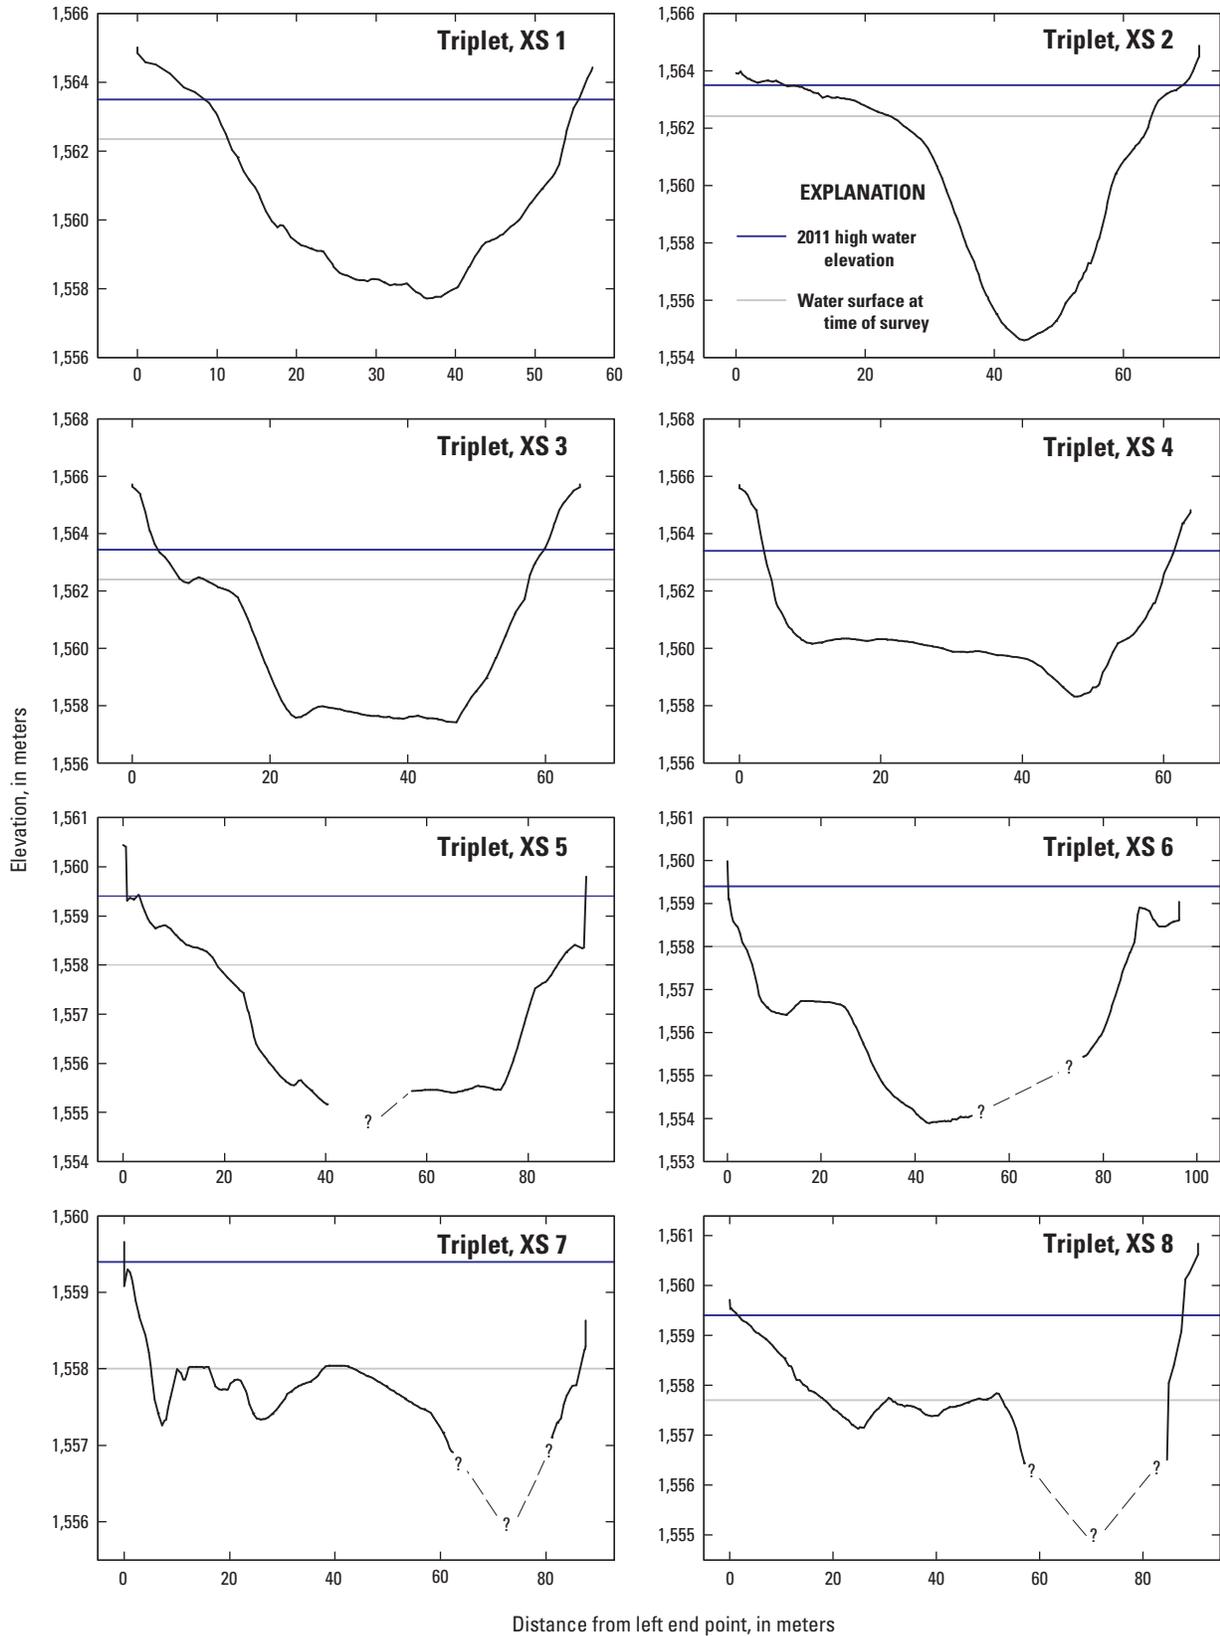
Figure 3-4 Long-term monitoring cross-sections extracted from the 2011 digital terrain models (DTMs) for the Triplet reach, Canyon of Lodore, Dinosaur National Monument, Colorado and Utah.
