High-Resolution Topography and Geomorphology of Select Archeological Sites in Glen Canyon National Recreation Area, Arizona

Scientific Investigations Report 2014–5126

By Brian D. Collins, Skye C. Corbett, Joel B. Sankey, and Helen C. Fairley

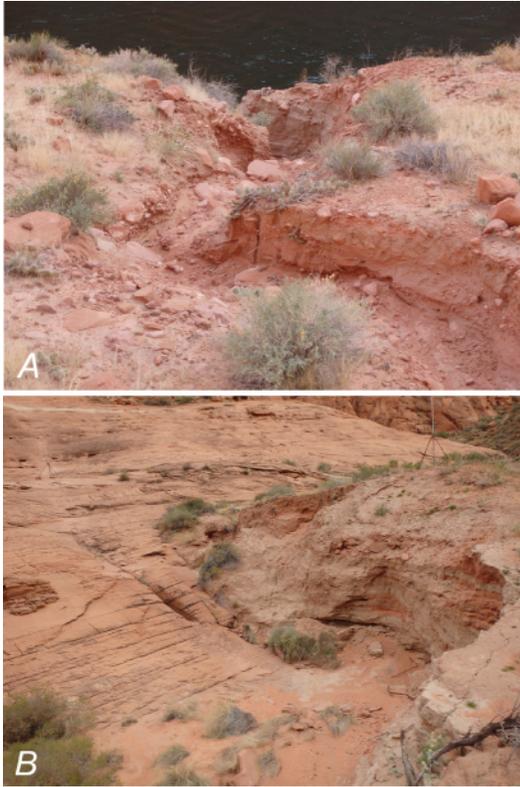
Figure 2. Gullying at (A) archeological site AZ:C:02:0032 and (B) site AZ:C:02:0075 in Glen Canyon National Recreation Area. These areas contain cultural artifacts buried by sediments subject to precipitation-induced erosion. Gully in (A) is ~1.6 m wide and runs over terrace edge to the Colorado River (in background). Gully in (B) is 2.5 m deep and is partly controlled by overland flow from bedrock surfaces (shown in left of photo). Survey rod in upper right of (B) is ~2.5 m tall.

of Glen Canyon Dam (fig. 2; Grams and others, 2007). Land managers and policy makers associated with managing the flow of the Colorado River are interested in understanding how the operations of Glen Canyon Dam have affected these deposits and how dam-controlled flows currently interact with other landscape-shaping processes such as precipitation-induced erosion, riparian vegetation expansion, and human recreational activities to alter the riparian landscape in lower Glen and Grand Canyons. One topic of particular interest to land managers of the Glen Canyon National Recreation Area (GCNRA) concerns how dam operations may be affecting the fine-grained Holocene fluvial deposits in lower Glen Canyon that serve as the foundation and primary geomorphic context for the many prehistoric archeological sites found in this reach (Fairley and others, 1994) and that also provide settings for modern recreational campsites.

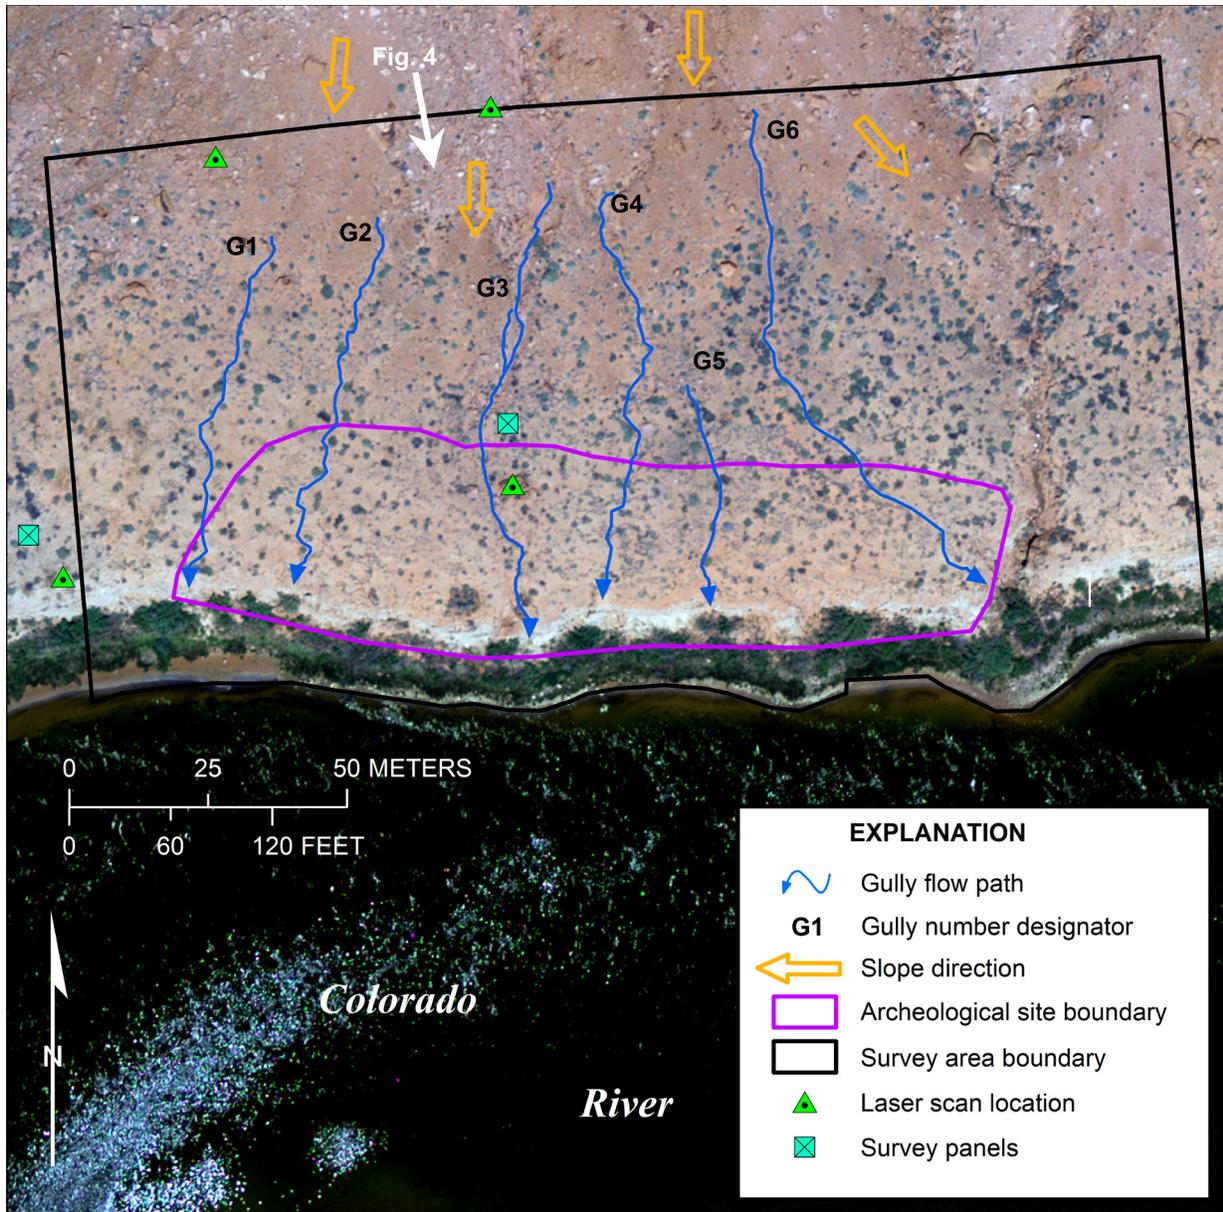
Figure 3. Site AZ:C:02:0032 survey map showing position of terrestrial lidar scanning locations, airborne lidar survey panels, and gully locations and flow paths. Three additional laser scan locations are positioned to the south and are not shown. White arrow indicates look angle of image in figure 4.

Site AZ:C:02:0032 lies on a terrace tread adjacent to a ~11-m-tall cutbank bordering the Colorado River (figs. 3 and 4). Geoarcheological analyses in the area indicate that the deposits represent at least three different cut-and-fill episodes, with alluvium of protohistoric age (post-1400 C.E.) and Puebloan age (900–1200 C.E.) overtopping and infilling gullies cut into a much older alluvial deposit composed of inter-bedded fluvial and slope-wash deposits (Anderson, 2006; Pederson and others, 2011). The vegetation in and around the site is a xeric shrub community consisting of irregularly spaced grasses, Fourwing saltbush (*Atriplex canescens*) and Mormon tea (*Ephedra* sp.) bushes, and prickly pear cacti (*Opuntia polyacantha* var. *erinacea*).

Terrestrial lidar topographic data at each archeological site (ranging in area from 2,200–4,700 m², as defined by the site boundaries shown in figs. 3, 5, 7, and 9) include several million points; for most sites ~70 percent are of the ground (non-vegetative) surface (table 5). Site AZ:C:02:0077 has a lower ground point percentage (~33 percent) due to dense vegetation within the site boundary. Overall point density ranges from 900–6,300 points/m². Data density is highest near laser scan locations; data density is lowest at the bottom of gullies, and behind vegetation and boulders that partially obscure the ground surface. In areas of dense vegetation, the point density can approach only a few points per square meter. However, average point spacing within most of the archeological site

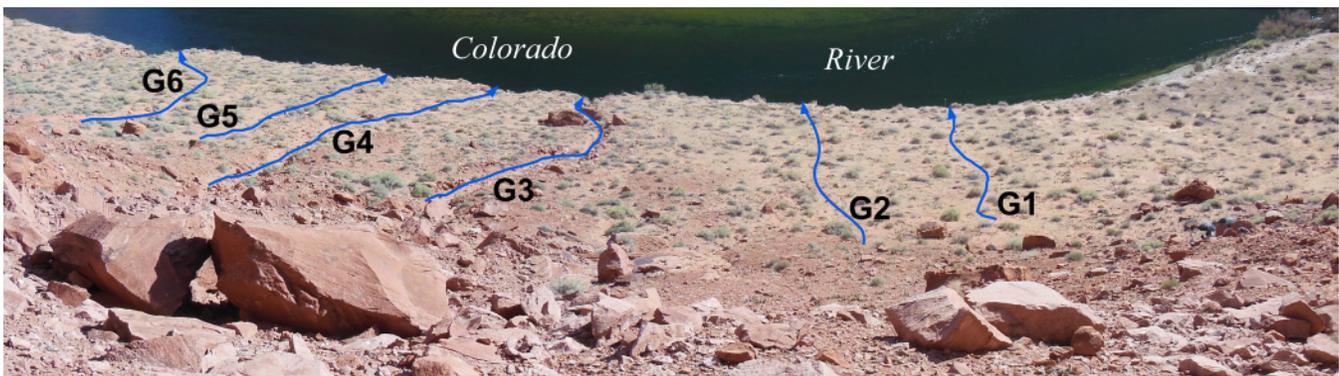
Figure 4. Site AZ:C:02:0032 survey area photo showing gully locations. Width of terrace along trace of gully G2 is ~50 m. View is to the south (see fig. 3).

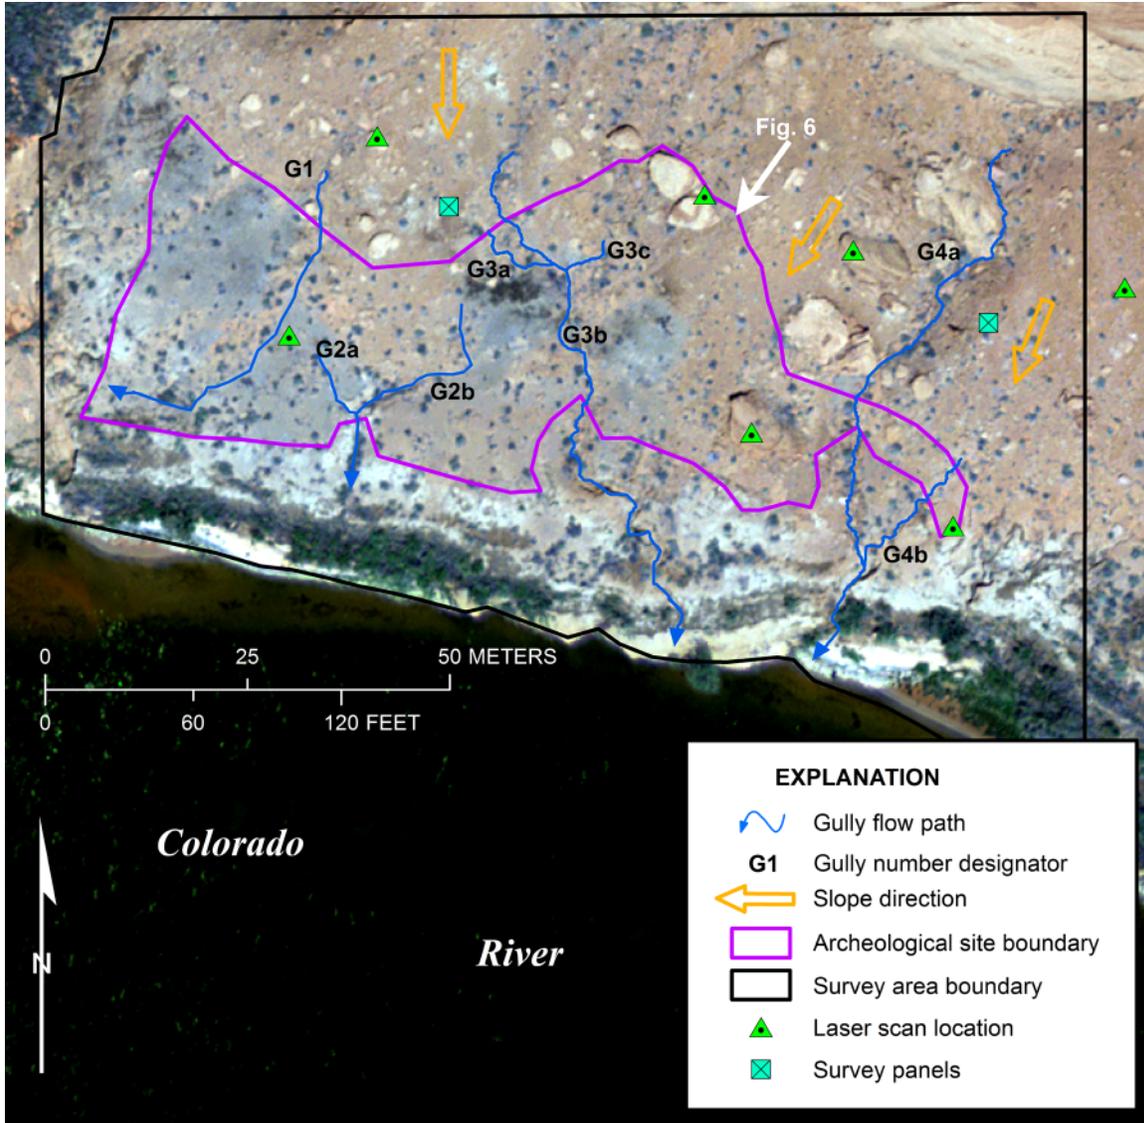
Figure 5. Site AZ:C:02:0035 survey map showing position of terrestrial lidar scanning locations, airborne lidar survey panels, and gully locations and flow paths. Three additional laser scan locations are positioned to the south and are not shown. White arrow indicates look angle of image in figure 6.

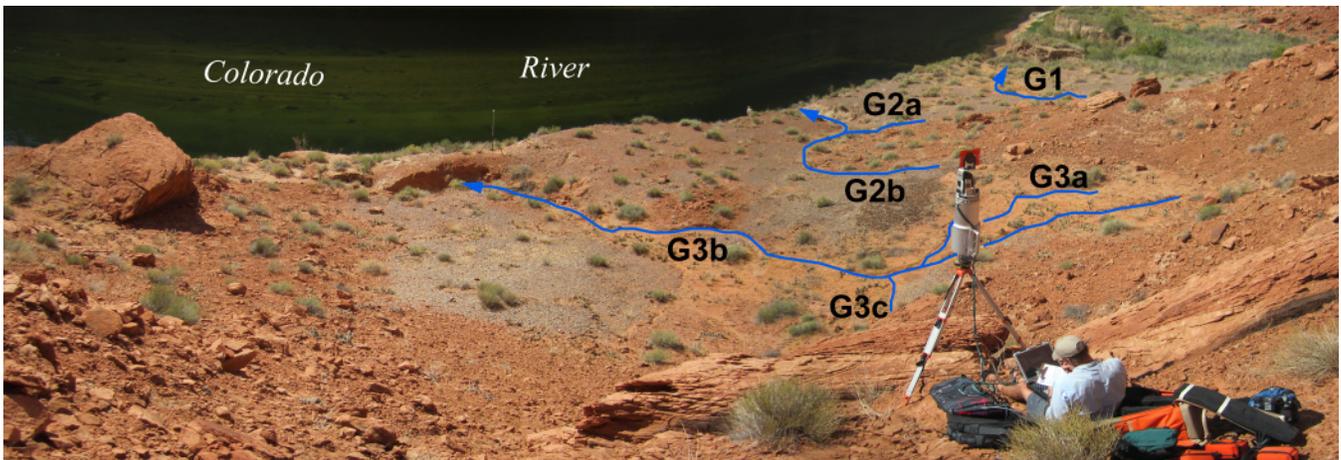
Figure 6. Site AZ:C:02:0035 survey area photo showing gully locations for G1 to G3. An additional gully (G4) is located out of view to the left of the photo. View is to the southwest (see fig. 5).

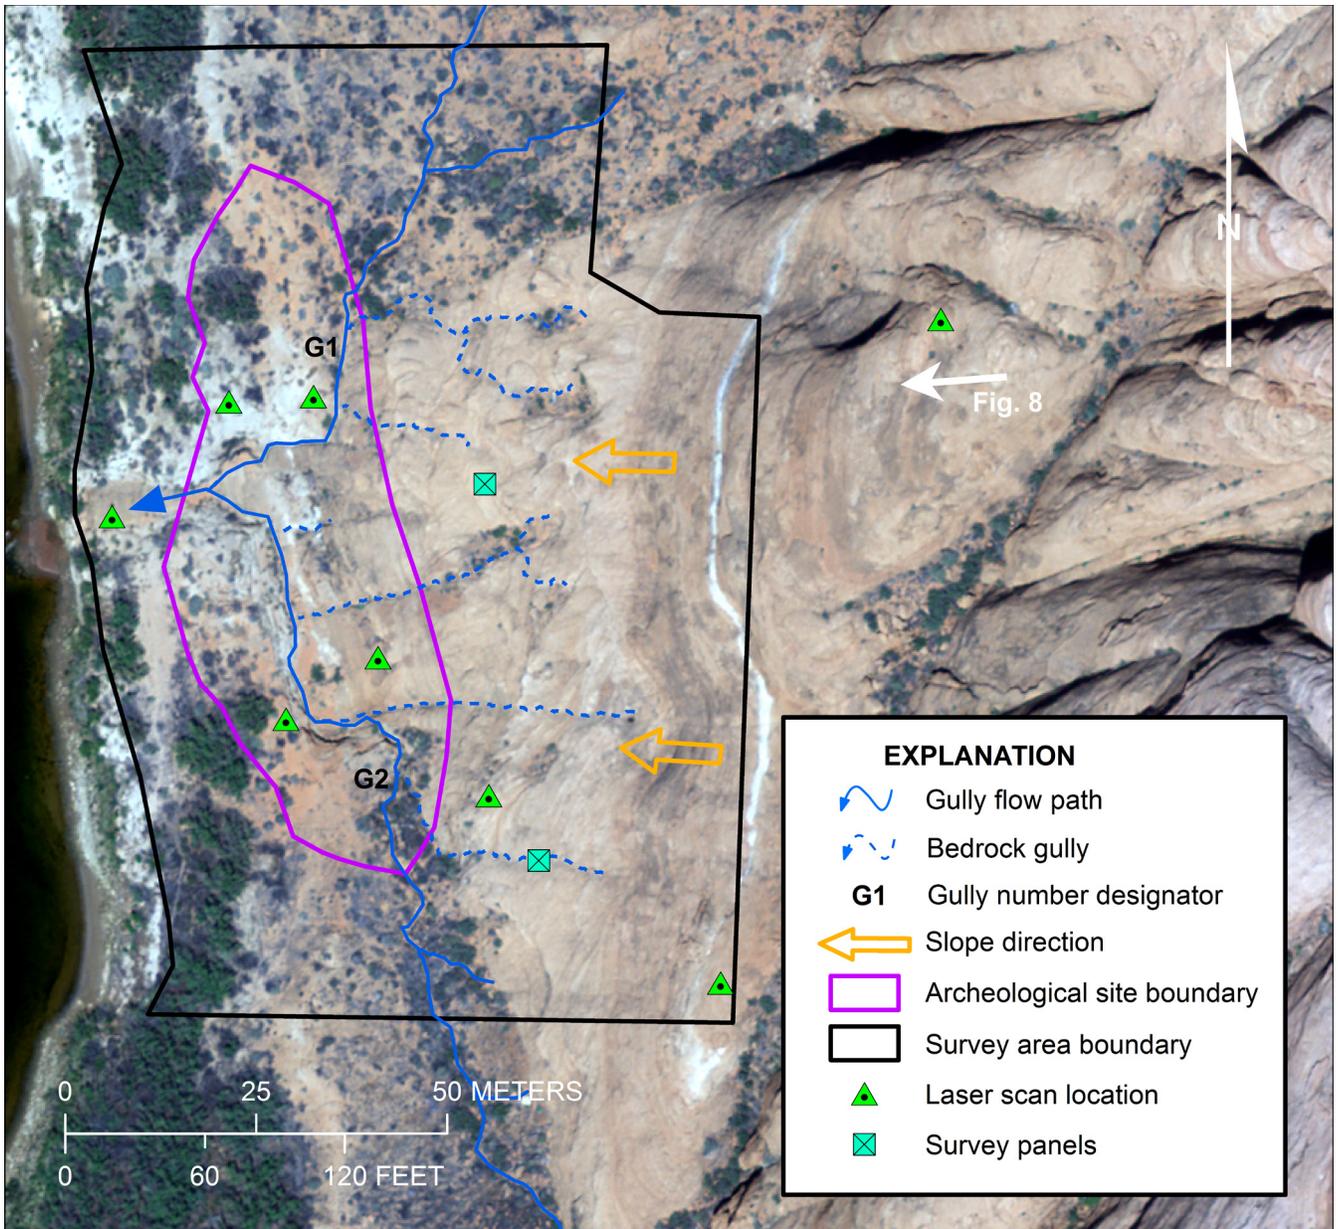
Figure 7. Site AZ:C:02:0075 survey map showing position of terrestrial lidar scanning locations, airborne lidar survey panels, and gully locations and flow paths. White arrow indicates look angle of image in figure 8.

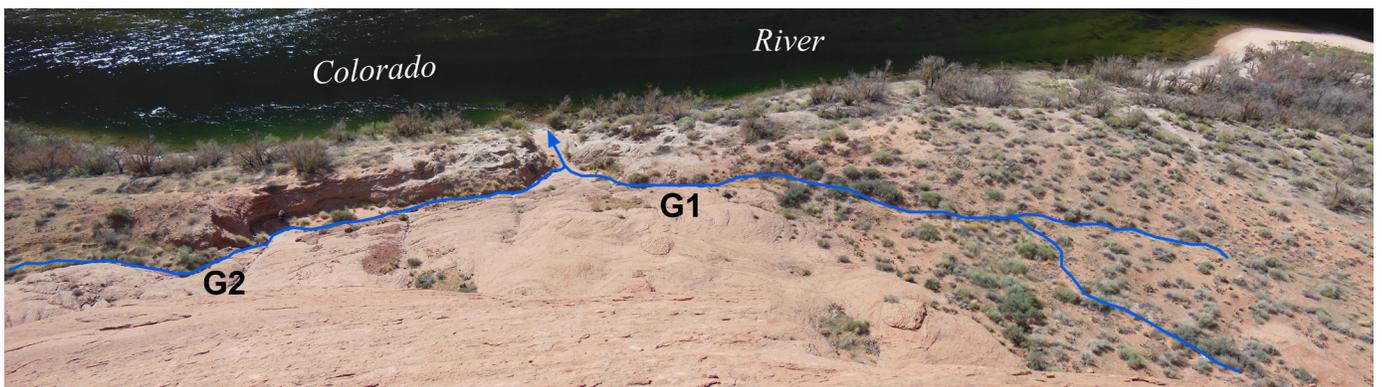
Figure 8. Site AZ:C:02:0075 survey area photo showing gully locations. Distance from “G2” label to confluence with gully G1 is ~ 40 m. View is to the west (see fig. 7).

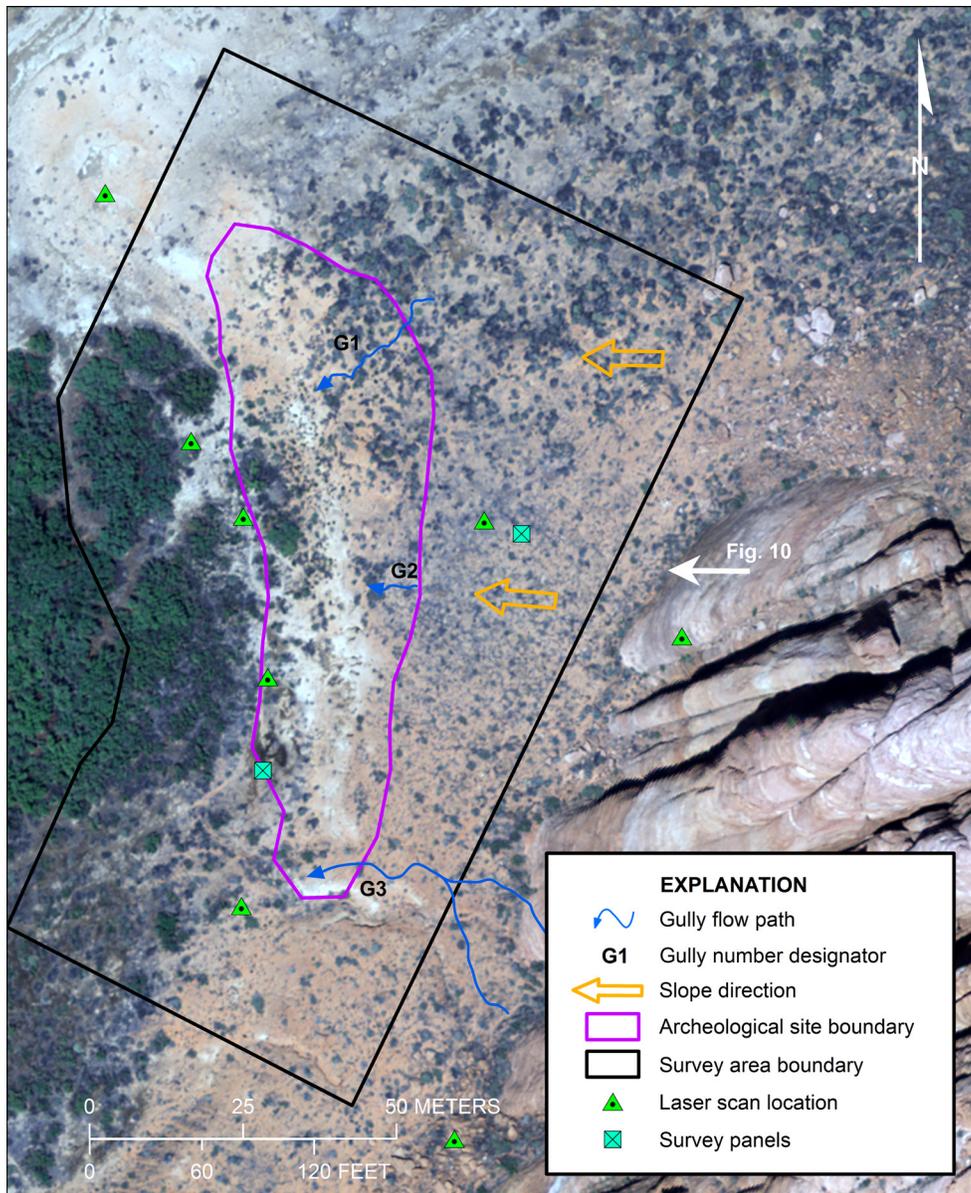
Figure 9. Site AZ:C:02:0077 survey map showing position of terrestrial lidar scanning locations, airborne lidar survey panels, and gully locations and flow paths. White arrow indicates look angle of image in figure 10.

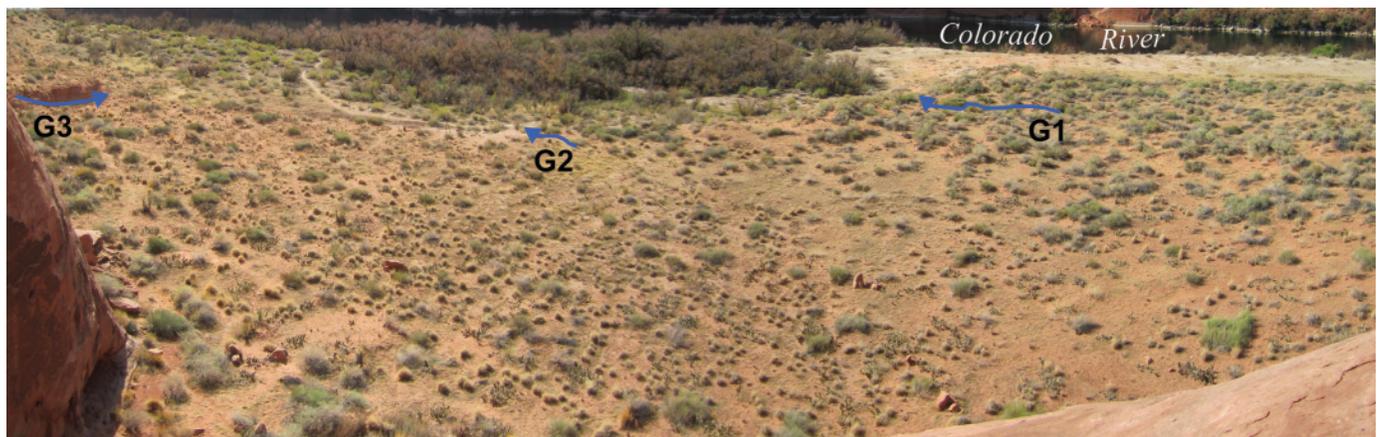
Figure 10. Site AZ:C:02:0077 survey area photo showing gully locations. Distance from bedrock cliff at lower left of image to the “G2” label is ~ 40 m. View is to the west (see fig. 9).

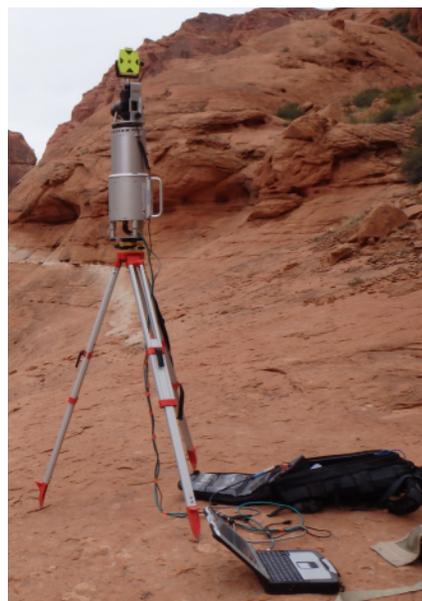
Figure 11. Photo showing terrestrial lidar data collection in Glen Canyon National Recreation Area. The laser (grey cylinder with handle) is connected to a laptop computer and batteries. A digital camera is mounted on top of the laser and provides color pixel data to the lidar point clouds. The total station prism (yellow and black backside shown) mounted on top of camera is used to georeference the instrument location.

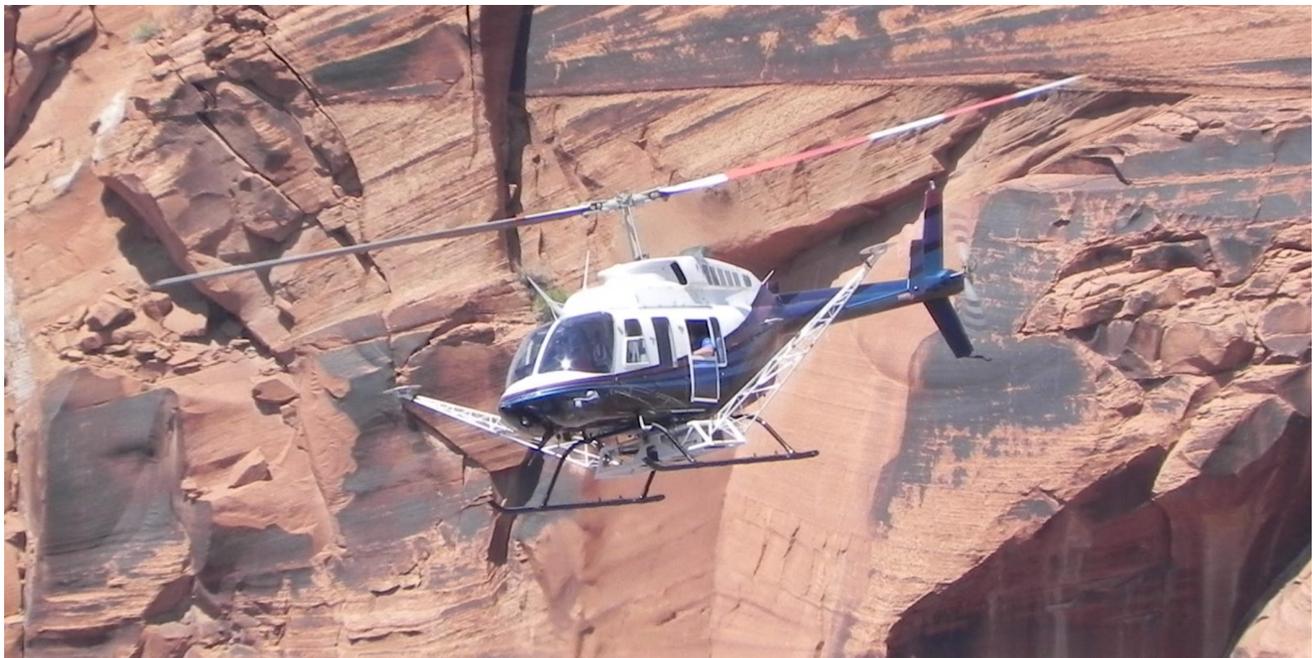
Figure 12. Photo showing airborne lidar data collection in Glen Canyon National Recreation Area. Image courtesy of Fugro Aerial & Airborne Mapping, Inc.

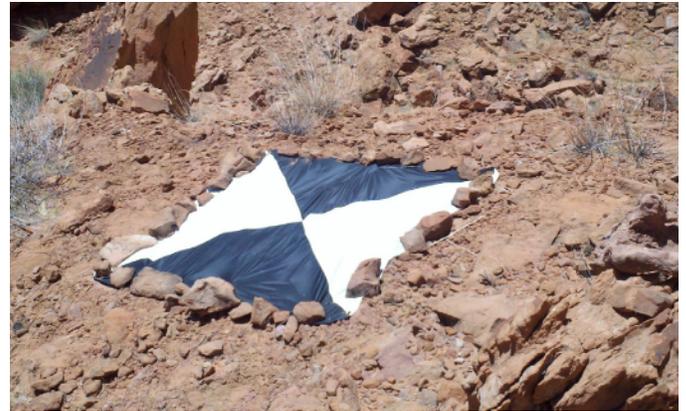
Figure 13. Photo showing iron-cross-type survey panel used for lidar data accuracy and point density comparison.

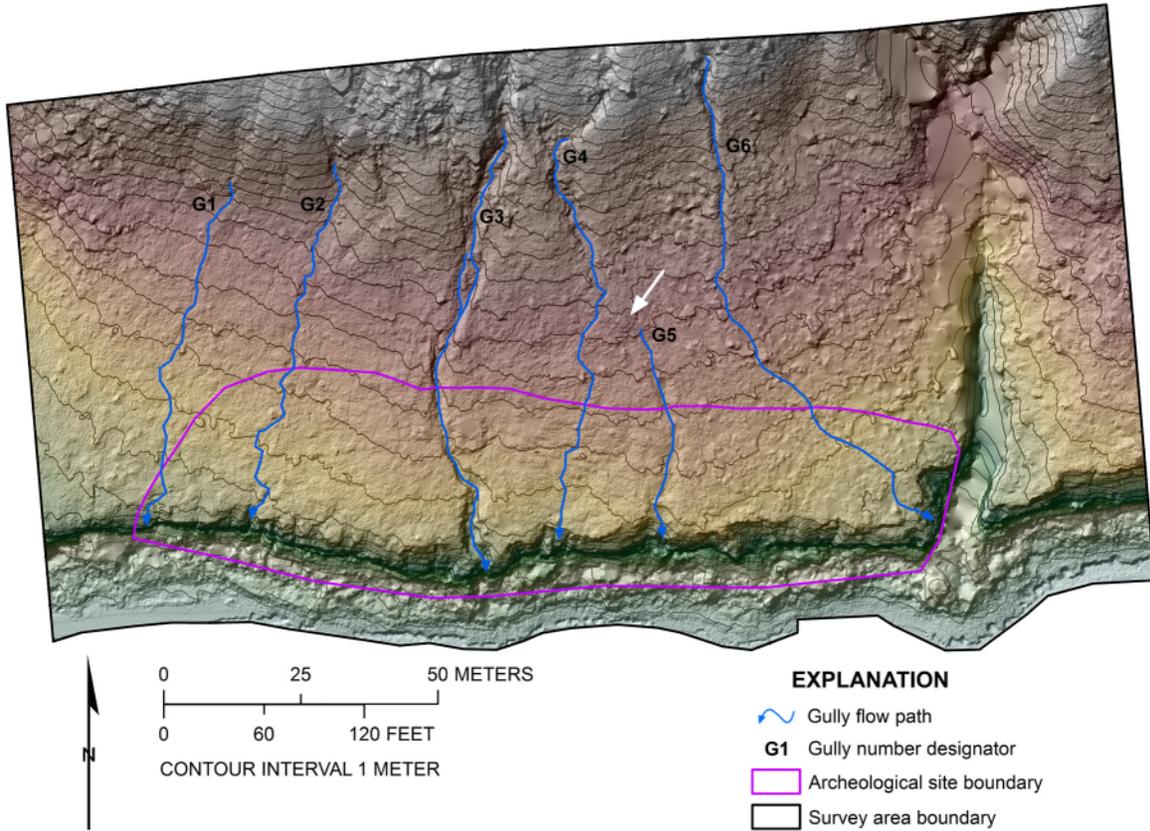
Figure 14. Site AZ:C:02:0032—Terrestrial lidar 5 cm gridded topographic surface map with 1 m contours and gully locations. Gullies are cross-referenced with geomorphology data presented in table 8. White arrow identifies location of lobe-shaped convex feature at top of gully G5 discussed in text.

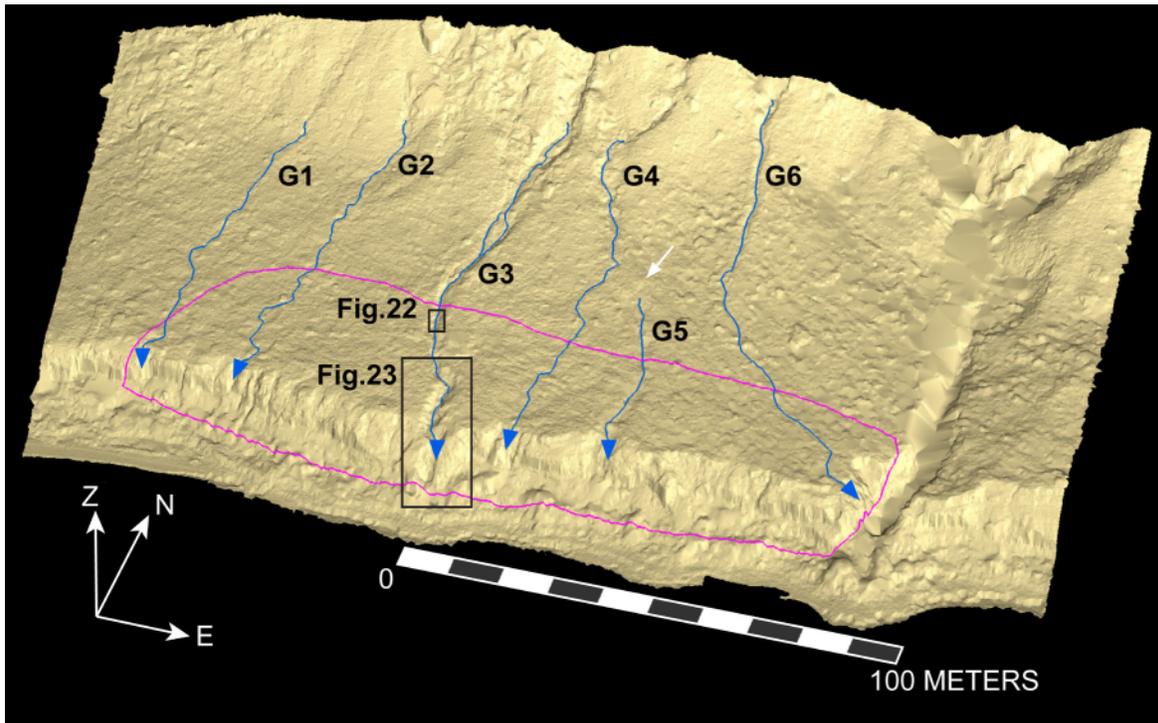
Figure 15. Site AZ:C:02:0032 site boundary (purple line)—Terrestrial lidar triangulated irregular network-based topographic surface map showing locations of gullies (blue lines). Gullies are cross-referenced with geomorphology data presented in table 8. White arrow identifies location of lobe-shaped convex feature at top of gully G5 discussed in text.

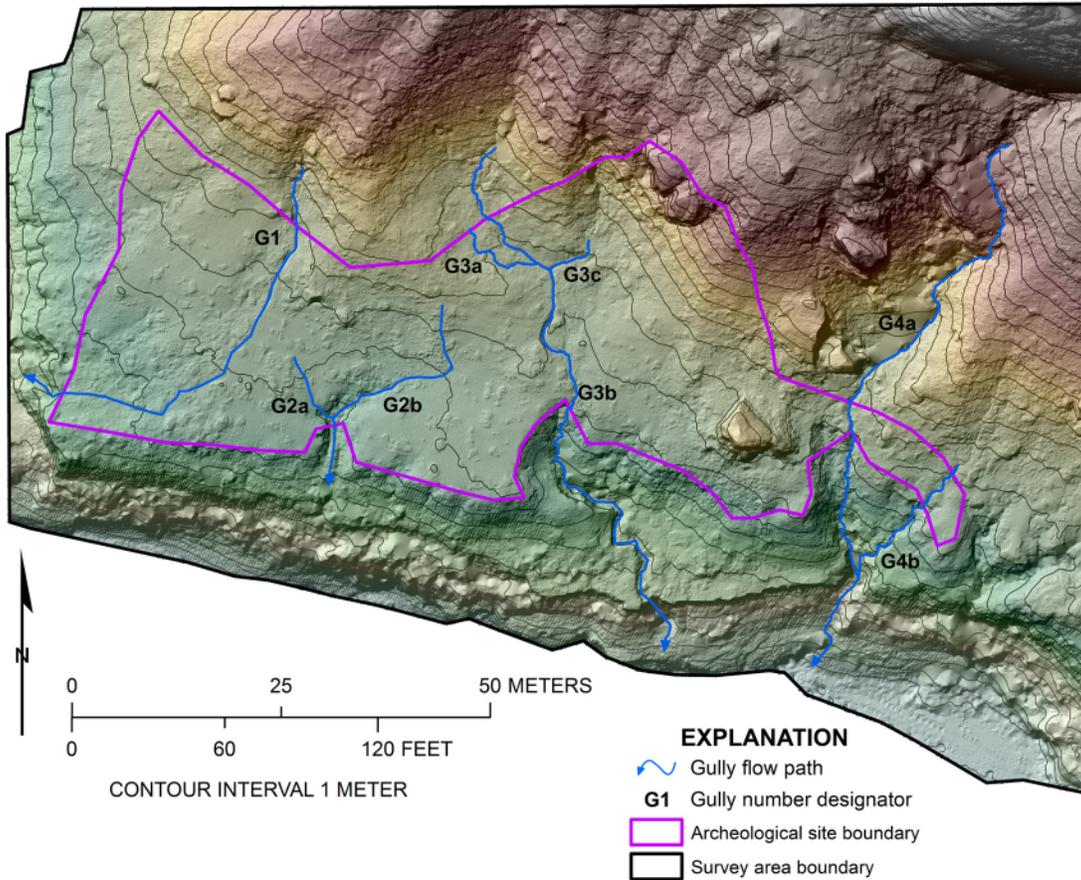
Figure 16. Site AZ:C:02:0035—Terrestrial lidar 5 cm gridded topographic surface map with 1 m contours and gully locations. Gullies are cross-referenced with geomorphology data presented in table 9.

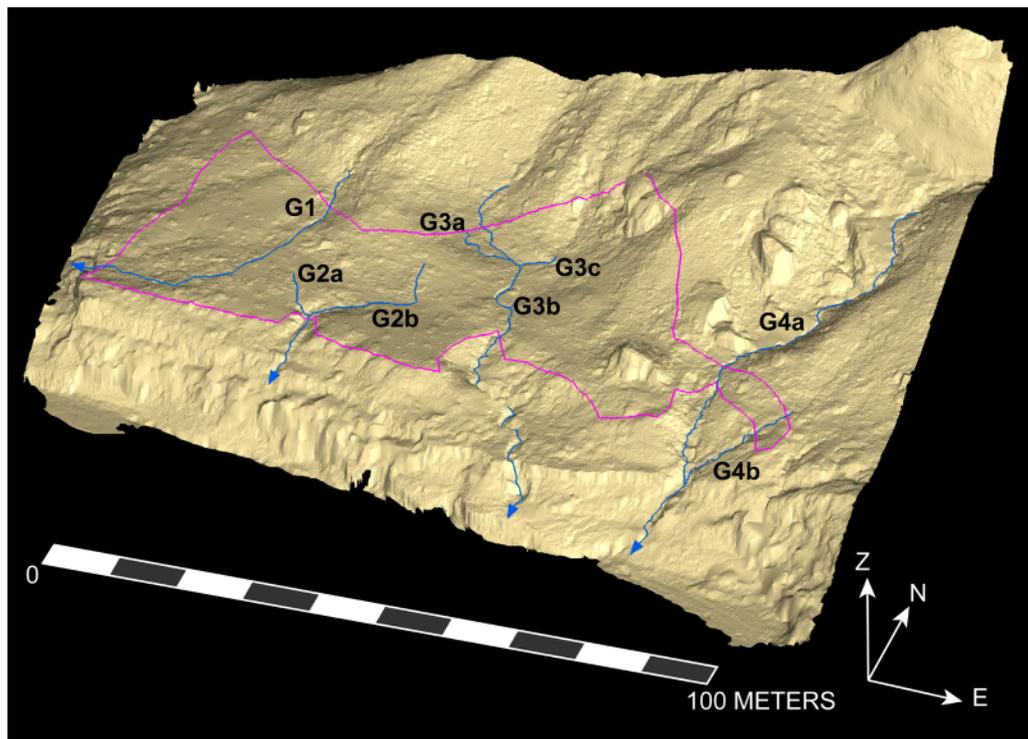
Figure 17. Site AZ:C:02:0035 (purple line)—Terrestrial lidar triangulated irregular network-based topographic surface map showing locations of gullies (blue lines). Gullies are cross-referenced with geomorphology data presented in table 9.

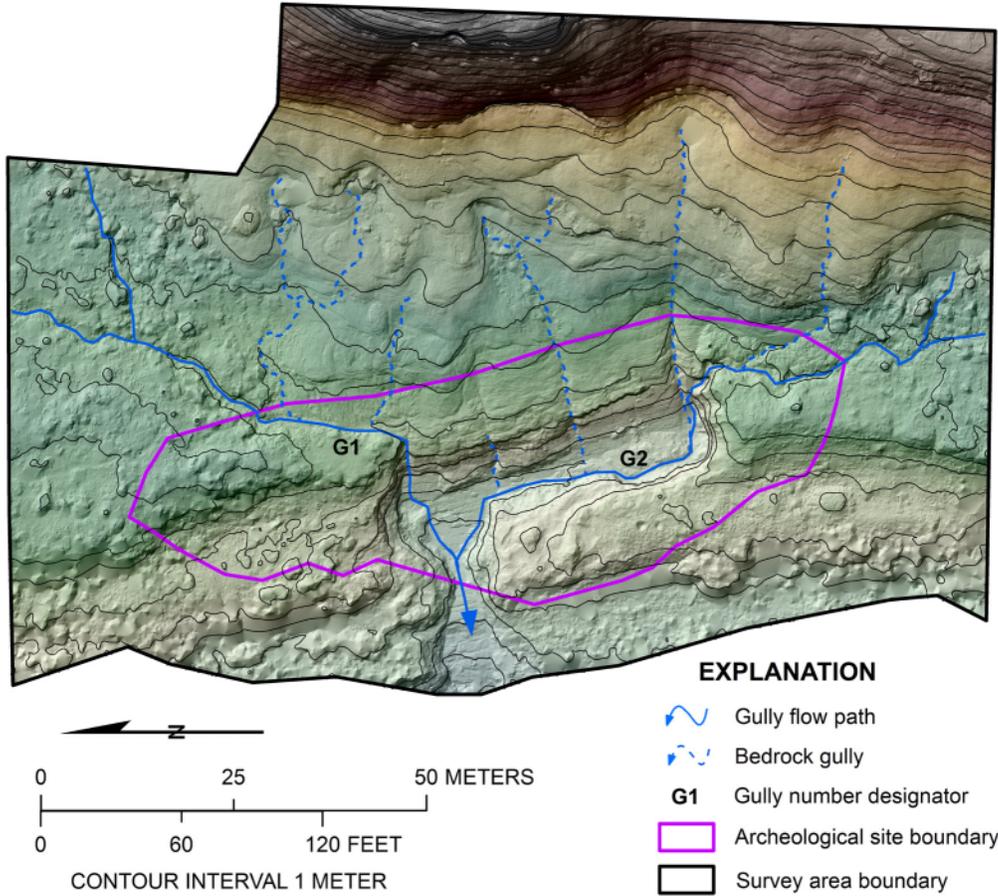
Figure 18. Site AZ:C:02:0075—Terrestrial lidar 5 cm gridded topographic surface map with 1 m contours and gully locations. Gullies are cross-referenced with geomorphology data presented in table 10.

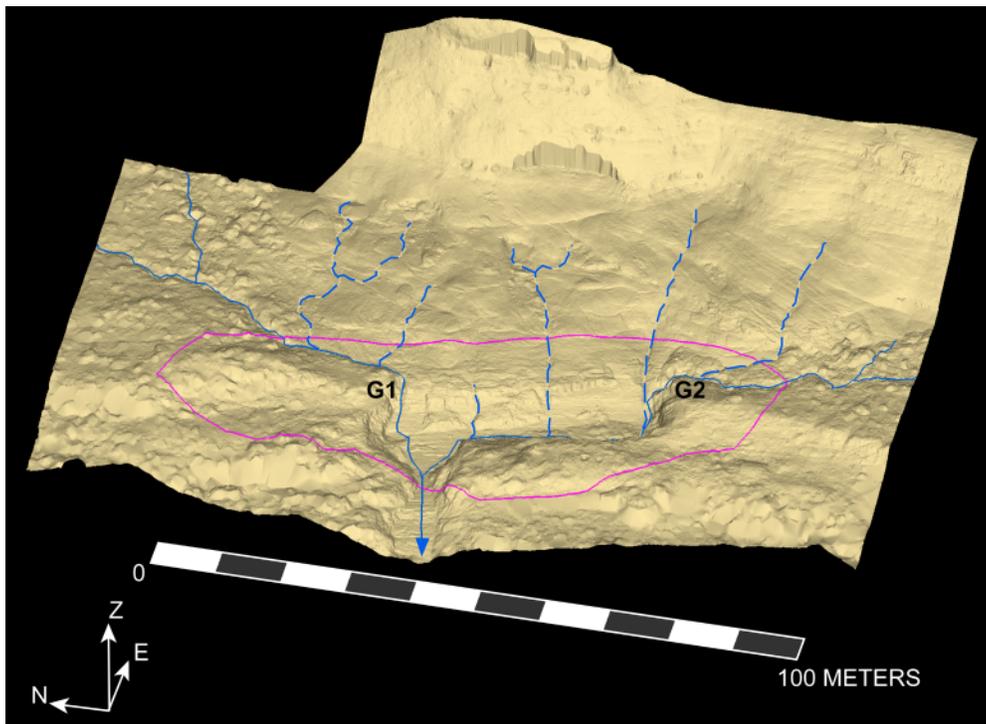
Figure 19. Site AZ:C:02:0075 (purple line)—Terrestrial lidar triangulated irregular network-based topographic surface map showing locations of gullies (blue lines). Gullies are cross-referenced with geomorphology data presented in table 10.

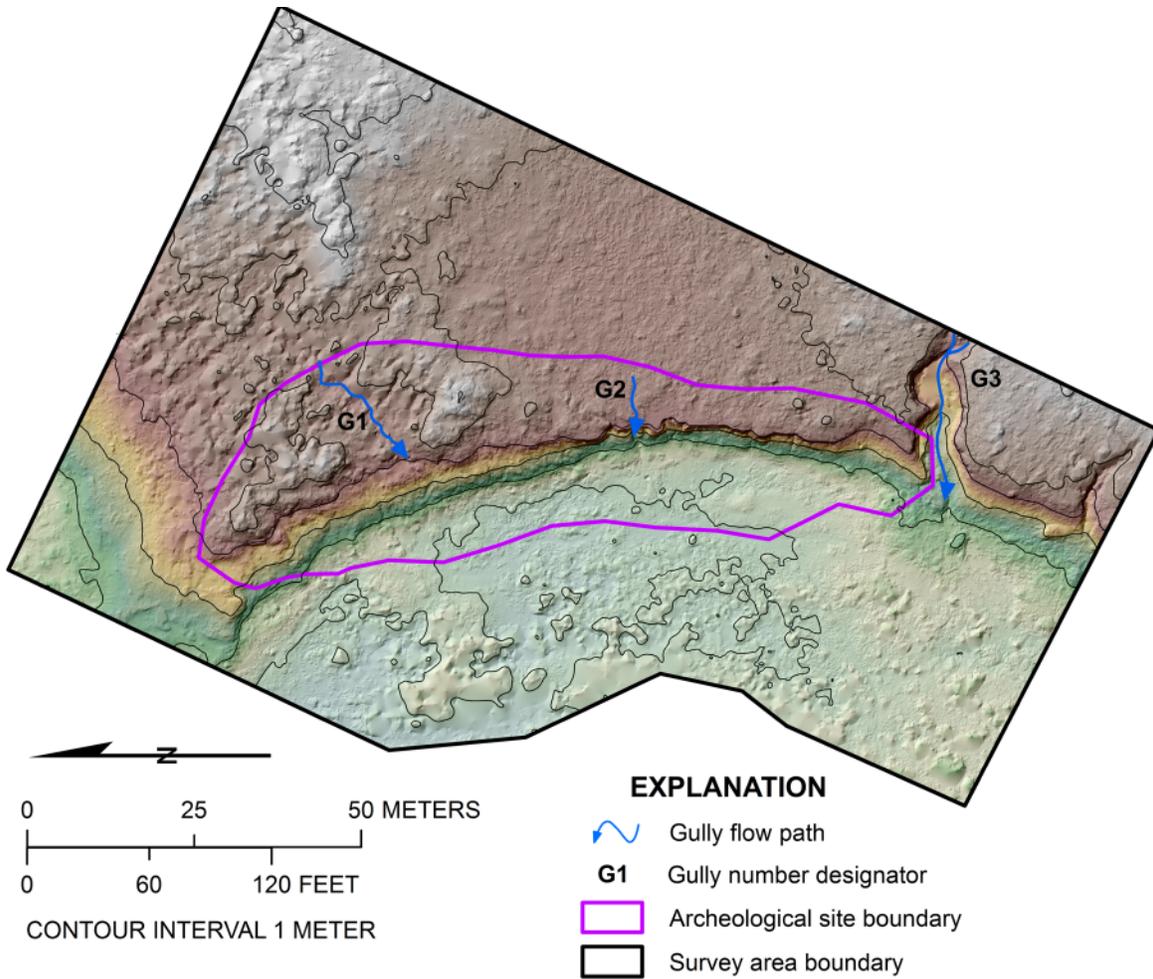
Figure 20. Site AZ:C:02:0077—Terrestrial lidar 5 cm gridded topographic surface map with 1m contours and gully locations. Gullies are cross-referenced with geomorphology data presented in table 11.

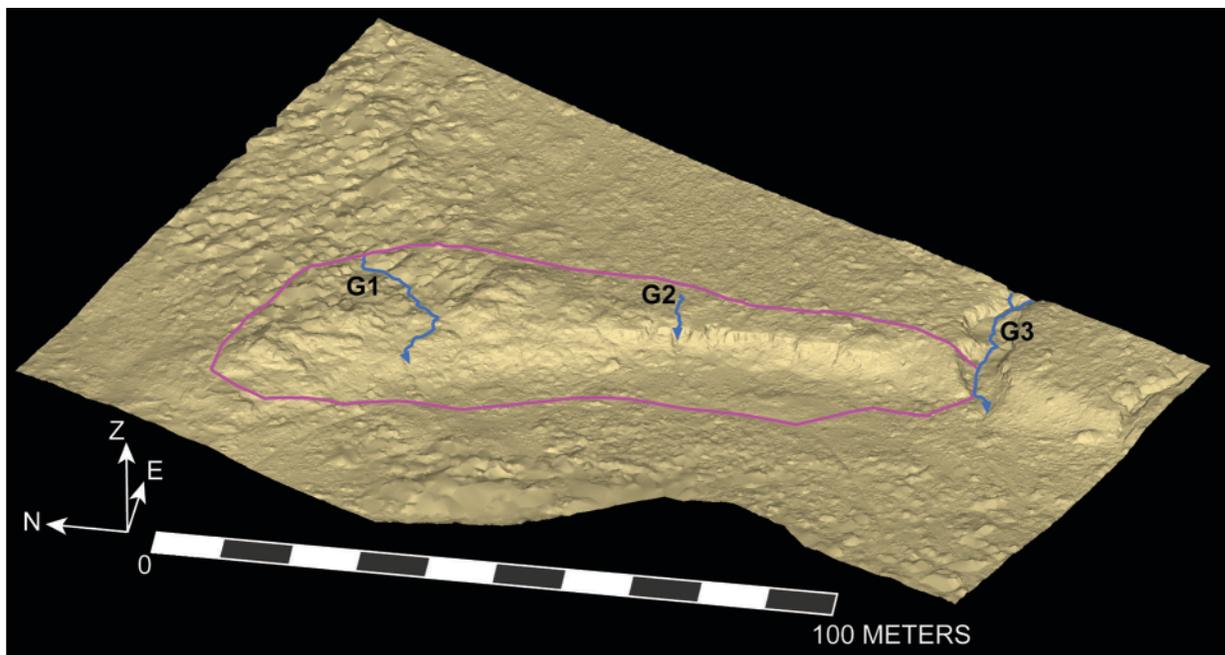
Figure 21. Site AZ:C:02:0077 (purple line)—Terrestrial lidar triangulated irregular network-based topographic surface map showing locations of gullies (blue lines). Gullies are cross-referenced with geomorphology data presented in table 11.

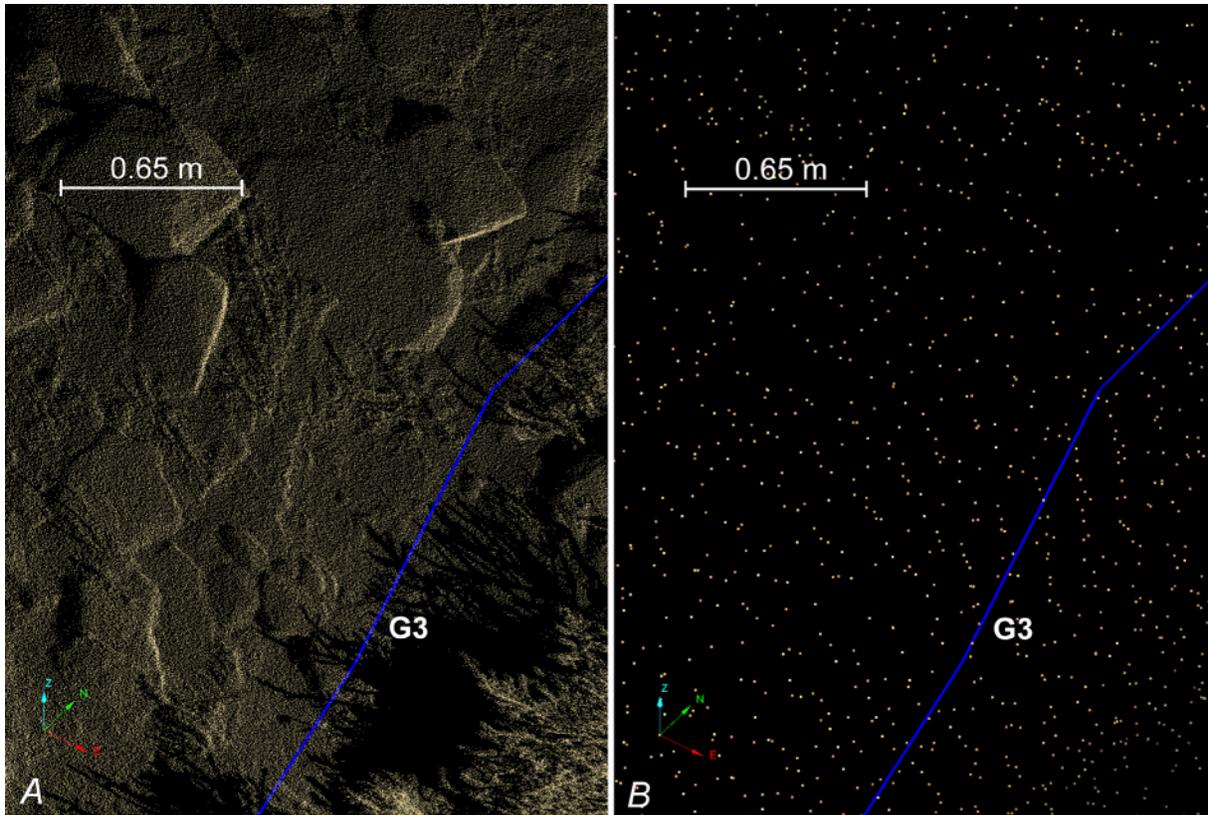
Figure 22. Point-cloud data of vegetation (lower right corner) and boulders (upper left corner) at site AZ:C:02:0032 (see fig. 15) using (A) terrestrial lidar data with ~1 cm point to point spacing, and (B) airborne lidar data with ~15 cm point to point spacing. Scale and perspective are identical in both images. Features are not identifiable in (B) due to the lower point density compared with (A).

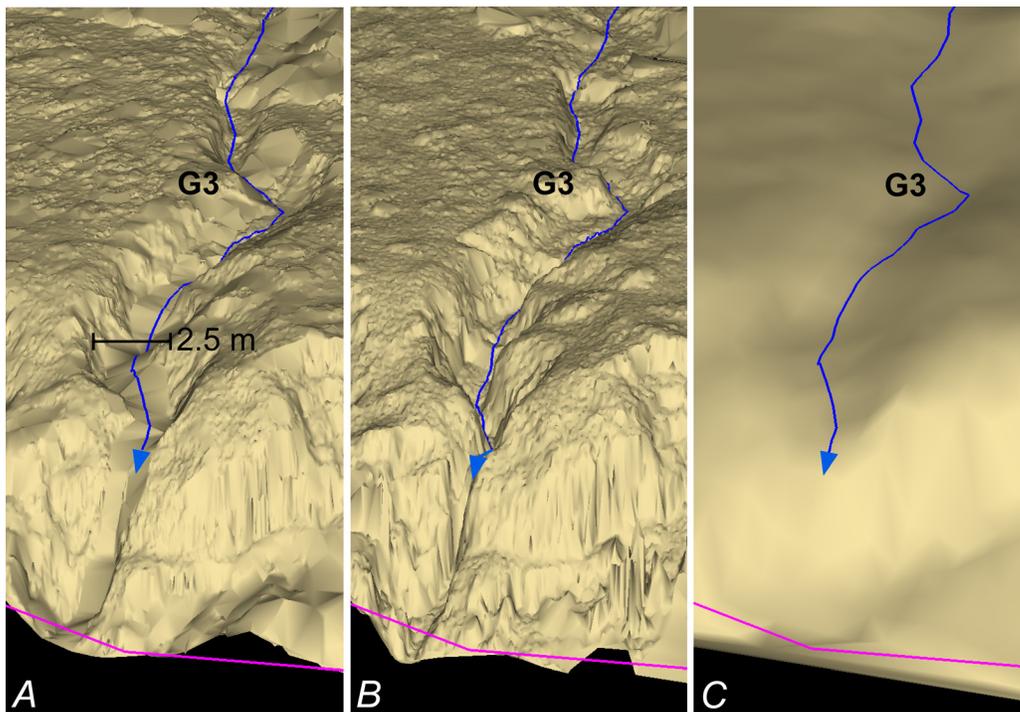
Figure 23. Surface resolution comparison at site AZ:C:02:0032, gully G3 (see fig. 15), among (A) terrestrial lidar data, (B) airborne lidar data and (C) airborne photogrammetric digital surface model data. Resolution is similar between (A) and (B), with the exception of the gully bottom that the airborne lidar characterized in greater detail. Resolution in (C) is less clear at this scale due to wider (1 m) point spacing in the digital surface model.
