High-Resolution Topography and Geomorphology of Select Archeological Sites in Glen Canyon National Recreation Area, Arizona

Scientific Investigations Report 2014–5126

By Brian D. Collins, Skye C. Corbett, Joel B. Sankey, and Helen C. Fairley

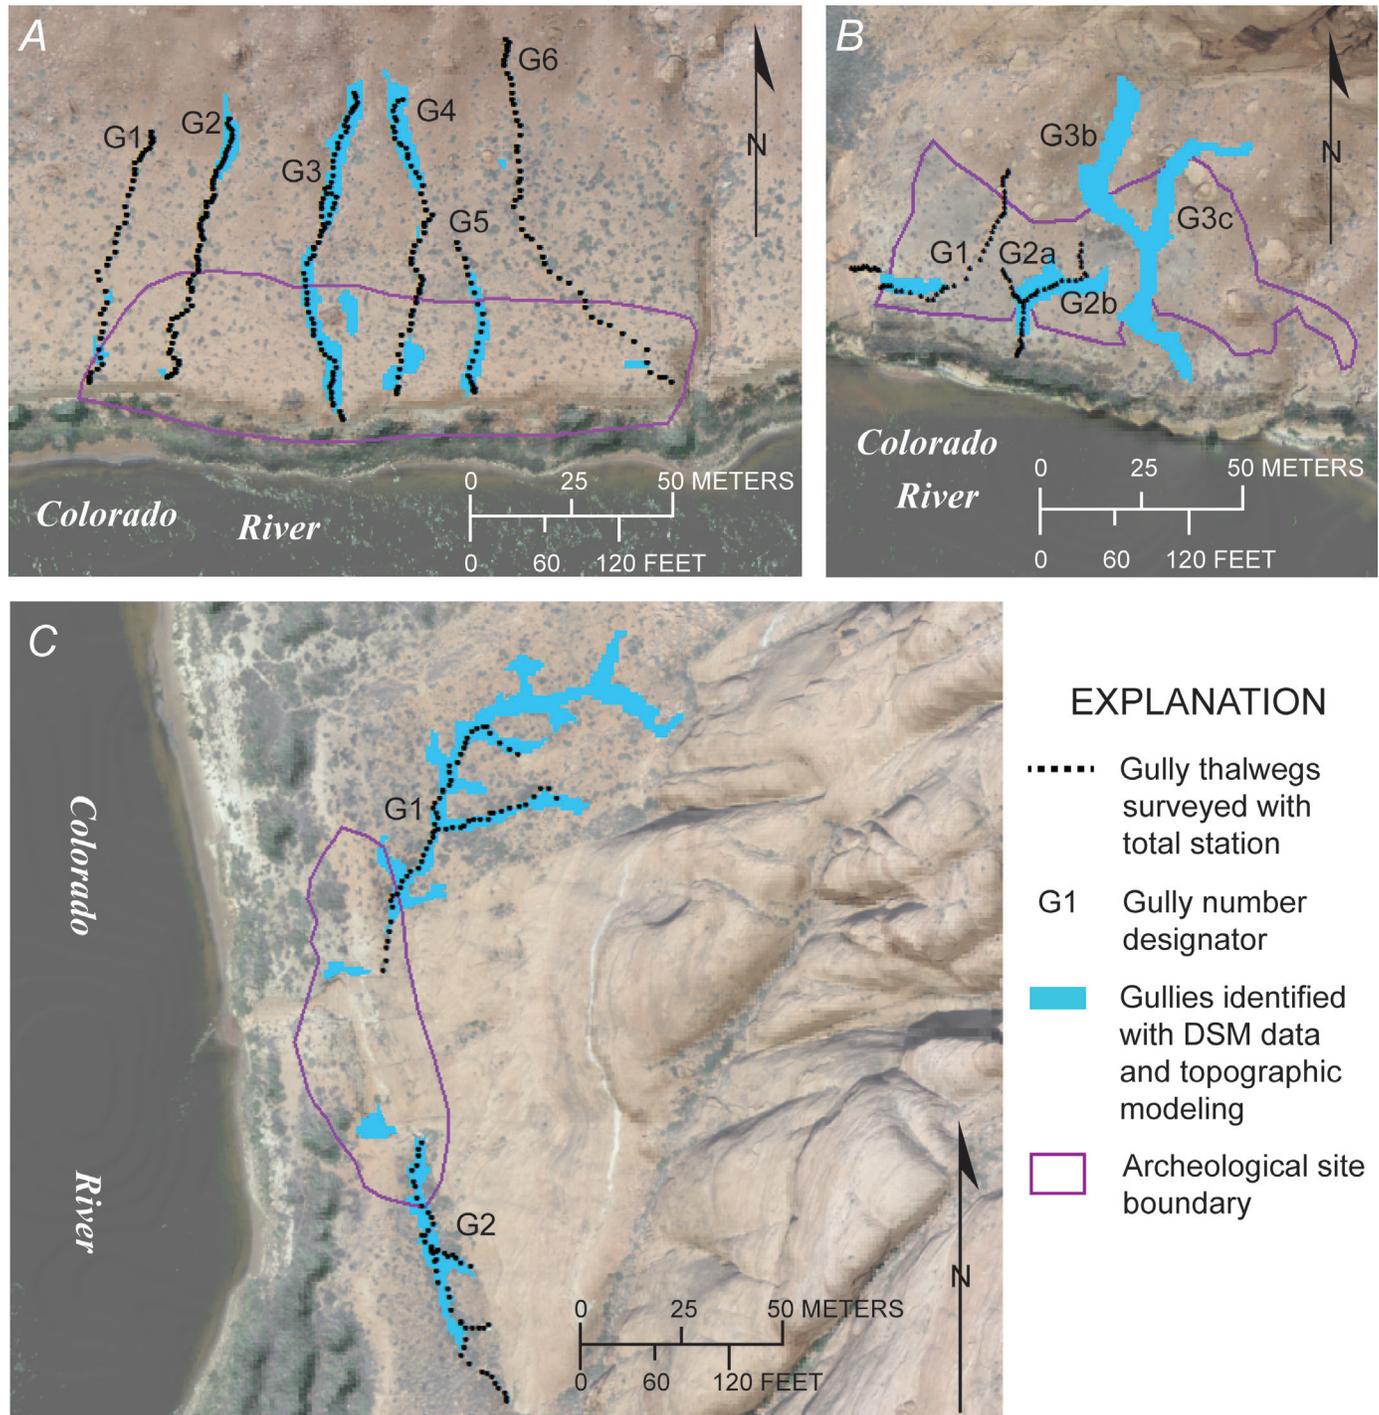
Figure 24. Results of objective gully delineation using airborne photogrammetric digital surface model data and topographic modeling at sites (A) AZ:C:02:0032, (B) AZ:C:02:0035 and (C) AZ:C:02:0075. Thalweg lengths were positively identified for 40-, 50-, and 90-percent of the total station surveyed length for the three sites, respectively. Increasing positively identified percentages reflect an increase in overall terrain slope at the sites; shallow gullies at flatter sites were not easily detected. Base map is composed of the digital surface model-derived hillshade overlain with imagery.

The more significant utility of DSM data is in performing landscape-scale geomorphological characterization, including watershed flow routing. Whereas these same routines can be performed using lidar data, photogrammetric DSMs are typically collected over much larger areas (the data presented herein being part of a larger canyon-wide 450 km long data set; Davis, 2012), thereby setting a much larger scale for regional analysis. Given our interest in identifying gullies using remotely sensed data, we evaluated the ability of the DSM data to automatically identify gully thalwegs (a thalweg is a line following the lowest points of a valley) using topographic modeling methods relative to conventional total station field surveying methods at three of the archeological sites (AZ:C:02:0032, AZ:C:02:0035, AZ:C:02:0075). We combined overland flow accumulation (ArcHydro Tools in ArcGIS v. 10.1, <http://www.esri.com/>; Greenlee, 1987; Jensen and Domingue, 1988; Tarboton and others, 1991) with plan convexity and roughness analyses (IDL programming language routine “TOPO_DOIT” in ENVI v. 4.8 software, <http://www.exelisvis.com/>) in a geographic information system (GIS) to objectively delineate gullies previously identified during field site visits (see Sankey and Draut, 2014). Our results (fig. 24) indicate that the DSM data can identify portions of gullies, but they are of limited utility for identifying the entire thalweg; in particular, shallow and narrow sections of gullies were not detectable due to the 1 m resolution of the data. The percentage of gully length identification (compared to the field survey data) was higher (90 percent) for areas with more deeply incised gullies (AZ:C:02:0075) compared to those with shallower gully cross-sections (AZ:C:02:0032; 40 percent), highlighting both the utility and limitation of DSM data for performing this type of analysis.
