Assessment of the Spatial Extent and Height of Flooding in Lake Champlain During May 2011, Using Satellite Remote Sensing and Ground-Based Information

Scientific Investigations Report 2014–5163

By David M. Bjerklie, Thomas J. Trombley, and Scott A. Olson

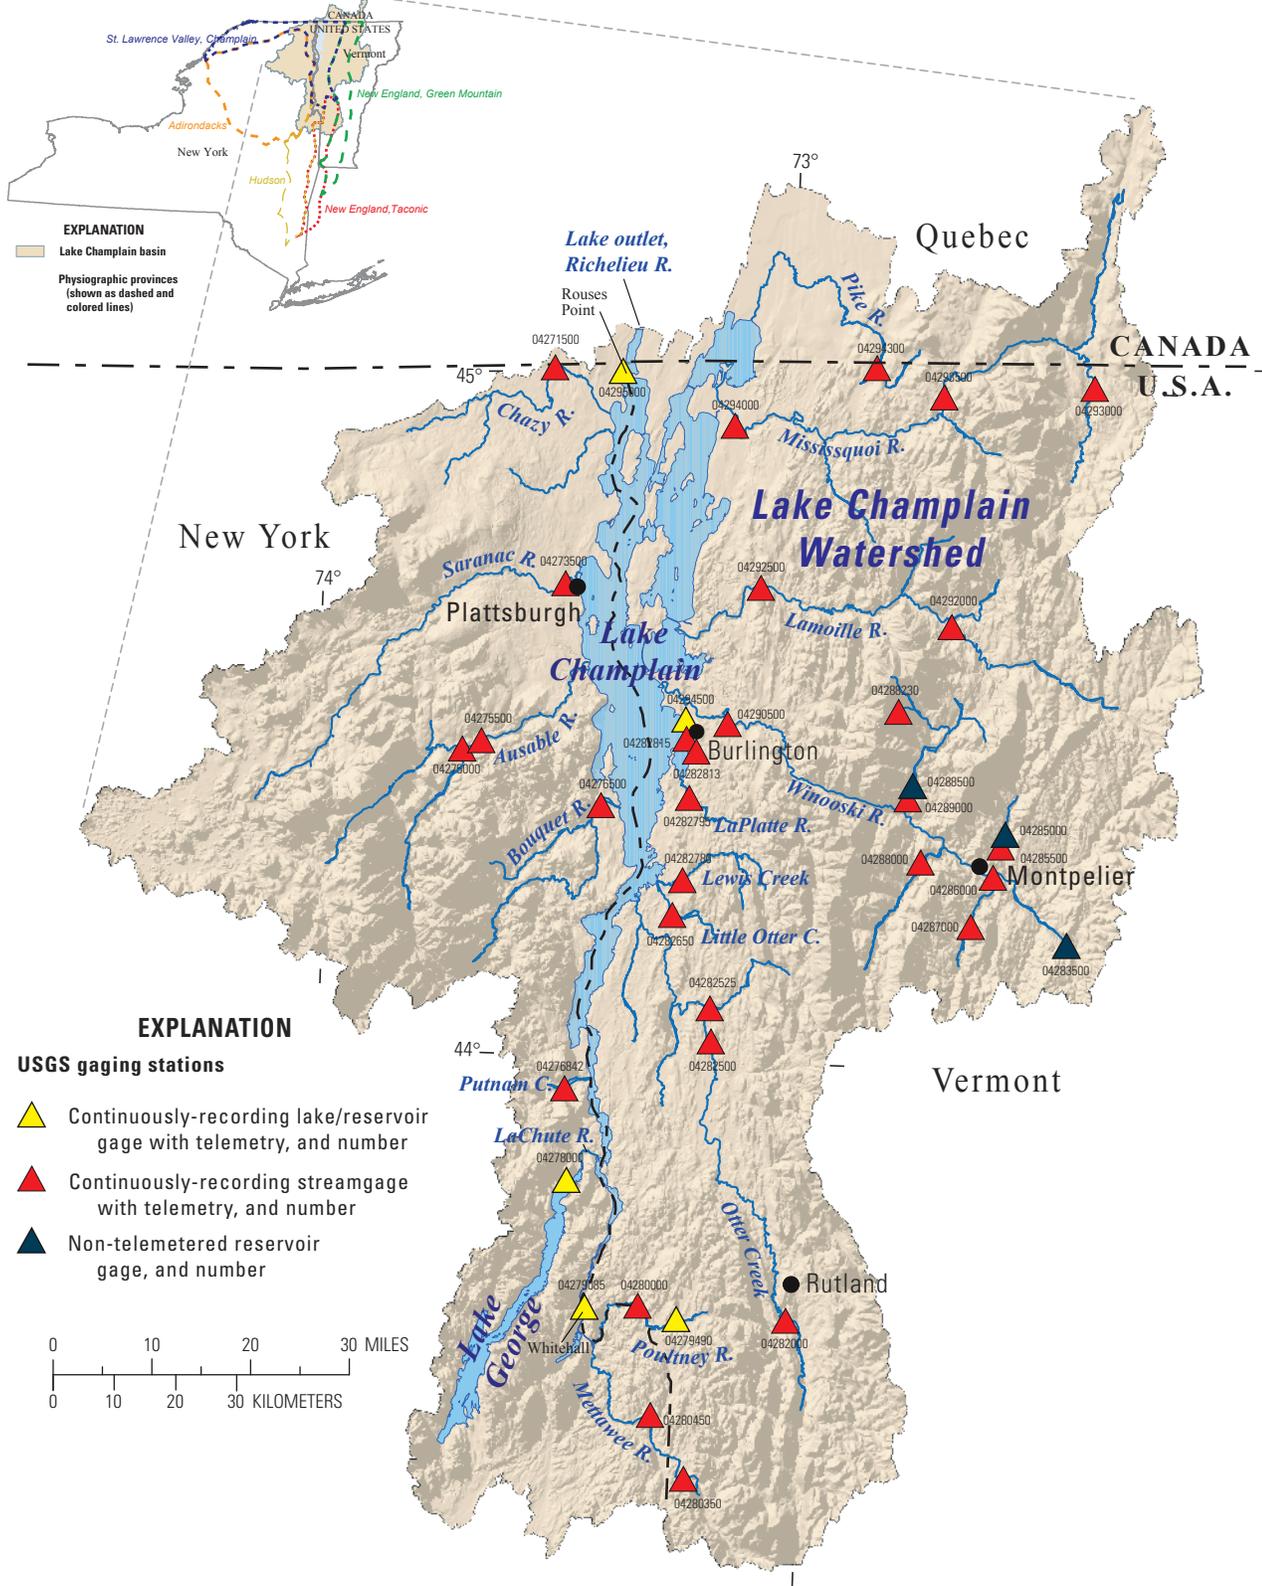
Figure 1. Lake Champlain Watershed and U.S. Geological Survey streamgages and lake/reservoir stage gages; from U.S. Geological Survey (2013a).

Lake Champlain lies in a broad valley between the Adirondack Mountains of New York and the Green Mountains of Vermont (fig. 1). The Lake Champlain Basin covers 8,234 square miles (mi²) in New York, Vermont, and Quebec, Canada, with the lake occupying only 5.4 percent of the basin (approximately 440 mi²). The lake extends 120 miles (mi) from Whitehall, N.Y., northward to the United States-Canadian border where it outflows into the Richelieu River in Quebec, which flows into the St. Lawrence River and eventually into the Atlantic Ocean at the Gulf of St. Lawrence. The lake has a surface area of approximately 435 mi² when the lake surface lake level is at its mean value of 96.5 feet (ft; 29.5 meters [m]; Shanley and Denner, 1999) with 587 mi of total shoreline (Lake Champlain Basin Program, 2002). The lake has three distinct regions: a narrow riverlike region at the southern end of the lake, a wide central region, and a wide northern region that includes several large islands. The largest rivers that flow into Lake Champlain include the Mississquoi, Lamoille, and Winooski Rivers and Otter Creek in Vermont and the Saranac, Ausable, La Chute (flowing from the outflow of Lake George into Lake Champlain), Poultney (flowing into the southern end of the lake), and Bouquet Rivers in New York. Lake Champlain was formed about 12,000 years ago as the last glacial period came to an end and the retreating glaciers left behind a large body of freshwater which included the Great Lakes, Lake Champlain, and much of the St. Lawrence River Valley (Lake Champlain Research Consortium, 2004).

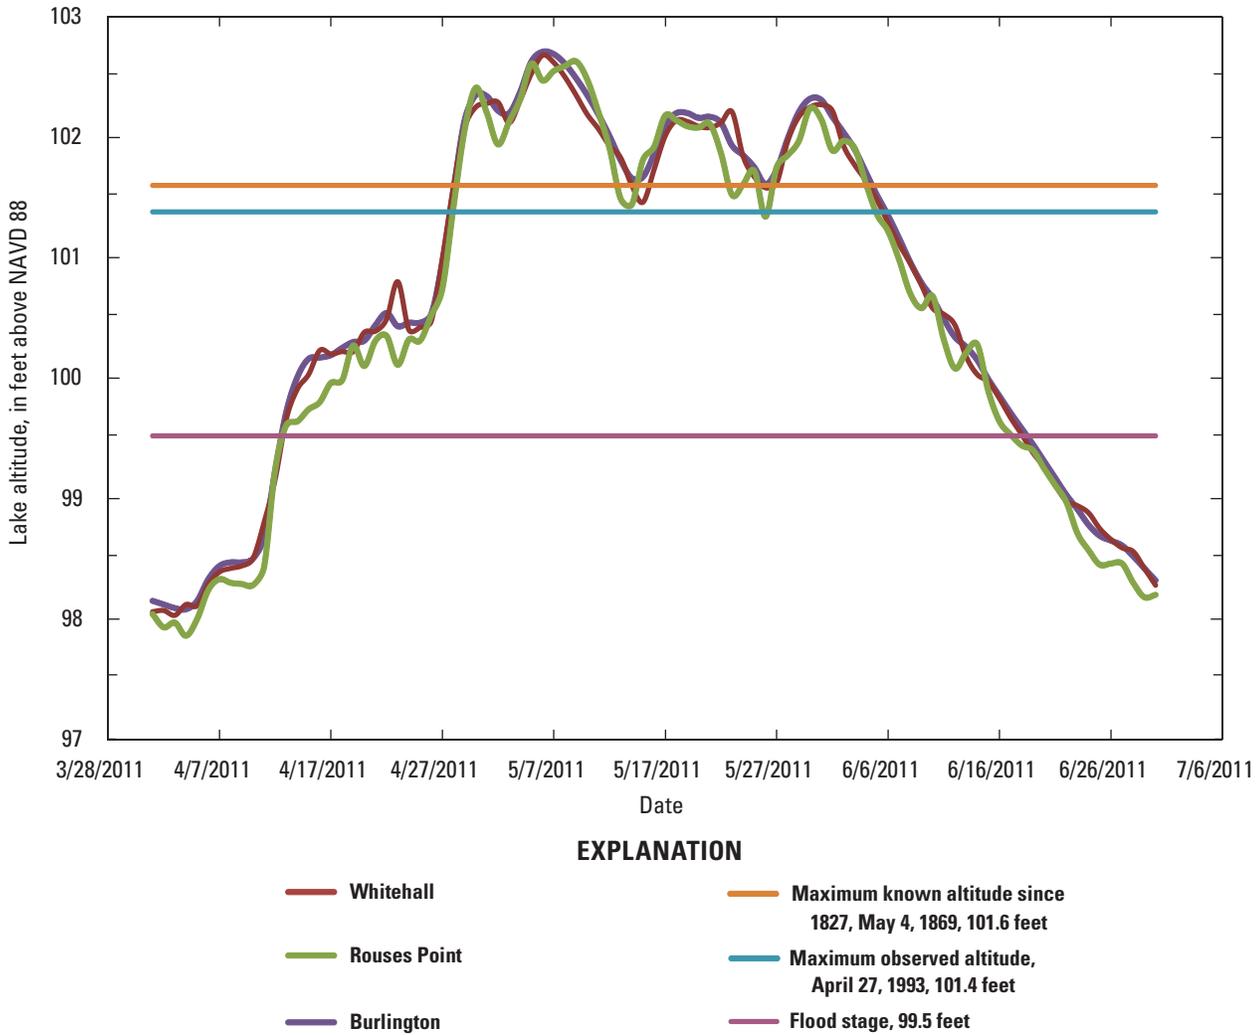
Figure 2. Daily mean lake level at the Burlington, Vermont, Rouses Point, and Whitehall, New York, gages from April to June 2011; from National Oceanic and Atmospheric Administration (2012).

The USGS maintains three continuously recording lake stage sensors with telemetry on Lake Champlain, including gages at Whitehall and Rouses Point, N.Y., and Burlington, Vt. The Rouses Point gage is located at the lake outlet and head of the Richelieu River and has records extending back to 1871. The gage records extend back to 1907, and records from the Whitehall gage extend back to 1998. Hydrographs of Lake Champlain water level during the height of the flooding from April 28 through June 15, 2011, for all three gages are shown on figures 2 and 3. Daily mean lake levels recorded at Burlington, Vt. (gage 04294500), from April to June 2011 are shown in figure 2. Continuous lake levels (plotted at 15-minute intervals, also from April to June 2011) through the period of flooding for the Burlington gage, the Whitehall gage (04279085), and the Rouses Point gage (04295000), are shown in figure 3. The daily mean water level in the lake fluctuated from 100 to 102.7 ft during May, remaining above the National Weather Service flood stage of 99.5 ft from early April to mid-June, and remaining above the highest known historic lake level of 101.6 ft (since recordkeeping began in 1827) and maximum measured lake level at the Burlington gage of 101.4 ft (1993) for most of May. The 15-minute lake levels for all three lake level gages (fig. 3) show the subdaily variation. The data show that daily variation can be as much as 0.4 ft, with the greatest fluctuation seen at Whitehall, located at the narrow southern end of the lake. The peak 15-minute lake levels were higher than the daily mean at all three stations. At Whitehall, the daily mean peak was 102.6 ft and the 15-minute peak was 103.1 ft, at Rouses Point the daily mean was 102.6 ft and the 15-minute peak was 102.7 ft, and at Burlington the daily mean peak was 102.7 ft and the 15-minute peak was 102.8 ft.

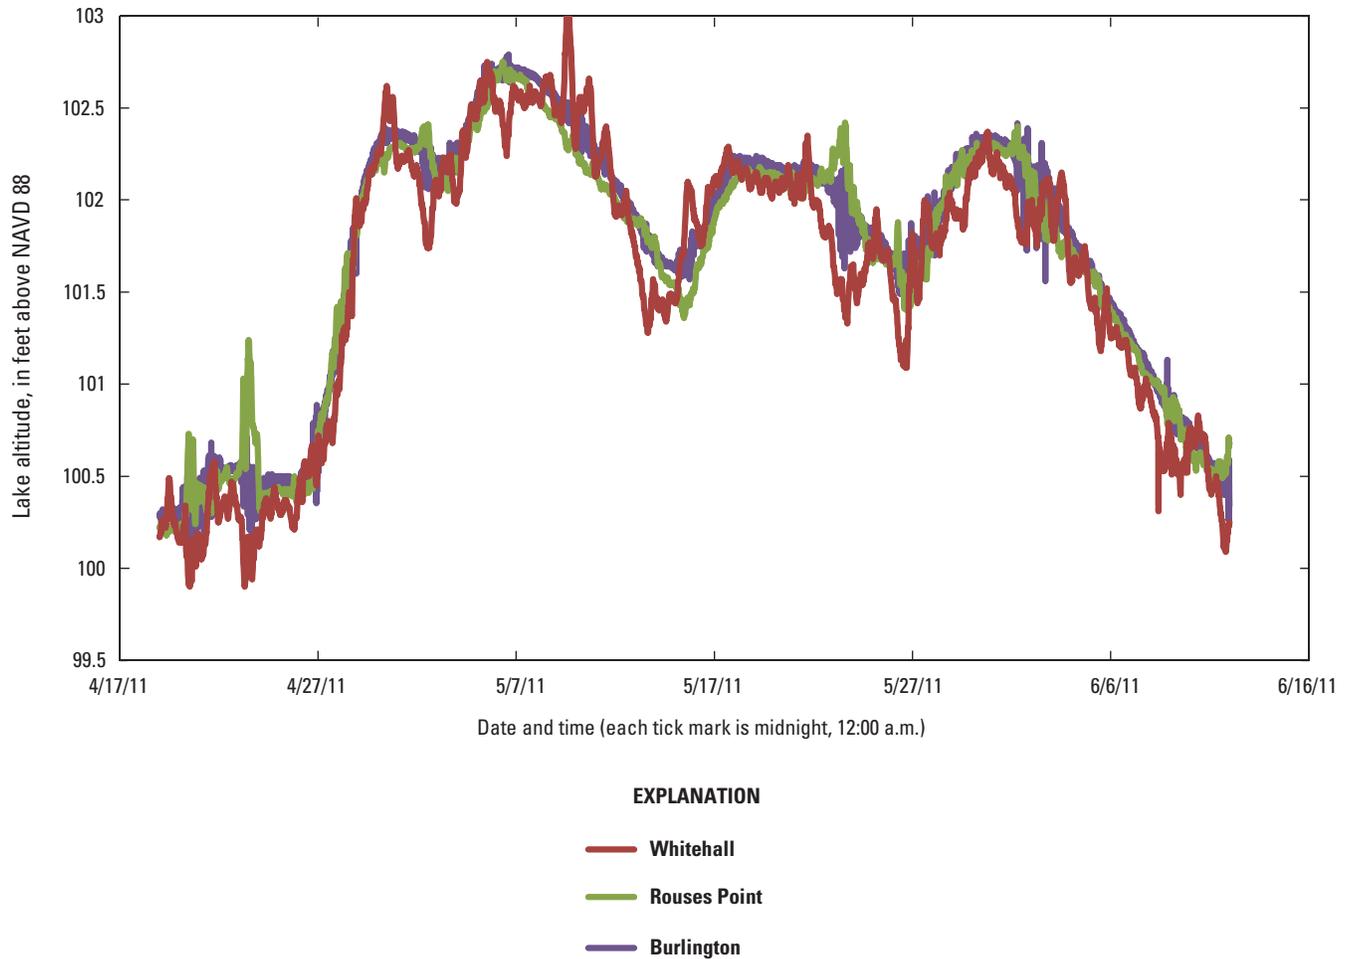
Figure 3. 15-minute lake level at the Rouses Point, New York, Burlington, Vermont, and Whitehall, N.Y., gages for the period from April to June 2011.

Gage levels at Rouses Point, Burlington, and Whitehall substantiate the differences in lake levels in Lake Champlain. The 15-minute recorded water levels at the three gages from April 19 to June 11, 2011, show that the daily mean lake water level was higher at Burlington than at Whitehall (by about 0.1 ft, mean difference of 0.085 ft) and higher at Burlington than at Rouses Point (also by about 0.1 ft, mean difference of 0.068 ft). The daily mean lake water-level difference

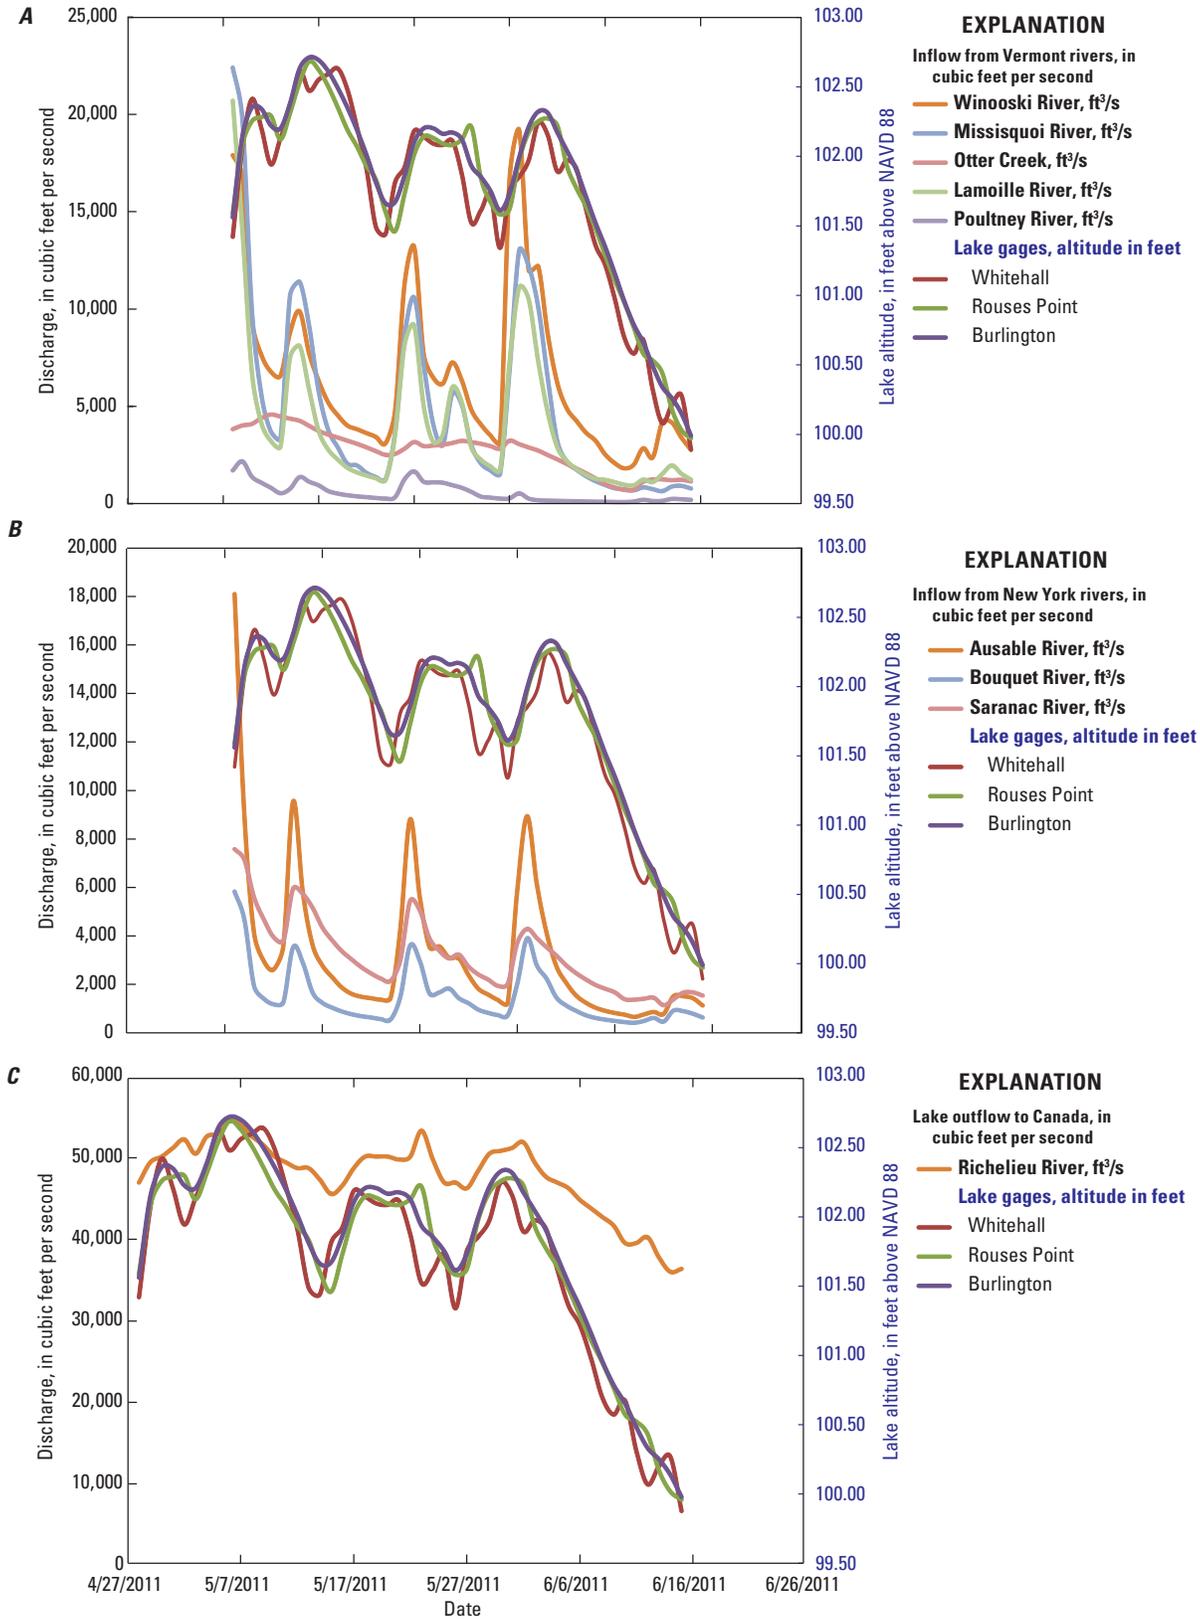
Figure 4. Daily mean river inflows to Lake Champlain measured at U.S. Geological Survey streamgages, daily mean outflow from the lake in the Richelieu River measured at Fryers Dam, and daily mean lake levels measured at Rouses Point, New York, Burlington, Vermont, and Whitehall, N.Y., between April 28 and June 15, 2011. *A*, the inflow hydrographs for rivers in Vermont and the lake levels; *B*, the inflow hydrographs for rivers in New York and the lake levels; and *C*, the outflow hydrograph for the Richelieu River and the lake levels.

River inflows to Lake Champlain for the most significant gaged rivers are shown on figure 4 and include the Mississquoi River at Swanton, Vt. (gage 04294000); the Lamoille River at East Georgia, Vt. (gage 04292500); the Winooski River at Essex Junction, Vt. (gage 04290500); Otter Creek at Middlebury, Vt. (gage 04282500); the Saranac River at Plattsburgh, N.Y. (gage 04273500); the Ausable River near Au Sable Forks, N.Y. (gage 04275500); the Poultney River near Fairhaven, Vt. (gage 04280000); and the Bouquet River at Willsboro, N.Y. (gage 04276500). (Gaging station locations are shown on fig. 1.) Outflow in the Richelieu River (Environment Canada gage 020J007) was derived from estimates at the weir located at Fryers Dam, Quebec. In general, all of the river inputs show similar timing of high and low flows, indicating similar snowmelt and rainfall timing occurring from the east (Vermont side) and west (New York side) of the lake. The largest peak inflows occurred from the Vermont side, and in general the peak lake levels occurred around two days after the peak inflows.

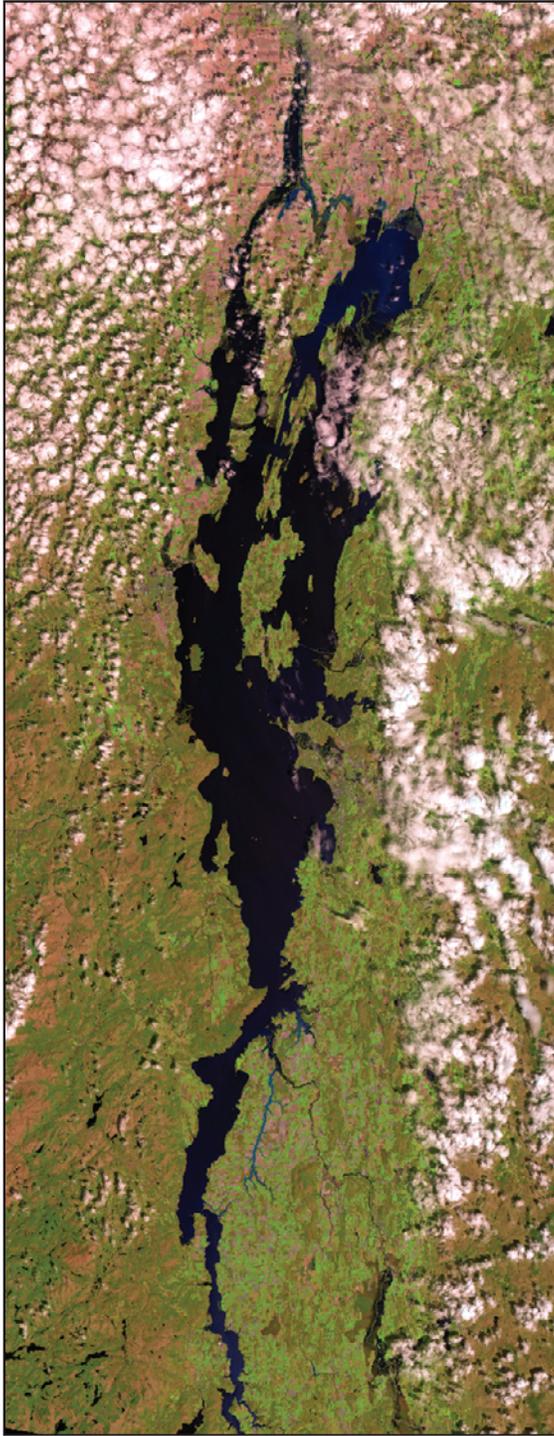
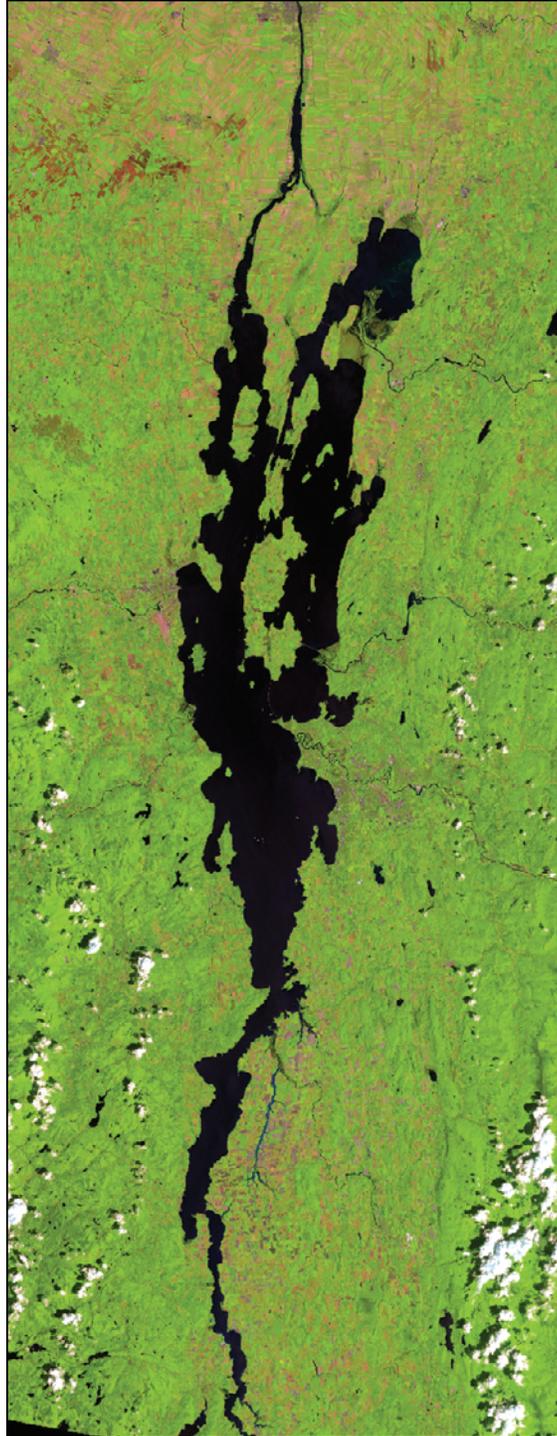
Figure 5. Landsat 5 image (bands 3, 4 and 5) of Lake Champlain. *A*, May 11, 2011, and *B*, July 14, 2011.

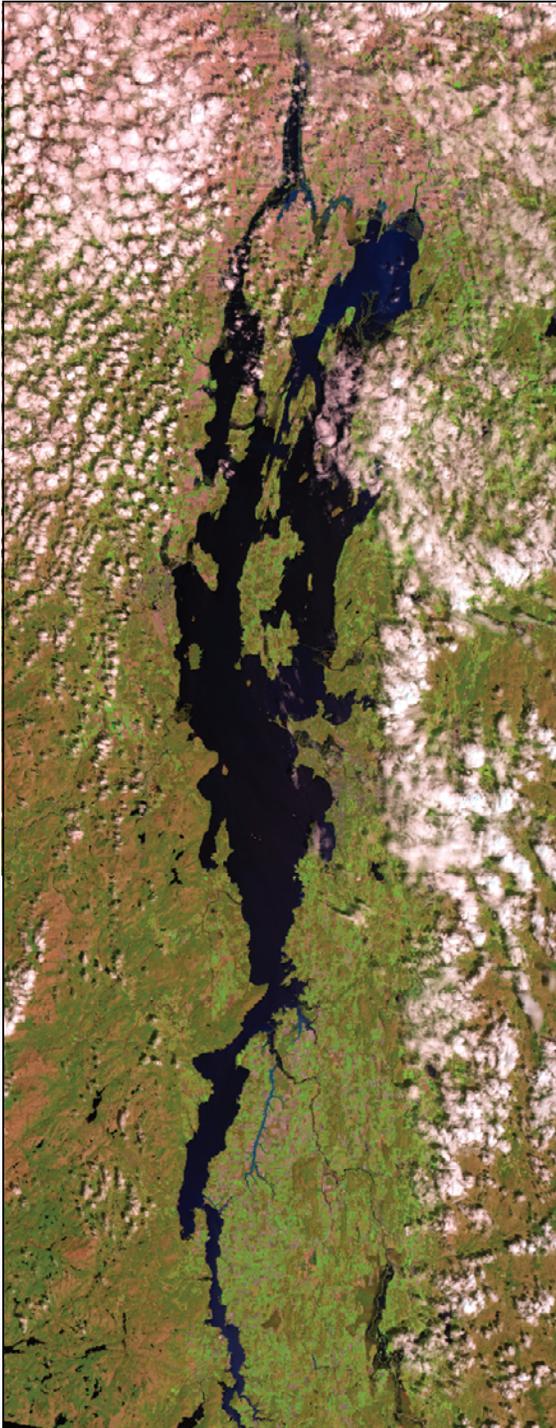
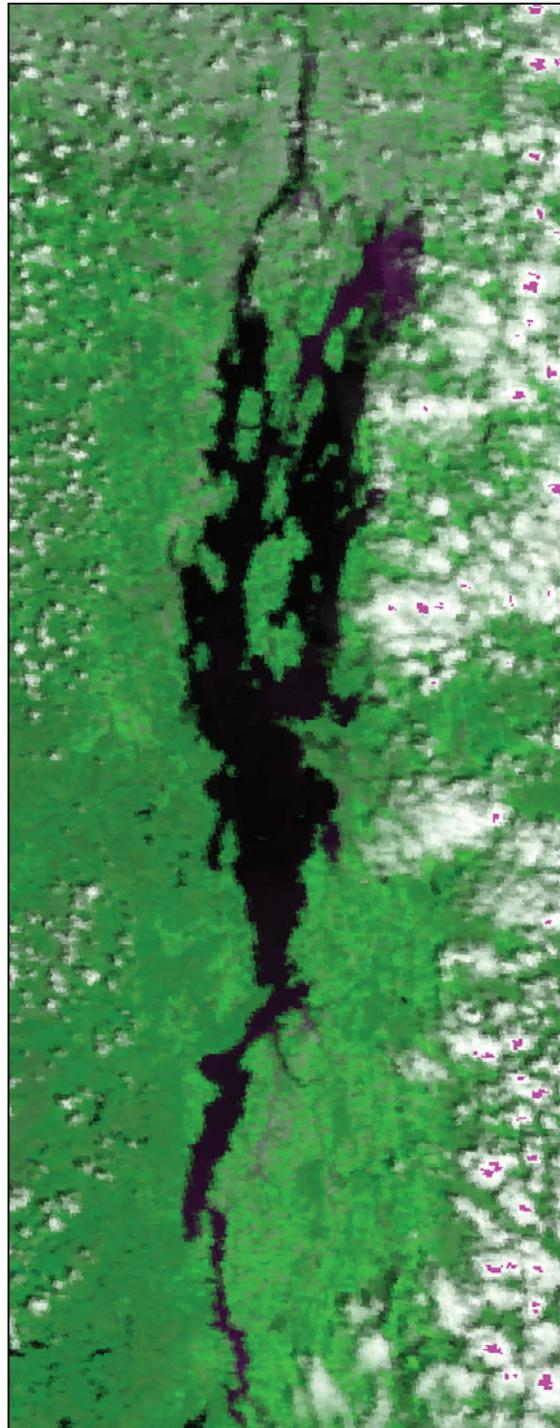
Figure 6. Landsat 5 and moderate resolution imaging spectroradiometer (MODIS) images of Lake Champlain. A, Landsat 5, May 11, 2011, and B, AQUA MODIS, May 11, 2011. Note the differences in cloud cover and resolution.

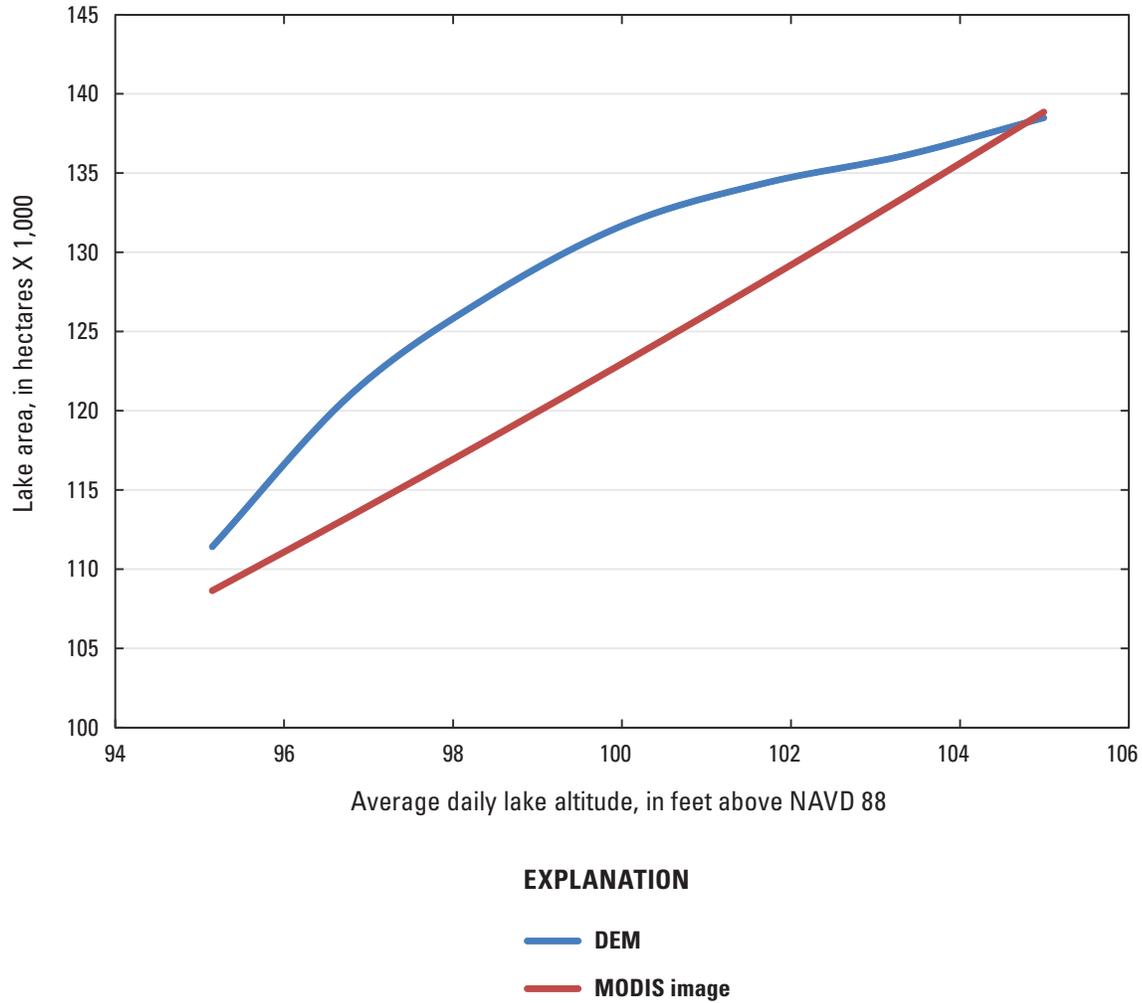
Figure 7. Relation between lake area, based on the corrected moderate resolution imaging spectroradiometer (MODIS) image and the 10-meter digital elevation model (DEM), and average lake level (stage).

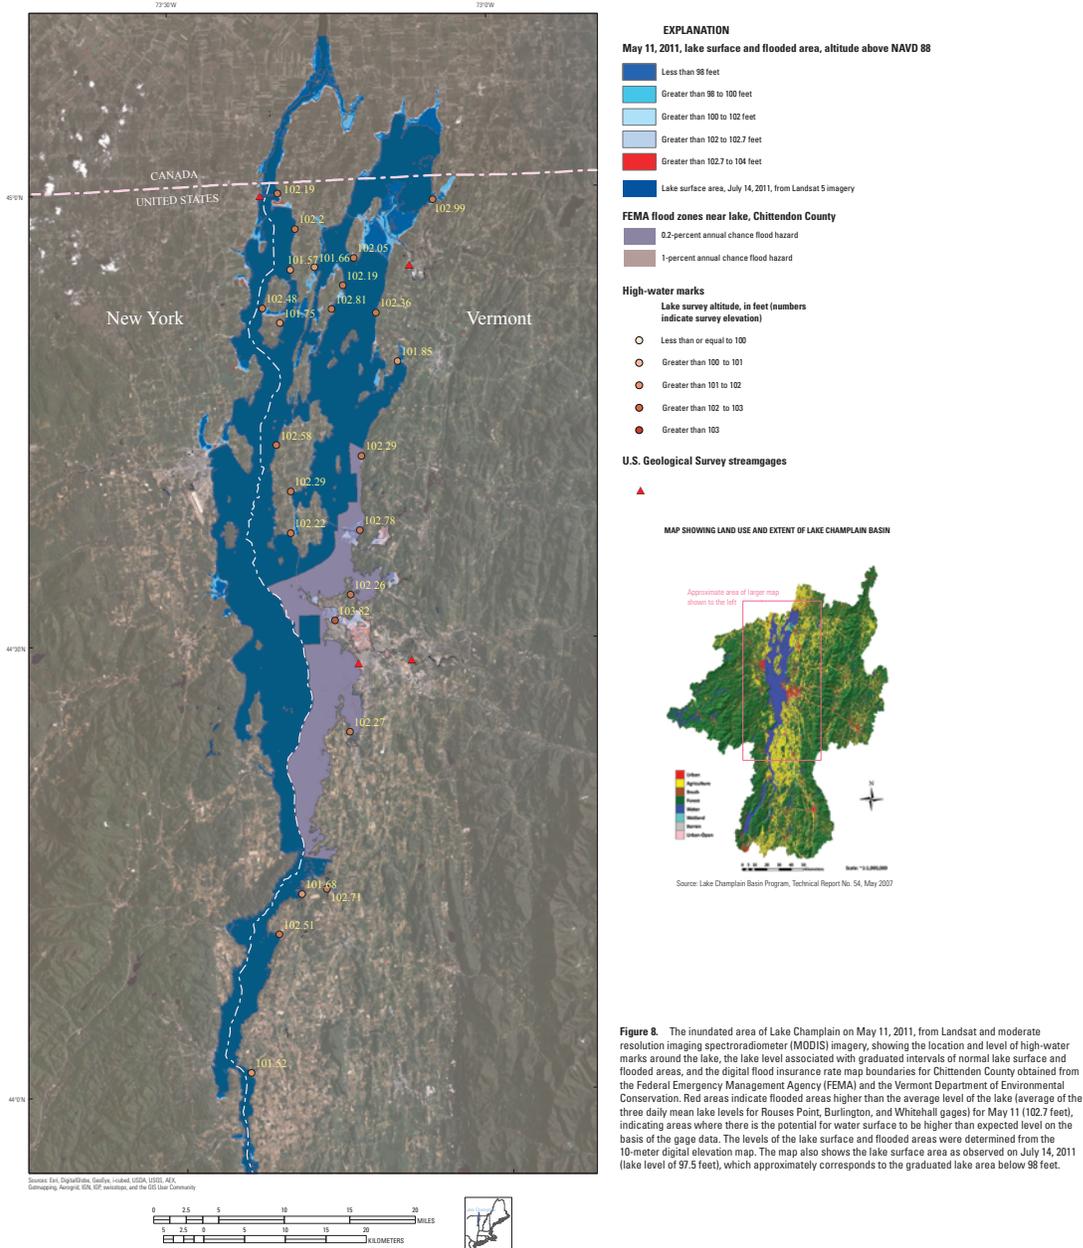
Figure 8. The inundated area of Lake Champlain on May 11, 2011, from Landsat and moderate resolution imaging spectroradiometer (MODIS) imagery, showing the location and level of high-water marks around the lake, the lake level associated with graduated intervals of normal lake surface and flooded areas, and the digital flood insurance rate map boundaries for Chittenden County obtained from the Federal Emergency Management Agency (FEMA) and the Vermont Department of Environmental Conservation. Red areas indicate flooded areas higher than the average level of the lake (average of the three daily mean lake levels for Rouses Point, Burlington, and Whitehall gages) for May 11 (102.7 feet), indicating areas where there is the potential for water surface to be higher than expected level on the basis of the gage data. The levels of the lake surface and flooded areas were determined from the 10-meter digital elevation map. The map also shows the lake surface area as observed on July 14, 2011 (lake level of 97.5 feet), which approximately corresponds to the graduated lake area below 98 feet.

The distribution of HWMs and flooded areas developed from the imagery are intersected with the 10-m DEM for the lake and are shown on figure 8. The intersection of the DEM with the inundated area from the imagery provides a means to estimate the height of the inundated area around the lake shoreline. The digital flood insurance rate map (DFIRM) boundaries for Chittenden County, Vt., are also shown on figure 8. The areas of highest water levels determined from the imagery—as intersected with 10-m DEM—show the highest water levels near river mouths and along the eastern shoreline in the northern and central part of the lake where the lake is widest and offers the longest wind fetch. The HWMs show a

similar pattern, with the highest levels along the eastern shoreline and in the northern part of the lake and the lowest levels in protected areas on the western shorelines.

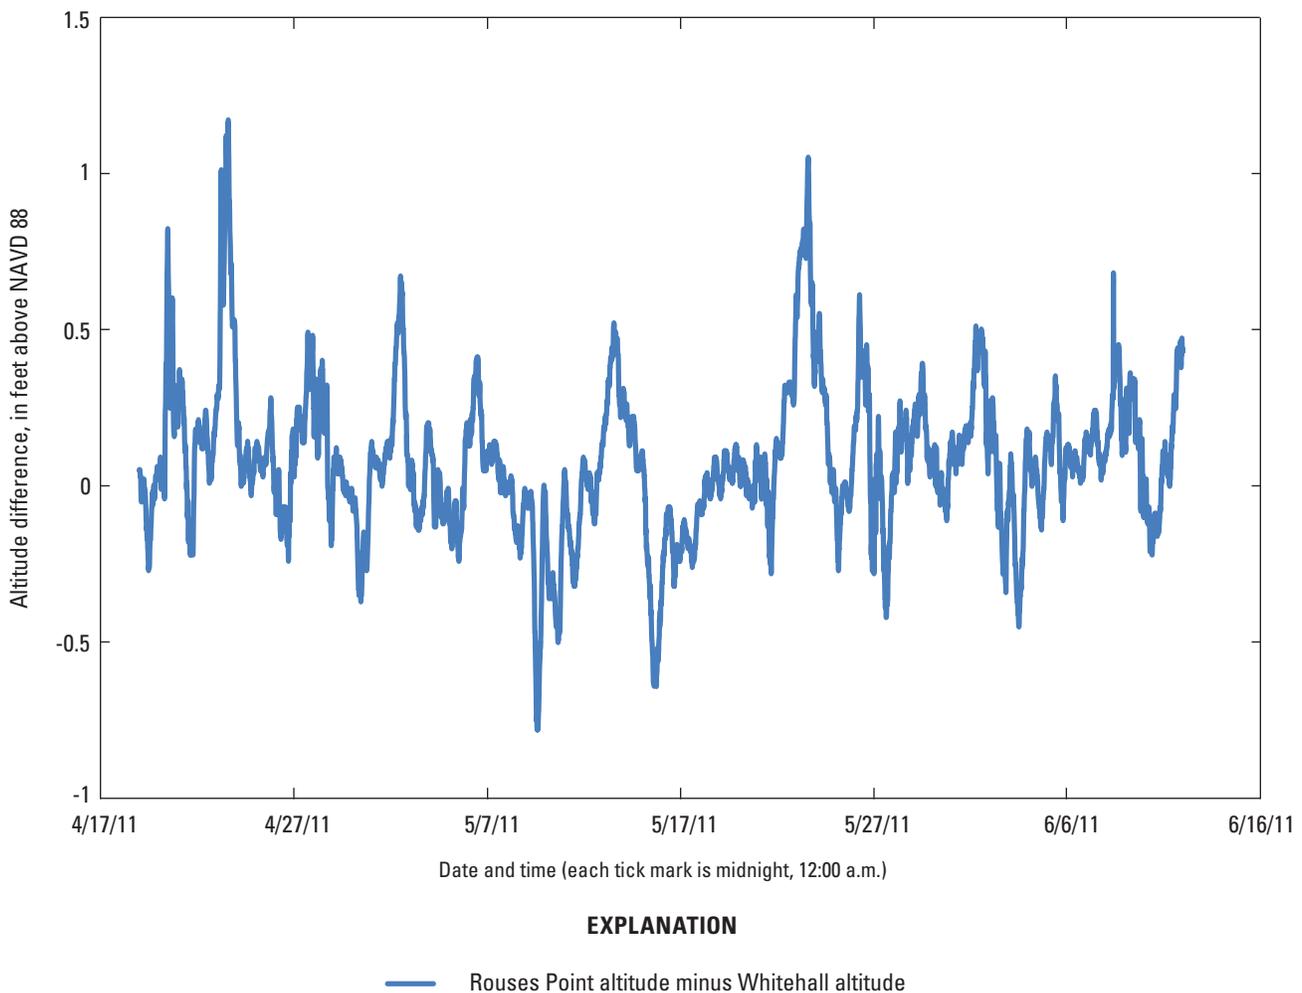
Figure 9. Differences in daily mean water levels, plotted against day from April to June 2011, between the Rouses Point and Whitehall gages.

differences) show no apparent correlation with lake level and illustrate the variable dynamics that occur up and down the lake. Similar variation in the differences occurs between all of the stations, suggesting that common mechanisms cause the differences but that the differences are independent of the static water level in the lake. This condition likely reflects the local effects of wind and river influx.
