Assessing Geomorphic Change along the Trinity River Downstream from Lewiston Dam, California, 1980 to 2011

Scientific Investigations Report 2015–5046

By Jennifer A. Curtis, Scott A. Wright, J. Toby Minear, and Lorraine E. Flint

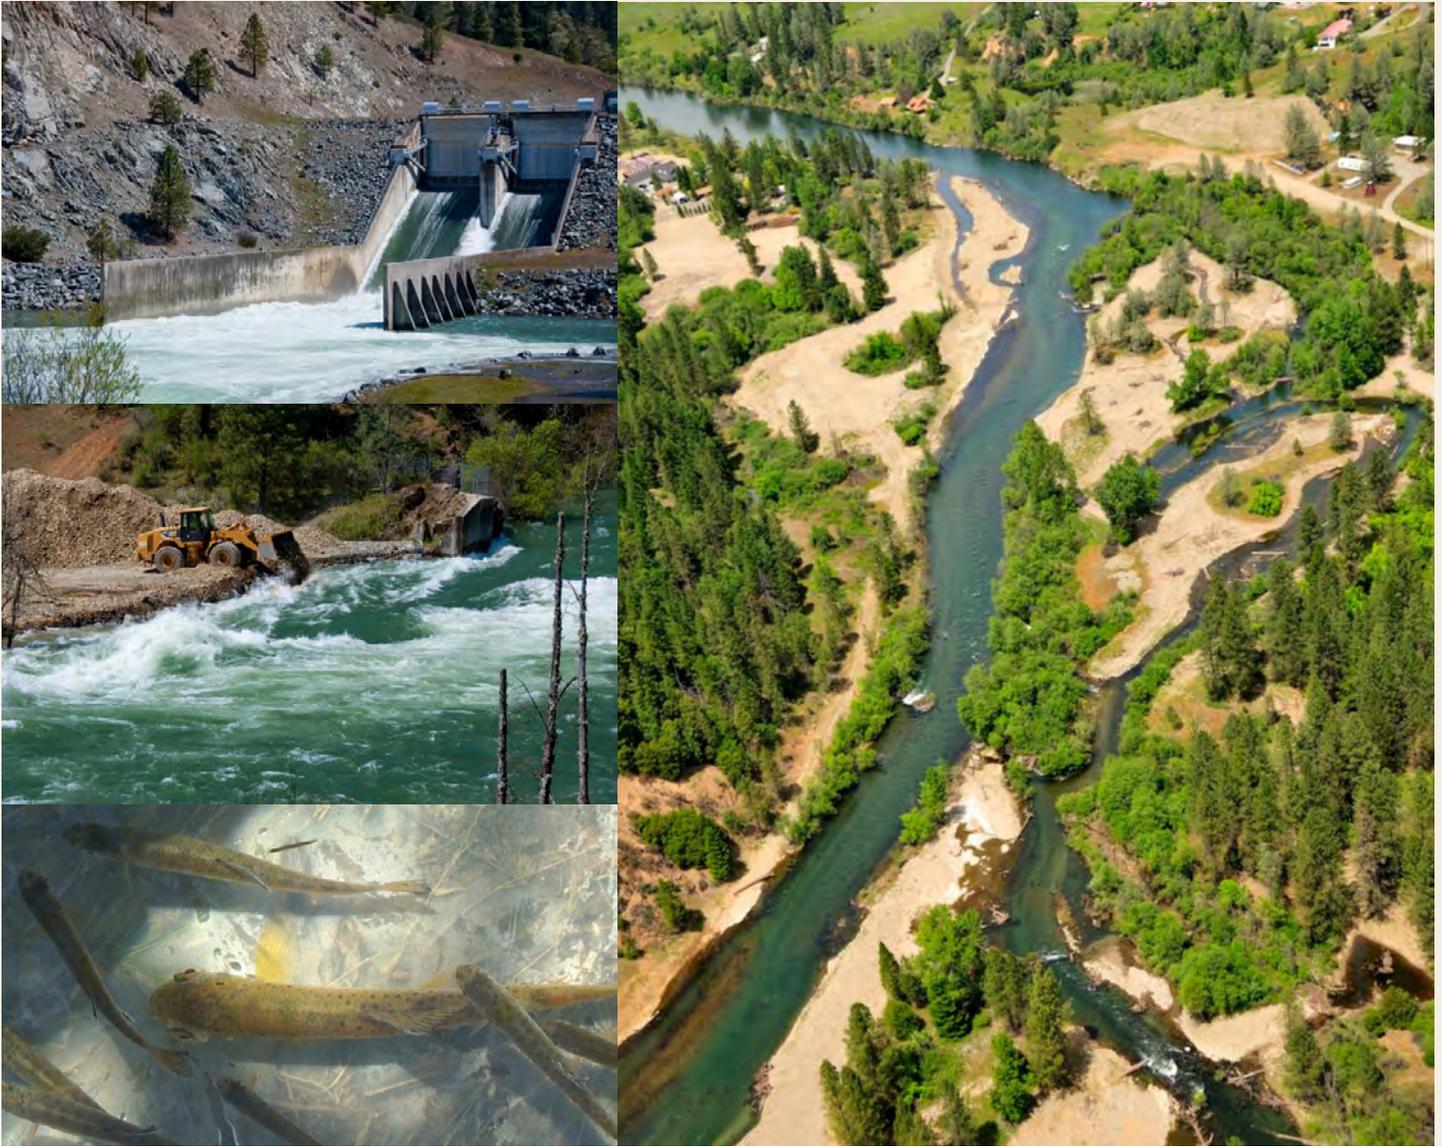
Cover: Photo mosaic showing 2011 peak flow release from Lewiston Dam and concurrent gravel augmentation at Lewiston gaging station (1.5 floodplain kilometers downstream from Lewiston Dam). Sawmill rehabilitation site and juvenile coho, 4 floodplain kilometers downstream from Lewiston Dam. Photo credit: Trinity River Restoration Program on-line photo archives.

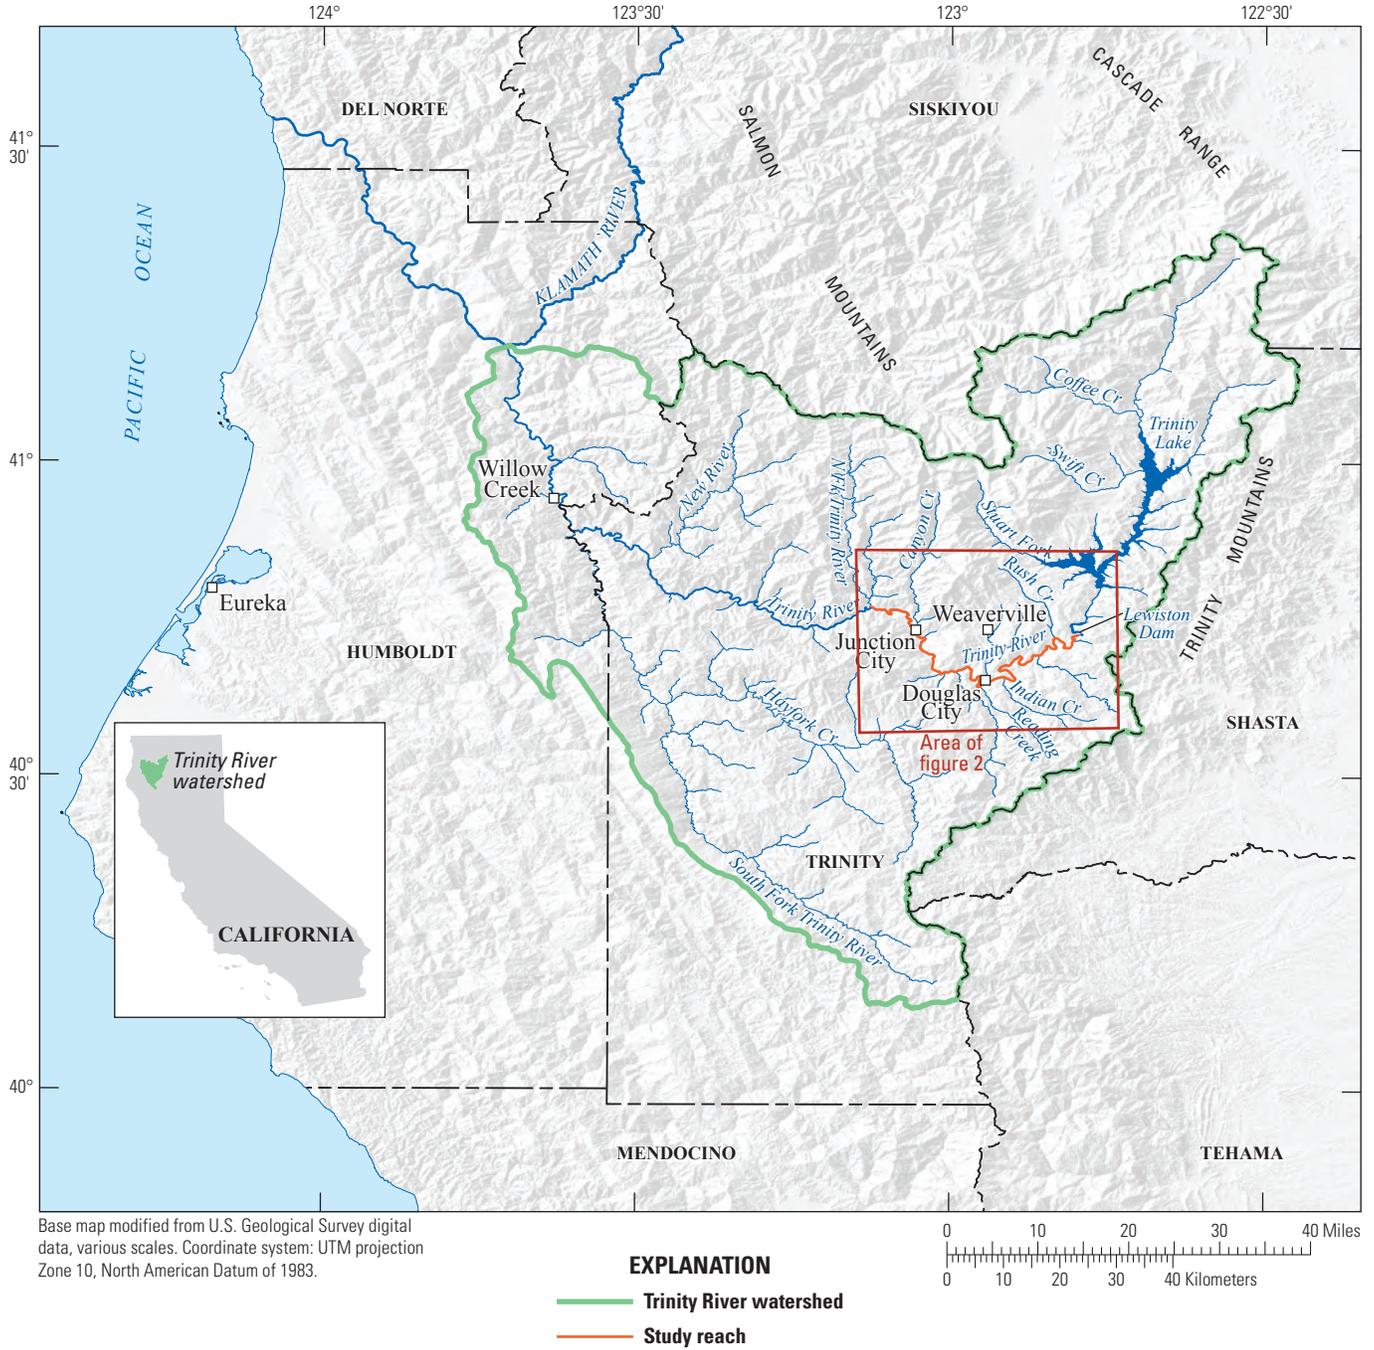
Figure 1. Study area, Trinity River, California.

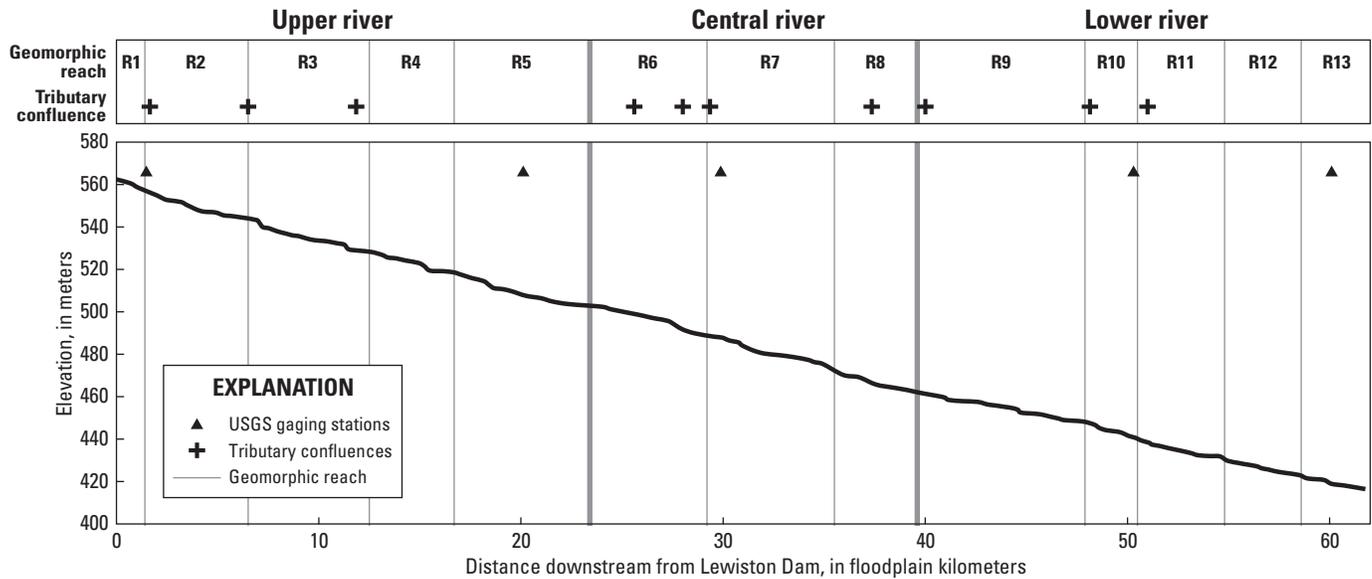
Figure 3. Elevation profile of the Trinity River restoration reach, California, estimated from 10-meter-resolution digital elevation data. See [table 3](#) for description of the 13 geomorphic reaches.

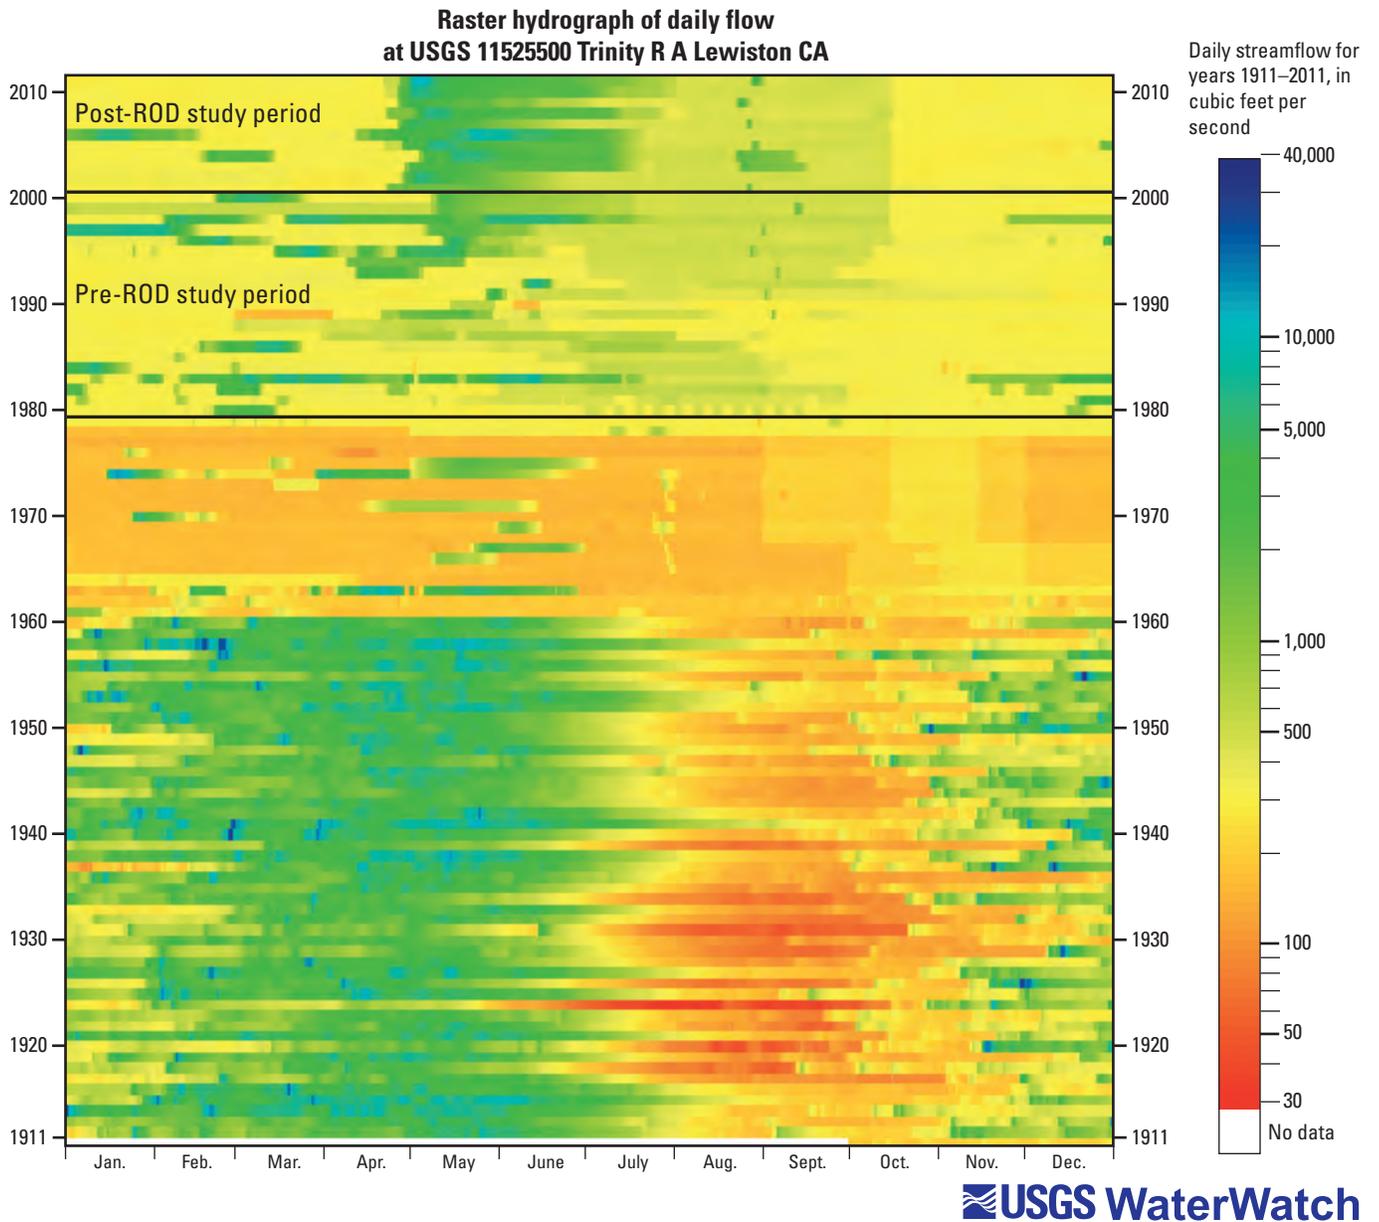
Figure 4. Raster hydrograph (http://waterwatch.usgs.gov/index.php?id=wwchart_rastergraph) showing mean daily flows measured 1.5 kilometers downstream from Lewiston Dam (fig. 2) along the Trinity River, California. Hydrograph shows monthly and annual variability of mean daily flows for 1911 to 2011. Pre- and post-ROD study periods are separated by the U.S. Department of the Interior Record of Decision (U.S. Department of the Interior, 2000). ROD, Record of Decision.

The influence of flow regulation and diversion on streamflow variability is readily apparent in mean daily flows recorded at the Lewiston gaging station (fig. 4; Trinity River at Lewiston, USGS station identification number 11525500), 1.5 km downstream from Lewiston Dam (fig. 2). The pre-dam flow regime included summer base flows, winter-storm peaks, and spring-snowmelt peaks, which created variable seasonal flow conditions. Post-dam flow variability decreased and flow releases from 1964 to 1973 were pursuant to the 1955 Congressional Act, which authorized construction and operation of the TRD by the Bureau of Reclamation. The TRD maintained daily flows between 150 and 250 ft³/s at the Lewiston gage, and the annual flow-release volume was set at 120.5 TAF, with periodic, larger safety-of-dam releases.

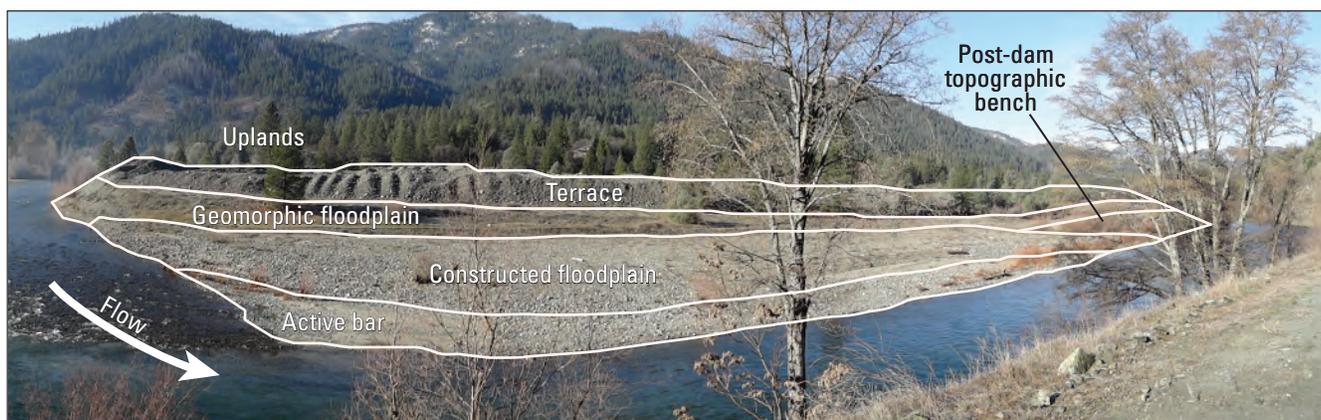
Figure 5. Example of the topographic relations among depositional and constructed features for the Trinity River downstream from Lewiston Dam, California (photograph by J.A. Curtis). Photo shows left bank downstream of Canyon Creek (51 floodplain kilometers, or FPkm).

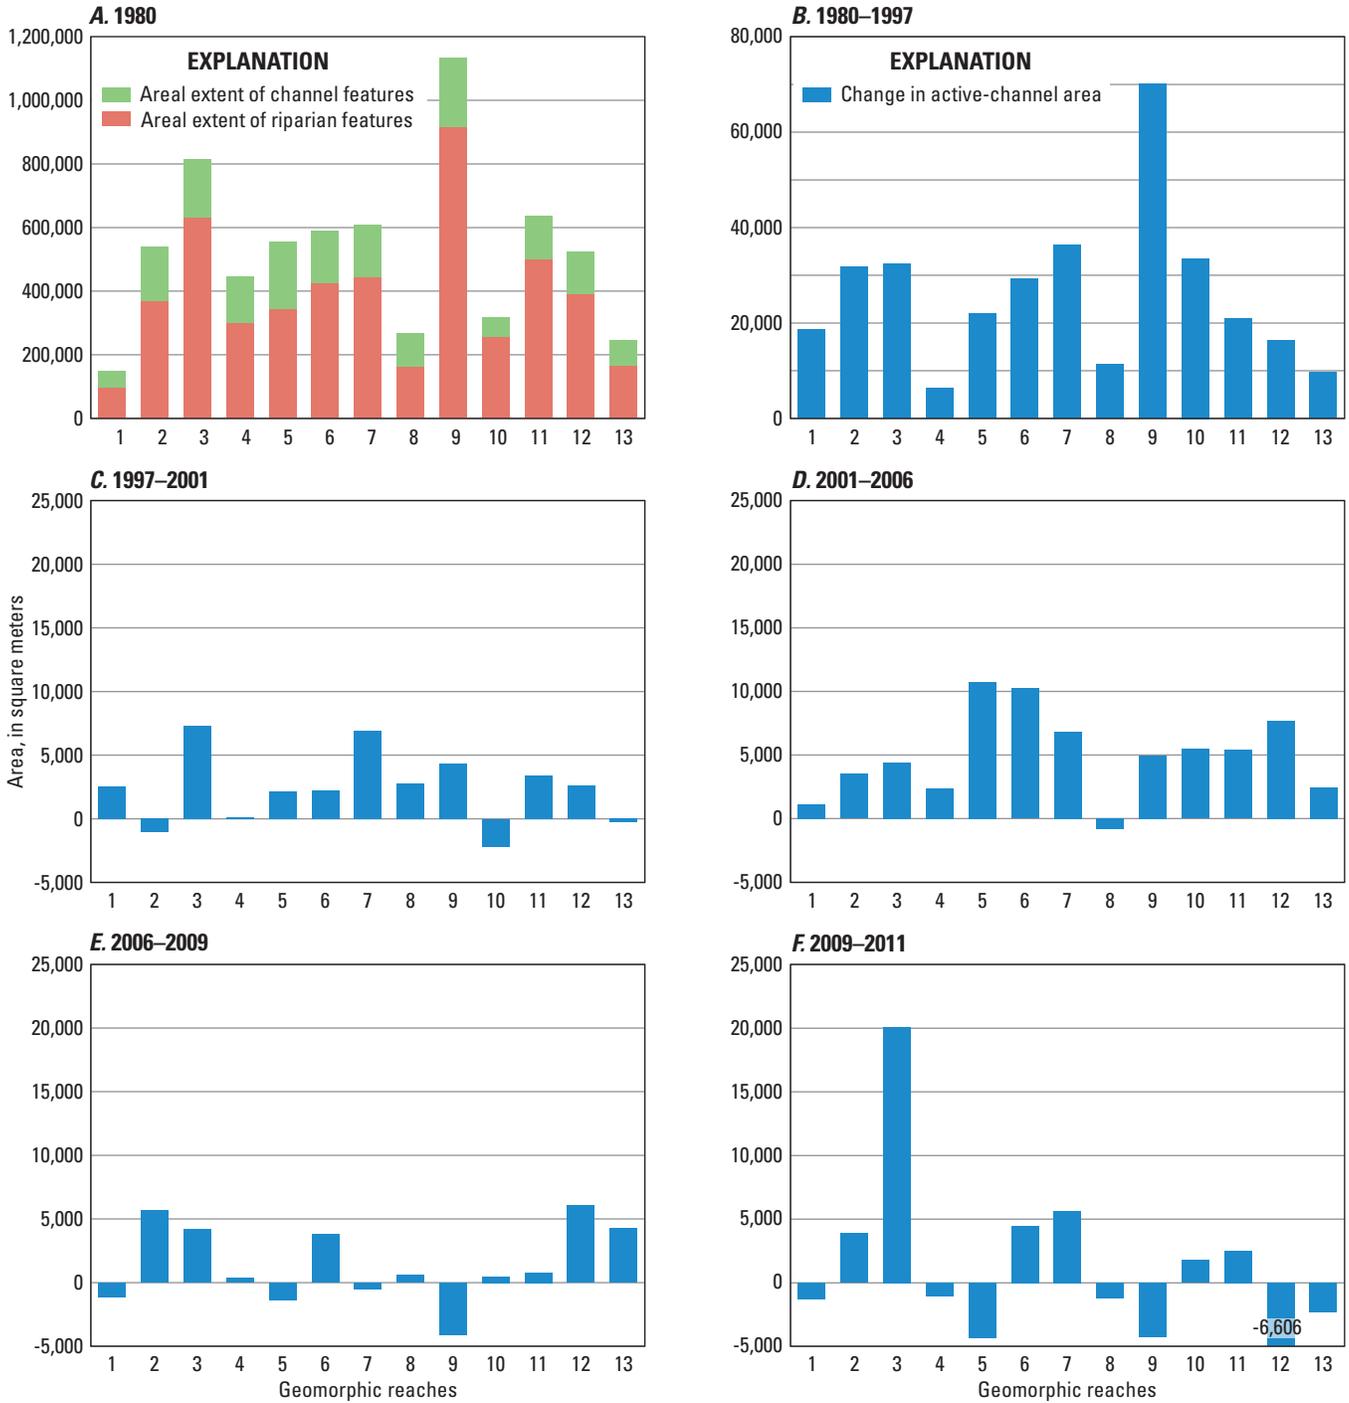
Figure 6. Areal extent of riparian and channel features along the Trinity River downstream from Lewiston Dam, California, A, in 1980, and change in active-channel area for five periods from 1980 to 2011: B, 1980 to 1997; C, 1997 to 2001; D, 2001 to 2006; E, 2006 to 2009; and F, 2009 to 2011. Note differences in y-axis scale among periods.

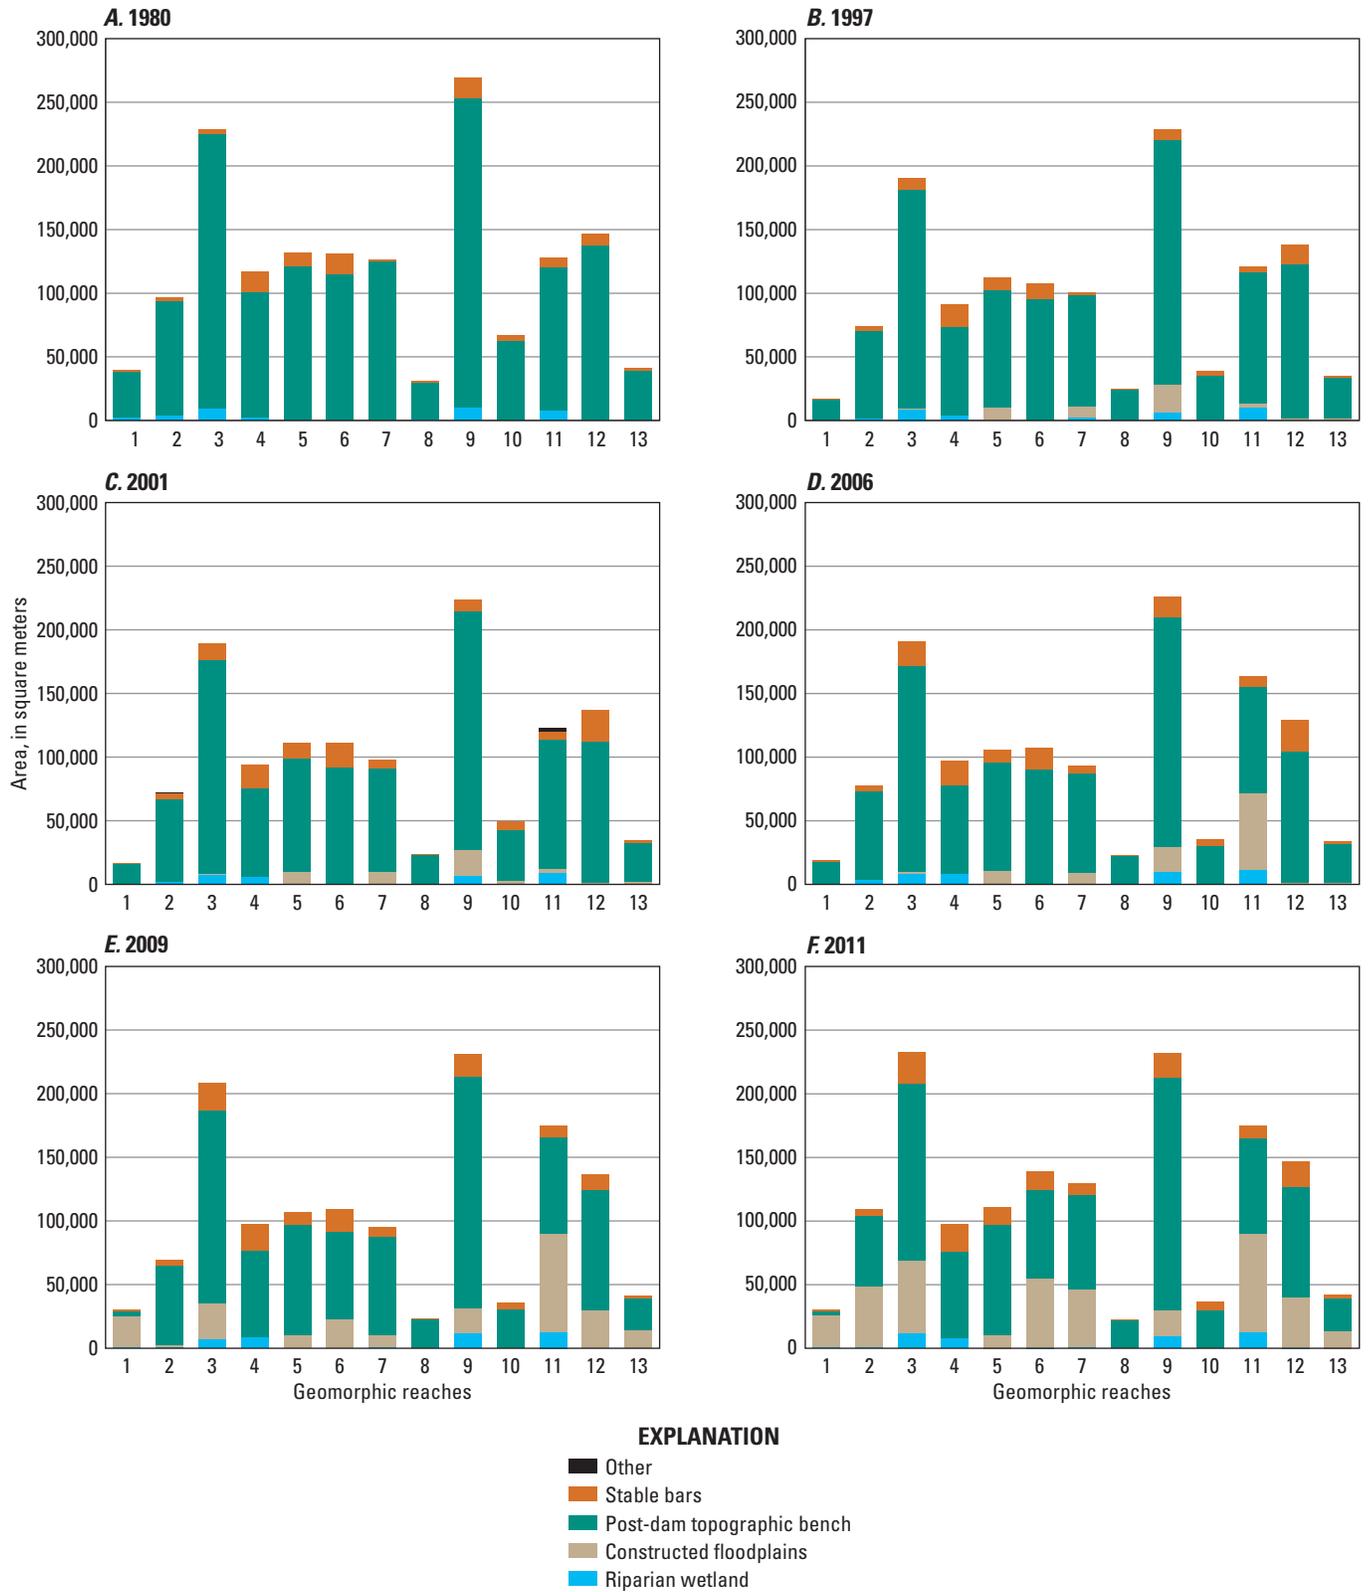
Figure 7. Areal extent of lower elevation riparian features along the Trinity River downstream from Lewiston Dam, California, in A, 1980; B, 1997; C, 2001; D, 2006; E, 2009; and F, 2011.

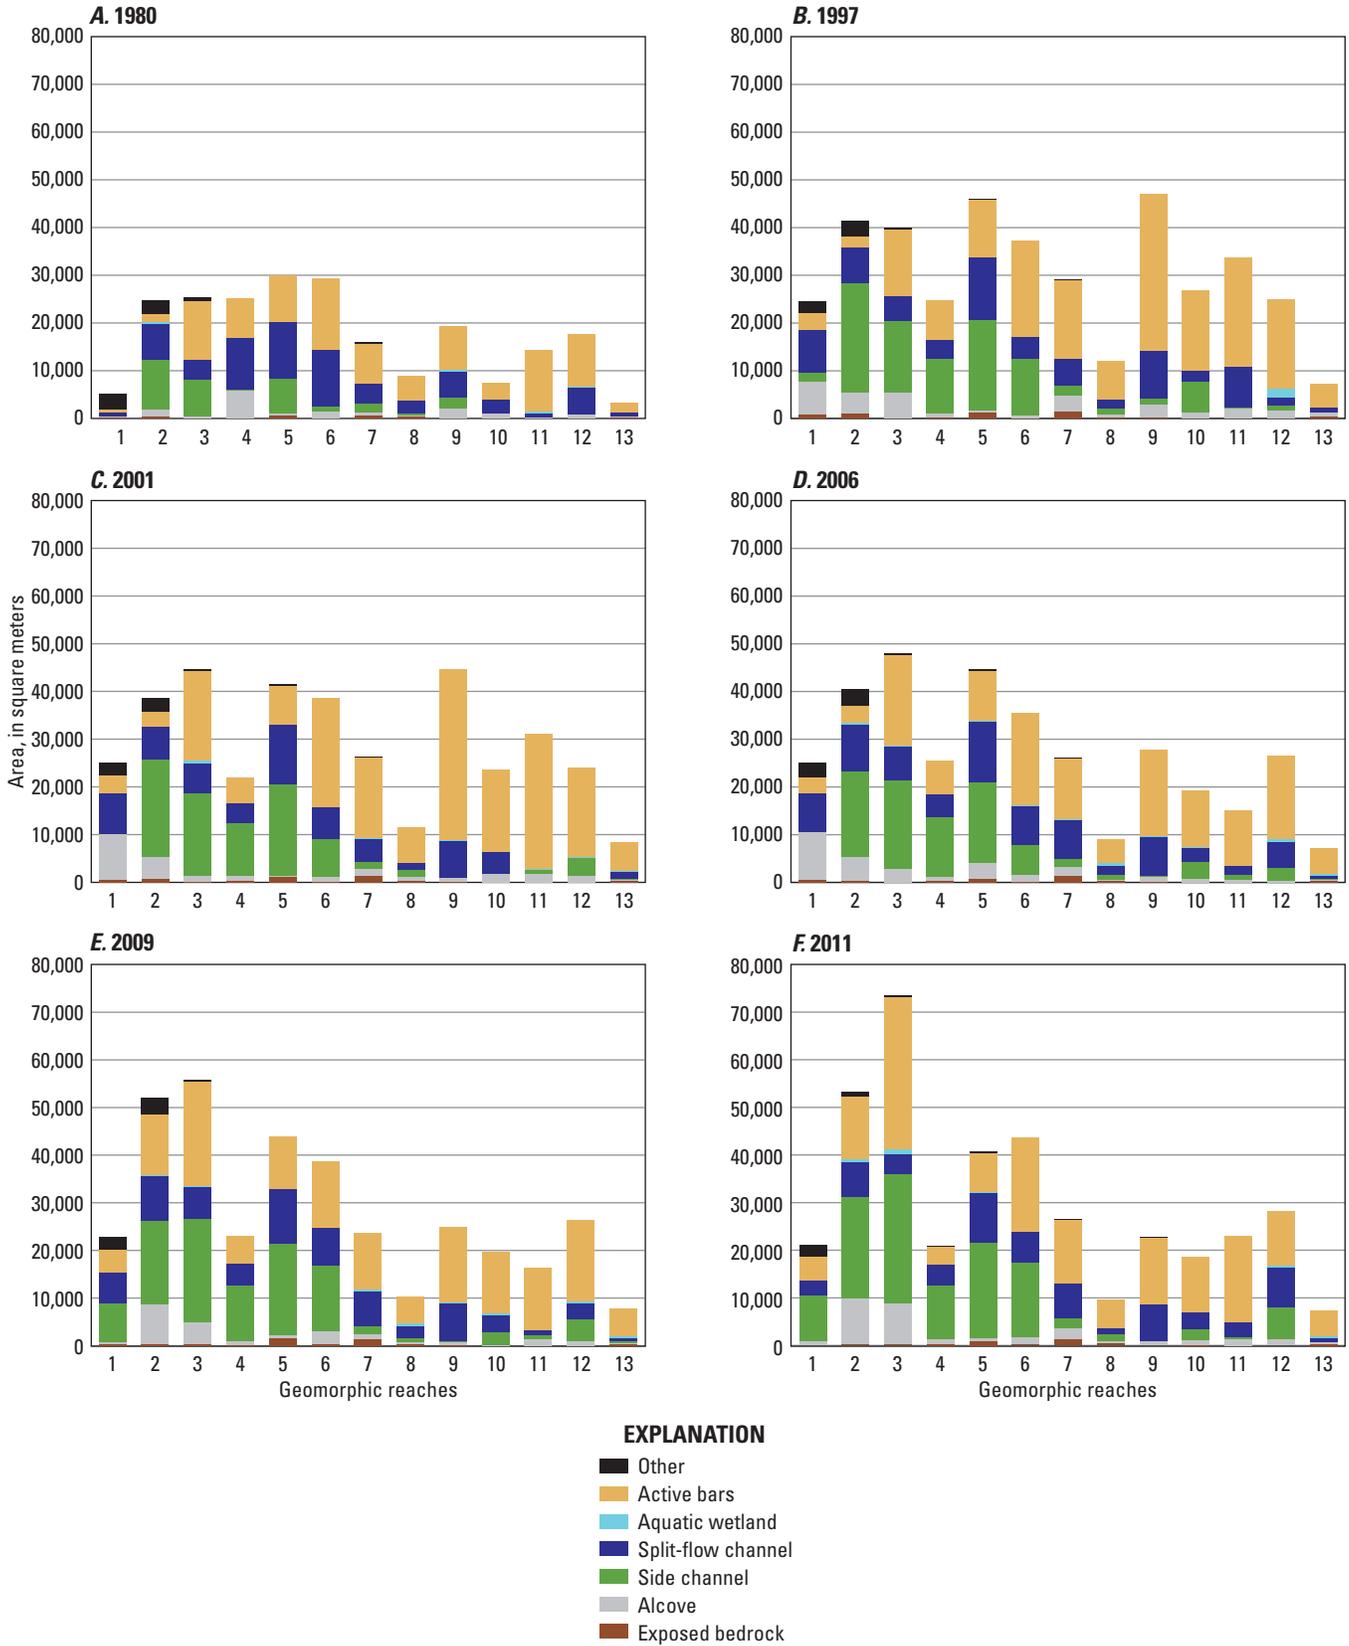
Figure 8. Areal extent of channel-complexity features within the active channel along the Trinity River downstream from Lewiston Dam, California, in A, 1980; B, 1997; C, 2001; D, 2006; E, 2009; and F, 2011.

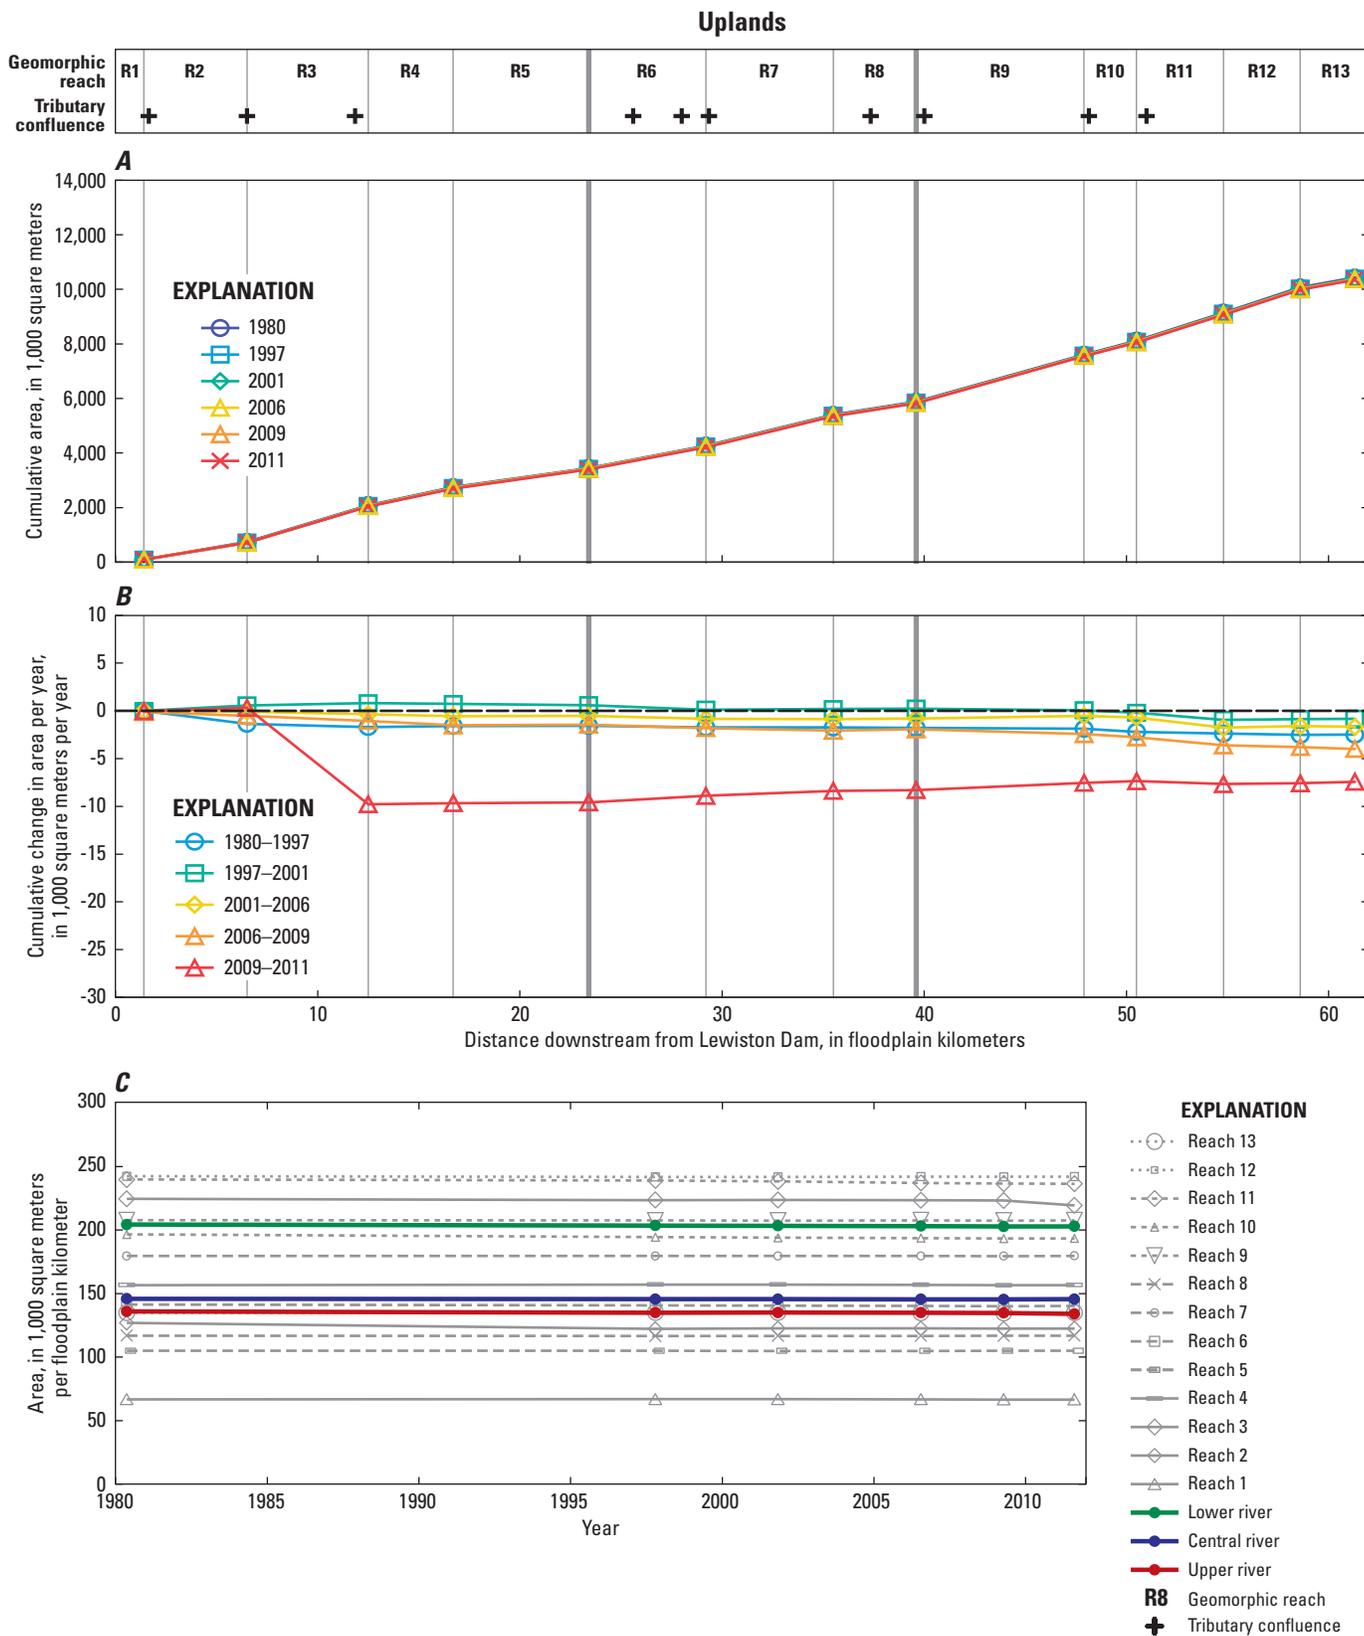
Figure 9. Area of uplands along the Trinity River downstream from Lewiston Dam, California, and change in upland area from 1980 to 2011: *A*, cumulative area by reach; *B*, cumulative change in area per year by reach; *C*, area by study reach and segments over time.

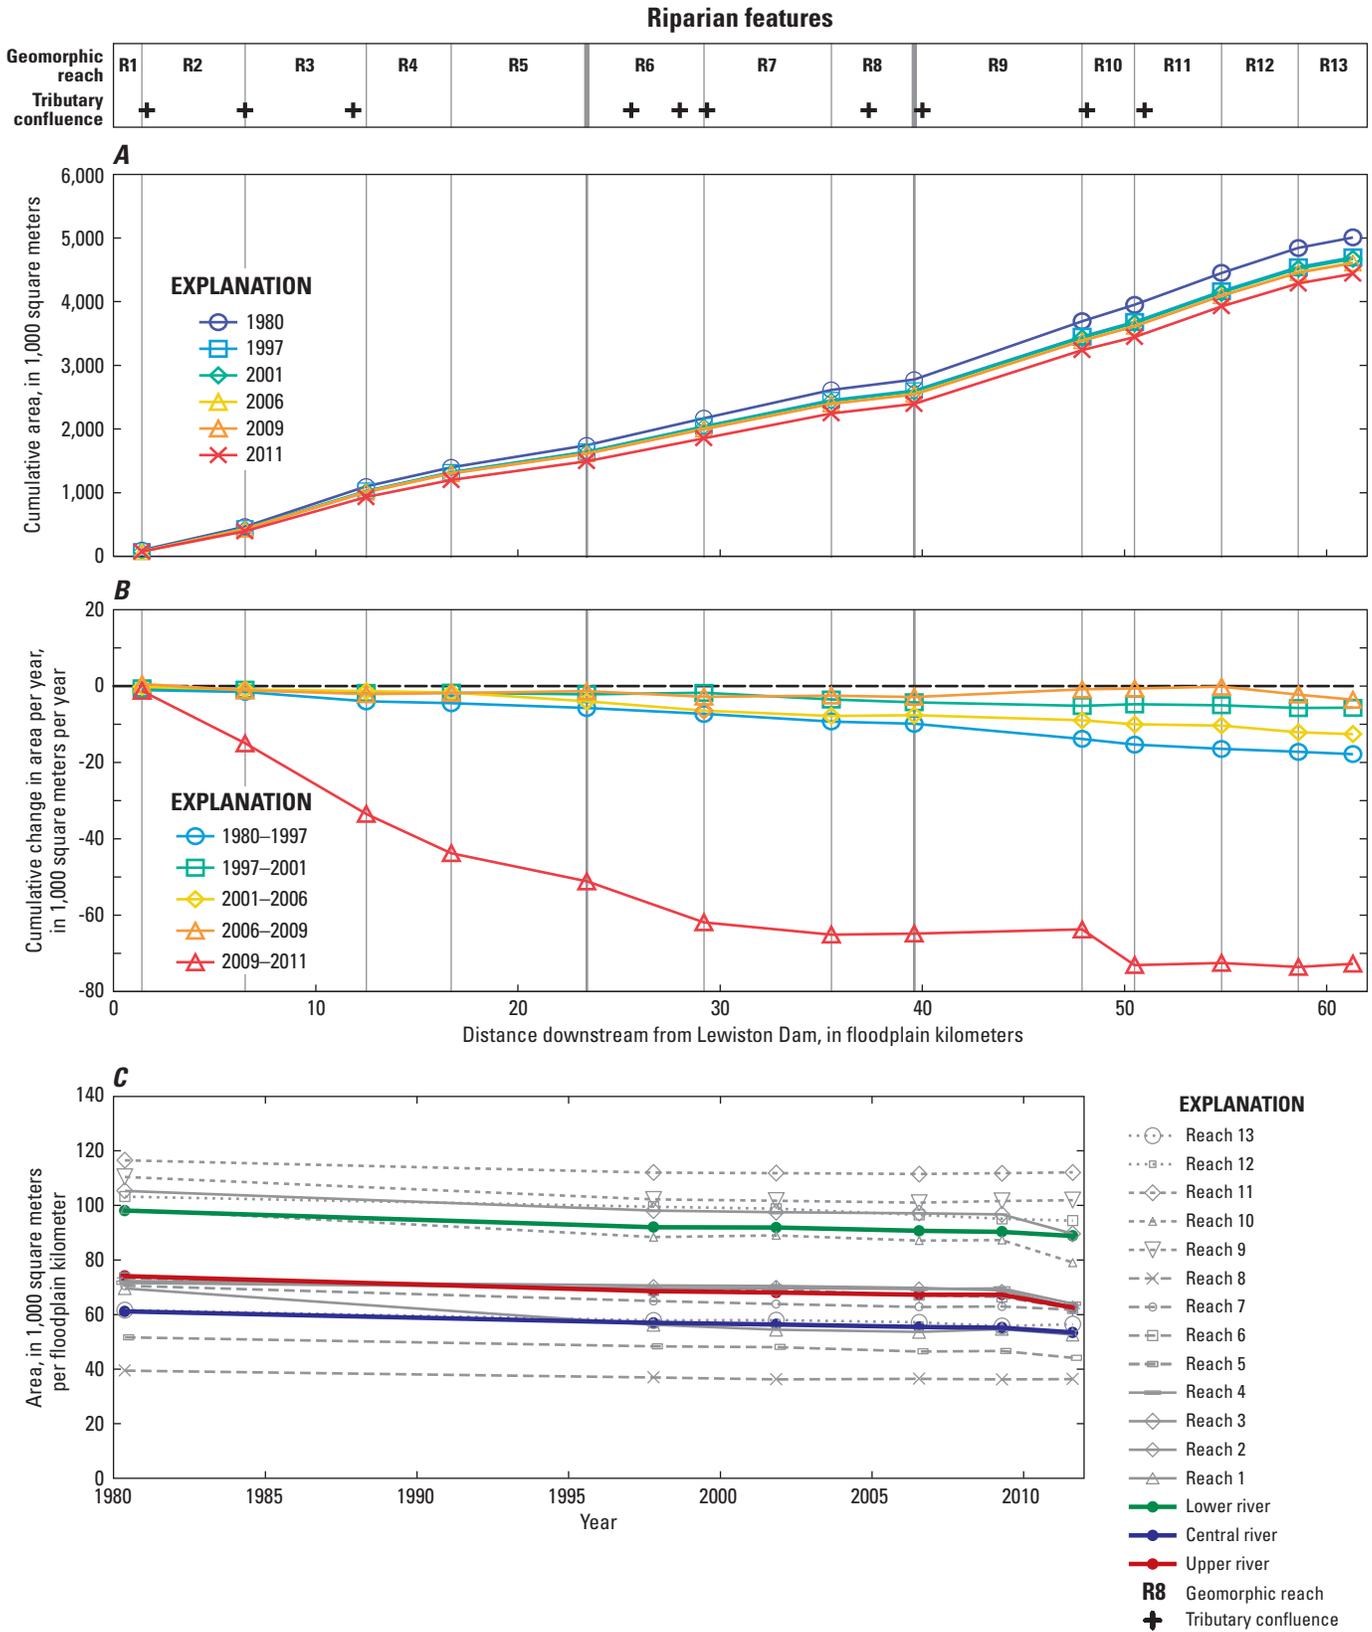
Figure 10. Area of riparian features along the Trinity River downstream from Lewiston Dam, California, and change in riparian area from 1980 to 2011: *A*, cumulative area by study reach; *B*, cumulative change in area per year by study reach; *C*, area by study reach and segments over time.

Riparian area generally decreased during the study period, but the decrease accelerated after 2009 (fig. 10B). The post-2009 decrease in riparian area was primarily caused by conversion of a large portion of pre-dam floodplain (fig. 11B) into a series of constructed floodplains by mechanical surface lowering. The area of post-dam benches also decreased during the study period, with the largest cumulative decreases from 1980 to 1997 (fig. 12A) caused by bank erosion and bar scour. Post-dam benches were also converted into constructed floodplains by vegetated berm removal and mechanical surface lowering. Floodplain construction accelerated during the post-ROD period, especially after 2006 (fig. 13).

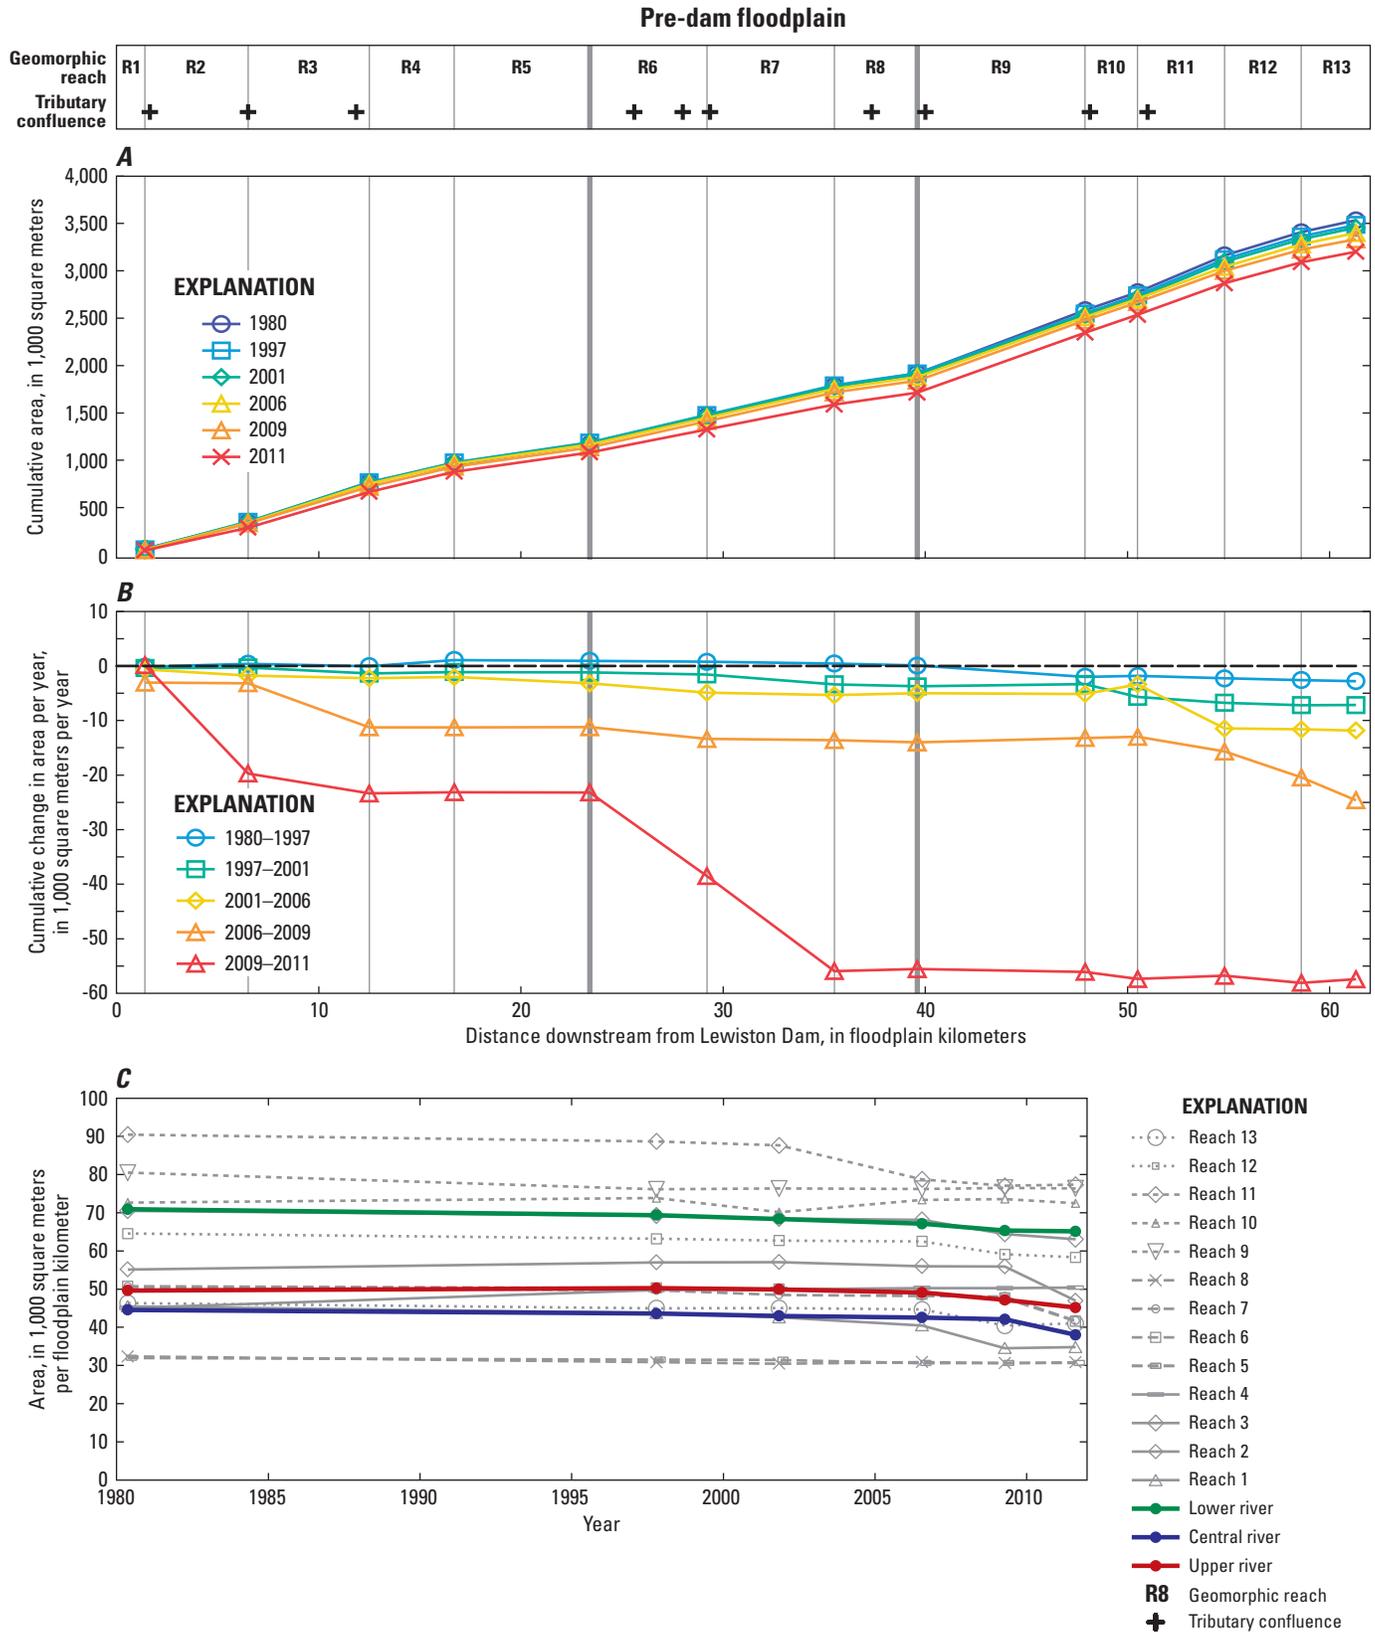
Figure 11. Area of the pre-dam floodplain along the Trinity River downstream from Lewiston Dam, California, and change in pre-dam floodplain area from 1980 to 2011: A, cumulative area by study reach; B, cumulative change in area per year by study reach; C, area by study reach and river segments over time.

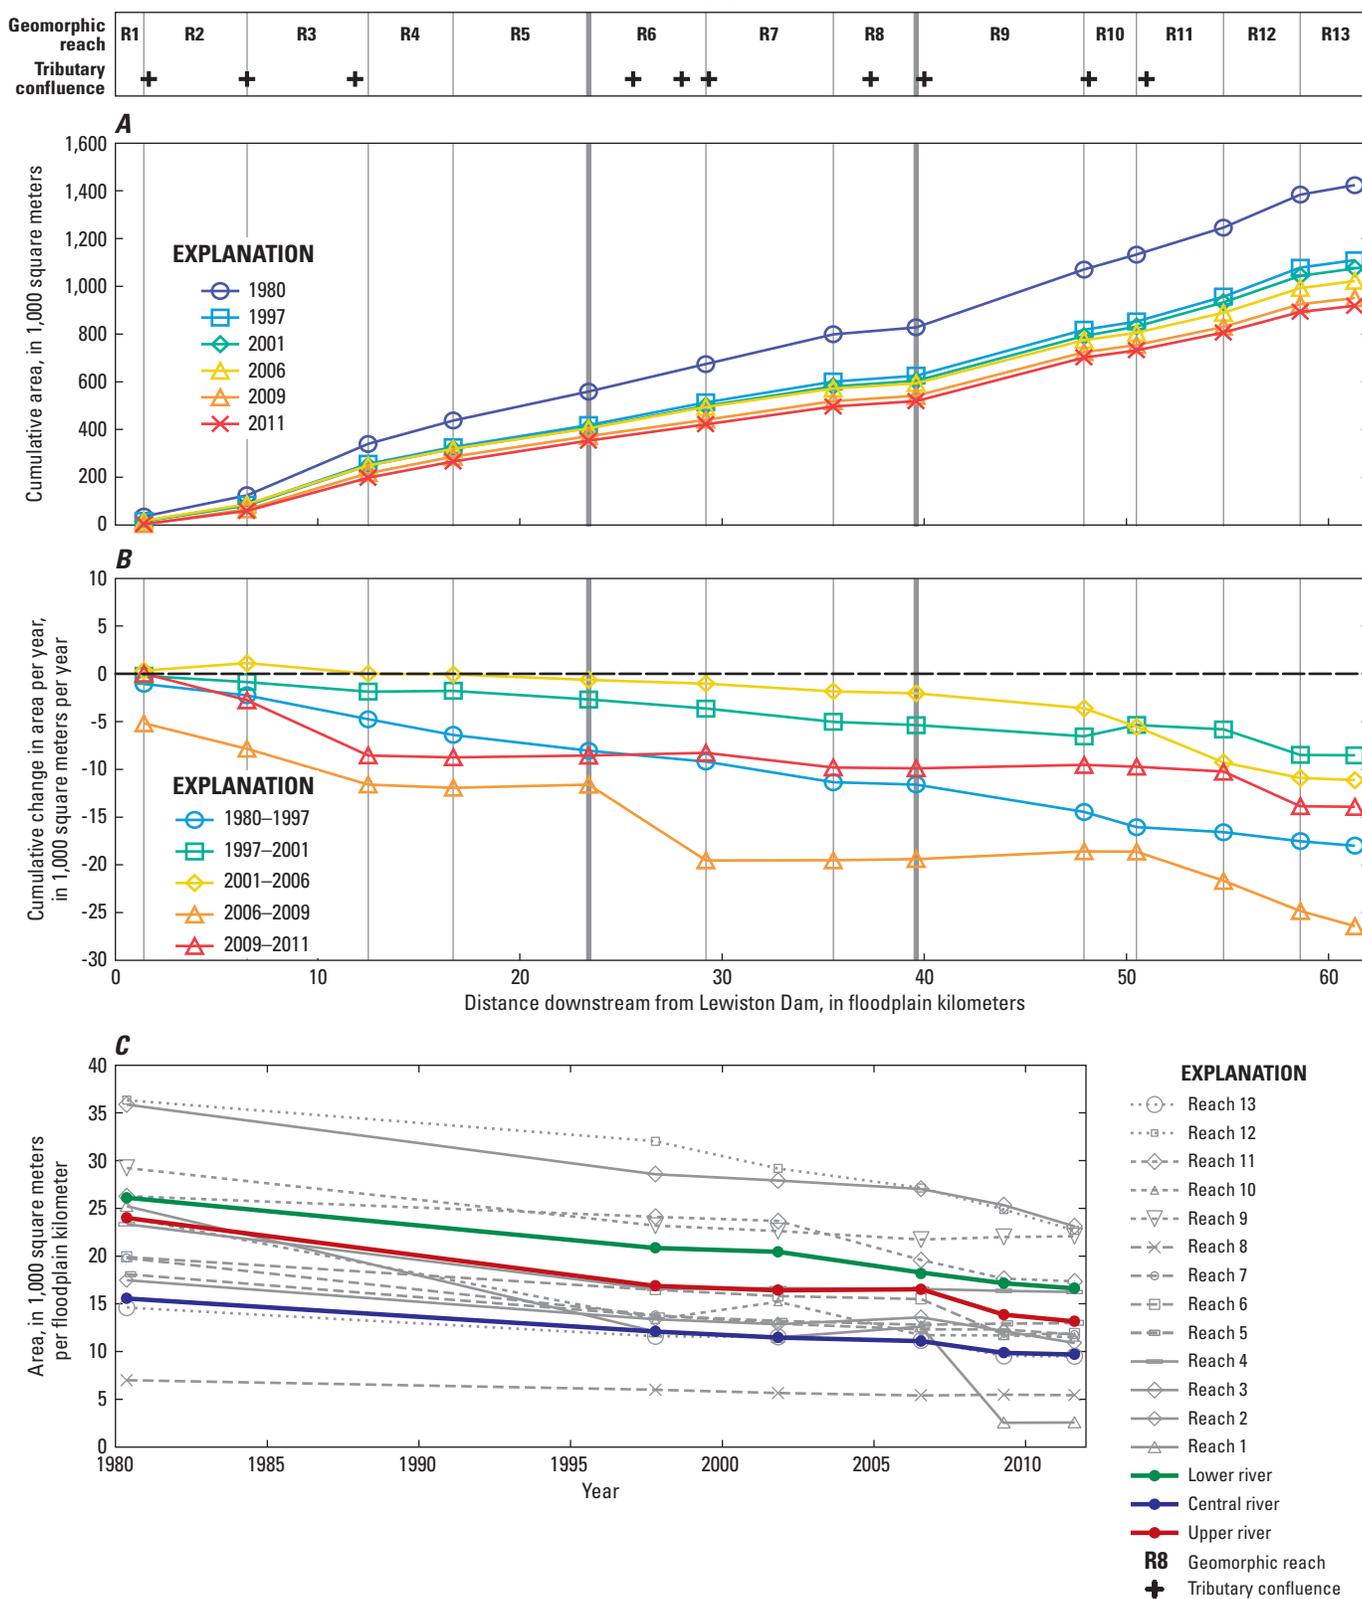
Figure 12. Area of post-dam benches along the Trinity River downstream from Lewiston Dam, California, and change in post-dam bench area from 1980 to 2011: *A*, cumulative area by study reach; *B*, cumulative change in area per year by study reach; *C*, area by study reach and river segments over time.
