Assessing Geomorphic Change along the Trinity River Downstream from Lewiston Dam, California, 1980 to 2011

Scientific Investigations Report 2015–5046

By Jennifer A. Curtis, Scott A. Wright, J. Toby Minear, and Lorraine E. Flint

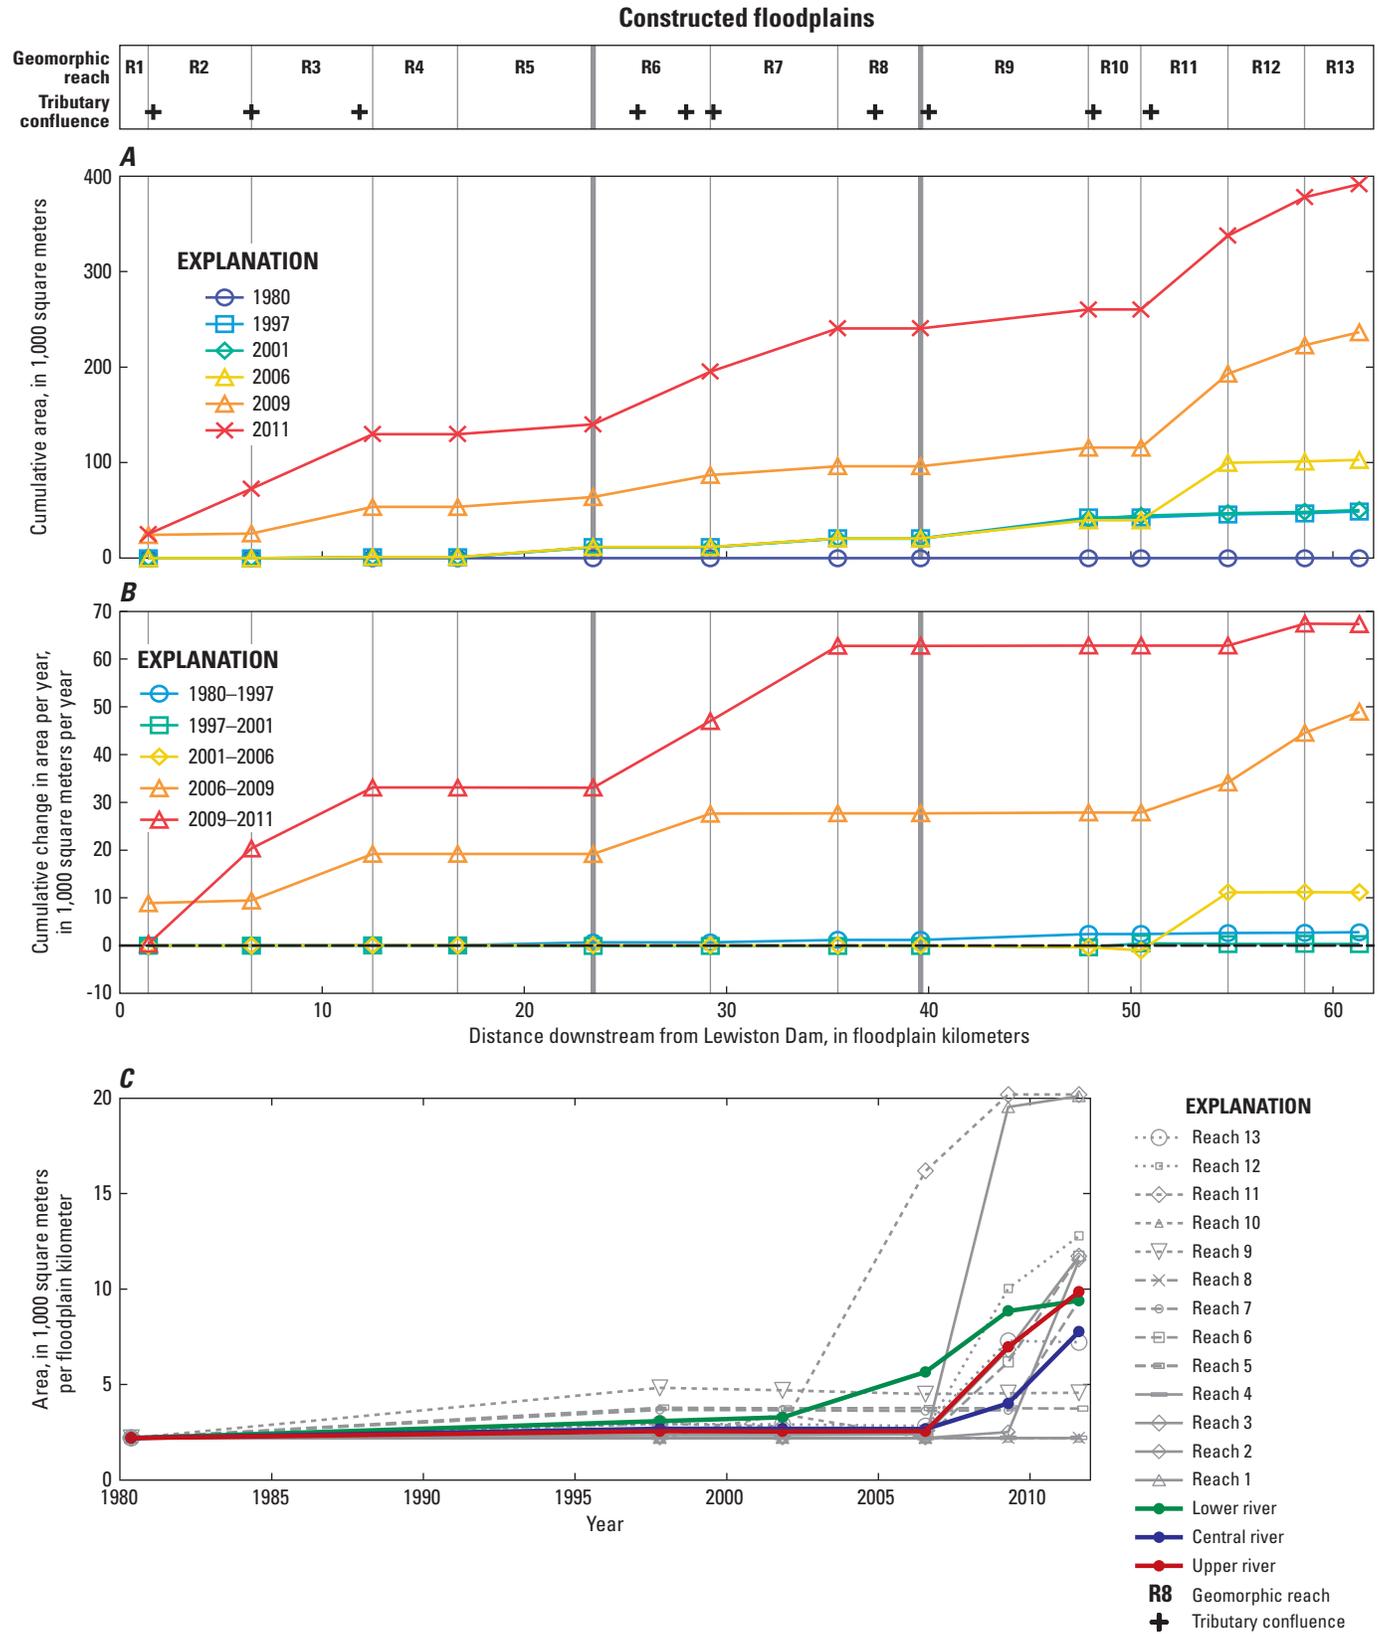
Figure 13. Area of constructed floodplains along the Trinity River downstream from Lewiston Dam, California, and change in constructed floodplain area from 1980 to 2011: *A*, cumulative area by study reach; *B*, cumulative change in area per year by study reach; *C*, area by study reach and river segments over time.

Riparian area generally decreased during the study period, but the decrease accelerated after 2009 (fig. 10B). The post-2009 decrease in riparian area was primarily caused by conversion of a large portion of pre-dam floodplain (fig. 11B) into a series of constructed floodplains by mechanical surface lowering. The area of post-dam benches also decreased during the study period, with the largest cumulative decreases from 1980 to 1997 (fig. 12A) caused by bank erosion and bar scour. Post-dam benches were also converted into constructed floodplains by vegetated berm removal and mechanical surface lowering. Floodplain construction accelerated during the post-ROD period, especially after 2006 (fig. 13).

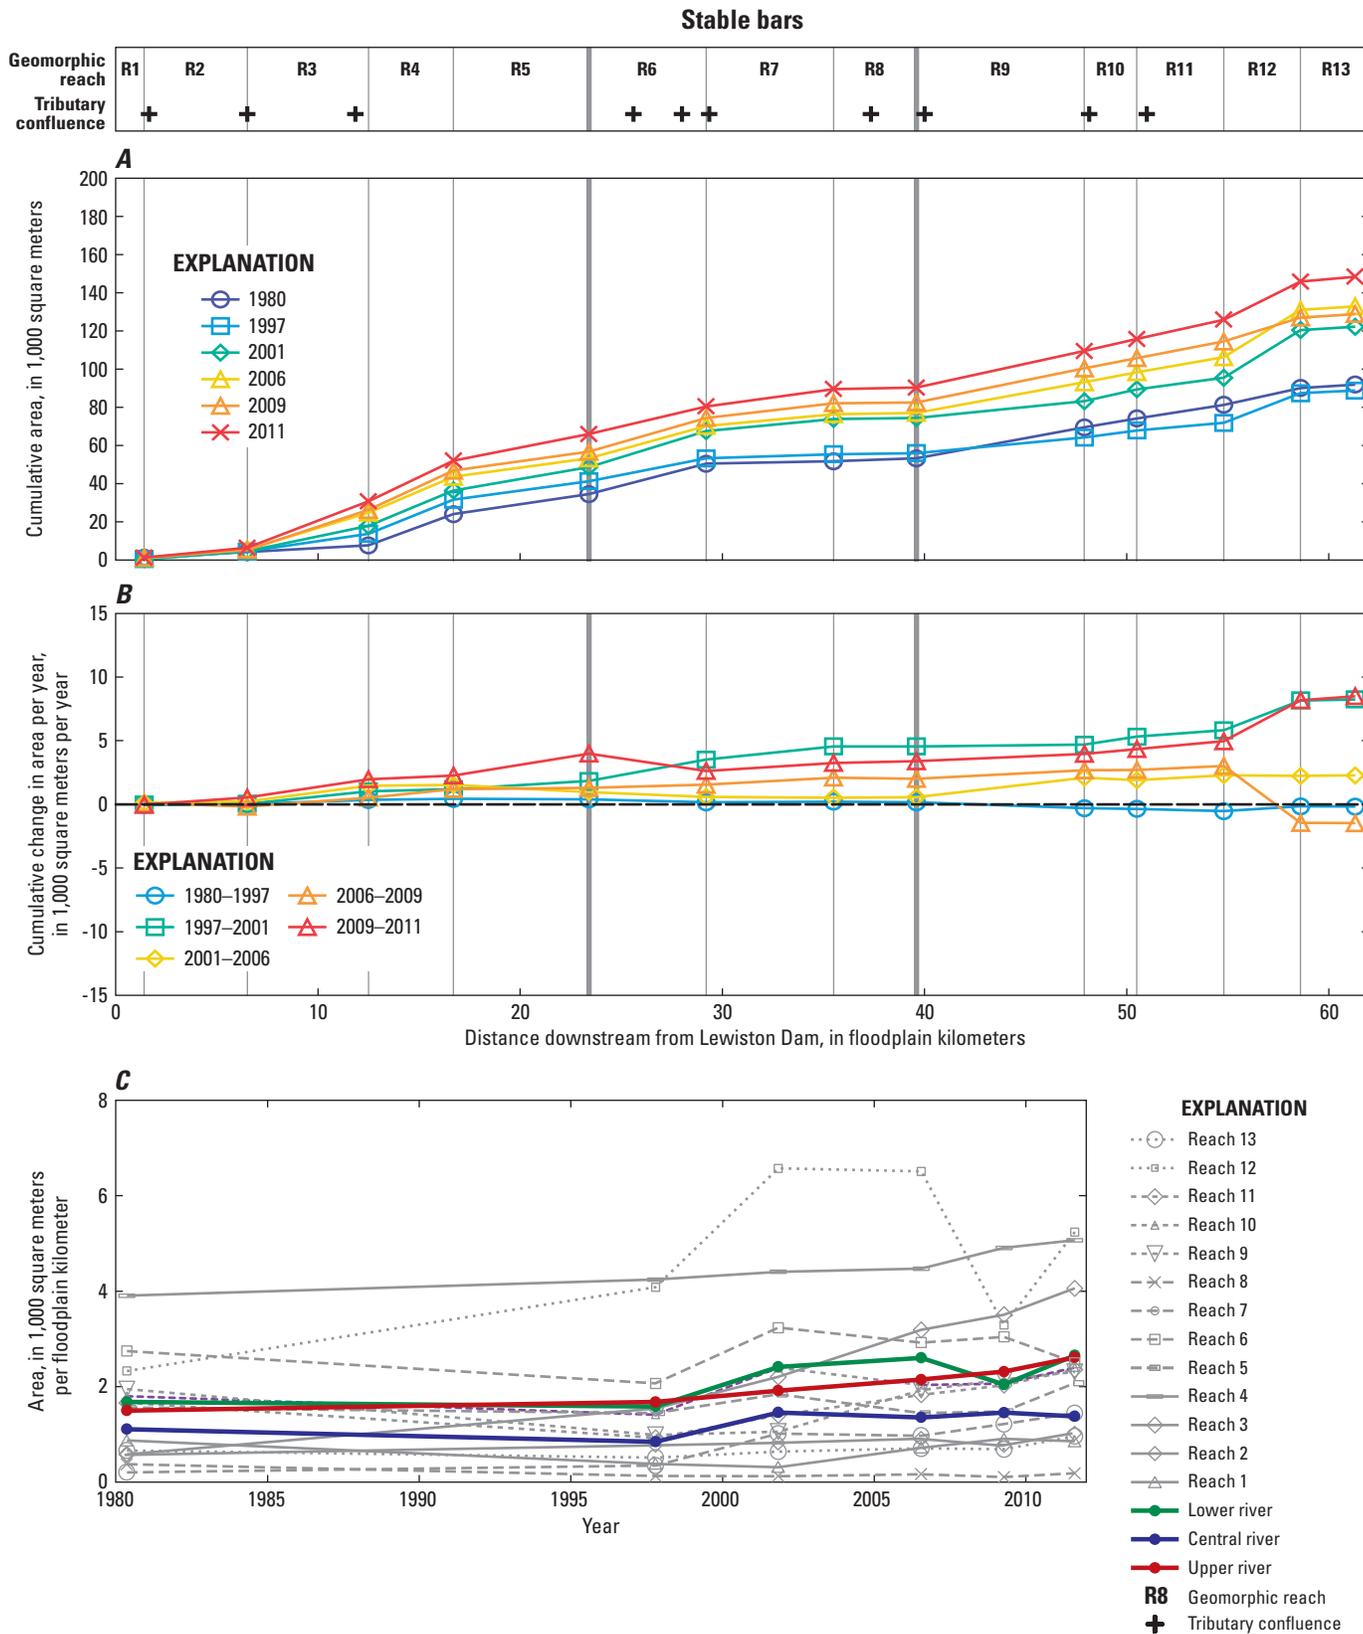
Figure 14. Area of stable bars along the Trinity River downstream from Lewiston Dam, California, and change in stable bar area from 1980 to 2011: *A*, cumulative area by study reach; *B*, cumulative change in area per year by study reach; *C*, area by study reach and river segments over time.

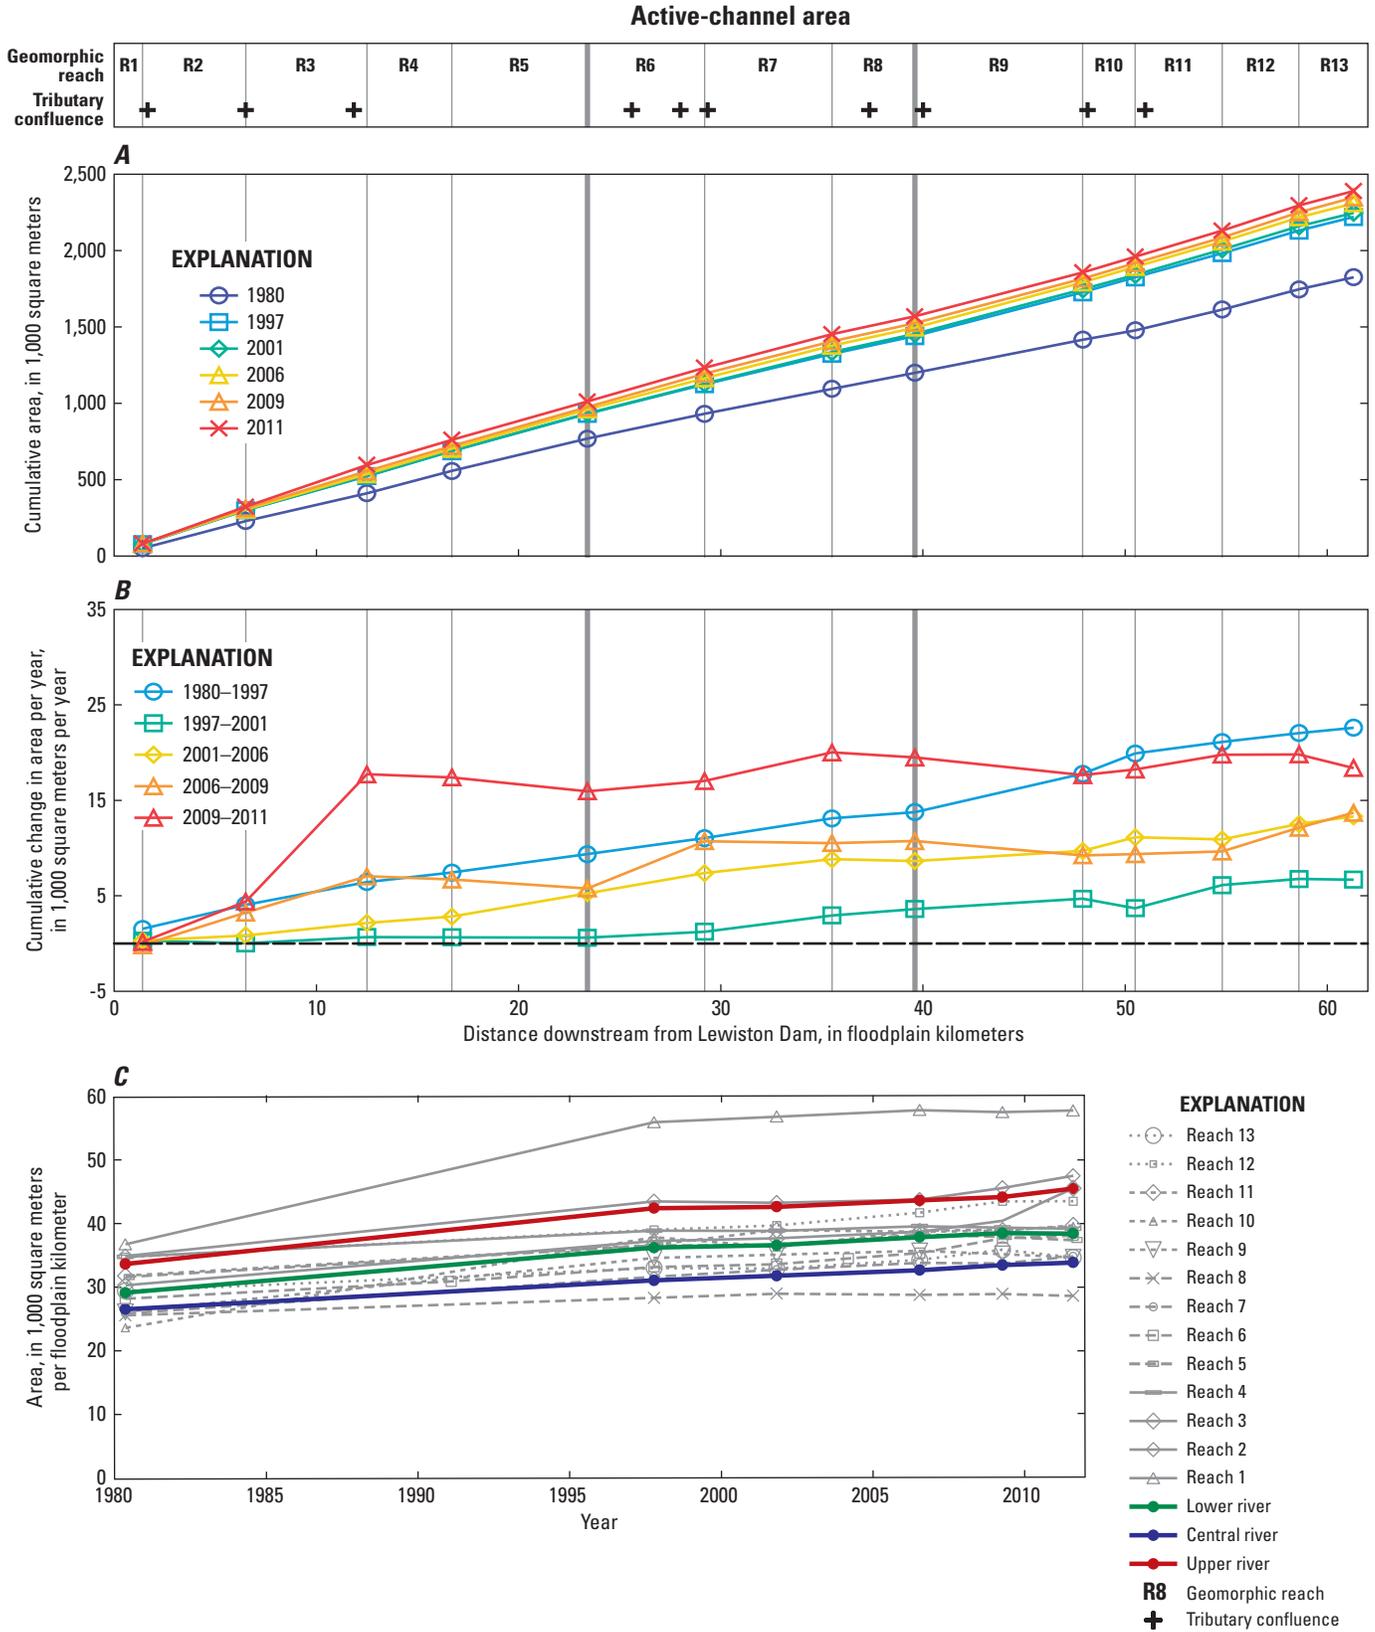
Figure 15. Area of the active channel along the Trinity River downstream from Lewiston Dam, California, and change in active channel area from 1980 to 2011: *A*, cumulative area by study reach; *B*, cumulative change in area per year by study reach; *C*, area by study reach and river segments over time.

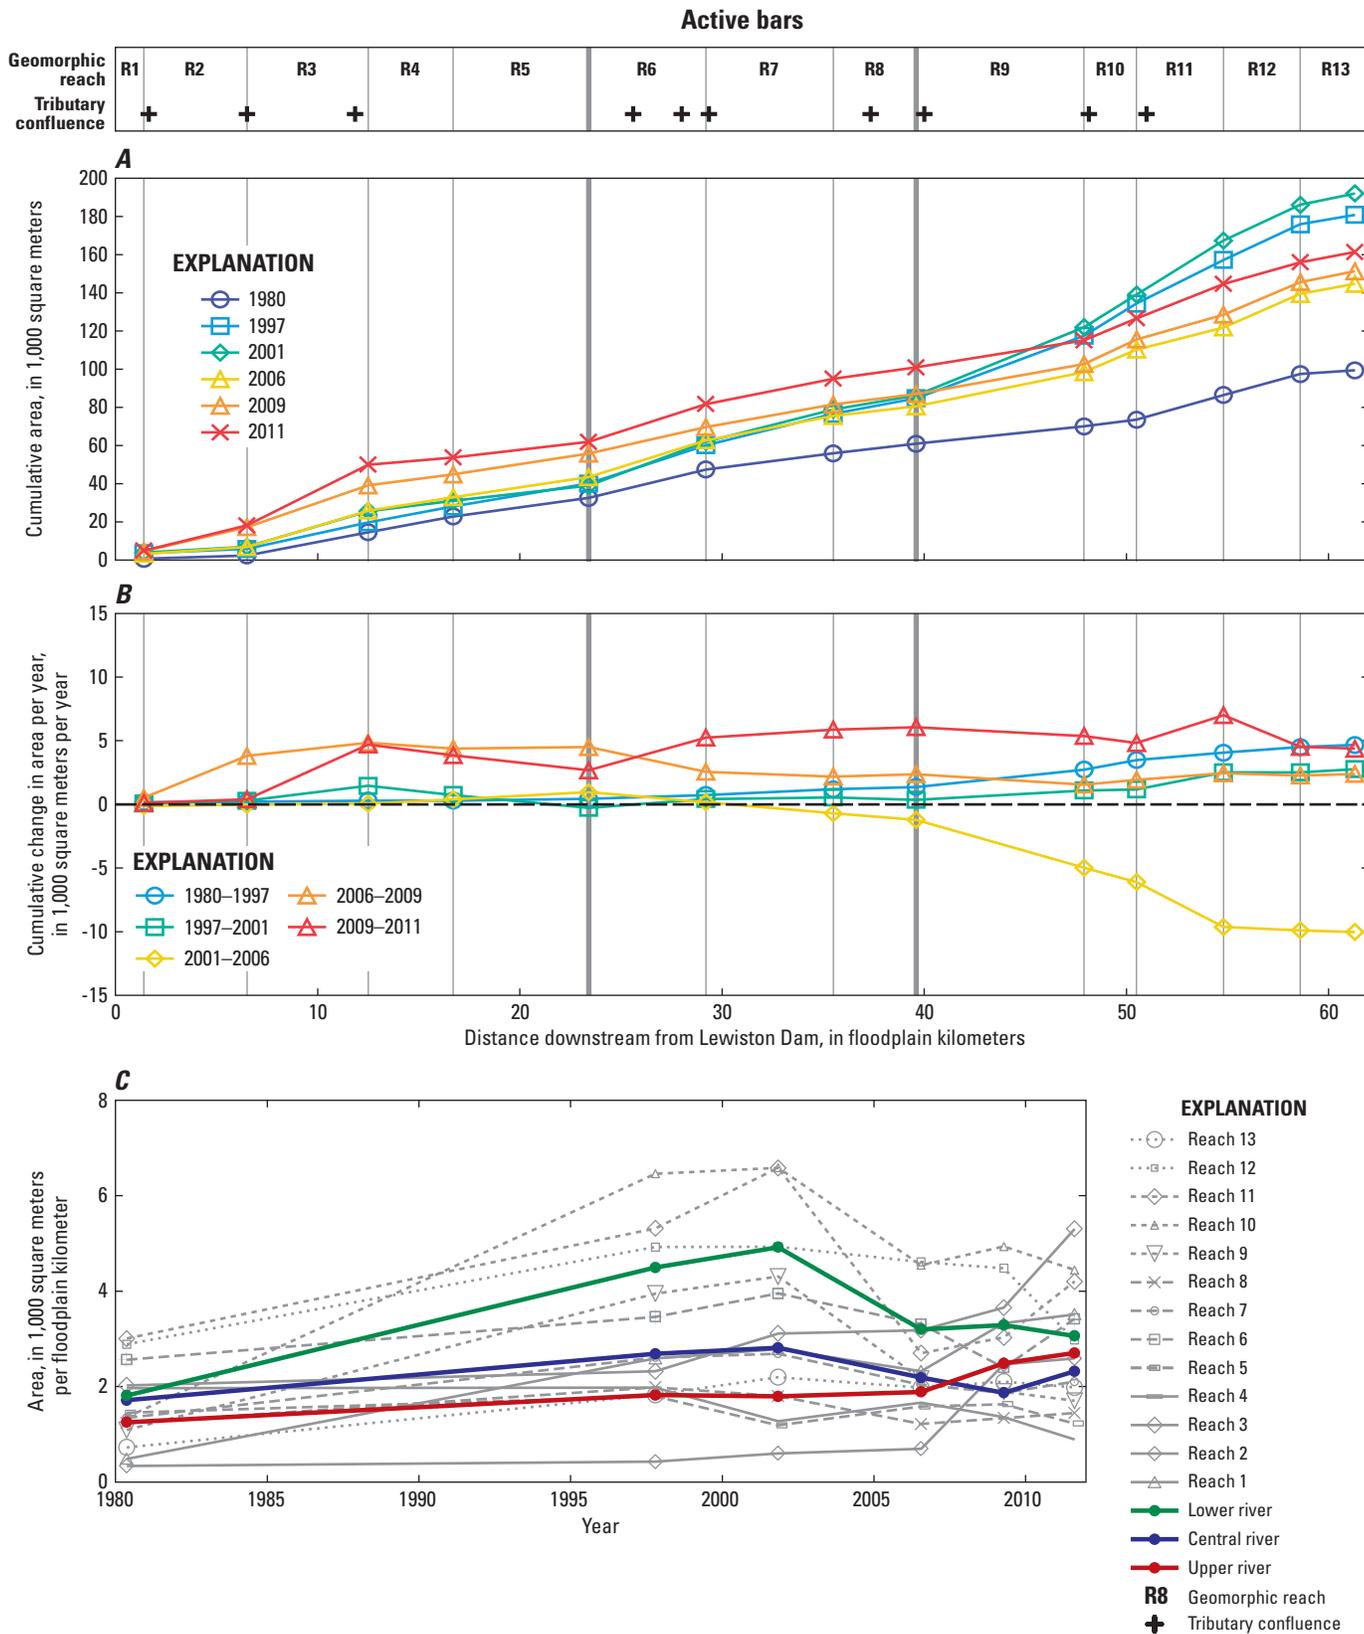
Figure 16. Area of active bars along the Trinity River downstream from Lewiston Dam, California, and change in active bar area from 1980 to 2011: *A*, cumulative area by study reach; *B*, cumulative change in area per year by study reach; *C*, area by study reach and river segments over time.

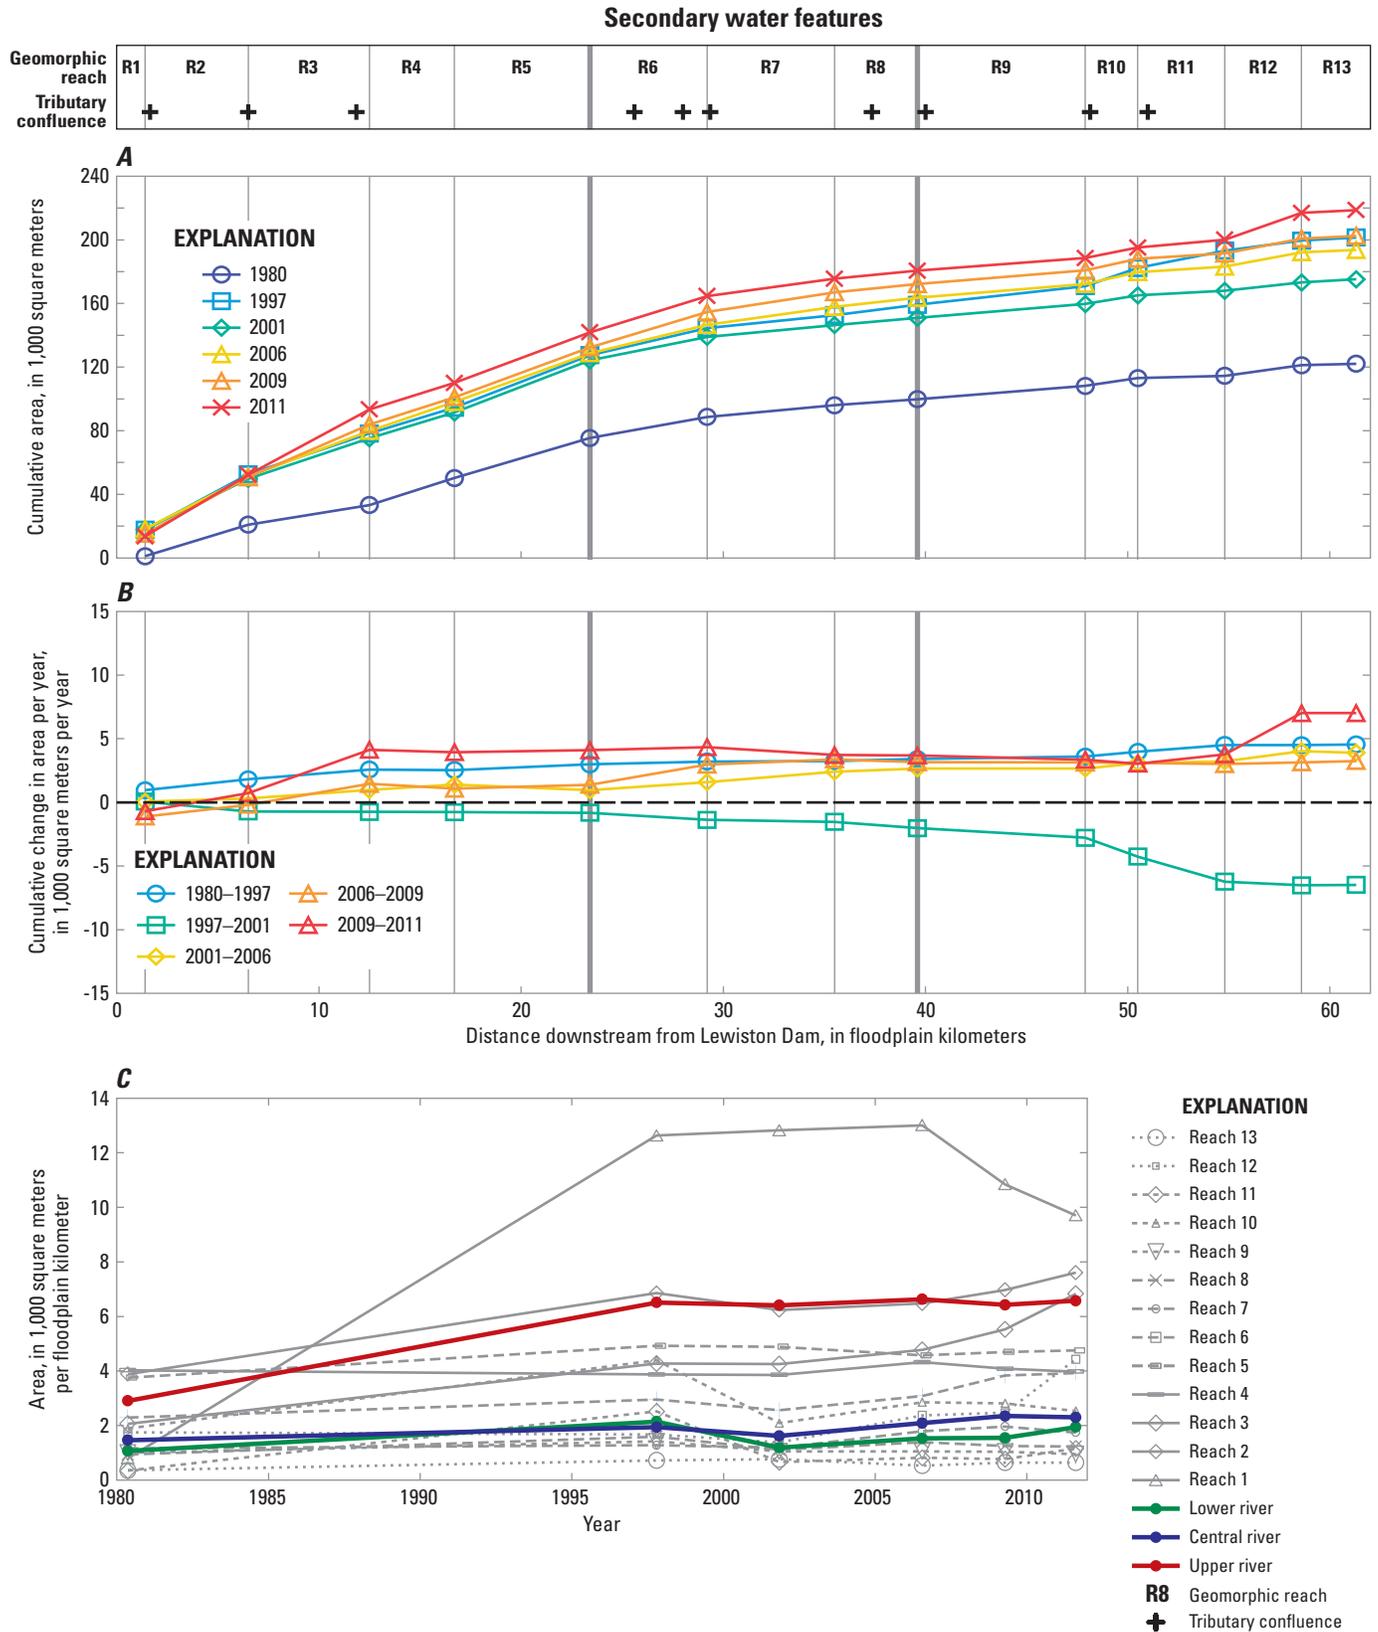
Figure 17. Area of secondary water features (split-flow channels, side channels, alcoves, and aquatic wetlands) along the Trinity River downstream from Lewiston Dam, California, and change in secondary water feature area from 1980 to 2011: *A*, cumulative area by study reach; *B*, cumulative change in area per year by study reach; *C*, area by study reach and river segments over time.

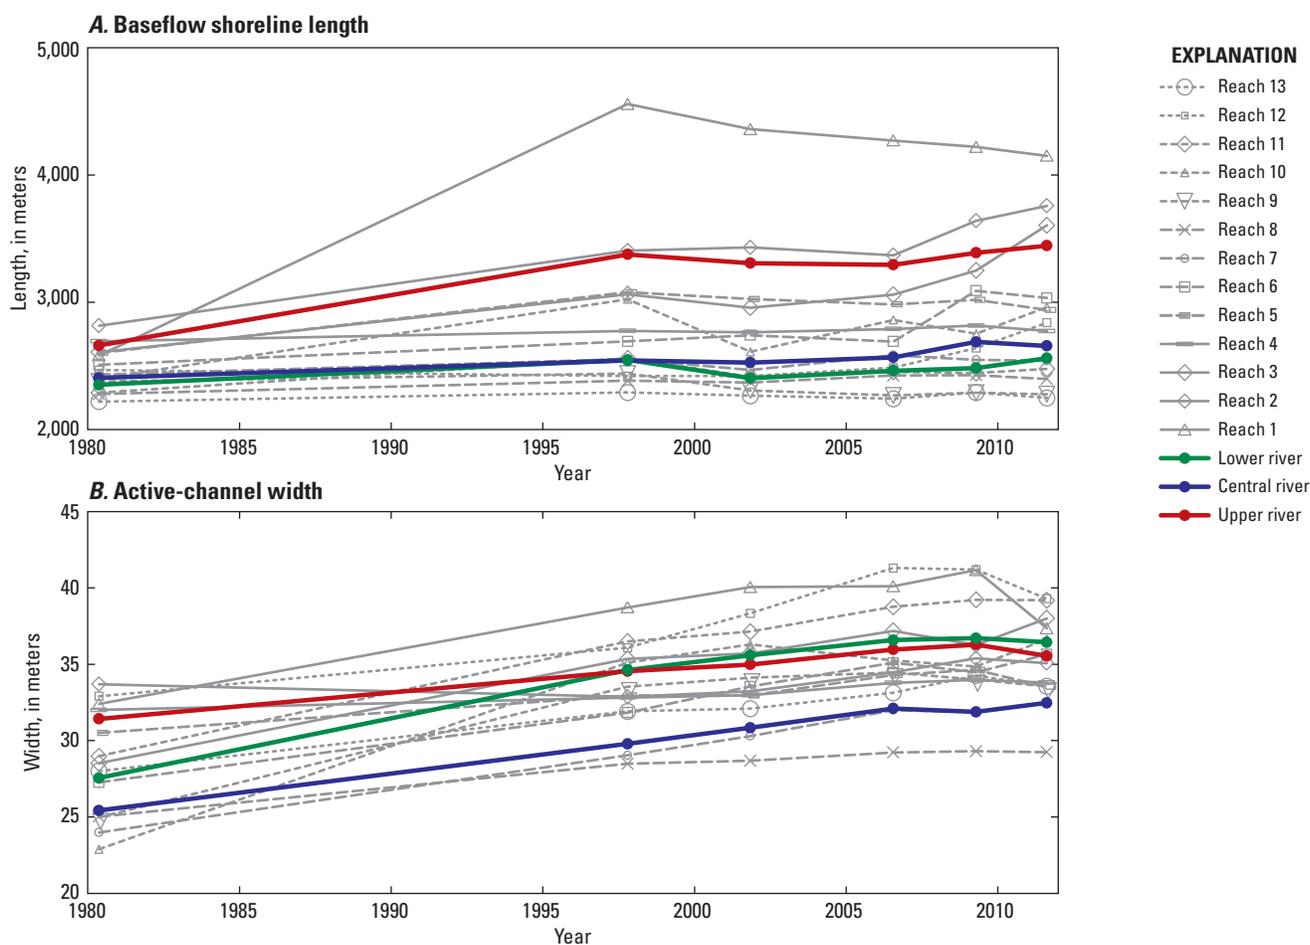
Figure 18. Temporal changes in the active-channel from 1980 to 2011 for the Trinity River downstream from Lewiston Dam, California: *A*, baseflow shoreline length; *B*, active-channel width.

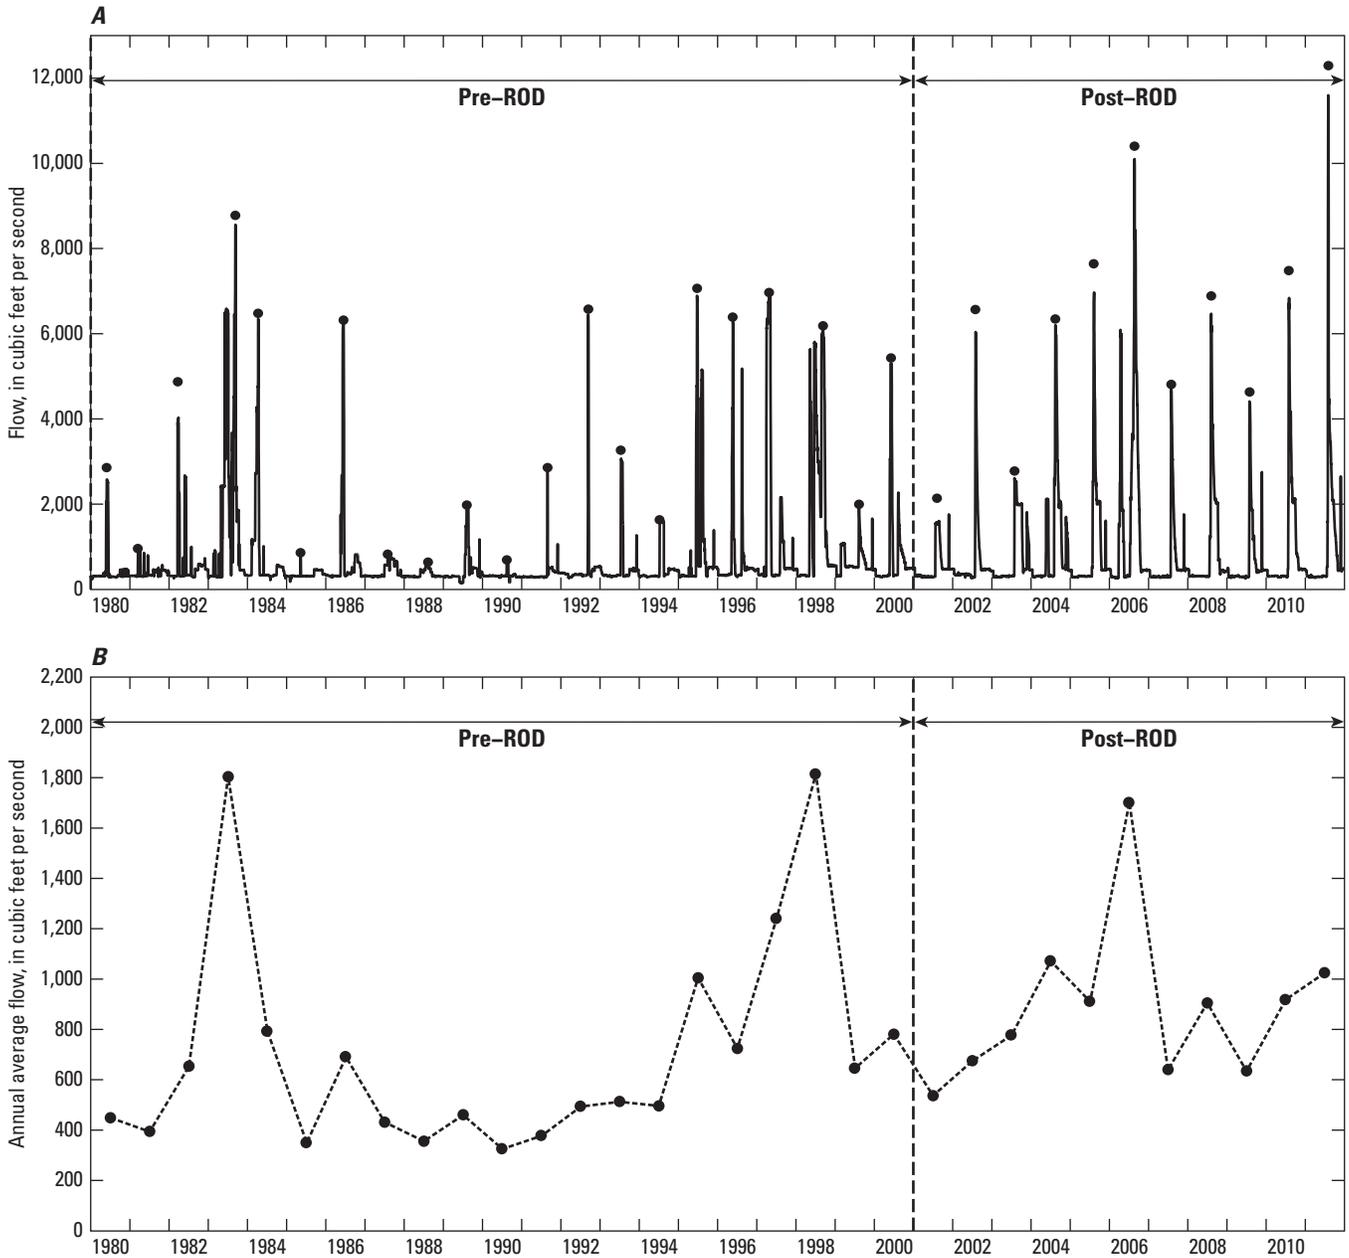
Figure 19. Streamflow measured at the Lewiston gage on the Trinity River, California, 1.5 km downstream from Lewiston Dam, from 1980 to 2011: *A*, mean daily and annual peak flows; *B*, annual average flows. ROD, Record of Decision.

Figure 19 presents mean daily flows, annual peaks, and annual average flows for the Lewiston gage. During the relatively wetter pre-ROD period, there were three water years (1983, 1997, and 1998) classified as “extremely wet,” and one year (1995) classified as “wet” (table 1). The years 1983 and 1995 bracketed a decade of lower flows from 1985 to 1994. During the relatively drier post-ROD period, one year (2006) was classified as “extremely wet,” and two years (2004 and 2011) were classified as “wet.”

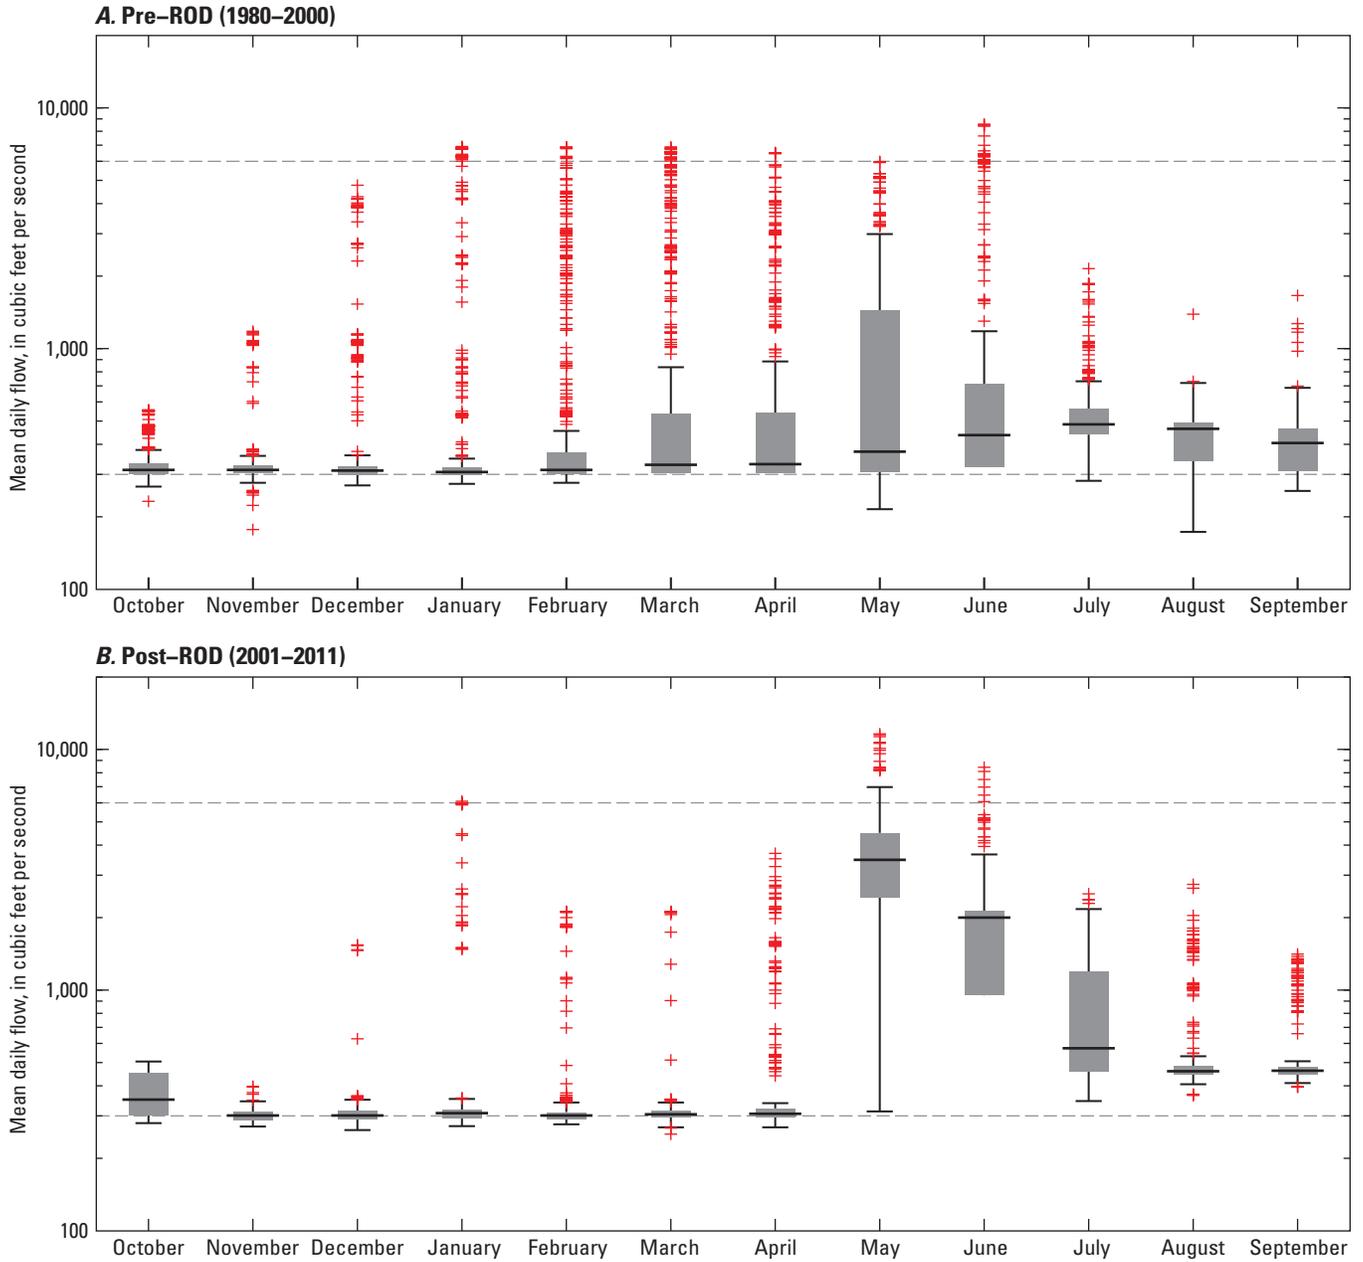
Figure 20. Mean daily flows from 1980 to 2011, grouped by month with minimum in-stream flow, for the Lewiston gage on the Trinity River, California: *A*, pre-ROD (Record of Decision) period; *B*, post-ROD period. The horizontal dashed lines indicate 300 cubic feet per second, which represents summer-baseflow conditions, and 6,000 cubic feet per second, which represents the post-ROD mean annual peak flow.

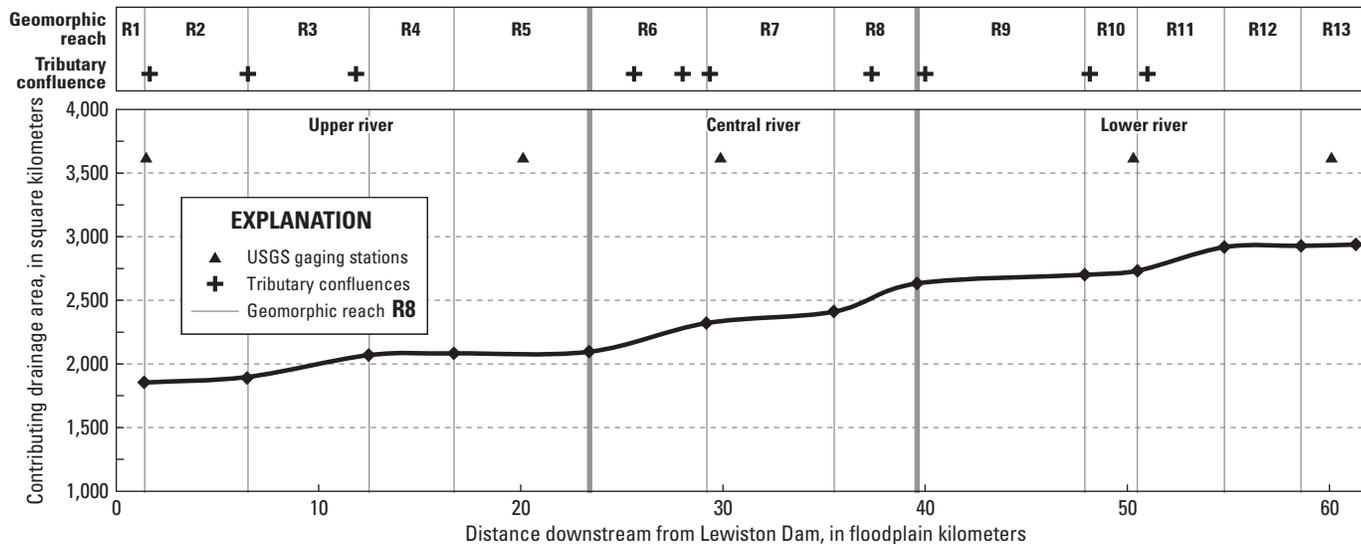
Figure 21. Contributing drainage area for 13 geomorphic reaches, delineated by vertical lines and described in table 2, along the Trinity River downstream from Lewiston Dam, California. USGS, U.S. Geological Survey.

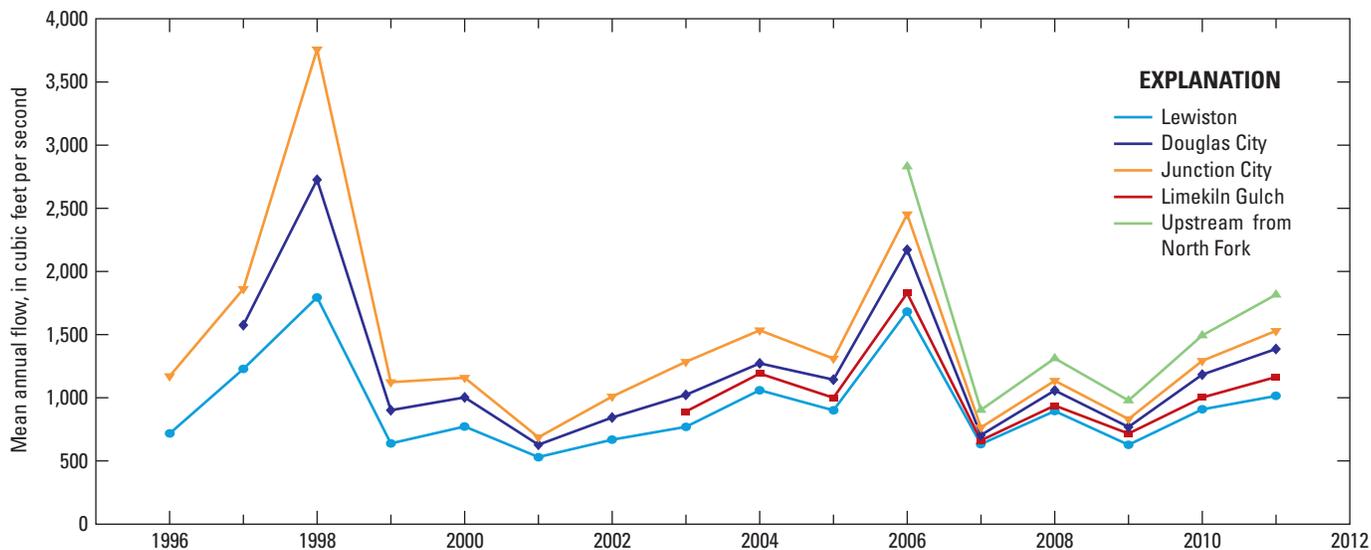
Figure 22. Mean annual flow measured at five mainstem gages on the Trinity River, California, downstream of Lewiston Dam, California, from 1996 to 2011.

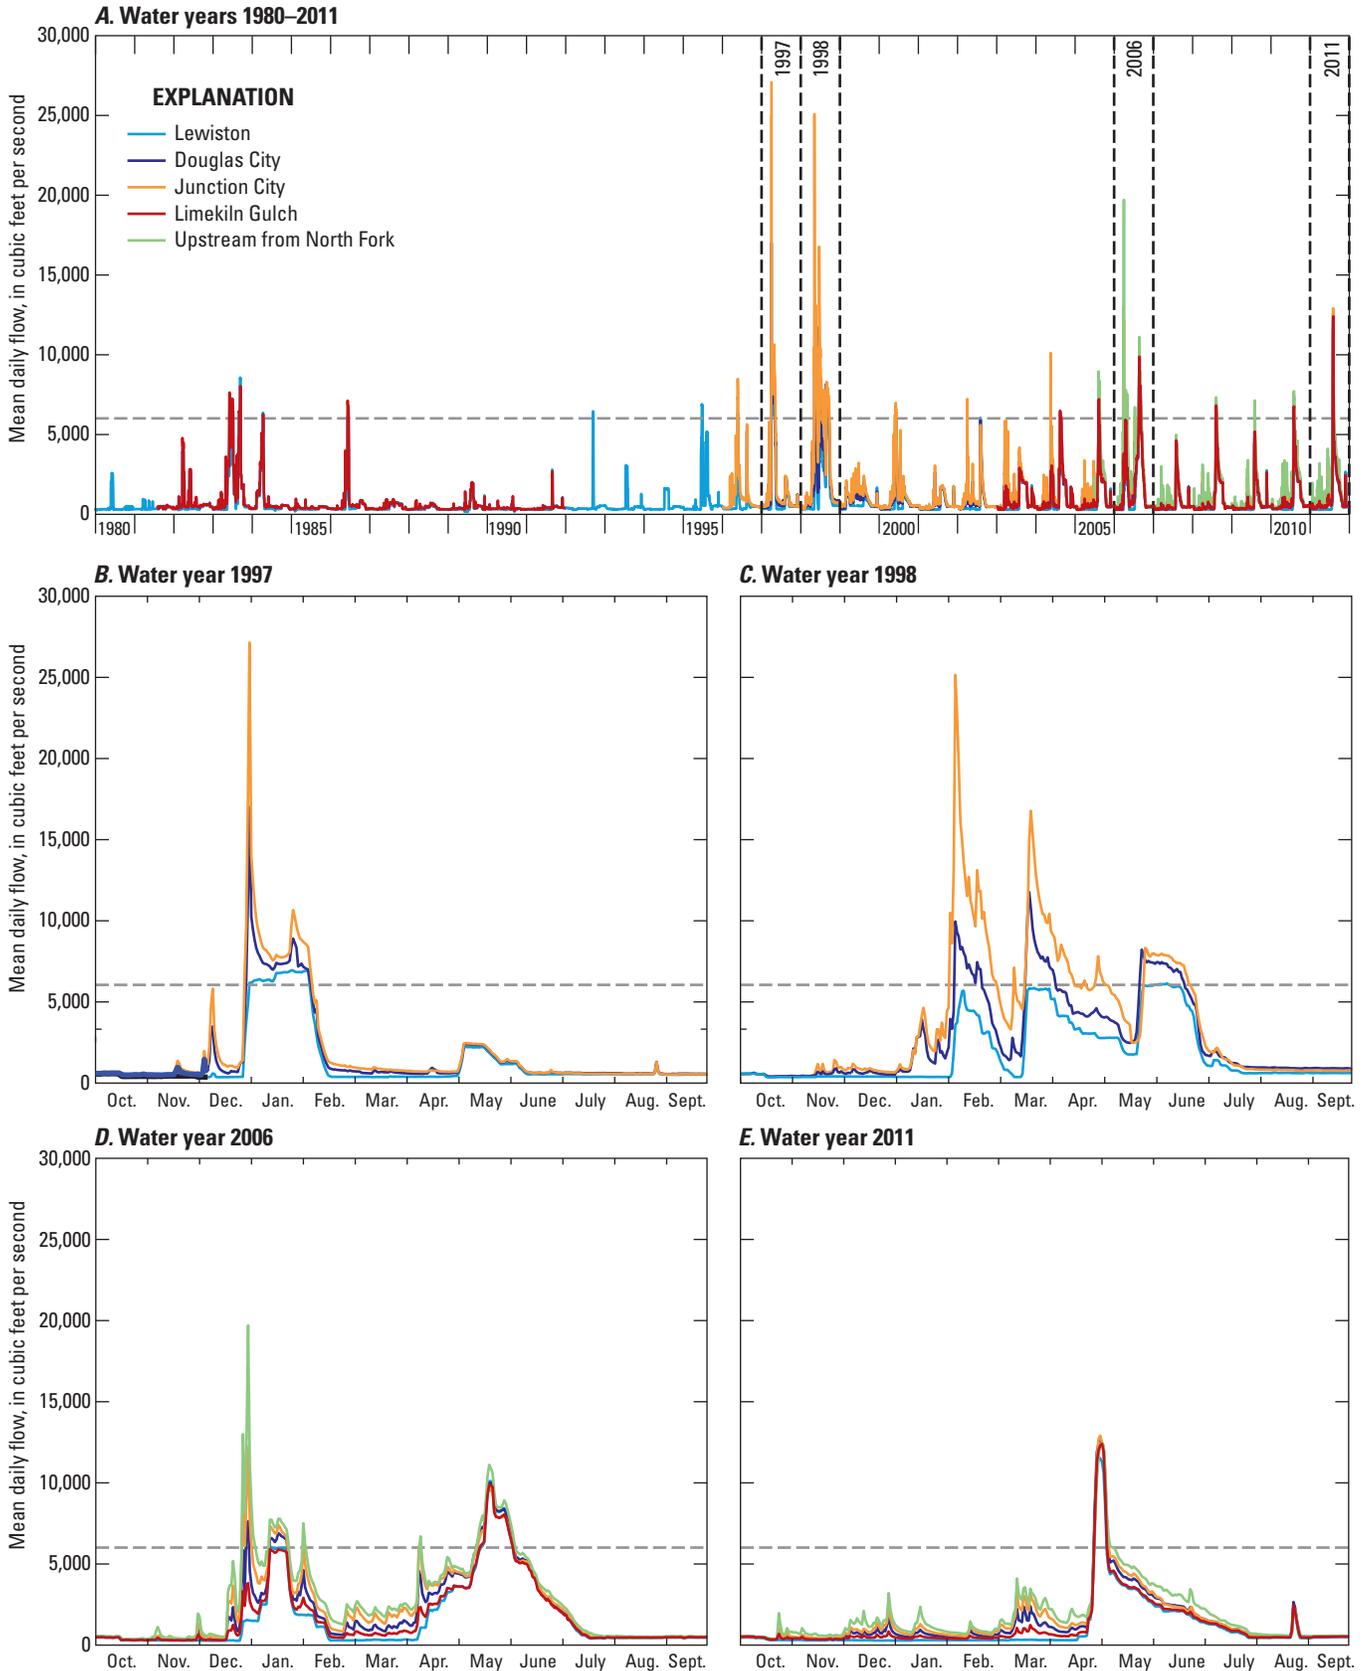
Figure 23. Mean daily flows measured at five mainstem gaging stations on the Trinity River, California, downstream from Lewiston Dam, from 1980 to 2011, and annual time series for four wettest years during the study period: *A*, 1997; *B*, 1998; *C*, 2006; *D*, 2011. Dashed horizontal line denotes 6,000 cubic feet per second, which represents the post-Record of Decision mean annual peak flow.

Figure 23 illustrates mean daily flows for mainstem gages and highlights two pre-ROD water years (1997, 1998) and two post-ROD years (2006, 2011), which represent the four largest tributary-flow events during the study period. The influence of tributaries on mainstem flows was clear in December 1997, when mean daily flows increased from about 6,900 ft³/s at Lewiston to 10,200 ft³/s at Douglas City and to 27,000 ft³/s at Junction City. In February 1998, mean daily flows increased from about 5,600 ft³/s at Lewiston to 9,900 ft³/s at Douglas City and to 25,000 ft³/s at Junction City. Mean daily flows released in December of 2006 were about 1,500 ft³/s at Lewiston, but increased to 7,500 ft³/s at Douglas City, to 12,000 ft³/s at Junction City, and to nearly 20,000 ft³/s at the North Fork gage (fig. 23D). In comparison, mean daily flows in May 2011, during the largest flow release since 1974 (Krause, 2012a), lacked tributary contributions because the flow release did not coincide with tributary runoff. In May 2011, flow releases at Lewiston peaked at 12,000 ft³/s, compared to 12,500 ft³/s at Limekiln Gulch, 12,900 ft³/s at Douglas City, 13,700 ft³/s at Junction City, and 12,900 ft³/s at the North Fork gage (fig. 23E).

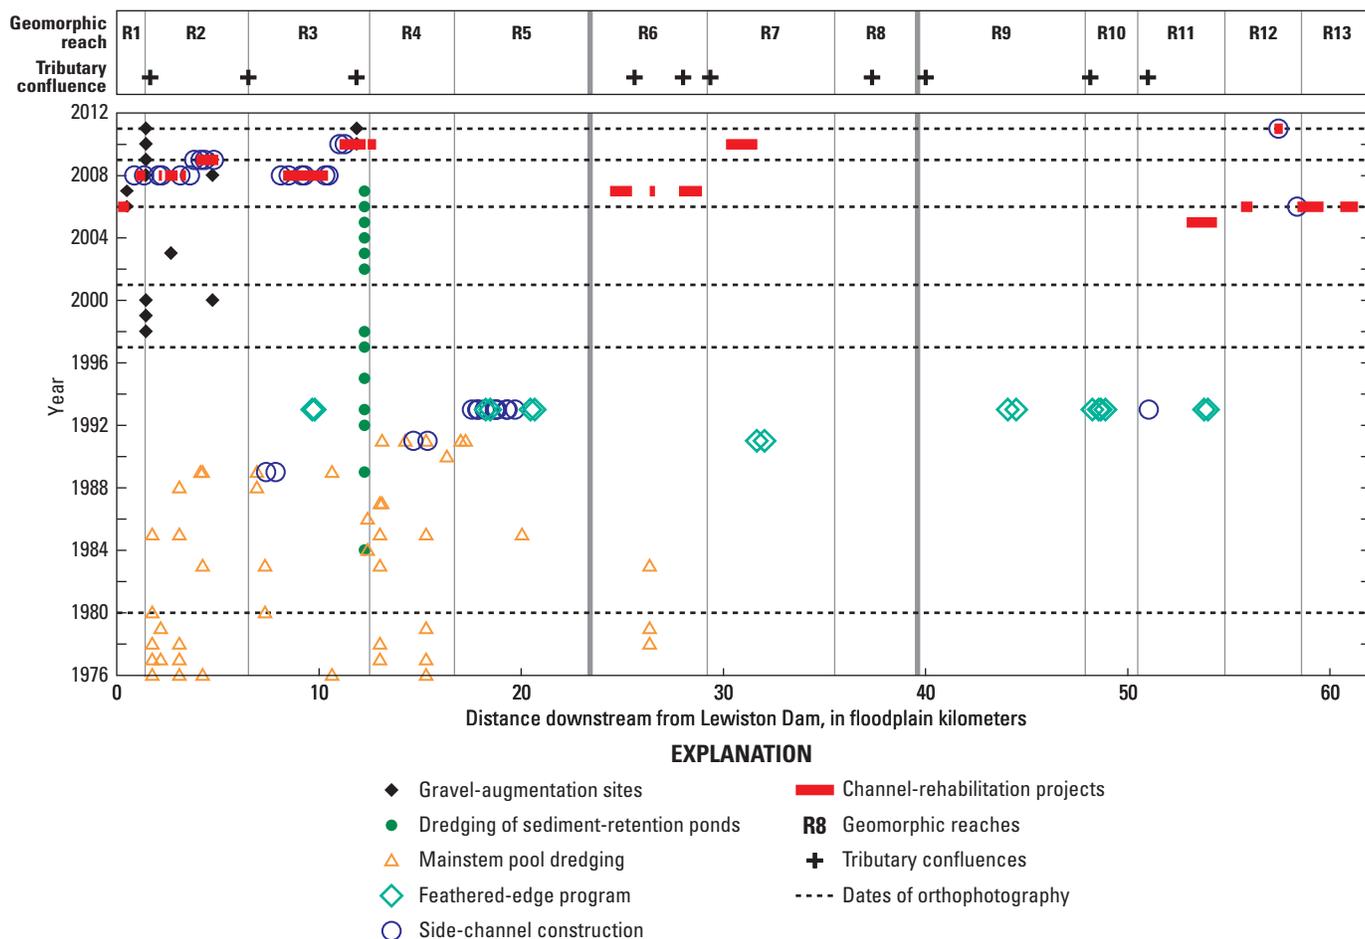
Figure 24. Summary of relevant management actions from 1976 to 2011 along the Trinity River downstream from Lewiston Dam, California.

In 1999, the TRFE determined the lack of rearing habitat continued to be a primary limiting factor for sustainable salmonid populations and made recommendations for prescriptive-flow management, channel rehabilitation, and augmentation of coarse bed-material-sized sediment adopted by the ROD in 2001. The TRFE identified 44 potential channel-rehabilitation sites and 3 potential side-channel sites. Construction of these projects began in 2005 under a phased approach to allow for monitoring and performance assessment (Trinity River Restoration Program and ESSA Technologies Ltd., 2009). From 2005 to 2011, 19 of the proposed rehabilitation projects were constructed (fig. 24).
