Assessing Geomorphic Change along the Trinity River Downstream from Lewiston Dam, California, 1980 to 2011

Scientific Investigations Report 2015–5046

By Jennifer A. Curtis, Scott A. Wright, J. Toby Minear, and Lorraine E. Flint

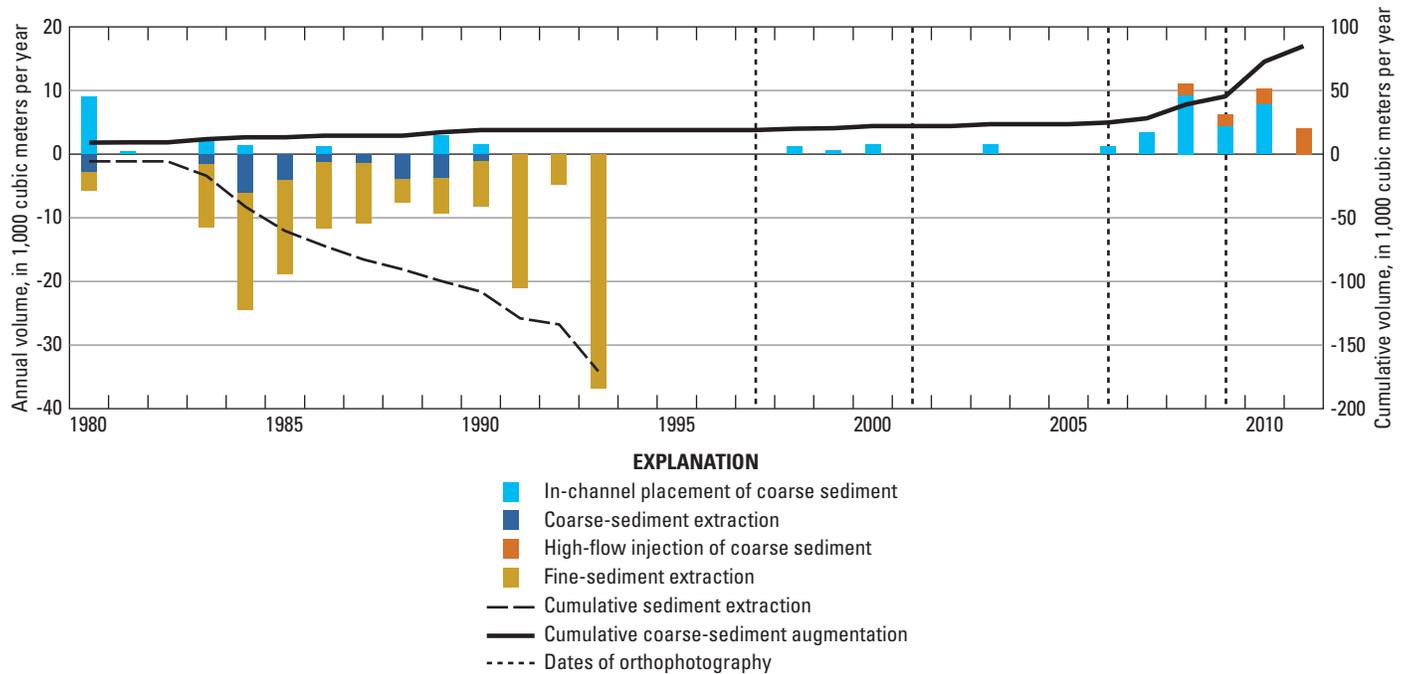
Figure 25. Annual and cumulative volumes of sediment extraction and augmentation for Trinity River downstream from Lewiston Dam, California, from 1980 to 2011 (Krause, 2012b).

Krause (2012a) provided a detailed history of sediment extraction and augmentation for the study reach, which is summarized in figure 25. Following dam closure, flow diversions, combined with elevated tributary sediment supply related to land use, caused significant aggradation of the channel bed with sand-sized bed material that filled pools and inundated spawning areas (U.S. Fish and Wildlife Service and Hoopa Valley Tribe, 1999). Sediment extraction, primarily by pool dredging, and to a lesser degree bar scalping, began in 1976 and continued until 1990. Extracted volumes of sediment were composed of approximately 15–25 percent coarse-grained sediment (greater than 16-mm in diameter) and about 75–85 percent finer grained material (less than 16 mm).

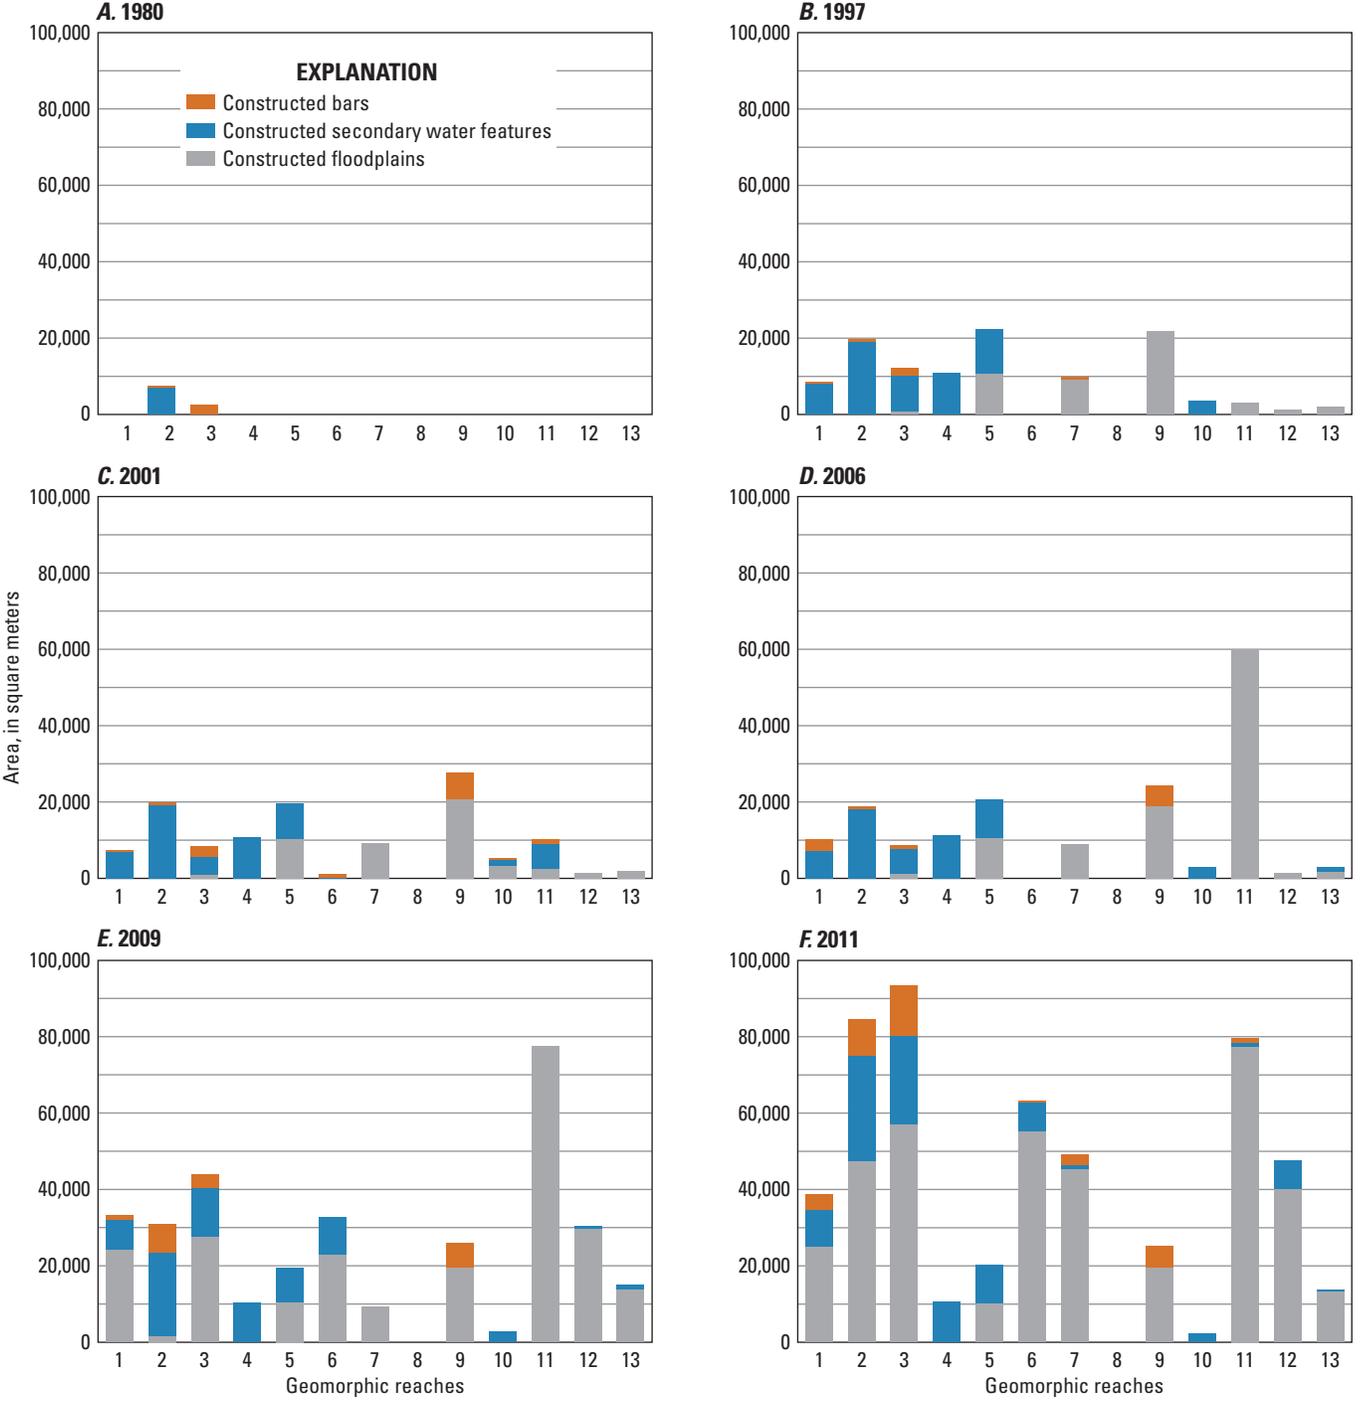
Figure 26. Bar graphs showing a summary of constructed riparian and channel features along the Trinity River downstream from Lewiston Dam, California, in 1980, 1997, 2001, 2006, 2009, and 2011.

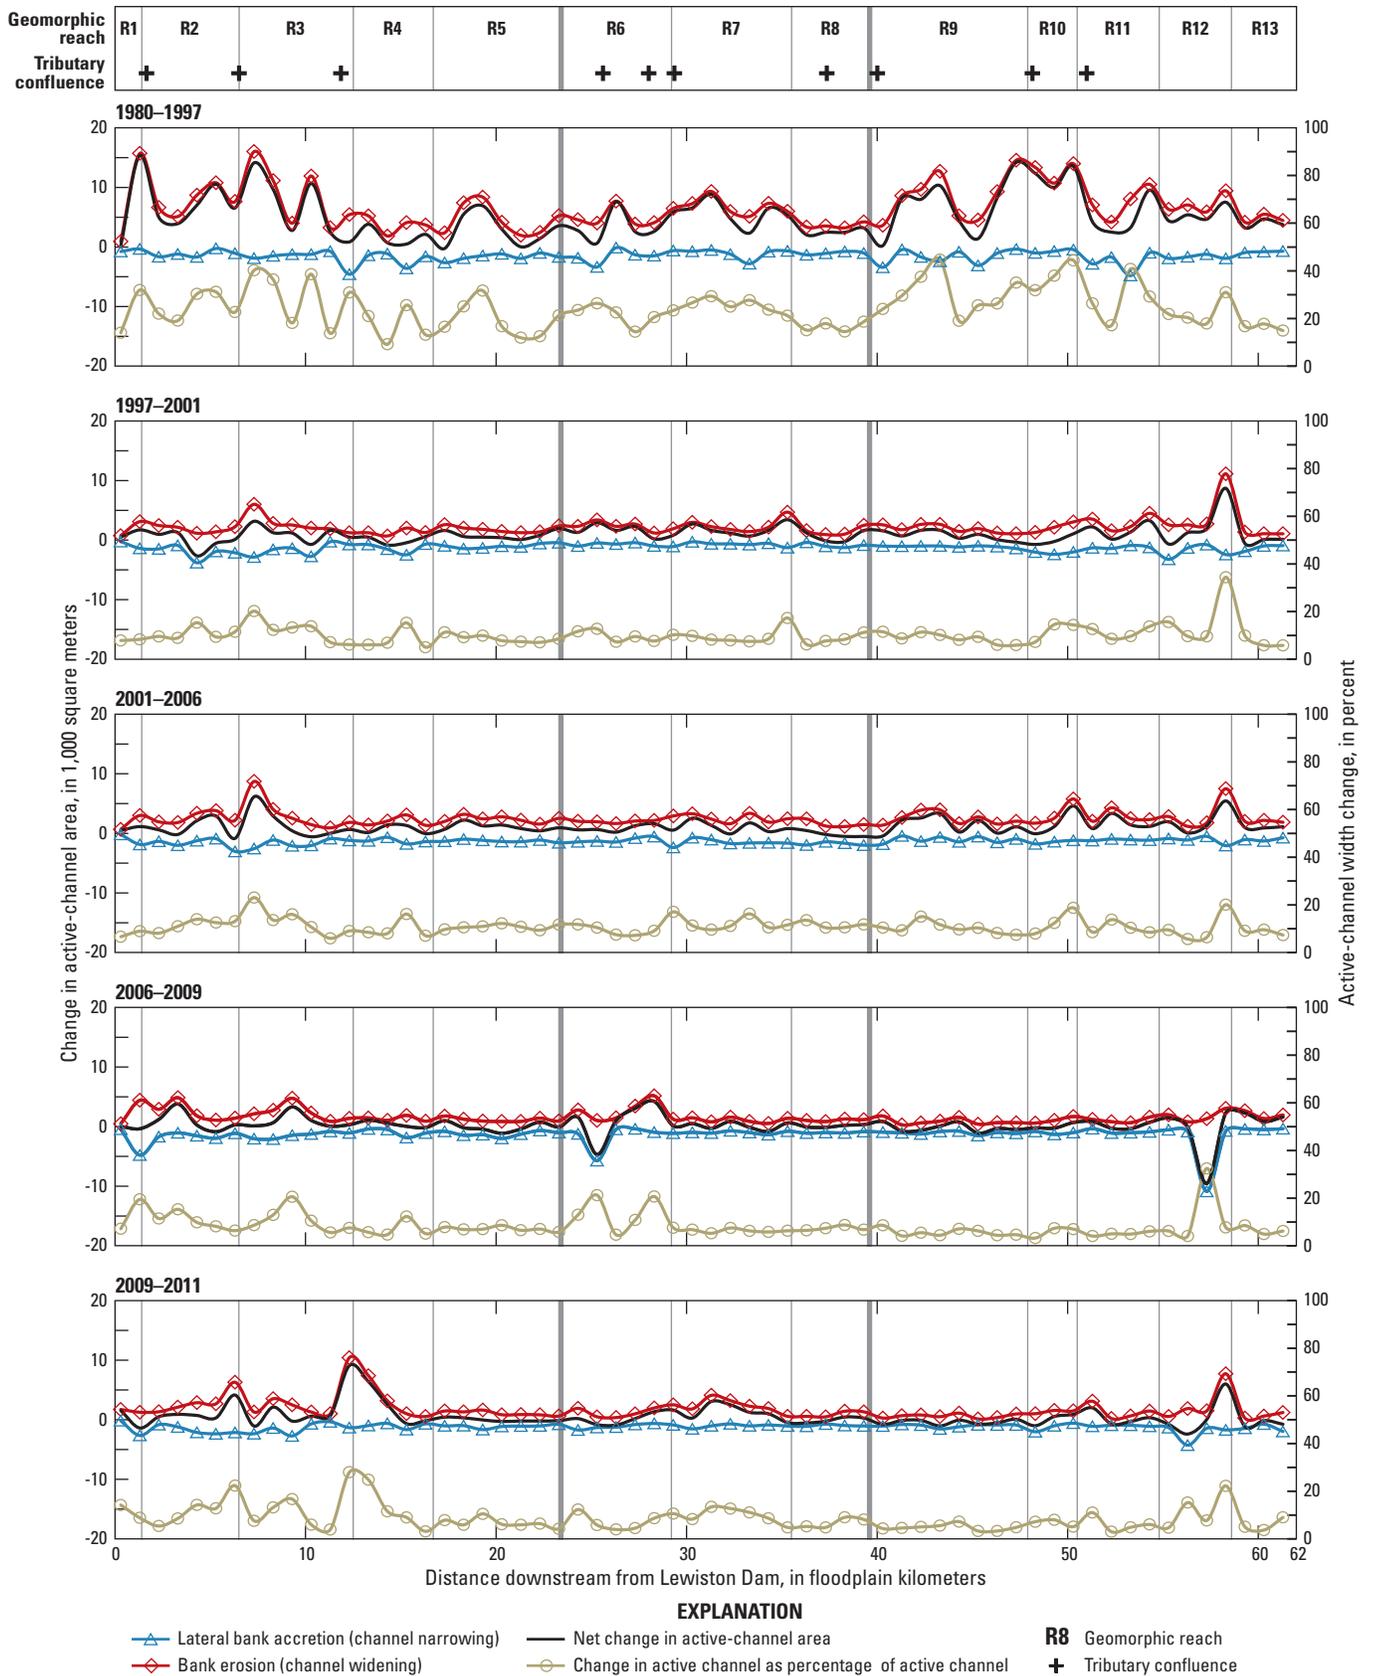
Figure 27. Changes in active-channel area due to bank erosion and accretion along the Trinity River downstream from Lewiston Dam, California, for five periods ending in 1997, 2001, 2006, 2009, and 2011.

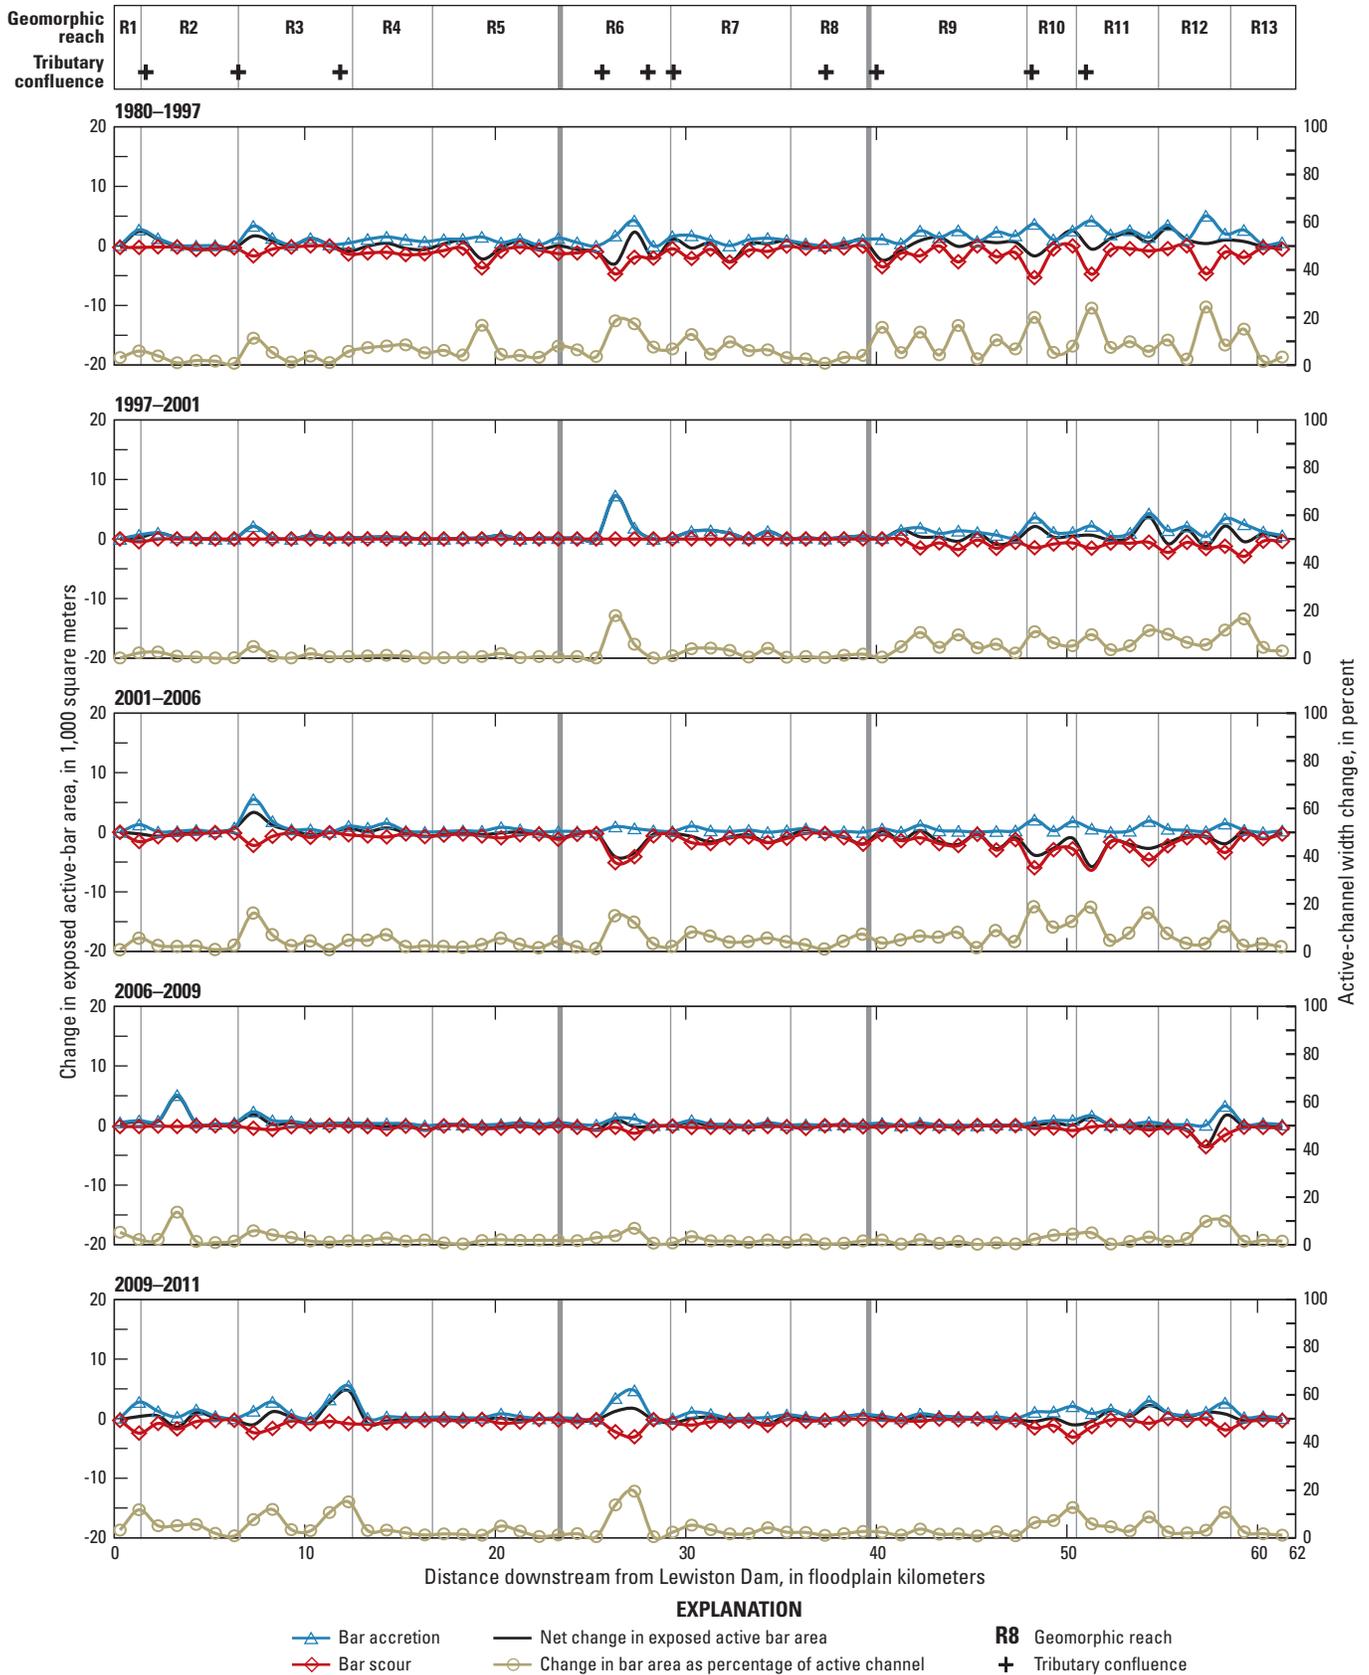
Figure 28. Changes in active-bar area due to bar scour and accretion along the Trinity River downstream from Lewiston Dam, California, for five periods ending in 1997, 2001, 2006, 2009, and 2011.

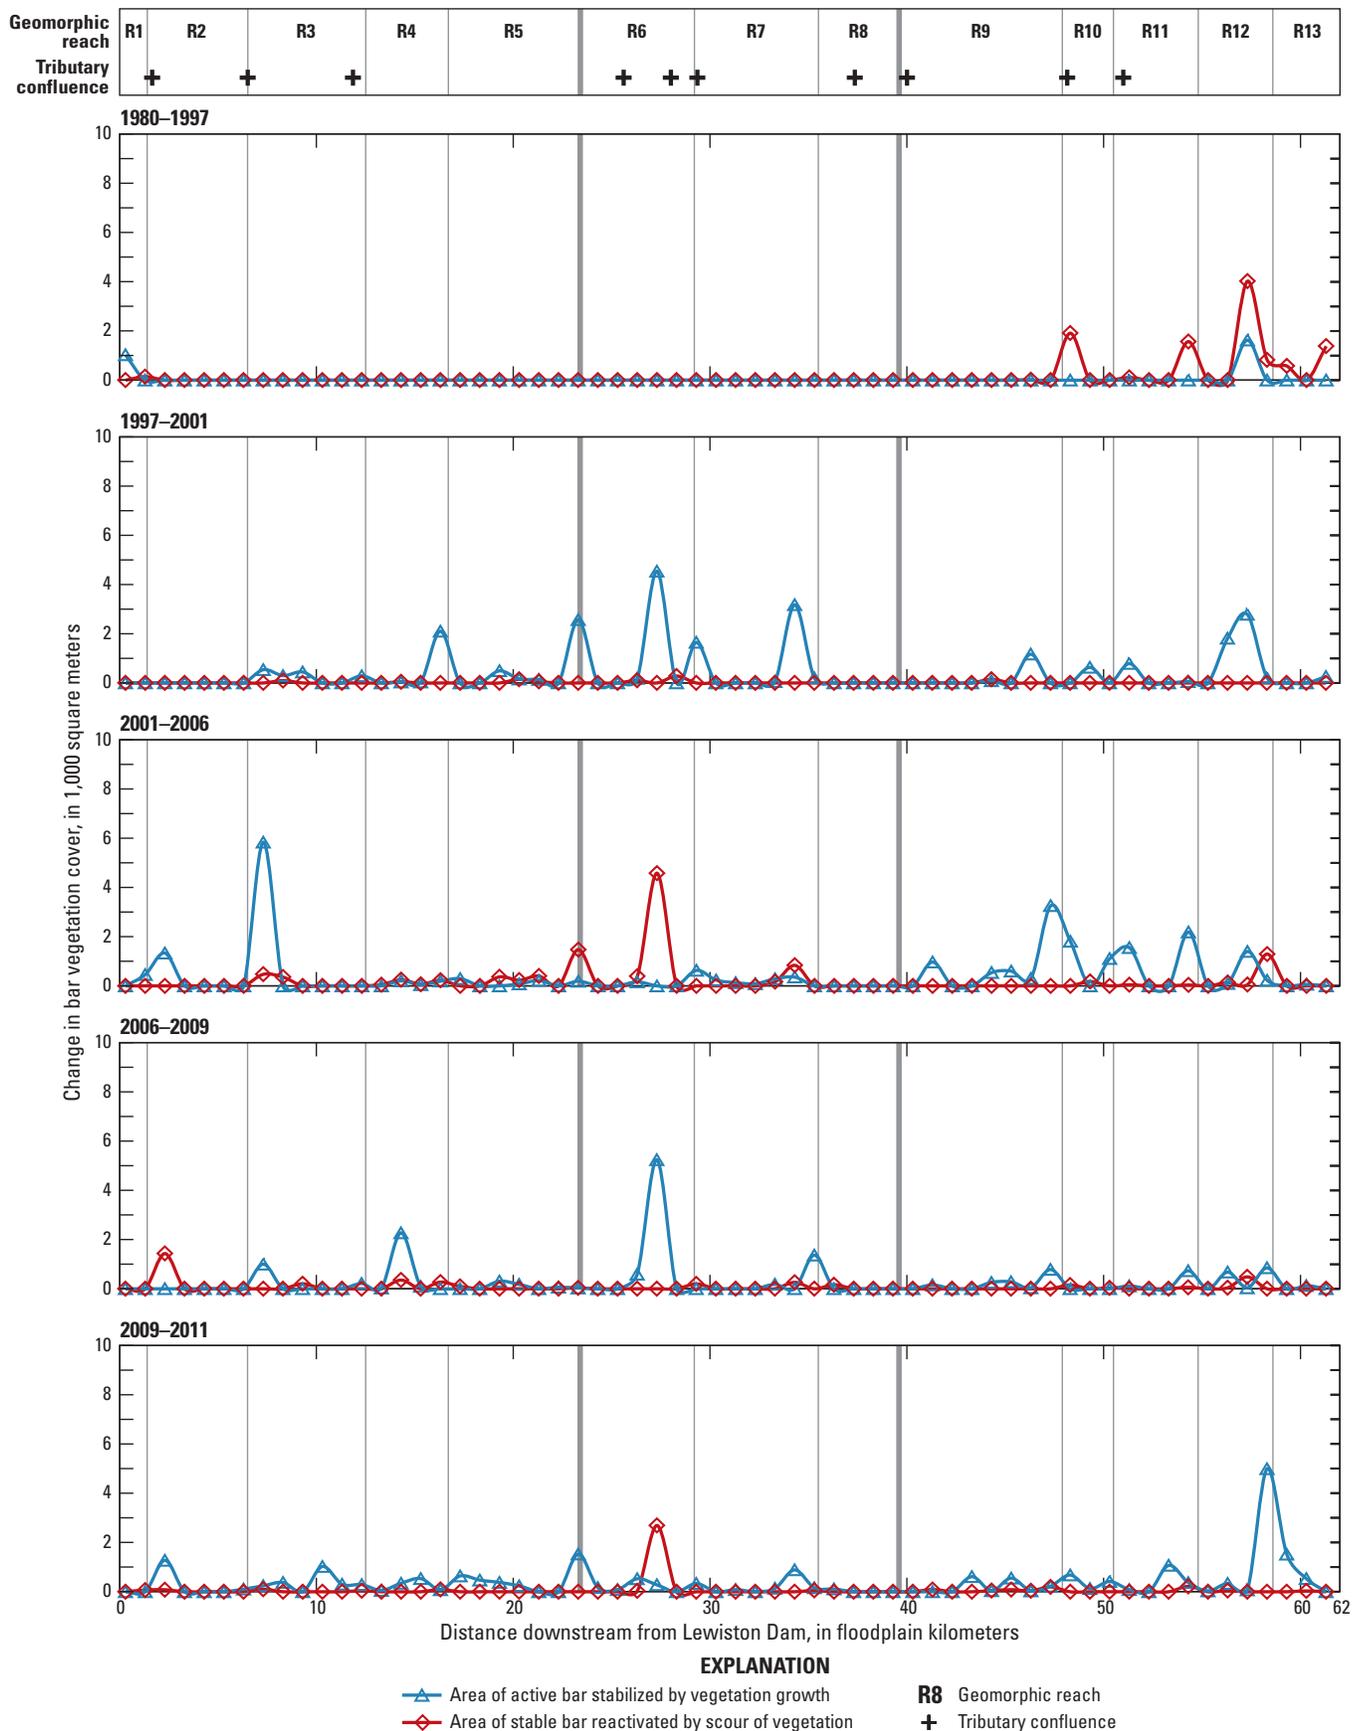
Figure 29. Changes in bar vegetation along the Trinity River downstream from Lewiston Dam, California, for five periods ending in 1997, 2001, 2006, 2009, and 2011.

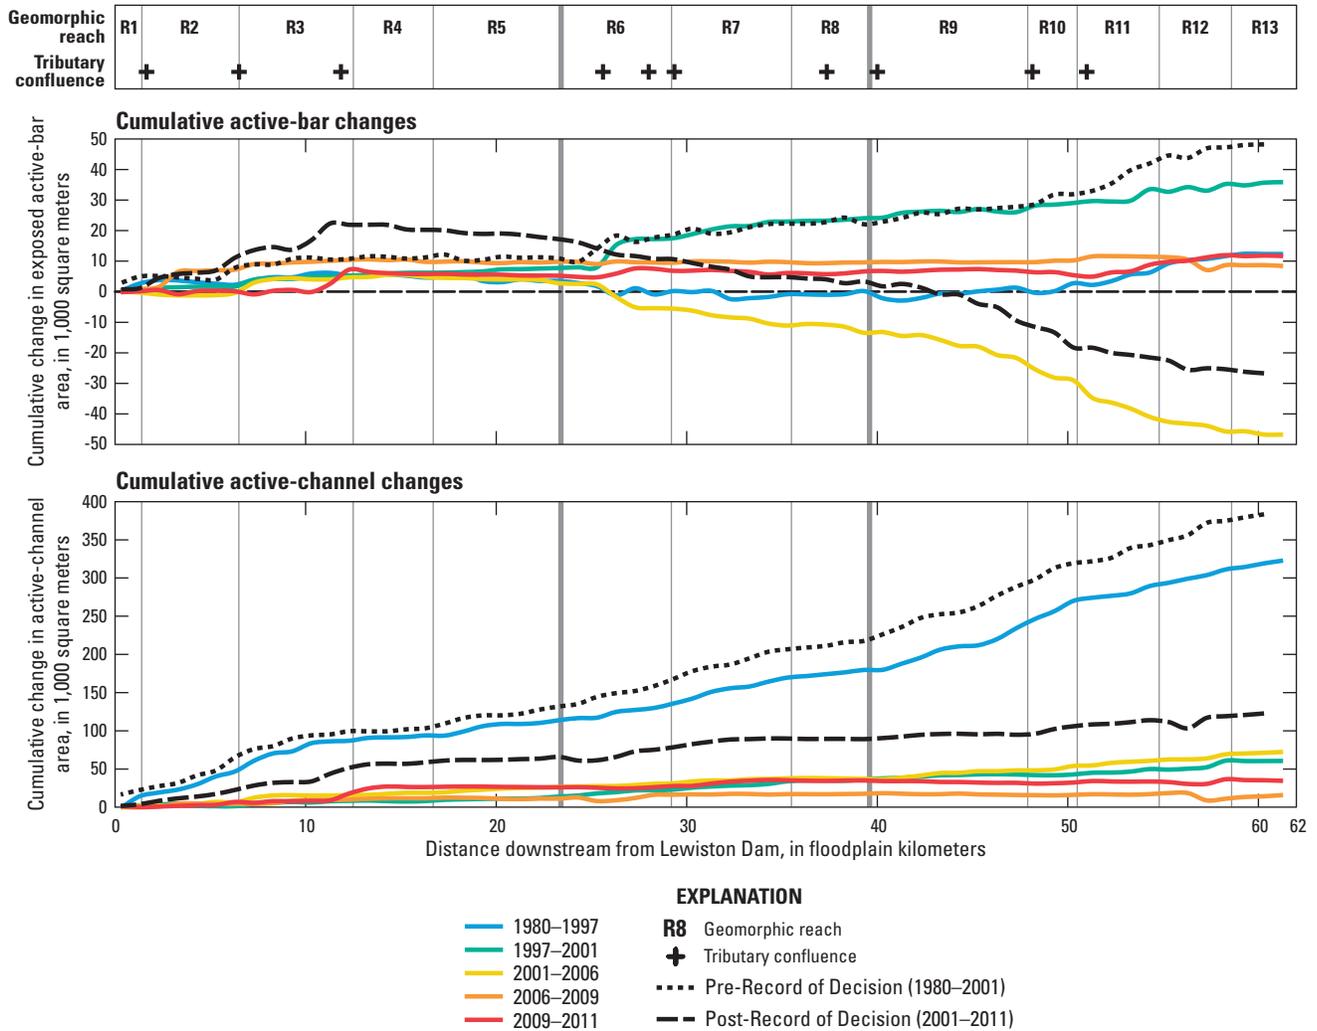
Figure 30. Cumulative downstream change in the areal extent of exposed active bars and of the active channel along the Trinity River downstream from Lewiston Dam, California, for five periods ending in 1997, 2001, 2006, 2009, and 2011.

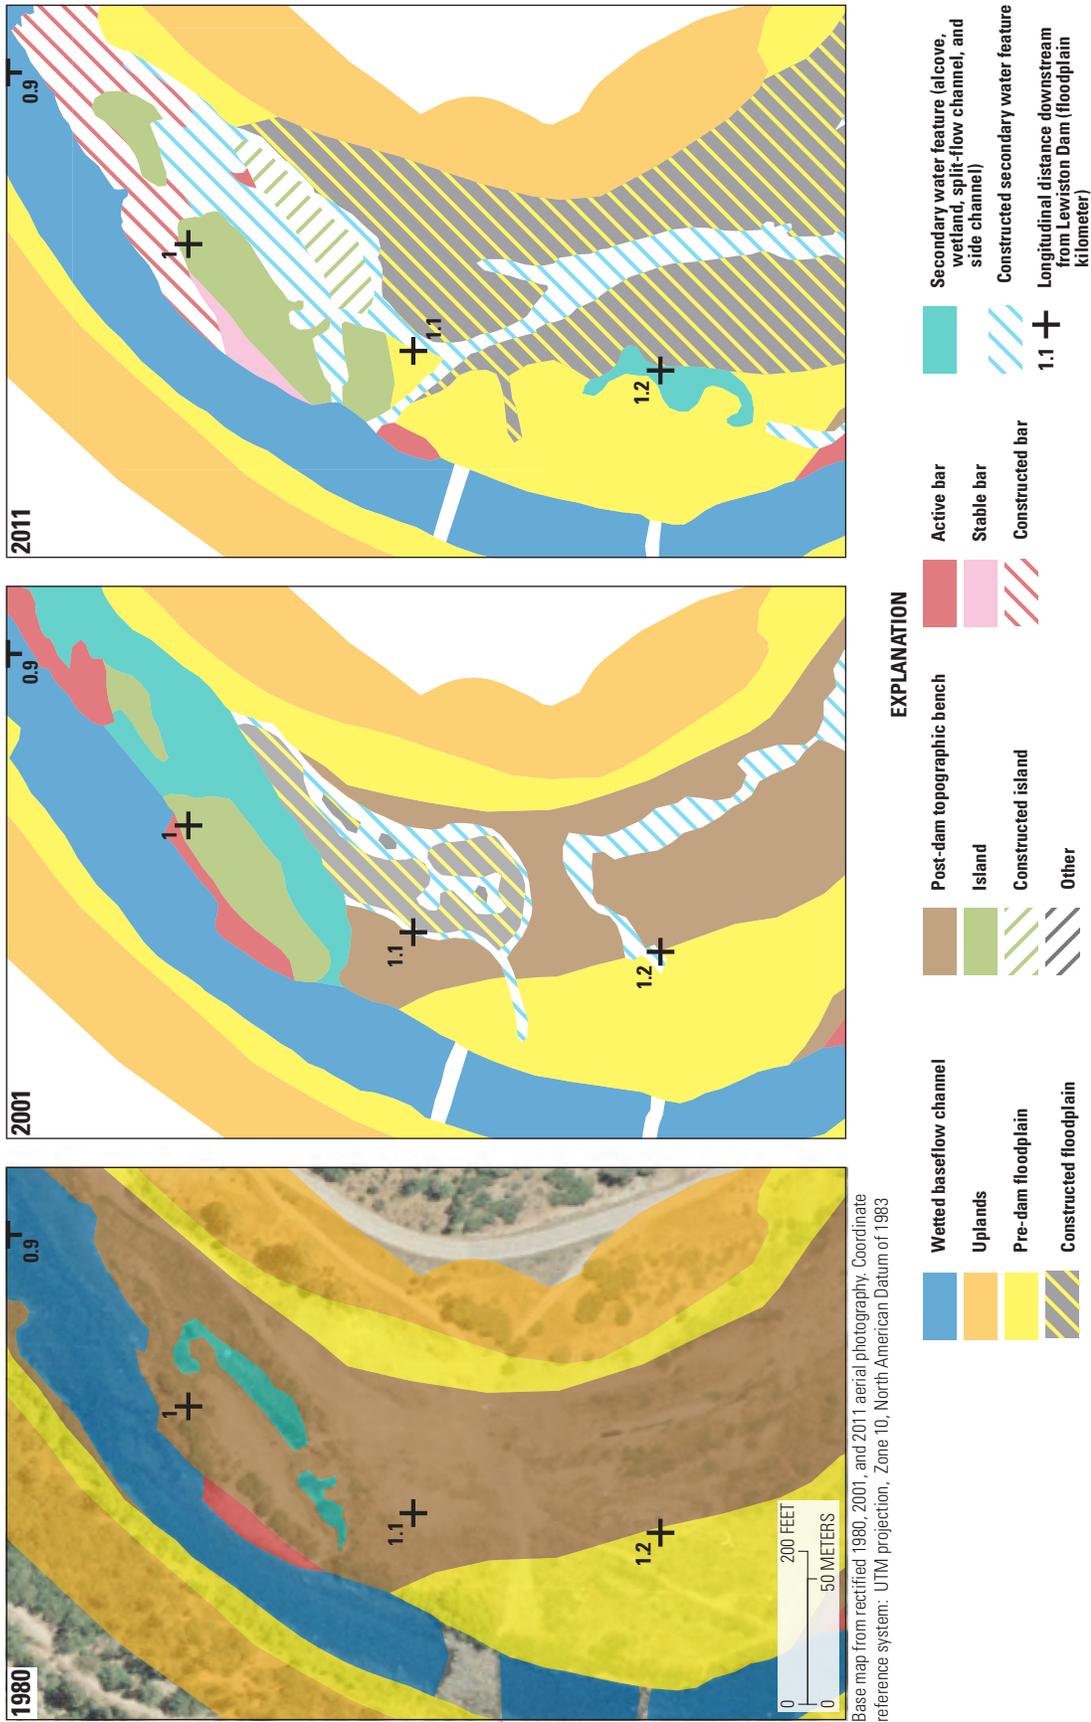
Figure 31. Geomorphic feature maps for the Sven Olbertson Rehabilitation Site on the Trinity River, California, 1.0 floodplain kilometers downstream from Lewiston Dam, in 1980, 2001, and 2011.

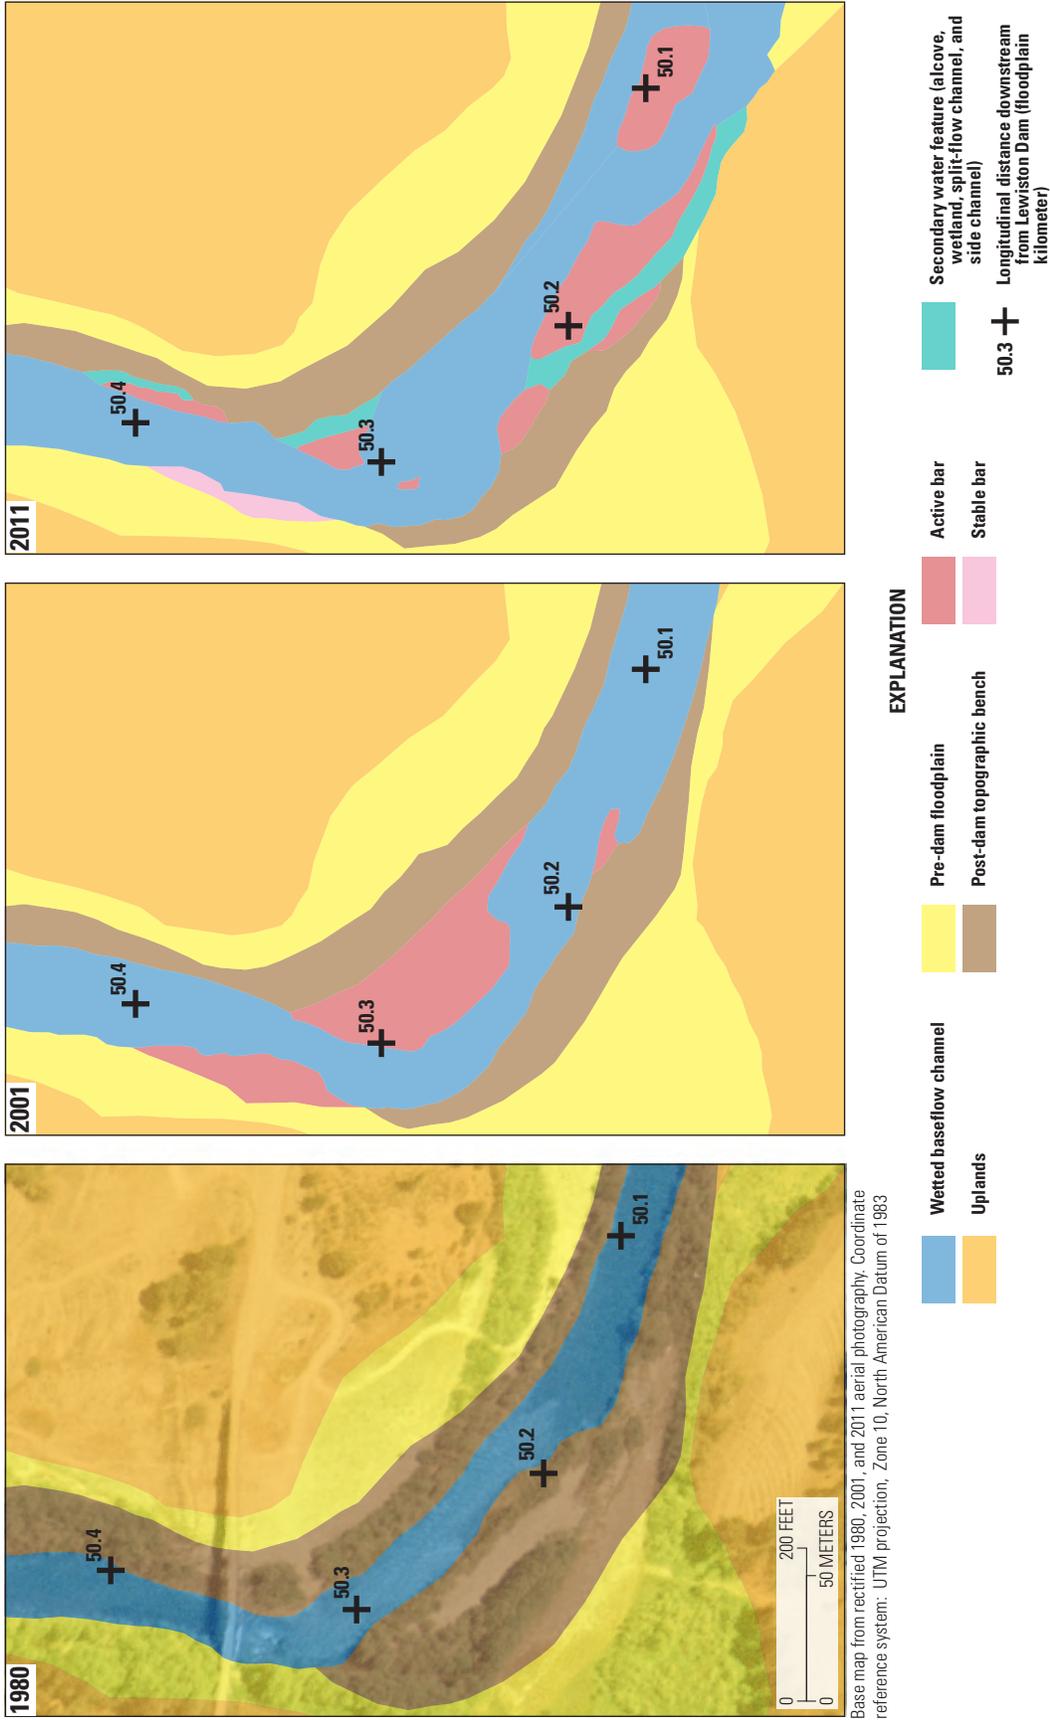
Figure 32. Geomorphic feature maps near Junction City on the Trinity River, California, 50.1 floodplain kilometers downstream from Lewiston Dam, in 1980, 2001, and 2011.

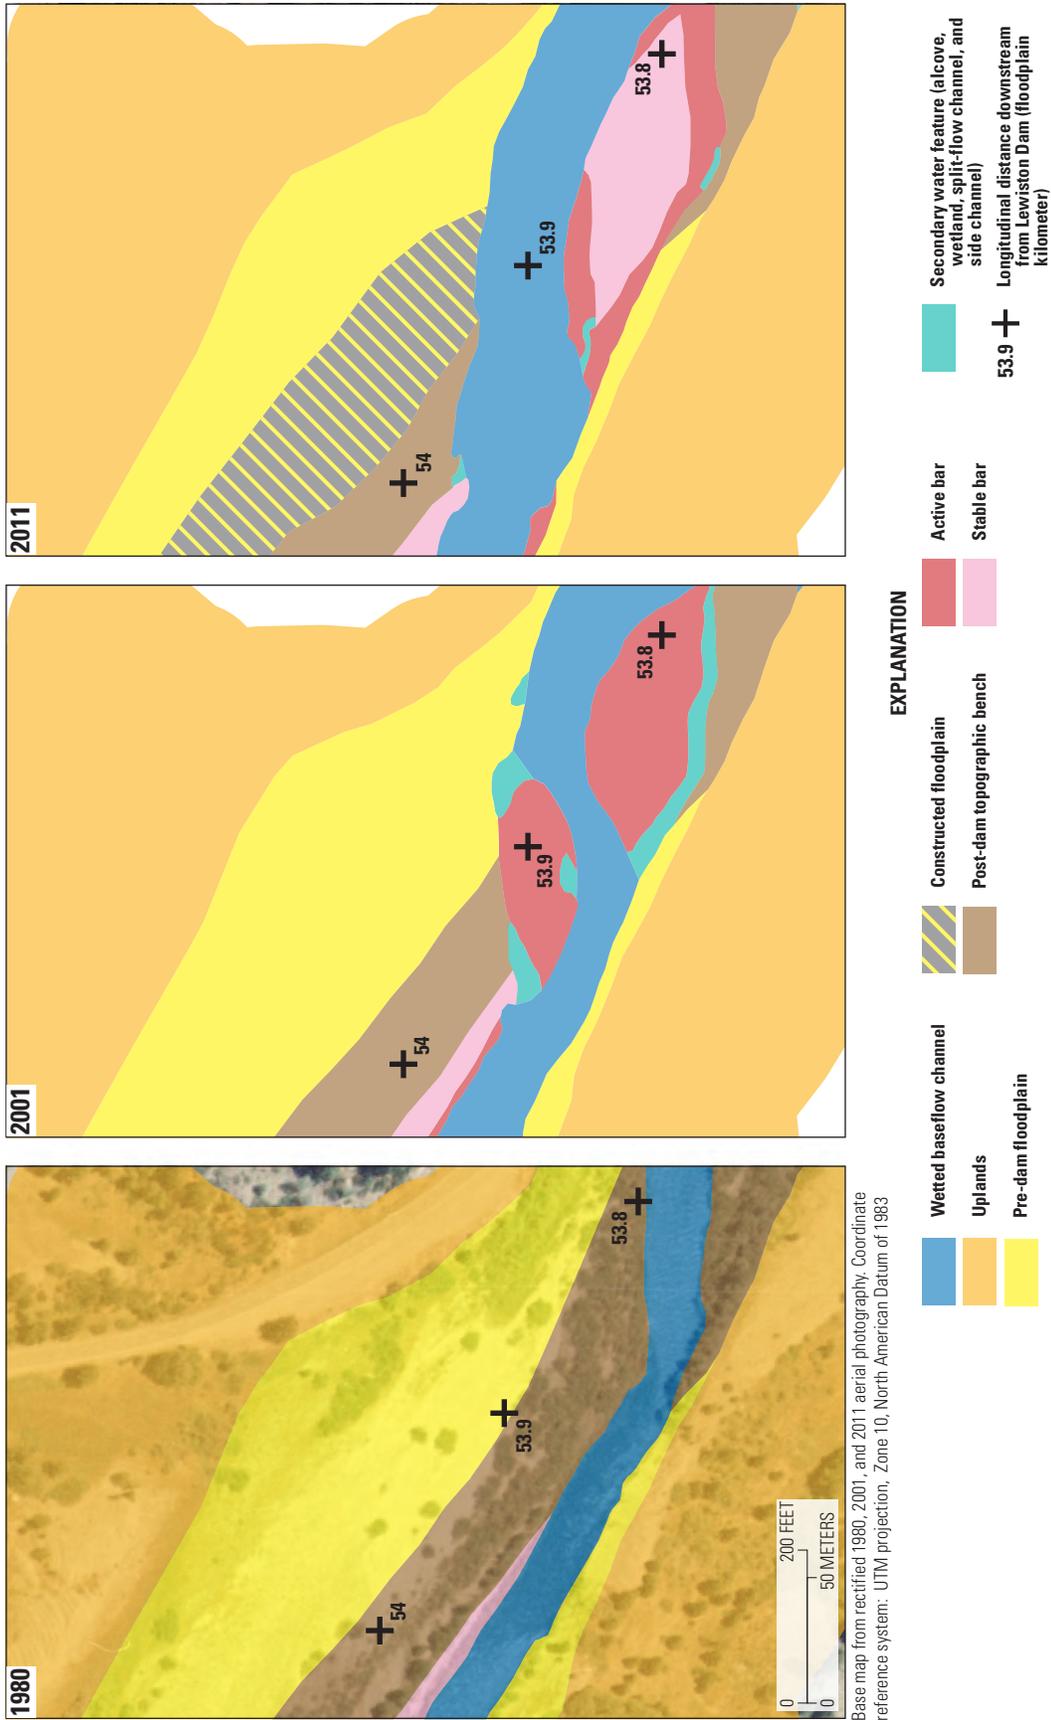
Figure 33. Geomorphic feature maps for Conner Creek Rehabilitation Site on the Trinity River, California, 53.8 floodplain kilometers downstream from Lewiston Dam, in 1980, 2001, and 2011.

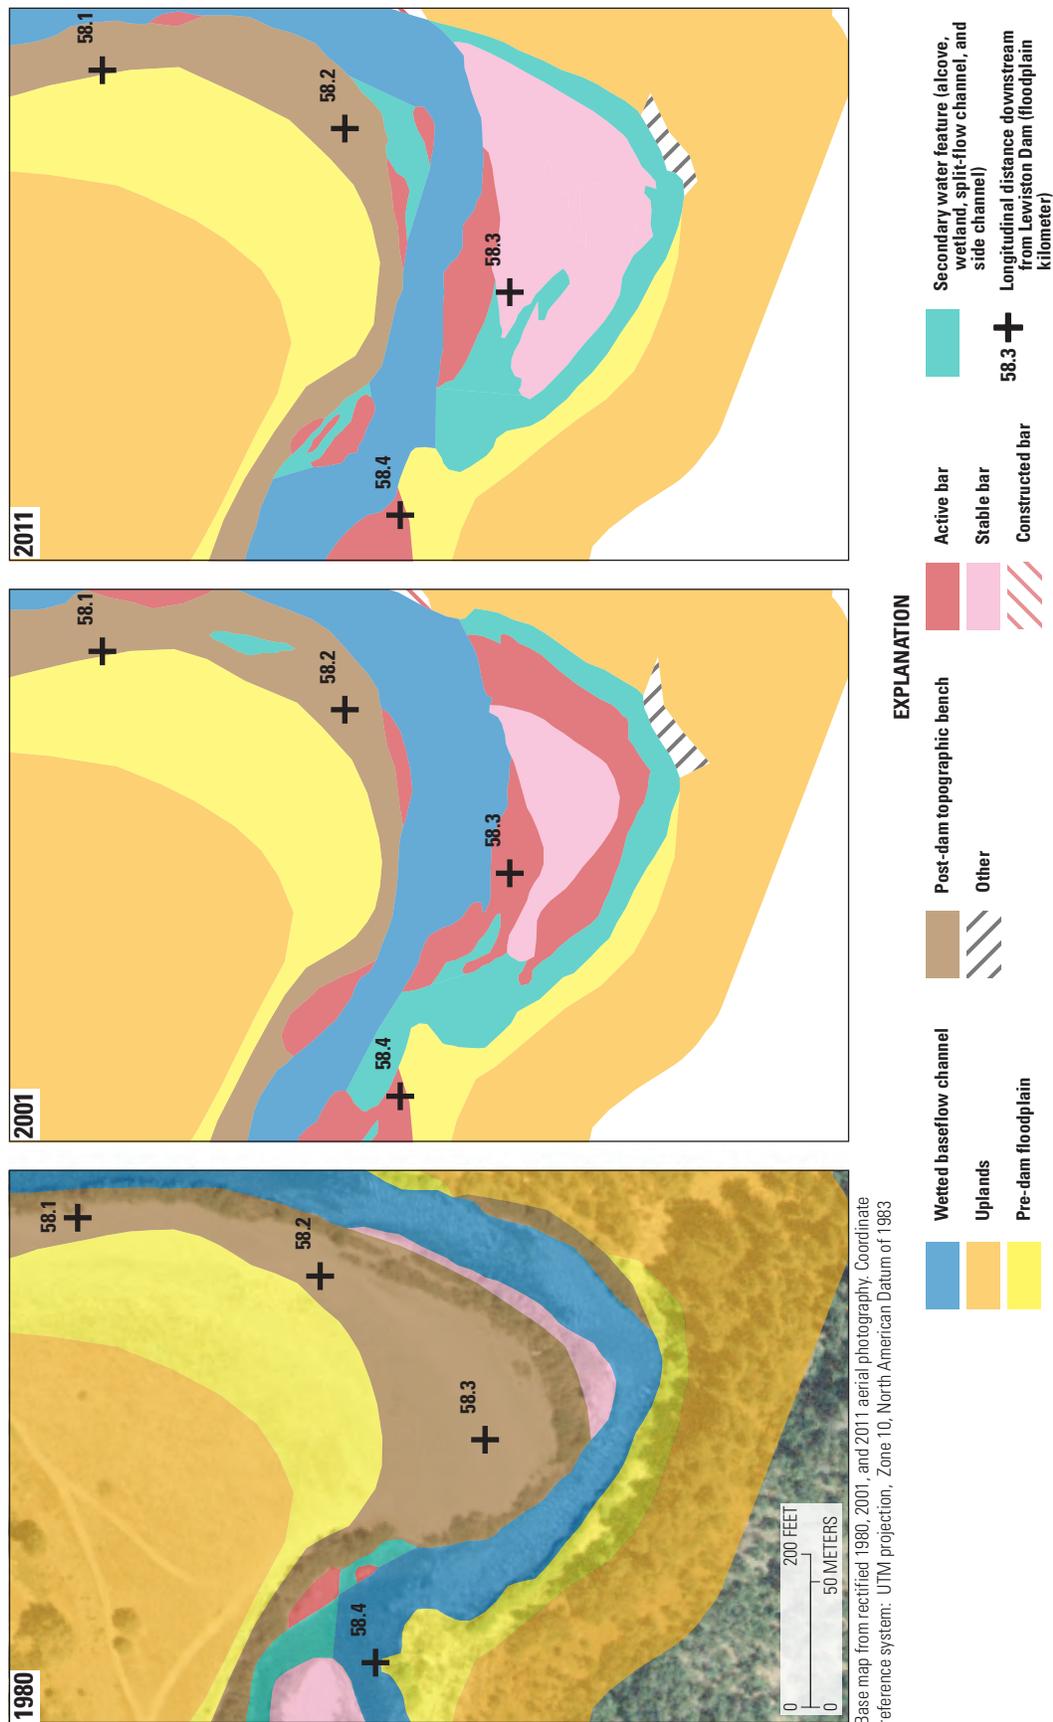
Figure 34. Geomorphic feature maps at Lime Point on the Trinity River, California, 58.1 floodplain kilometers downstream from Lewiston Dam, in 1980, 2001, and 2011.
