Sunny Day Conditions

By
Heriberto Torres-Sierra and Julieta Gómez-Fragoso
2015

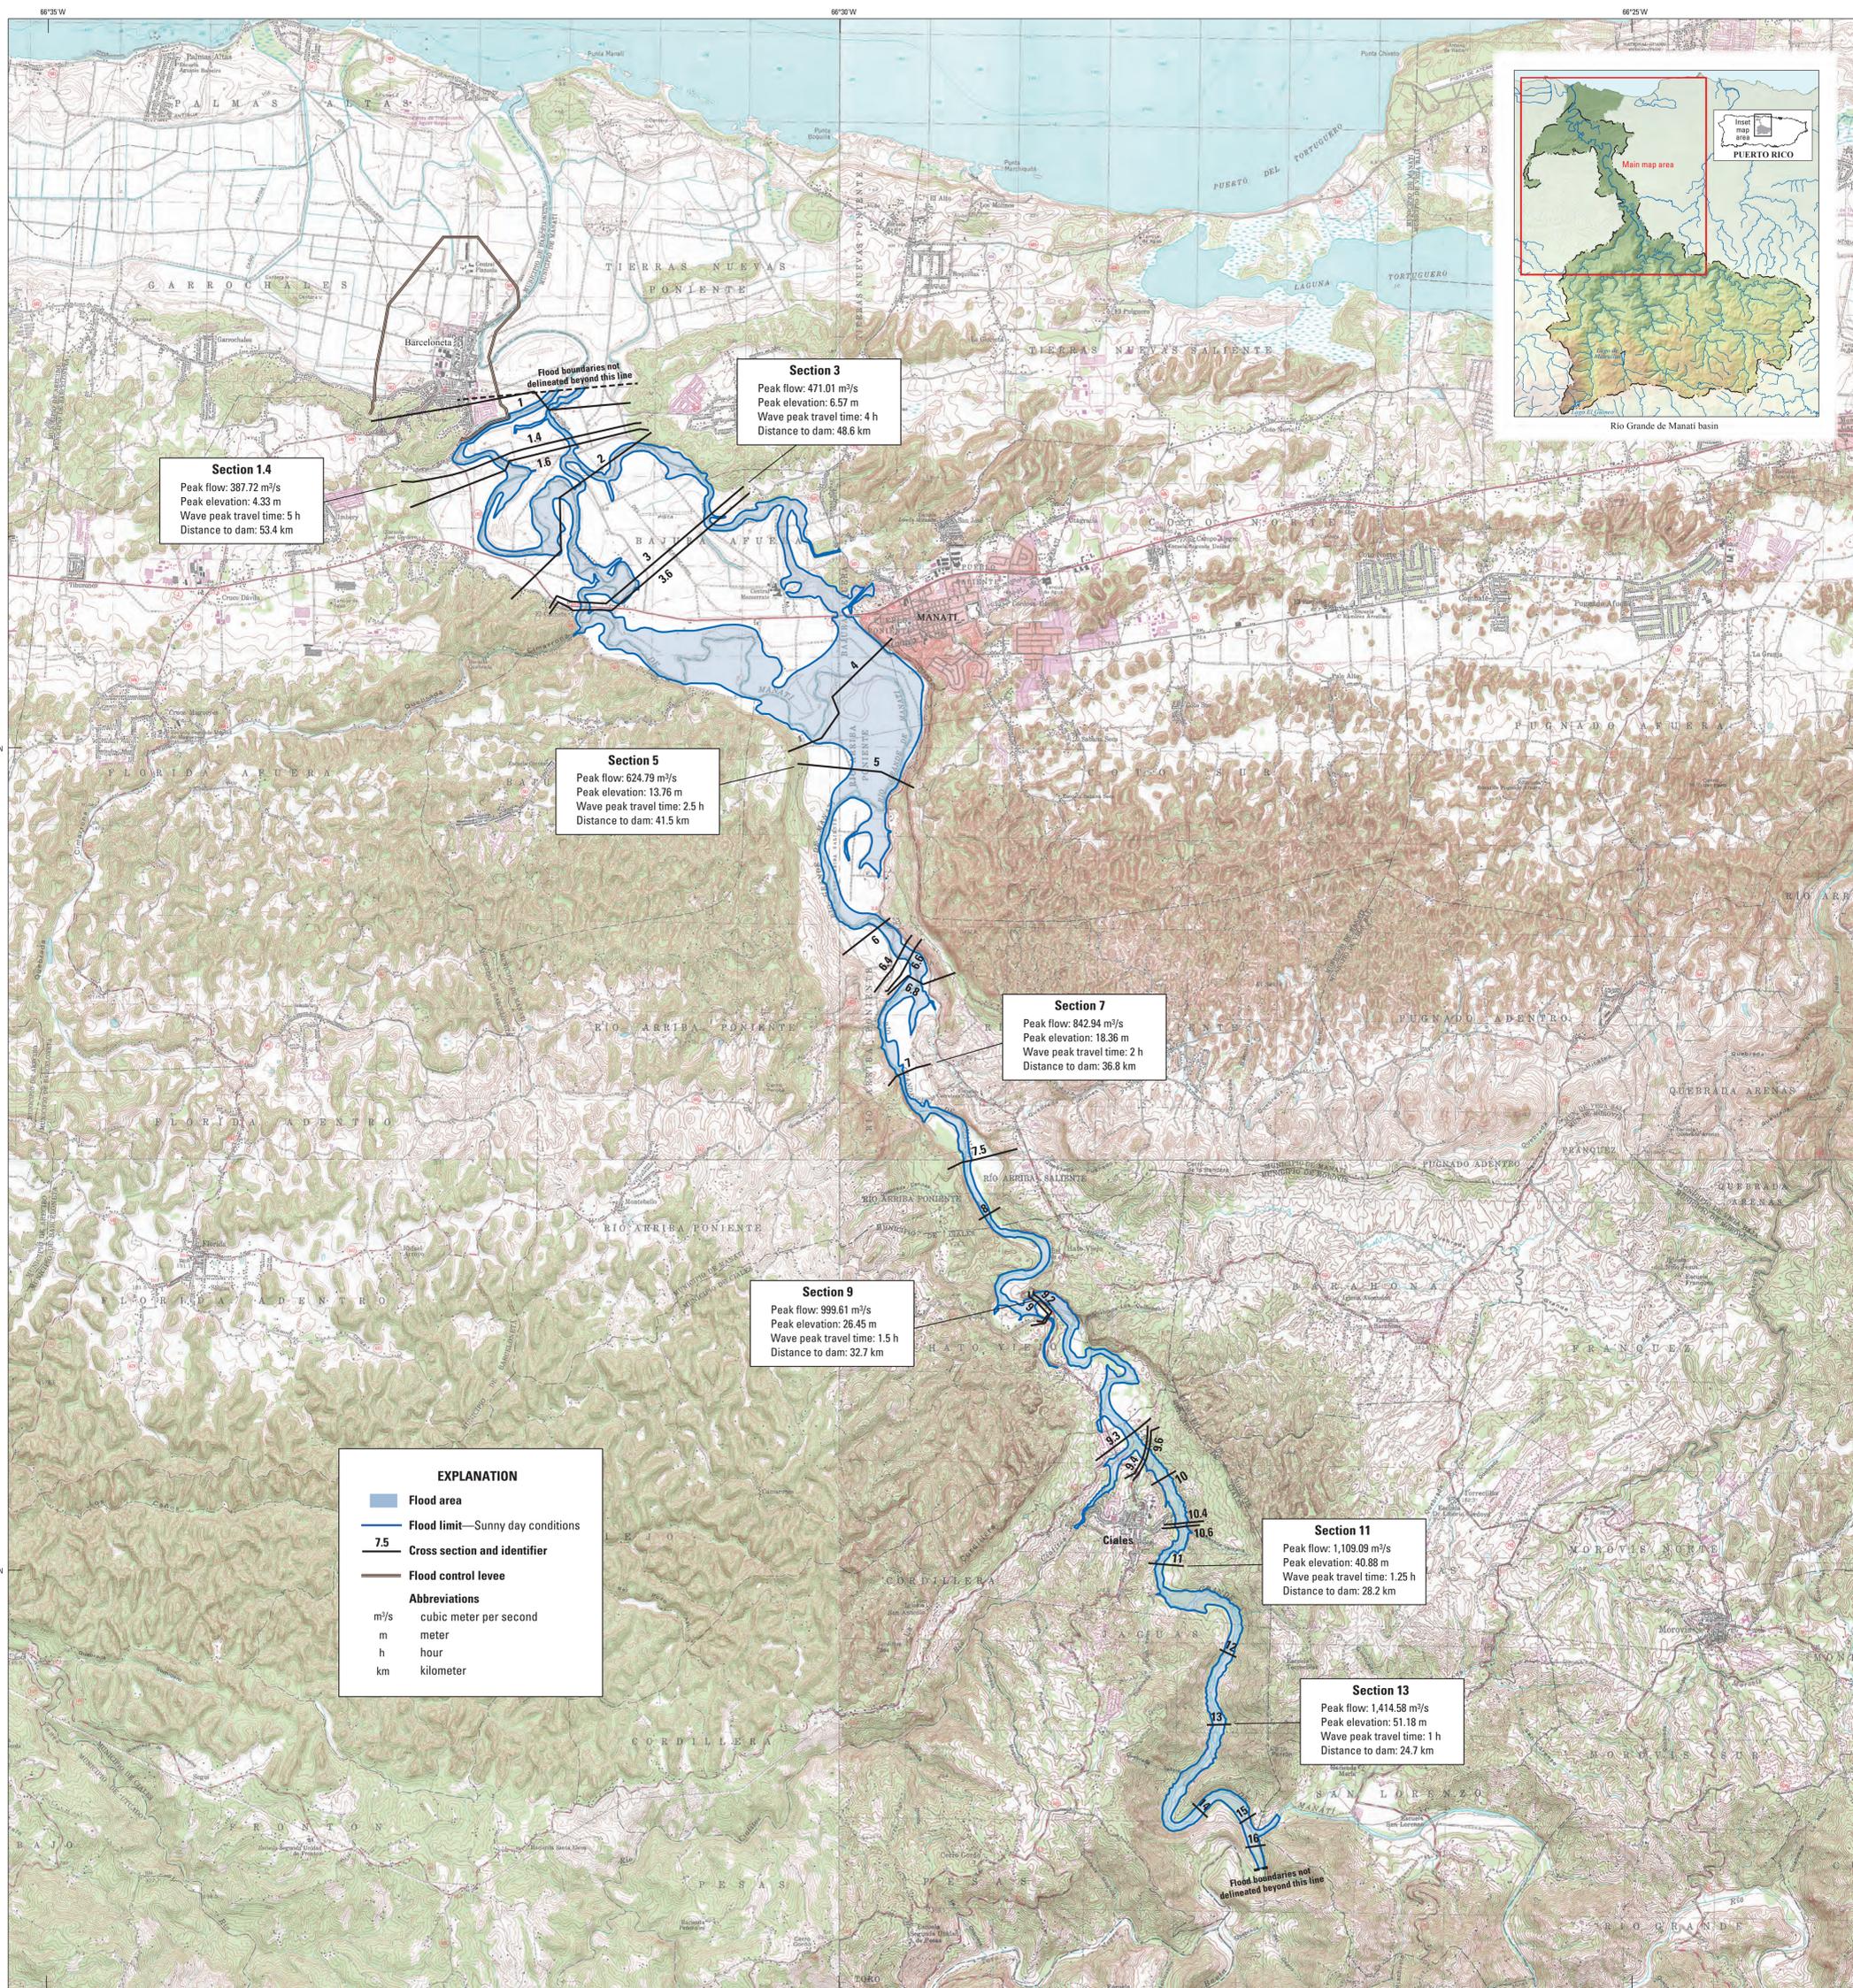
Base modified from U.S. Geological Survey Digital Raster Graphics for Barceloneta, Manatí, Florida, and Ciales, 1:25,000. Elevation from U.S. Geological Survey, National Elevation Dataset (NED). Lambert conformal conic projection, Puerto Rico Datum, 1940 Adjustment. Flood area delineated from hydraulic model results using the U.S. Army Corps of Engineers, Hydrologic Engineer Center's River Analysis System (HEC-RAS).
