# Satellite Monitoring of Dramatic Changes at Hawai'i's Only Alpine Lake—Lake Waiau on Mauna Kea Volcano

Scientific Investigations Report 2015–5076

By Matthew R. Patrick and James Kauahikaua

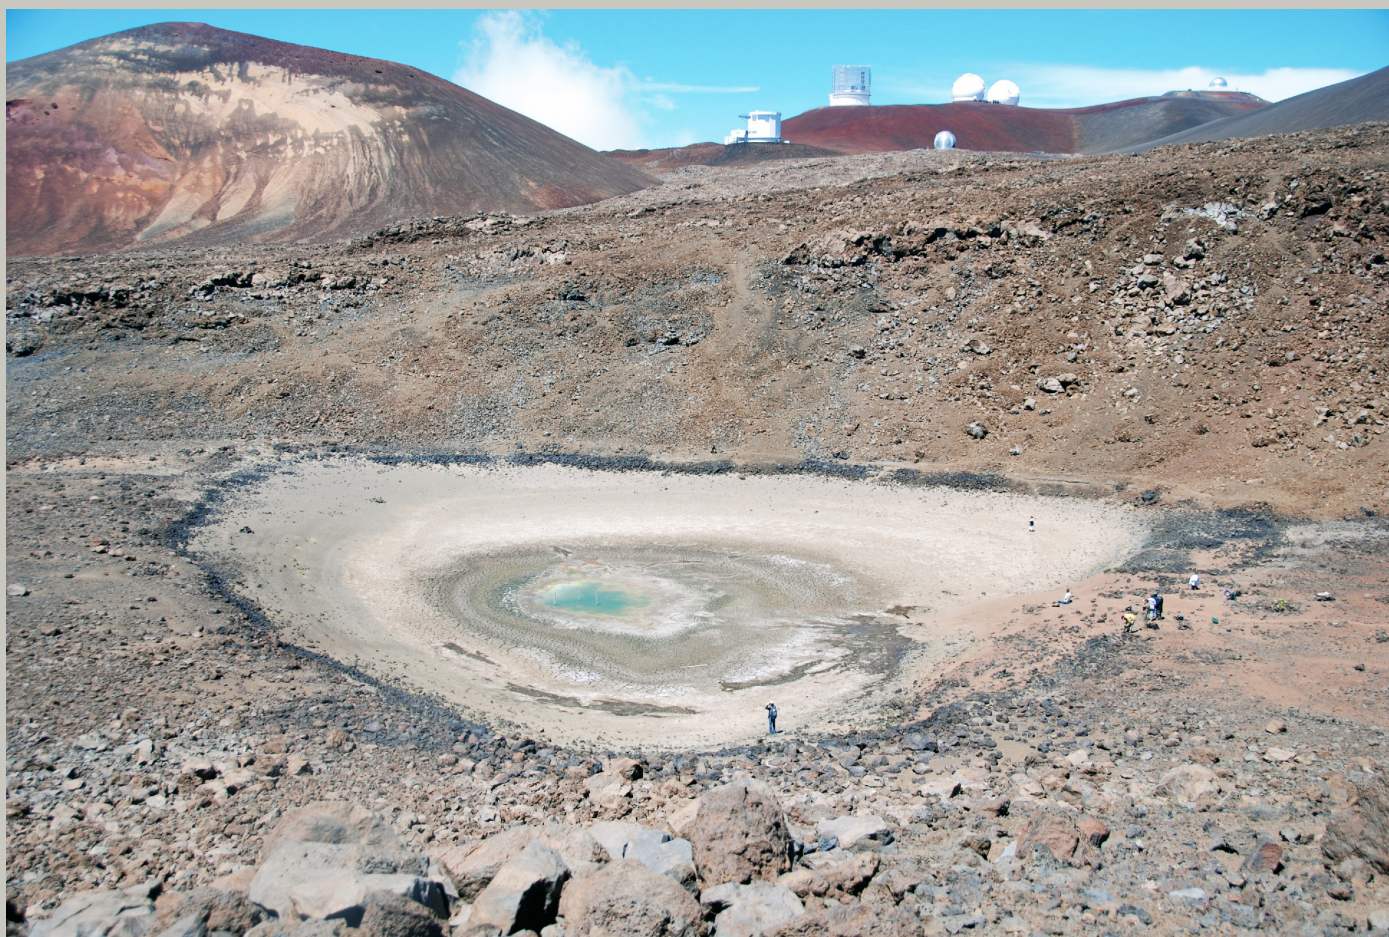
#### FRONT COVER

Photograph of Lake Waiau, near the summit of Mauna Kea volcano, Hawai'i, September 26, 2013. At this time the lake had nearly disappeared, with only a small, 10-meter-wide pool (green area) remaining at the bottom of the former lakebed. (U.S. Geological Survey photograph by Rebecca Rossi.)

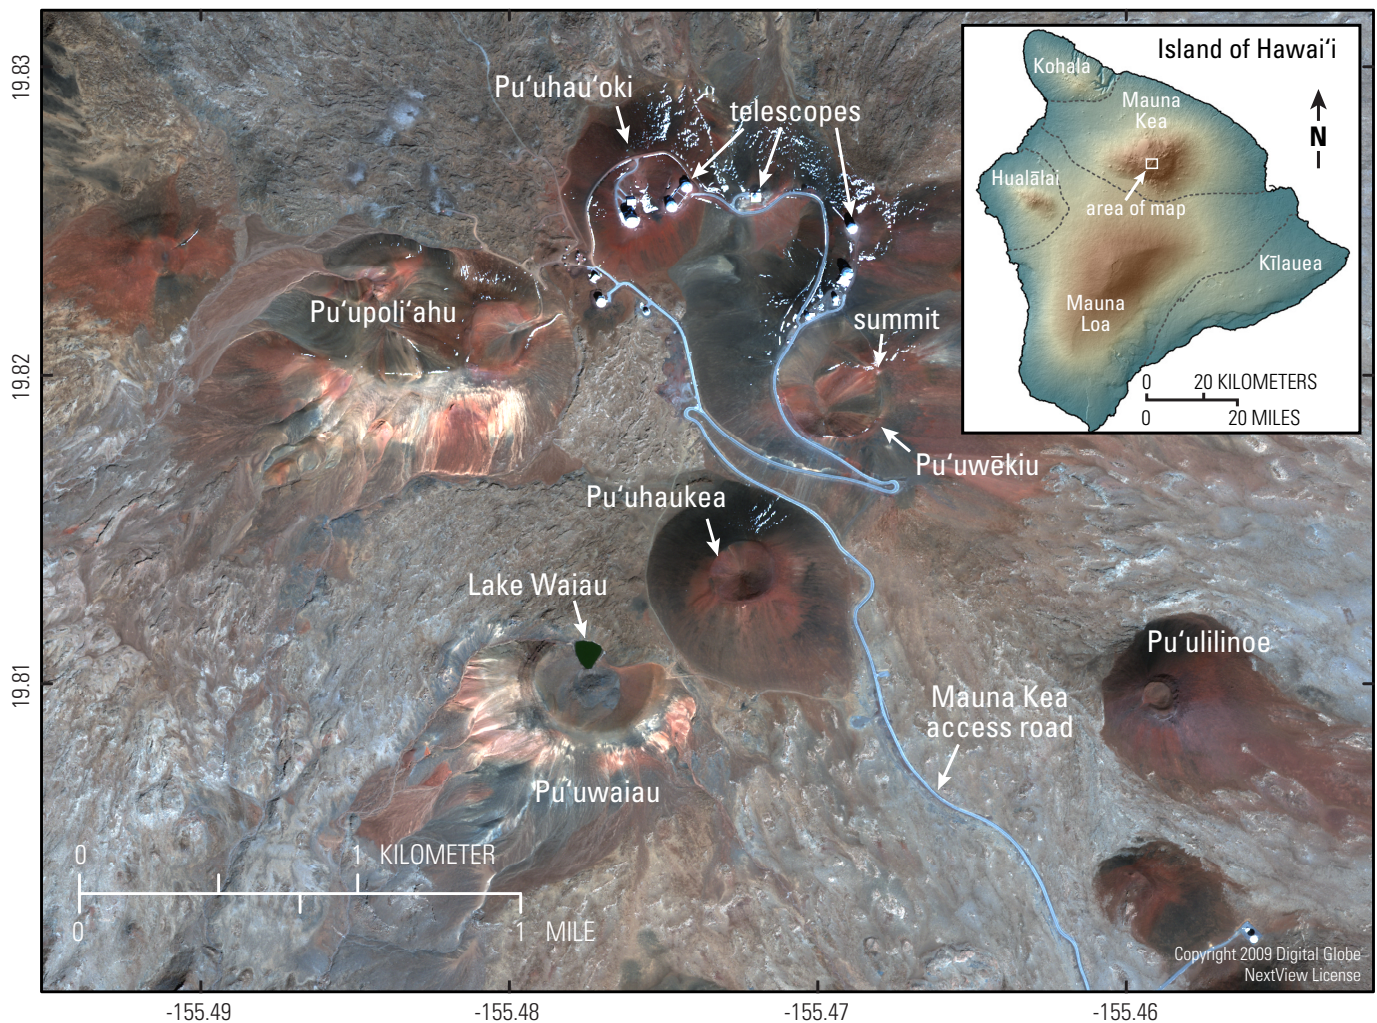
**Figure 1.** High-resolution satellite image of summit region of Mauna Kea volcano, Hawai'i. GeoEye 1 image, bands 3-2-1 (red-green-blue, RGB) from November 23, 2009. Image shows the position of Lake Waiau in relation to other prominent summit cinder cones and the summit access road. The true summit is atop Pu'uwēkiu, near several astronomical telescopes. Inset shows a shaded-relief map of the Island of Hawai'i. Dotted gray lines mark the surface boundaries between the five volcanoes that form the island. The small white box at the summit of Mauna Kea shows the footprint of the main image.

Lake Waiau is a small body of water situated just below the summit of Mauna Kea volcano on the Island of Hawai‘i (fig. 1). It is one of the highest lakes in the United States—at an elevation of 3,970 m—and is the only alpine lake in Hawai‘i. The lake is sacred in Hawaiian tradition, as the summit of Mauna Kea is considered the “piko,” or umbilical cord, connecting the Earth to the heavens (Maly and Maly, 2005).

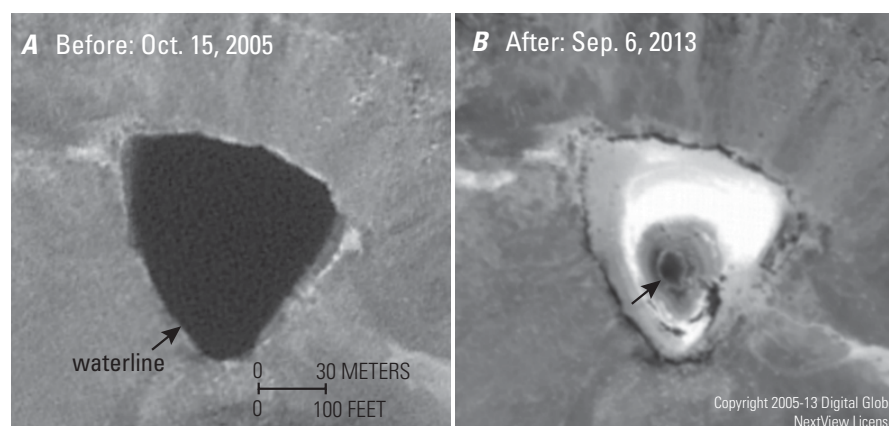
**Figure 2.** Satellite images of Lake Waiau on Mauna Kea volcano, Hawai‘i, before and after the reduction in lake size. The arrow marks the waterline in both images. *A*, An Orbview satellite image from 2005, when the lake was about 100 meters (m) long (north-south direction). *B*, WorldView 2 panchromatic satellite image of the lake from 2013 when it had nearly disappeared and was only about 15 m long. The light colored area is dry lakebed, and dark colored spots represent active seeps. See figure 6 for field photos taken around the same time as *B*. Outflow gully is notch at northwest corner of lake. North at top in both images.

Before the recent changes we document here, Lake Waiau was triangular in shape, with the long axis (north-south) about 100 meters (m) (fig. 24). Water level in the lake commonly fluctuated, depending on precipitation (Woodcock, 1980; Laws and Woodcock, 1981), and was approximately 3 m in depth at

Recent field reports note a remarkable shrinking of the lake over the past few years, to sizes that are unusual in modern memory (fig. 2*B*; Patrick and Delparte, 2014; Delparte and others, 2014). For this study, we collected satellite images and aerial photographs of the lake to document recent changes and create a detailed time series of lake size. An assessment of climatic processes underlying recent changes in lake area was conducted using monthly precipitation data and drought conditions as estimated by the National Drought Monitor (National Drought Mitigation Center, 2014), which integrates climatic and hydrologic data along with reported field conditions in making drought declarations.

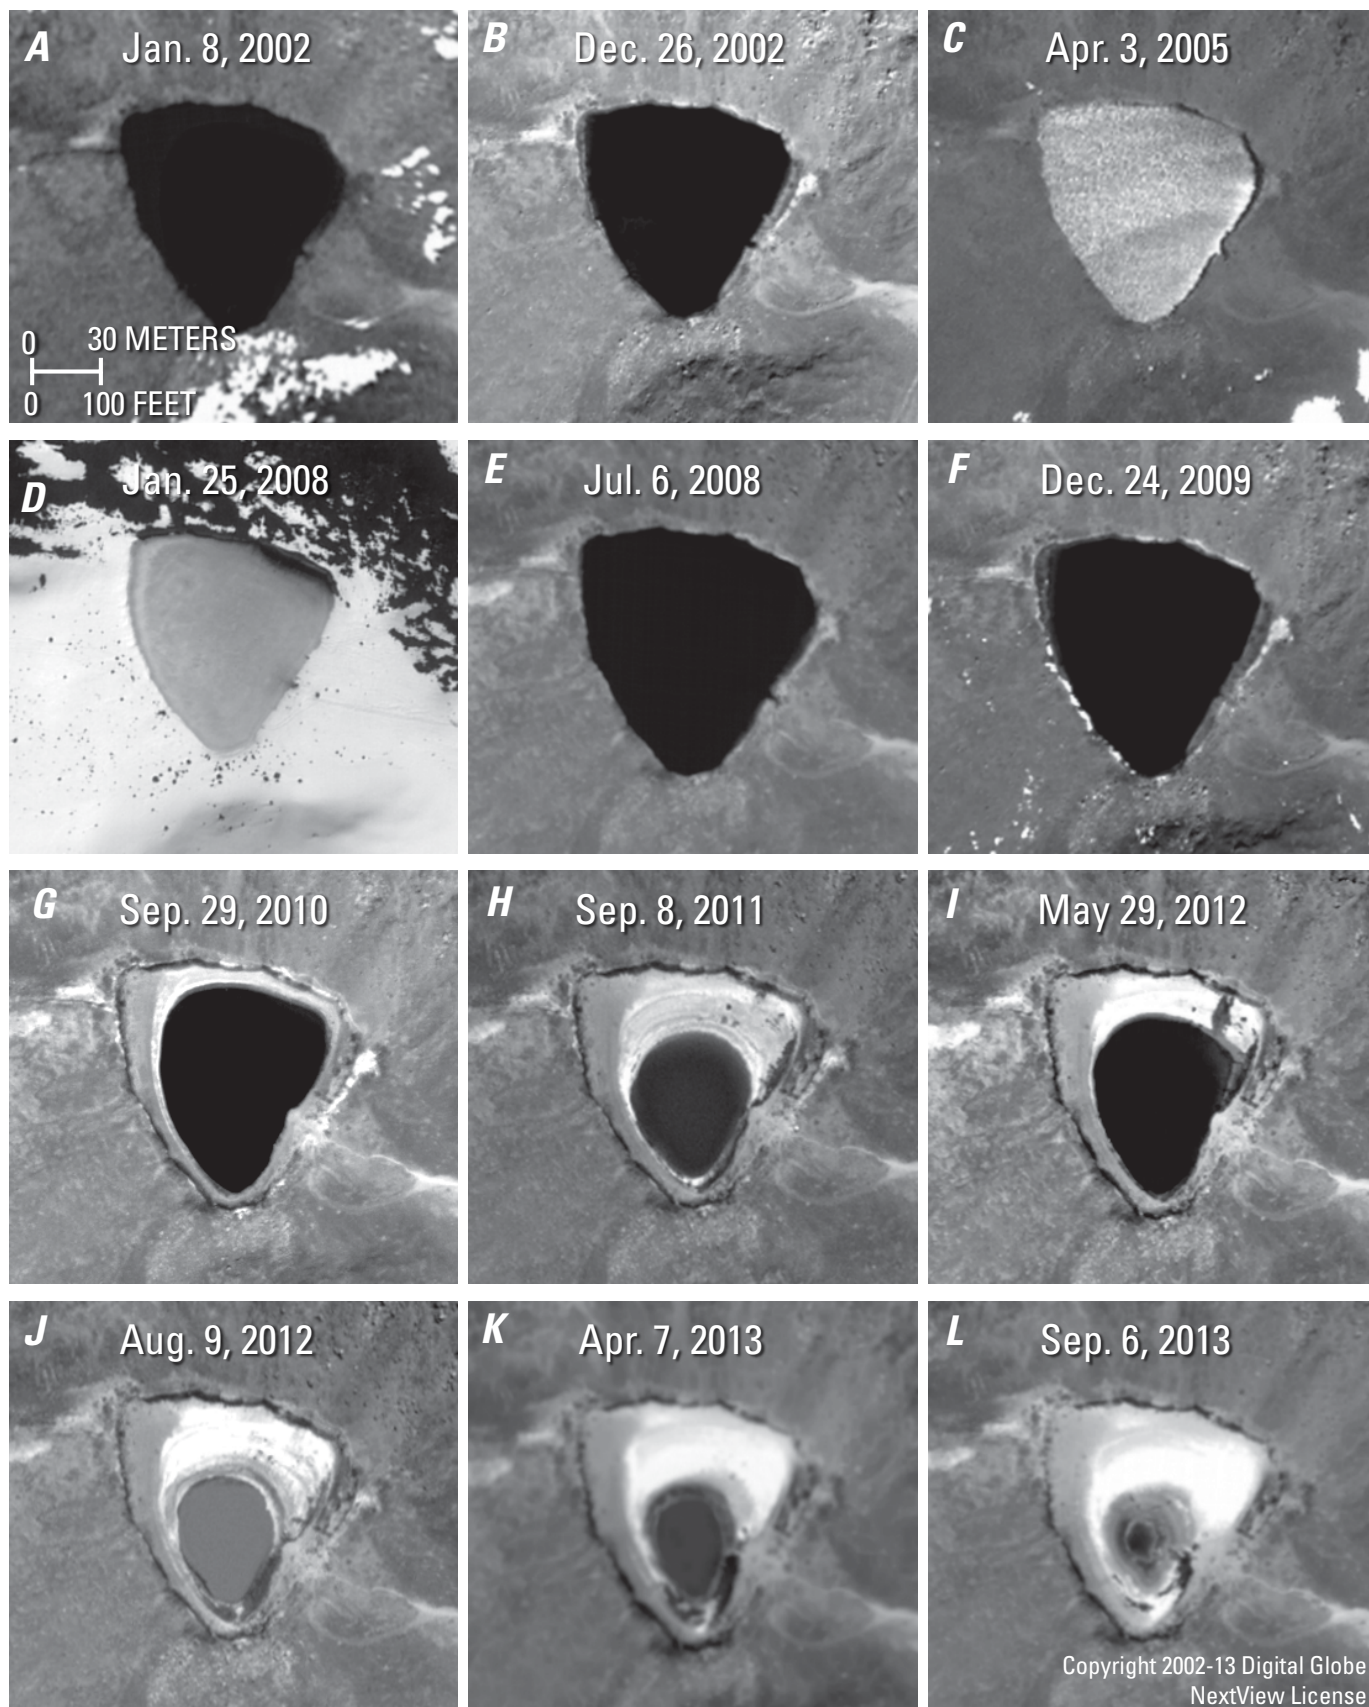
**Figure 3.** Satellite images during 2002–2014 showing changes in the size of Lake Waiau on Mauna Kea volcano, Hawai'i. A–L show satellite images at the marked dates. Dramatic shrinking of the lake began in 2010, as bracketed by F and G. North at top.

Figures 3 and 4 show the surface area of Lake Waiau during 2000 to 2014, based almost exclusively on high-resolution satellite data (table 1). From 2000 to late 2009, the lake's surface area fluctuated between 5,000 and 7,000 m<sup>2</sup>. This corresponds with north-south dimensions ranging from approximately 90 to 100 m. Owing to steeper bounds on the north and south margins, most of the variation in size was accommodated along the east-west axis of the lake. At times of larger surface area, the west margin of the lake would be very close to, or at, the spillway gulley adjacent to the lake.

A decrease in the lake's surface area, below the typical range, began in 2010, bracketed by images on December 24, 2009, and September 29, 2010 (fig. 3). The former image shows the lake area within its usual range (5,000–7,000 m<sup>2</sup>), but the latter image is already below the typical range of variation, suggesting that an unusual shrinking phase had already begun by the latter date. From September 2010 to September 2013, the reduction in lake surface area followed a roughly linear trend, dropping ~100 m<sup>2</sup> per month. Even during the dramatic plunge in lake surface area following 2010, the lake did show seasonal variations consistent with previous behavior (Ehlmann and others, 2005). Superimposed on the decline are several small peaks (early 2011 and early 2012) that correspond with winter months, presumably representing recharge due to precipitation from winter storms.

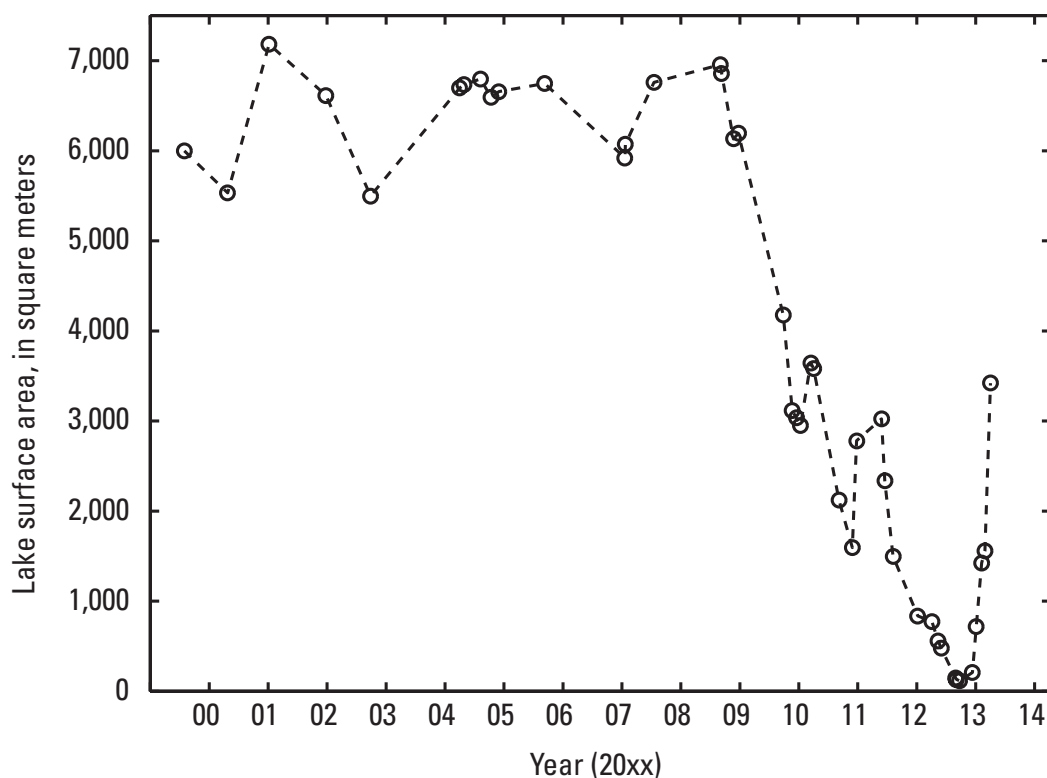
**Figure 4.** Graph of the measured surface area of Lake Waiau on Mauna Kea volcano, Hawai'i, 2000–2014. Most of these data points originate from high-resolution satellite images. The first data point (August 2000) originates from Ehlmann and others (2005), who stated a rough estimate of the surface area for that time.

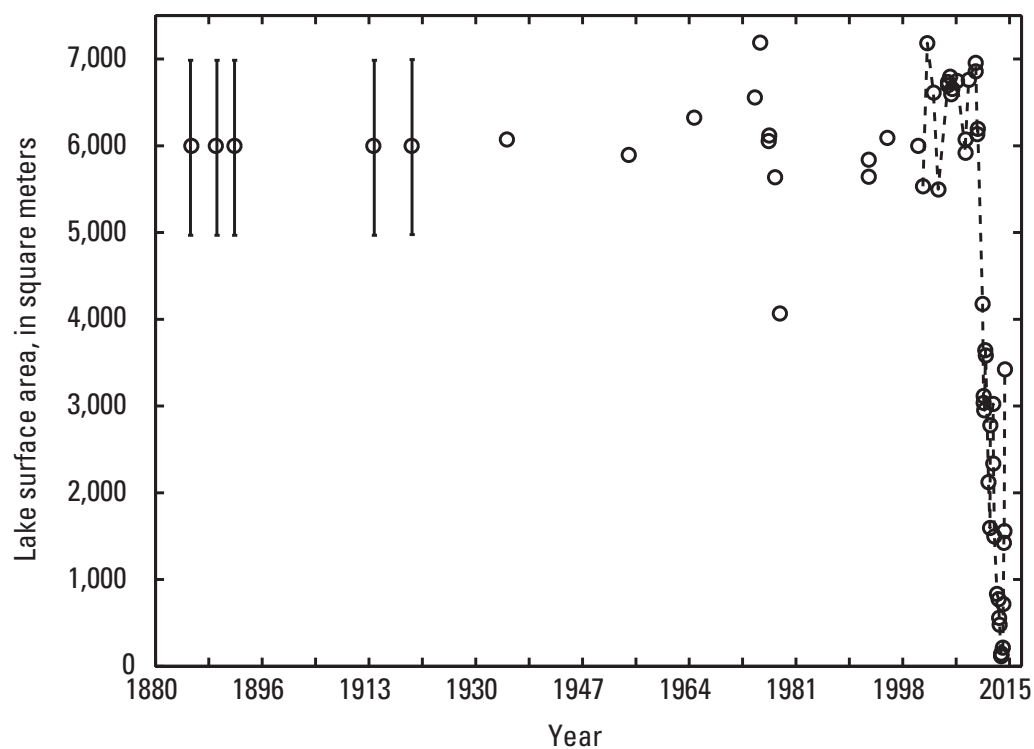
**Figure 5.** Graph of the surface area of Lake Waiau on Mauna Kea volcano, Hawai'i, 1885–2014. The first five data points originate from historical photographs showing the lake level consistent with recent (pre-2010) observations, which we interpret to represent a surface area within the lake's typical pre-2010 range (5,000–7,000 square meters) as indicated by error bars. Data points after 2000 are shown connected with a dotted line, but points before that year are not connected due to sparseness.

Aerial photographs, along with a few field reports, show the state of the lake between 1935 and 2000 (fig. 5). Consistent with the 2000–2009 trend shown in the satellite data, the majority of surface-area measurements are between 5,000 and 7,000 m<sup>2</sup>, again suggesting that this is the typical historical range for the lake's area. One outlier is 1978, when surface area of the lake plunged to about 4,100 m<sup>2</sup>, which occurred during a drought (Woodcock, 1980).

Historical photographs push the time series back further. A photo in Brigham (1909) from 1889 shows the lake at a relatively full level, which we assume represents the lake's surface area in the typical pre-2010 range (5,000–7,000 m<sup>2</sup>). Photographs from 1885, 1892, 1914, and 1920 from the HVO archive also show the lake at a full level, and we assign the same lake area.

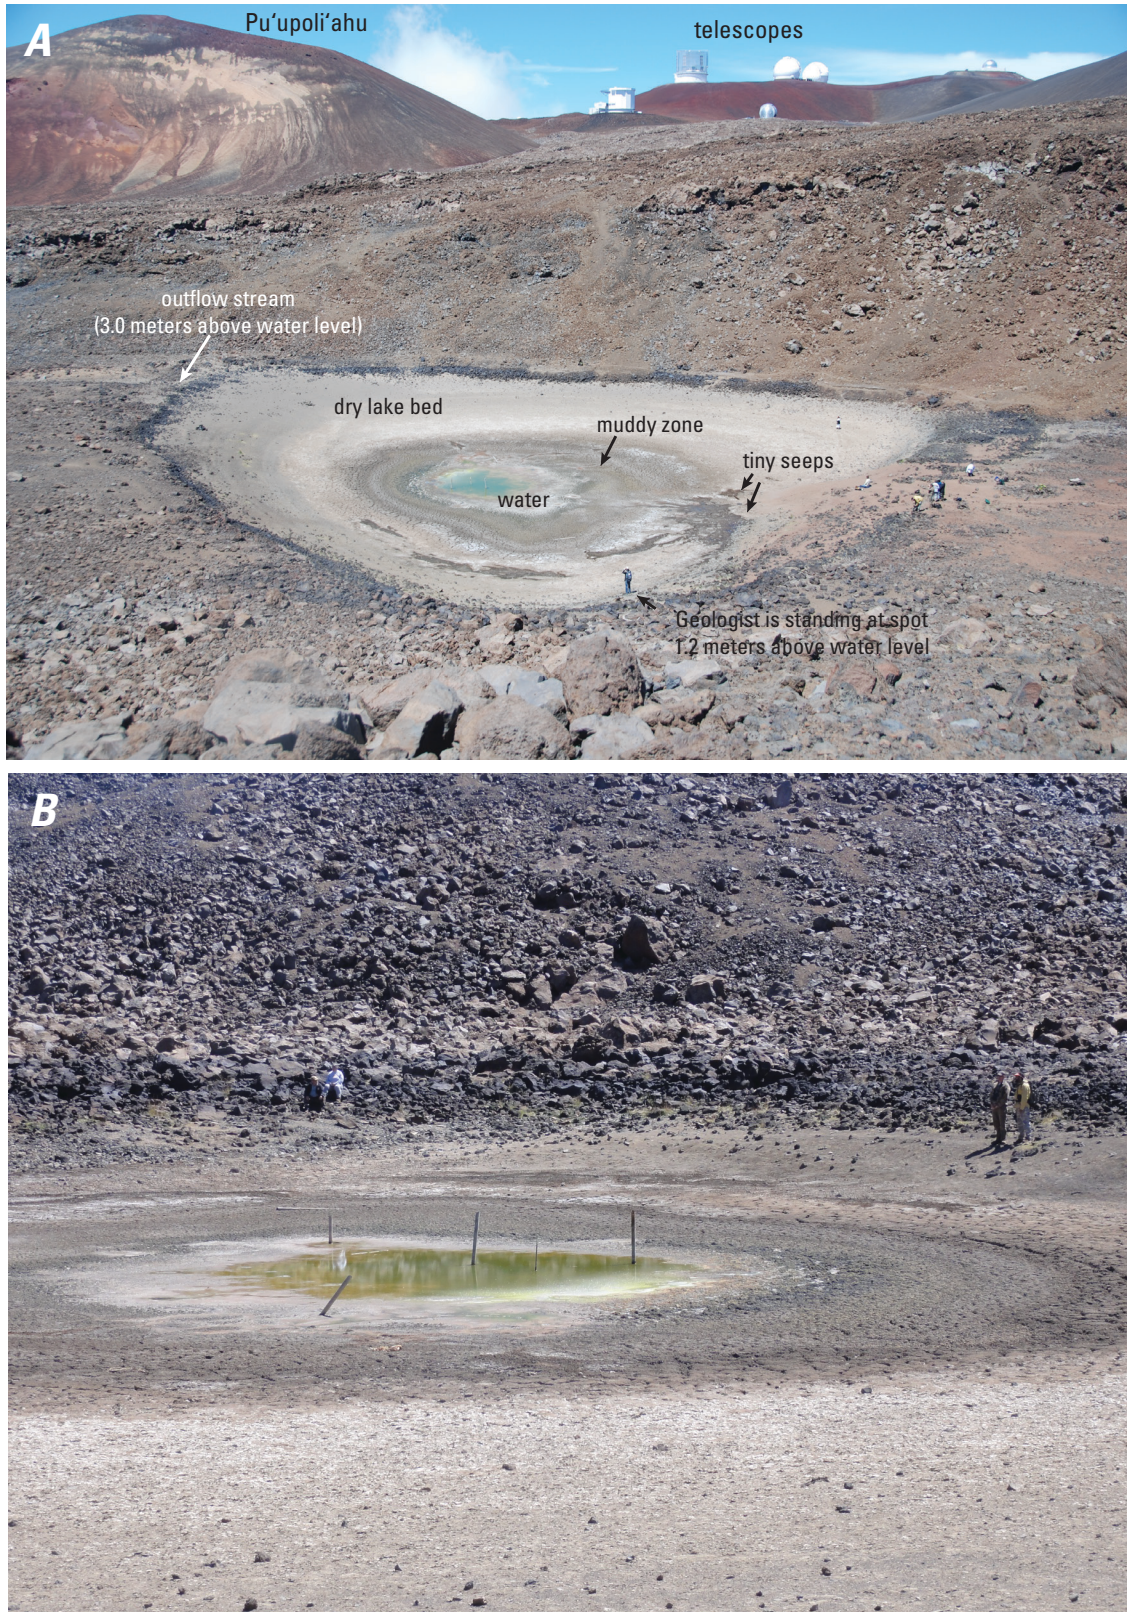
**Figure 6.** Photographs of Lake Waiau on Mauna Kea volcano, Hawai'i, on September 26, 2013, when the lake had nearly disappeared. *A*, View of the lakebed, looking north. Geologists are standing on the eastern shoreline for scale (U.S. Geological Survey photograph by Rebecca Rossi). *B*, Close-up view of the remaining lake water, looking south from the northern shoreline (U.S. Geological Survey photograph by Matthew Patrick). Geologists on the shoreline for scale. The pipes sticking out of the lakebed presumably represent casings from research drilling projects.

Our visit on September 26, 2013, confirmed that the lake was vanishingly small and that most of the former area of the lake was dry lakebed (fig. 6). The lakebed consisted of three zones:

1. *Water*—In the center of Lake Waiau was the remaining pool of water, which was very small and shallow. The water was greenish and did not seem to be more than 20 cm deep (based on the surrounding slope). Measurements along the two main axes of the water body were made with a laser rangefinder. The north-south length (339° azimuth) was 13.5 m, while the

east-west length (73° azimuth) was 10.8 m. Assuming a simple ellipse, the area is 114 m<sup>2</sup>. Sticking out of the water were a few pipes, which were presumably abandoned from previous coring of the lake sediment (Woodcock and others, 1966, or Peng and King, 1992).

2. *Muddy zone*—Surrounding the water was a zone of dark-brown ground with many mud cracks, and this appeared to be a partially wet, muddy zone. A few pipes stuck out of this zone, as well, and there was one pipe, about a meter or two long, resting on its side on the surface.

3. *Dry lakebed*—Surrounding the muddy zone, what appeared to be a dry lake surface formed most of the lakebed. The color of this dry lake area was tan, with rocks here and there sticking out of the ground or sitting on the surface. At least two tiny seeps, where water seeped up from below ground, were in the southeastern quadrant of the dry lake area. These seeps had small (10 cm wide) pools of stagnant water that fed tiny, stagnant channels of water unconnected with the lake but which soaked into the ground. The seep areas were obvious, because the ground around them was dark brown, much like the appearance of the muddy zone around the lake. There appeared to be at least two other tiny seeps in the southern part of the lakebed as well. An abrupt break in slope seemed to correspond with the high waterline, and there is a line of dark rocks at this level. The overflow spillway at the northwestern corner of the lake represents the absolute high watermark of the lake. This spot was 3.0 m above the water level (measured by laser rangefinder), which means that the maximum depth of the lake is also about 3.0 m.

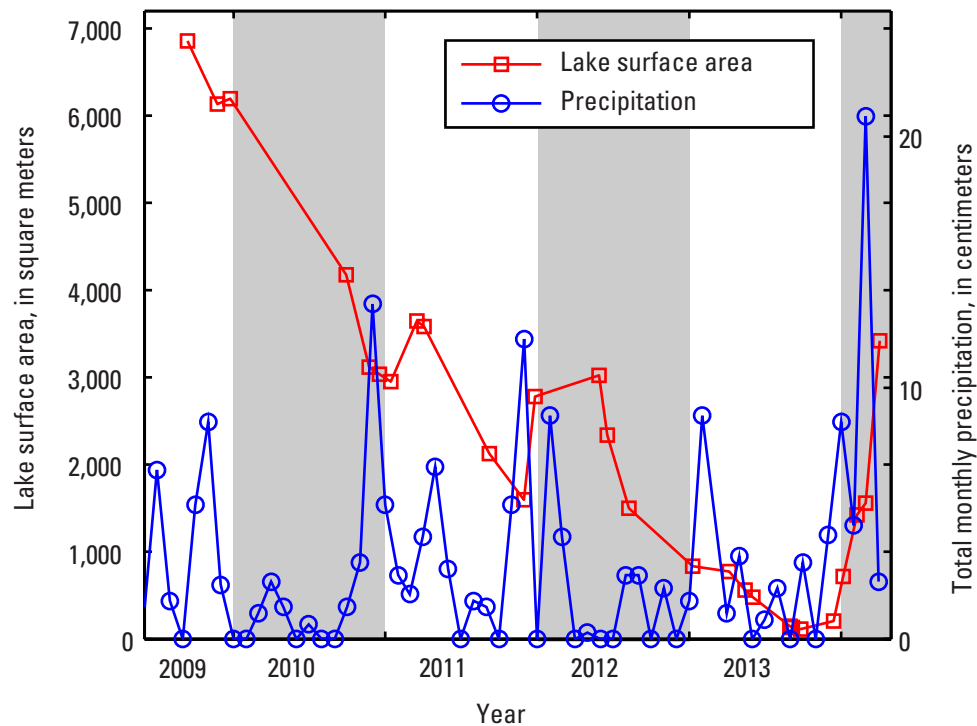
**Figure 8.** Graph comparing the surface area of Lake Waiau on Mauna Kea volcano, Hawai'i, and precipitation during a decline of the lake, 2009–2014. Transient increases in surface area, in early 2011 and early 2012, are superimposed on the overall decline. These peaks follow seasonal peaks in precipitation. A rebound in lake surface area accompanies increased precipitation in 2014. Also compare the lake surface area trend to figure 9.

Figure 8 shows the correspondence between precipitation at Hale Pohaku and the surface area of Lake Waiau during the decline in lake area from 2010 to 2014. The overall declining trend in lake surface area has several distinct peaks (early 2011 and early 2012). The early 2011 and 2012 peaks appear to correspond to seasonal peaks in precipitation. The rebound in lake area in 2014 corresponds in time with a large spike in precipitation. This early 2014 precipitation included several winter storms that blanketed the summit area in snow. This correlation is consistent with the observations by Woodcock (1980), who showed that the lake level was sensitive to precipitation.

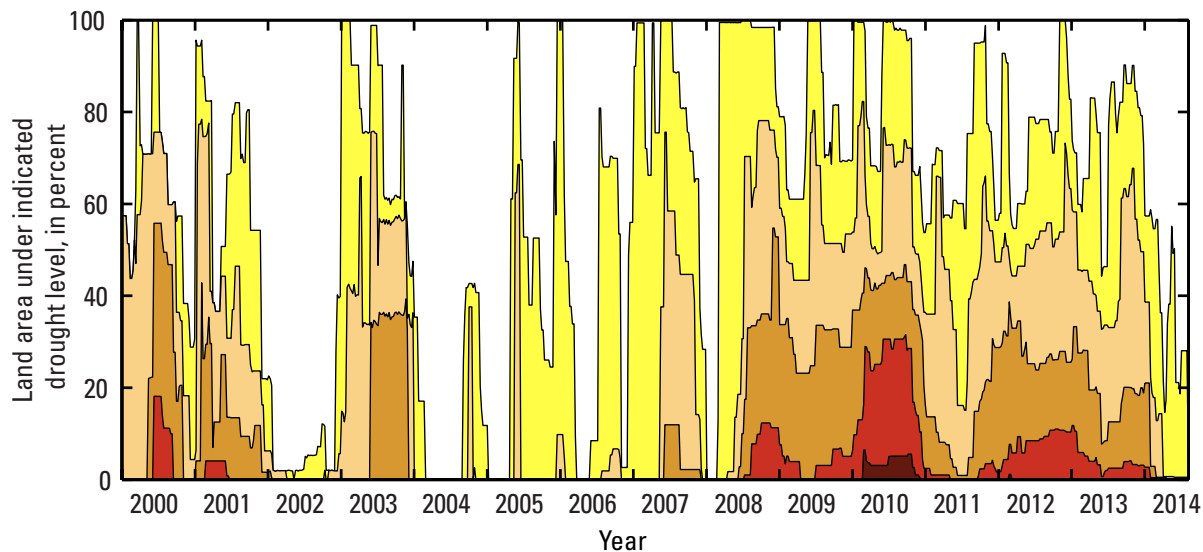
**Figure 9.** Graph of drought data for the State of Hawaii from the National Drought Mitigation Center (2014). The graph shows the percent of the State under a particular intensity of drought according to the U.S. Drought Monitor Classification Scheme (see <http://droughtmonitor.unl.edu/AboutUs/ClassificationScheme.aspx>). Note that elevated and sustained drought conditions began in 2008, with drought intensities increasing during 2010. Drought levels abated in 2014, at which time the lake area rebounded (see figs. 4 and 8).

Data from the National Drought Mitigation Center shows the trend in drought conditions for the State of Hawaii since 2000 (fig. 9) (National Drought Mitigation Center, 2014). Elevated and sustained drought conditions began in 2008, with extreme drought (category D3) appearing in mid-2008 for roughly 30 percent of Hawai'i. This intensified in March 2010,

when category D4 (exceptional drought) conditions appeared in parts of Hawai‘i. These D4 areas were limited to areas on the leeward sides of Kohala and Mauna Kea, close to (but not necessarily encompassing) Lake Waiau, based on the National Drought Mitigation Center maps. Drought levels appear to abruptly drop in early 2014, with the disappearance of even moderate drought across the State, consistent with the increase in precipitation shown in figure 8.
