Electrical Resistivity Investigation of Fluvial Geomorphology to Evaluate Potential Seepage Conduits to Agricultural Lands along the San Joaquin River, Merced County, California, 2012–13

Scientific Investigations Report 2016–5172

By Krishangi D. Groover, Matthew K. Burgess, James F. Howle, and Steven P. Phillips

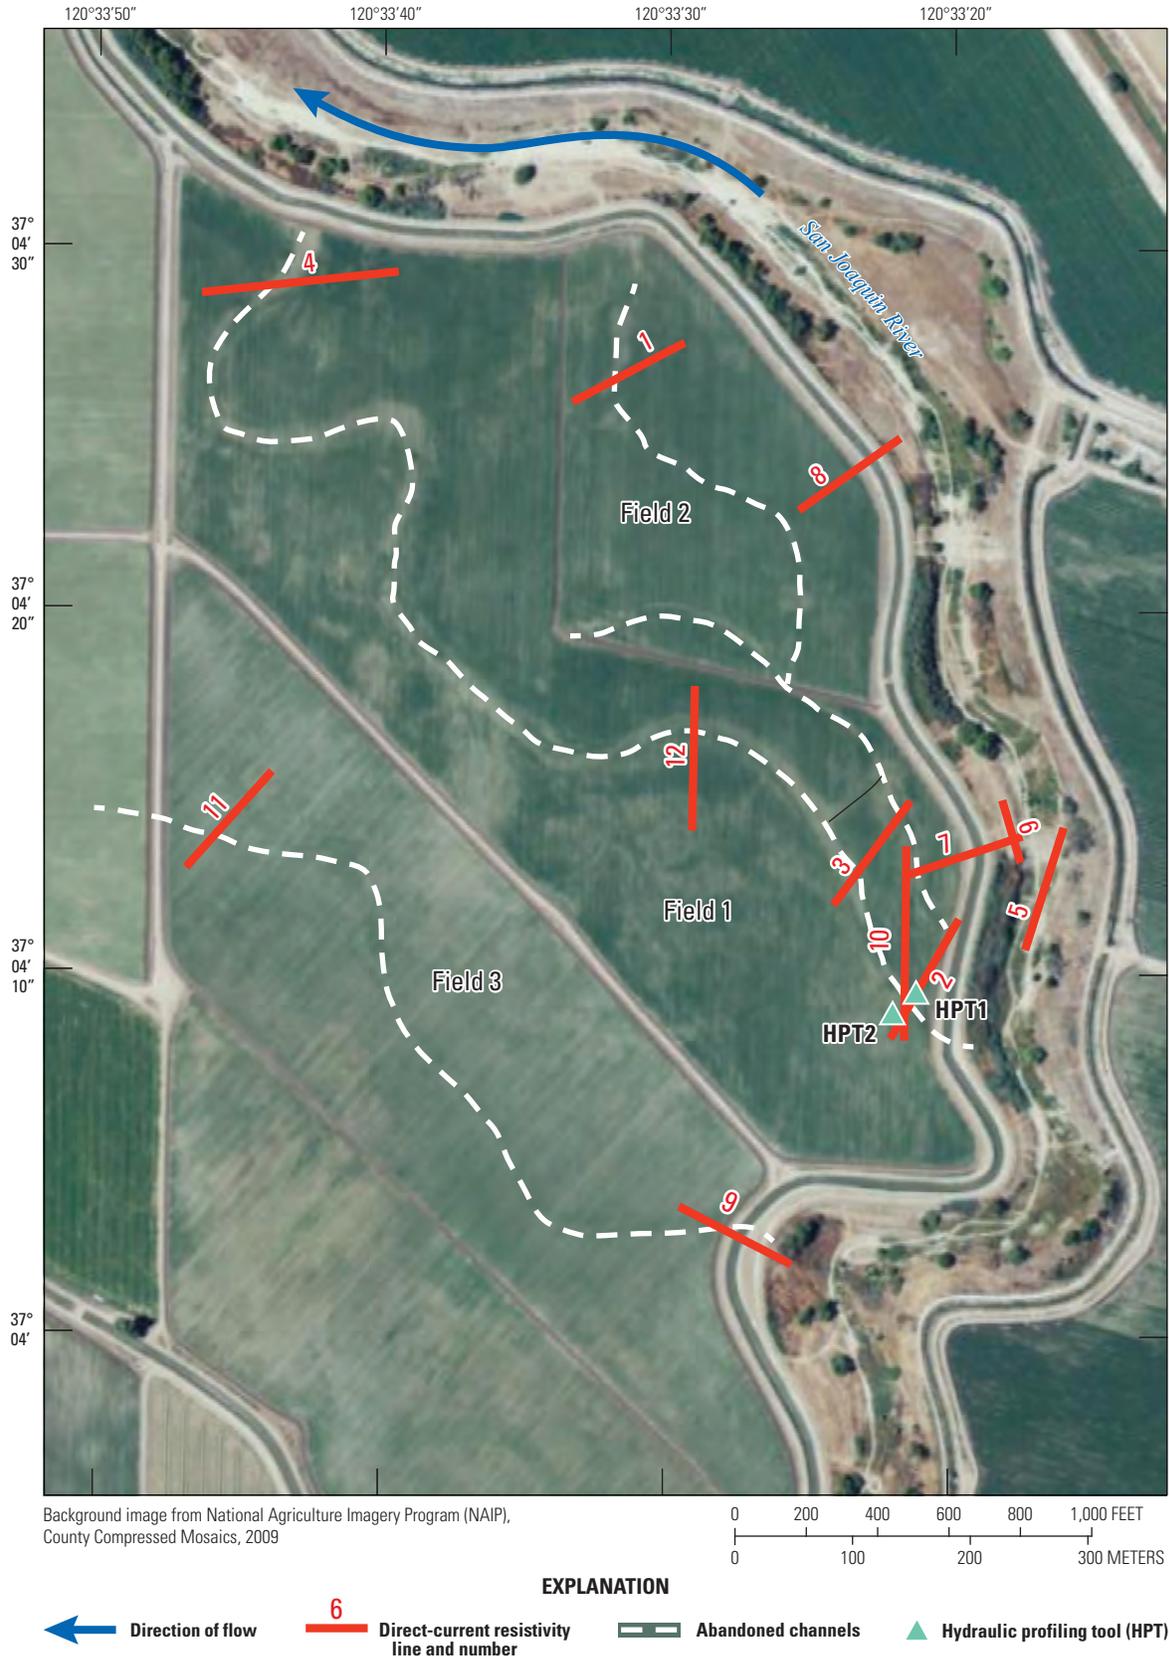
Figure 2. Study area west of the active San Joaquin River, Merced County, California, with field numbers and showing locations of direct-current resistivity lines and hydraulic profiling tool surveys. Sinuous traces of abandoned meanders are visible throughout the image, including areas not discussed in this report. Abandoned channel meanders are highlighted with dashed white lines.

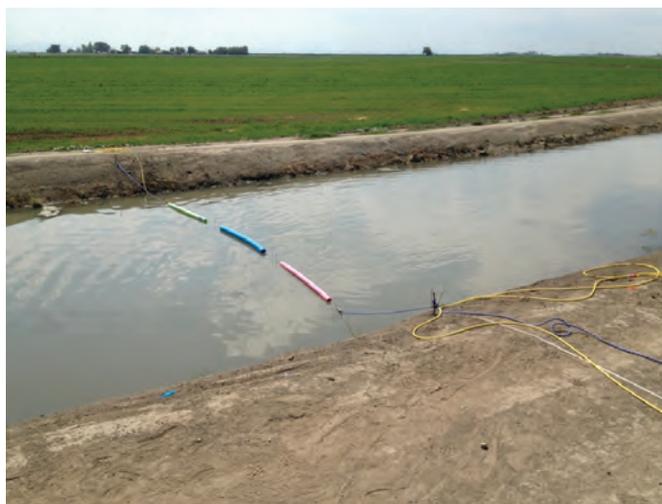
Figure 5. Photograph showing direct-current resistivity cables crossing an irrigation canal, Merced County, California. Electrodes were floated on the water surface with foam floats. Electrode spacing remained consistent by marking the distance along the rope pulled tight across the canal.

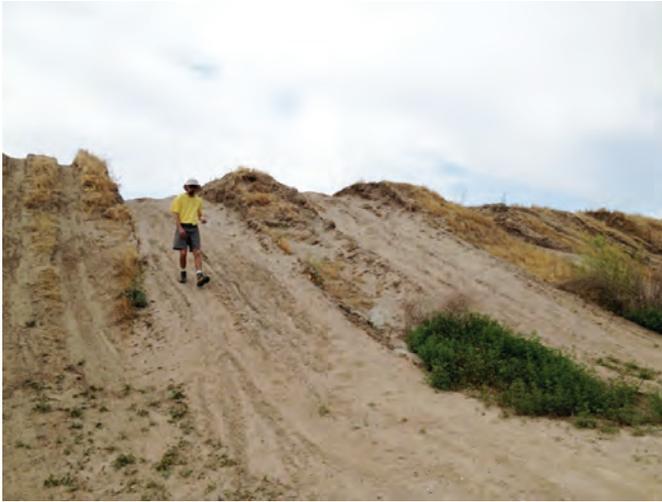
Figure 15. Sandy bank of a point-bar deposit along the northeast end of line 7 (figs. 2, 14) in the San Joaquin River, Merced County, California, 2013.

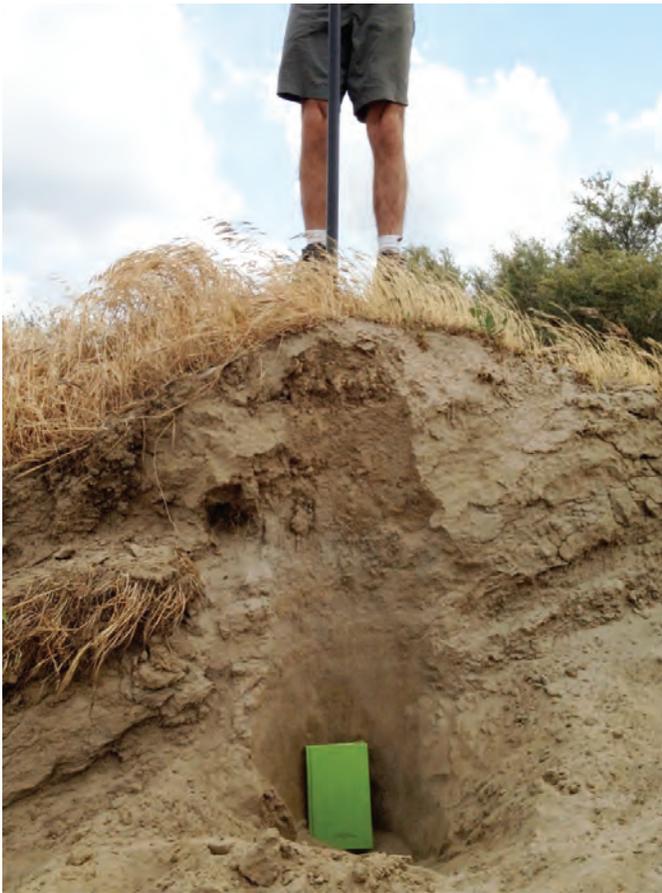
Figure 16. Excavation into river bank at a point-bar deposit along the northeast end of line 7 (figs. 2, 14) in the San Joaquin River, Merced County, California, 2013.

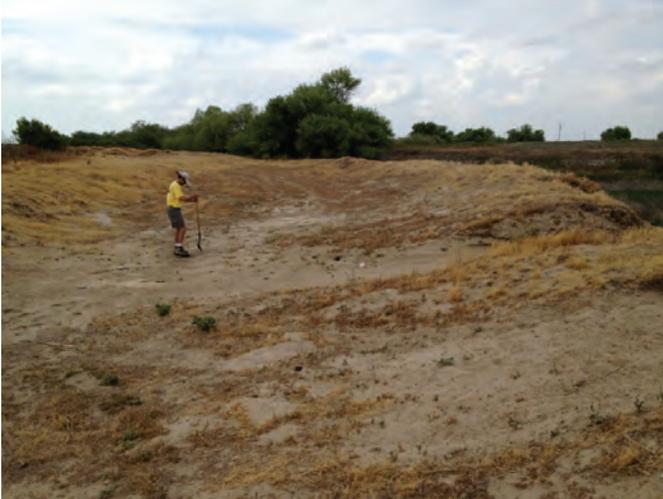
Figure 24. View to the northwest along a sandy surface of a chute channel, San Joaquin River, Merced County, California. Area of figures 15 and 16 is the slope to the right of this photo.
