Geomorphology and Vegetation Change at Colorado River Campsites, Marble and Grand Canyons, Arizona

Scientific Investigation Report 2017–5096

U.S. Department of the Interior
U.S. Geological Survey

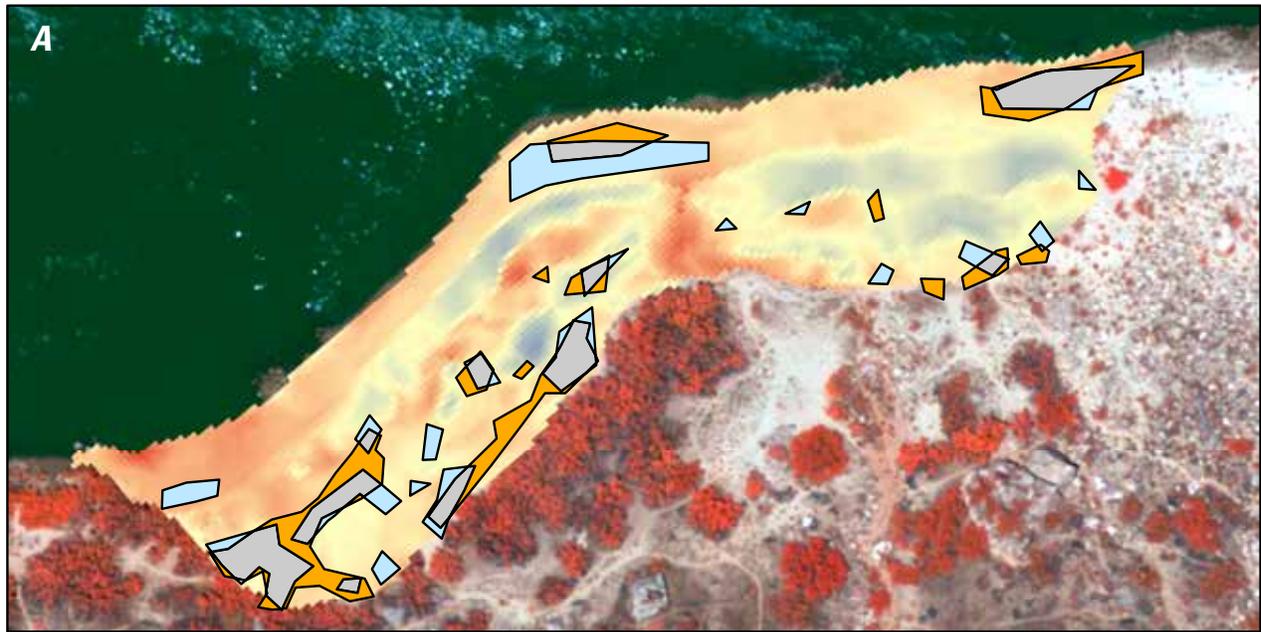
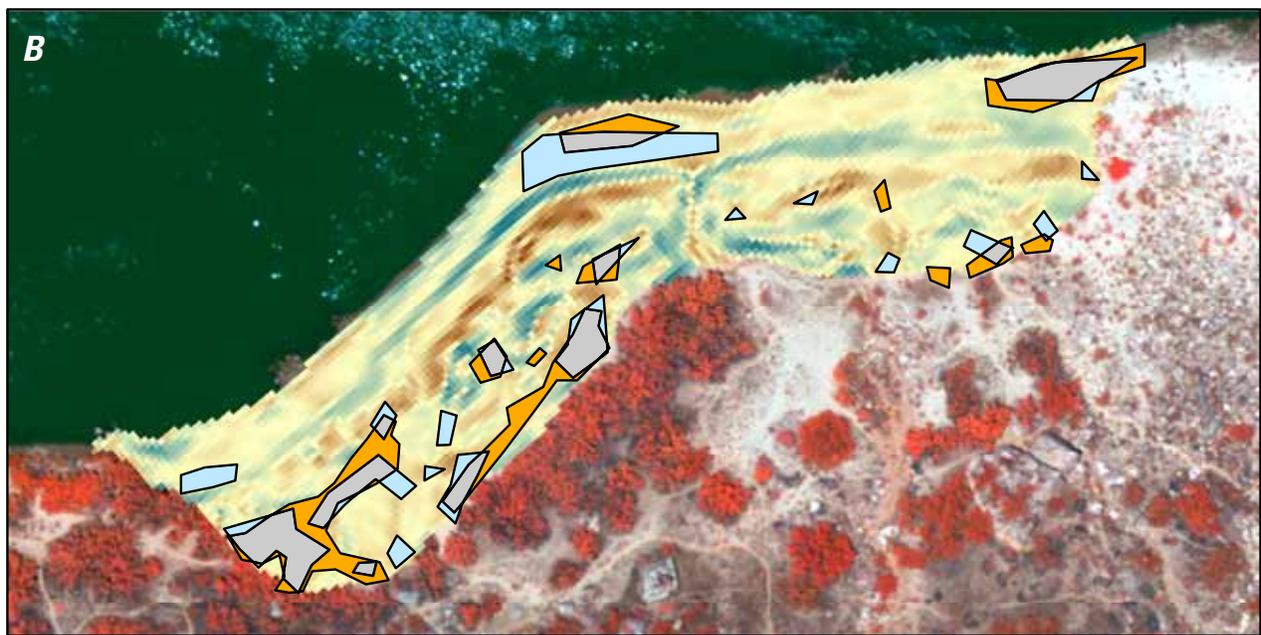
Figure 8. Example aerial image of a monitoring site, Eminence at river mile 44.5 left, along the Colorado River corridor in Grand Canyon National Park, Arizona, overlaid with digital elevation models (DEMs). DEMs of sandbars were used to monitor campsite change along the river. DEMs were generated from total-station survey data to create (A) elevation- and (B) slope-difference rasters. Difference rasters represent the change in elevation and slope of the sandbar between 2002 and 2009. m, meters. U.S. Geological Survey aerial image from May 2009 displayed as false-color composite, with green photosynthetically active vegetation displayed as red.

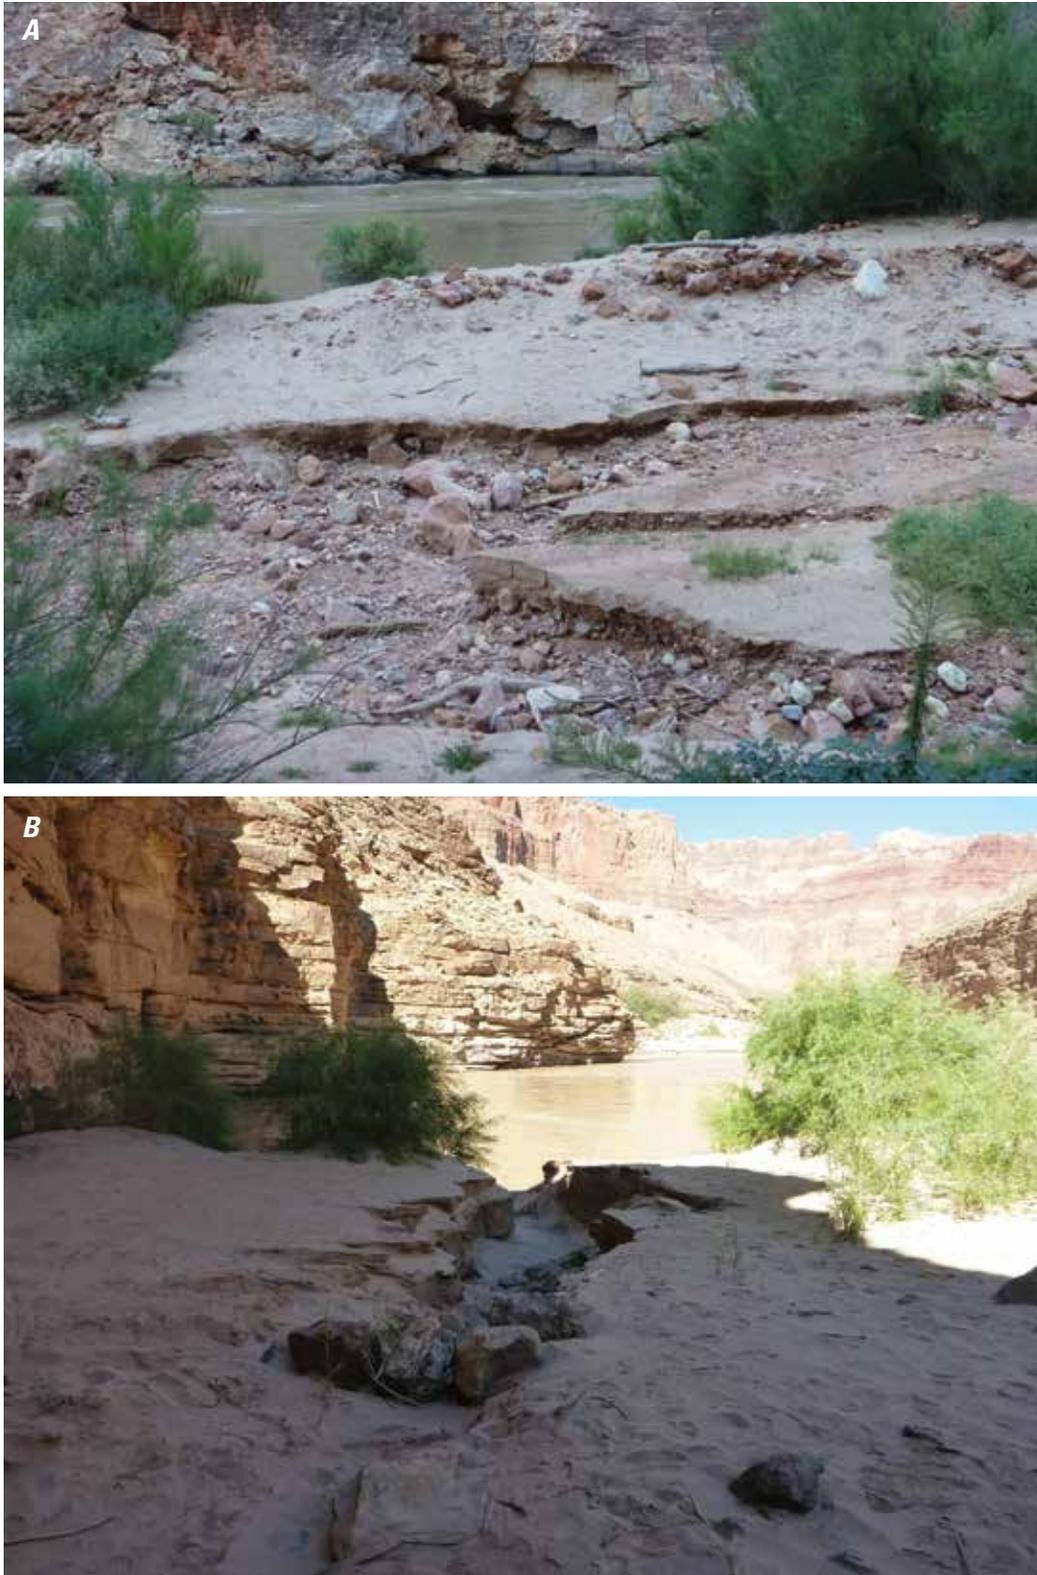
Figure 11. Example photographs of sandbar gullying caused by hillslope runoff leading to recent losses in campsite area along the Colorado River corridor in Grand Canyon National Park, Arizona. *A*, Gullying at Nautiloid (river mile 35.1 left). *B*, Gullying at Crash Canyon (river mile 63.0 right). Nautiloid photograph (*A*) was taken on September 24, 2013, and is looking down on the tributary channel that cuts through the site. Crash Canyon photograph (*B*) was taken on September 27, 2013, looking upstream. (U.S. Geological Survey photographs.)

To distinguish erosion caused by hillslope runoff from erosion caused by fluvial process, gullies were identified from the 2002 and 2009 sandbar surfaces based on the topographic data. Gullies are drainage features that incise into the sandbar surface and are caused by hillslope runoff generated from storm events. Gullies can be small surface features less than 1 m in width or depth (often referred to as rills) or can be large features that are several meters in width or depth (fig. 11). Flow-direction and flow-accumulation rasters were derived from the sandbar-slope rasters in ArcGIS. Raster cells of flow accumulation allowed identification of potential gullies and were further discerned using 0.25-m contour lines generated from the DEMs. Total-station derived surfaces at the long-term monitoring sites support a 0.25-m contour interval at the 95-percent confidence level based on analysis of interpolation uncertainty between total-station survey points (Hazel and others, 2008; Kaplinski and others, 2017)). A series of remote cameras located throughout the river corridor take photographs of sandbars on a daily basis, and these photographs were used to verify the presence of gullies.

Gullies present in 2009 were intersected with areas of campsite loss to determine the amount of loss occurring as a result of hillslope runoff. Gullies present in 2002 were intersected with areas of campsite gain to determine the amount of gain caused by gully infilling. Gullies can infill by fluvial deposition from the mainstem river, alluvial deposition from hillslope transport or backwasting, or aeolian deposition of windblown sand (Sankey and Draut, 2014; Collins and others, 2016; East and others, 2016). The type of infilling was verified with the remote-camera photographs when possible.

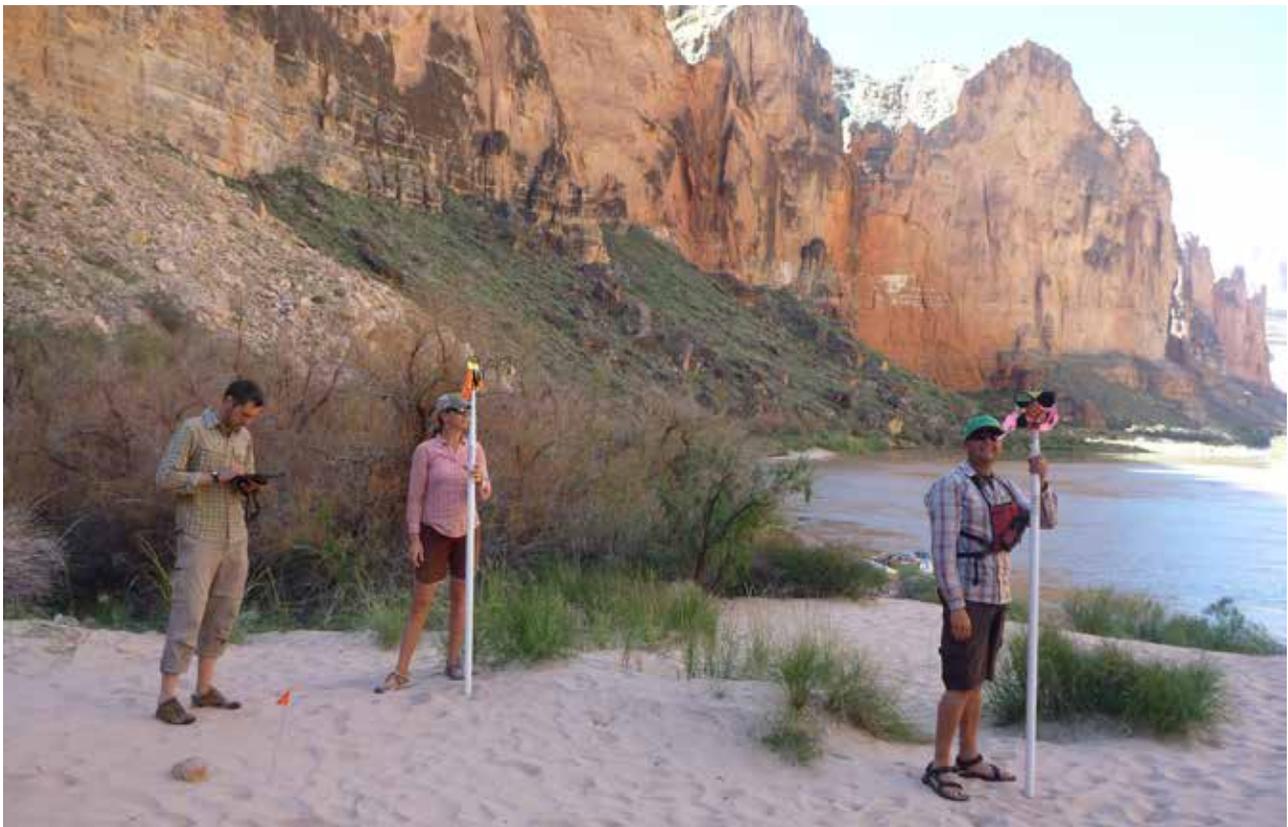
Figure 29. Photograph of scientists conducting concurrent computer-tablet and total-station surveys to map campsite area at Eminence (river mile 44.5 left) along the Colorado River corridor in Grand Canyon National Park, Arizona (U.S. Geological Survey photograph).
