# **Peak Discharge, Flood Frequency, and Peak Stage of Floods on Big Cottonwood Creek at U.S. Highway 50 Near Coaldale, Colorado, and Fountain Creek below U.S. Highway 24 in Colorado Springs, Colorado, 2016**

Scientific Investigations Report 2017–5107

By Michael S. Kohn, Michael R. Stevens, Amanullah Mommandi, and Aziz R. Khan

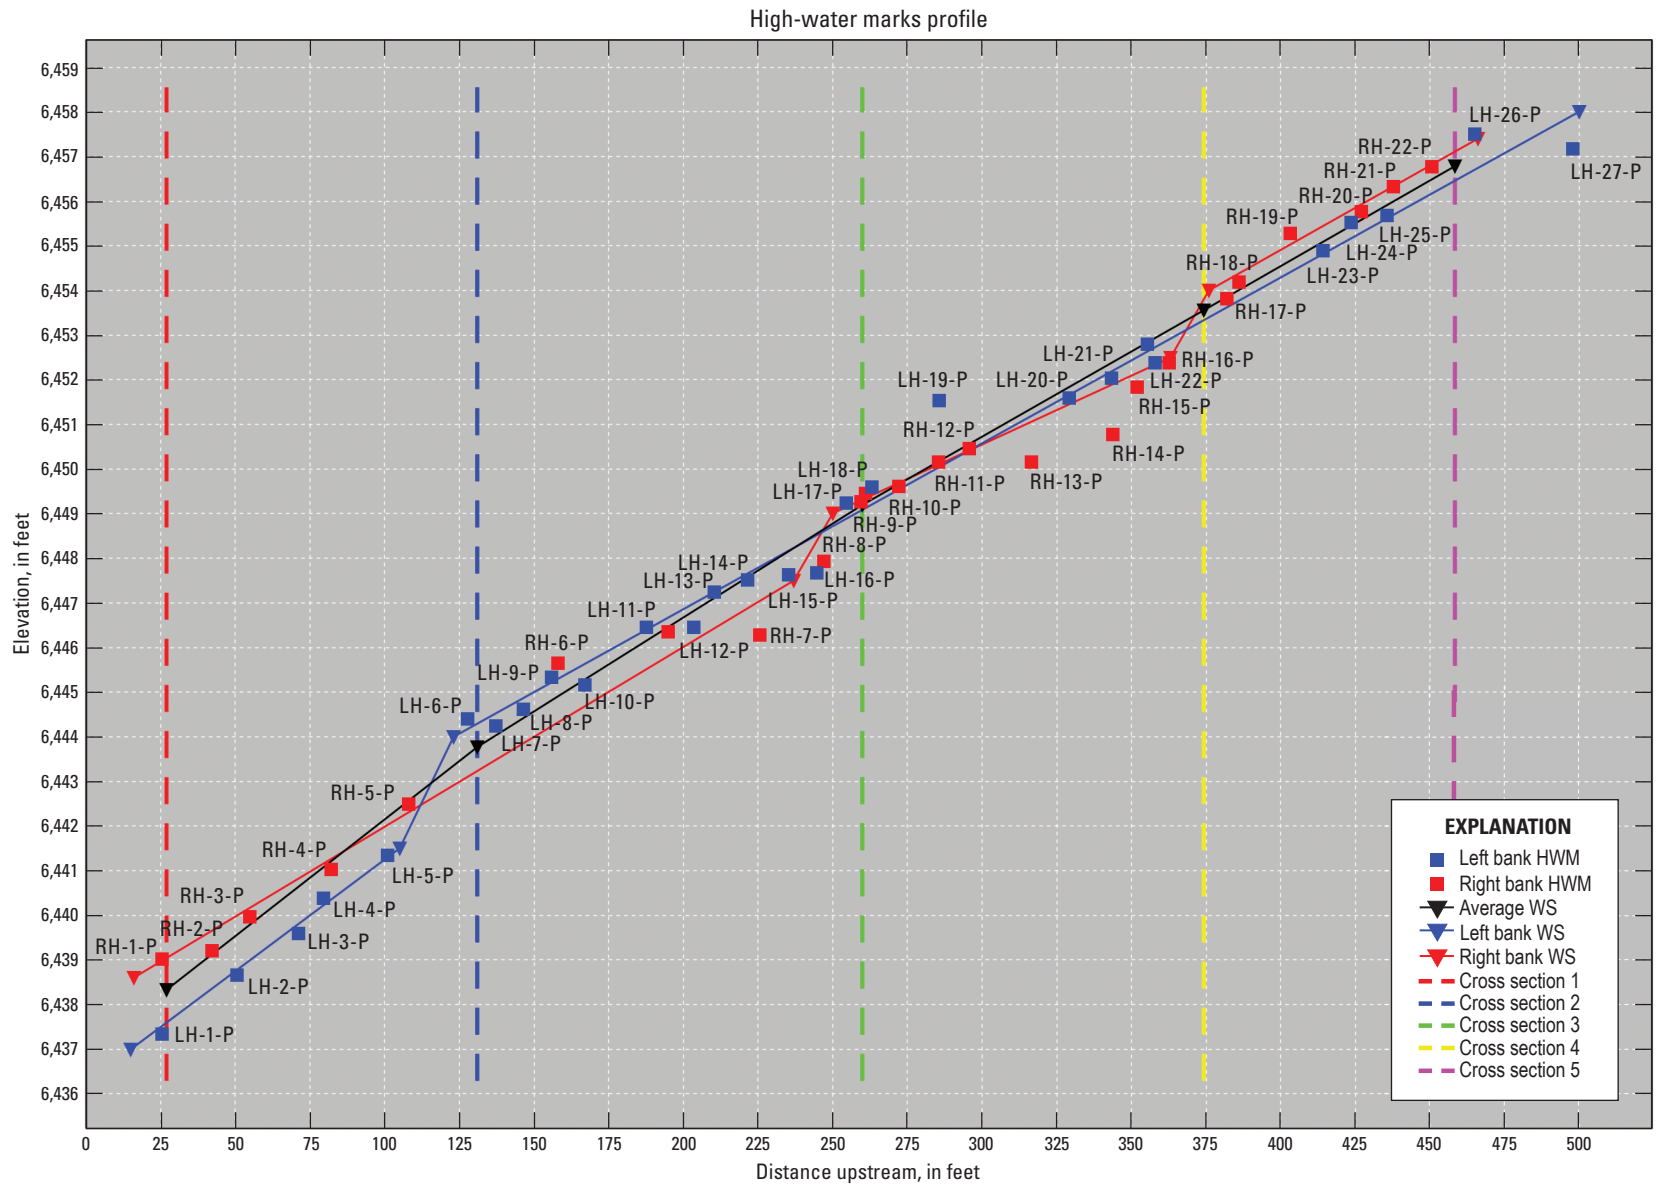
**Figure 4.** Profile view of the left and right bank high-water marks (HWMs) and cross sections for Big Cottonwood Creek at U.S. Highway 50 near Coaldale, Colorado; generated using the Slope-Area Computation Graphical User Interface. For readability, not all data points are labeled. [WS, water surface]

table 2 of Koenig and others (2016). The SACGUI was used to establish a longitudinal baseline (for downstream stationing) on the plan-view plot of the Big Cottonwood Creek site (fig. 3). High-water marks were plotted (fig. 4) in the field on September 20, 2016, to determine the optimal cross section locations, as recommended in Benson and Dalrymple (1967) (fig. 4).

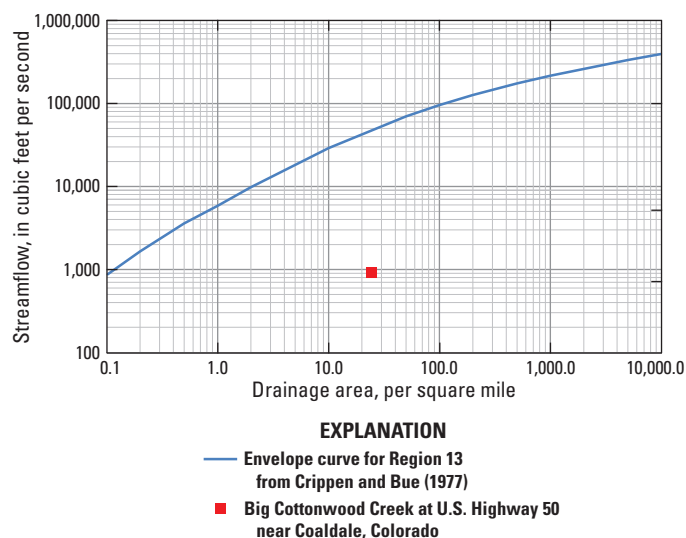
**Figure 7.** The envelope curve for Region 13 from Crippen and Bue (1977) with the flood of August 23, 2016, on Big Cottonwood Creek at U.S. Highway 50 near Coaldale, Colorado.

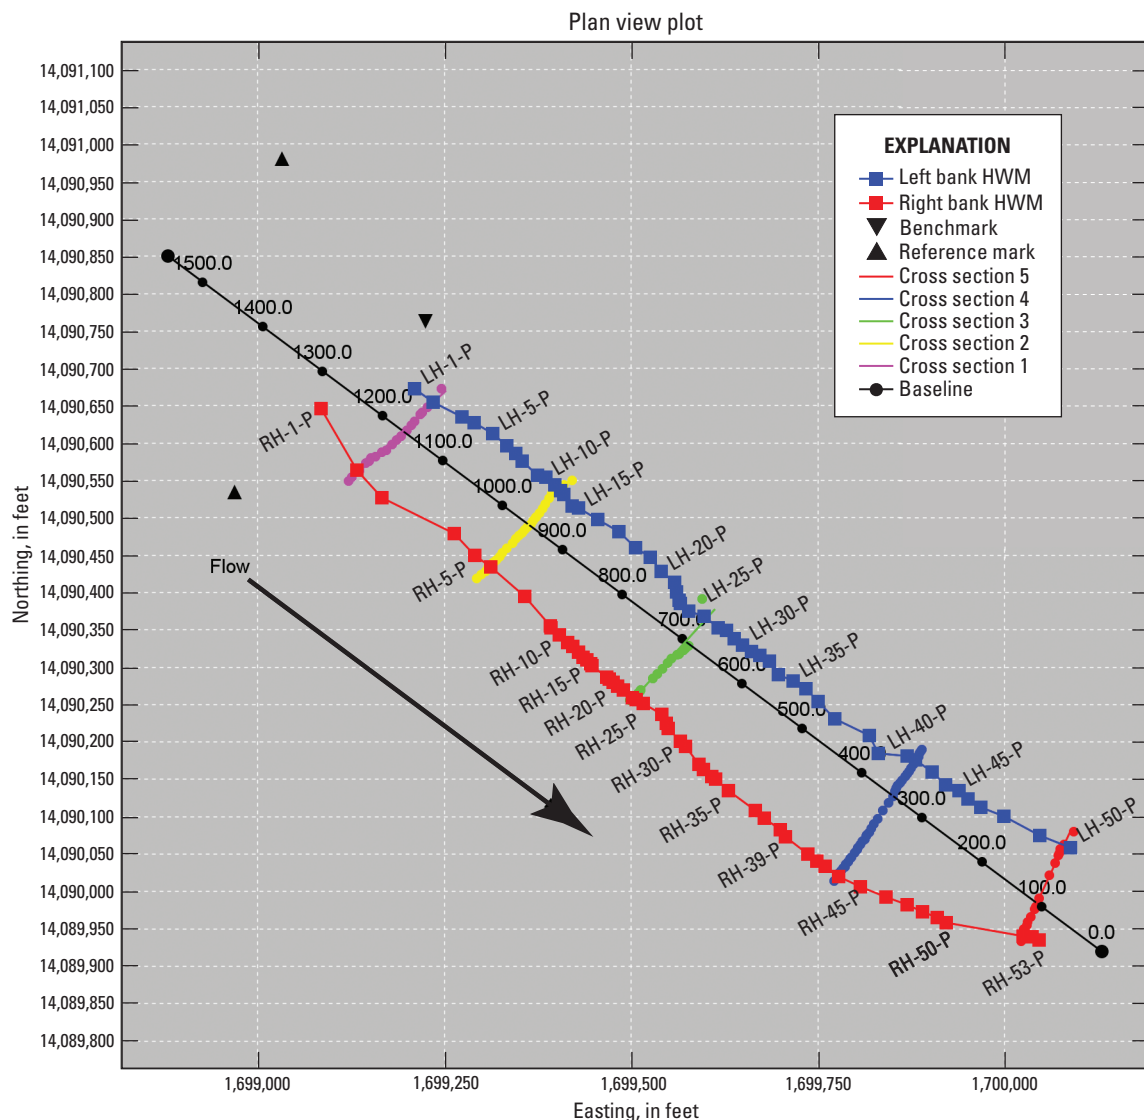
**Figure 10.** Plan view of the site showing the left and right bank high-water marks (HWMs) and cross sections for Fountain Creek below U.S. Highway 24 in Colorado Springs, Colorado; generated from the Slope-Area Computation Graphical User Interface. For readability, not all data points are labeled.

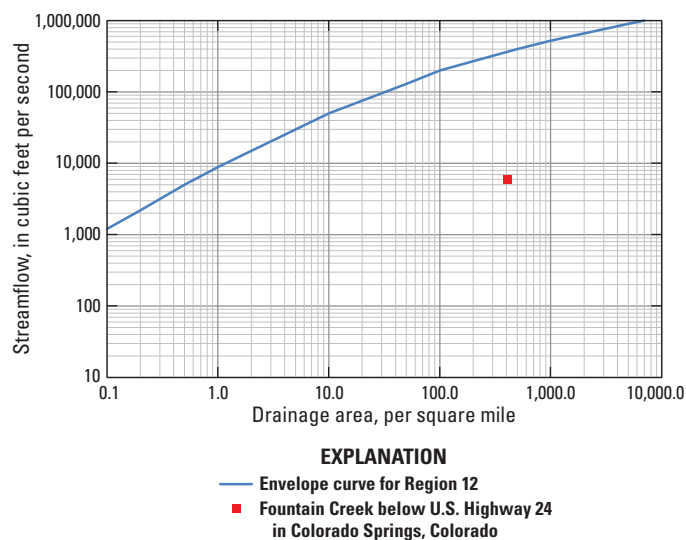
**Figure 14.** The envelope curve for Region 12 from Crippen and Bue (1977) with the flood of August 29, 2016, on Fountain Creek below U.S. Highway 24 in Colorado Springs, Colorado.
