Assessment of an In-Channel Redistribution Technique for Large Woody Debris Management in Locust Creek, Linn County, Missouri

Scientific Investigations Report 2017–5120

By David C. Heimann

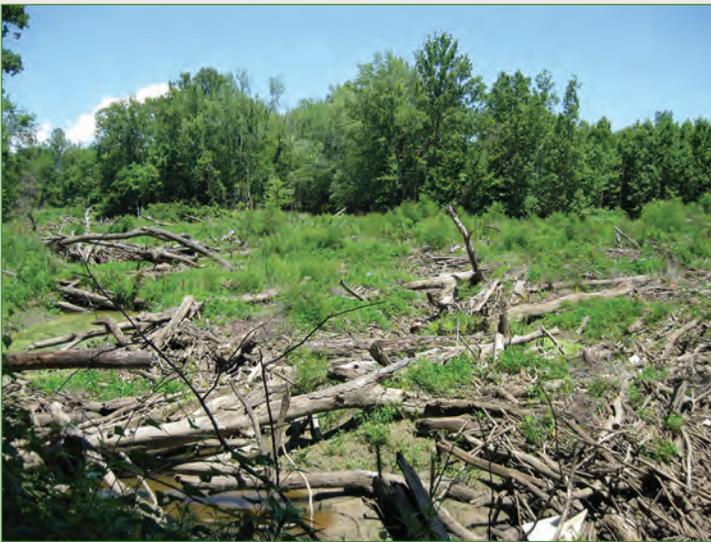
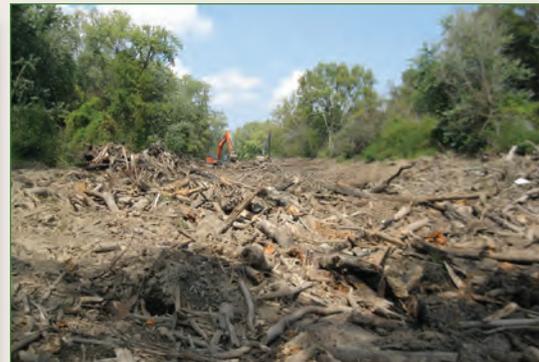
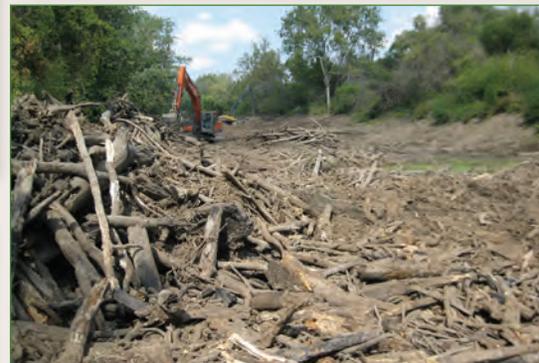
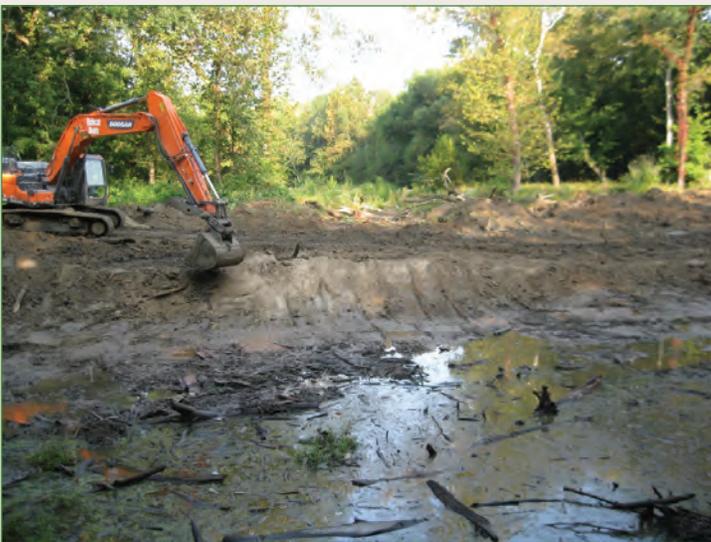
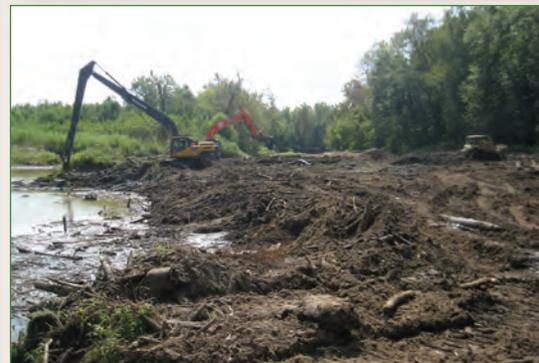
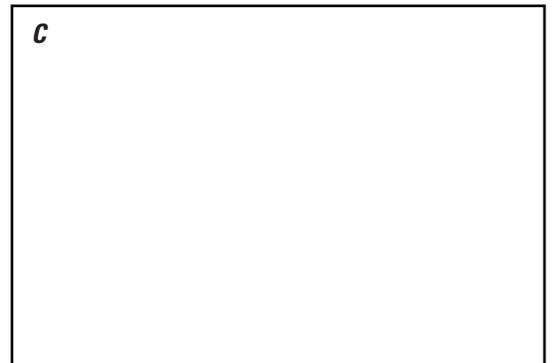
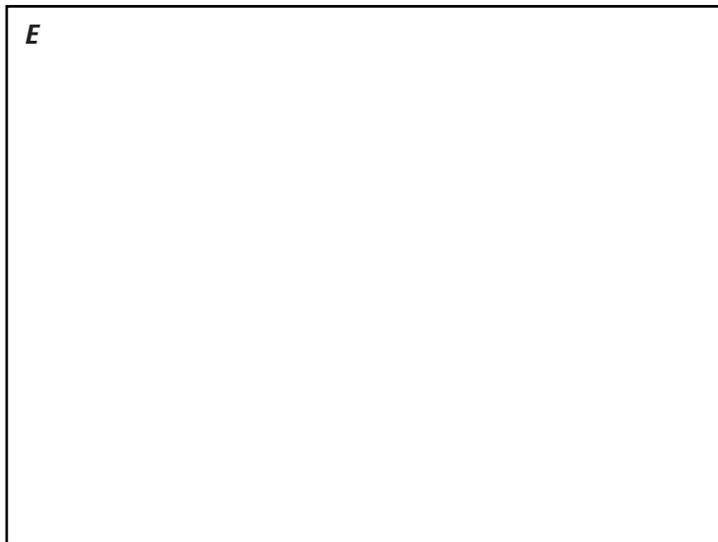
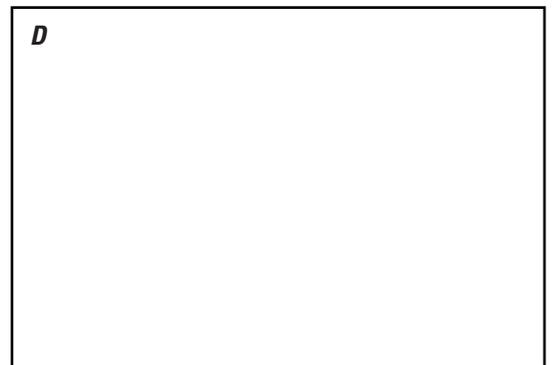
Cover. Photographs showing redistribution and treatment of large woody debris in Locust Creek at the north end of Pershing State Park, September 2017. *A*; Pre-redistribution and treatment. *B*, *C*, and *D*; During redistribution and treatment. *E*; Post-redistribution and treatment. Photographs by Tom Woodward, Missouri Department of Natural Resources, Pershing State Park.

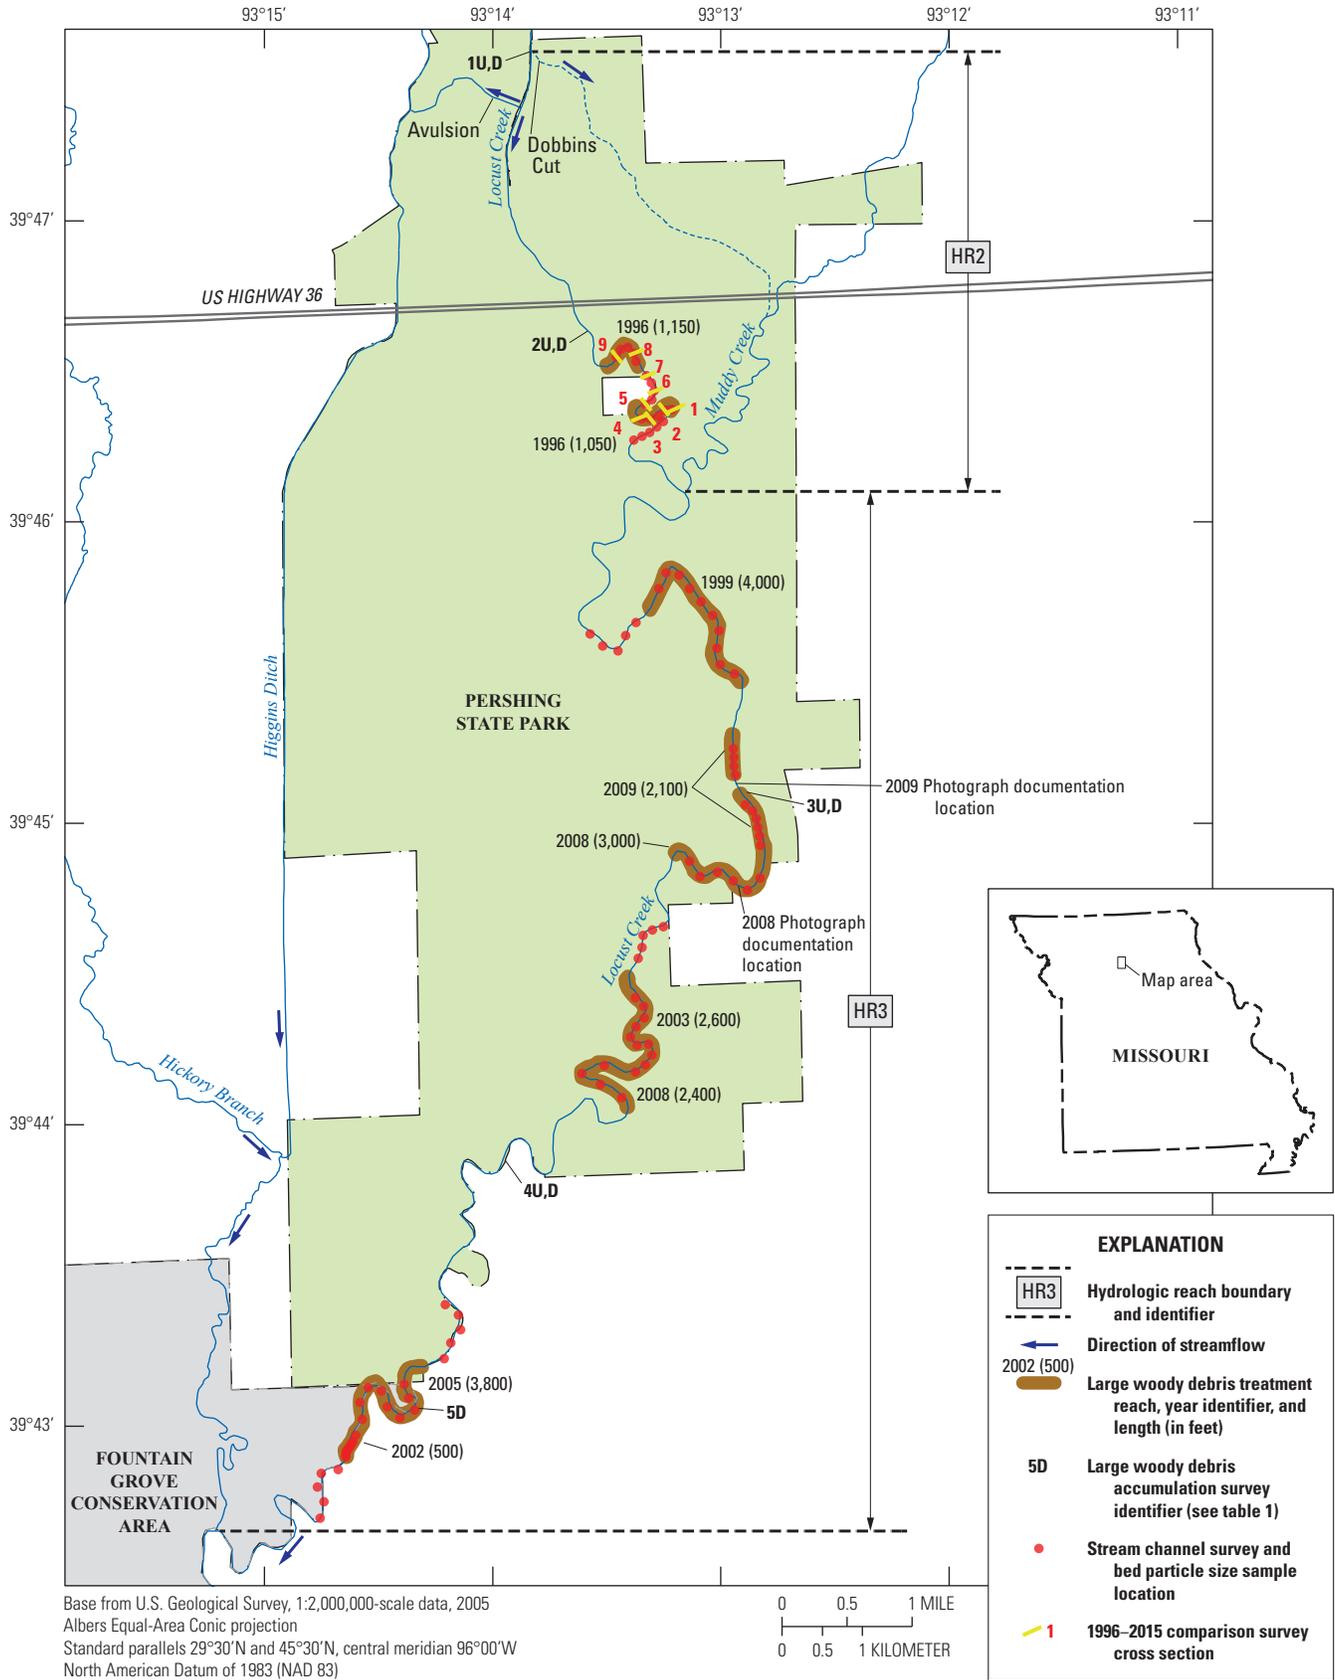
Figure 2. Large woody debris treated reaches, large woody debris accumulation survey locations, and channel survey and channel bed material particle-size sampling locations.

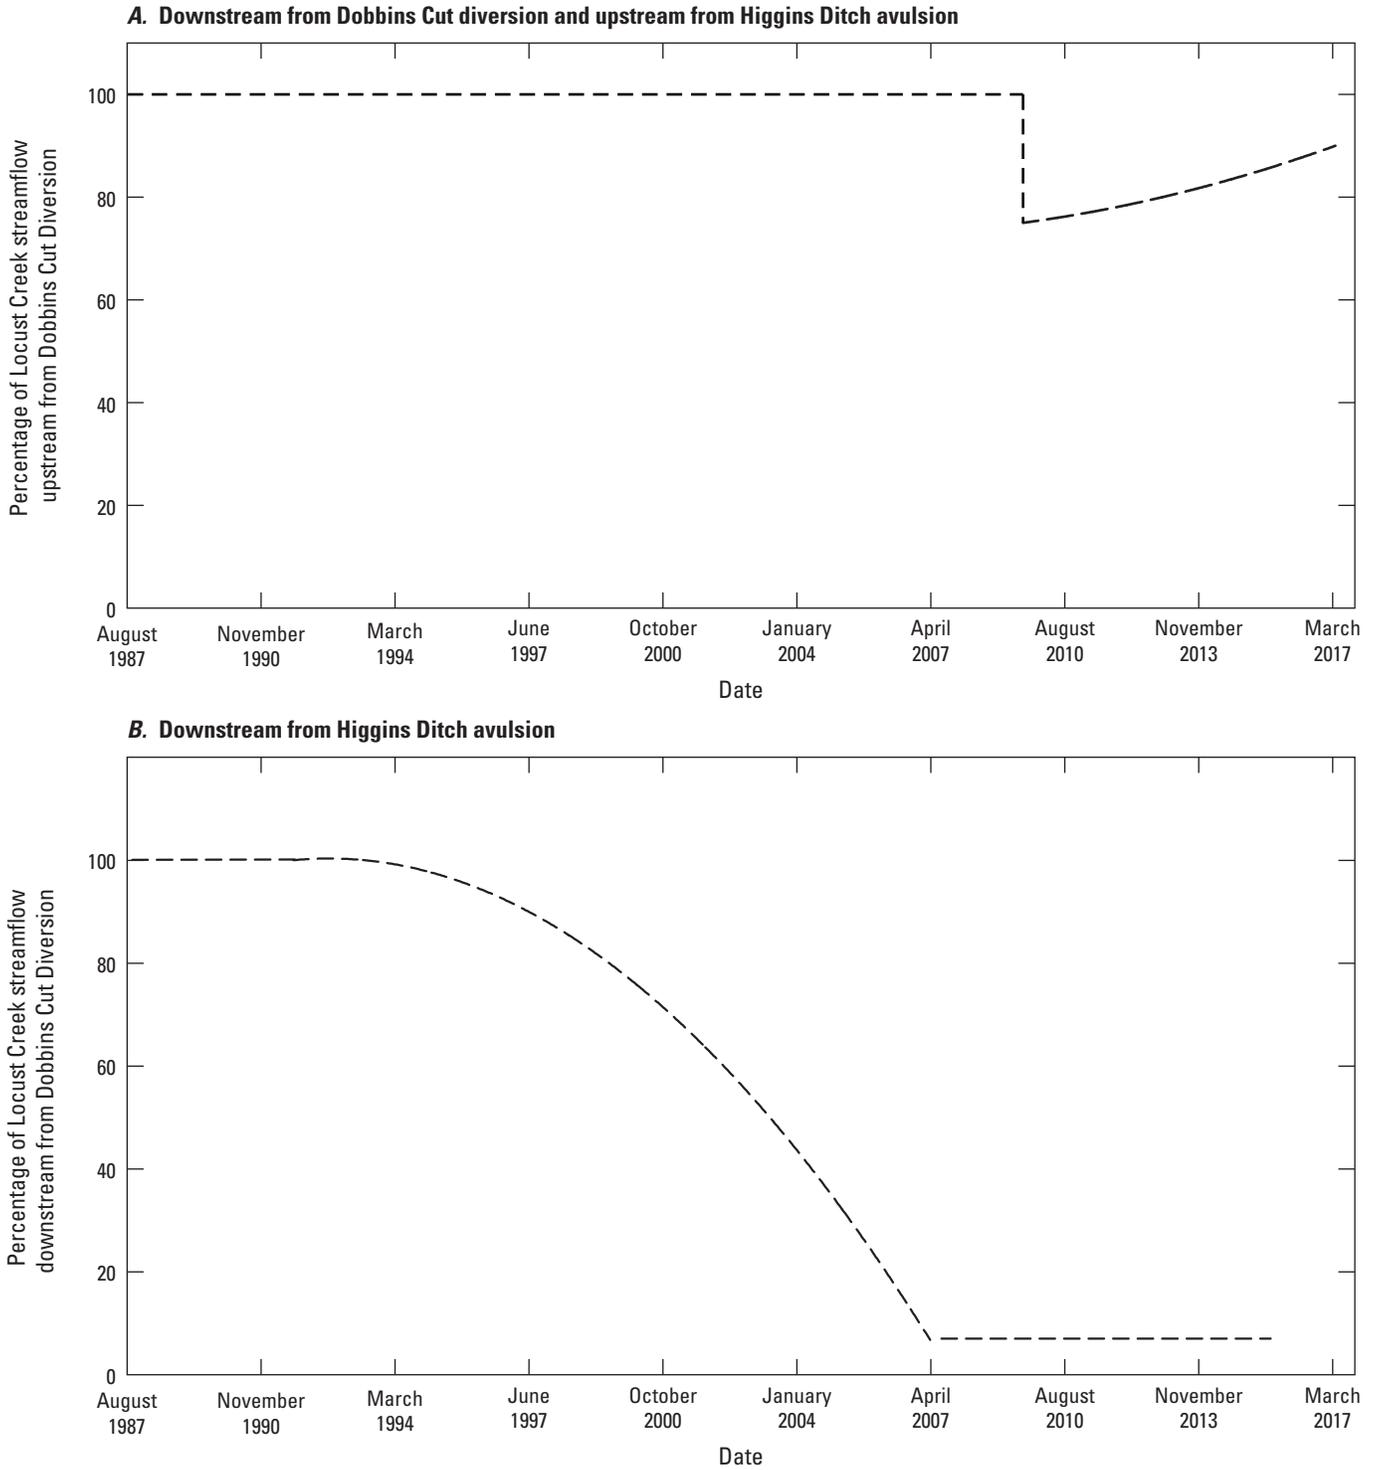
Figure 4. Hypothetical temporal change in Locust Creek streamflow. A, Streamflow downstream from Dobbins' Cut diversion. B, Streamflow downstream from Higgins Ditch avulsion.

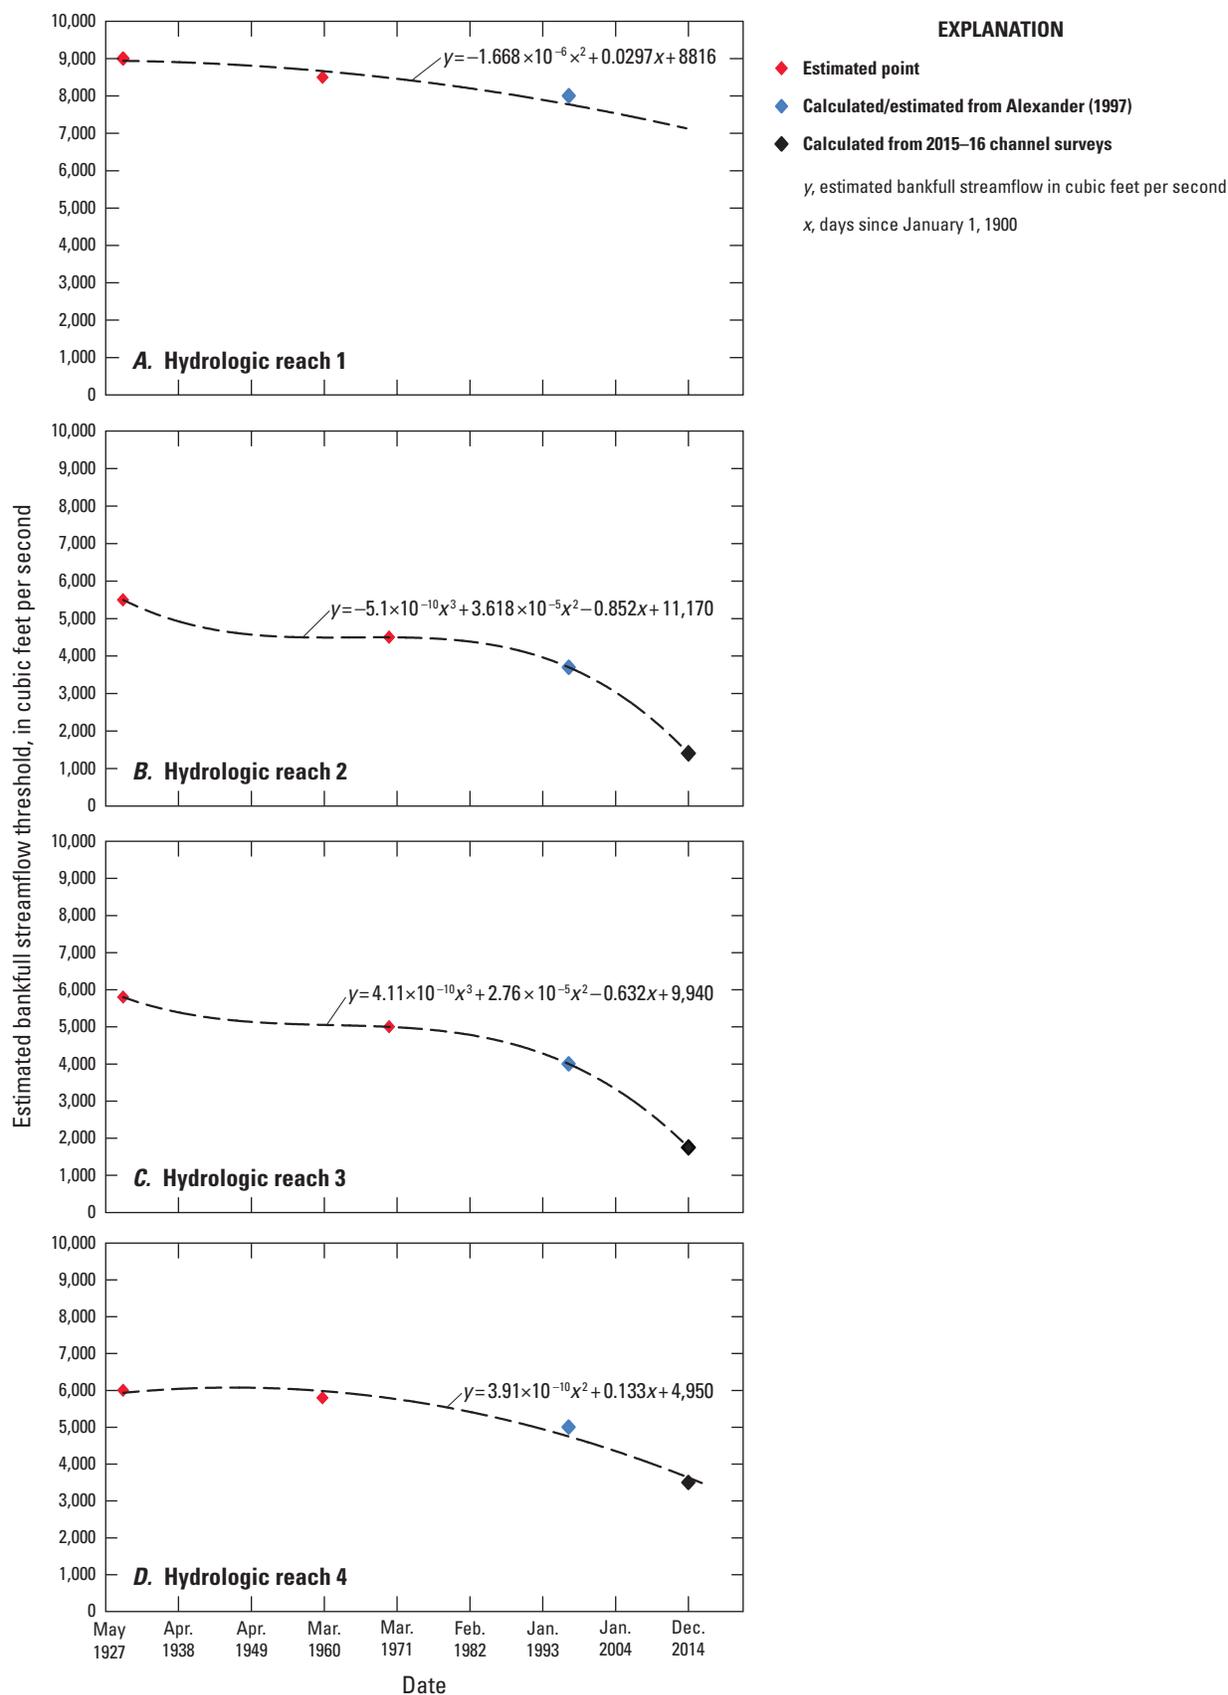
Figure 5. Estimated temporal change in the bankfull streamflow threshold in Locust Creek hydrologic reaches 1–4, 1930–2016 water years.

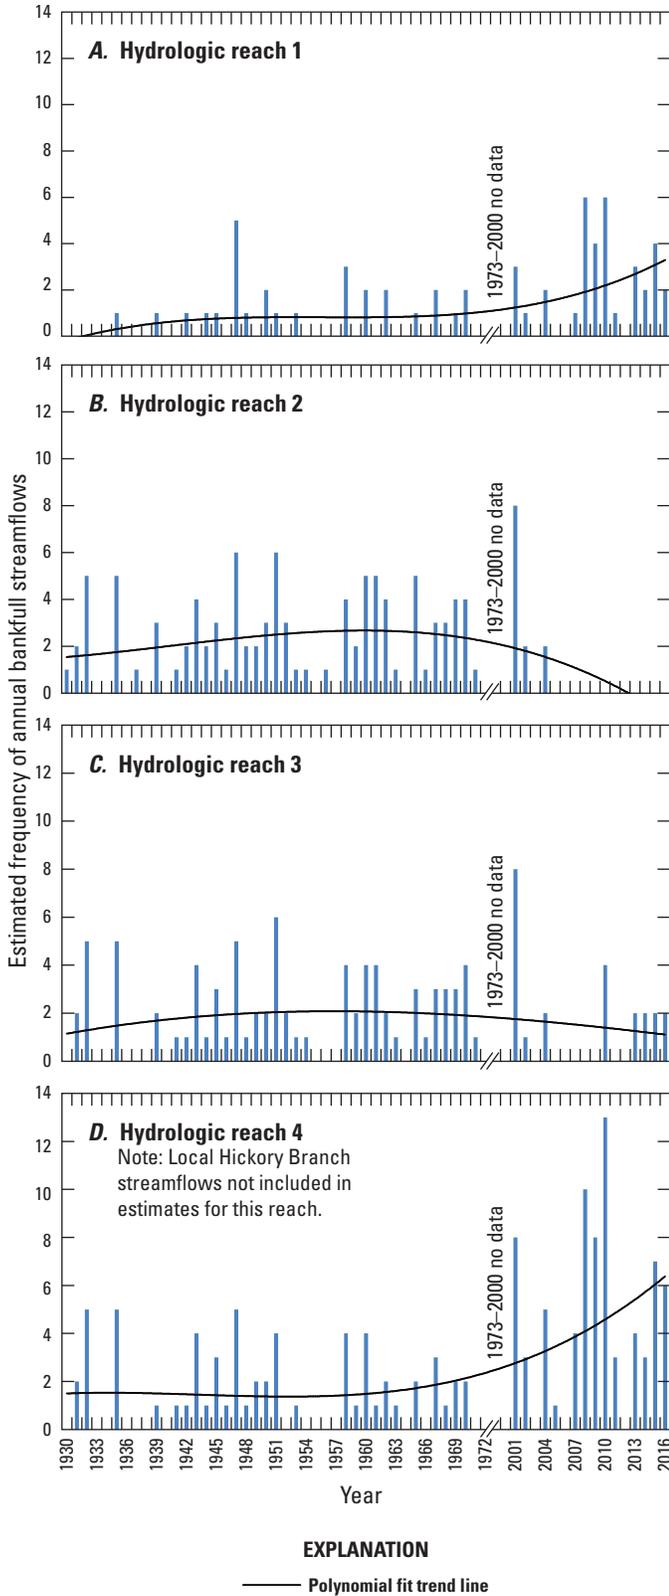
Figure 6. Frequency of Locust Creek bankfull streamflows by hydrologic reach developed using daily mean streamflow data from the U.S. Geological Survey streamgauge Locust Creek near Linneus, Missouri, 1930–2016.

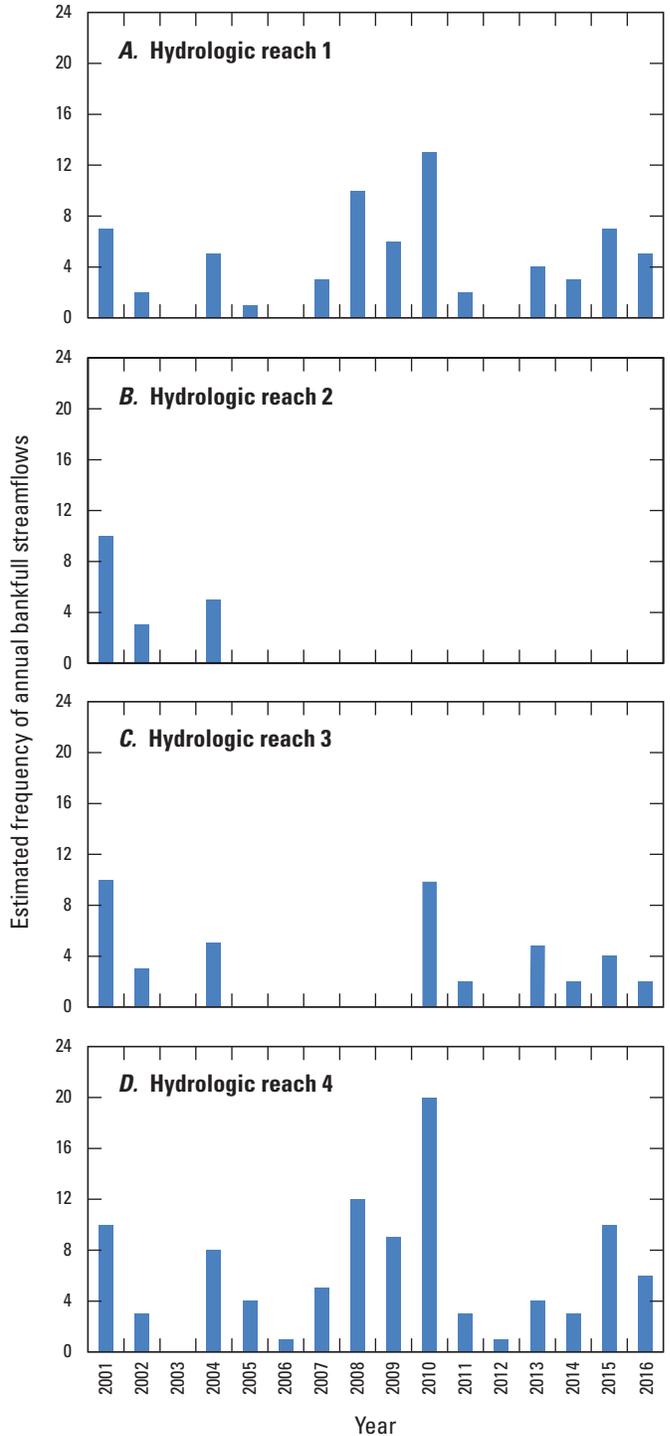
Figure 7. Frequency of Locust Creek bankfull streamflows by hydrologic reach developed using 15-minute streamflow data from the U.S. Geological Survey streamgauge Locust Creek near Linneus, Missouri, 2001–2016.

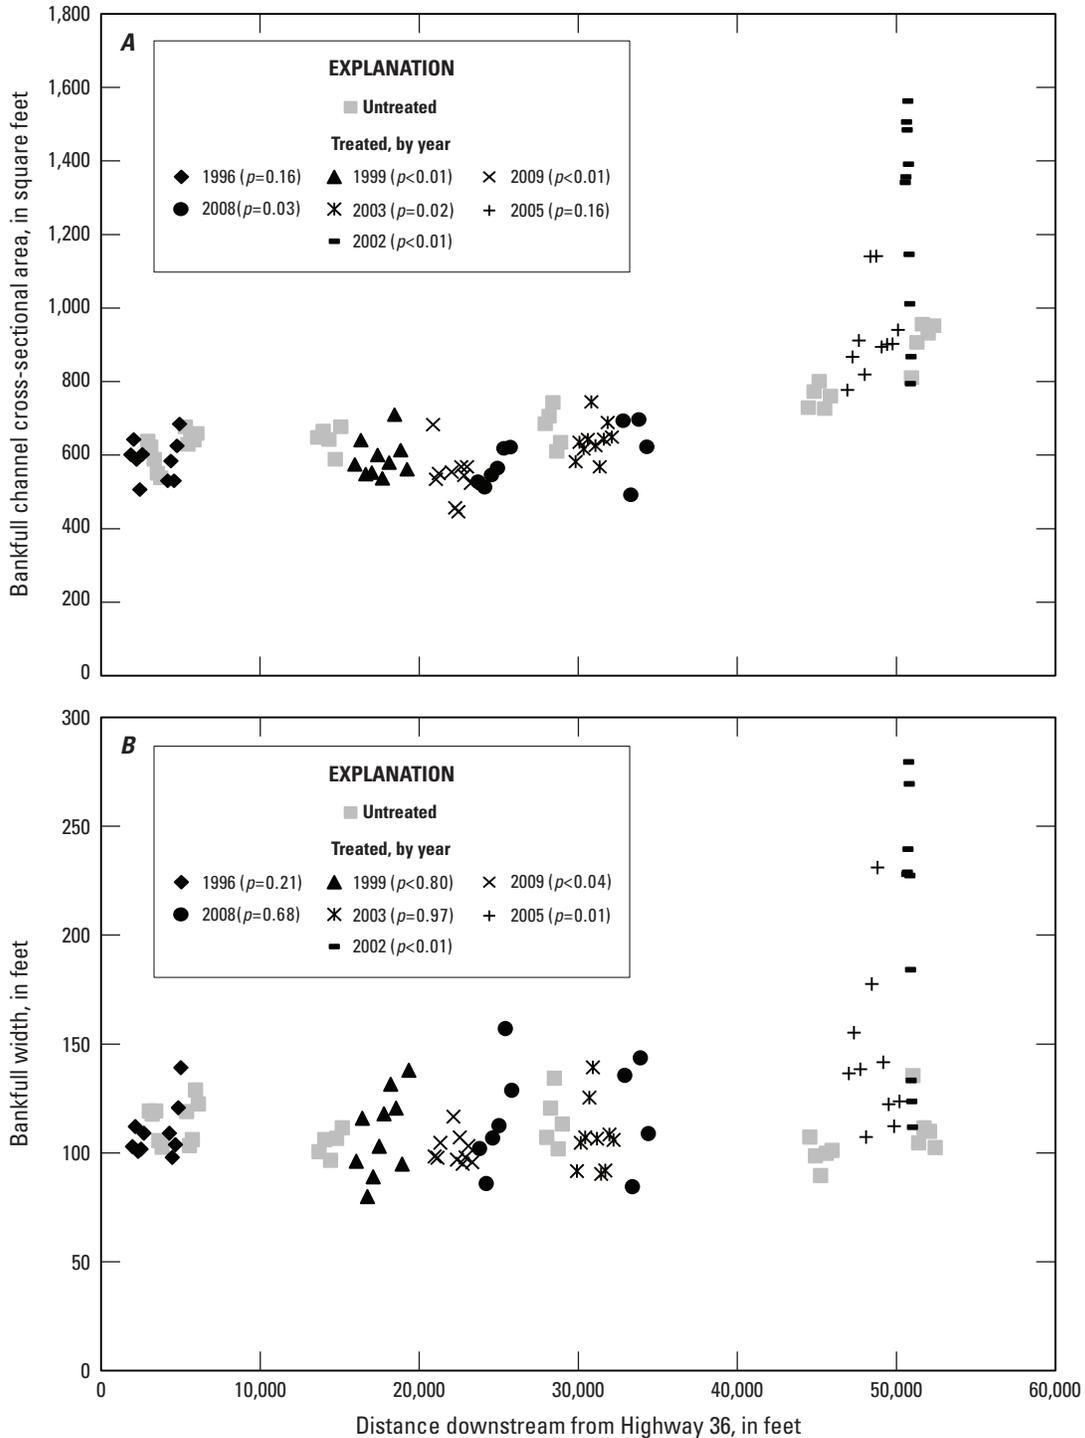
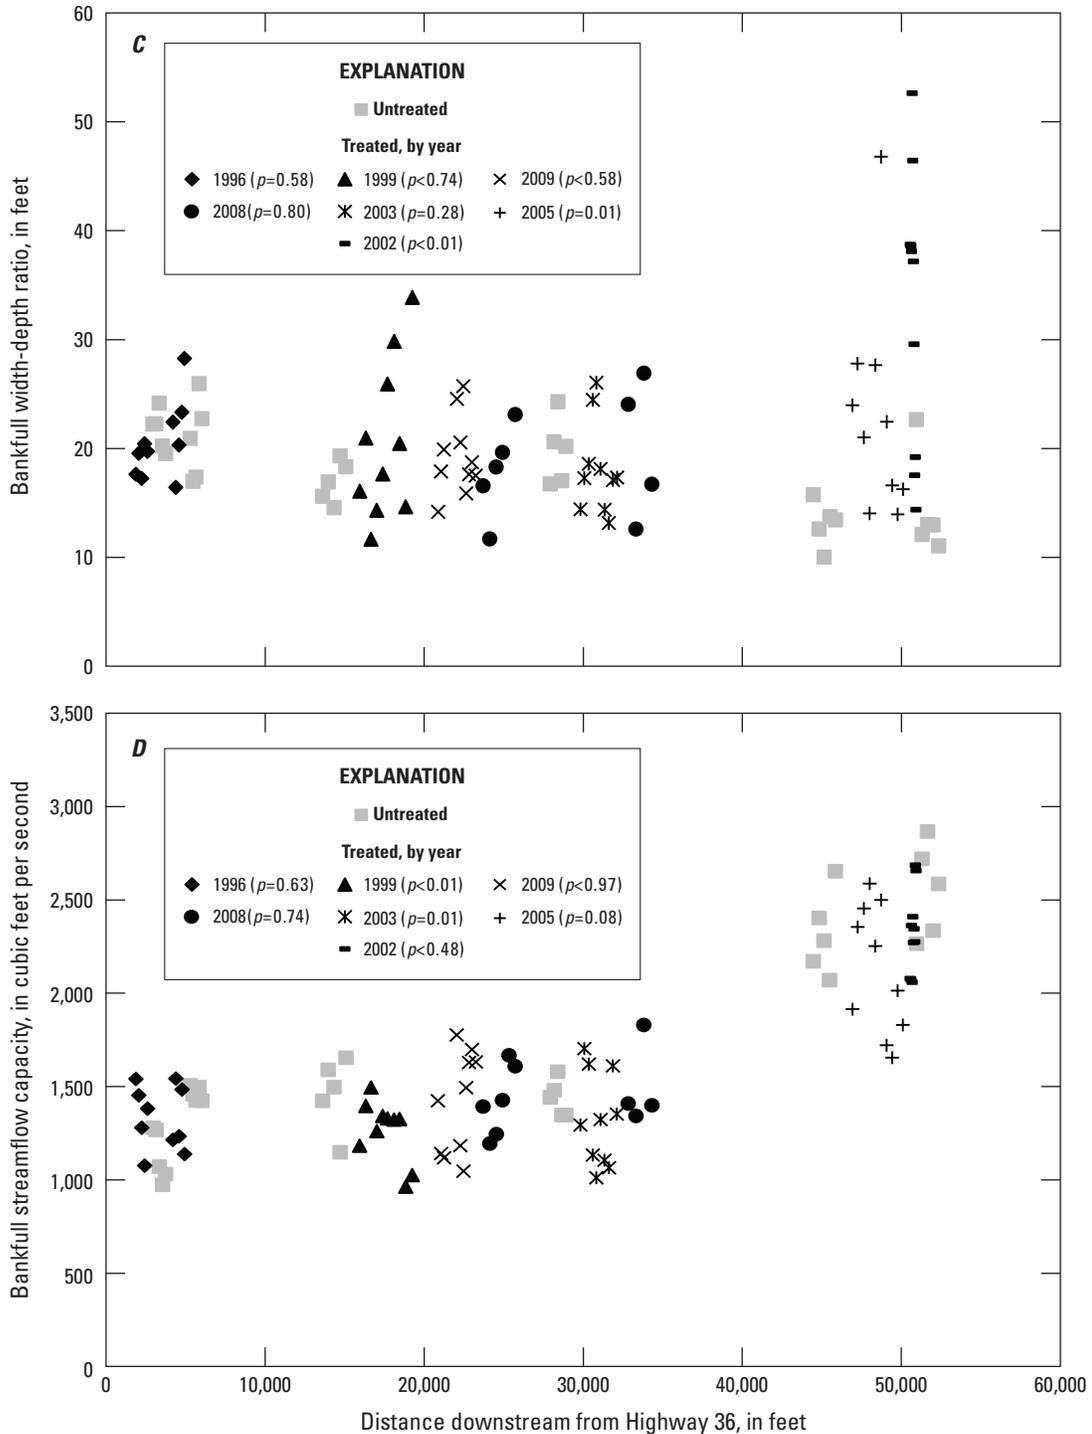
Figure 8. A, distribution of Locust Creek bankfull channel cross-sectional area; B, bankfull width; C, bankfull width-depth ratio; and D, bankfull streamflow capacity for treated and untreated reaches by longitudinal channel distance.

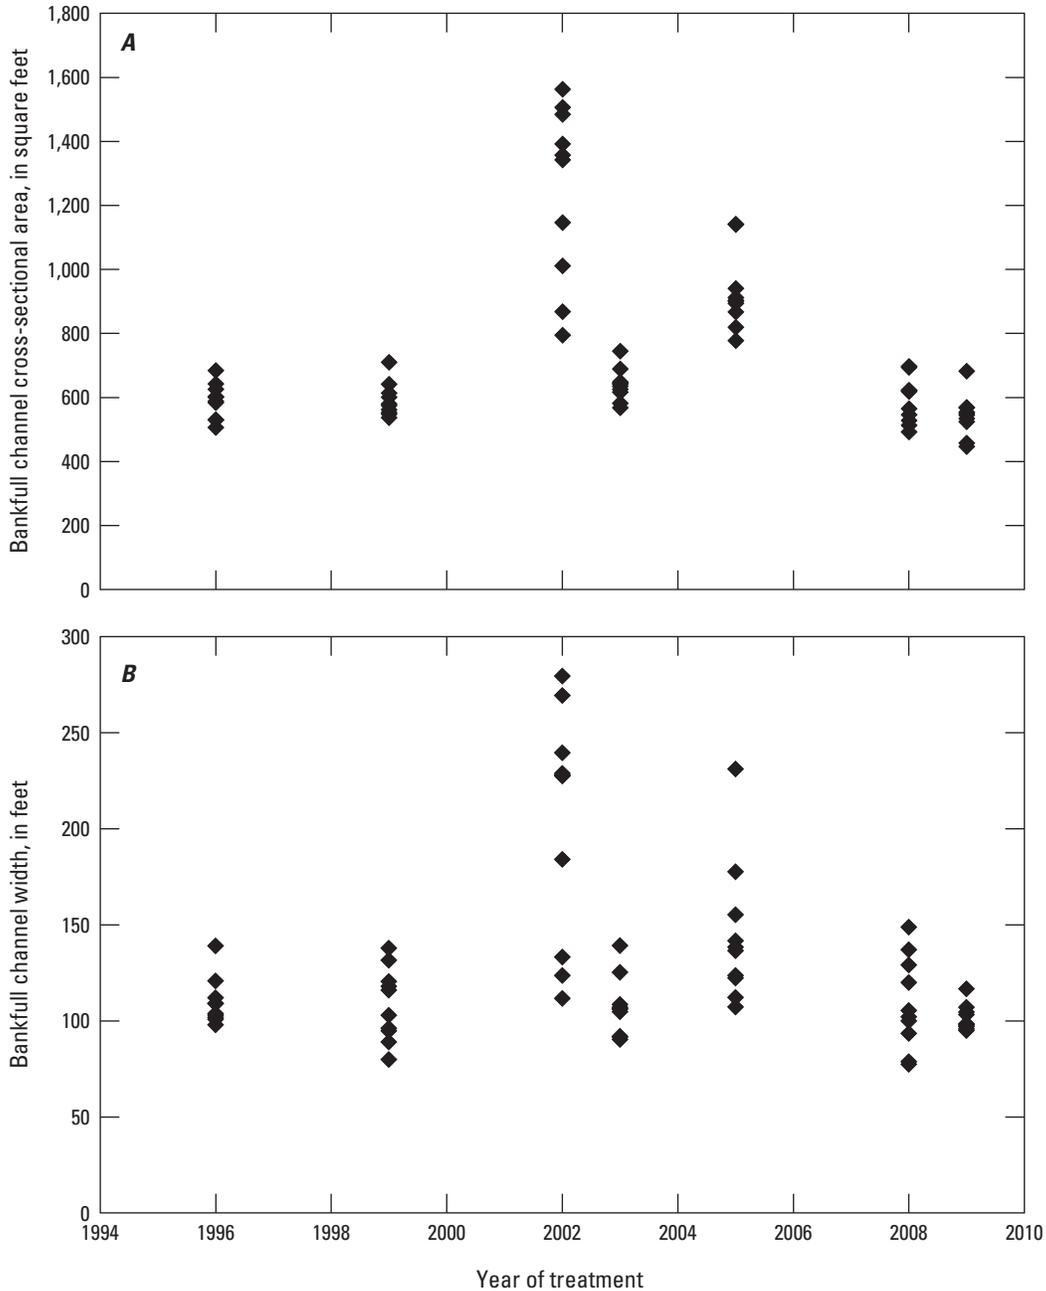
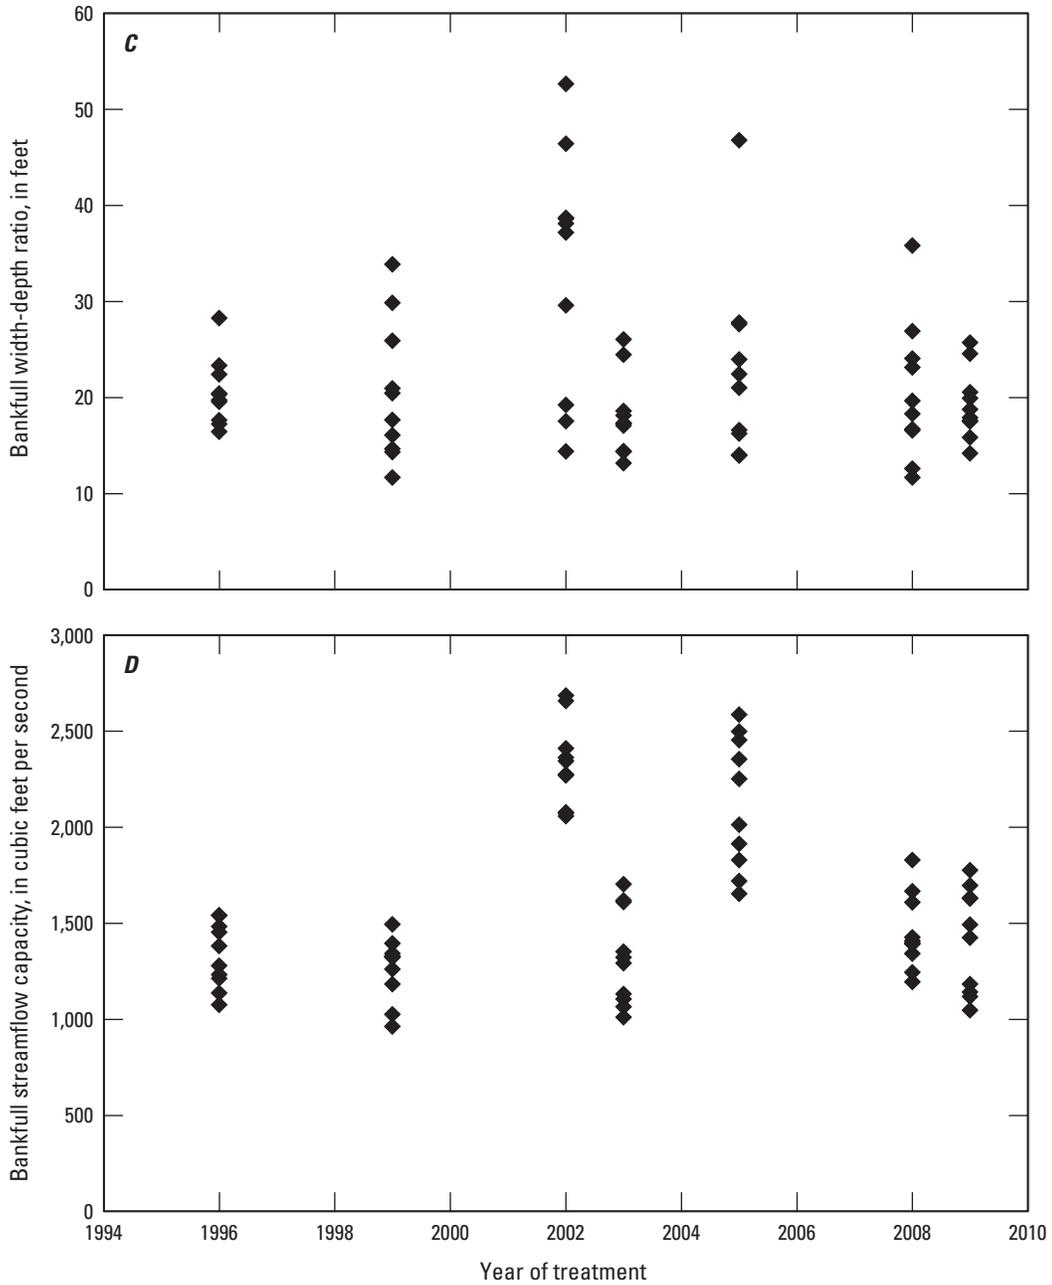
Figure 9. Distribution of *A*, Locust Creek bankfull channel cross-sectional area; *B*, bankfull width; *C*, bankfull width-depth ratio; and *D*, bankfull streamflow capacity by year of large woody debris treatment.

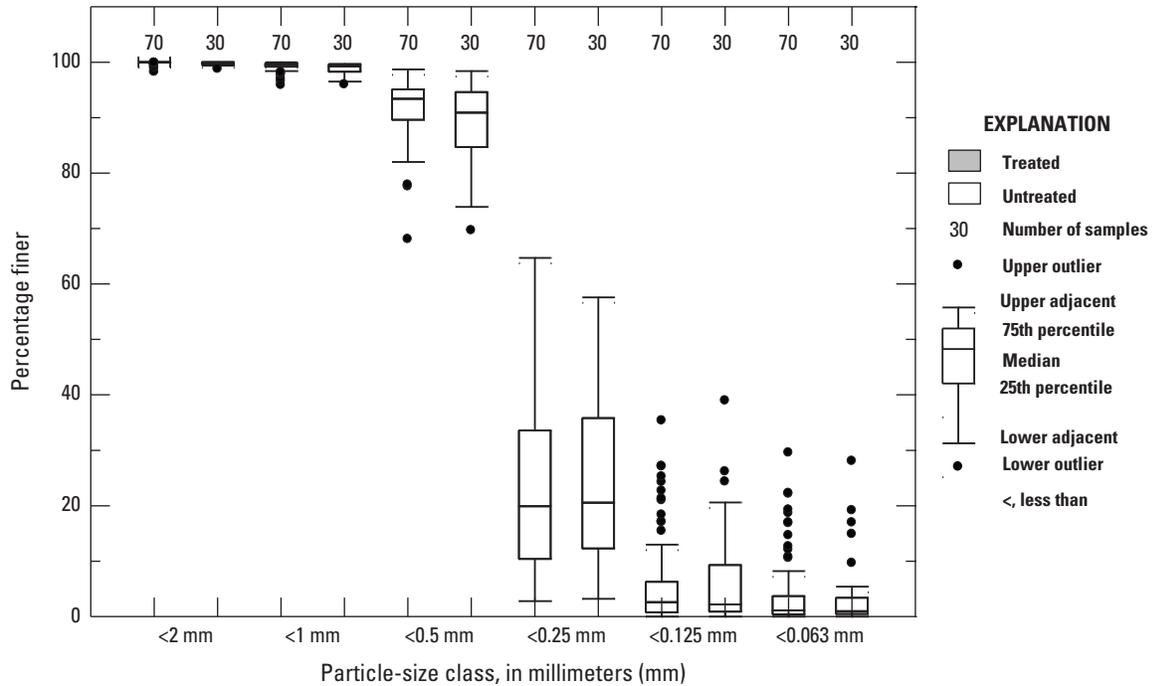
Figure 10. Distribution of particle-size classes of Locust Creek bed material samples from reaches with redistribution of large woody debris (treated) and from untreated reaches.

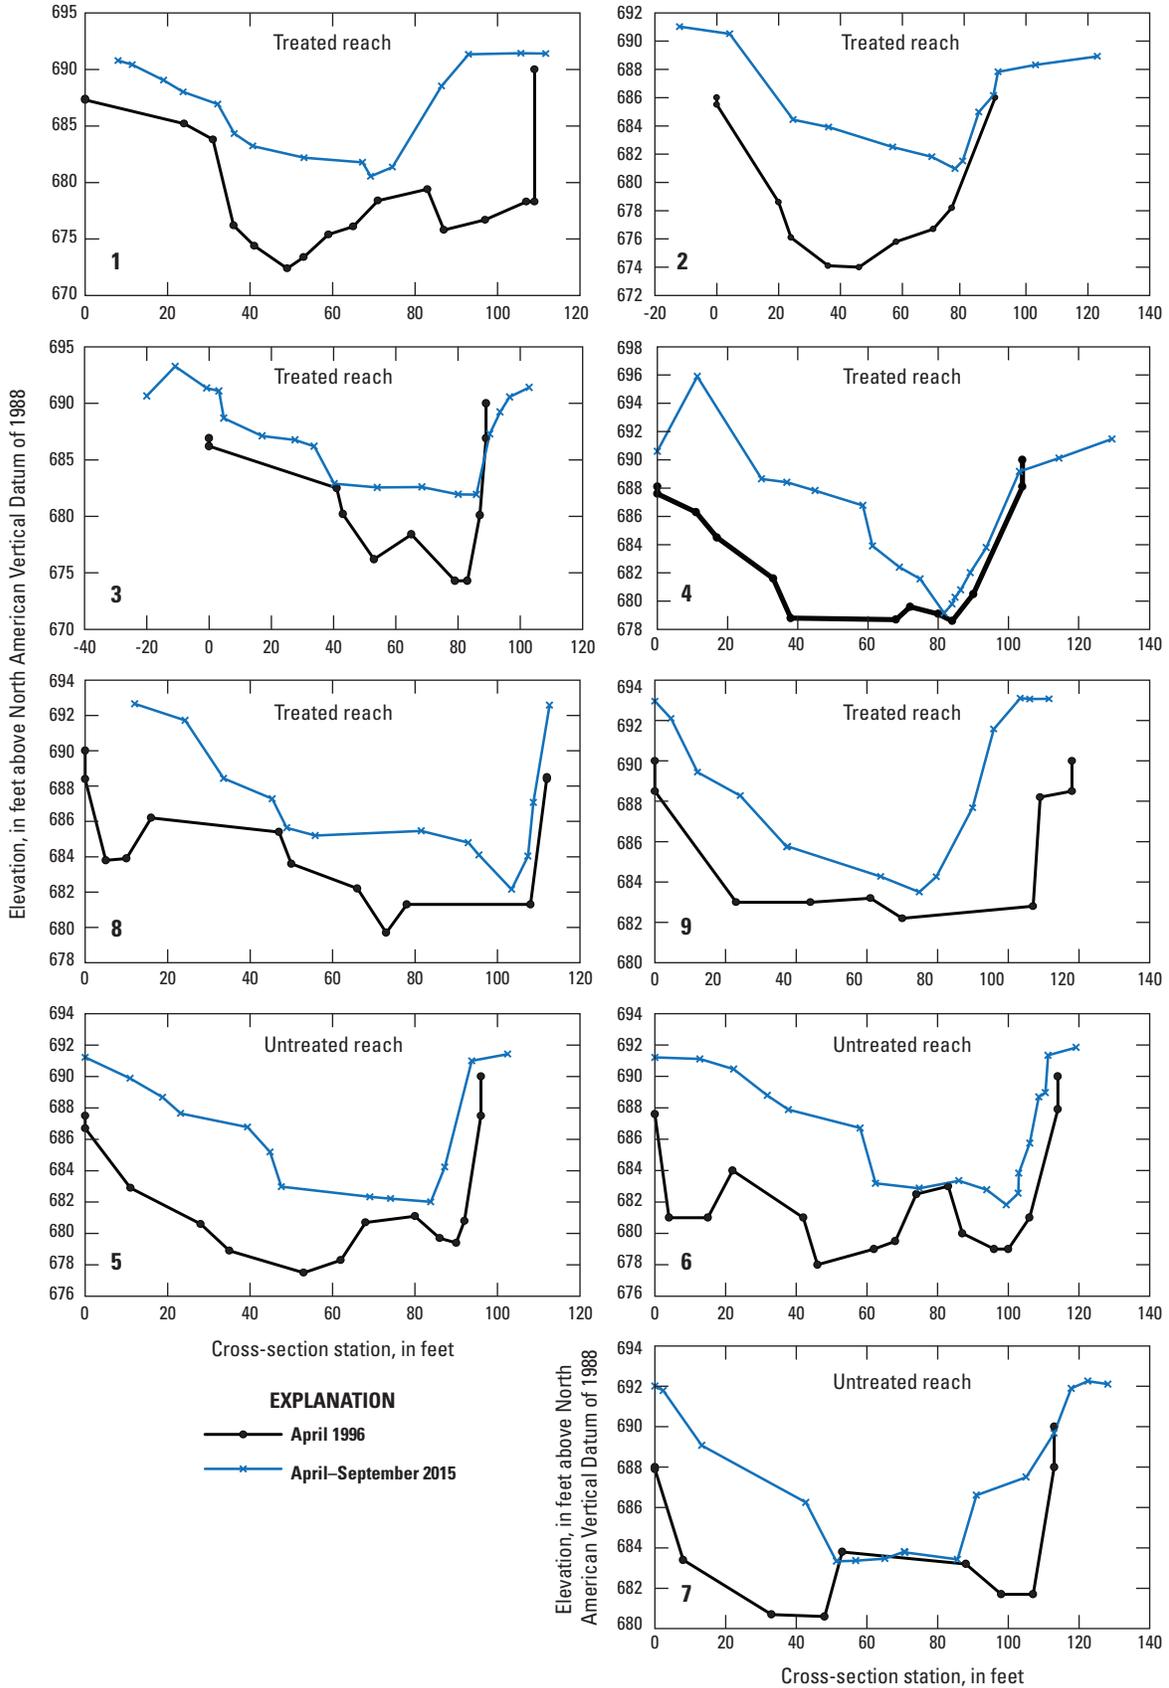
Figure 11. Comparison of selected channel cross sections surveyed in 1996 and 2015 in treated and untreated reaches of Locust Creek.

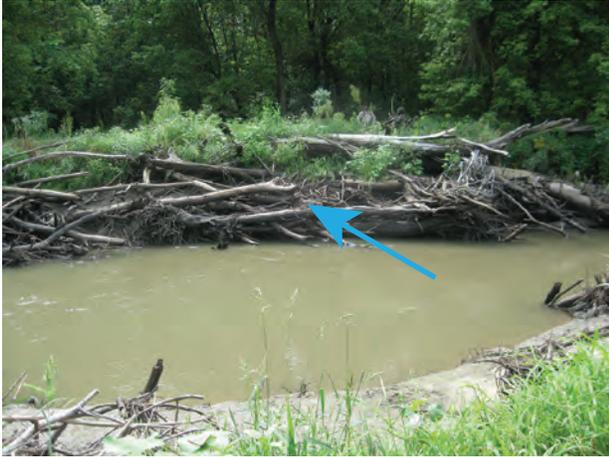
Year 1, 2010, "As much material as possible was incorporated into the bank. The excess, which was mostly the larger and heavier material, was placed on top. Stable bank material locked in place." (10 bankfull streamflows in 2010 water year, 10 cumulative).

Figure 12. Photographs and field notes documenting the status of redistributed large woody debris in the Locust Creek 2008 treatment reach during 2010–13.

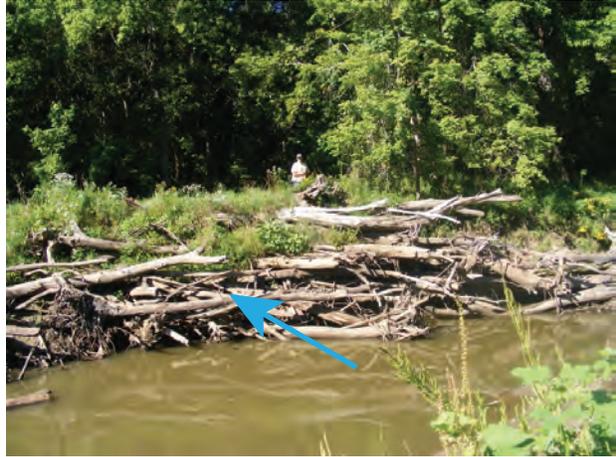
Year 2, 2011, "Sediment in and around the large woody debris is eroding, but the material is still stable." (2 bankfull streamflows in 2011 water year, 12 cumulative).

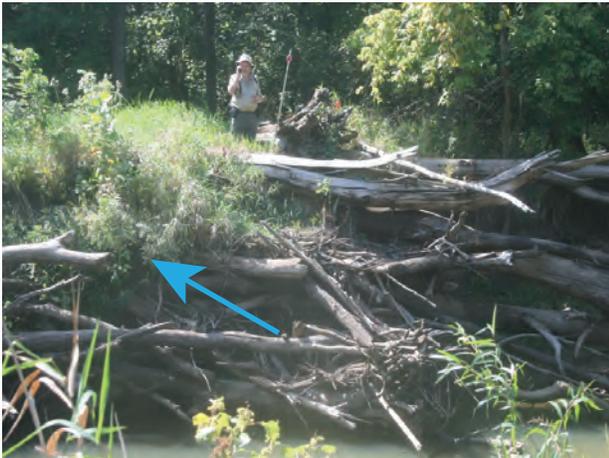
Year 3, 2012, "Lost 1 foot of bank material at top of bank. Large woody debris still in place." (0 bankfull streamflows in 2012 water year, 12 cumulative).

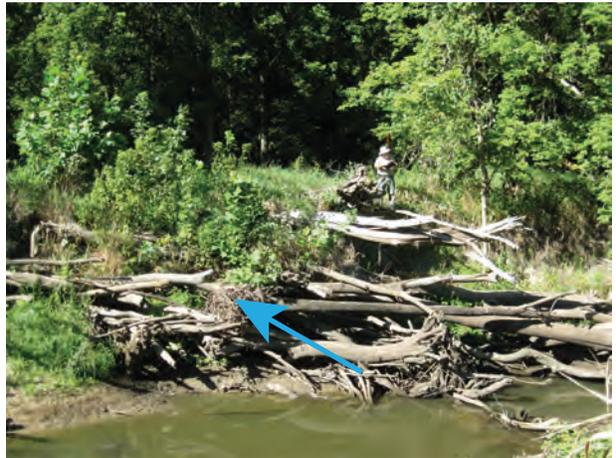
Year 4, 2013, "No change, bank and large woody debris stable. Substantial woody vegetation established on large woody debris." (5 bankfull streamflows in 2013 water year, 17 cumulative).

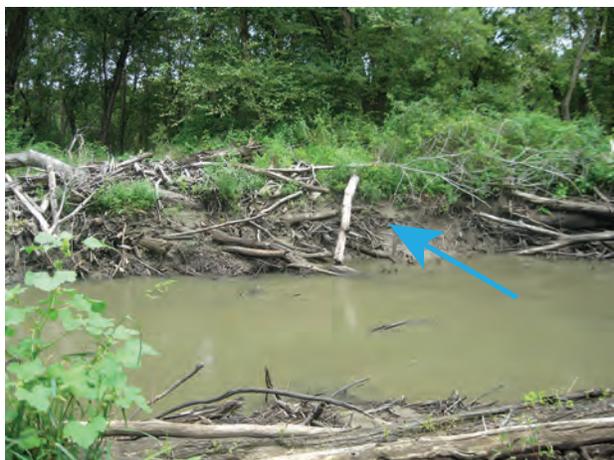
Year 1, 2010, "Left descending bank, material pulled to this side." (10 estimated bankfull streamflows in 2010 water year, 10 cumulative).

Figure 13. Photographs and field notes documenting the status of redistributed large woody debris in the Locust Creek 2009 treatment reach during 2010–13.

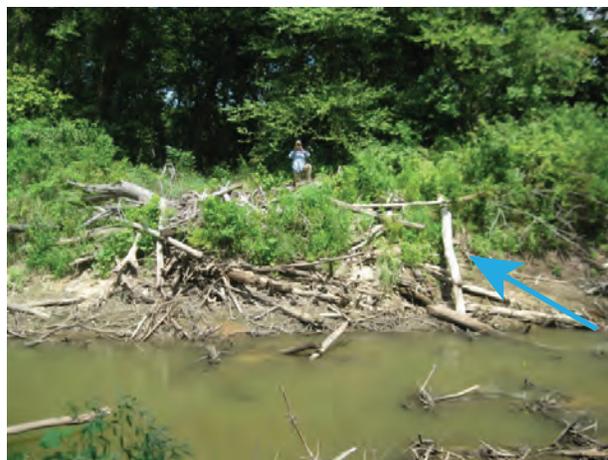
Year 2, 2011, "No change noted at this location. Woody material has not moved." (2 estimated bankfull streamflows in 2011 water year, 12 cumulative).

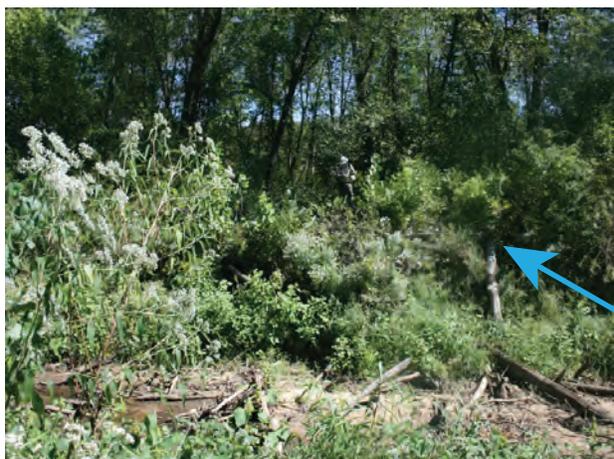
Year 3, 2012, "No changes to bank, sediment at toe/low water, vegetation growth." (0 estimated bankfull streamflows in 2012 water year, 12 cumulative).

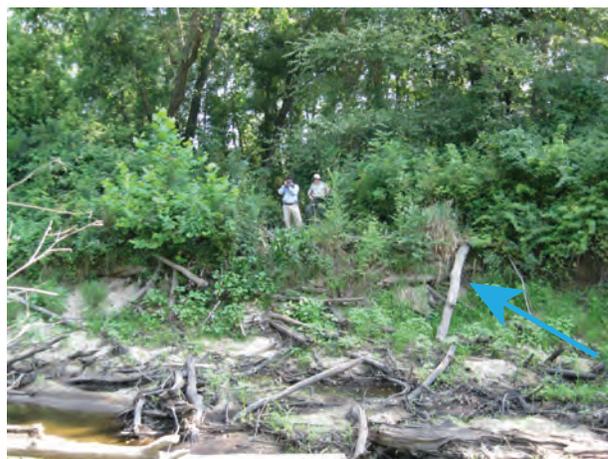
Year 4, 2013, "No changes noted." (5 estimated bankfull streamflows in 2013 water year, 17 cumulative).
