# Streambed Scour Evaluations and Conditions at Selected Bridge Sites in Alaska, 2013–15

Scientific Investigations Report 2017–5149

By Robin A. Beebee, Karenth L. Dworsky, and Schyler J. Knopp

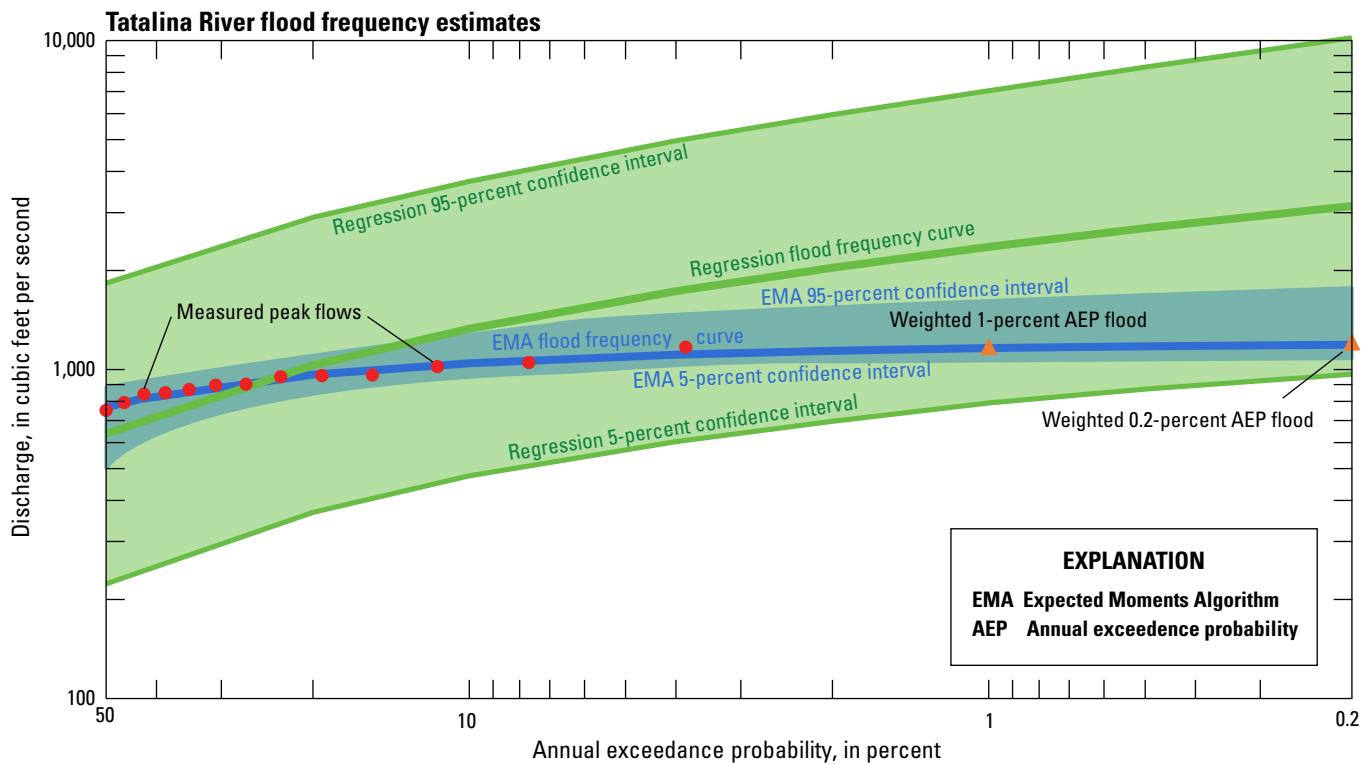
**Figure 9.** Flood frequency curves used to calculate the weighted 1- and 0.2-percent annual exceedance probability floods, with 5- and 95-percent confidence intervals for each analysis and measured peak flows at Tatalina River near Takotna, Alaska.

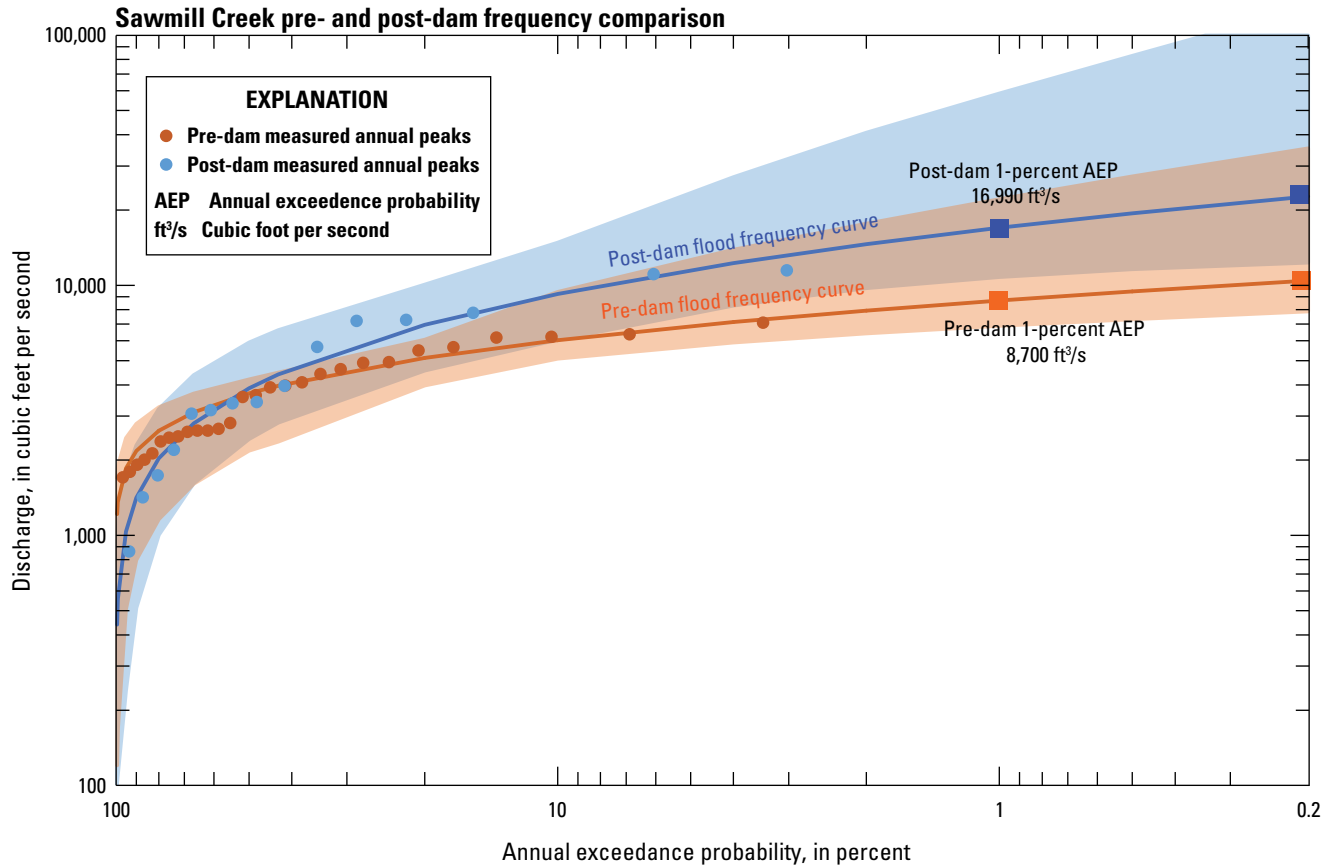
**Figure 11.** Flood frequency curves for the pre- and post-dam periods at Sawmill Creek near Sitka, Alaska.

Sawmill Creek below Blue Lake Dam is a more complicated case. The Blue Lake Hydroelectric Dam was built between 1958 and 1961, and was expanded in 2012. Blue Lake spills annually during high-flow periods. Stream gaging records from 1921 to 1957, before the dam was built, show a different flood regime than those after the dam was built. The highest measured pre-dam flood was 7,100 ft<sup>3</sup>/s. The highest measured post-dam flood was 11,500 ft<sup>3</sup>/s in 2005. Two floods estimated to be 12,000 ft<sup>3</sup>/s in 1972 and 1993 are reported in Federal Energy Regulatory Commission (FERC) licensing documents (City and Borough of Sitka Electric Department, 2010). An EMA analysis for the pre- and post-dam periods show significantly different results ([fig. 11](#)). The 1-percent AEP flood varies from 8,700 ft<sup>3</sup>/s using pre-dam peak flows to 16,990 ft<sup>3</sup>/s using post-dam peak flows. However, the maximum spillway capacity at Blue Lake Dam is 14,000 ft<sup>3</sup>/s and the FERC licensing documents suggest that the dam is operated in order to regulate spill during floods (City and Borough of Sitka Electric Department, 2010). The 1- and 0.2-percent AEP floods used in this analysis consist of the 14,000 ft<sup>3</sup>/s maximum spillway flood added to the maximum powerhouse output of 520 ft<sup>3</sup>/s, and the respective regression-analysis-derived flood numbers for the drainage basin below Blue Lake.

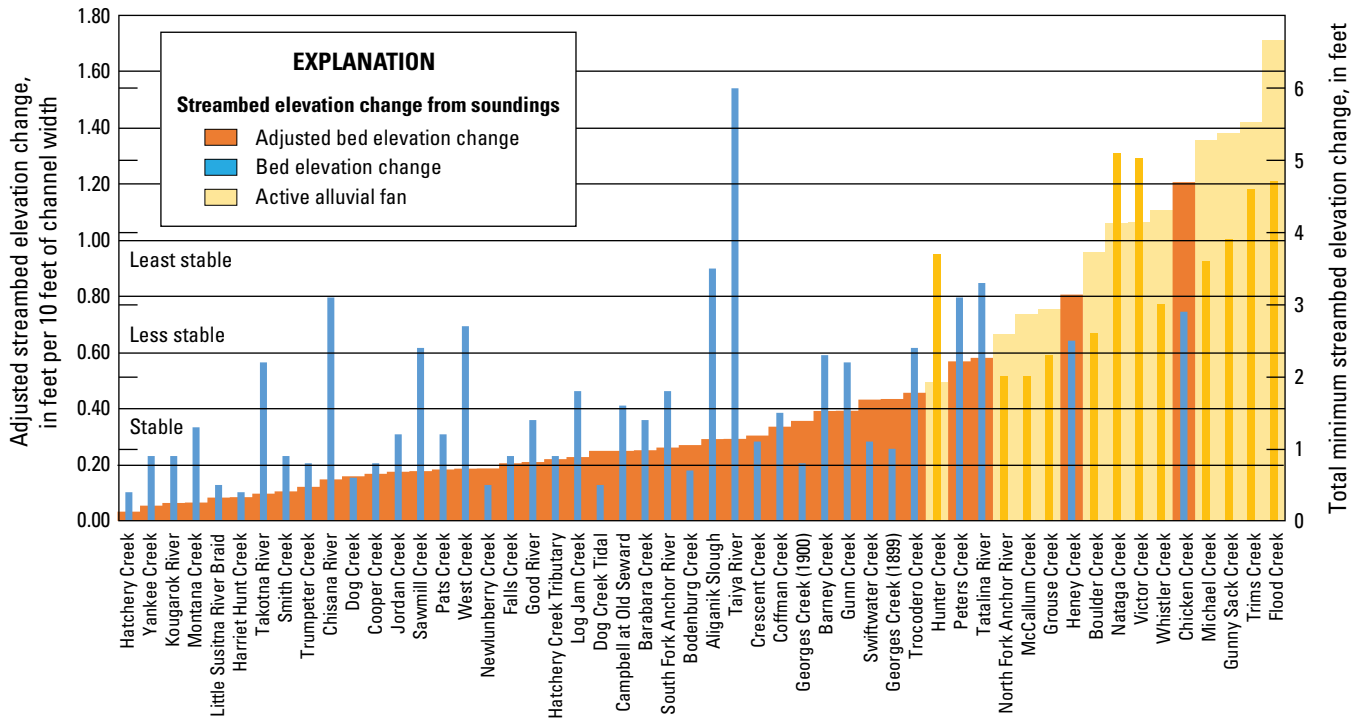
**Figure 12.** Sounding-based stream stability at 52 river- and stream-spanning bridges in Alaska.

Soundings did not show definitive signs of either long-term aggradation or degradation at any study sites, although evidence for degradation at Victor Creek is presented in section, “[Unstable Sites—Victor Creek Bridge 607](#).” The average change in minimum bed elevation between successive soundings was less than or equal to 0.5 ft at all sites. Most sites had 0.1 ft or less cumulative change. However, numerous sites on alluvial fans showed evidence of dredging, which typically is done to combat aggradation and would prevent aggradation from appearing in the sounding record.

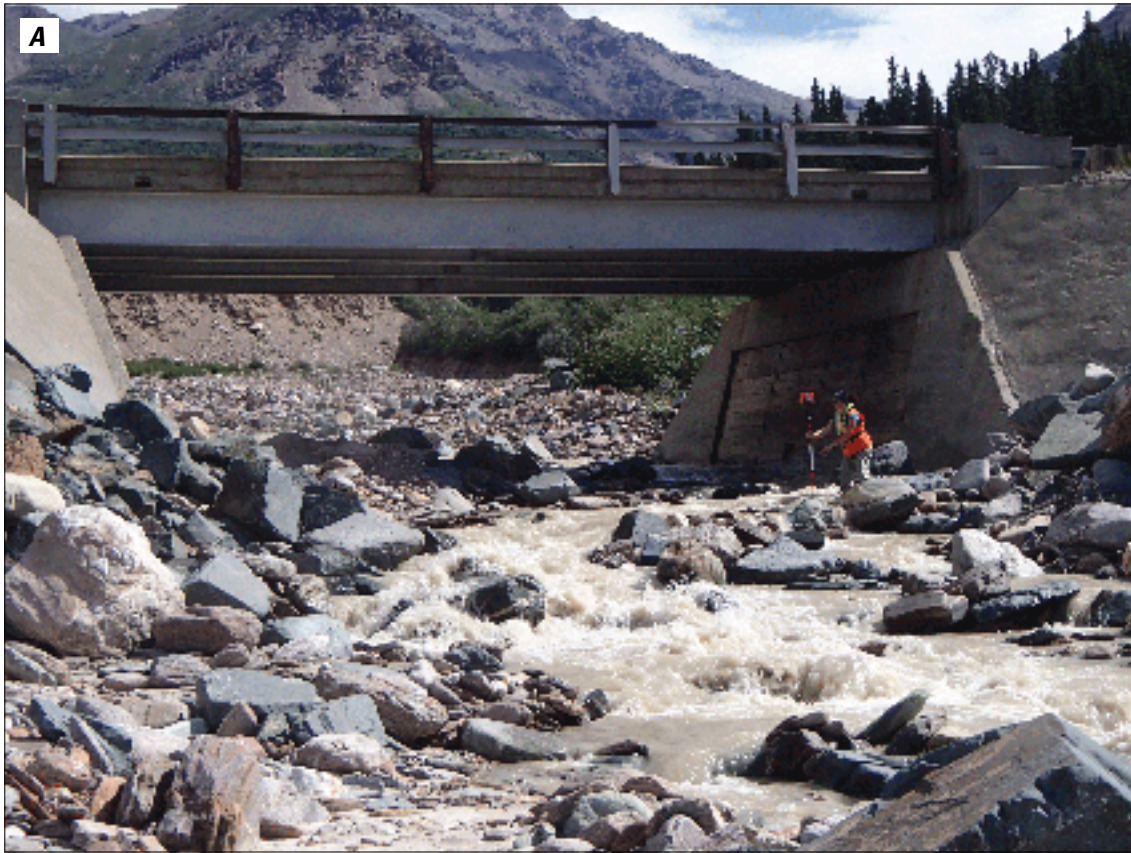
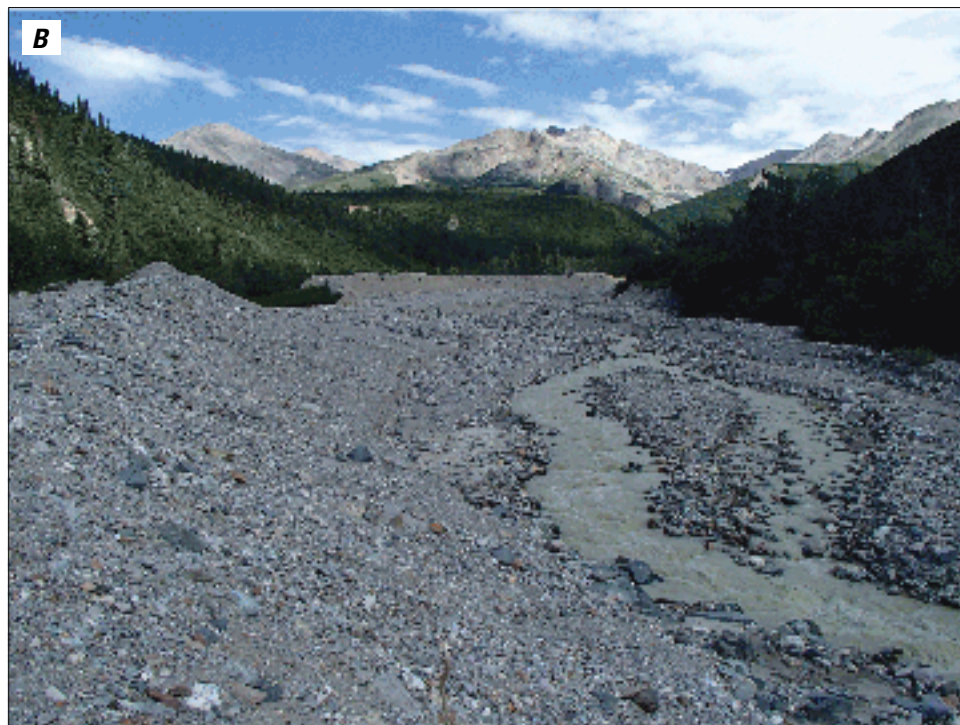
**Figure 13.** “Less stable” alluvial fans at (A) Gunny Sack Creek Bridge 590 and (B) Whistler Creek upstream of Bridge 587, Alaska.

The Richardson Highway crosses these fans near the upper or middle part of the depositional area. The Trans-Alaska Pipeline crosses underneath each stream about 500 ft downstream of the highway. All these channels are geomorphically unstable, and instability is reflected in the sounding record for all but McCallum Creek. All these streams are relatively steep and high velocity, and are composed of cobble and boulder beds (fig. 13). Boulder weirs are used to prevent trenching at the pipeline crossing, and guidebanks or simple berms are used to stabilize channels at the bridge. The risk of catastrophic contraction or abutment scour at these sites is minimized by high sedimentation rates, grade control downstream, and armoring in the bridge channel. The most common problems are fill loss around the abutment wingwalls, which are steep and subject to high velocities and contraction-related flow separation during floods. Aggradation during a flood also could lead to overtopping of the road approaches and more rapid abutment loss.
